ROADS TO HEAVEN, TO HELL, AND BACK, SOMEWHAT

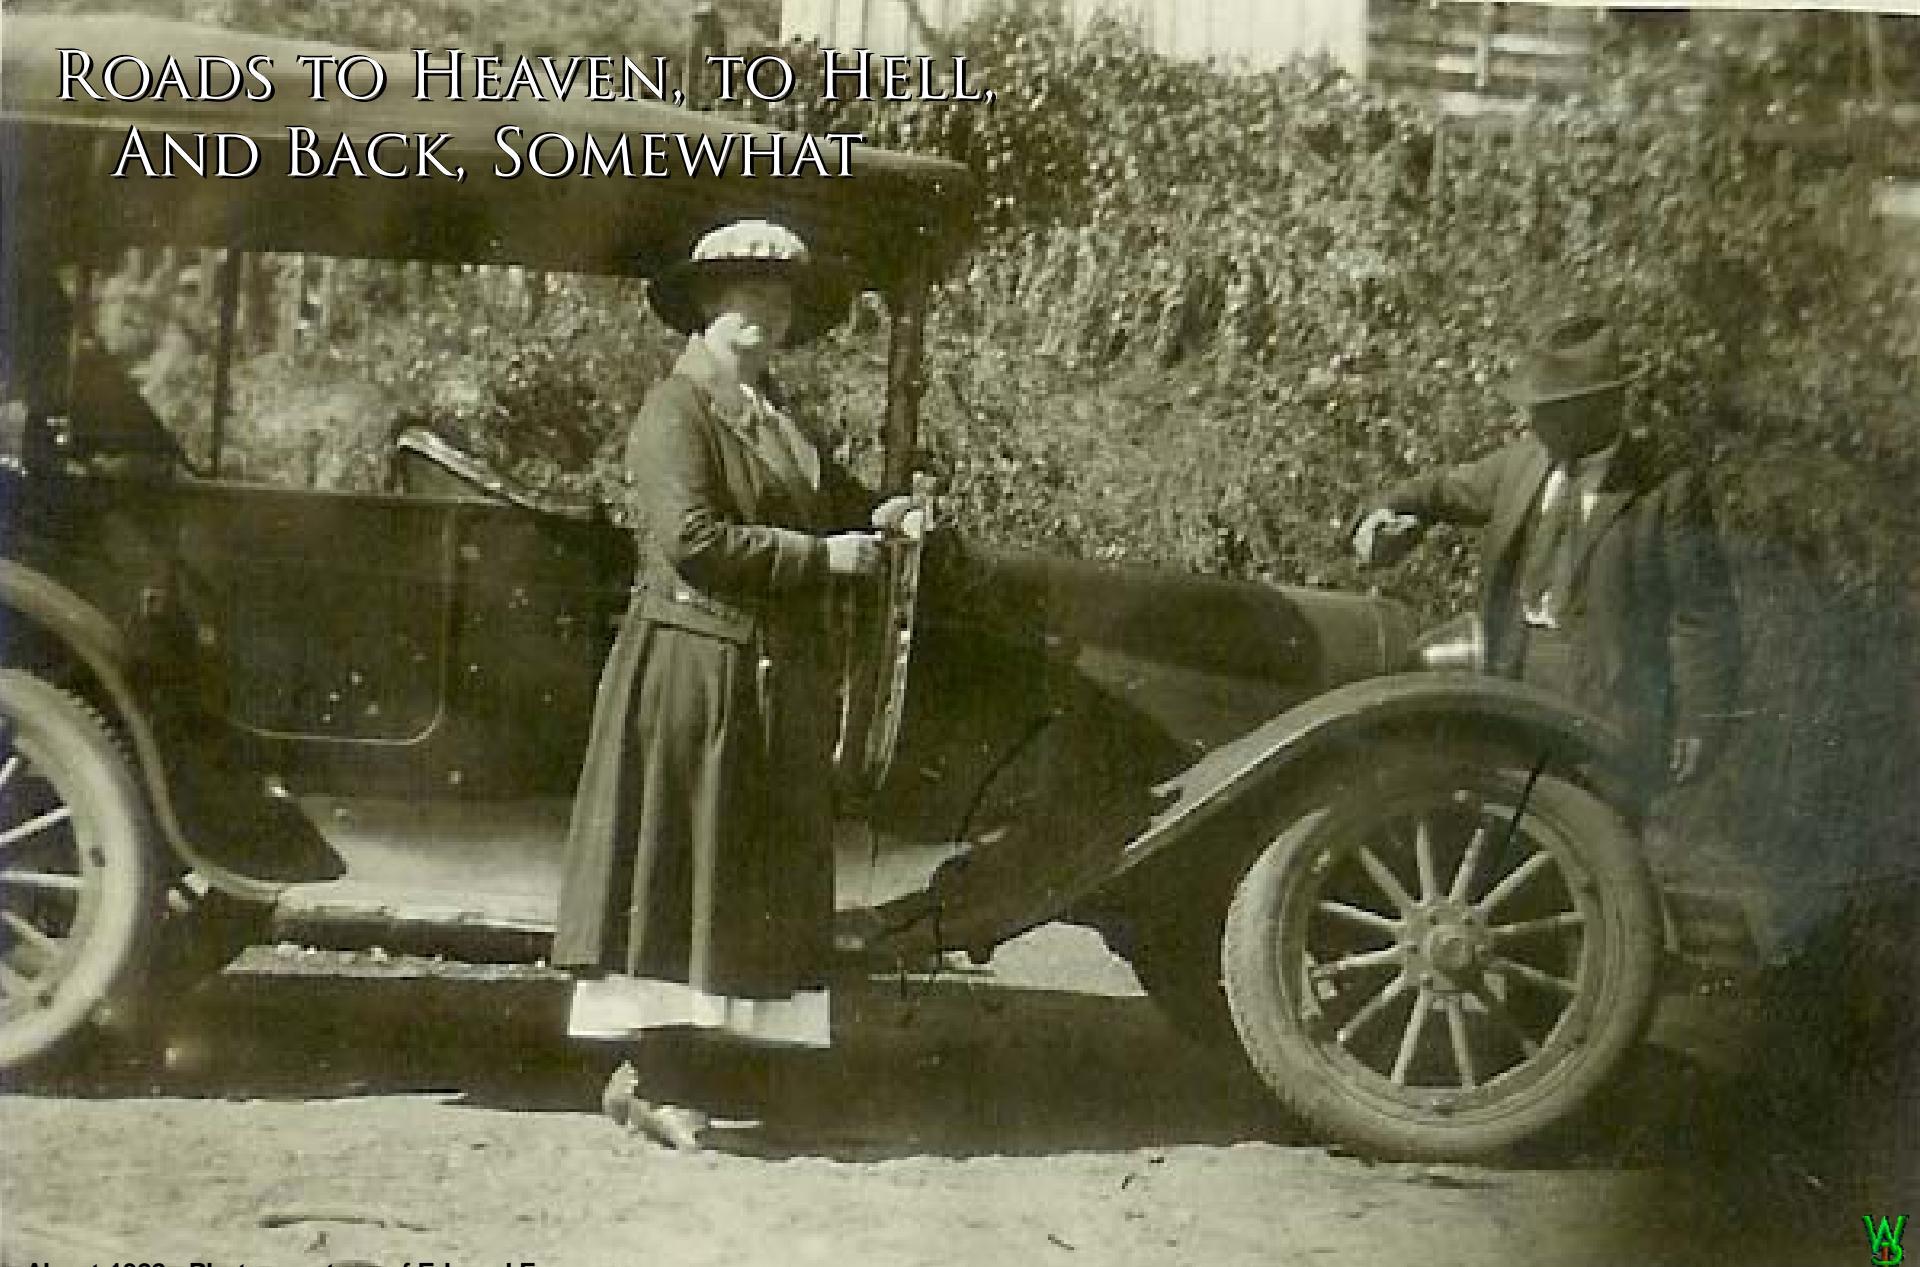
About 1922 - Photo courtesy of Edward Fenn

This is Ed Fenn's road in front of his house near Glenwood, CA (note the *Vinca major* on the bank behind the car). Back then, typical road construction was with dynamite, shovels, and very crude grading blades. Slopes receiving the fill were not cleaned or benched and the fills were not compacted. What few culverts were installed were wood. In the winter, the surface was mud.

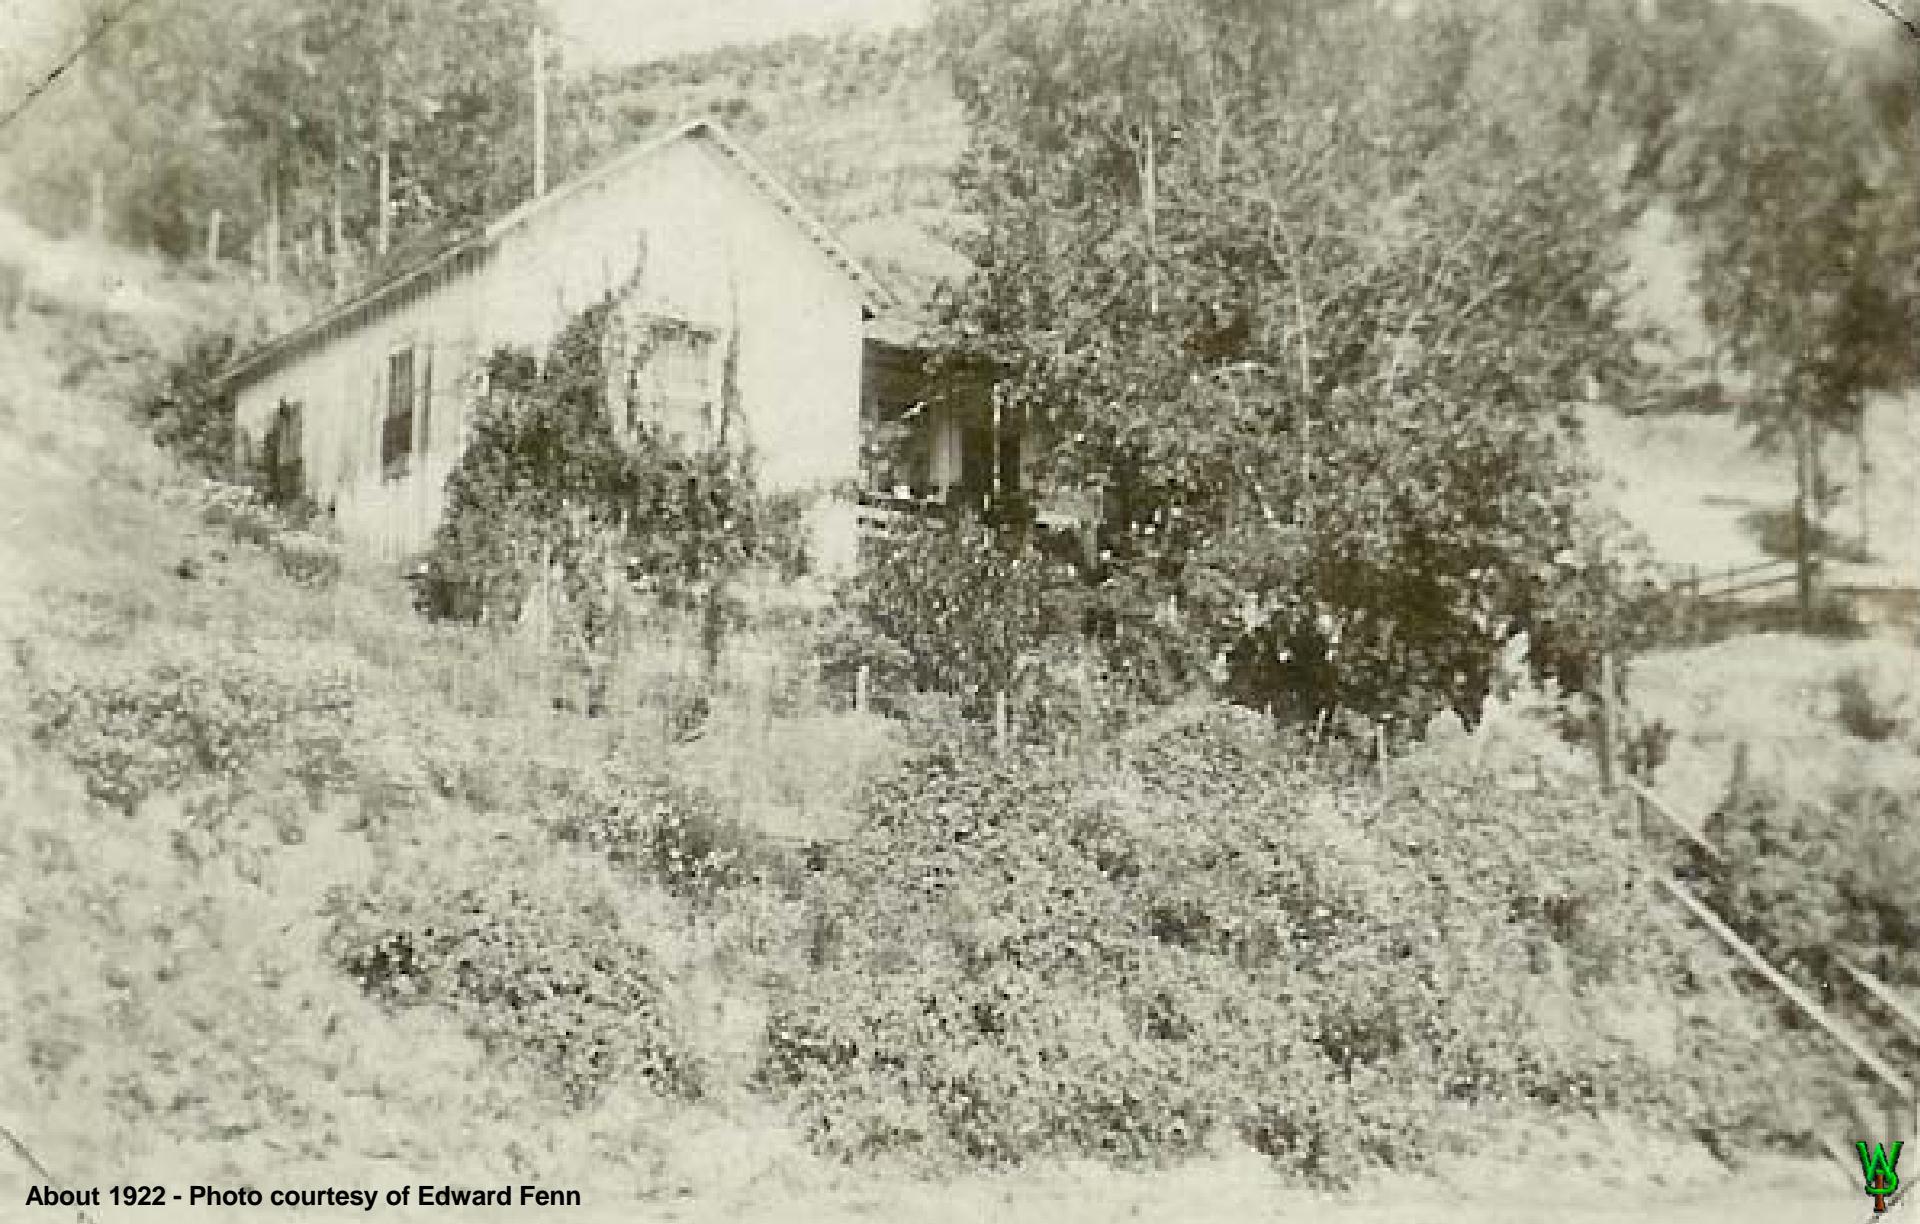
About 1922 - Photo courtesy of Edward Fenn

The watershed area behind the house was considerable, but the runoff no longer came down this draw to the right of the house because the road collected it from the slopes above, conducted it to the left behind the house, hit a switchback, and came back in front of the house to the right. In the background are a few eucalyptus that were planted here, possibly to stabilize the original channel.

The orchard is behind on the top of the hill. Today, the eucalyptus is a forest 150' tall with 4' trunks, while the hilltop is a long abandoned Christmas tree farm, with pines over 100' tall. There is currently no way to get a useful repeat photo.

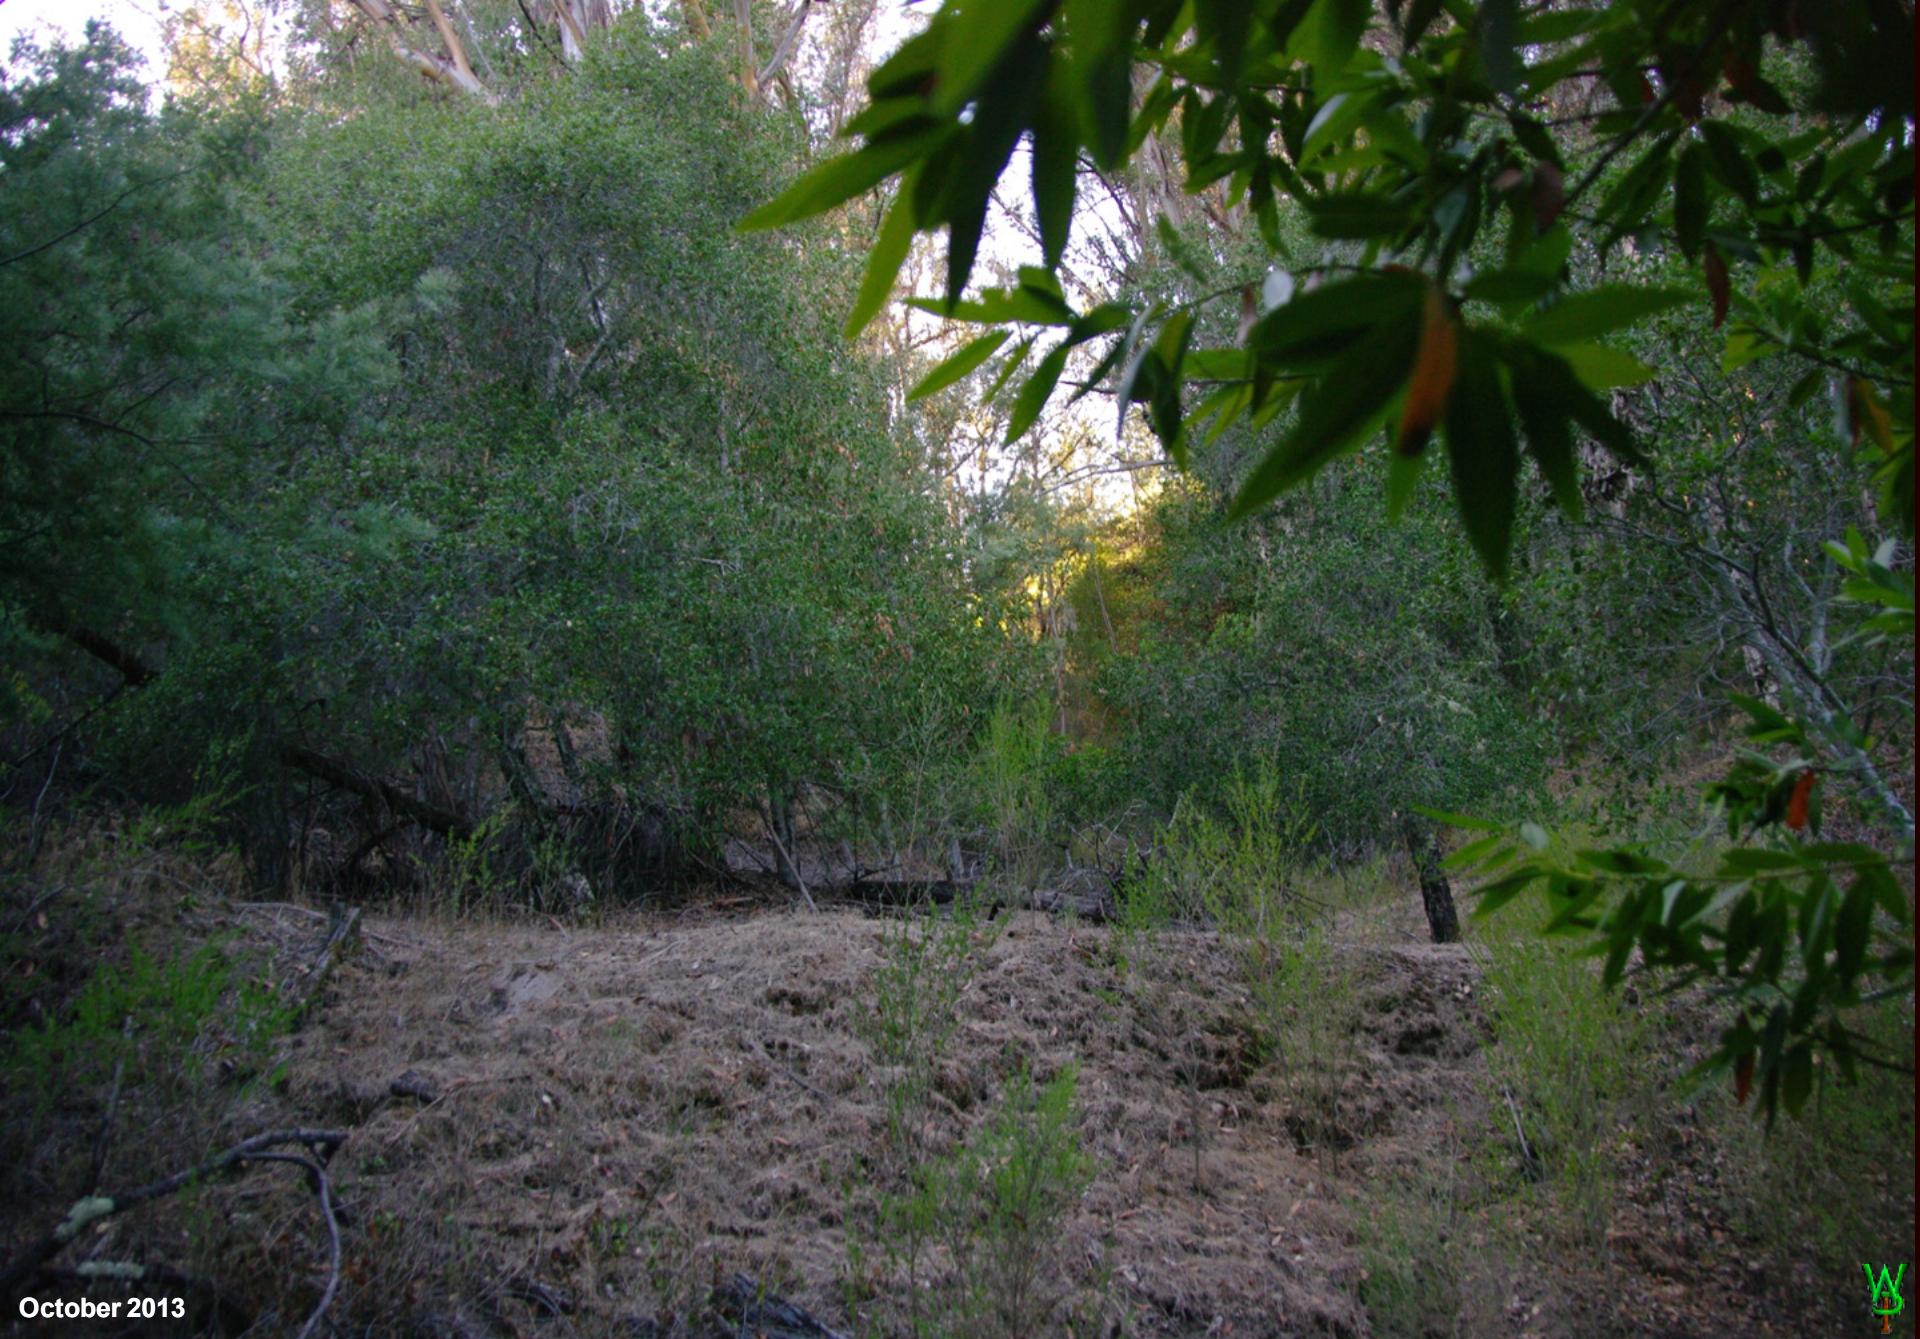
October 2013

But I tried anyway. Yep, there is no doubt that this is it. I found the old root cellar dug into the hill that Ed Fenn told me would be behind where the house had once been. The redwood "sleepers" that once formed the house foundation are still there.

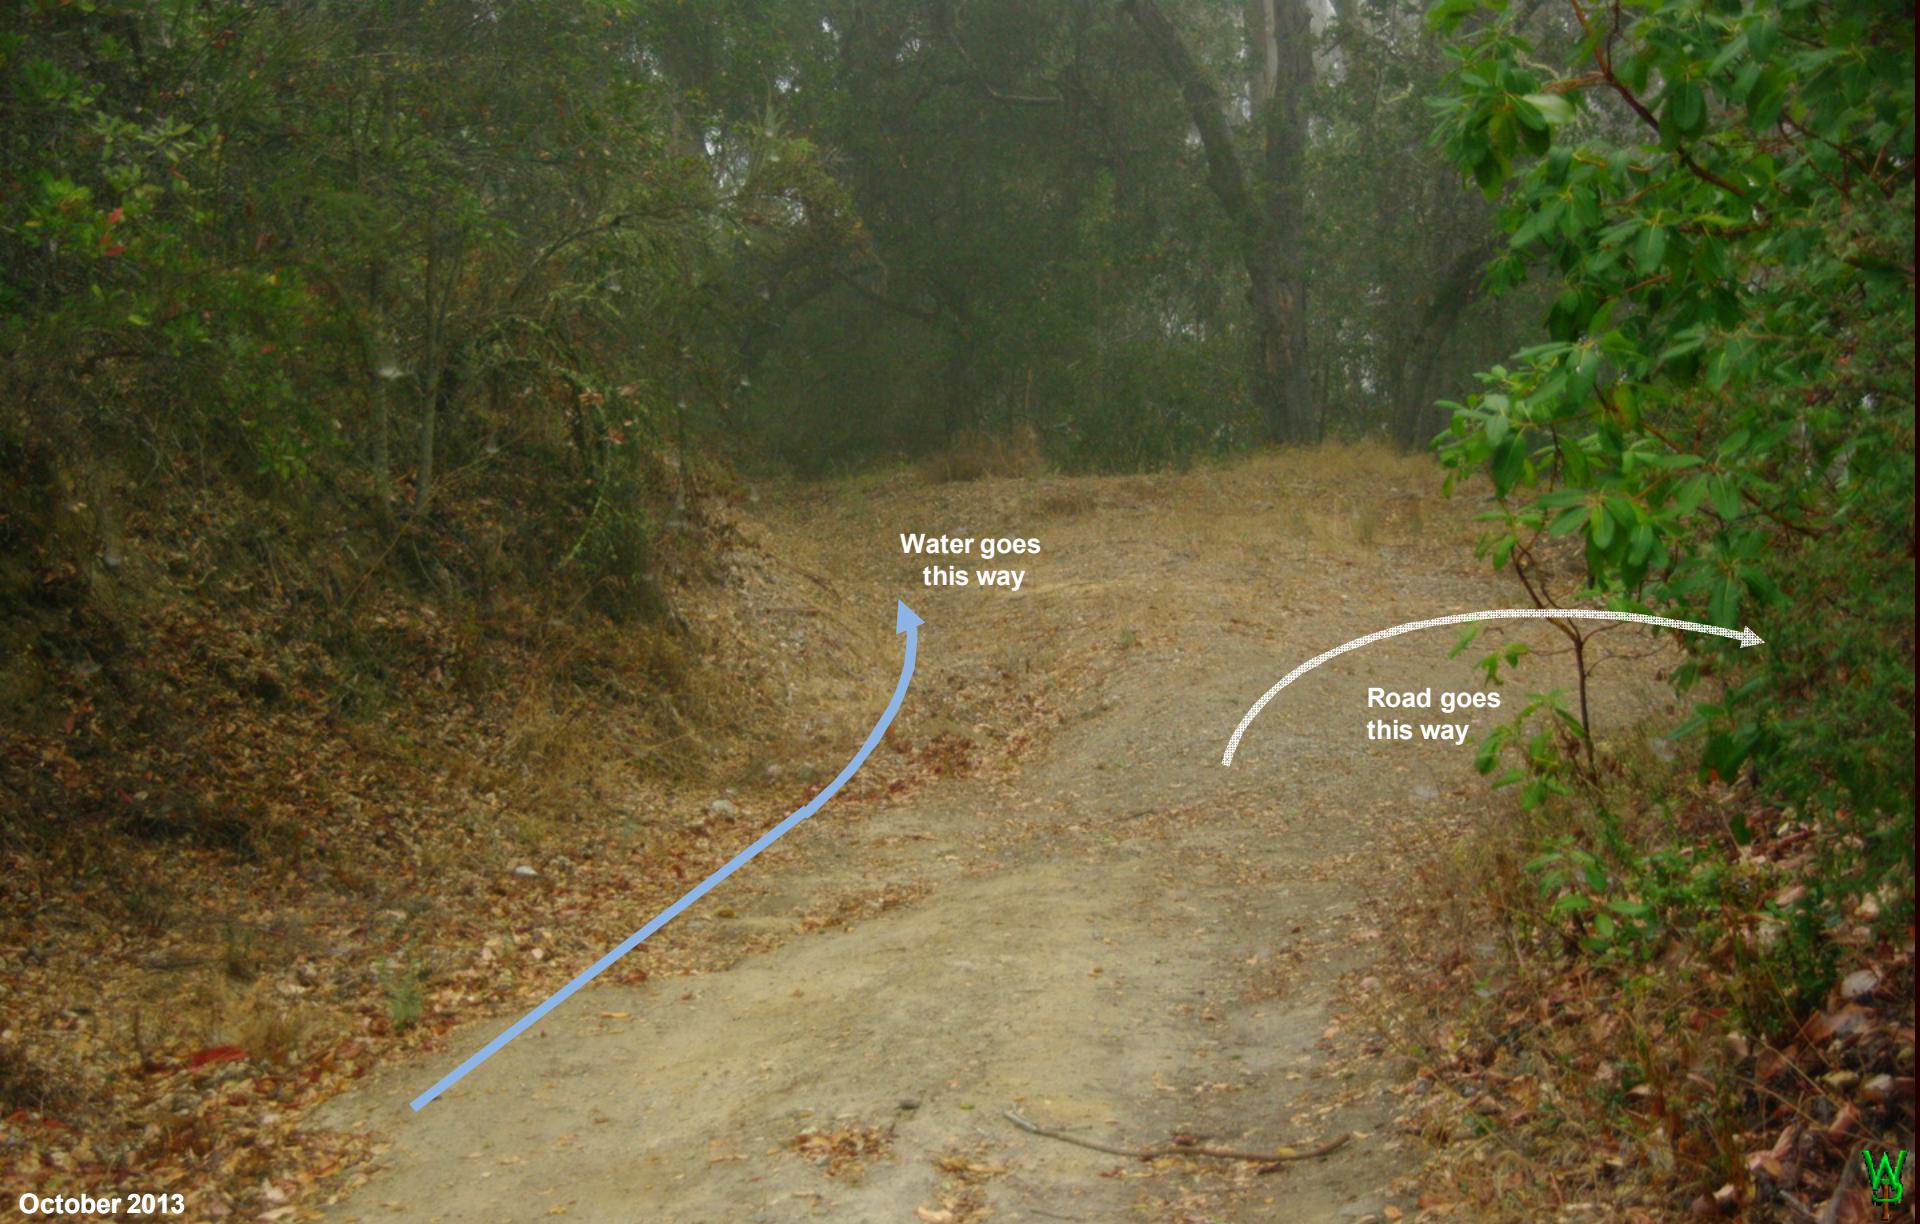
October 2013

To reduce erosion on the road I had to reduce the flow of water onto it at the entrance and then distribute the rest. The first step was to divert what was coming off the County road into the eucalyptus stand. This entails a requirement for sufficient capacity to take all the water coming down the County road for nearly a quarter mile in the event that but a single County culvert plugs (it's happened). That collection area is 5-6 acres because so many landowners along that stretch dump their water onto the County road... because it is a commons. It was already coming down this road entry so I simply made the best of things. I need to clean it out too.

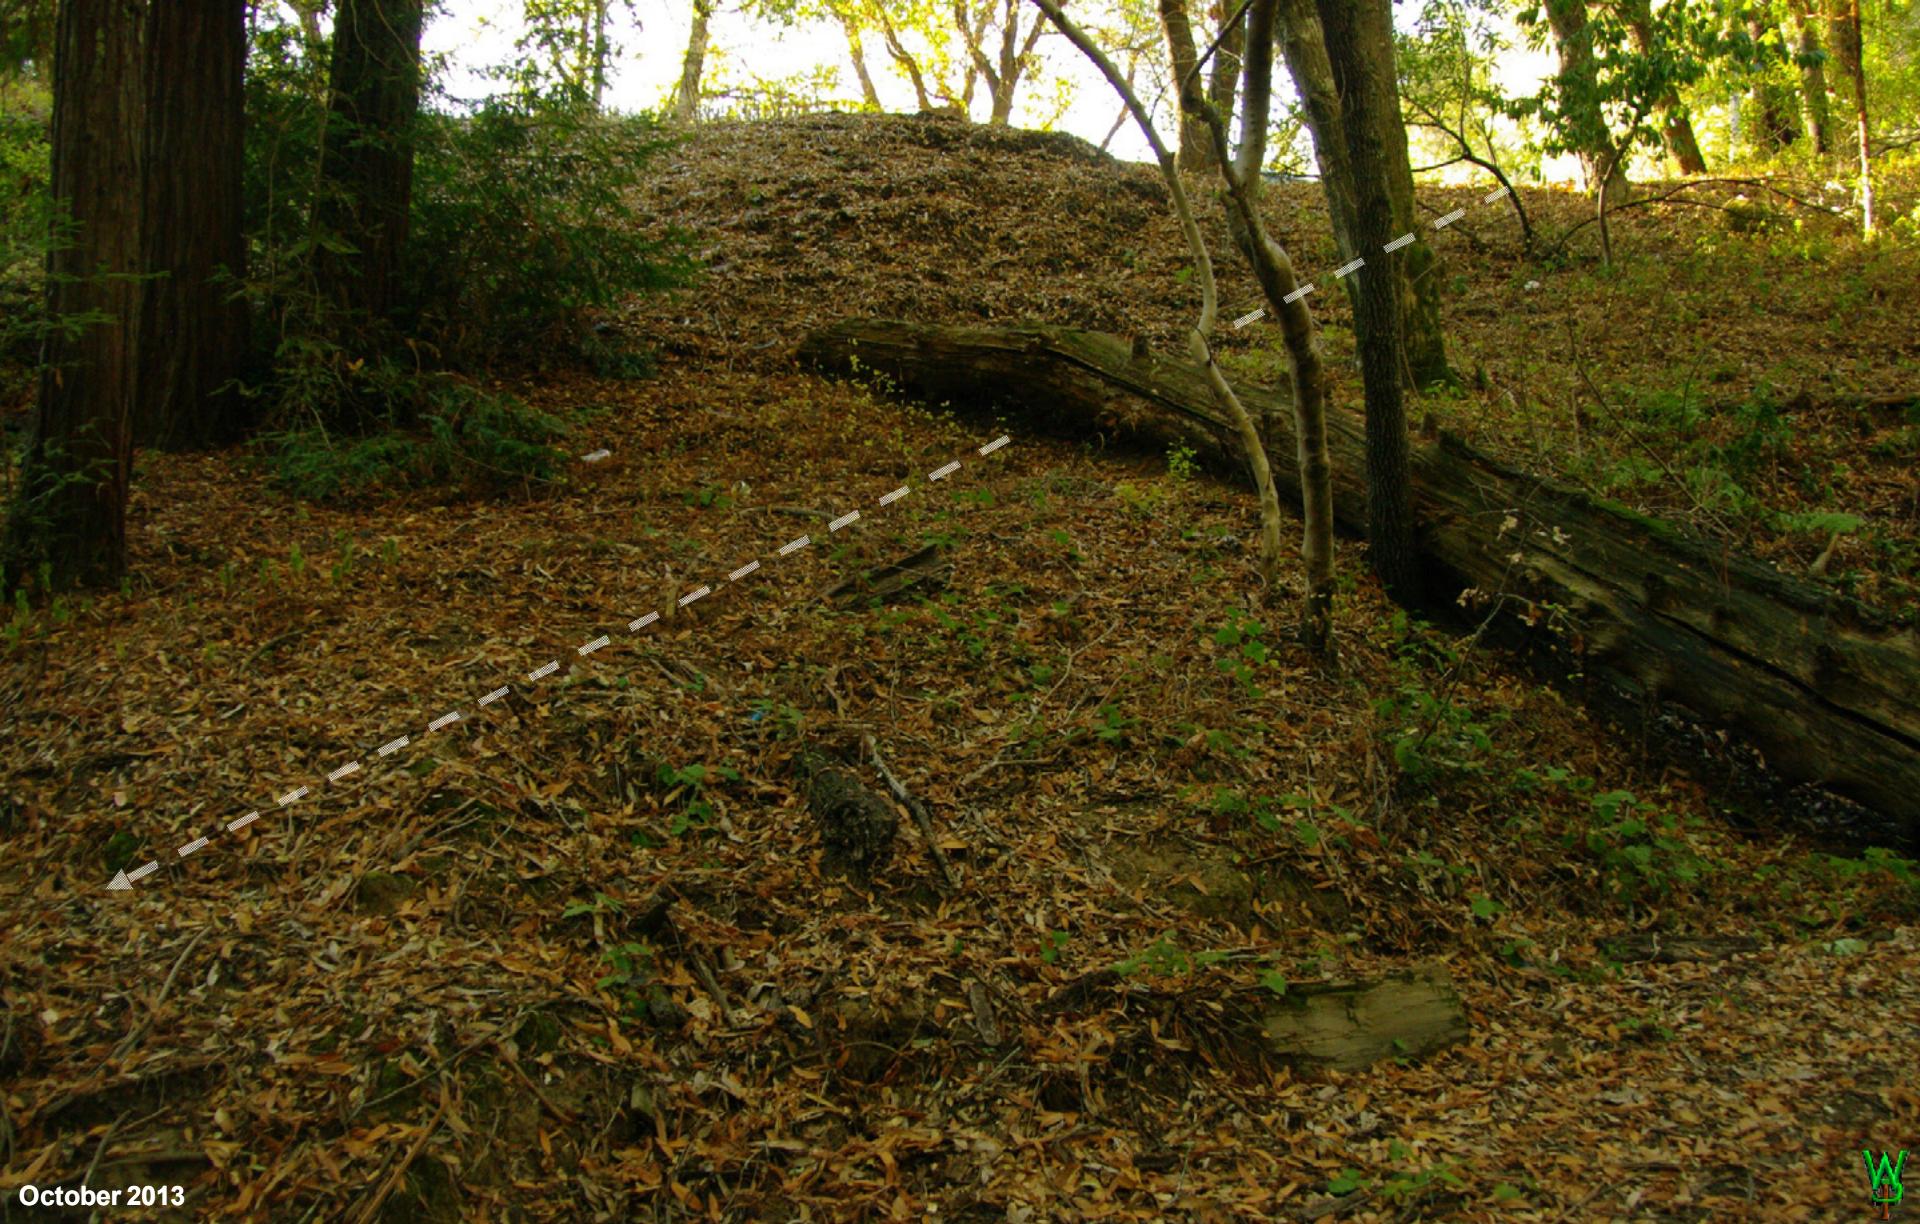
October 2013

Then I filled in this long abandoned road segment (arrow) where the water originally entered Fenn's road. This was a Type II case turned into a useless gully. So, I retired it in 2003 by having the County fill it with ditch cleanings and then I graded it out. This kind of thing takes a lot of fill, 6-8 dump trucks worth. The County lawyers no longer allow them to do this because somebody sued them for fill contaminated with wood (this despite the recipient having signed a release agreeing to take it as is). Now they have to truck the fill some 20 miles to a landfill and I have a harder time getting fill with which to fix old problems.

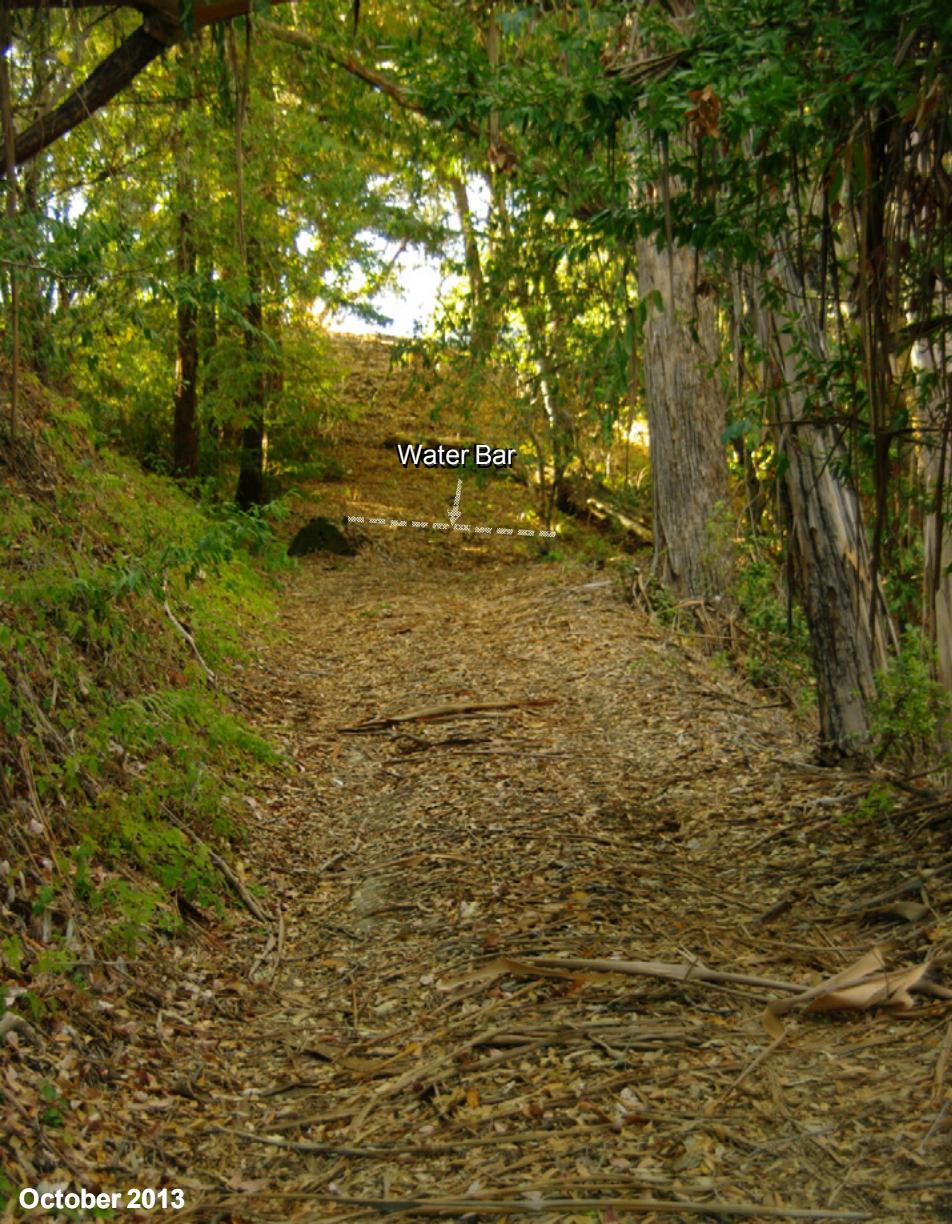
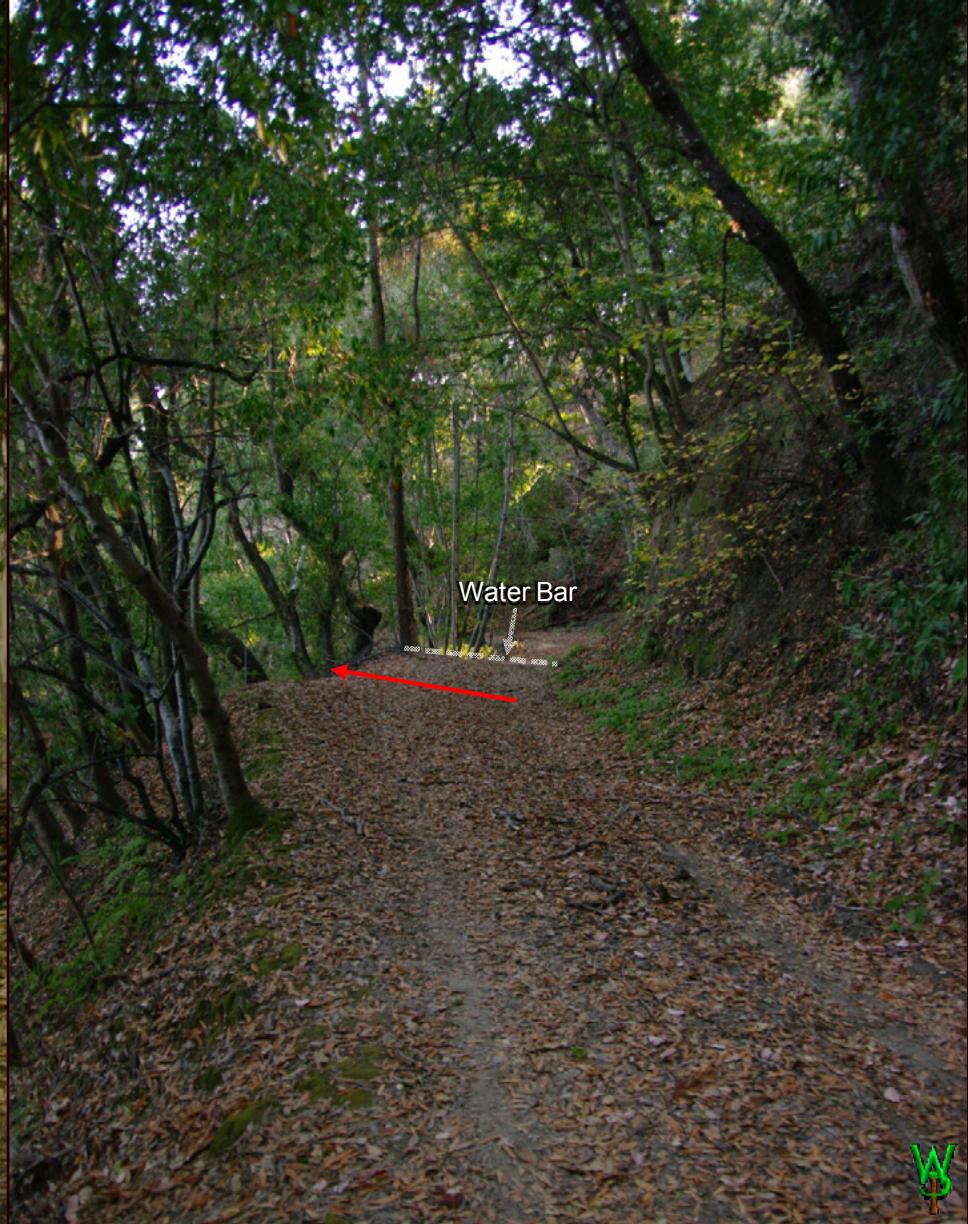
October 2013

We installed and maintain 2 concrete culverts (concrete burns less easily) with water-bars behind them in case they plug before I get to them (the culvert at left is behind the water bar). I also had other out-sloped water-bars made at outside corners to shed the water (right). These drainage improvements are separated by less than 100 feet. As long as the culverts are maintained, and we install a gate to keep idiot joy-riders from tearing up the water bars in the winter, this is stable. If and when I come up with more material, I can then reinforce the water bars and build more of an out-sloped configuration which will reduce these concentrated flows.

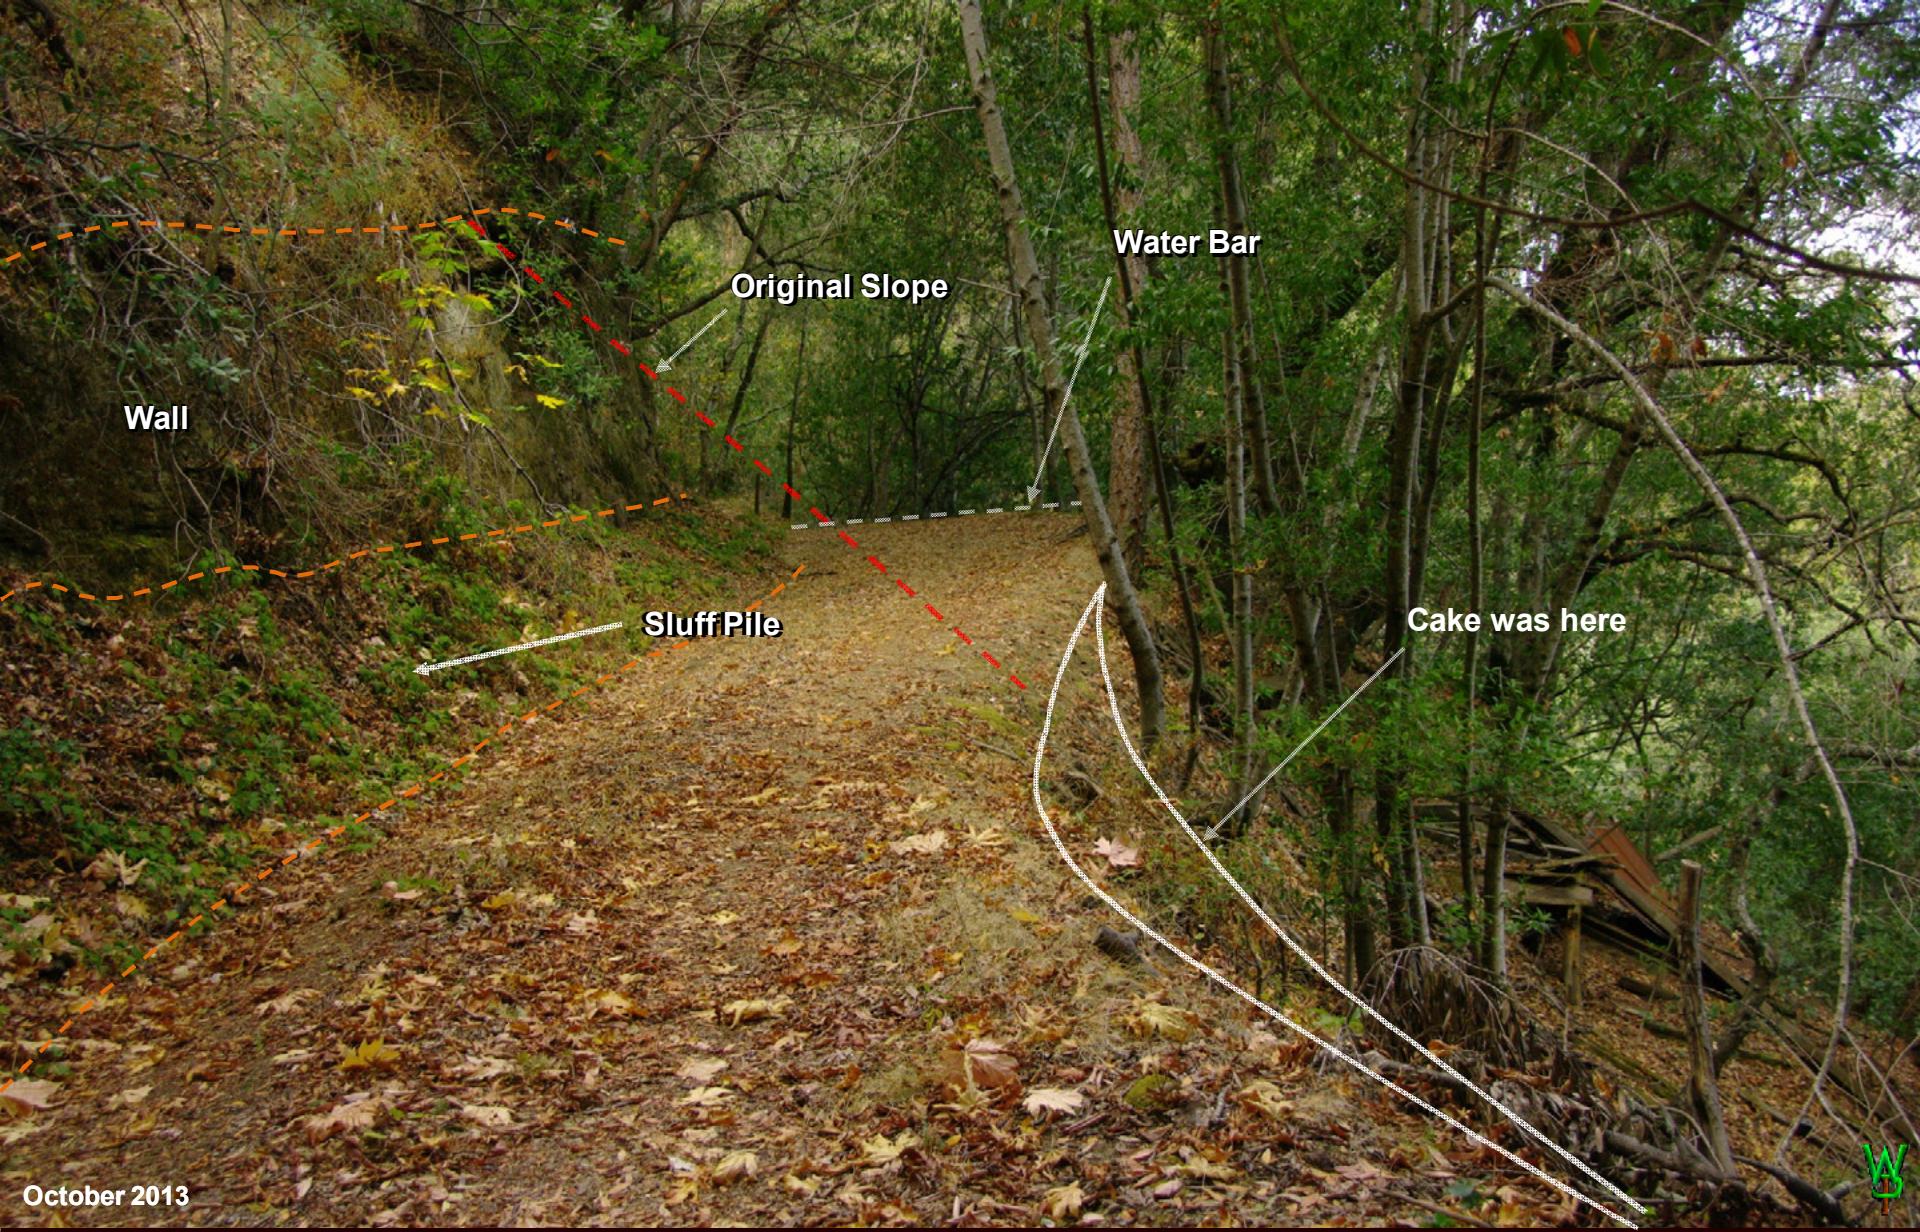
October 2013

Before I put in the water bar, the flow came this way. Here, this upper section of Fenn's road suffered a Type I failure: Runoff from above added to the flow that came down the in-sloped road from the entry until the combined flow ran to the outside, and just took the cake. All that is left of the road is cut rock. It will take a lot of fill to slope this outward, but as long as the water bars work, fill material will slowly accumulate as it has on the left. Over the years, I will dress what comes down as I can and deposit what fill I have available starting behind the water bar and working downward.

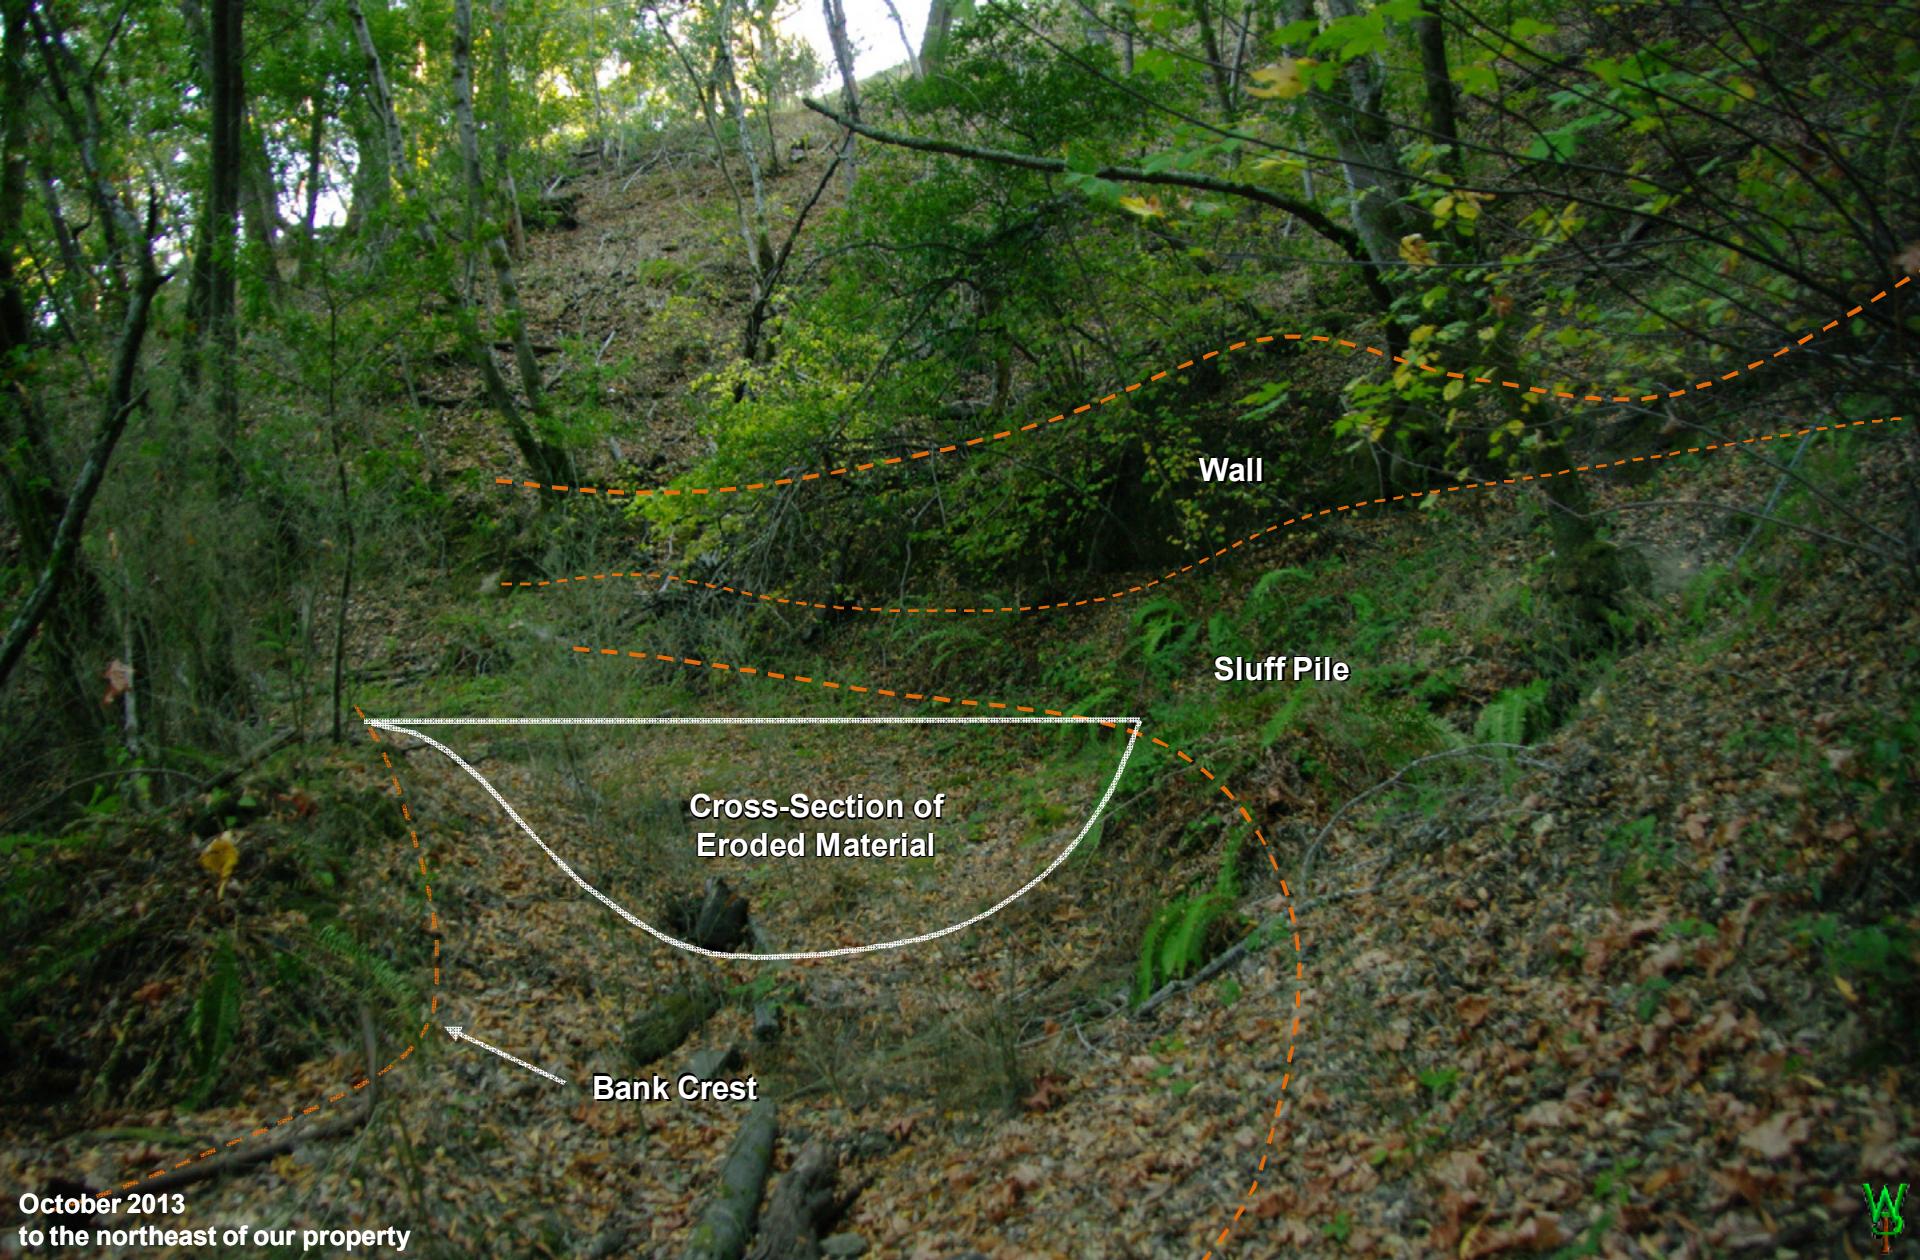
In the old days, if the surface got rough or the shoulder washed away, they just cut the road deeper into the hillside... and deeper, and deeper... This section of Fenn's road below said switchback,. This part of the road suffered a Type II failure: erosion down the middle. It left a bank down-slope on the left and the sluff against the inside wall of sandstone on the right. This is no longer cutting because of how we did the diversion. My estimate is that the loss of material is about four feet deep.

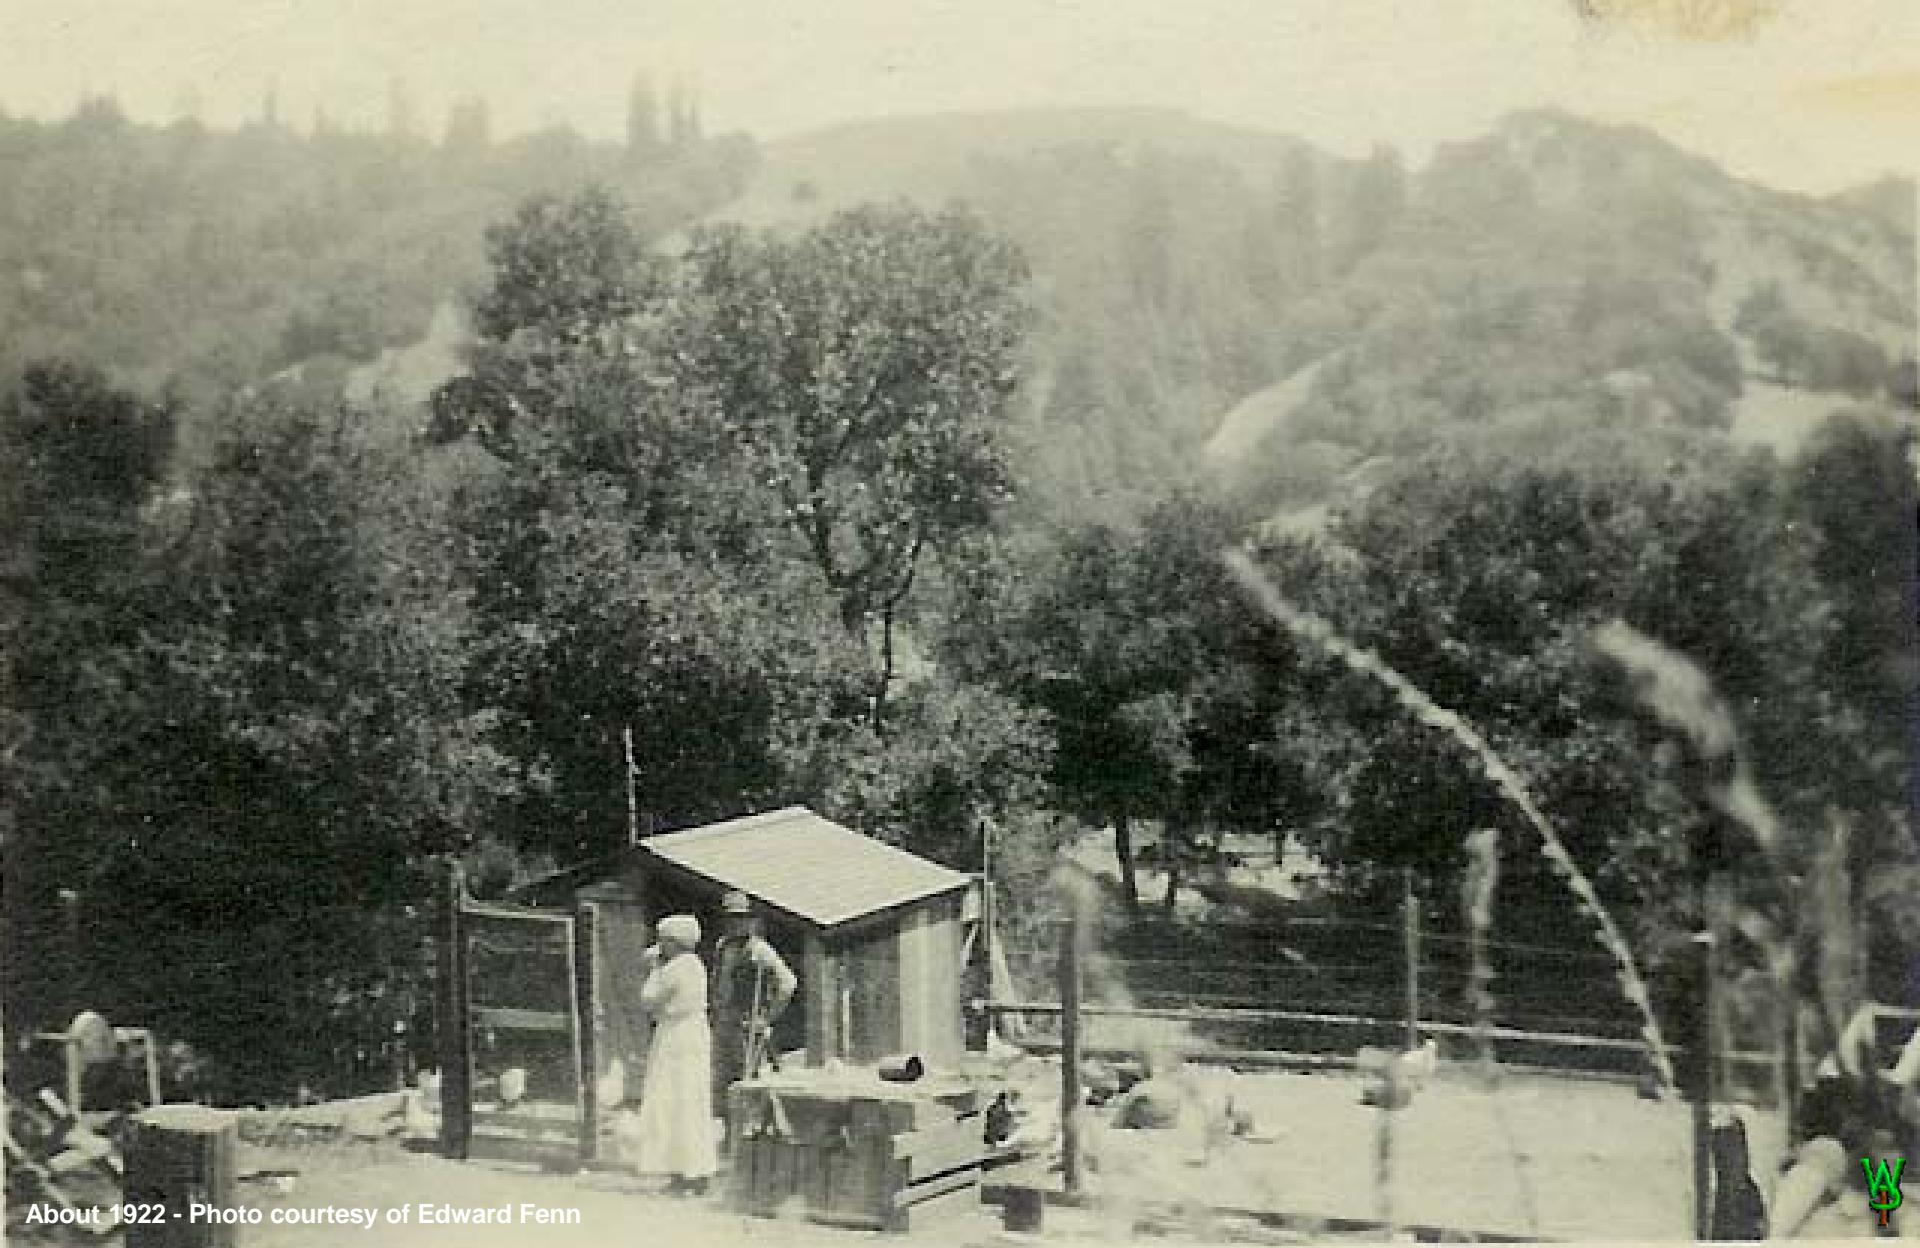
About 1922 - Photo courtesy of Edward Fenn

To the right of Ed Fenn's house in the last old photo was his chicken coop. Below it you can see the outside of his road to Glenwood. There was probably no outside shoulder; rutting probably started what you are soon to see.
