ROADS TO HEAVEN, TO HELL, AND BACK, SOMEWHAT

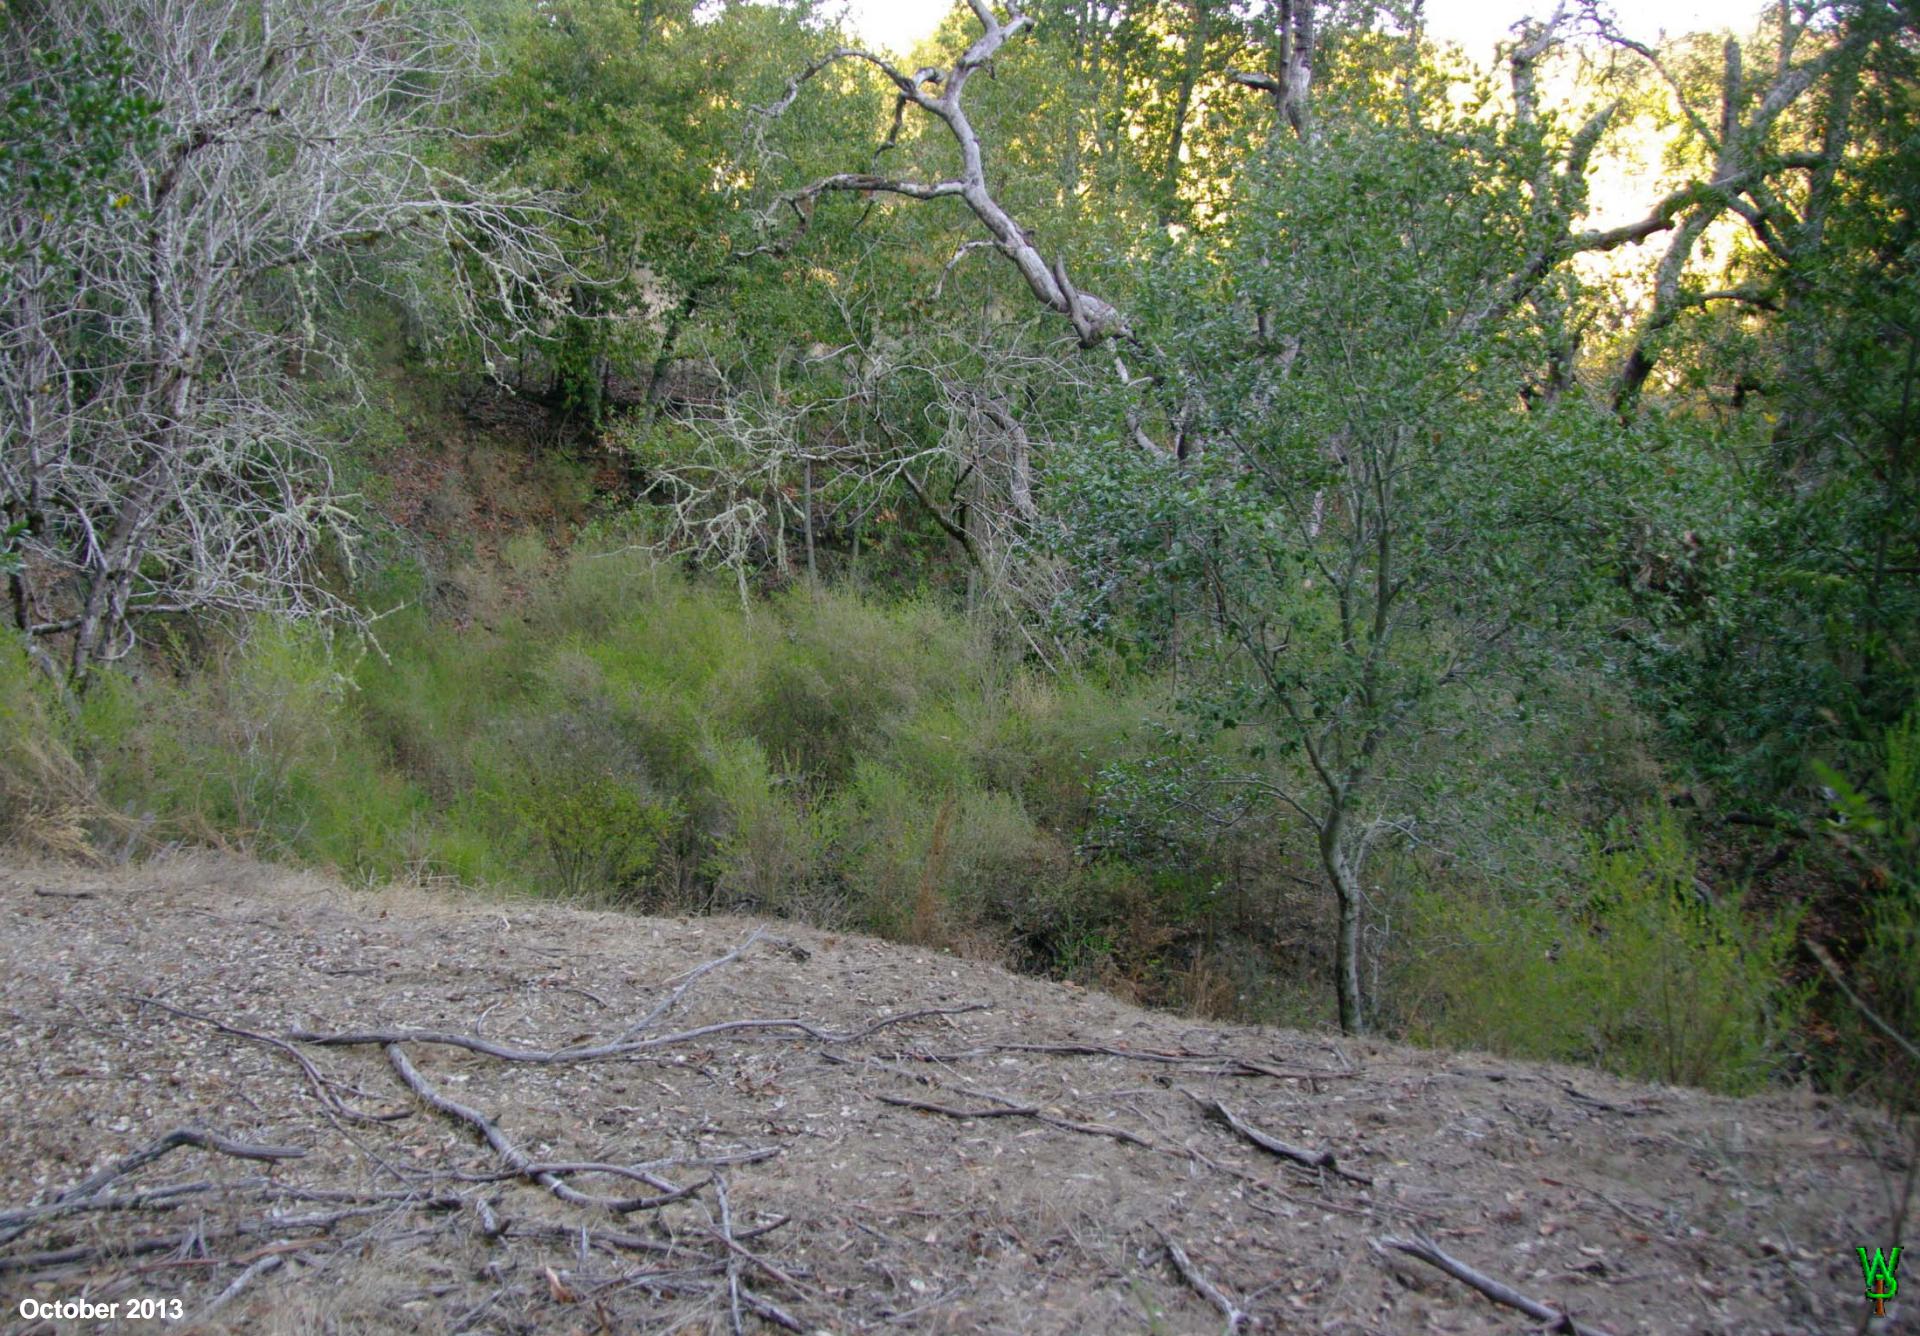
October 2013

This is a view of that same spot today from closer to the edge and without benefit of the height of the porch.
Obviously, it would be easier to see what happened without all that broom.

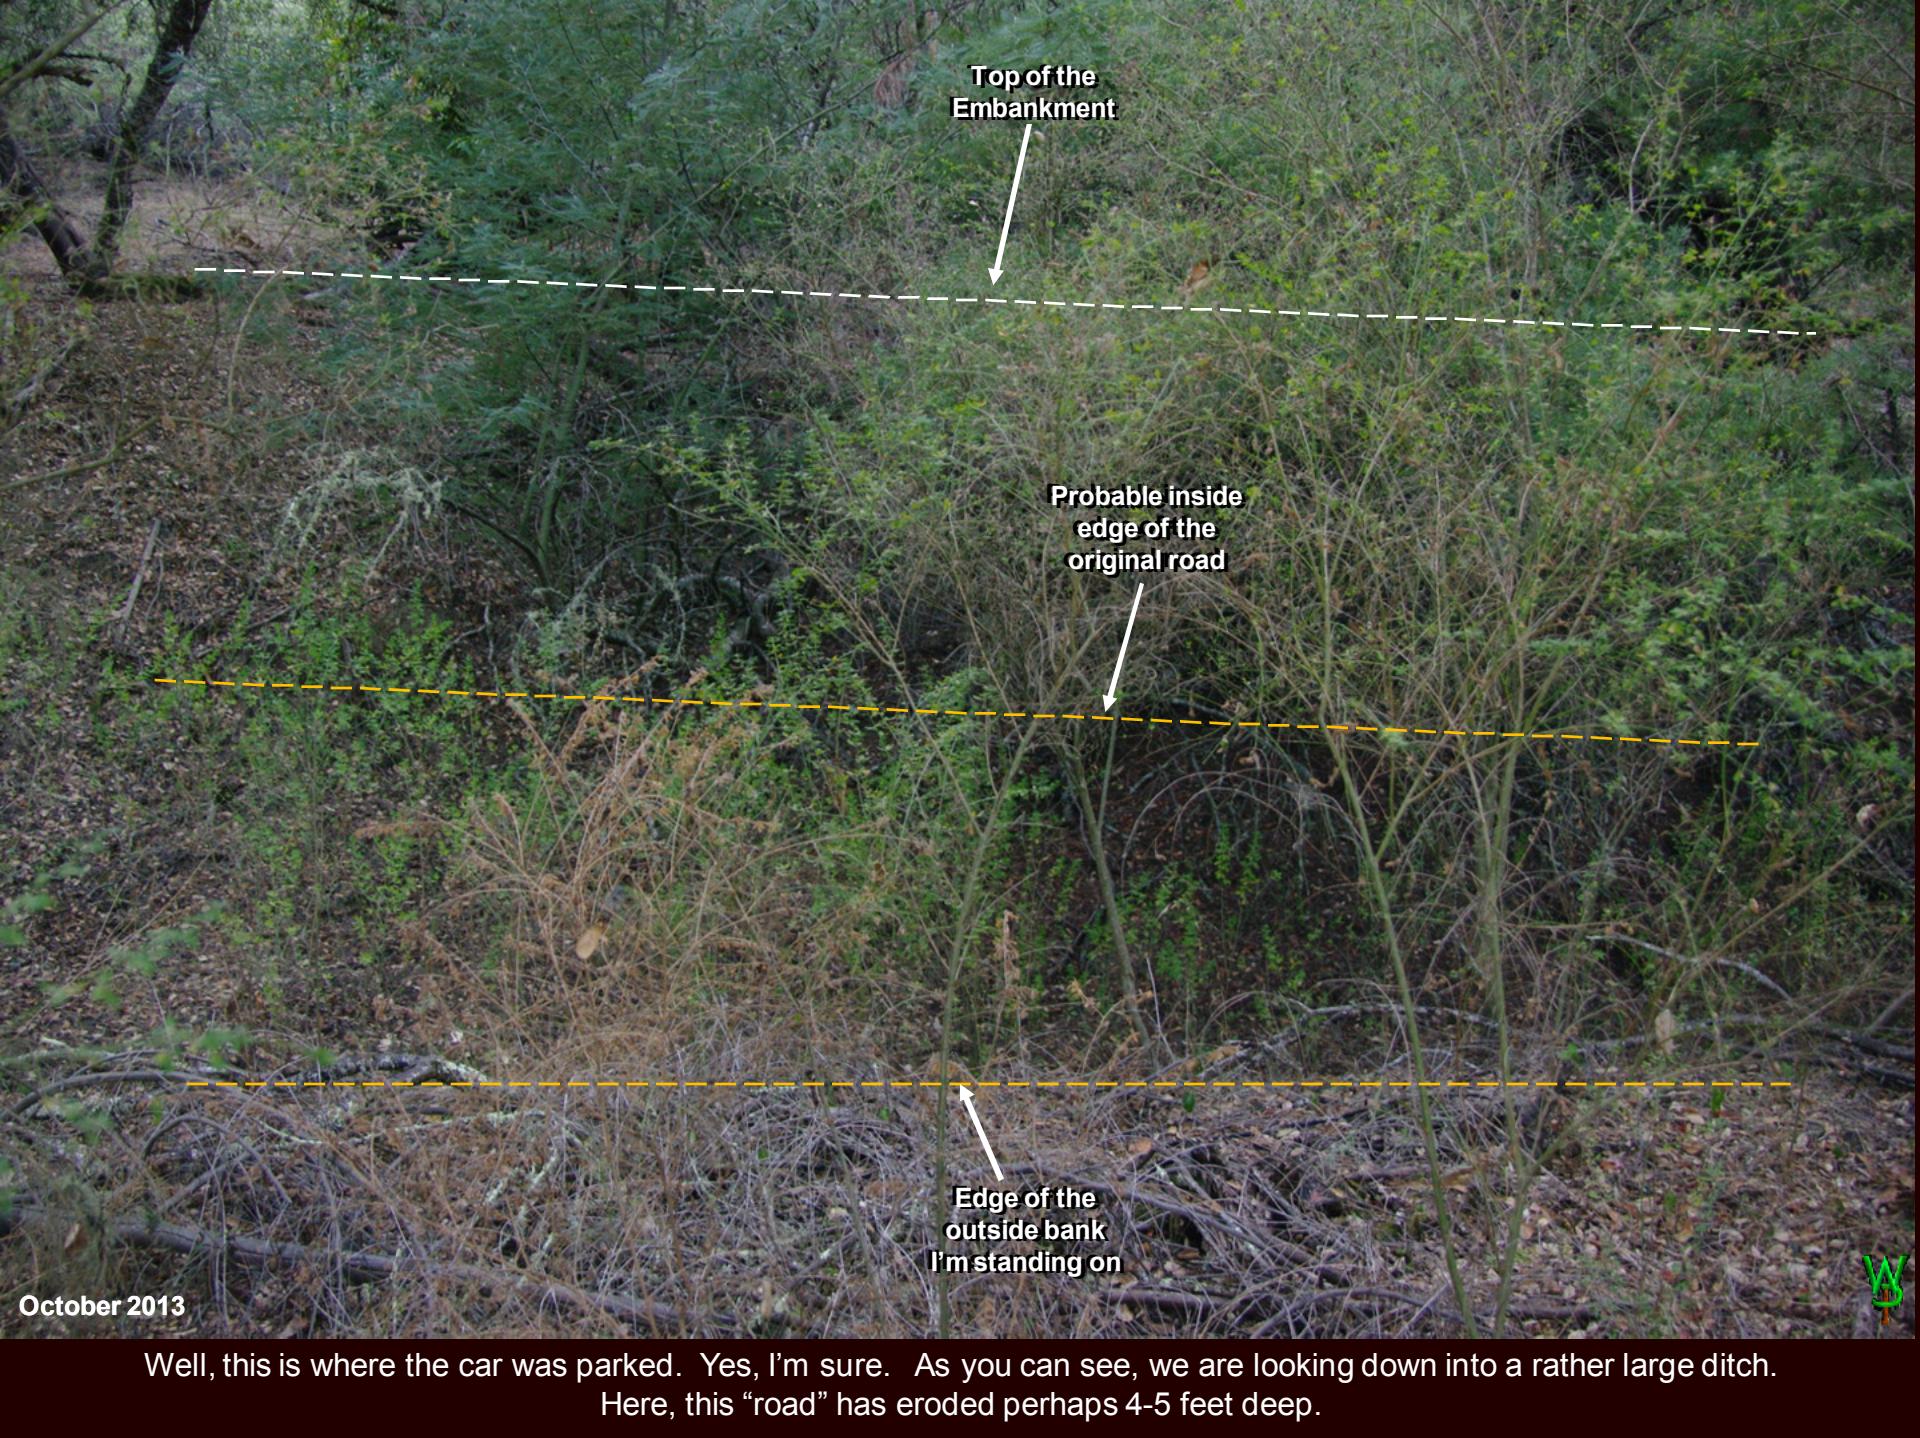
October 2013

Well, this is where the car was parked. Yes, I'm sure. As you can see, we are looking down into a rather large ditch. Here, this "road" has eroded perhaps 4-5 feet deep.

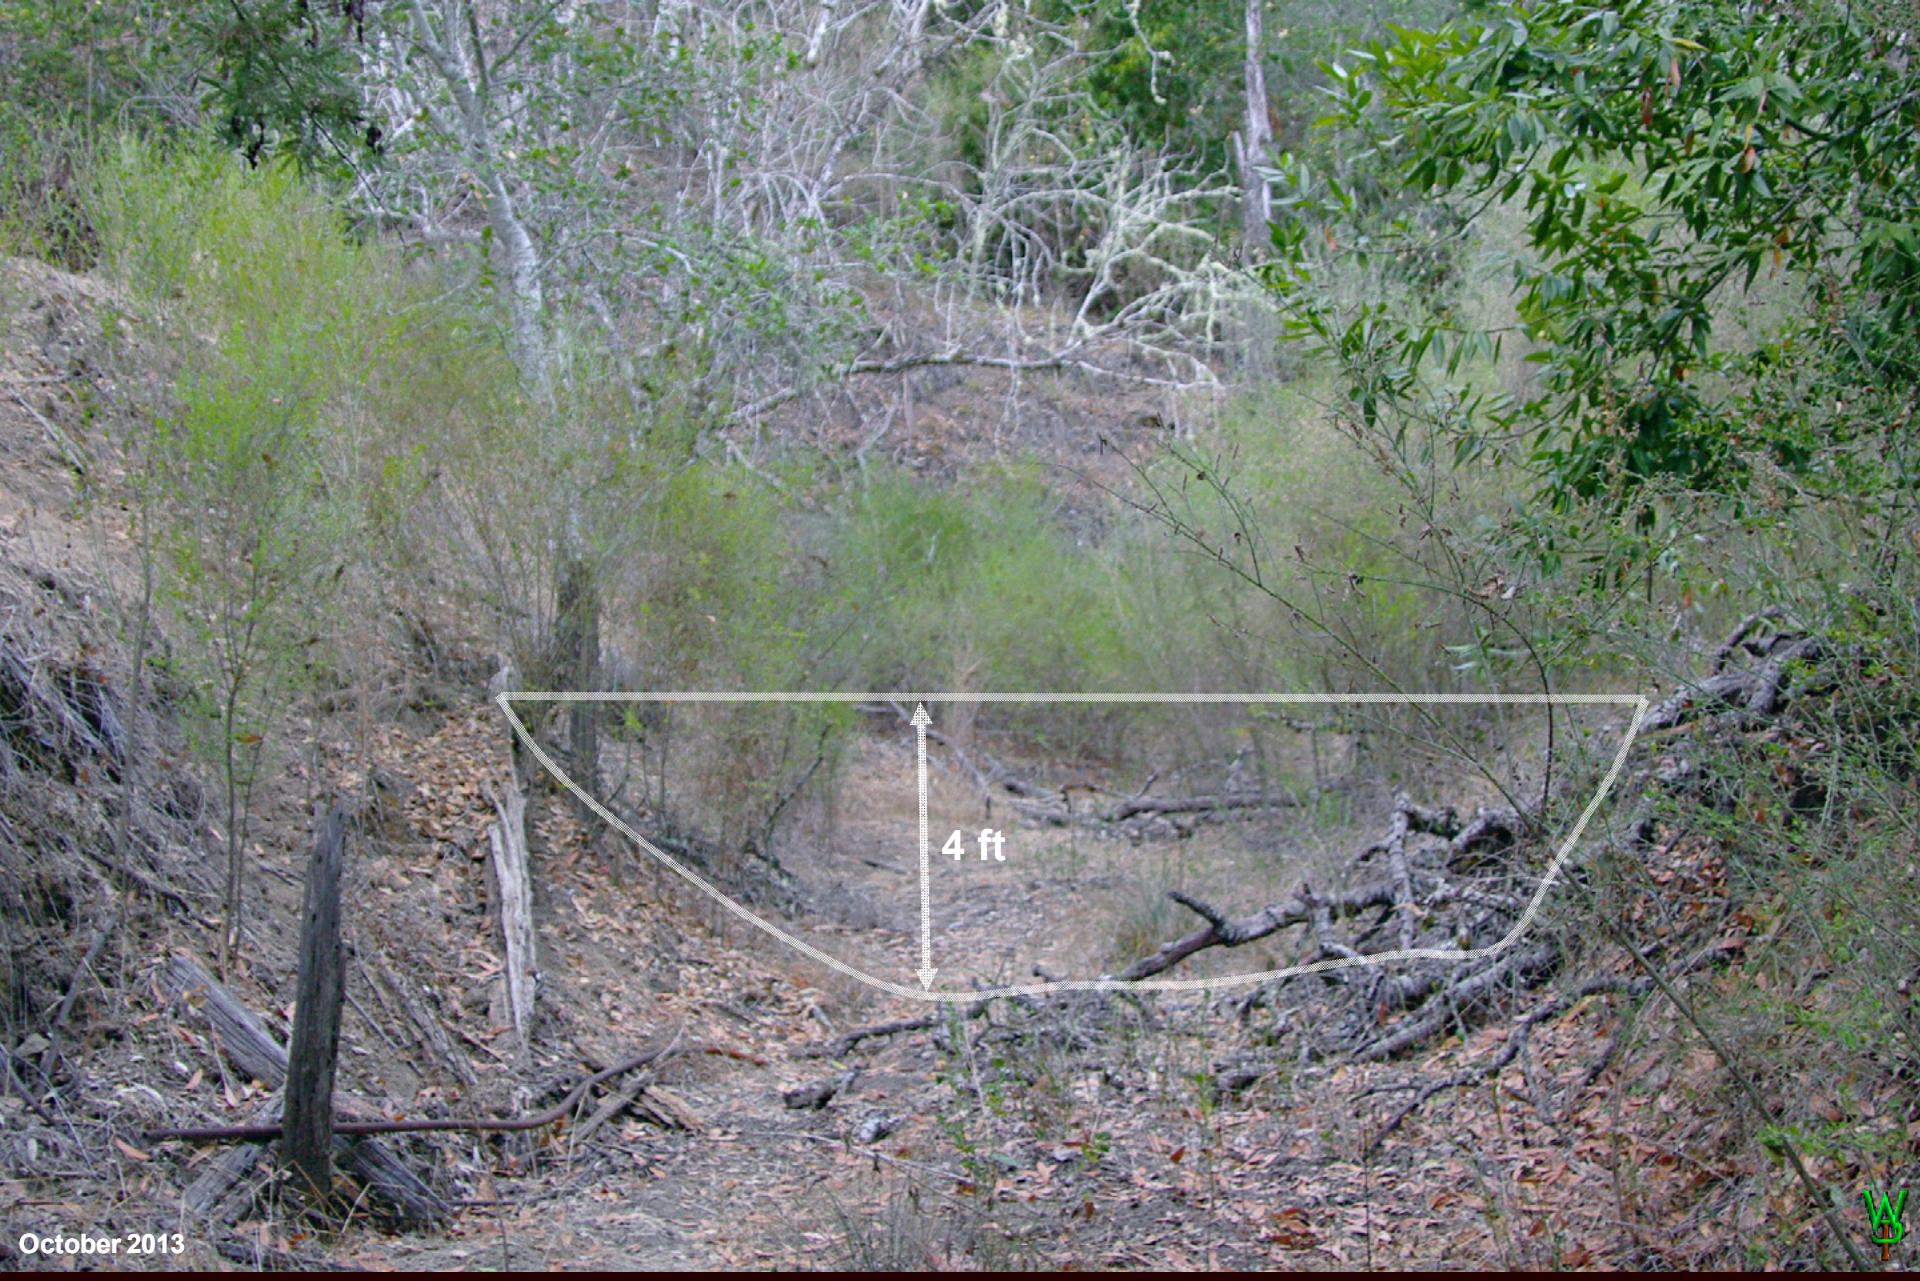
October 2013

Here it is as a cross-section, just above where the water from the road rejoined the original channel. This is what I'm calling a "Type II" road failure. I have had a County planner tell me with a straight face that "The County wants these roads to go back to Nature." From its appearance, do you think it will do that on its own, or will it just keep cutting? There was a lot of water that came down here until we changed its course at the top. Yet this is not our property. Did I do the right thing?

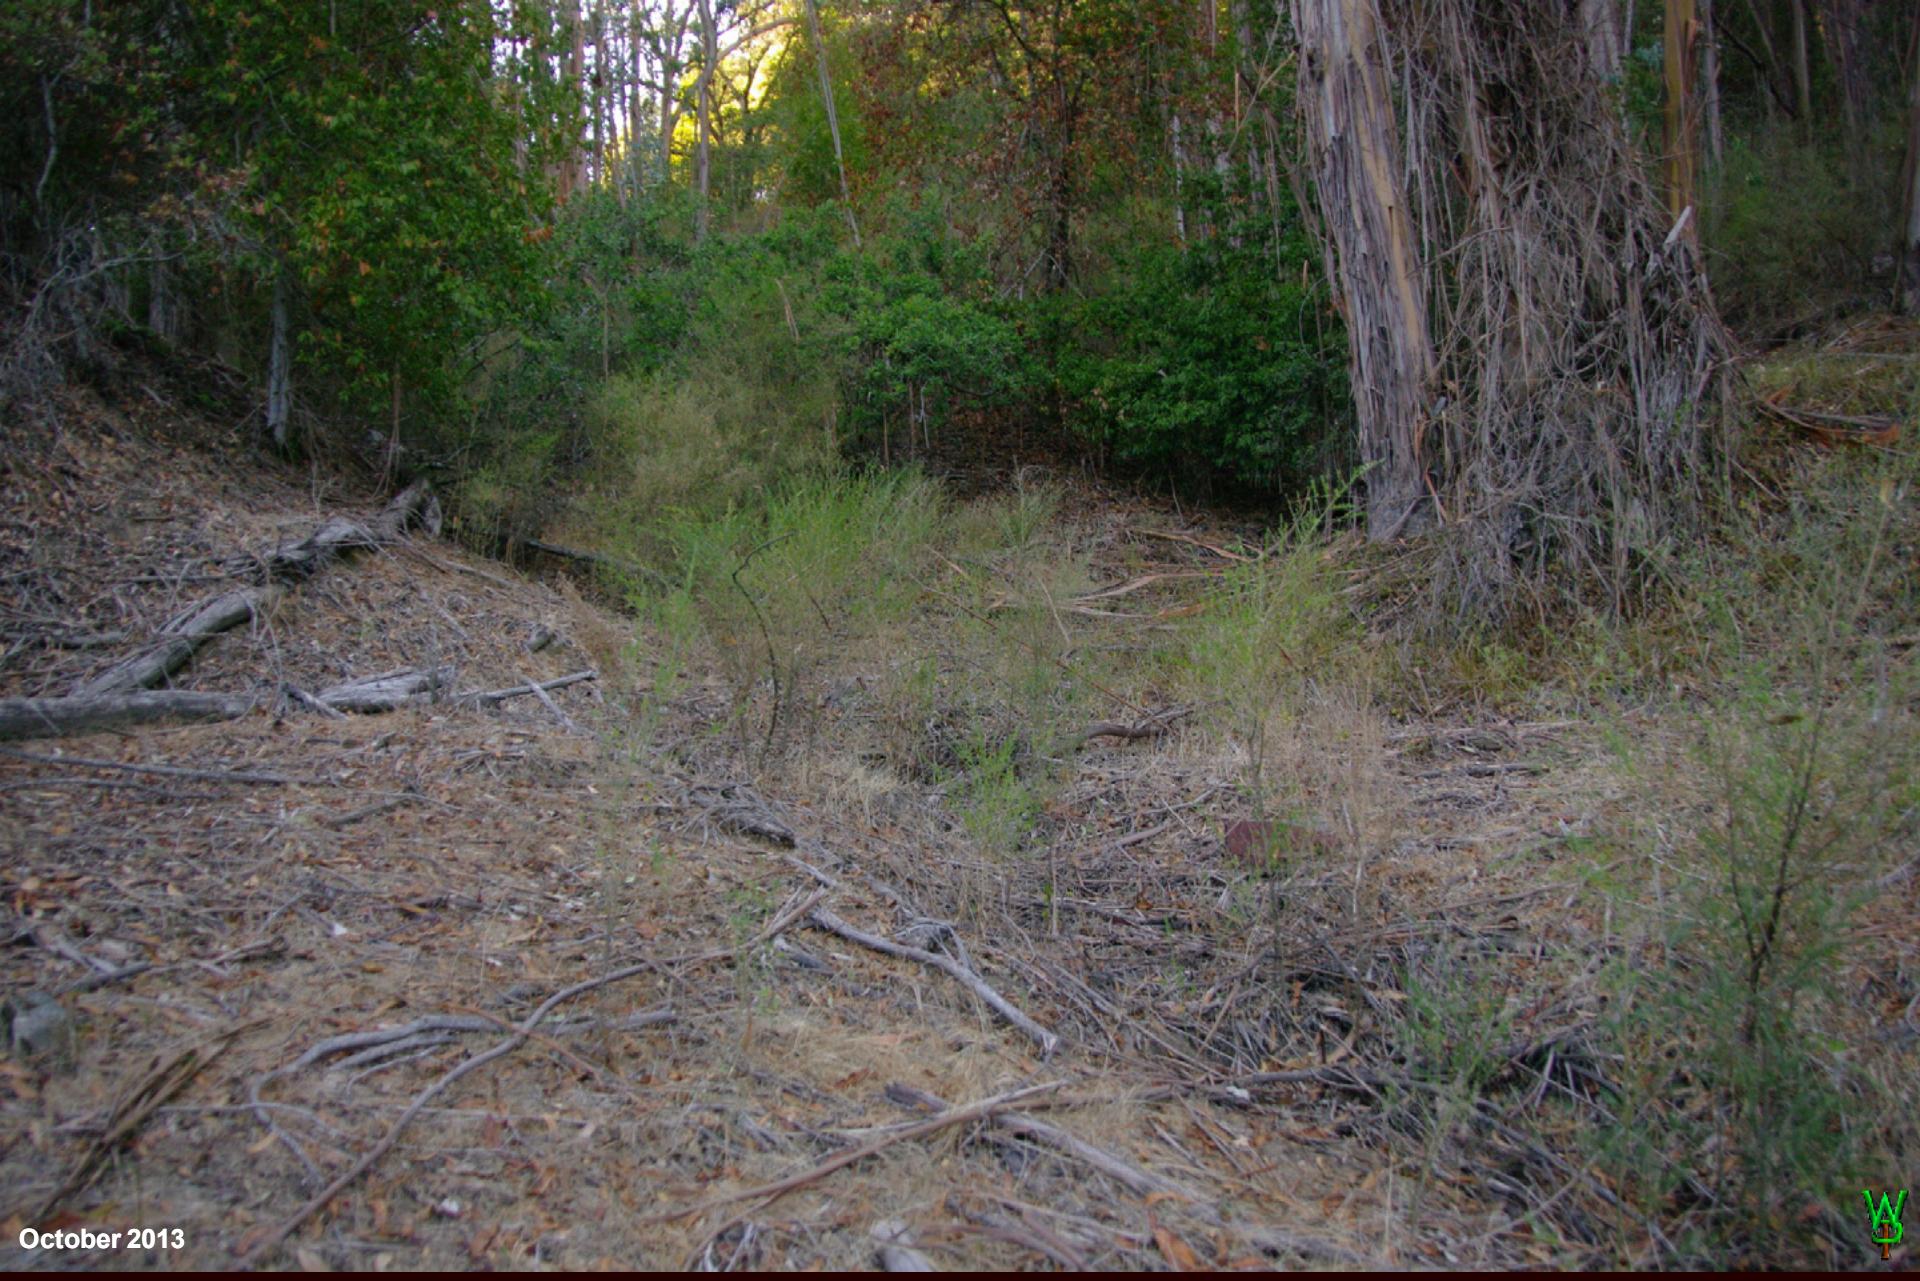
October 2013

Here is where the water comes out of the eucalyptus grove Fenn planted, which quite apparently did its job. There is little apparent channel incision here after 23 years at full flow except at the very bottom where there are no trees. Effectively, my diverting the water at the top into that original channel and diffusing the rest did arrest the channeling of the Type II road surface. It's a fixable situation now. Do you see the material available to do it? Yes, eucalyptus works fine. It is dense, rots slowly, and is obviously plentiful.

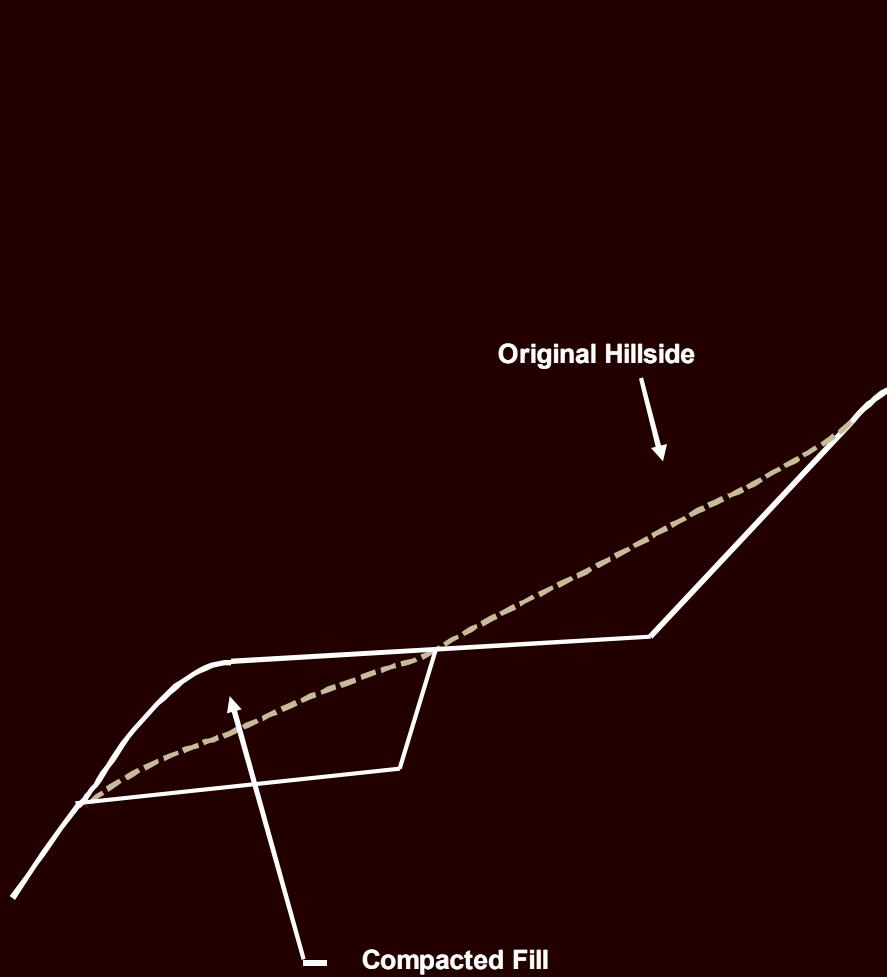
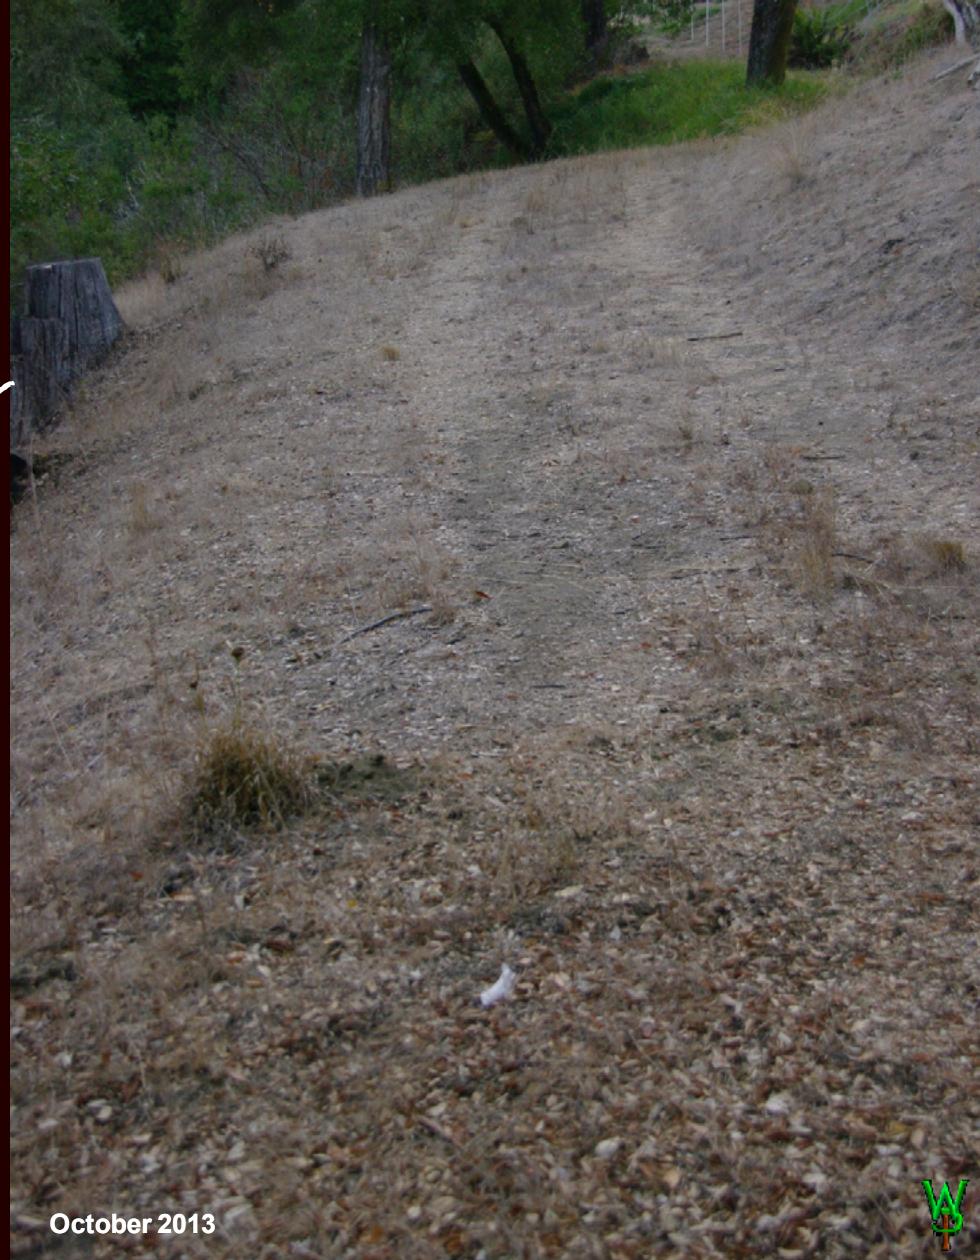
October 2013

This road was changed from an in-slope to an out-slope configuration in 2006, typical of the design for timber haul roads today. I would love to be able to shape our other roads to be like this one: out-sloped, wide, and maintenance free but for cleaning out one cross ditch once-a-year. This kind of road is particularly resistant to gopher damage, because there is not enough water at any one point to enter a hole and turn it into a trench. So, why don't I do it? I don't have the fill material I need, yet.

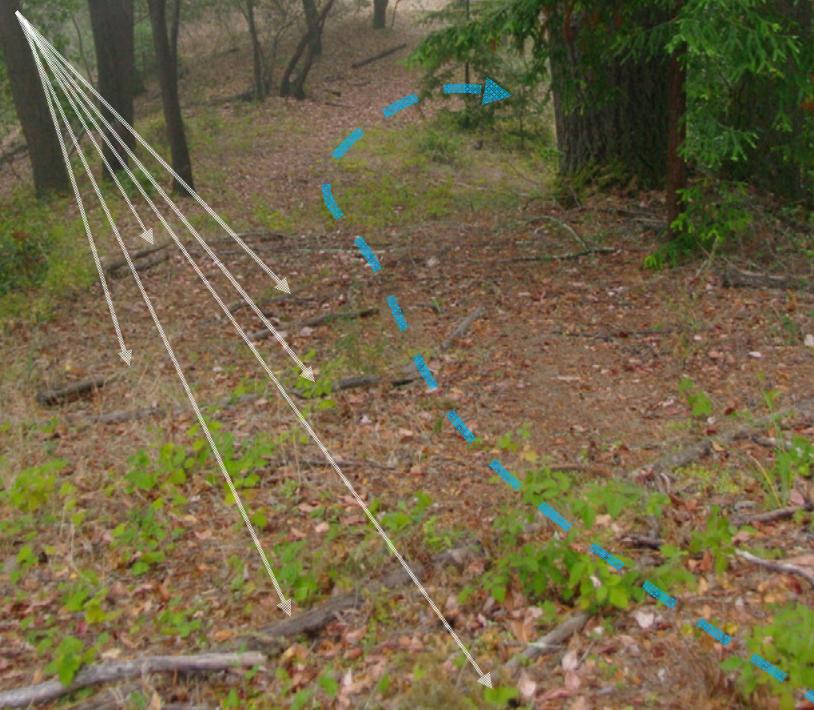
2013

"Strategically placed branches" direct flow over this stump hump

This road is the backup drainage for a flat that occasionally spills off one end. The ridge has impossibly steep sidewalls; so there is really no good place to drop the water off to the sides. So what I did is run the water down the spine while slowing and retaining it with strategically placed branches, losing altitude until the grade into the channel was much more gradual. The presumption is that the ridges are of harder material than the gullies (that may not be true). Still, the propensity for a convex surface is to break up the flow into smaller and more chaotic flows, thus reducing surface wear. The branches last about 15 years.

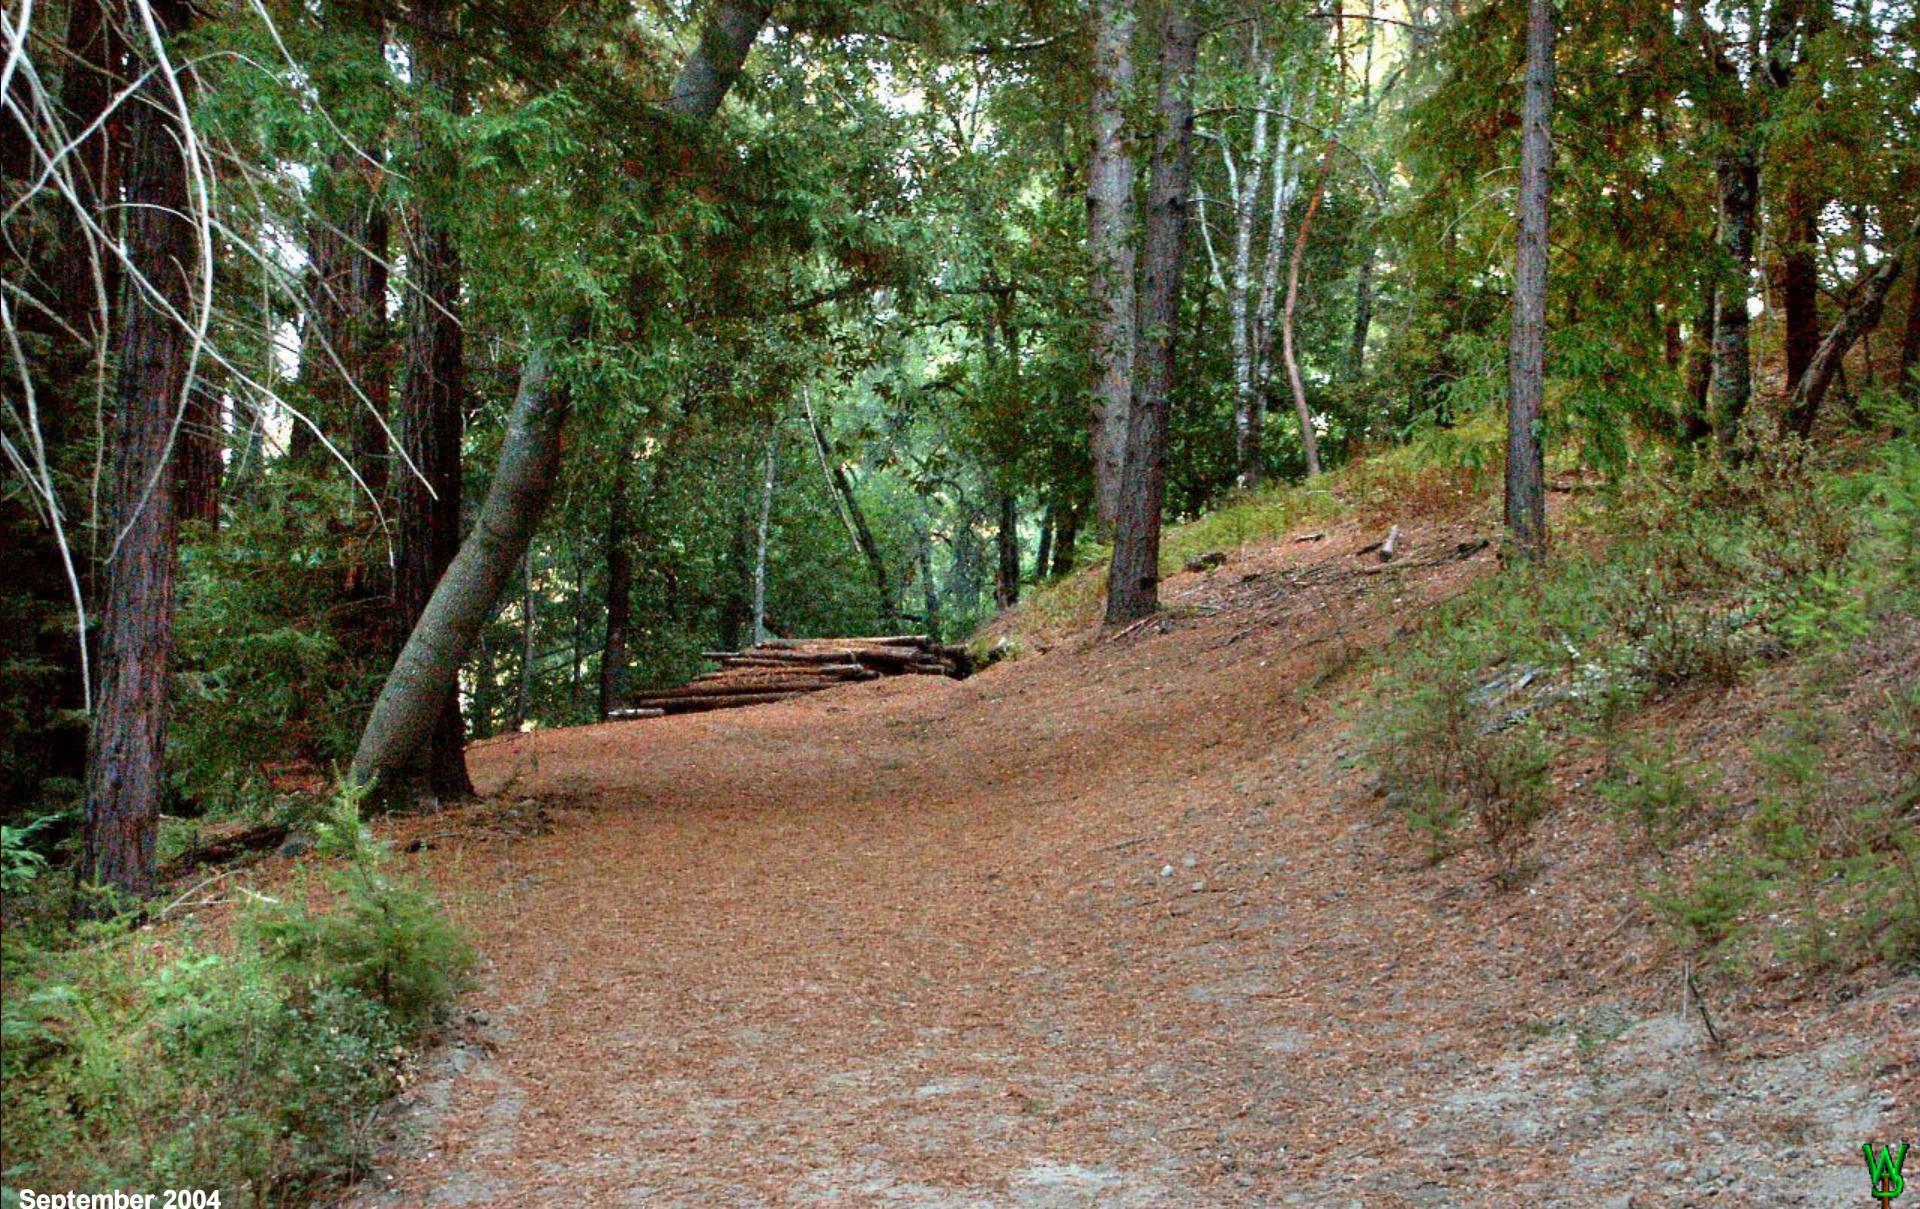
September 2004

This road is to get equipment in and material out for forest thinning or brush and weed control. To that end, I changed the grade from an in-sloped to an out-sloped drainage configuration, thus eliminating the need for culverts. It has worked beautifully to reduce the flow in the channel below, and has required no maintenance at all other than weeding. The two fir trees on the right are there to be gin-poles for purpose of high-lead yarding redwood logs out of the stand. The deck of skinny logs at the end of the road are for future corral posts or a pole barn should the need arise. I can't sell them to anyone with a better use.

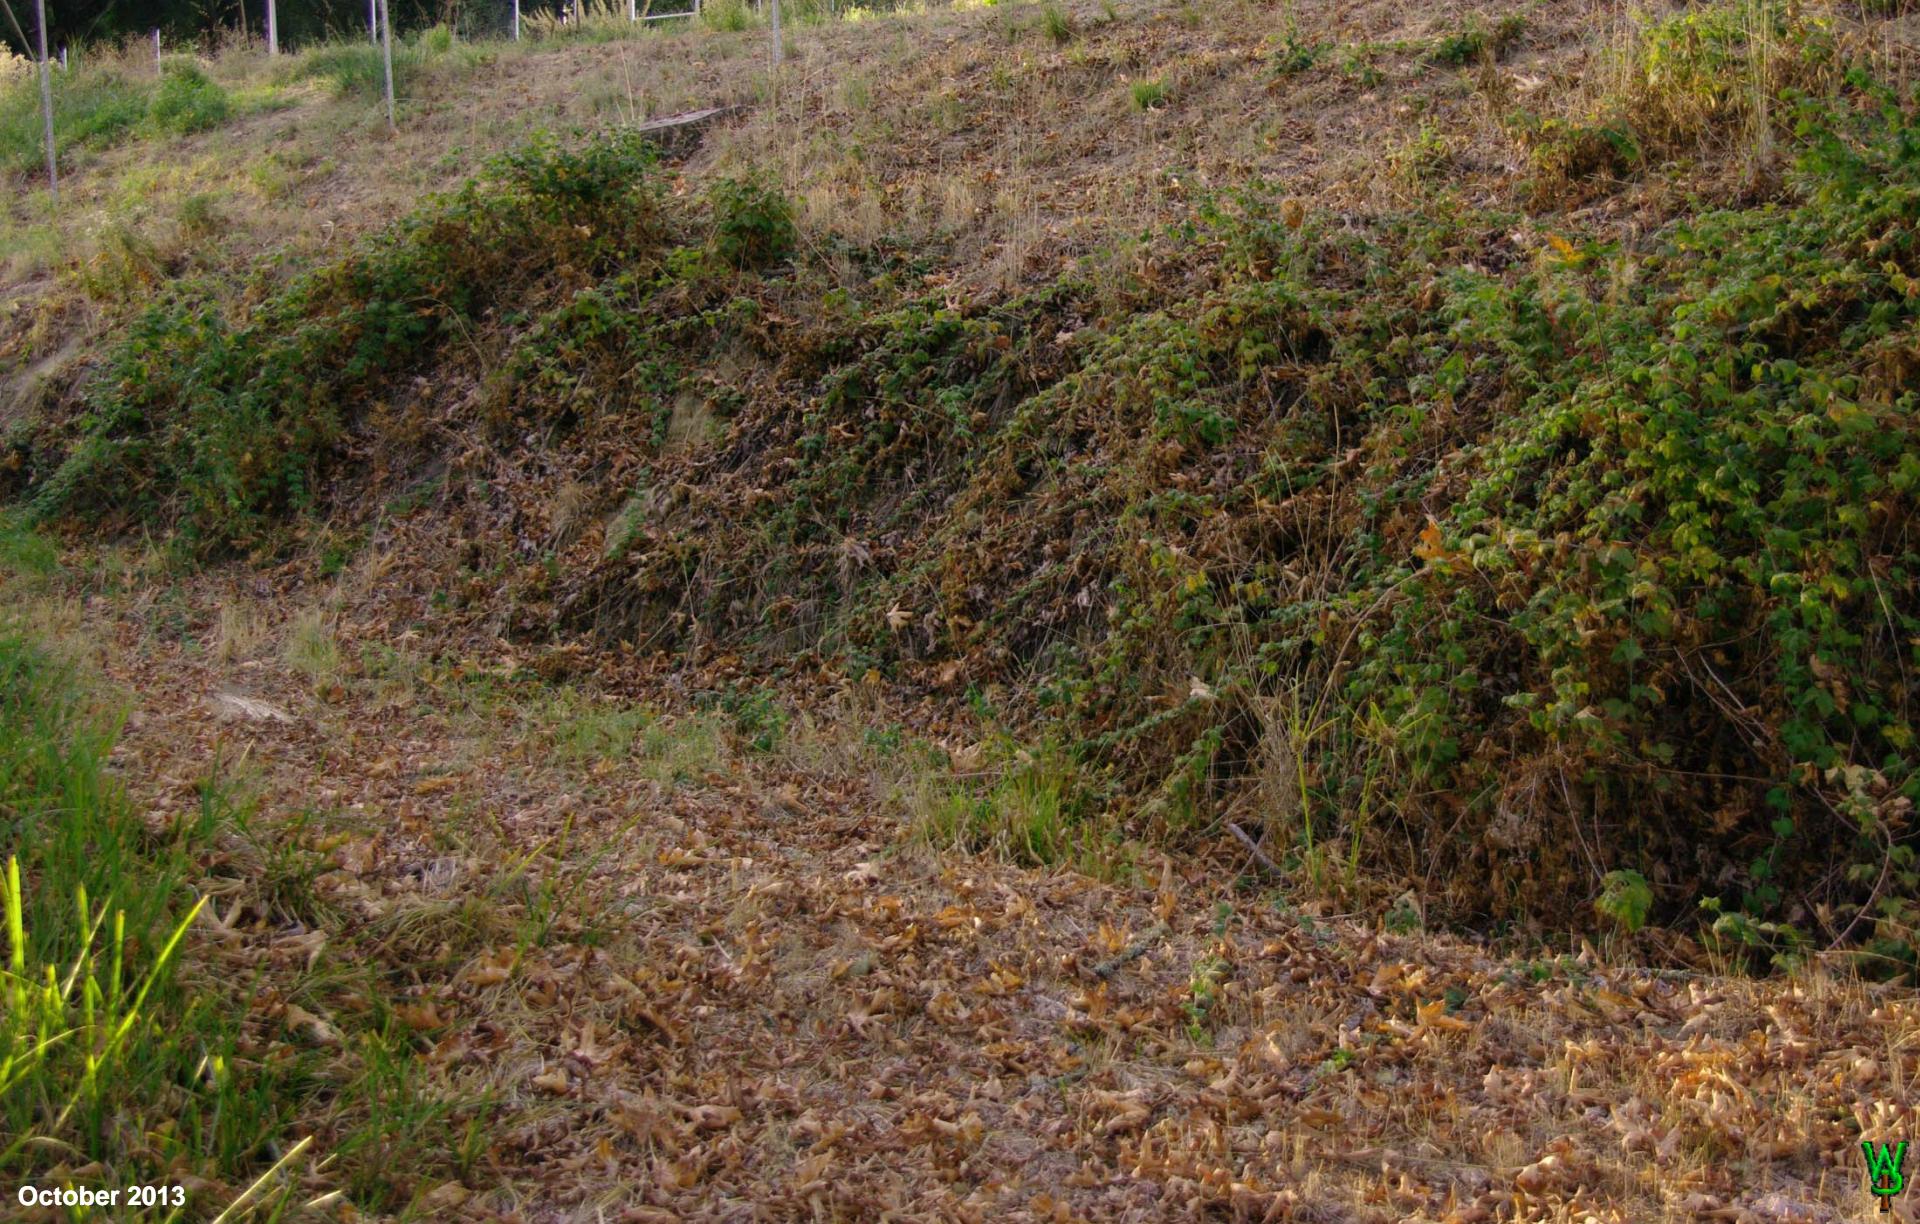
October 2013

Are we done? No! There are roads here that could be better, particularly with regard to how they collect water. The problem with this culvert is the east facing wall of the slope on the northern half of this place (to the left) is so steep, there is no good place to run the water down it. Sometimes you have to make one, as we did in the case of the rock drainages you have seen. That just takes time and money to get done. I've done one channel every several years with this one left to do. Hopefully I will have the situation corrected within my lifetime. In any case, this one gets its ditch cleaned and a bigger water-bar as soon as I get to...

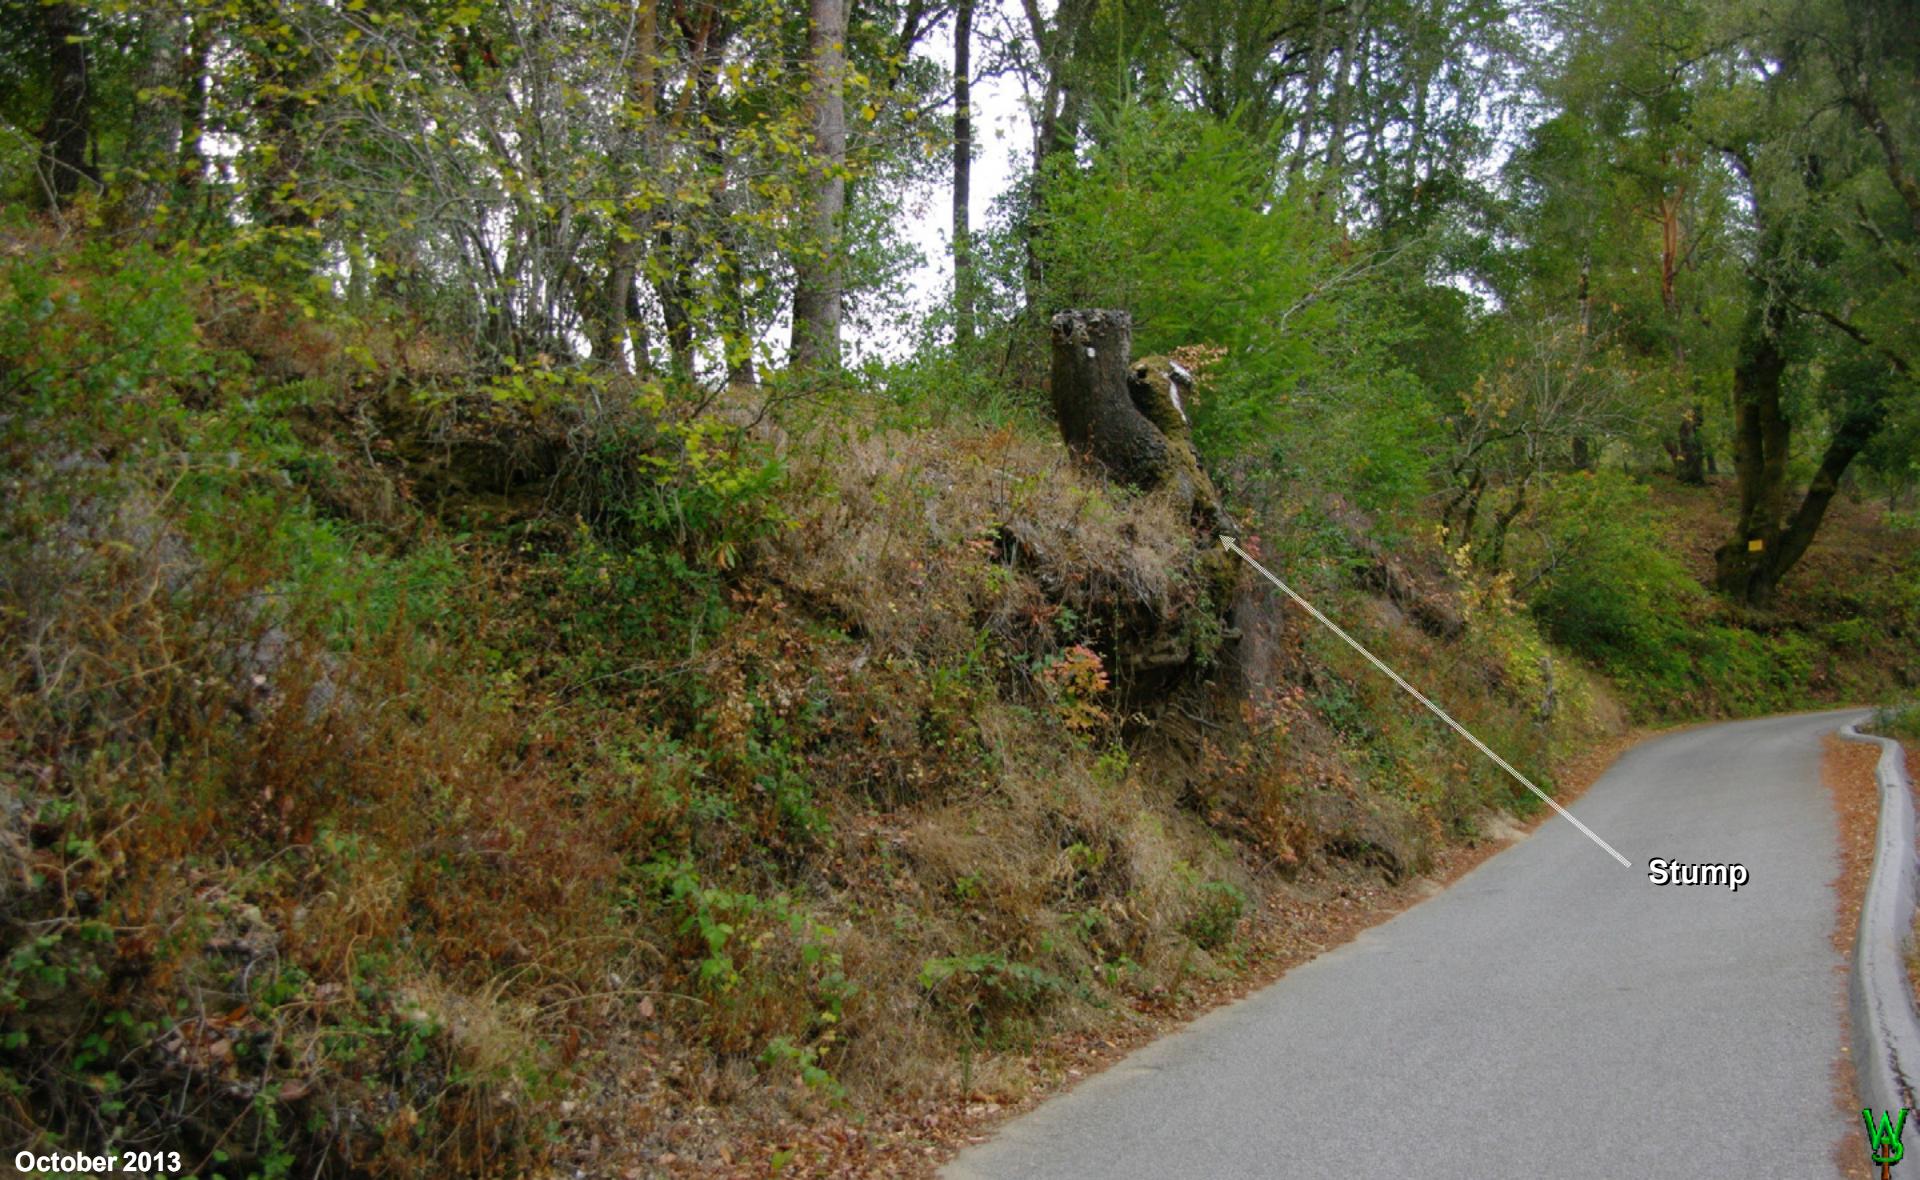
October 2013

...this. This is a different type of problem, one that is *going* to happen, since made more complex by lawyers. The original problem is the stump. Although I removed the weight of the tree, it was doomed to slide. However, it slid a LOT sooner because the County cleans the ditches (since filled with sluff) to keep the water off the pavement. The County lawyers have spoken: 'There shall be no water on pavement' because they don't want to be sued. The problem with that "logic" is that anybody stupid enough to drive fast enough to hydroplane on this single-lane, treacherous, windy road deserves what they get. Ditch cleaning undermined the slope by digging the blade into the hillside, the ditch filled within a couple of months, and the water runs on the pavement anyway.
