ROADS TO HEAVEN, TO HELL, AND BACK, SOMEWHAT

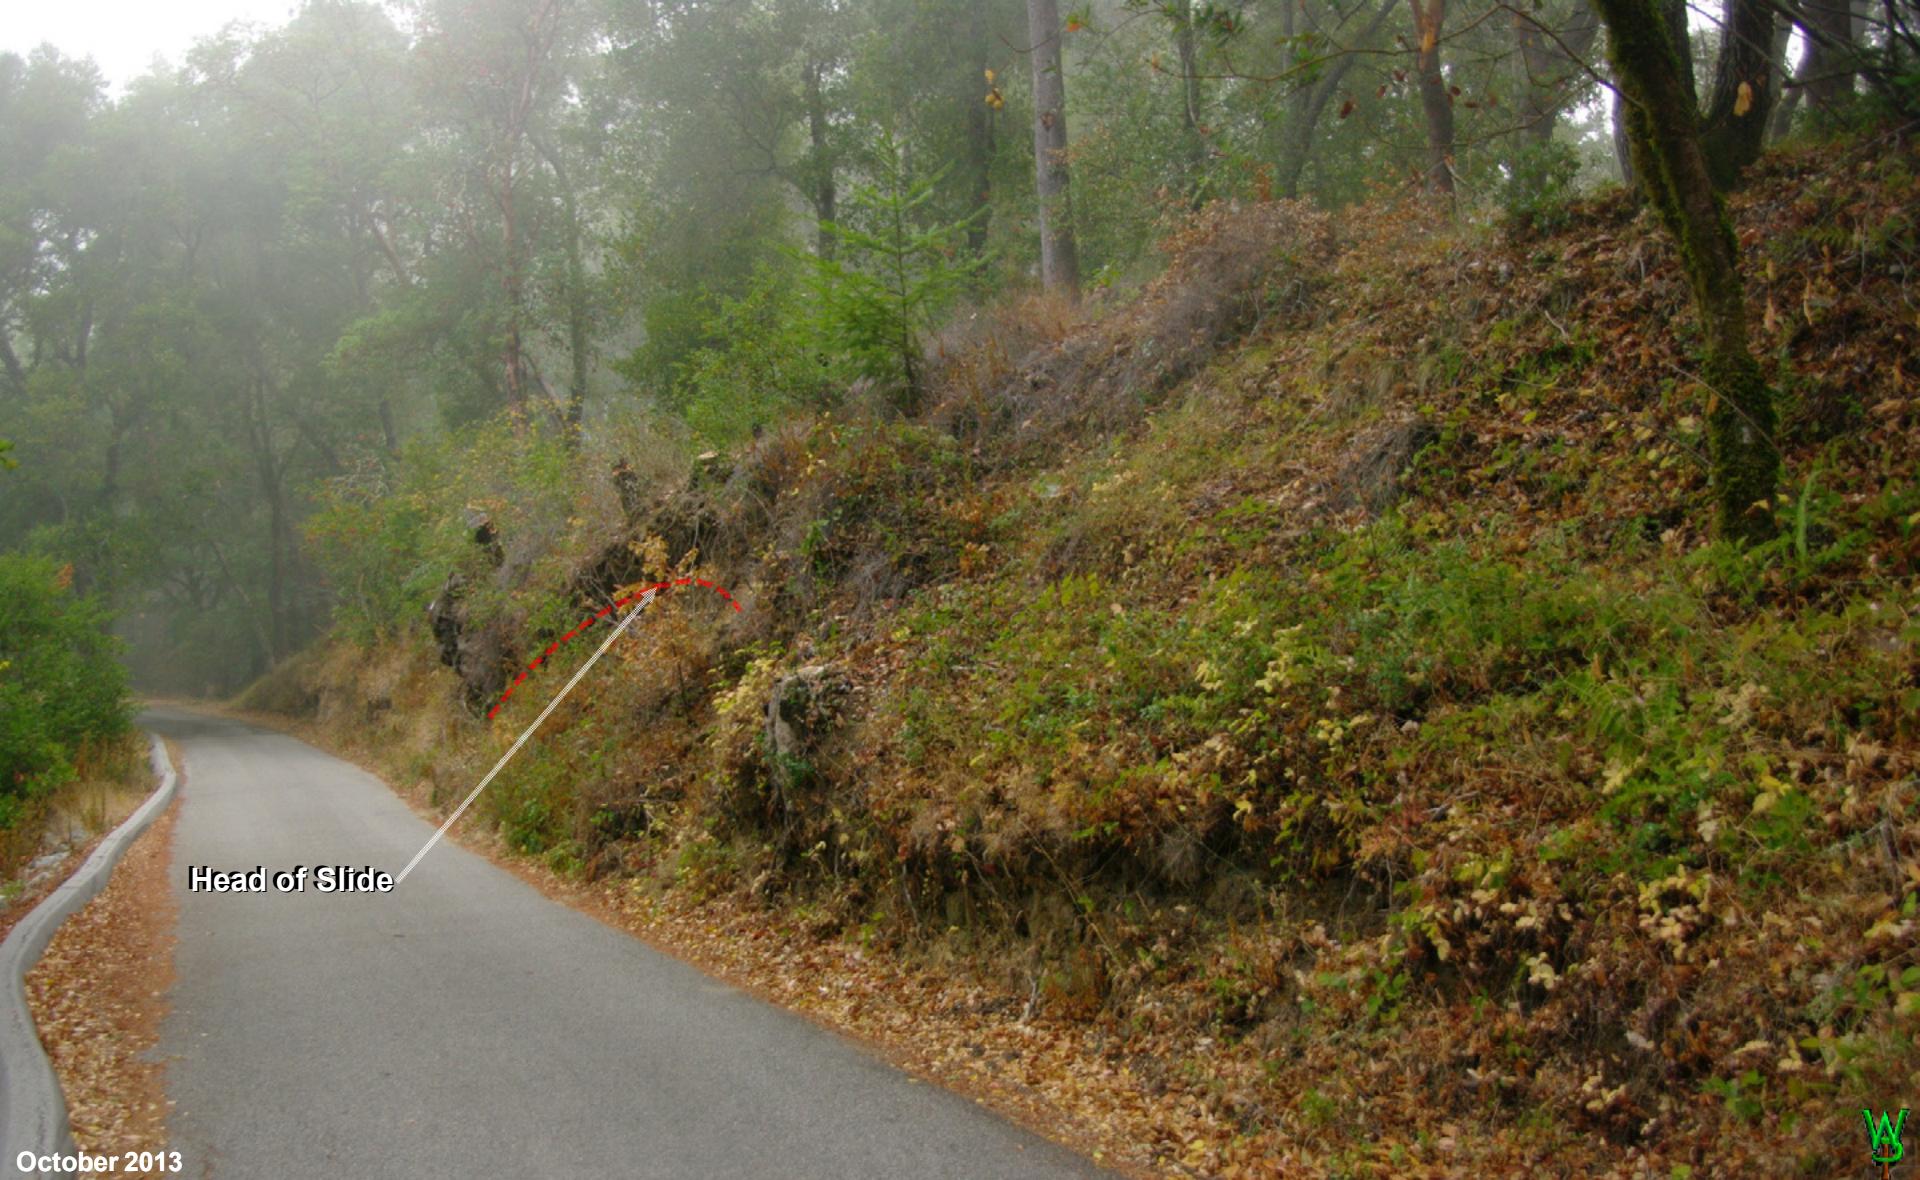
Head of Slide

Here is another view from the other side. The roots had tangled with other stumps and started to pull the top off the whole slope. The reason I am making a point of this is that the customary landowner practice is to wait for a storm and allow the stump to fall and block the road. Then the County comes along (after dealing with probably bigger problems elsewhere) and cleans it up for free. Then they hydro-seed the whole slope with exotic grasses and hope it doesn't fail. I can't let that happen. So the Department of Public Works gave me a permit (free) to get rid of this mess. I'll reslope the whole bank and you will get to see a revegetation project like no one has ever seen. After all, innovative process development using native plants is what this place is all about. We'll see if it works.

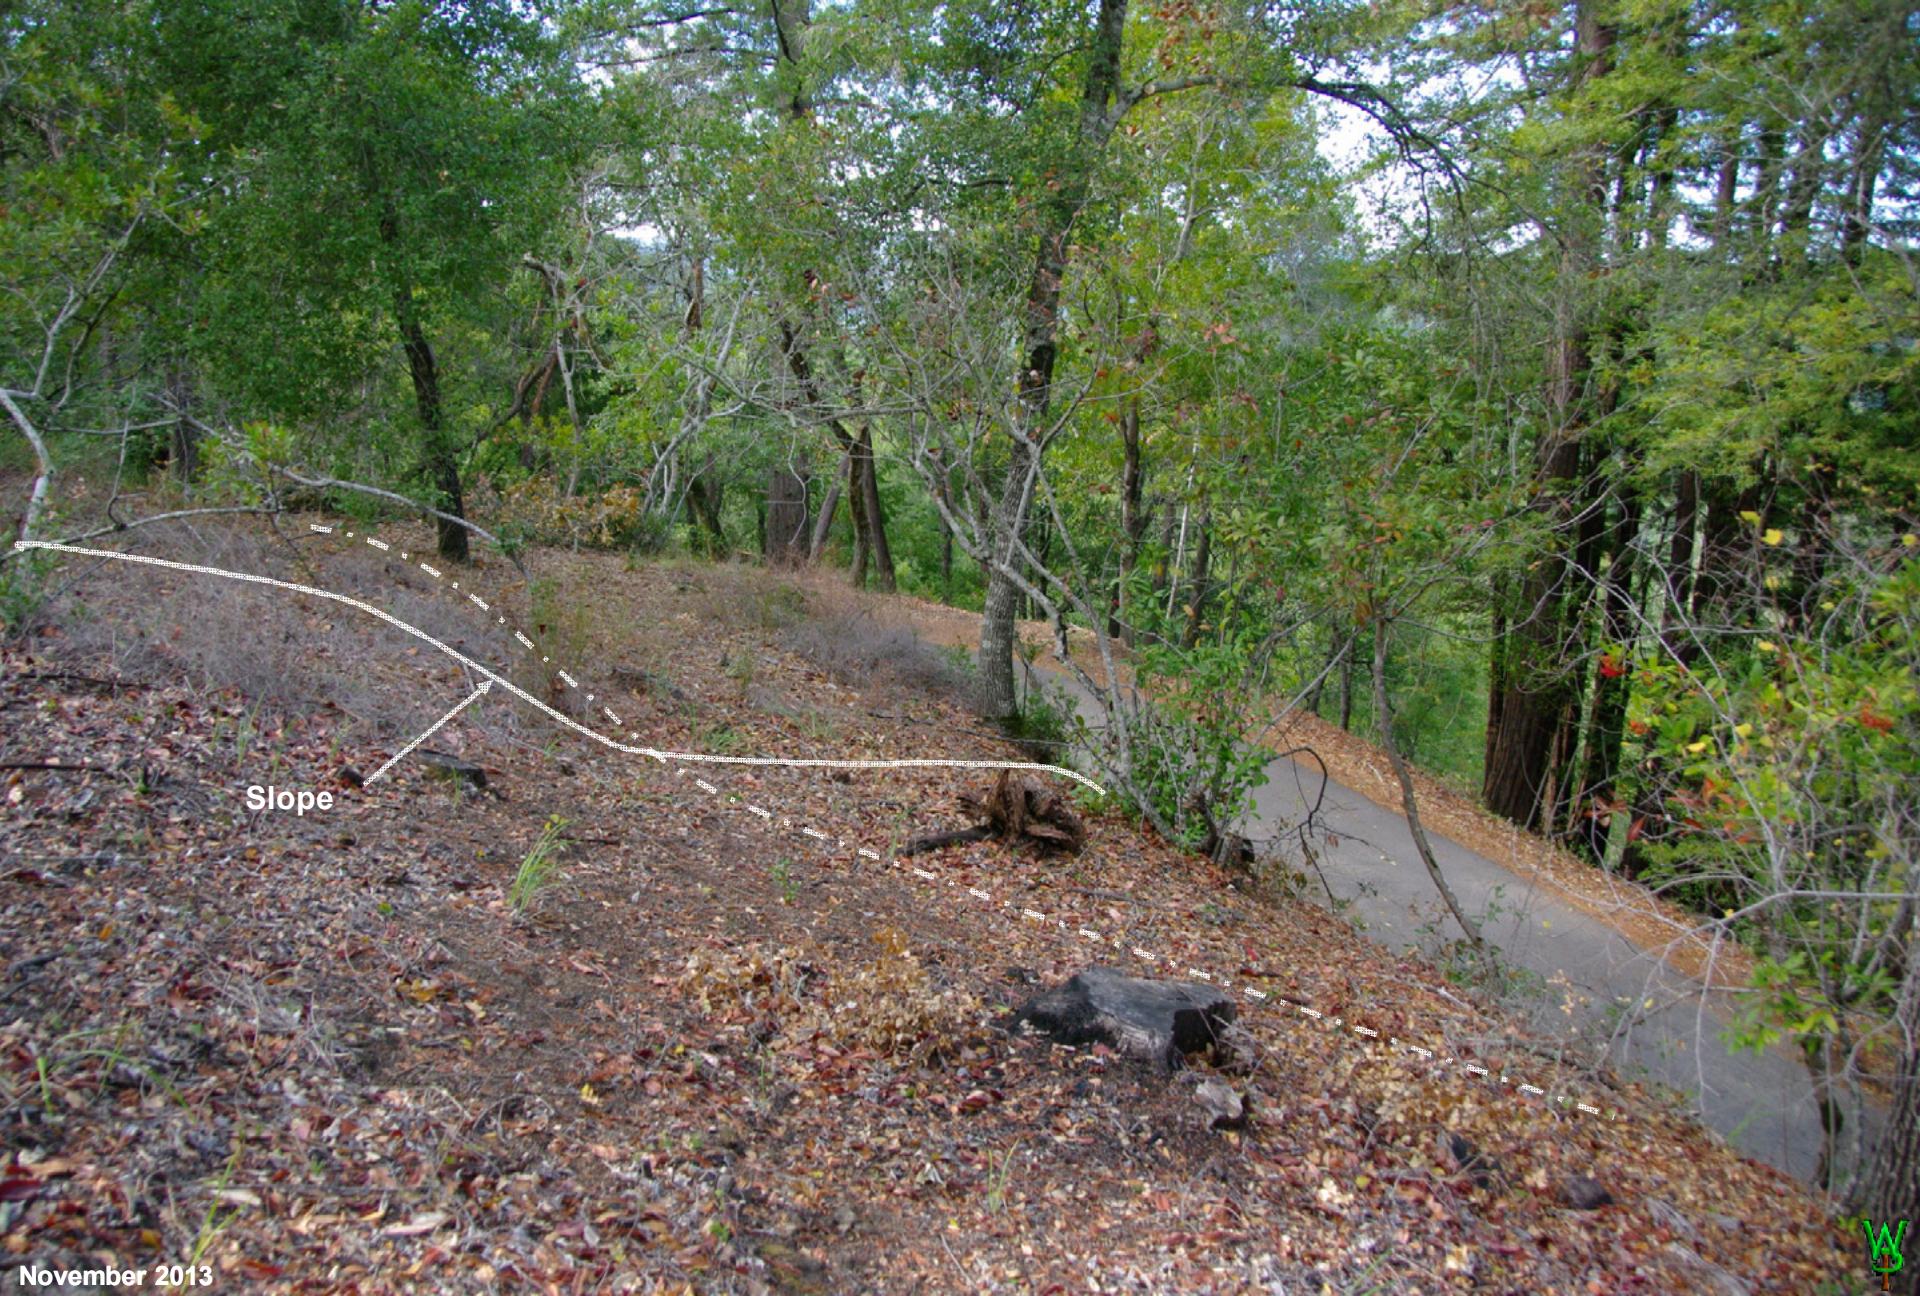
November 2013

Yet there was a minor complication to beginning the job to which you are now a witness, one that required a bit of extra documentation for posterity. Note that the grade on the side opposite the line becomes almost flat across the slope. Note also how this flat section follows roughly the same grade as the county road below.

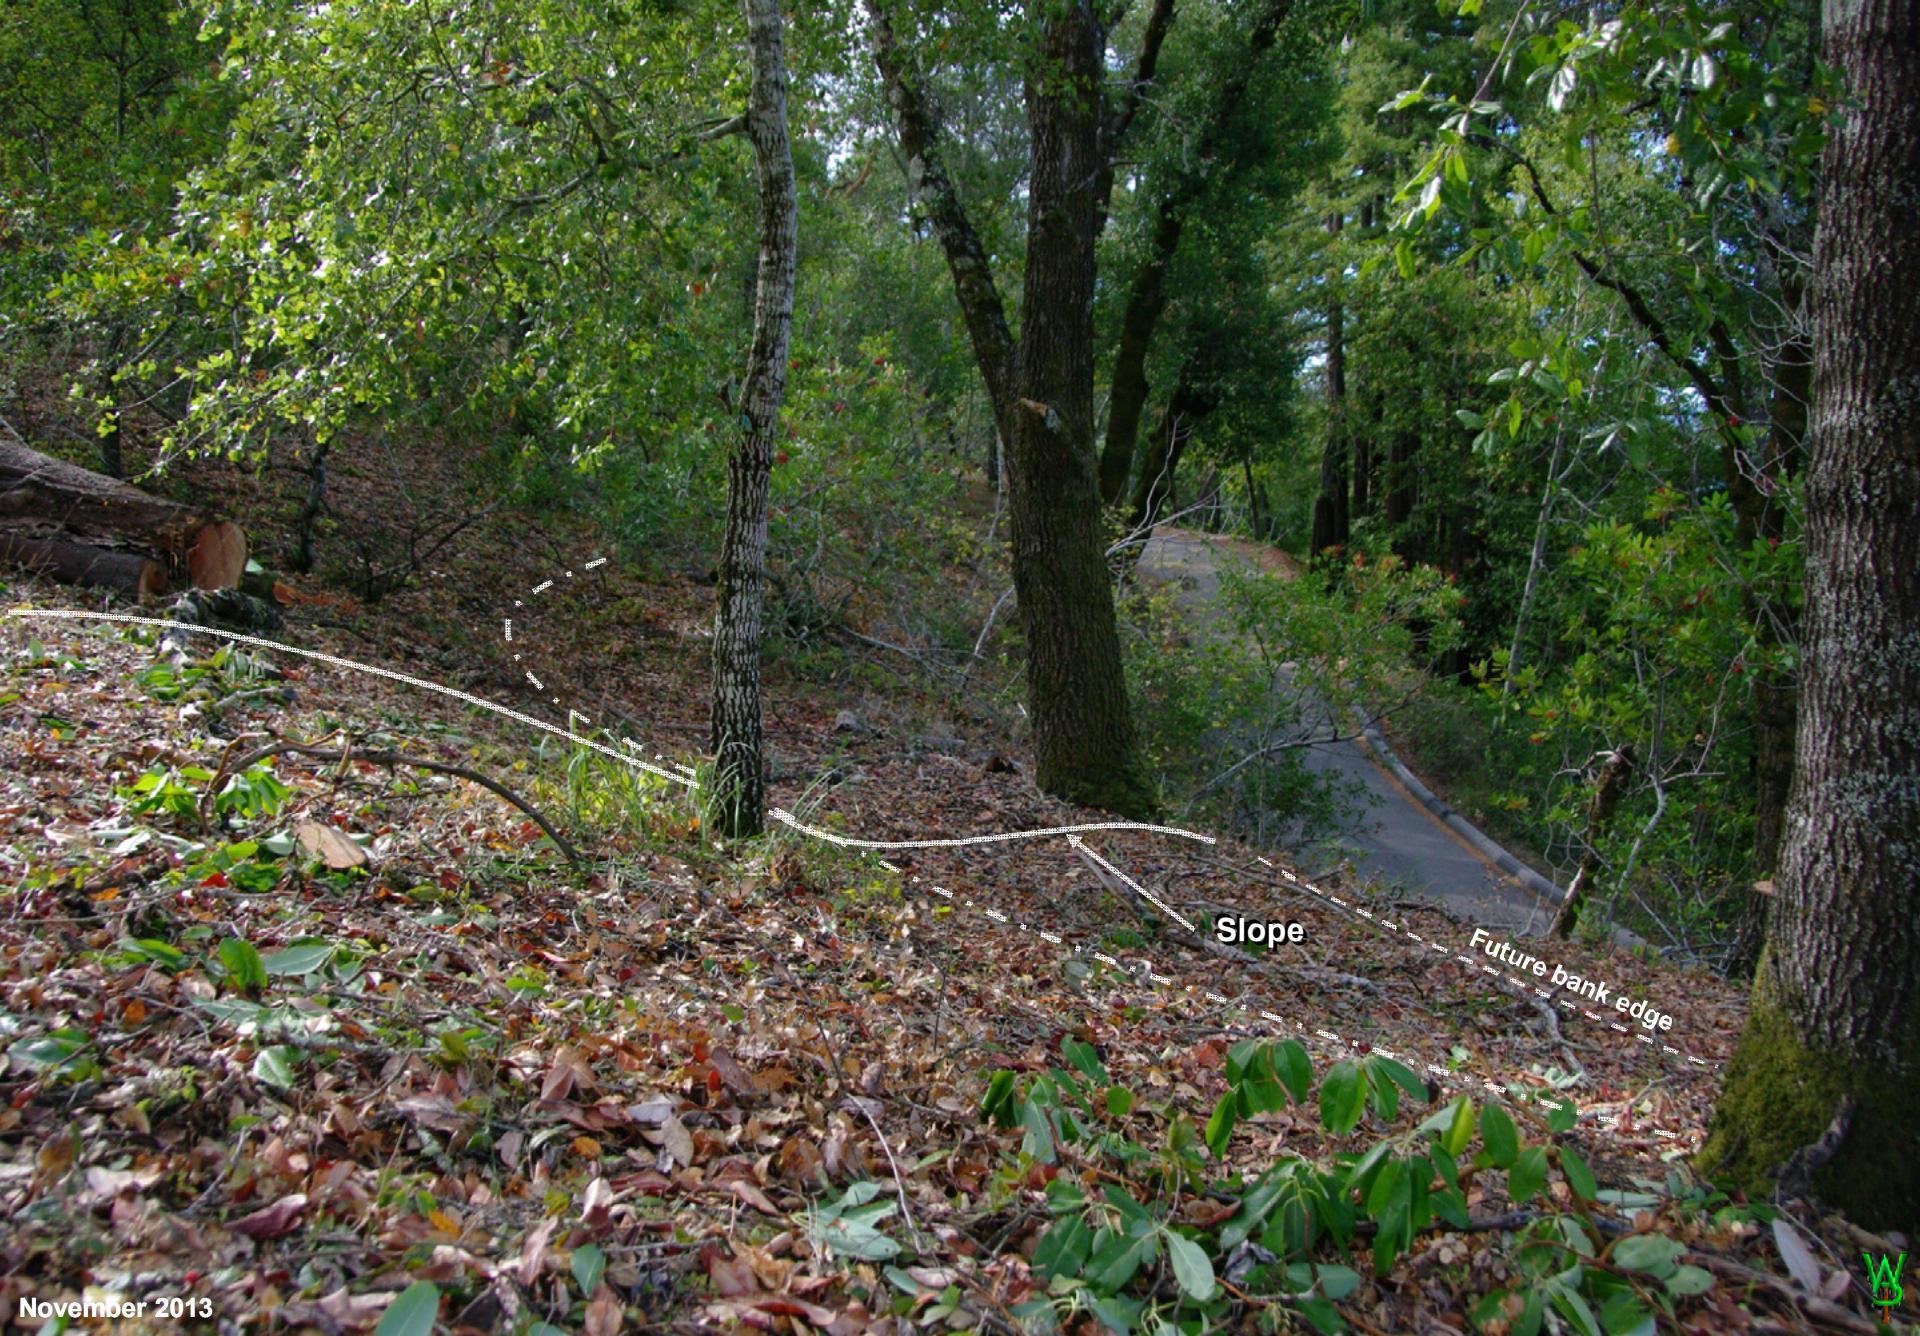
November 2013

Here we are just south and above what will be the beginning of where I will be cutting into the slope to reshape it. The track is about six to eight feet wide, too narrow for a car, or even most wagons.

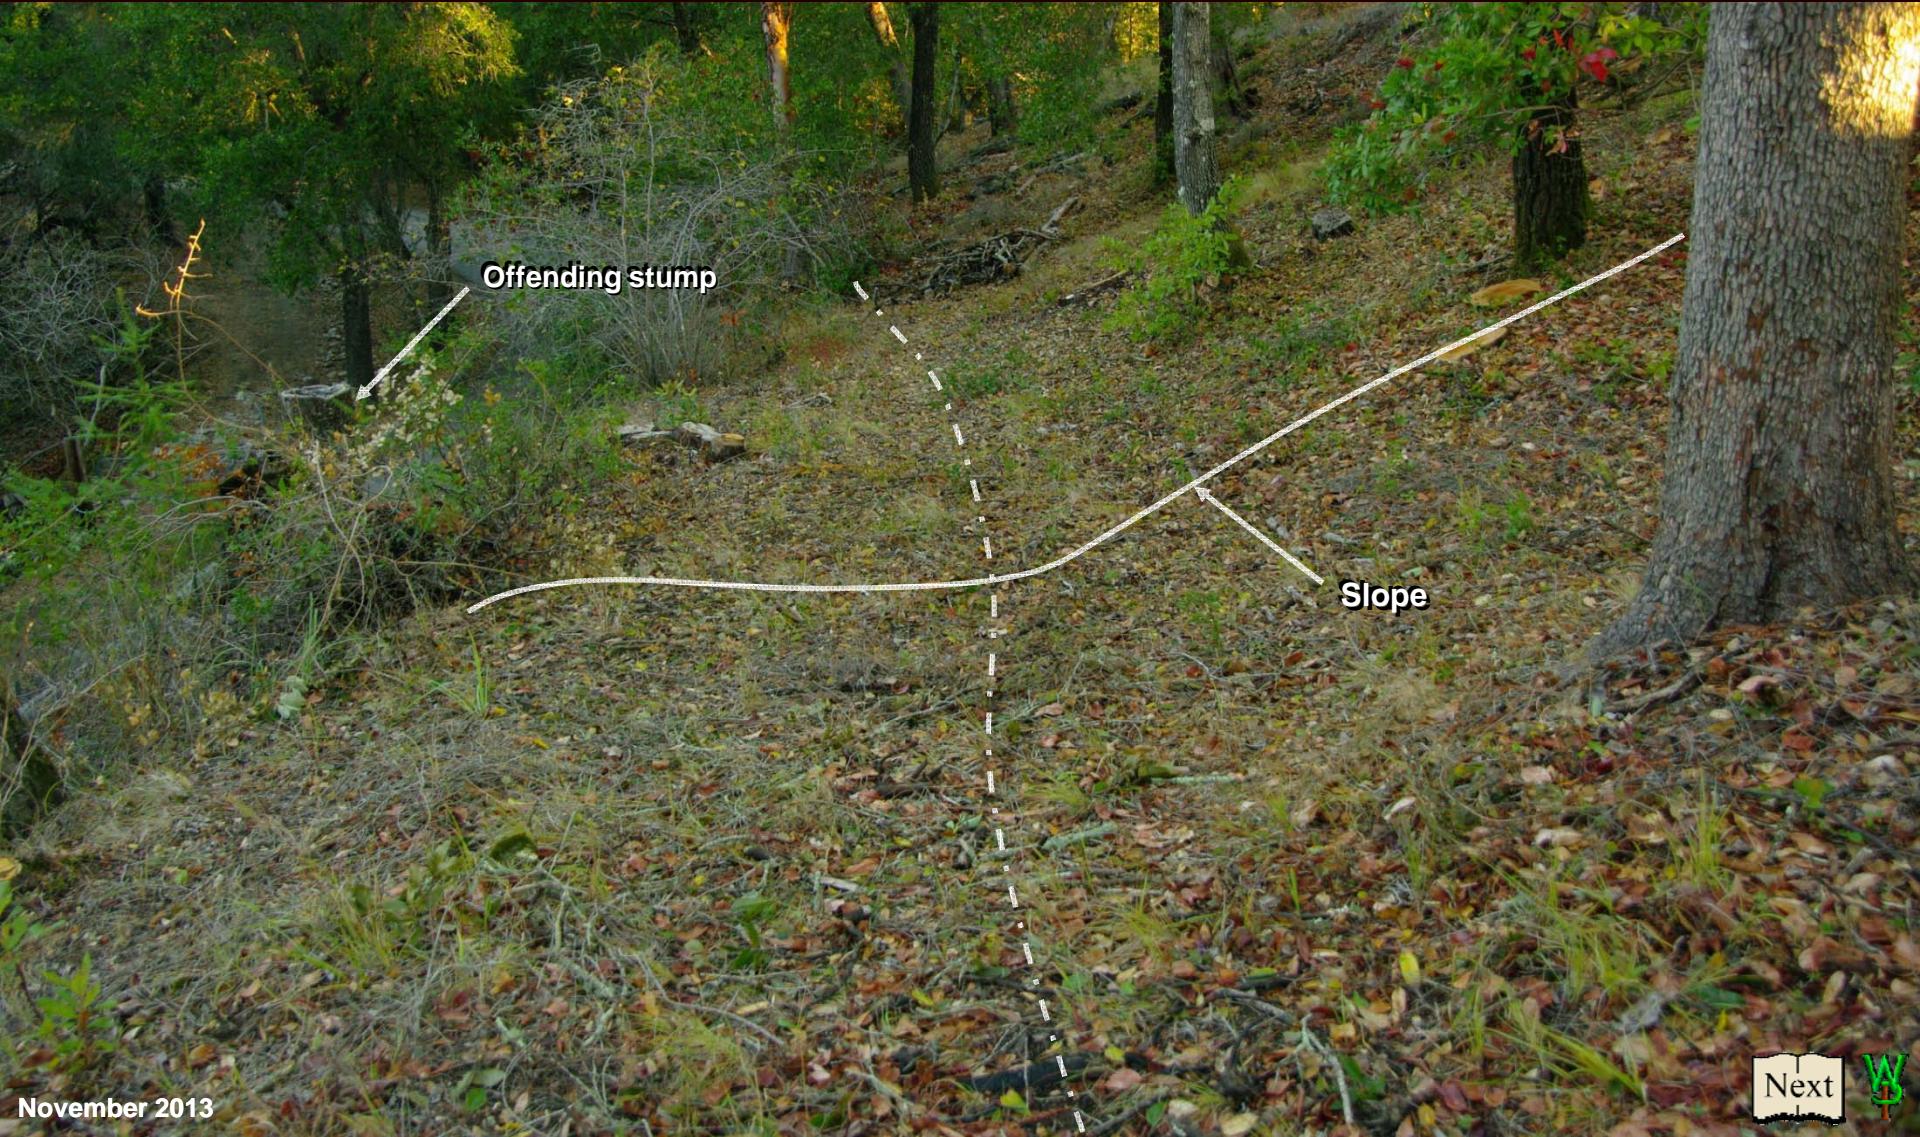
November 2013

Even without the road below, the original slope would never have been level across it as it is here. It is almost as if this was an even older road, one made long ago, except that the only "older road" made before Charley McKiernan made his in the late 1850s was the one made by the Indians of Mission Santa Clara in 1791. Accordingly, it seems likely that this may indeed be that old Spanish track.

Unfortunately, sloping this bank will remove just about all of the old road. What to do? Get the permit, document it for the archaeological record, check it with a metal detector, and scrape it off to stockpile the native grasses and save the topsoil for the revegetation job. It is saddening to take out this likely vestige of the mission era, and it does cause one to ponder what the Indians had to do to build it or how the land might have looked to the Spanish when they passed by, but it's just how things have to be.
