FEELING DRAINAGE

WILDERGARTEN 4.0

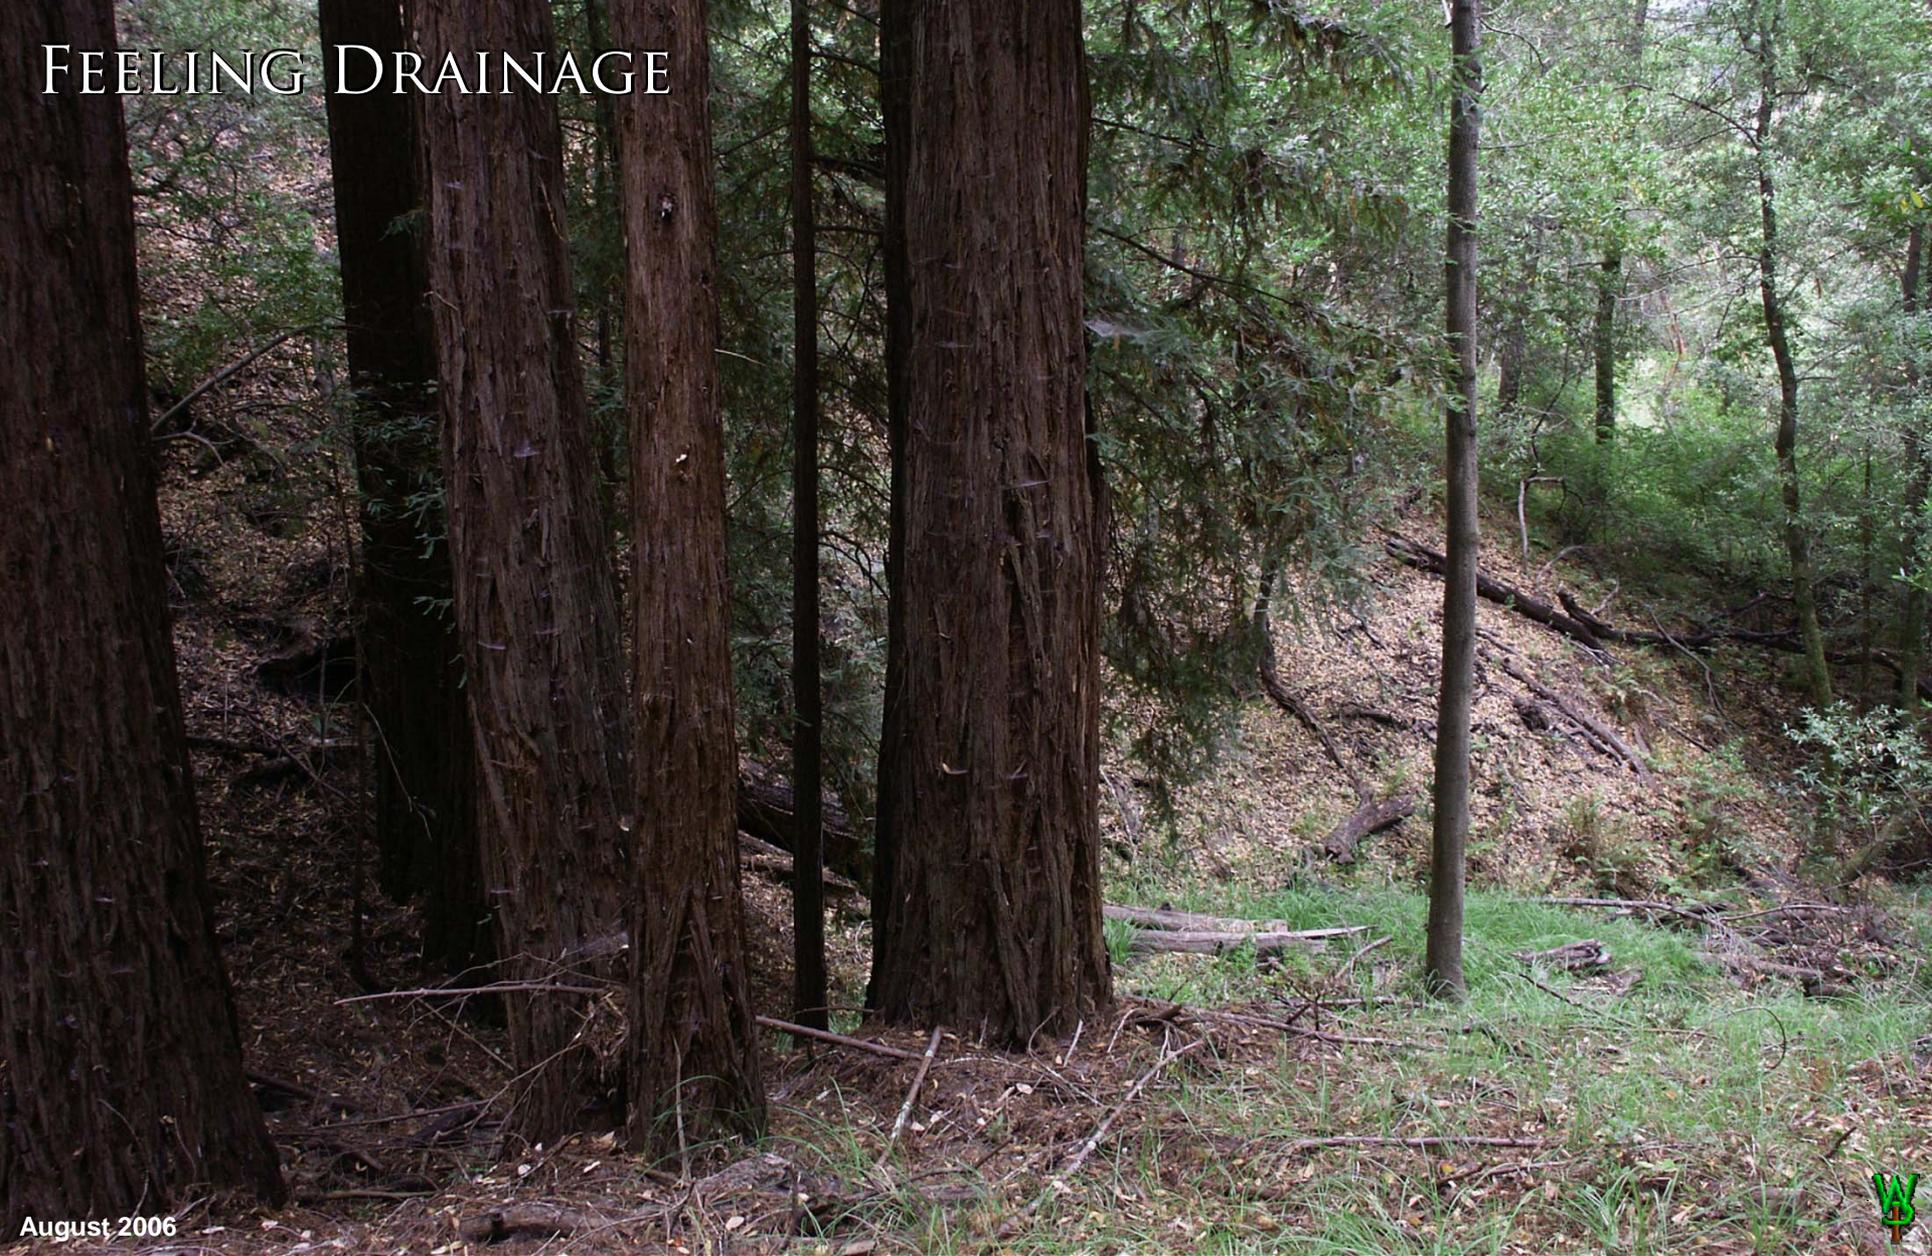
August 2006

One of the ways in which the sponsors of the environmental industry have driven the domestic timber industry into ruin has been with claims that logging releases sediment into streams, thus harming "endangered" fish (never mind the fact that the fish were more abundant at a time when fishing, timber harvests, grading, and drainage practices were totally unregulated). A logging job surely does release sediment, just as not logging can also do, in a much bigger way. This was one of two spots that taught me why. Can you see it?

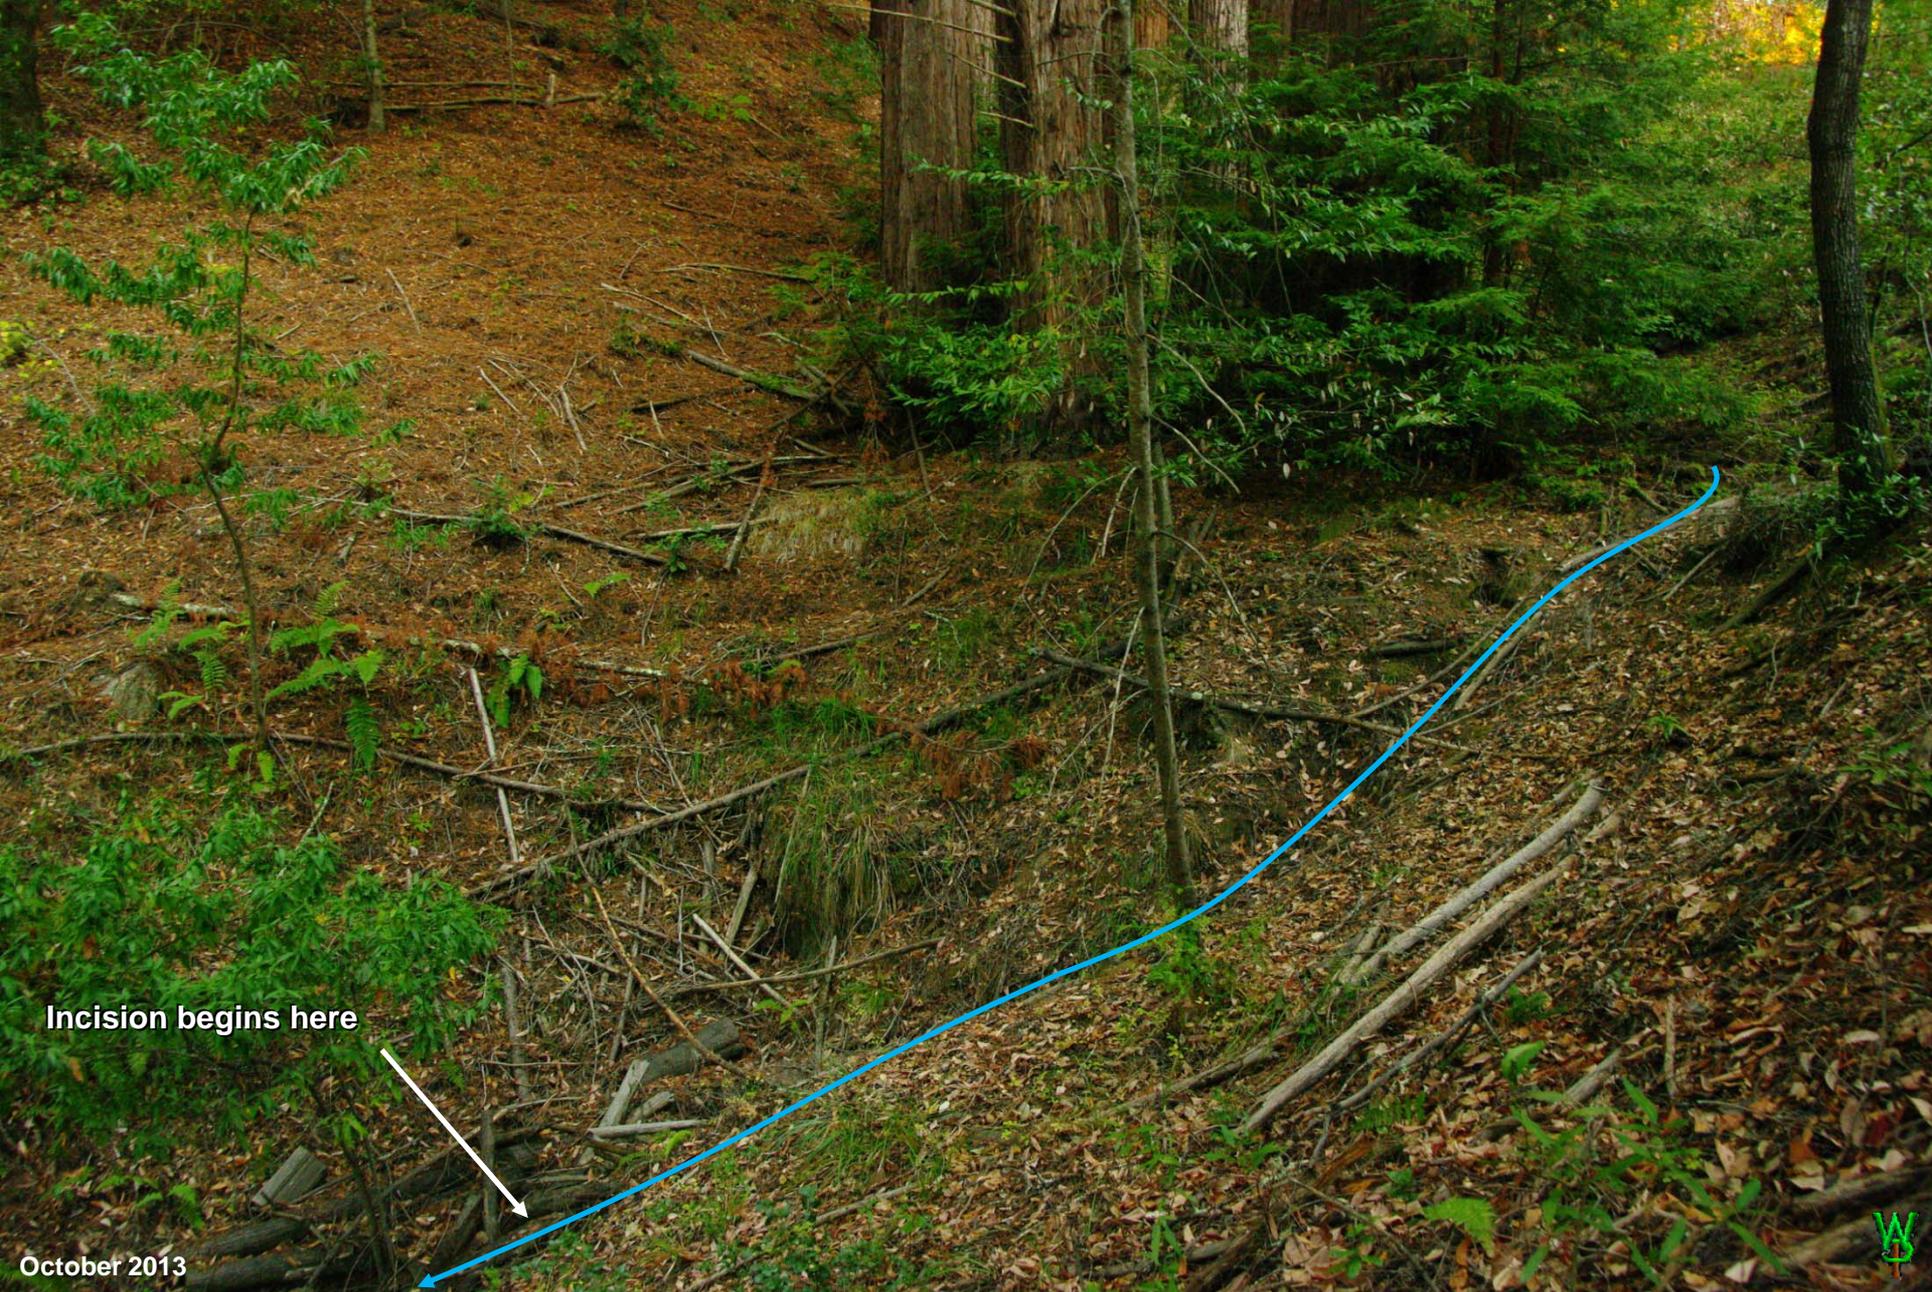
October 2013

Incision begins here

Here is the same cluster of redwood trees seen from the other side. It should be fairly obvious that the root mass of these trees inhibited a considerable amount of erosion of the stream bed , also called “channel incision” such as you see below them. From this example, I have learned to reverse that incision process for reasons we’ll get to soon.

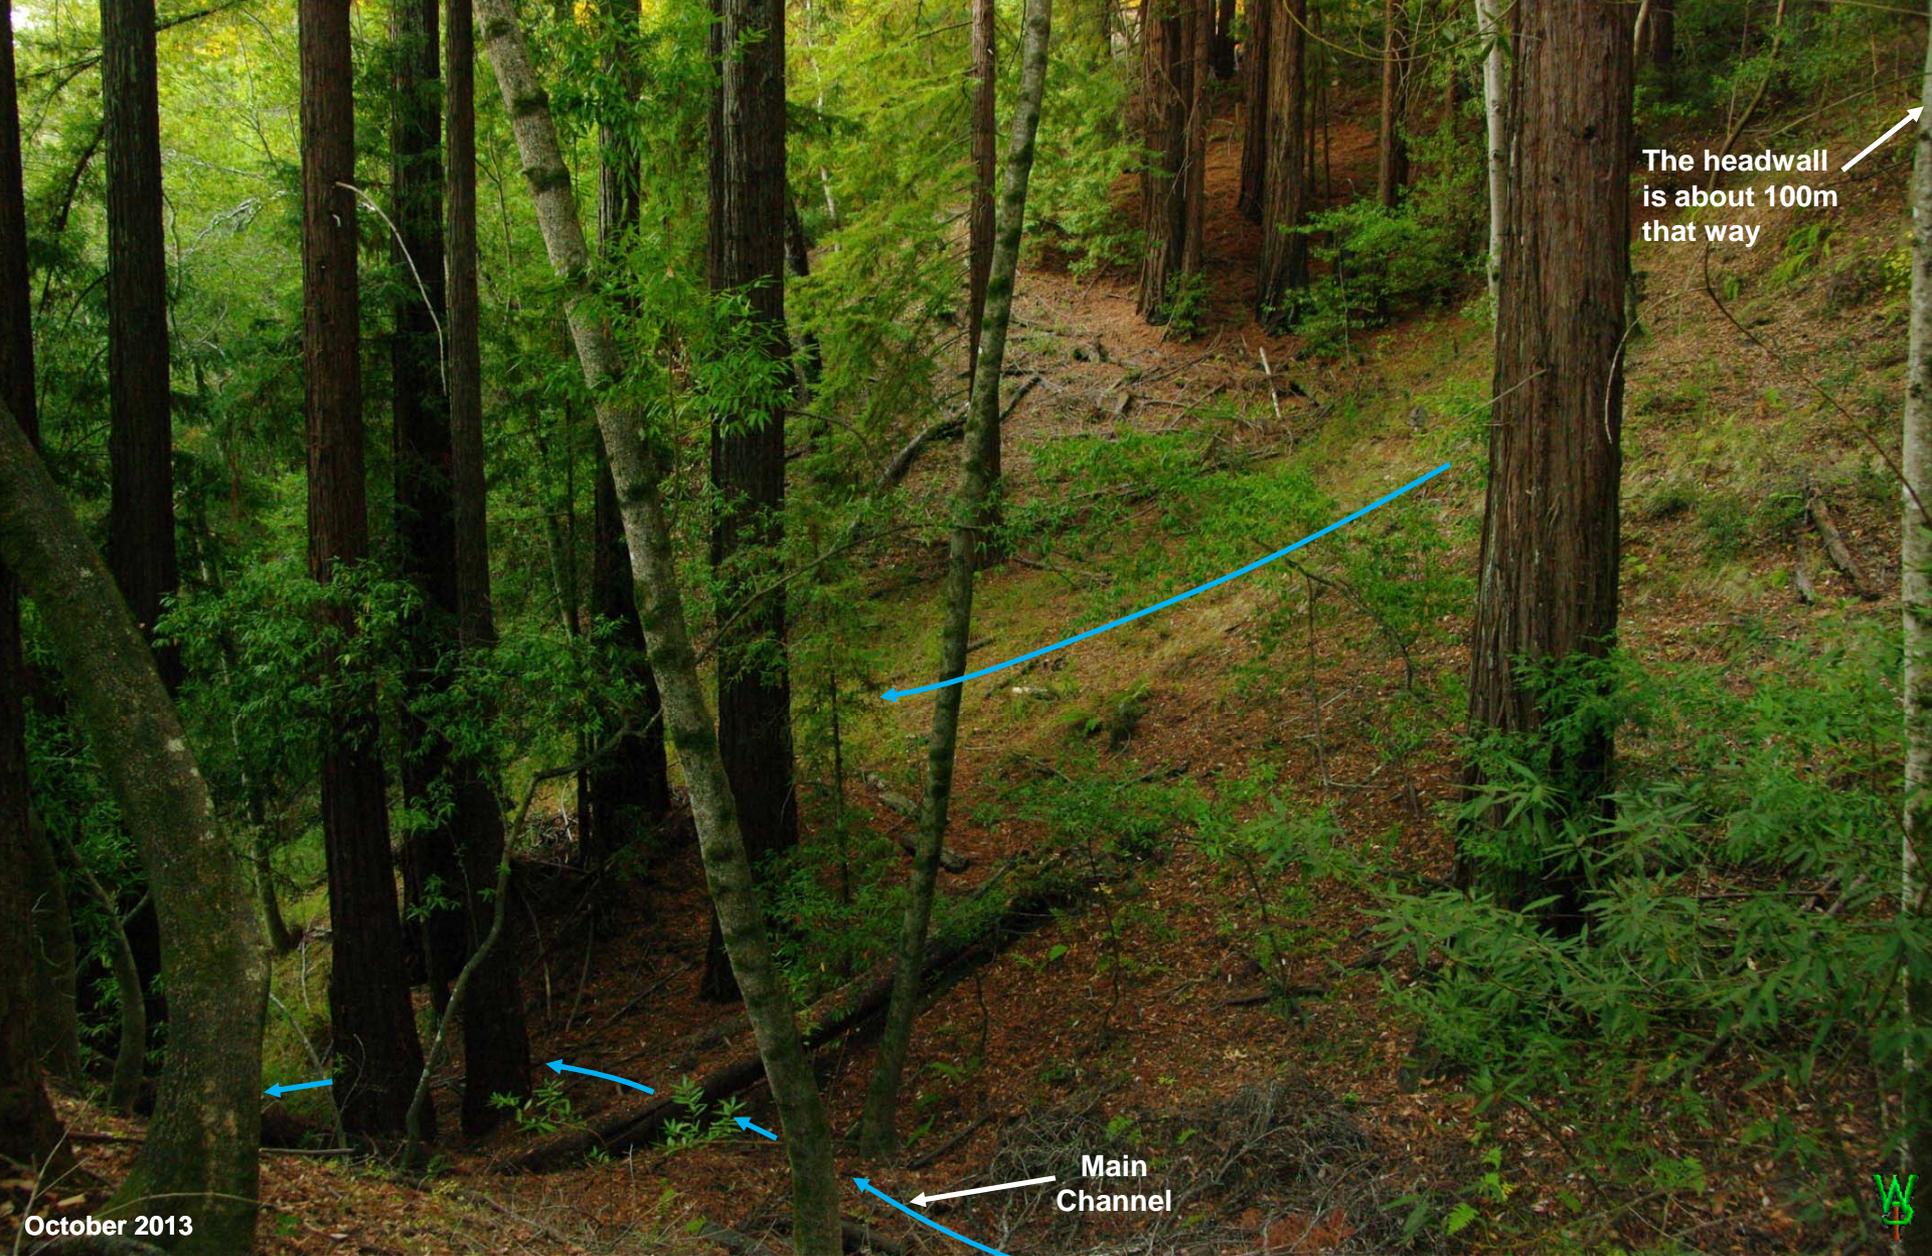
October 2013

The headwall is about 100m that way

Main Channel

Looking down the channel from the same spot, it isn't hard to see another landslide deposit with trees on top at the lower left. At the top of the draw to the right is a rotational slope failure with a steep headwall. I suspect that the green swath behind the trees is alluvial deposition on top of a colluvial lens. Based upon the stumps I have counted in this area, none of these trees is over 100 years old. Unlike the next draw to the north (TBD), there are no large old stumps. This has probably all happened since it was first logged.

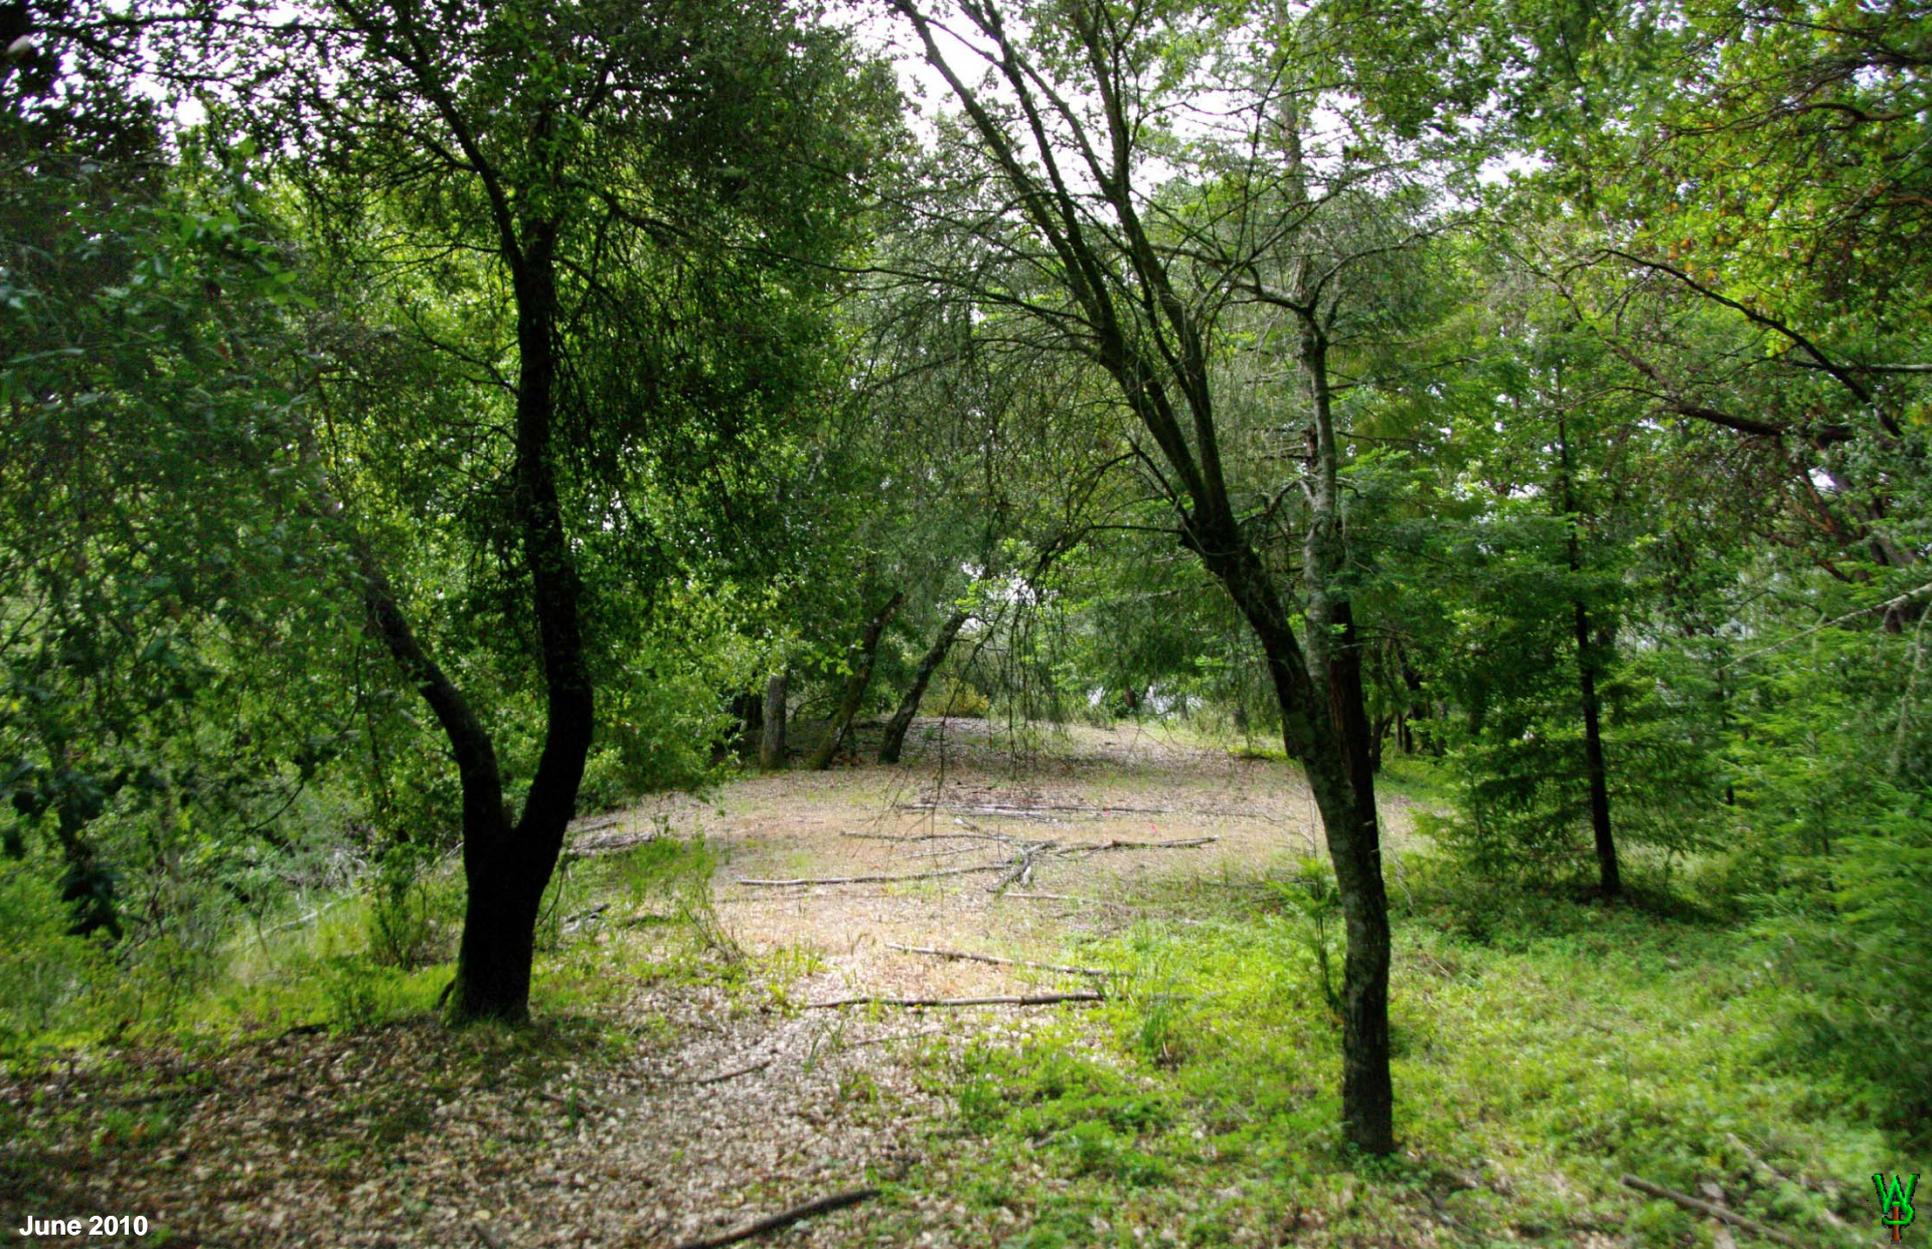
June 2010

You may remember this image from the repeat photos in the Introduction. The first thing I did to impede channel incision was to cut trees to the right side of this ridge, about 100 feet *above* the channel. Although cutting the bay trees up here was legal (not a timber harvest), it did reduce “stream canopy cover,” which could get you fined on a commercial job. The thing is, “How much shade is the right amount?” It turns out that when it comes to canopy cover, sometimes more is worse.

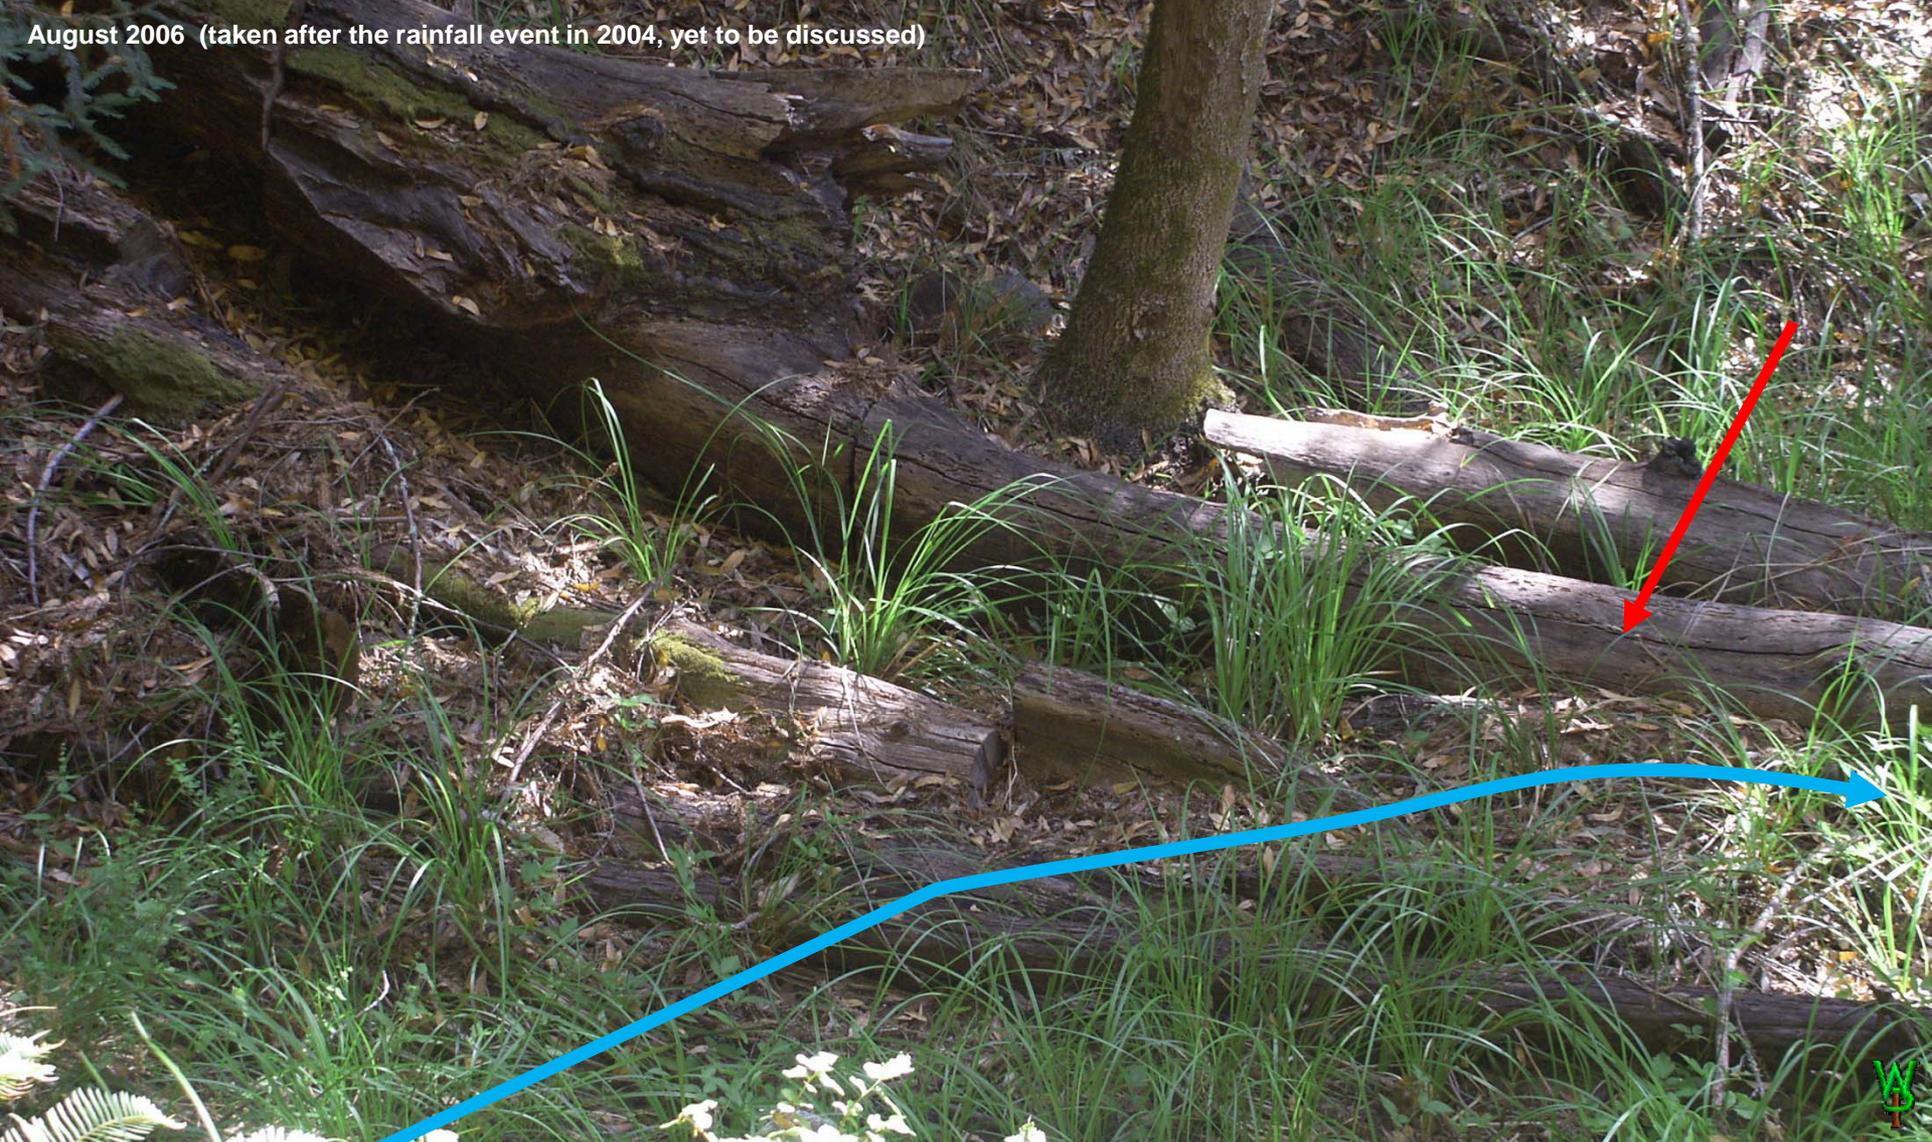
August 2006 (taken after the rainfall event in 2004, yet to be discussed)

This location is just downstream of the cluster of redwoods two slides prior and below the ridge on the prior slide. Thinning the trees up above allowed sunlight to stimulate the growth of Santa Barbara Sedge down here. Once it was established, I bucked this log bridging the stream (red arrow) such that it would deflect the flow to the right over the top of a colluvial deposit, just to see what would happen (I could always part it and send the water back into the original channel). The old channel was incising at the base of a steep slope I wanted to stabilize. I knew that if the slope failed, the water would go over the colluvium and carry away a considerable amount of sediment anyway. This dead madrone had gone down by itself, and I wish I'd cut it first as the root ball tore a heck of a hole out of the side of the hill (one of those things I just didn't get to in time). Turns out, I was just in time...

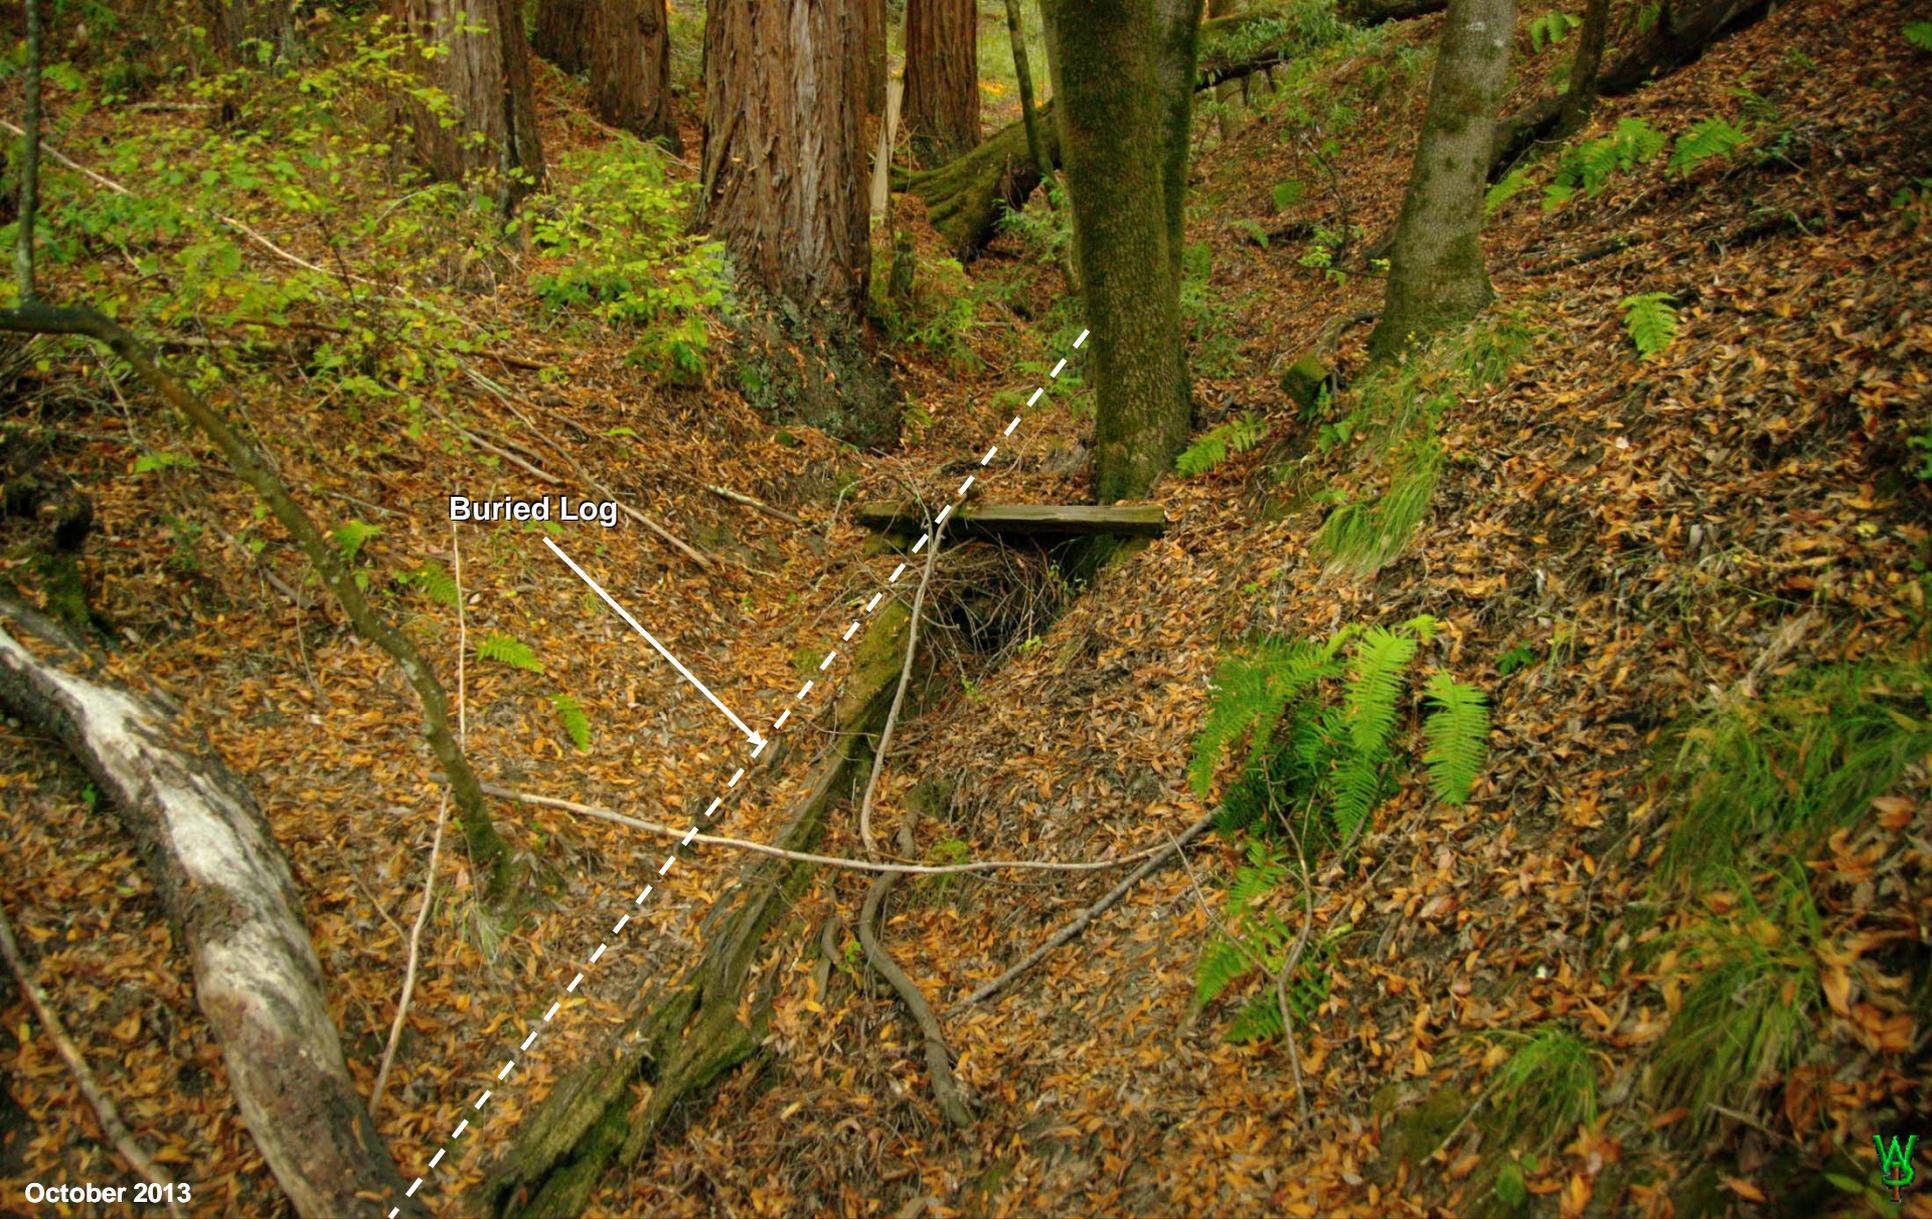
October 2013

Buried Log

Here is the other 'thing that taught me what to do,' and it is what shaped the toe of that slide. This log is *underneath* the landslide with the trees sitting on top. It is one very substantial log. It was cut by a saw on one end, so it is impossible for the slide to be over 150 years old. From the size of the trees, my guess is that it has been here about 90 years. If the Vaquero sandstone substrate is relatively uniform, it may be that wood has been *the* critical factor in defining channel shape and distribution in this region. Once the channels start, they tend to keep cutting in the same location, unless there is faulting or somebody does something, as we shall see.

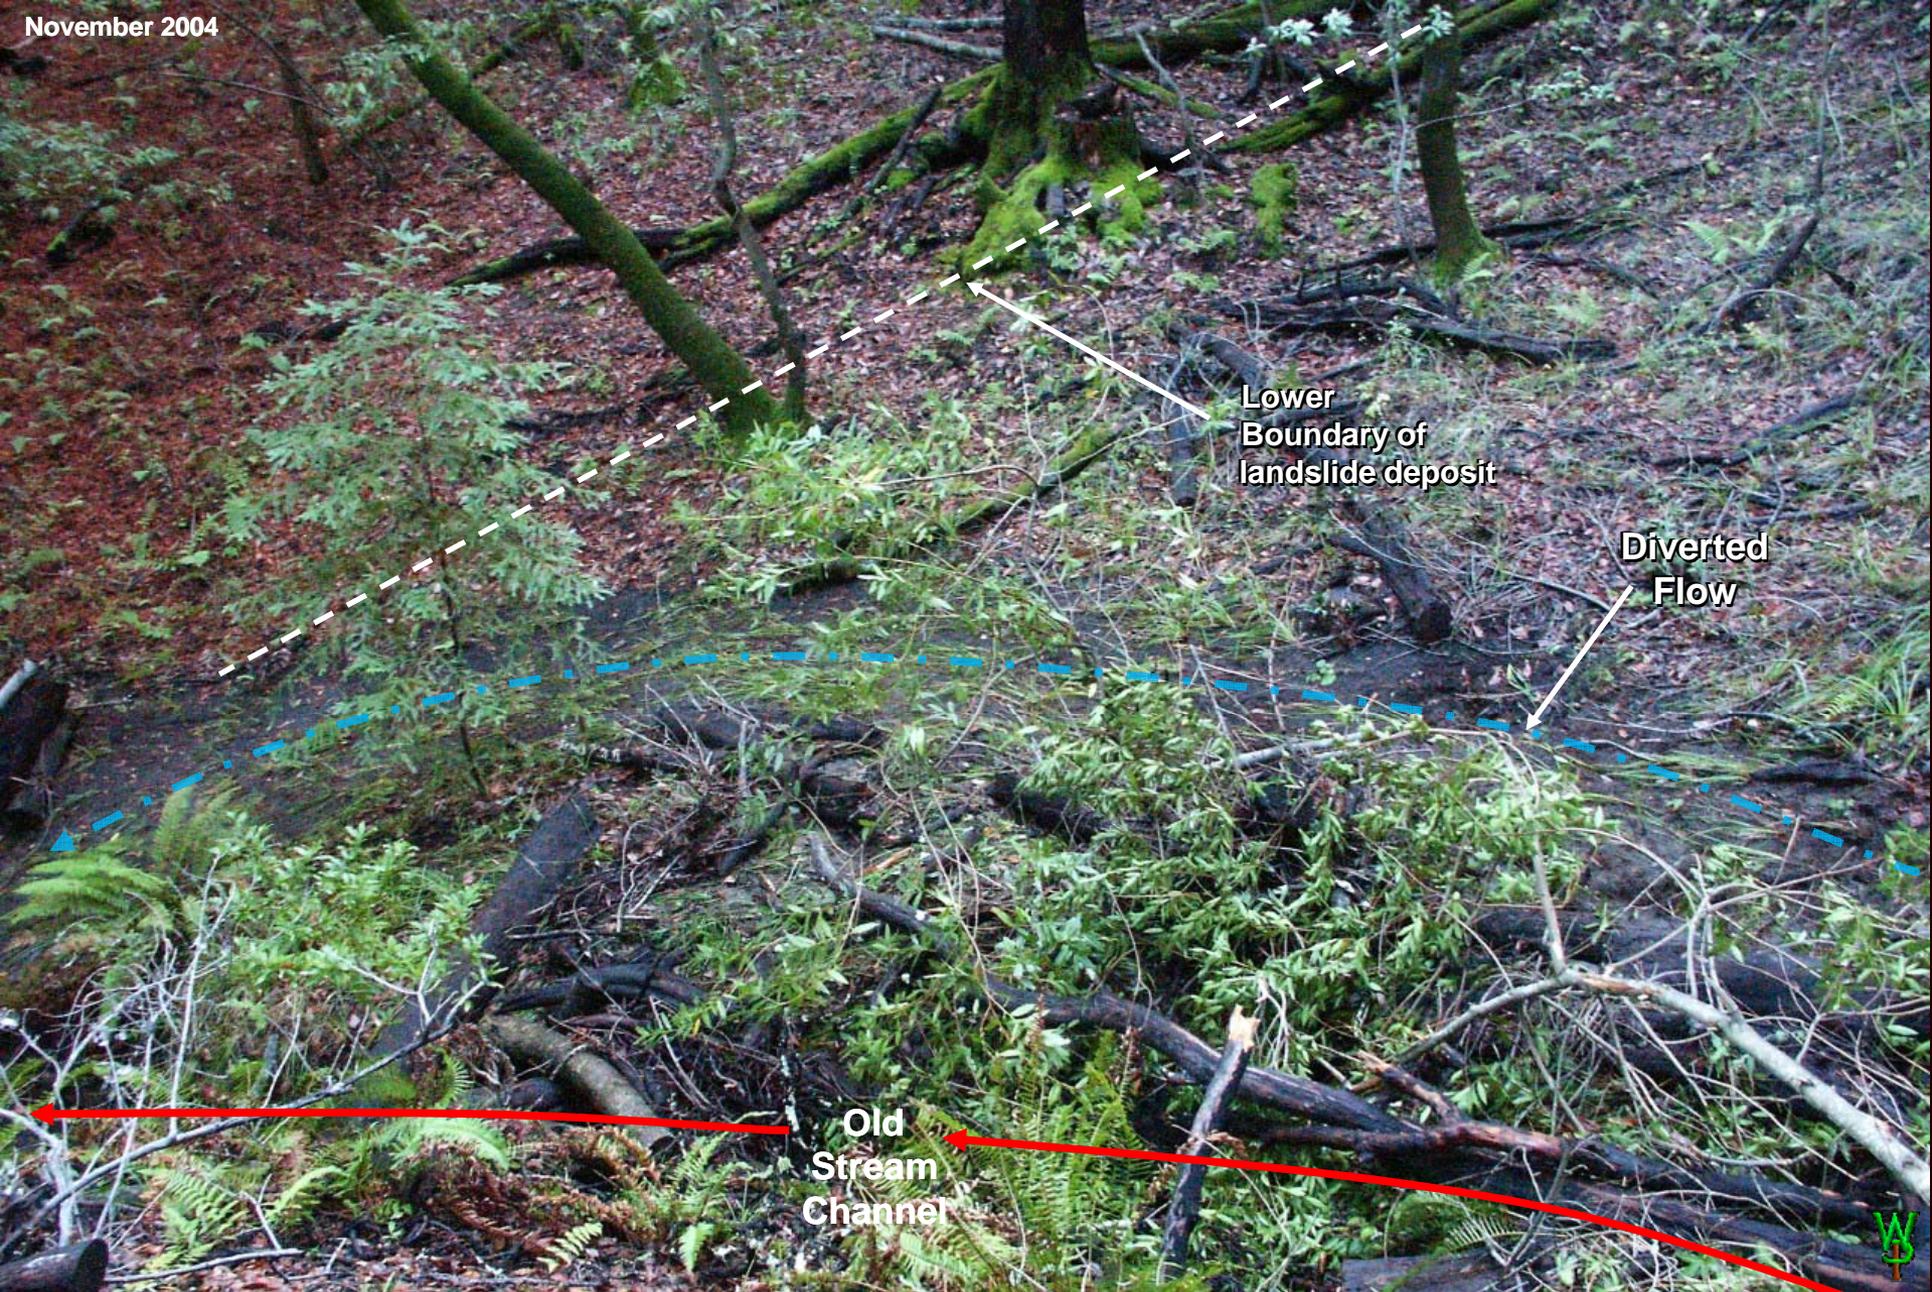
Lower
Boundary of
landslide deposit

Diverted
Flow

Old
Stream
Channel

Most people would never guess that *reducing* canopy cover has anything to do with reducing erosion, but then, most people do not understand how amazing sedges can be in doing that job. As to the risk of a debris flow in case something goes wrong, there is a big flat area just below the outlet to this stand for the water to fan out and lose energy.

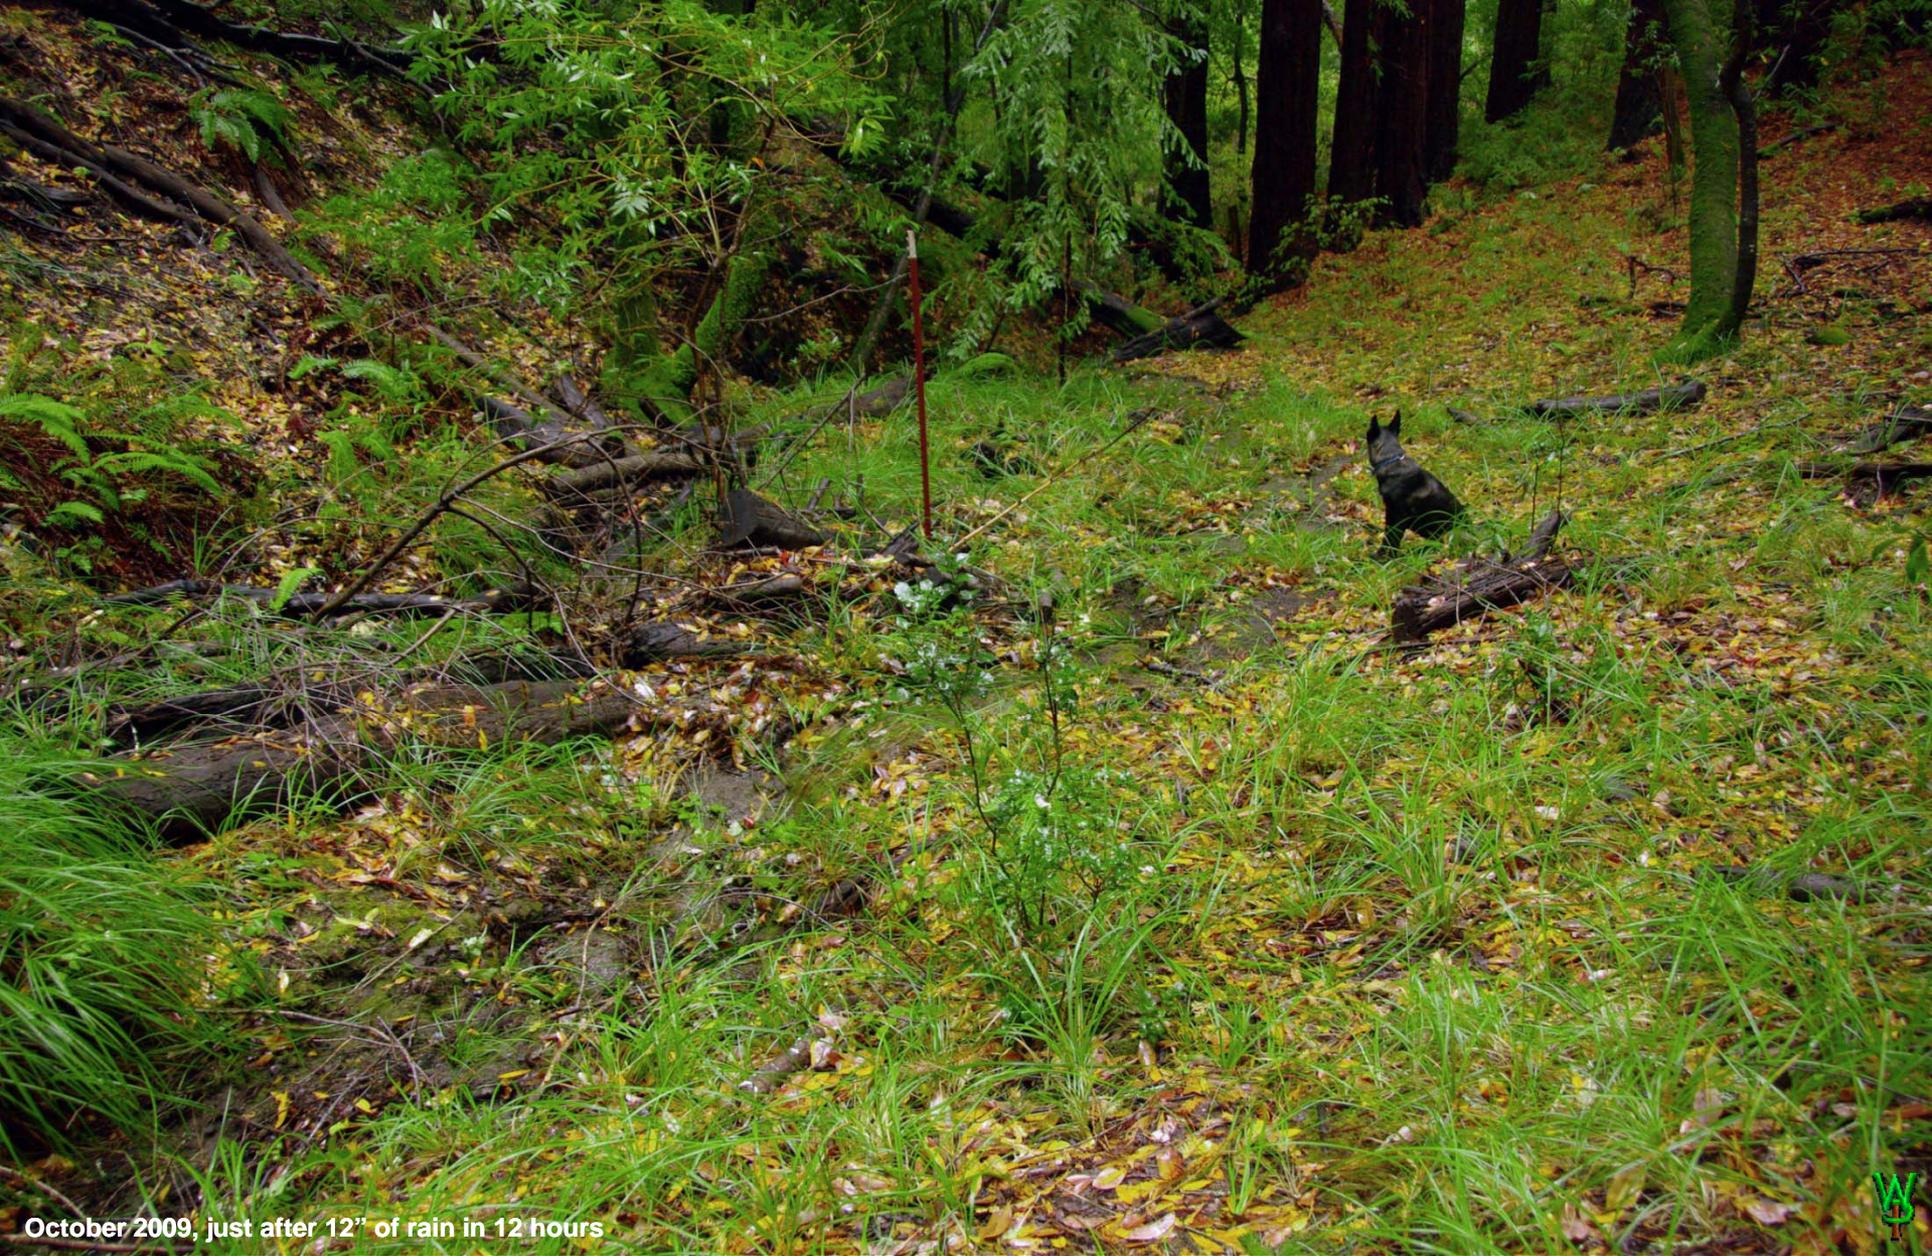
October 2009, just after 12" of rain in 12 hours

Here it is after five years of winter rains and just after another monster storm. If you look carefully, you'll see not erosion but *deposition* of sediment in the foreground at the head of the diversion. That material is from all over our property, from the my neighbor across the road, various stumps from fallen trees, etc, but probably the biggest source is gophers, ground squirrels, moles, and rabbits. I use that material to stabilize the draw over time, as you will see in our next example in the next channel in the middle of the property.

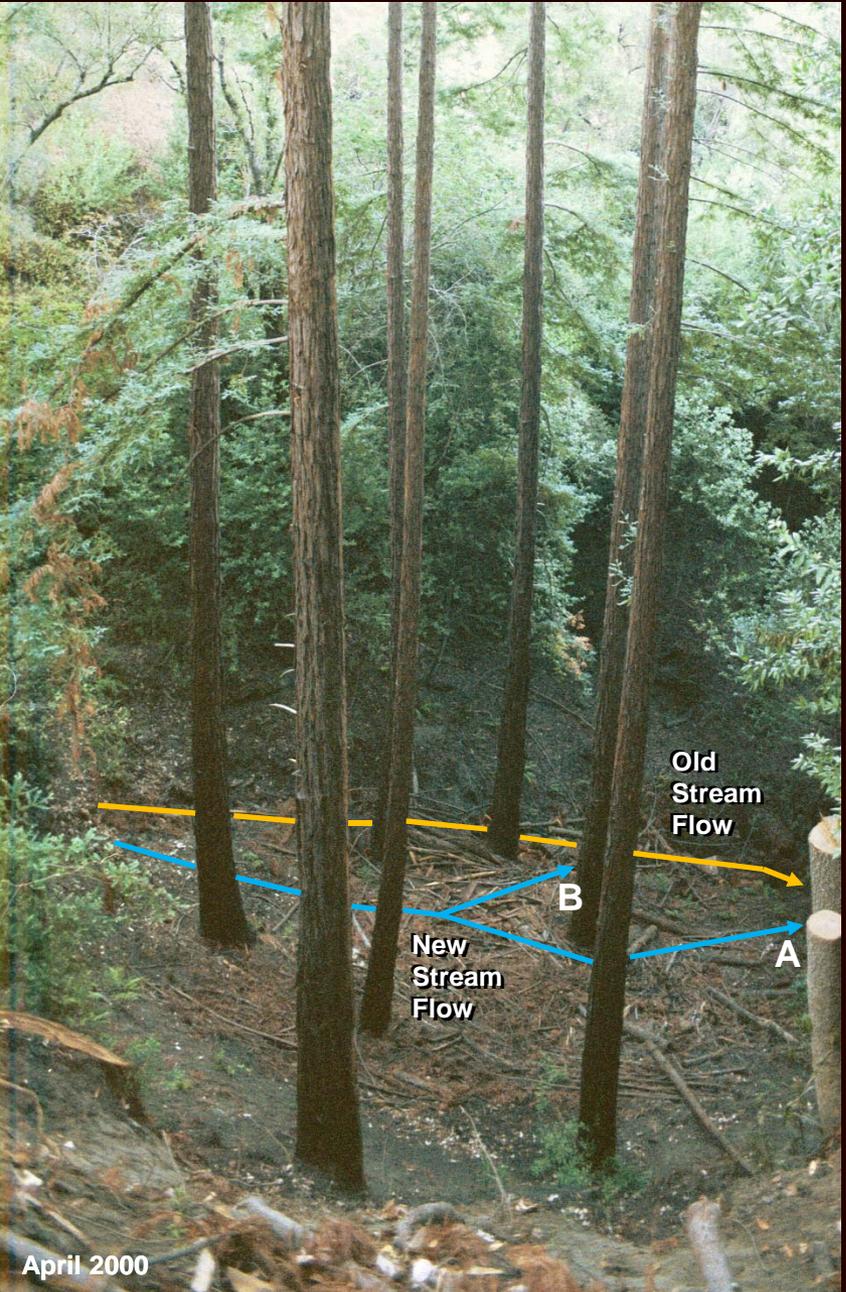
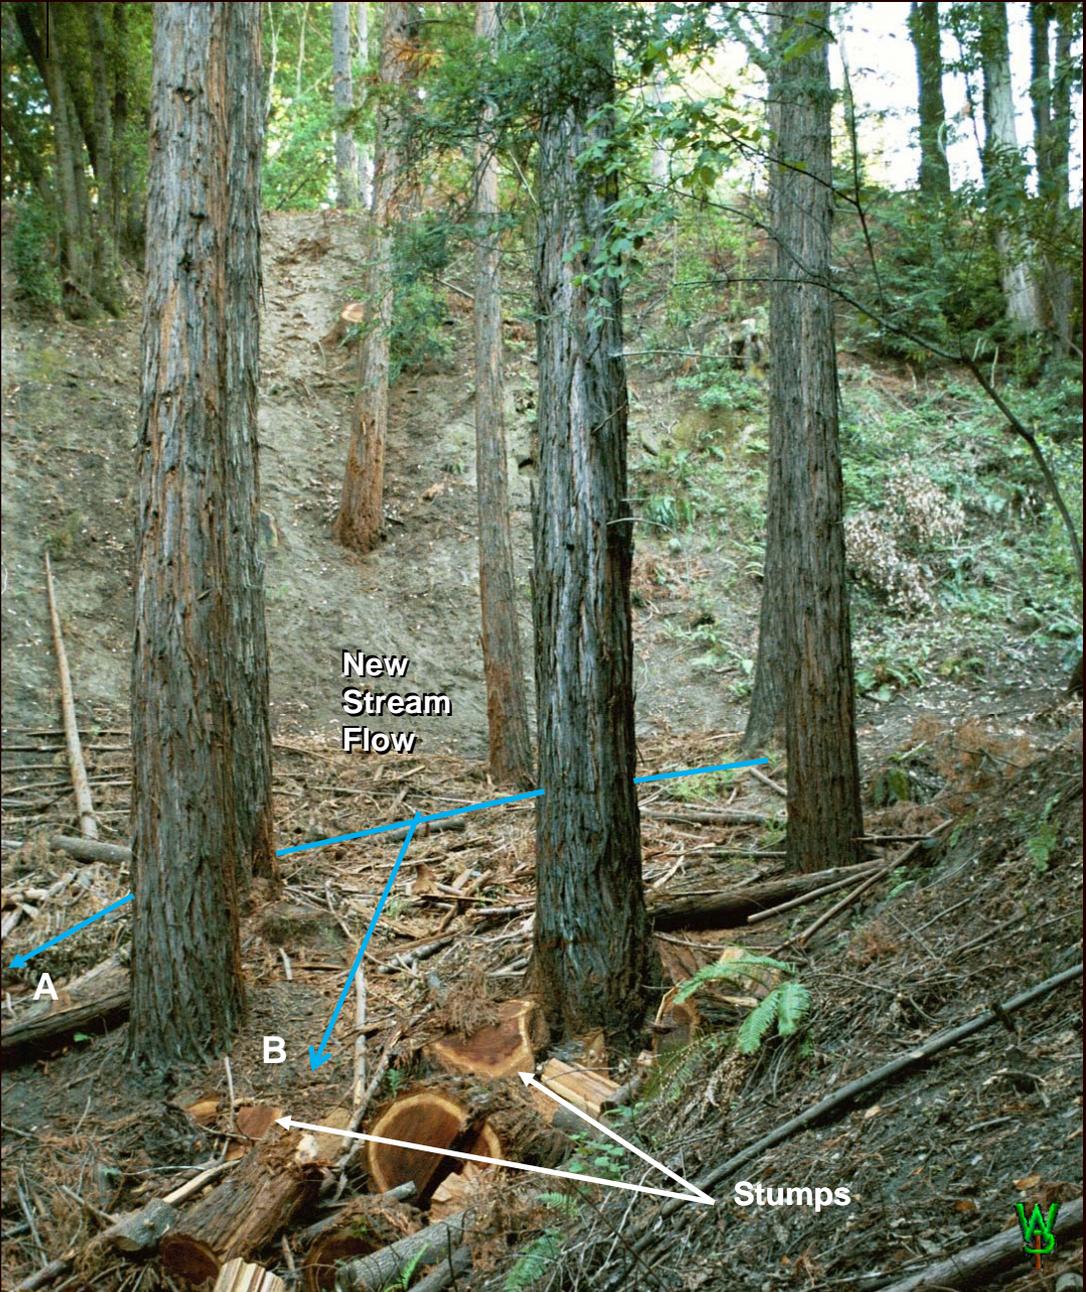
April 2000

As you can see on the left, I broke the flow into two streams, meaning that the total energy hitting any one spot is greatly reduced. The run-out slope "A" is a great deal lower which also reduces water velocity. Flow "B" smacks headlong into a stump, which being redwood will last a good long time, especially because it will re-sprout new trees. Because of the slope, I don't expect much deposition here.
