FEELING DRAINAGE

WILDERGARTEN 4.0

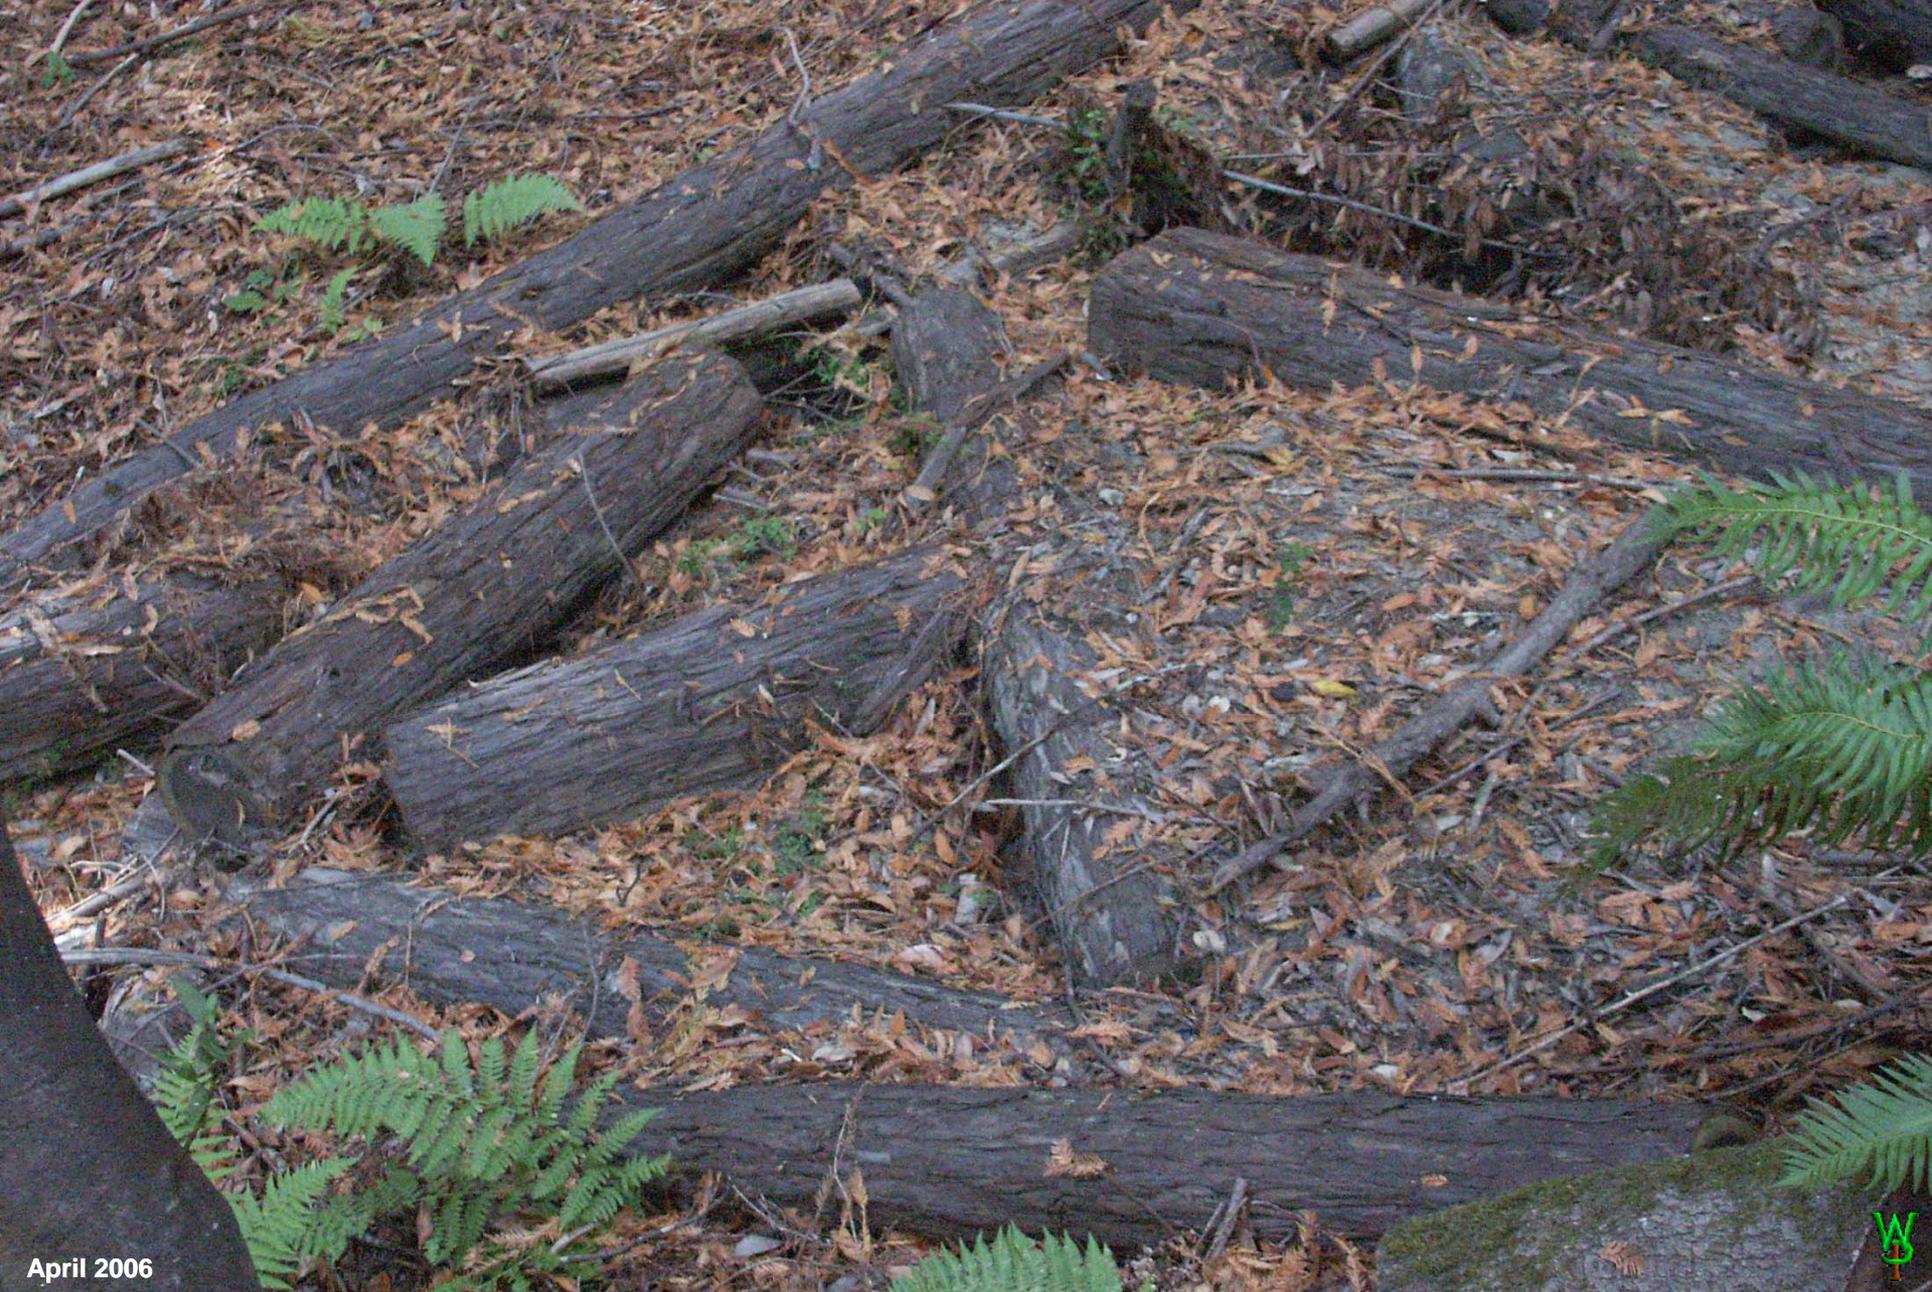
April 2006

Here we are just below that cluster. This wood wasn't just 'dumped into the creek;' it was placed carefully with higher outside walls to contain a huge flow inside the channel with the inside pieces triangulated to wedge each other while breaking the flow into a very convoluted path. It isn't hard to see the sediment that it captured.

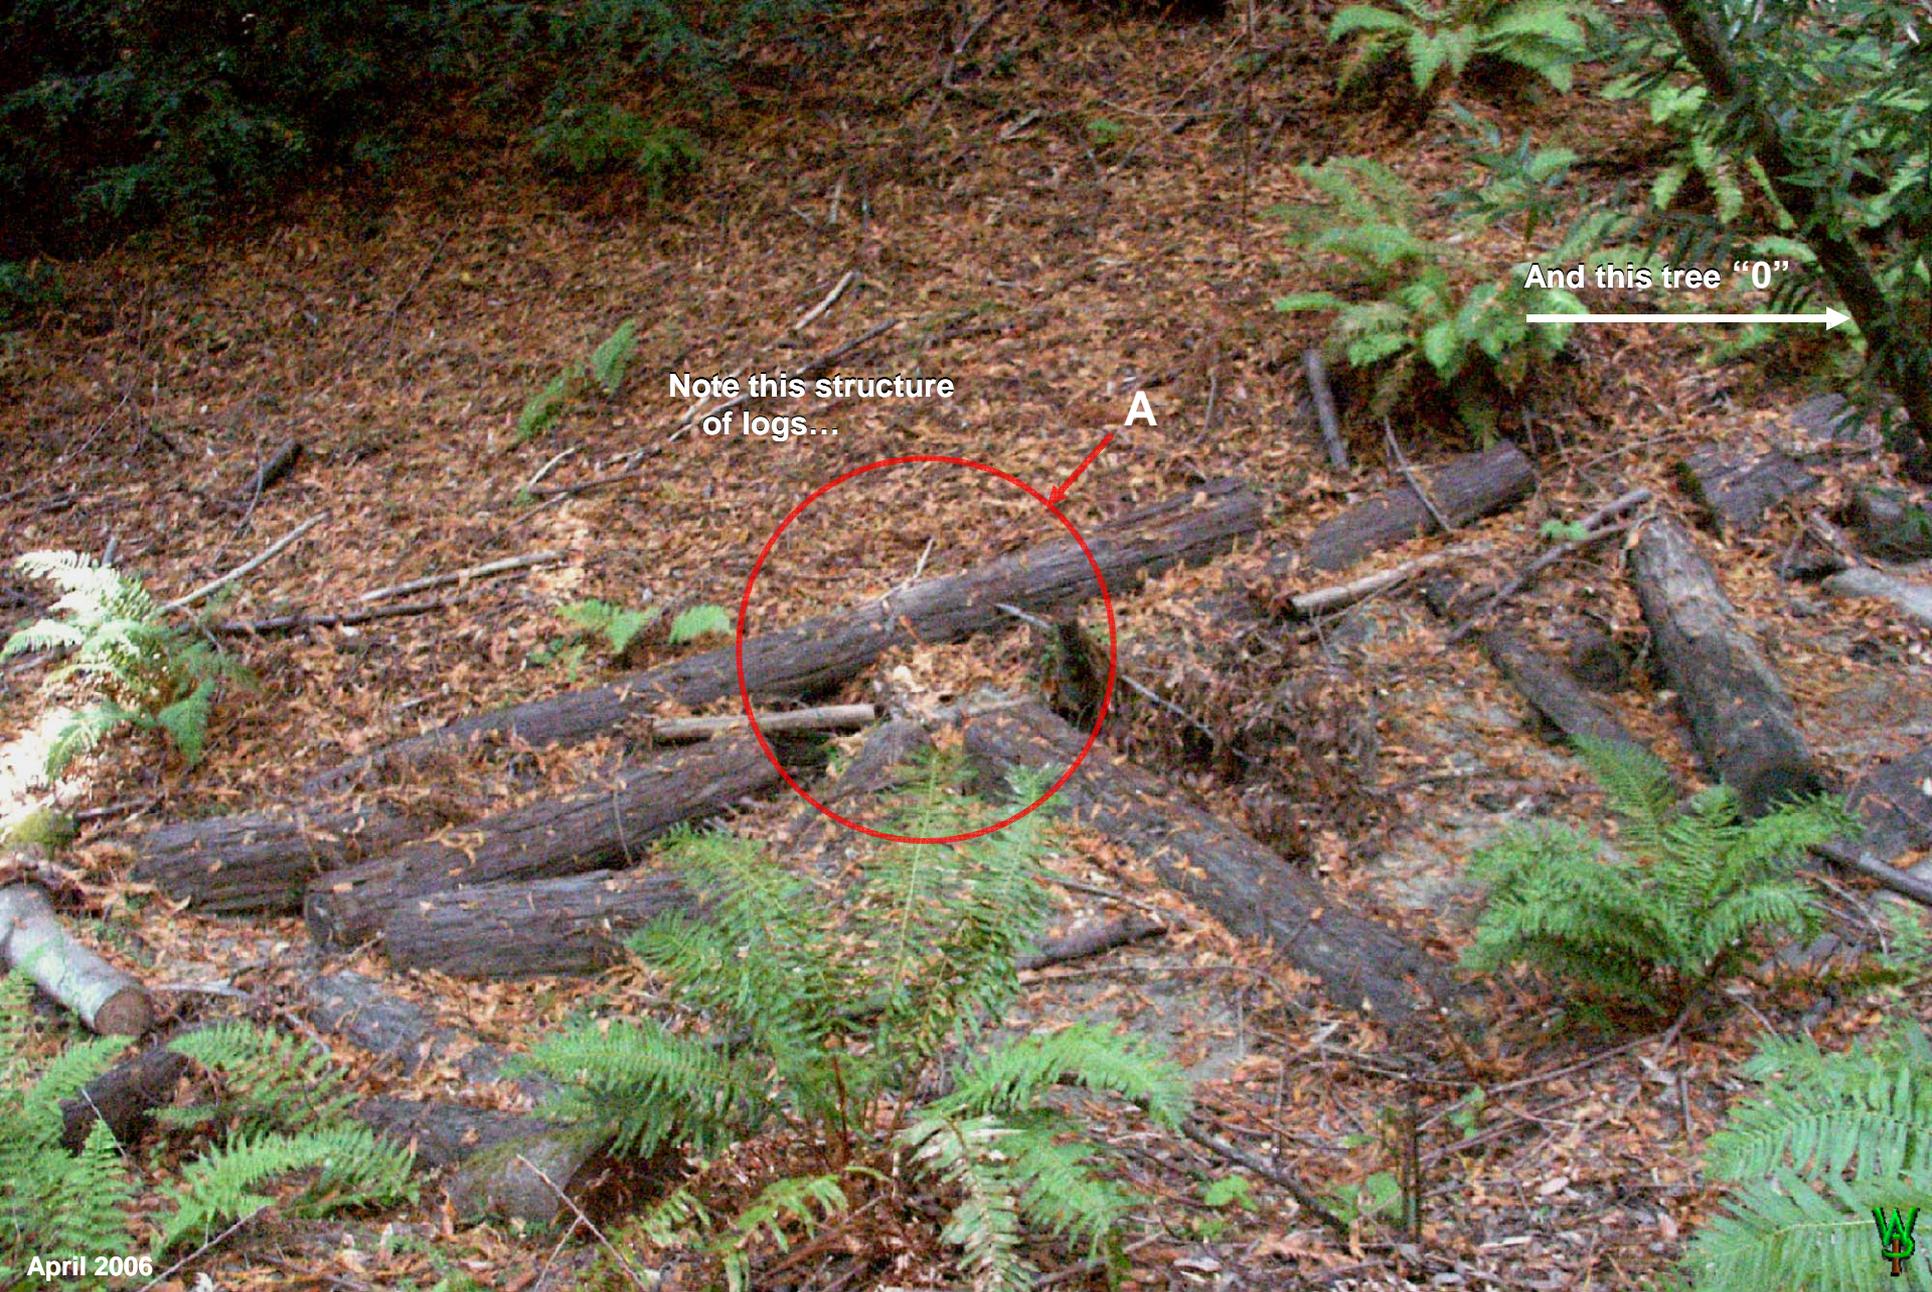
April 2006

Note this structure
of logs...

A

And this tree "0"

All those tiny sources of sediment add up to a lot that was once lost off the property every year. This photo was taken six years after my original 'logging job' in 2000. The sediment has almost completely filled a channel 6-8 feet wide and 2-4 feet deep. Note the circled structure "A" for reference from slide to slide.

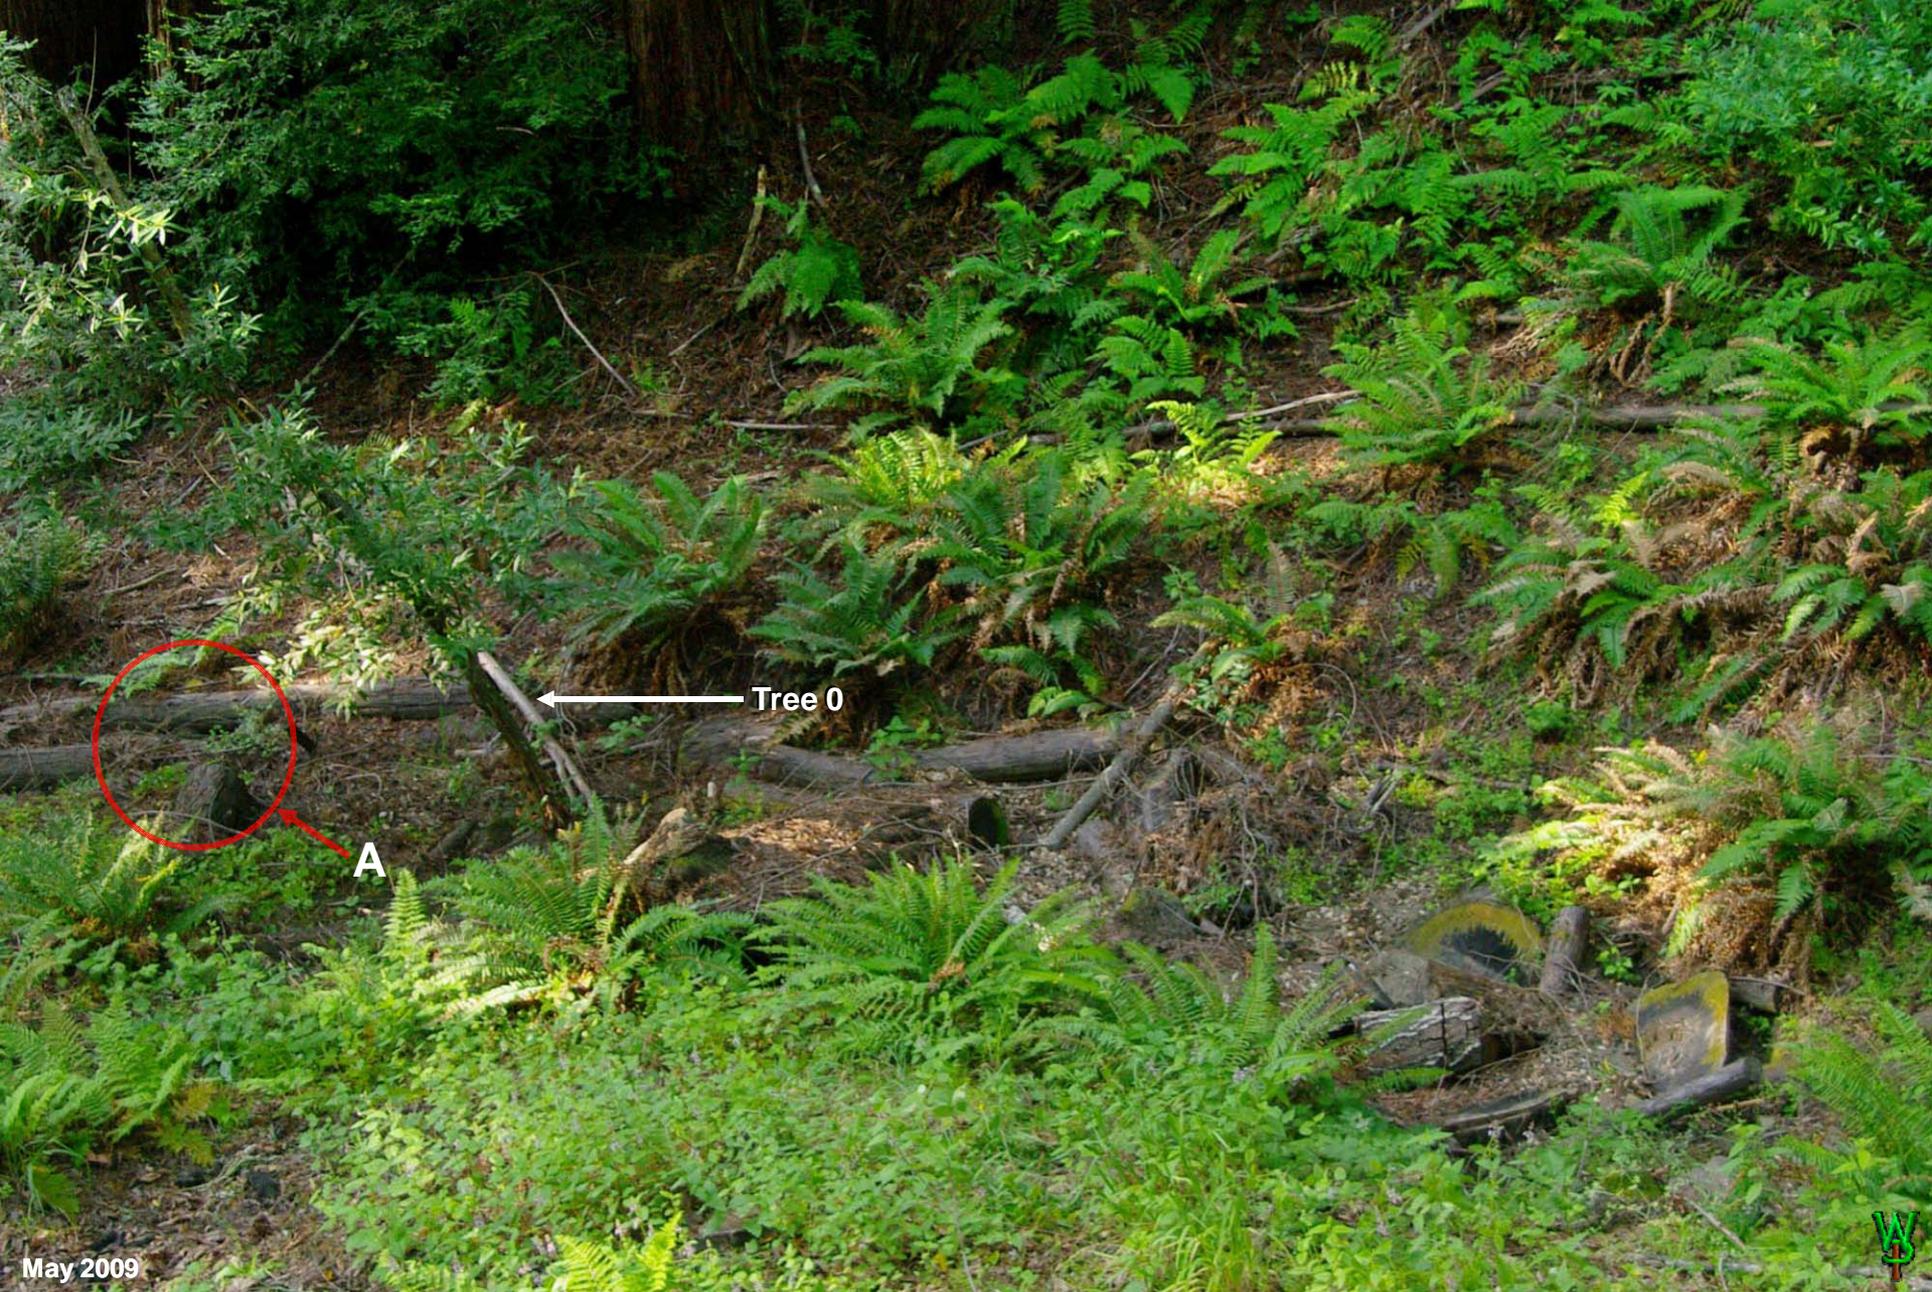
May 2009

This is the same channel three years later from a little wider view. Logging made the material to line the bed and collect the annual deposition. Logging thinned the slopes so that light could reach the canyon bottom to stimulate the vegetation. It's working, but more thinning is needed for the sedges to really take. More sediment will help too. Note "Tree 0" with the white arrow for location.

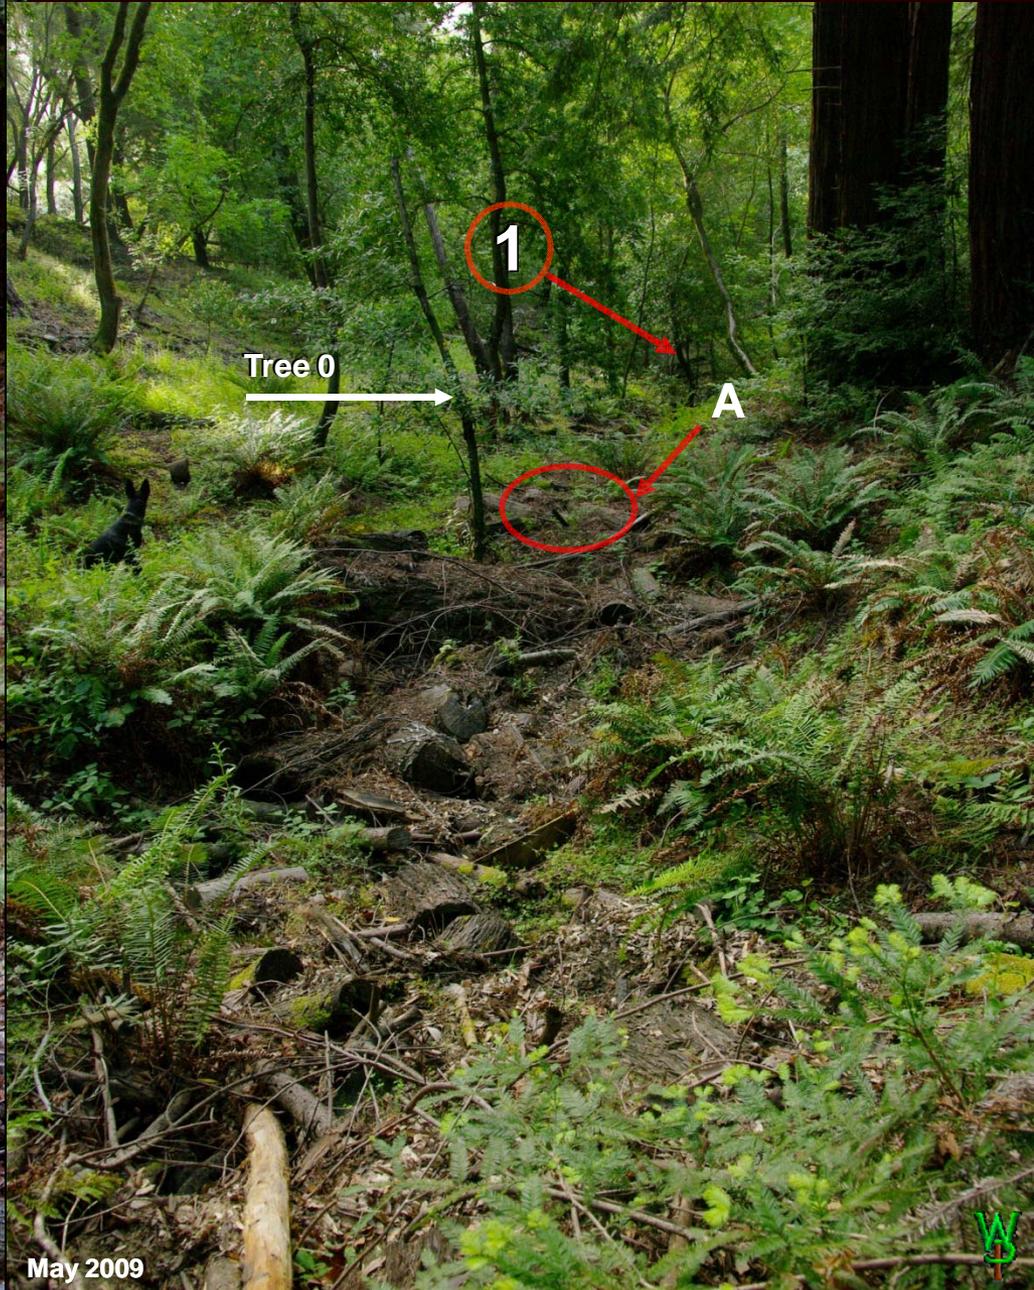
From above, L+6, same channel. This year, I thinned bay trees above the left background and put more wood into the stream along the dashed line down to the circled tree (1).

Here it is L+9 from a spot just to the right (new vegetation was in the way). Thinning the hillside on the left allowed in a lot more light. The stream bed is still filling in and more plants are taking root.

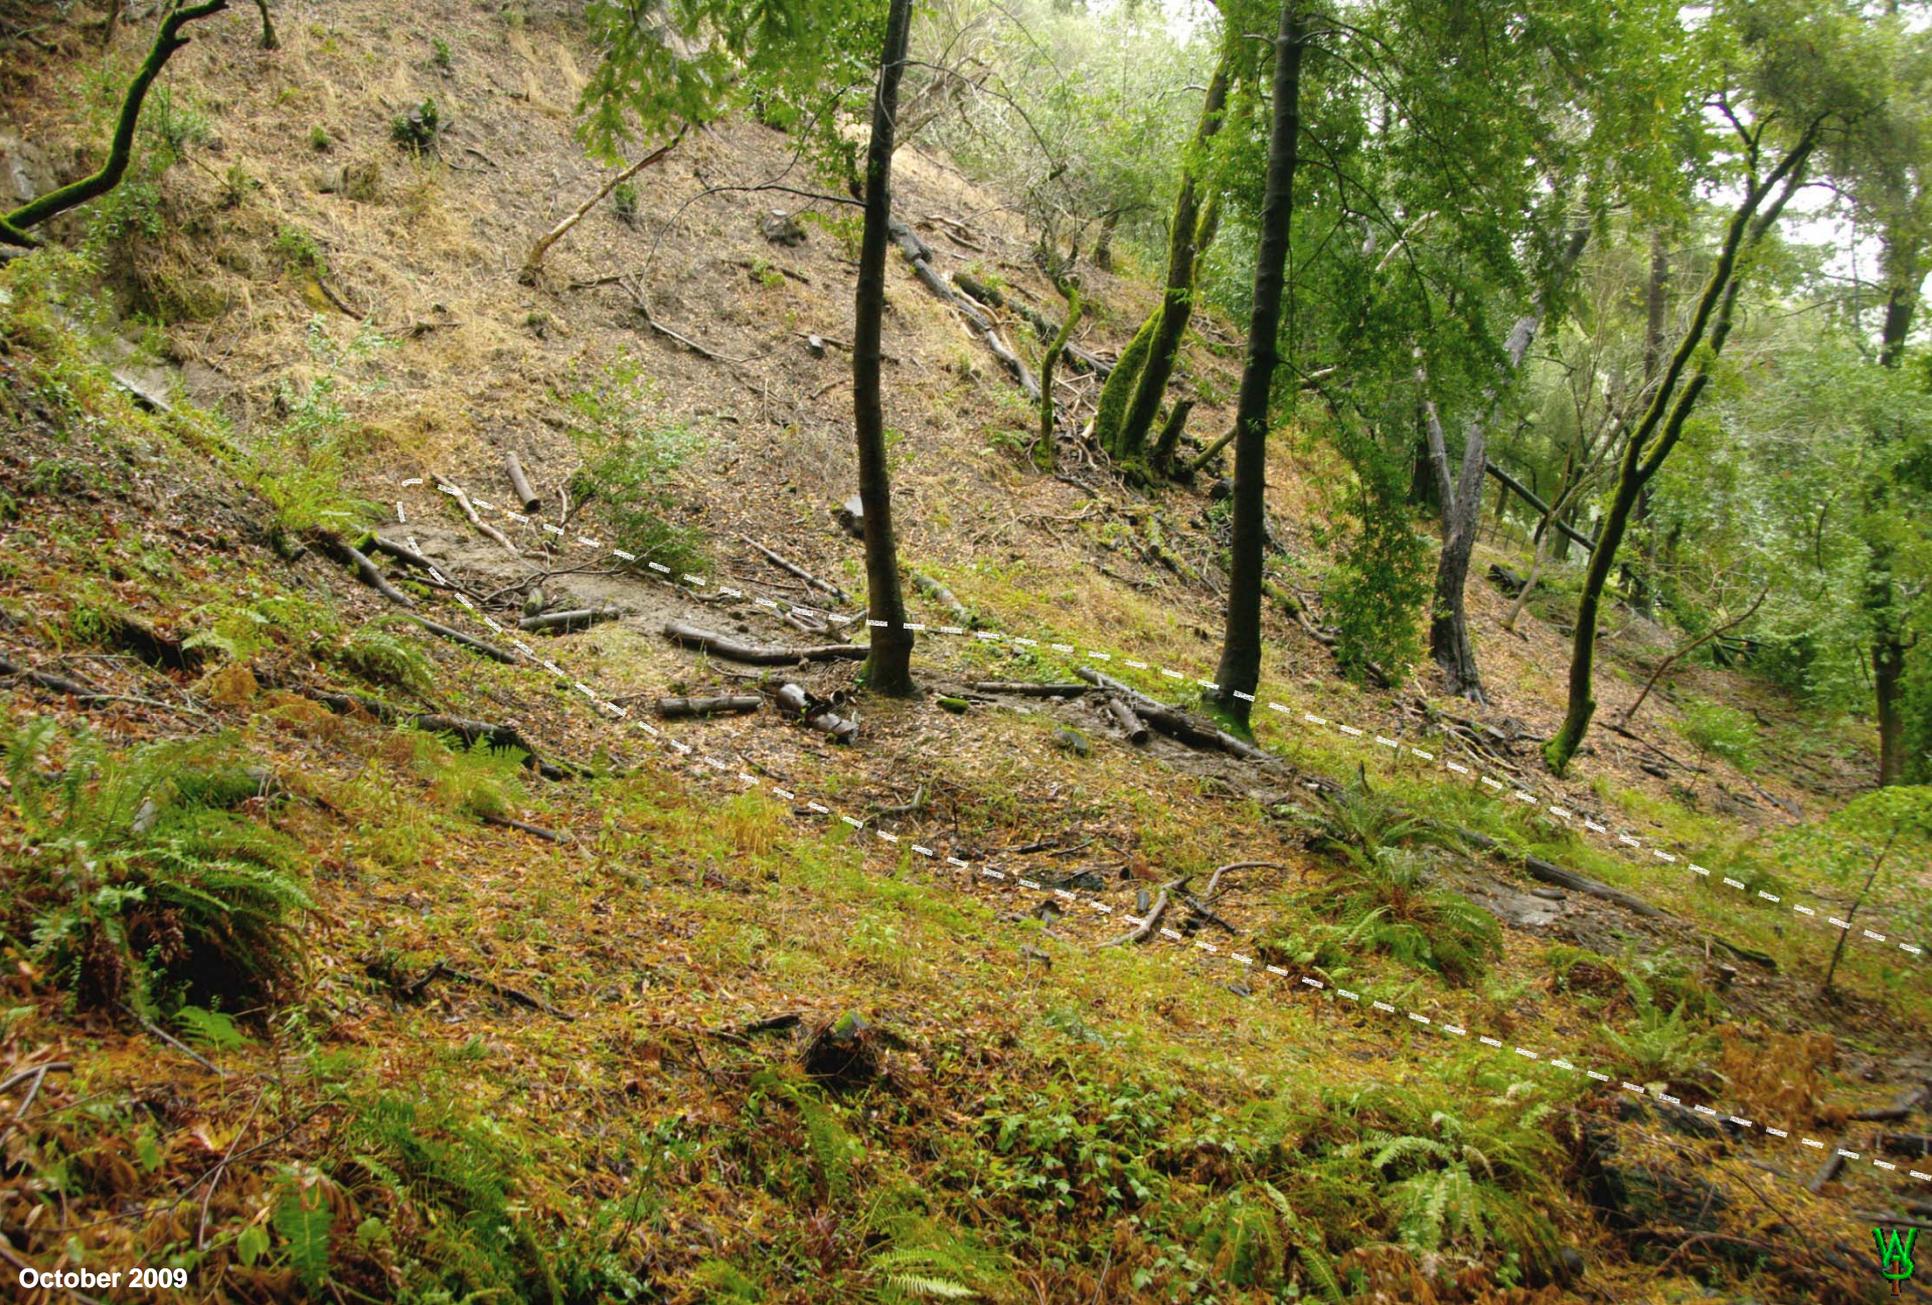
October 2009

Besides the material filling this channel from all over the property, I also mine some of it from this older alluvial deposition. The pieces of wood you see chocked against the trees steer the flow across the pillow pile of sediment and into the stream. It's slow, but it works.

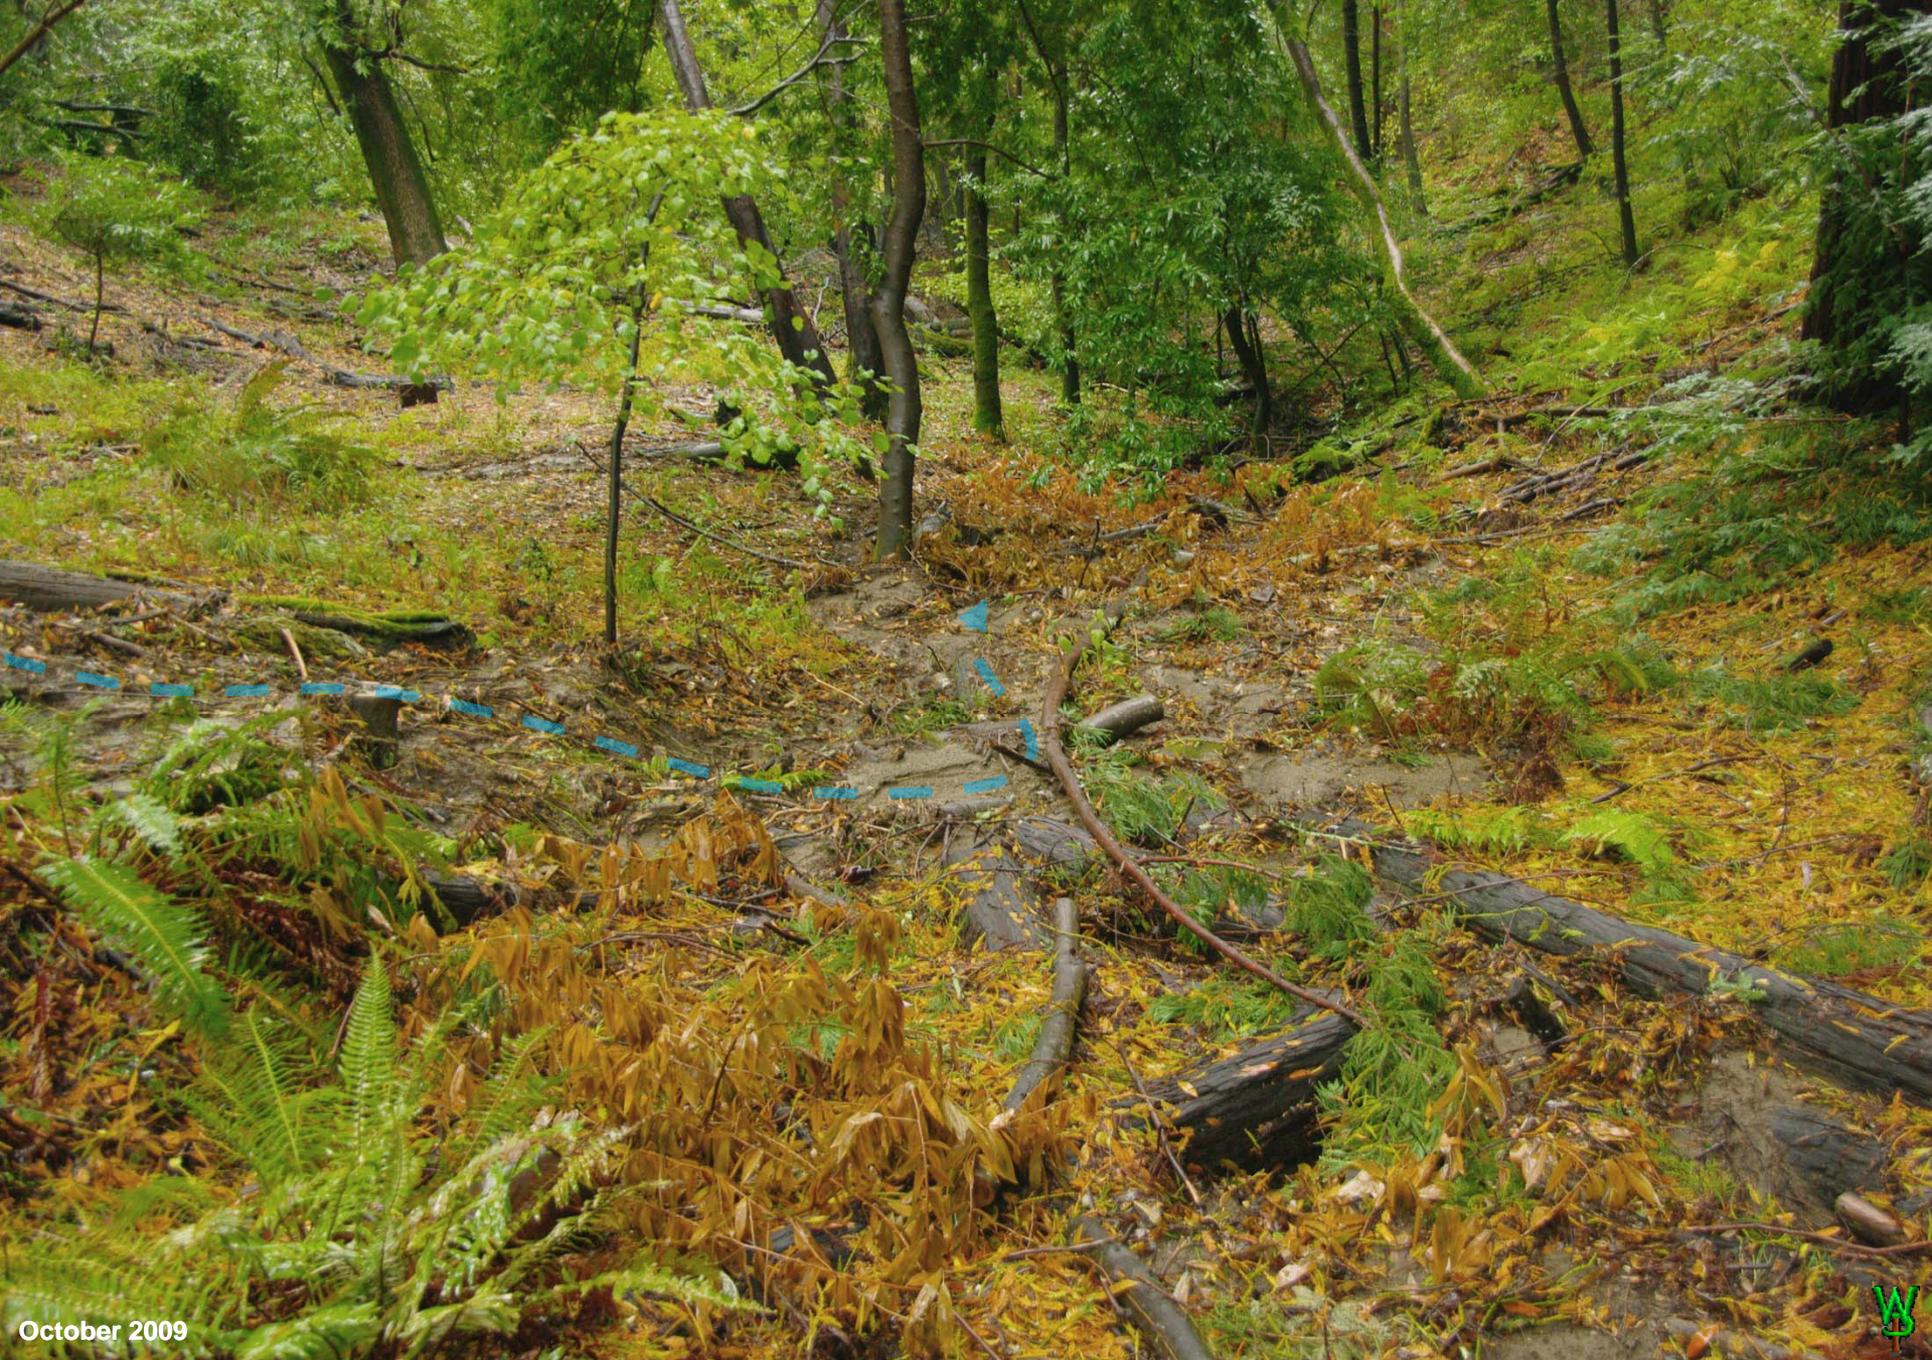
October 2009

Here is where it enters the main channel from the left. Note the branches to slow it down and divert it downstream.

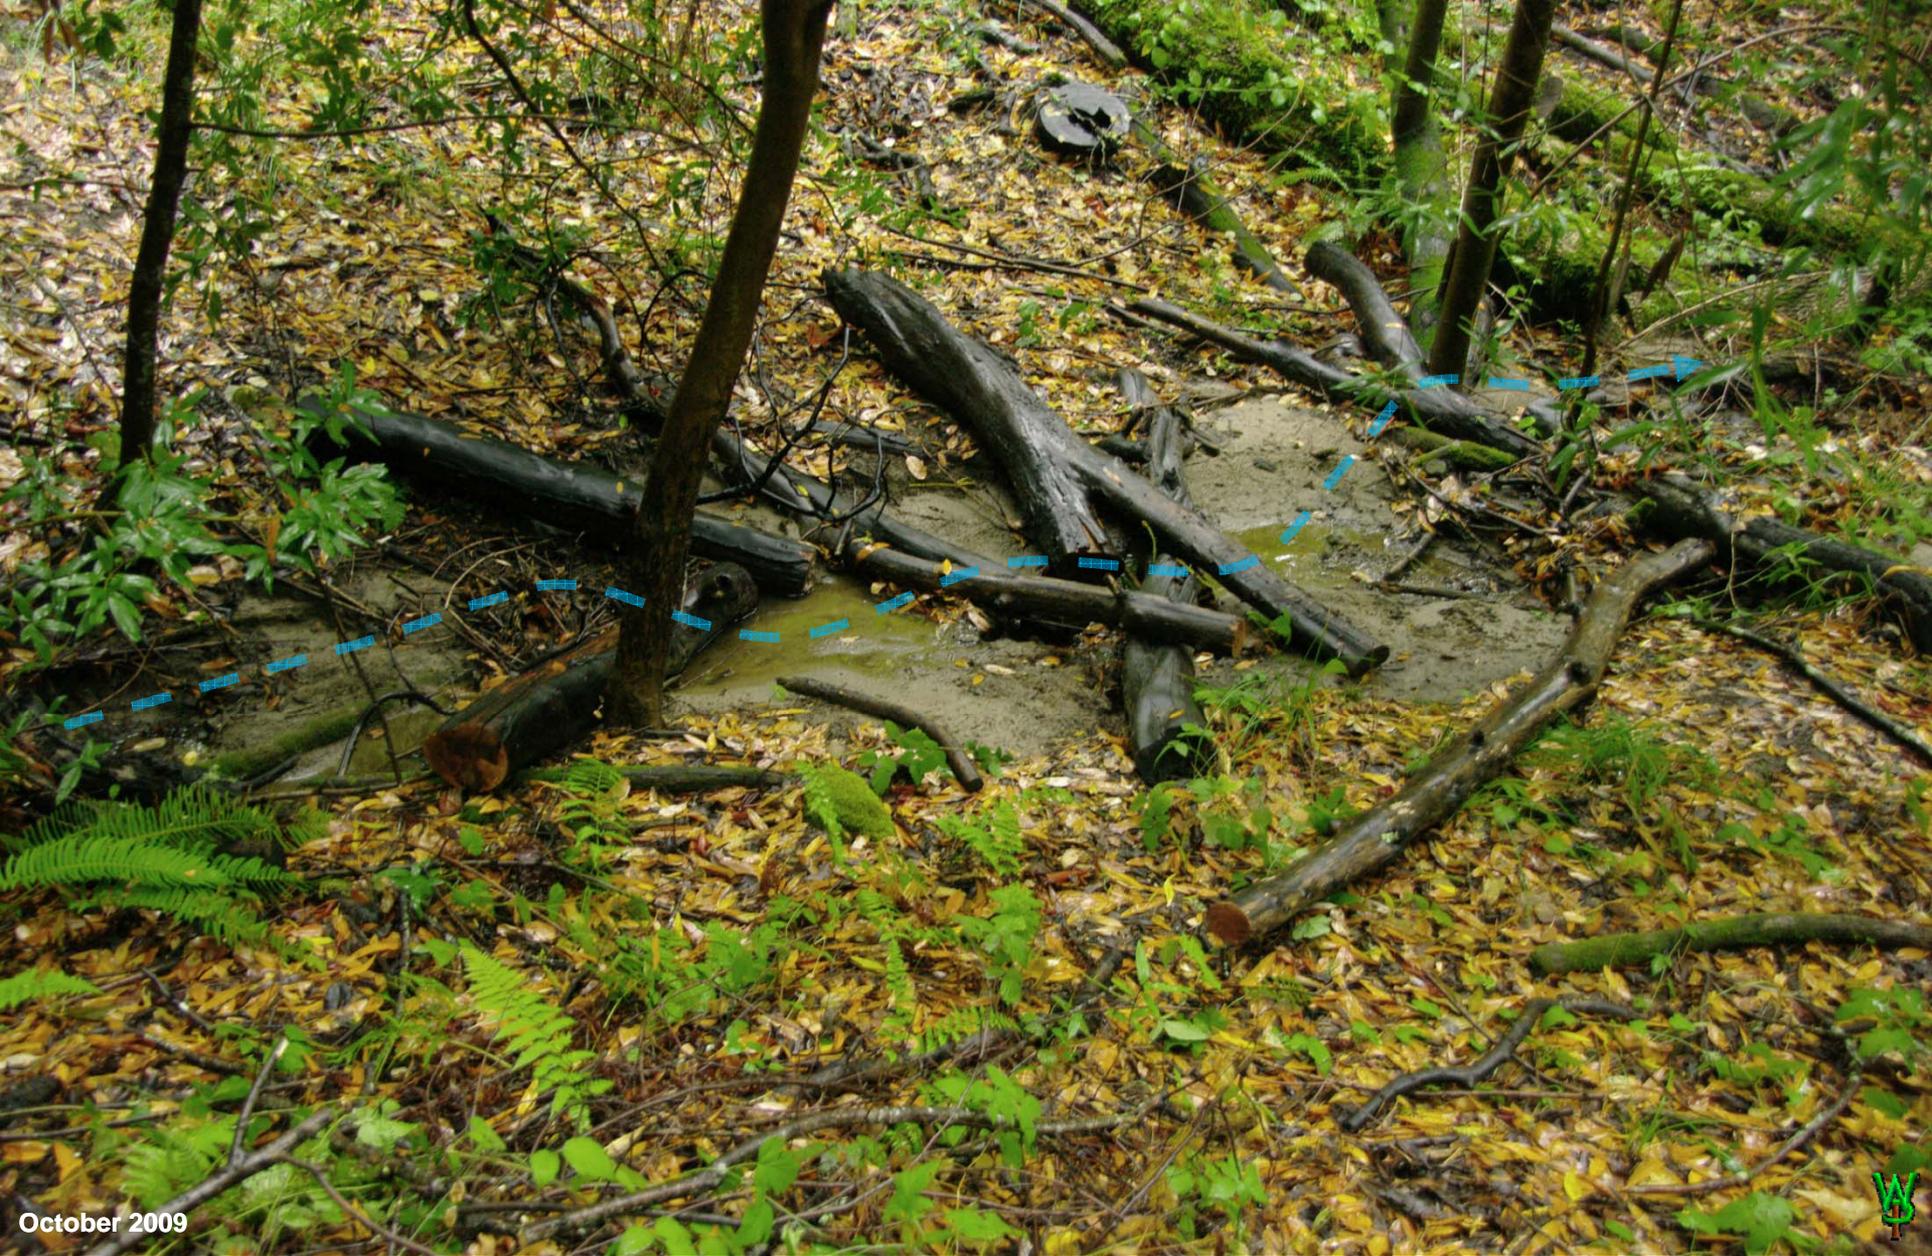
October 2009

This is just downstream on the way to that (1) tree, immediately after that same 12" deluge in as many hours. The logs are chocked to cause the material to drop. When a section fills in, the water carries the sediment down to the next trap. From this storm, the additional buildup was a maximum of about 3" thick. The trees anchor the system but they also make it dark. I want to get the sedges going, so I thinned them a few years later on after this had time to settle and consolidate.

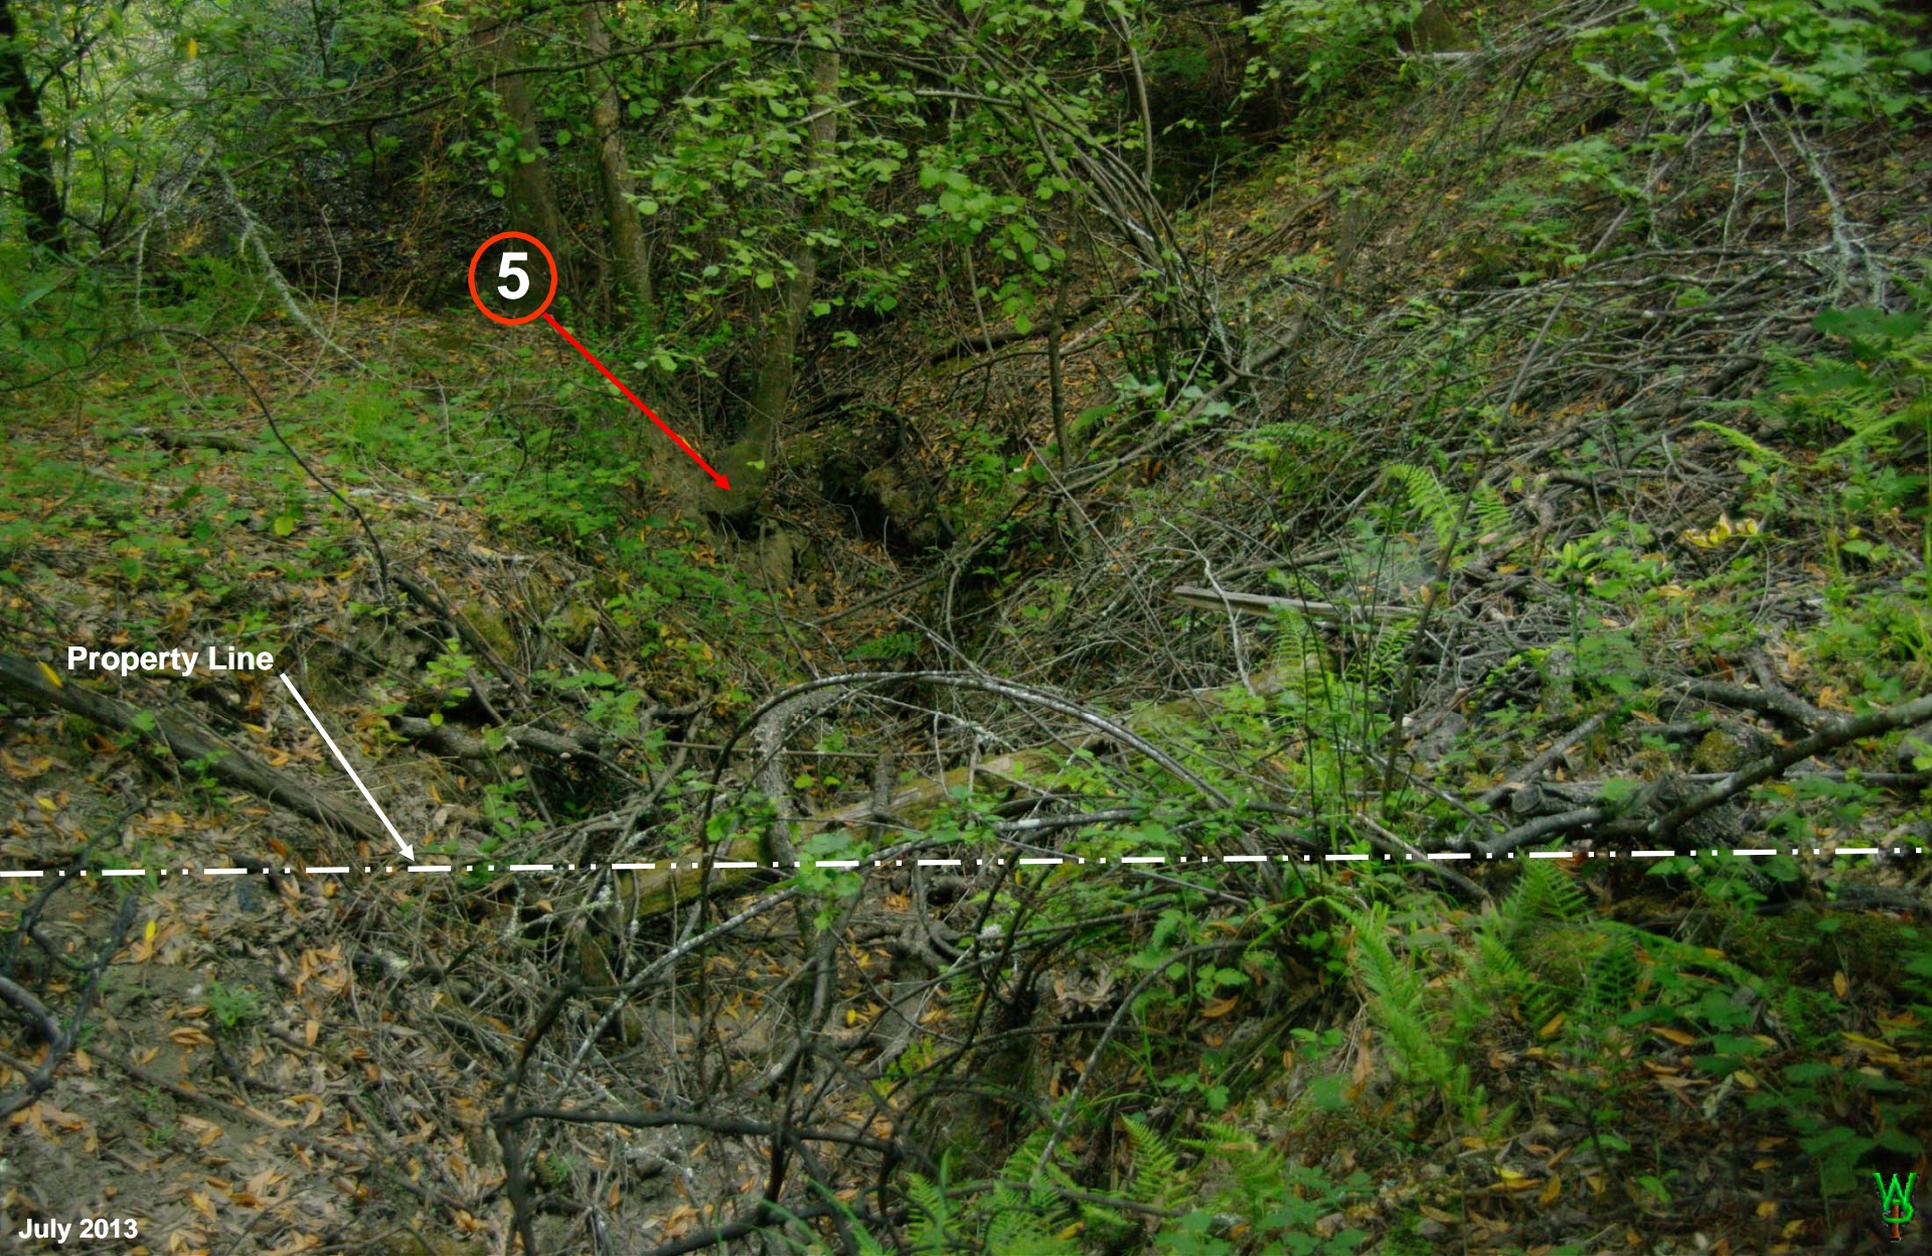
July 2013

Below the property line, the channel now averages fifteen feet wide and 6-8 ft deep, with a secondary embankment two thirds of the way down upon which the tree (5) is sitting. The channel cross section stabilizes from there at about 20-30 ft wide and 10-15 ft deep. What you can't see is the pocket to the left that has probably lost about 60 cubic yards of soil. No thinning, no groundcovers. Without treatment, the incision here will only get worse and the banks will fall in and be carried away.

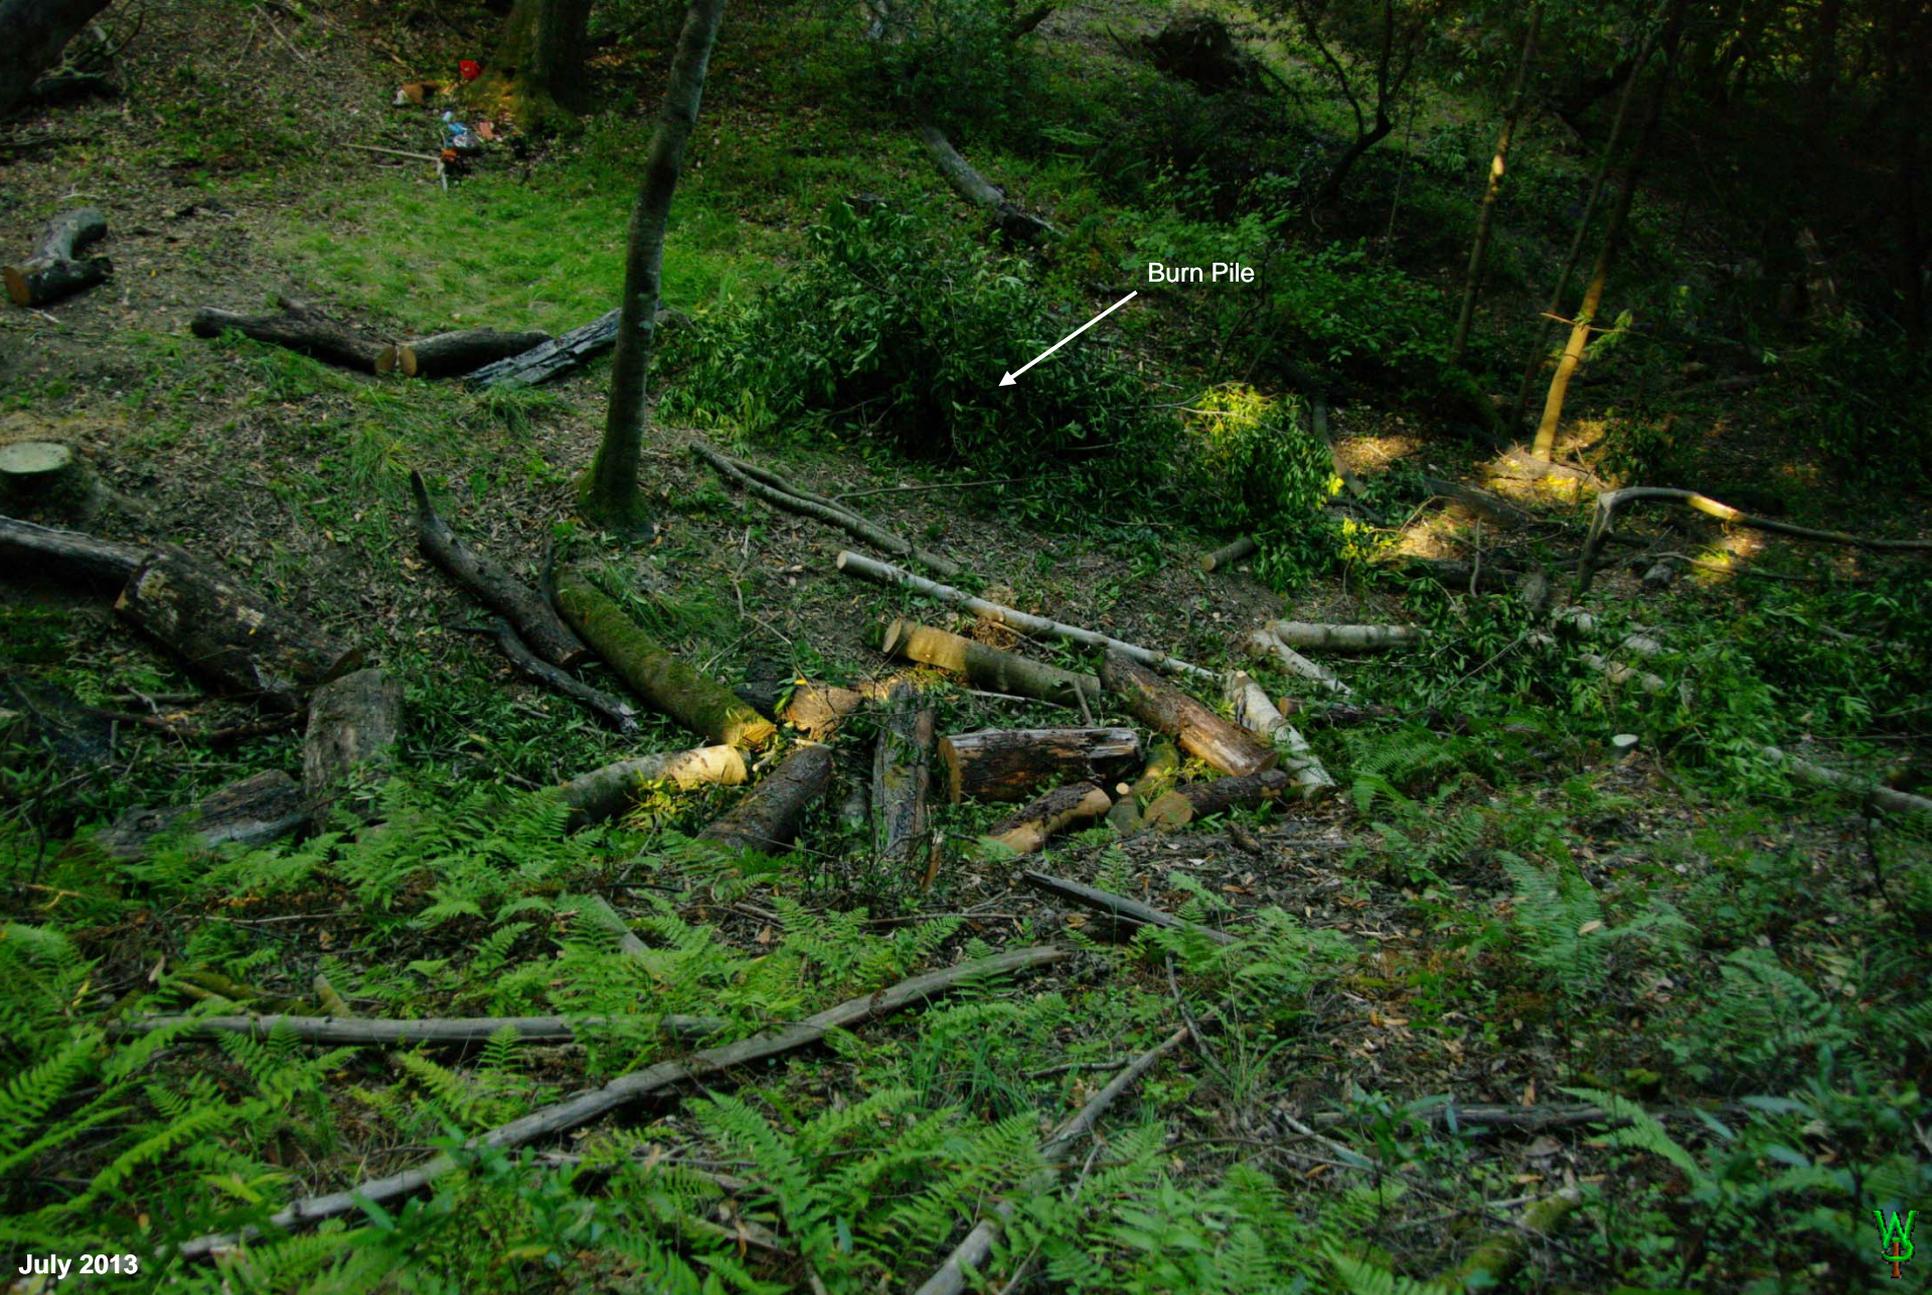
July 2013

A valley oak (*Q. lobata*) had died of old age nearby and in falling took out an old madrone, so I cut up the logs, dropped a couple of bays, and added another layer in 2013. From here on, the material will be redwood if I can afford to thin some of the nearby trees. OK, so this was my way of doing things. Let's take a look at the product of the local competition.
