FEELING DRAINAGE

WILDERGARTEN 4.0

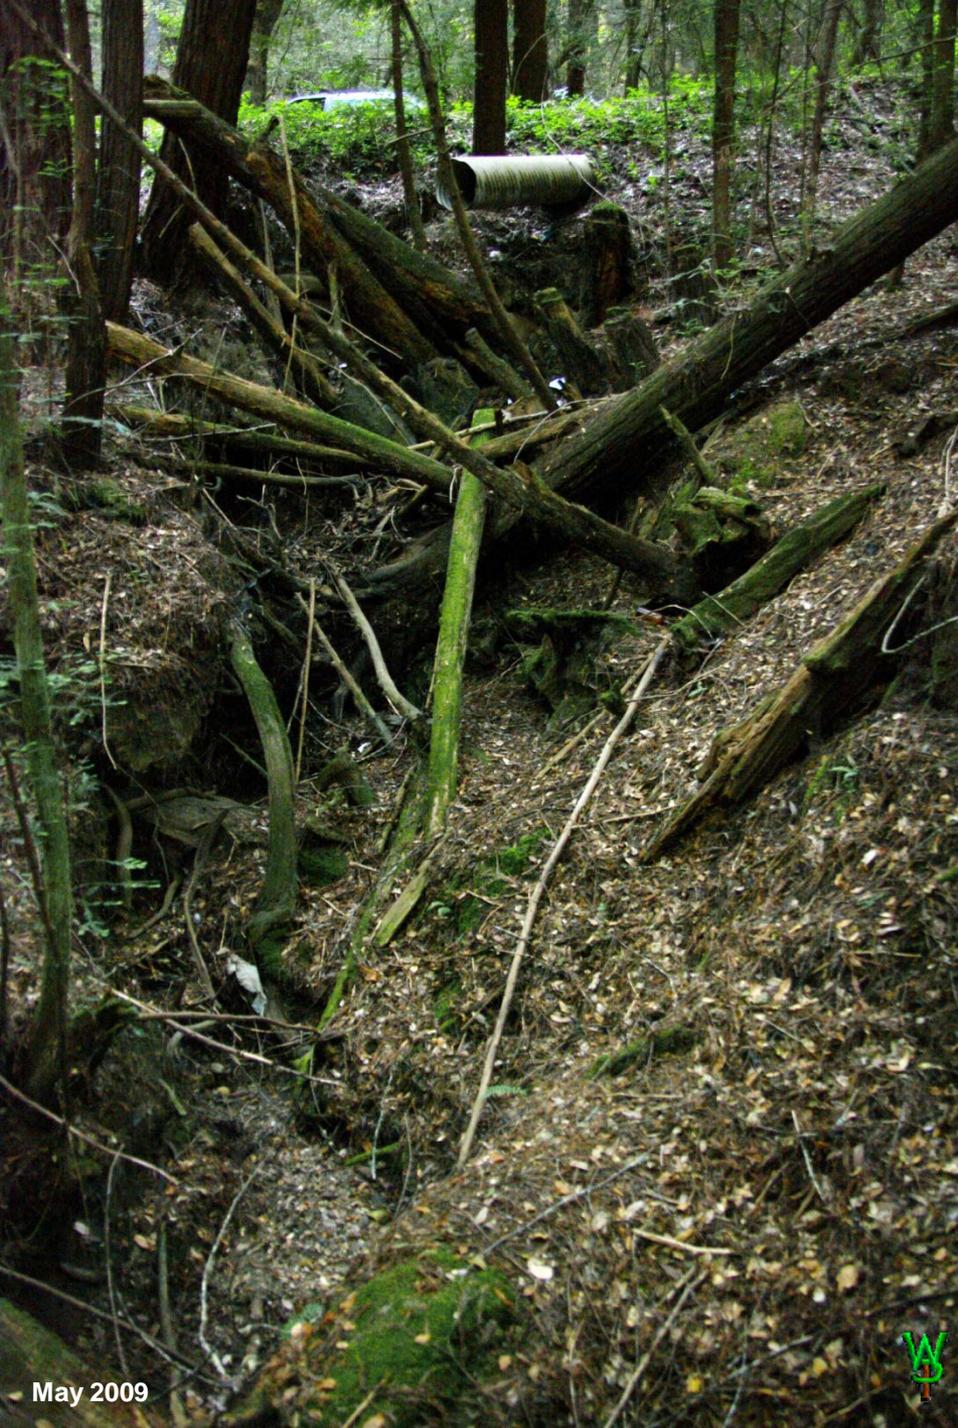
The channel here is 30-40 feet wide and well over 20 feet deep. The culvert in this photo is 24" in diameter (a fairly small flow in these mountains). There is another channel up the road, that was abandoned when this culvert was put in, but it is not nearly so bad (this pipe looks to be about 30 years old). There hasn't been ANY logging here for at least fifty years.

It's shady here, so they've got their canopy cover. As a result, there is no green vegetation. See how the root masses on the left are undercut? That is what would have happened to my "wall of wood." As bank erosion causes the walls to collapse under the weight of the trees, they fall, with the logs hitting the opposite bank while still hanging from their roots. They are *bridging* the channel with the water running *underneath* the logs while the stream washes the now loose soil on the root mass away and the bed keeps cutting. So much for "recruitment."

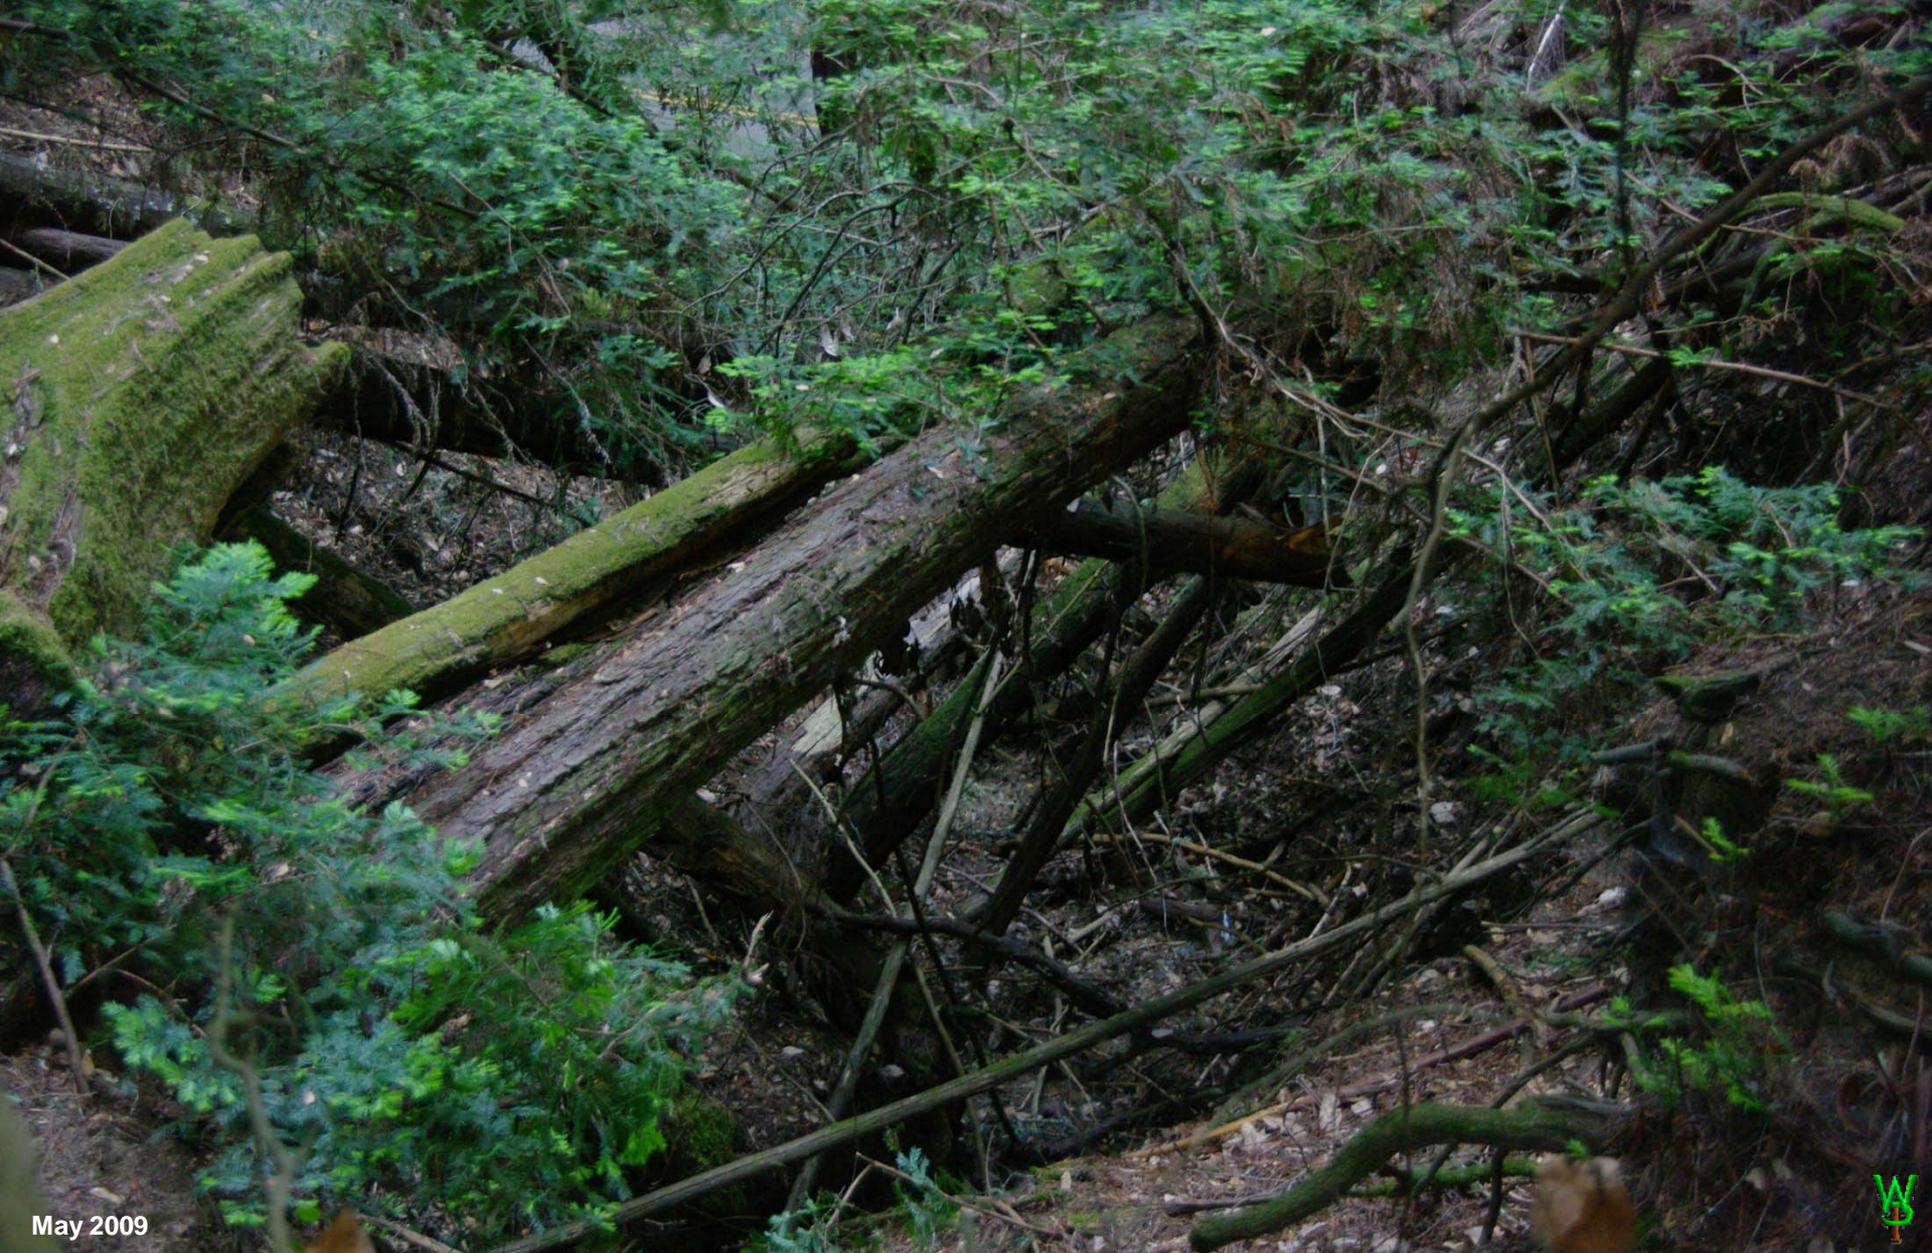
May 2009

This is about 100' below the culvert outlet, looking downstream. Again, there are no effective groundcovers because it is way too dark. The logs bridge the channel so the stream is still down-cutting beneath them. **This stream bed was not here before the logging.** In fact, this flow was channeled away from a failed culvert into this one long after this area was logged and new trees were well established. This is “preservation,” “recruitment,” and “canopy protection” at its best. What you see is what you *will* get.

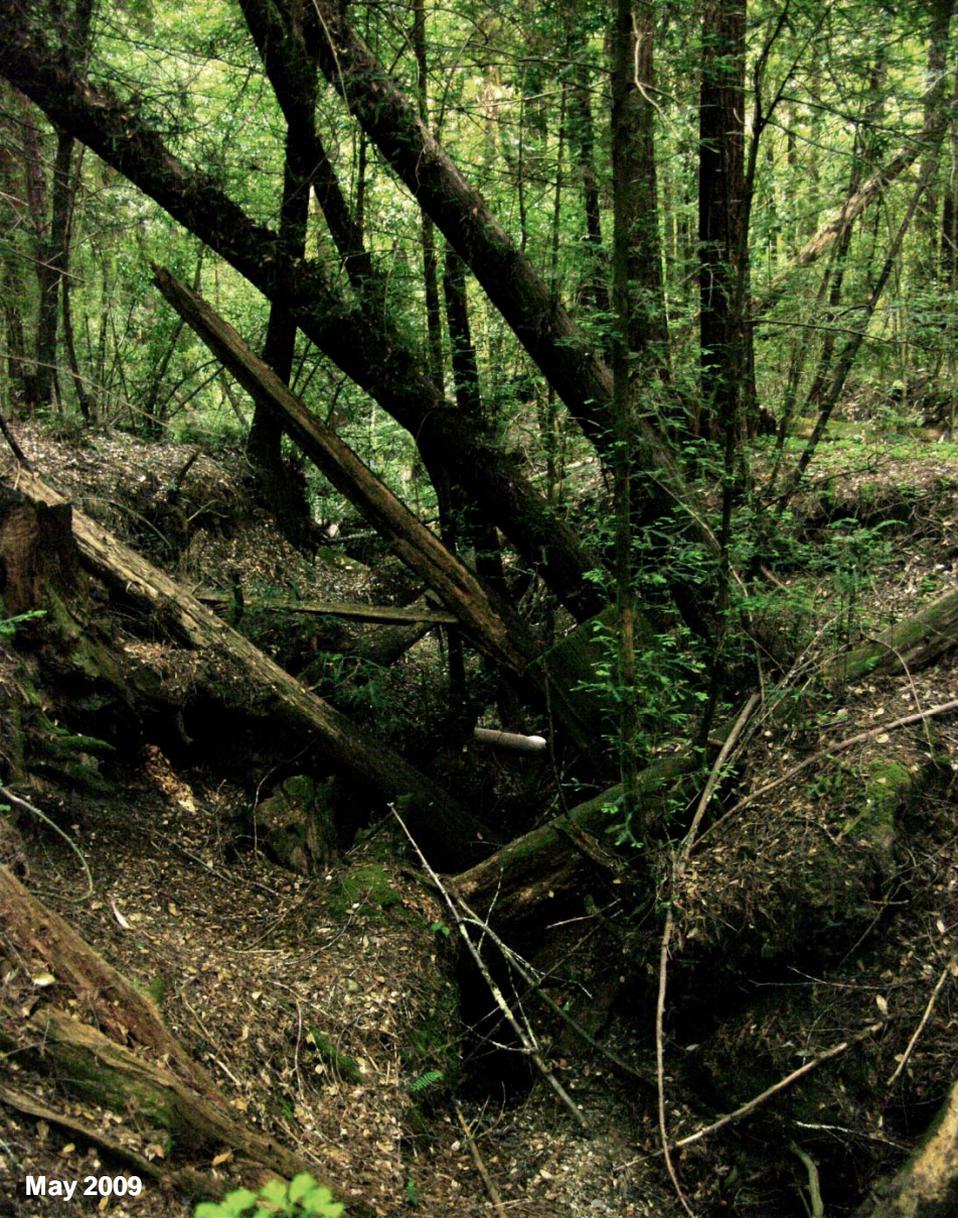
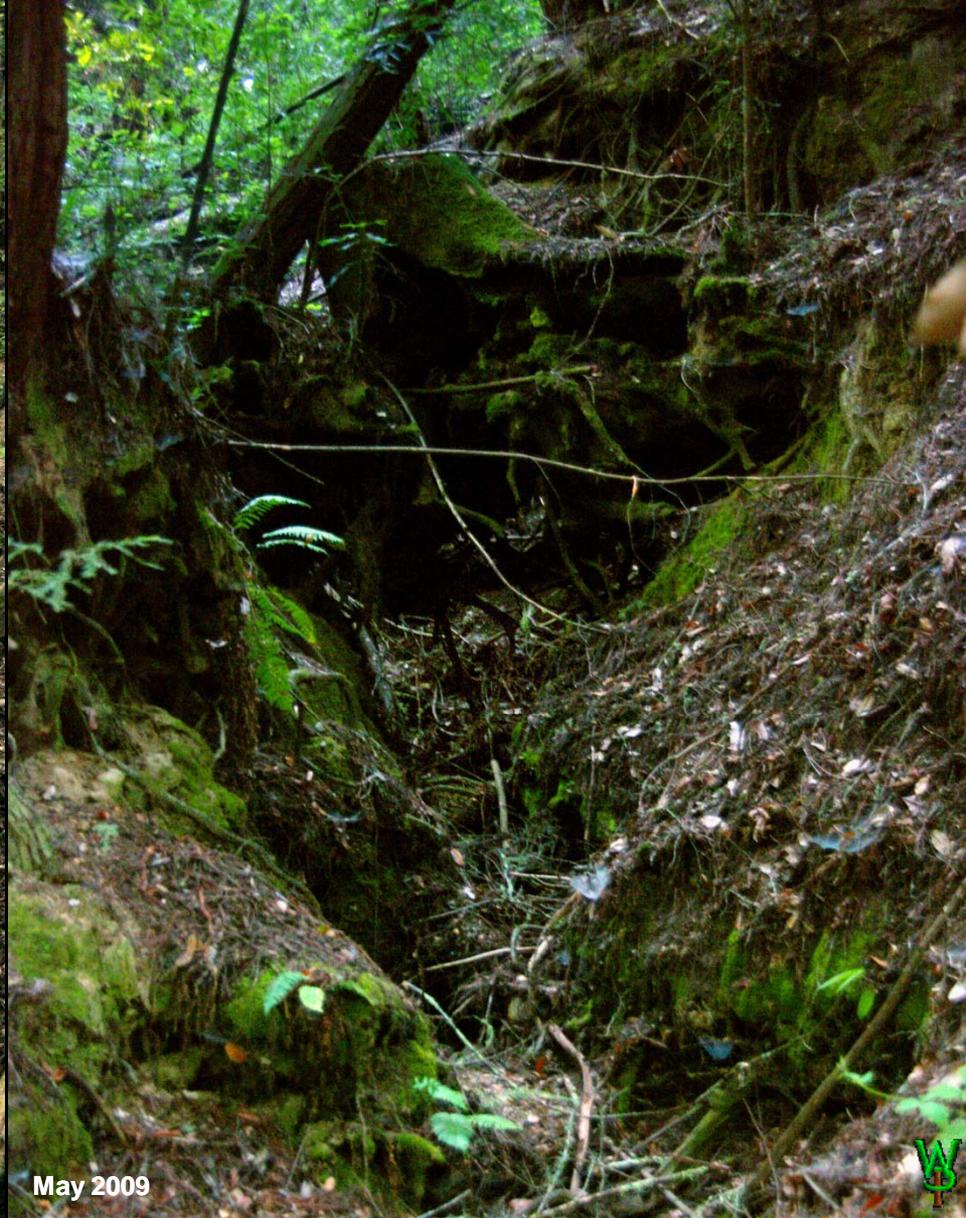
This drainage channel is only about 75 yards long. There isn't any part of it where "recruitment" or dark canopy are working. At right is the bottom of the channel at the lower County road, which effectively limits the cutting by making a hard bottom. Here you see a root wad spanning the bottom of the channel. If "recruitment" was going to work, you would see it here. It did not. The belief underlying the regulations that 'Nature can heal anything' is just as dumb as was fire suppression and for the same reason: Suppress fire and you get catastrophic fire; suppress logging to stop erosion and what you will get is catastrophic landslides into incised channels .

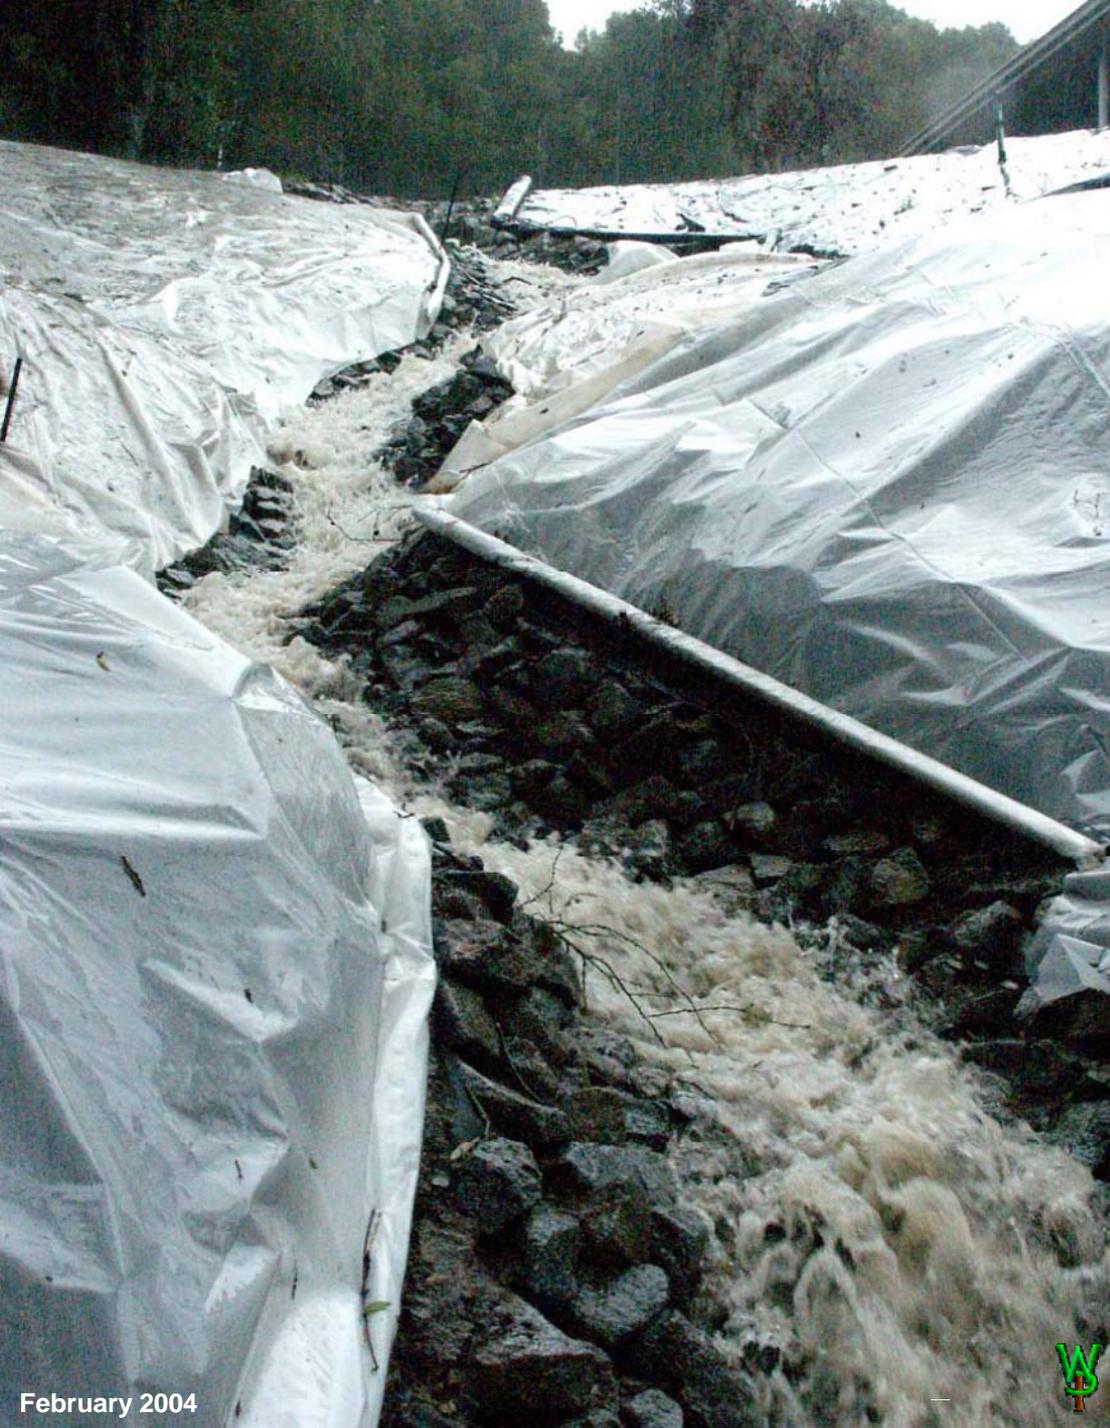
In this project, I collected surface water into the rock lined stream to preclude rilling in a manner similar to engineering designs over the last 100 years except that this slope was shaped like a watershed with benches mimicking lateral tributaries. It does require monitoring for damage from gophers and ground squirrels just as “natural” slopes also do.

The plastic was stapled to battens, rolled around them, and either screwed to timbers or to steel stakes. This tarp system has survived 50mph winds undamaged, a design that could allow work to be done in the dead of winter between deluges when the soil is damp enough for good compaction. So far, after ten years, there have has been no maintenance needed other than clearing the channel annually of tree branches and other plant debris.

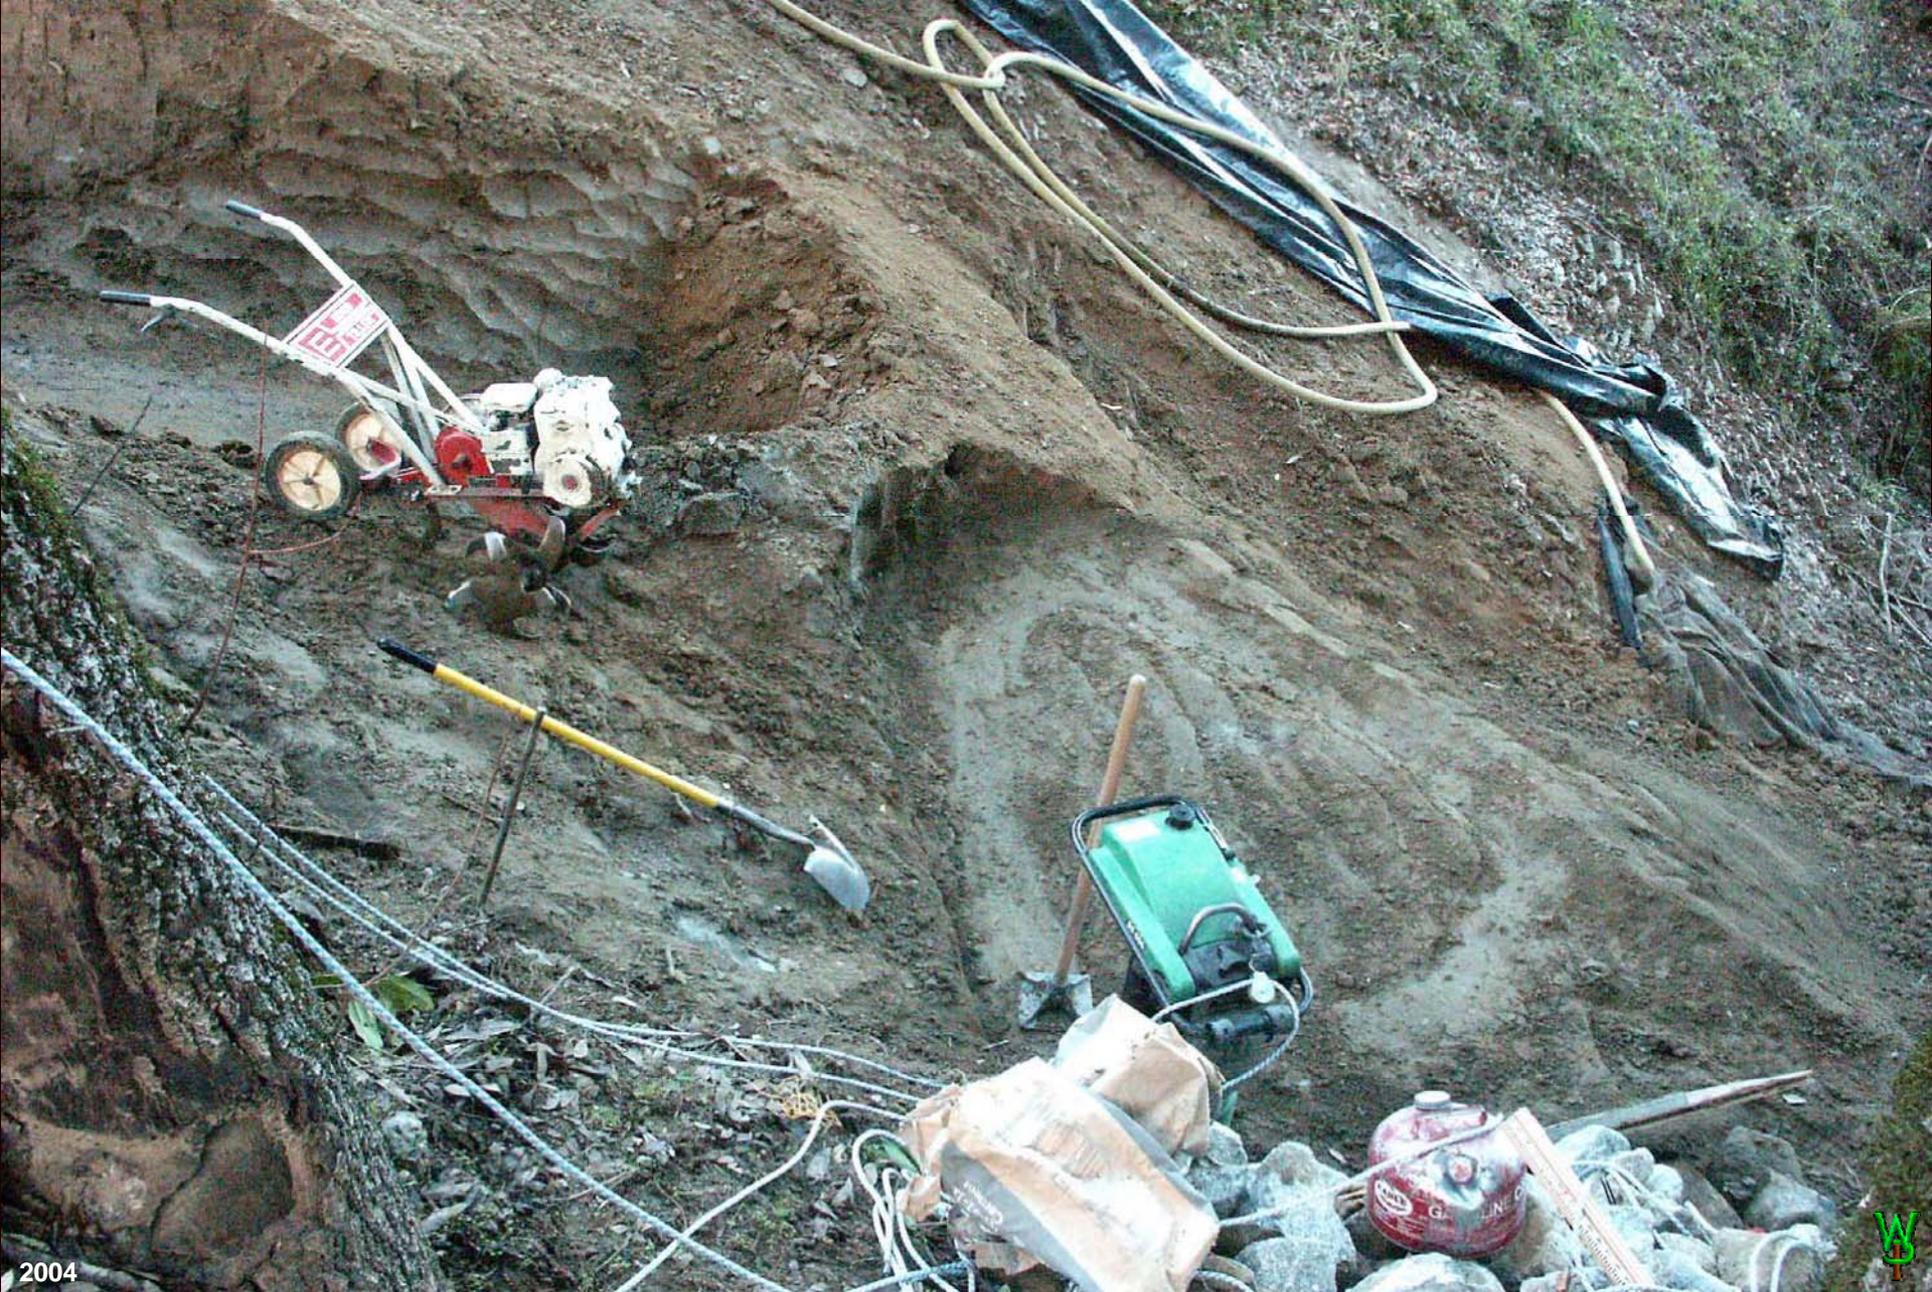
2004

In parts of this project I used the equivalent of a half-sack mix of cement in the soil to reinforce the structure to simulate the attributes of the parent rock and withstand tunneling by ground-squirrels without caving in. It is steep here. Interestingly, the grasses seem to prefer this cemented fill compared to the parent material.

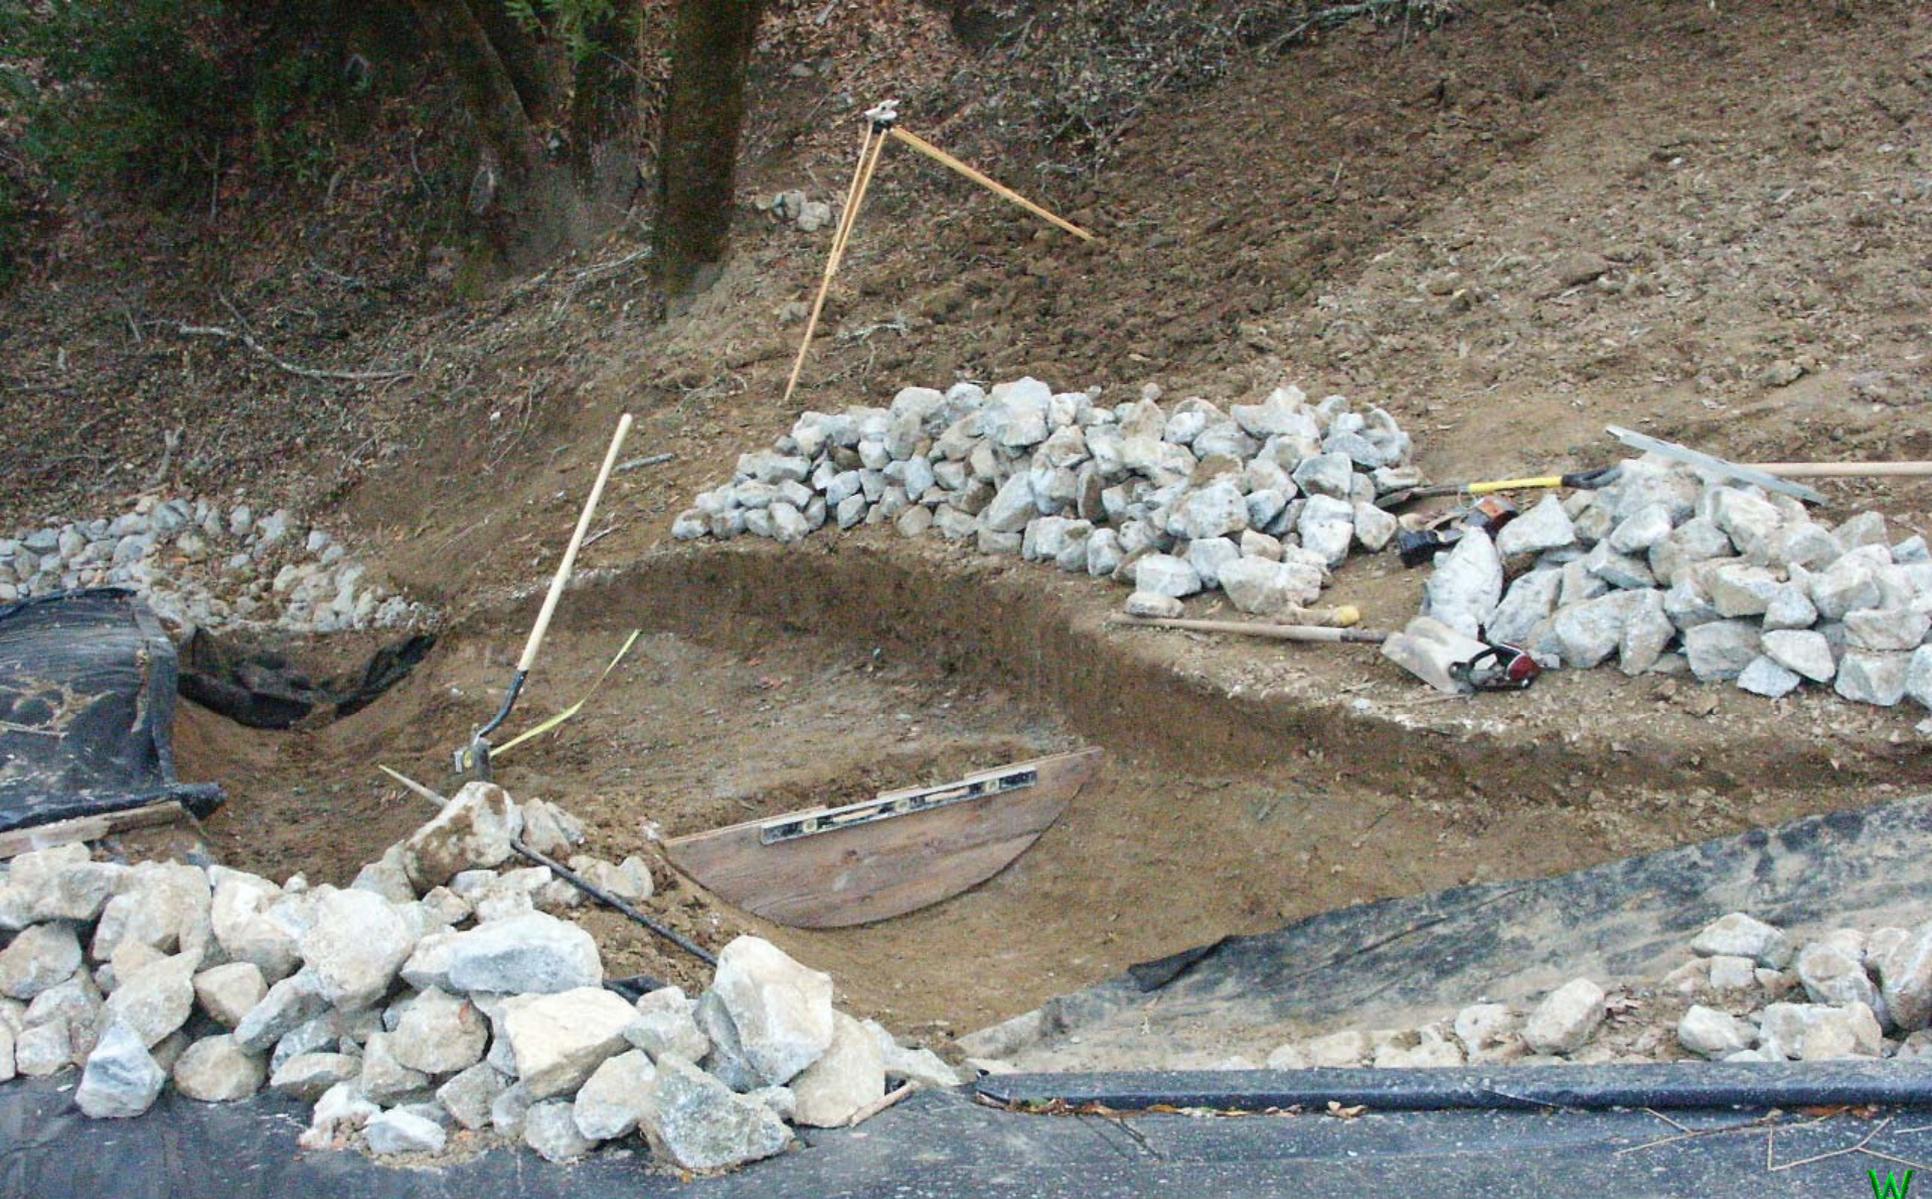
2004

When digging one of these affairs, the process is somewhat iterative. Obviously I had surveyed the slope and laid out the future grade on the computer so that I would have the rate of fall worked out as I dug it. There is also the problem of staging the materials, both those that come out and those that go in. The goal is to have a mass balance between the two to minimize the need to either add or remove fill or rock while simultaneously reducing the need to move it any farther than is absolutely necessary.

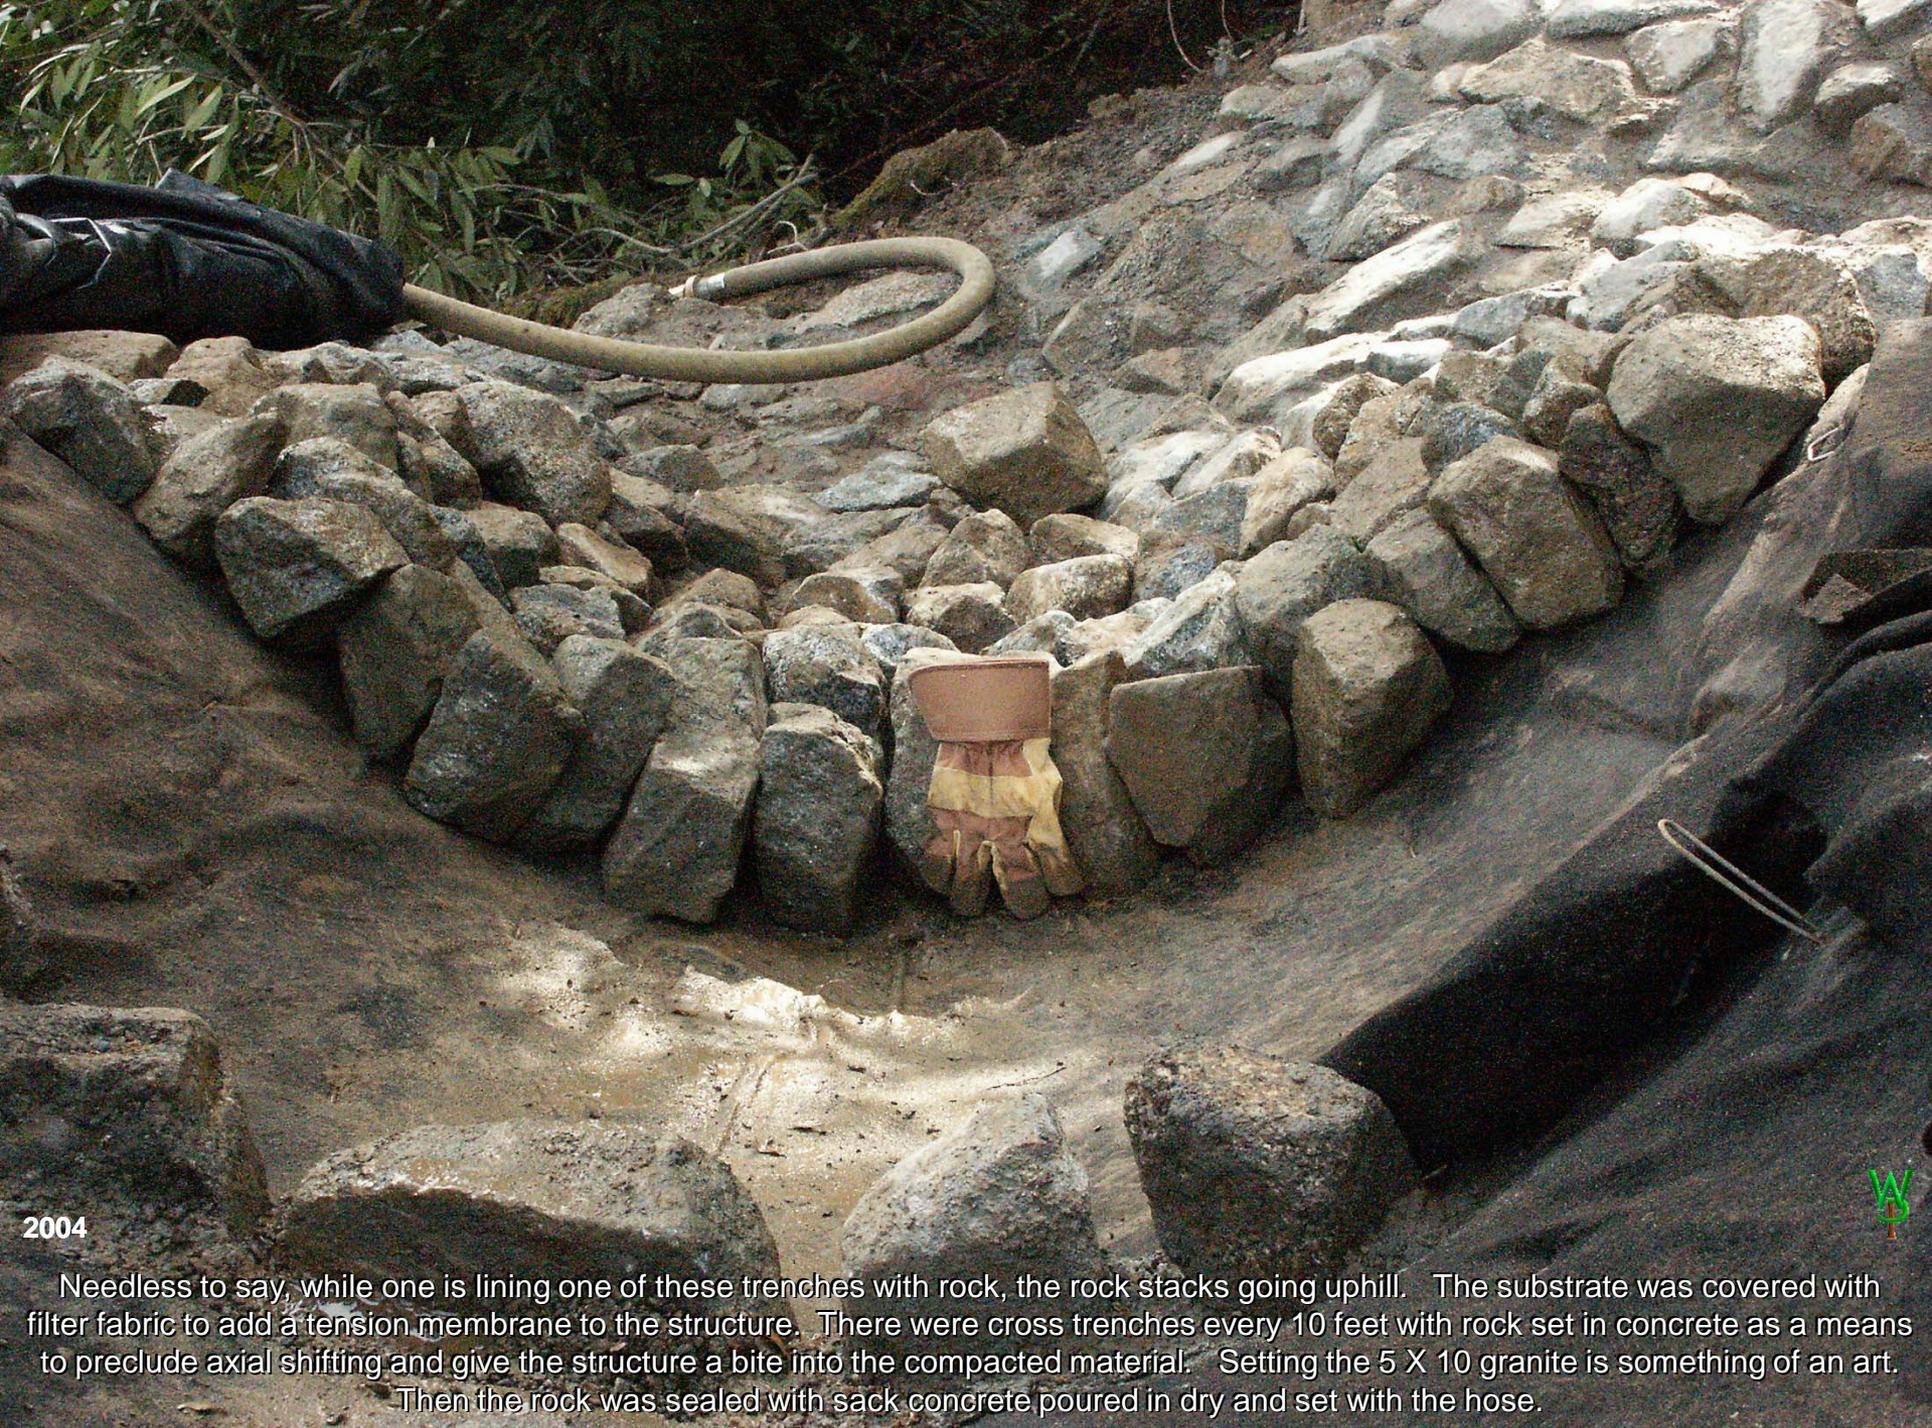
2004

Needless to say, while one is lining one of these trenches with rock, the rock stacks going uphill. The substrate was covered with filter fabric to add a tension membrane to the structure. There were cross trenches every 10 feet with rock set in concrete as a means to preclude axial shifting and give the structure a bite into the compacted material. Setting the 5 X 10 granite is something of an art. Then the rock was sealed with sack concrete poured in dry and set with the hose.

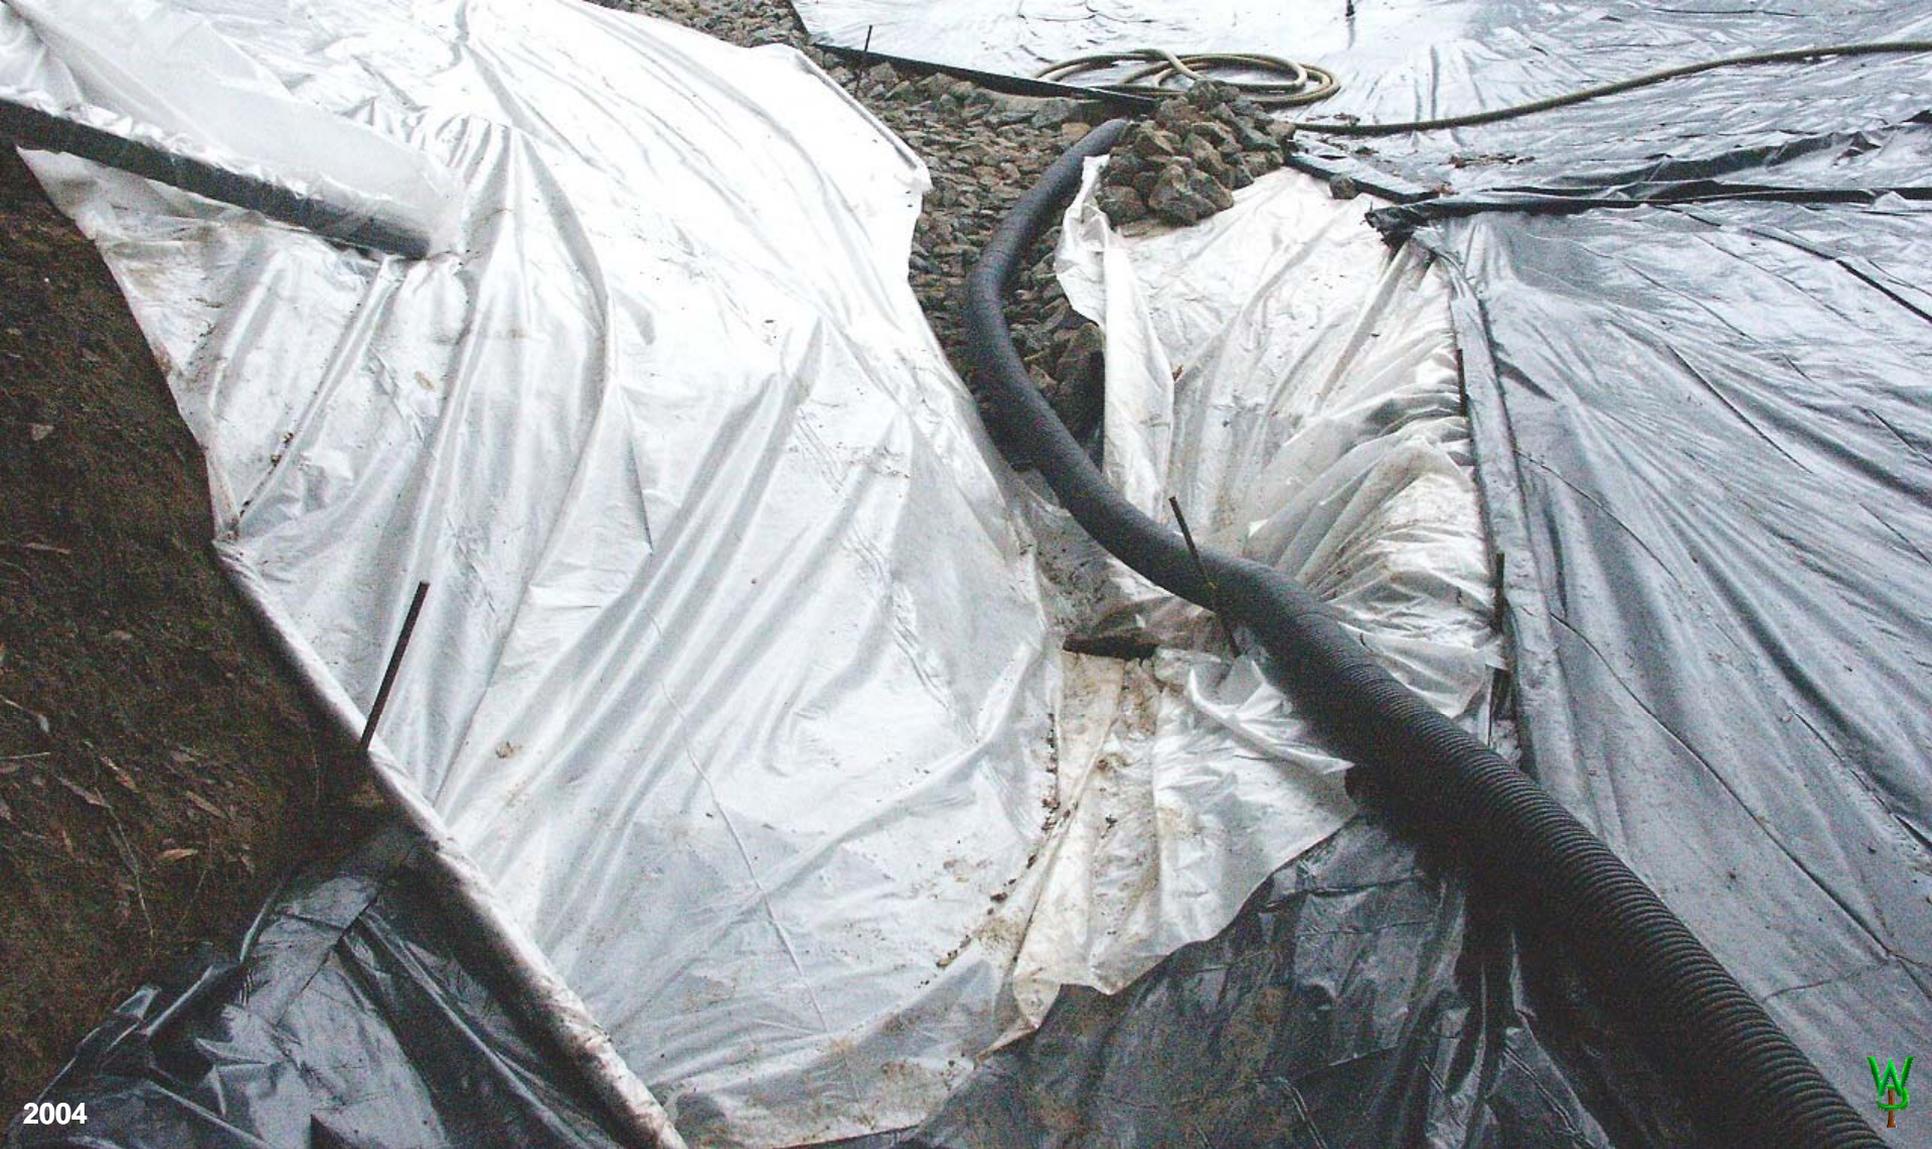
2004

One builds the rock liner from bottom-to-top, yet once I got close to the target, I started upward from a cross ditch near the inlet up to meet it and then met that cross ditch from the one immediately below it to assure a smooth transition. Yet at the same time, there is the risk that if it rains during the job, the water comes from the top down, from which there can be a enough of a flow to wipe out the entire job. The technology to manage the water is not terribly difficult, but the discipline required to assure that it is installed in time while simultaneously under the pressure to finish can be demanding, as there are details involved that make all the difference in its ruggedness that do take time to install. The plastic is stapled to the battens, which then are rolled and screwed to stakes. The hose is screwed to the outlet of a pipe collecting surface drains. Once the rock was done, I had to pack the remaining fill from the trench.

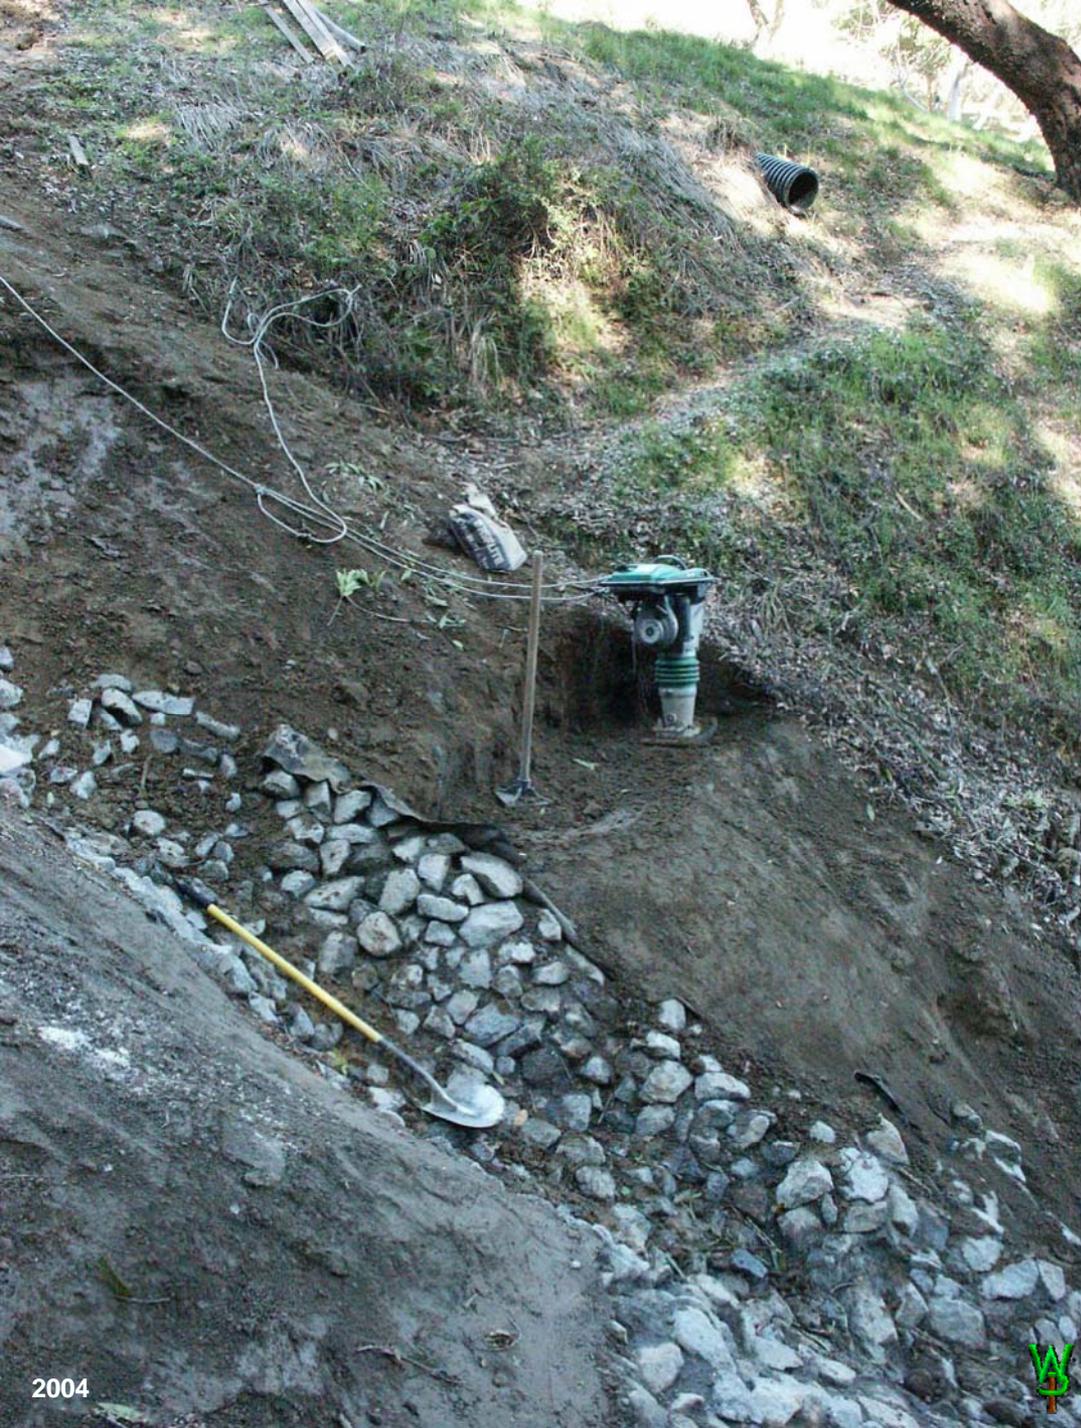
The slope was steeper than it looks. The small amount of extra fill I needed was brought down in buckets. Footing was treacherous.

The hand-tamping marks on the face are visible. I don't think I'll ever forget slamming that iron plate into it over and over. Day after day, wrestling that thumper out of the way and on top of the pile, starting it up and getting control on a tiny bench like that. This was one heck of a lot of work.

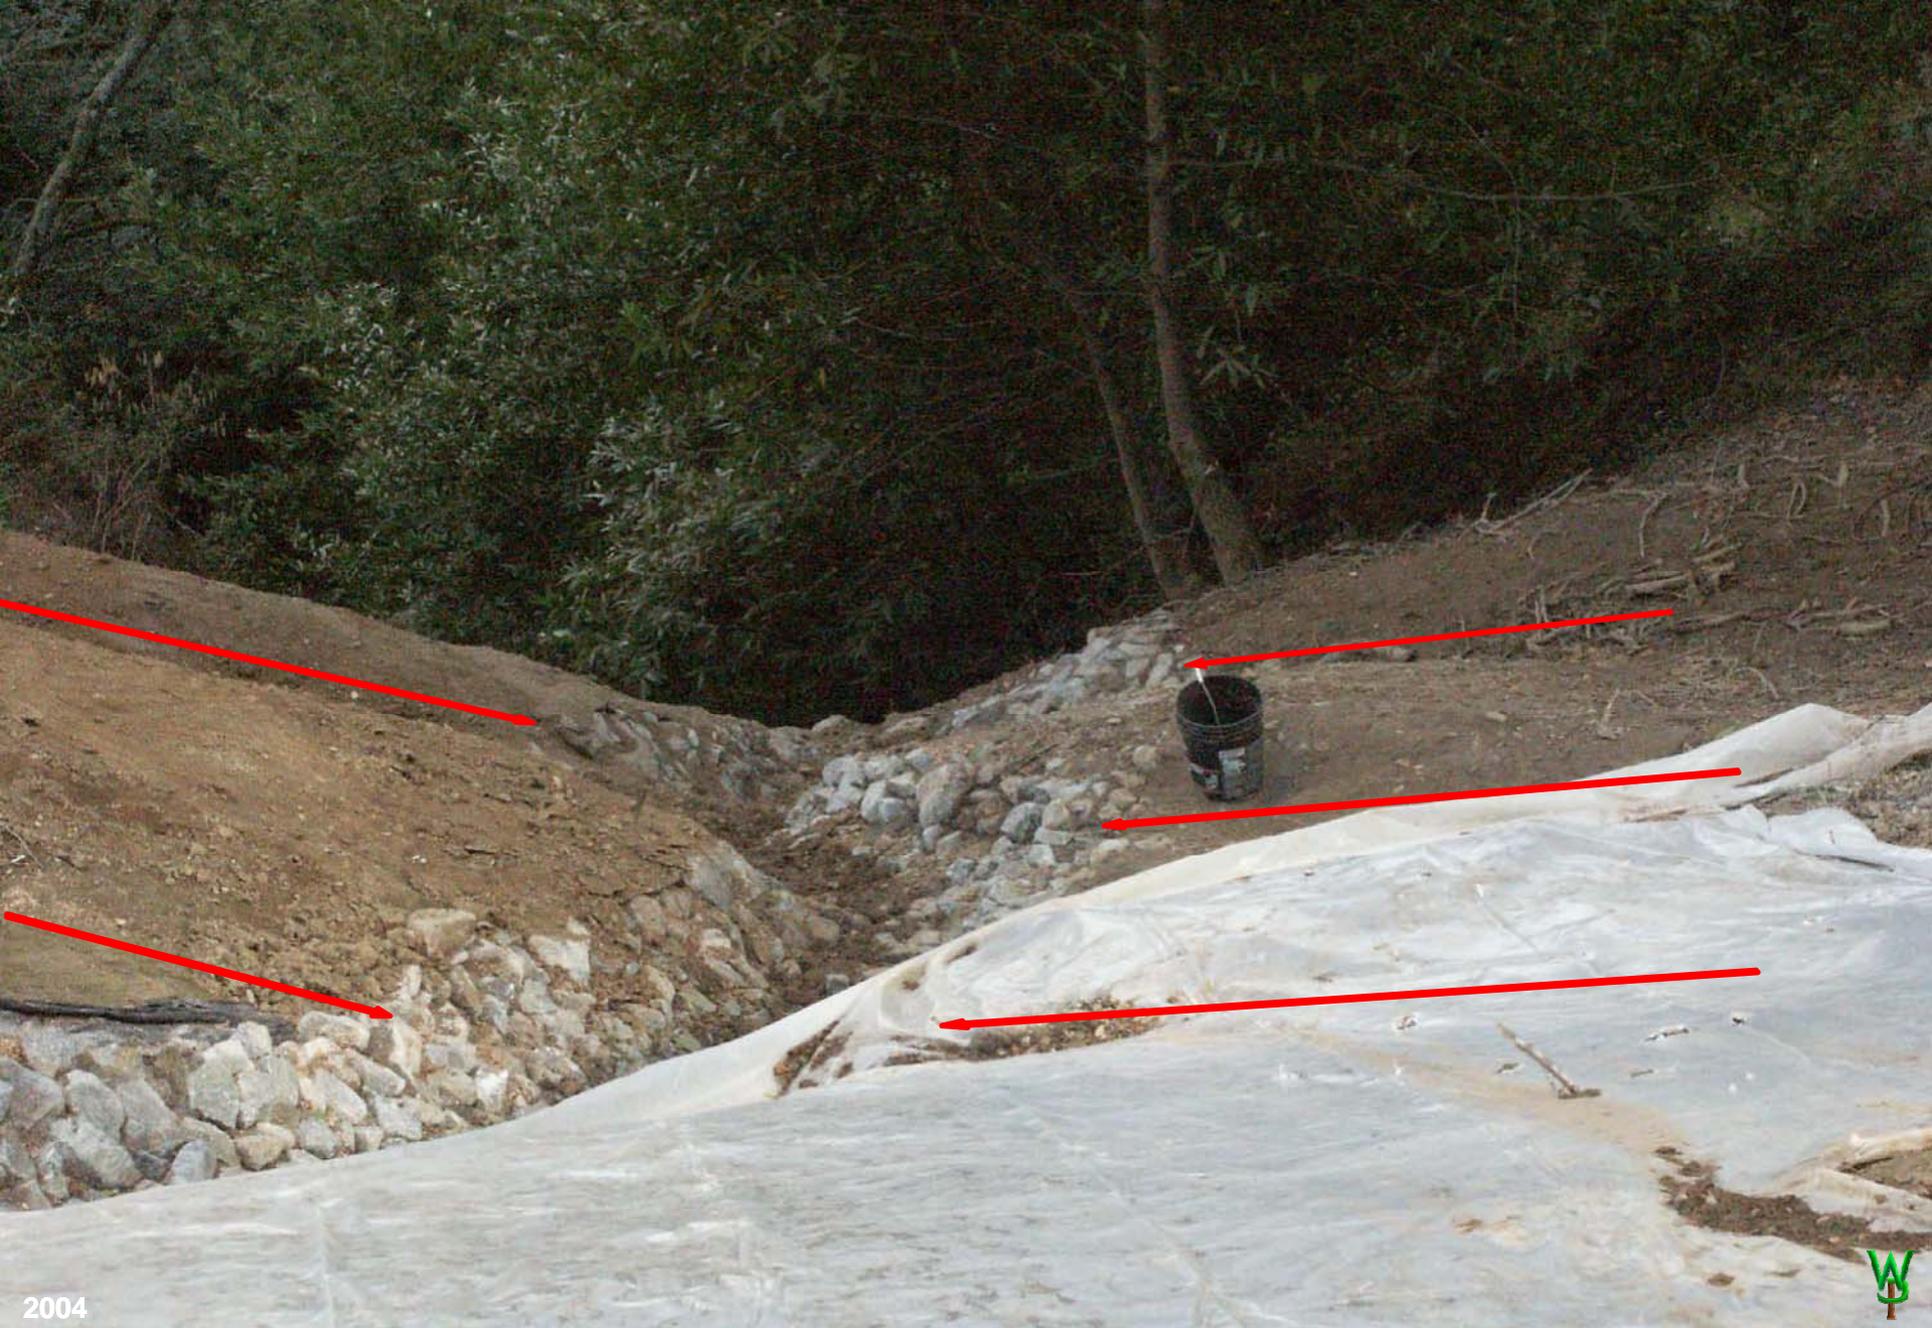
2004

It is steep here. The arrows indicate the alternating benches to catch and redirect sheet wash to the channel. The plastic was not only to preclude rain impingement and sheet wash but was part of a multivariable revegetation experiment. Then it rained...
