FEELING DRAINAGE

WILDERGARTEN 4.0

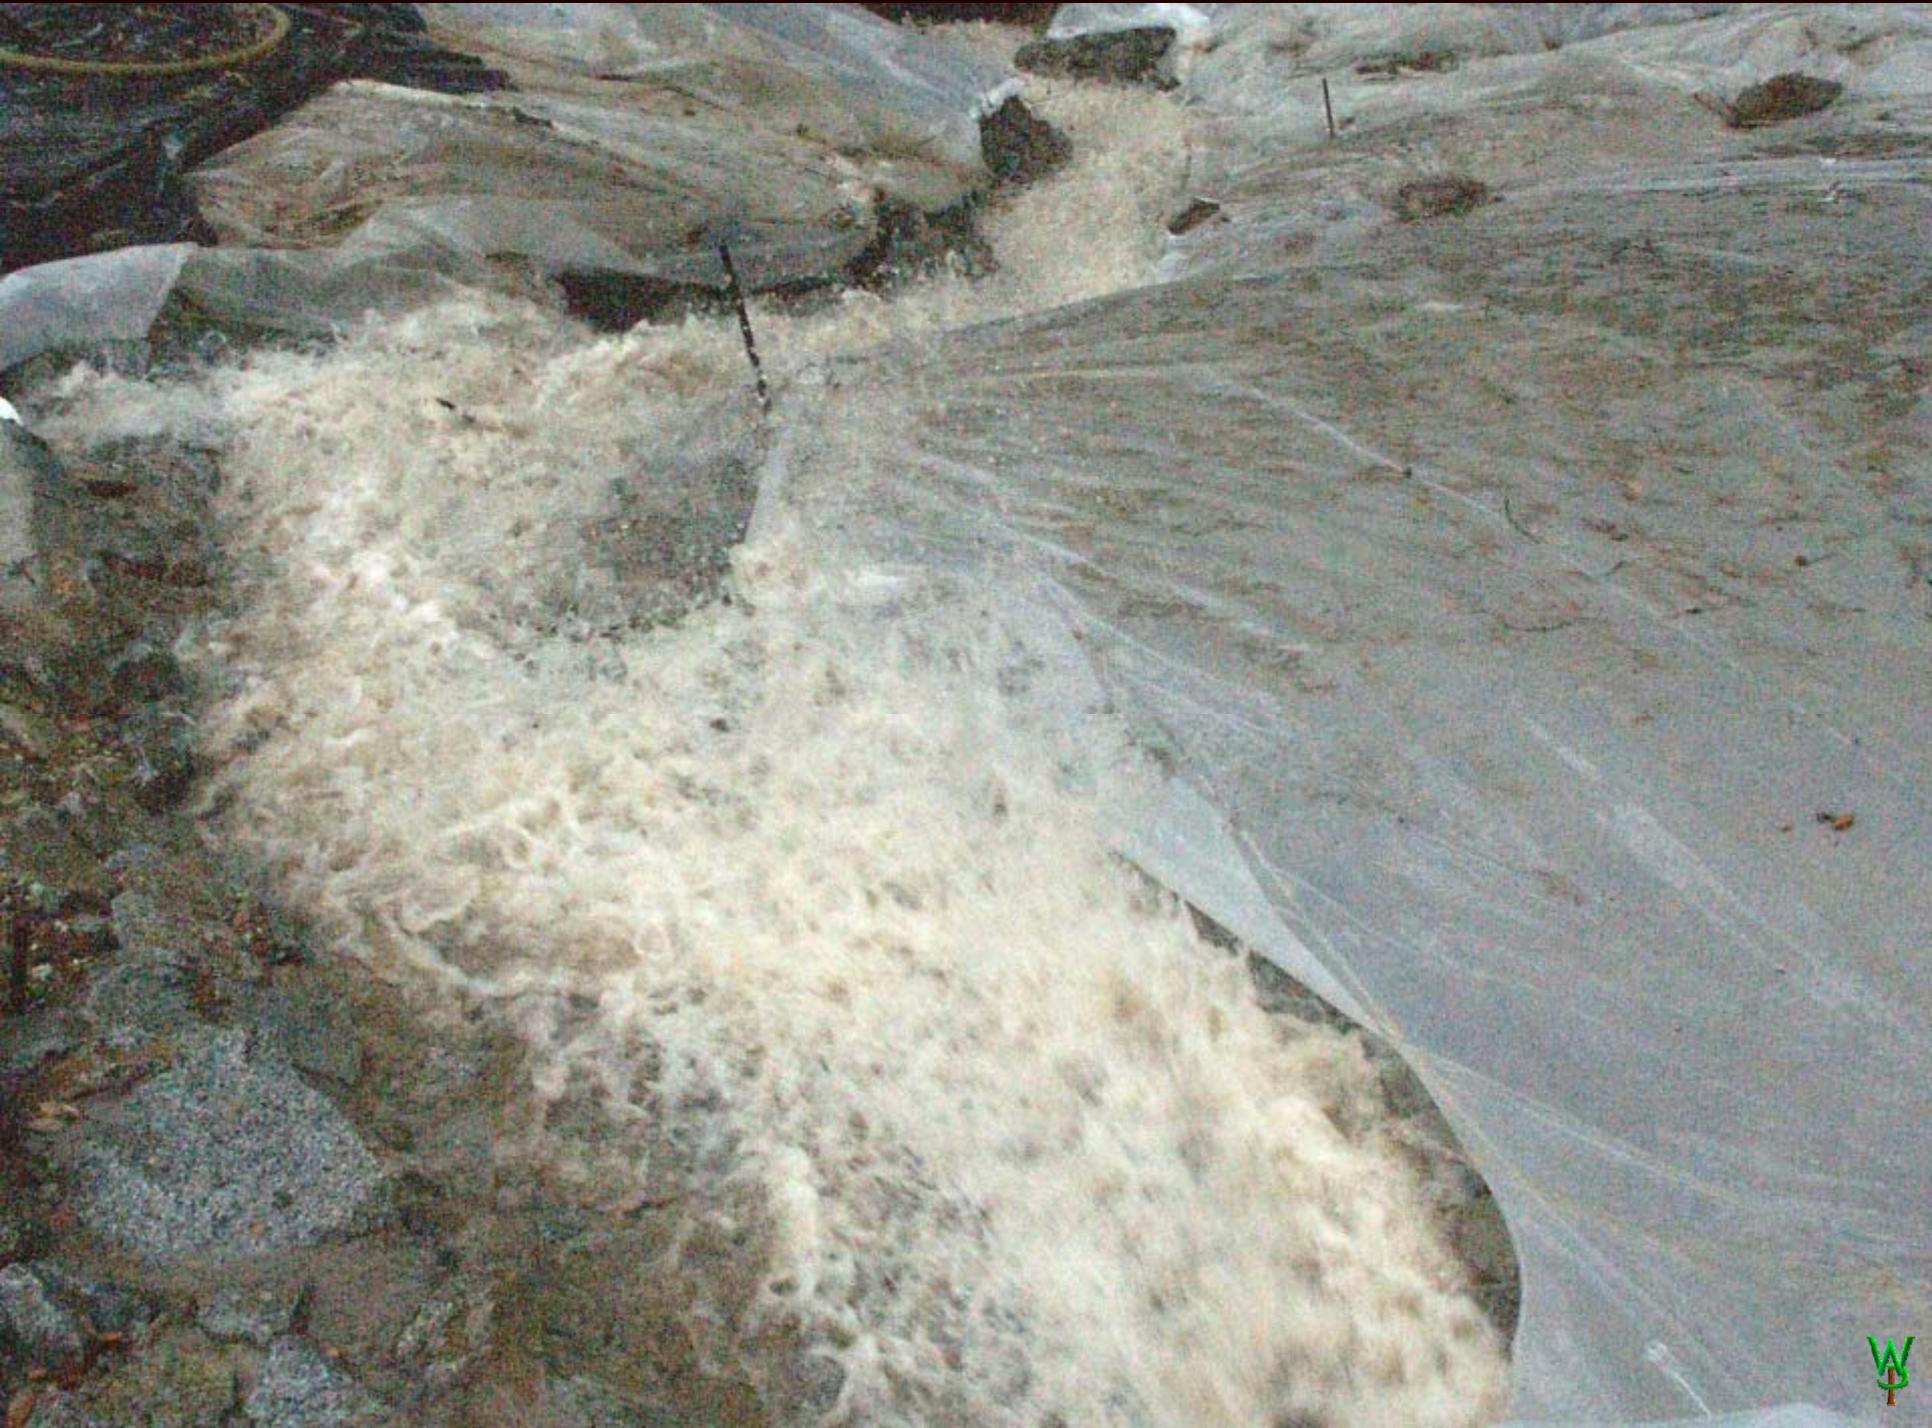
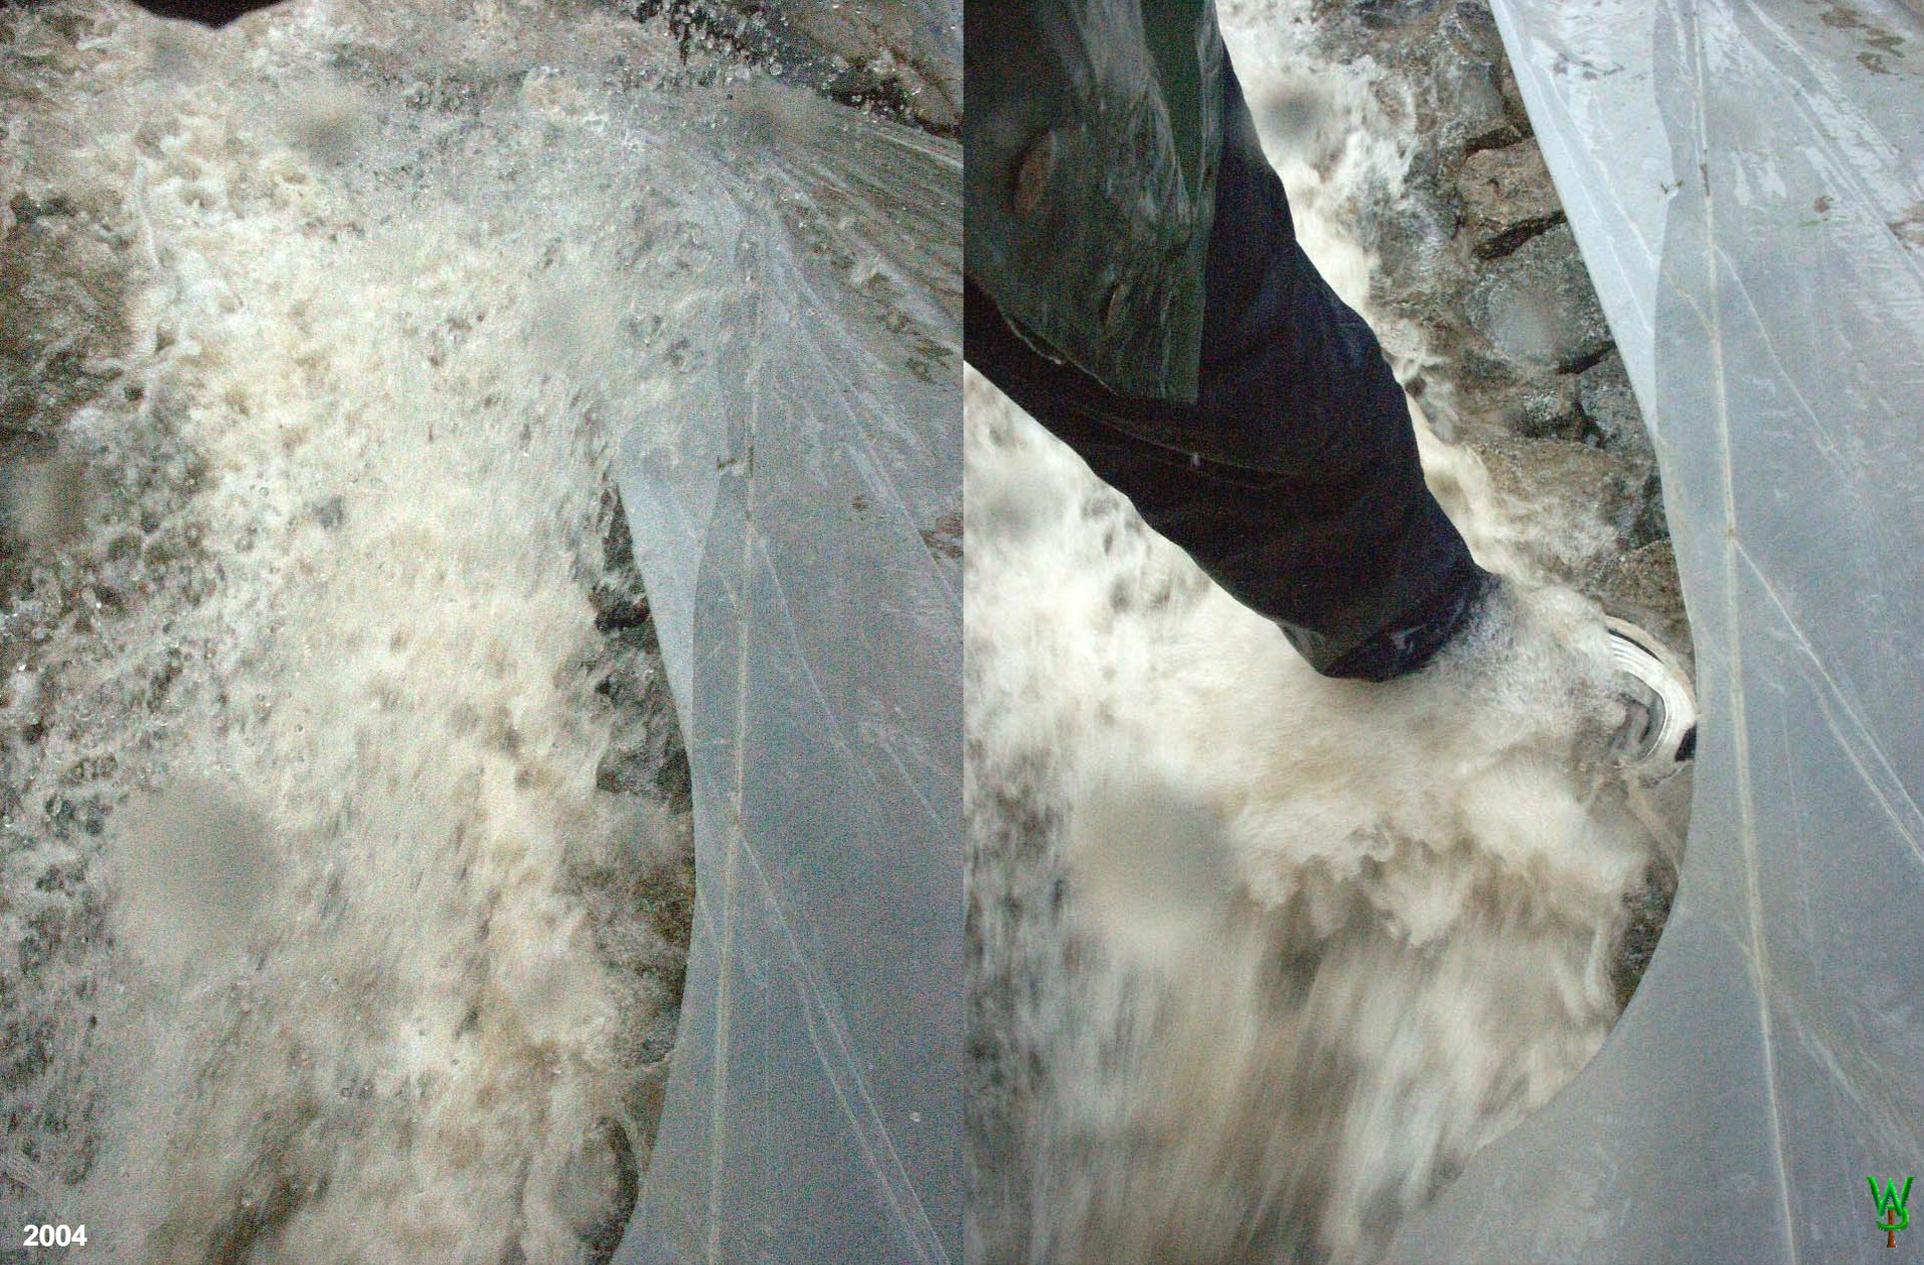
2004

This is when one gets to do the final tweaking. It is very hard to predict how the flow will behave when it exits a pipe. So I waited before dry-setting the rock around the outlet until a storm came to know exactly where and how to adjust for splashing. In this case it only took a couple of hours to reshape the surface.

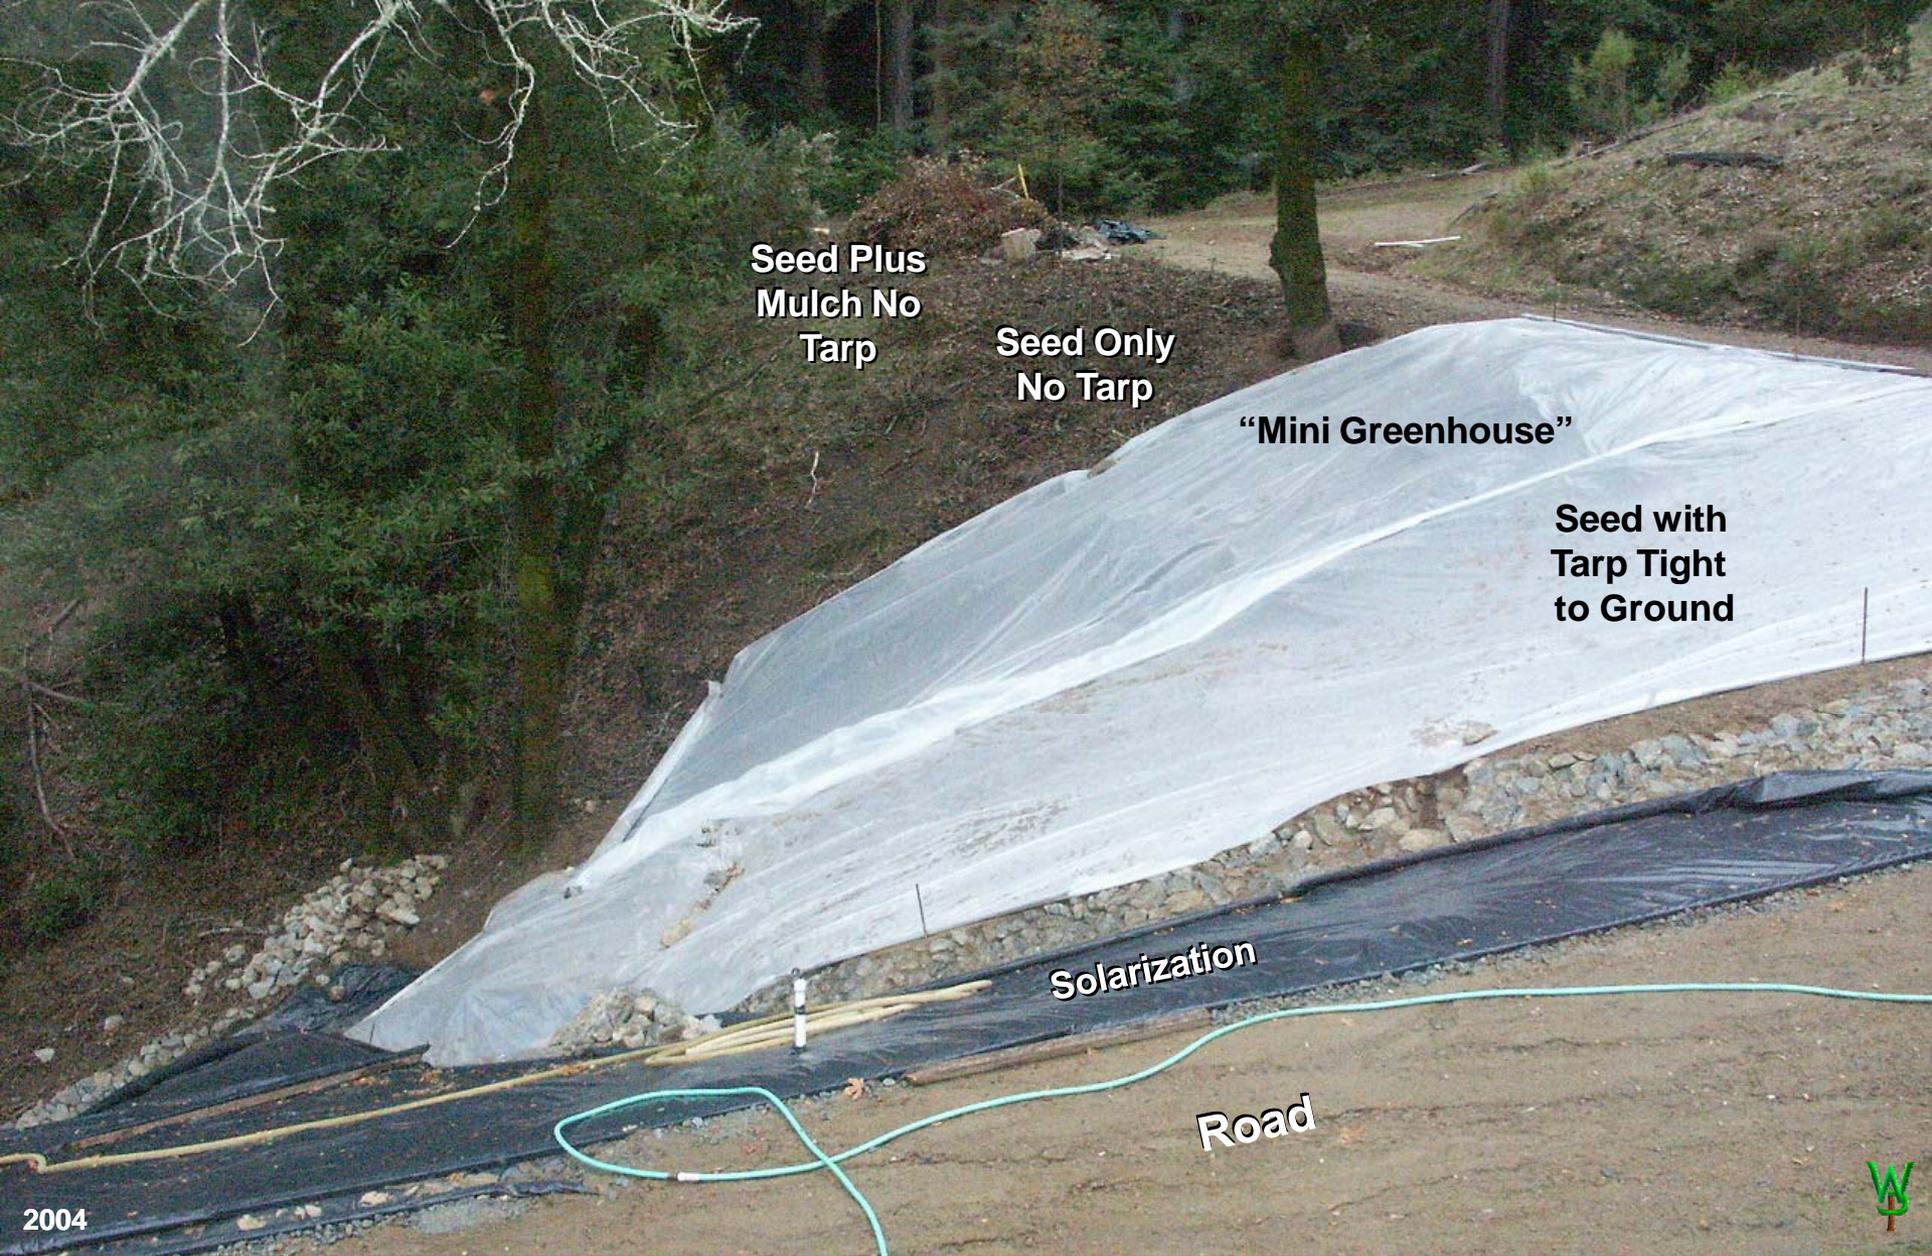
2004

**Seed Plus
Mulch No
Tarp**

**Seed Only
No Tarp**

“Mini Greenhouse”

**Seed with
Tarp Tight
to Ground**

Solarization

The plastic was set either tight on the surface or held aloft by a “mulch” of chopped tree branches forming mini greenhouses to improve the establishment of the grasses. Segments were held with rolled battens screwed to 4 X 6 timbers staked to the surface. The sector in black faces south, so I thought it appropriate to kill a year’s worth of seed by solarization, especially as it had yet to be integrated to some re-grading of the road immediately above it.

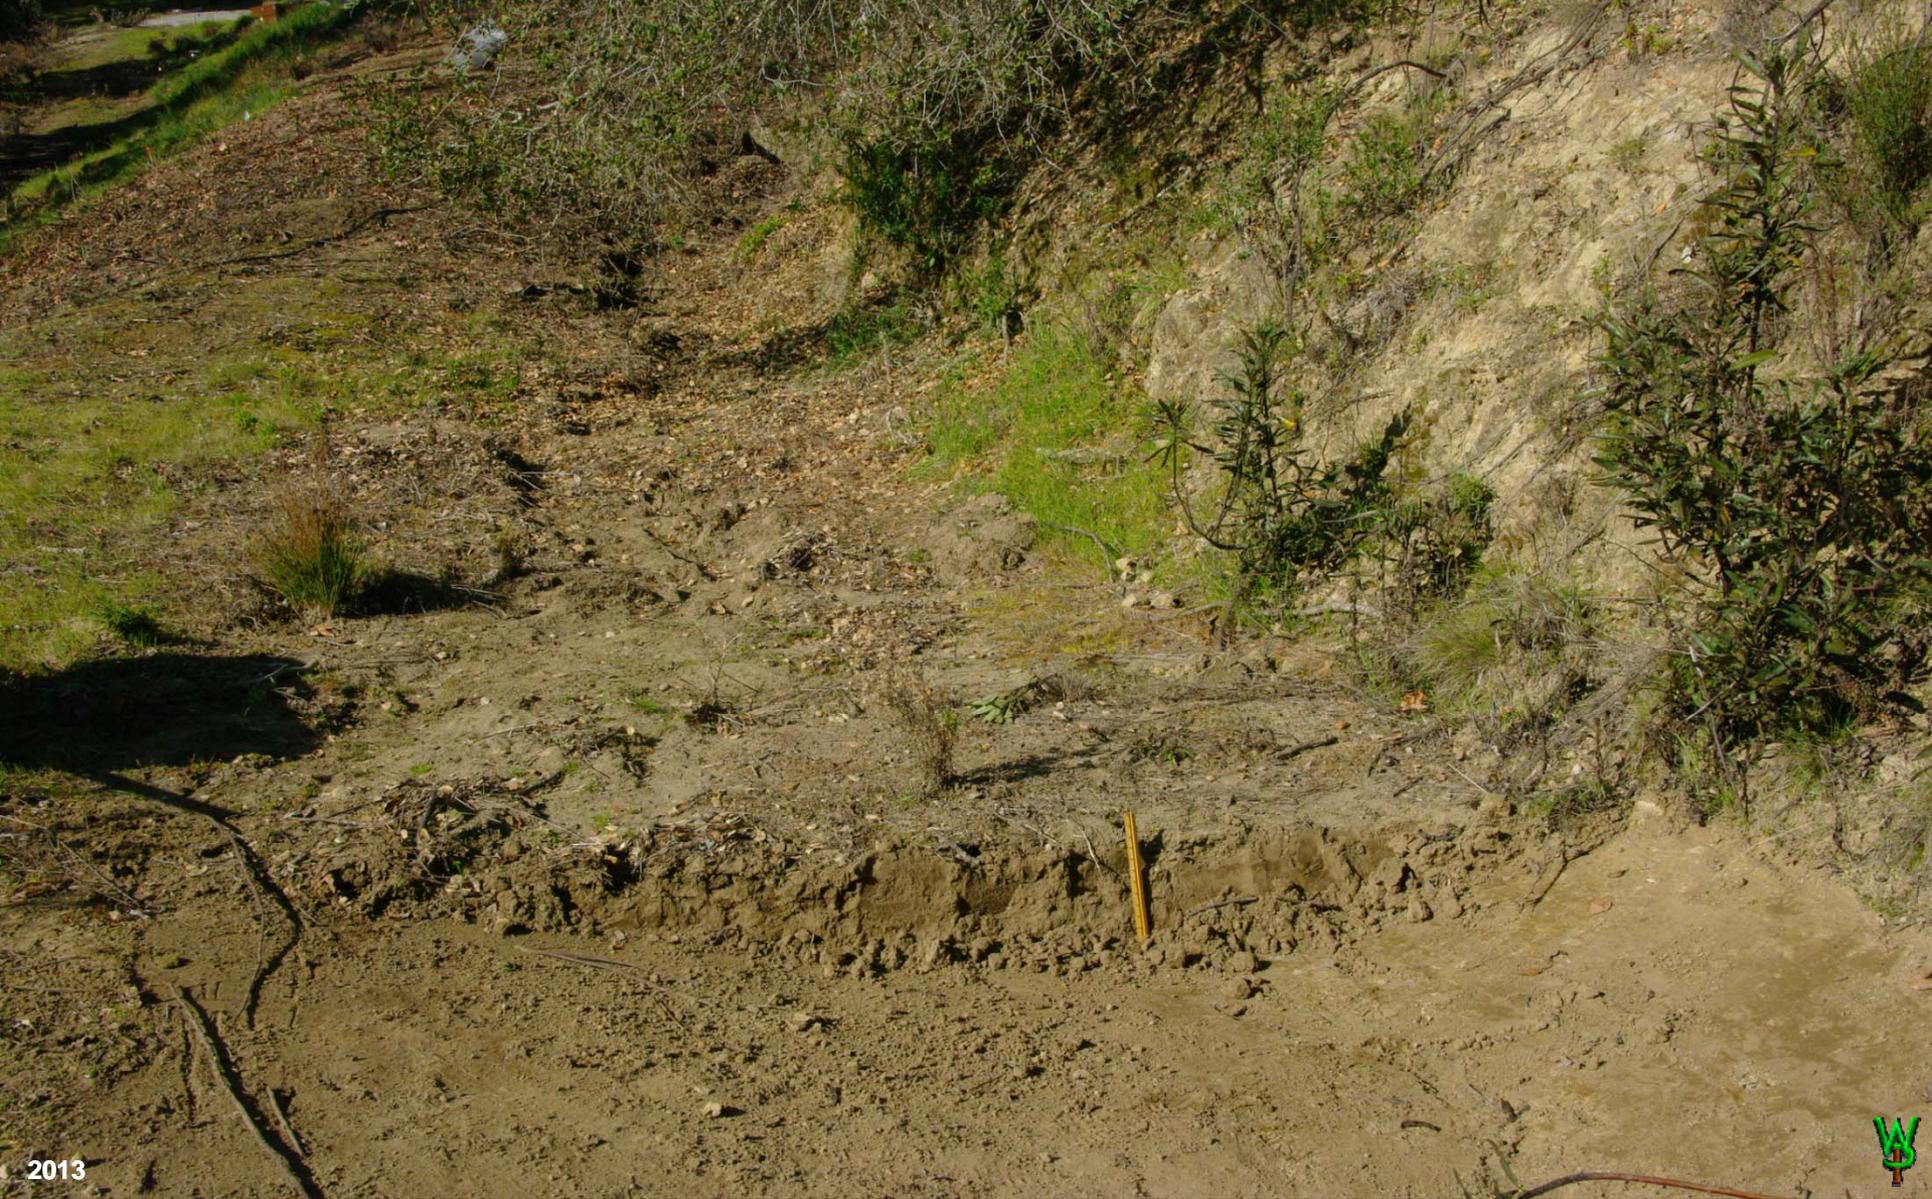
2013

You do not always get your choice of routes for runoff because of the history of how the land was used. In this case, there is a series of old benches of perched fills that once supported various out-buildings. This drainage is sized to handle the water off the entire upper north-half of the property. The slope below the road is so steep that if this much water were to go over the outside of those fills, there would be severe damage to the hillside. So I transit the flow above them on a low slope, this area serves as a catchment basin for sediment. About every 10 years, I dig it out; else the water would eventually dump down those erosive fill slopes.

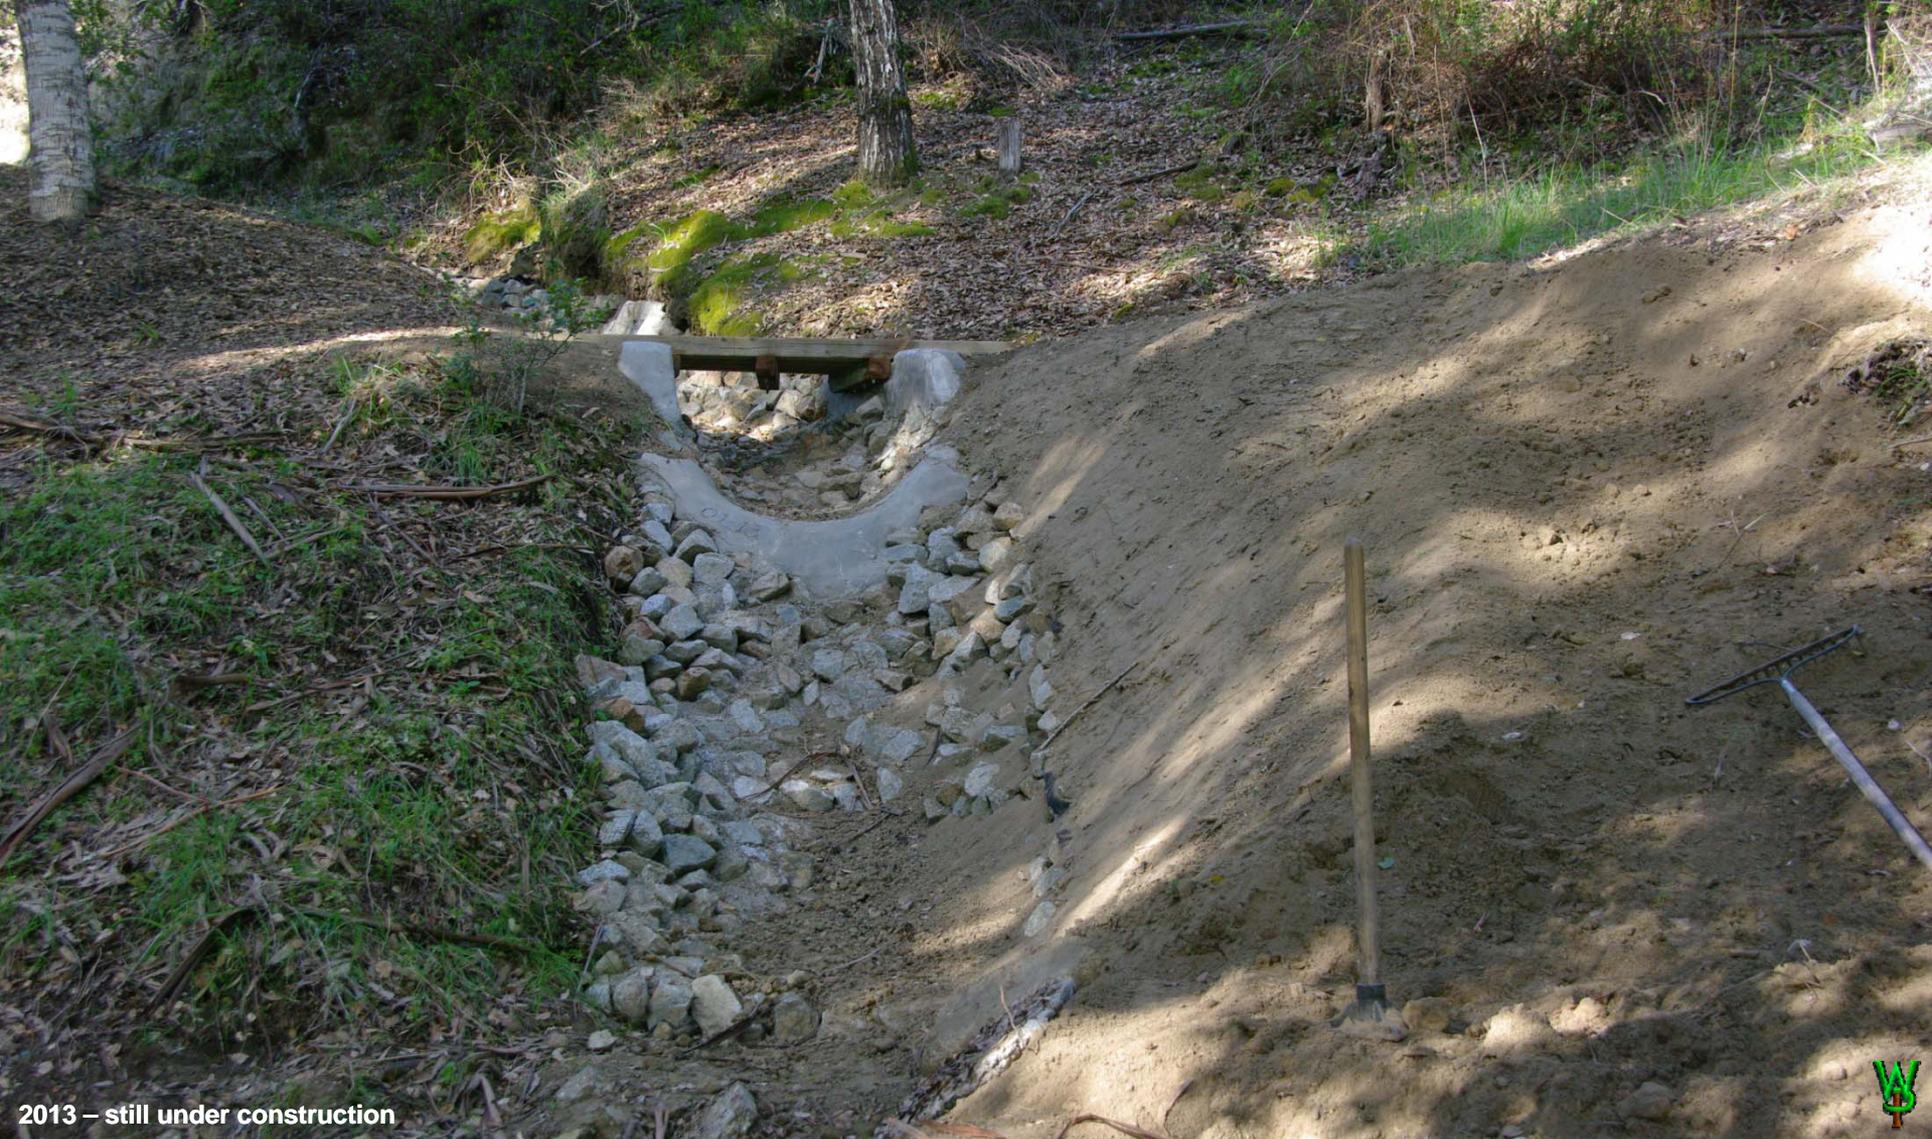
2013 – still under construction

I built this upgrade to that channel to drop the water onto the lower road which acts as a secondary transit and sediment catchment area. The sediment I dug out was packed into what once was a rather ugly eroded hole once cut by water diverted around one of the old structures. The bridge is a way to get the sediment out of the basin on the prior page to a larger water-bar in a safe spot that assures the flow will head in the right direction. Each of these projects deals with history. They are expensive and time-consuming. “We” can either “leave it alone,” to allow whole slopes eventually to fail and weep sediment for decades, or we can maintain it. Yet if the policy preference is to leave it alone, then the policy makers should admit that they don’t really care about the sediment. Hypocrisy as a matter of policy, as we have today, is a 14th Amendment violation of equal protection.

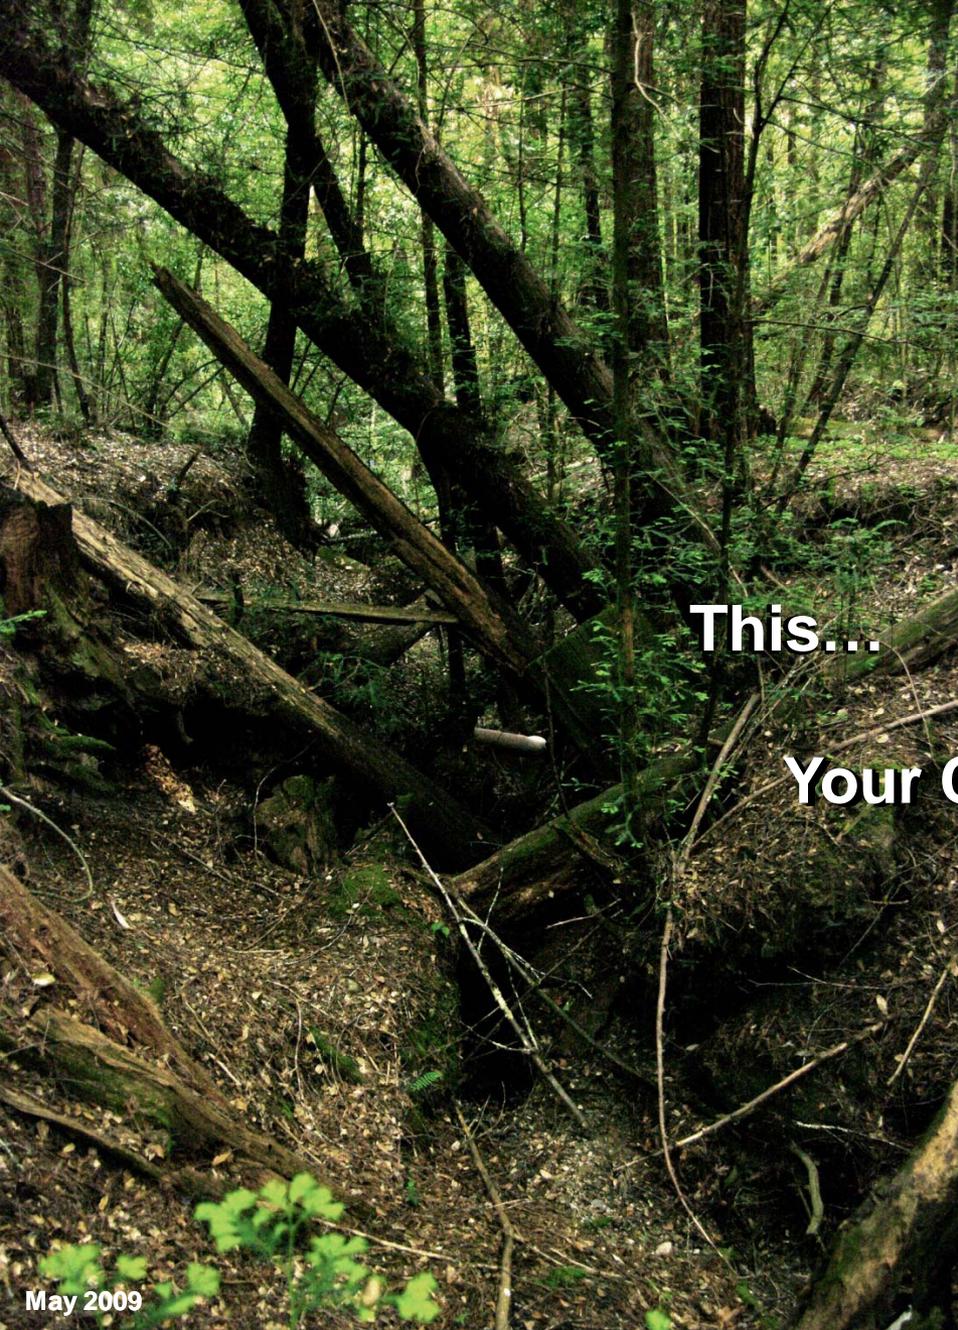
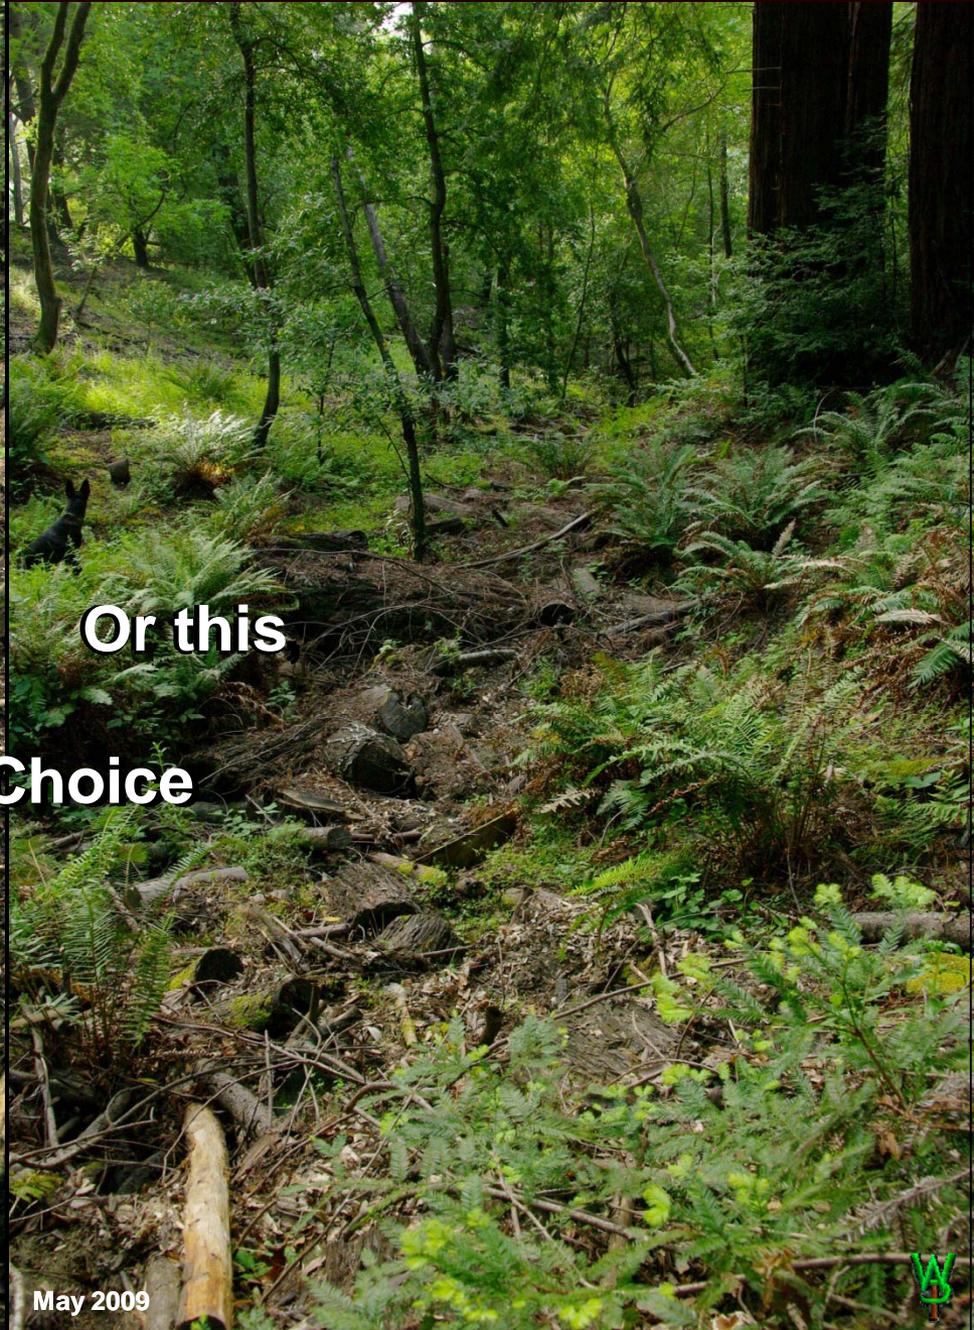
This...

Or this

On the left is a government job. On the right is what a landowners can do, if you let us. Had mine been a commercial job, it would have been a completely illegal modification of a "Natural" stream. Take your pick, the responsibility for the consequences are on you.
