FEELING DRAINAGE

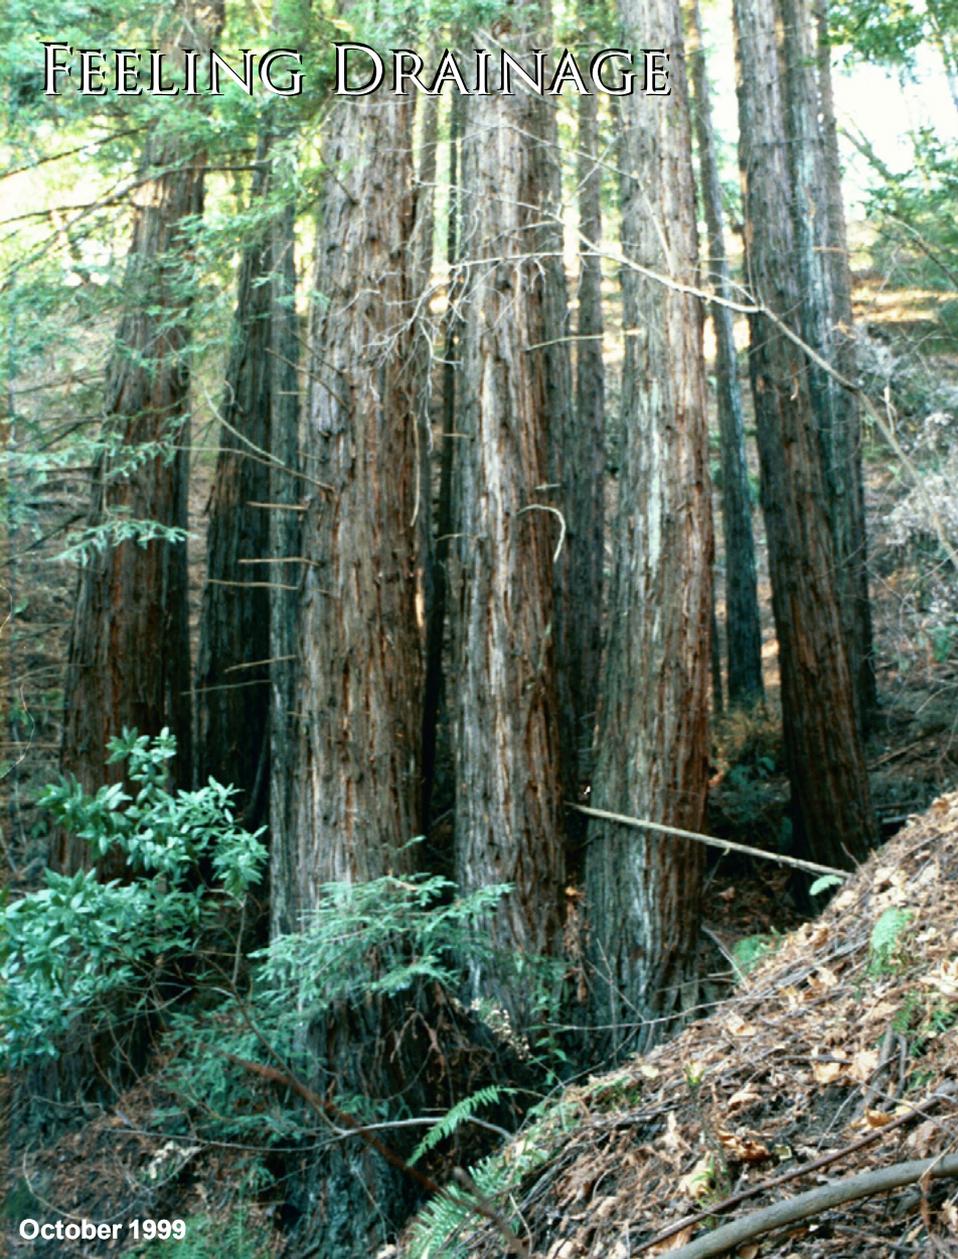
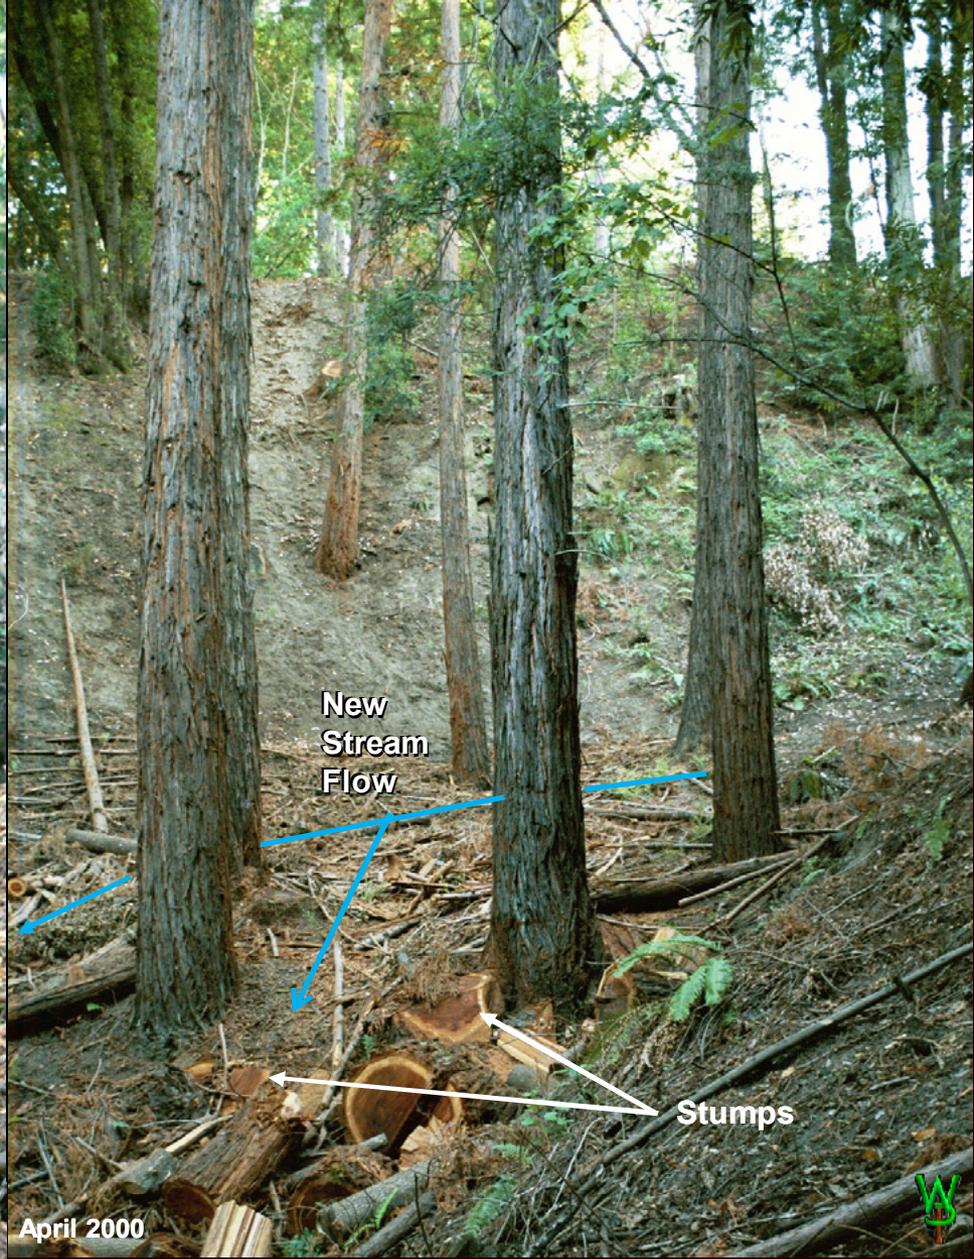
On the left is that same “wall of wood” I somehow discerned needed thinning. The stream ran in front of them and was starting to undercut their support (you will soon see what happens should that process progress). So now I’m going to show how logging can not only prevent landslides as we have seen, it can (1) help armor the bottom of the channel with impressive native plants *and* (2) it can *reverse* channel erosion that would otherwise undermine the slope above until it fails catastrophically.

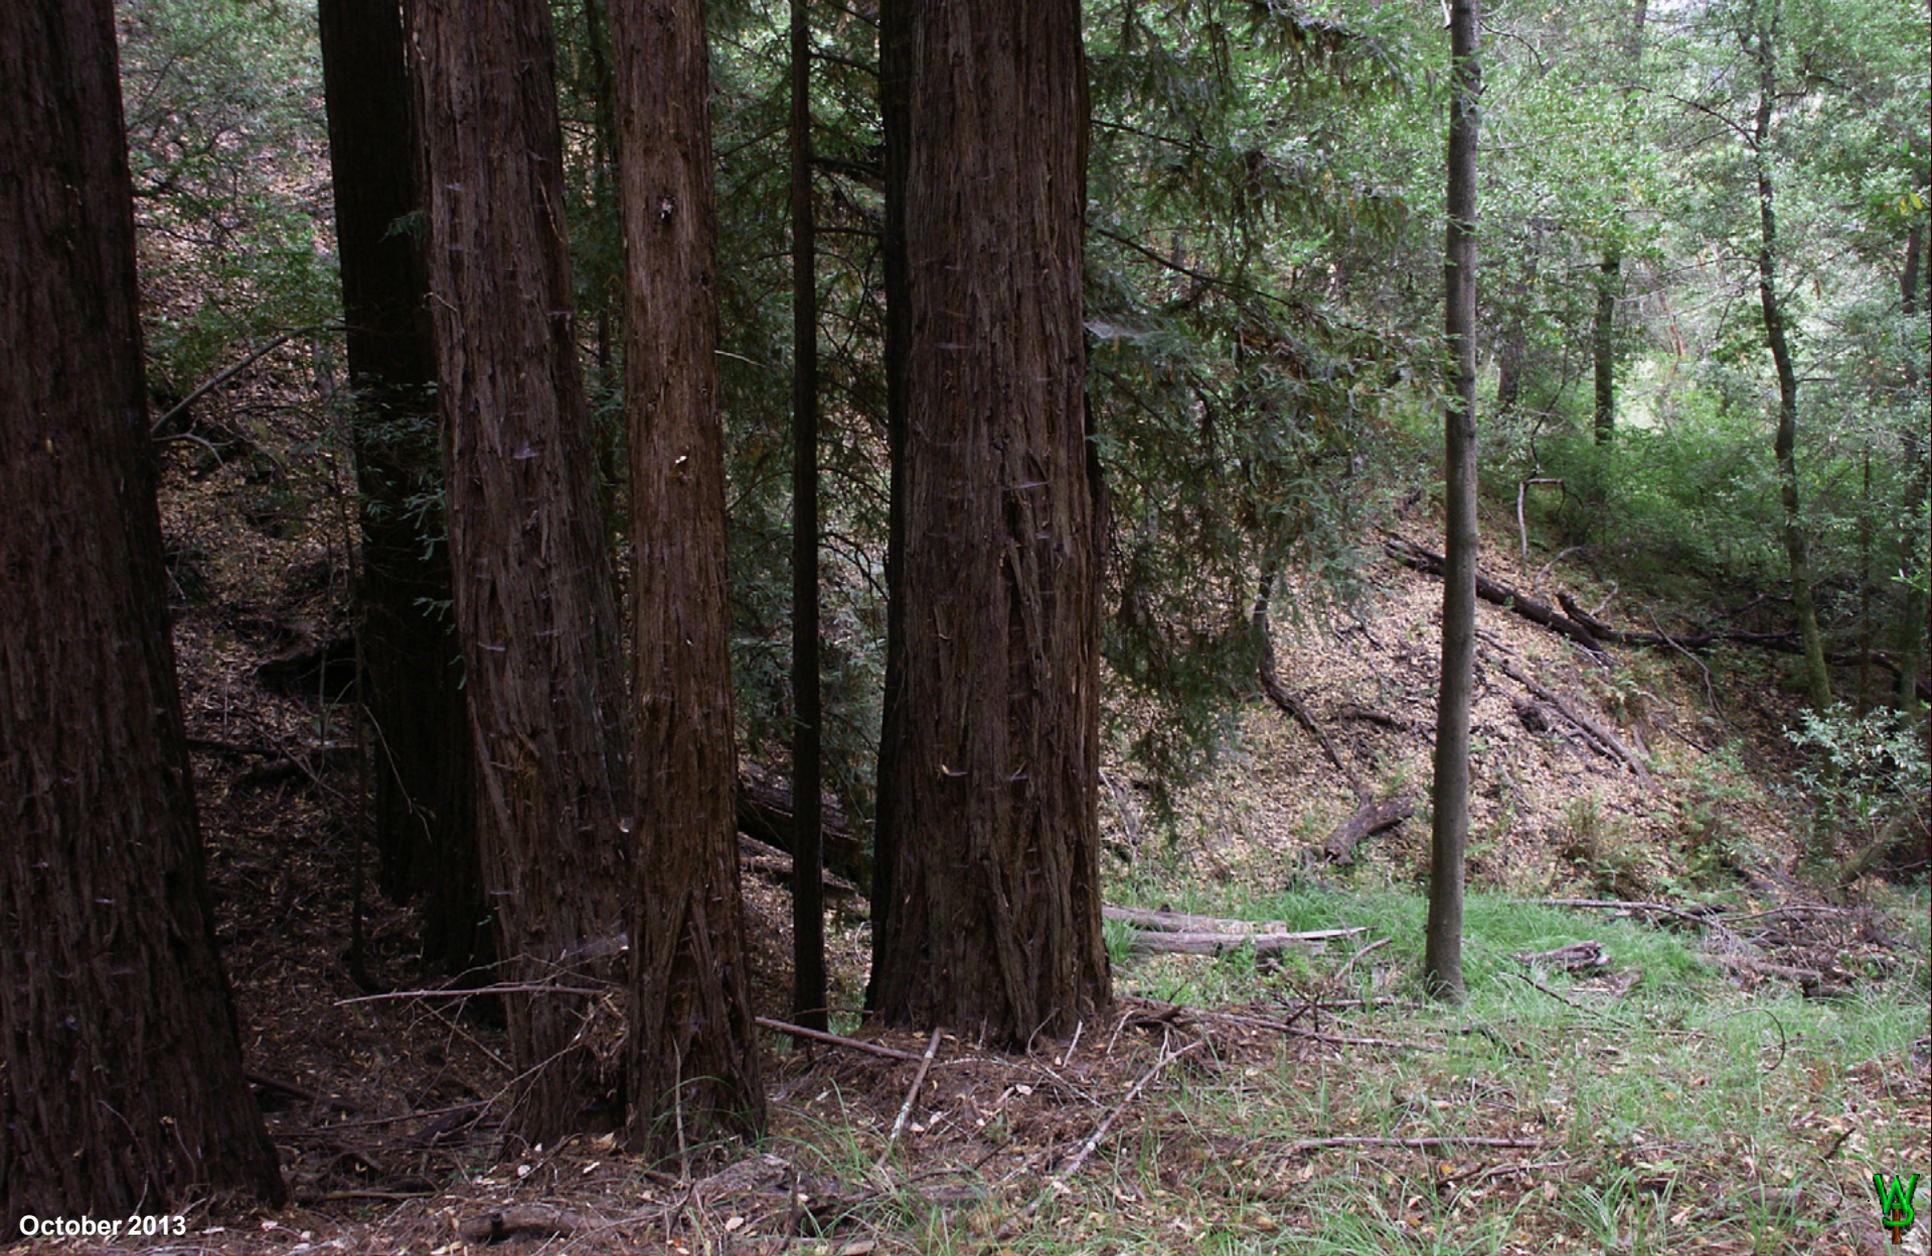
One of the ways in which the environmental industry has driven the timber industry into ruin has been with claims that logging releases sediment into streams, thus harming “endangered” fish (never mind the fact that the fish were more abundant at a time when fishing, timber harvests, grading, and drainage practices were totally unregulated). A logging job surely does release sediment, just as not logging can also do, in a much bigger way. This was one of two spots that taught me what to at least attempt, and why. Can you see it?

Incision begins here

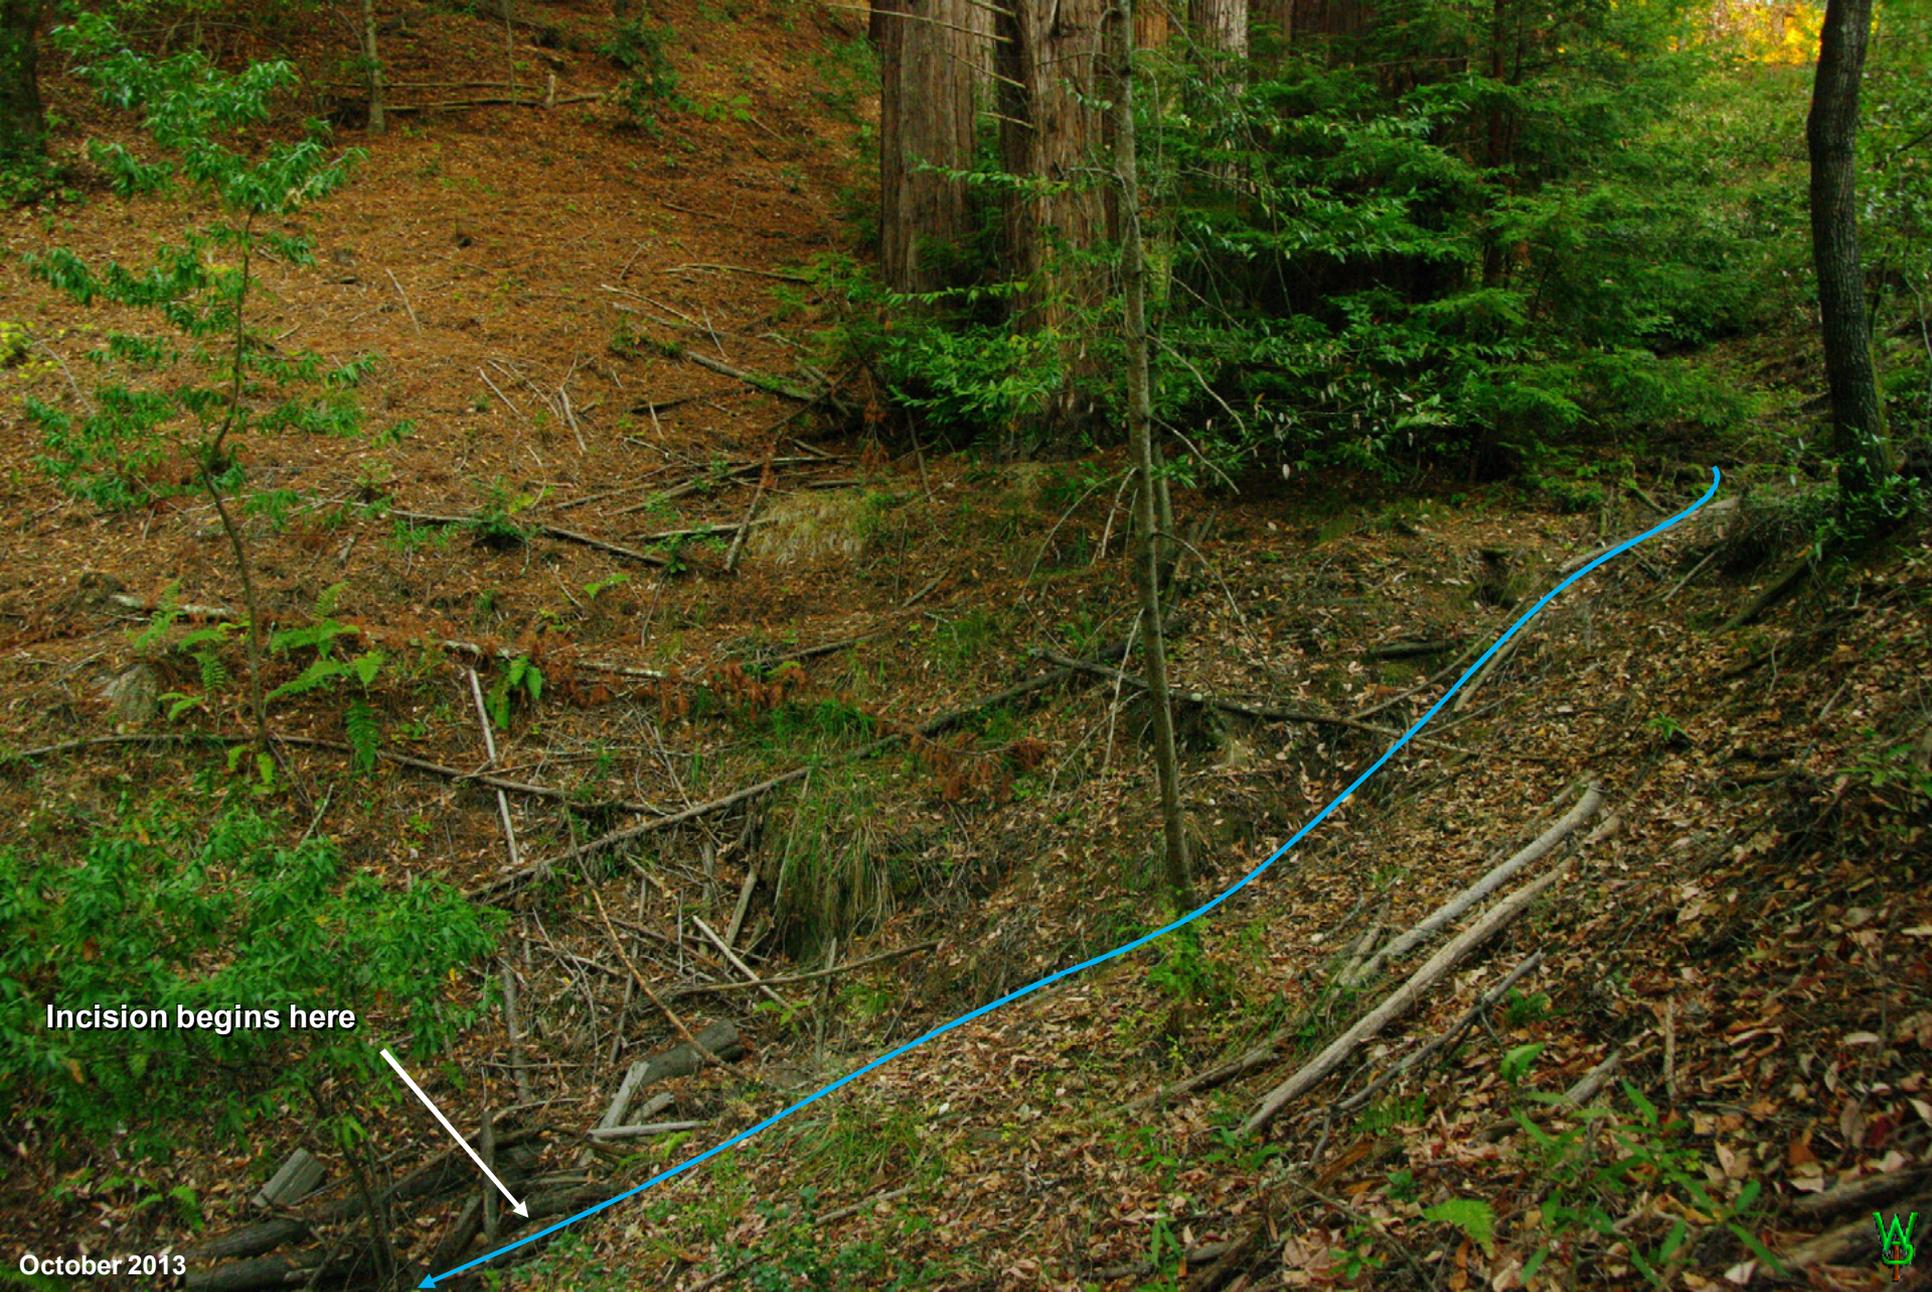
Here is the same cluster of redwood trees seen from the other side. It should be fairly obvious that the roots of these trees have inhibited a considerable amount of erosion of the stream bed , also called “channel incision” such as you see below them. What I do here reverses that incision process for reasons we’ll get to soon.

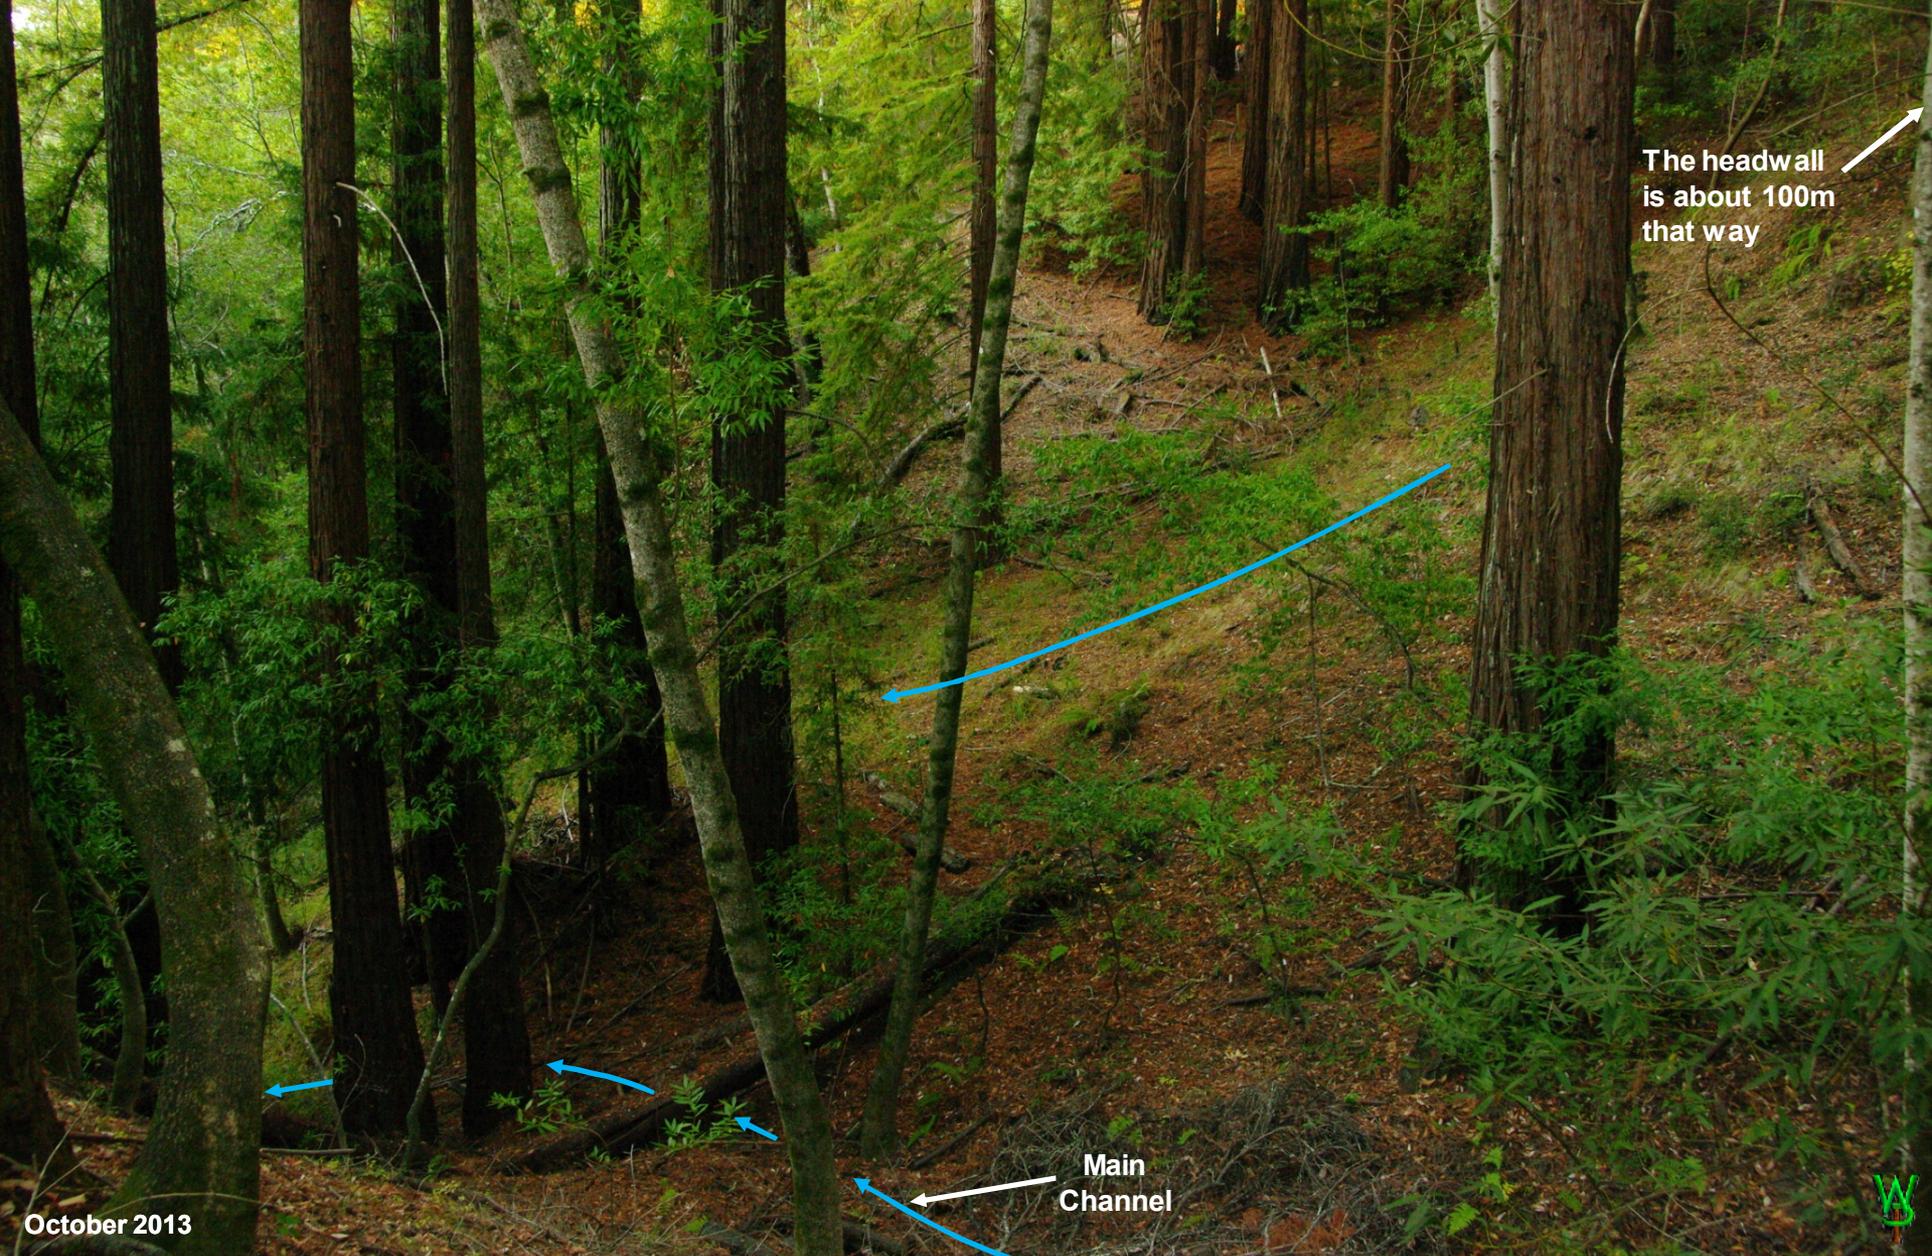
Looking down the channel from the same spot, it isn't hard to see another landslide deposit with trees on top at the lower left. At the top of the draw to the right is a rotational slope failure with a steep headwall. I suspect that the green swath behind the trees is alluvial deposition on top of a colluvial lens. Based upon the stumps I have counted in this area, none of these trees is over 100 years old. Unlike the next draw to the north (TBD), there are no large old stumps. This has probably all happened since it was first logged.

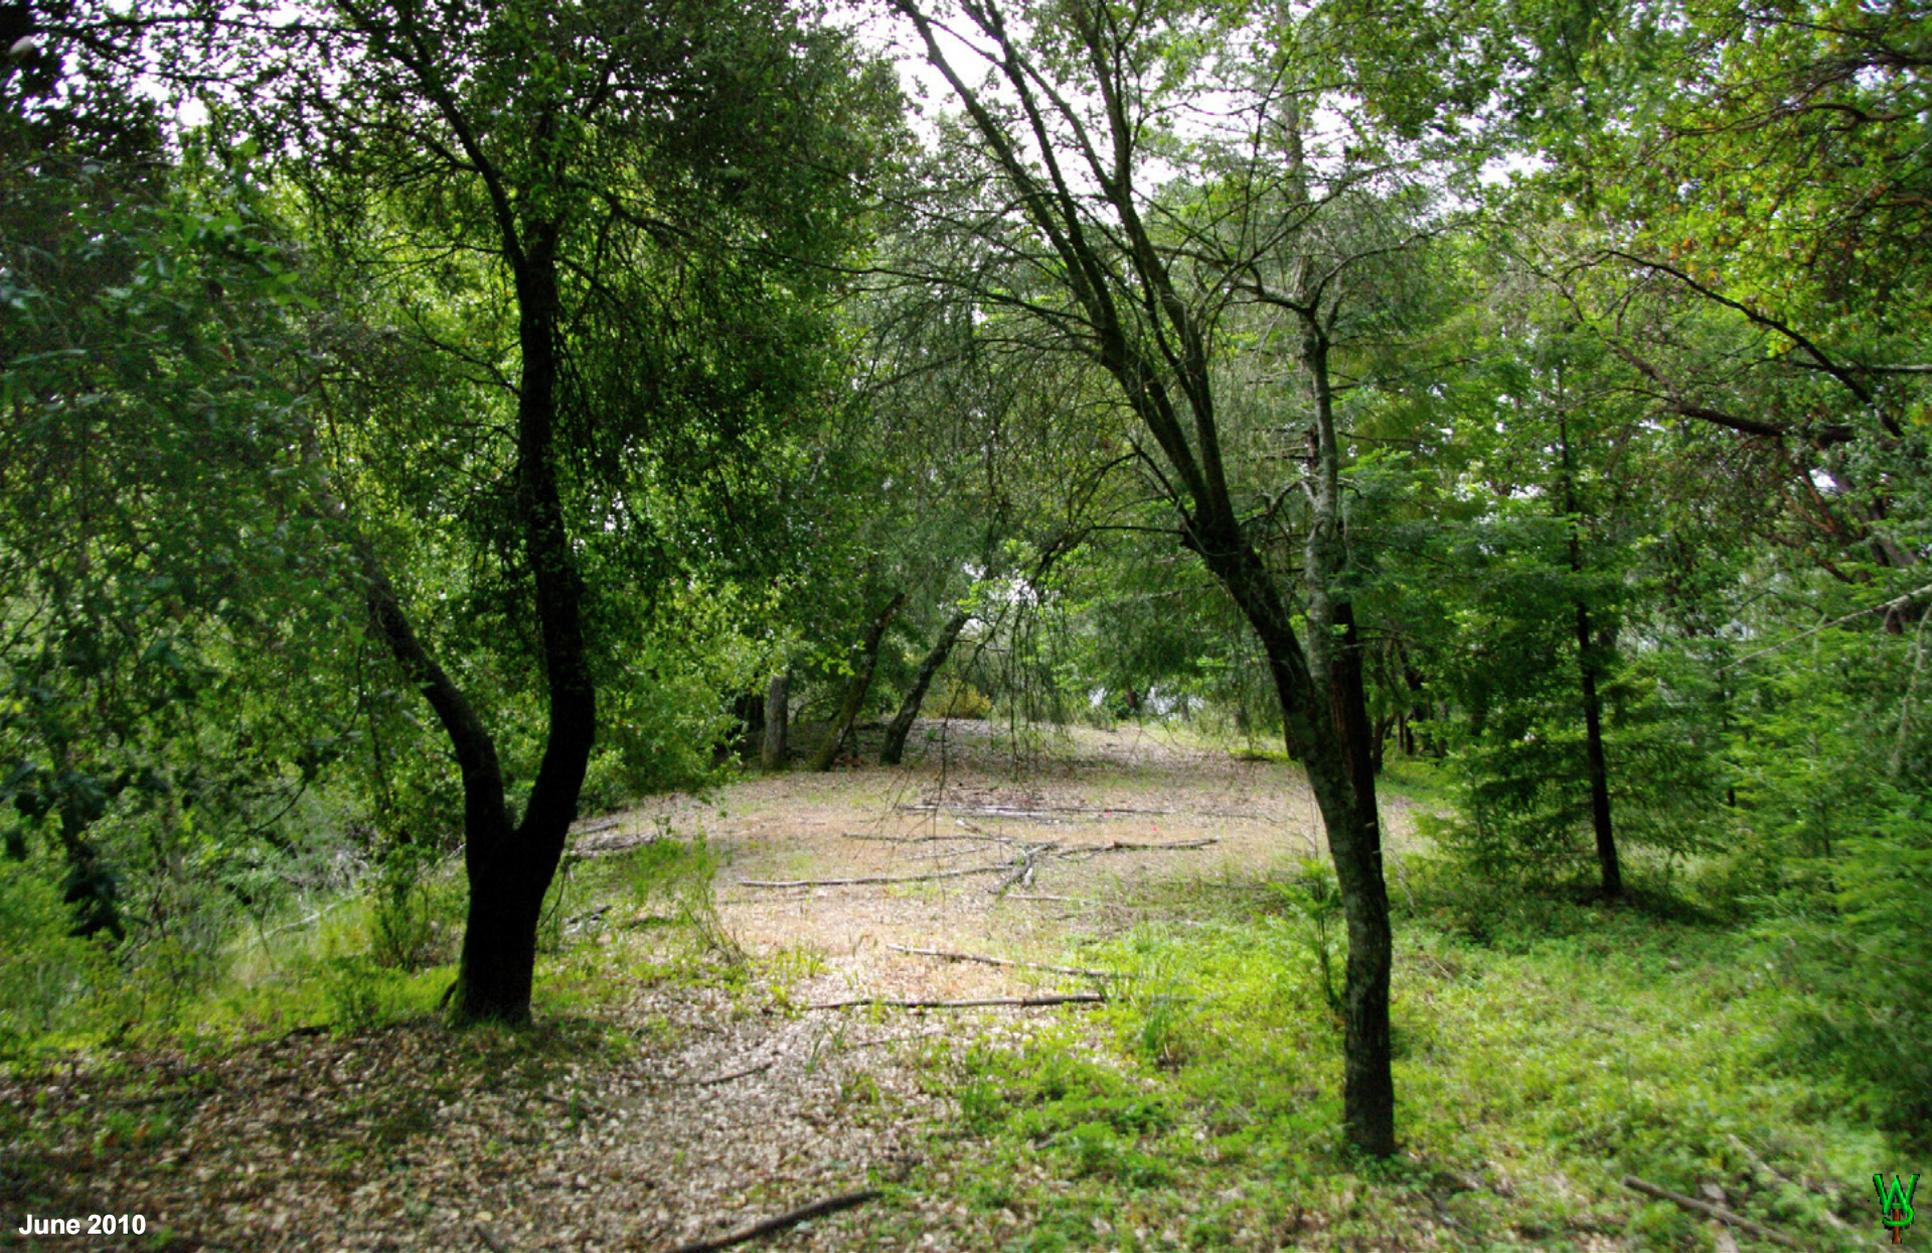
You may remember this image from the repeat photos in the Introduction. The first thing I did to impede channel incision was to cut trees to the right side of this ridge, about 100 feet *above* the channel. Although cutting the bay trees up here was legal (not a timber harvest), it did reduce “stream canopy cover,” which could get you fined on a commercial job. The thing is, “How much shade is the right amount?” It turns out that when it comes to canopy cover, sometimes more is worse.

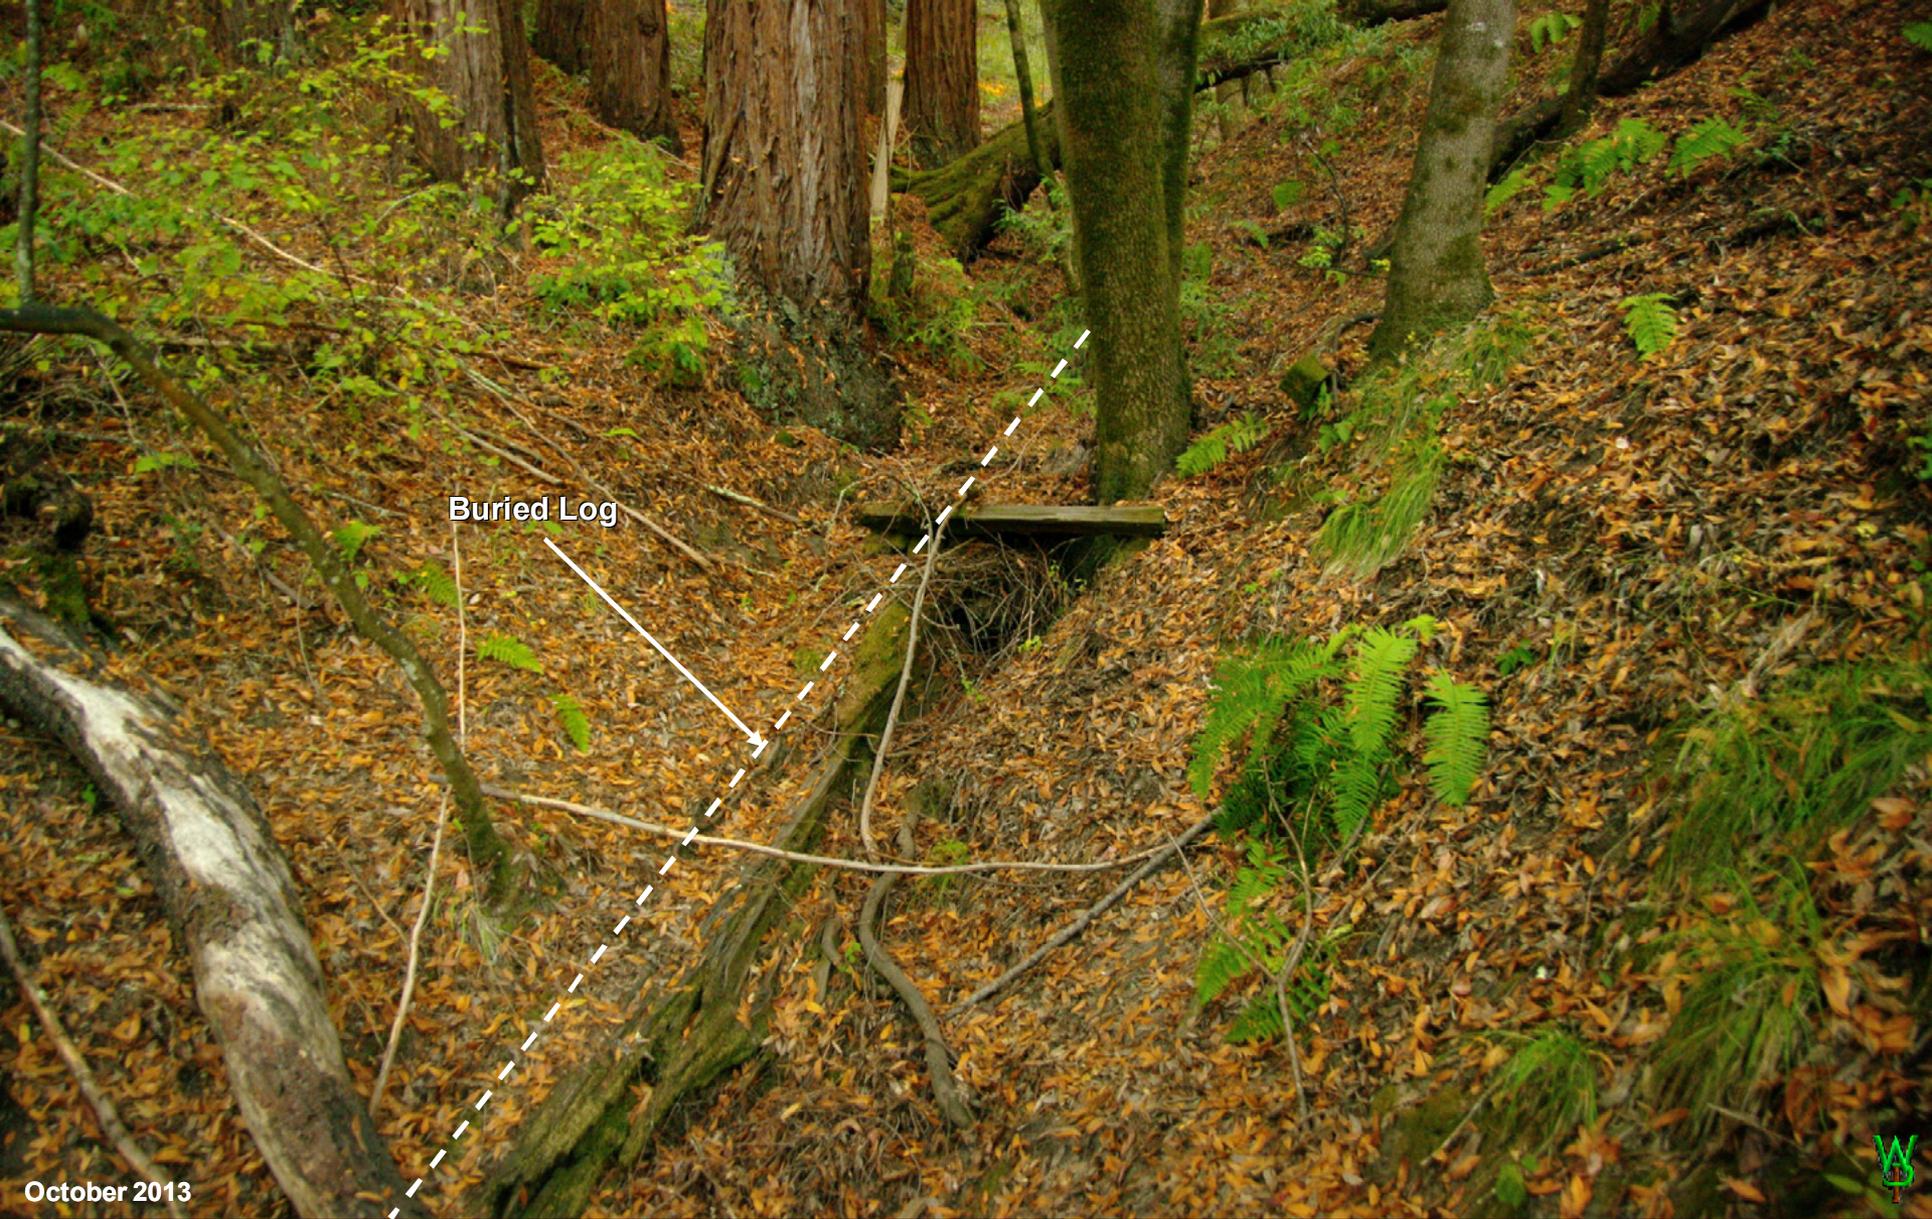
Buried Log

Here is the other 'thing that taught me what to do,' and it is what shaped the toe of that slide. This log is *underneath* the landslide with the trees sitting on top. It is one very substantial log. It was cut by a saw on one end, so it is impossible for the slide to be over 150 years old. From the size of the trees, my guess is that it has been here about 90 years. If the Vaquero sandstone substrate is relatively uniform, it may be that wood has been *the* critical factor in defining channel shape and distribution in this region. Once the channels start, they tend to keep cutting in the same location, unless there is faulting or somebody does something, as we shall see.

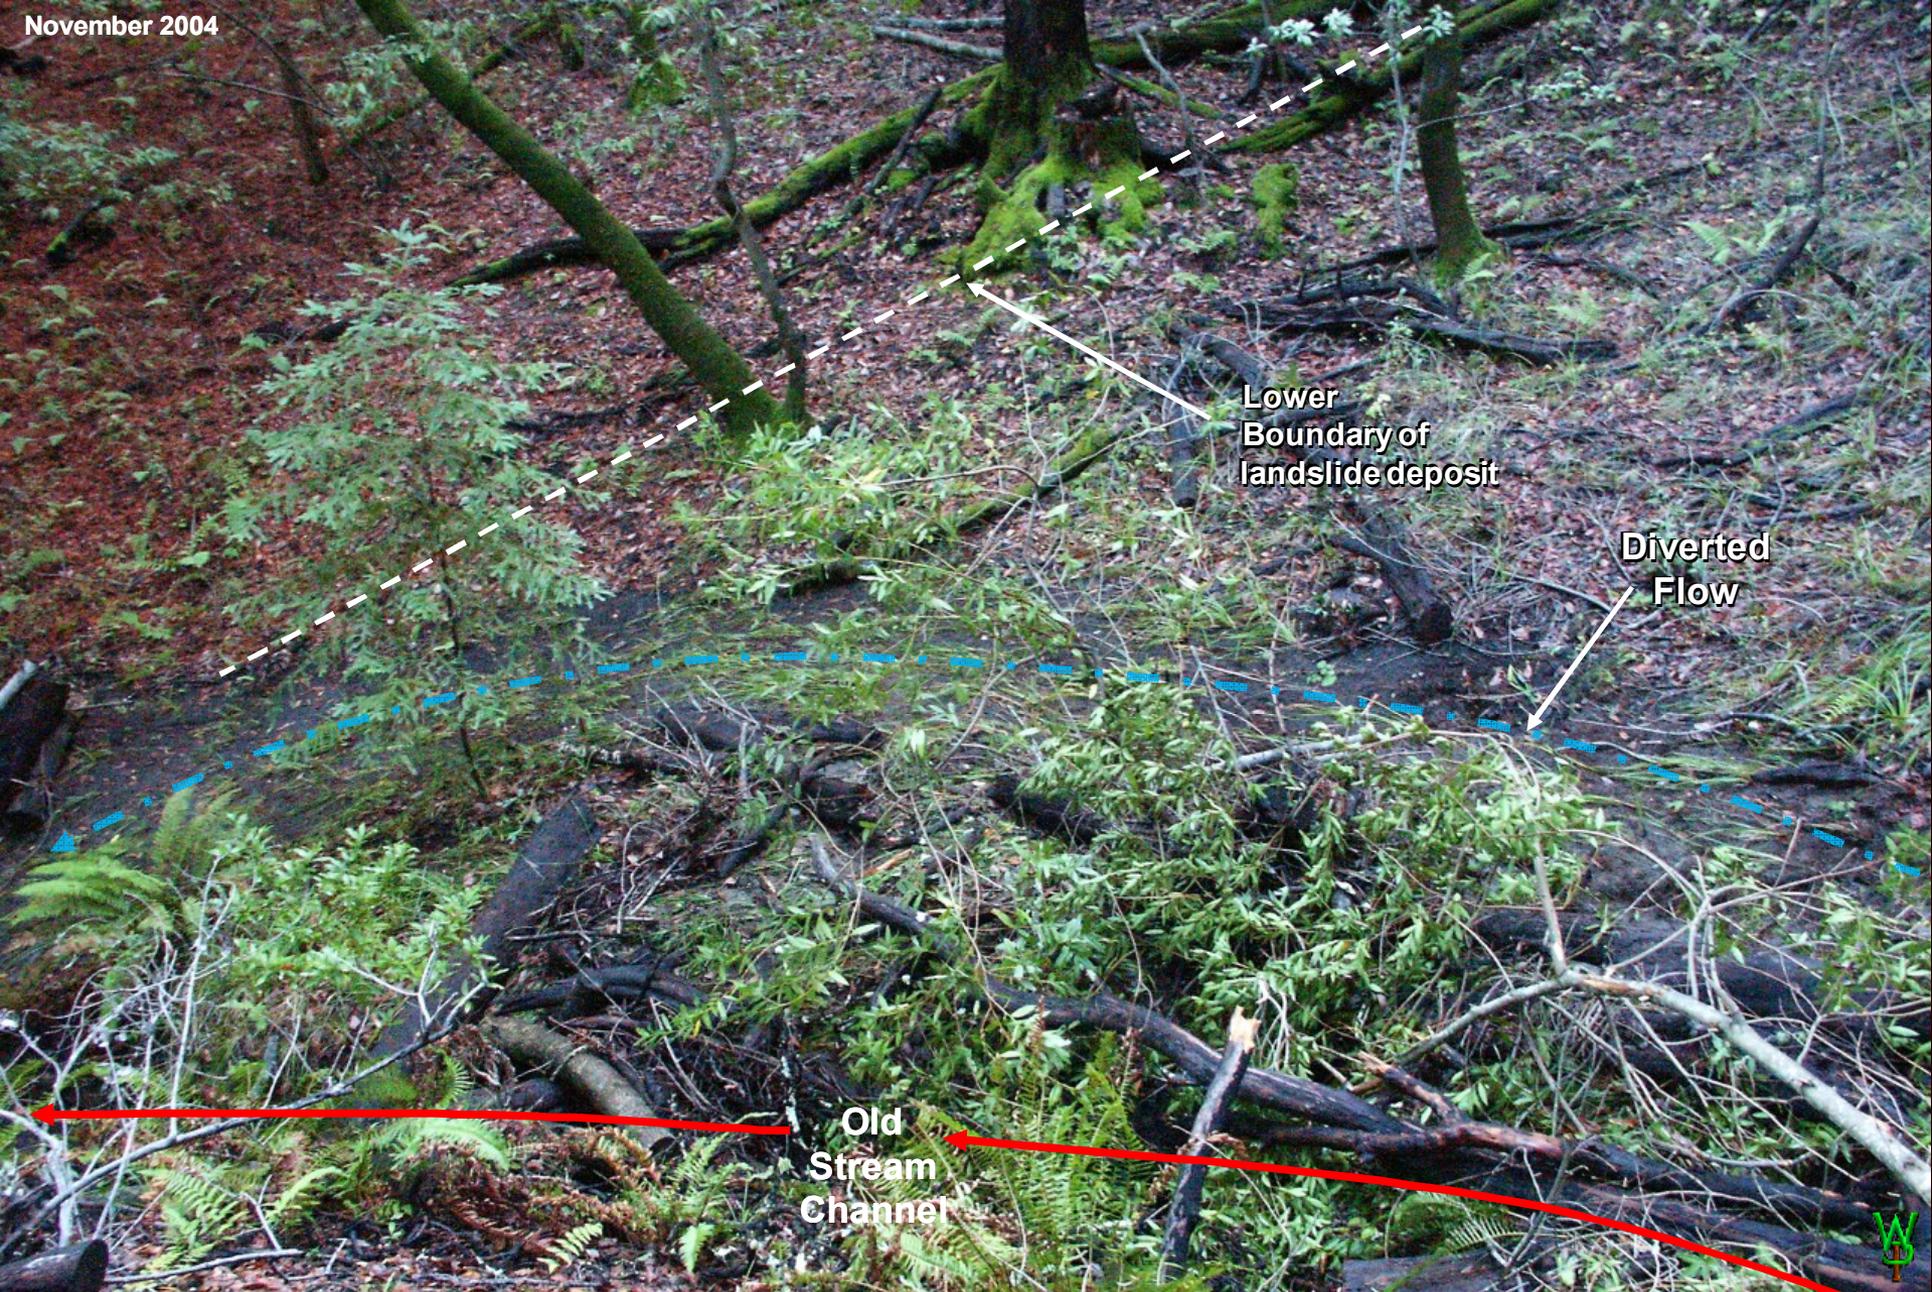
All I am doing here is taking the principle one step farther to reverse channel incision. Most people would never guess that reducing canopy cover has anything to do with that goal, but then, most people do not understand how powerful sedges can be in managing erosion. As to the risk of a debris flow, there is a big flat area just below the outlet to this stand for the water to fan out and lose energy.

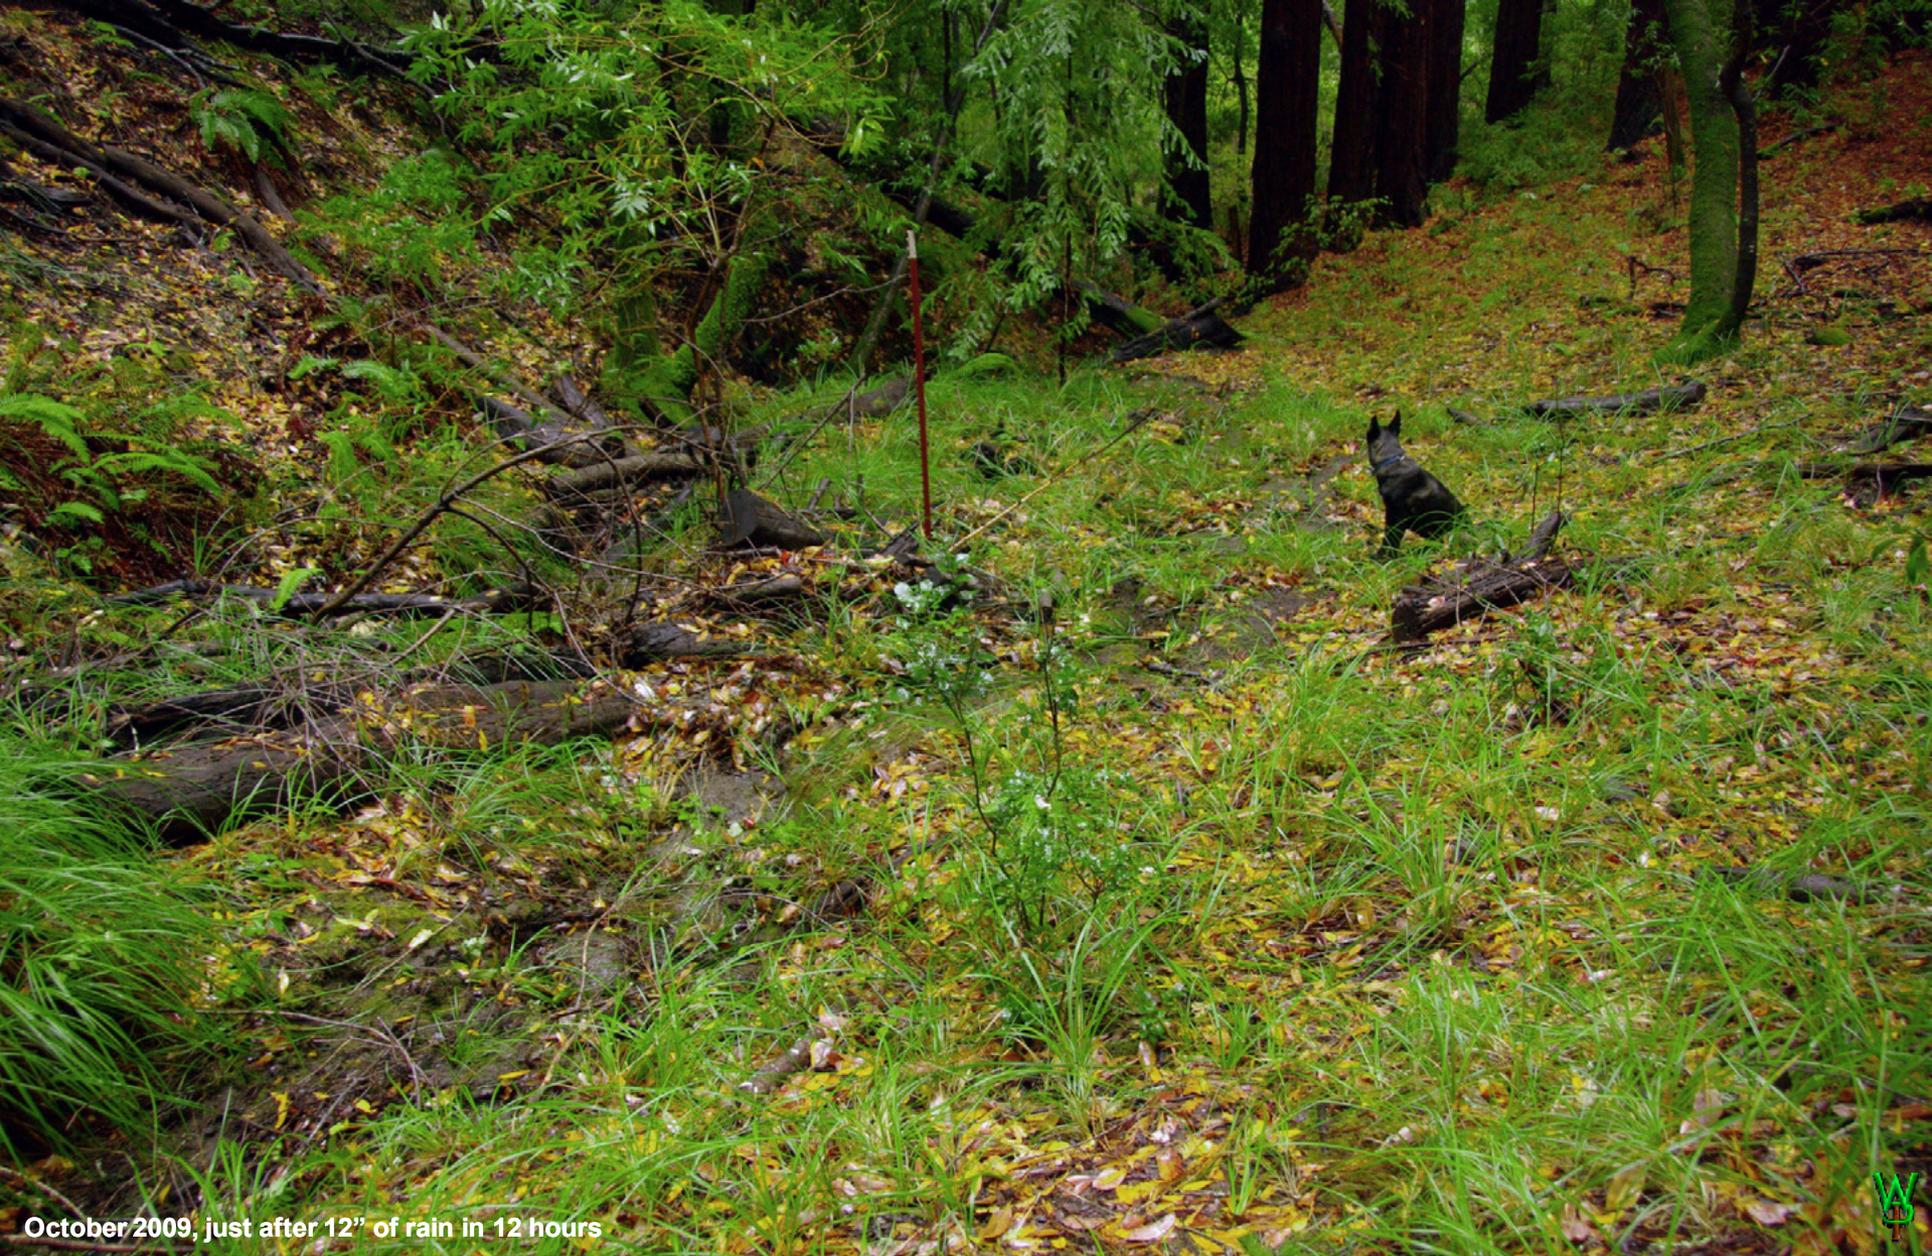
Here it is after five years of winter rains and just after another monster storm. If you look carefully, you'll see not erosion but *deposition* of sediment in the foreground at the head of the diversion. That material is from all over our property, from the my neighbor across the road, various stumps from fallen trees, etc, but probably the biggest source is gophers, ground squirrels, moles, and rabbits. I use that material to stabilize the draw over time, as you will see in our next example in the next channel just to the north.

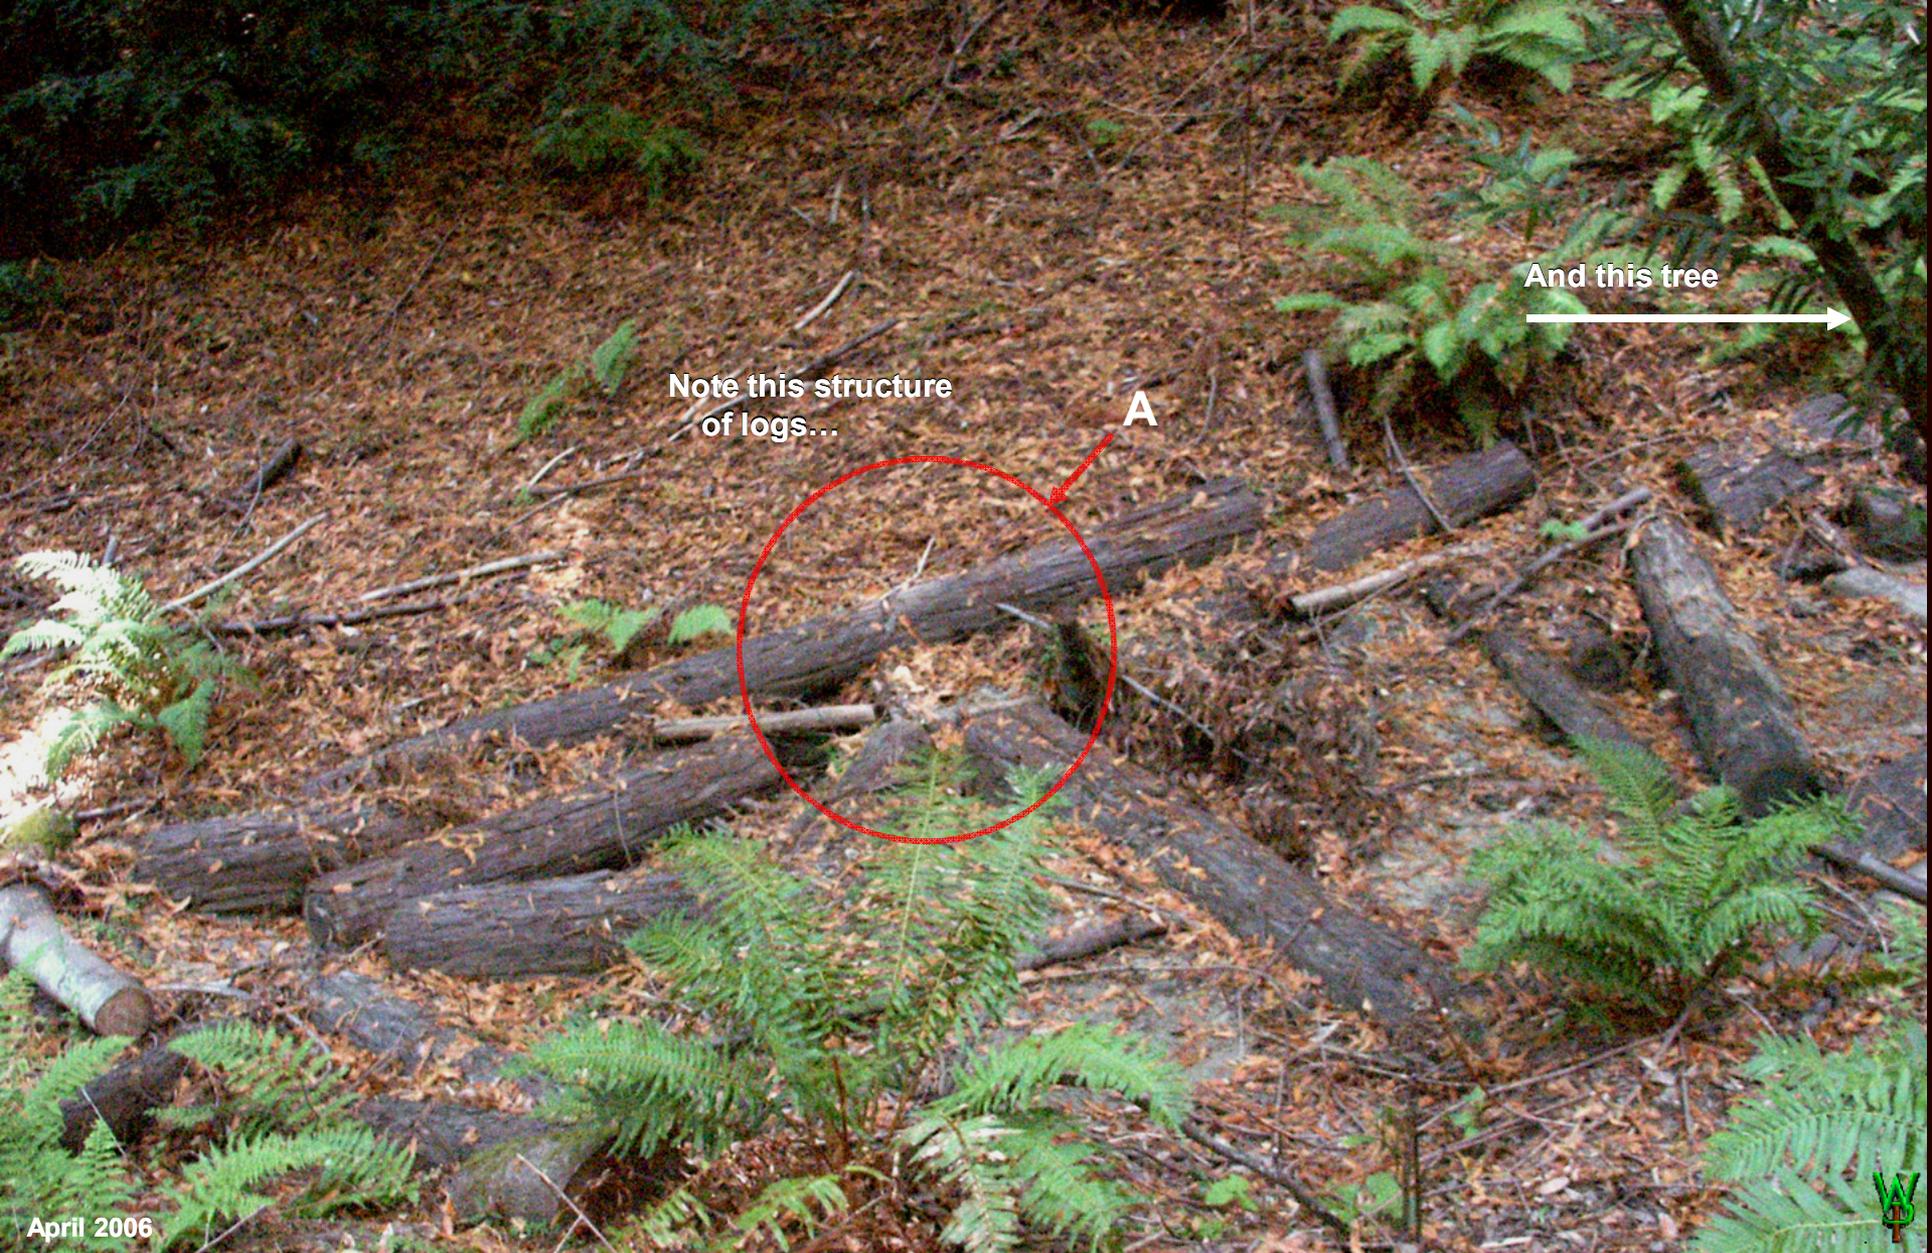
All those tiny sources add up to a fair bit of sediment once lost off the property every year. So, I decided to solve a problem with it. This photo was taken six years after my original redwood 'logging job' in 2000. These interlocked structures of left-over logs form stepped weirs with vertical drops and slow runs that trapped sediment. There are raised sidewalls to contain the flow. The sediment has almost completely filled a channel 6-8 feet wide and 2-4 feet deep. Note the circled structure "A" for reference from slide to slide.
