FEELING DRAINAGE

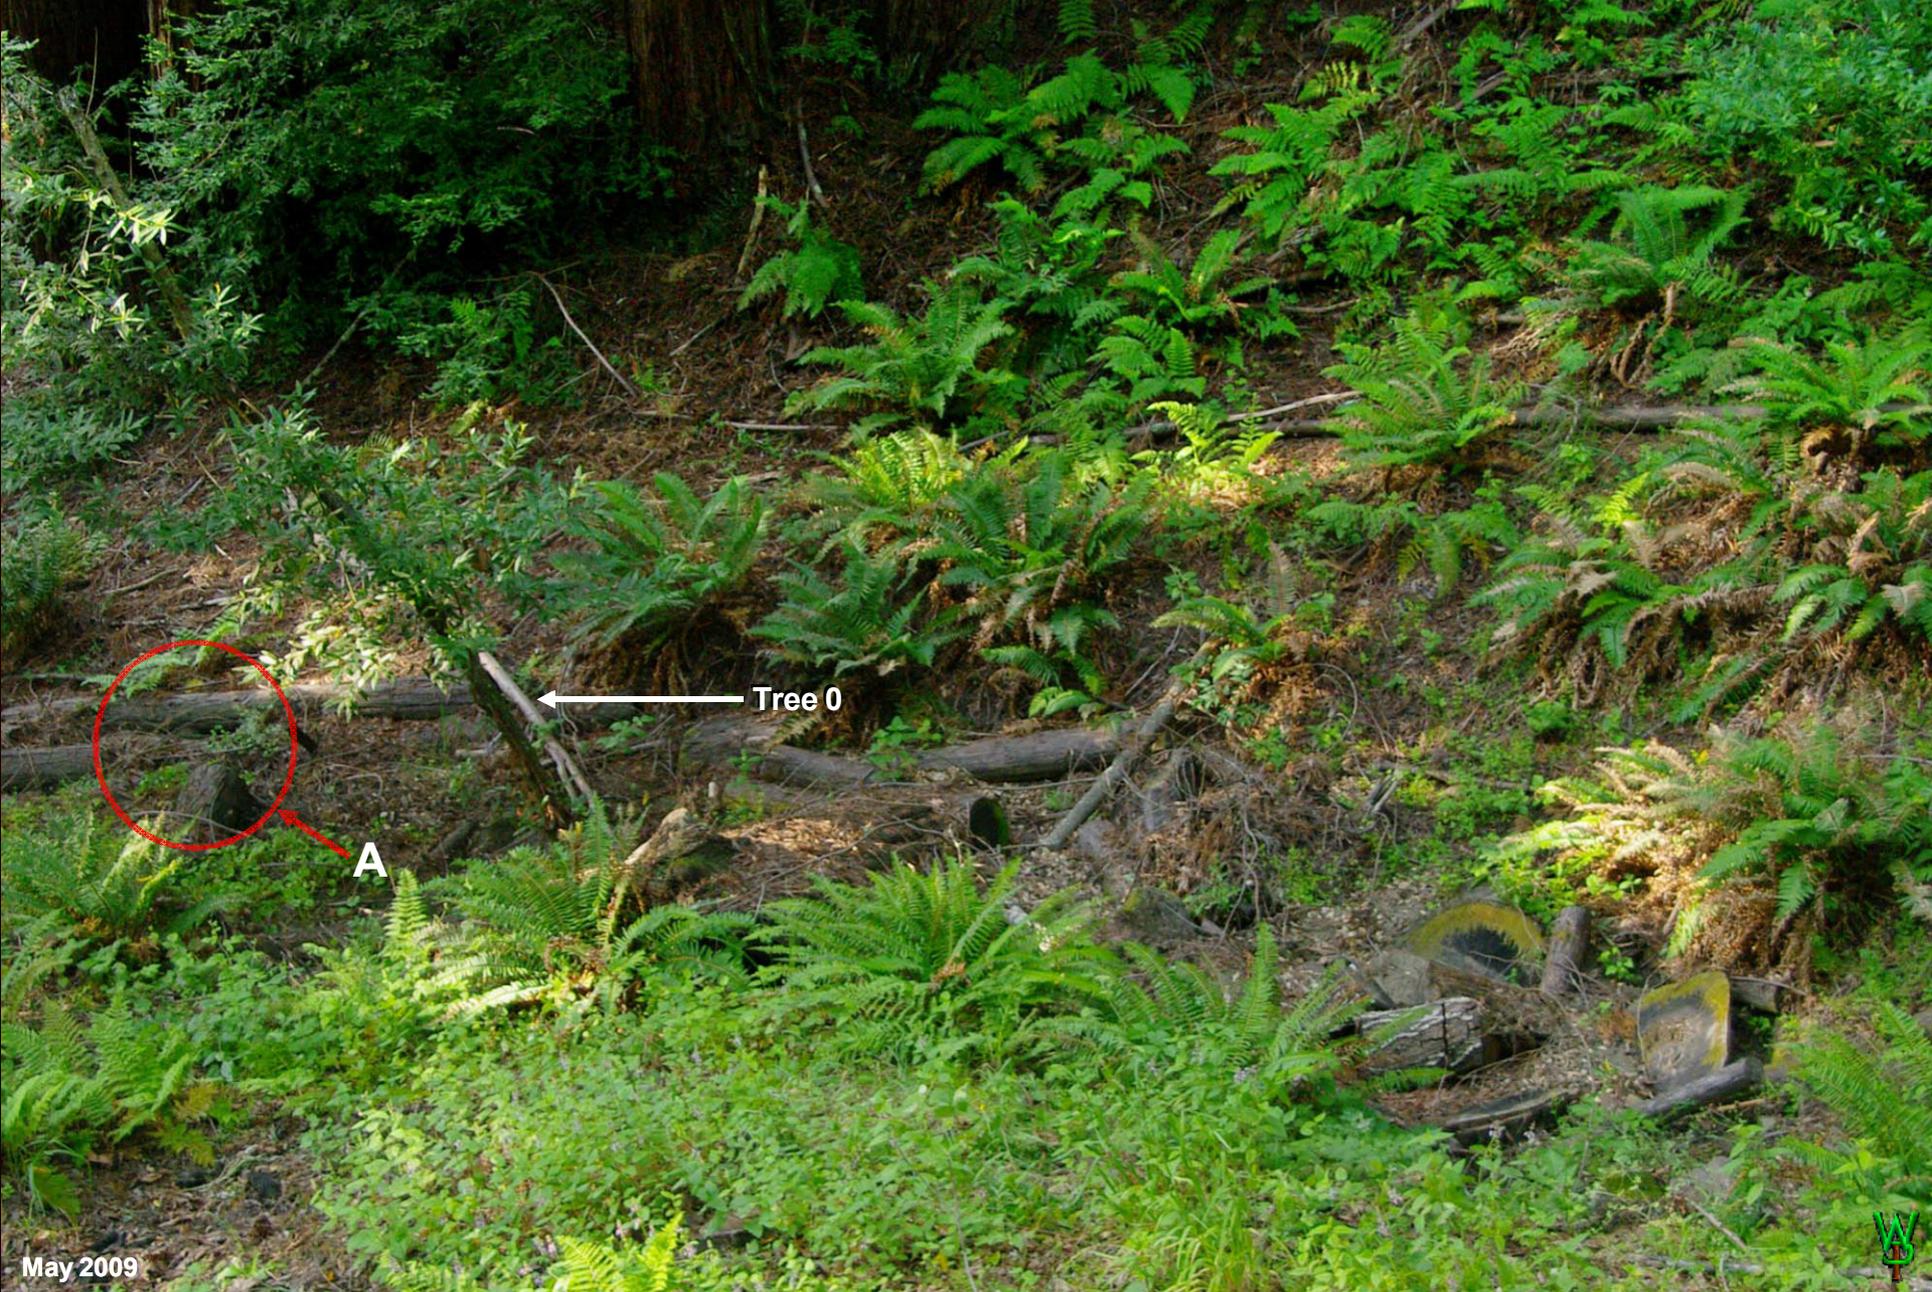
This is the same channel three years later from a little wider view. Logging made the material to line the bed and collect the annual deposition. Logging thinned the slopes so that light could reach the canyon bottom to stimulate the vegetation. It's working, but more thinning is needed for the sedges to really take. More sediment will help too. Note "Tree 0" with the white arrow for location.

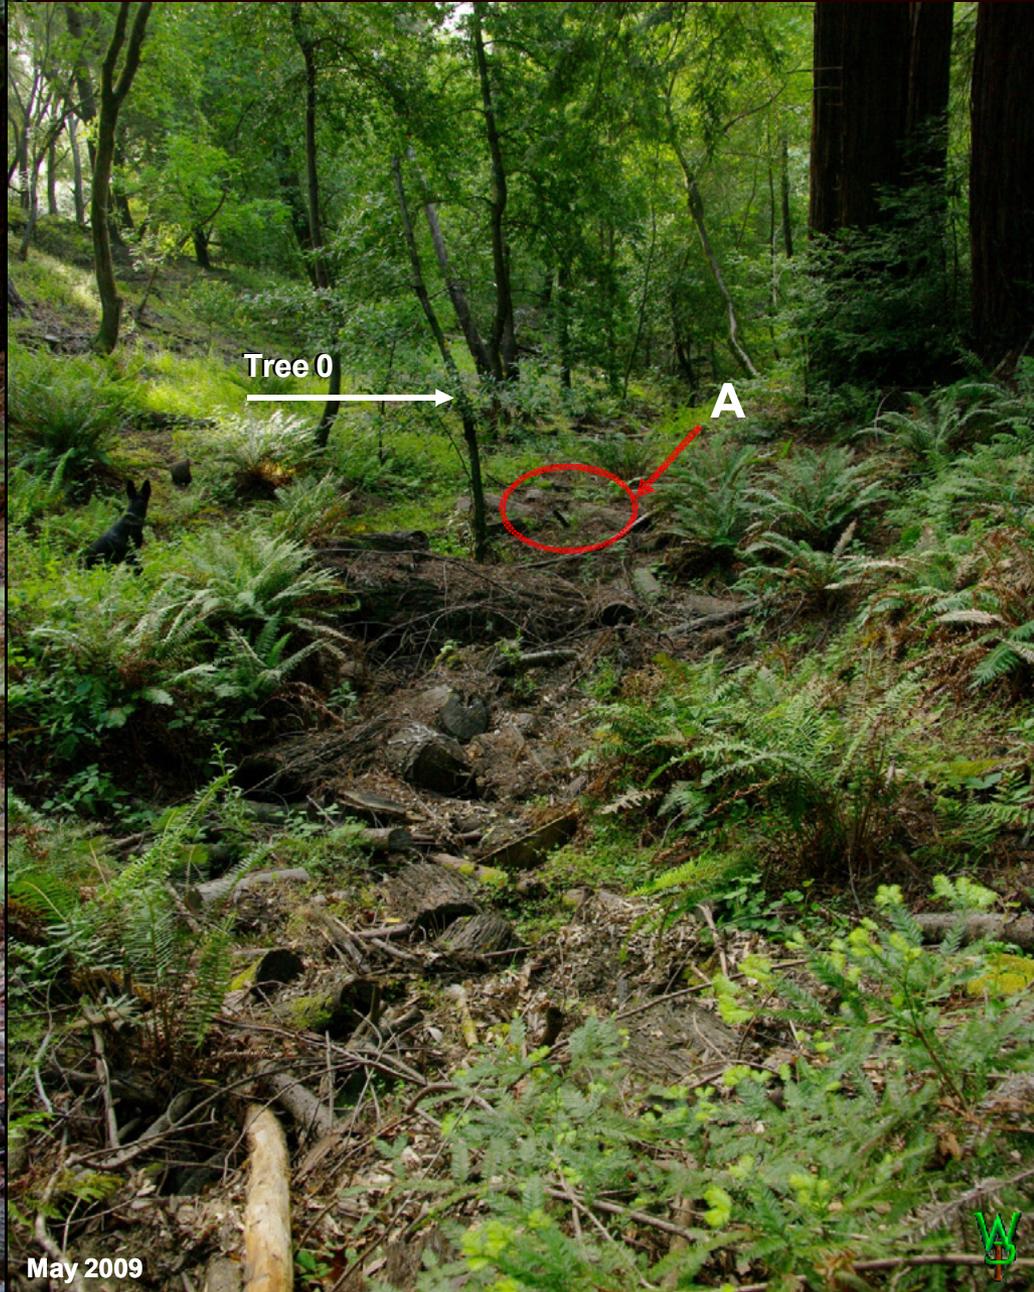
From above, L+6, same channel. This year, I thinned bay trees above the left background and put more wood into the stream along the dashed line down to the circled tree (1).

Here it is L+9 from a spot just to the right (new vegetation was in the way). Thinning the hillside on the left allowed in a lot more light. The stream bed is still filling in and more plants are taking root.

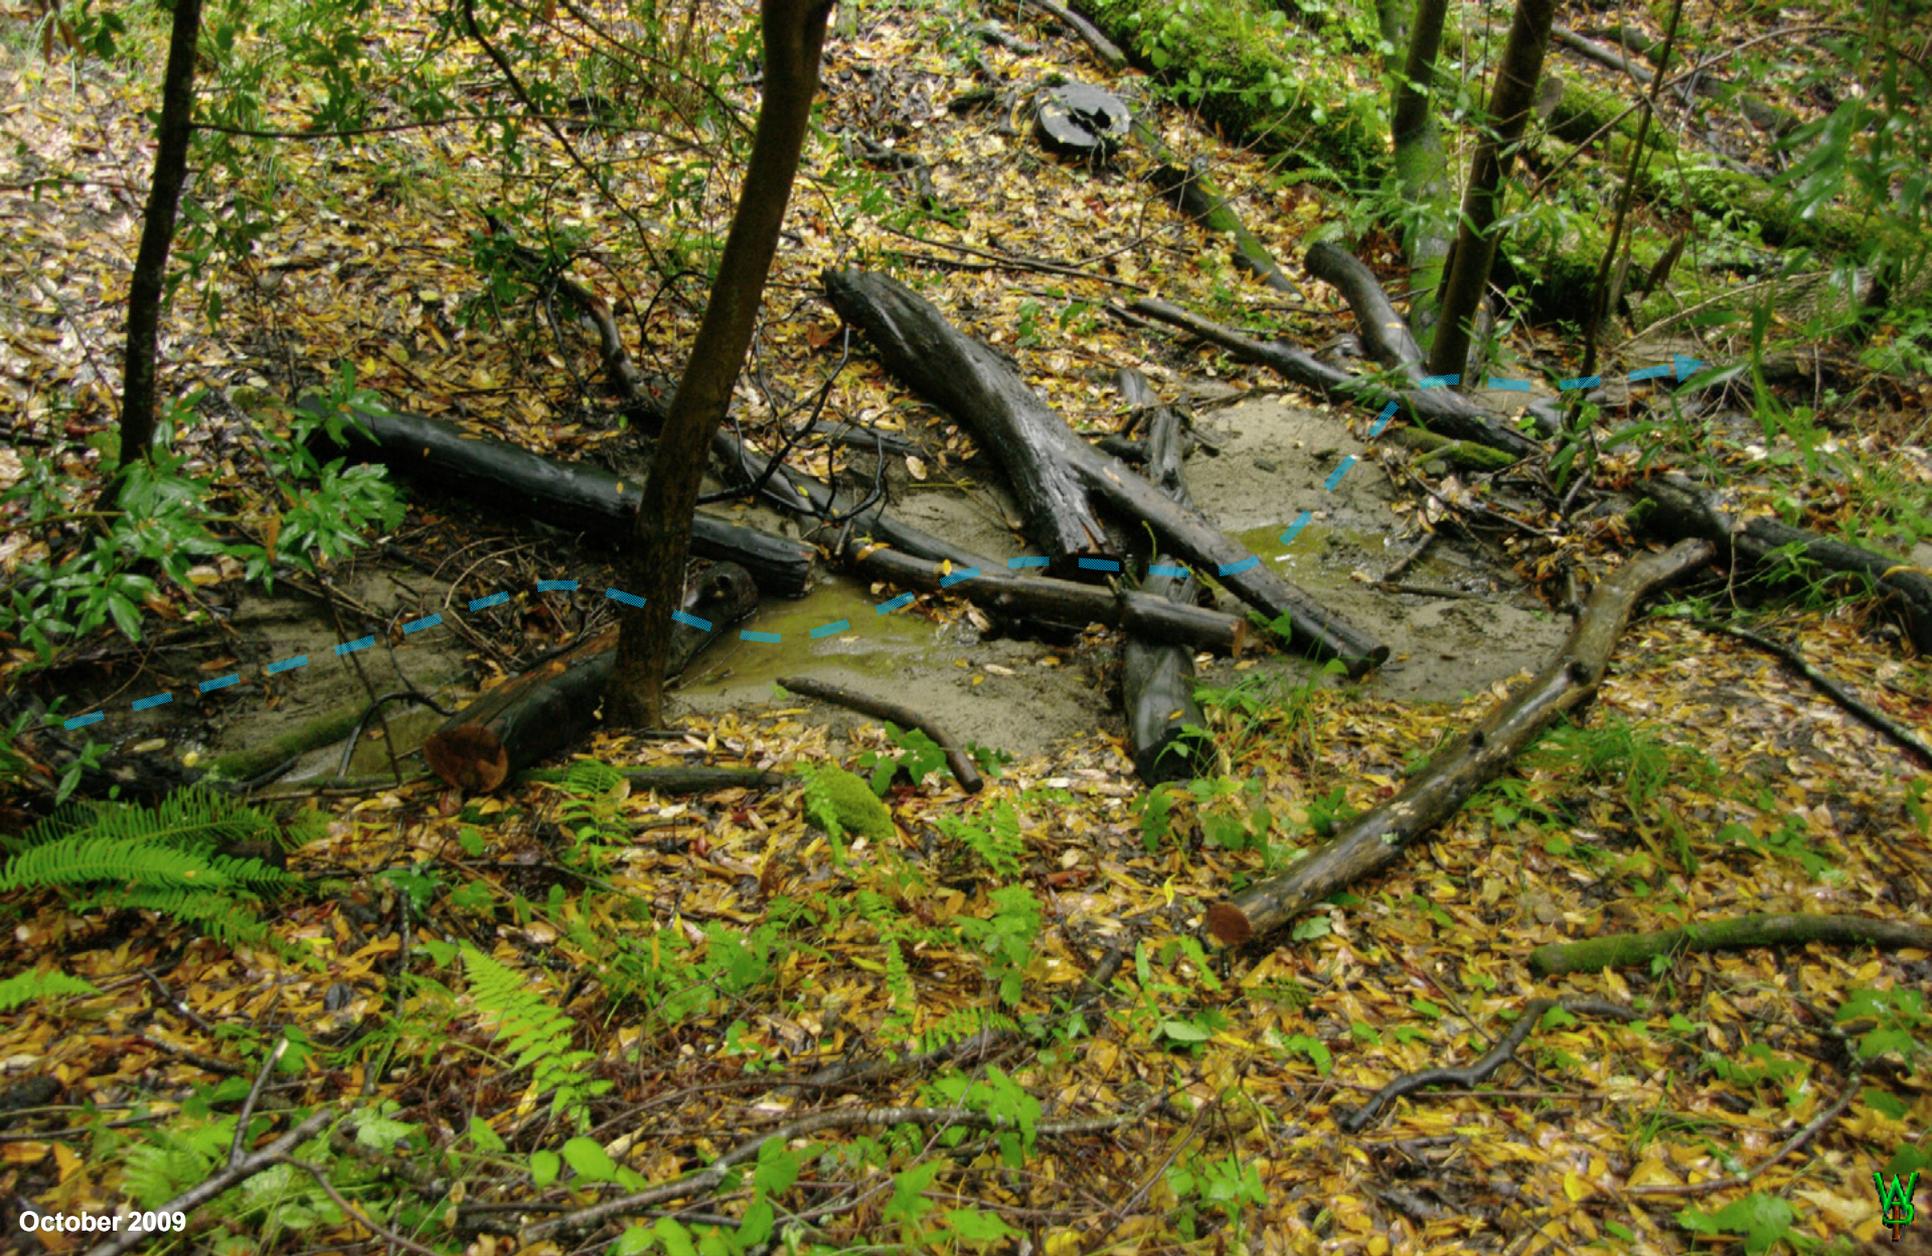
This is just downstream on the way to that (1) tree, immediately after that 12" deluge in as many hours. The logs are chocked to cause the material to drop. When a section fills in, the water carries the sediment down to the next trap. From this storm, the additional buildup was a maximum of about 3" thick. The trees anchor the system but they make it dark. I want to get the sedges going, so I thinned them a few years later on after this had time to settle and consolidate.

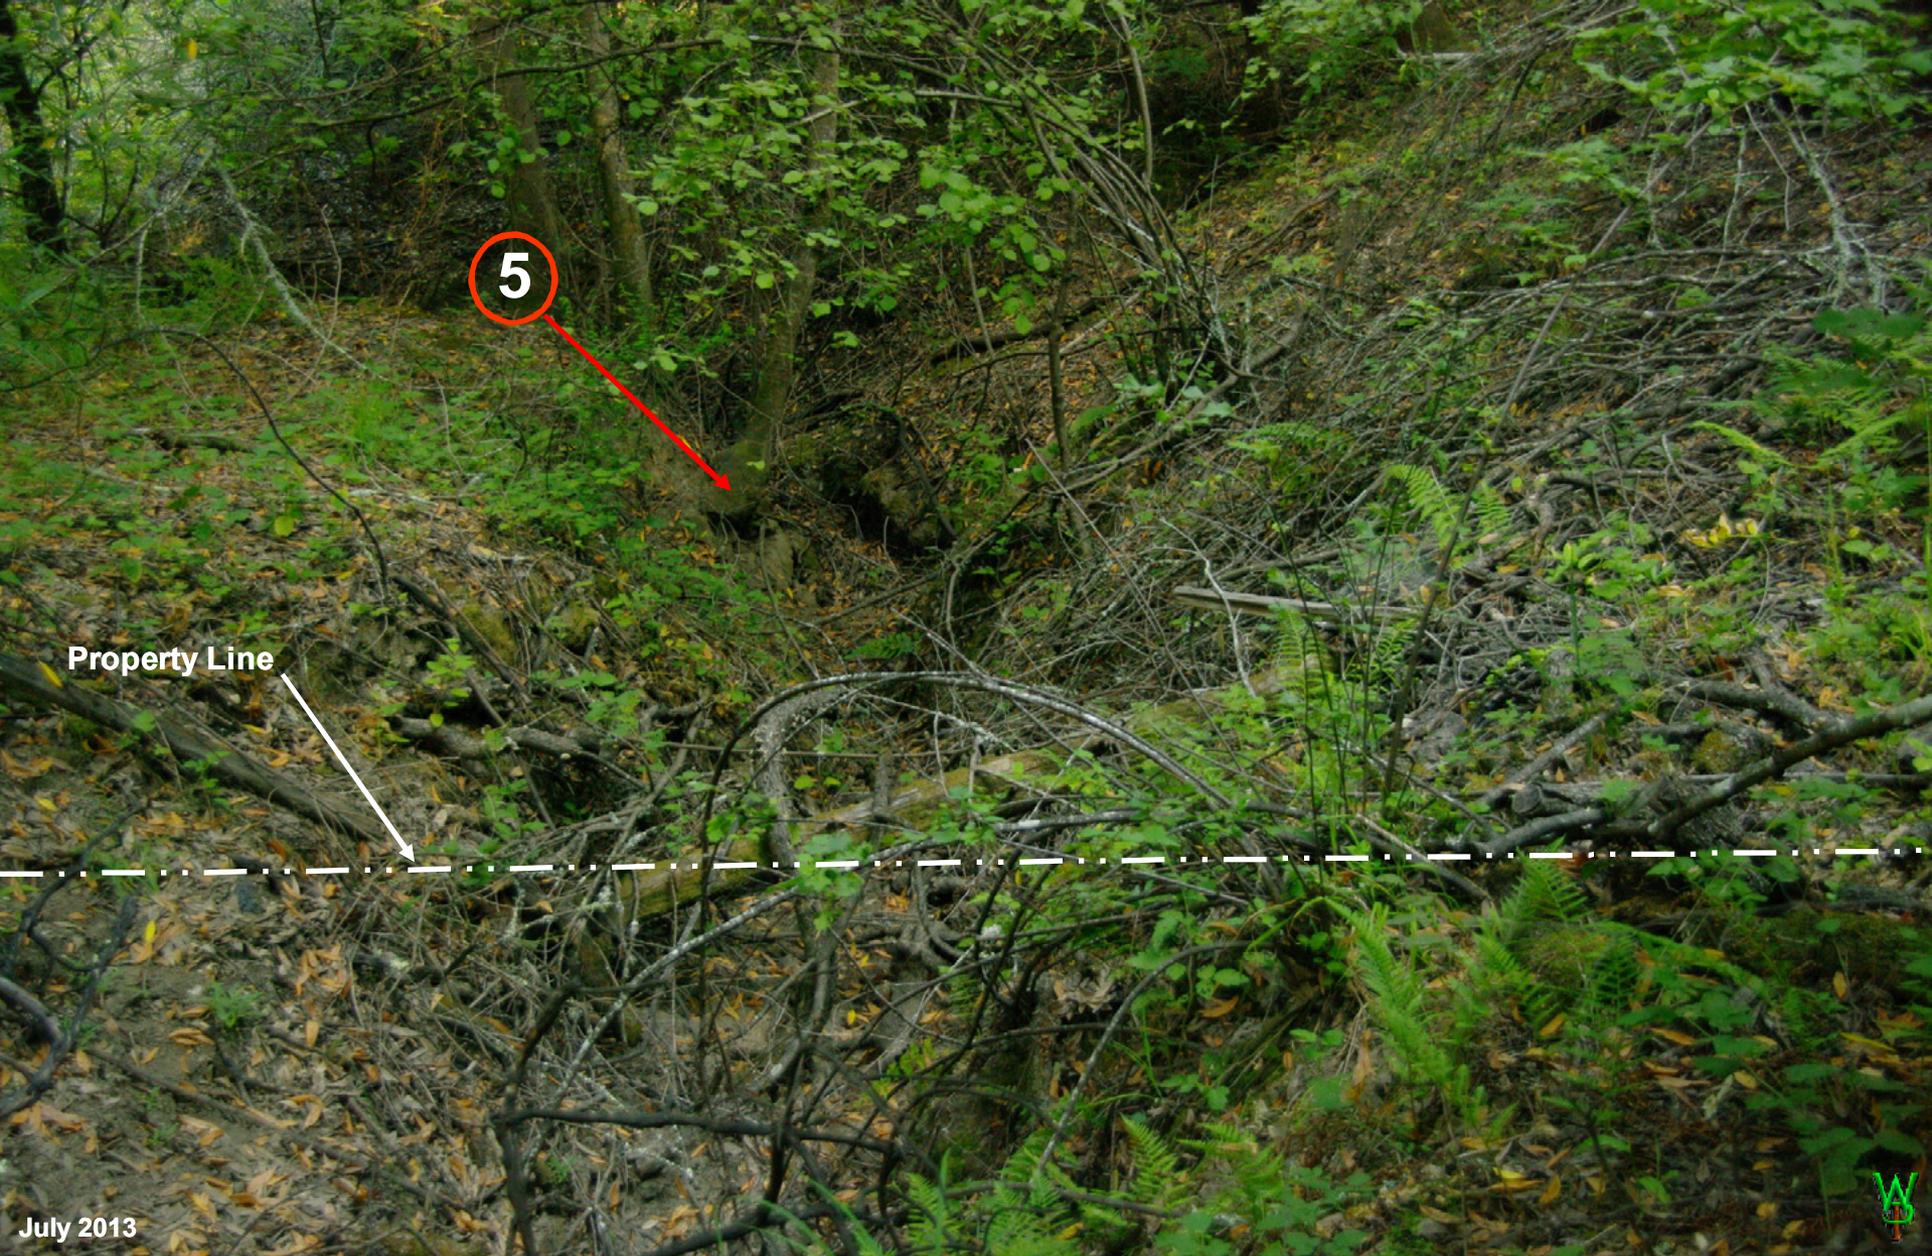
Below the property line, the channel now averages fifteen feet wide and 6-8 ft deep, with a secondary embankment two thirds of the way down upon which the tree (5) is sitting. The channel cross section stabilizes from there at about 20-30 ft wide and 10-15 ft deep. What you can't see is the pocket to the left that has probably lost about 60 cubic yards of soil. No thinning, no groundcovers. Without treatment, the incision here will only get worse and the banks will fall in and be carried away.

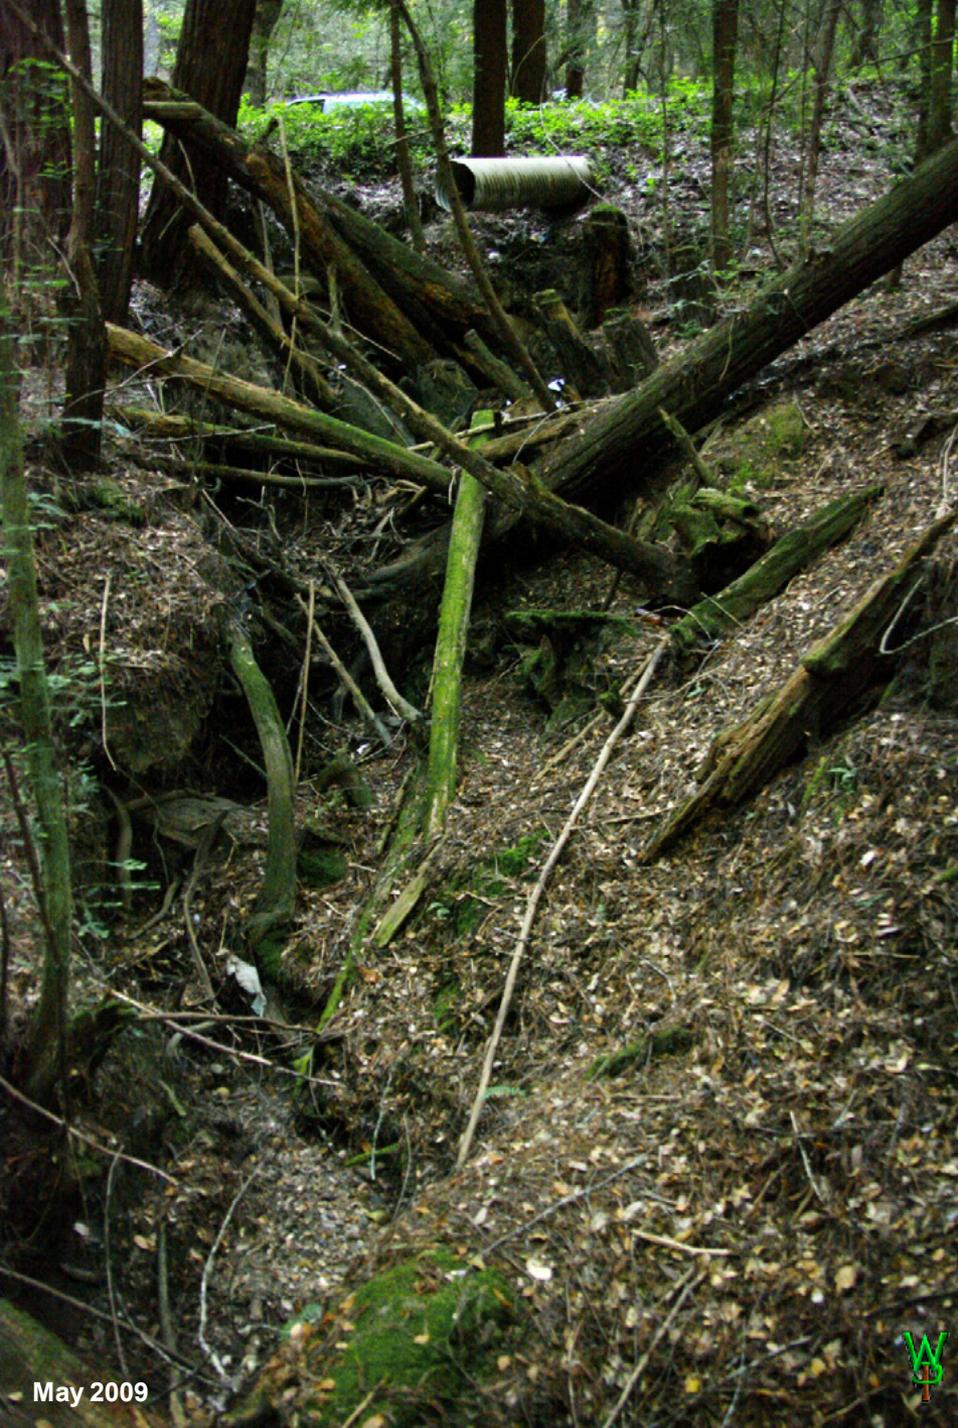
The channel here is 30-40 feet wide and well over 20 feet deep. The culvert in this photo is 24" in diameter (a fairly small flow in these mountains). There is another channel up the road, that was abandoned when this culvert was put in, but it is not nearly so bad (this pipe looks to be about 30 years old). There hasn't been ANY logging here for at least fifty years.

It's shady here, so they've got their canopy cover. As a result, there is no green vegetation. See how the root masses on the left are undercut? As bank erosion causes the walls to collapse under the weight of the trees, they fall in and then hit the opposite bank while still hanging from their roots. They are *bridging* the channel with the water running *underneath* the logs while the stream washes the soil on the root mass away and keeps cutting. The fallen trees do virtually nothing to halt the flow or armor the channel.

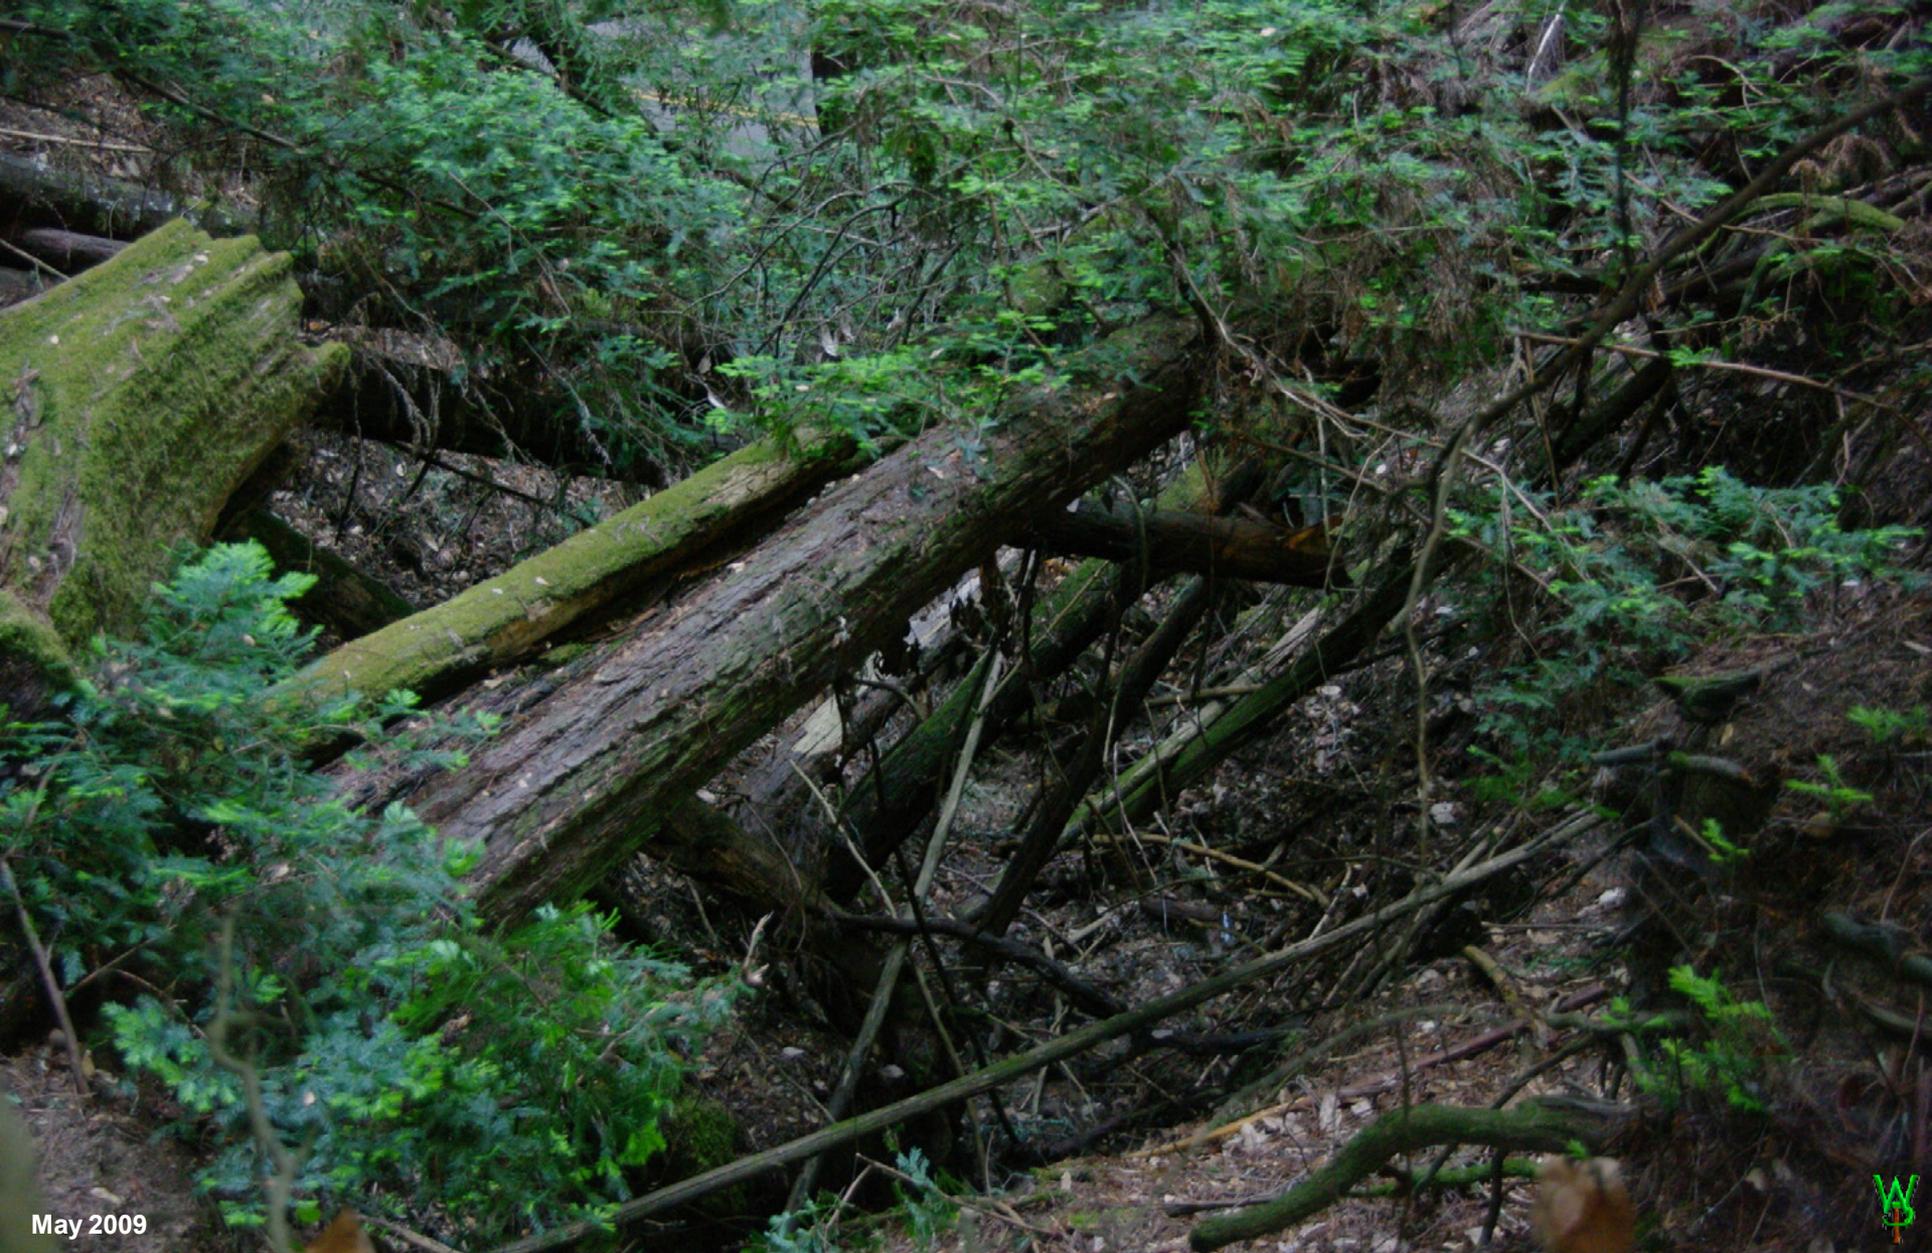
This is about 100' below the culvert outlet, looking downstream. Again, there are no effective groundcovers because it is way too dark. The logs bridge the channel so the stream is still down-cutting beneath them. **This stream bed was not here before the logging.** In fact, this flow was channeled away from a failed culvert into this one long after this area was logged and new trees were well established. This is "preservation," "recruitment," and "canopy protection" at its best. What you see is what you *will* get.

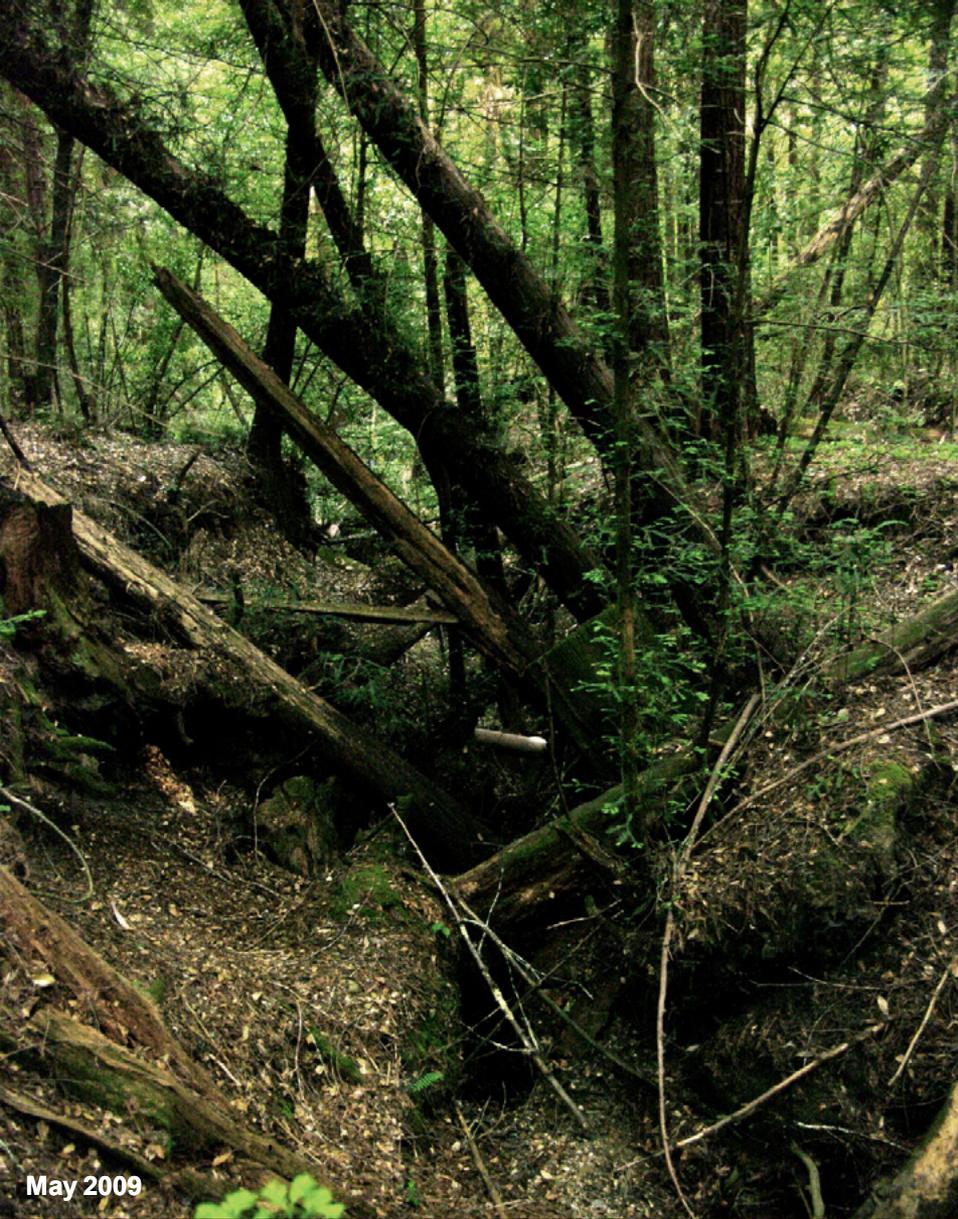
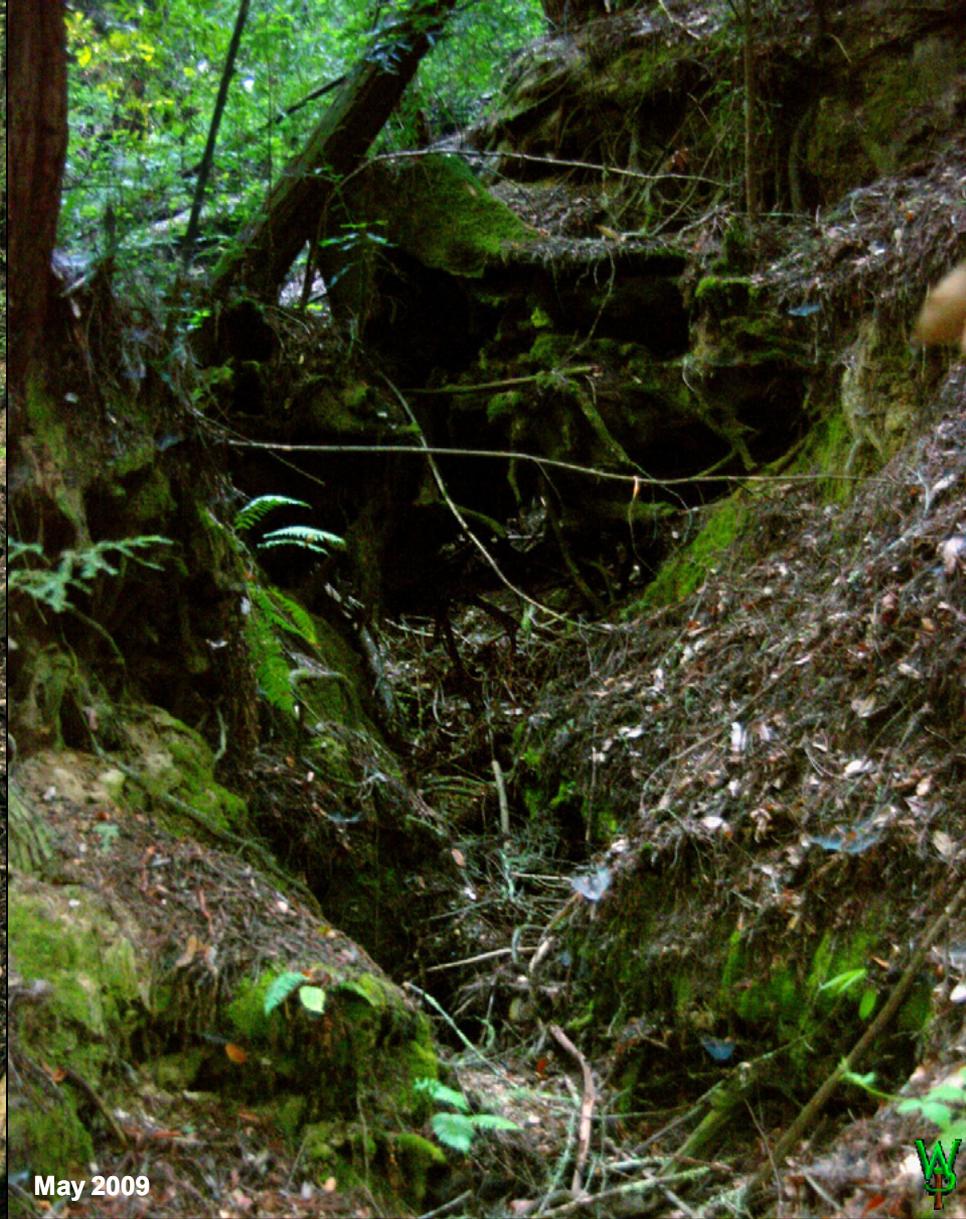
This drainage channel is only about 75 yards long. There isn't any part of it where "recruitment" or dark canopy are working. At right is the bottom of the channel at the lower County road, which effectively limits the cutting by making a hard bottom. Here you see a root wad spanning the bottom of the channel. If "recruitment" was going to work, you would see it here. It did not. The belief that 'Nature can heal anything' underlying the regulations are just as dumb as was fire suppression and for the same reason: Suppress fire and you get catastrophic fire; suppress logging to stop erosion and what you will get is catastrophic landslides into incised channels .

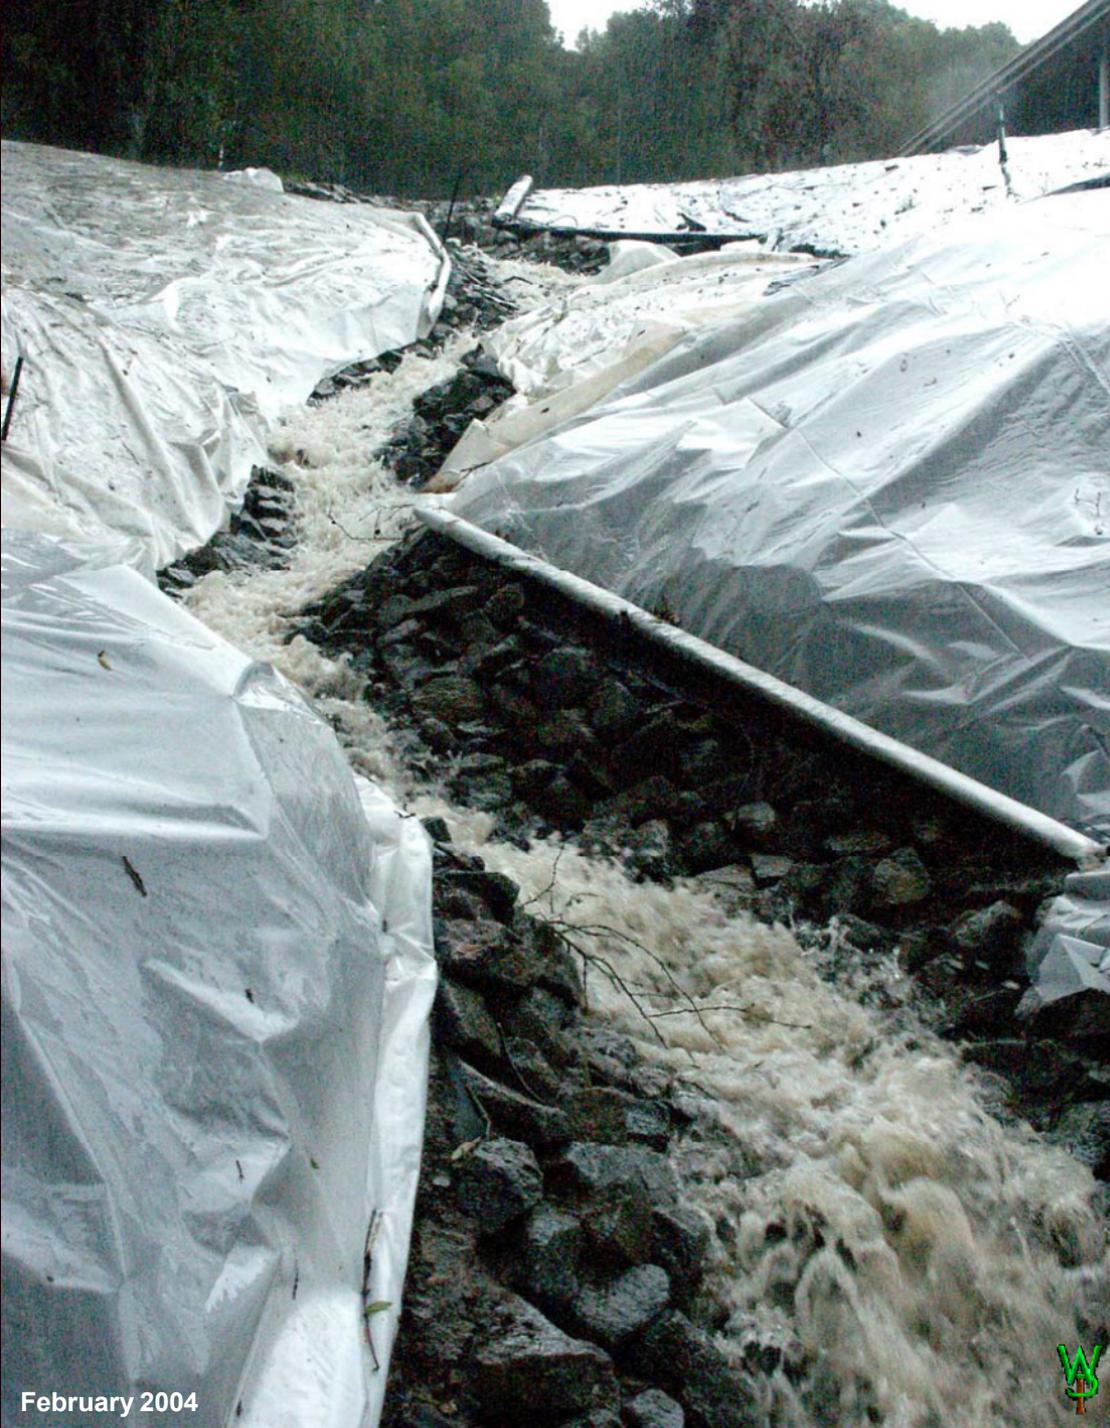
In this project, I collected surface water into the rock lined stream to preclude rilling in a manner similar to engineering designs over the last 100 years except that this slope was shaped like a watershed with benches mimicking lateral tributaries. It does require monitoring for damage from gophers and ground squirrels just as “natural” slopes also do.

The plastic was stapled to battens, rolled around them, and either screwed to timbers or to steel stakes. This tarp system has survived 50mph winds undamaged, a design that could allow work to be done in the dead of winter between deluges when the soil is damp enough for good compaction. So far after nine years, no problems and no maintenance other than clearing the channel annually of tree branches and other plant debris.

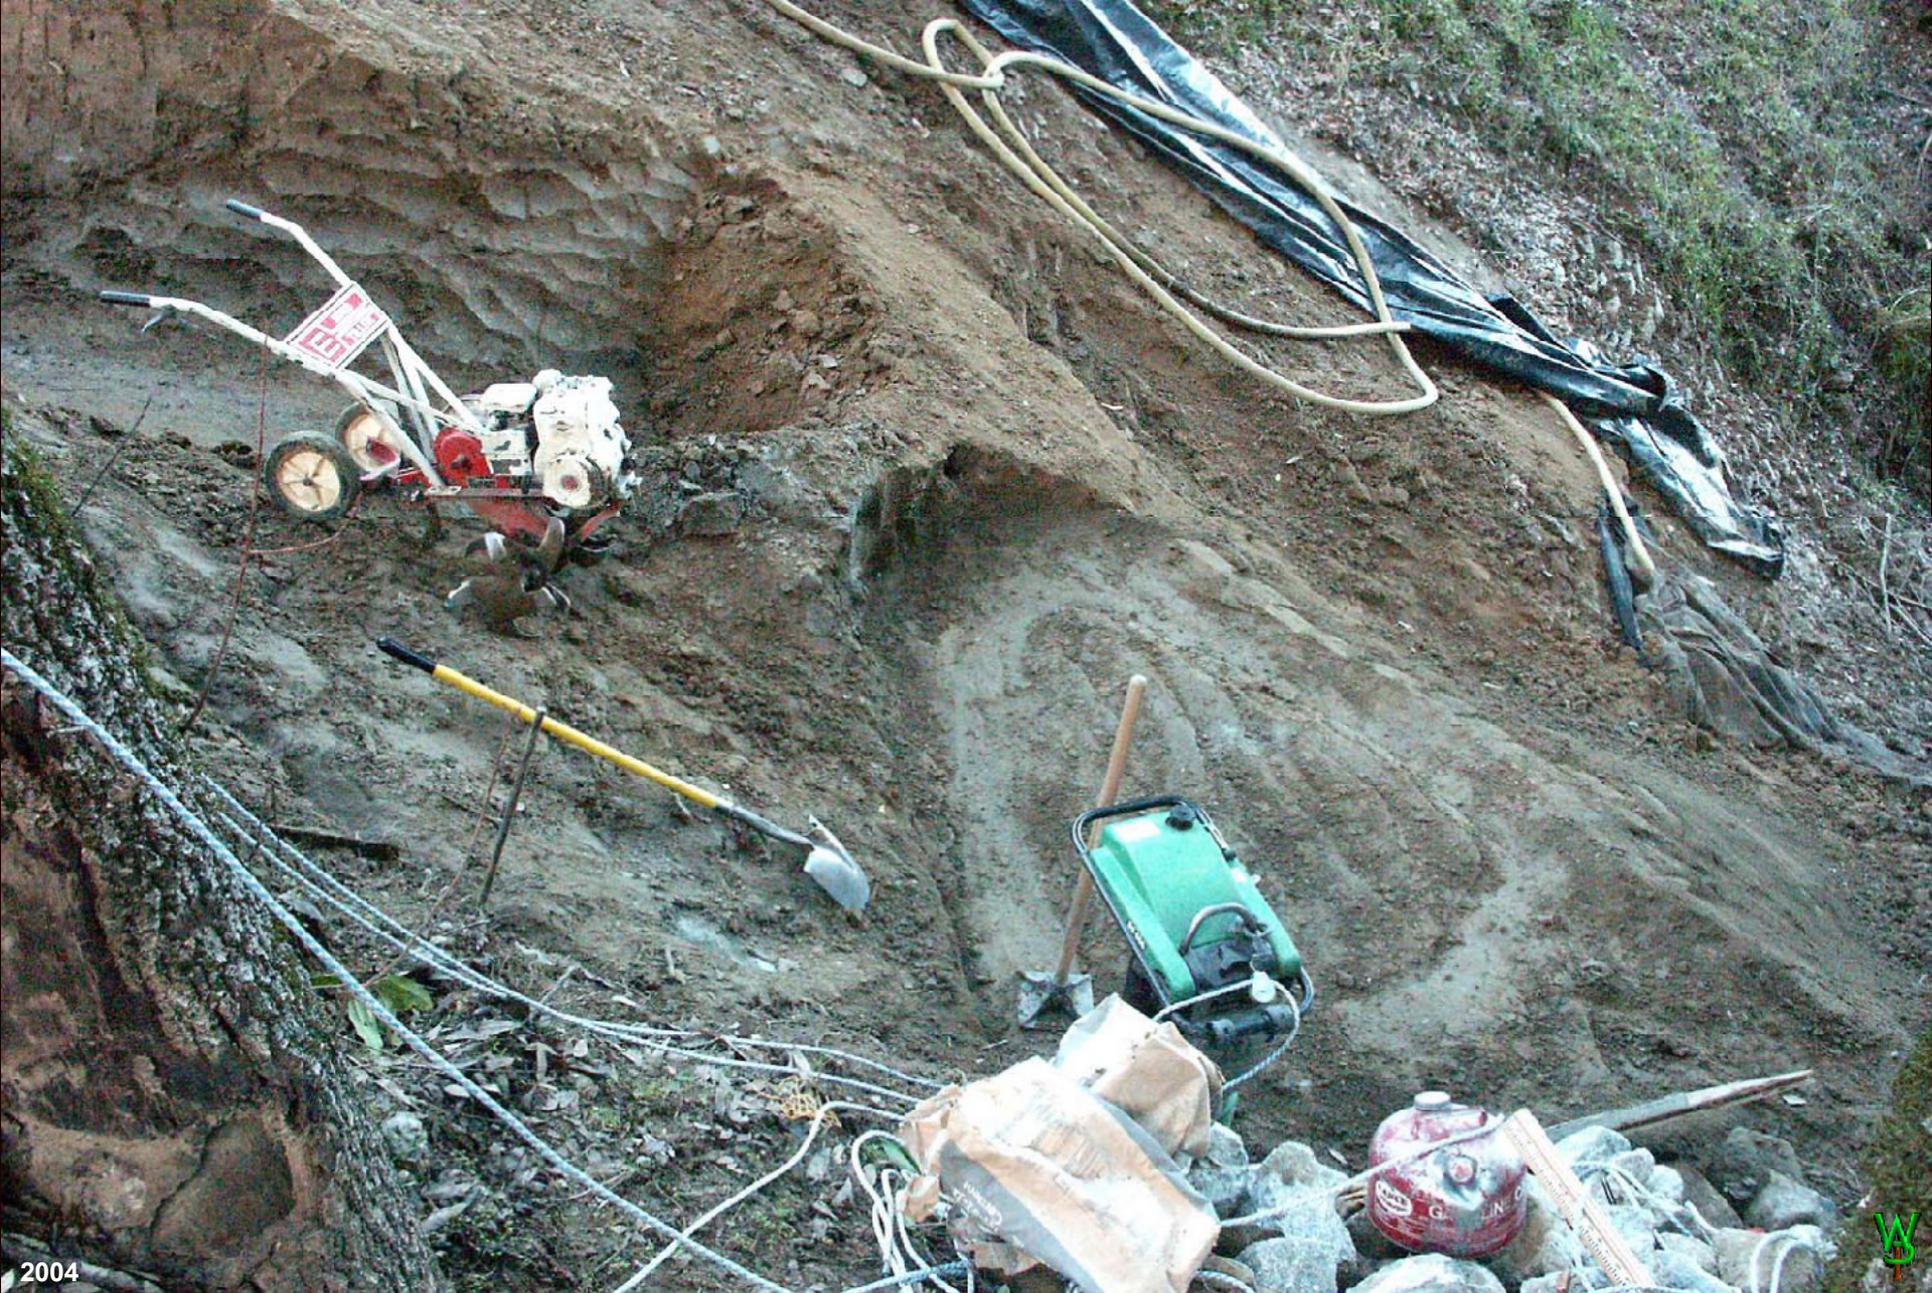
In parts of this project I used the equivalent of a half-sack mix of cement in the soil to reinforce the structure to simulate the attributes of the parent rock and withstand tunneling by ground-squirrels without caving in. It is steep here. Interestingly, the grasses seem to prefer this cemented fill compared to the parent material.

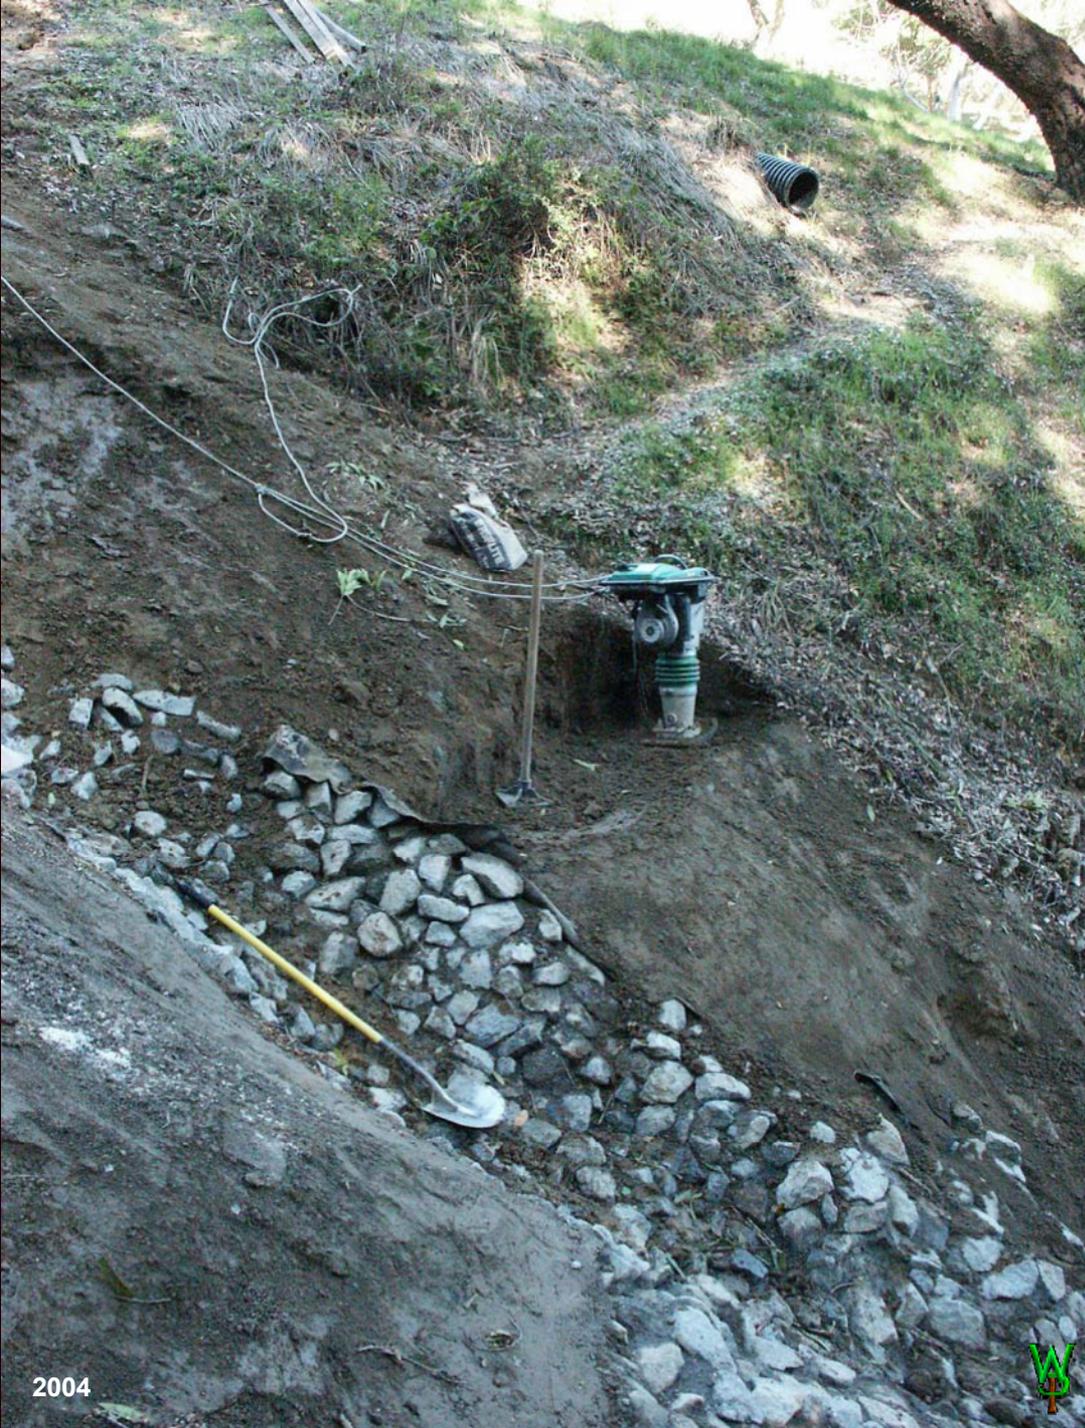
The slope is steeper than it looks. The extra dirt was brought down in buckets. Footing was treacherous.

The hand-tamping marks on the face are visible. I don't think I'll ever forget slamming that iron plate into it over and over. Day after day, wrestling that thumper out of the way and on top of the pile, starting it up and getting control on a tiny bench like that. This was one heck of a lot of work.

The 5 X 10 rock is set in filter fabric with periodic dams of rocks set into concreted cross ditches about every ten feet. Dry sack concrete was poured into the gaps as a "mortar."
