FEELING DRAINAGE

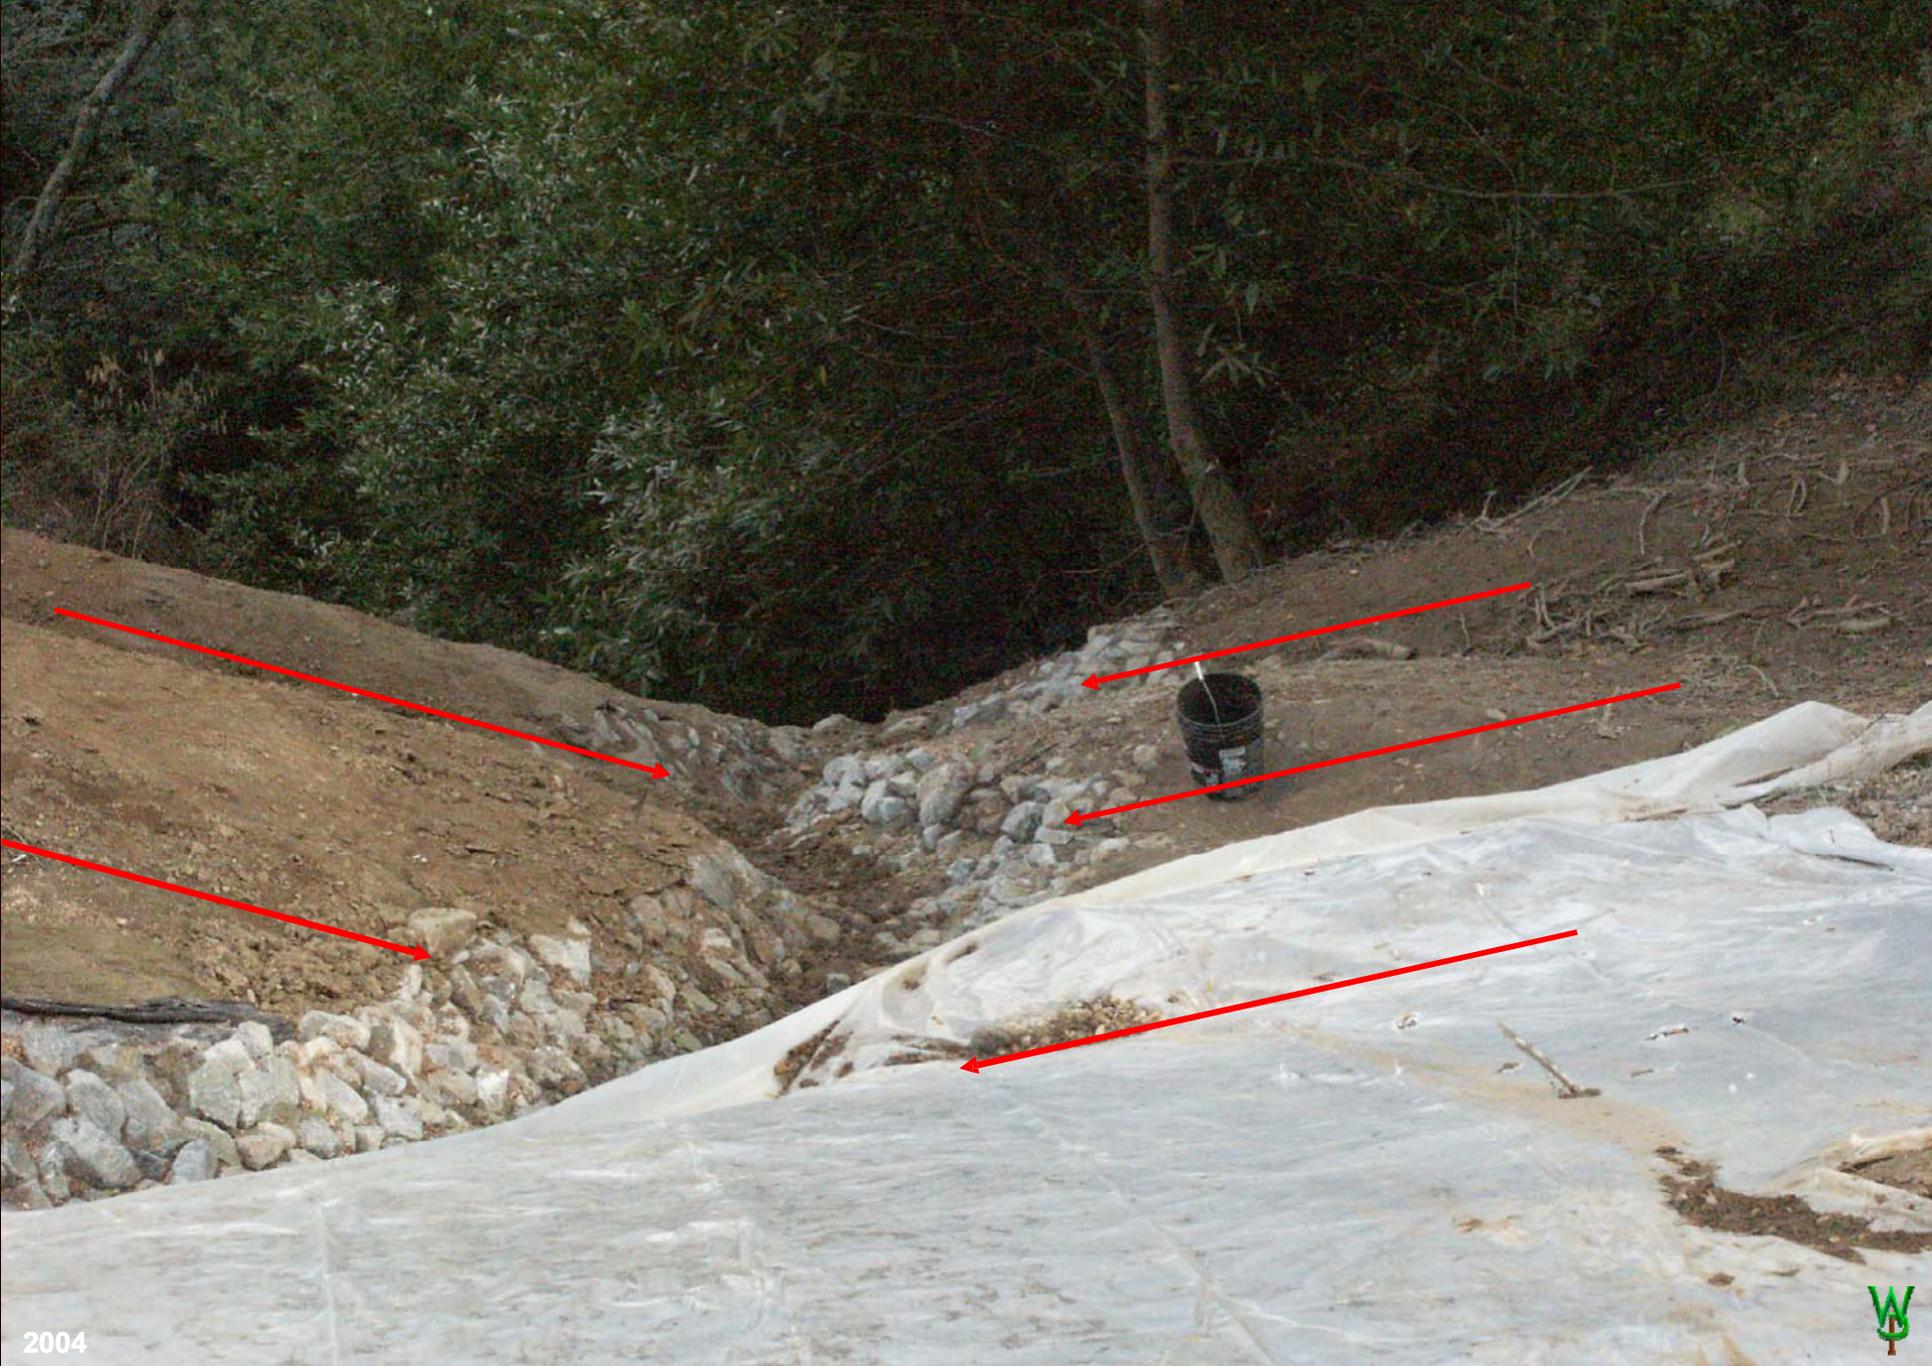
It is steep here. The arrows indicate the alternating benches to catch and redirect sheet wash to the channel.

The plastic was part of an experimental array for revegetation. It was either tight on the surface or held aloft by a “mulch” of chopped tree branches forming mini greenhouses to improve the establishment of the grasses. As long as one doesn’t use too much mulch and there is enough moisture getting under the plastic to keep the grasses going, these tarp-houses at least **triple** grass growth.

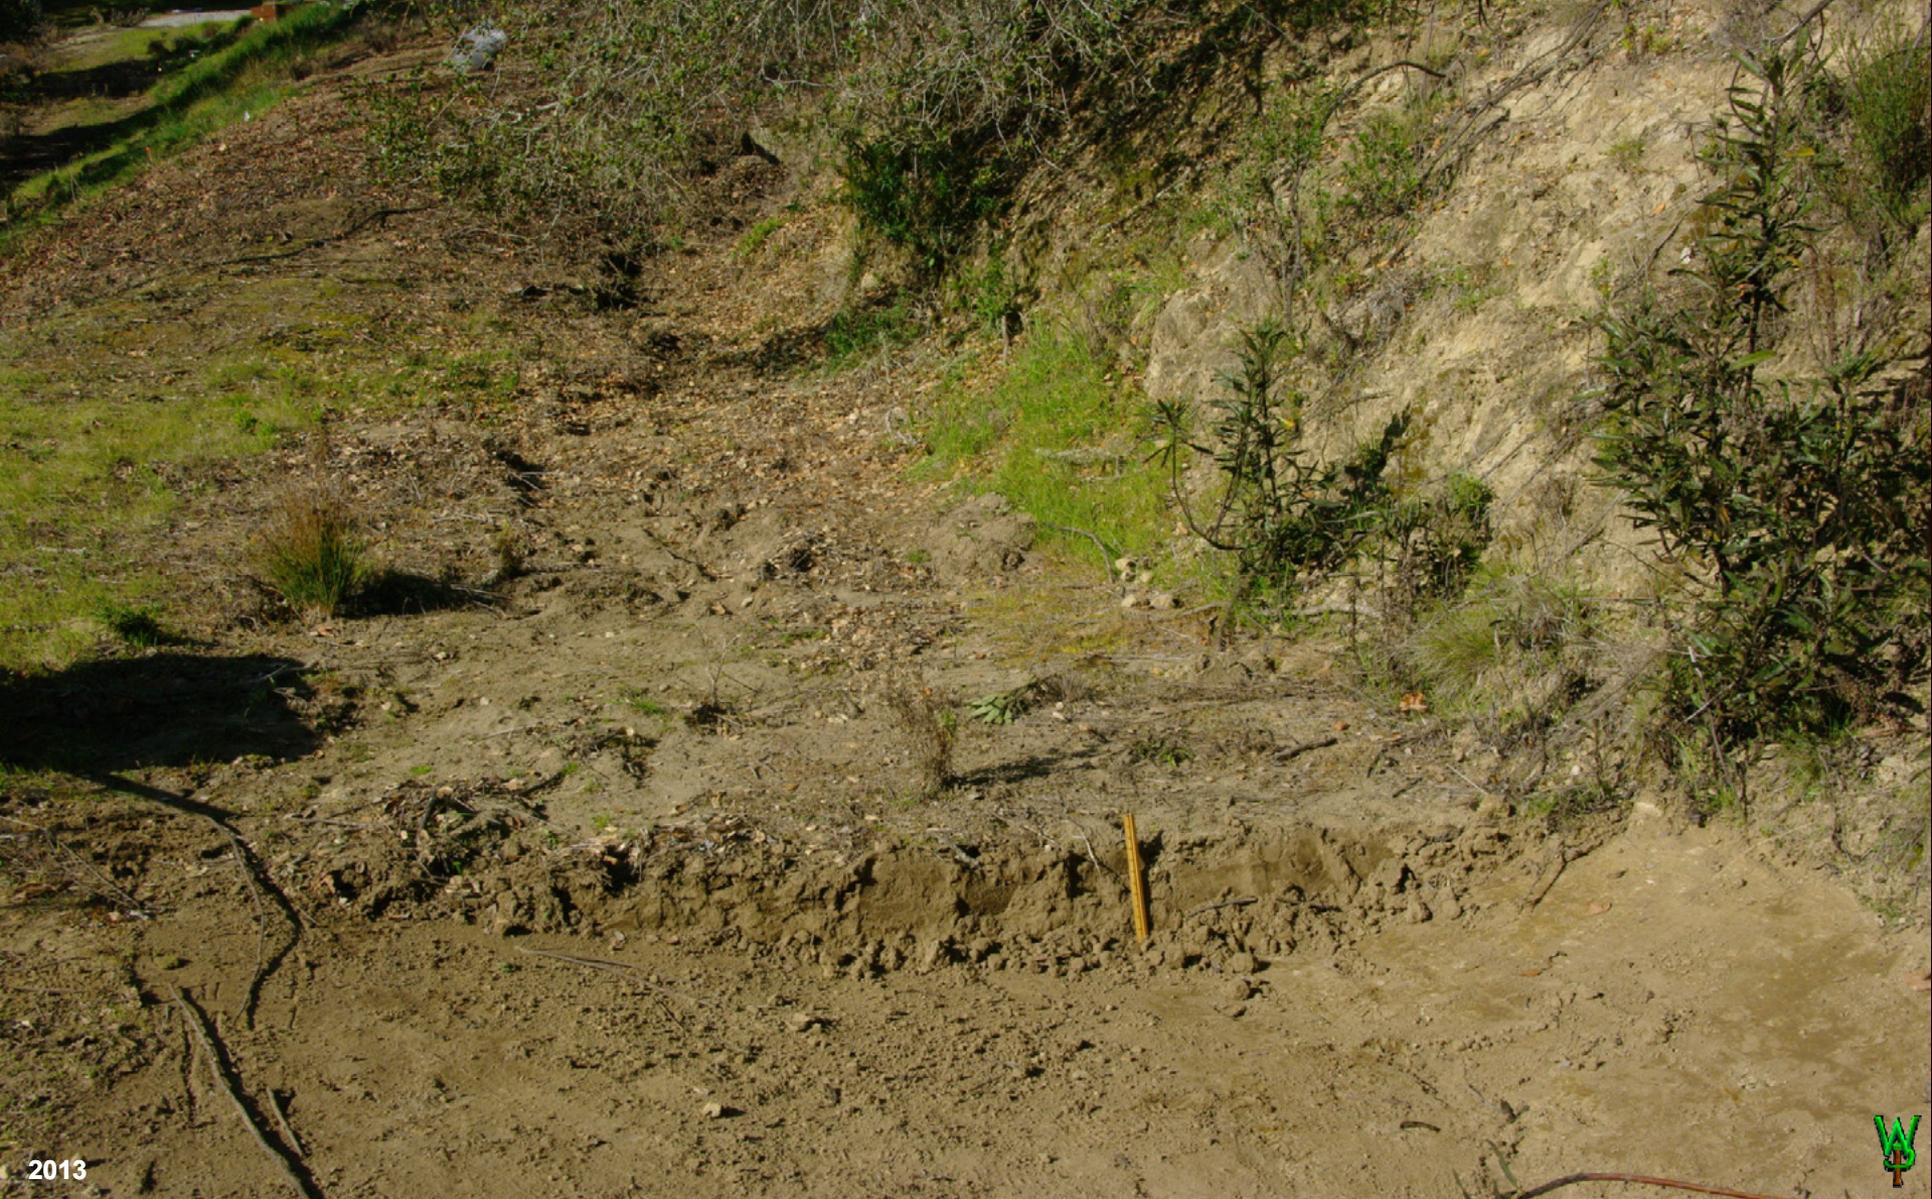
This drainage farther north is sized to handle the water off the north half of the property. You do not always get your choice of routes for runoff because of the history of how the land was used. In this case, there is a series of old benches of perched fills that once supported various out-buildings. The slope below the road is so steep that if this much water were to go over the outside of those fills, there would be severe damage to the hillside. So I transit the flow above them on a low slope, this area serves as a catchment basin for sediment. About every 10 years, I dig it out; else the water would eventually dump down those erosive fill slopes.

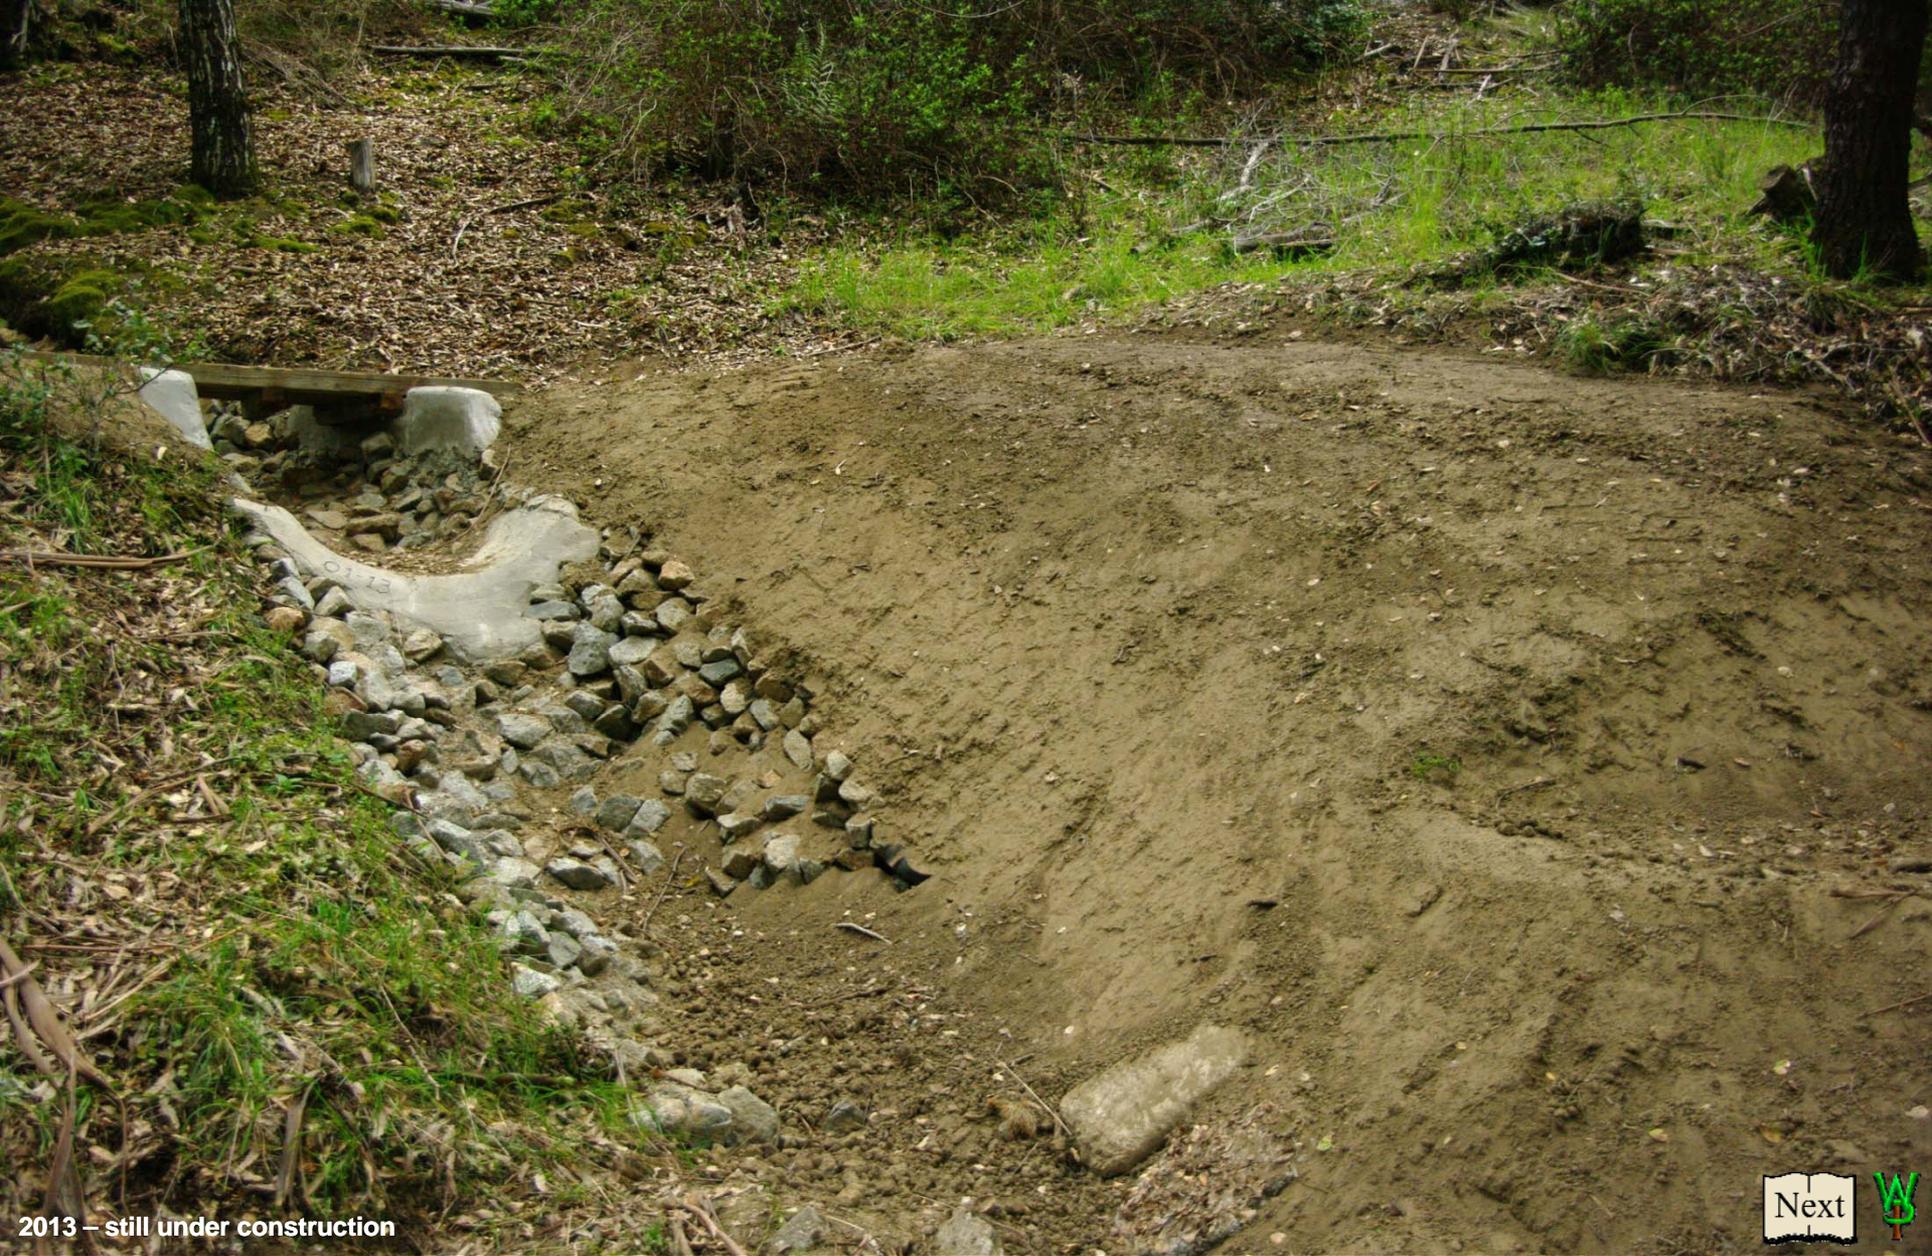
I built this upgrade to that channel to drop the water onto the lower road which acts as a secondary transit and sediment catchment area. The sediment I dug out was packed into what once was a rather ugly eroded hole cut by water diverted around one of the old structures. The bridge is a way to get the sediment out of the place I don't want it to build a larger water-bar in a safe spot that assures the flow will head the right way. Each of these projects deals with that history. They are expensive and time-consuming.
