# FEELING DRAINAGE

# WILDERGARTEN 5.4

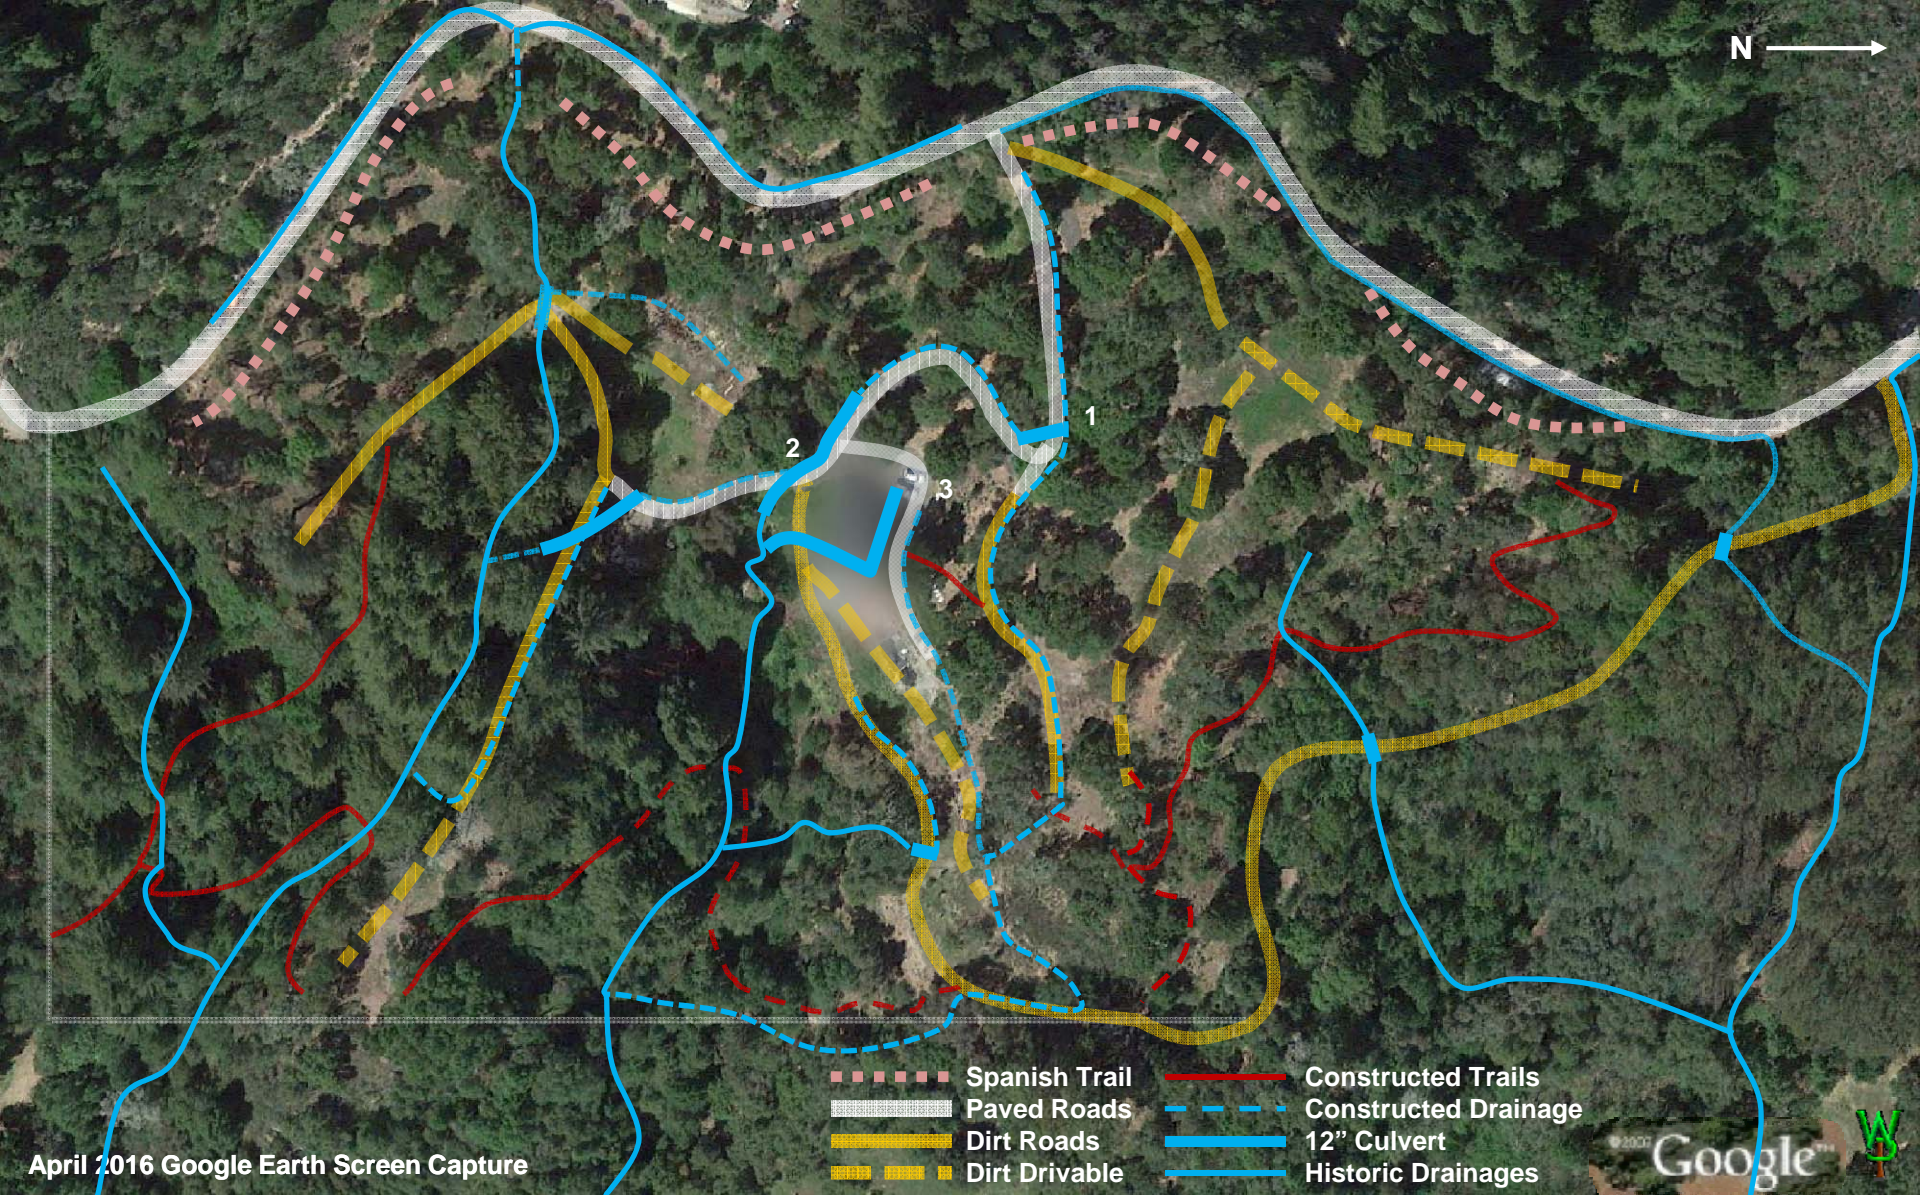
April 2016 Google Earth Screen Capture

This is a map of all the roads, trails, and drainages on this property. Roads and the drainage features particular to them were covered in [the previous chapter](#). This chapter is about what is done to manage specifically water pathways. Each [orange letter](#) on this and the other aerial images in this chapter corresponds to where they were taken on this property (some with an arrow indicating the direction). If you wish to keep track while reading, there is [a separate file consisting of the aerial photos from this chapter](#), which you can then keep open in another window as you read. My purpose in documenting them this carefully is for future repeat photos, as vegetation management, and particularly forestry is elemental to many of these drainage management problems.

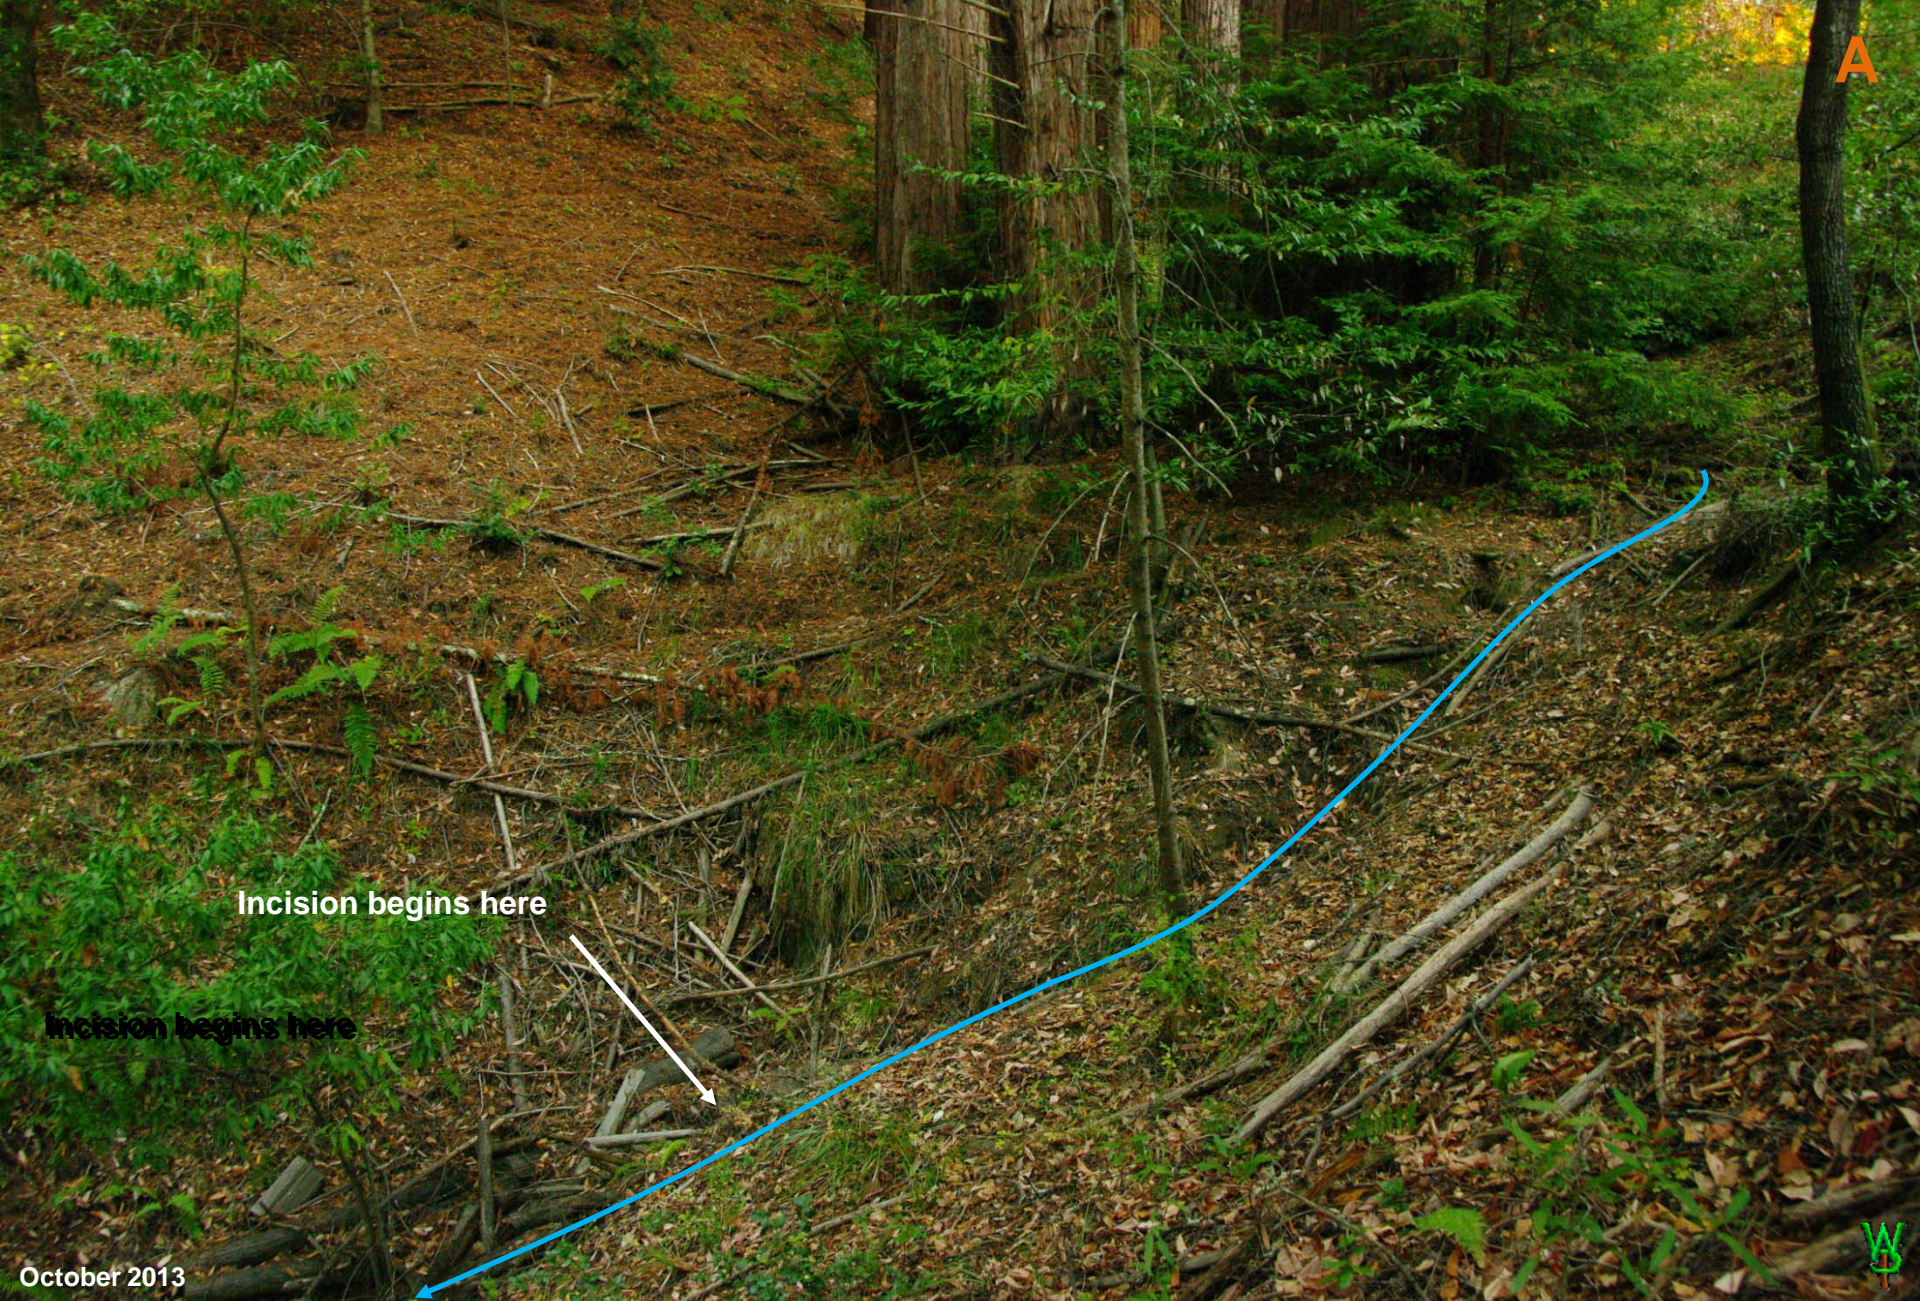
Here is the other cluster of redwood trees seen from below. It should be fairly obvious that the root mass of these trees inhibited a considerable amount of erosion of the stream bed, also called "channel incision" such as you see below them.

From this example, I have learned to reverse that incision process for reasons we'll get to soon.

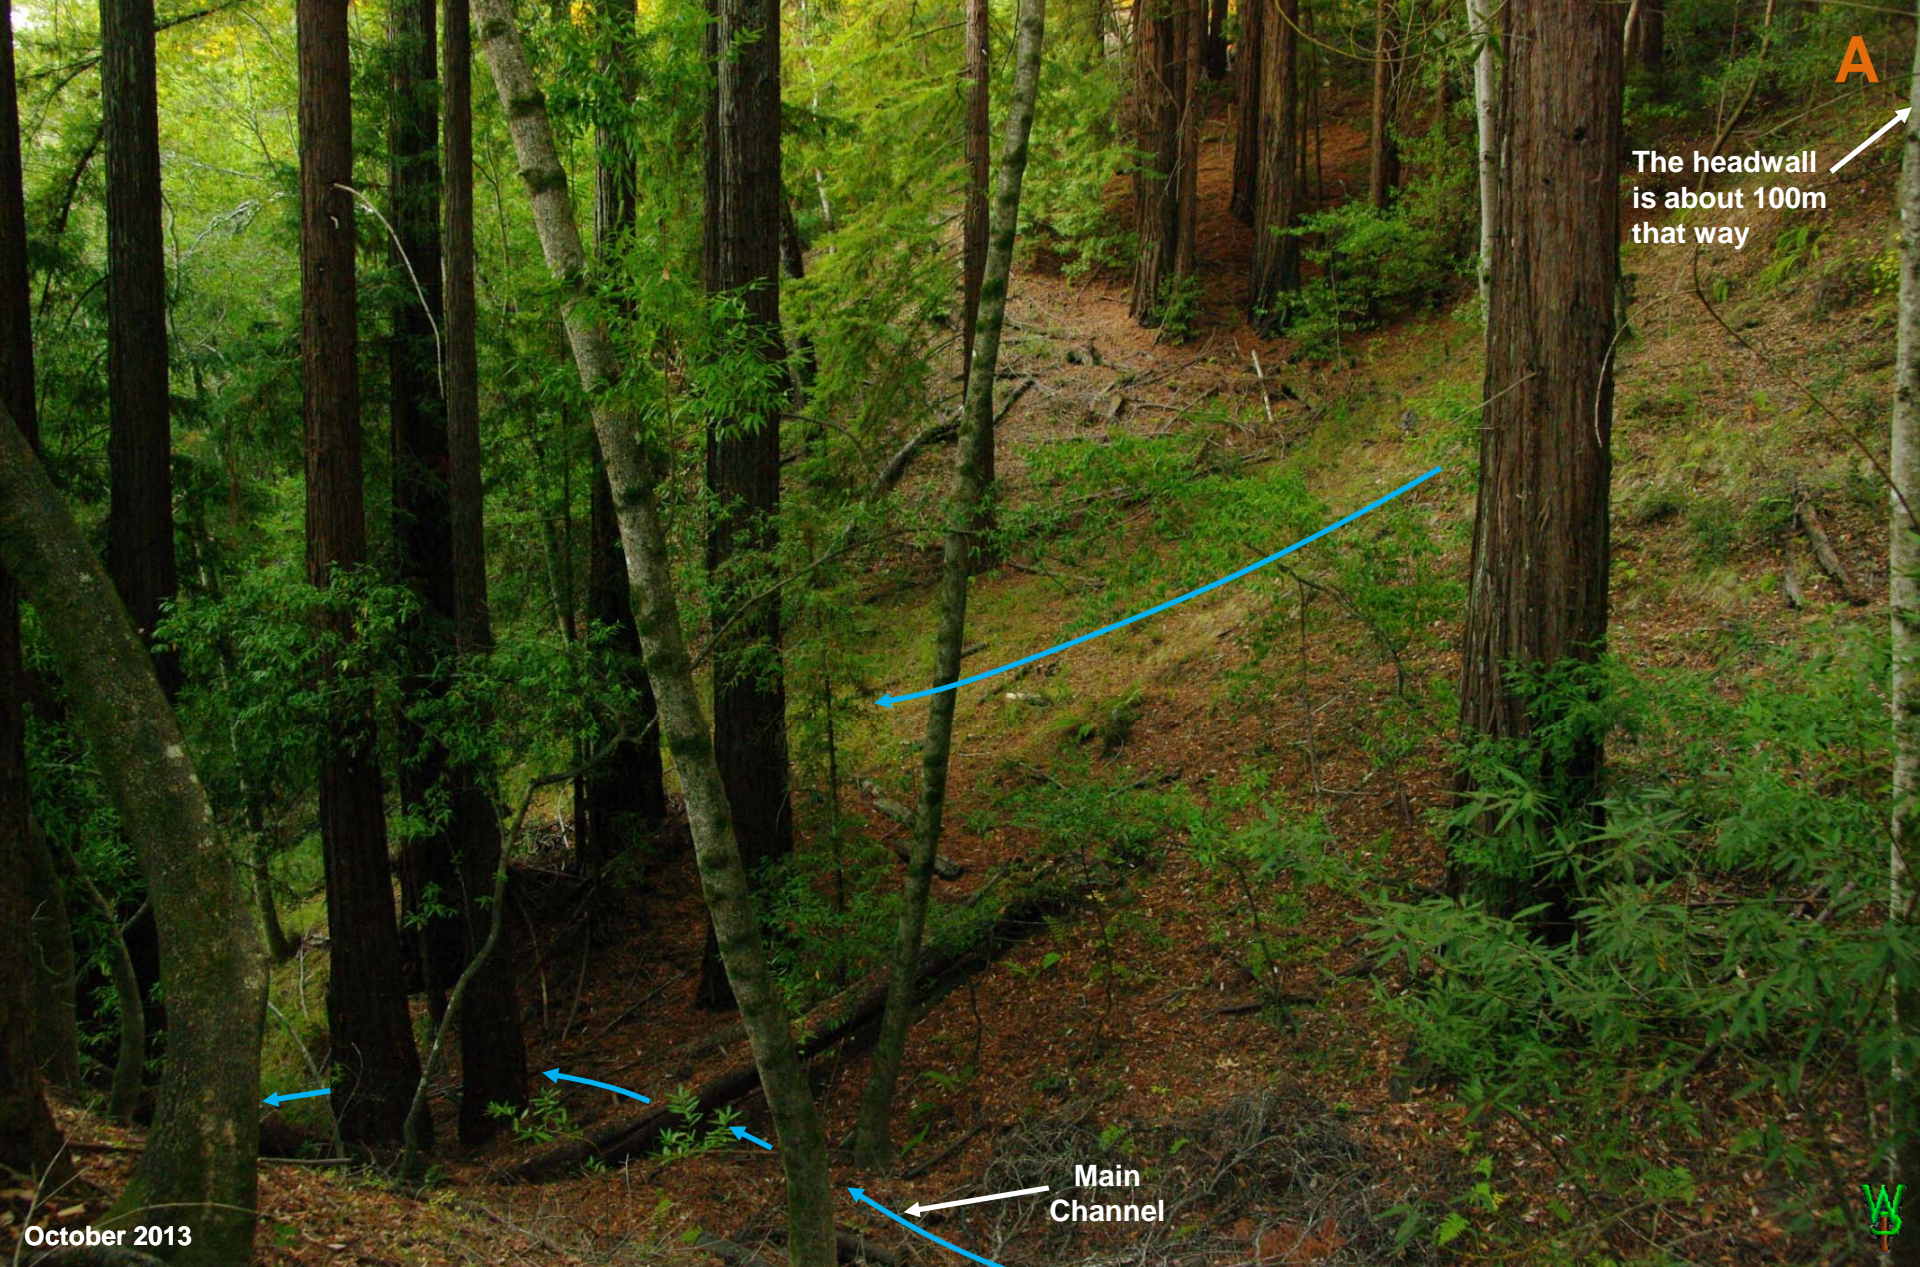
Looking down the channel from the same spot, it isn't hard to see another landslide deposit with trees on top at the lower left. At the top of the draw to the right is a rotational slope failure with a steep headwall. I suspect that the green swath behind the trees is alluvial deposition on top of a colluvial lens. Based upon the stumps I have counted in this area, none of these trees is over 100 years old. Unlike the next draw to the north (TBD), there are no large old stumps. This has probably all happened since the area was first logged.

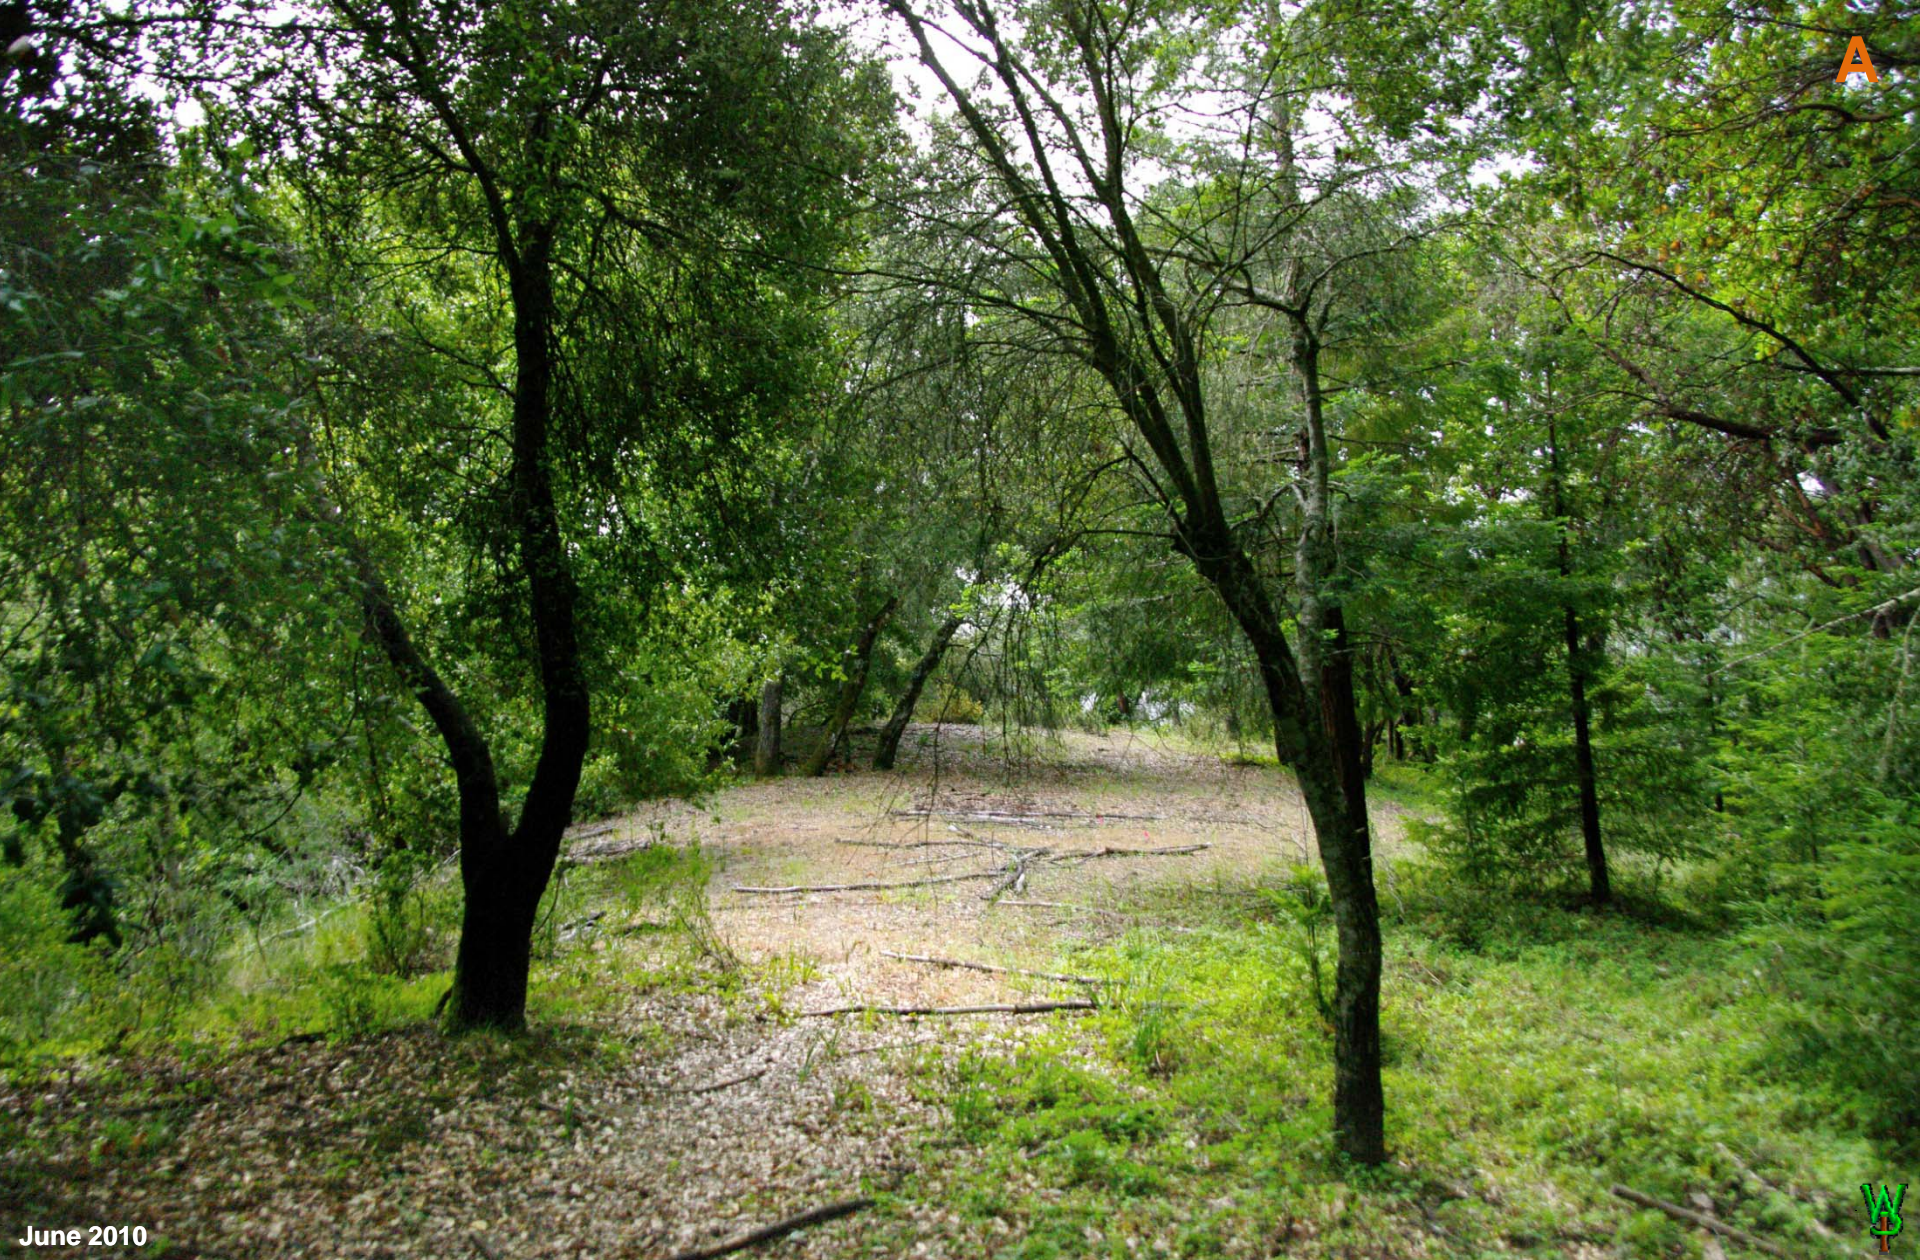
You may remember this image from the repeat photos in the Introduction. The first thing I did to impede incision in the channel to the right was to cut trees on the right side of this ridge, about 100 feet *above* the channel. Although cutting the bay trees up here was legal (not a timber harvest), it did reduce “stream canopy cover,” which could get you fined on a commercial job. The thing is, “How much shade is the right amount?” It turns out that when it comes to canopy cover, there may be such a thing as “too much.”

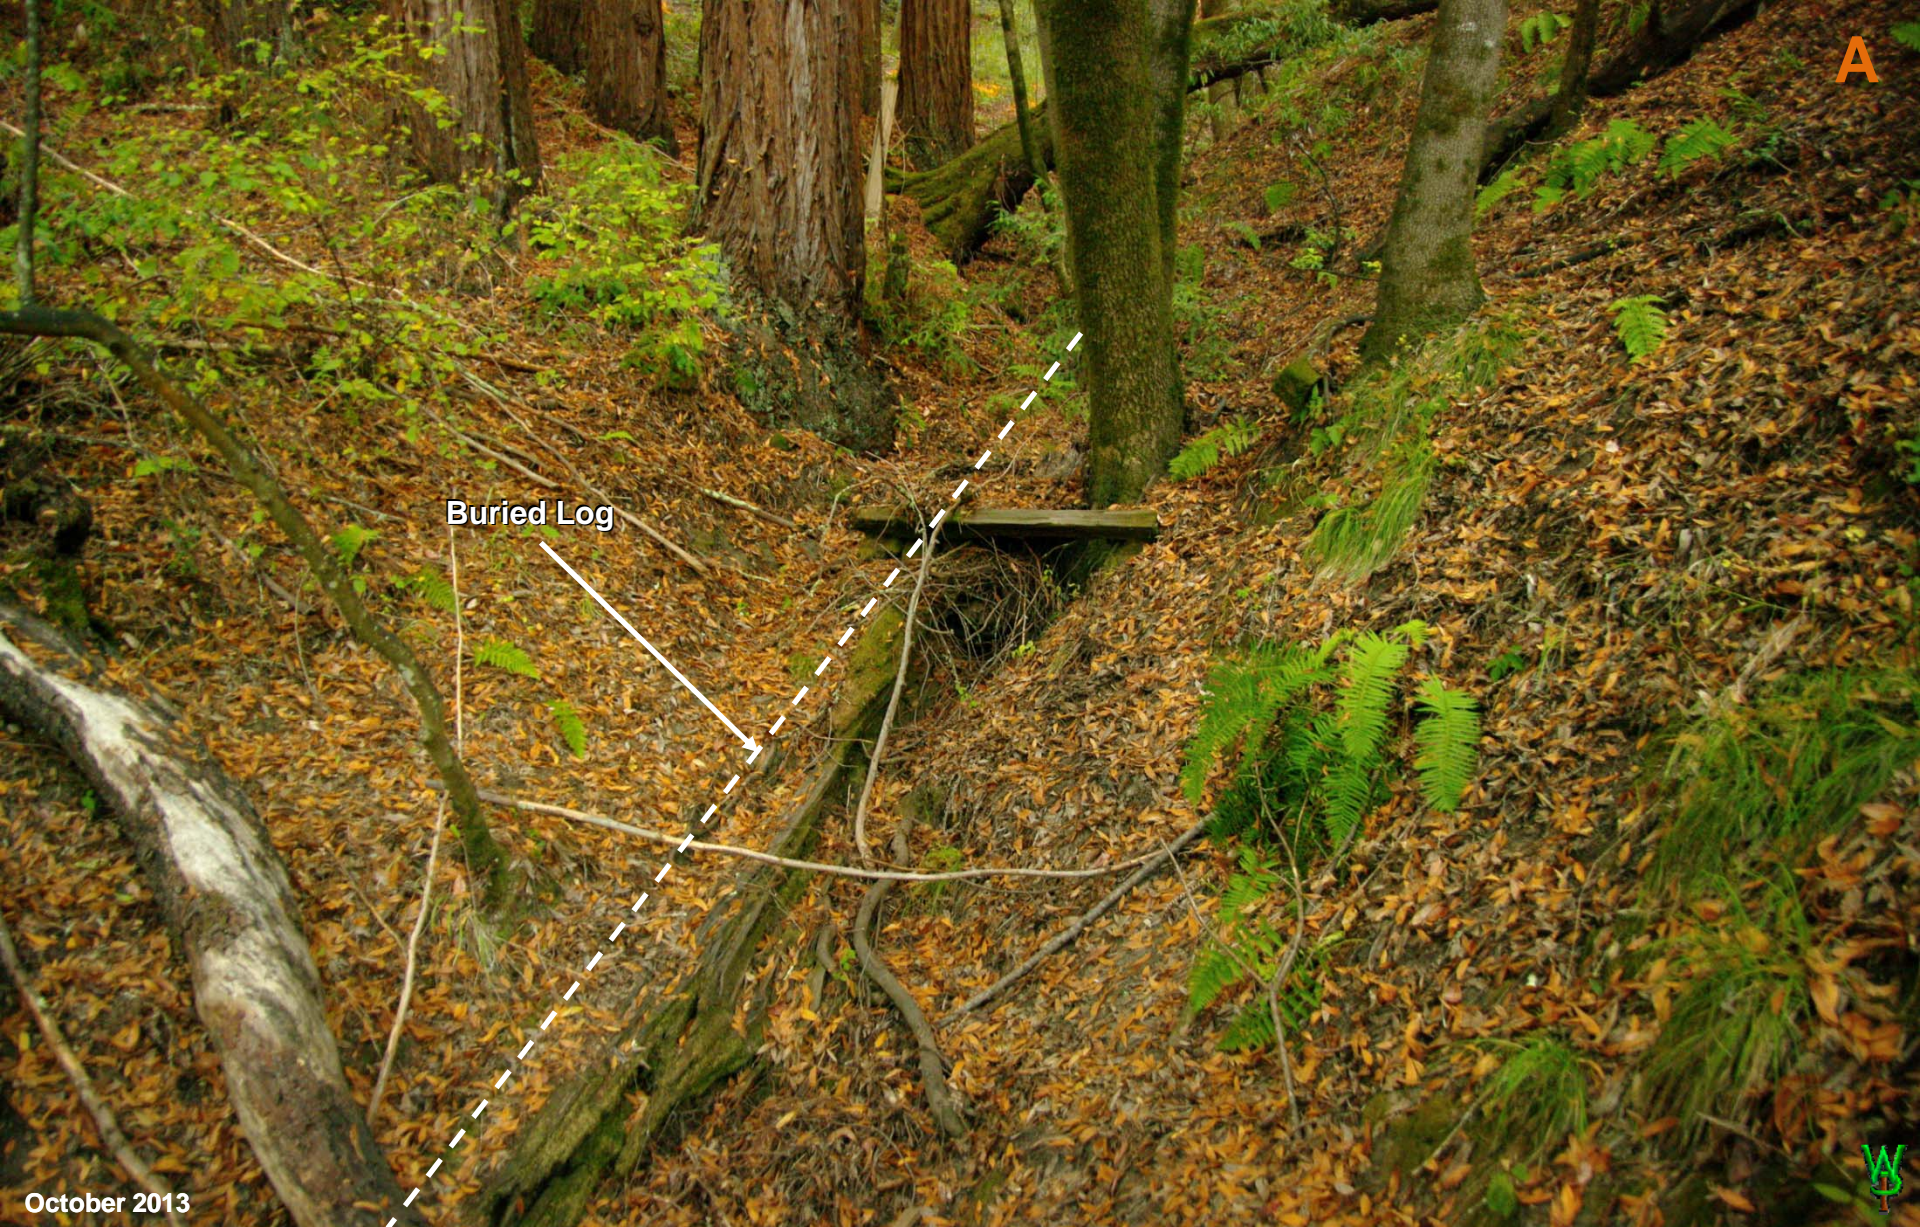
Buried Log

Here is the other 'thing that taught me what to do,' and it is what shaped the toe of that slide. This log is *underneath* the landslide with the trees sitting on top. It is one very substantial log. It was cut by a saw on one end, so it is impossible for the slide to be over 150 years old. From the size of the trees, my guess is that it has been here about 90 years. If the Vaquero sandstone substrate is relatively uniform, **it may be that wood has been the critical factor in defining channel shape and distribution in this region.** Once the channels start, they tend to keep cutting in the same location, unless there is faulting or somebody does something, as we shall see.

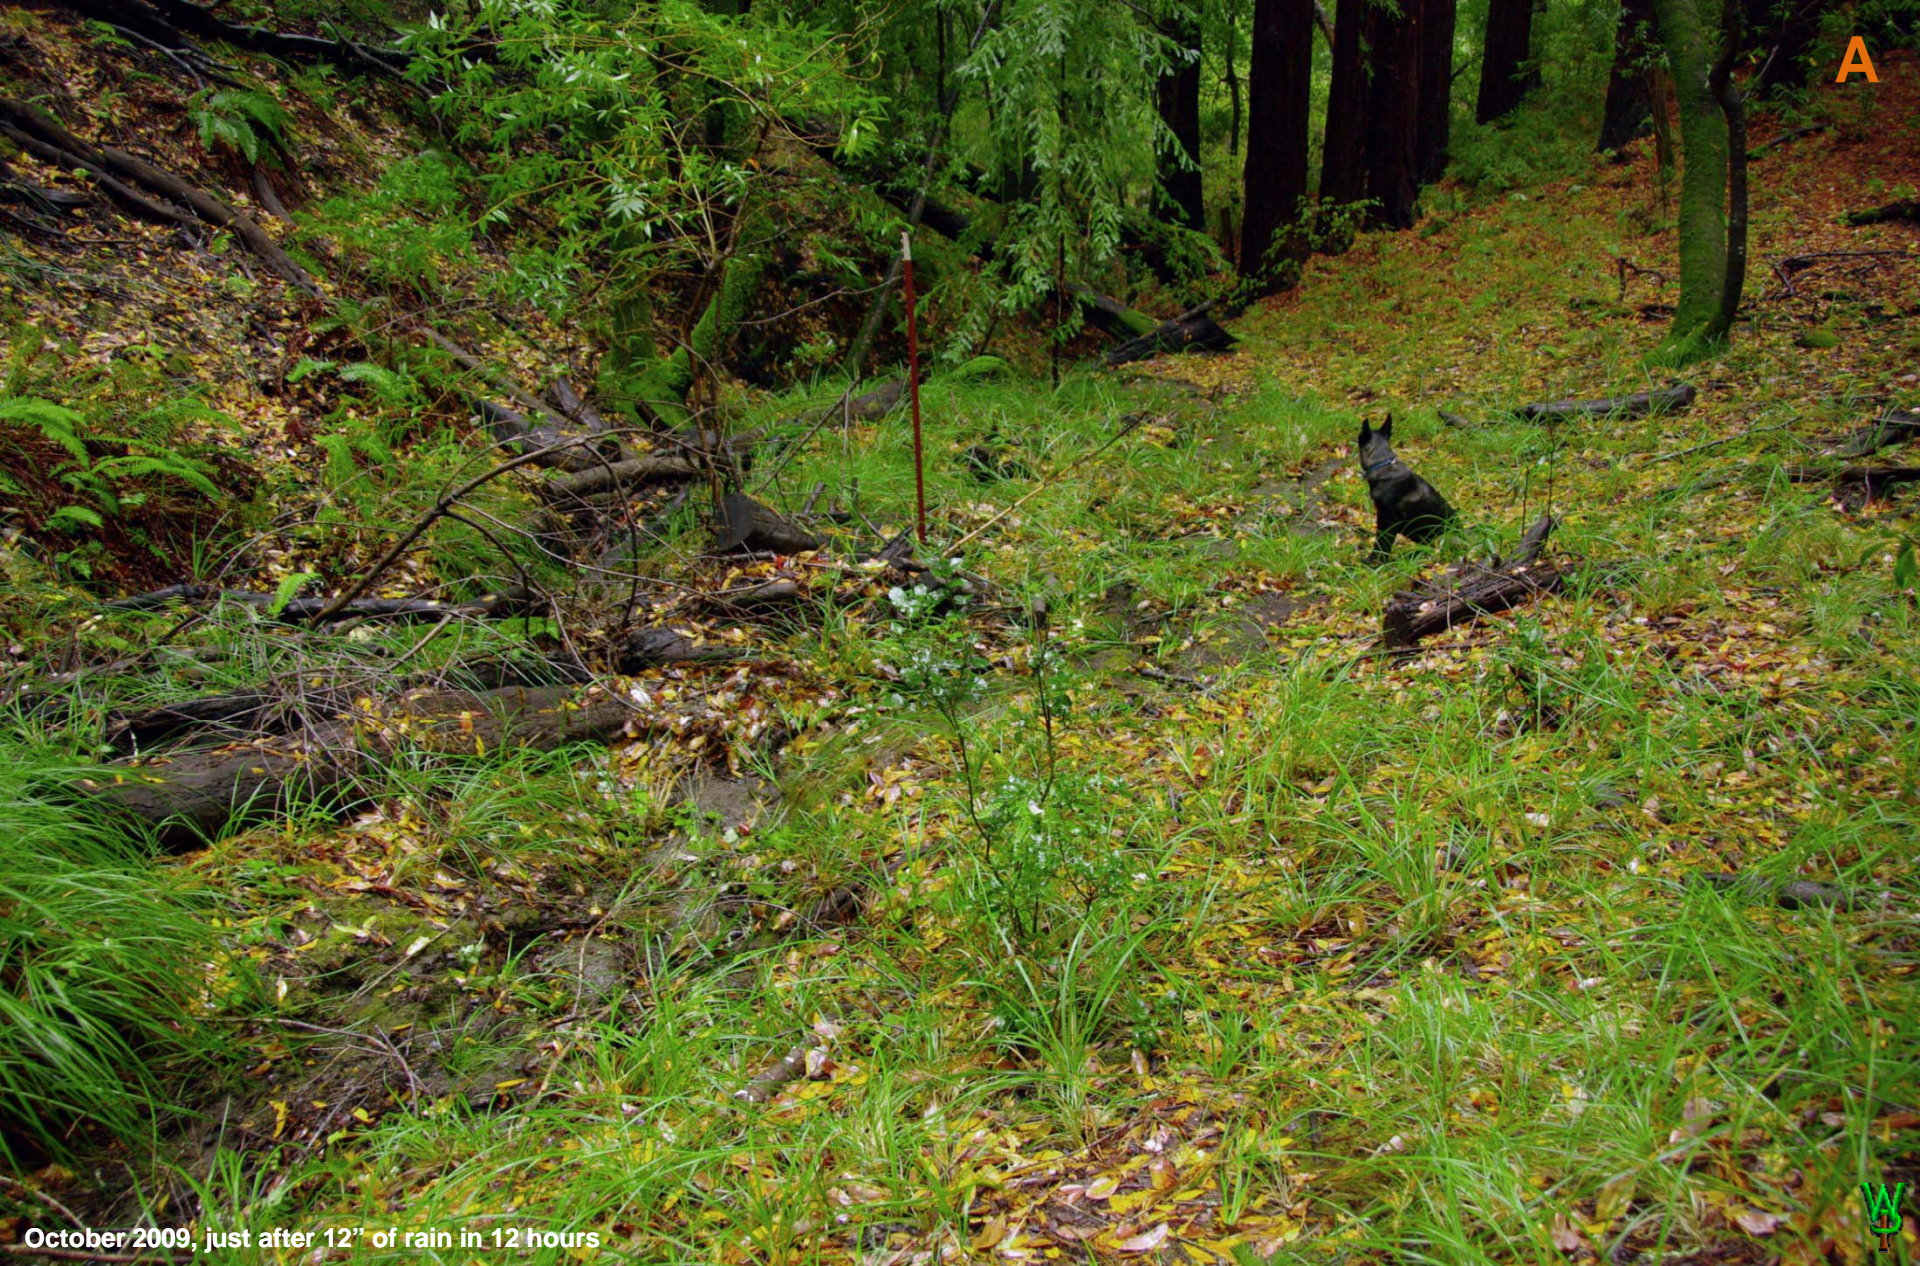
Here it is after five years of winter rains and just after another monster storm. If you look carefully, you'll see not erosion but *deposition* of sediment in the foreground at the head of the diversion. That material is from all over our property, from the my neighbor across the road, various stumps from fallen trees, etc, but probably the biggest source is gophers, ground squirrels, moles, and rabbits. I use that material to stabilize the draw over time, as you will see in our next example in the next channel in the middle of the property.

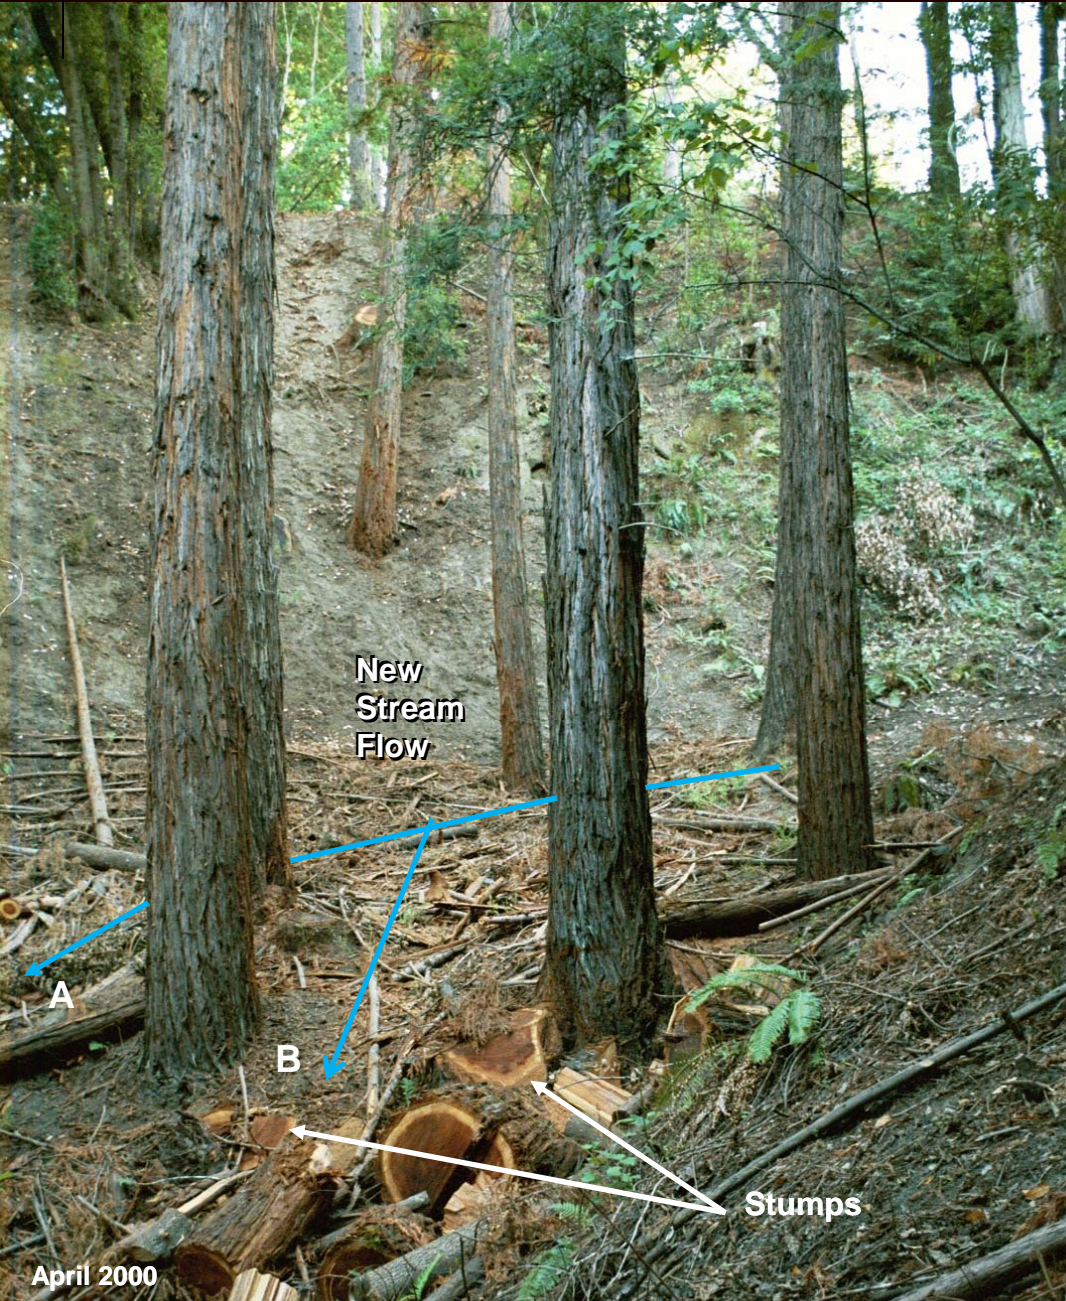
As you can see on the left, I broke the flow into two streams, meaning that the total energy hitting any one spot is greatly reduced. The run-out slope "A" is a great deal lower which also reduces water velocity. Flow "B" smacks headlong into a stump, which being redwood will last a good long time, especially because it will re-sprout new trees. Because of the slope, I don't expect much deposition here.

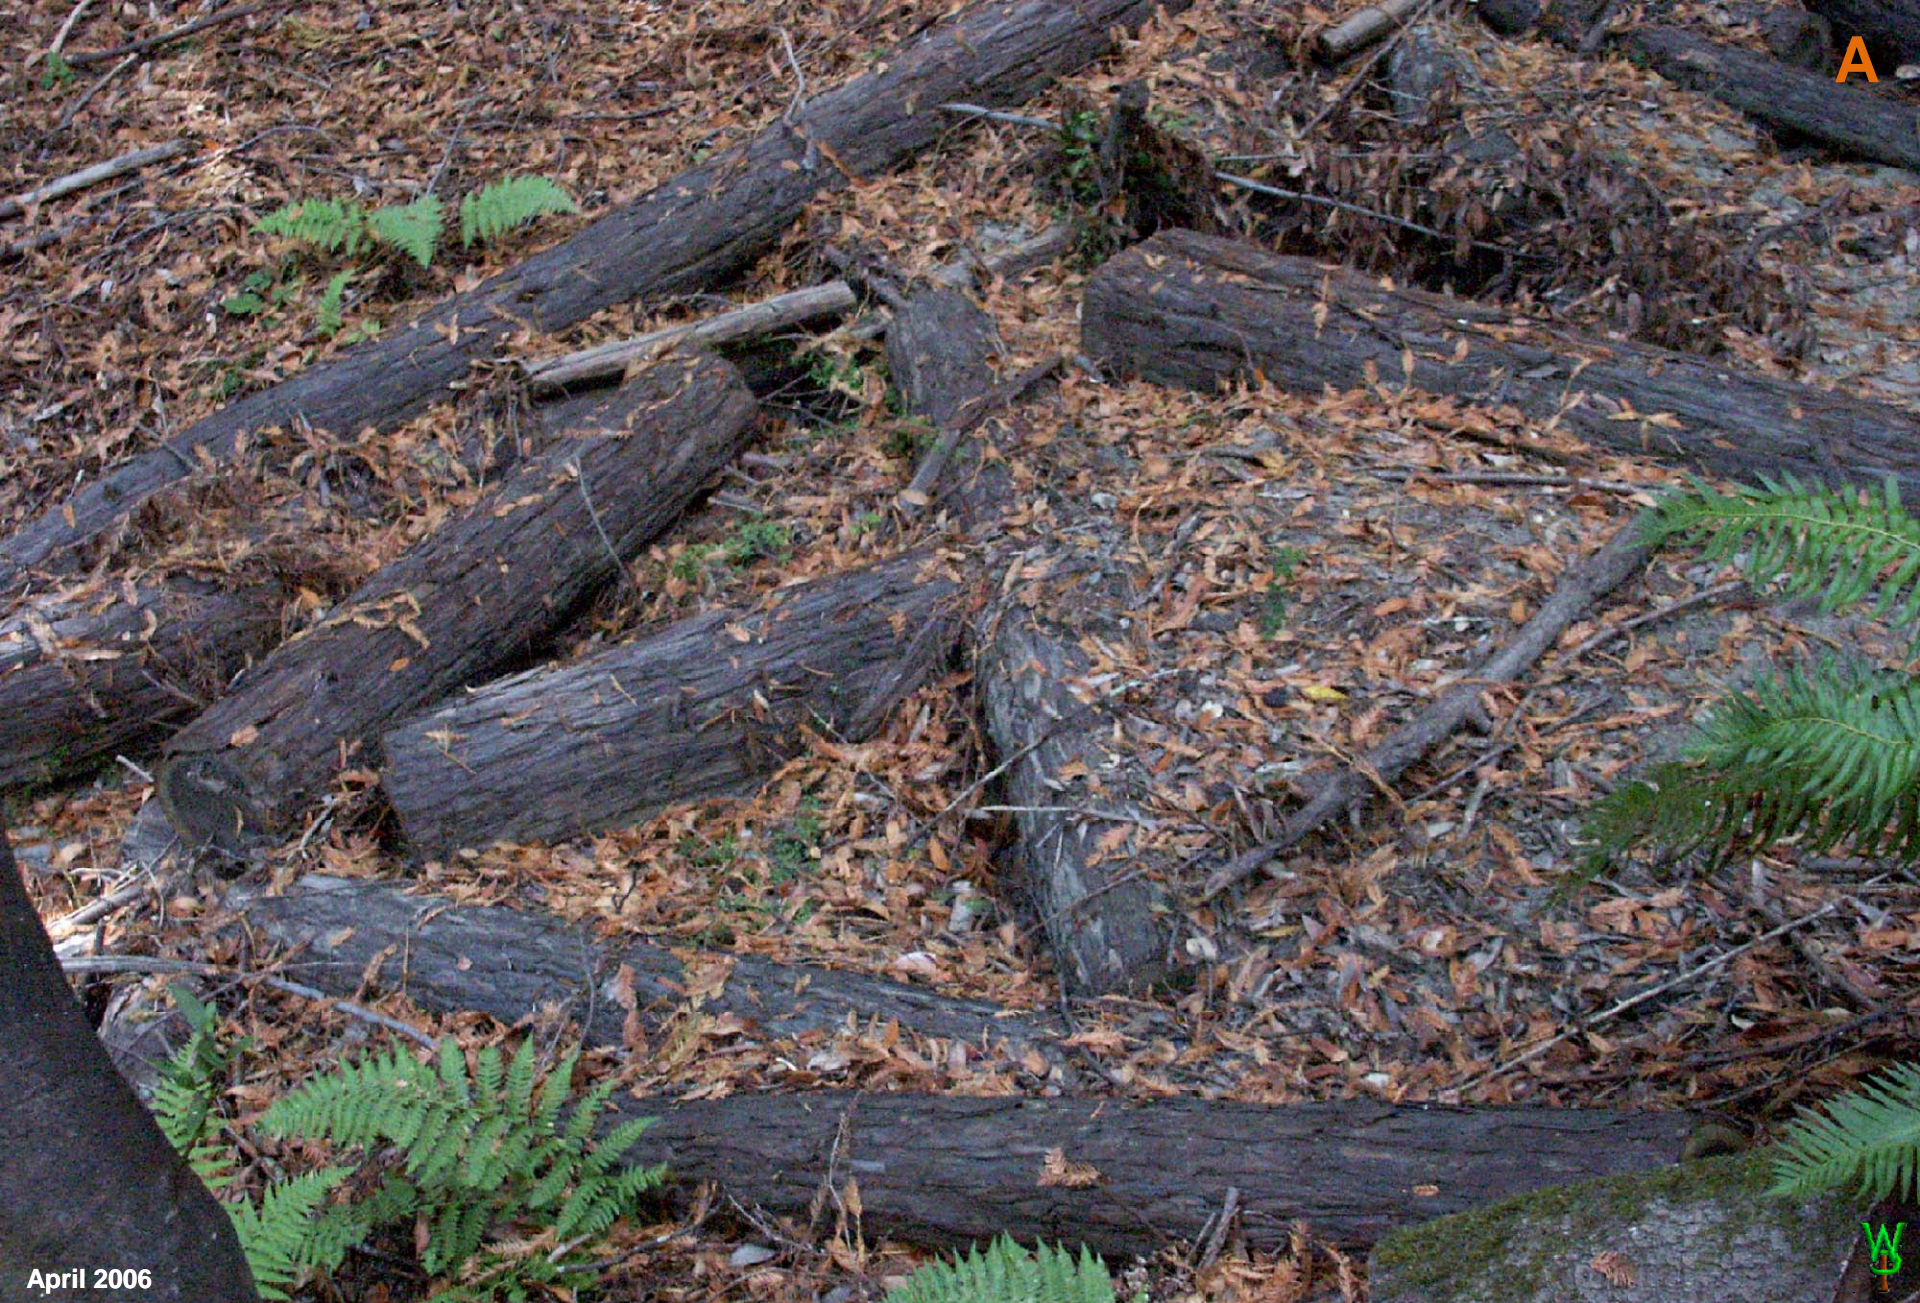
This wood was placed on top of what you just saw. As you can see, it wasn't just 'dumped into the creek;' it was placed carefully with higher outside walls to contain a huge flow inside the channel, with the inside pieces triangulated to wedge each other while breaking the flow into a very convoluted path. It isn't hard to see the sediment that it captured, but where and how did it originate?

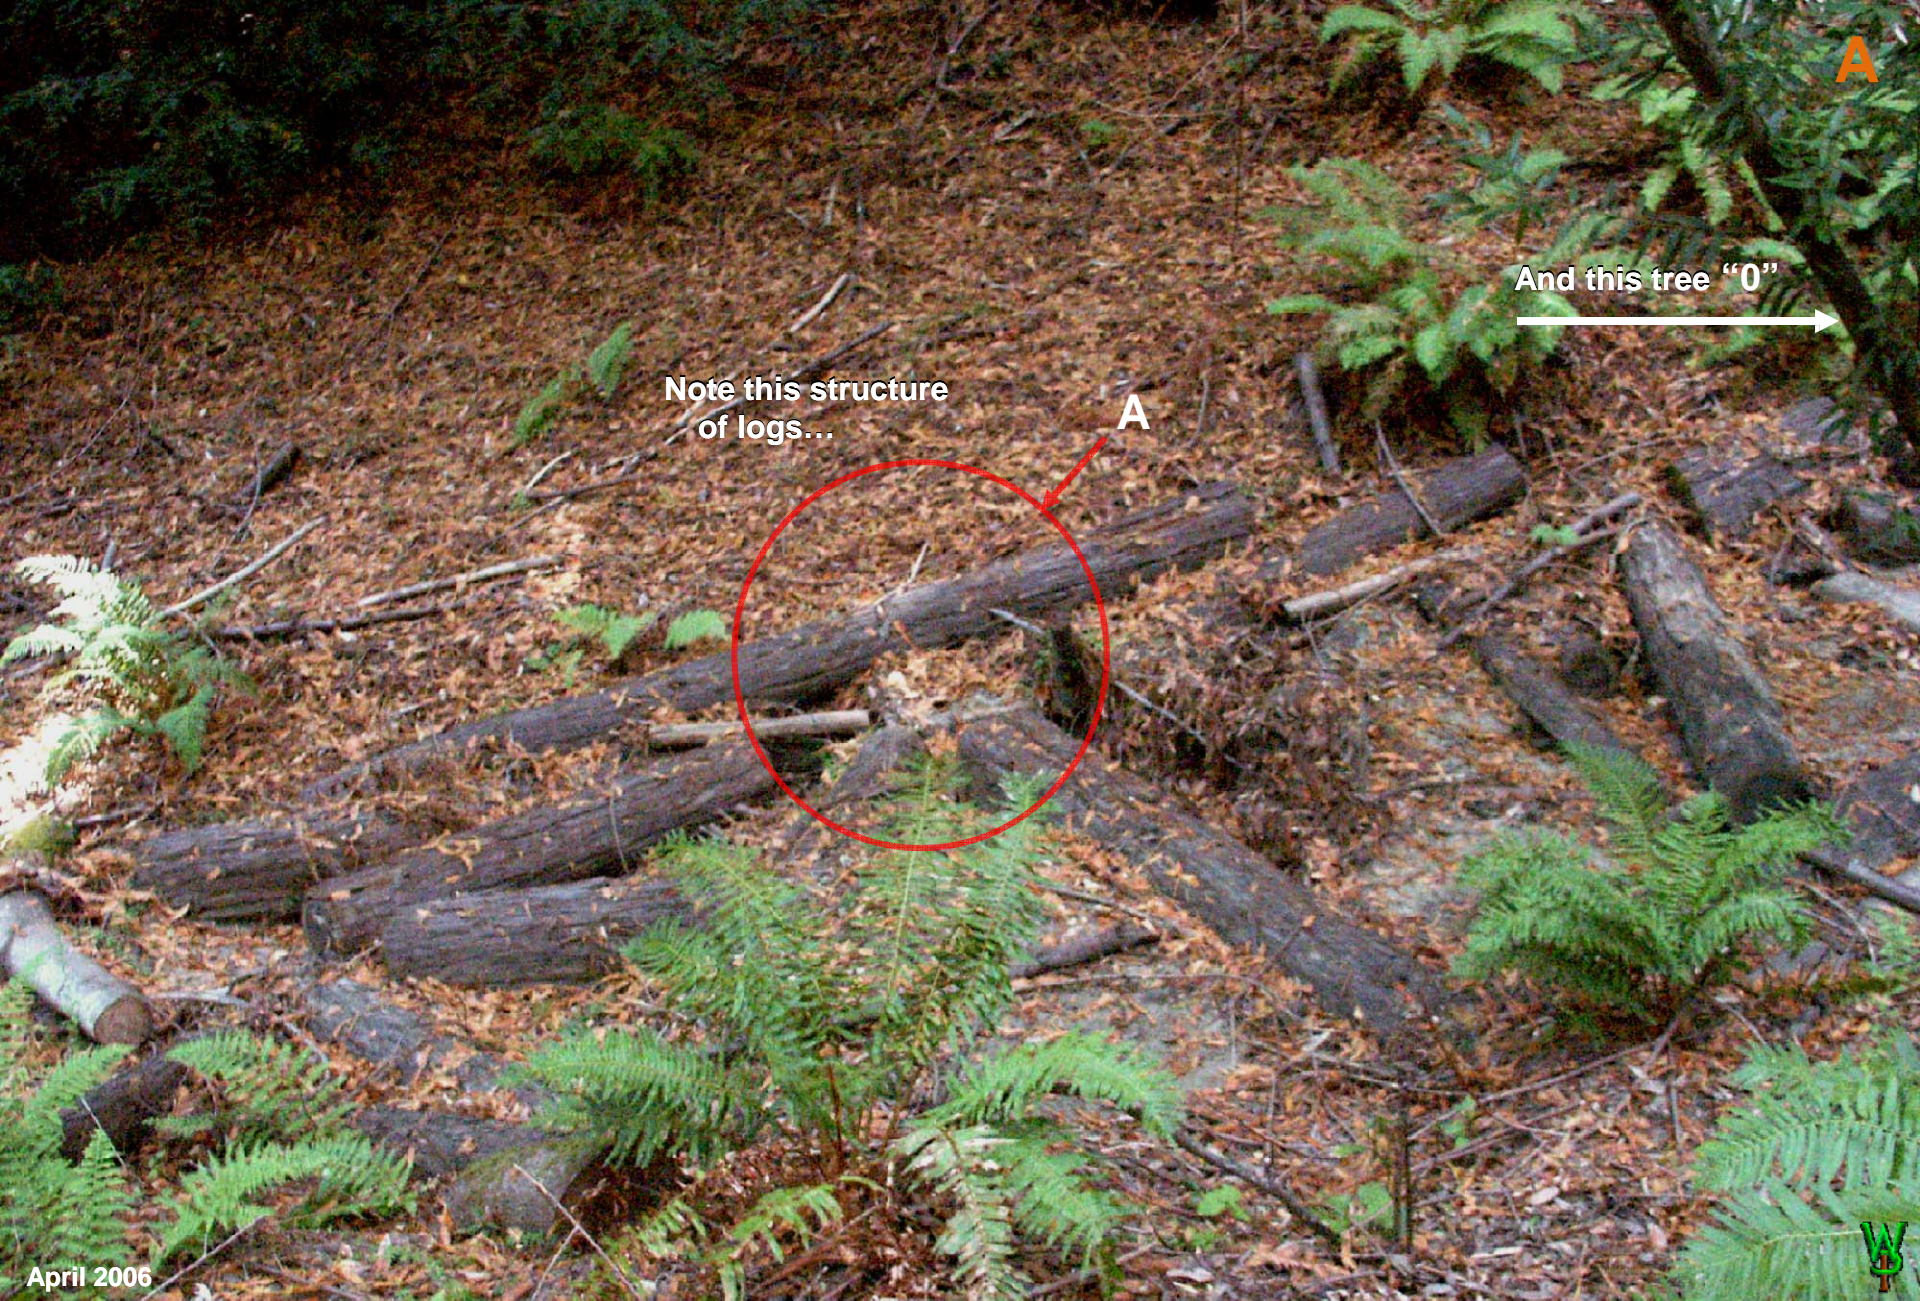
Gophers, ground-squirrels, me tromping around... all those tiny sources of sediment add up to a lot that was once lost off the property every year. This photo was taken six years after my original 'logging job' in 2000. The sediment has almost completely filled a channel 6-8 feet wide and 2-4 feet deep. Note the circled structure "A" for reference in the coming slides.
