# FEELING DRAINAGE

# WILDERGARTEN 5.4

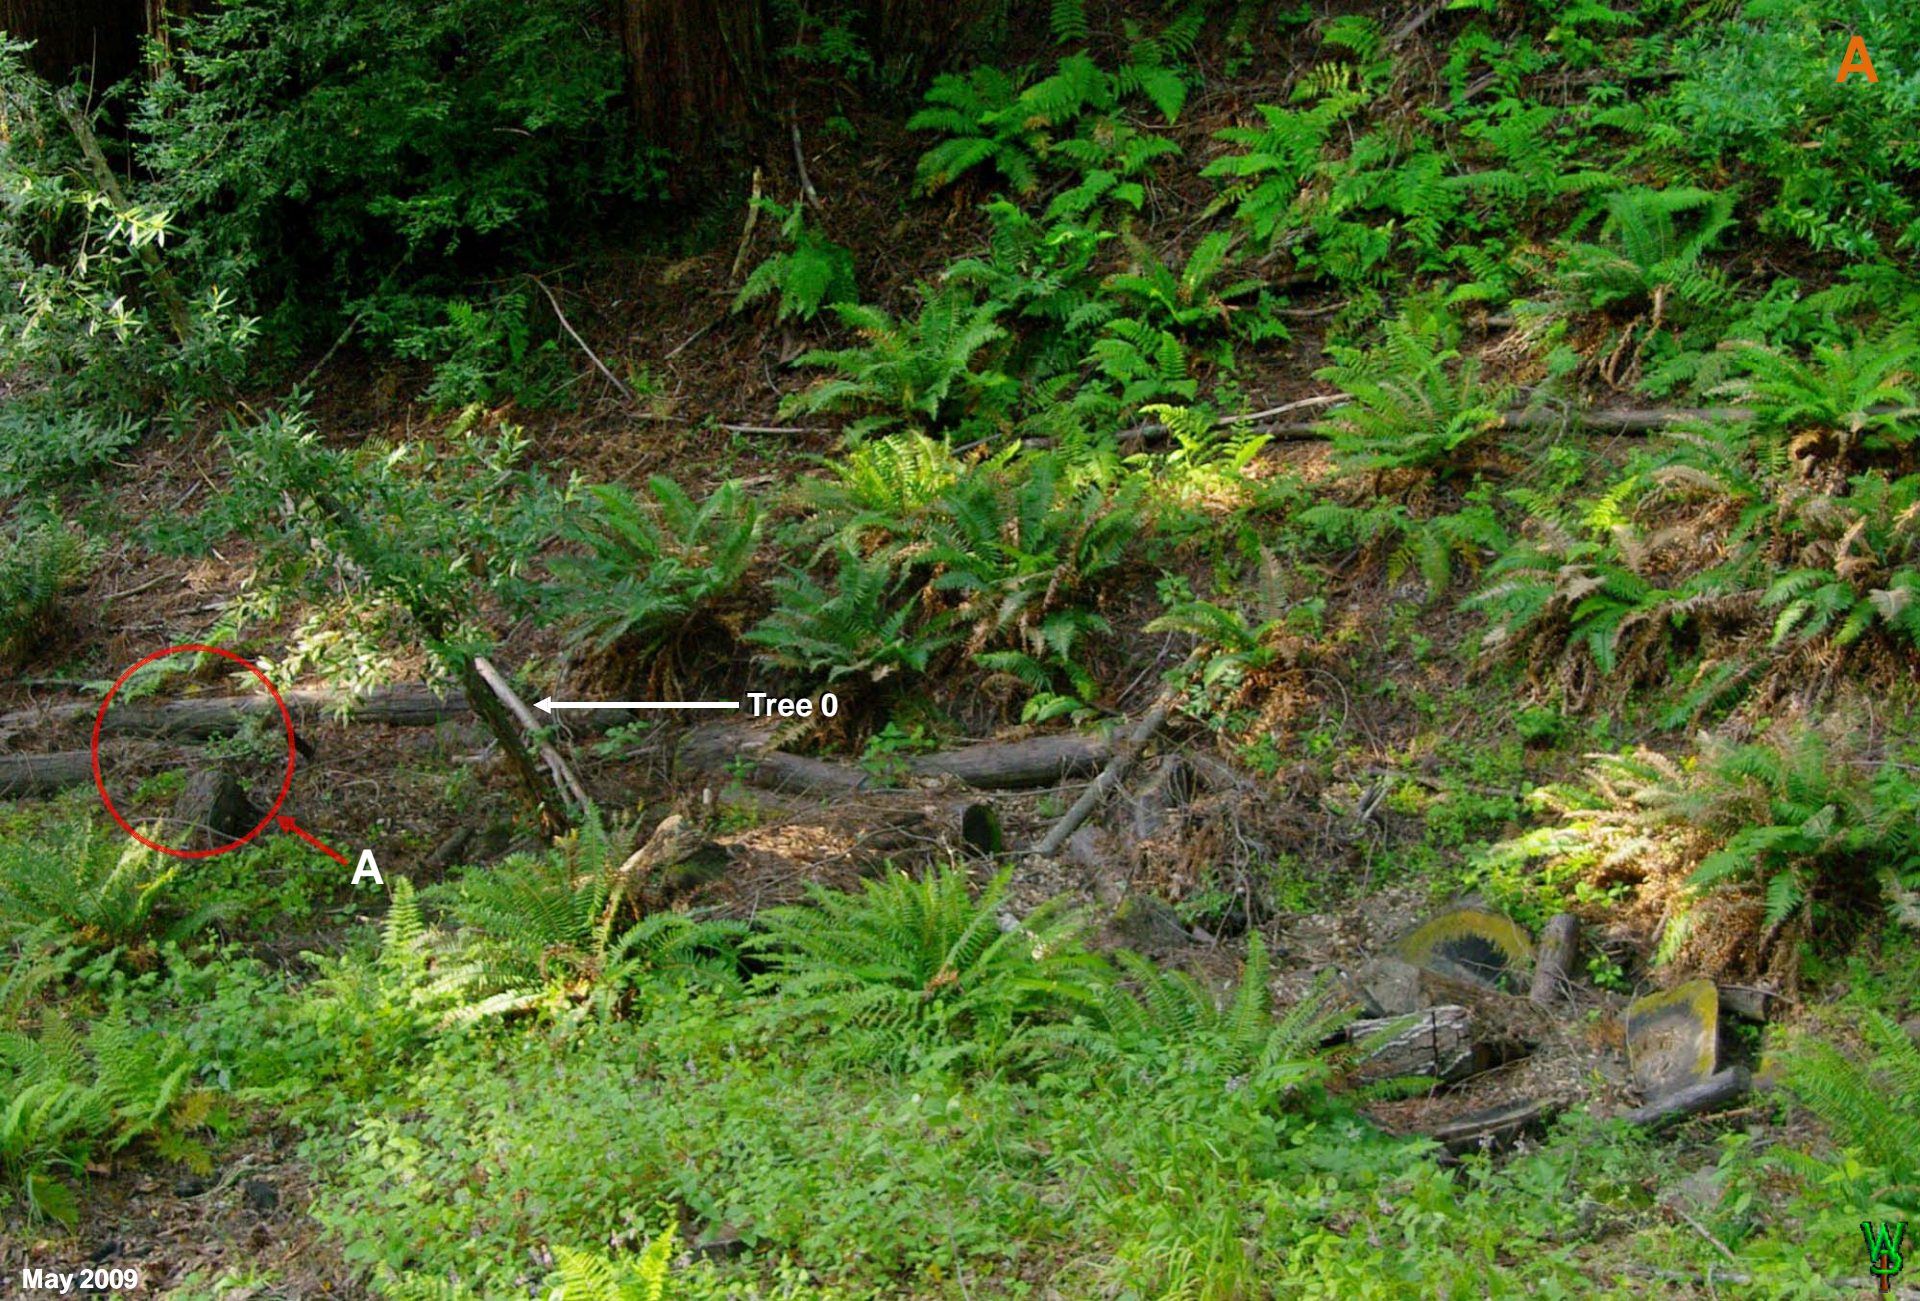
This is the same channel three years later from a little wider view. Logging made the material to line the bed and collect the annual deposition. Logging thinned the slopes so that light could reach the canyon bottom to stimulate the vegetation. It's working, but more thinning is needed for the sedges to really take. More sediment will help too. Note "Tree 0" (the white arrow) as a reference location.

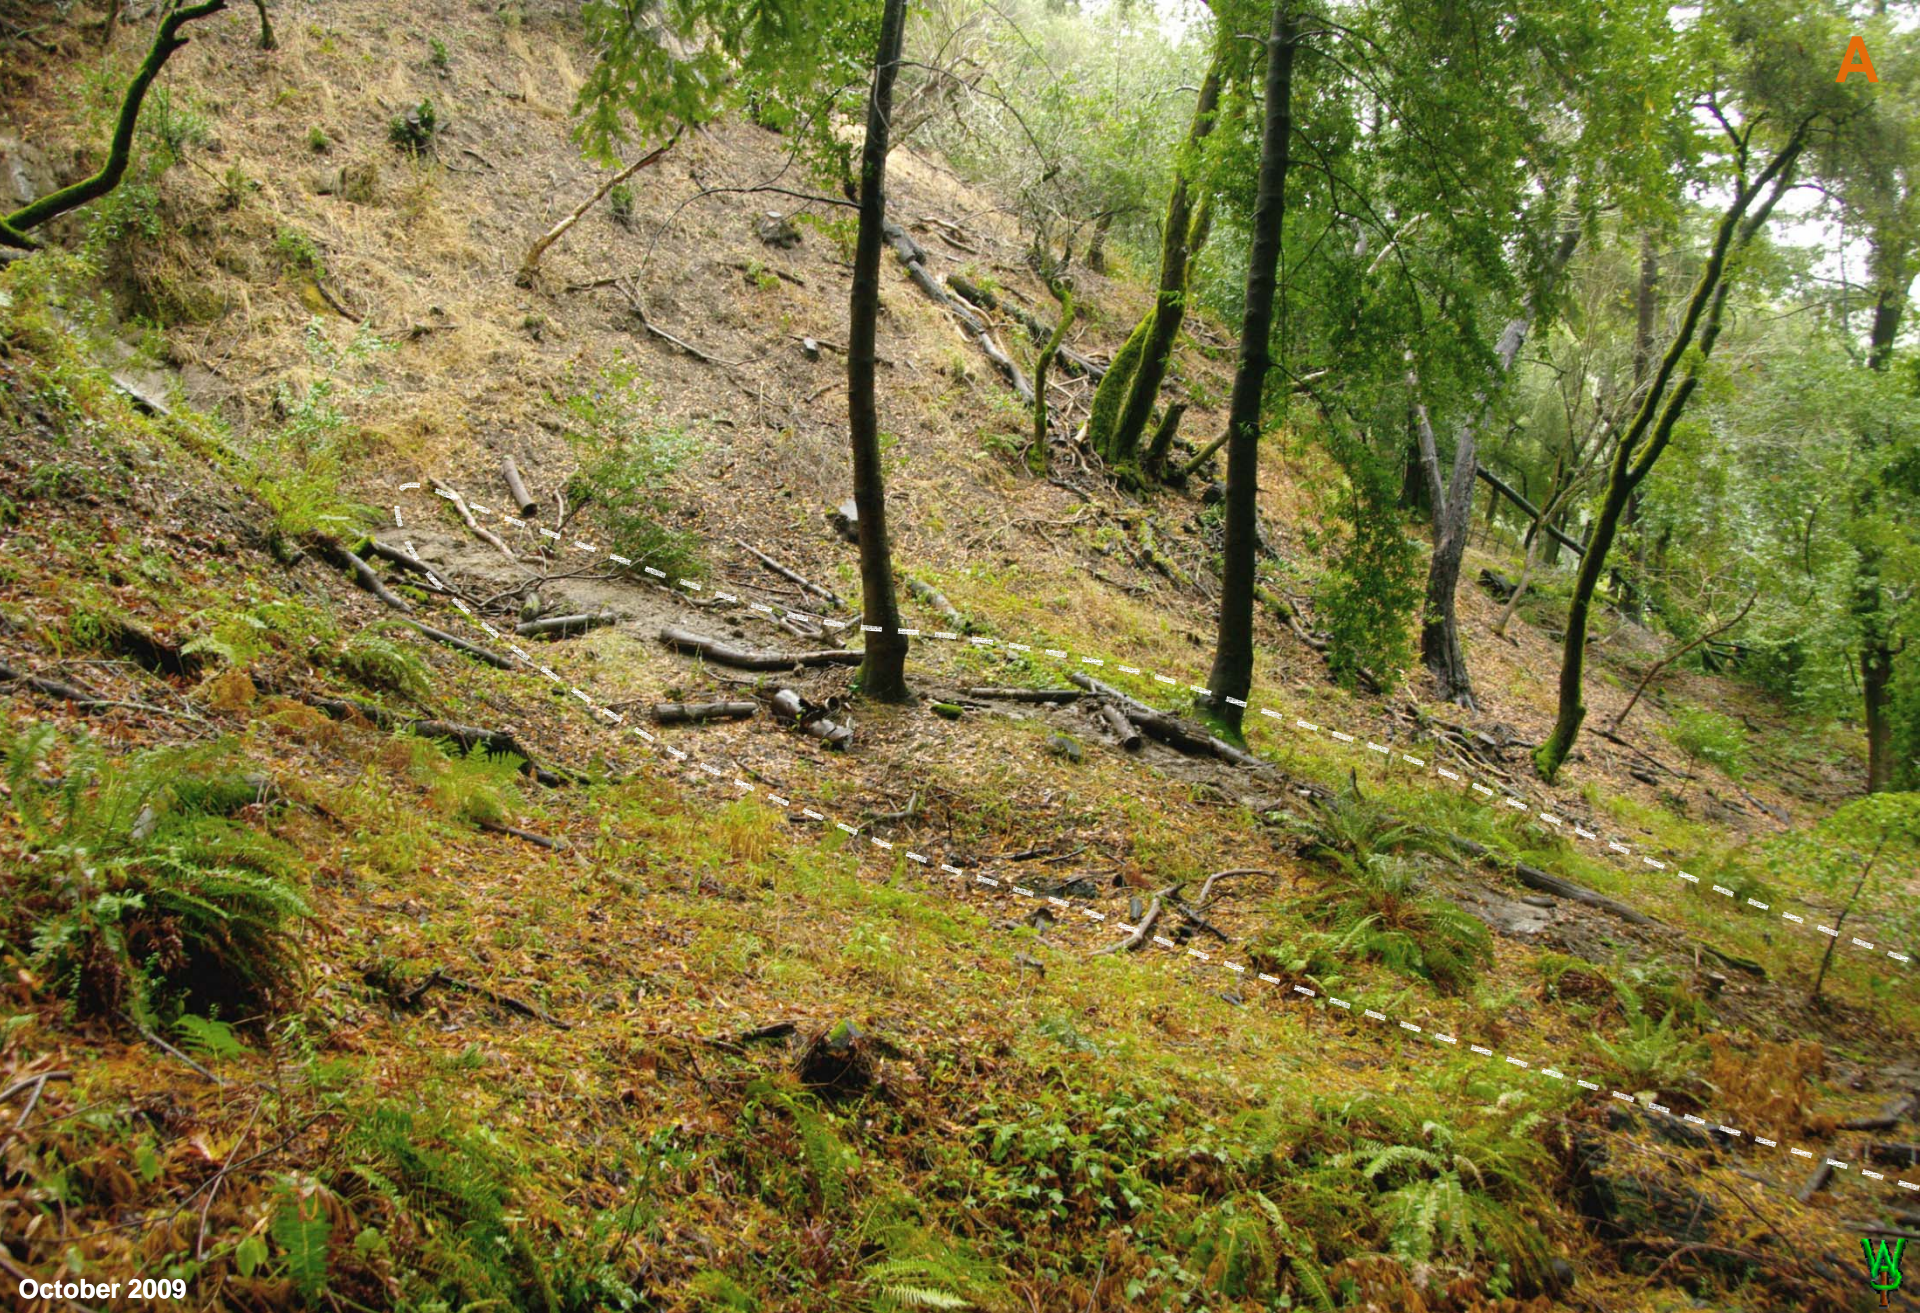
This is just downstream on the way to that (1) tree, immediately after that same 12" deluge in as many hours. Besides the material filling this channel from all over the property, I also "mine" more from this alluvial fan of old stream deposition. The pieces of wood you see chocked against the trees steer the flow across the pillow pile of sediment and into the stream. It's slow, but it works.

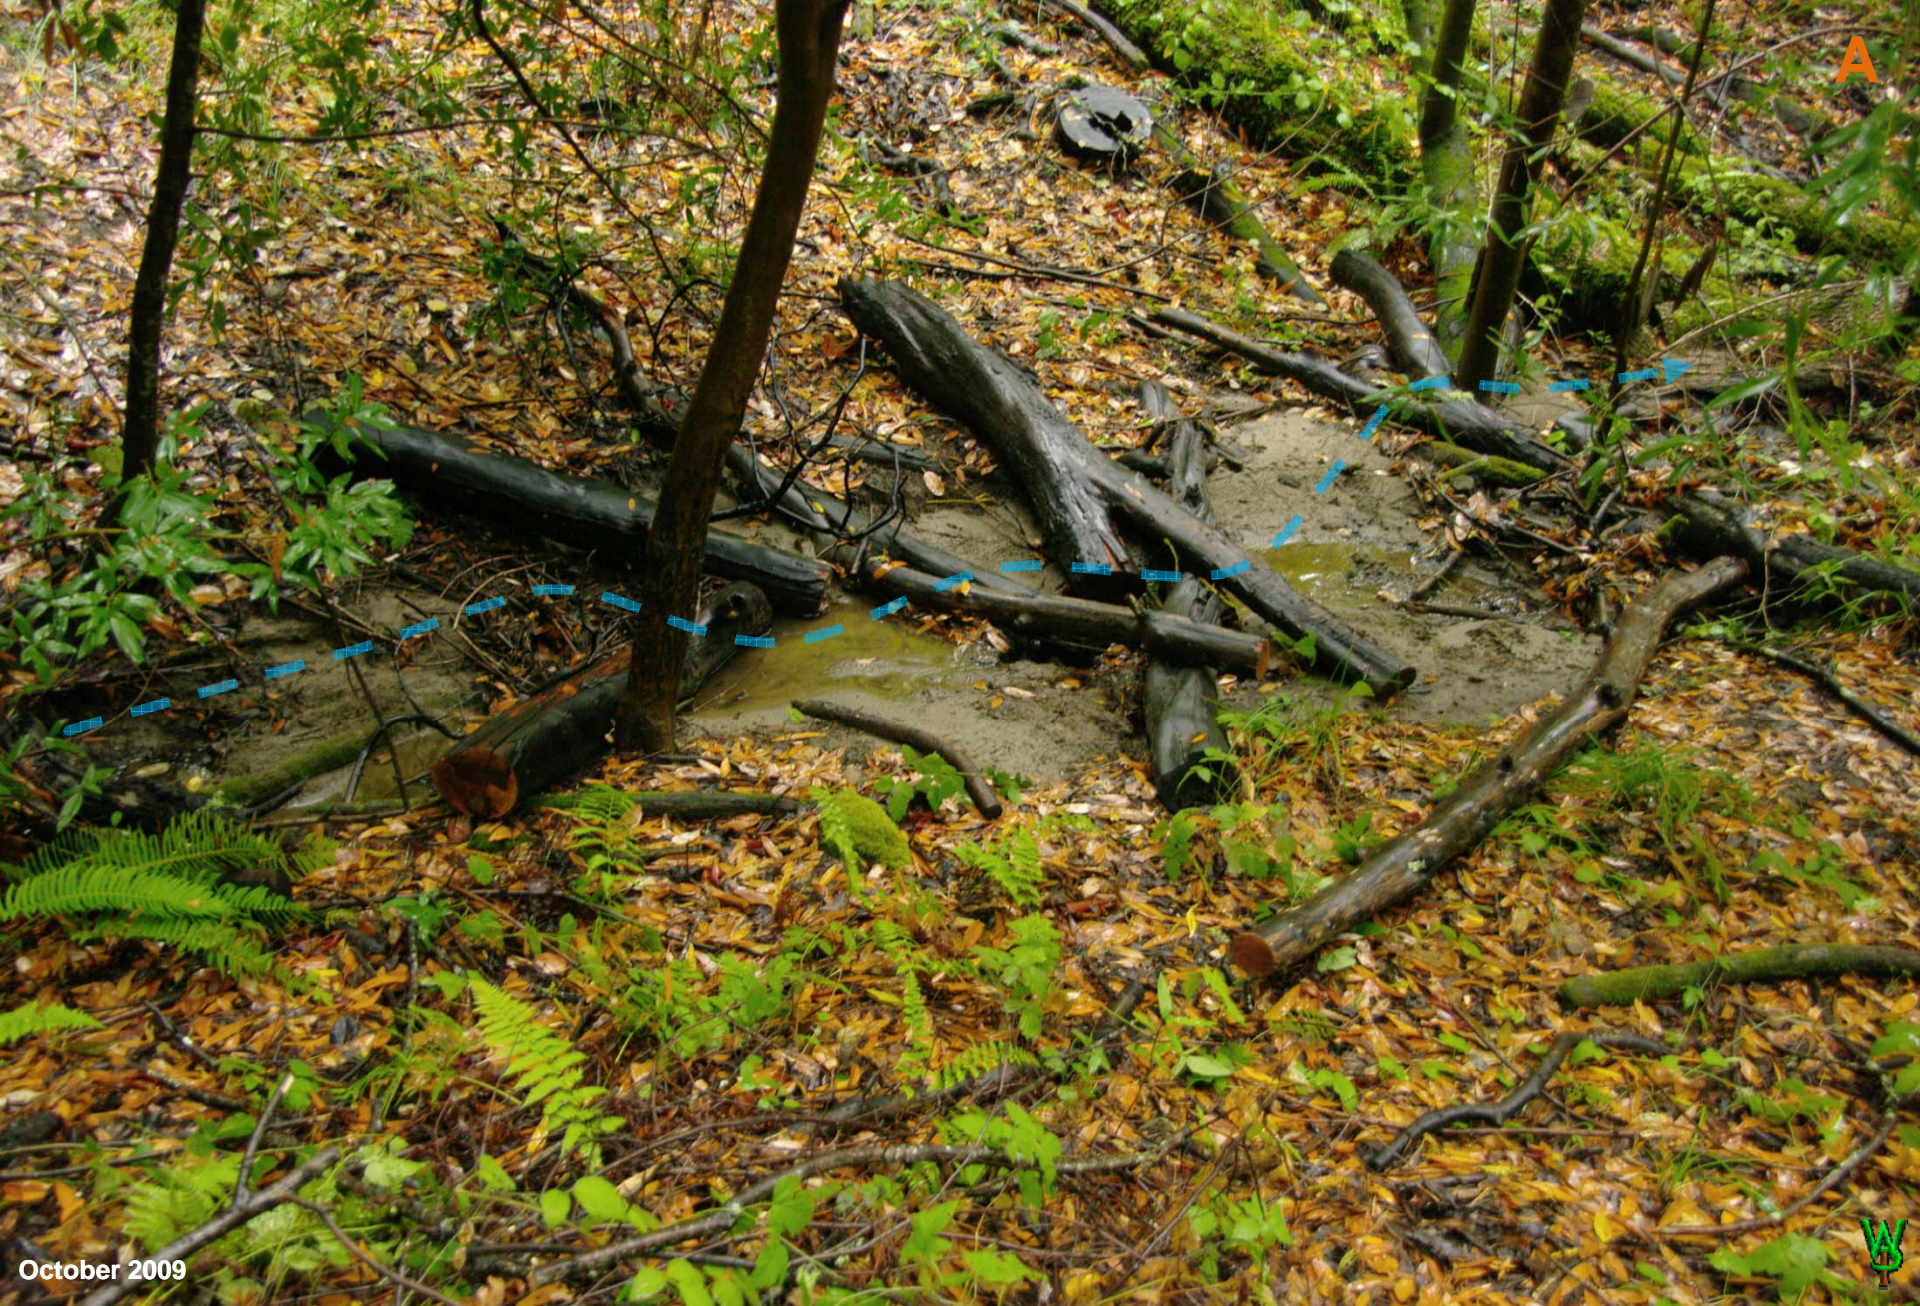
The logs are chocked to cause the material to drop. When a section fills in, the water carries the sediment down to the next trap. From this massive storm, the additional buildup was about 3" thick. The trees anchor the system but they also make it dark. I want to get the sedges going, so I thinned them a few years later on after this had time to settle and consolidate.

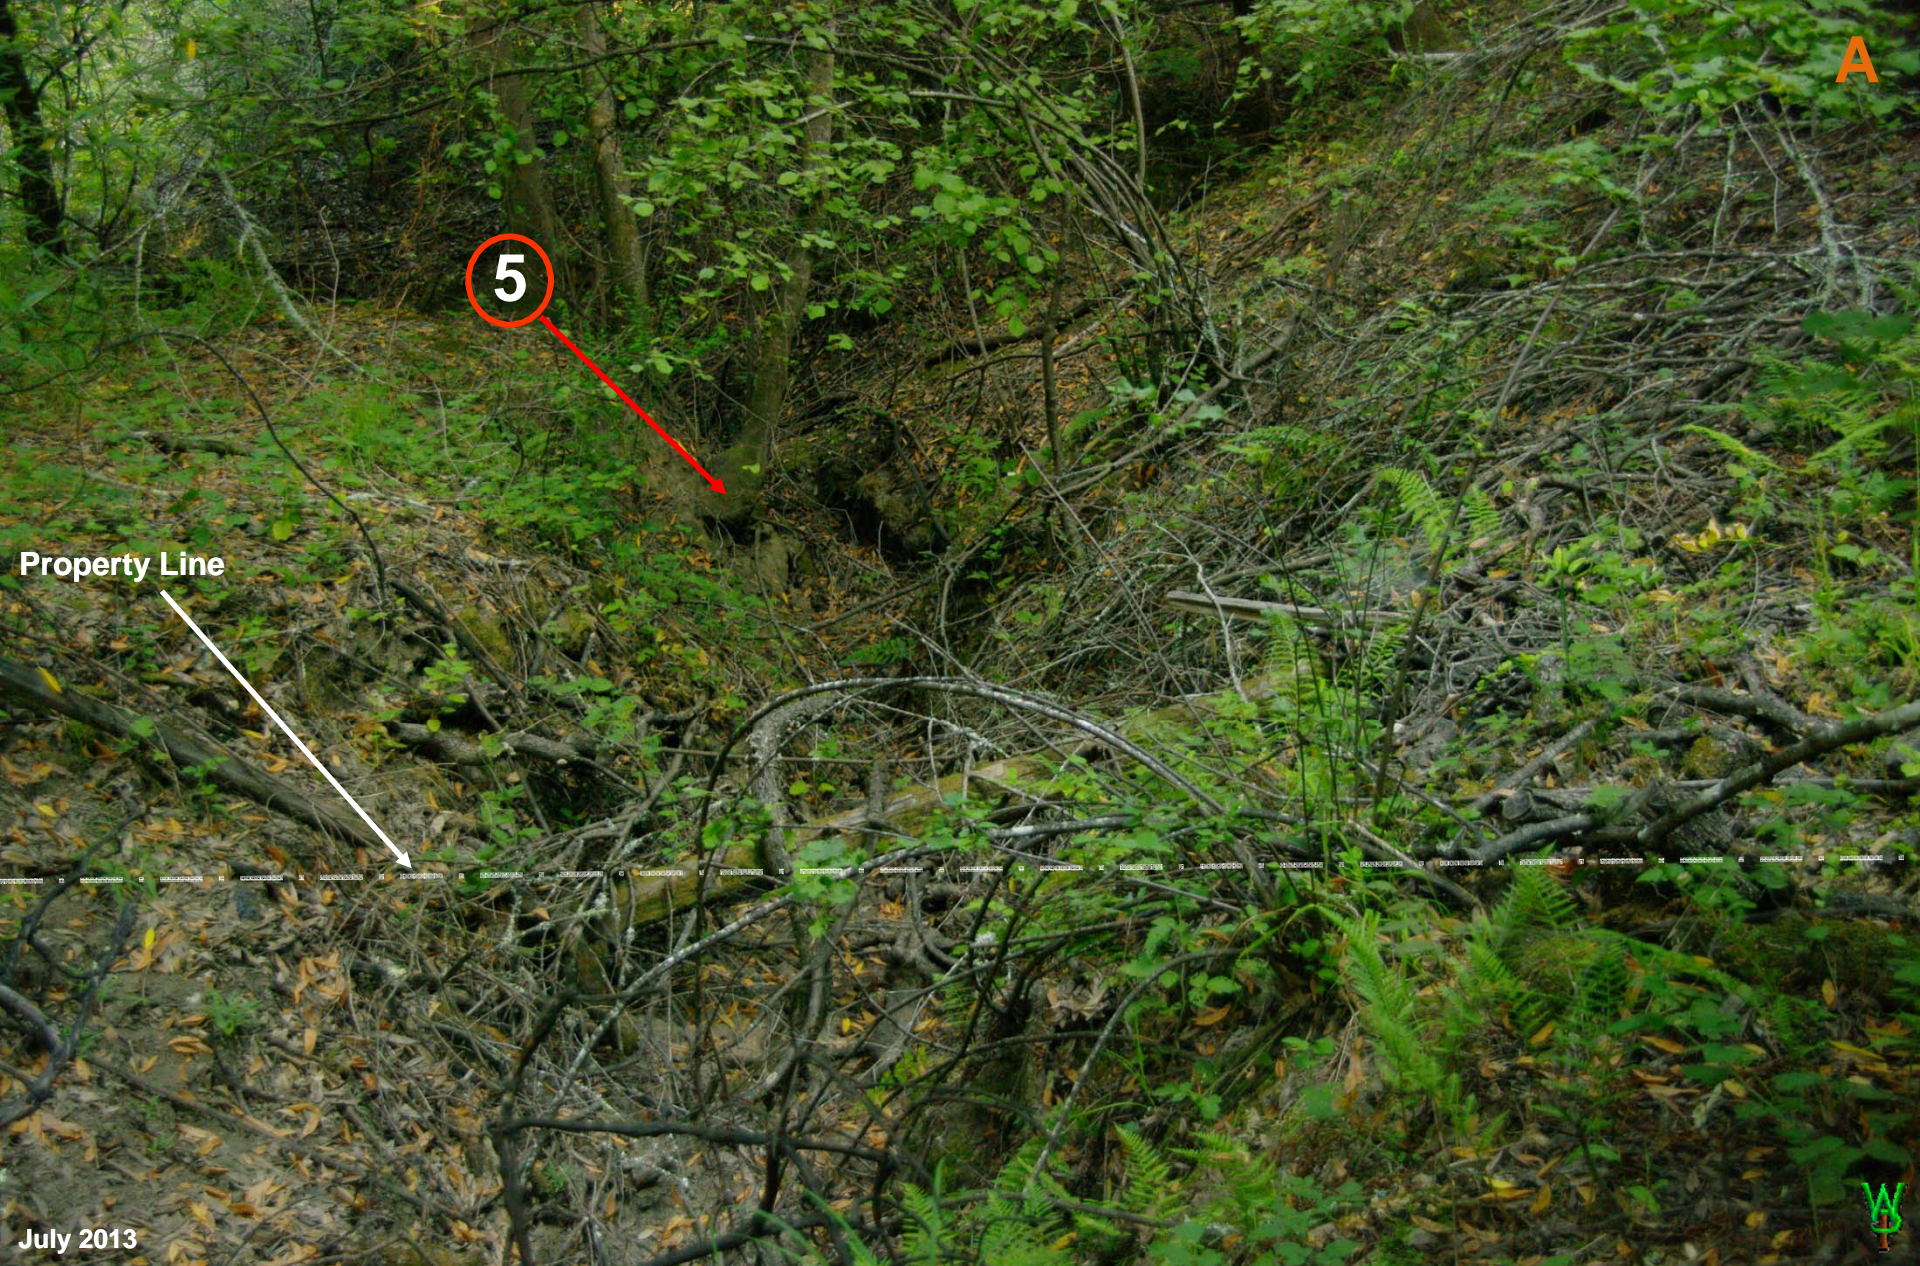
Below the property line, the channel now averages fifteen feet wide and 6-8 ft deep, with a secondary embankment two thirds of the way down upon which the tree (5) is sitting. The channel cross section stabilizes from there at about 20-30 ft wide and 10-15 ft deep. What you can't see is the pocket to the left that has probably lost about 60 cubic yards of soil. Without treatment, the incision here will only get worse, the banks will eventually fall in, and be carried away. No thinning, no groundcovers, lost soil, in that order.

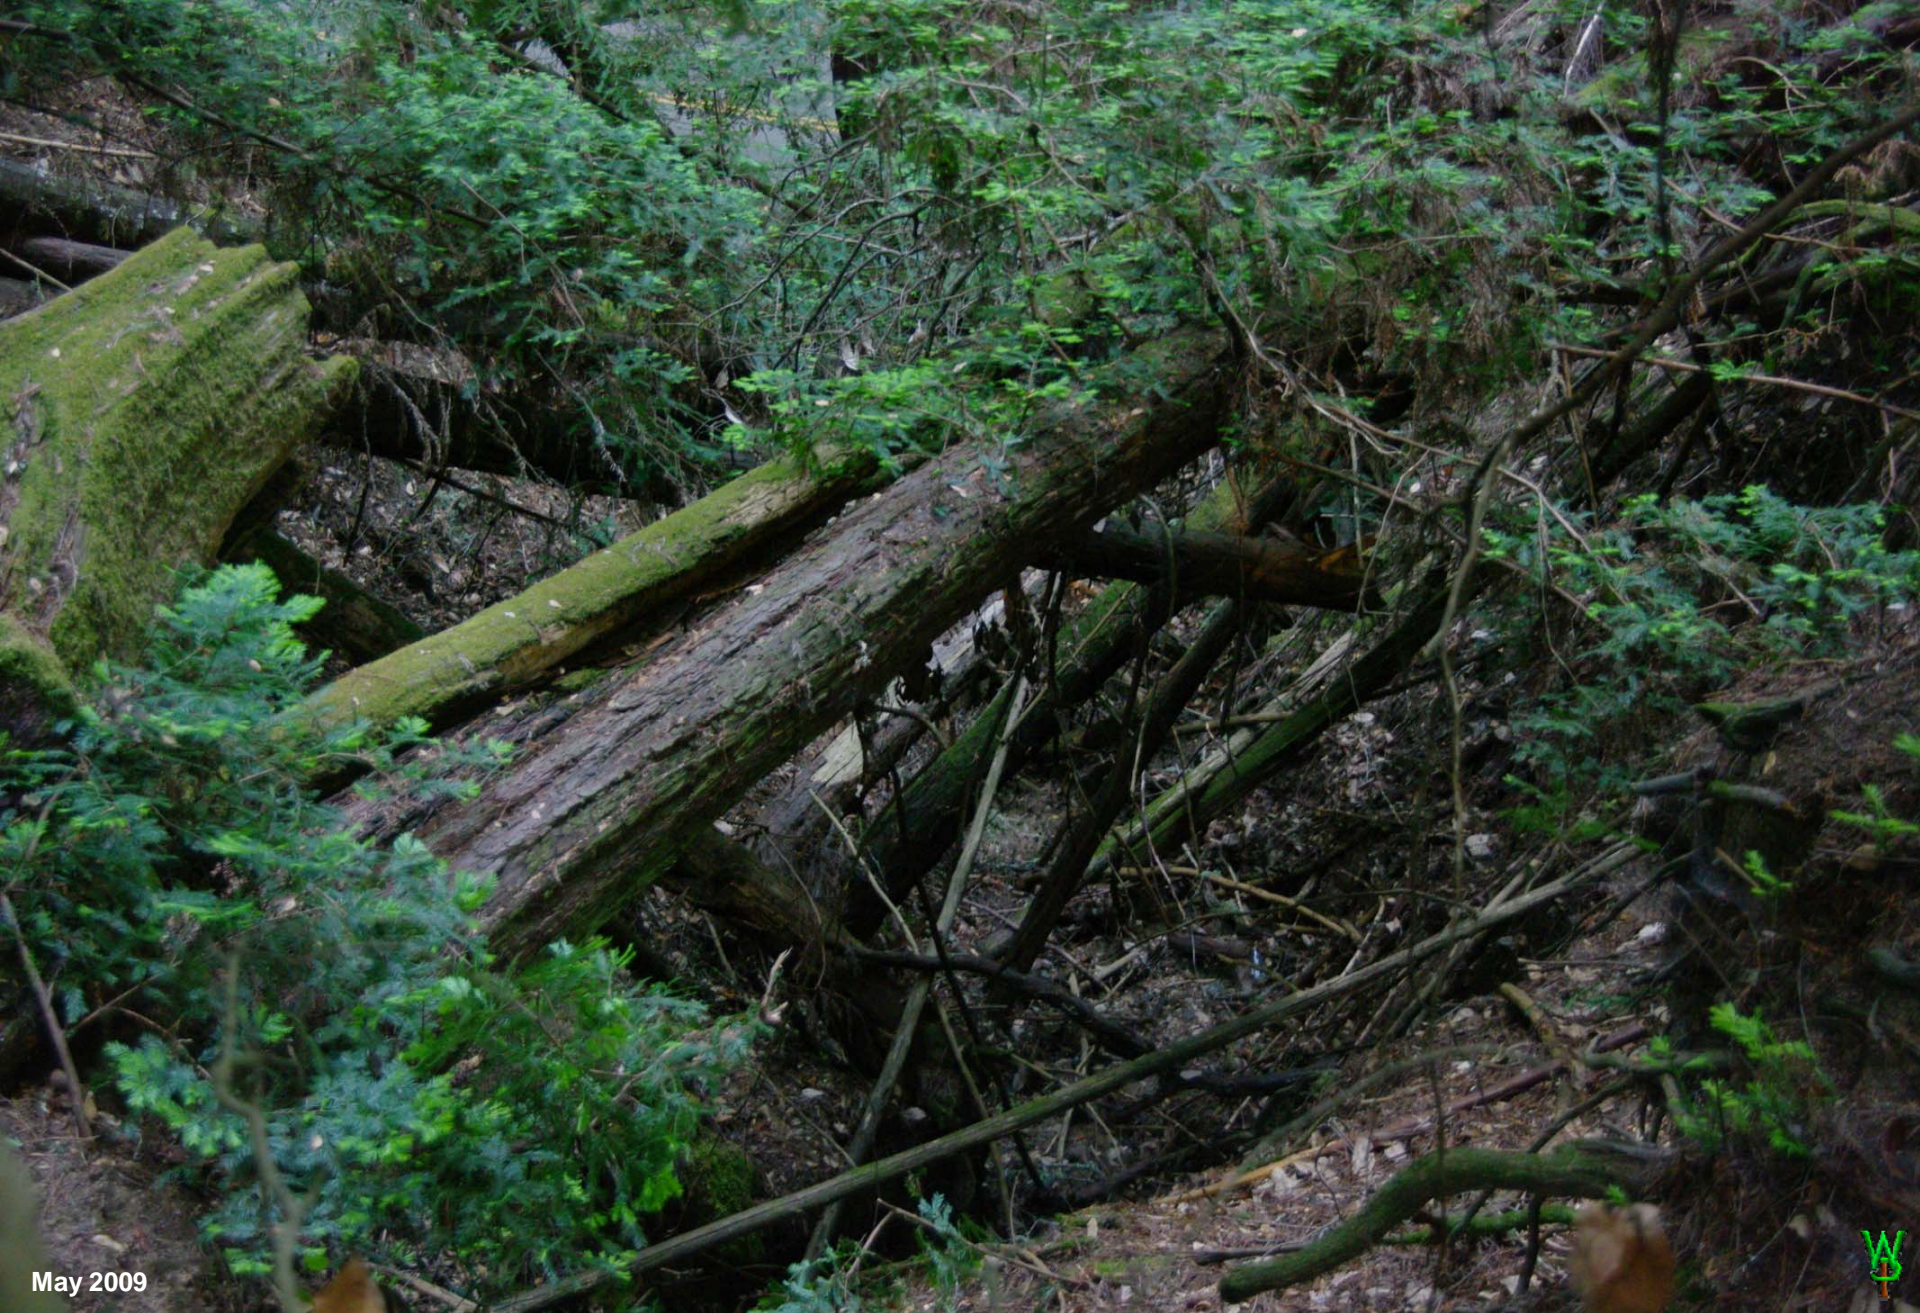
This is about 100' below the culvert outlet, looking downstream. Yet the incision is still getting worse! There are no effective groundcovers because it is way too dark. The logs bridge the channel so the stream is still cutting beneath them. This is "preservation," "recruitment," and "canopy protection" at its best. What you see is what you *will* get in a situation like this.

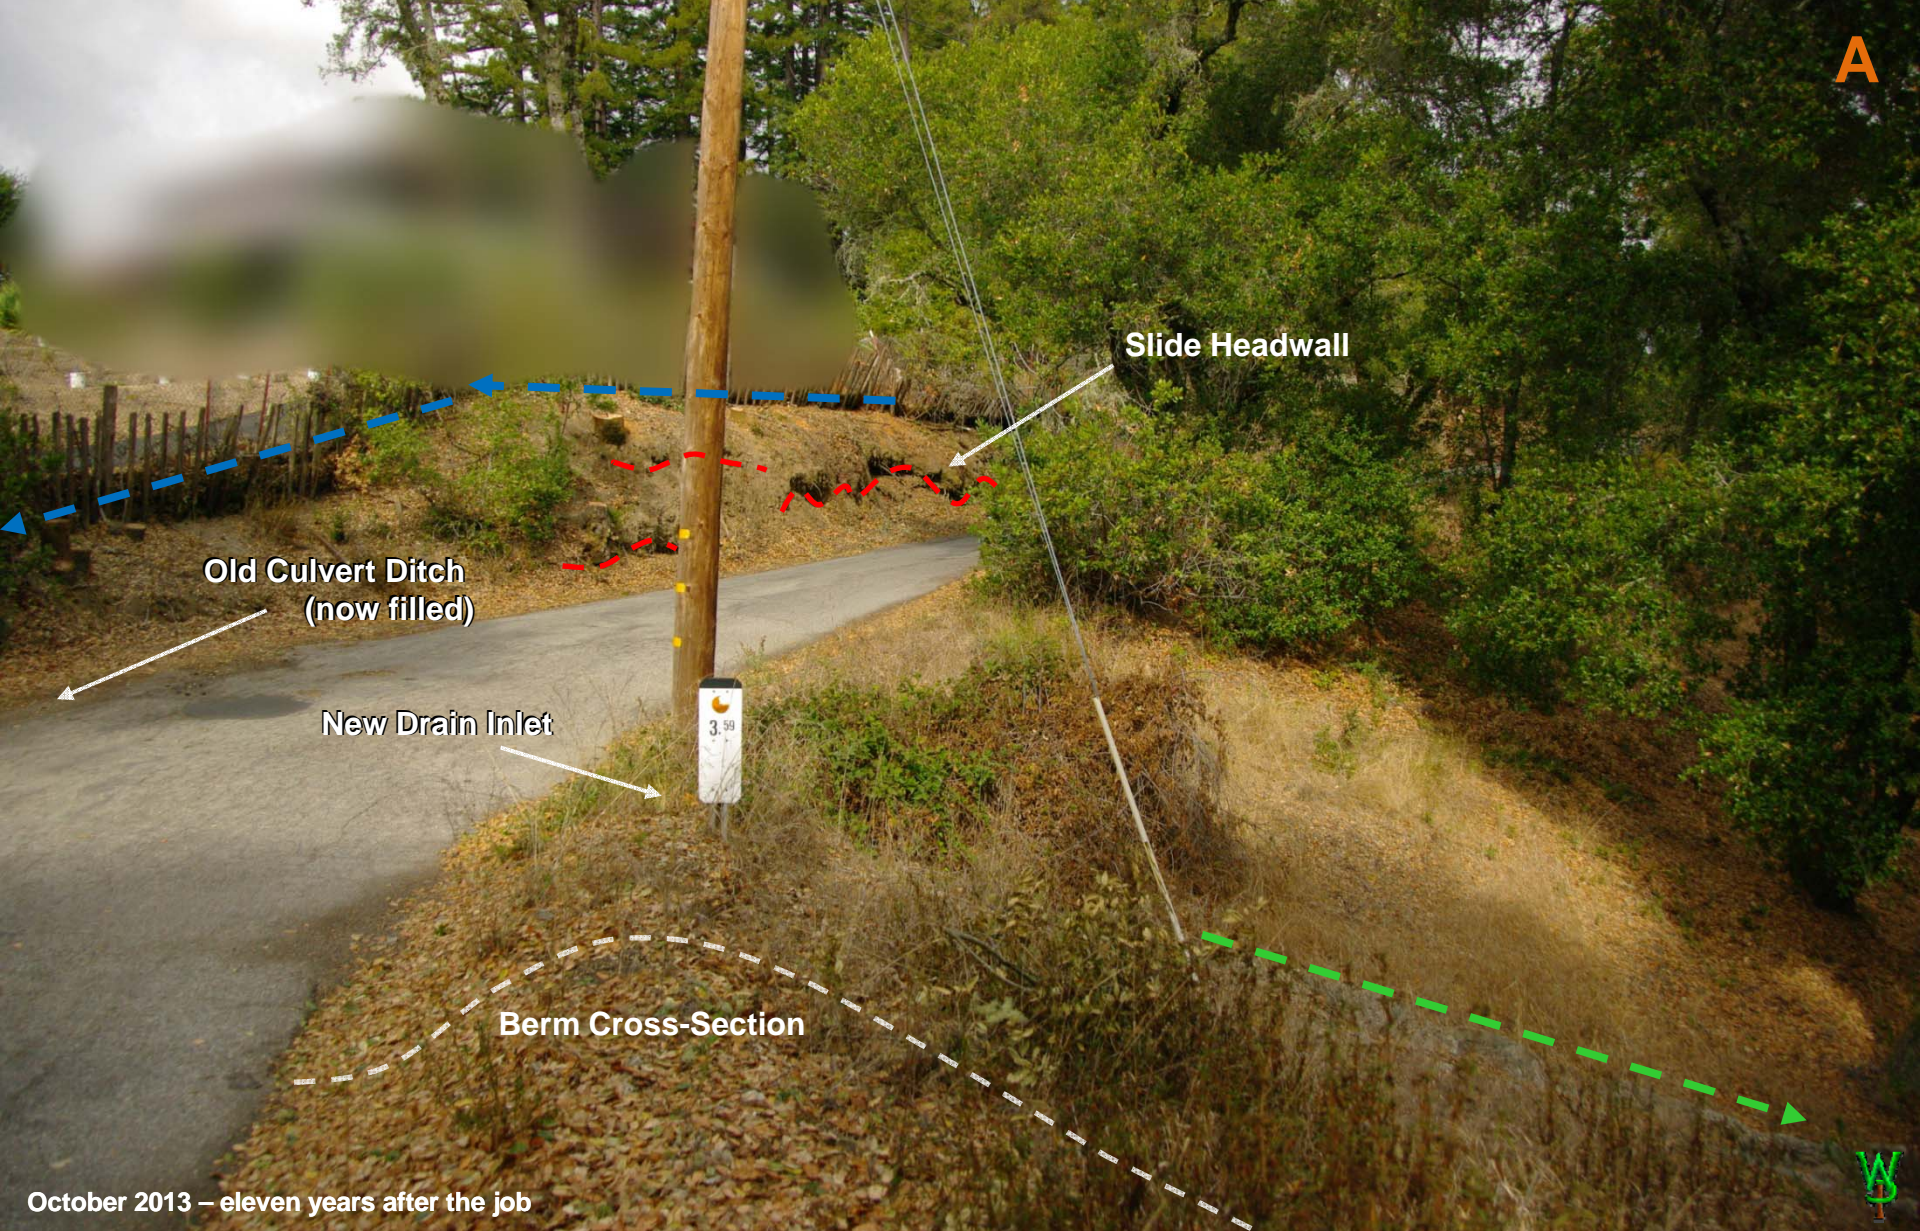
Adding to the collection area, behind the fence (blue line) there is a curb at the lower edge of the driveway to protect the embankment on which it is sitting, now undermined by County ditch cleaning. The driveway, curb, and the road collect and shed nearly an acre of rainwater runoff concentrated here at the corner. The grade of the road once tilted to the left, channeling the water to the culvert. When the culvert plugged, the water went down the embankment on the right and washed the soil away. I know, you see soil here. I fixed it.

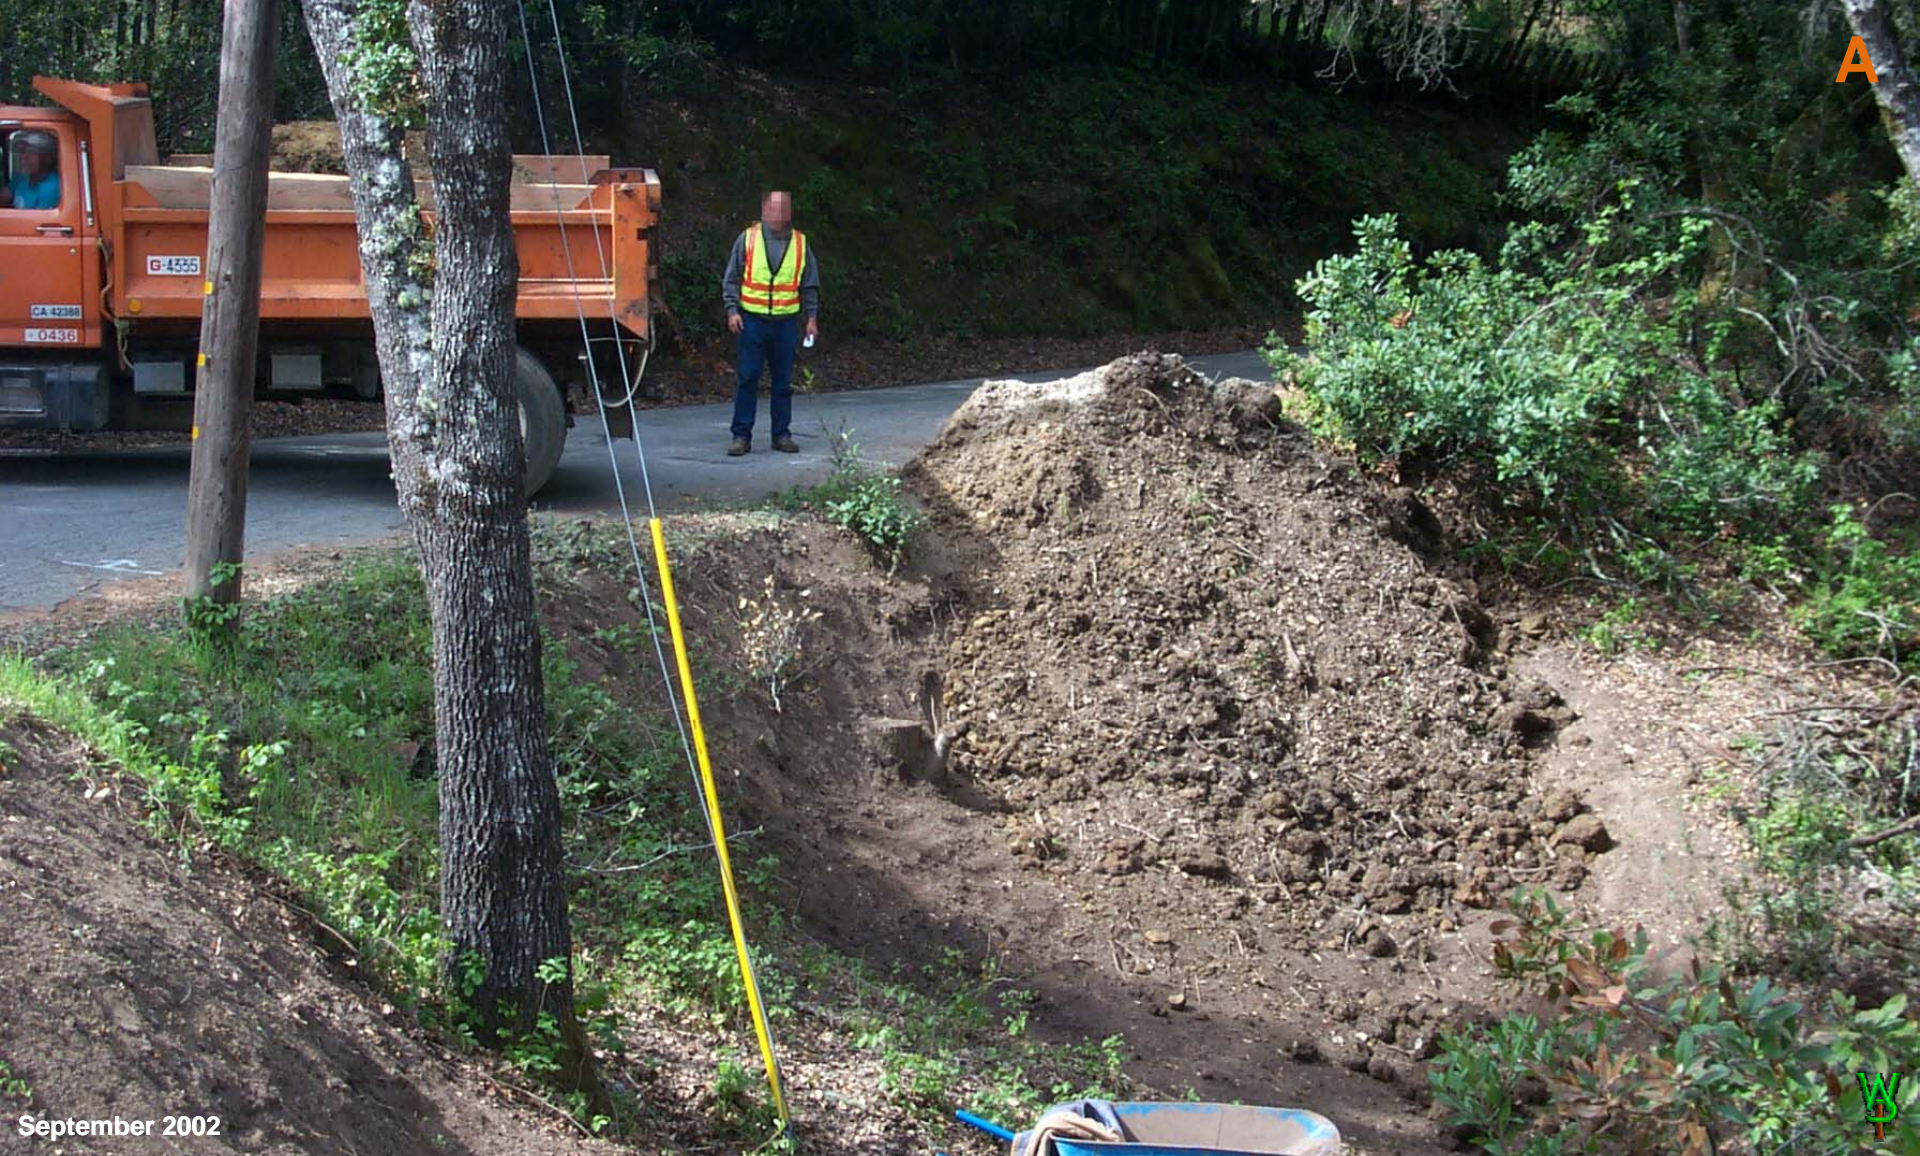
I cleared the vegetation (the tree went that day). The County dumped in ditch cleanings as fill. I had it packed and shaped with an excavator. I rocked in the old culvert ditch on the opposite side and the County paved it next time they came in with a patch crew, making the road wide enough that cars can now pass each other at the corner. I got free fill dirt to repair the damage the culvert had done; they saved money on trucking dirt and reinforcing the road. Everybody wins, right? Well, the lawyers keep trying to make such projects impossible. No, this is not as good as “engineered fill.” It is not as good as digging it all out and compacting it to specification. It has settled a little, which was expected. I have a supply of material nearby with which to fill those few spots that will need it. Slowly it will stabilize and for far less money.

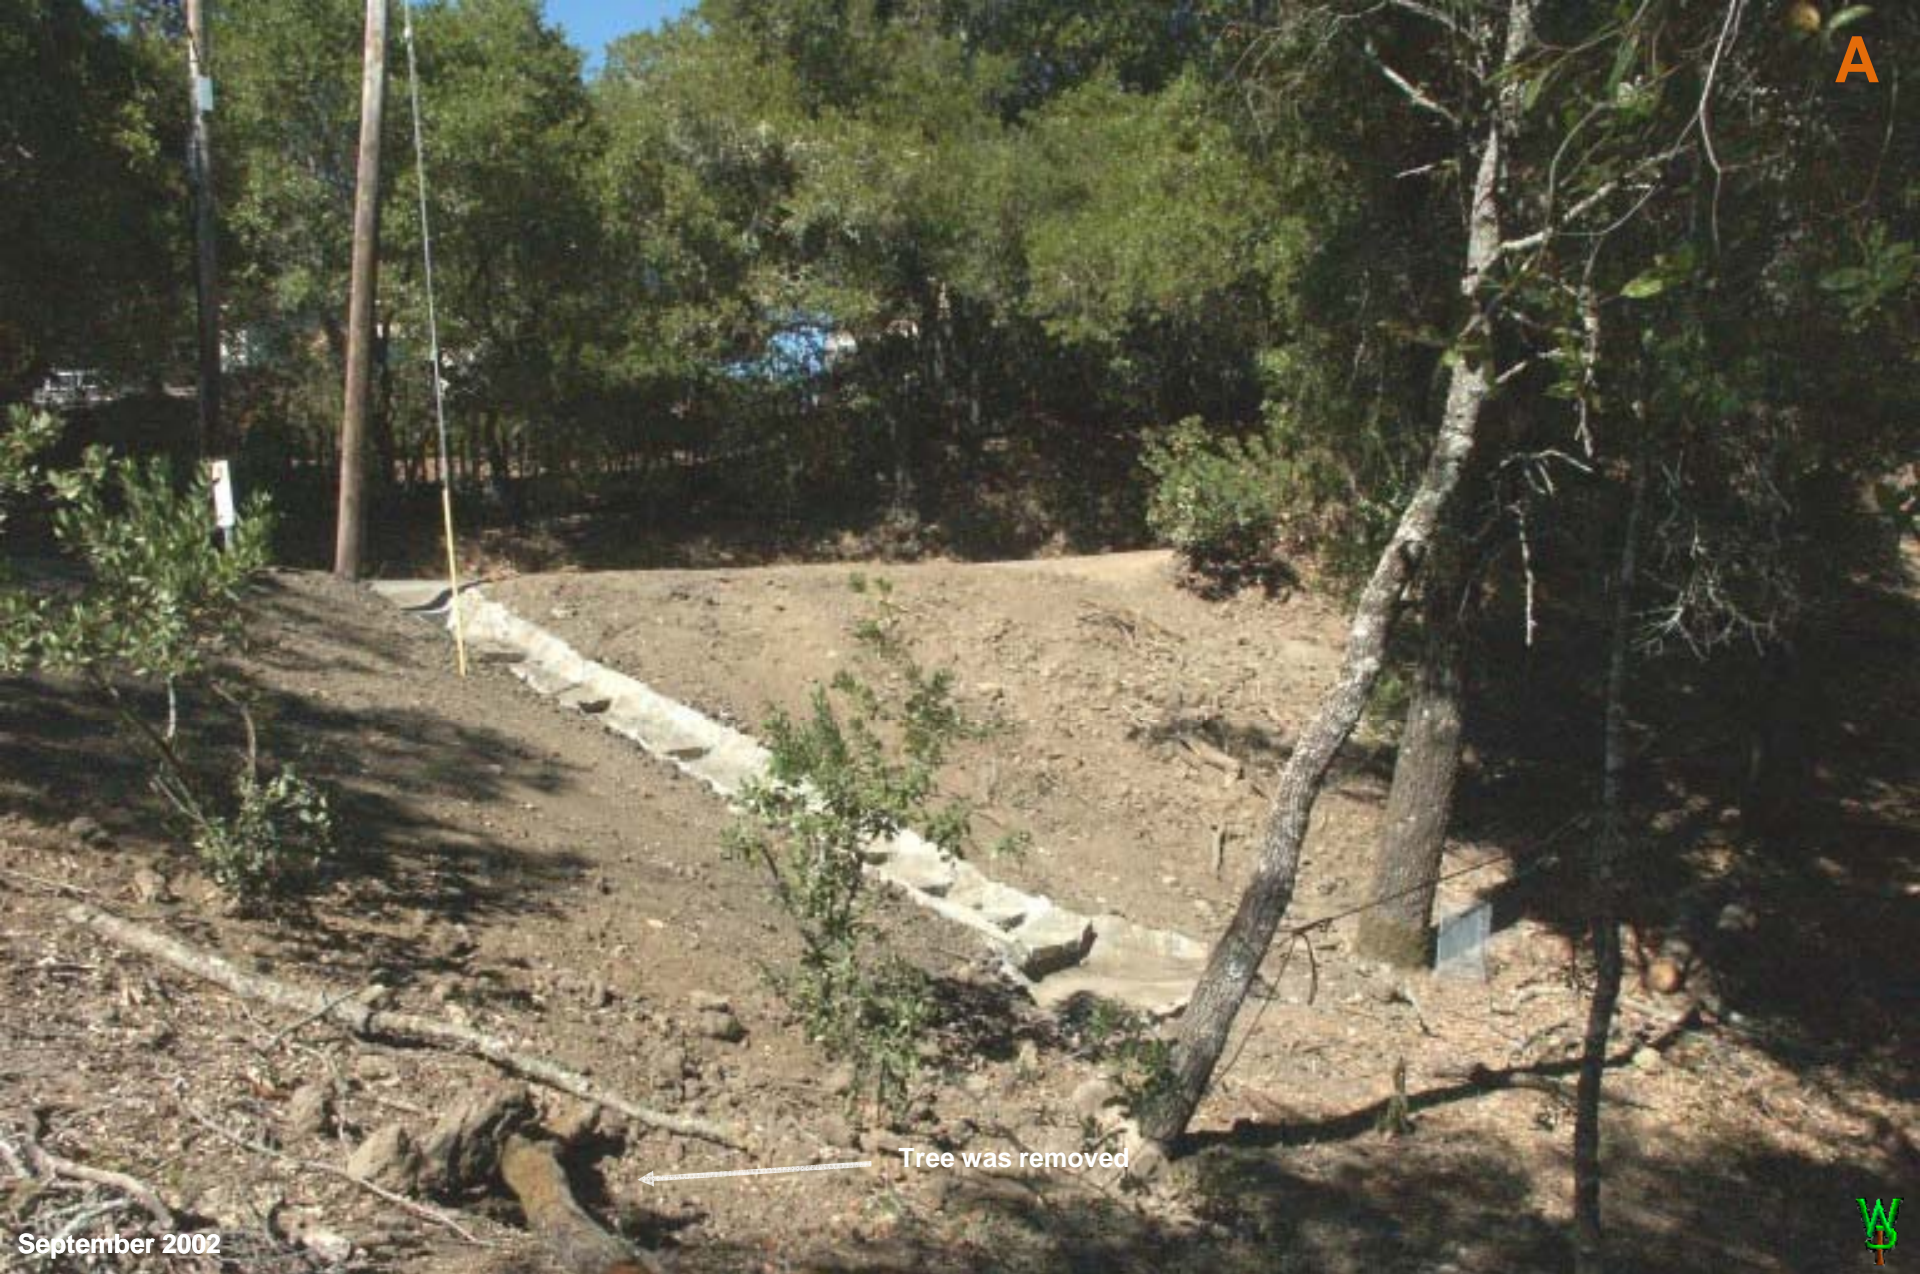
Once I had the somewhat compacted fill, I built this drainage channel/stairway with recycled slab concrete. The end has a wall with two outlets, allowing me to alternate the drainage path with a log placed such the it diverts the flow. I sowed the slope with hand-collected native grass seed. But I needed one more thing to complete the revegetation to hold the seed. I needed mulch and I could not import straw because it would contaminate the area with new weeds. Little did I know.

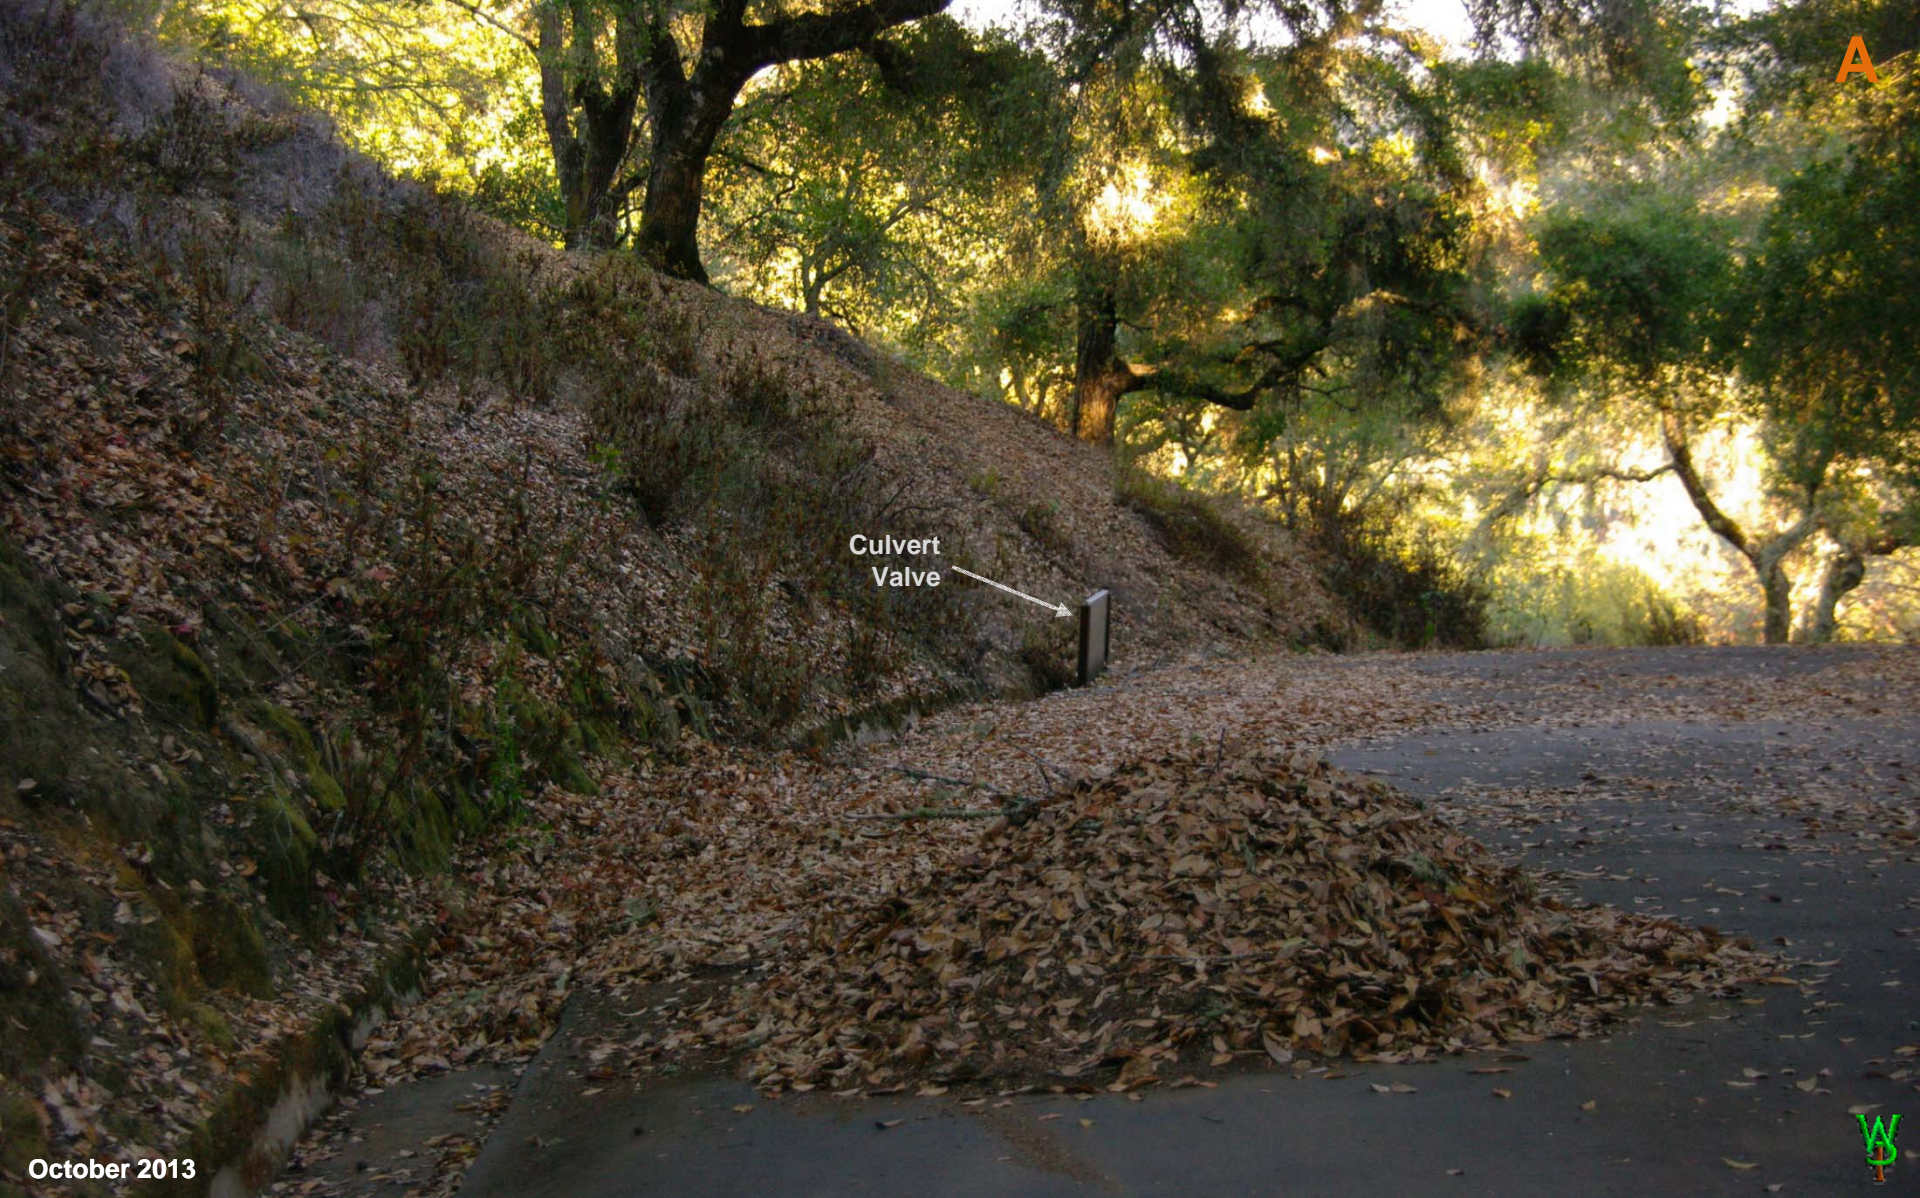
This was another one of those “things you learn along the way.” Every year, just before it rains, I clean almost four truckloads of leaves out of the drainage system along my driveway. So, rather than import non-native straw for my seeding projects, I planned to use that oak leaf litter as a protective mulch for the seed to keep the surface moist and reduce erosion due to rain impingement. Well, it did all of that, but it also brought me a crop of exotic large seeded rattlesnake grass (*Briza maxima*) a patch of which had been not far uphill from the top of the driveway. I learned right there that the old maxim about ‘what goes downhill’ applied to seed too. I’ve since prioritized my native grass reestablishment projects from the top-down in the same manner. Since then, the leaves have been clean.
