# FEELING DRAINAGE

# WILDERGARTEN 5.4

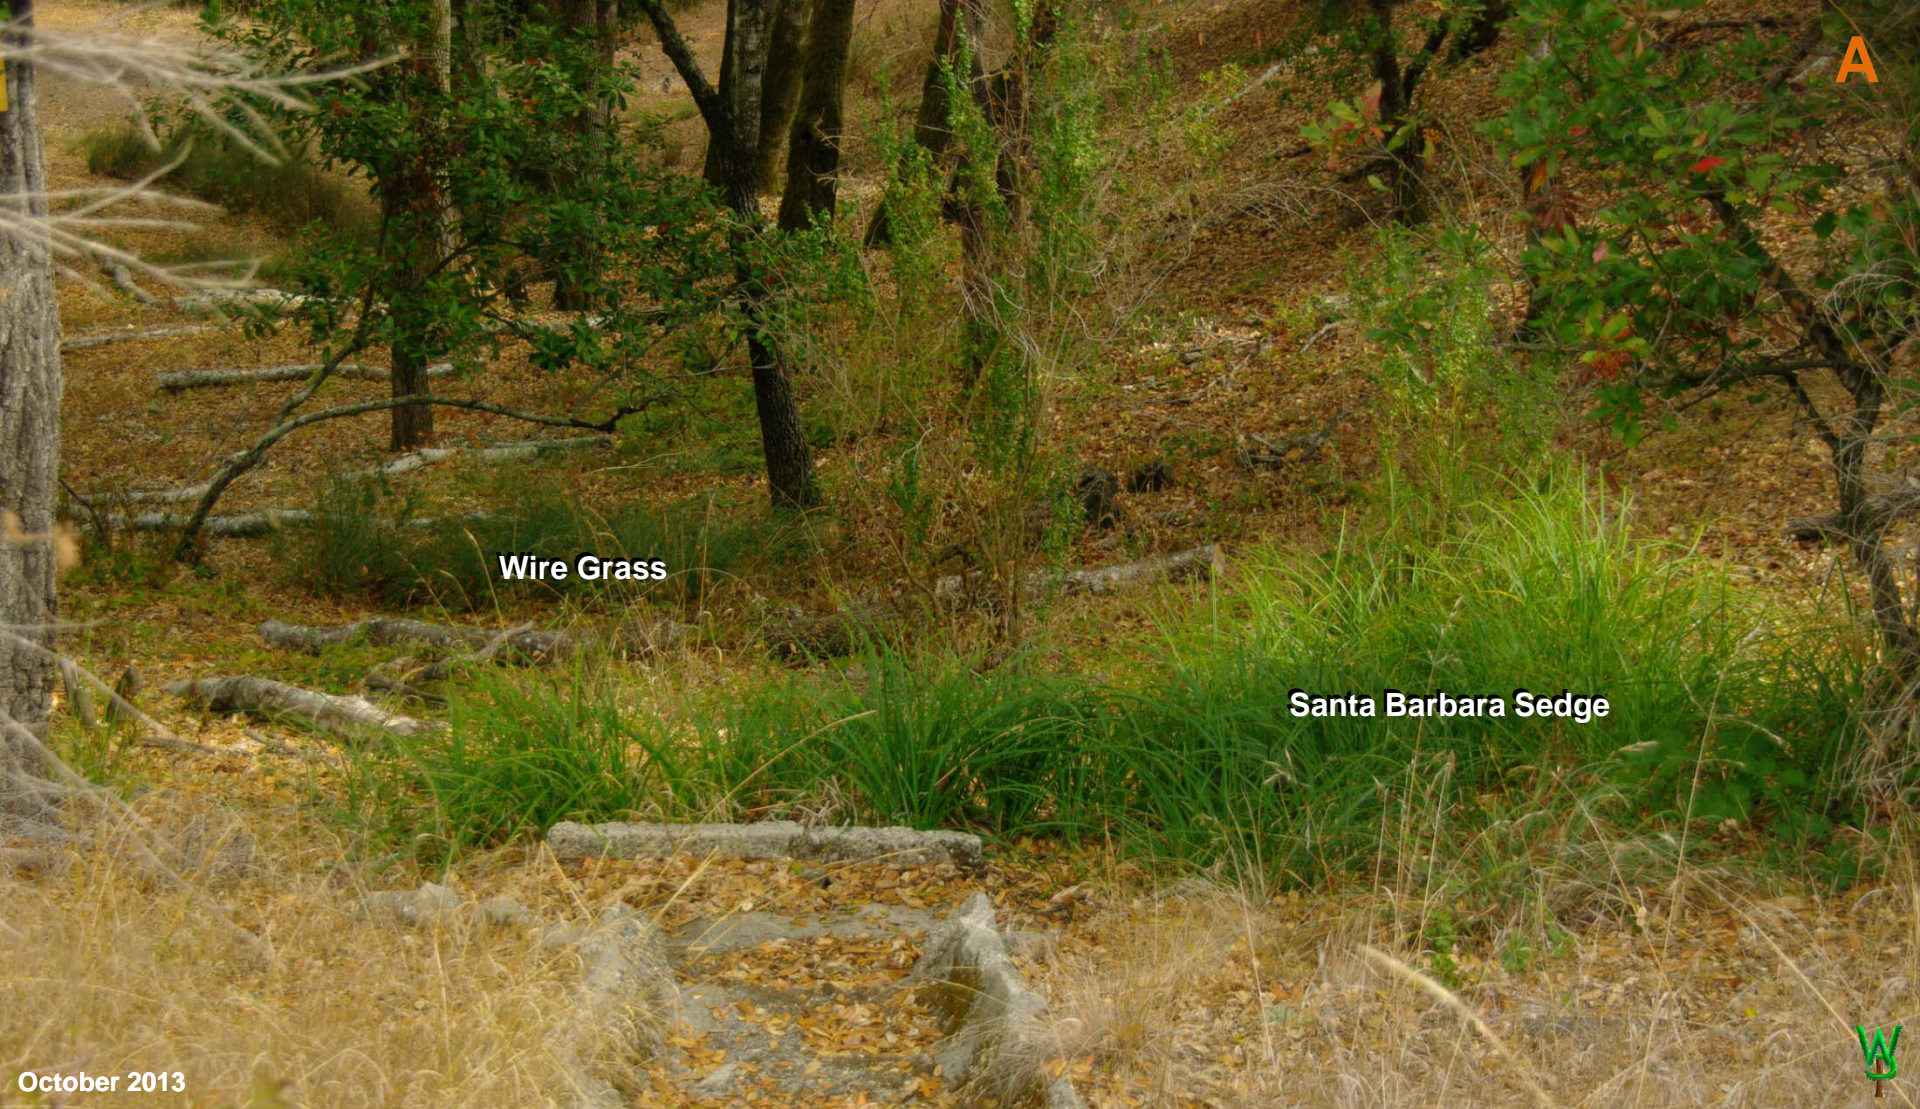
I transplanted our friend Santa Barbara sedge (*Carex barbarae*) at the drain outlet to dissipate the energy. Below it, wood steers the separated flows to minimize incision. Below that is another tough riparian plant, wire grass (*Juncus patens* - not really a grass but a rush). The functional difference between the rush and the sedge is that the wire grass is better at collecting sediment but does not lay down flat under runoff like the sedge does. Wire grass also grows in clumps, not making as continuous a surface as the sedge. I hope to have a lot more coverage in this drainage now that I thinned it this year, with more to come (I'll probably get rid of the coyote brush). **The channel that once ran down the middle of this drainage below was then three to four feet deep.** I chocked that with wood and filled it. So with rot and compaction I may yet need to bring in a little more fill and transplant more sedges. Yes, I did all this work to deal with a runoff problem caused by my neighbor and the County long ago. It's cheaper than fighting over it.

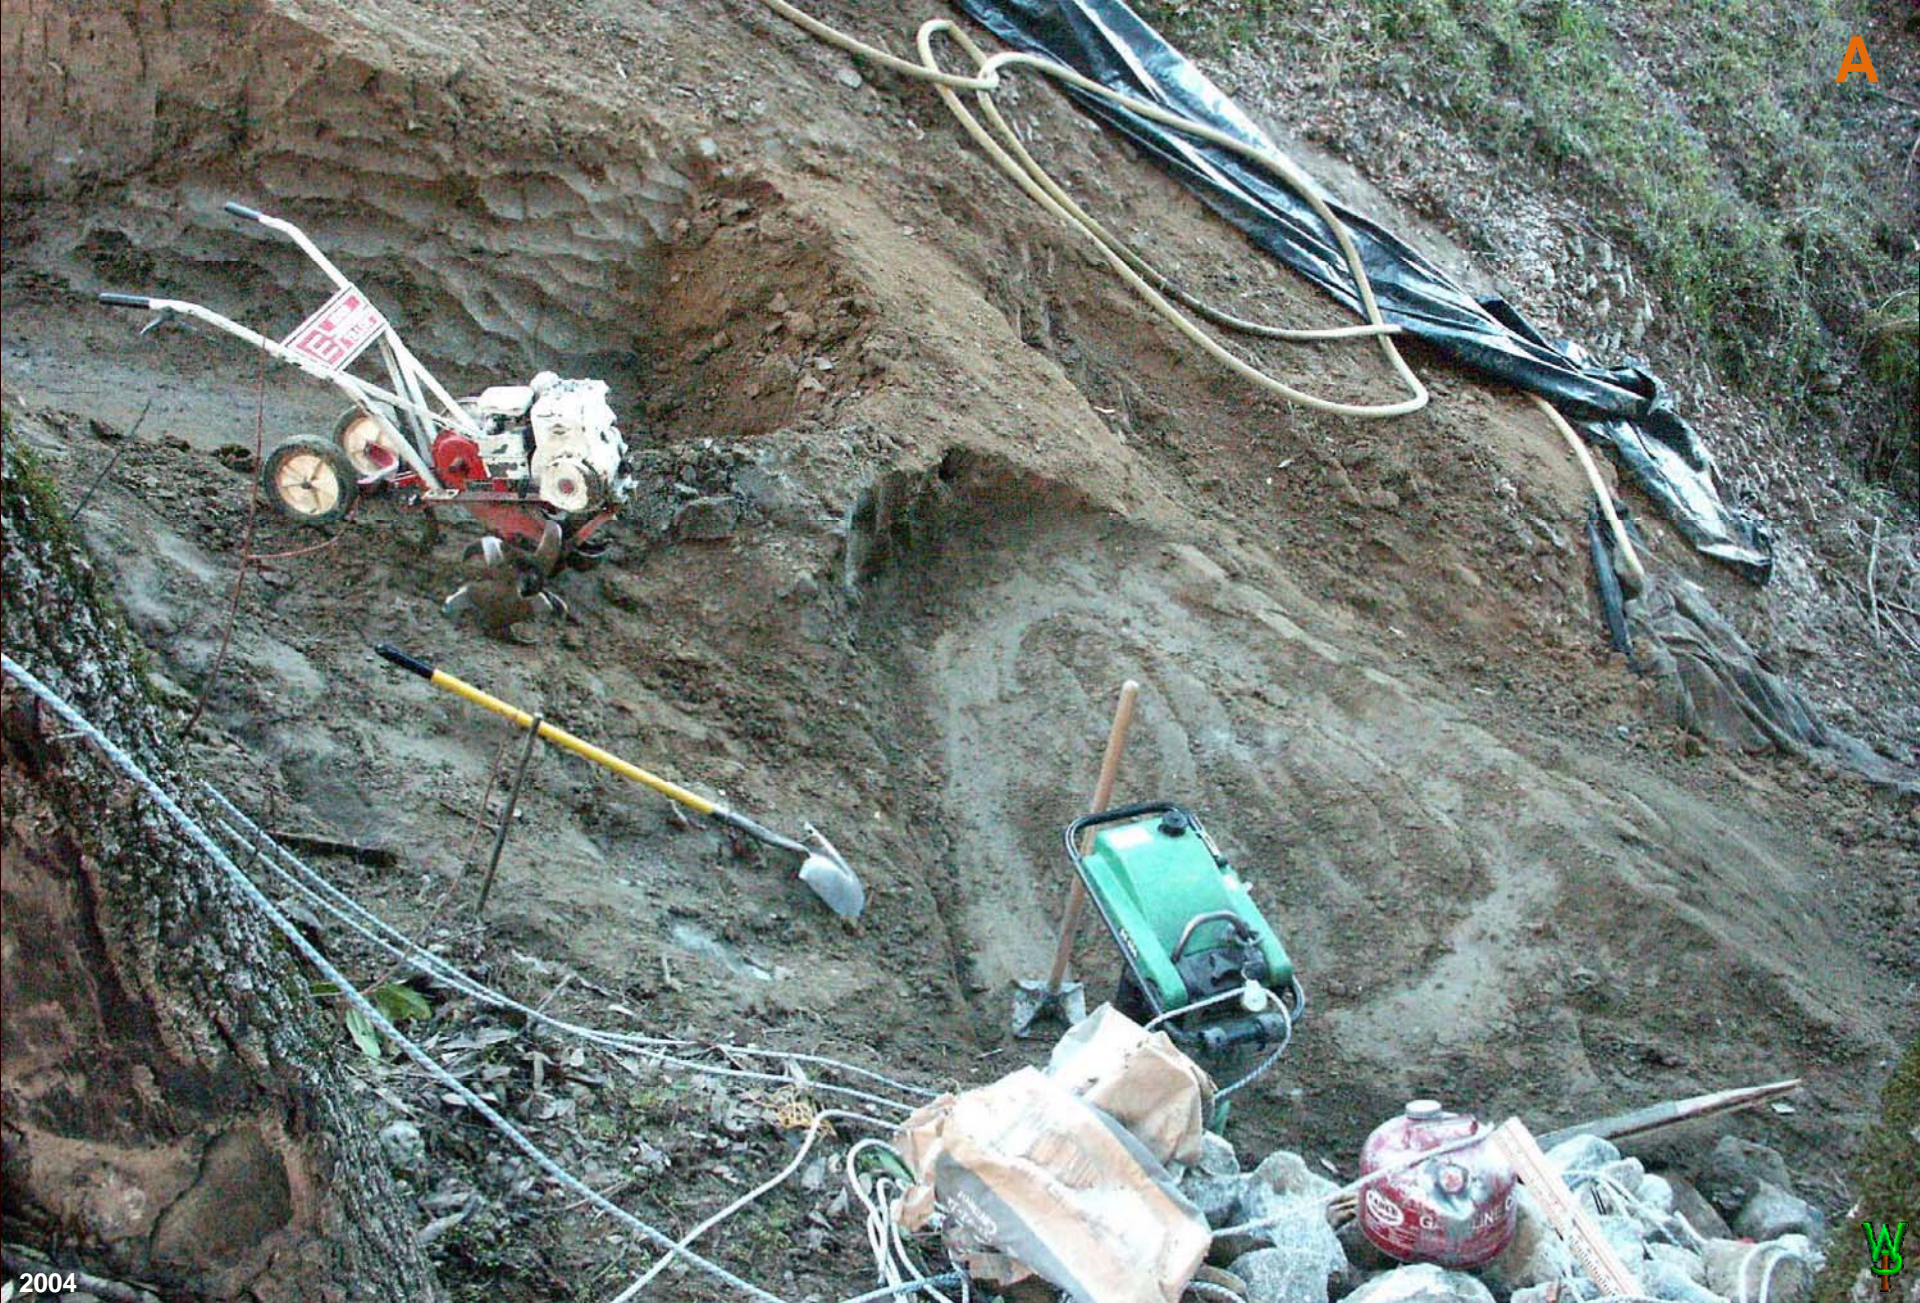
In parts of this project, I used the equivalent of a half-sack mix of cement in the soil to reinforce the structure to simulate the attributes of the parent rock and withstand tunneling by ground-squirrels without caving in. It is steep here. Interestingly, the grasses seem to prefer this cemented fill compared to the parent material.

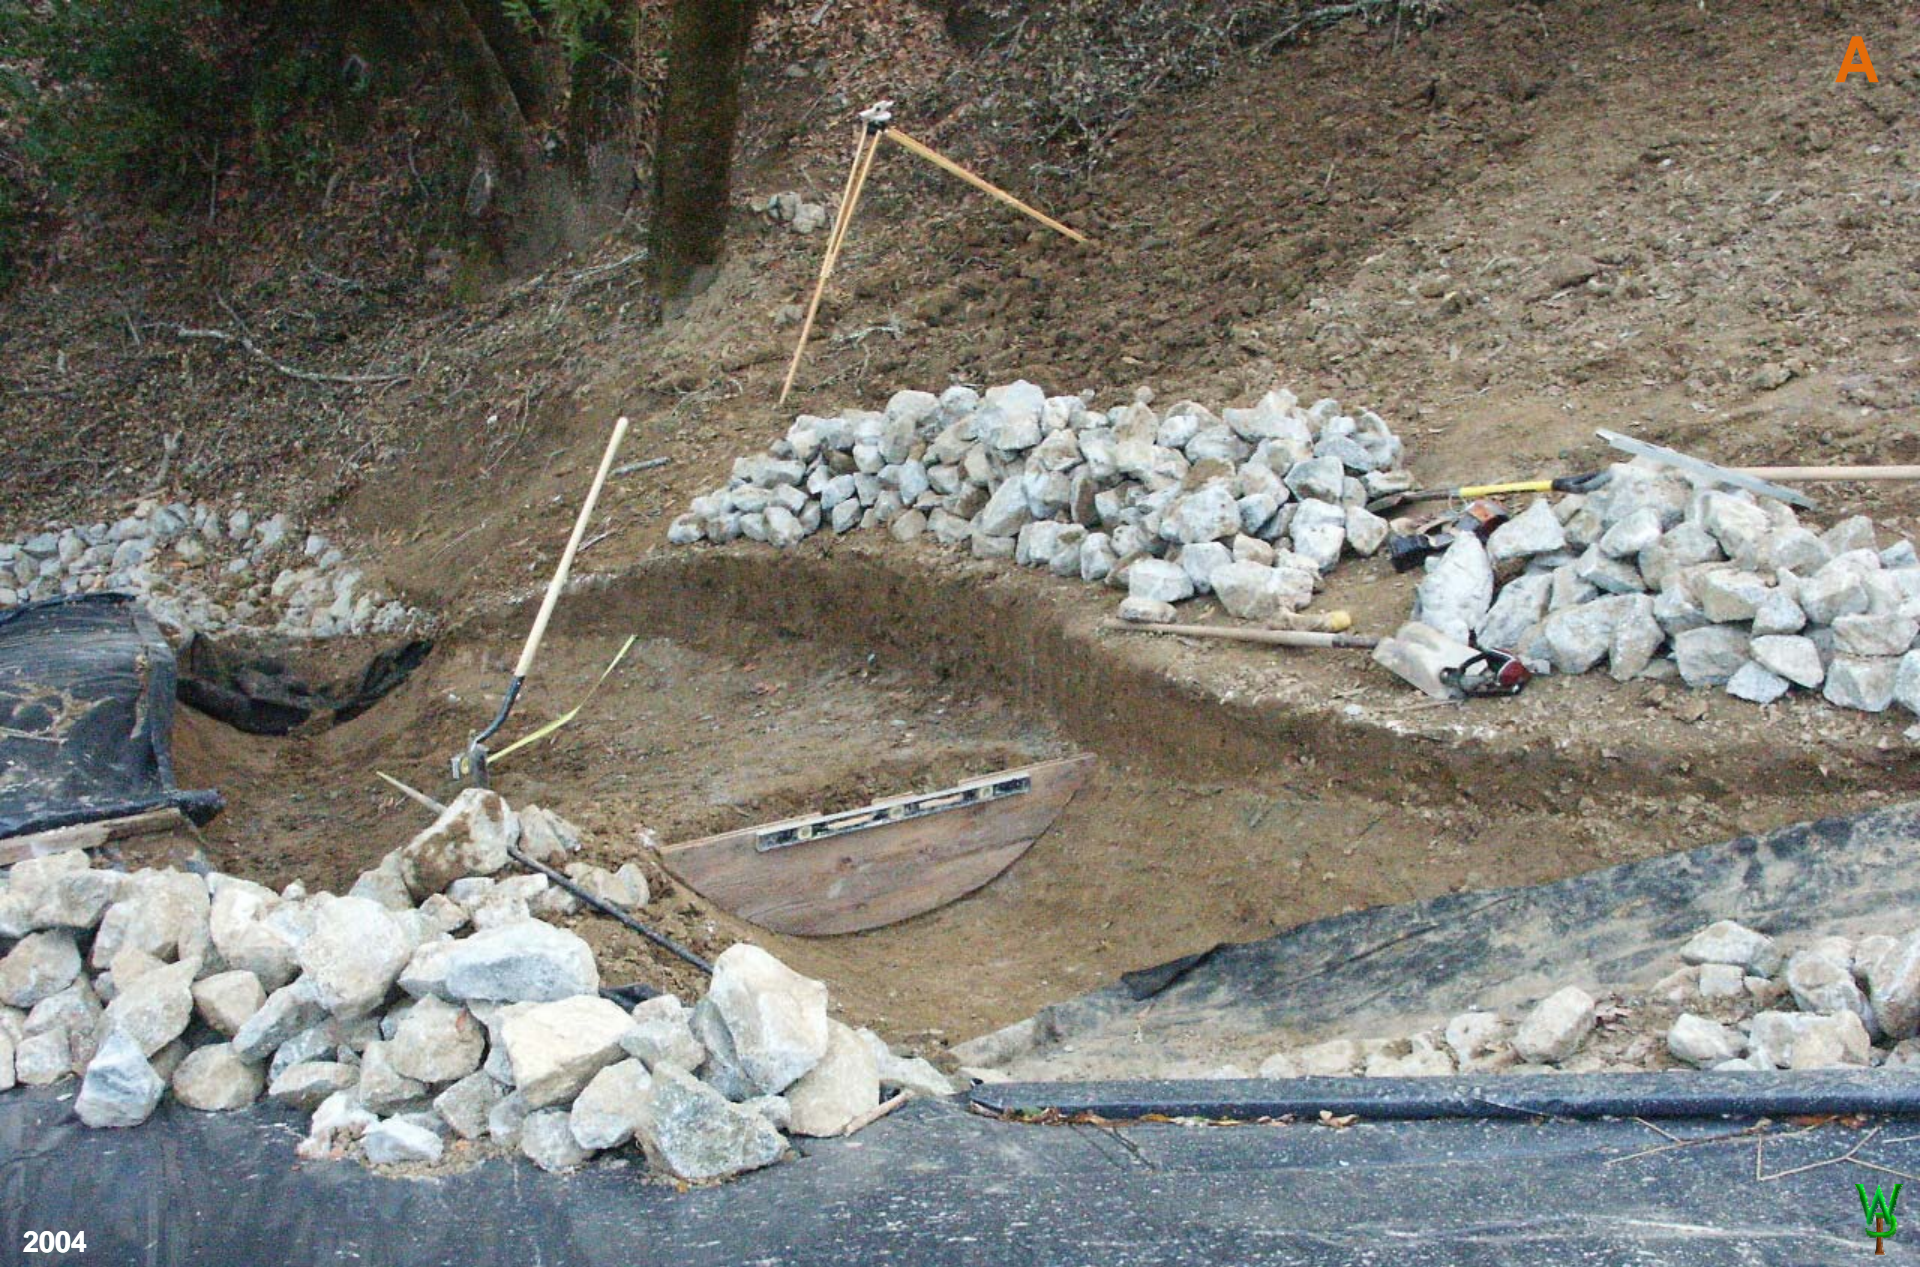
When digging one of these affairs, the process is somewhat iterative. Obviously I had surveyed the slope and laid out the future grade on the computer so that I would have the rate of fall worked out as I dug it. There is also the problem of staging the materials, both those that come out and those that go in. The goal is to have a mass balance between the two to minimize the need either to add or remove fill or rock while simultaneously reducing the need to move it any farther than is absolutely necessary.

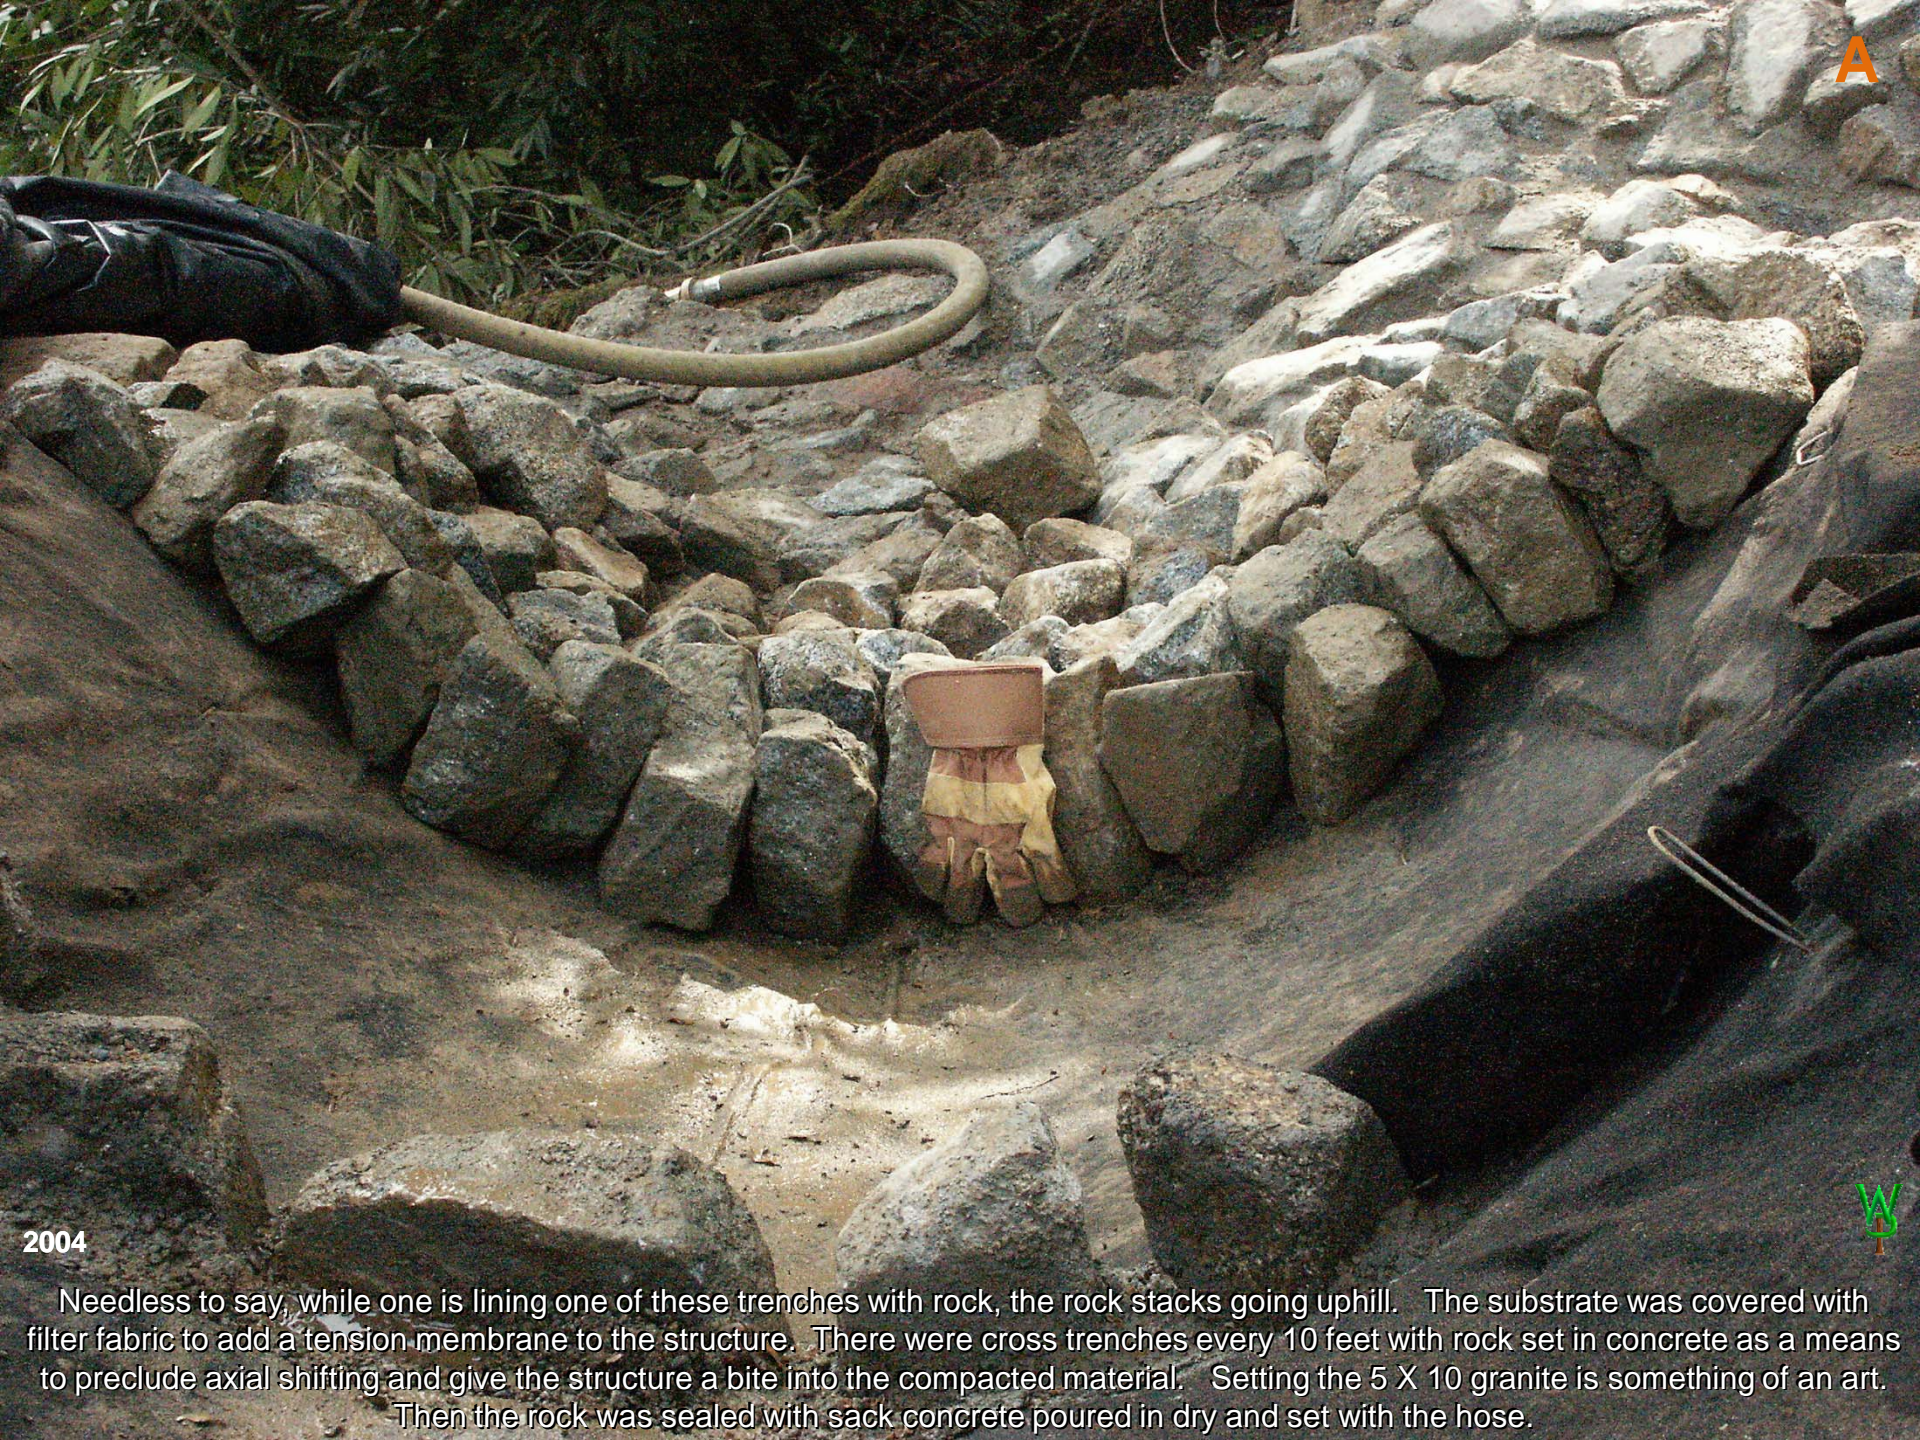
Needless to say, while one is lining one of these trenches with rock, the rock stacks going uphill. The substrate was covered with filter fabric to add a tension membrane to the structure. There were cross trenches every 10 feet with rock set in concrete as a means to preclude axial shifting and give the structure a bite into the compacted material. Setting the 5 X 10 granite is something of an art. Then the rock was sealed with sack concrete poured in dry and set with the hose.

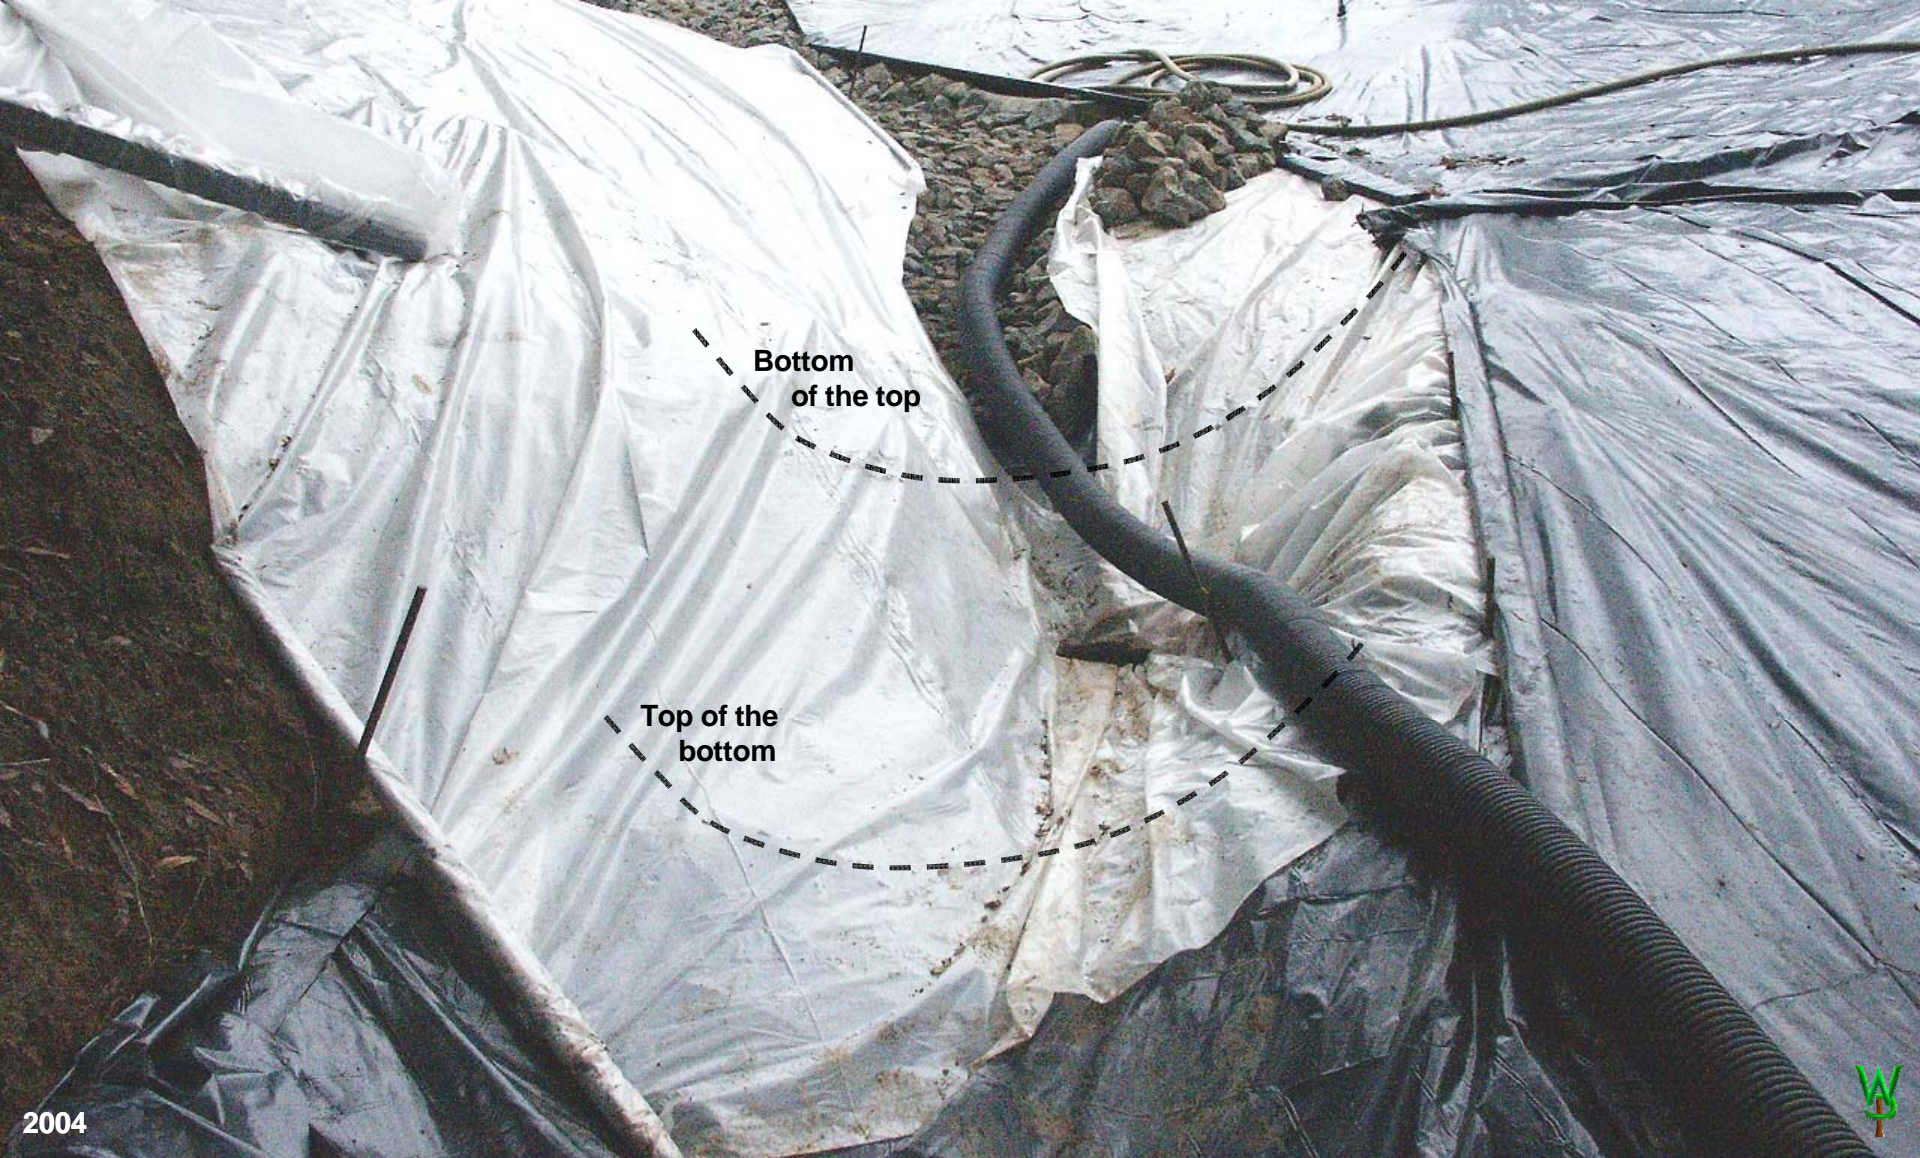
One builds the rock liner from bottom-to-top, yet once I got close to the target, I started upward from a cross ditch near the inlet up to meet it and then met that cross ditch from the one immediately below it to assure a smooth transition. Yet at the same time, there is the risk that if it rains during the job, the water comes from the top down, from which there can be a enough of a flow to wipe out the entire job. The technology to manage the water is not terribly difficult, but the discipline required to assure that it is installed in time while simultaneously under the pressure to finish can be demanding, as there are details involved that make all the difference in its ruggedness that do take time to install. The plastic is stapled to the battens, which then are rolled and screwed to stakes. The hose is screwed to the outlet of a pipe collecting surface drains.

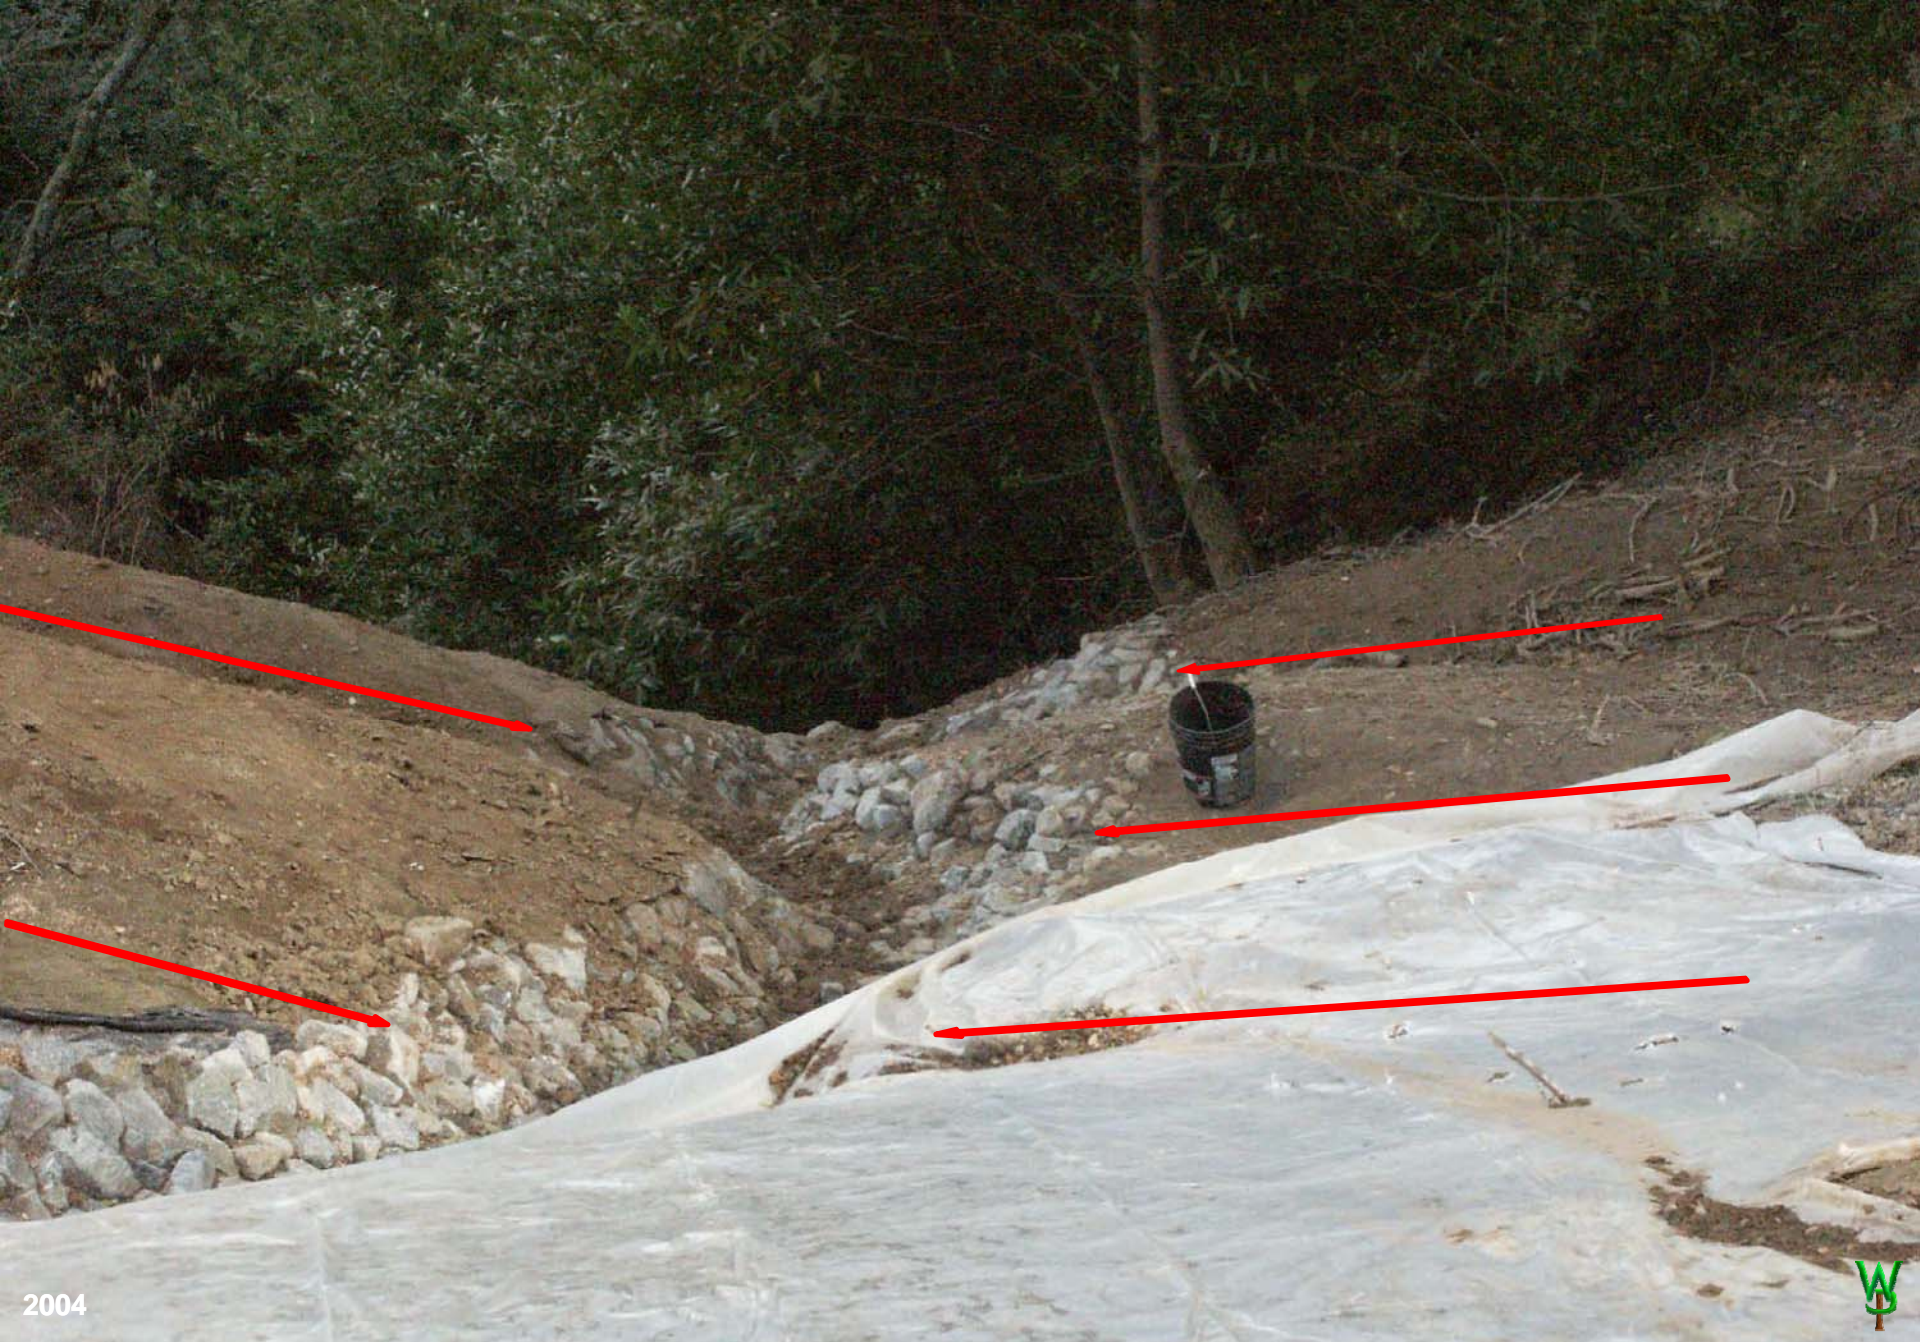
It is steep here. The arrows indicate the alternating benches to catch and redirect sheet wash to the channel. The plastic was not only to preclude rain impingement and sheet wash but it was part of a multivariable revegetation experiment. Then it rained...

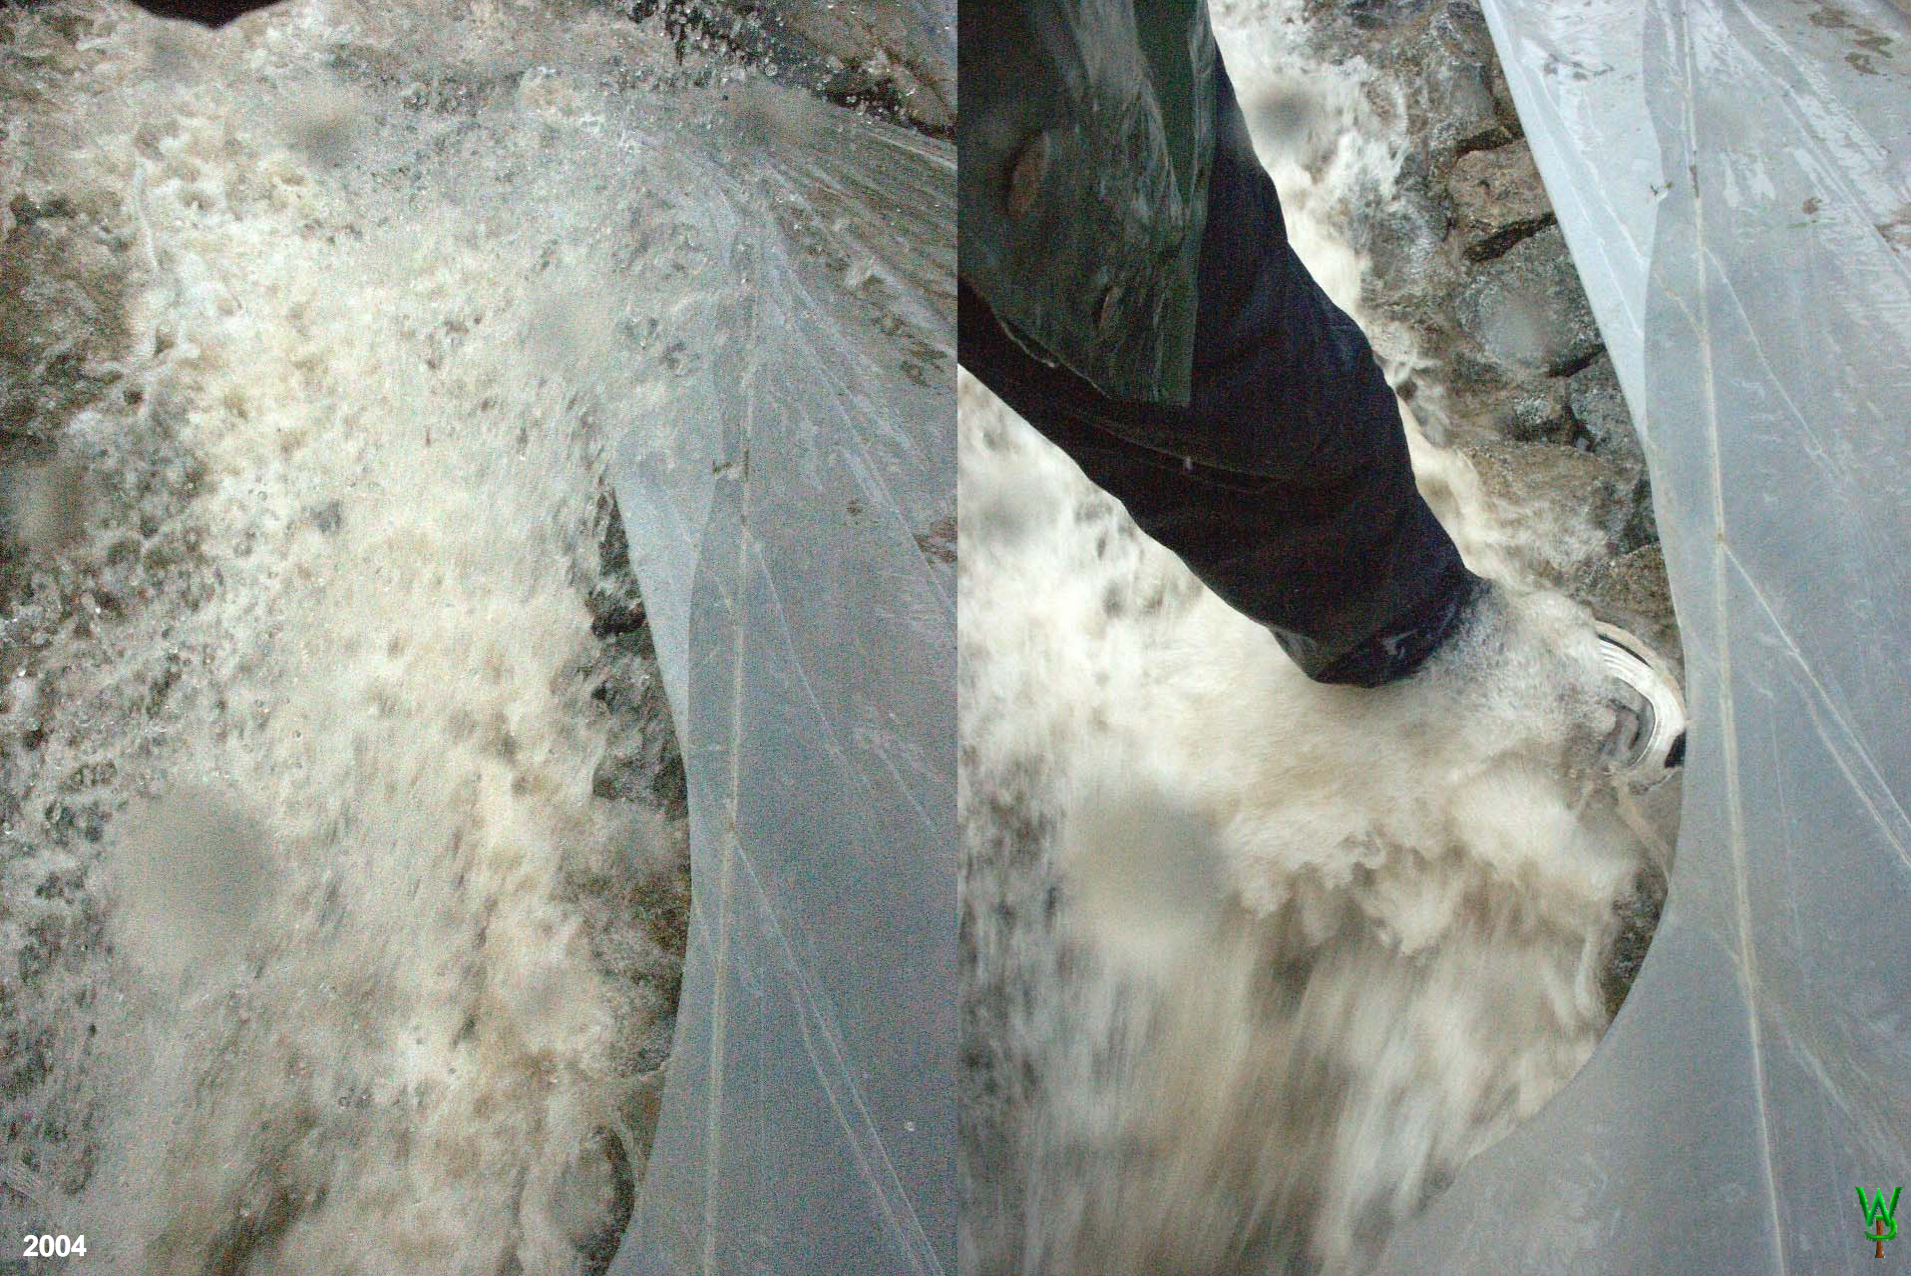
This is when one gets to do the final tweaking. It is very hard to predict how the flow will behave when it exits a pipe. So I waited before dry-setting the rock around the outlet until a storm came to know exactly where and how to adjust for splashing. In this case it only took a couple of hours to reshape the surface.

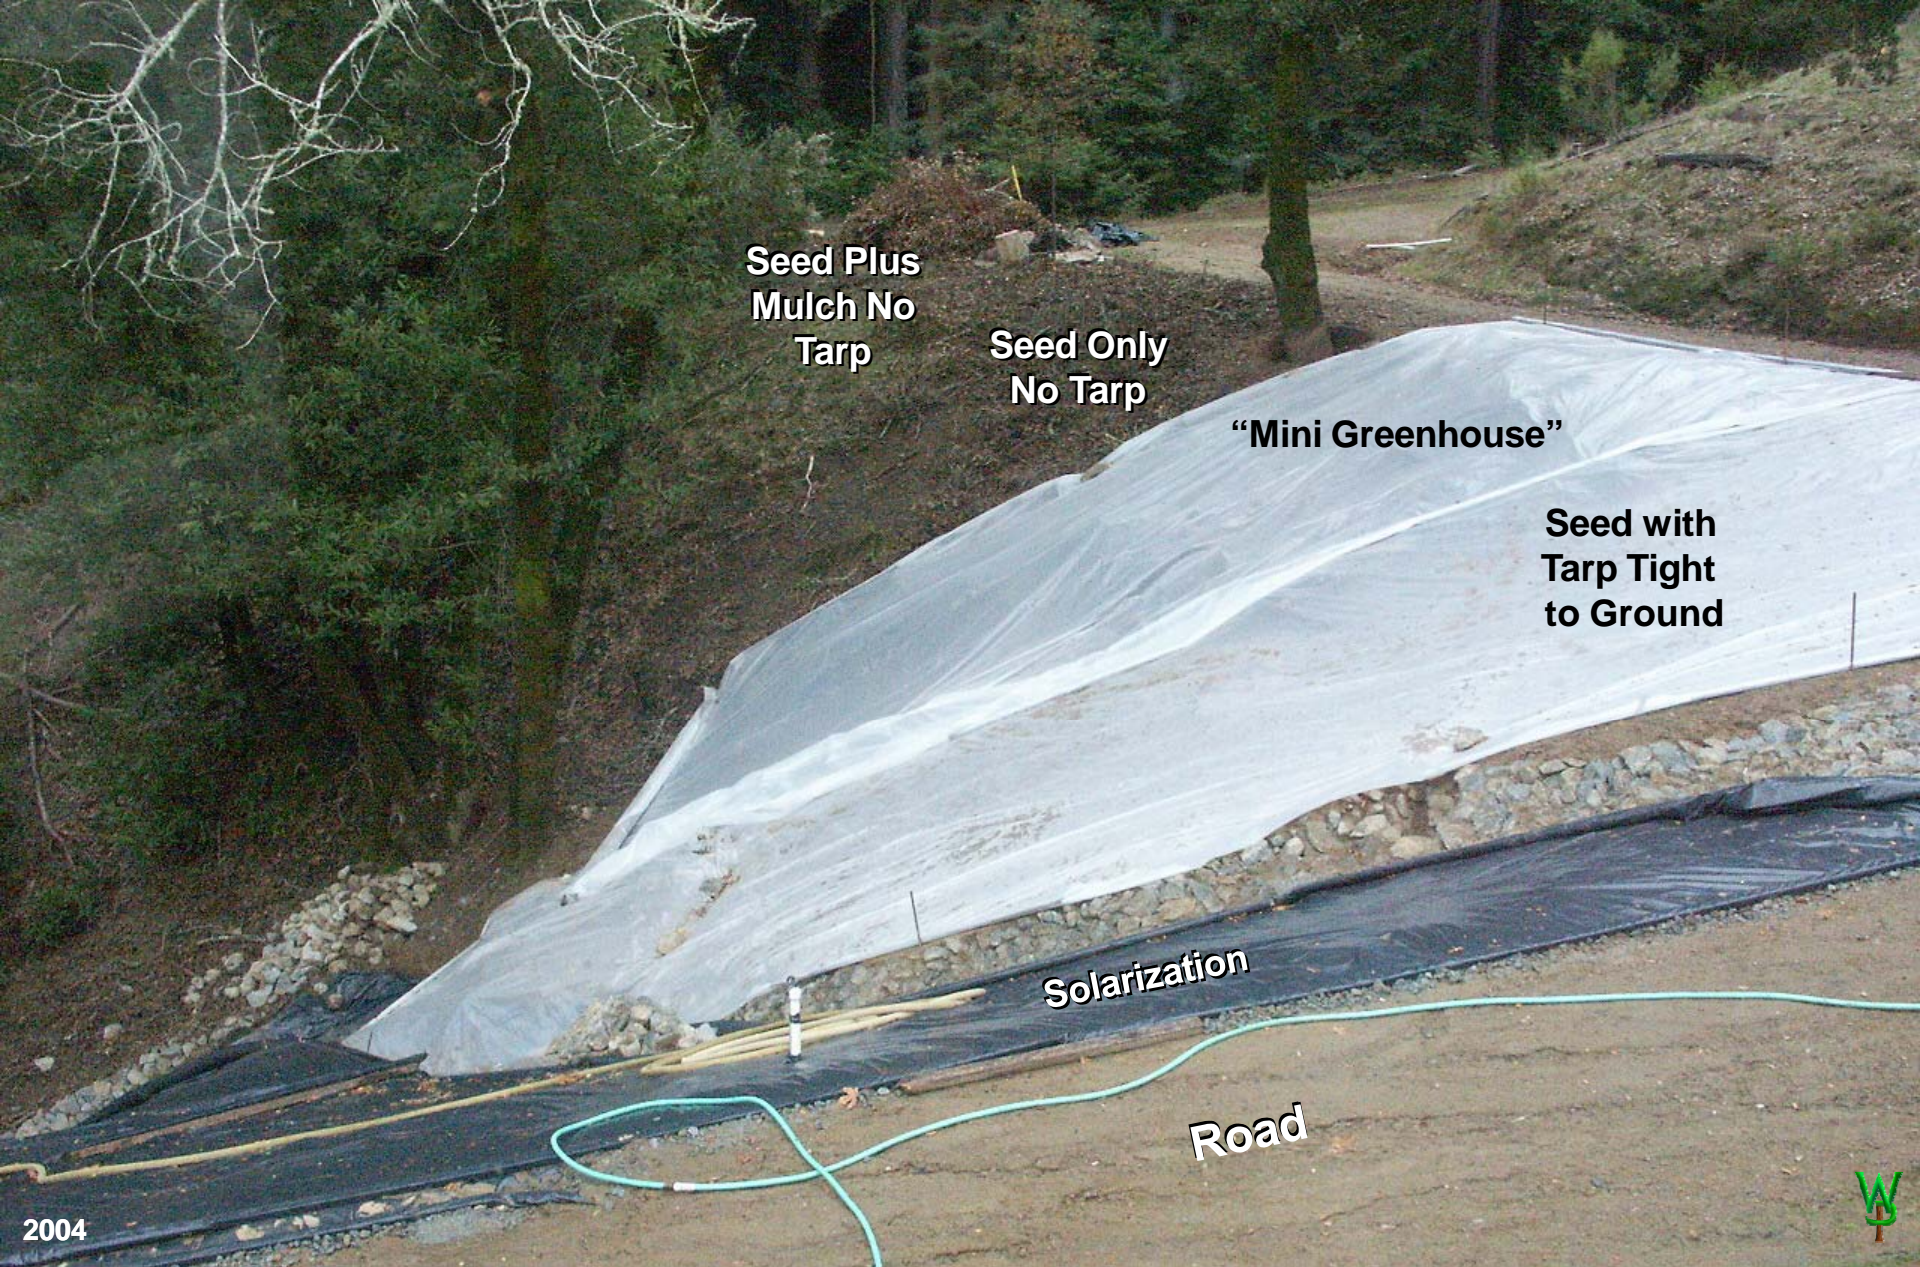
The plastic was set either tight on the surface or held aloft by a “mulch” of chopped tree branches forming mini greenhouses to improve the establishment of the grasses. Segments were held with rolled battens screwed to 4 X 6 timbers staked to the surface. The sector in black faces south, so I thought it appropriate to kill a year’s worth of seed by solarization, especially as it had yet to be integrated to some re-grading of the road immediately above it.

As long as one doesn't use too much mulch and there is enough moisture getting under the plastic to keep the grasses going, these tarp-houses at least **triple** grass growth.

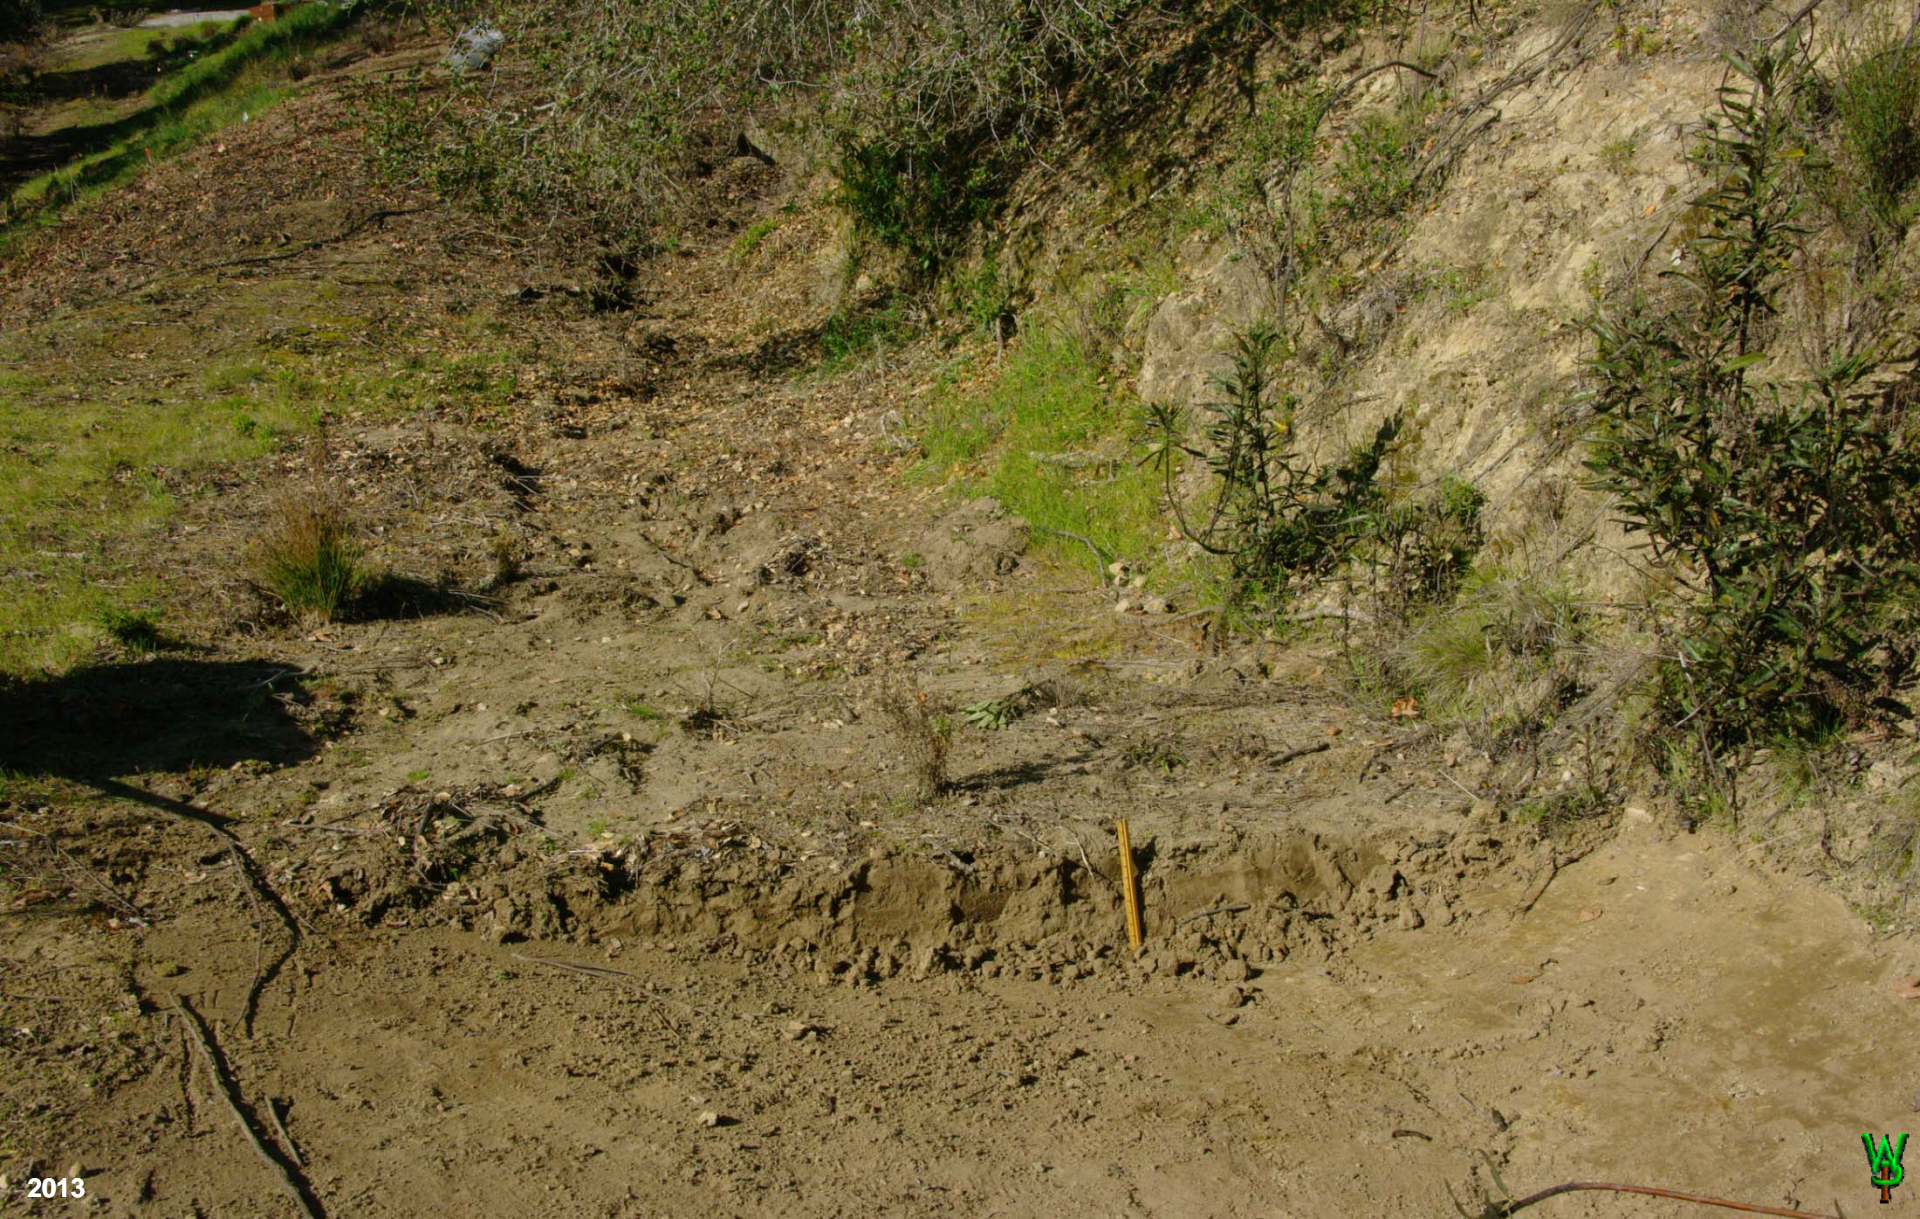
You do not always get your choice of routes for runoff because of the history of how the land was used. In this case, there is a series of old benches of perched fills that once supported various out-buildings. This drainage is sized to handle the water off of three acres from above. The slope below the road is so steep that if this much water were to go over the outside of those fills, there would be severe damage to the hillside. So I transit the flow across the slope above them on a low grade, this area serves as a catchment basin for sediment. About every 10 years, I dig it out; else the water would eventually dump down those erosive fill slopes.
