# FEELING DRAINAGE

# WILDERGARTEN 5.4

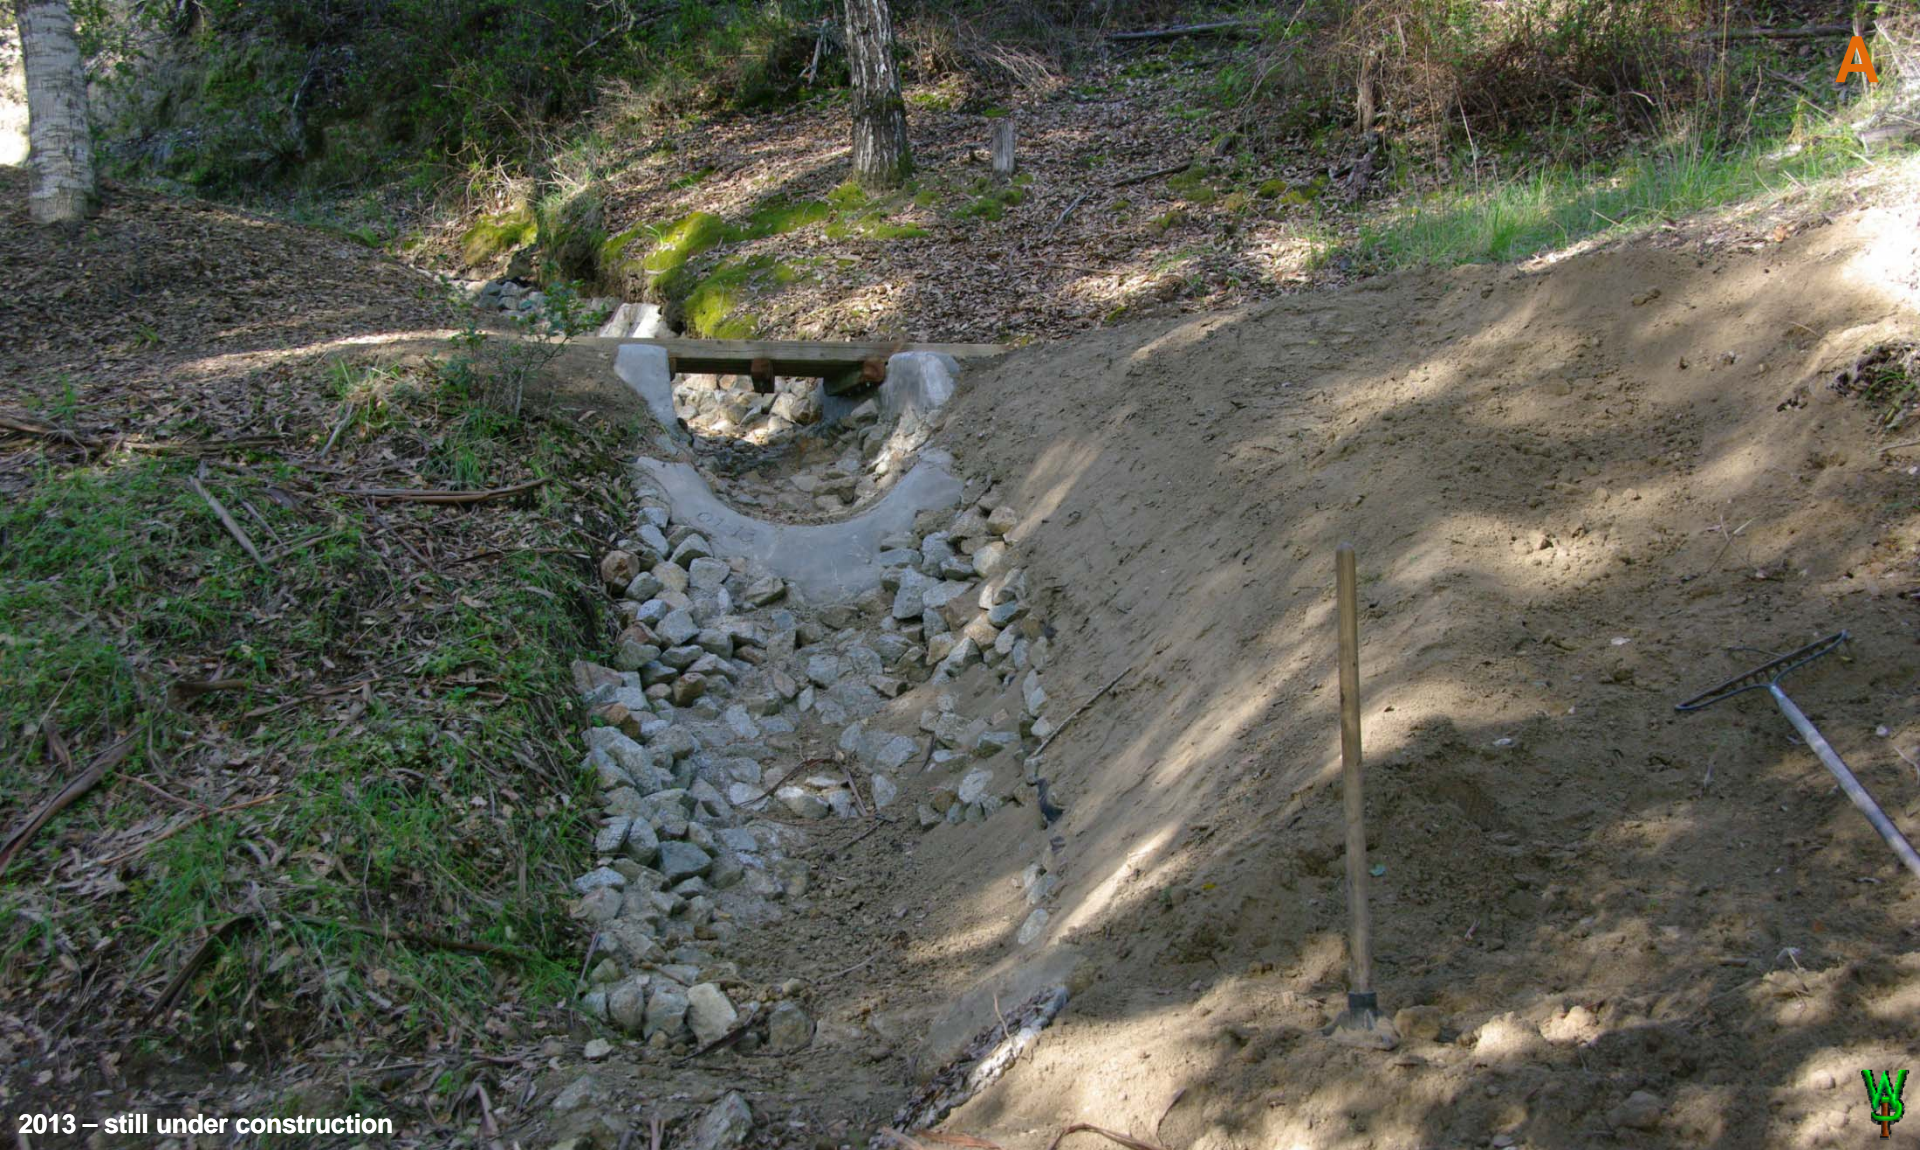
I built this outlet from that channel to drop the water onto the lower road which acts as a secondary transit and sediment catchment area. The sediment I dug out was packed into what once was a rather ugly eroded hole once cut by water diverted around one an old cabin that burned down in 1979. The bridge is a way to get the sediment out of the basin on the prior page to a larger water-bar in a safe spot that assures the flow will head in the right direction. Each of these projects deals with history. They are expensive and time-consuming. “We” can either “leave it alone” to allow whole slopes eventually to fail and weep sediment for decades, or we can maintain it. Yet if the policy preference is to leave it alone, then the policy makers should admit that they don’t really care about the sediment. Hypocrisy as a matter of policy (what we have today) is a 14<sup>th</sup> Amendment disproportionate burden on landowners.
