ROADS TO HEAVEN, TO HELL, AND BACK, SOMEWHAT

WILDERGARTEN 5.4

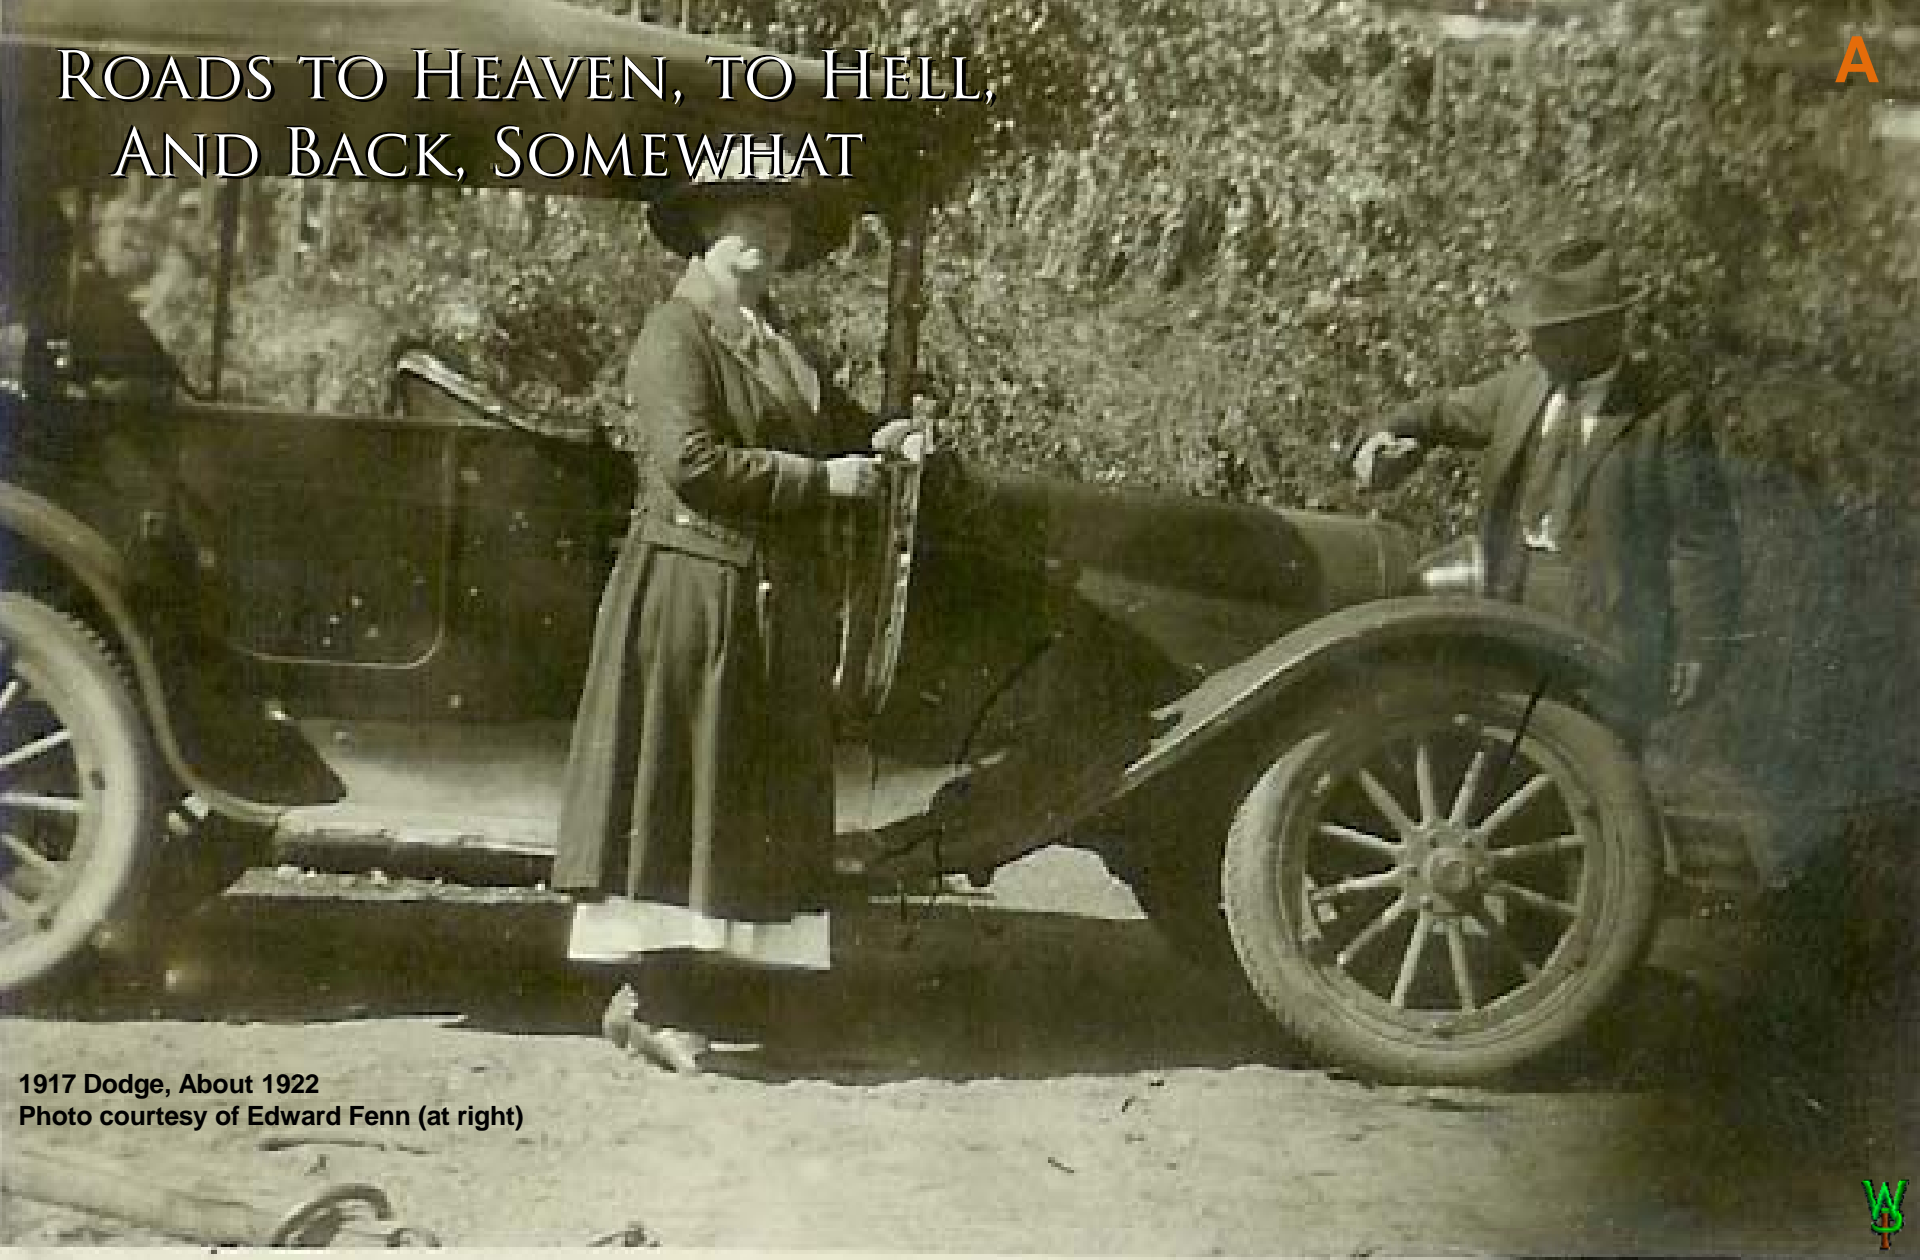
1917 Dodge, About 1922
Photo courtesy of Edward Fenn (at right)

Recall from [the site history](#), that Ed Fenn bought property along Mr. McKiernan's road astride Charlie Martin's road from Glenwood. This is that latter road as it passed in front of Ed's house (note the *Vinca major* on the bank behind the car). Typical road construction back then was with dynamite, shovels, and horse-drawn grading blades. Slopes receiving the fill were not cleaned or benched and the fills were not compacted. If it slid, they fixed it. What few culverts were installed were wood. In the winter, the surface was mud.

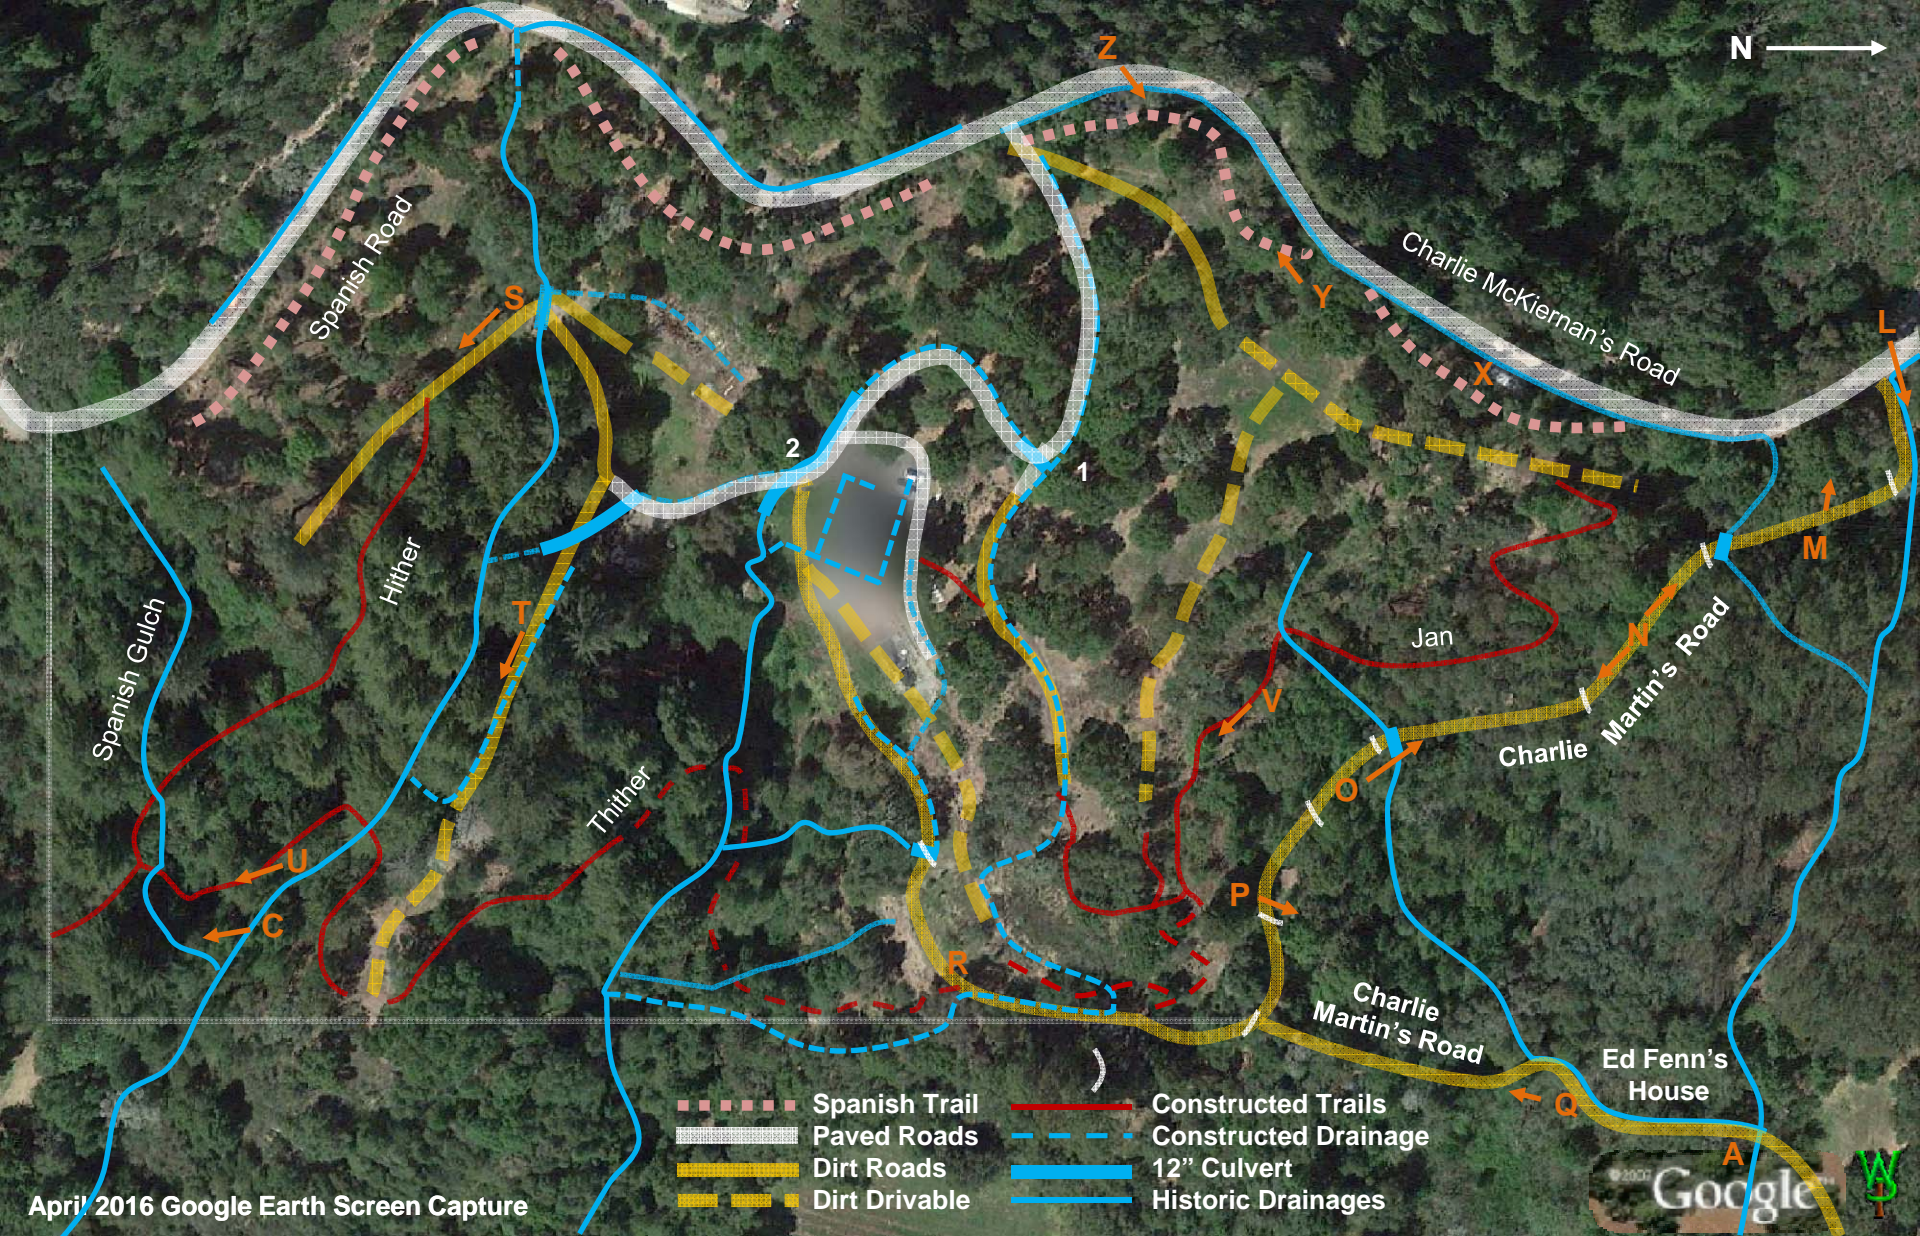
This is a map of all the roads, trails, and drainages on this property. Each orange letter on this and the other aerial images in this chapter corresponds to where they were taken (some with an arrow indicating the direction). If you wish to keep track while reading, there is a separate file consisting of the aerial photos from this chapter which you can then keep open in another window as you read. My purpose in documenting them this carefully is to help locate future repeat photos, as vegetation change, and particularly forestry is elemental to many of these road and drainage management problems.

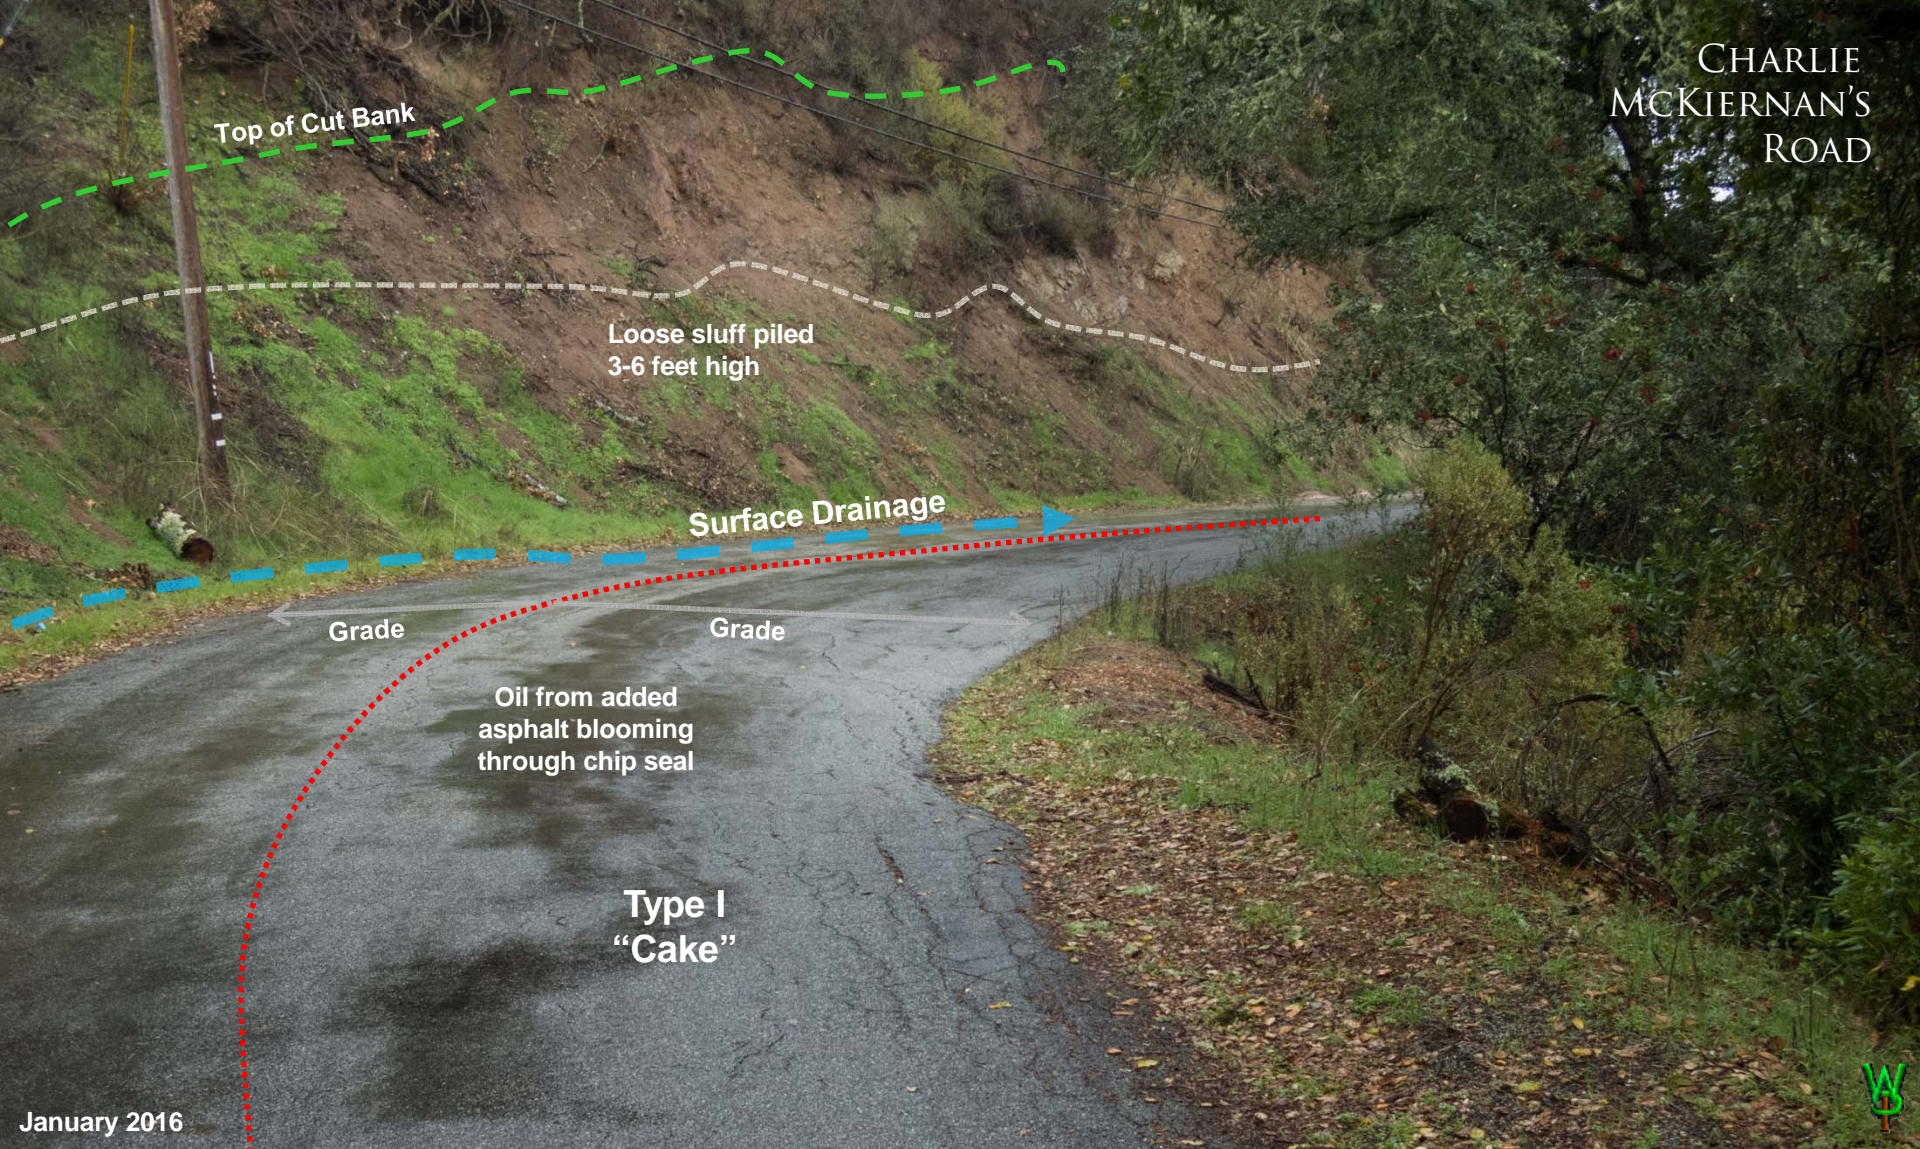
January 2016

We will start with Type I road failures. When Charley McKiernan blasted out the rock and pushed it aside to make the road, the fill was neither benched nor compacted; the cake was loose fill sitting on a slip of rotting organic matter. But the loads were light and Charlie had plenty of dynamite to make more fill if he needed it. After all, this 25 mile road was built in two years without heavy equipment. The few houses here at that time were not much more than cabins. The road came first, or no houses. With big expensive houses above the slope today, the County cannot lay back the slope angle to reduce material sliding onto the road. So the County just keeps adding pavement to the cake and ditching out the sluff and either piling it on the other side or hauling it away. The only way to stabilize the hillside now is with proper vegetation management or outrageously expensive retaining walls.

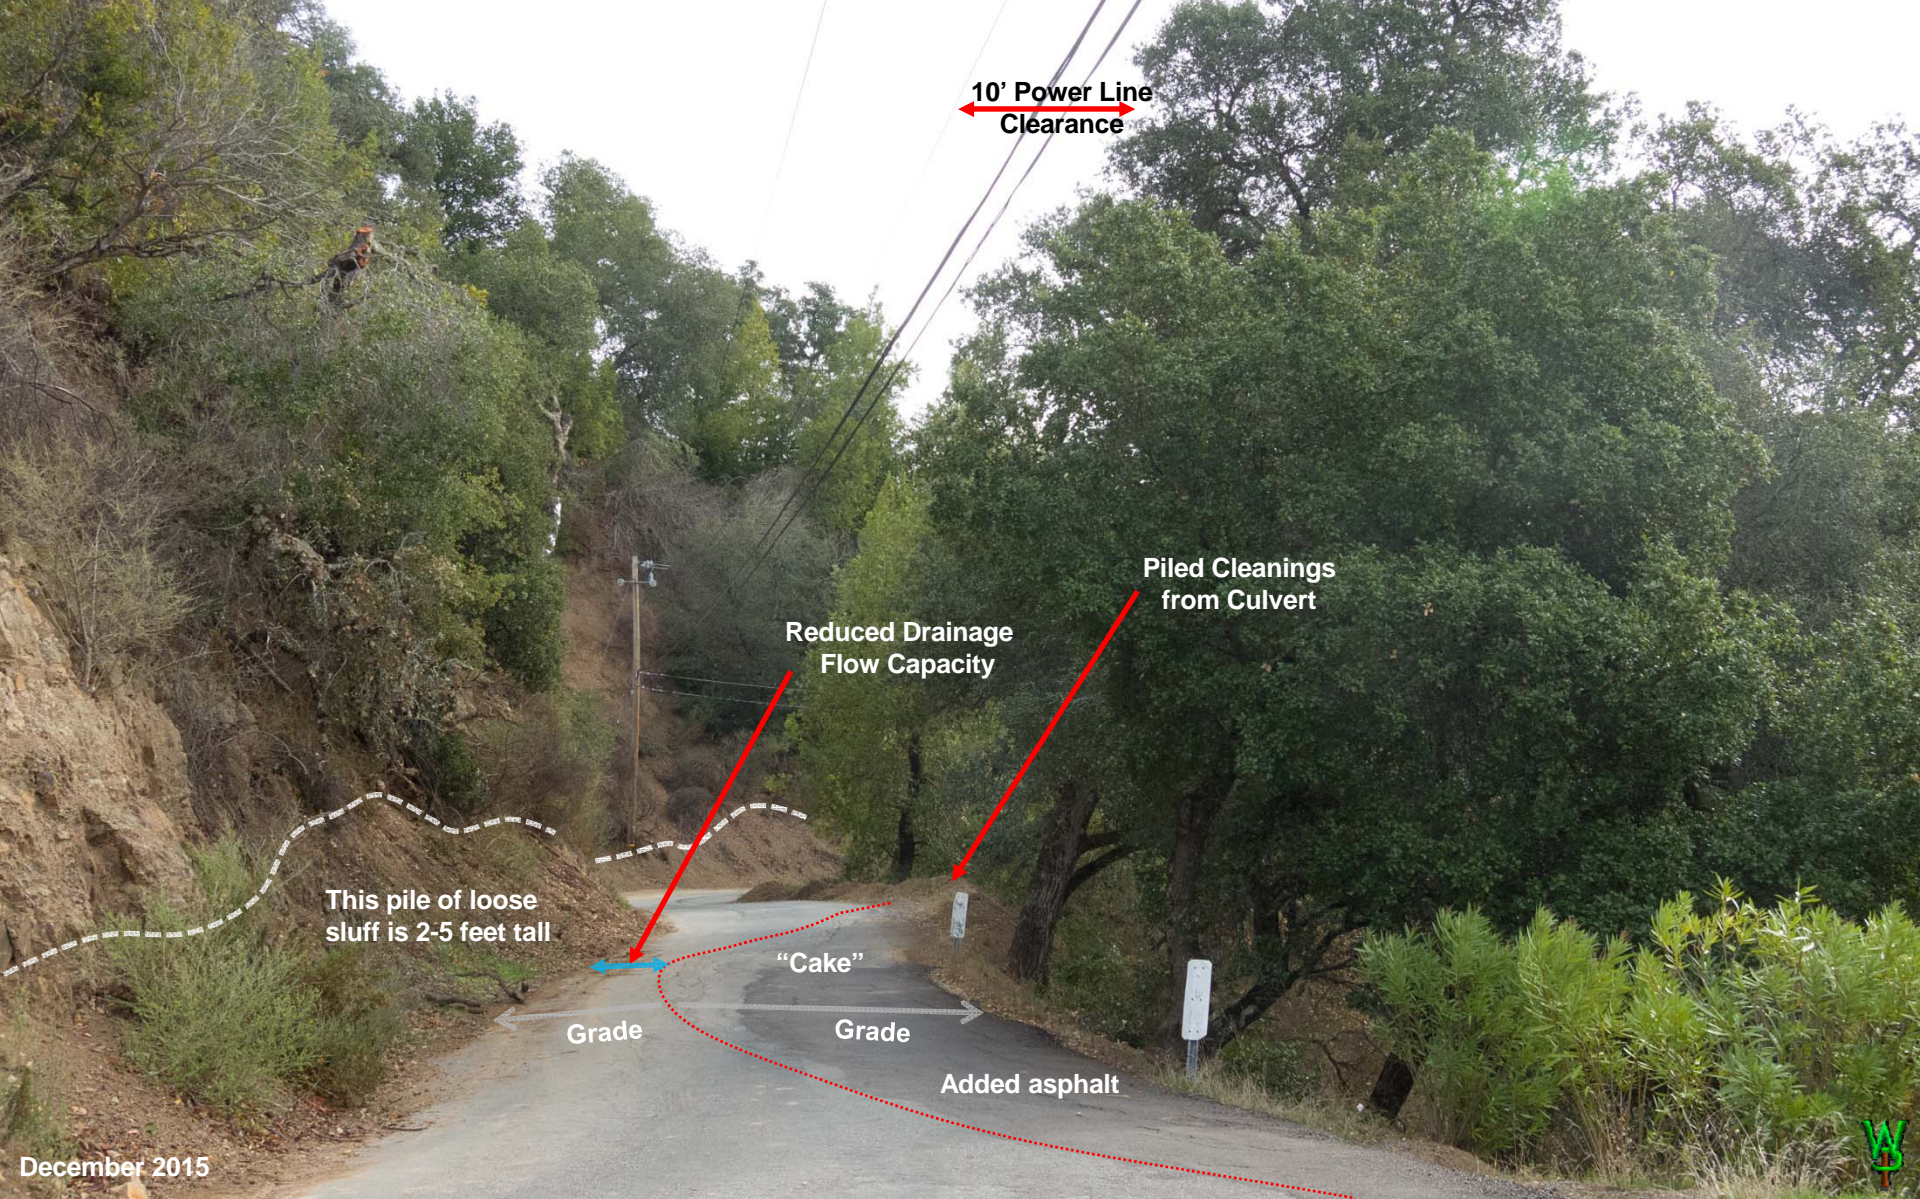
December 2015

"Cake"

Added asphalt

As the cake settles down the hill and loose dirt falls down the cut bank, the in-sloped part of the road channeling drainage narrows. Worse, as the trees grow, they lean out from the unstable slope. When they fall *from above* the road, they block surface drainage with roots and soil, forcing water out and over the outside bank. When they fall *below* the road, They pull the cake down with them.

The County responds to the subsidence by topping the cake with "cold patch," hoping to retain the water and keep the cake from becoming saturated with runoff. They don't touch the trees (it's expensive and people would complain!). The power company *must* maintain line clearances which removes weight that leaves the trees unbalanced, increasing the leverage they exert against the hill.

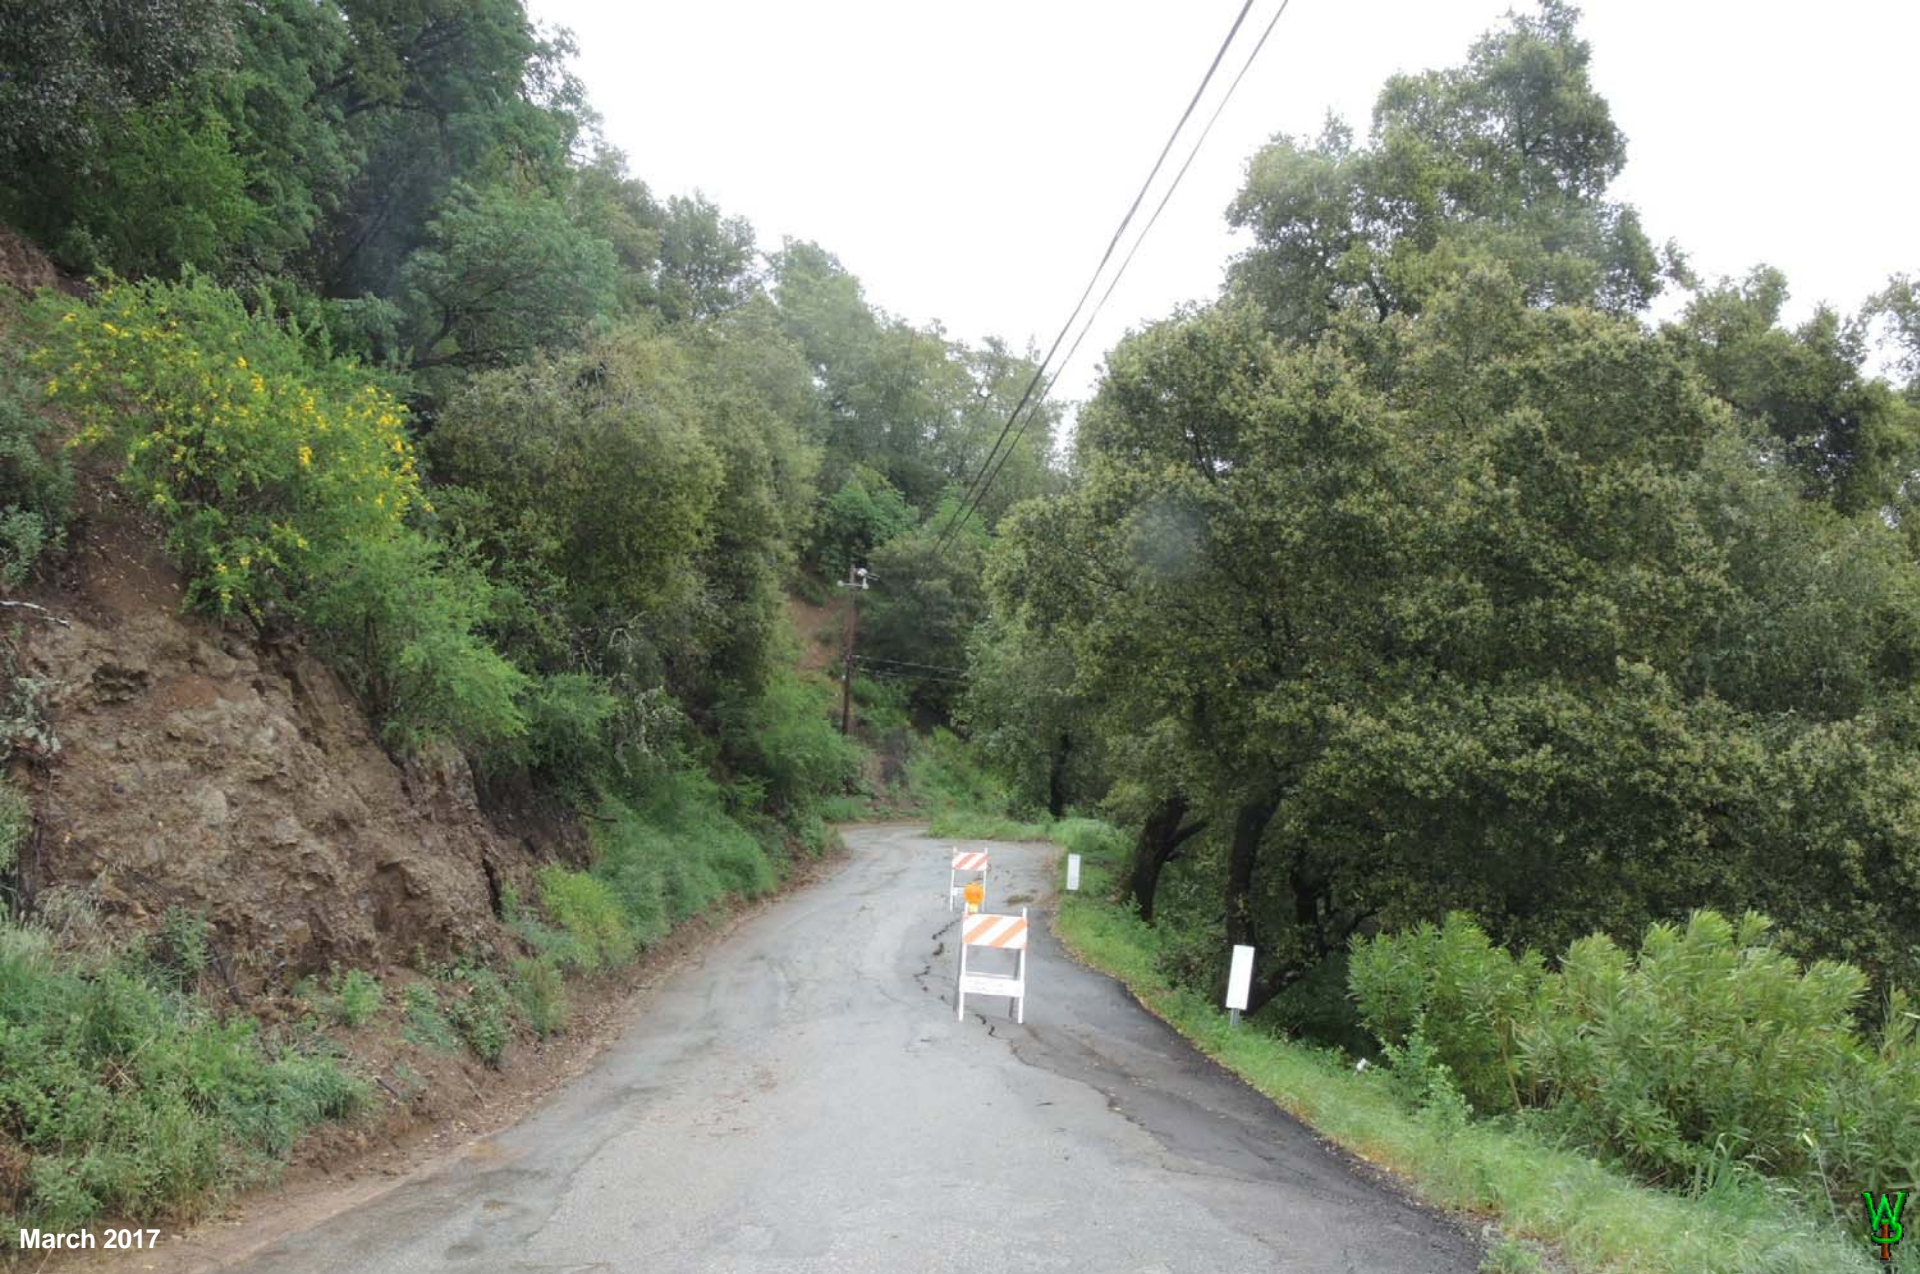
March 2017

80 inches of rain added significant weight and plasticity to the cake, inducing the trees to lean farther and the cake to slide 4-6 inches in but a few weeks. The County calls this a “Natural” disaster. I call it a road construction and maintenance disaster. Nobody argues that it would have been cheaper to fix the road before the storms. So, WHY are we systematically waiting? It’s about using the failure to justify State and Federal “disaster” money. We all know where that money comes ultimately from. But where does the water go?

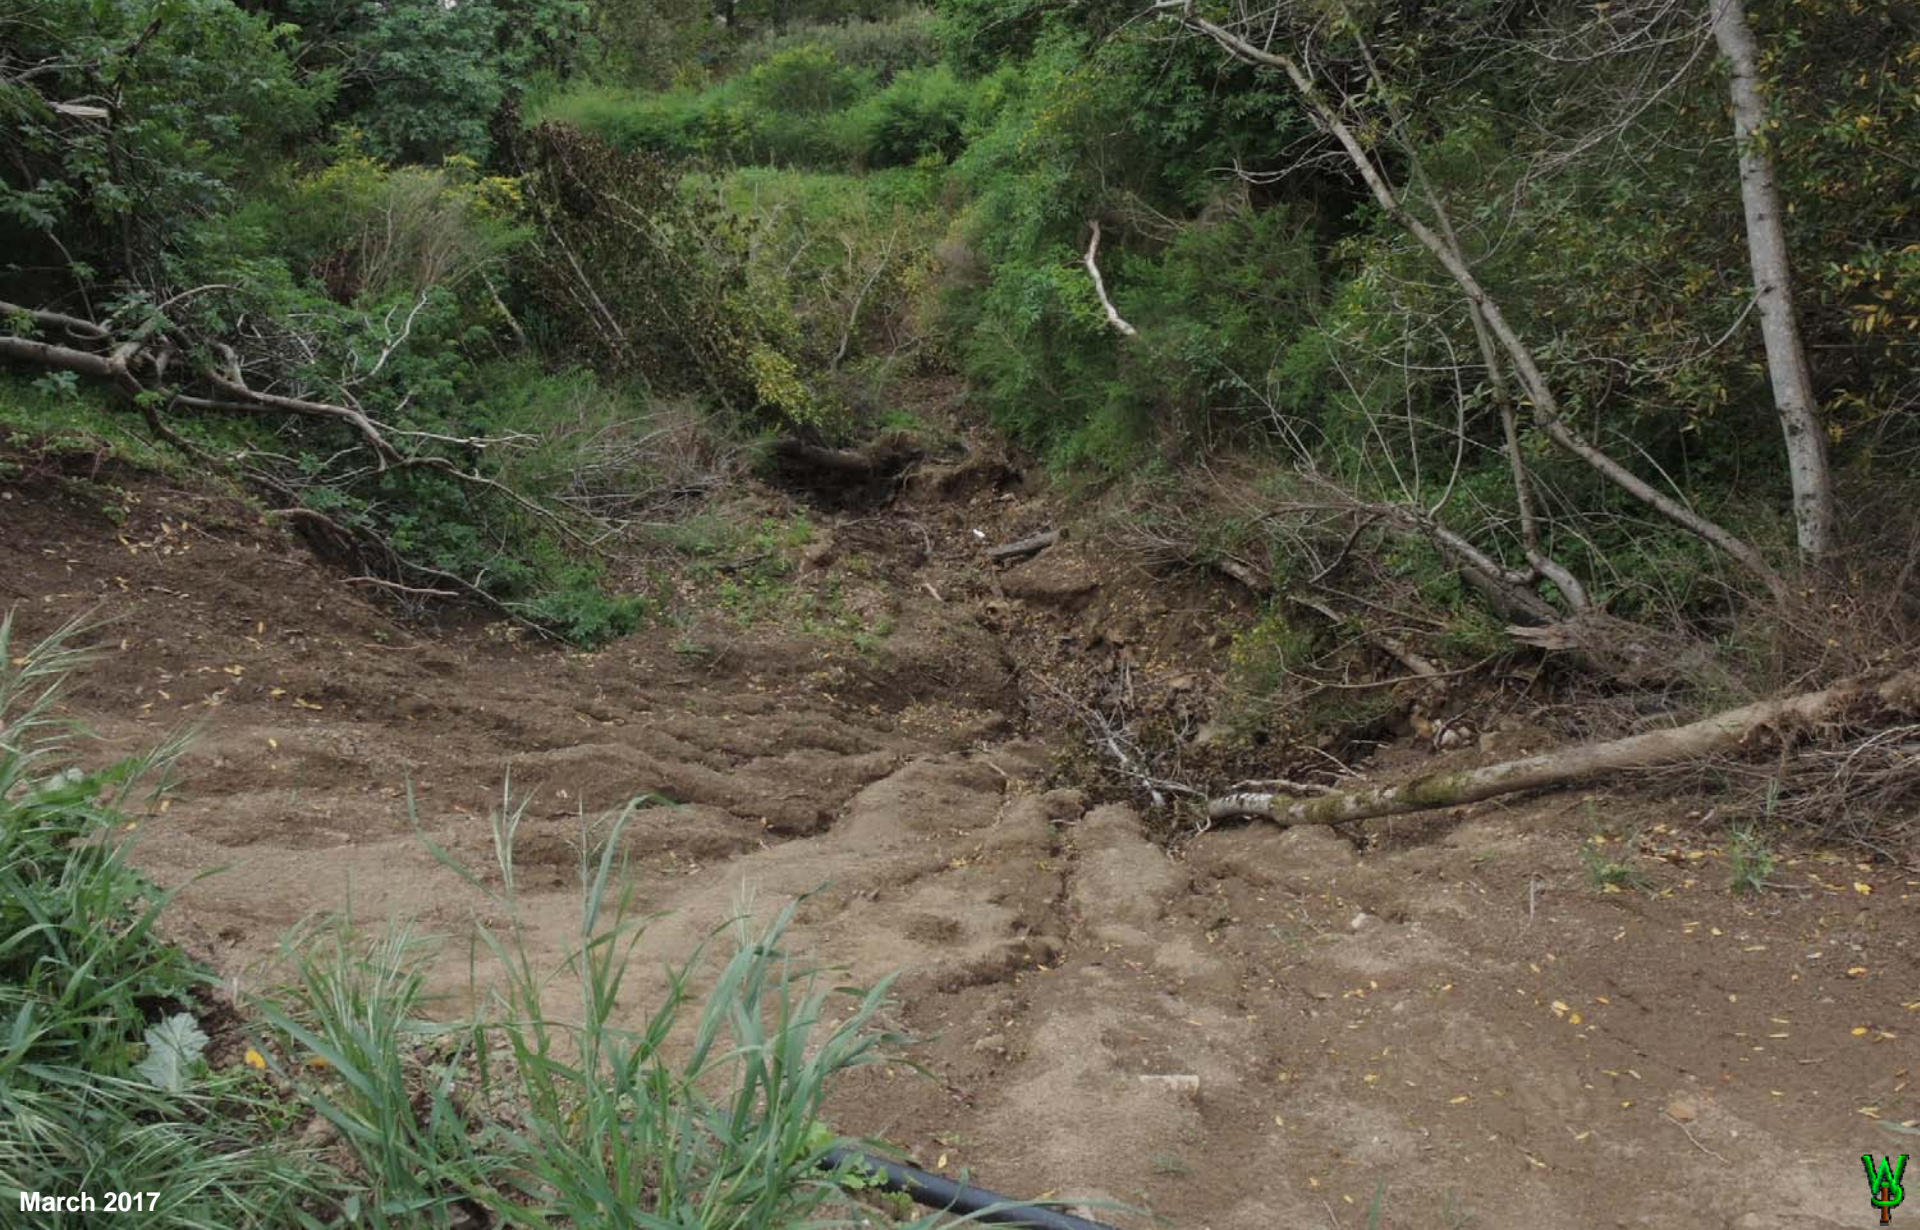
March 2017

What happened? The rotted culvert (to the right of this image) had broken and just took the cake, dumping at least 100 cubic yards down the hill on that poor guy who built all those retaining walls and cleaned the culvert for years. He had finally satisfied the planners. He was just starting to build his house. He had the foundation and first floor built. Then the poor guy up and died. The people up the hill who've been dumping water down that trench with the tree in it remain, and the County has done NOTHING to hold them accountable for the failure of the slope above. Maybe they'd point to a rotten culvert as the cause in their defense?

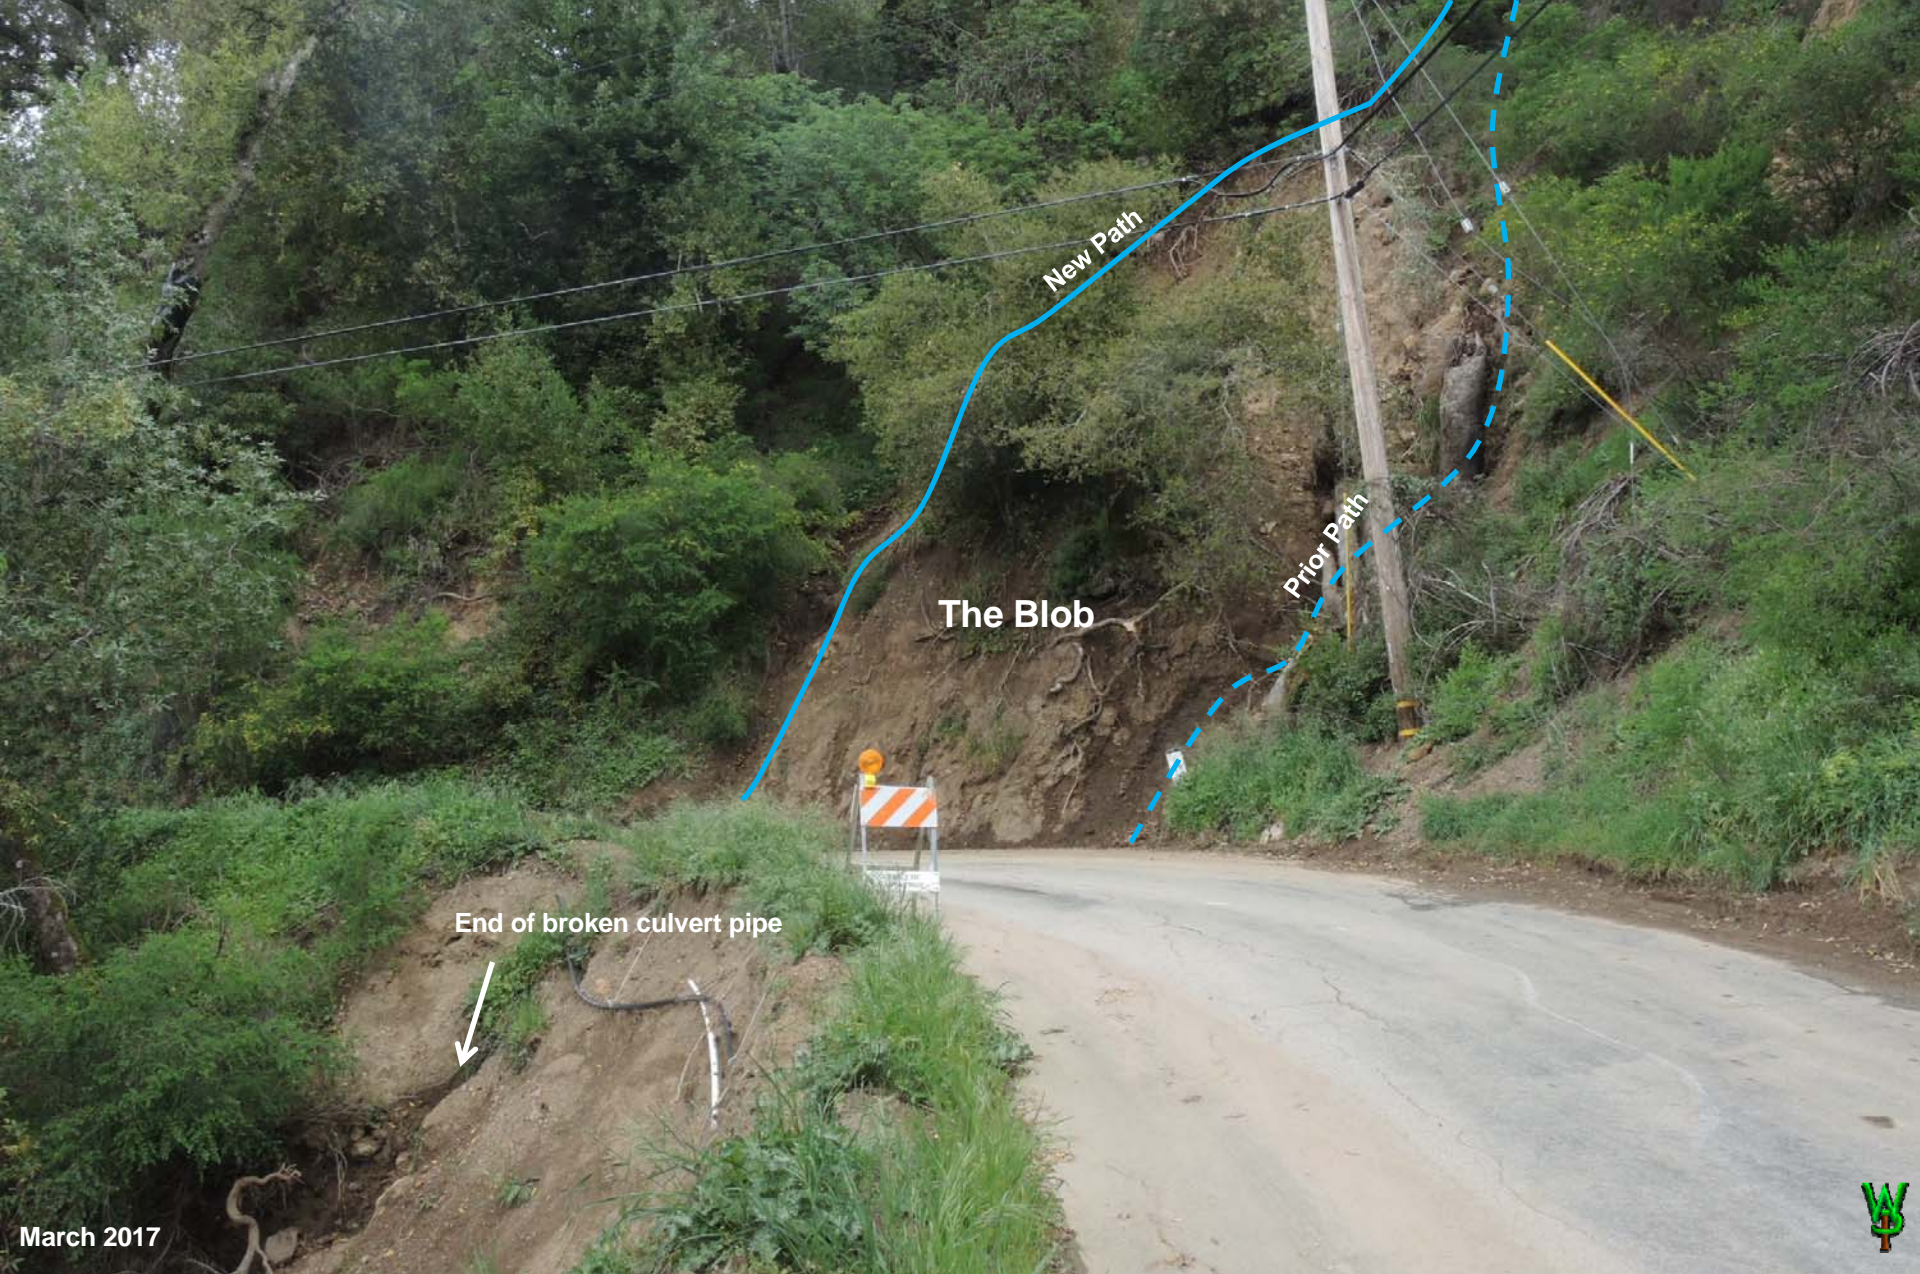
March 2017

Well, it gets worse. The County had cut the road maintenance budget severely, and watched while the runoff from above found a new path, thus creating a blob of unsupported “rock” above the slope. Said “new” path brought down about 20 yards of material, which obviously inhibited the performance of the culvert which, because the bottom of it had rusted out, was leaking water into the substrate and soaking and undermining the cake under the road with the obvious consequences. System failure is usually a team effort.

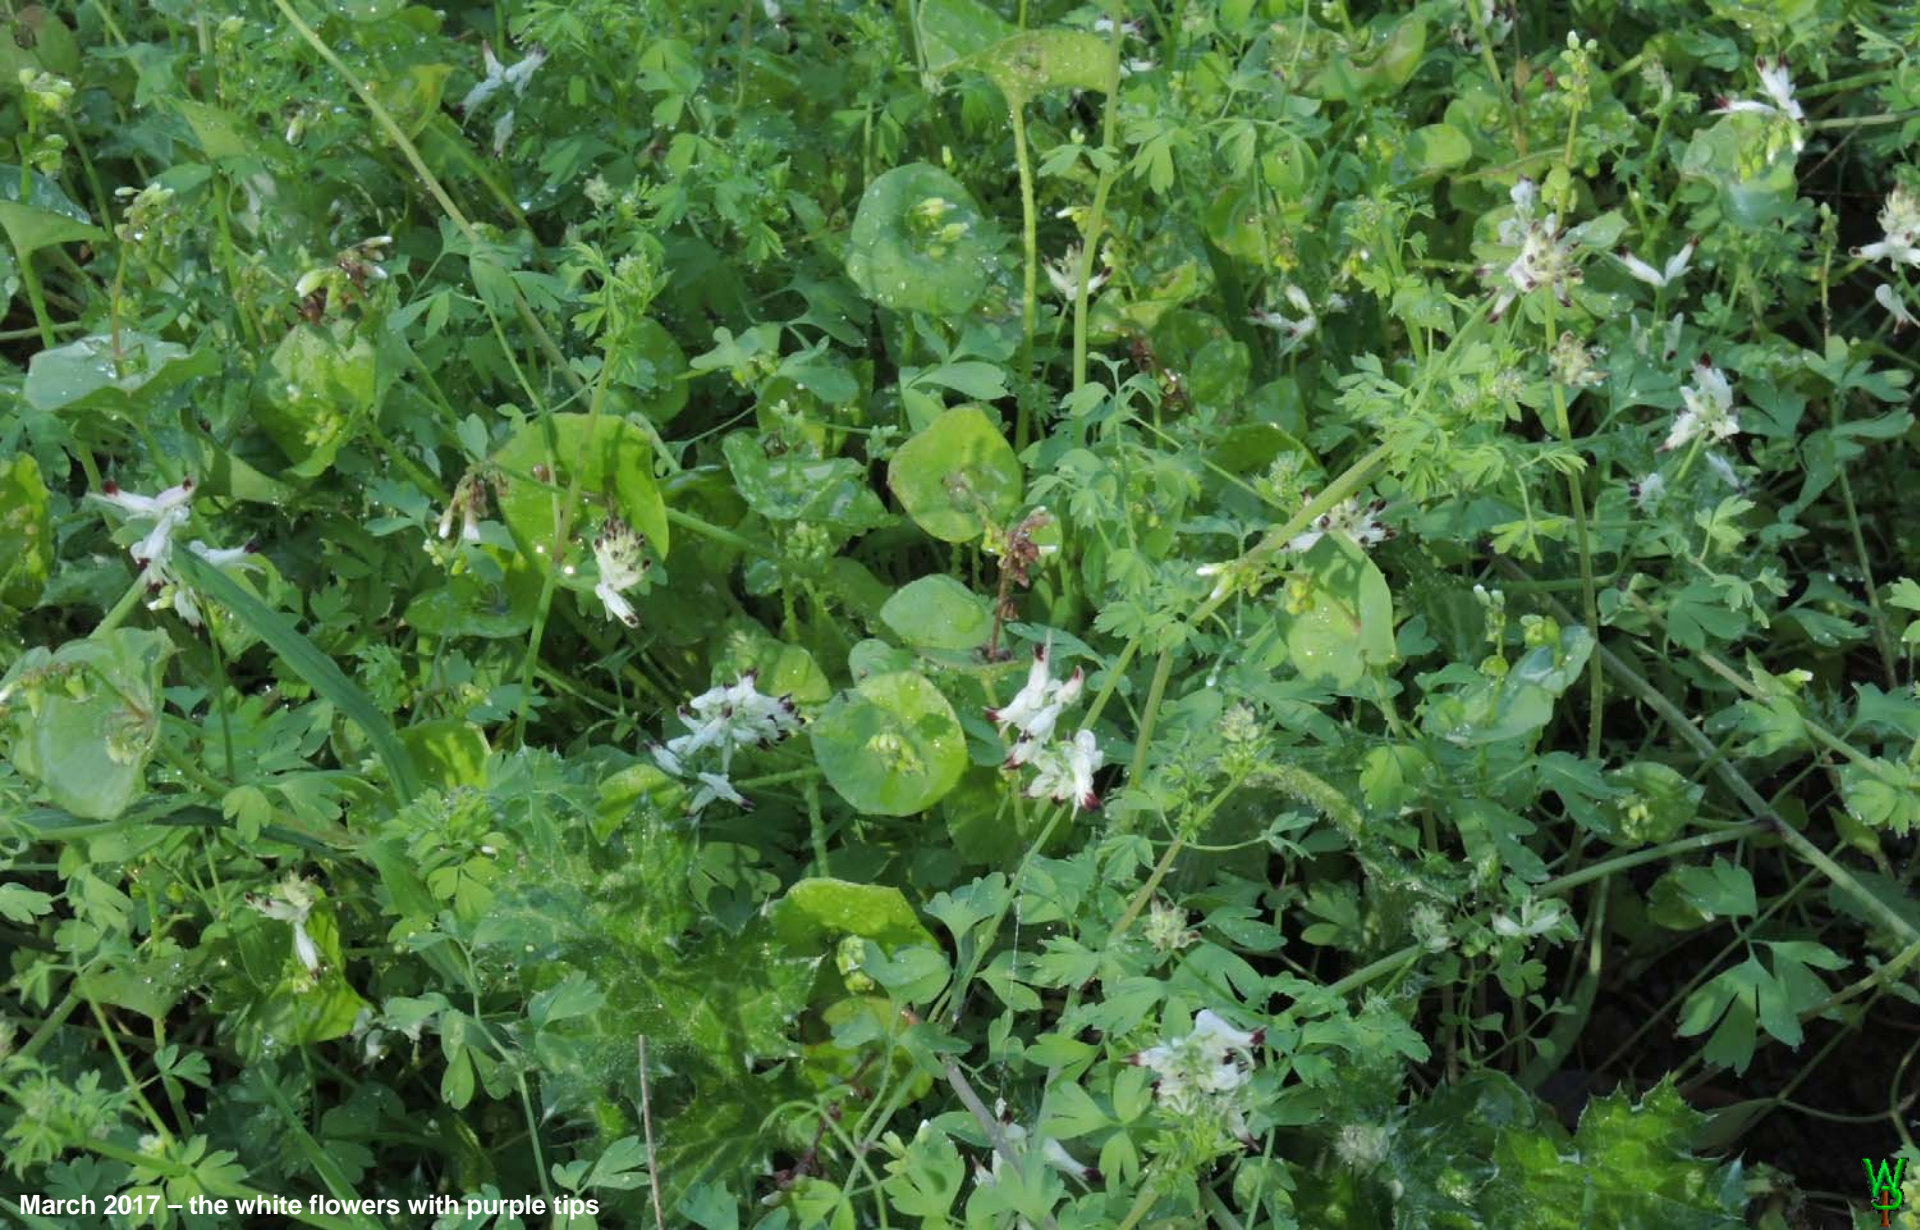
March 2017 – the white flowers with purple tips

Just down the road about 20 feet from the slide is a recently introduced invasive exotic species, “fumitory” (*Fumaria parviflora*), a member of the poppy family. They make a LOT of seed. What do you bet the seed went down the hill with the slide? Gosh, just a small squirt of Roundup a couple of years ago would have prevented it too. And what do you know but the County banned roadside spraying pursuant to the demands of environmental activists! Did they pull the weeds instead? This is what you get with a democratized commons: lousy roads at higher cost with more environmental damage. So, why can't the County fix a culvert?

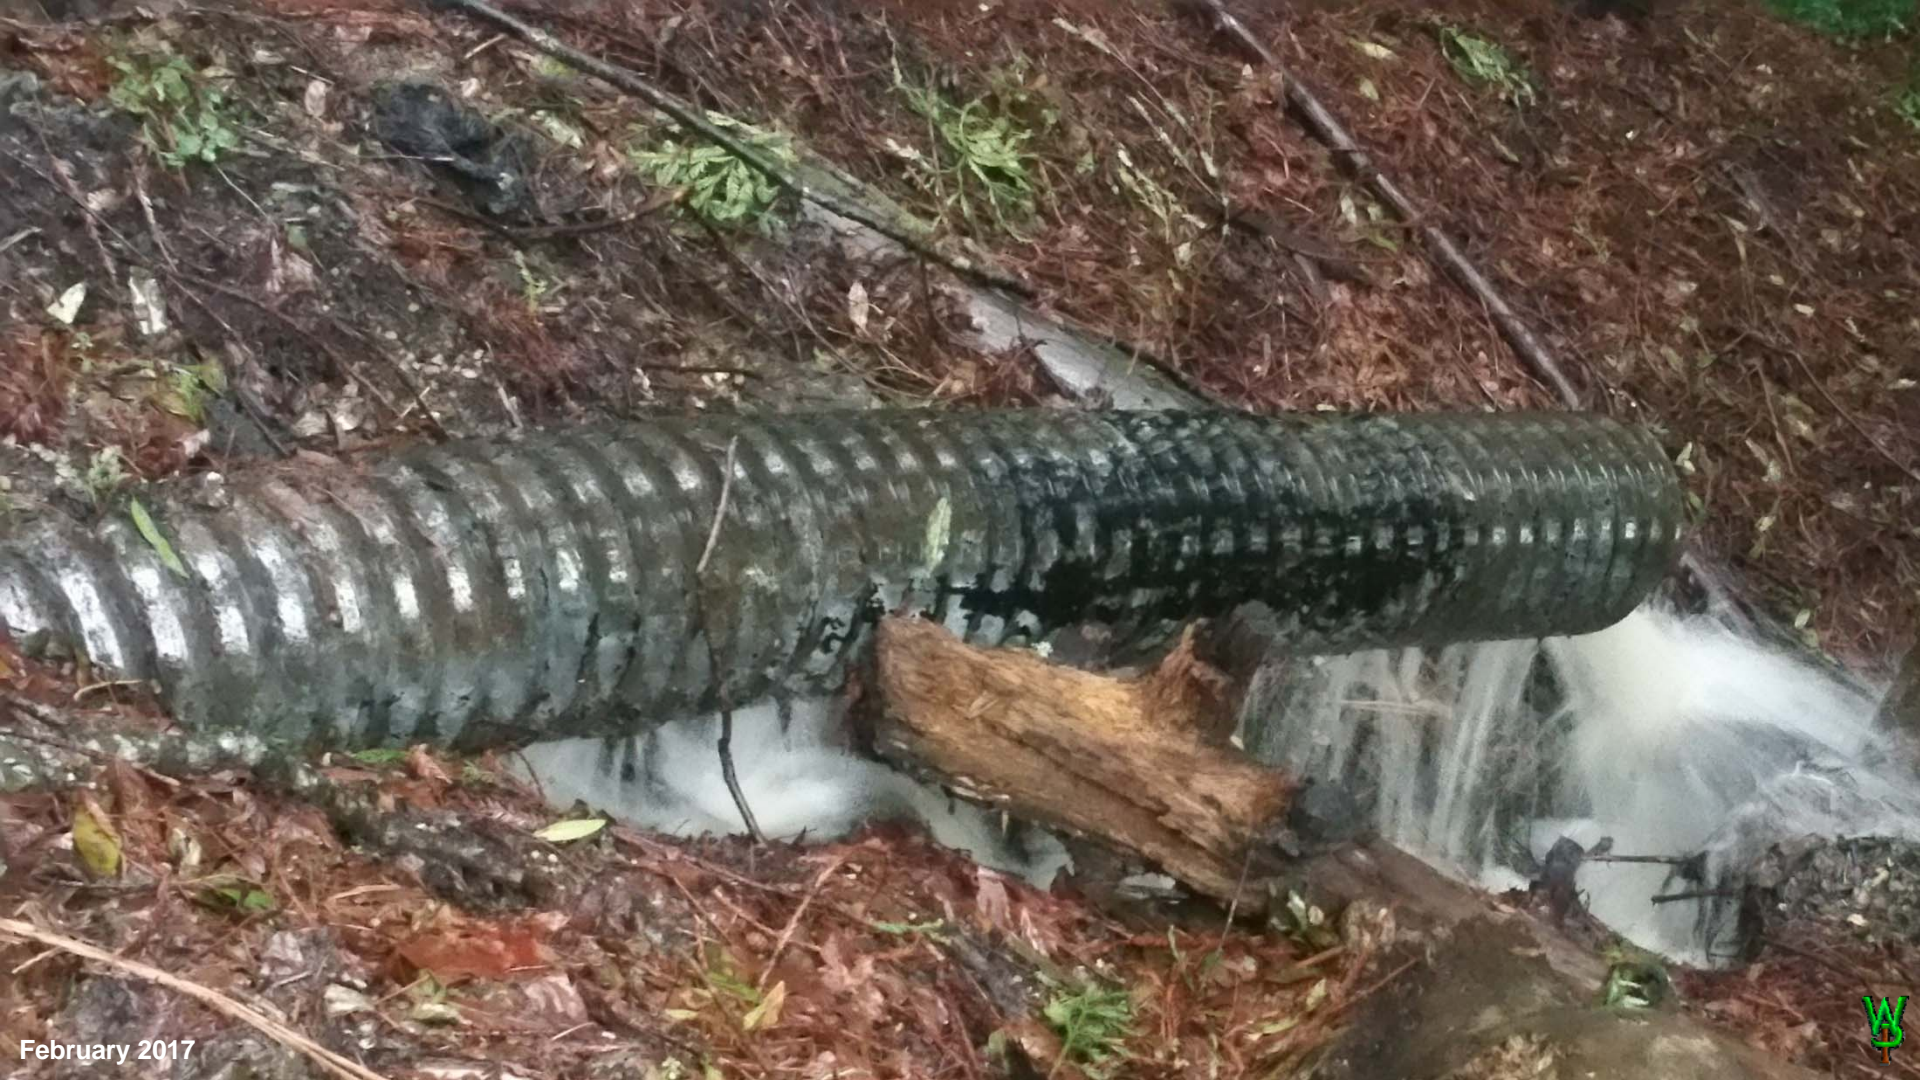
February 2017

This is another culvert just up the road, so rusted out that it is leaking out the bottom, just like the one that made the slide. In fact, there are three wash-outs along this road this year, all with this same cause with this one to come. The reason the County doesn't fix culverts in advance is simple: It takes YEARS to get a permit for a new culvert from the State Department of Fish and Wildlife. They get to "protect" coho salmon, an introduced fish fraudulently listed as endangered with County personnel as principal instigators, as documented in my book, *Natural Process*. This permitting process, supposedly to protect the fish from silt, is so slow and expensive that it defers maintenance to the point that roads fail, causing more silt in streams than without the State's bureaucrats and rules. It's their road now, but what the heck, negligence brings in more State and Federal "disaster" MONEY! The democratized commons is becoming a **socialized commons**: bureaucrats holding public assets hostage to increase cash flow, producing even lousier roads at higher cost with more environmental damage. Please do not tell me that this is unintentional. All the contractors know how this works.
