ROADS TO HEAVEN, TO HELL, AND BACK, SOMEWHAT

WILDERGARTEN 5.4

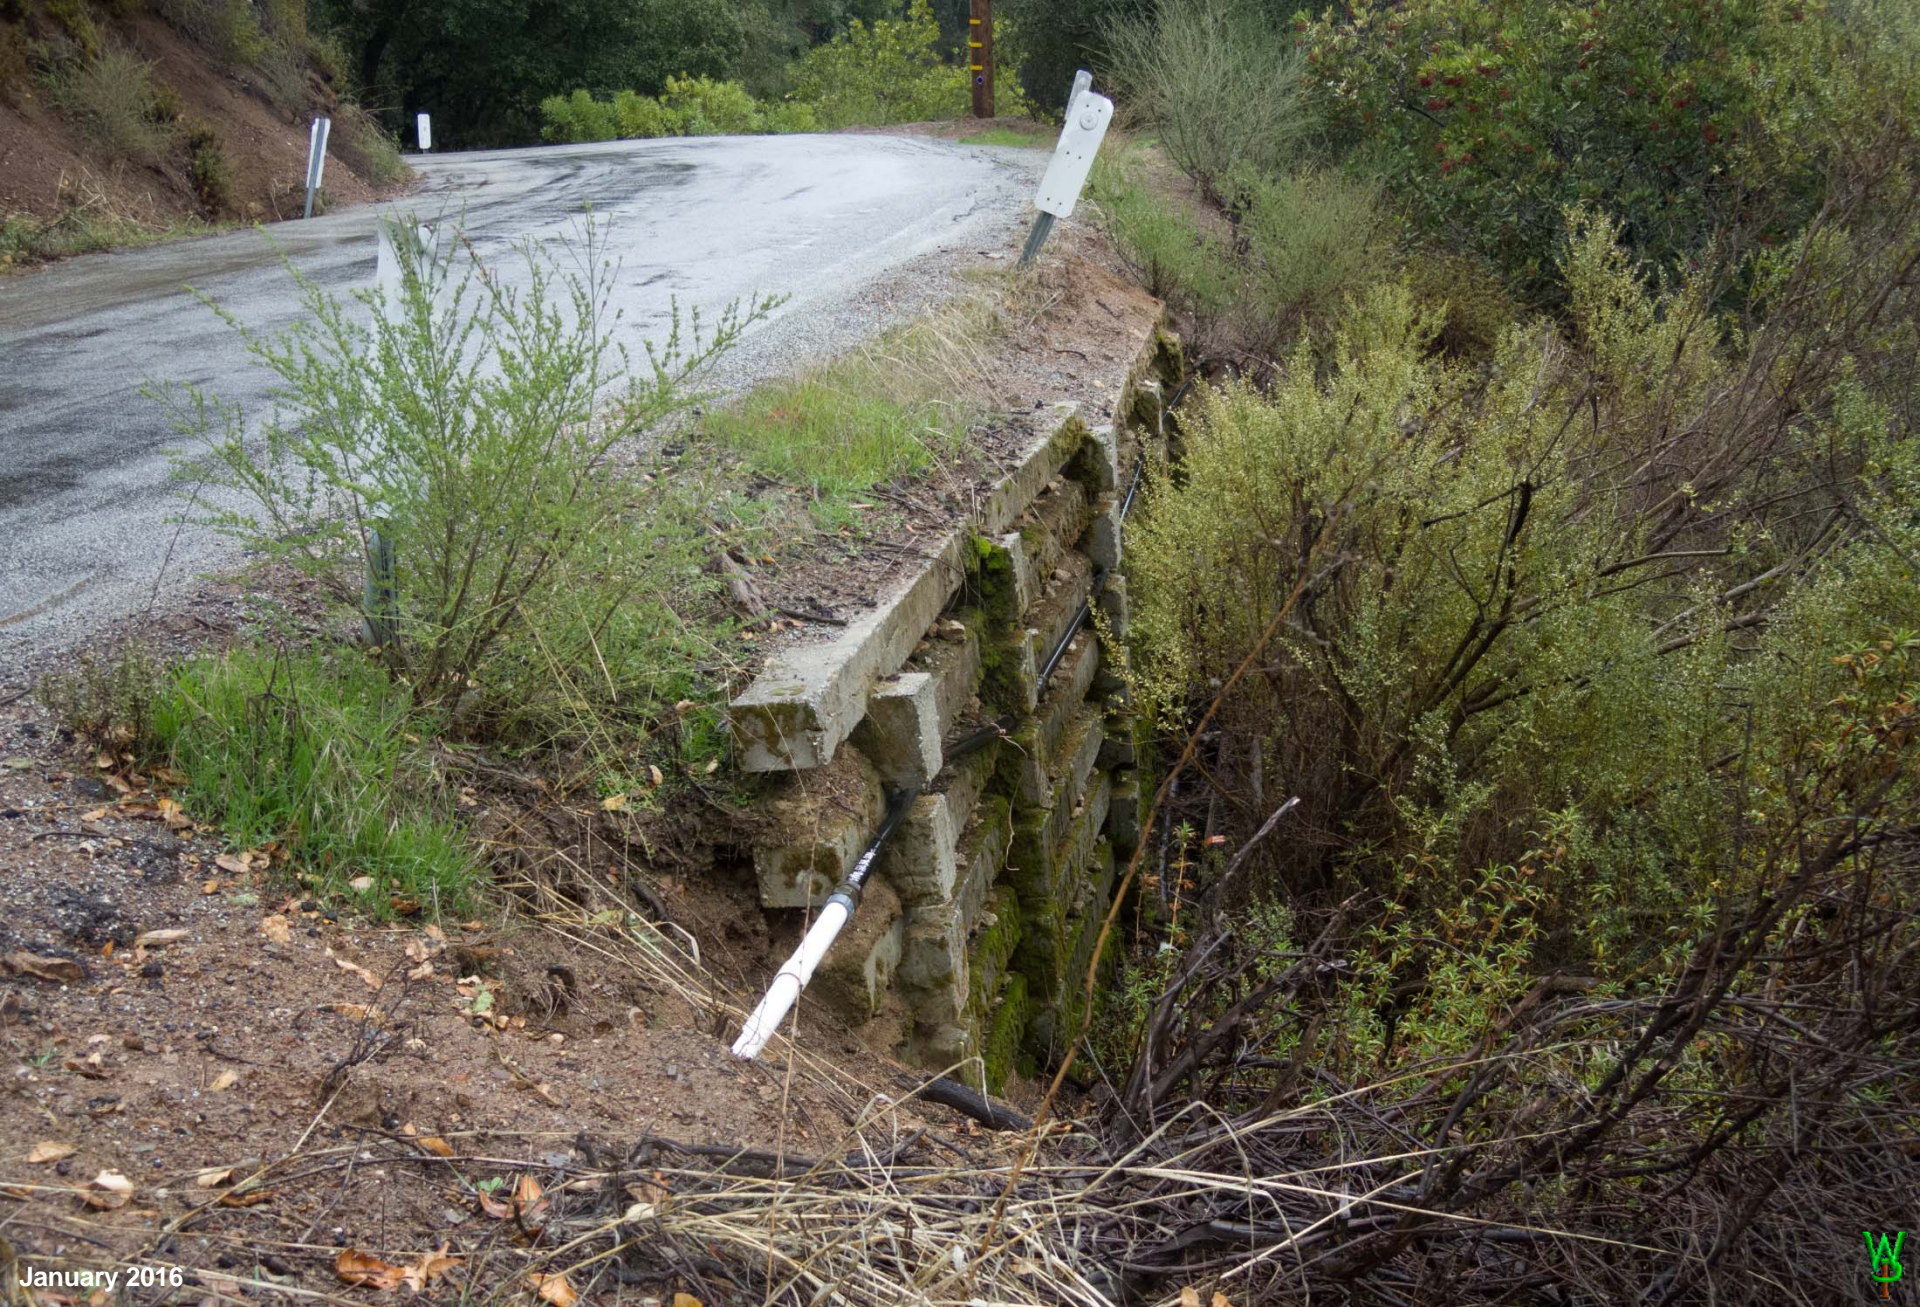
January 2016

The usual fix for small Type I failures is called a “crib,” basically digging out the cake, making a box with a flat floor on a “stable” substrate, and filling it with rock. Sometimes it is done with concrete “Lincoln logs” and large gravel like you see here. Note: The pipe is the main water supply for nearly 70 homes, many without water storage adequate to fight a fire.

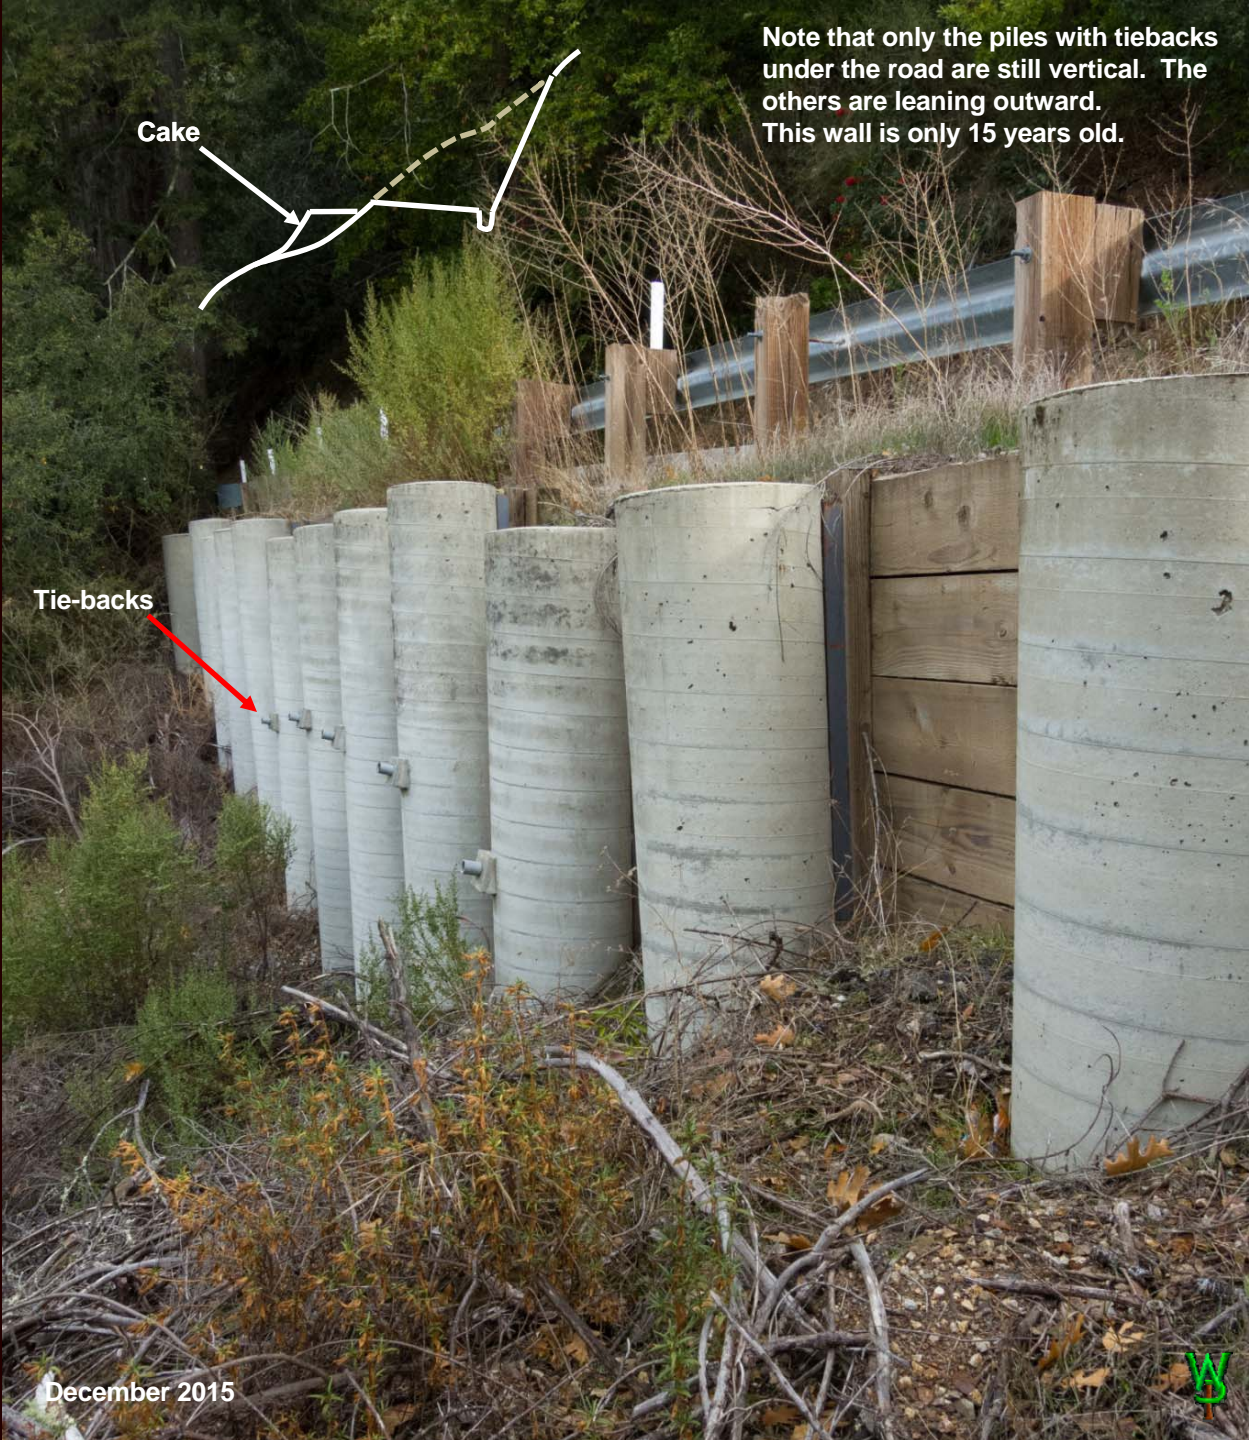
Note that only the piles with tiebacks under the road are still vertical. The others are leaning outward. This wall is only 15 years old.

Today, when the road failure is too big to be addressed with a simple crib, the usual fix is for the Federal government to fund repairs with "disaster relief" money. The governing legislation specifies that the money is to be used **only** for repairs, and not improvements that prevent future repairs even if they are cheaper than the repairs (sigh). So they have to put the roads back where they were, usually with pricey feats of engineering like this one at right: a row of concrete pilings cast in holes drilled deep into the substrate.

When the pilings get too tall to hold the load or if the substrate is too soft, they are connected with "tie-backs" (steel rods either anchored to blobs of concrete "dead men" or fastened directly into the hill (right).

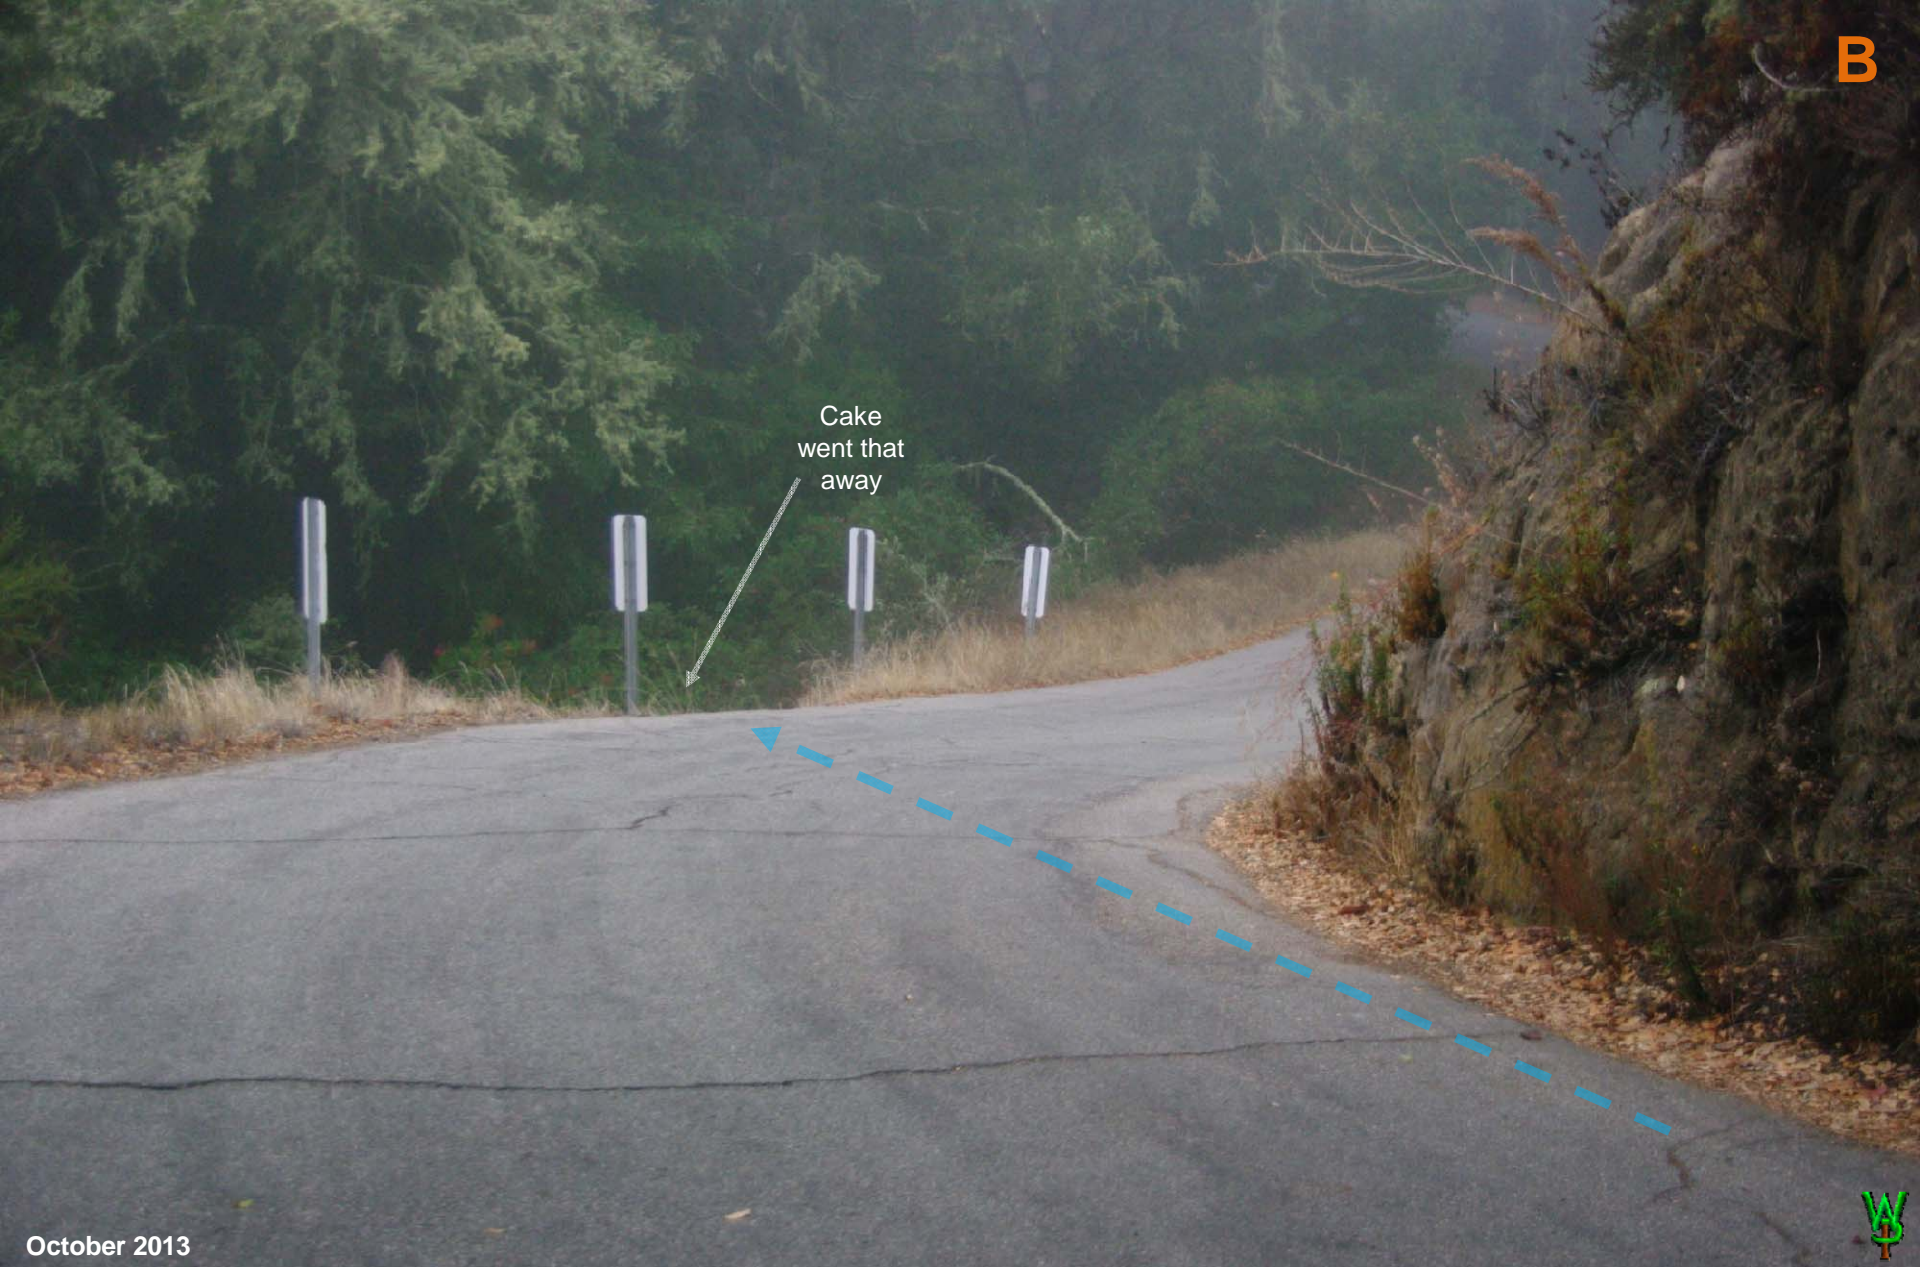
October 2013

Just beyond the south end of our place, the road suffered a smallish Type I failure: The remaining cake at this blind one-lane turn had slumped far enough that the road surface sloped away from the ditch. The remaining in-sloped grade collected water that ran down the ditch to where it kicked out due to accumulated sediment. The flow then ran away from the ditch, across the road and, in 2011, just took the cake. This situation is less usual in that said “cake” was the same sluff as the parent material. This whole hillside is sluff.

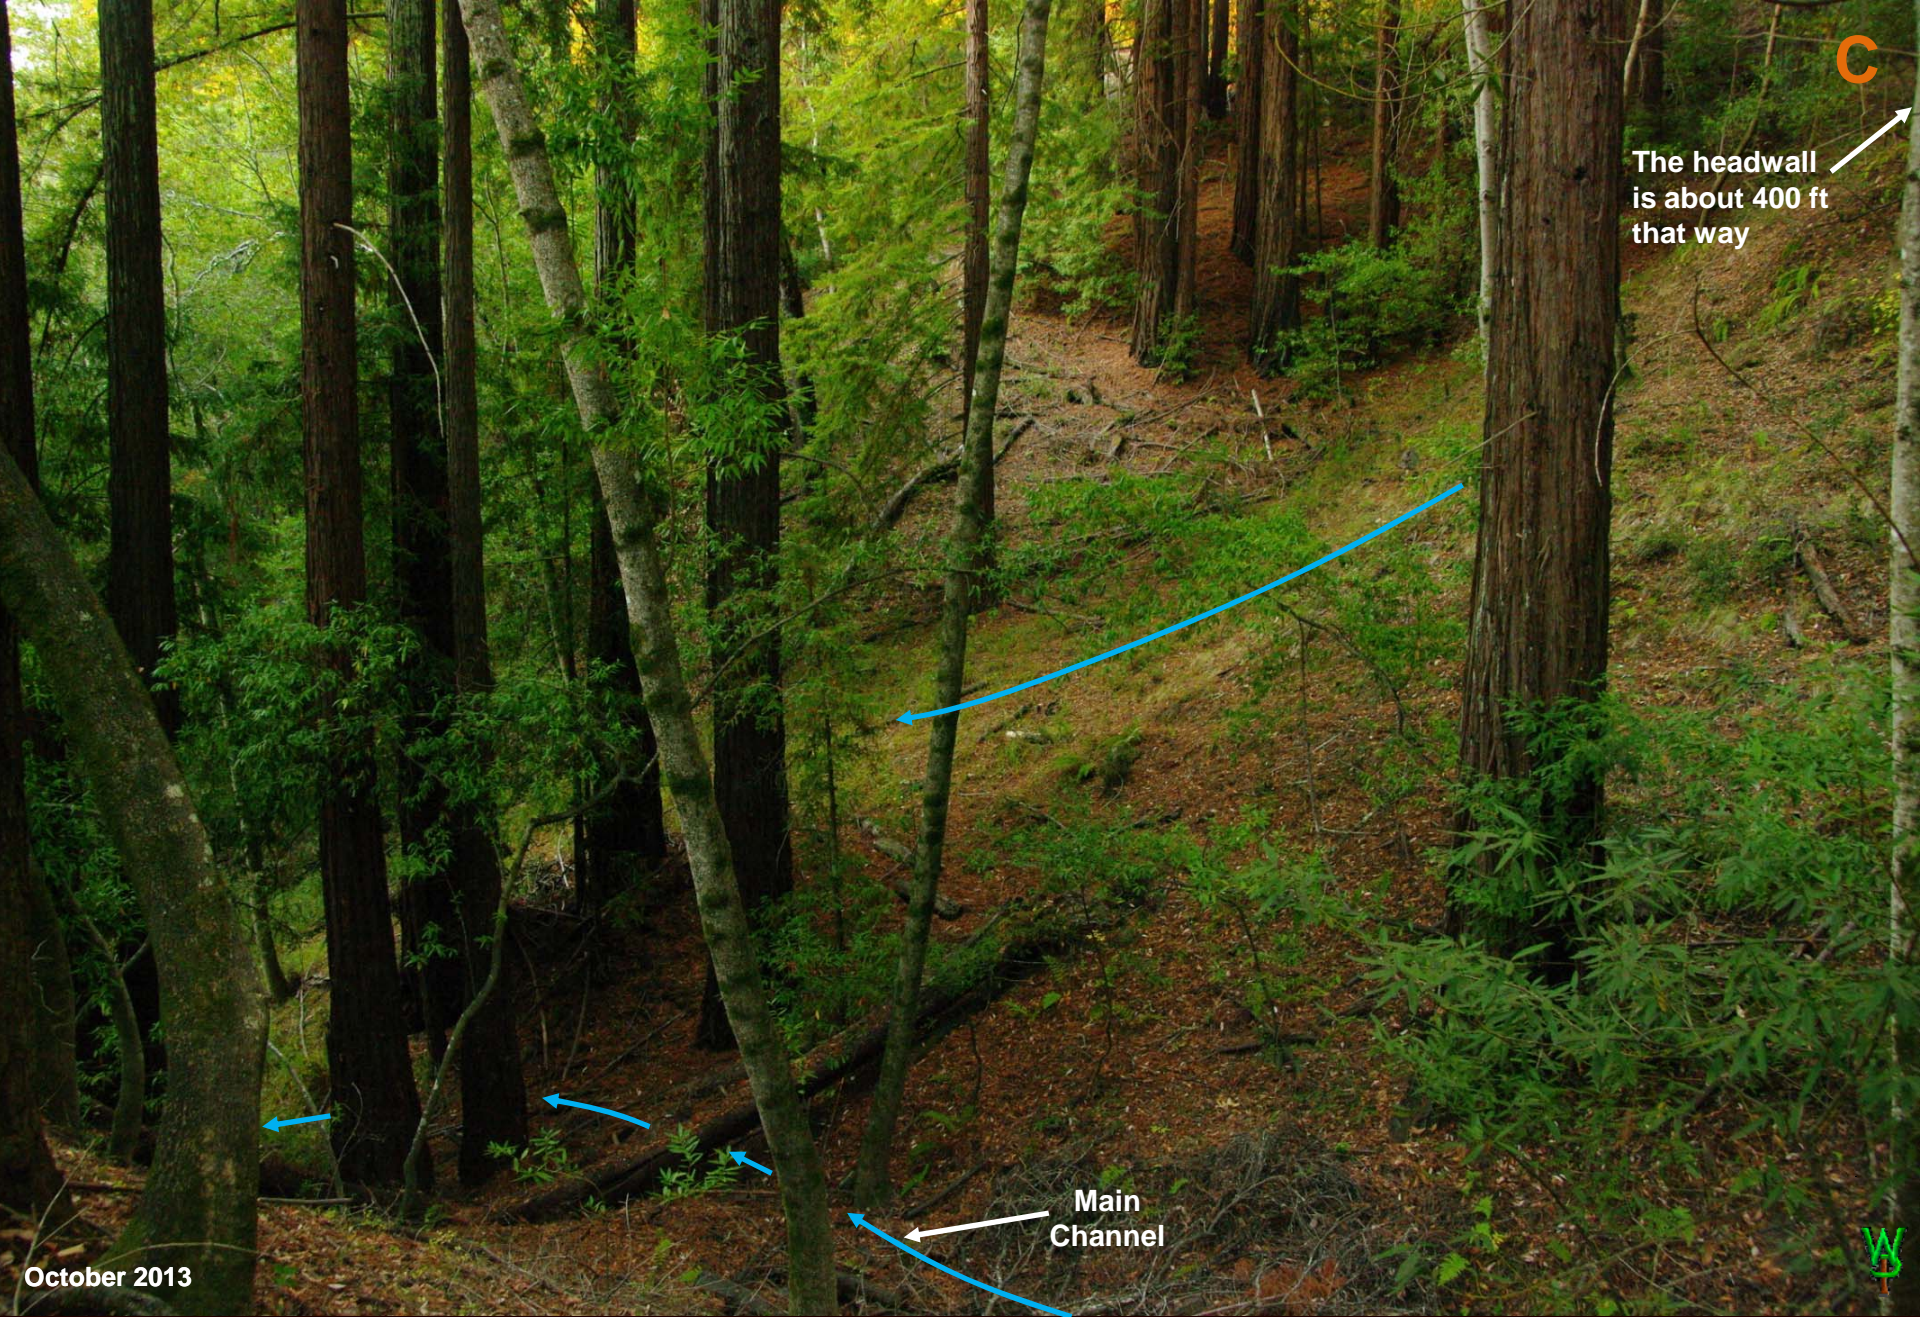
October 2013

The headwall is about 400 ft that way

Main Channel

This image is from the previous chapter on **drainage** with the gully headwall “100m that way” (upper right) along the County road (“Cake 2,” prior slide). From what I can tell, this drainage channel, representing **about 30-50,000 cubic yards of lost material**, was started when the Spanish channeled the water with their inside drainage ditch and dumped it off at the corner onto the colluvium.

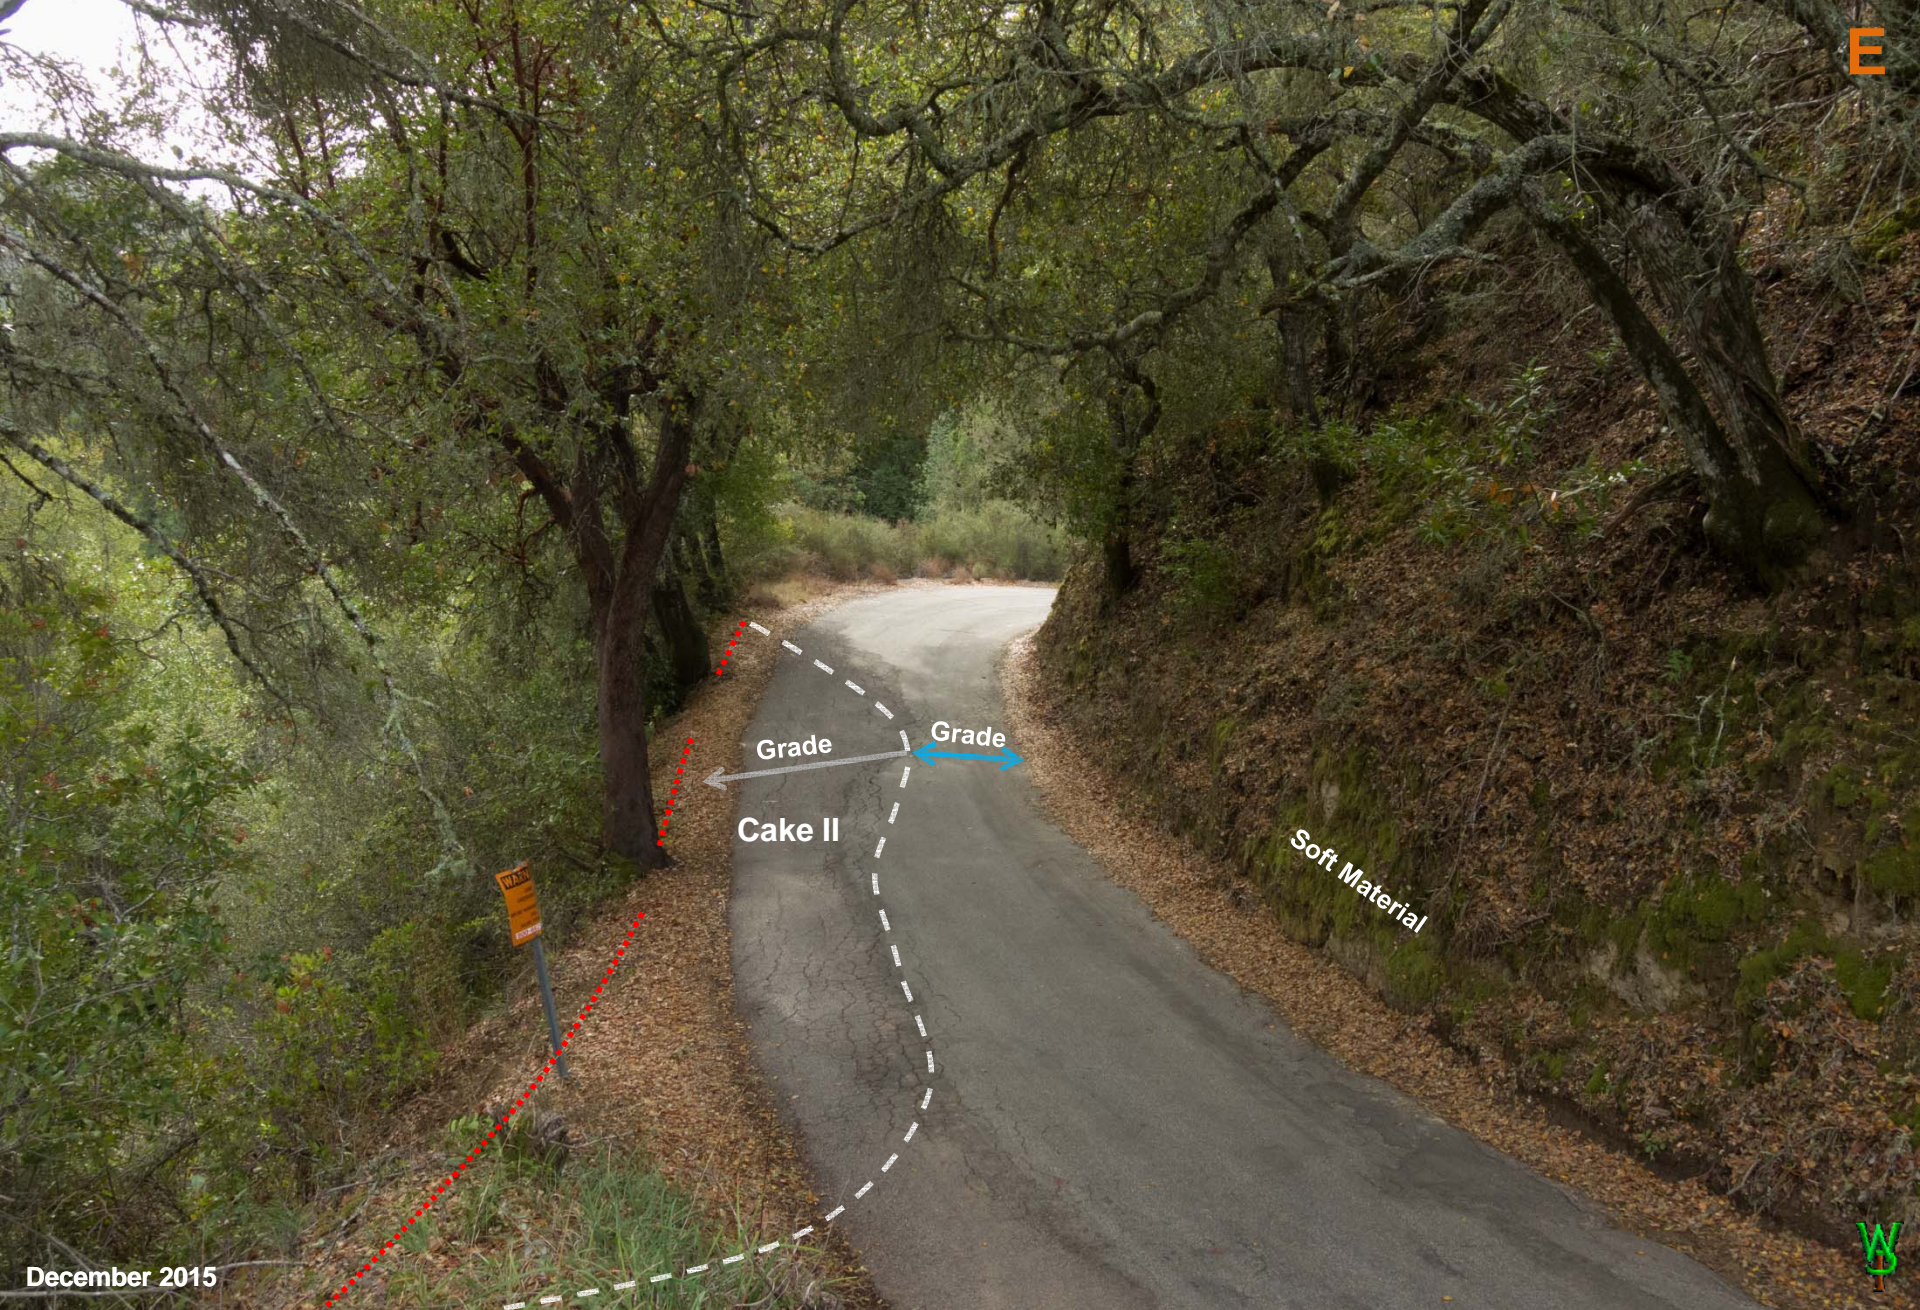
December 2015

This is a look from the “bump” on the prior slide. With the trees growing in soft material leaning out over the road, it is only a matter of time until one falls, bringing a chunk of dirt with it. That will fill the rest of the drainage “ditch” and send the runoff over the edge and down the **headwall**. Needless to add, if the trees leaning from atop said headwall go down, they could close the road as well.

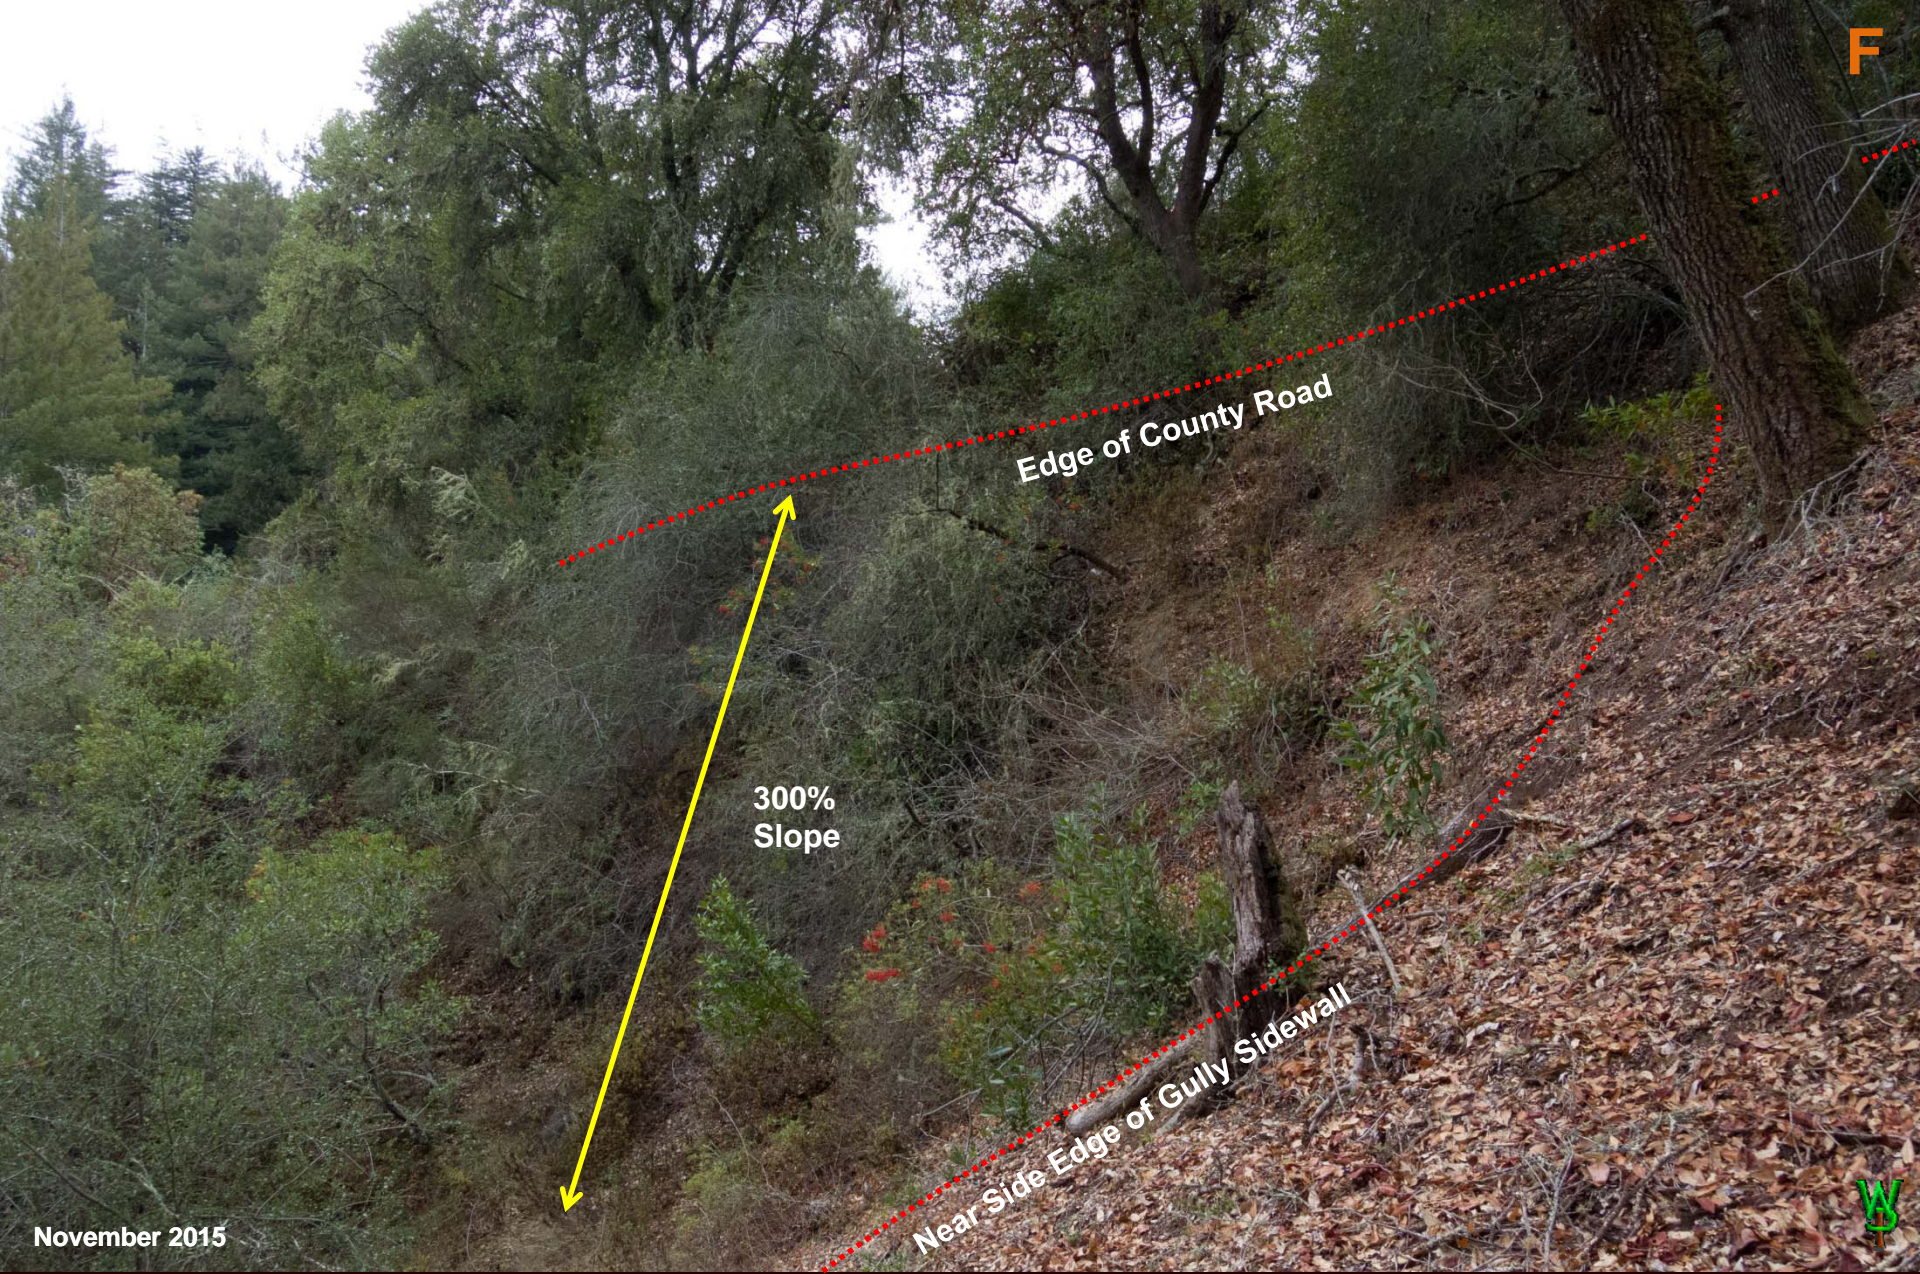
November 2015

This is a side view of the headwall from below the “bump,” and this is just the beginning. Can’t see it? Note that what you do see on most of it is light, early successional brush such as this *Ceanothus cuneatis*, but there is stump from a fallen oak in the foreground indicating that the most recent slide on this side of the gully was only about 50 years ago. This is slower than the usual rate of succession in this area, but it is a north-facing slope of a material that does not usually support trees for very long.

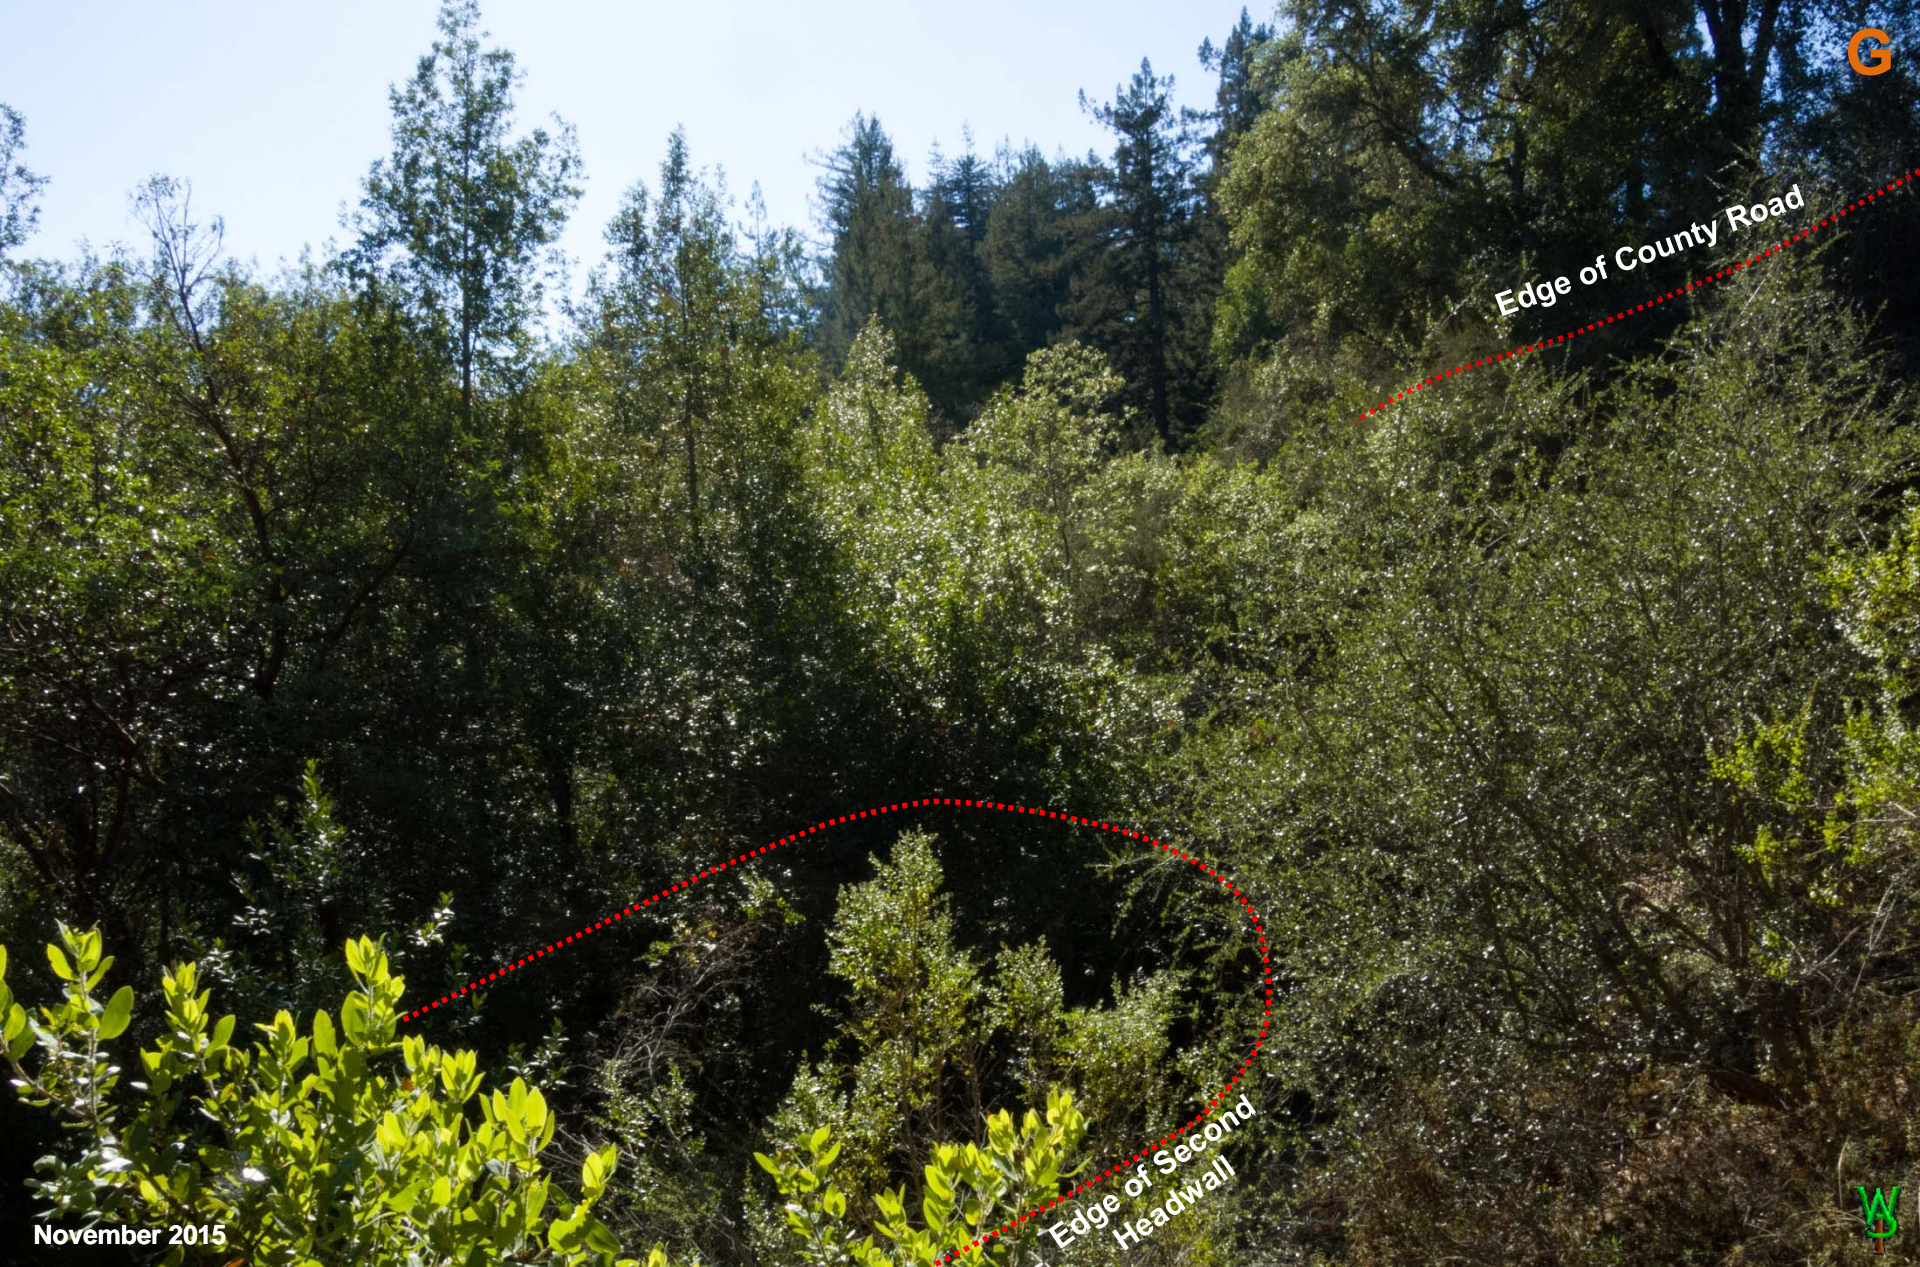
November 2015

Edge of County Road

Edge of Second Headwall

Panning left, the next headwall down *is* filled with trees, and here is why I am going into so much detail on roads in a chapter under “Forestry”: Poor drainage and vegetation management come together to make this very expensive problem worse both for the land, wildlife, and for people who depend upon it. This gully stair-steps in successive slides forming an average 300% slope about 70 feet high, too tall to simply drill pilings for a retaining wall. It is now completely unstable ...because of trees?

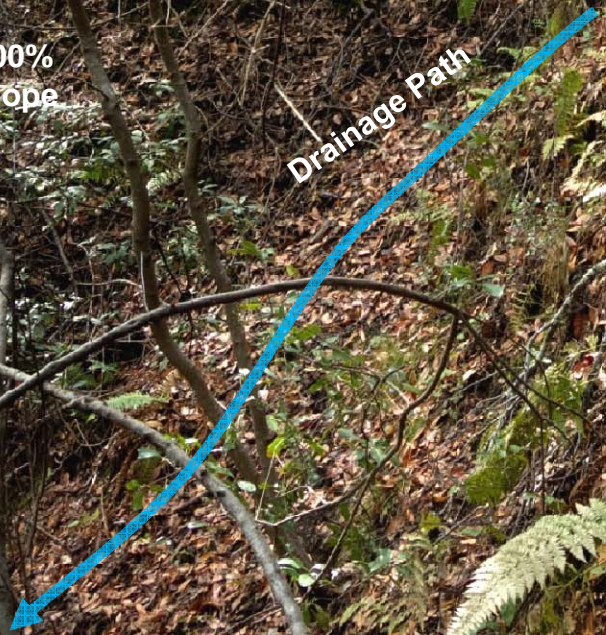
Drainage Path

300% Slope

We are just to the left and down-slope from the second headwall looking along the right sidewall of the gully to the other side and uphill. Trees undermine this headwall. The slope stair-steps in successive slide headwalls, forming an average 300% slope about 70-100 feet tall below the road, too tall to drill pilings for a retaining wall into a material that will not hold much anyway. On the far side (north facing) wall are older trees, of which the madrone (red arrow) is typical: It grew out of the loose sluff seeking light, fell, and then it grew upward again, imparting considerable leverage against the slope to tear out the root wad. That soil material is so soft one can dig it with bare hands. Did I say this problem was big?

To simply "leave it alone" will guarantee that this slope and road fails, frequently, sending significant amounts of sediment downstream each time. So, besides grading the County road into the hill, somebody should manage the vegetation to slow the rate at which this slope undermines the road.

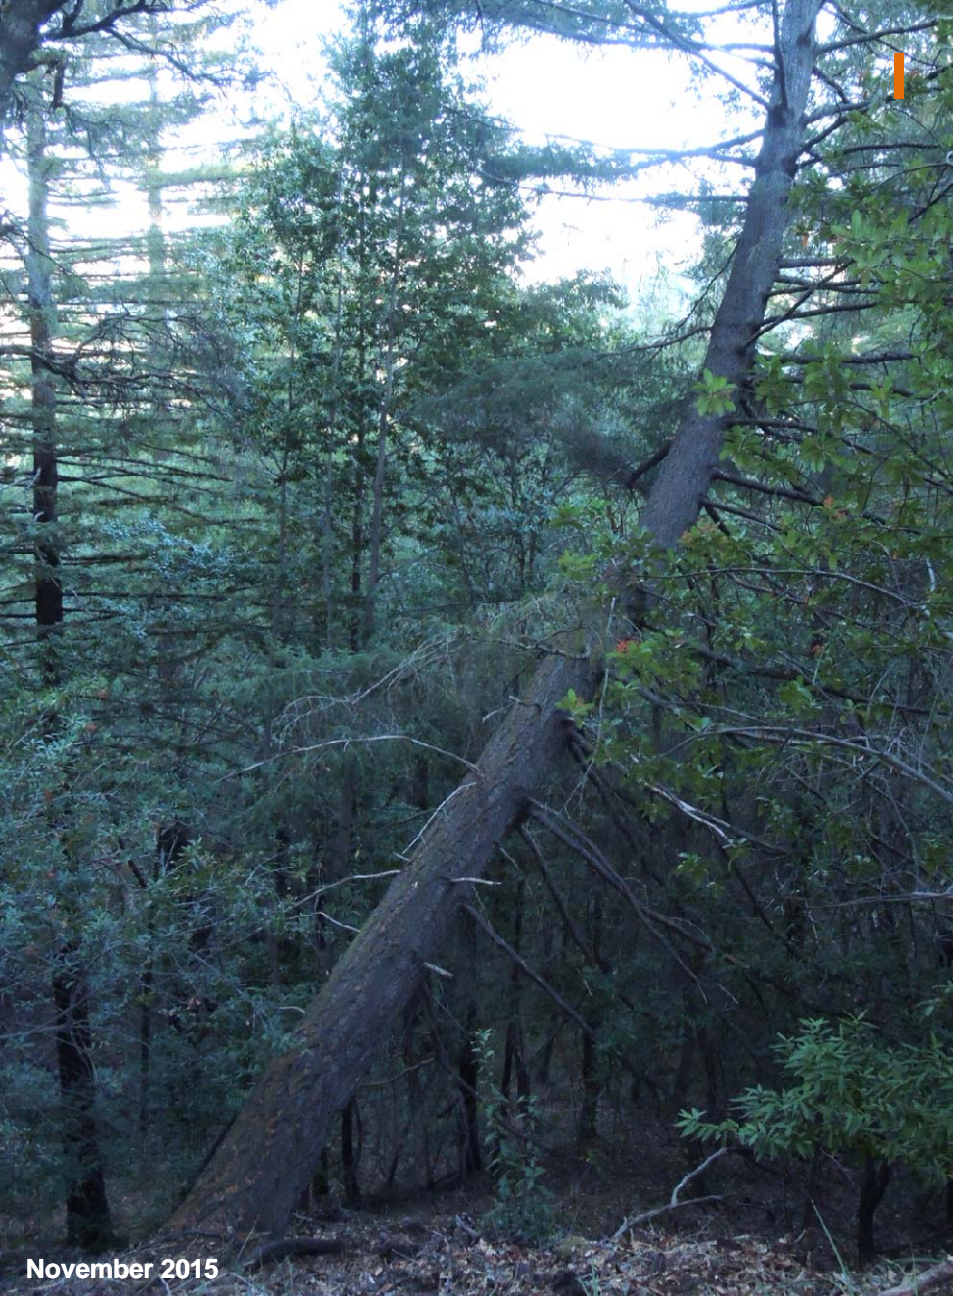
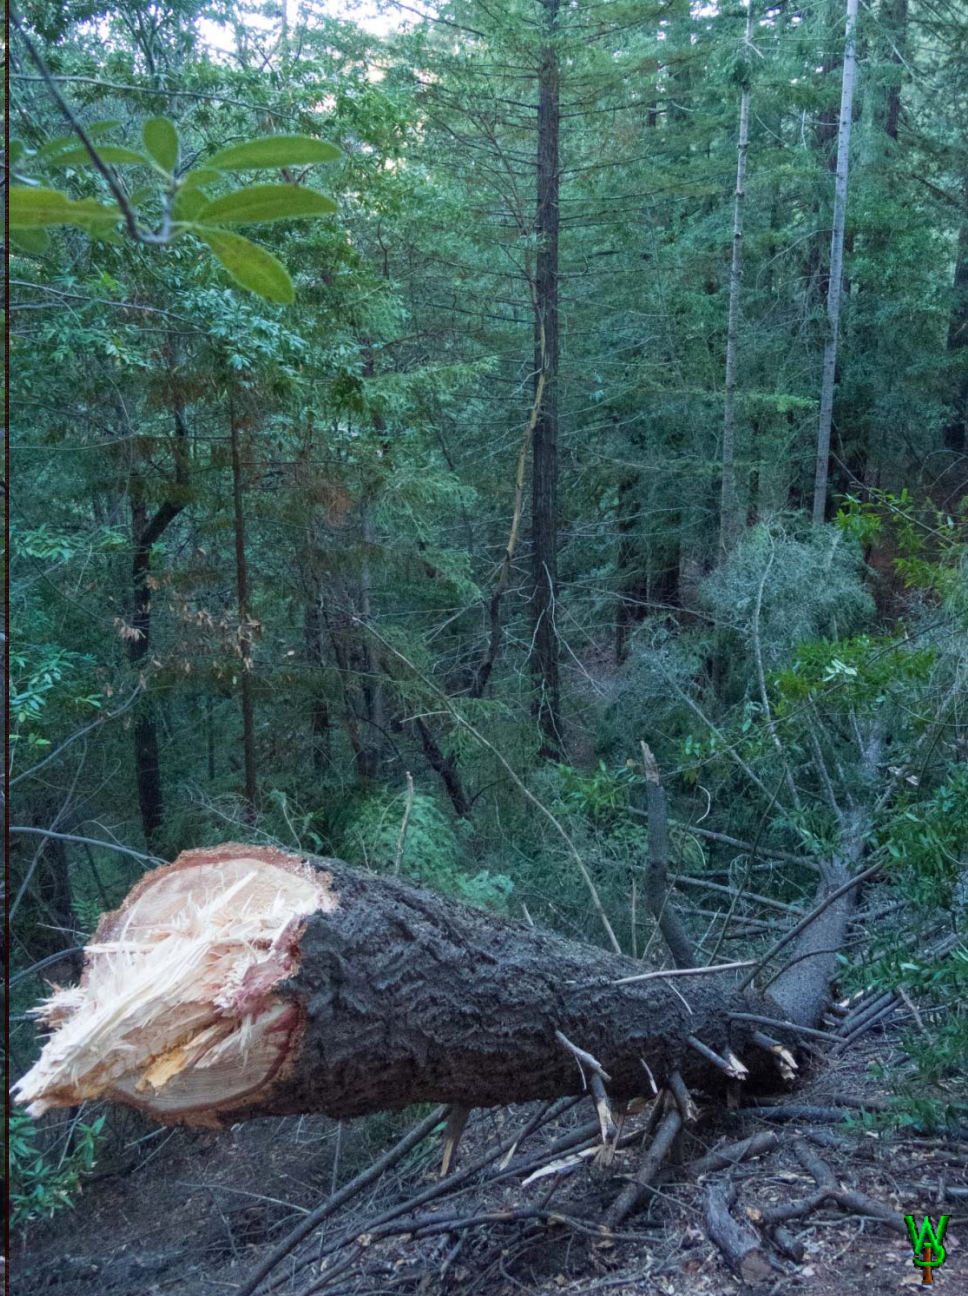
November 2015

Some leaning trees get extreme. This fir grew on the slope that forms the near sidewall of the gully (facing southeast). It was 30" dbh and leaning out at a 40° angle from vertical. Taking trees like this down and cutting them up on a slope like this is hazardous. The wood is worthless (too much internal stress). Yet trees like this take out big holes from the side of the hill if allowed to fall on their own.
