ROADS TO HEAVEN, TO HELL, AND BACK, SOMEWHAT

WILDERGARTEN 5.4

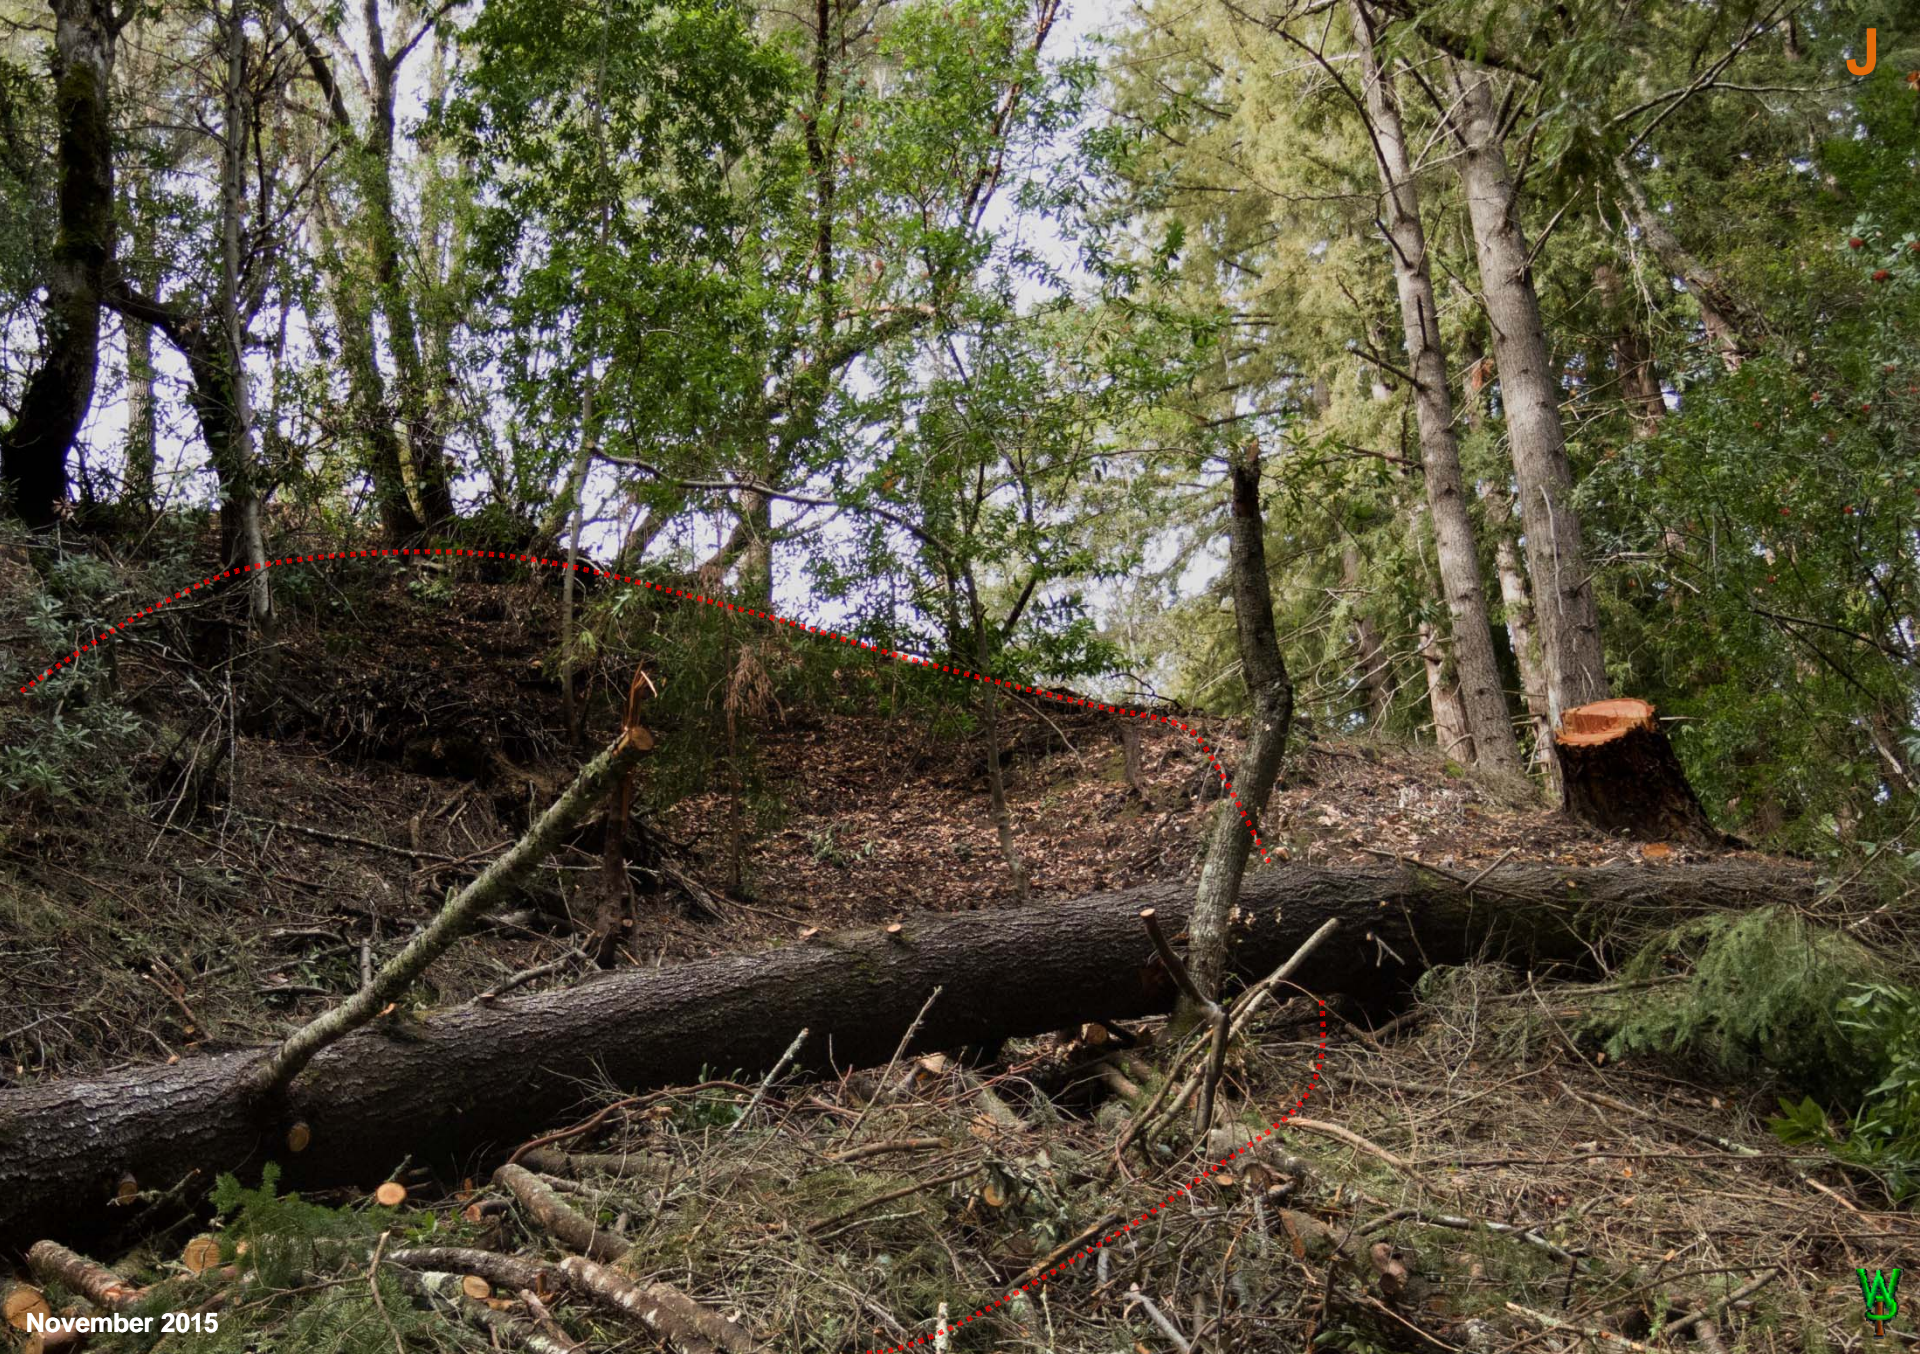
November 2015

Like this. This hole from a fallen tree is about 30 feet across and twice as high. This type of erosion is called "pit and mound." This is how trees undermine the slide headwall and cause entire slopes to fail as we saw in the section on [redwood logging](#).

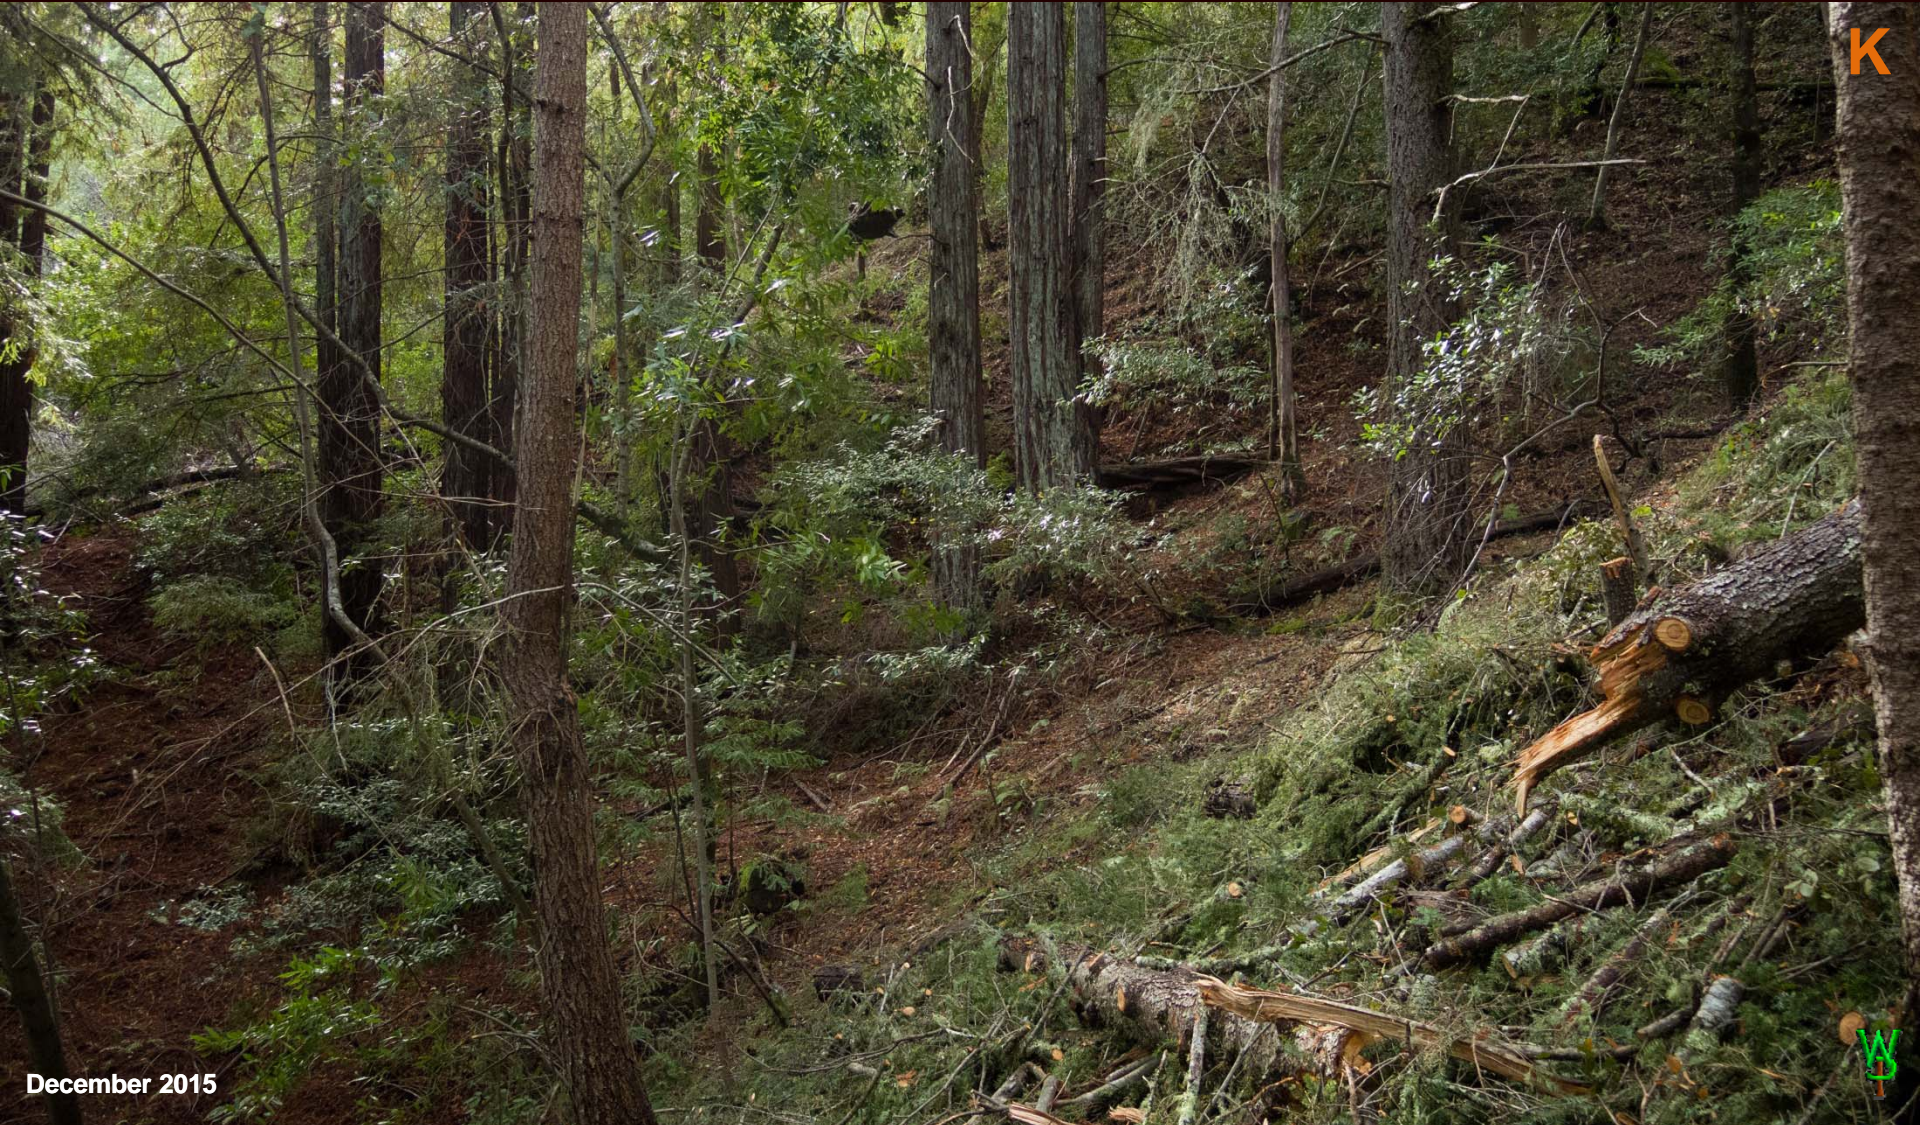
December 2015

Below the headwall on the north-facing wall, half-way down toward the main drainage, we have 60-70 year-old redwoods with fir and redwood more recently invading the south east wall (foreground). There is a problem with redwood: Except for the lower slopes on the bottom of the gully, tall trees susceptible to windage on a weak substrate are hazardous. Over the intermediate term of 100 years or so, they will likely fall and tear out huge holes, destabilizing the slopes above. Redwood does fine in the bottom with thimbleberry snowberry and other low growing covers, but I may have to keep it smaller on top or grow something else. On the steeper south-facing side, I'll grow toyon and coffeeberry at the top because they are light, deep rooted, don't burn easily. Toyon regenerates rapidly from roots when coppiced or burned, as will madrone farther down. The fir and redwood on the south-facing side probably has to go because it will shade out such low-mass deep rooted trees and shrubs. Fir will not do well in the shade north of larger redwoods.

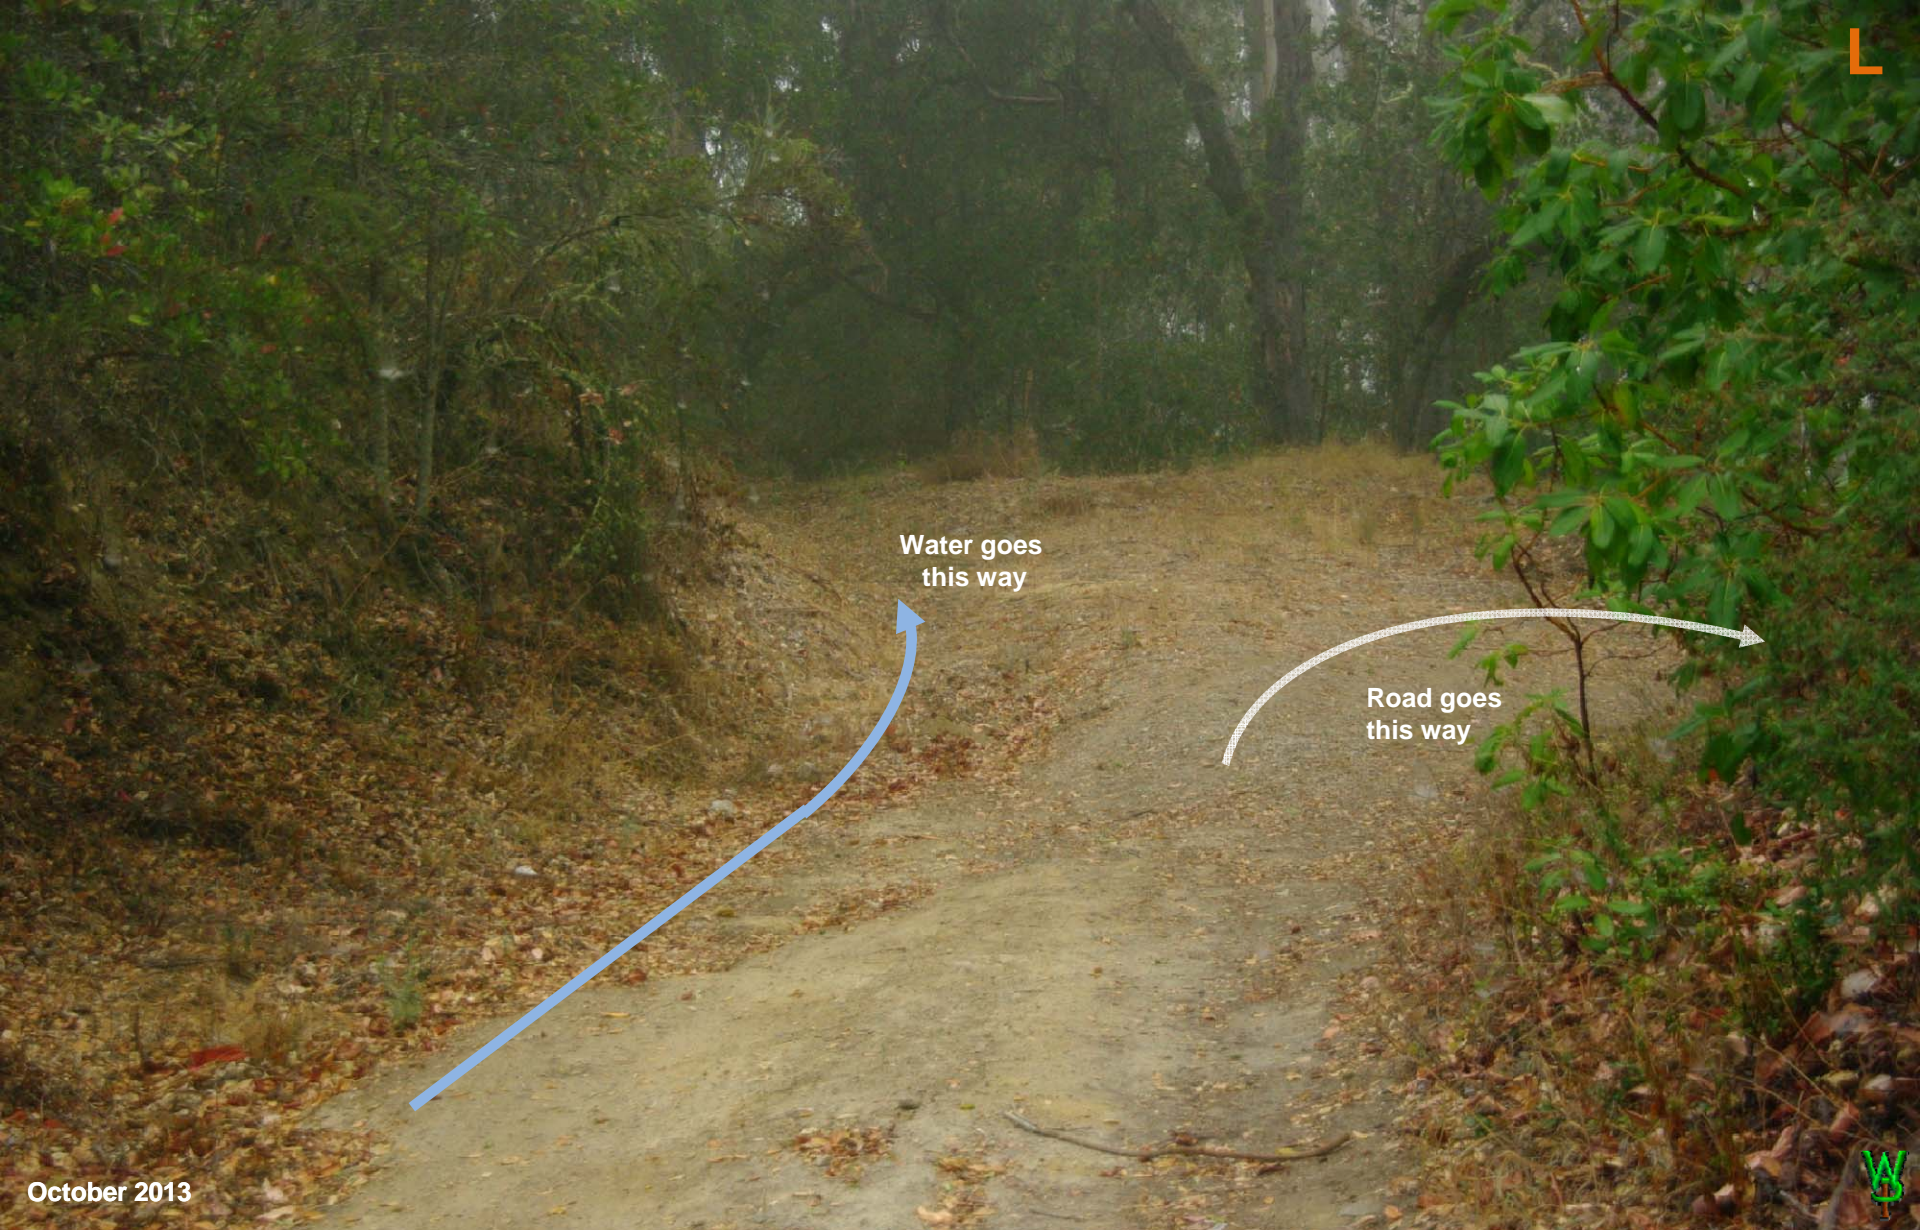
October 2013

To reduce erosion on the road I had to reduce the flow of water onto it at the entrance and then distribute the rest. The first step was to divert what was coming off the County road into the eucalyptus stand. This entailed a requirement for sufficient capacity to take all the water coming down the County road for nearly a quarter mile in the event that but a single County culvert plugs (it's happened). That collection area is now 15-16 acres because so many landowners along that stretch dump their water onto the County road... because it is **a commons**. It was already coming down this road entry so I simply made the best of things. I need to clean it out too.

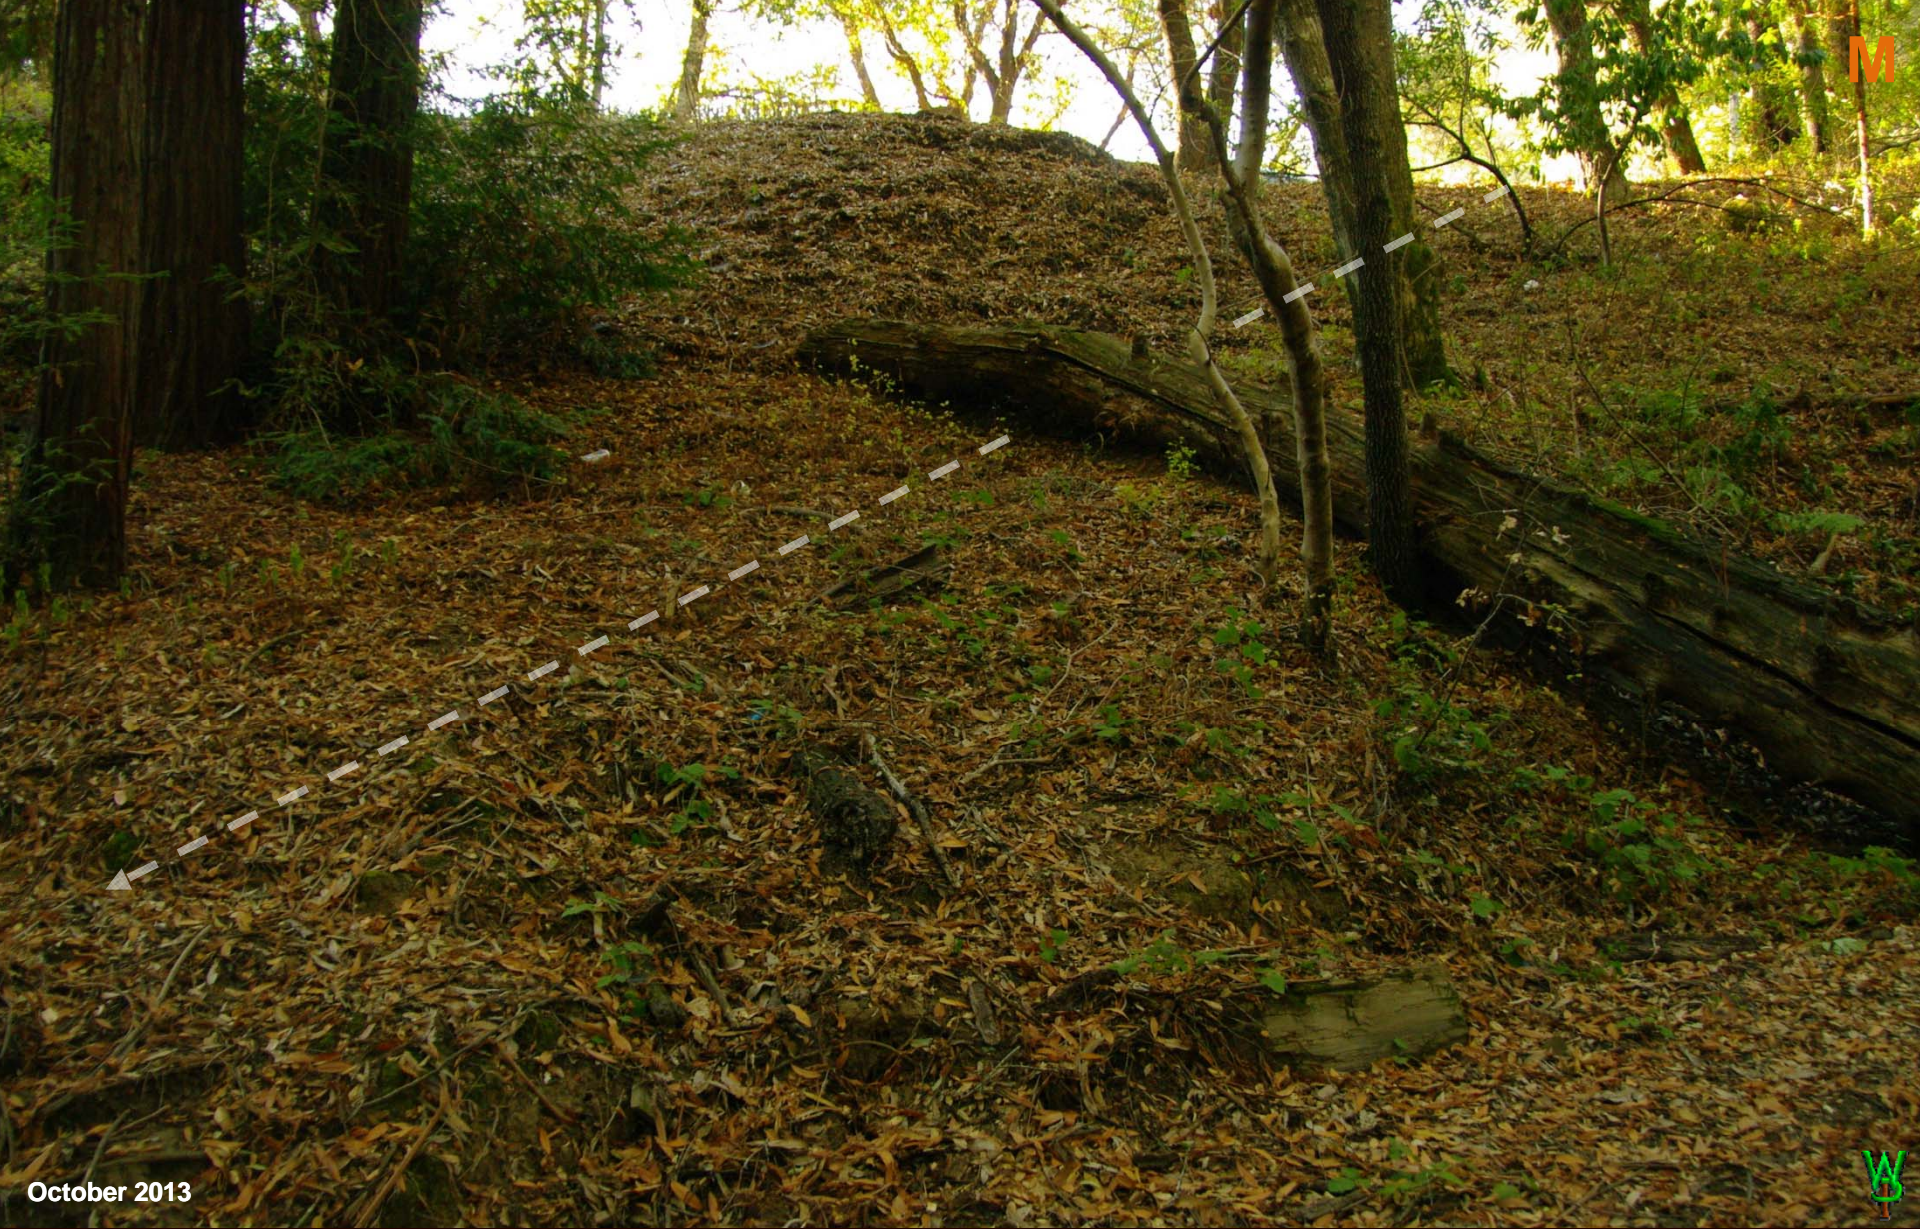
October 2013

Then I filled in this long abandoned road segment (arrow) where the water originally entered Fenn's road. This was a Type II case turned into a useless gully. So, I retired it in 2003 by having the County fill it with ditch cleanings and then I graded it out. This kind of thing takes a lot of fill, 6-8 dump trucks worth. The County lawyers ordered the Department of Public Works to stop doing this because somebody sued them for fill contaminated with wood (despite having signed a release agreement to take it as is). Public Works has to truck the fill some 20 miles to a landfill and I have a harder time getting fill with which to fix old problems.

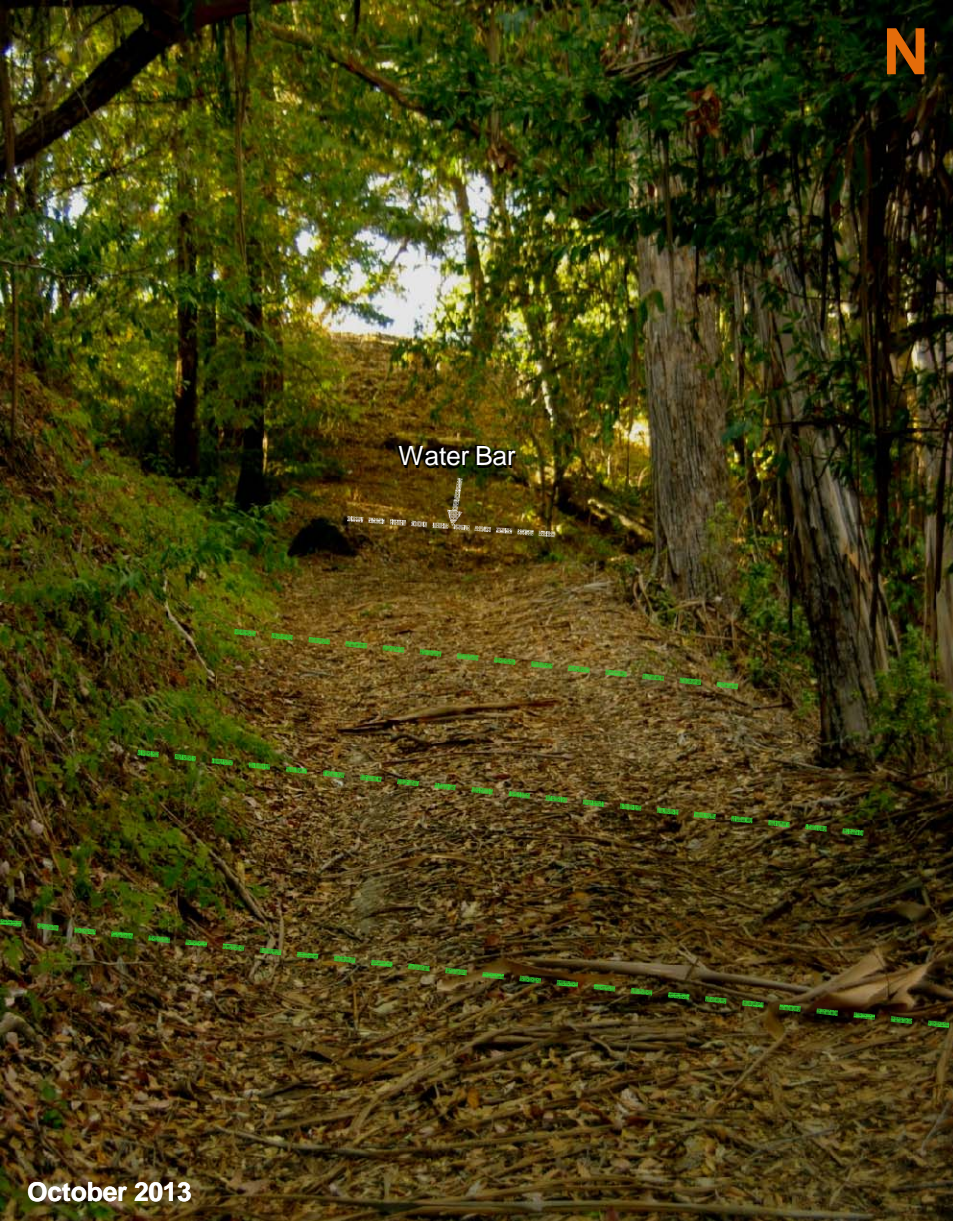
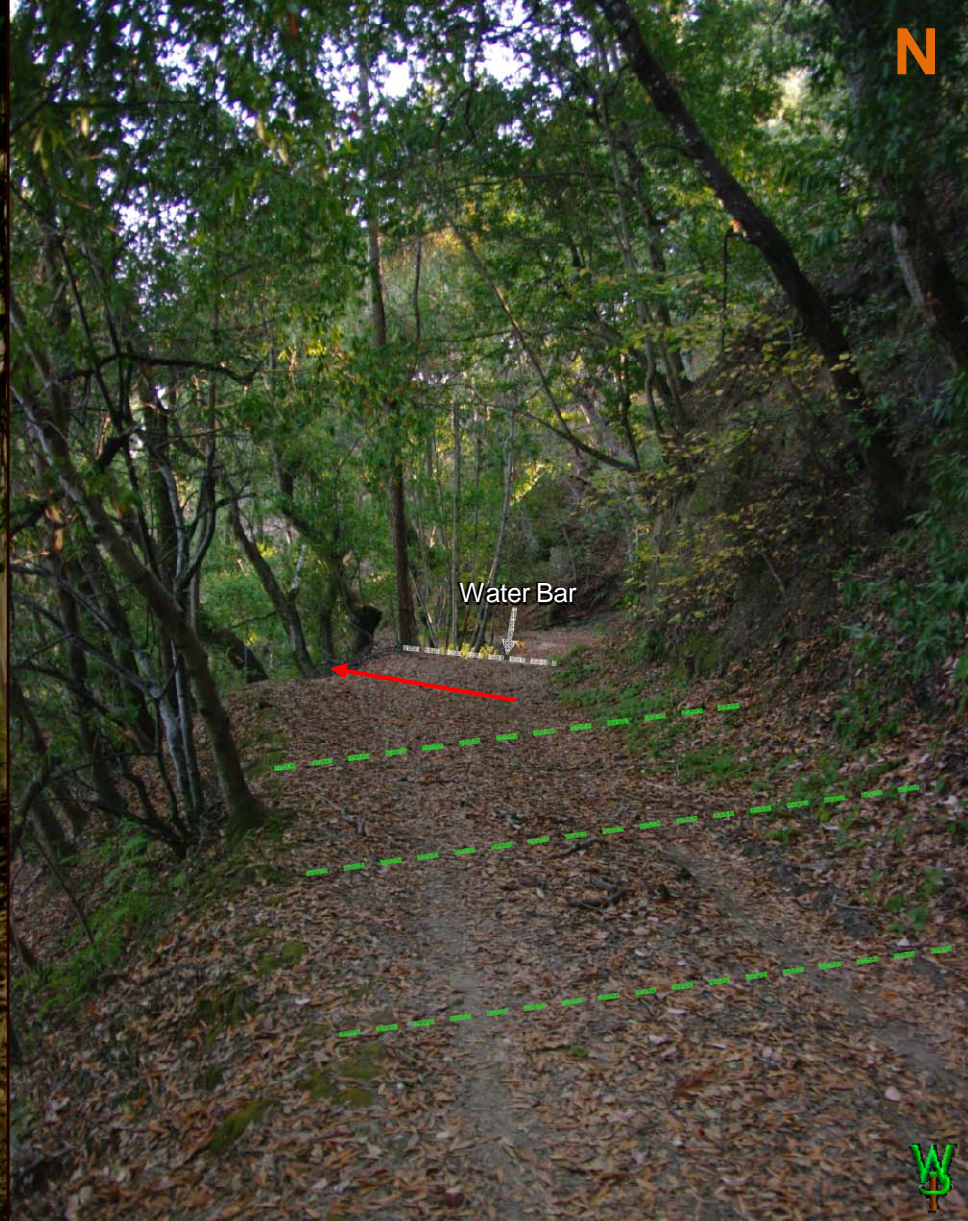
October 2013

Like this. Down the road, I installed and maintain 2 concrete culverts (plastic burns) with water-bars behind them in case they plug (the culvert at left is above the water bar). I also had other out-sloped water-bars made to shed the water at outside corners (right). These drainage improvements are separated by less than 100 feet. As long as the culverts are cleaned and we install a gate to keep joy-riders from tearing up the water bars in the winter, this is stable. If and when I come up with more material, I can then reinforce the water bars and build more of an out-sloped configuration which will reduce these concentrated flows (ideal grades in green).

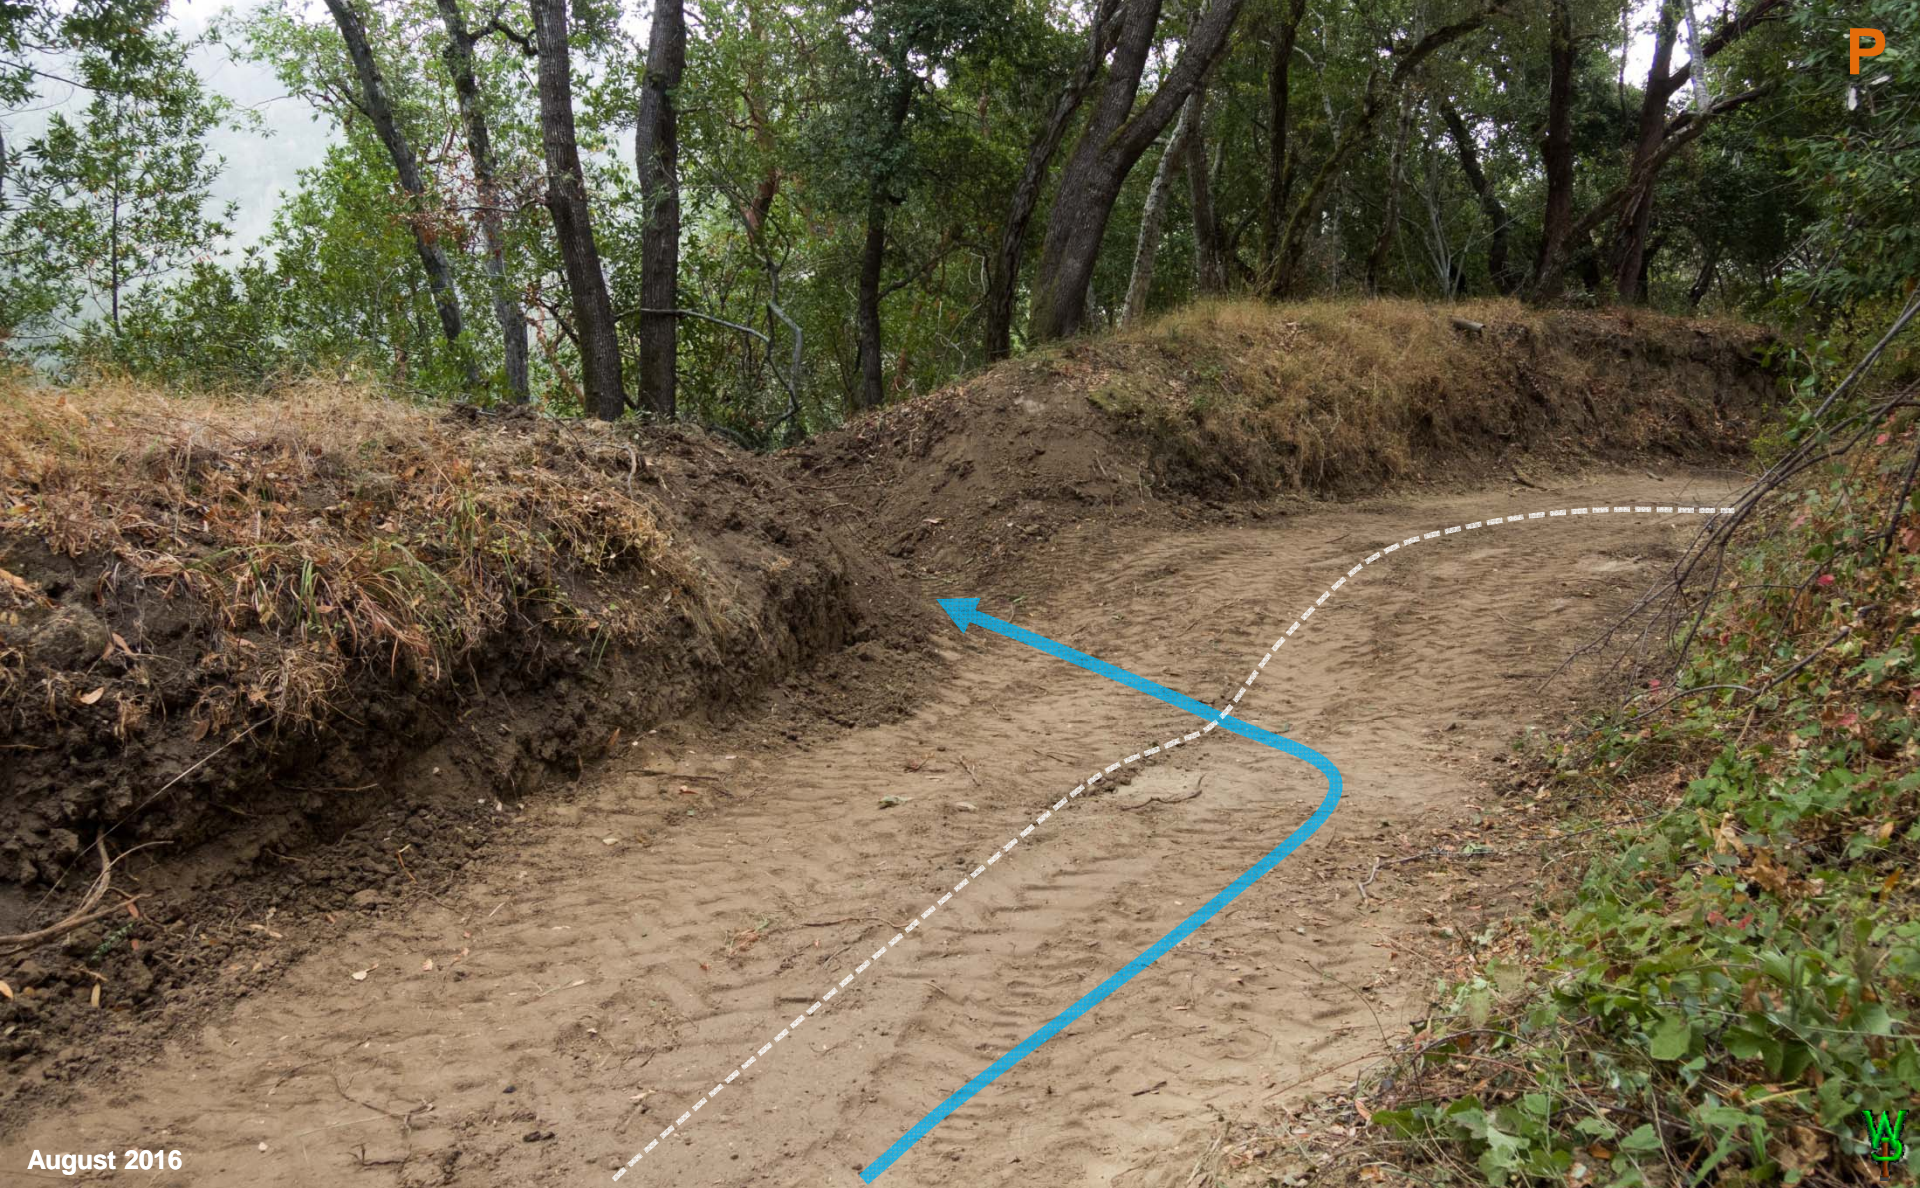
August 2016

Farther down Martin's Road adjacent to our property is this Type II channel. The cut extended over 100' without an outlet, so it became an incising bog in winter. Here, I've made a substantial and gradual water bar out of an overhang that I sloped off farther down, channeling the water through the embankment. In making that outlet, I exposed what may be the best accumulation of native soil I have yet found. It will definitely be analyzed, as such opportunities are rare. I've come to hate driving a backhoe over water bars!!! Years ago, I would have wanted to take out the entire outside bank just to have the road out-sloped and "fixed." Since then, I've realized that this is easily available material for future maintenance, simply removing it from the ends of the outside embankments.

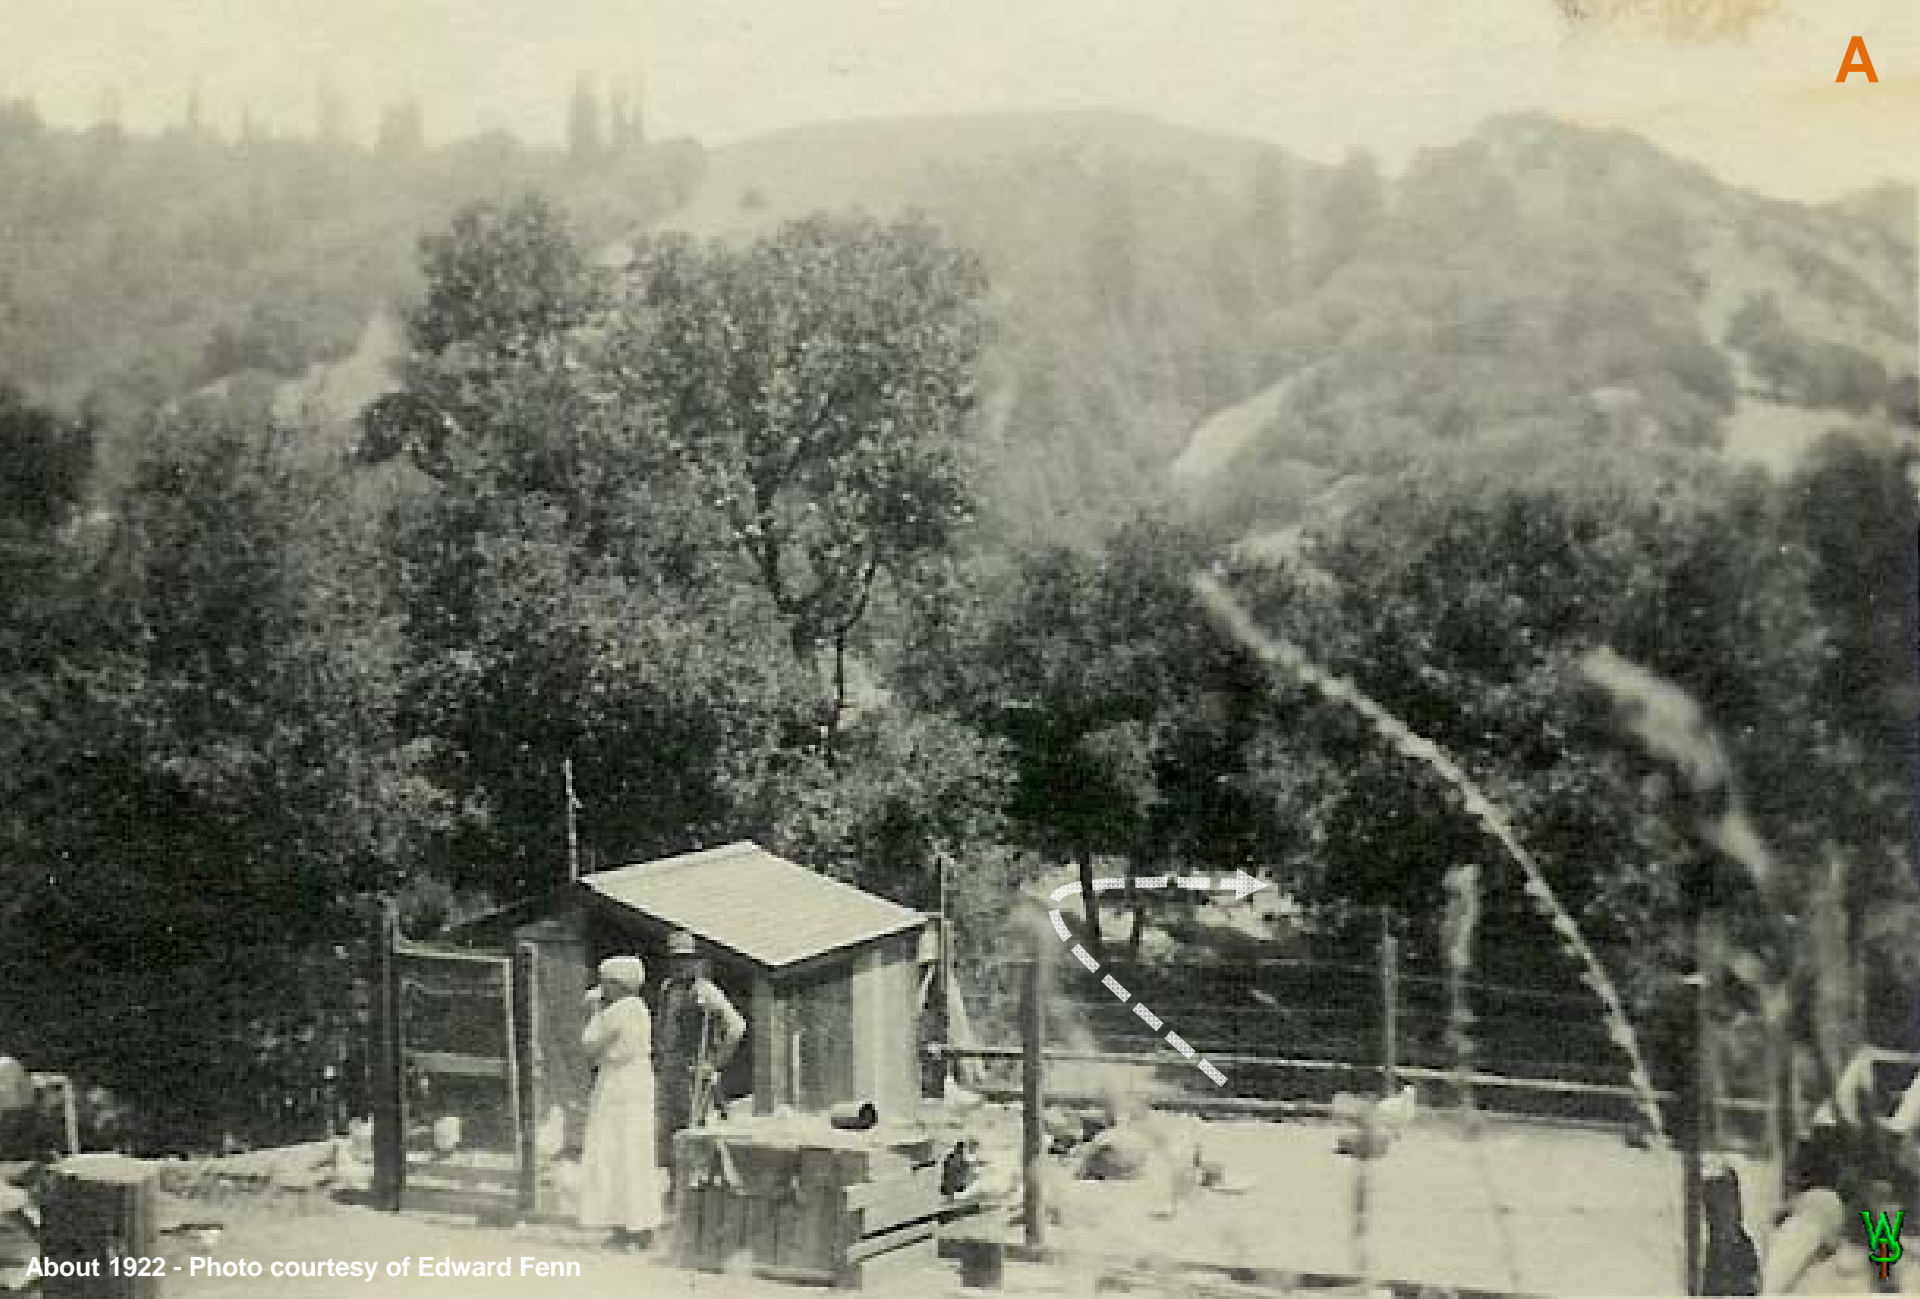
About 1922 - Photo courtesy of Edward Fenn

To the right of Ed Fenn's house in the last old photo was his chicken coop. Below it you can see the outside of his road to Glenwood (arrow). There was probably no outside shoulder; rutting probably started what you are soon to see. Note the young trees. What happened in this spot is representative of what we see elsewhere with old roads all over the American West.

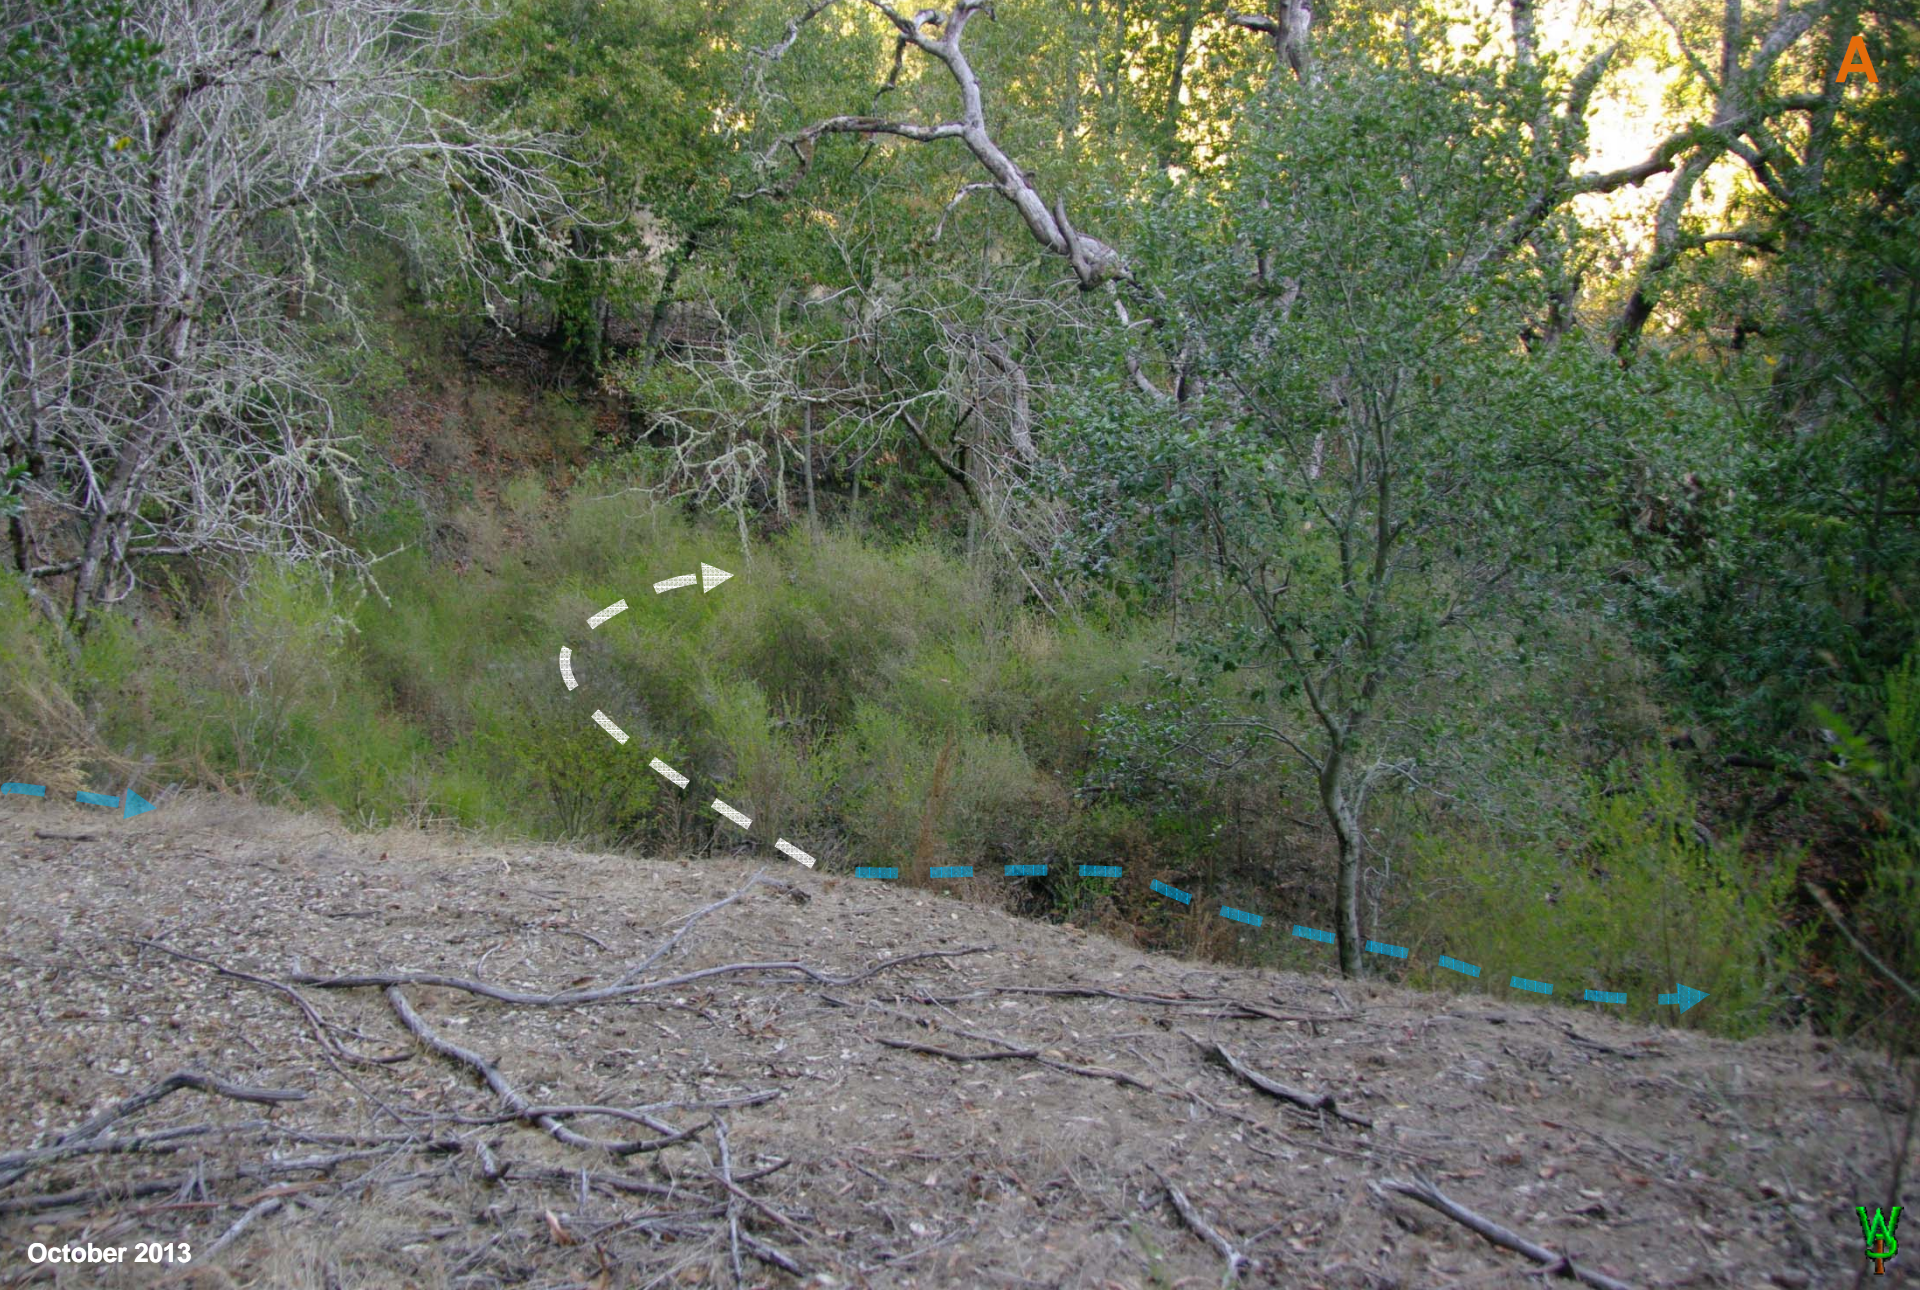
October 2013

This is a view of that same spot today from closer to the edge (because of vegetation) and without benefit of the height of the porch. Obviously, it would be easier to see what happened without all that broom. I'll see what I can do to get a better image after the property owner and I cut some trees. The channel to which I returned the water is indicated in blue.

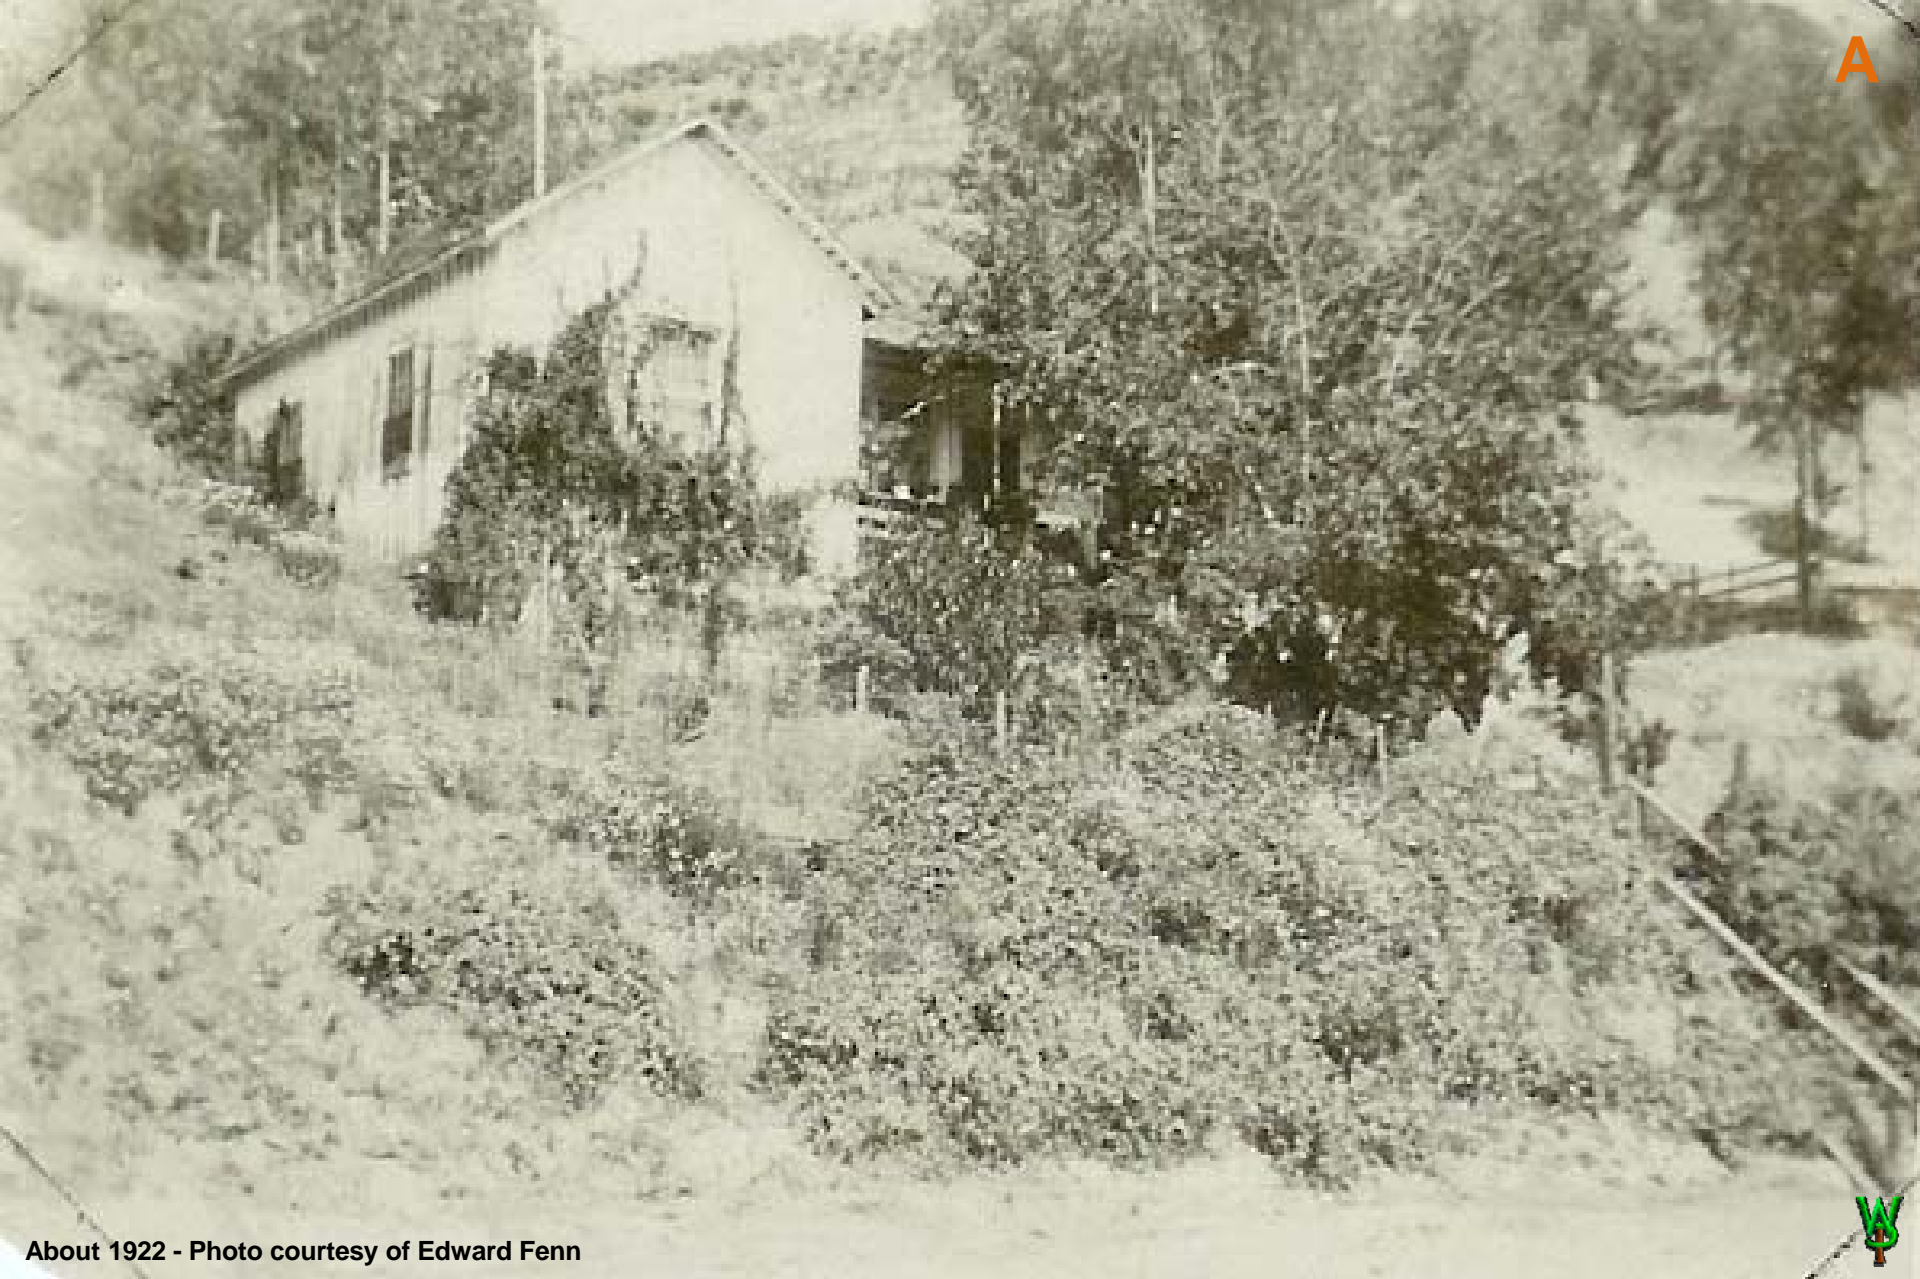
About 1922 - Photo courtesy of Edward Fenn

Returning to the original photo, what developed in front of the house was a Type II failure. The road was graded level across from the slope above. It then rutted and eroded as the water channeled down the surface to the right. The former creek channel is to the right of the stairs in the right front foreground. Despite the diversion above, the collection area is still substantial. Please note the blackberry shrubs on the slope in the foreground, the eucalyptus behind, and the stairs to the right front.
