ROADS TO HEAVEN, TO HELL, AND BACK, SOMEWHAT

WILDERGARTEN 5.4

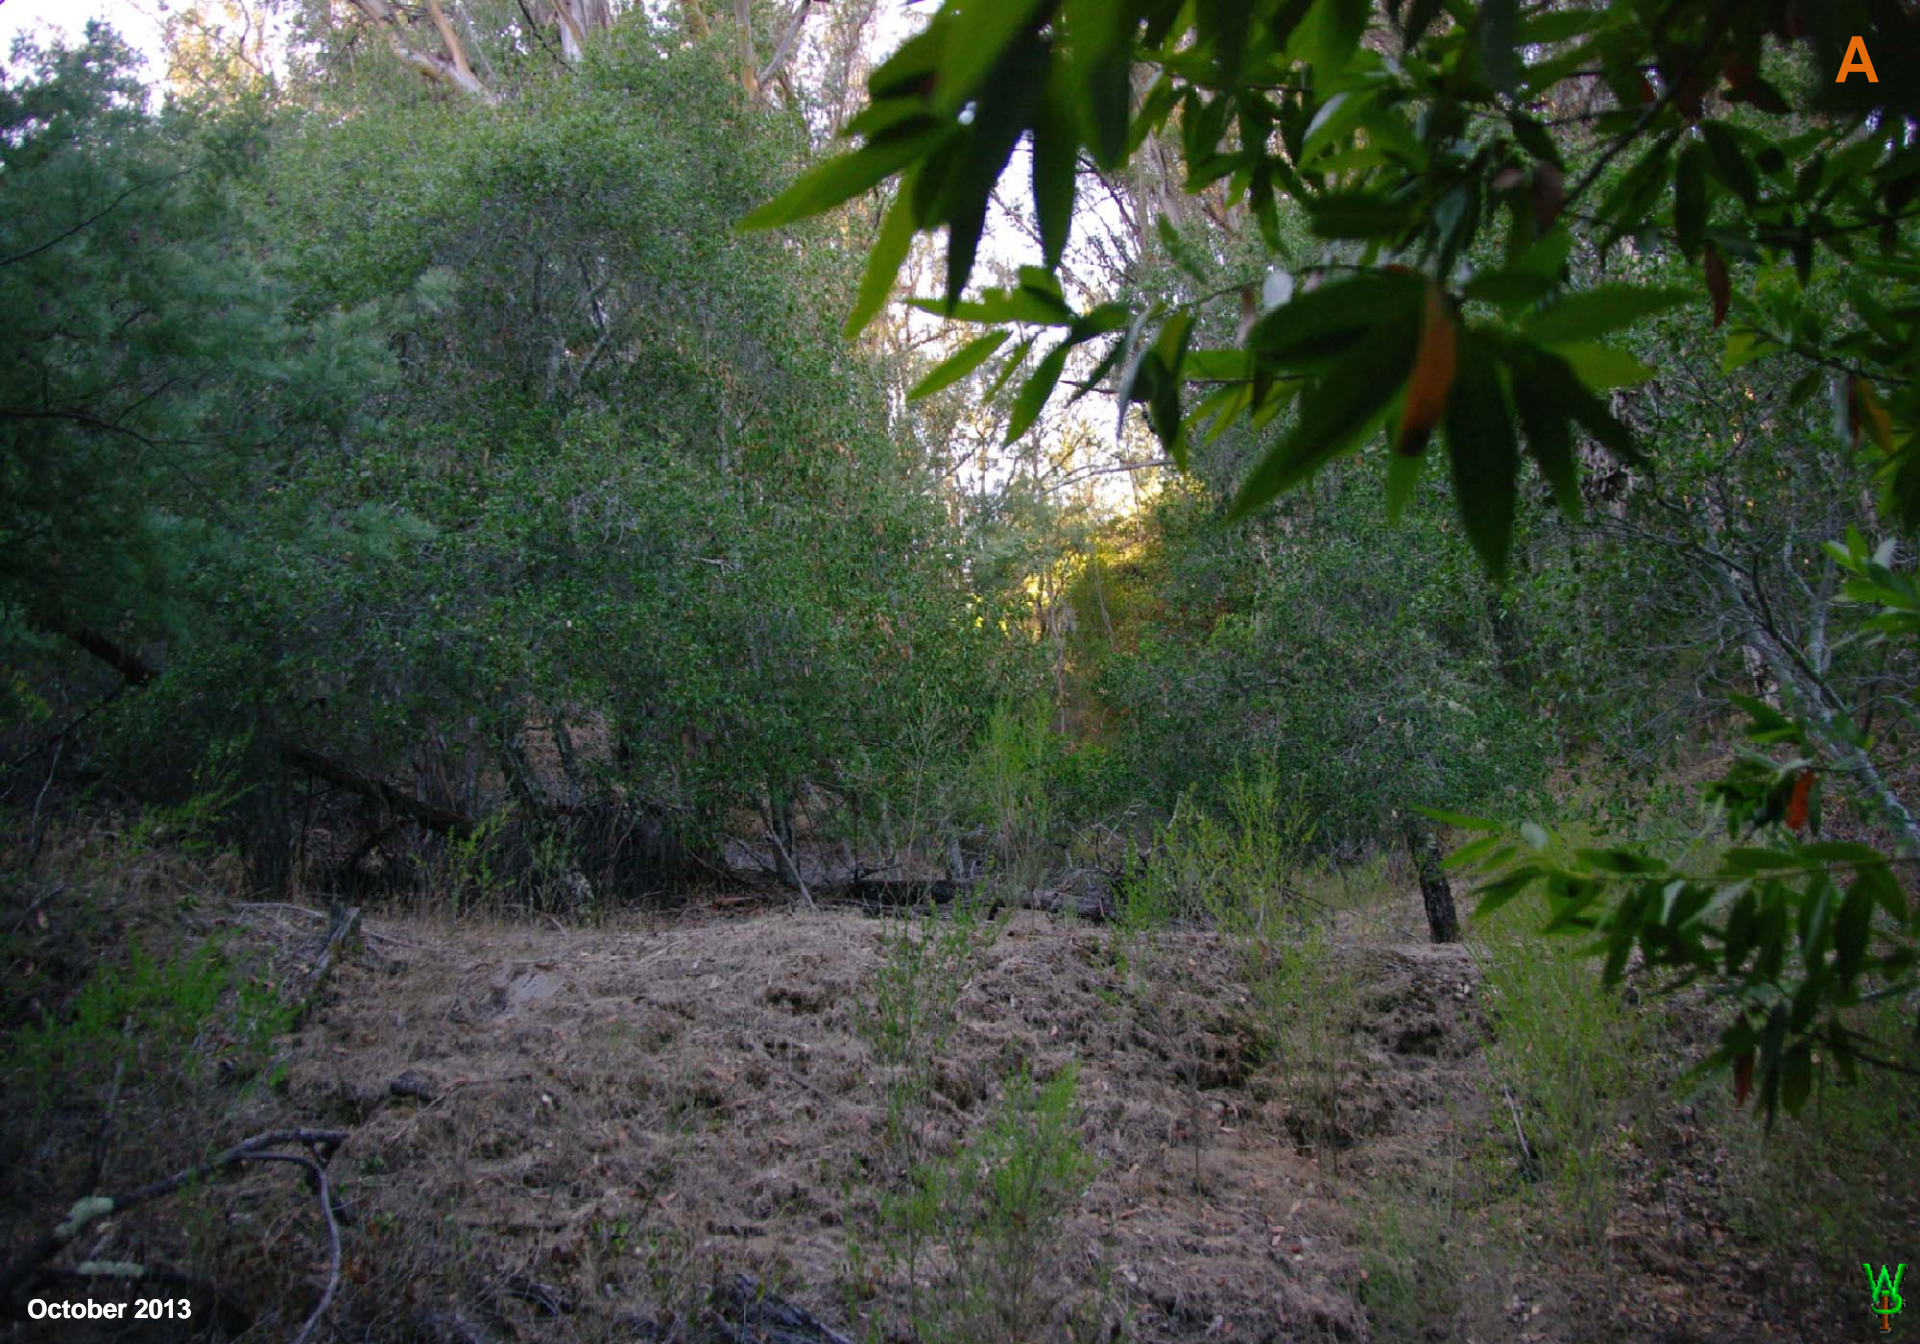
October 2013

Yes, there is no doubt that this is the same spot. I found the old root cellar dug into the hill that Ed Fenn told me would be behind where the house had once been. The redwood “sleepers” that once formed the house foundation are still there.

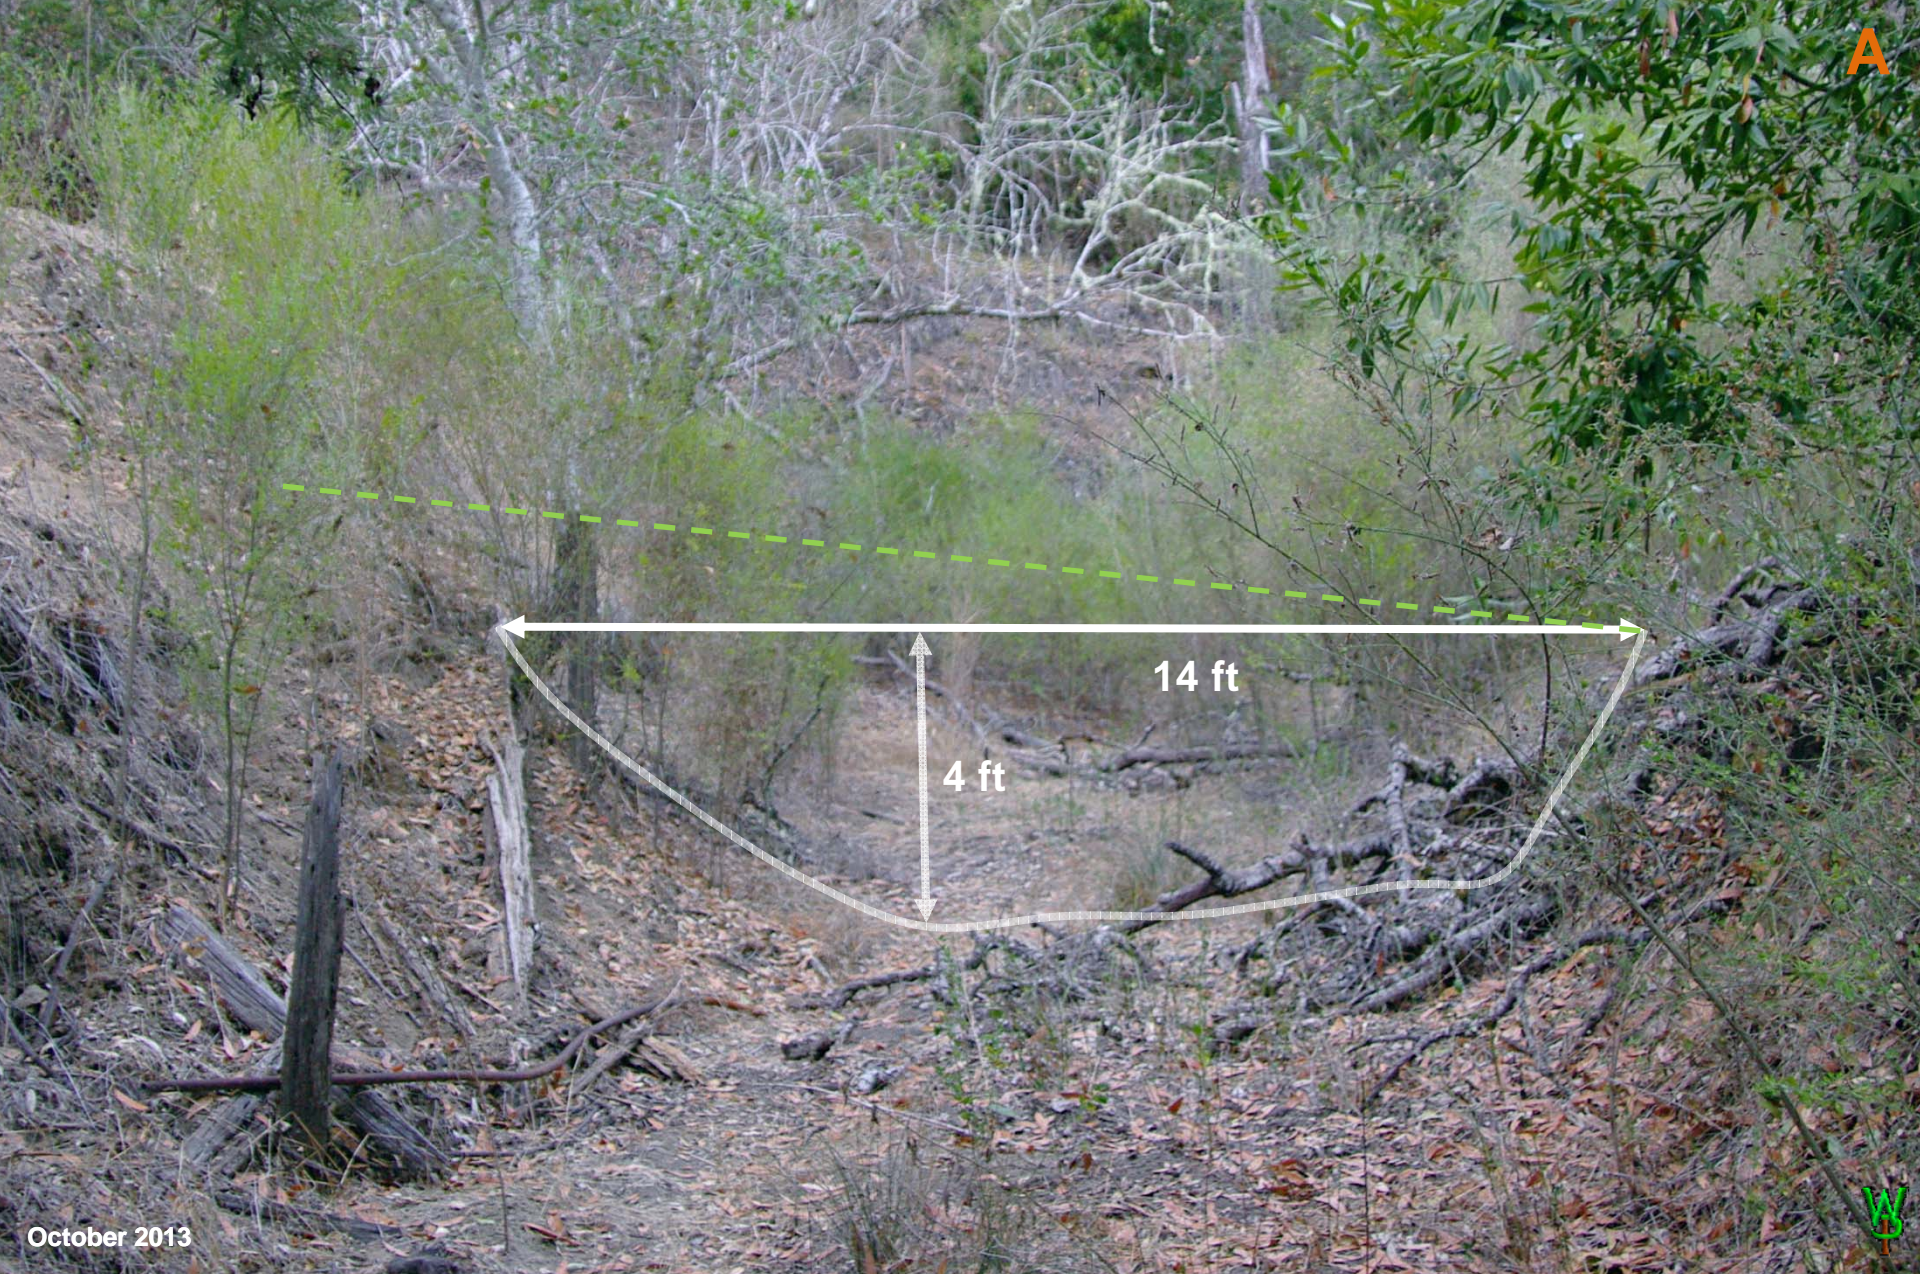
October 2013

Here is the repeat cross-section photo (I would need a ladder for the original perspective). Altogether, I estimate that over 2,000 cubic yards of material have been lost from in front of this old house site. So, where do we get the material to fix it? The rock nose above the road that the County needs to cut back would do the job nicely and would save the County from having to truck it out of the area. It would also enable firefighting equipment to get up the hill from the valley below or provide an emergency evacuation route.

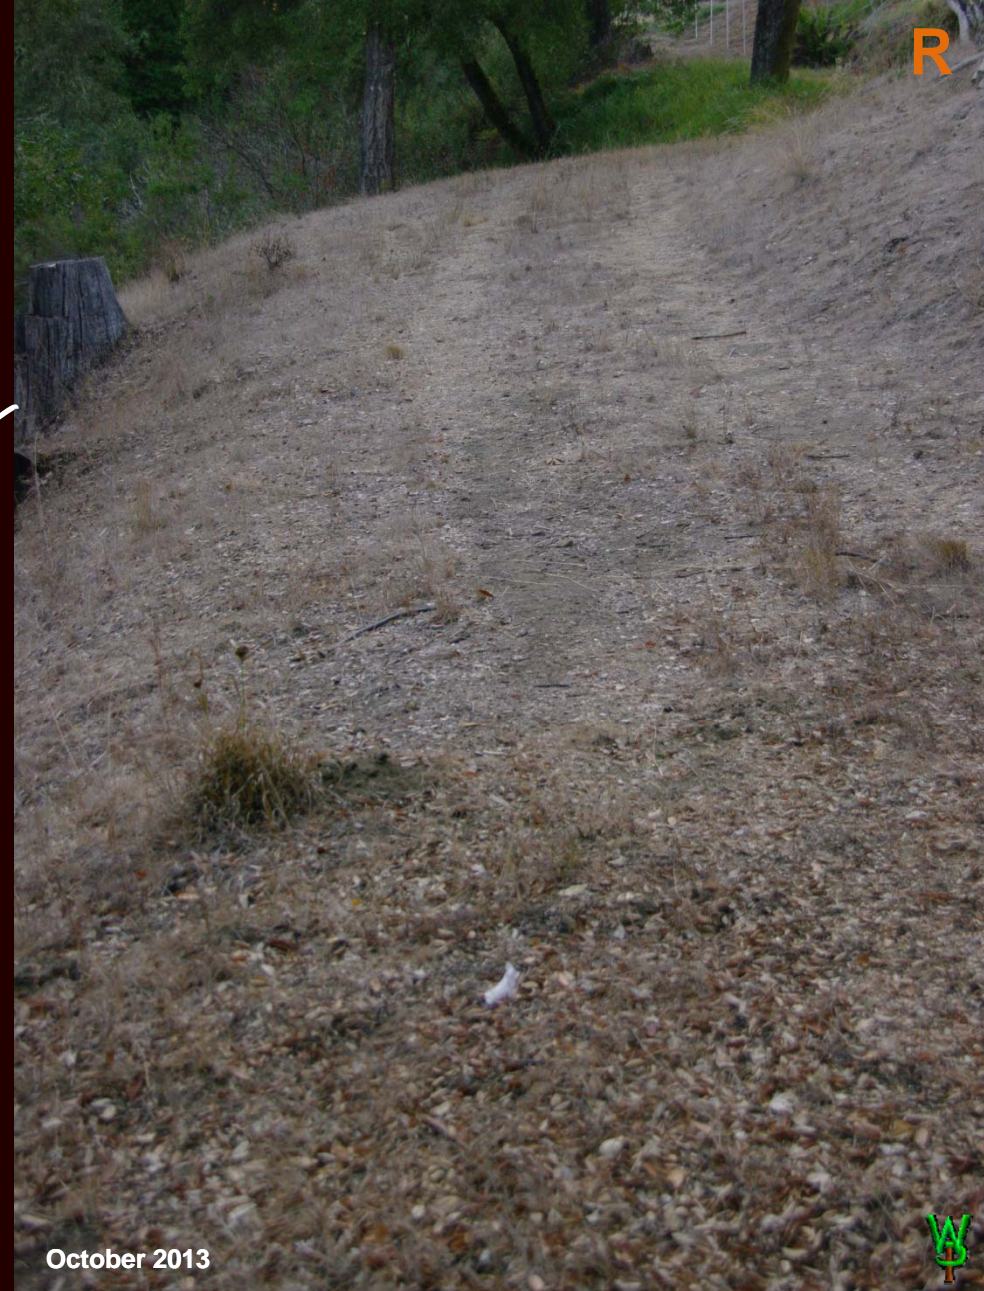
October 2013

As to what I am doing here, I reshaped this old Type I road to an out-slope in 2006. This is typical of the design for timber haul roads today. It is virtually maintenance free and particularly resistant to gopher damage, because there is not enough water at any one point to enter a hole and turn it into a trench. So, why don't I do it elsewhere? I don't have the fill material I need.

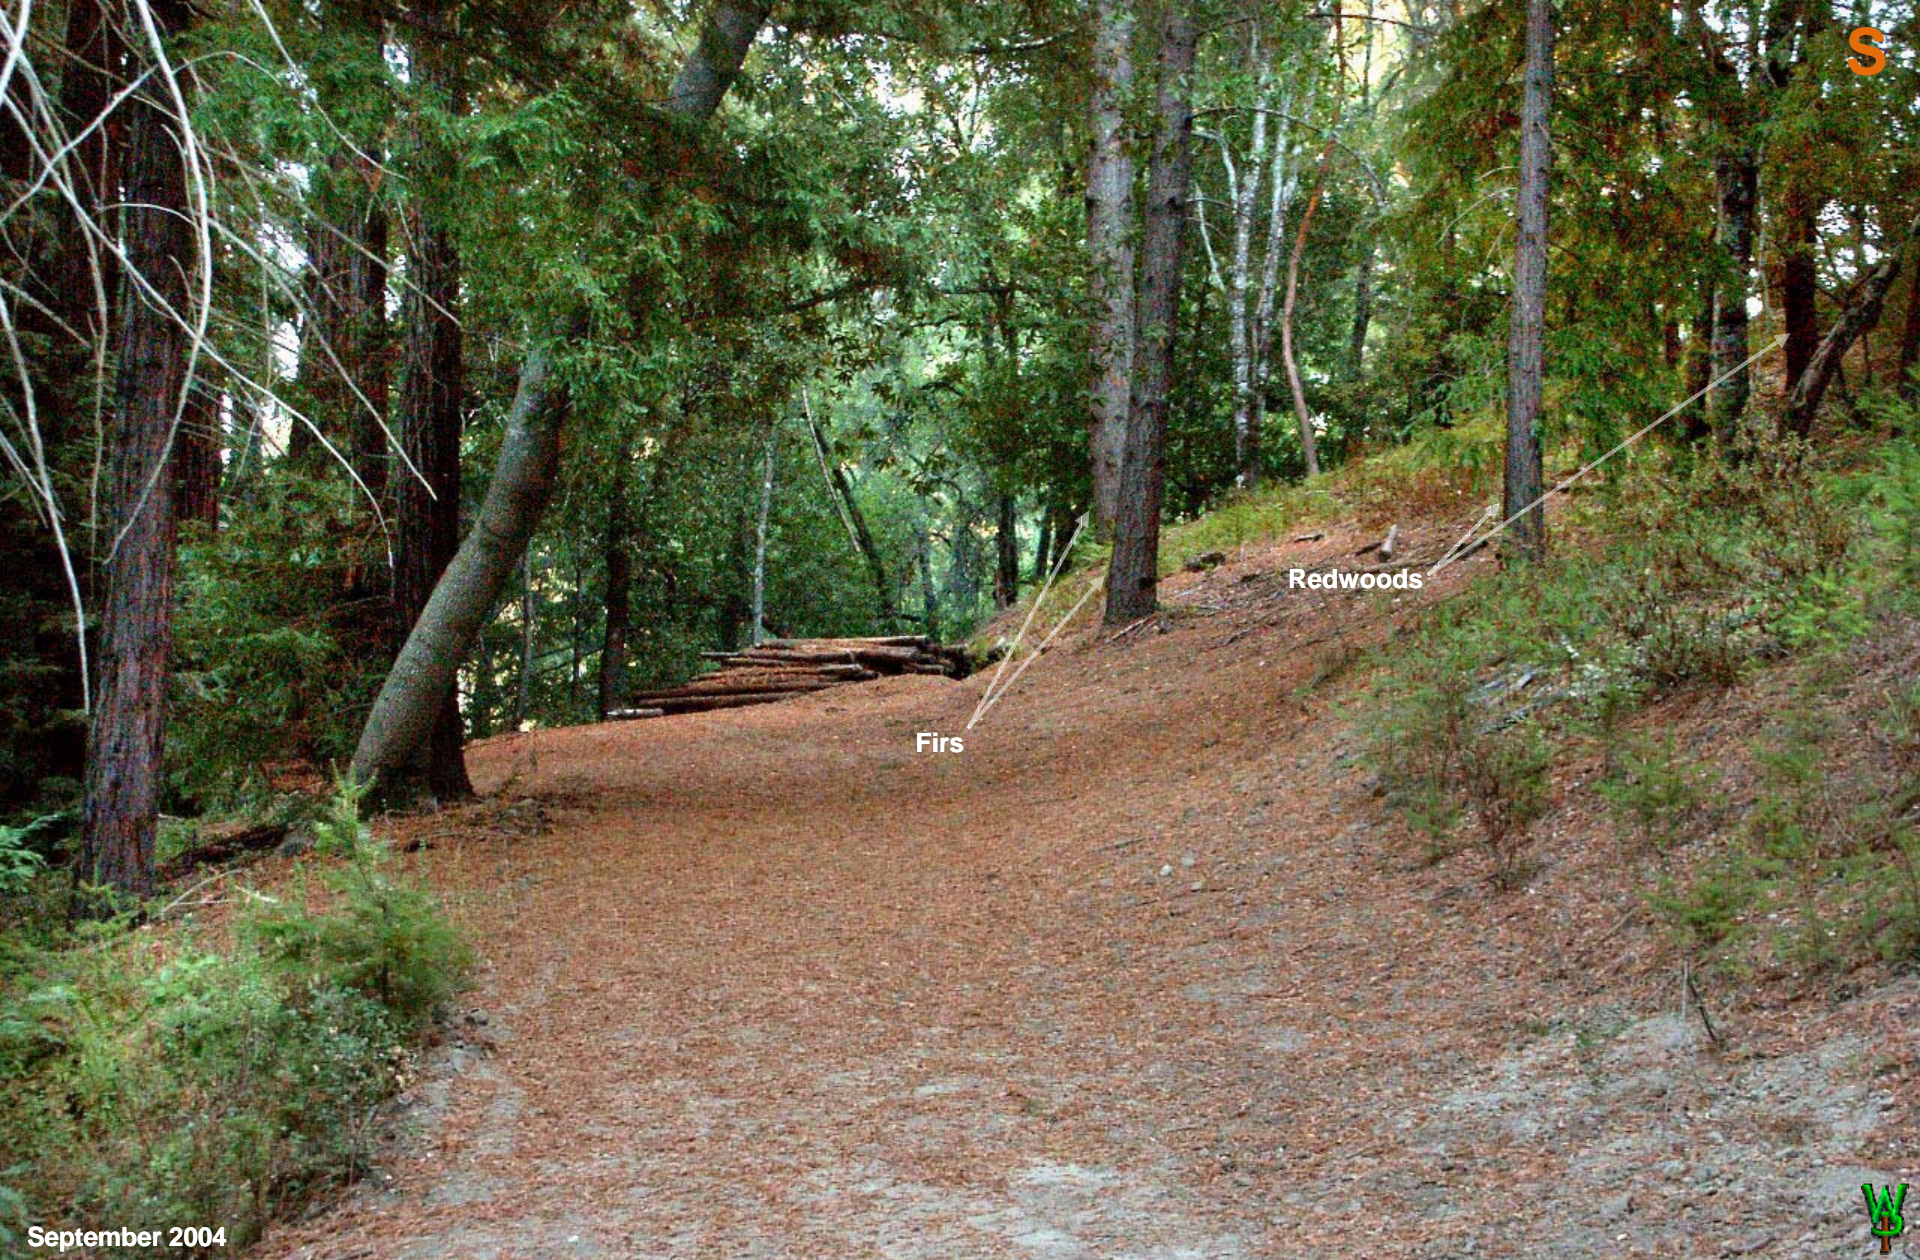
September 2004

This old road was re-graded to get equipment in and material out for both forest thinning and brush control. To that end, I changed the grade from an in-sloped to an out- sloped drainage configuration, thus eliminating the need for culverts. It has worked beautifully to reduce the flow in the channel below, and has required no maintenance at all other than weeding. The two fir trees on the right are there for a windbreak and for high-lead yarding redwood logs out of the stand on the left. The redwoods to the right are now gone.

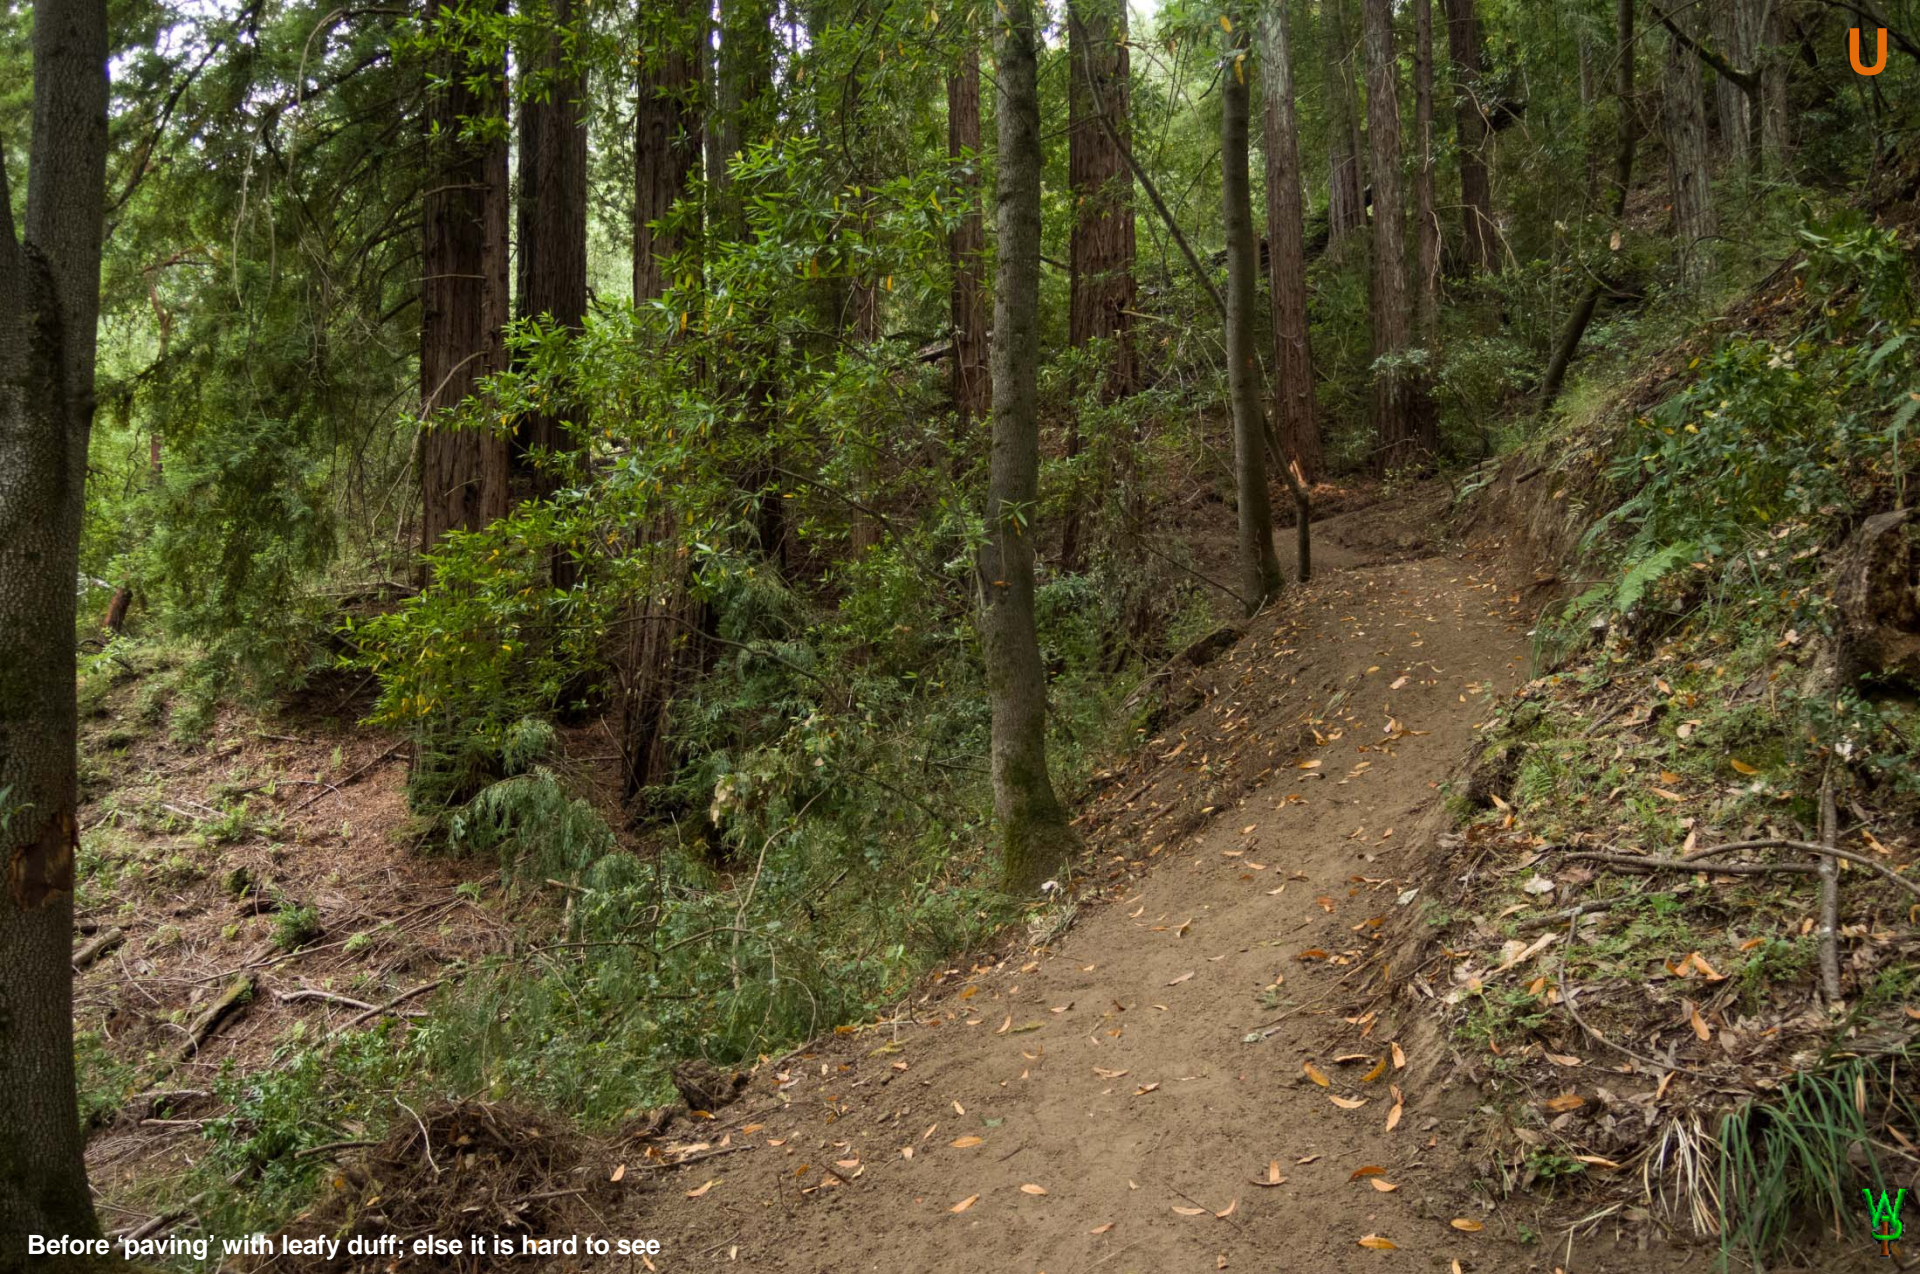
Before 'paving' with leafy duff; else it is hard to see

A word here about trails. Trails are basically small roads. They have similar drainage and stability issues but lower loads and surface wear (although raindrop impingement is an issue). The first time I thought about this was at the suggestion of a visiting docent from Jasper Ridge. At first I was taken aback, but had I known how affordable and useful trails are I would have done this many years ago. Picking trail routes is one of the more satisfying art projects I've undertaken in a very long time. Animals love them.

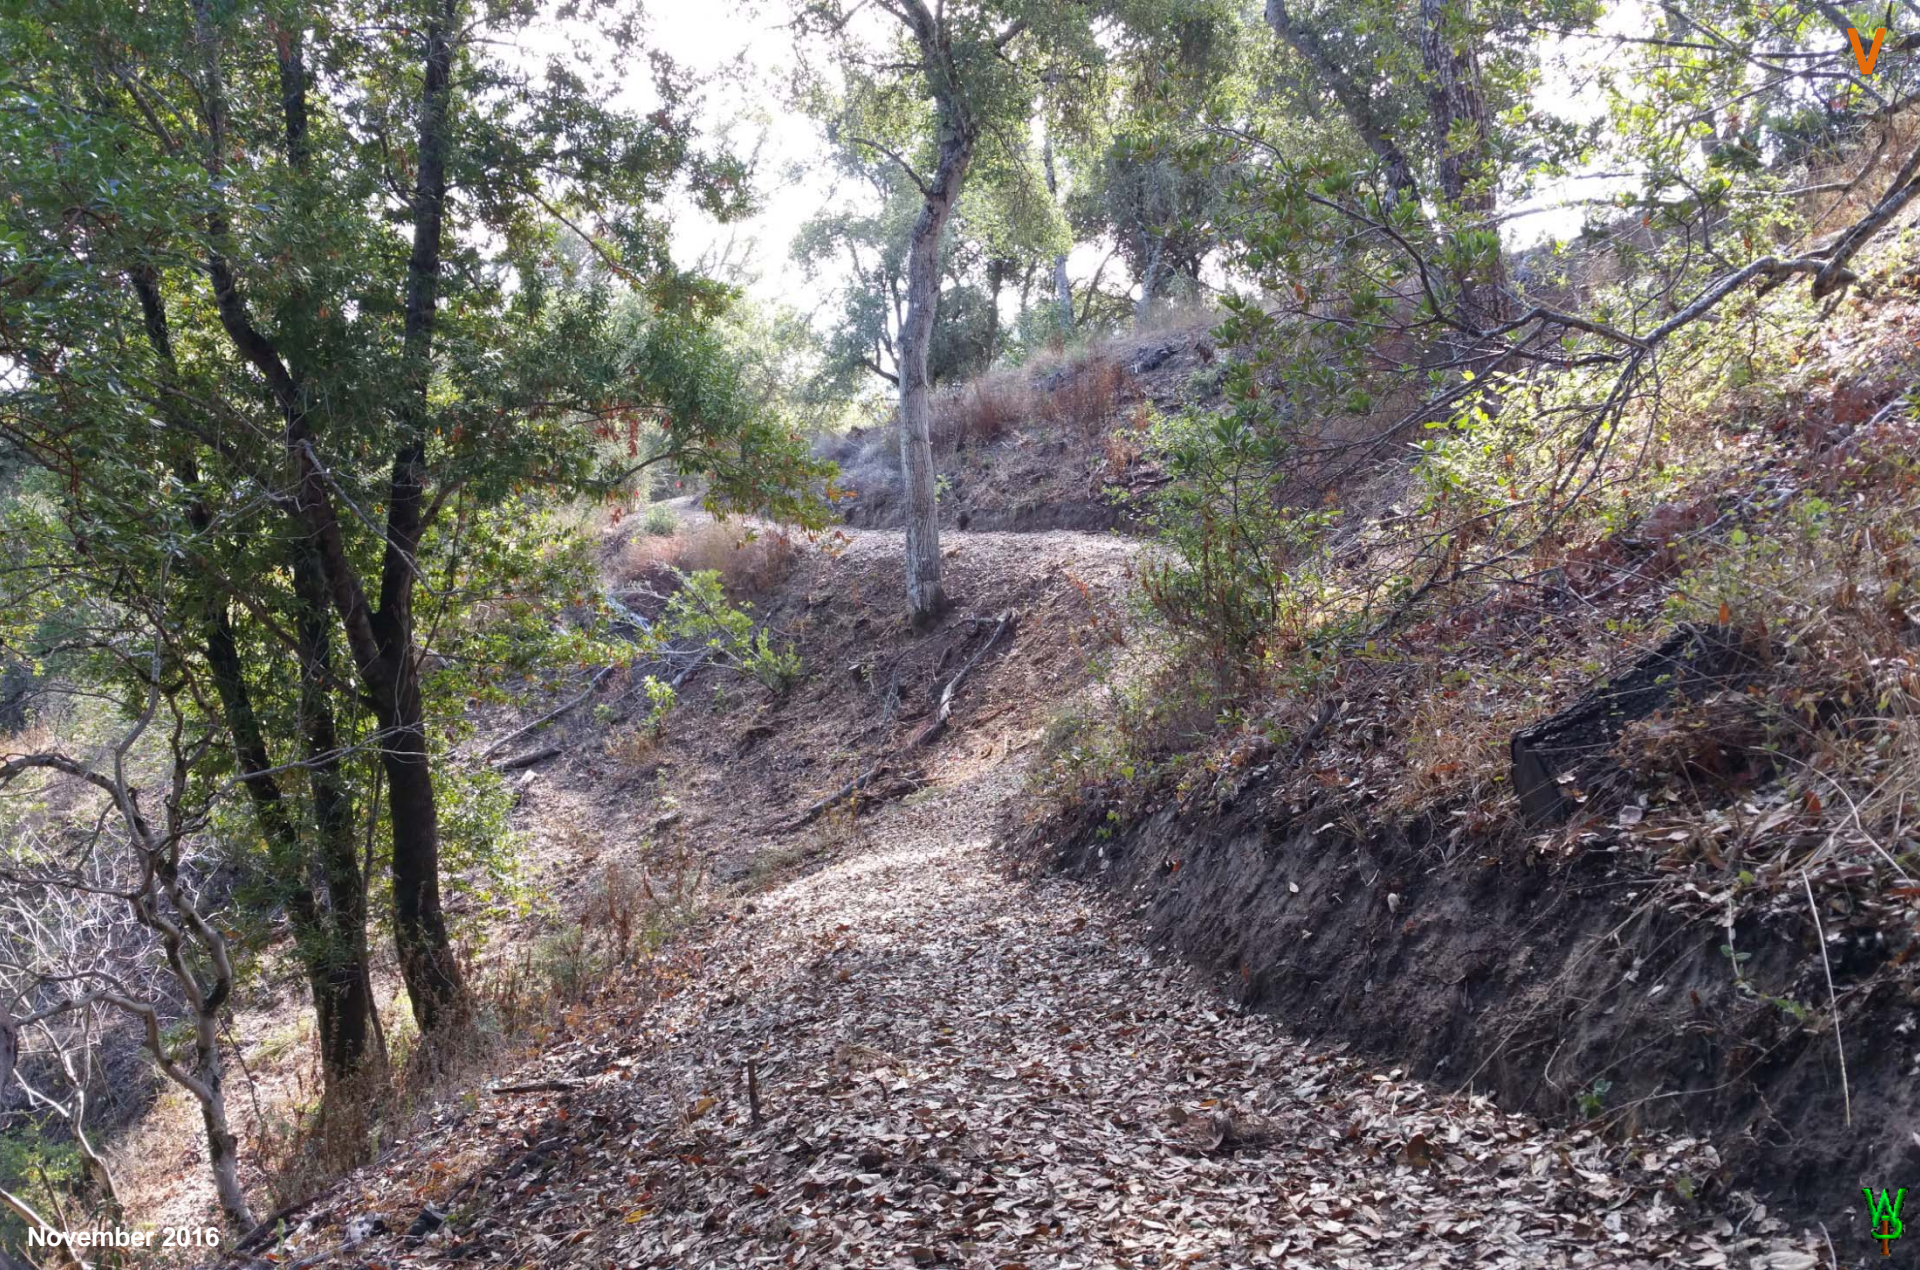
November 2016

Making trails is a lot of work. An excavator capable of digging one cannot make an out-sloped surface (too dangerous to the operator when he catches a root). The out-slope gets built by pulling material back up to the uphill side of the path with a rake, or in buckets and chipping off the top edge of the cut from above with a pick. Clods get broken with a vibratory plate. Then a hand-rake shapes the surface. Water and pack it with the vibe plate. Then "pave" it with leafy duff to protect it from raindrop impingement.

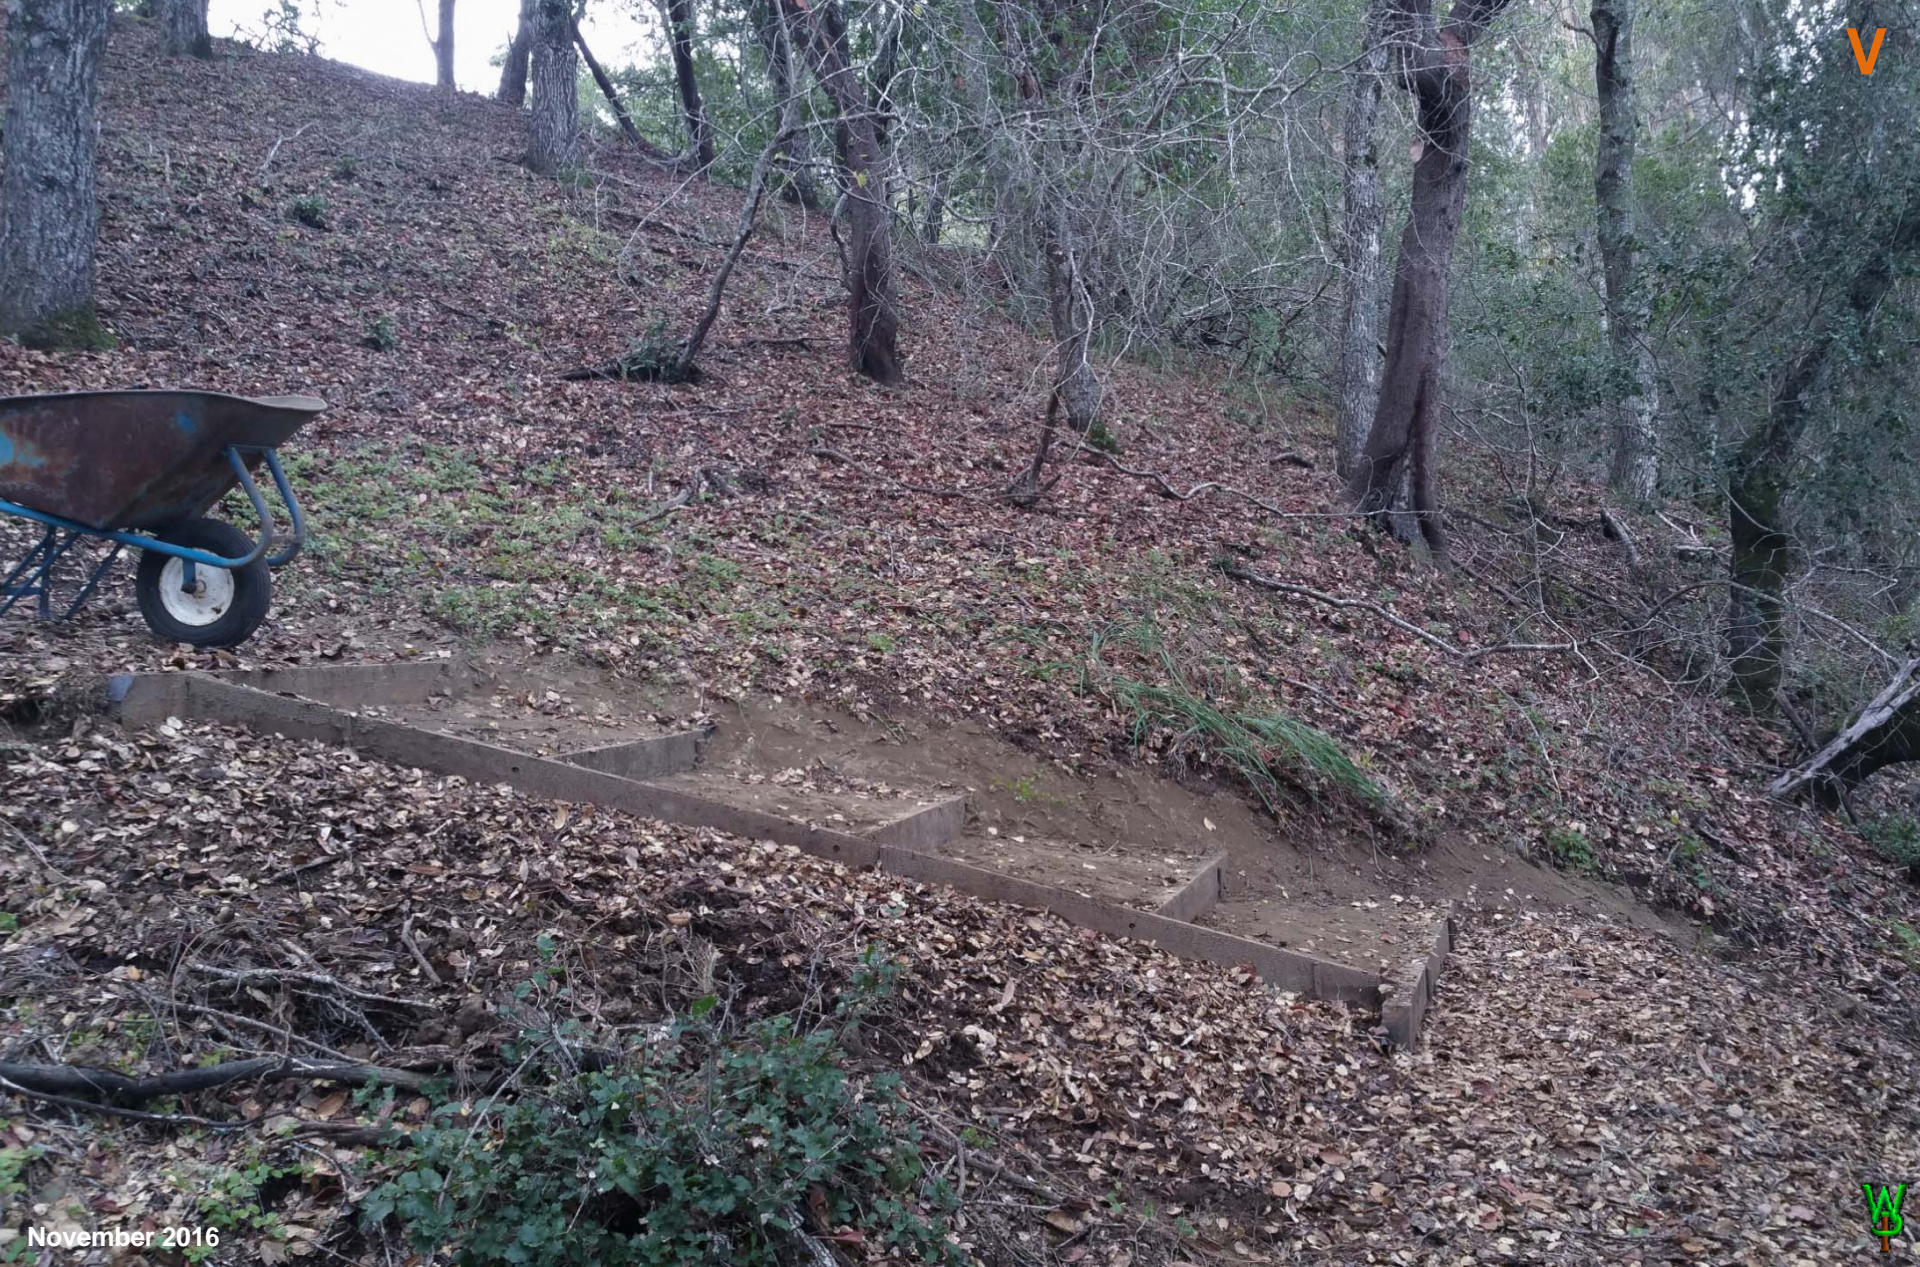
November 2016

Stairs help keep the grade more manageable. Making the stair frame is one thing, bringing in the fill is another. By the time this spot was compacted, it required almost six yards, which may not be a lot of fill to move with a tractor, but it's a lot to load into a wheelbarrow by hand and creep down a steep grade for a couple hundred yards. So it's wise to plan the route such that moving dirt is minimized but then, it's also wise to keep the grade of the trail low to minimize surface erosion. It's about tradeoffs.

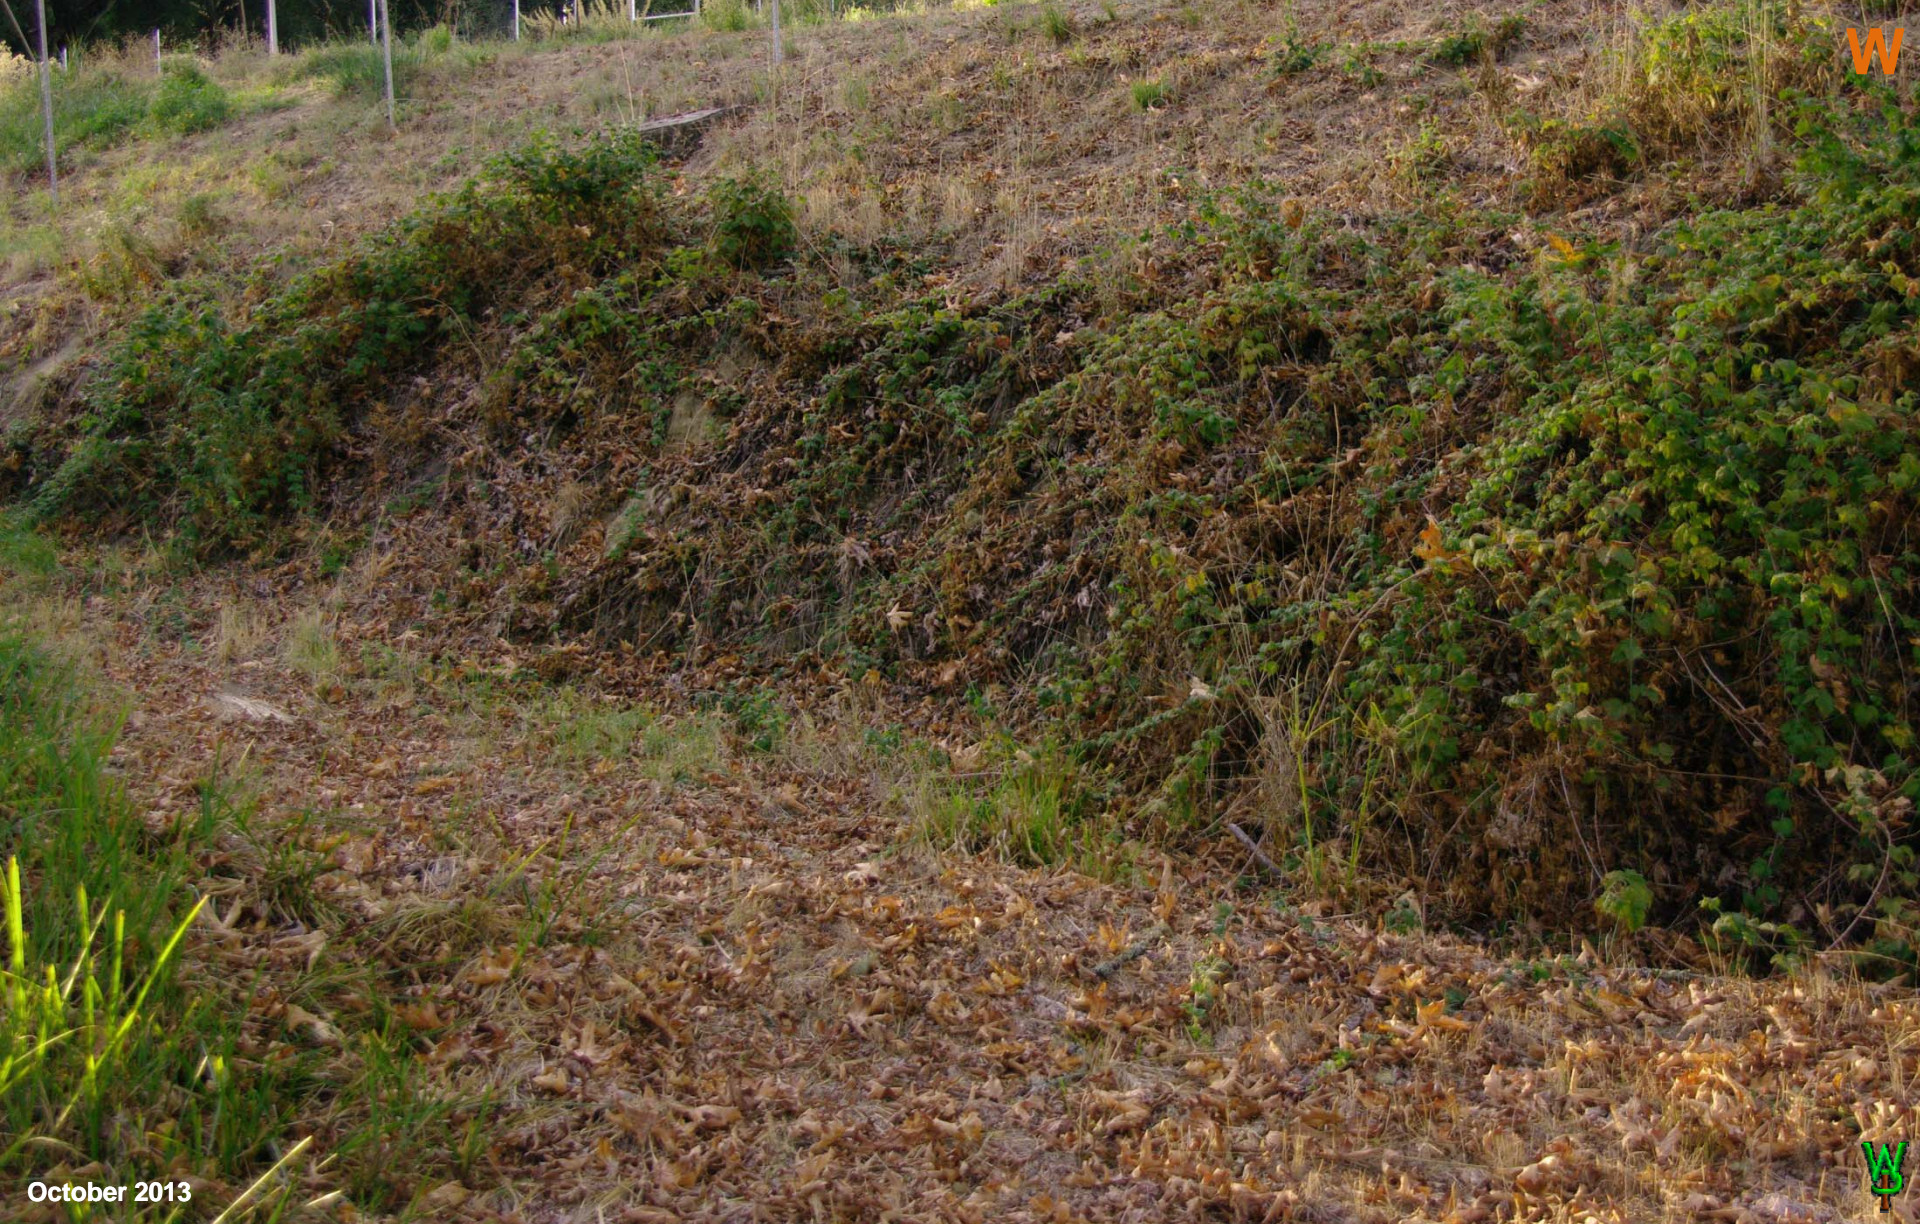
October 2013

But are all my roads perfect? No! There are some that could be better, particularly in how they collect water. The problem with this culvert is that the east facing slope on the northern half of this place (down to the left) is so steep, there is no good place to run the water down it. Sometimes you have to make one, as we did in the case of the rock drainages you have seen. That just takes time and money to get done. I've done one channel every several years with two left to do. Hopefully I will have the situation corrected within my working lifetime. In any case, this one gets its ditch cleaned and a bigger water-bar as soon as I get done with...

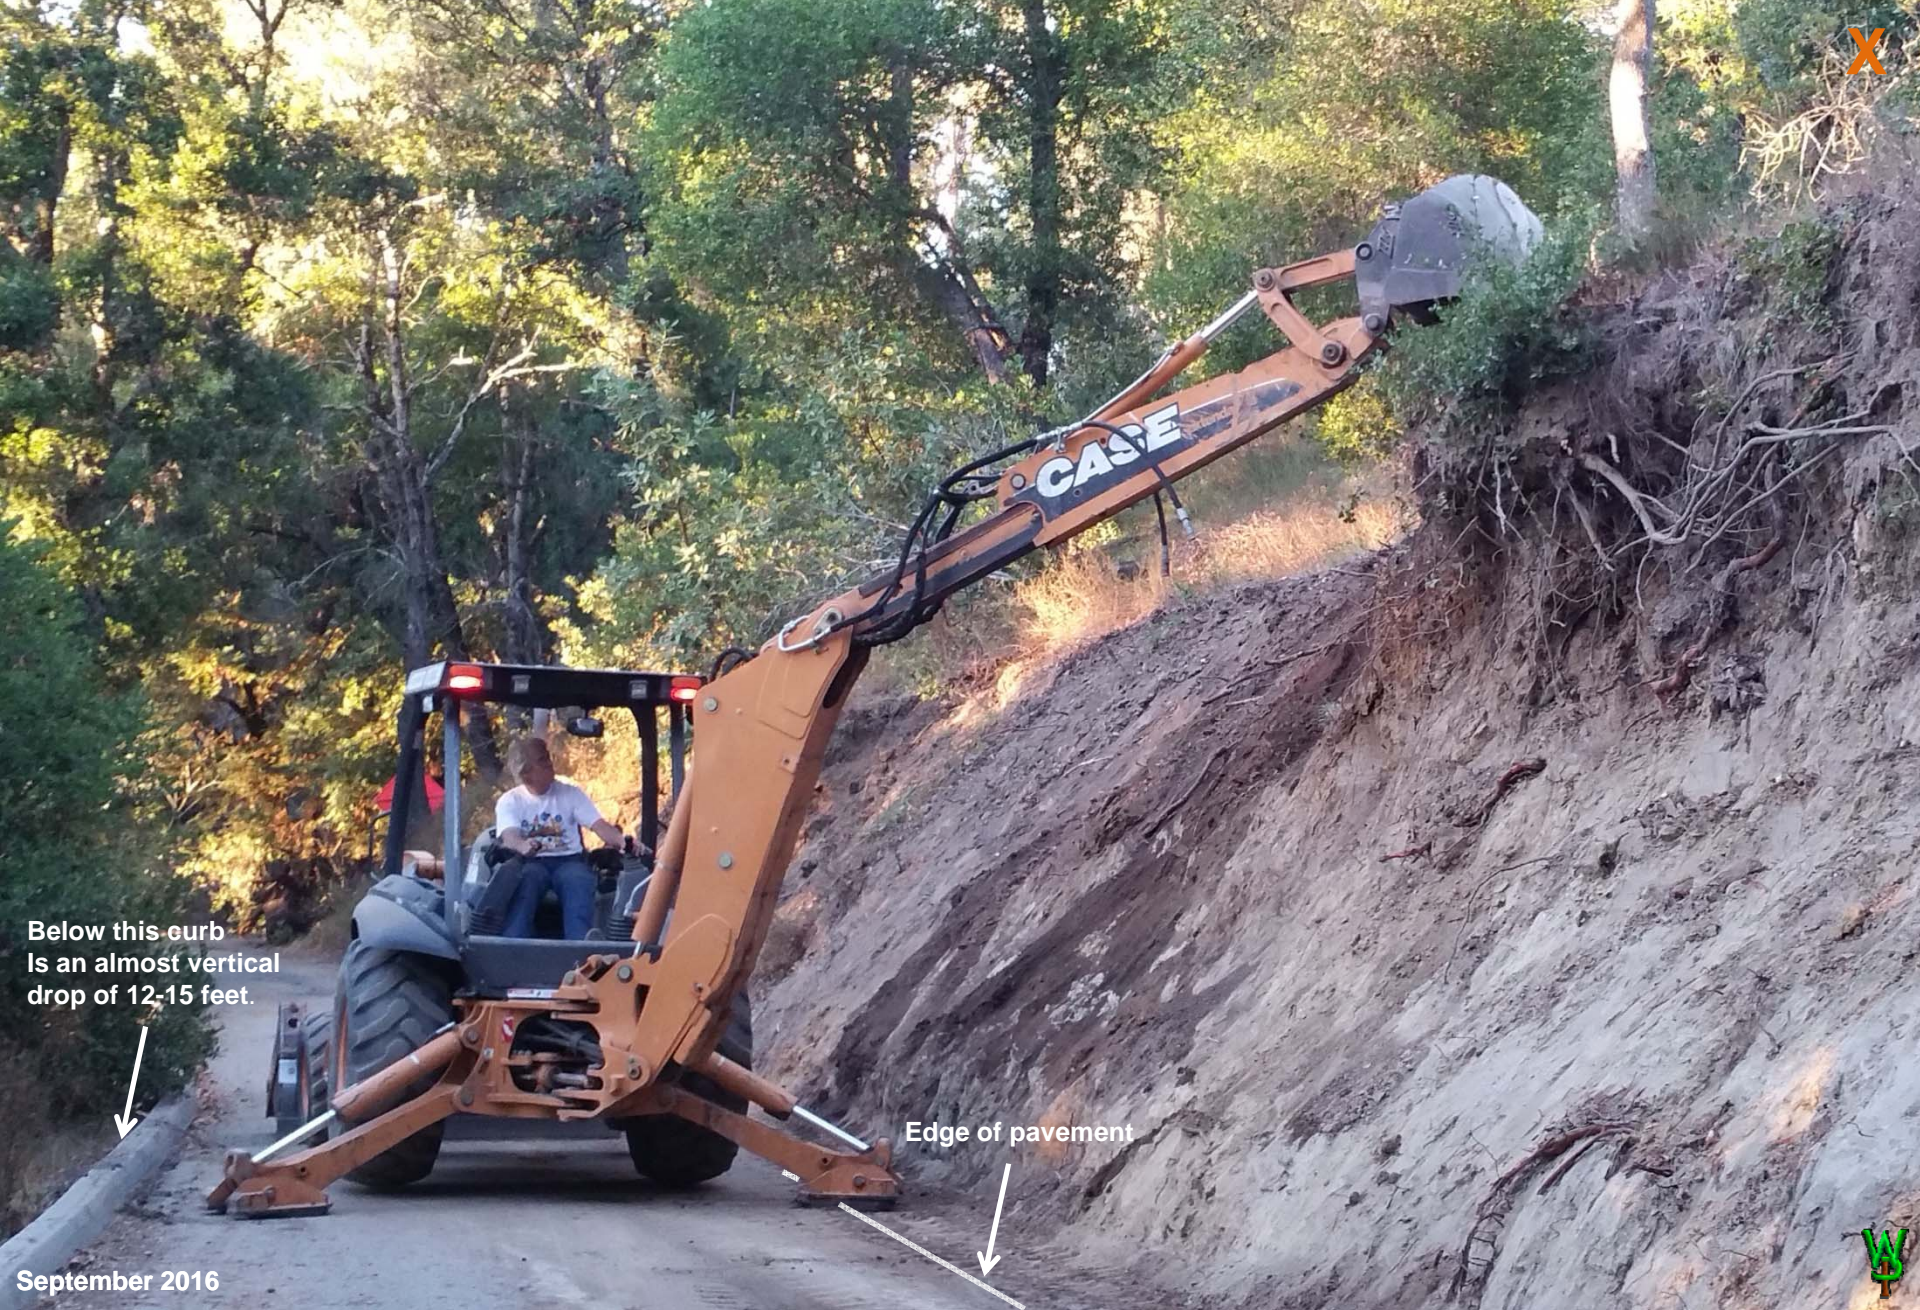
Below this curb
Is an almost vertical
drop of 12-15 feet.

I sloped the hill and shuttled out the fill using it to improve drainage on dirt roads elsewhere. Dug out the ditch by hand to provide support from the pavement surface for a 10"X24" berm in the ditch of 1-1/2" drain-rock to resist impact from car tires (you can see the tracks already). Moistened the fill, mixed it, backfilled the ditch, and compacted it in 3 lifts. Added more above the first course and packed it. Had contractors round off the top edge with an excavator and grind the remaining stumps. After \$10,000 of our money and three months of arduous labor, it's ready for topsoil. Had the County done this, it would have probably cost you \$50,000 more.
