ROADS TO HEAVEN, TO HELL, AND BACK, SOMEWHAT

WILDERGARTEN 5.4

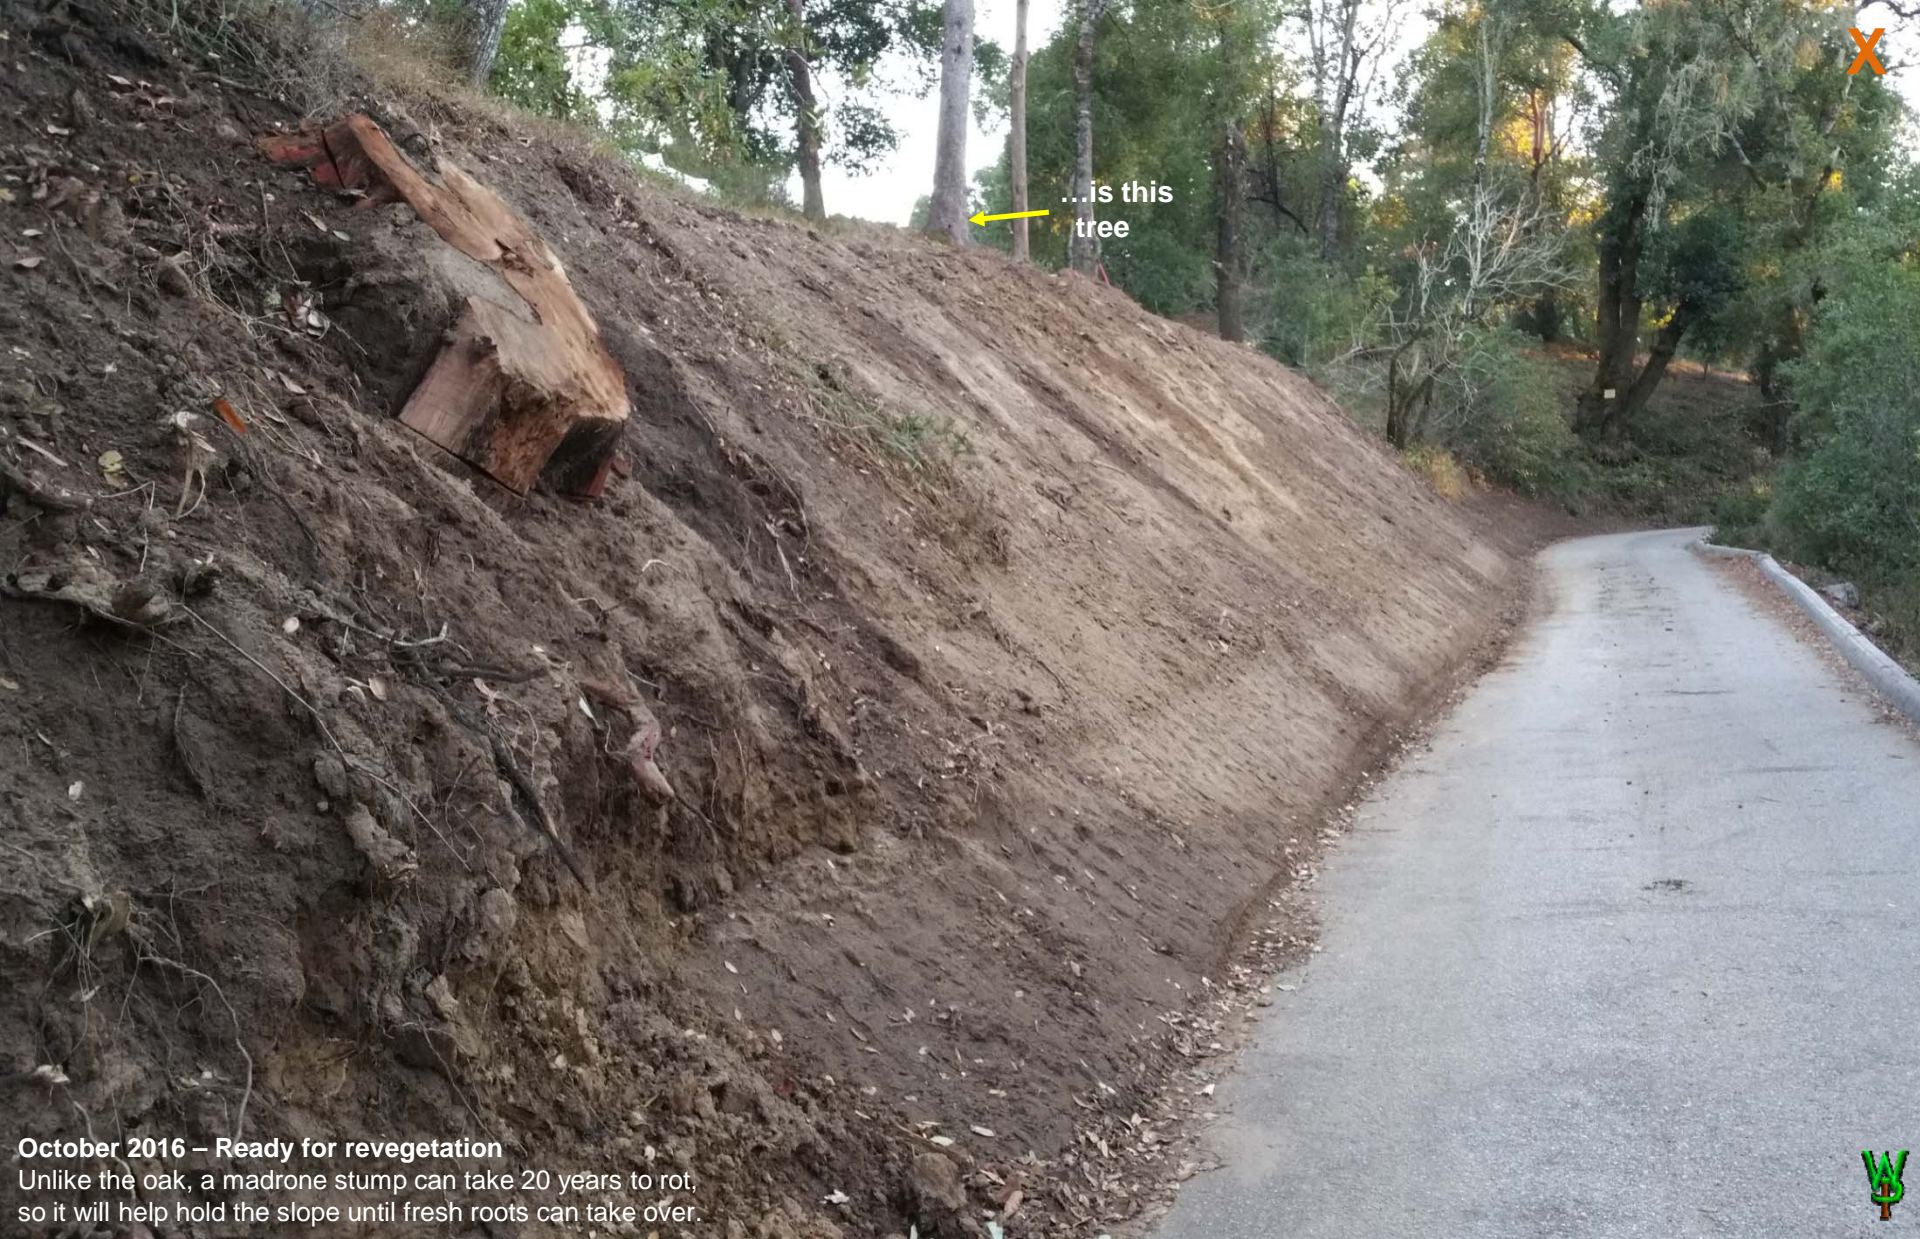
October 2016 – Ready for revegetation

...is this tree

Unlike the oak, a madrone stump can take 20 years to rot, so it will help hold the slope until fresh roots can take over.

I sloped the hill and shuttled out the fill using it to improve drainage on dirt roads elsewhere. Dug out the ditch by hand to provide support from the pavement surface for a 10"X24" berm in the ditch of 1-1/2" drain-rock to resist impact from car tires (you can see the tracks already). Moistened the fill, mixed it, backfilled the ditch, and compacted it in 3 lifts. Added more above the first course and packed it. Had contractors round off the top edge with an excavator and grind the remaining stumps. After \$10,000 of our money and three months of arduous labor, it's ready for topsoil. Had the County done this, it would have probably cost you \$50,000 more.

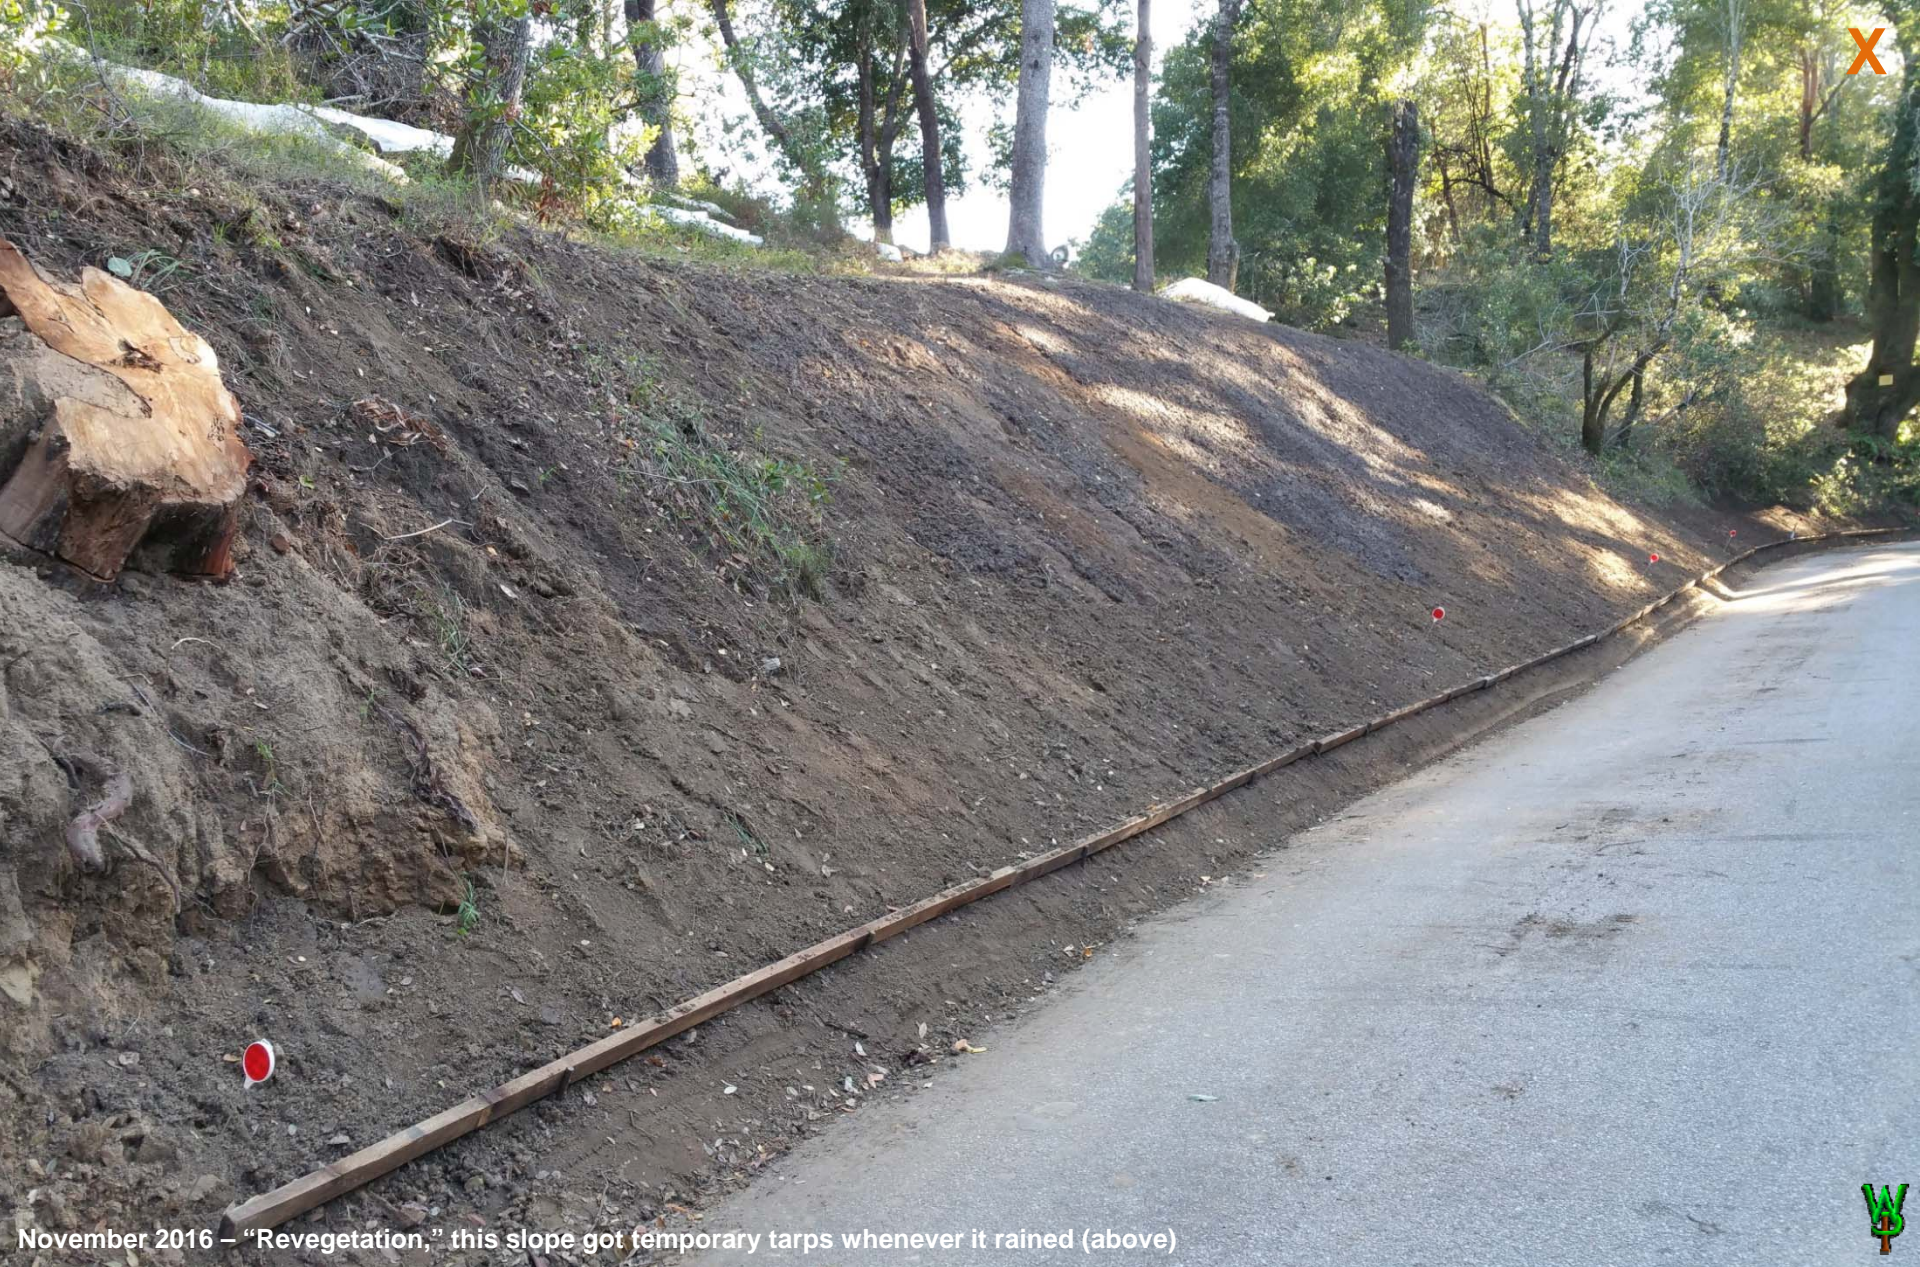
November 2016 – “Revegetation,” this slope got temporary tarps whenever it rained (above)

Revegetation started with a topsoil slurry from the top. It was spread by hand, but it could be done with a hopper mixer feeding an articulated conveyor. The bottom third was tossed with a shovel. Water that down so that it forms a film. Plop in some irises, sedges, buckeye seeds, toyon seedlings, elderberry started from cuttings, Ceanothus, and other such. Keep watering until the rains come for regeneration from remnant roots of wild peas and our awesome grasses for steep slopes, *Calamagrostis rubescens*, and *Agrostis halii*.

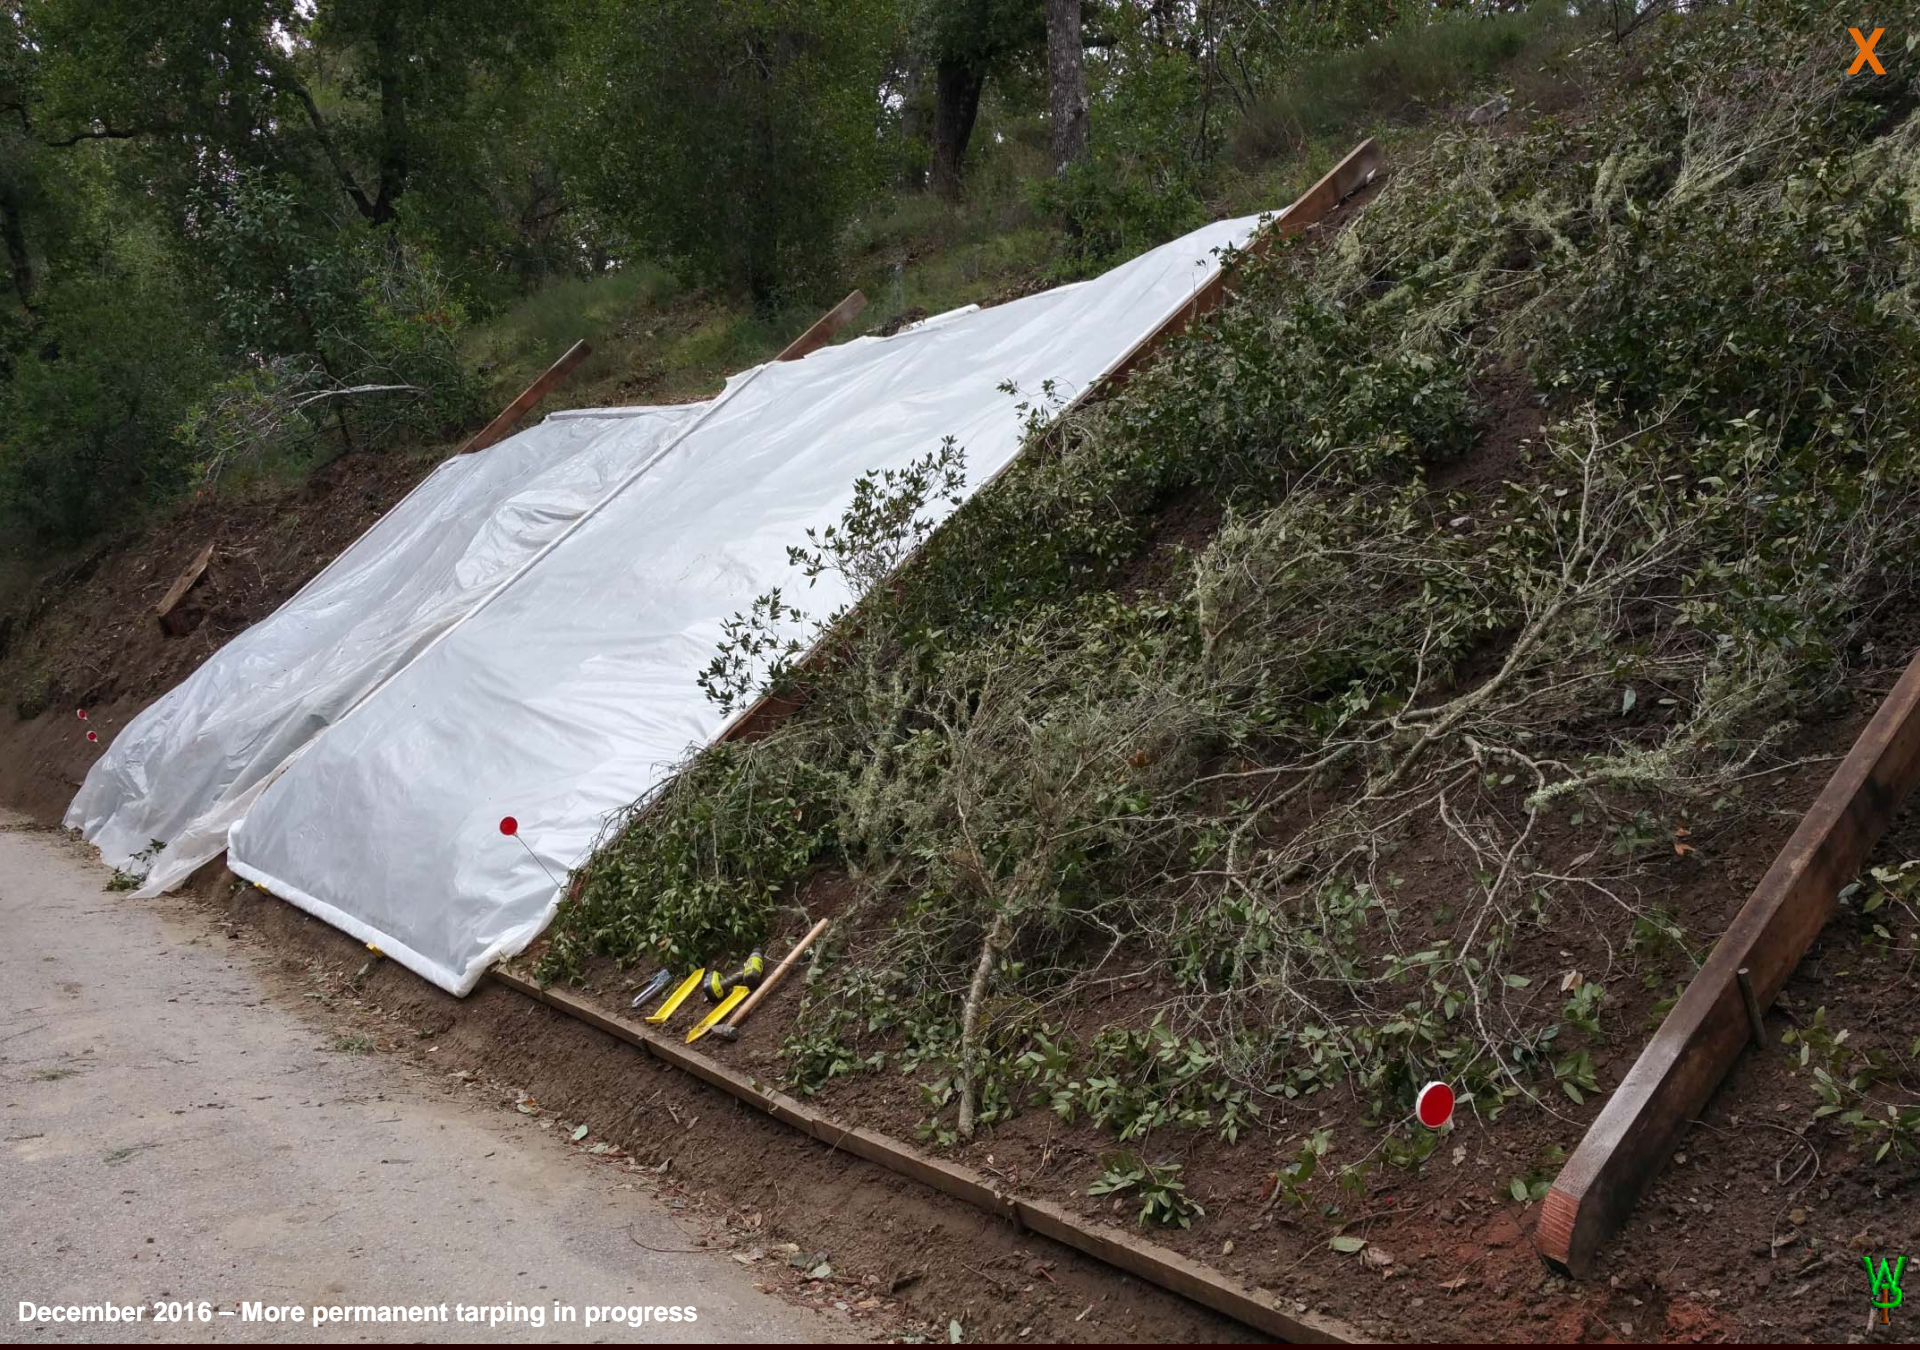
December 2016 – More permanent tarping in progress

When the heavy rains came it got cold, with a plastic cover with the edges wrapped in battens screwed to 3X6 timbers. Effectively, this is similar to the “mini-greenhouse” technology used in the [grassland restoration](#) chapter. Note the date. Unfortunately, I was too late.

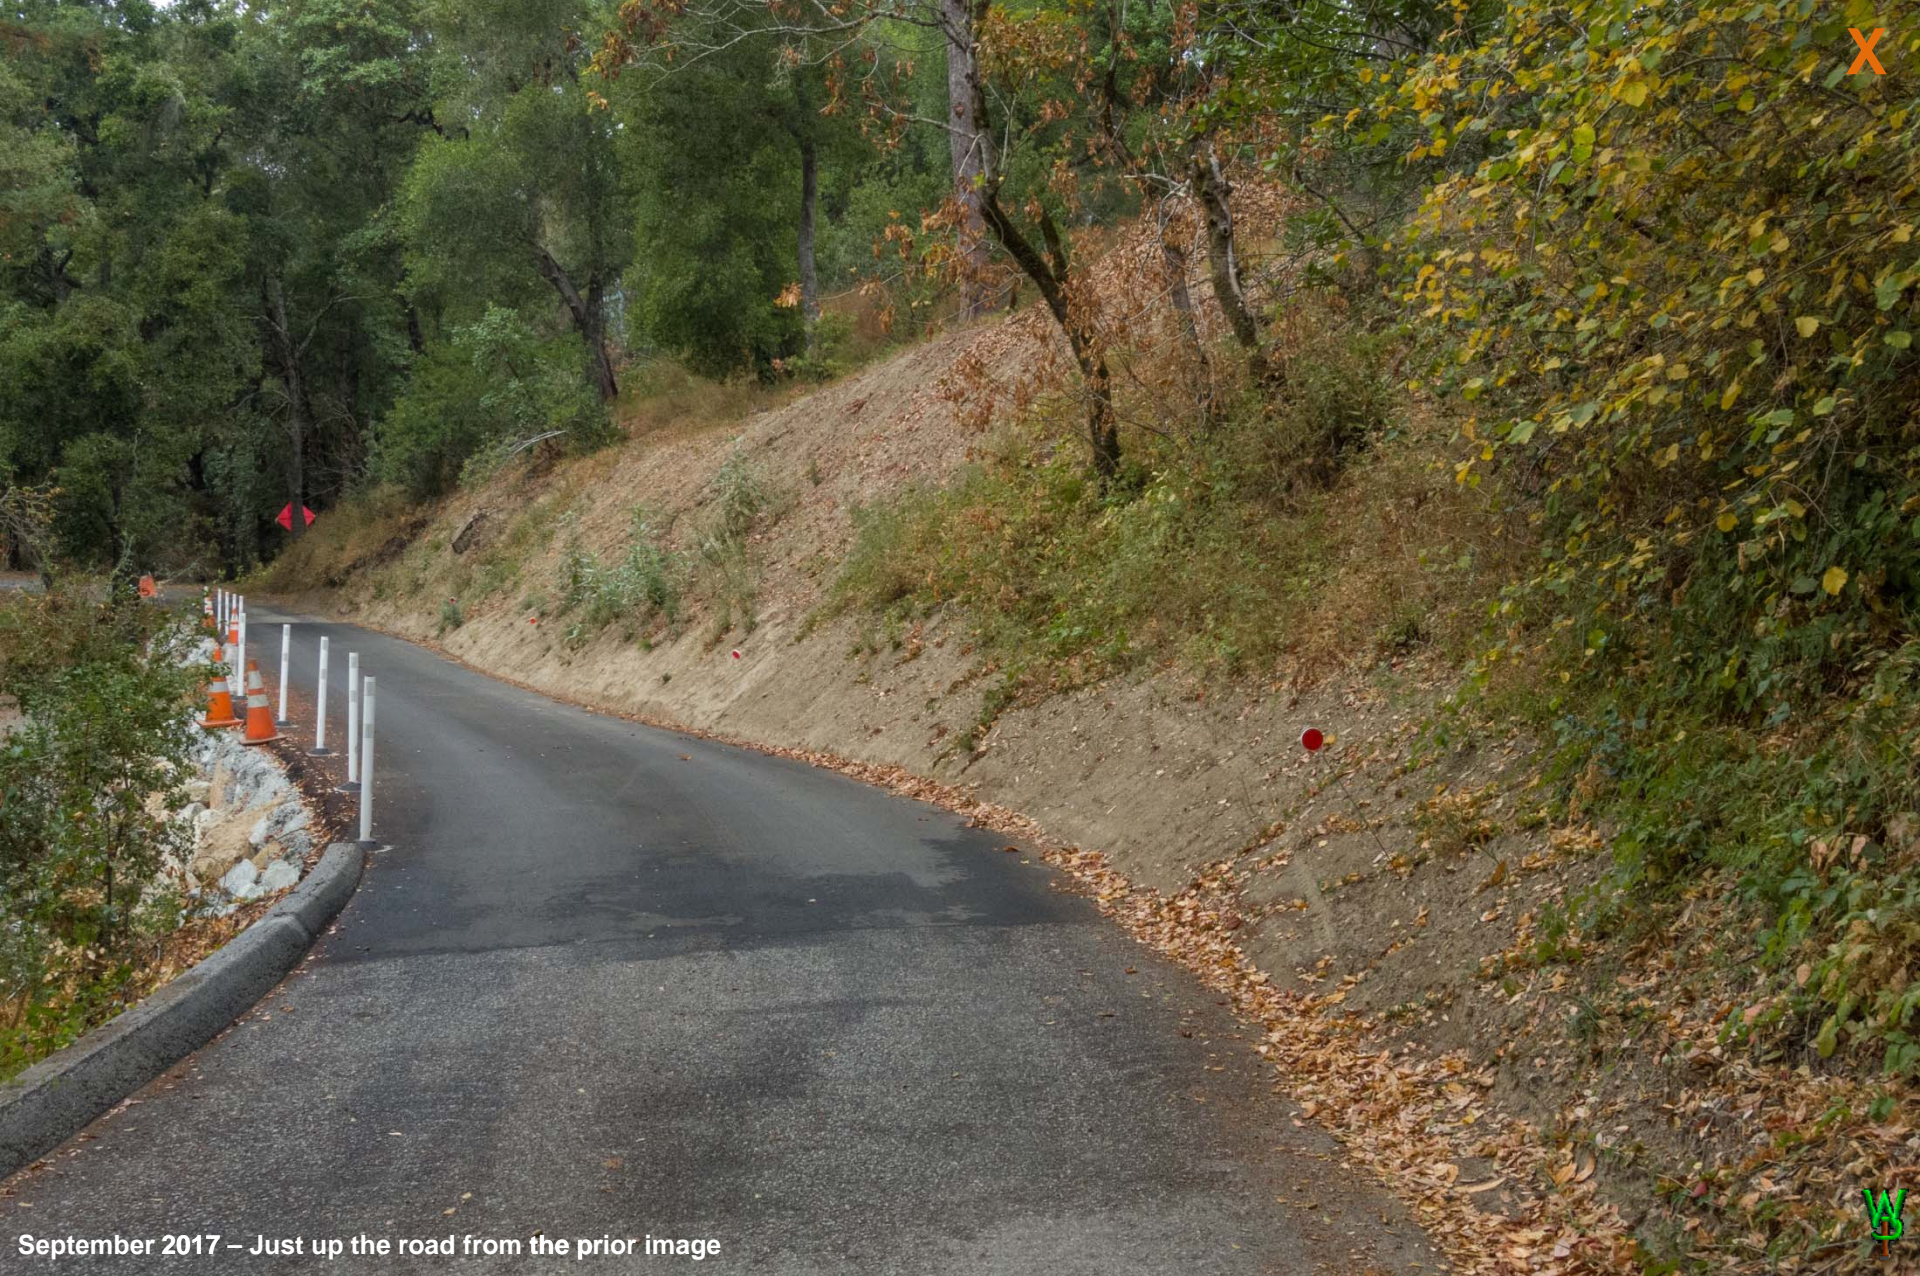
September 2017 – Just up the road from the prior image

I was too late finishing the project and it got too cold for the roots to sprout, partly because this part of the project was in shade almost all day when the winter sun was at a low angle. Then we got that infamous 87 inches of rain. Some of the plants I put in did take (especially the shrubs), but I am sure by now the bulk of those root nodes I spread on the surface are dead. So this part may get a classic seed and mulch treatment before being again covered with timbers, tops and plastic as before.

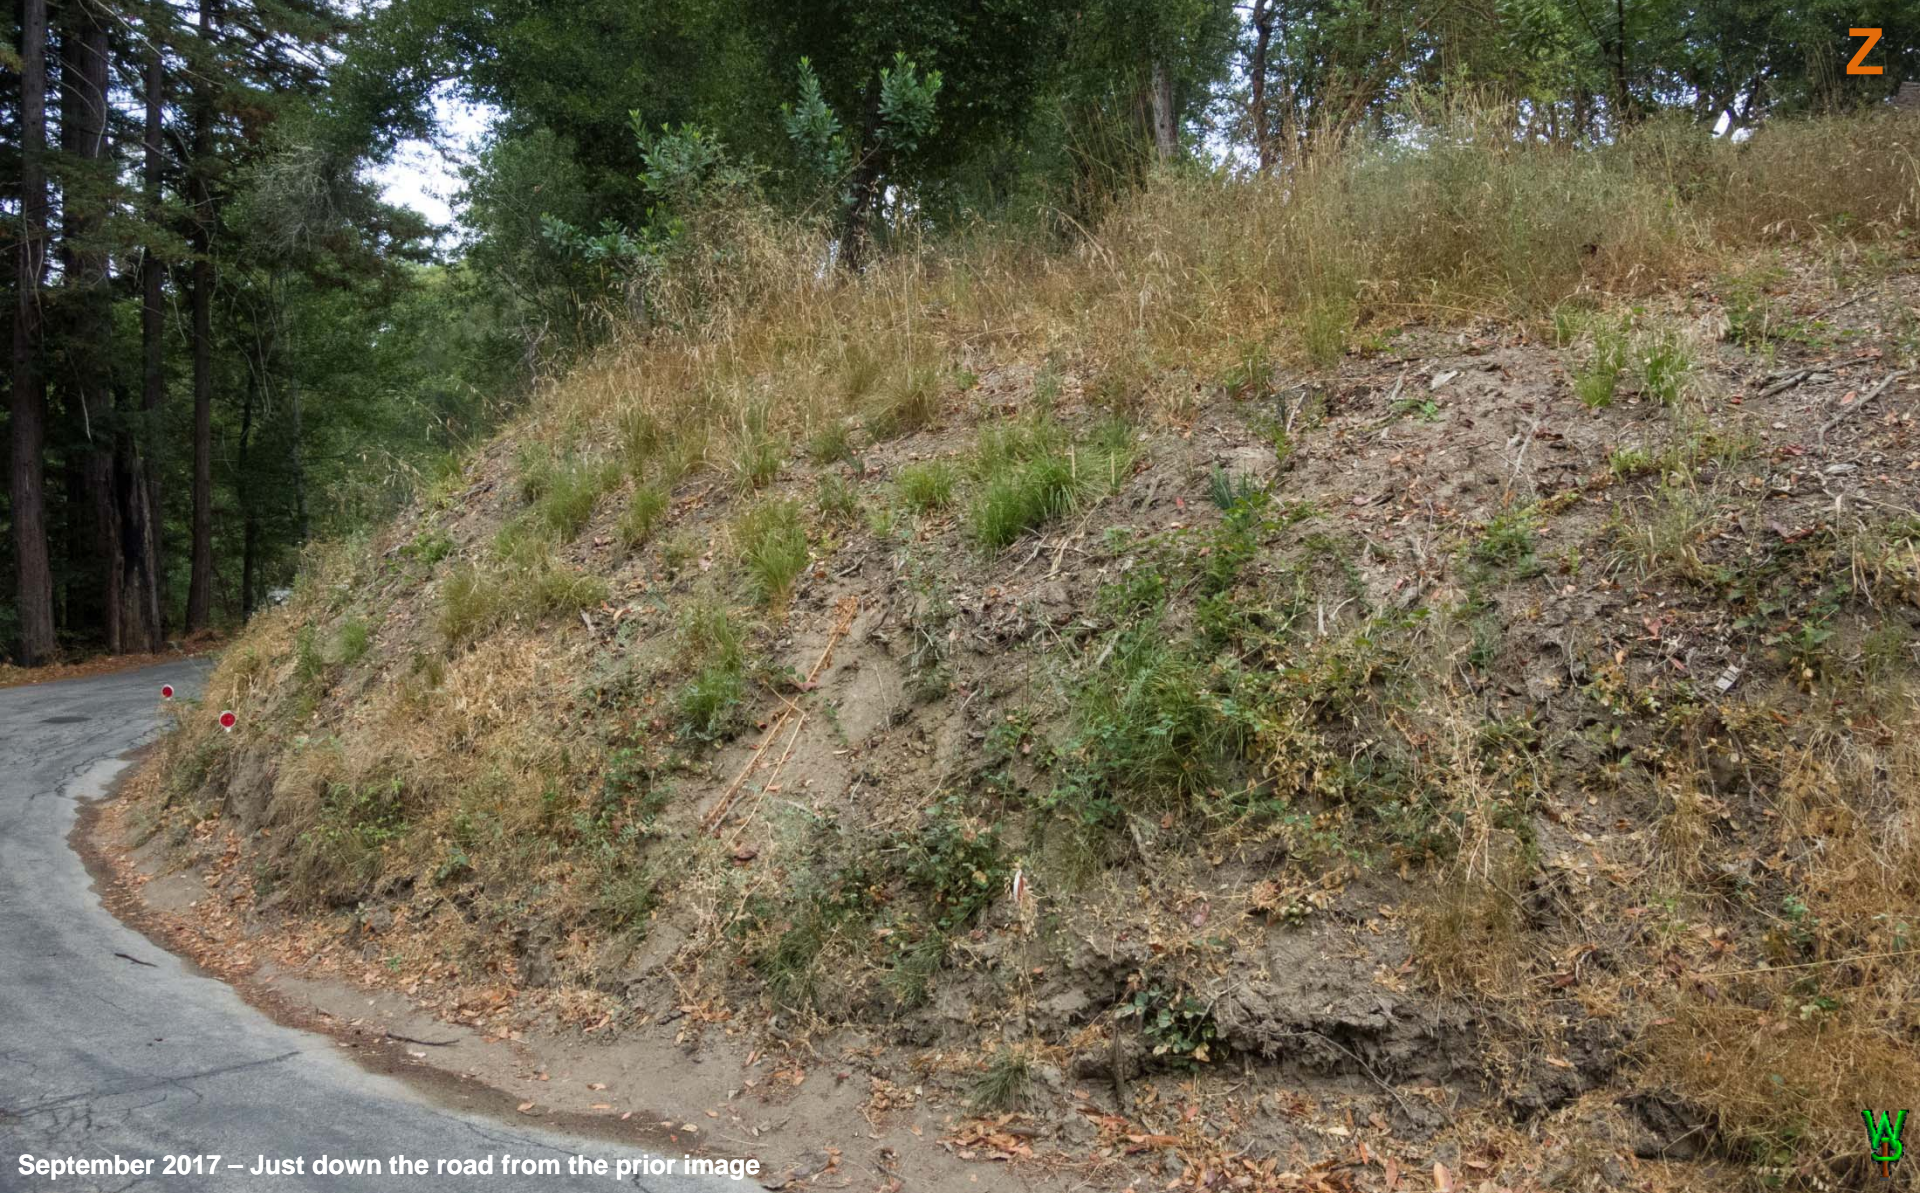
September 2017 – Just down the road from the prior image

This project got rain in the early fall, and then was covered by mid-October. That provided enough warmth for good root development. I removed the plastic to weed it in the spring. To me, this is a perfectly acceptable outcome because I have sufficient number deep-rooted individuals of species that spread by rhizomes well enough distributed to establish a full cover. To the County, this is not yet enough cover for an erosion control project, principally because they usually seed with annuals that cover every inch with shallow rooted grasses. Yet this is September, and these bunch grasses are green. Had I watered it over the summer, these grasses would have met that full cover expectation with more soil-holding power than do the annuals the County uses. We have only to wait.
