FEELING DRAINAGE

WILDERGARTEN 6.4

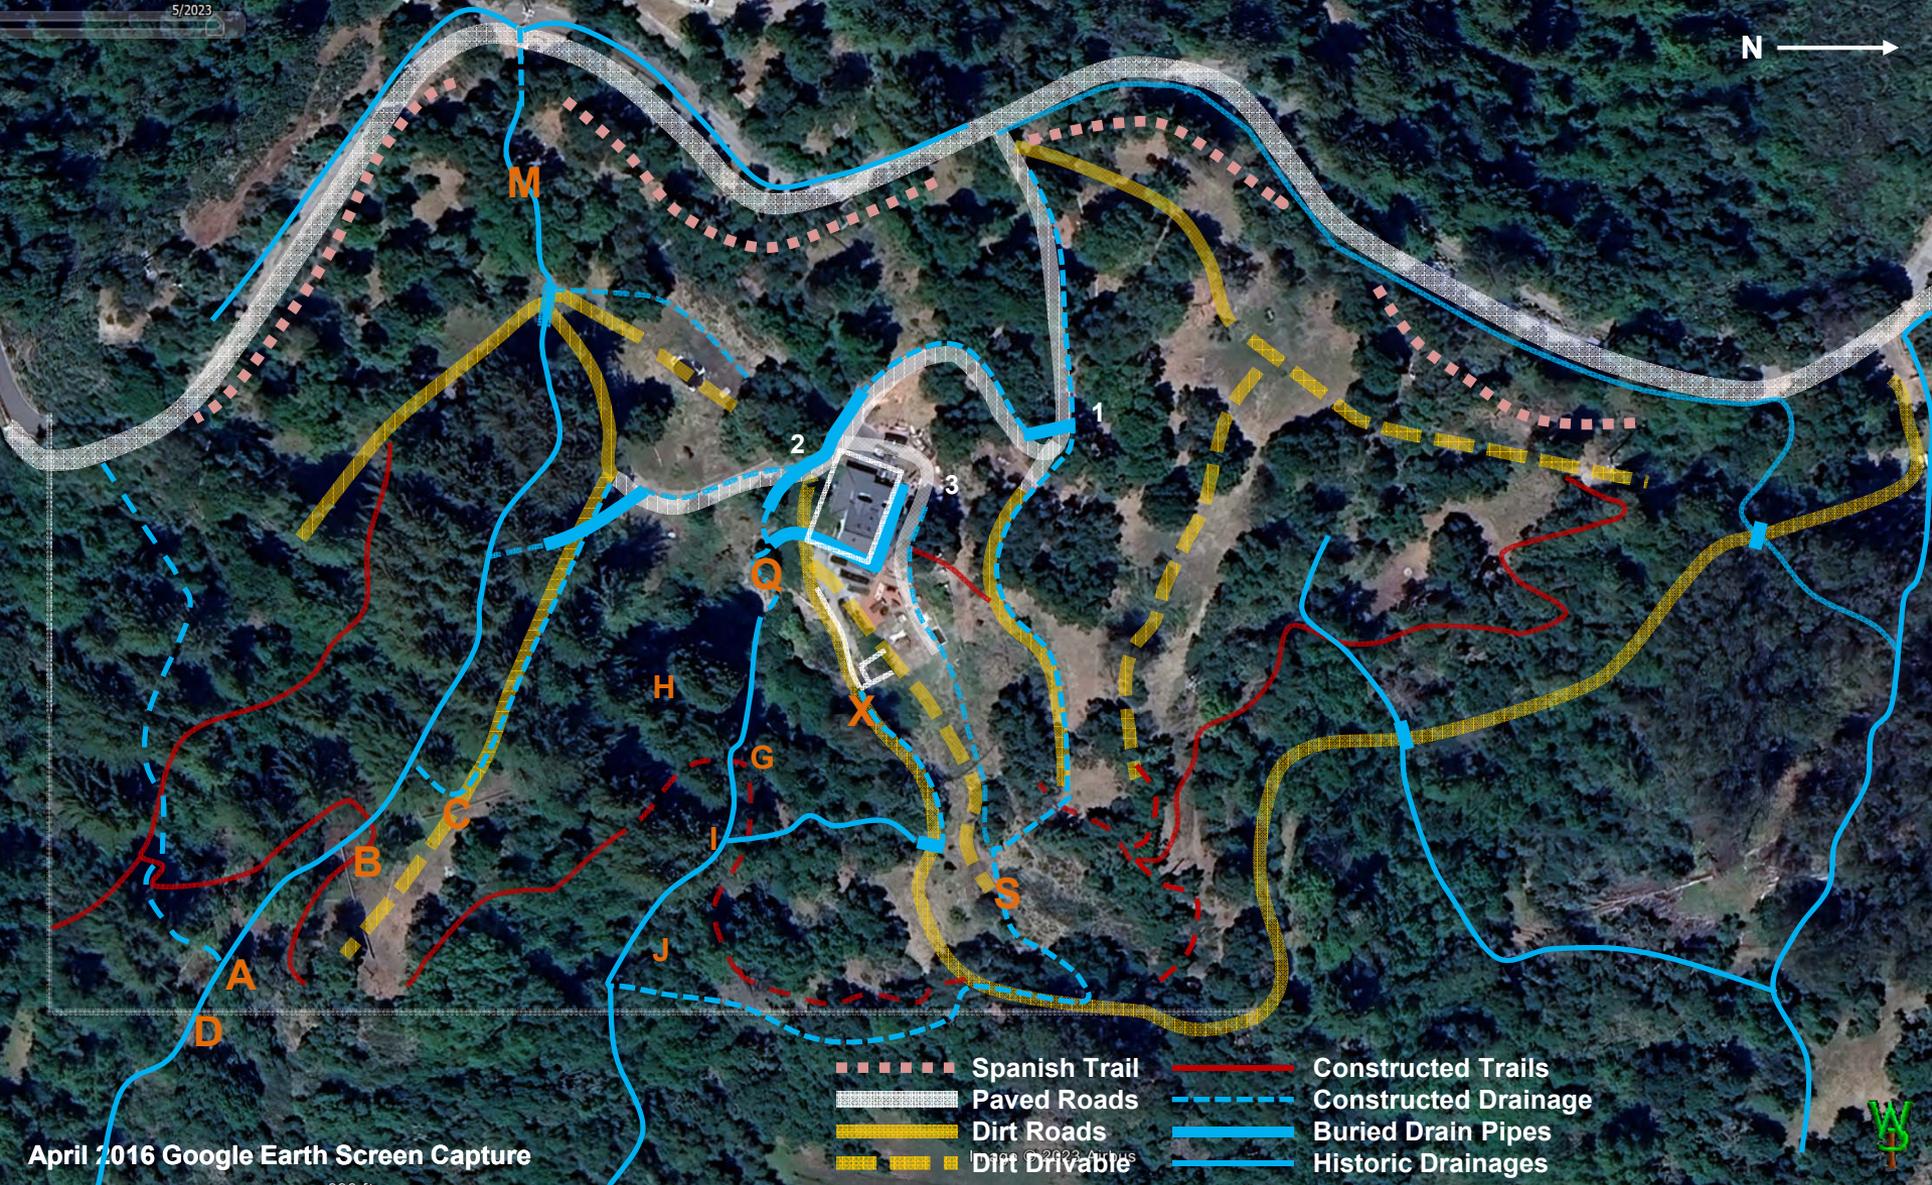
April 2016 Google Earth Screen Capture

This is a map of all the roads, trails, and drainages on this property. Roads and the drainage features particular to them were covered in [the previous chapter](#). This chapter is about what is done to manage specifically water pathways. Each **orange letter** on this and the other aerial images in this chapter corresponds to where they were taken on this property (some with an arrow indicating the direction). If you wish to keep track while reading, there is [consisting of aerial photos and vegetative maps over time](#), which you can then keep open in another window as you read. My purpose in documenting them this carefully is for future repeat photos, as vegetation management, and particularly forestry is elemental to many of these drainage management challenges.

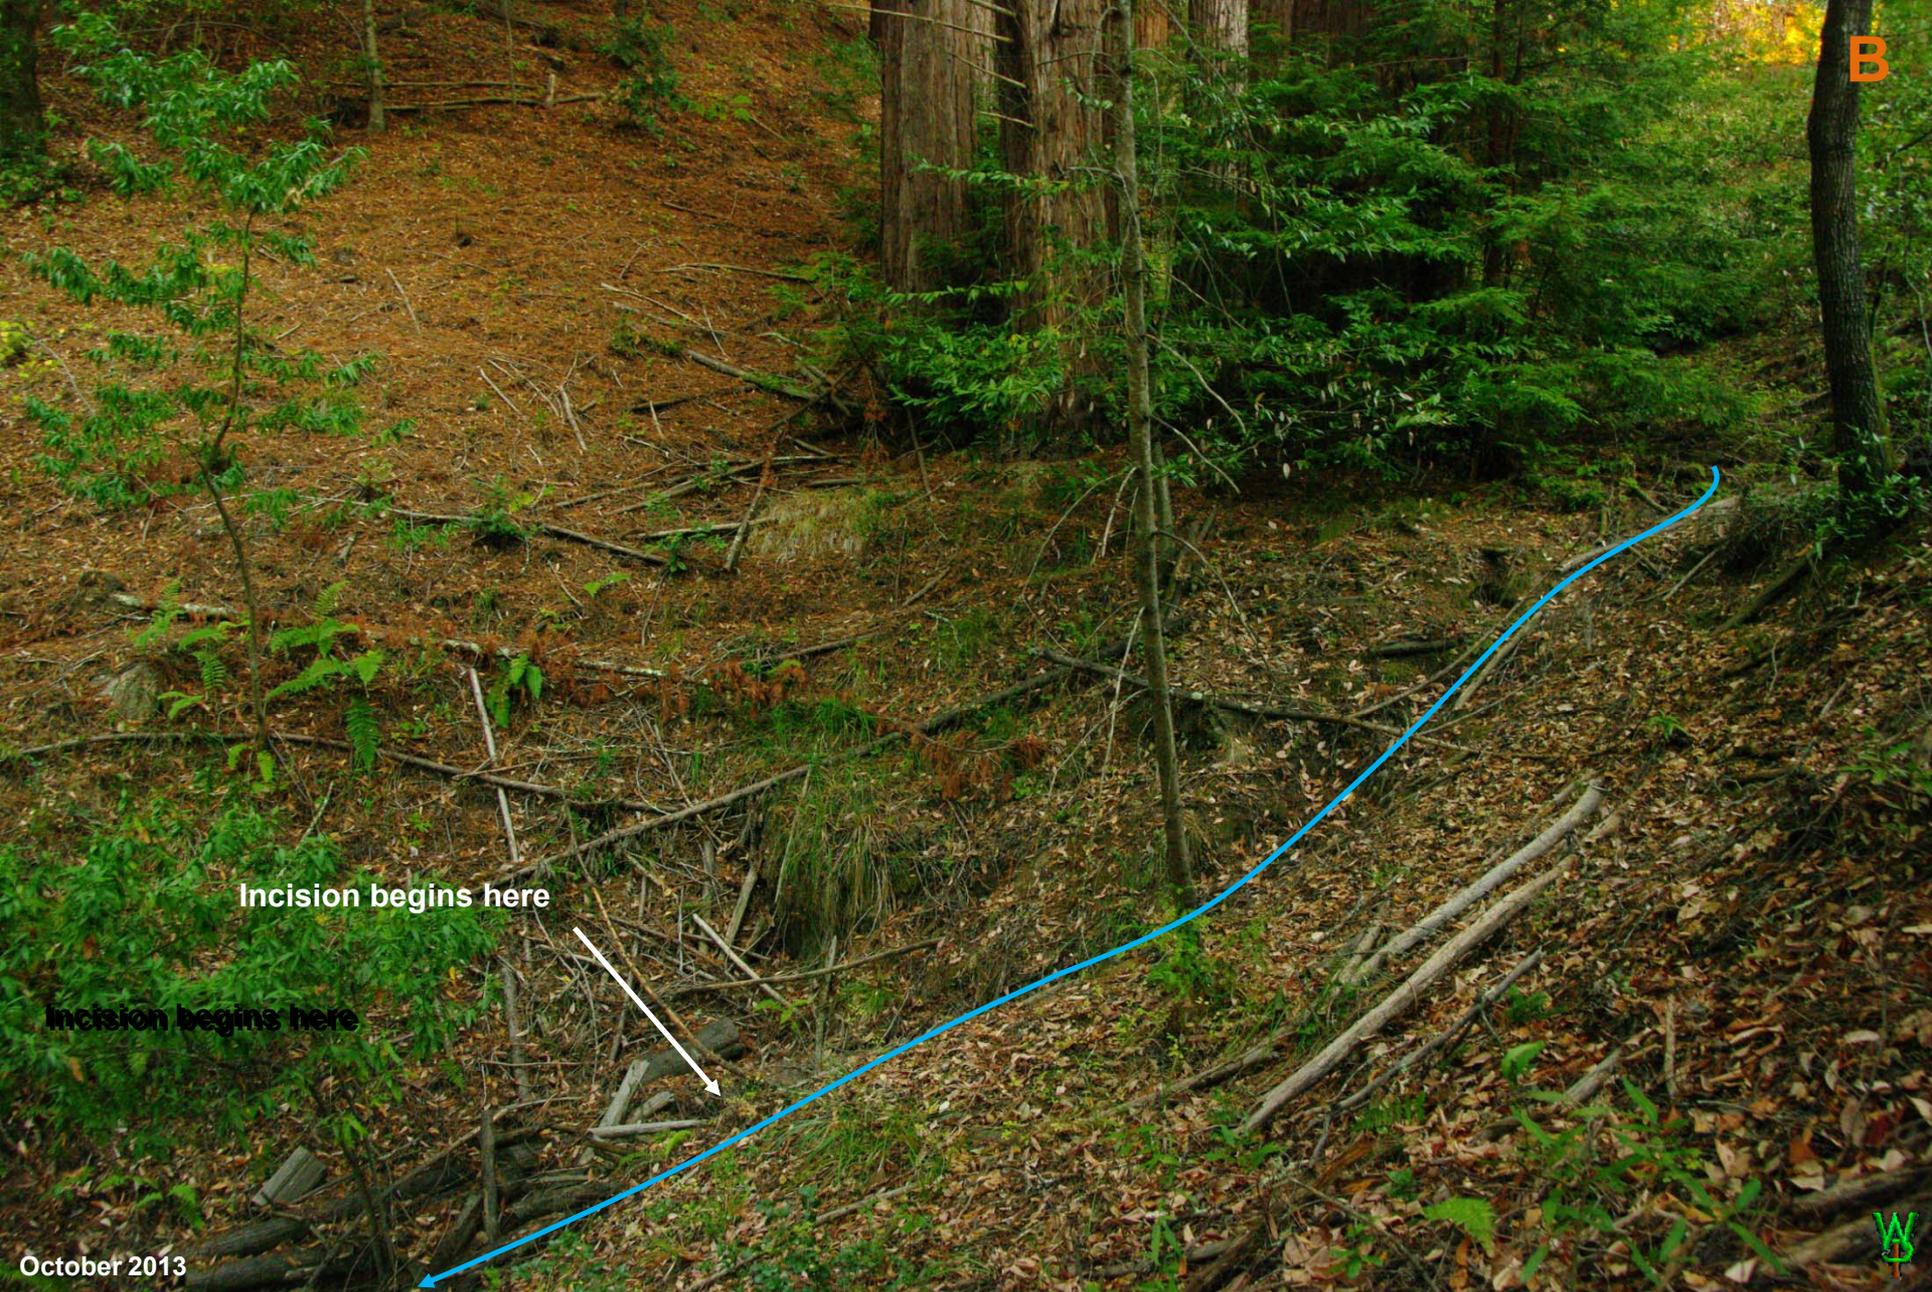
October 2013

Incision begins here

Here is a similar cluster of redwood trees just upstream seen from below. It should be fairly obvious that the root mass of these trees inhibited a considerable amount of erosion of the stream bed, also called "channel incision" such as you see below them. From this example, I learned how to reverse that incision process for reasons we'll get to soon.

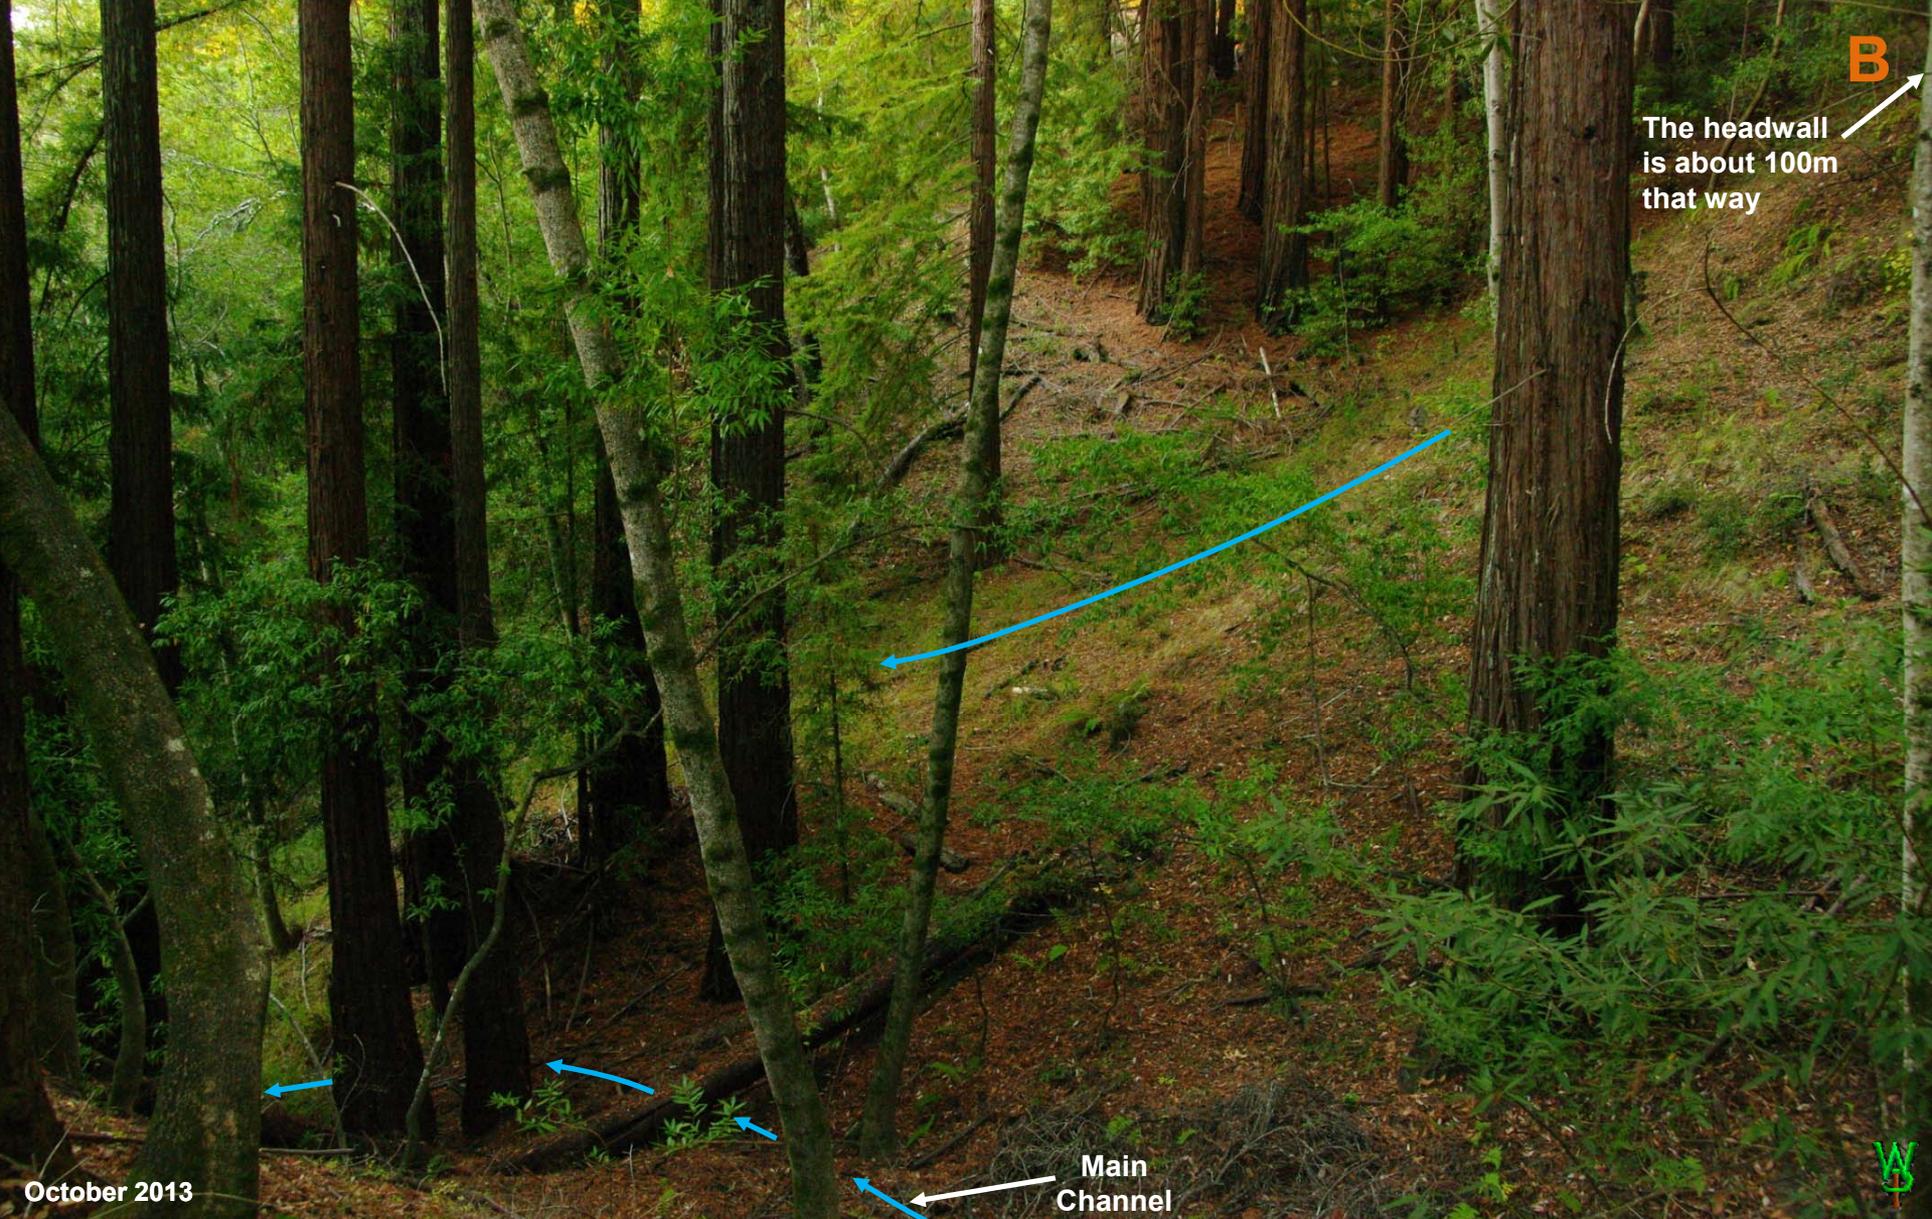
October 2013

Looking down the channel from the same spot, it isn't hard to see another landslide deposit with trees on top at the lower left. At the top of the draw to the right is the Spanish Gulch, a rotational slope failure with a steep headwall with a second below the road, I suspect was created by vegetation falling into the Gulch. I suspect that the green swath behind the trees is alluvial deposition on top of a colluvial lens. Based upon the stumps I have counted in this area, none of these trees is over 120 years old. Unlike the next draw to the north (TBD), there are no large old stumps. This forest started **after** the area was first logged.

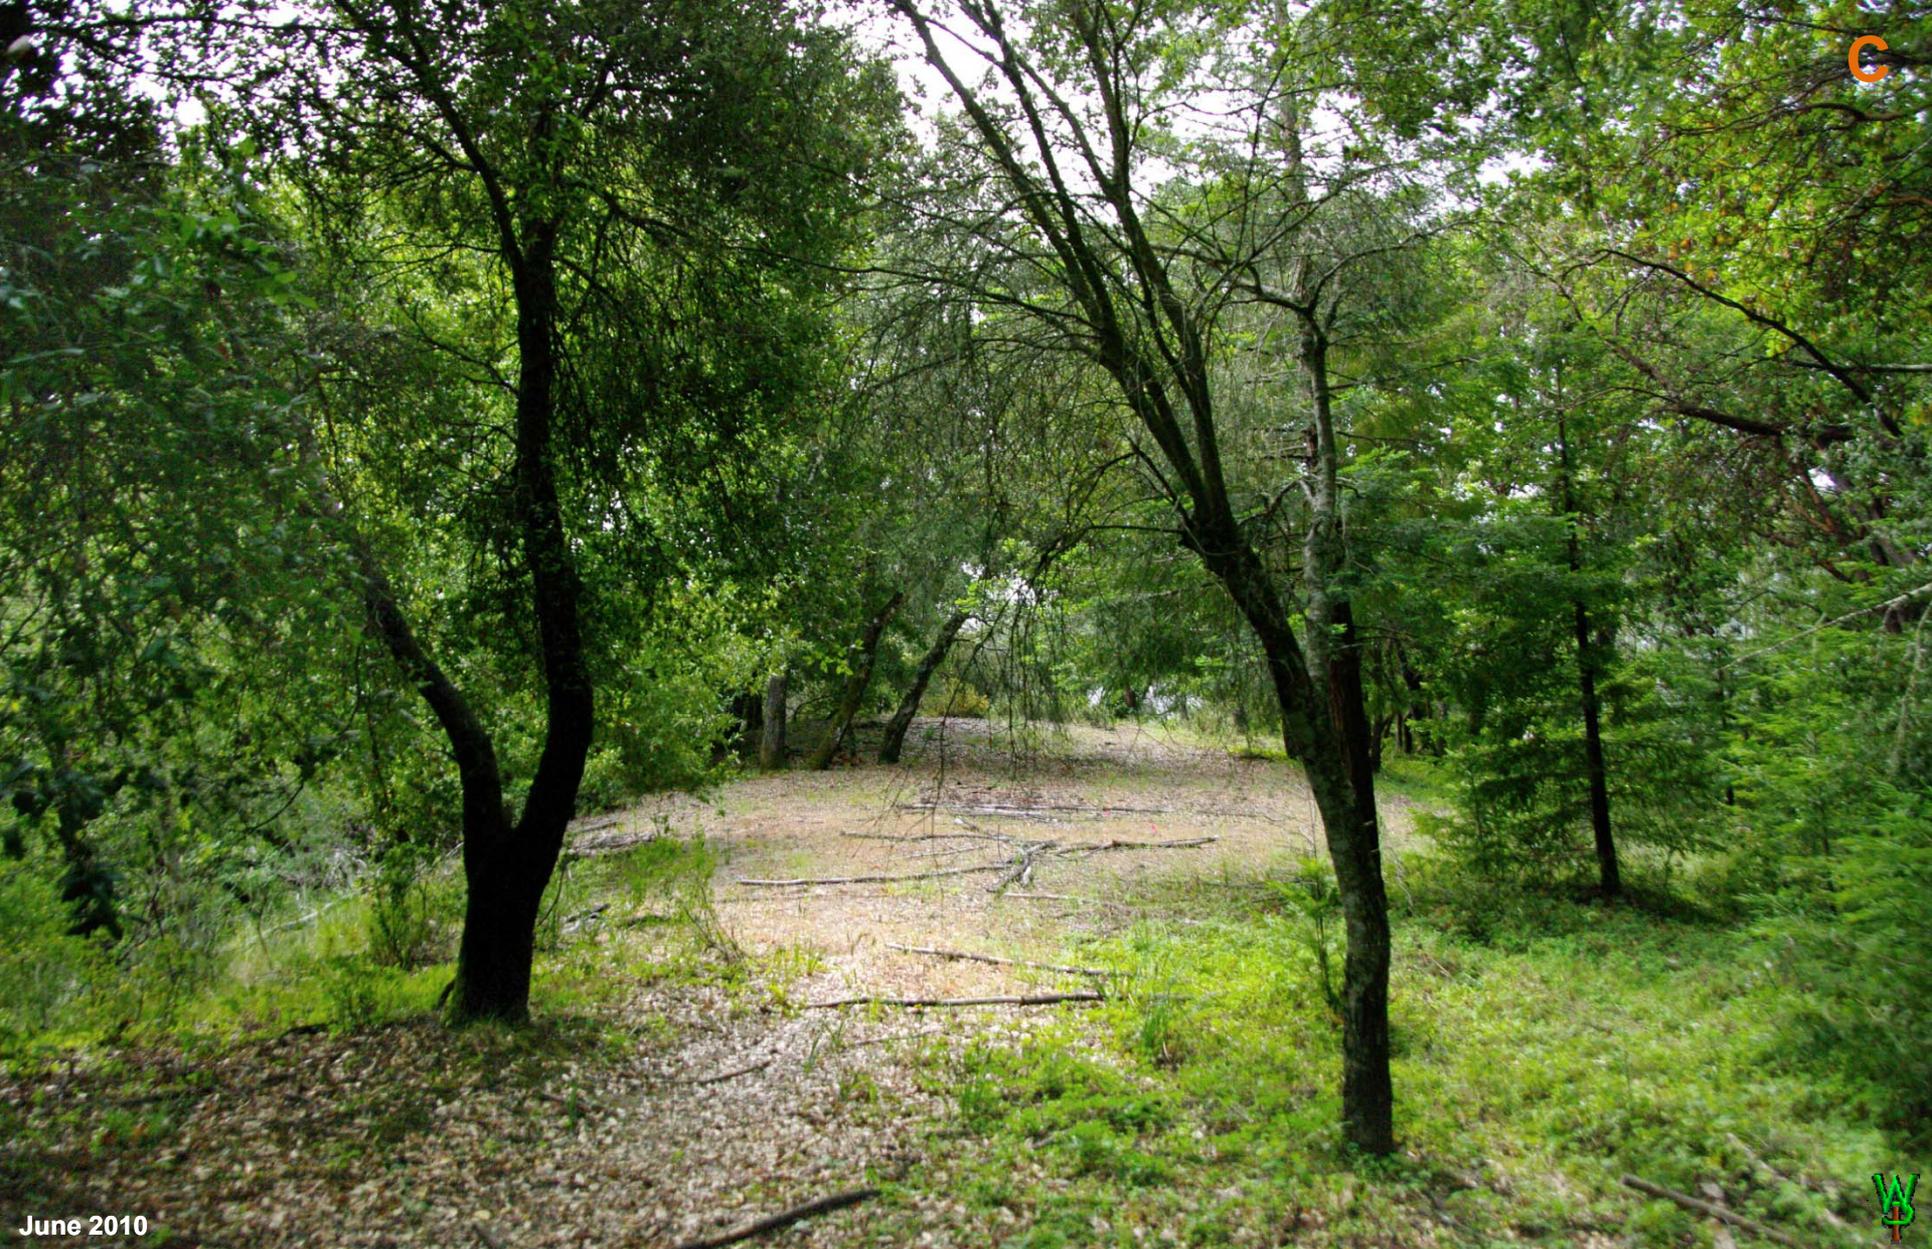
June 2010

You may remember this image from the repeat photos in the Introduction. The first thing I did to impede incision in the channel to the right was to cut trees on the right side of this ridge, about 100 feet *above* the channel. Although cutting the bay trees up here was legal (not a timber harvest), it did reduce “stream canopy cover,” which could get you fined on a commercial job. The thing is, “How much shade is the right amount?” It turns out that when it comes to canopy cover, there may be such a thing as “too much.”

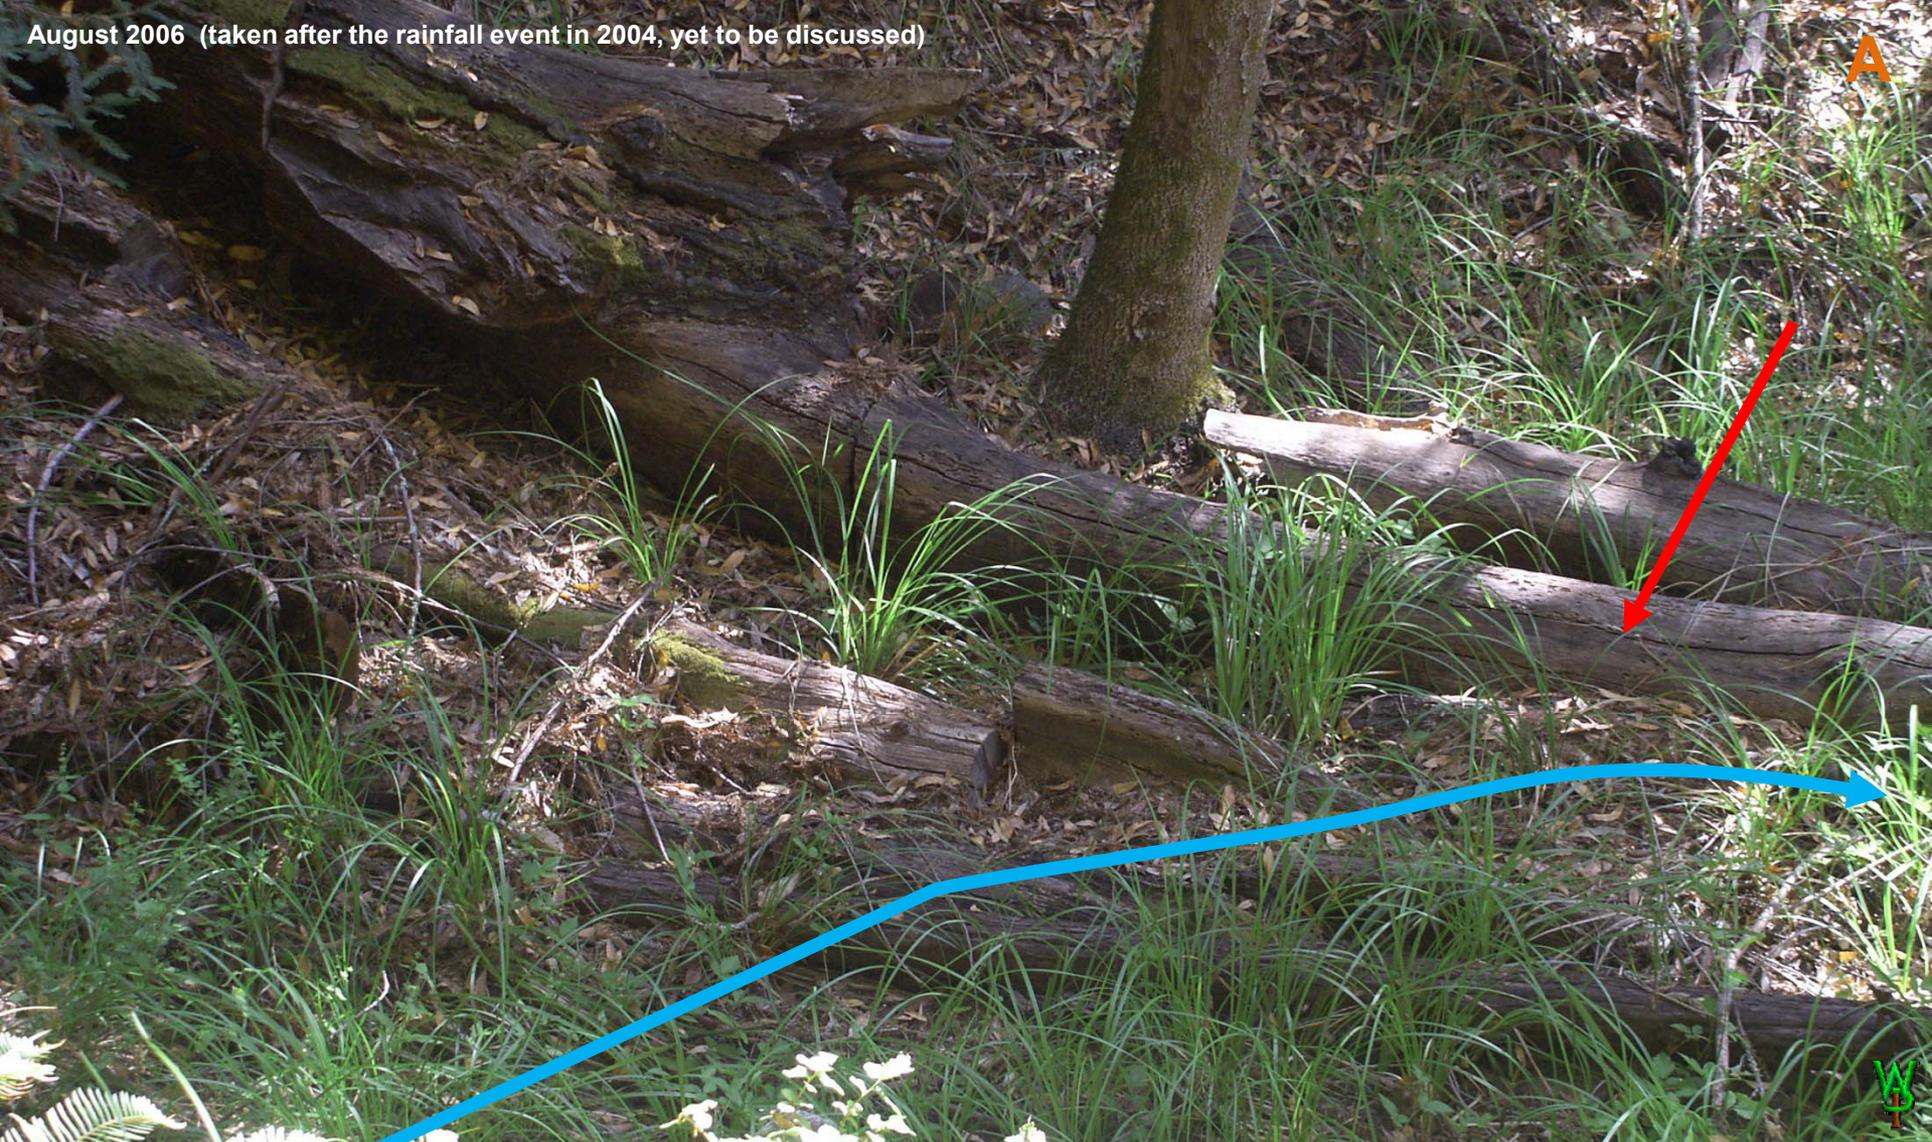
This location is just downstream of the cluster of redwoods two slides prior and below the ridge on the prior slide. Thinning the trees up above allowed sunlight to stimulate the growth of Santa Barbara Sedge down here. Once it was established, I bucked **this log** that was bridging the stream such that it would deflect the flow to the right over the top of a colluvial deposit, just to see what would happen (I could always part it and send the water back into the original channel). The old channel was incising at the base of a steep slope I wanted to stabilize. I knew that if the slope failed, the water would go over the colluvium and carry away a considerable amount of sediment anyway. This dead madrone had gone down by itself, and I wish I'd cut it first as the root ball tore a heck of a hole out of the side of the hill (one of those things I just didn't get to in time). Turns out, I was just in time...

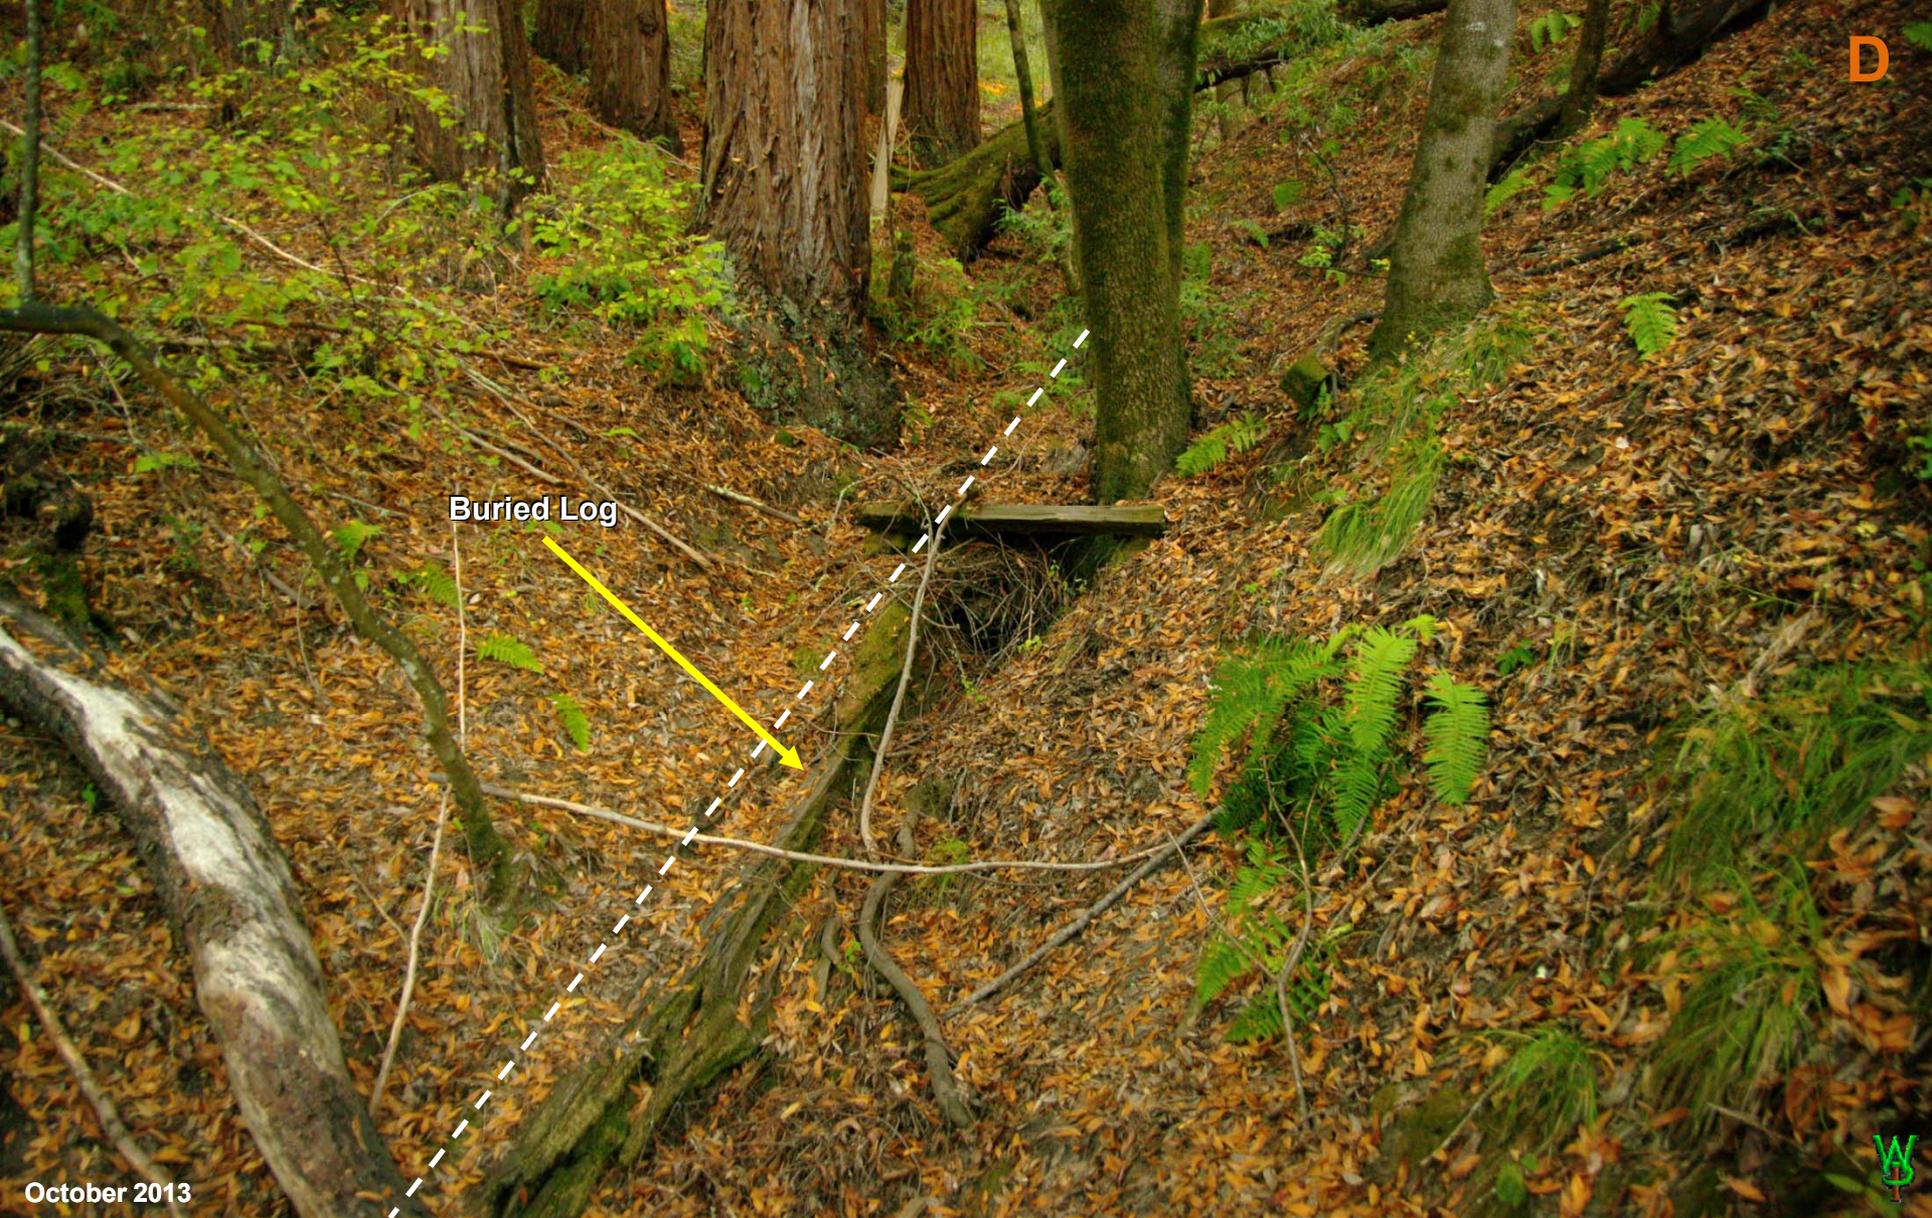
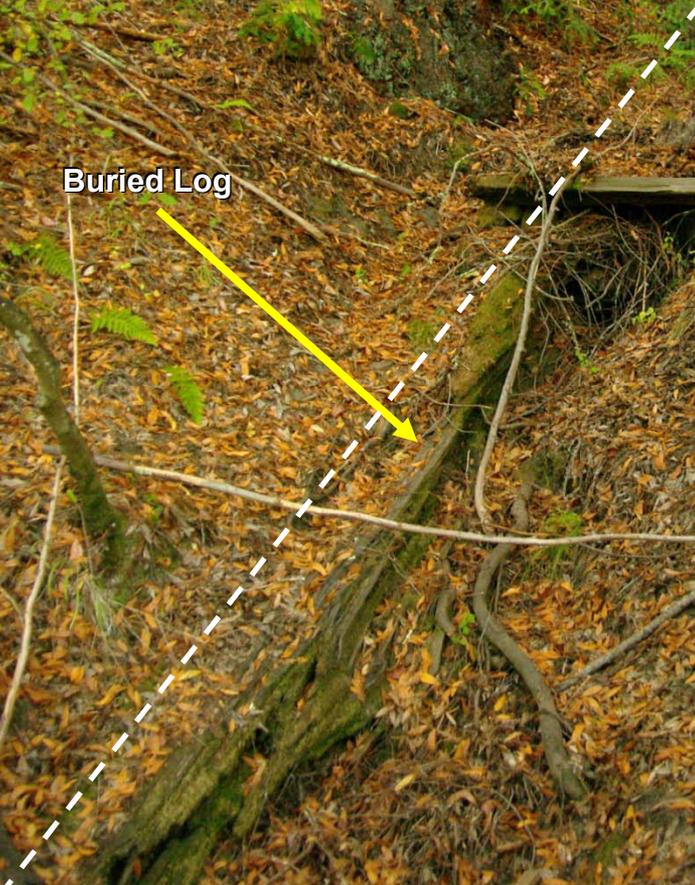
October 2013

Buried Log

Here is the other 'thing that taught me what to do,' and it is what shaped the toe of that slide. **This log** is *underneath* the landslide with the trees sitting on top. It is one very substantial log. It was cut by a saw on one end, so it is impossible for the slide to be over 150 years old. From the size of the trees, my guess is that it has been here about 90 years. If the Vaquero sandstone substrate is relatively uniform, **it may be that wood has been the critical factor in defining channel shape and distribution in this region.** Once the channels start, they tend to keep cutting in the same location, unless there is faulting or somebody does something, as we shall see.

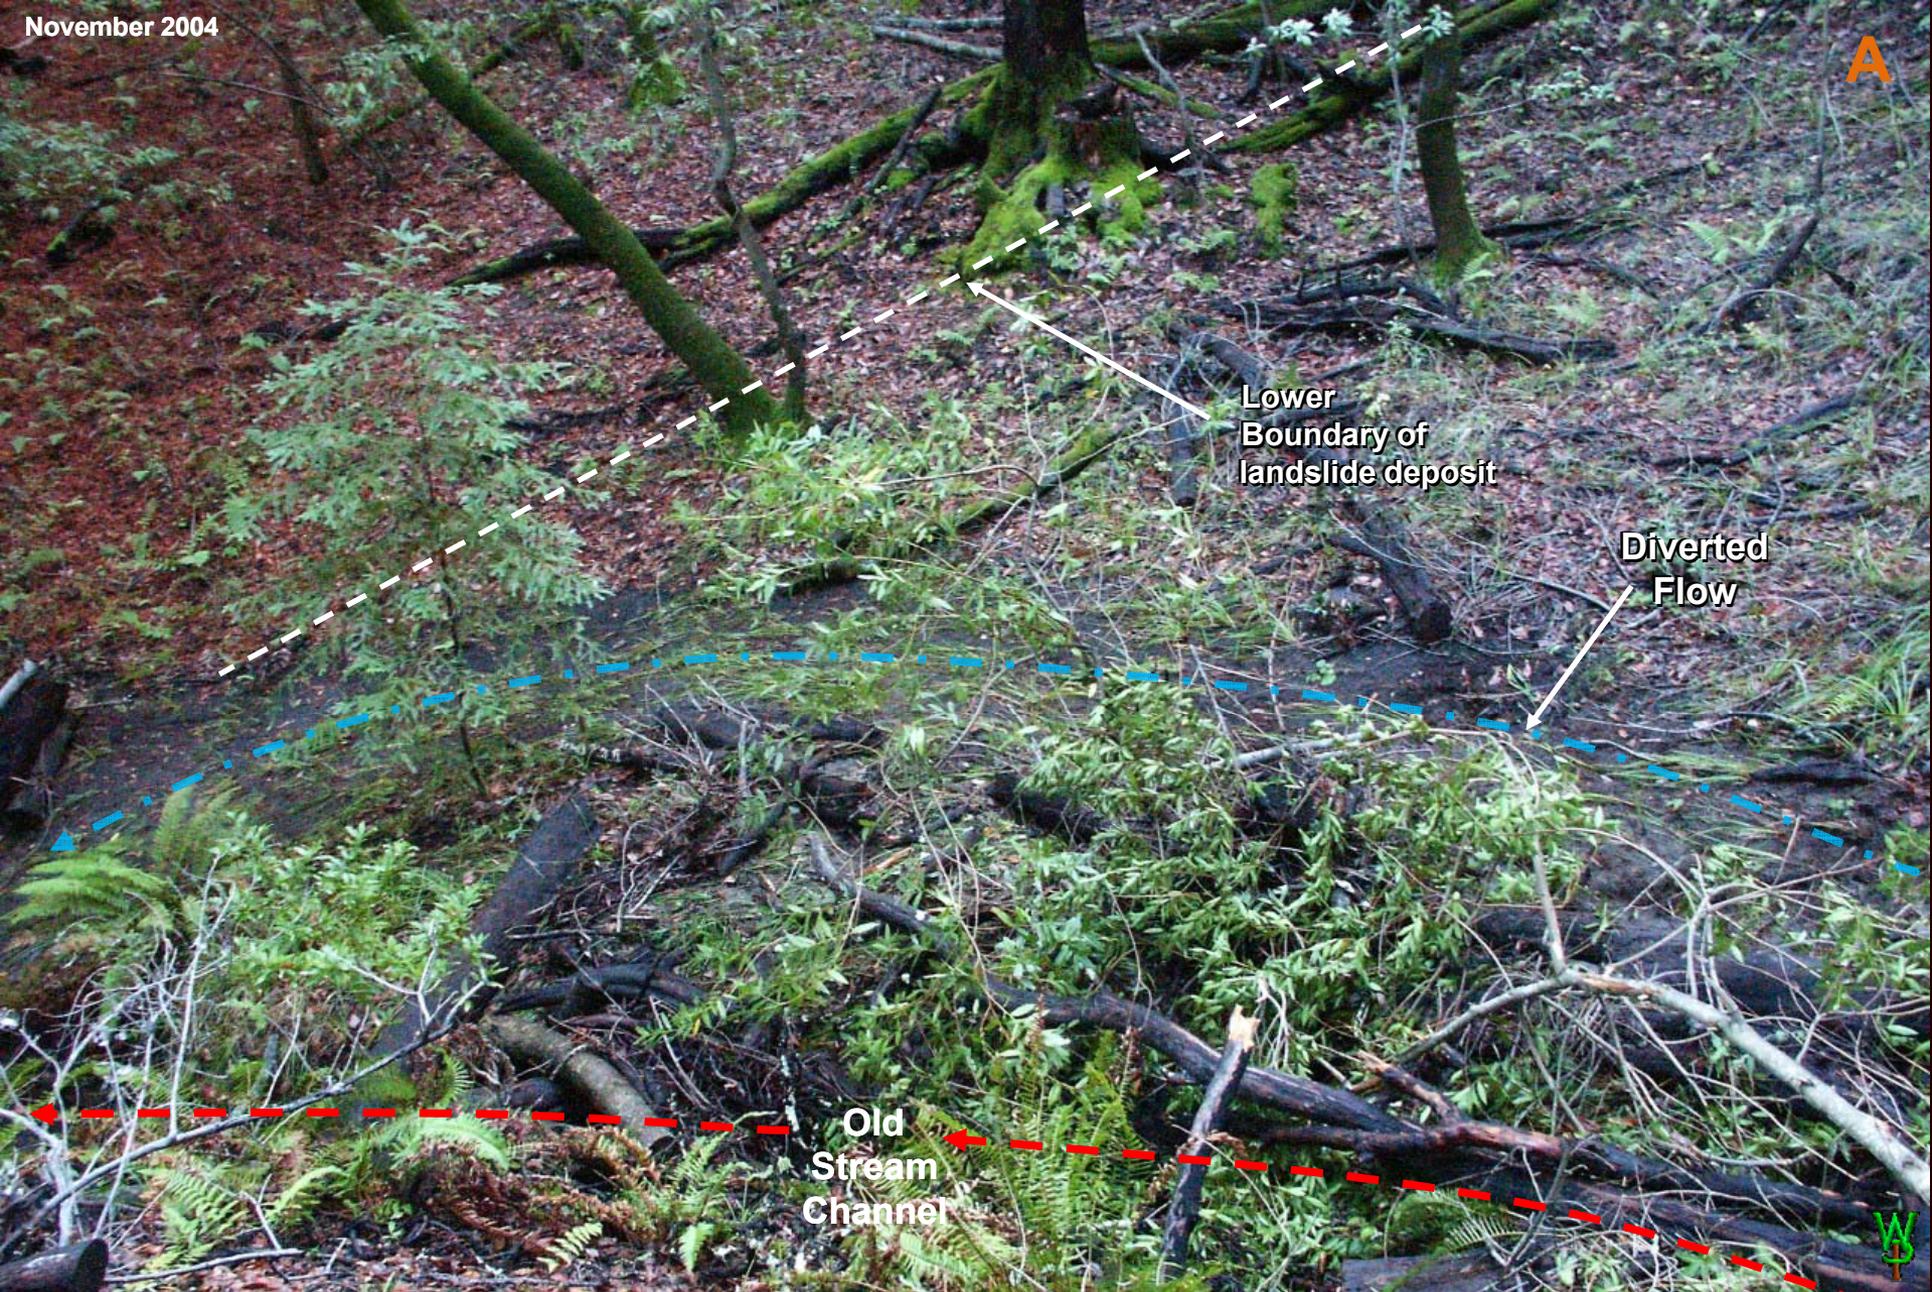
Lower
Boundary of
landslide deposit

Most people would never guess that *reducing* canopy cover has anything to do with reducing erosion, but then, most people do not understand how amazing sedges can be in doing that job. As to the risk of a debris flow in case something goes wrong, there is a big flat area just below the outlet to this stand for the water to fan out and lose energy.

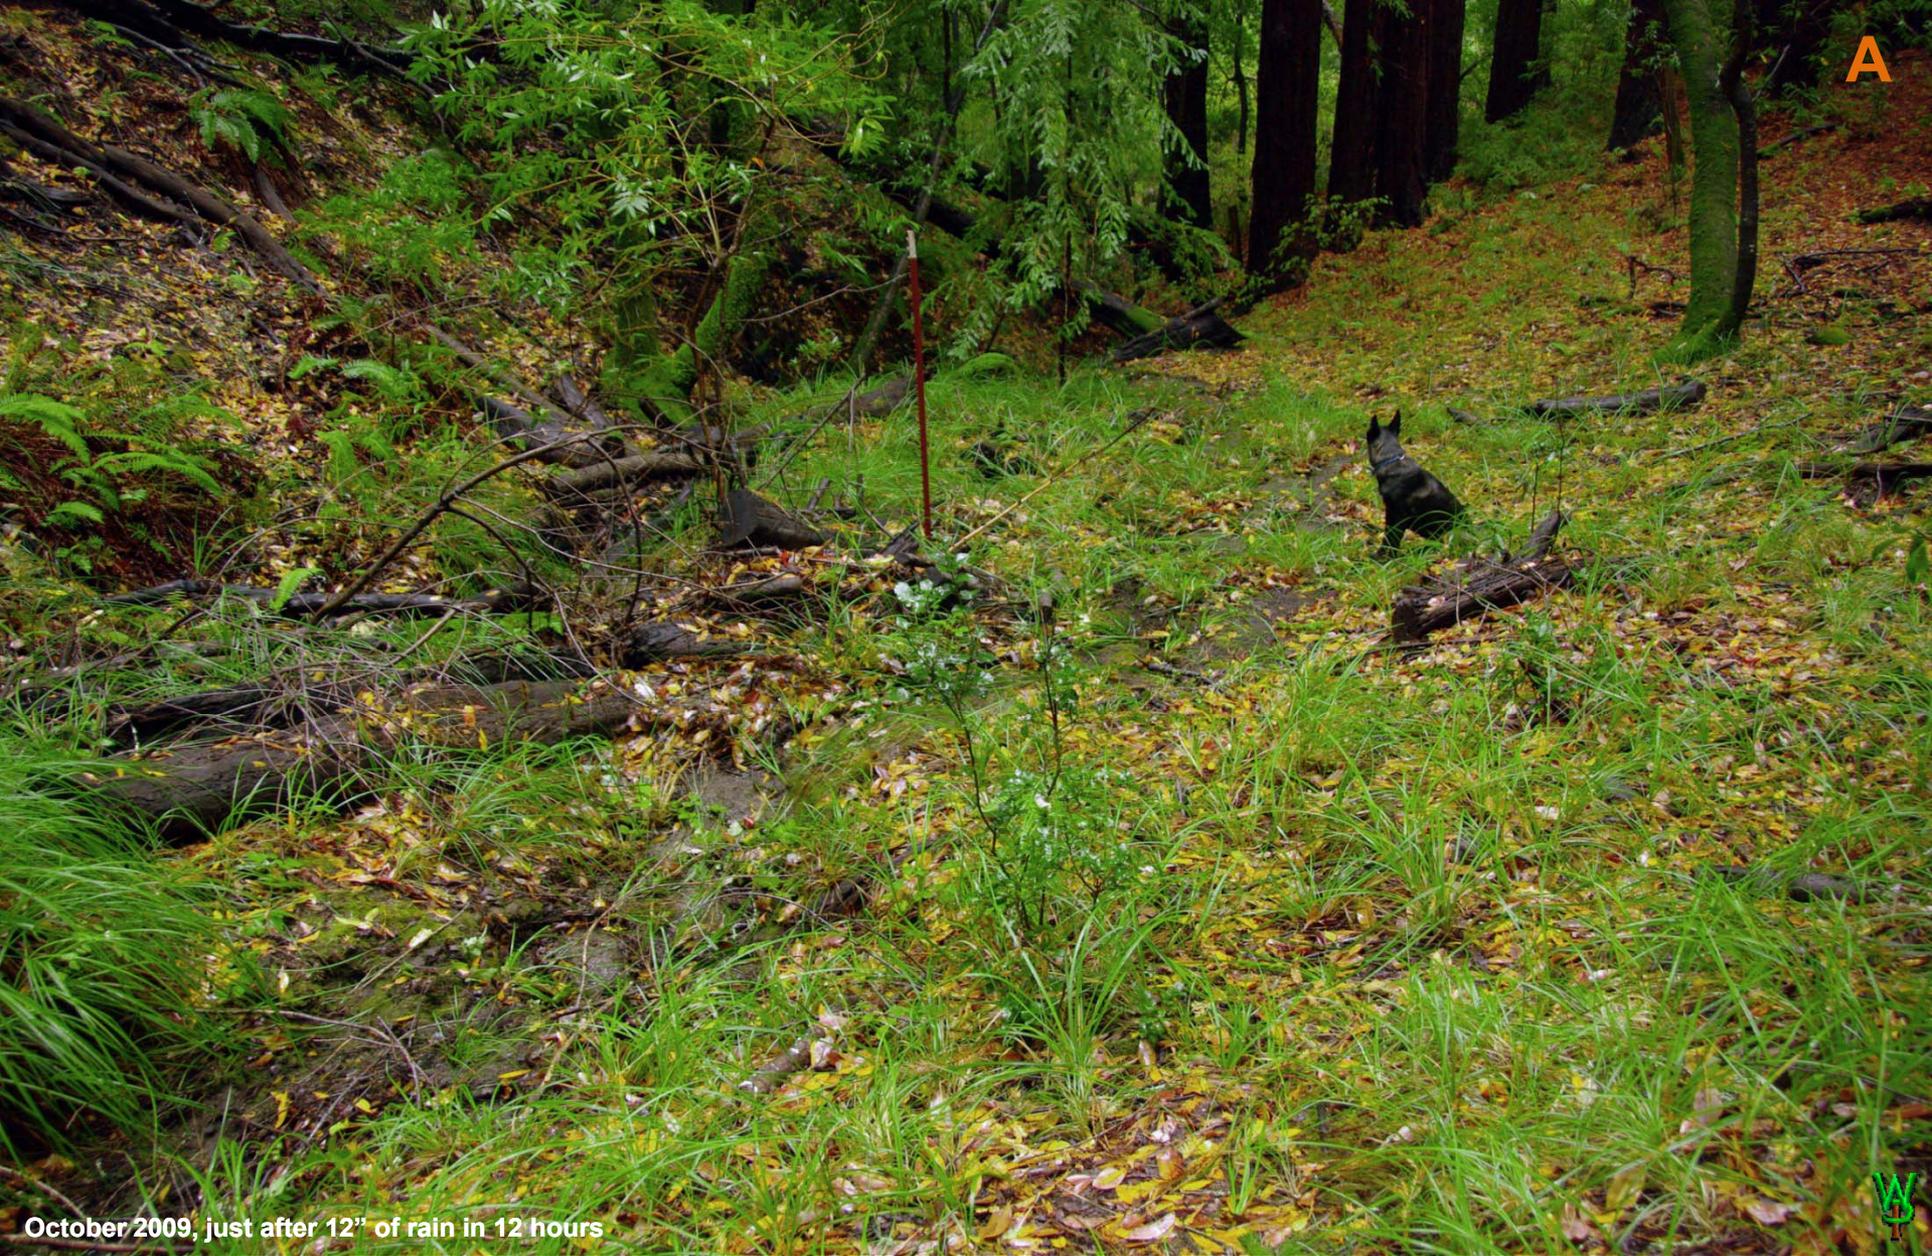
October 2009, just after 12" of rain in 12 hours

Here it is after five years of winter rains and just after another monster storm. If you look carefully, you'll see not erosion but *deposition* of sediment in the foreground at the head of the diversion. That material is from all over our property, from the my neighbor across the road, various stumps from fallen trees, etc, but probably the biggest source is gophers, ground squirrels, moles, and rabbits. I use that material to stabilize the draw over time, as you will see in our next example in the next channel in the middle of the property.

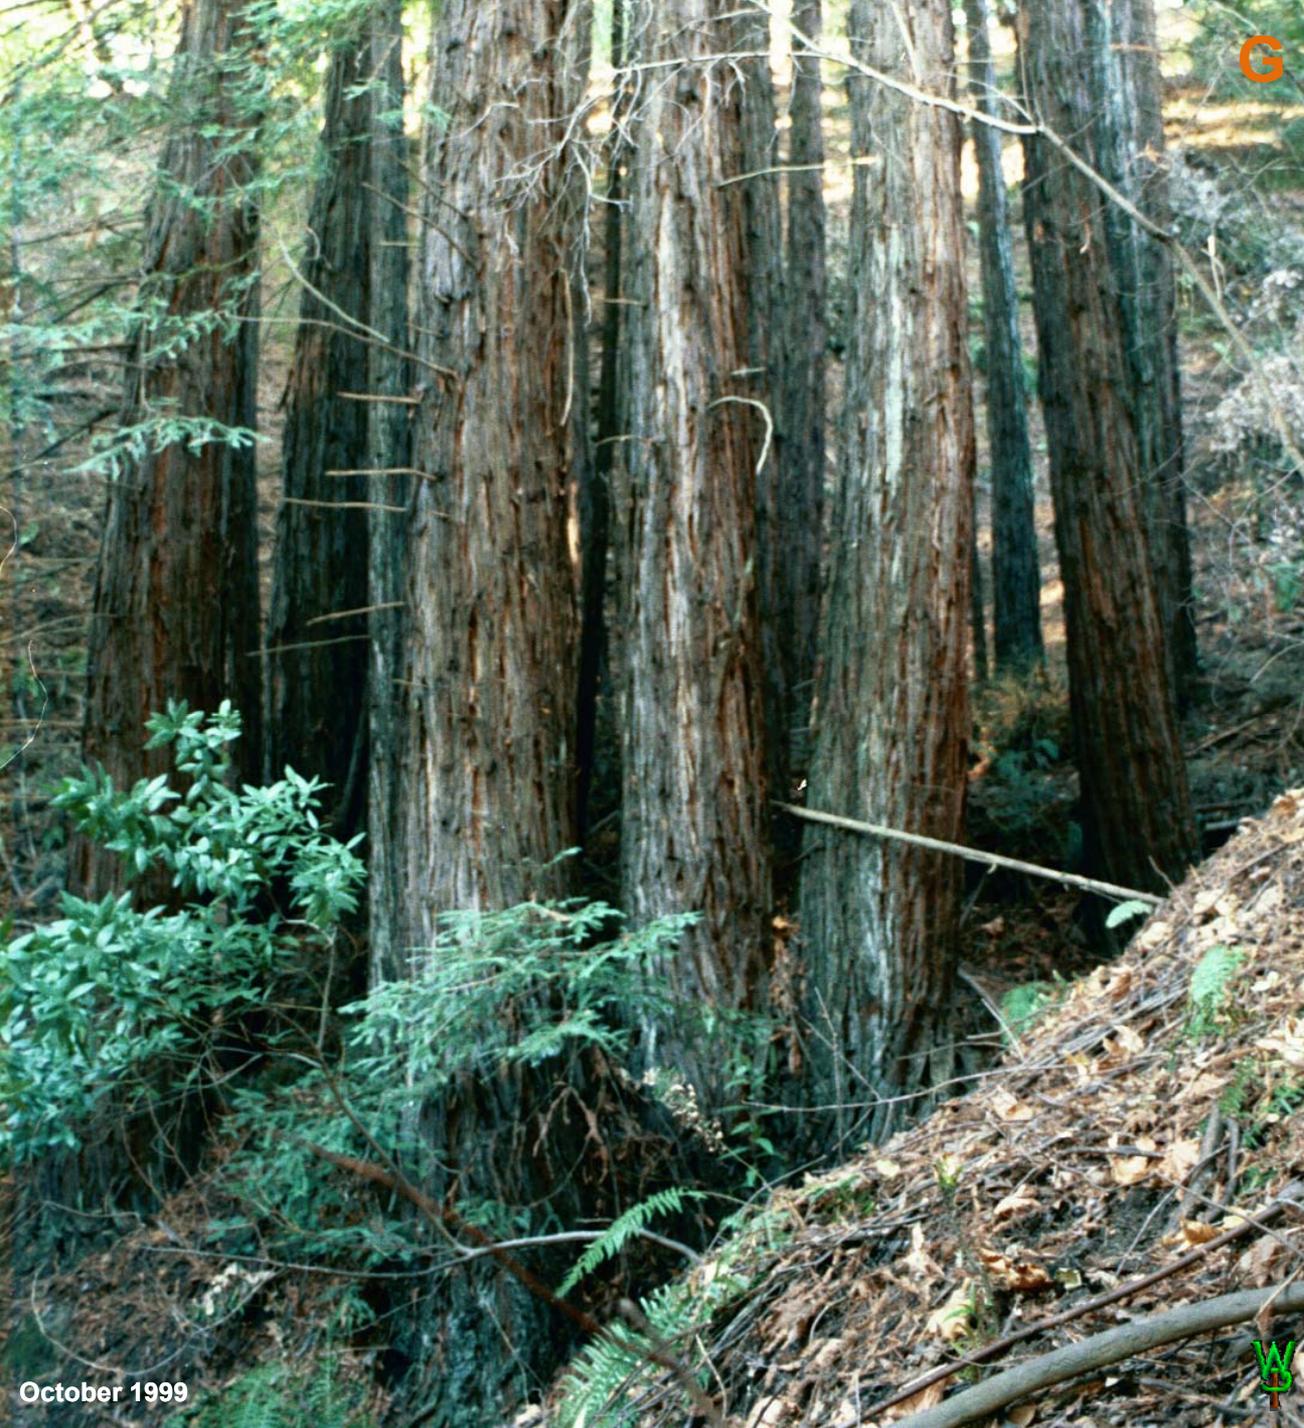
Let's go back to the center draw, starting with our now familiar logging job discussed under [Conifer Forestry](#).

On the left is that now-familiar "wall of wood" I somehow discerned needed thinning. The stream ran in front of them and was starting to undercut their support. You will soon see what happens should that process progress.
