FEELING DRAINAGE

WILDERGARTEN 6.4

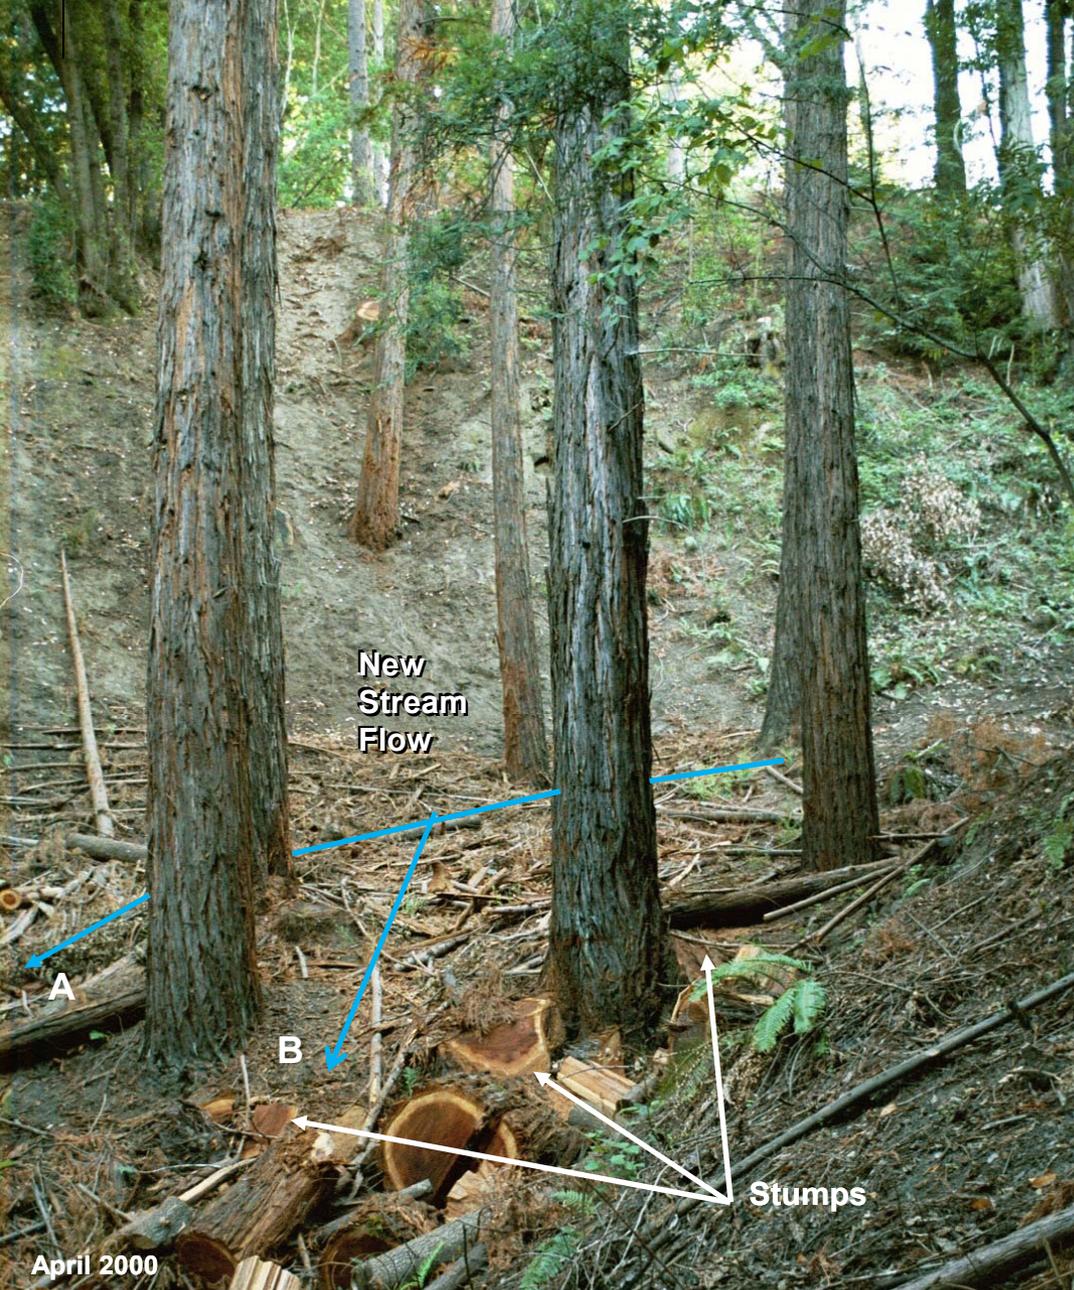
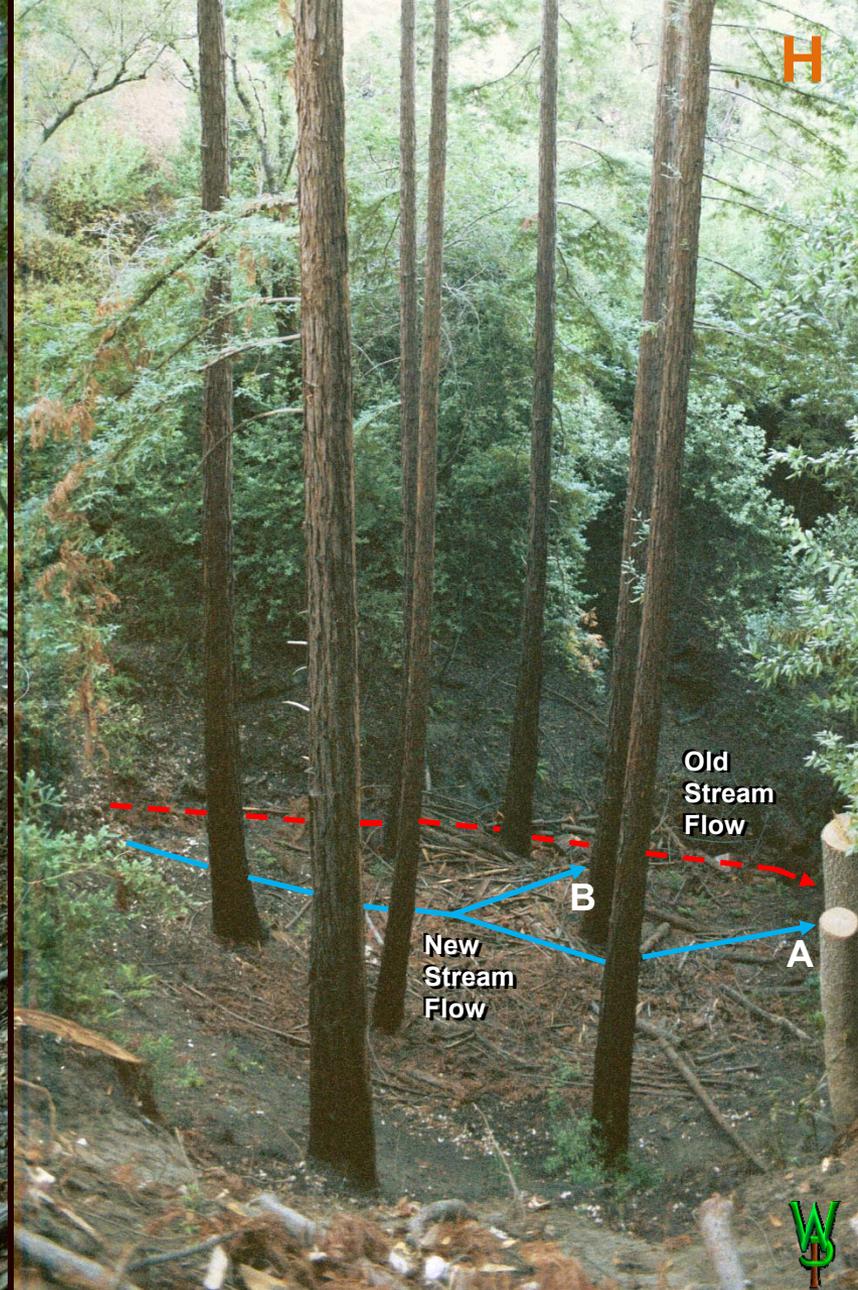
As you can see on the left, I broke the flow into two streams, meaning that the total energy hitting any one spot is greatly reduced. Flow "A" is a great deal lower in slope which thus reduces water velocity. Flow "B" smacks headlong into a stump, which being redwood will last a good long time, especially because it will re-sprout new trees. Because of the slope, I don't expect much deposition here.

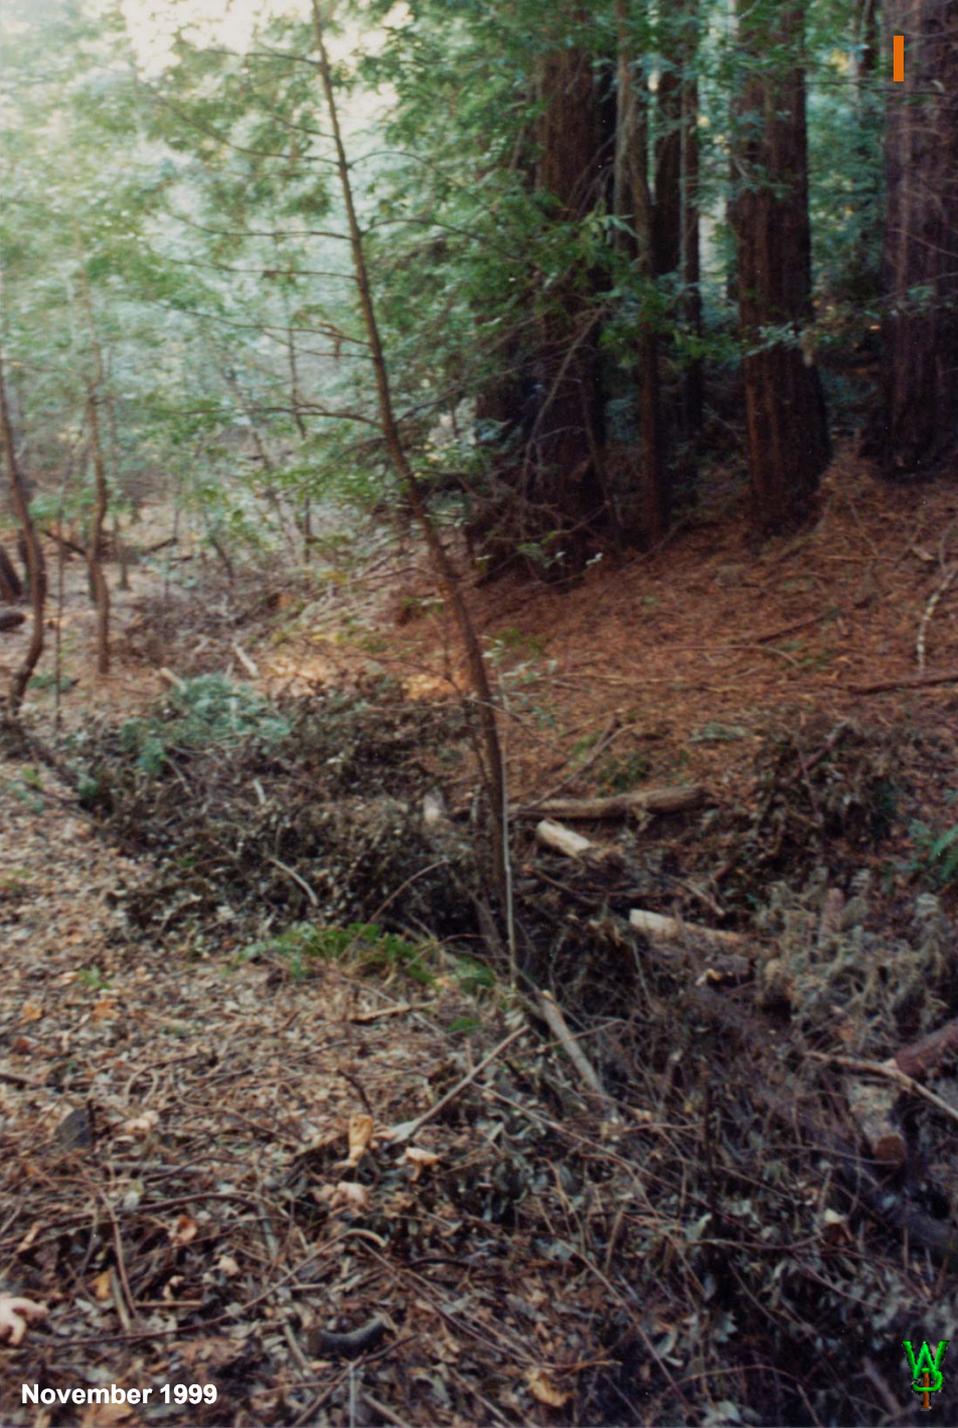
This is what the drainage just below that stand looked like before I began that logging job. I had already started removing small trees that would “get in the way” as well as cleaning up the forest in general. Up until that point, this draw was so dark that there was nothing alive on the ground. Not even ferns grew here.

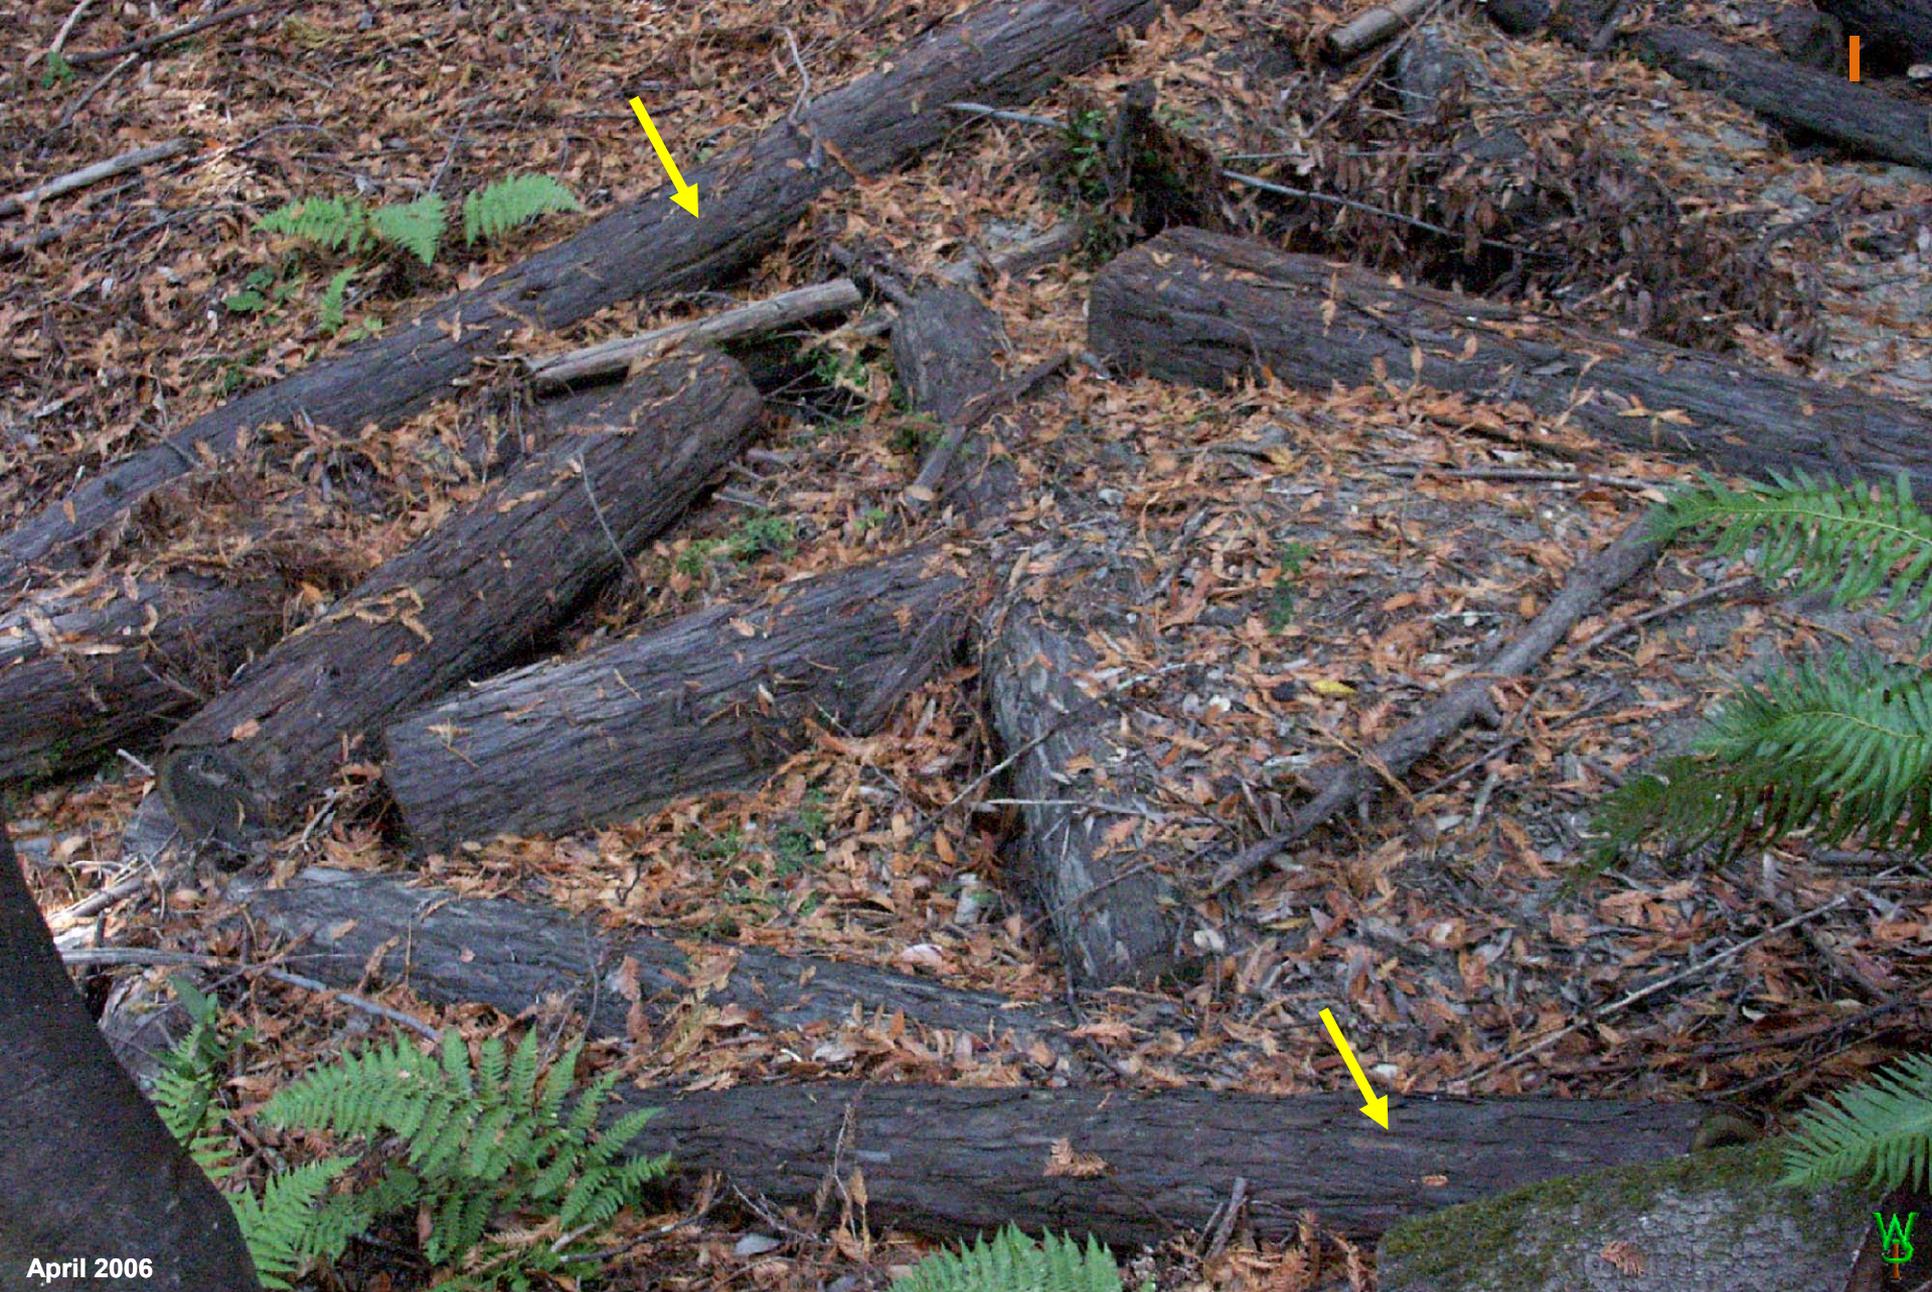
April 2006

This wood was placed on top of what you just saw. As you can see, it wasn't just 'dumped into the creek;' it was placed carefully with **higher outside walls** to contain a huge flow inside the channel, with the inside pieces triangulated to wedge each other while breaking the flow into a very convoluted path. It isn't hard to see the sediment that it captured, but where and how did it originate?

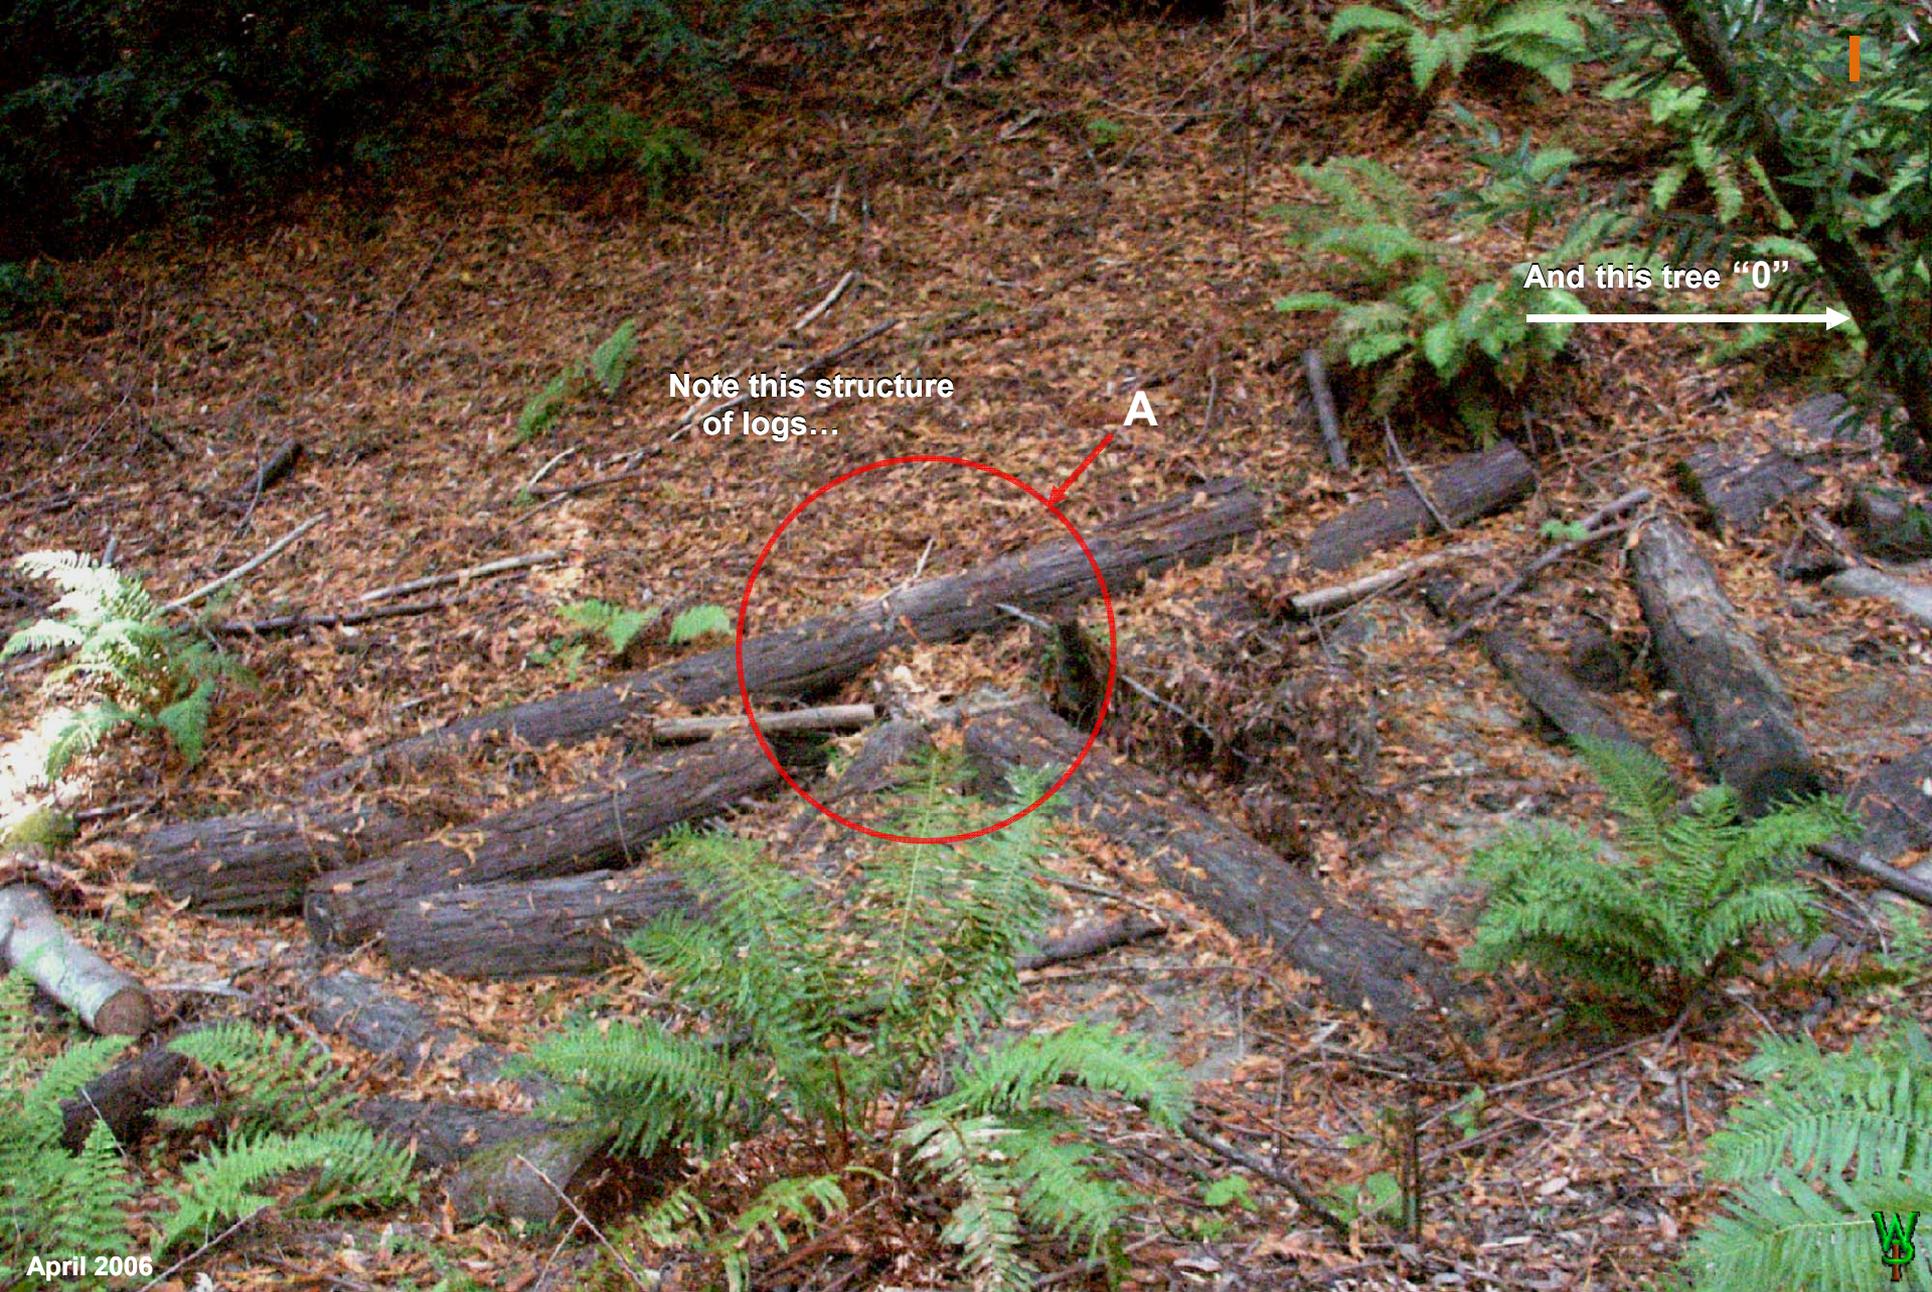
April 2006

Gophers, ground-squirrels, me tromping around... all those tiny sources of sediment add up to a lot that was once lost off the property every year. This photo was taken six years after my original 'logging job' in 2000. The sediment has almost completely filled a channel 6-8 feet wide and 2-4 feet deep. Note the circled structure "A" for reference in the coming slides.

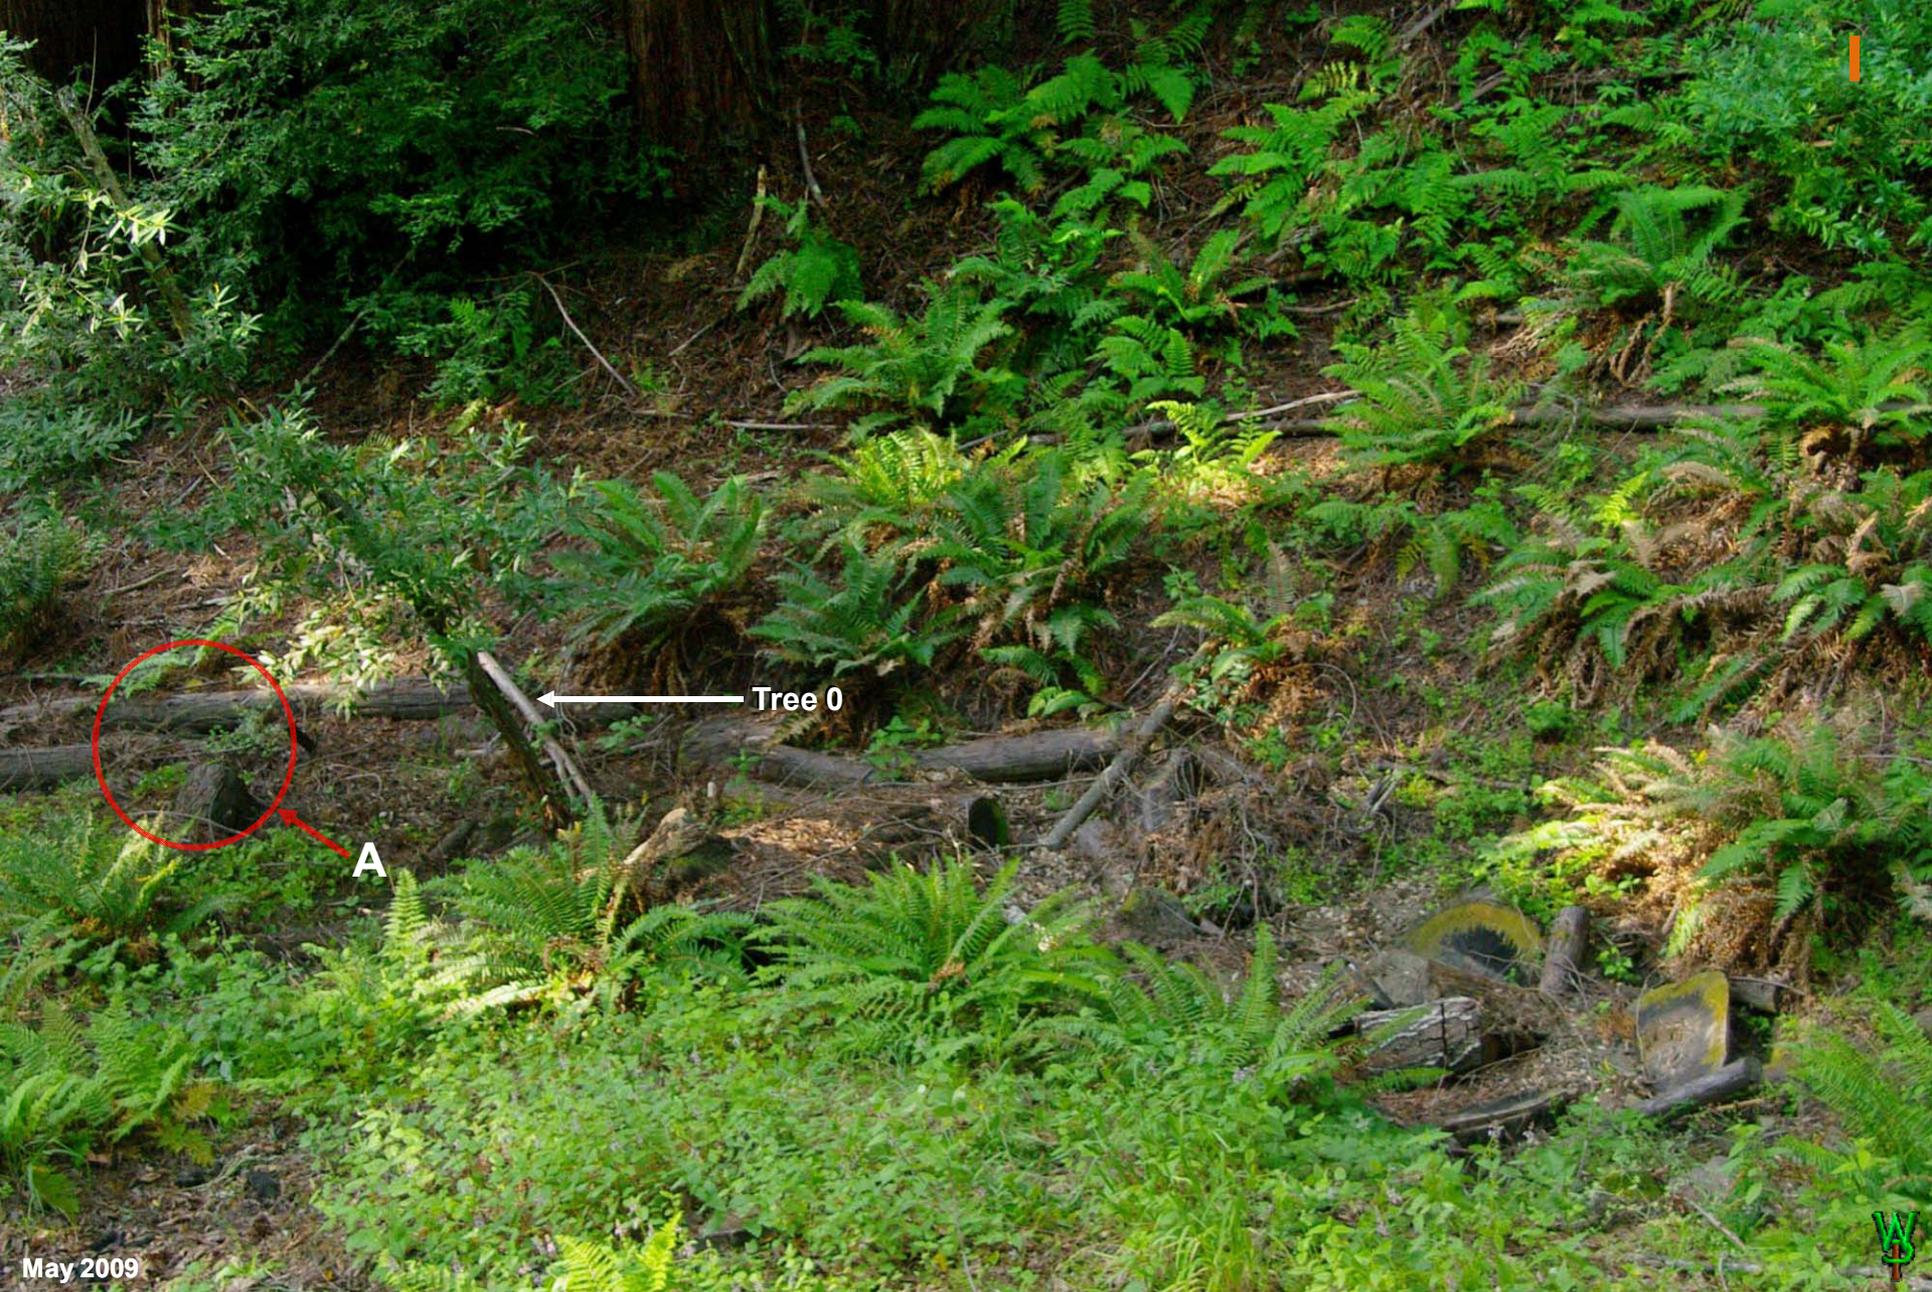
May 2009

This is the same channel three years later from a little wider view. Logging made the material to line the bed and collect the annual deposition. Logging thinned the slopes so that light could reach the canyon bottom to stimulate the vegetation. It's working, but more thinning is needed for the sedges to really take. More sediment will help too. Note "Tree 0" (the white arrow) as a reference location.

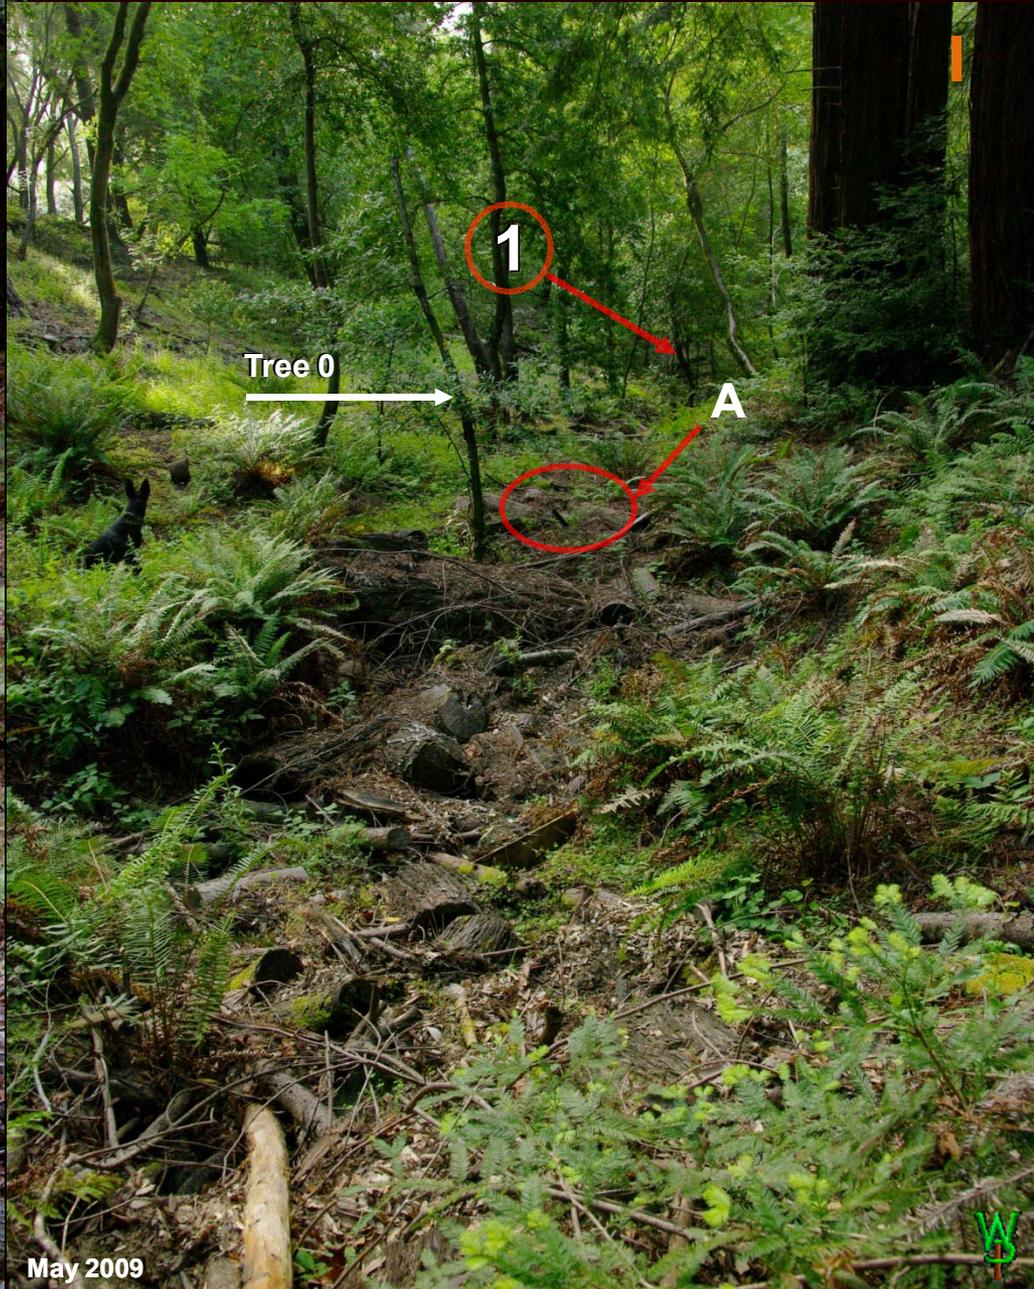
Repeating the series from the end, I had thinned more bay trees above the left background and put *more* wood into the stream between "Tree 0" and the circled tree (1).

Here it is L+9 from a spot just to the right (new vegetation was in the way). Thinning the hillside on the left allowed in a lot more light. The stream bed is still filling in and more plants are taking root.

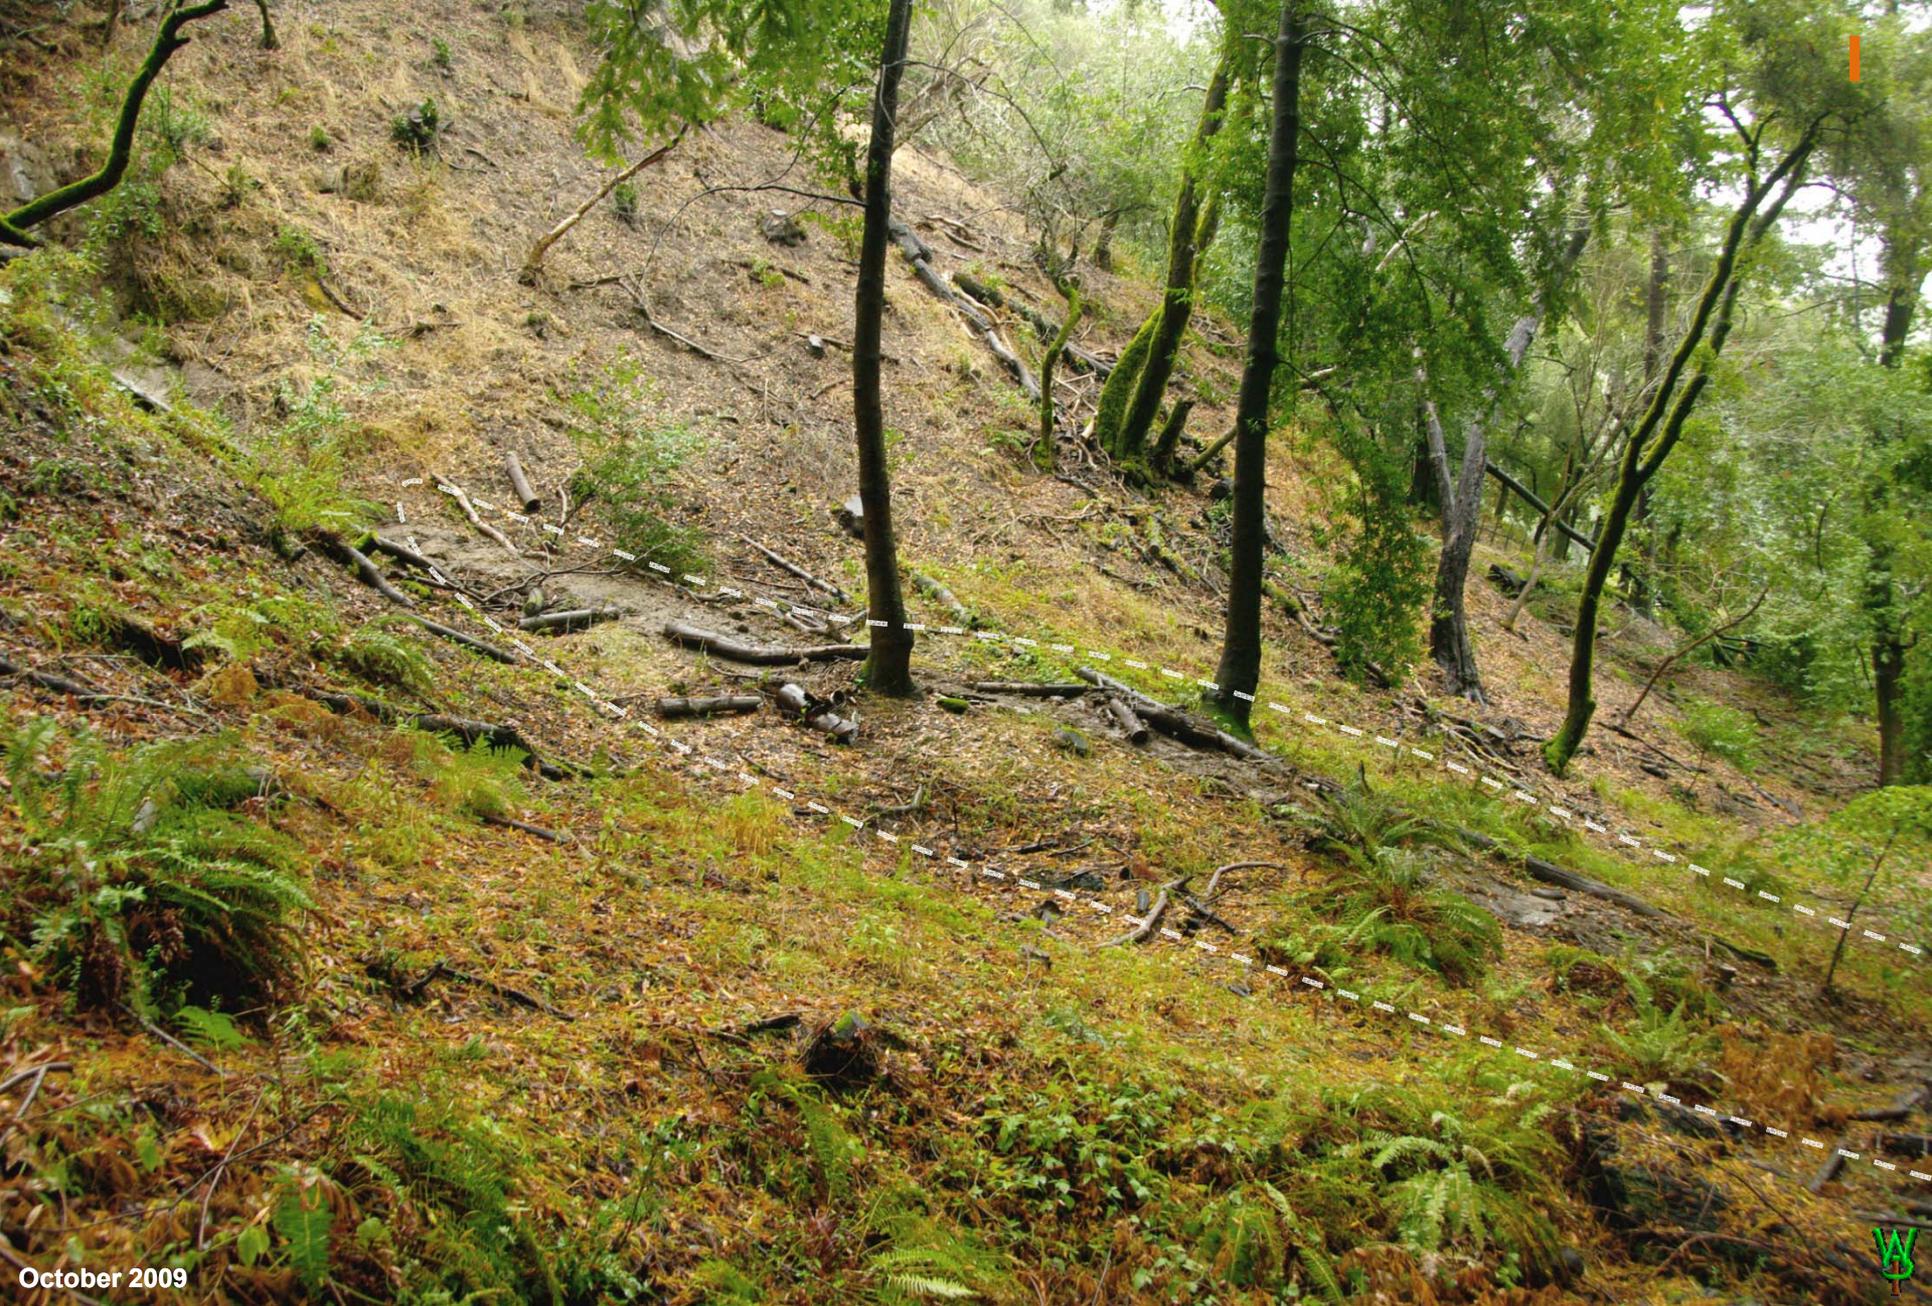
October 2009

This is just downstream on the way to that (1) tree, immediately after that same 12" deluge in as many hours. Besides the material filling this channel from all over the property, I also "mine" more from this alluvial fan of old stream deposition. The pieces of wood you see chocked against the trees steer the flow across the pillow pile of sediment and into the stream. It's slow, but it works.

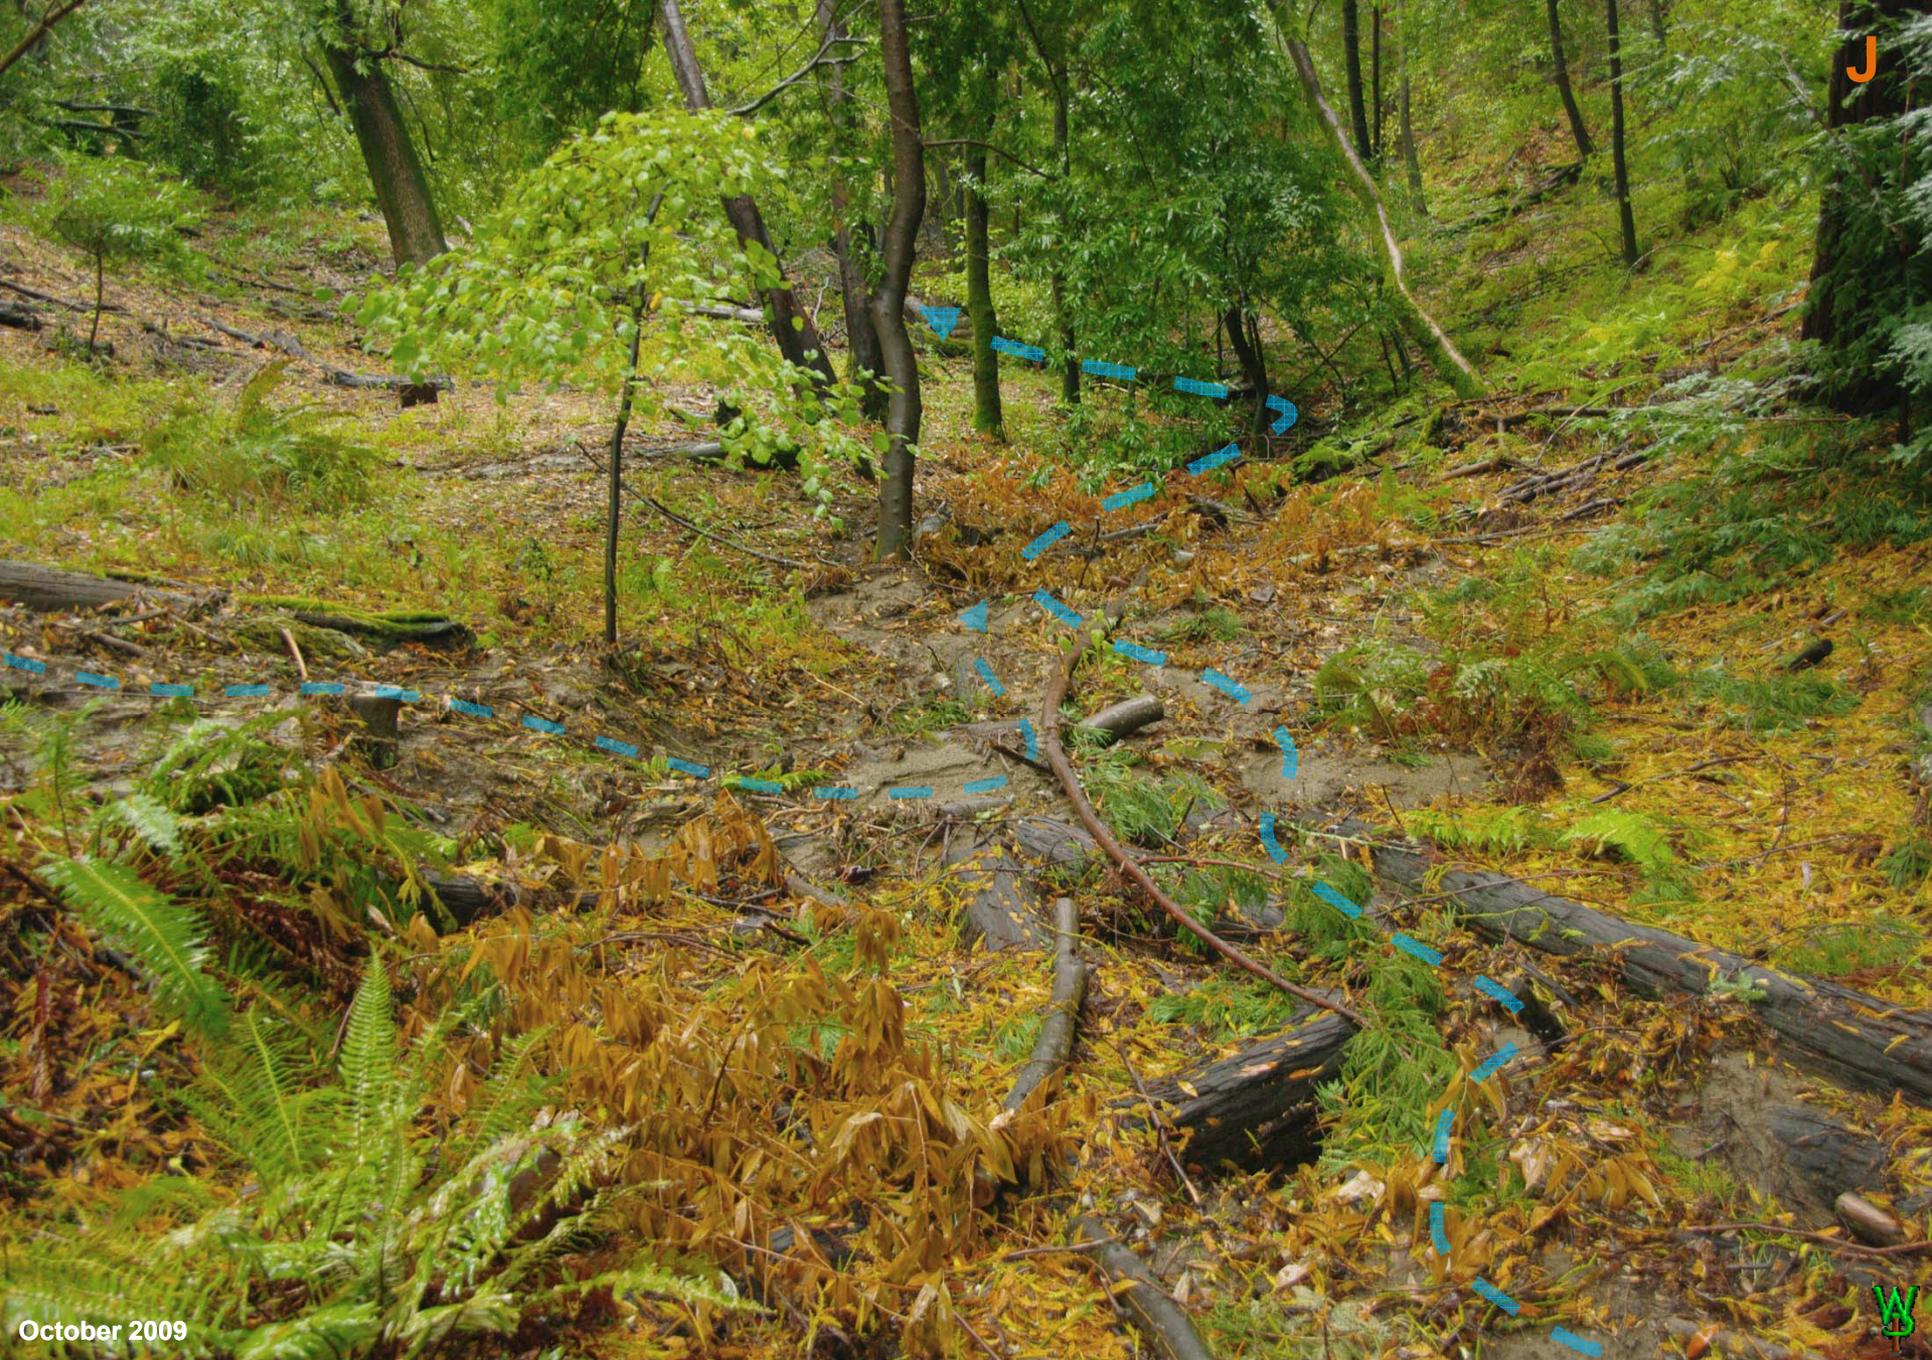
October 2009

Here is where it enters the main channel from the left. Note the branches to slow it down and divert it downstream.

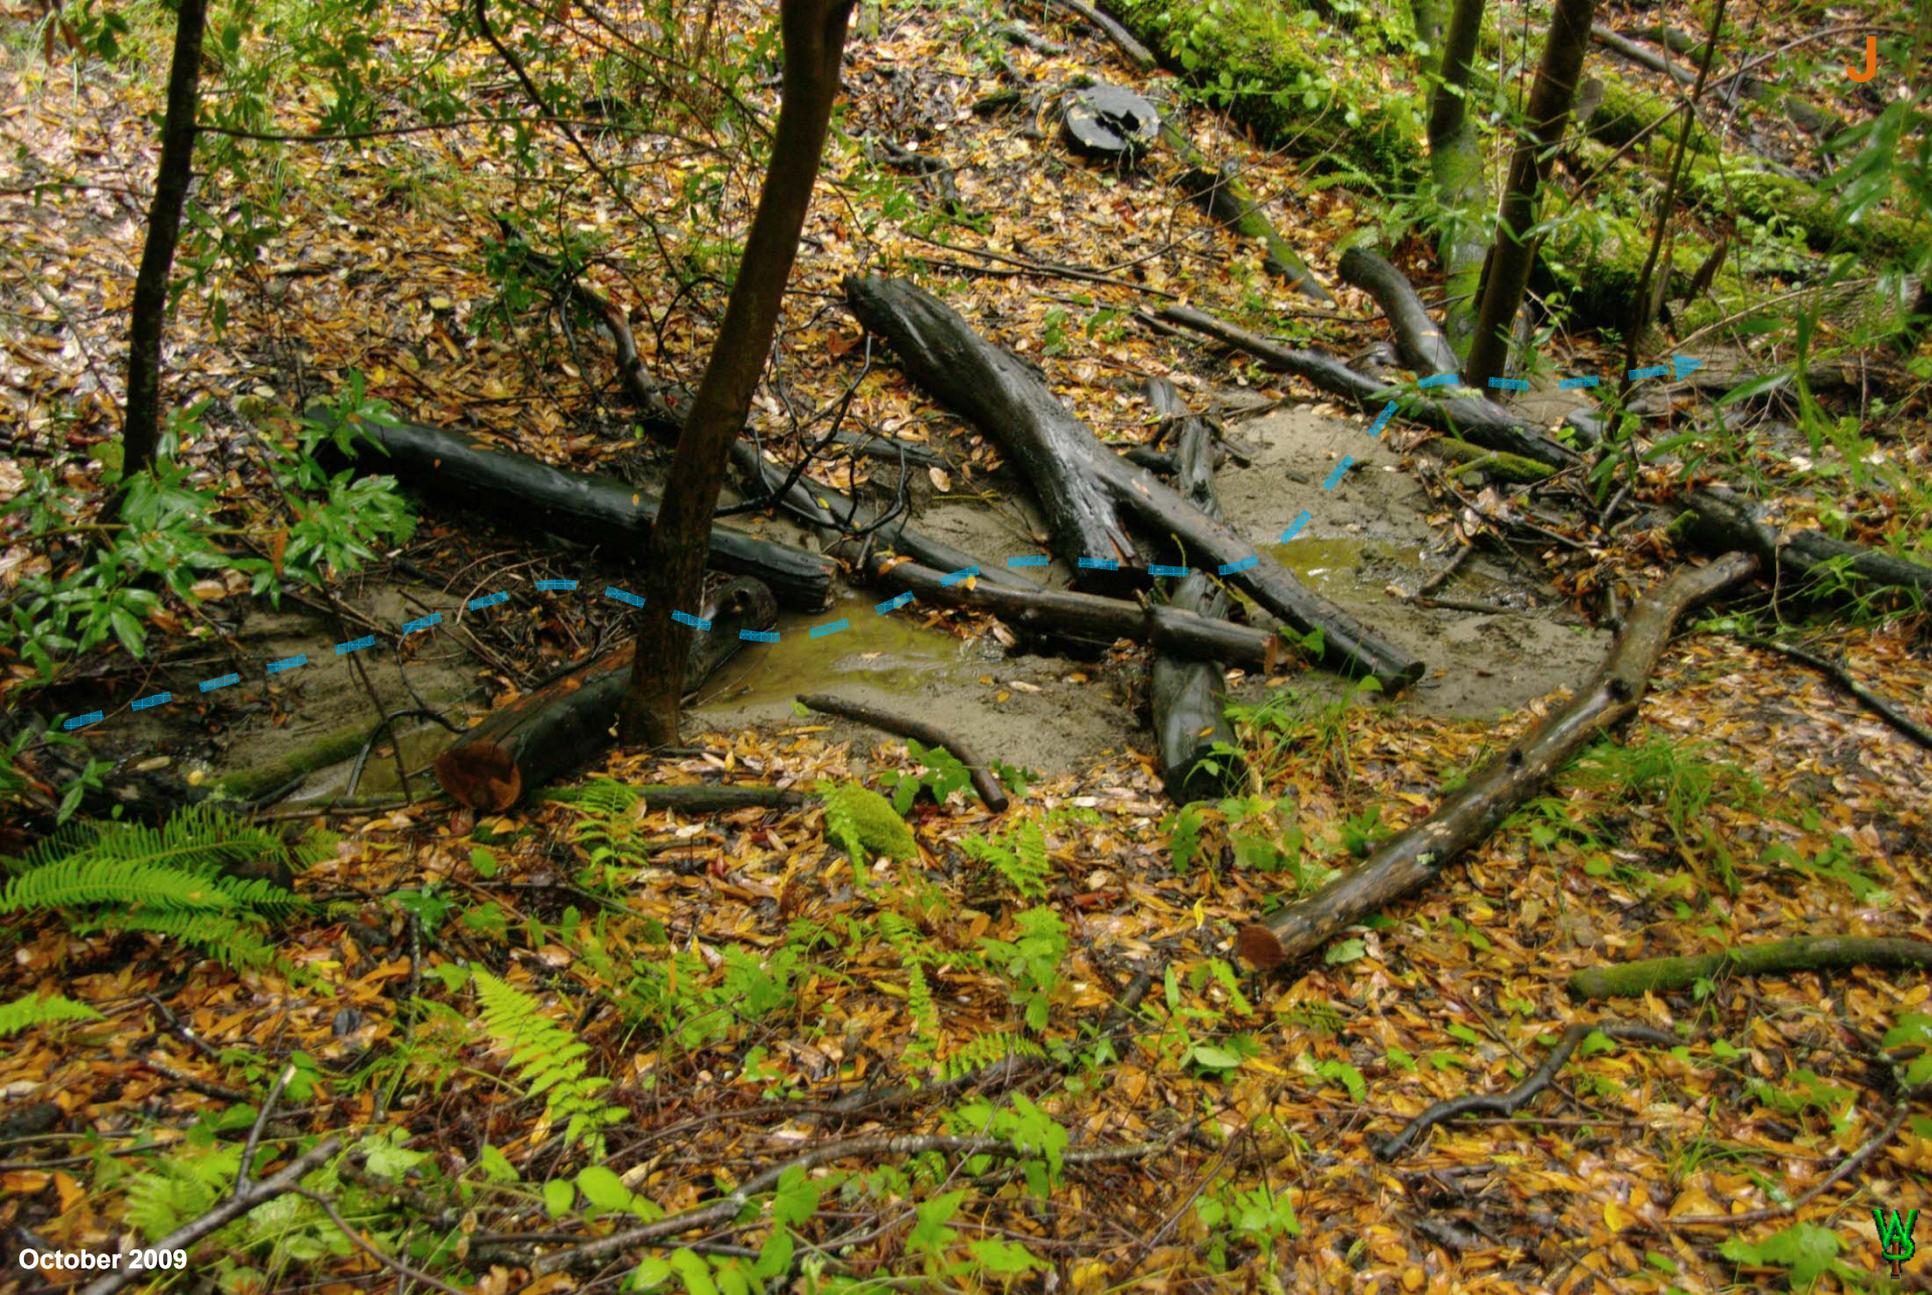
October 2009

The logs are chocked to cause the material to drop. When a section fills in, the water carries the sediment down to the next trap. From this massive storm, the additional buildup was about 3" thick. The trees anchor the system but they also make it dark. I want to get the sedges going, so I thinned them a few years later on after this had time to settle and consolidate.
