FEELING DRAINAGE

WILDERGARTEN 6.4

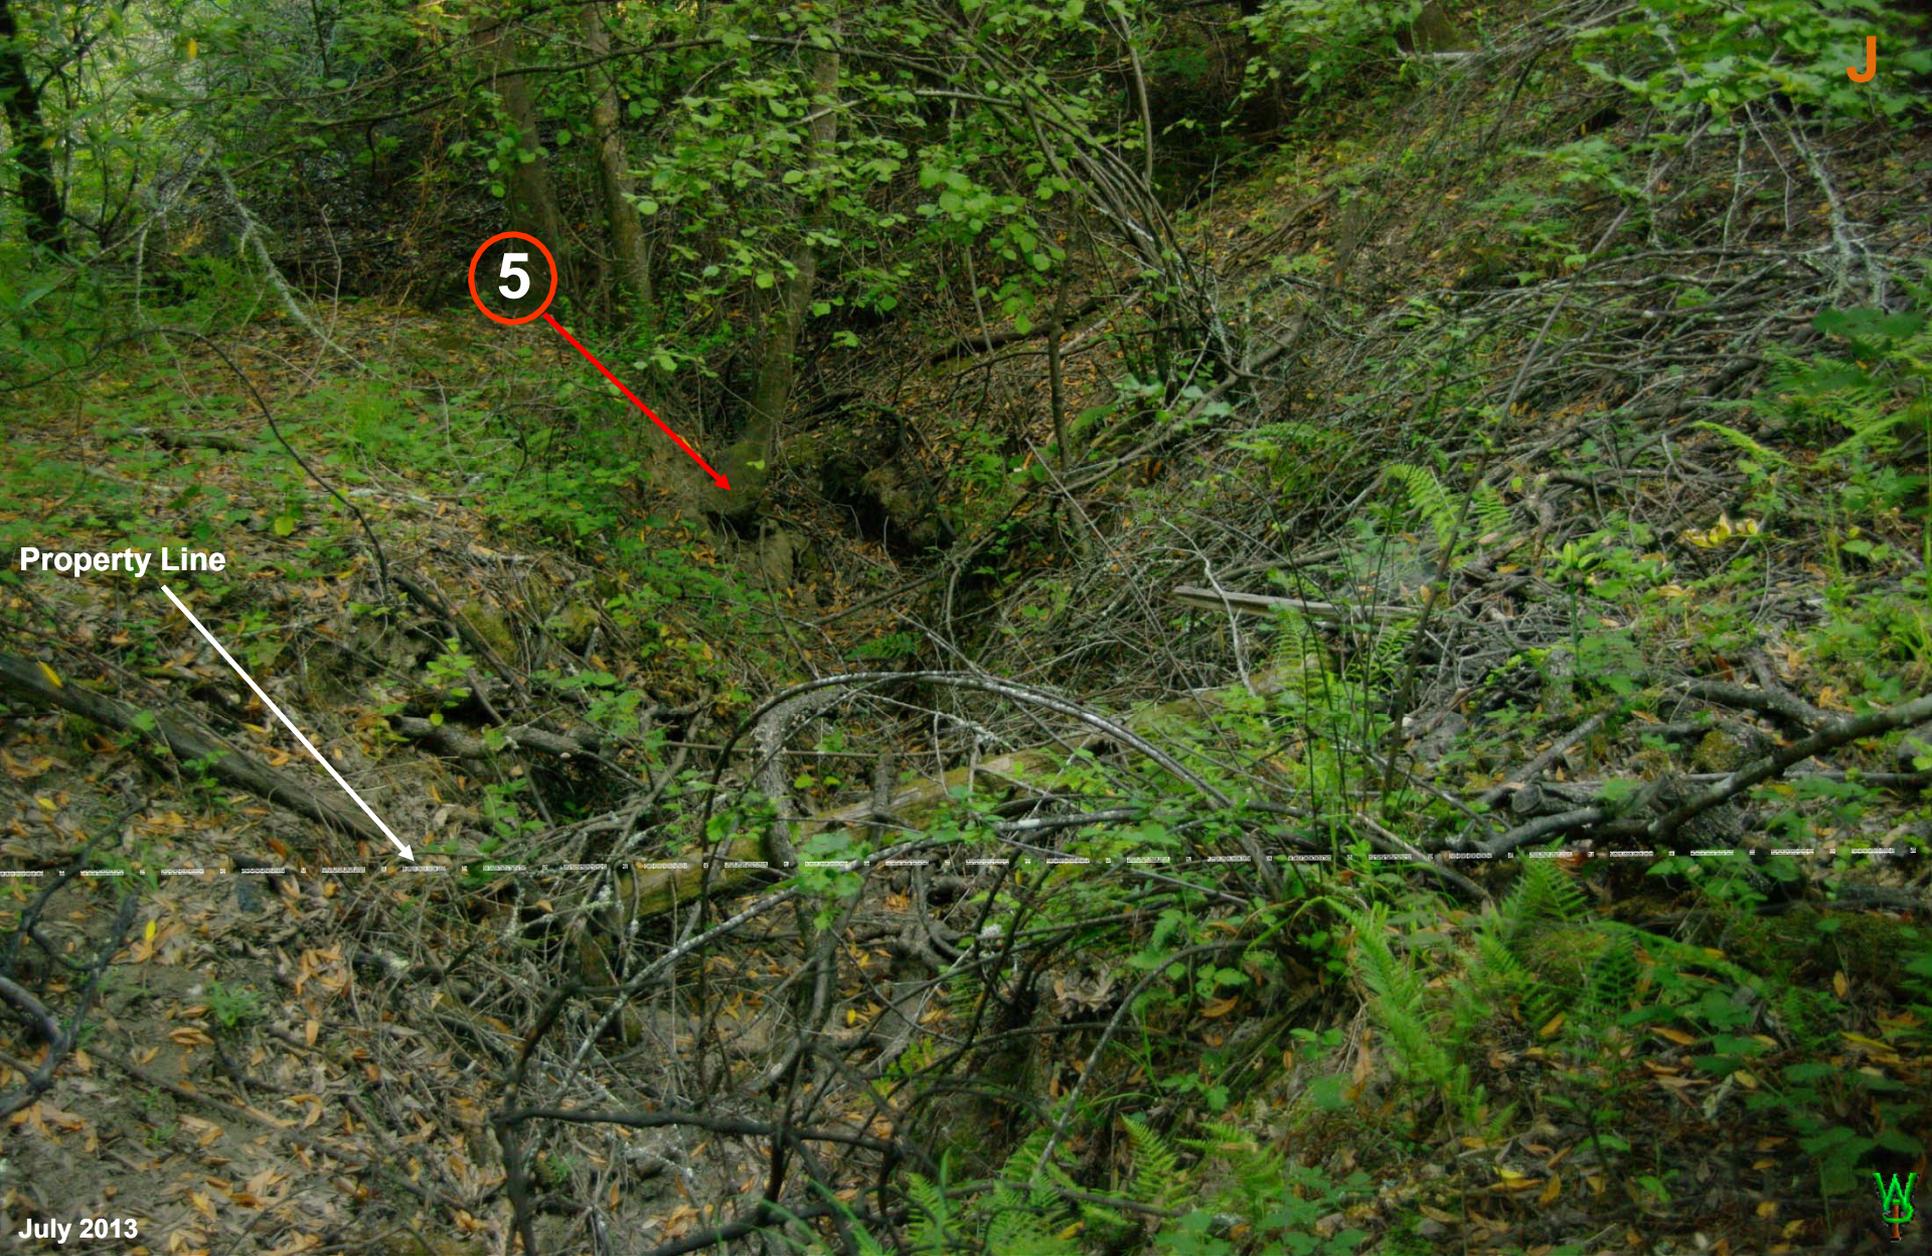
July 2013

Below the property line, the channel now averages fifteen feet wide and 6-8 ft deep, with a secondary embankment two thirds of the way down upon which the tree (5) is sitting. The channel cross section stabilizes from there at about 20-30 ft wide and 10-15 ft deep. What you can't see is the pocket to the left that has probably lost about 60 cubic yards of soil. Without treatment, the incision here will only get worse, the banks will eventually fall in, and be carried away. No thinning, no groundcovers, lost soil, in that order.

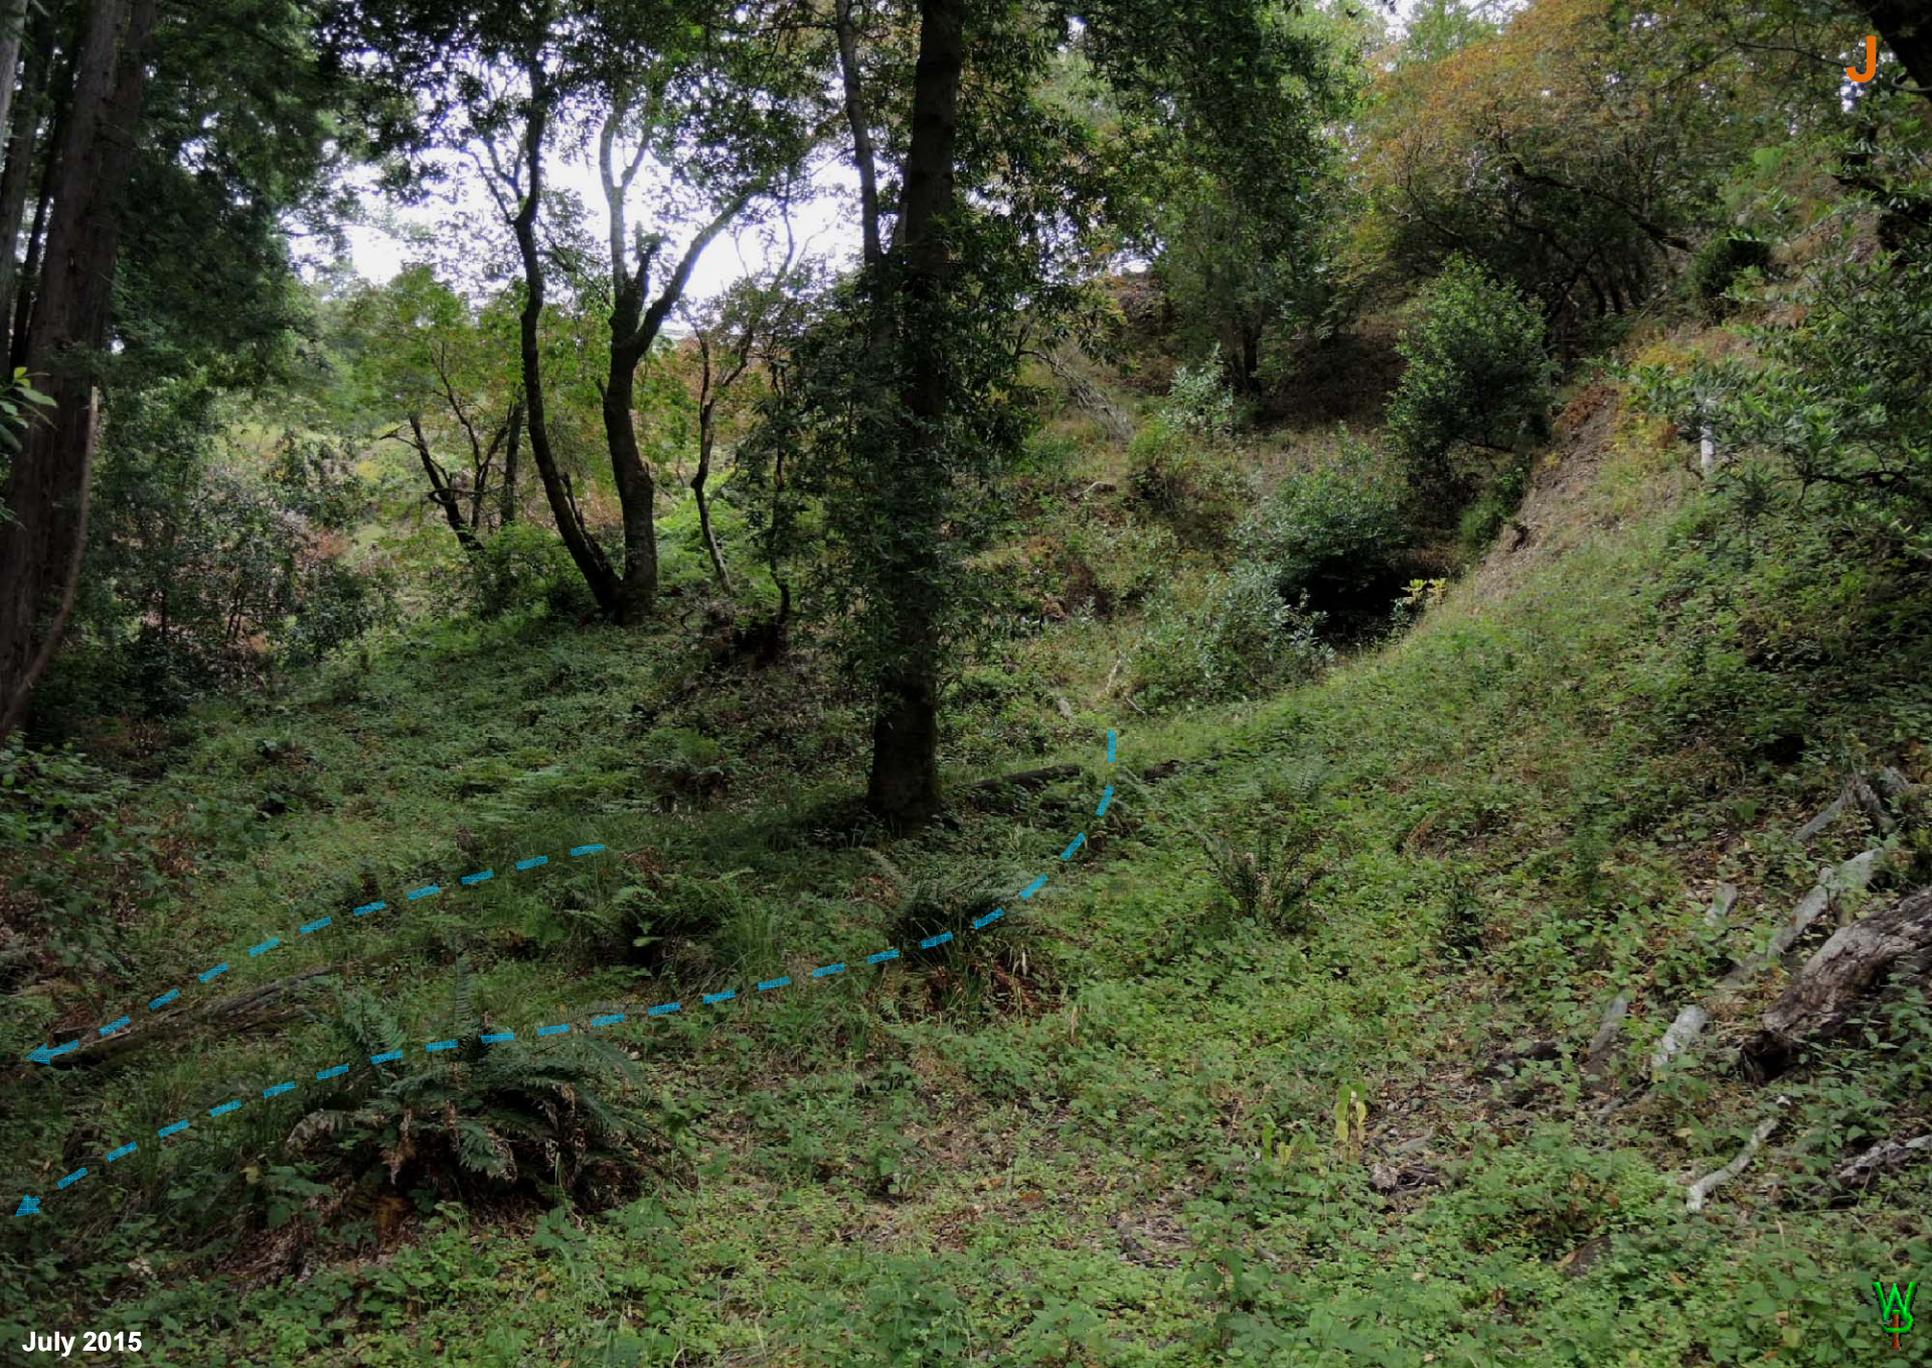
July 2015

With regard to our groundcover, this is that same alluvial fan a few years later from below.

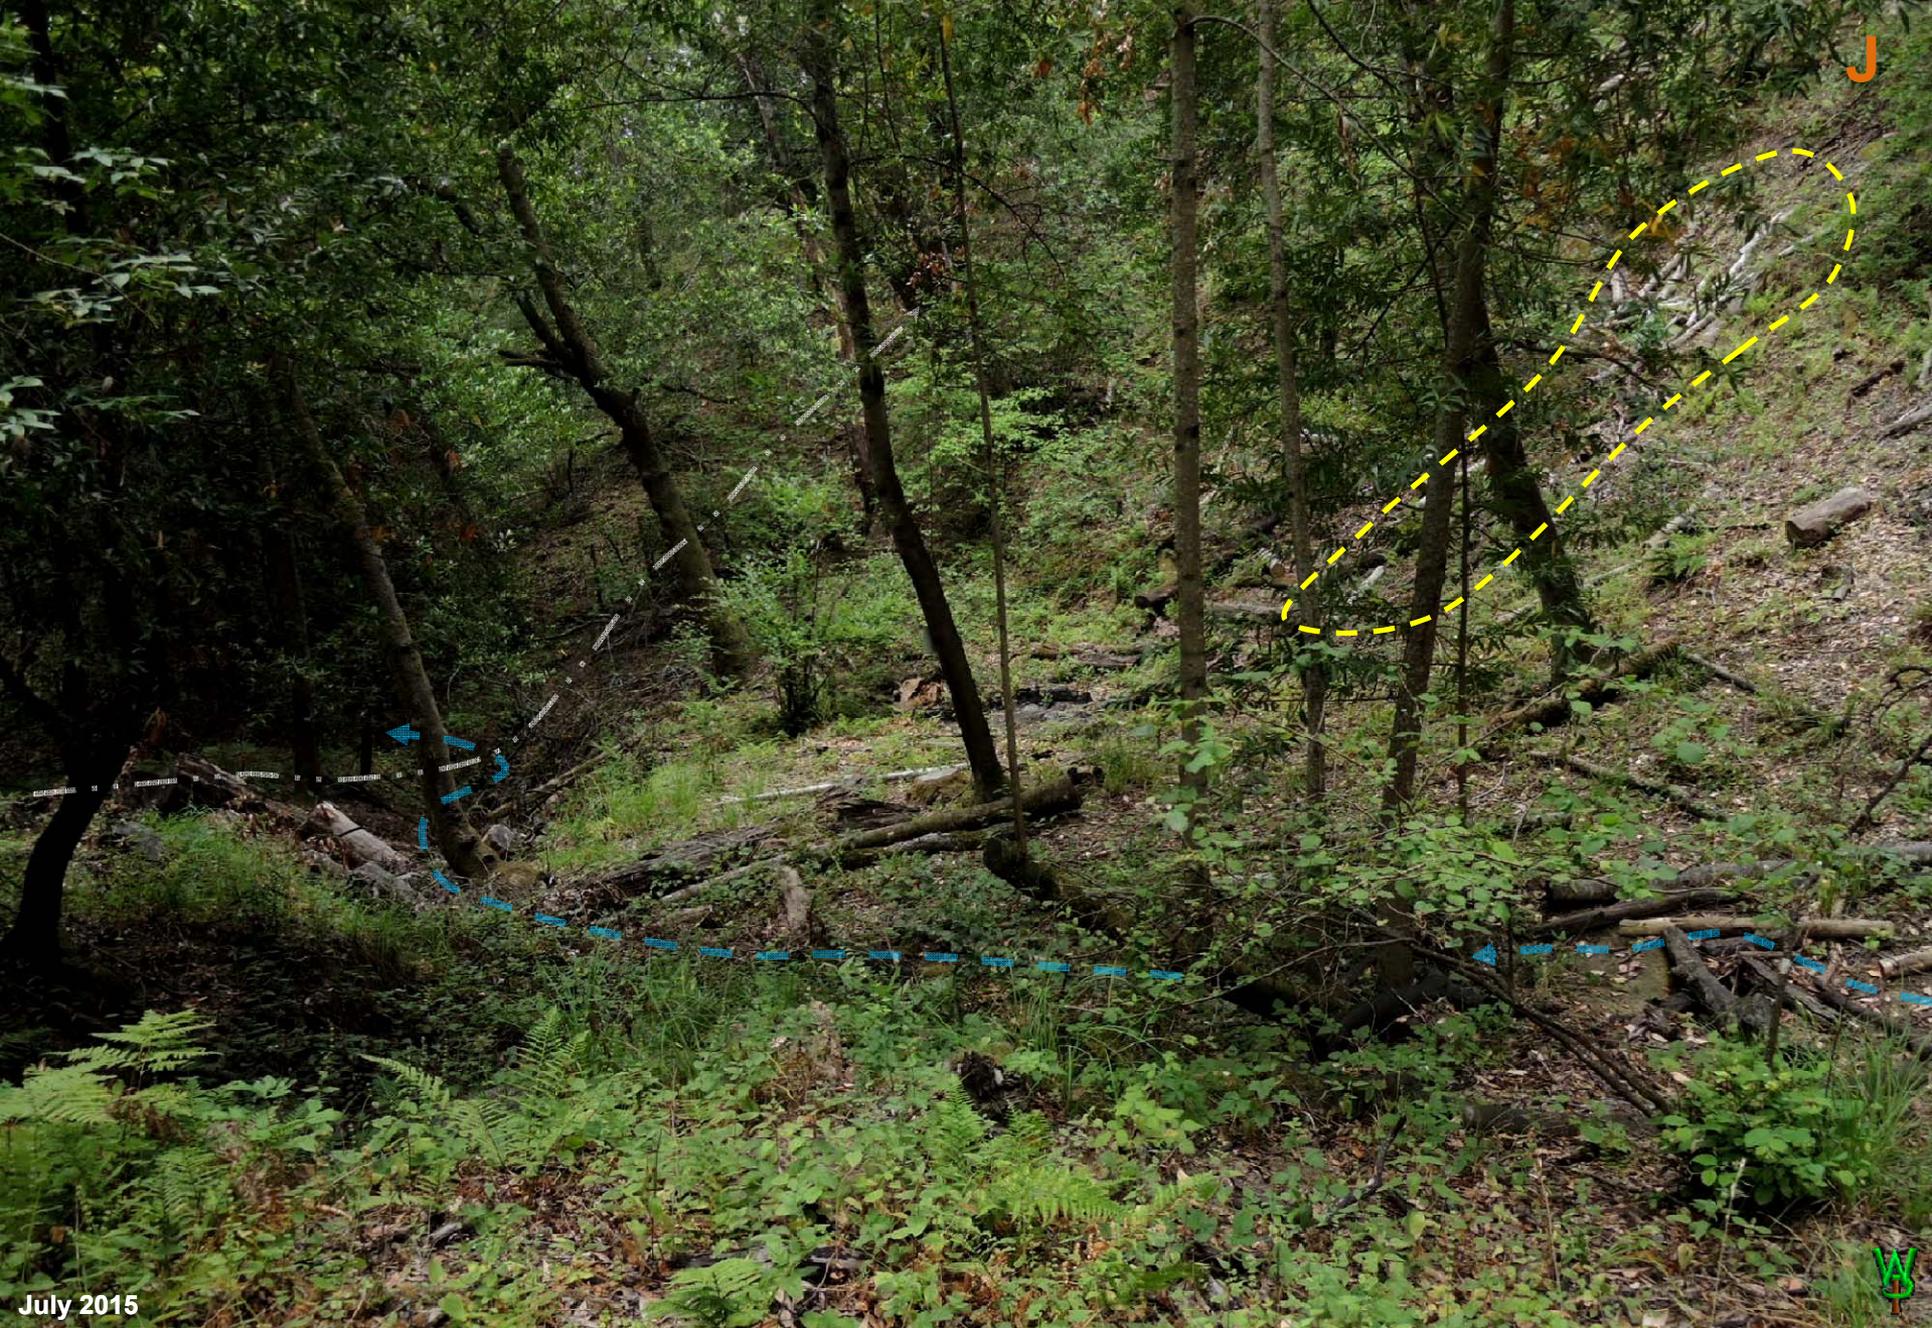
July 2015

Note the **logs on the upper right**. I thinned this opposite side of the draw last fall. Yes, the cover is 100% native and weeded every year. Note also how dark it gets on the left. That is the property line (white).

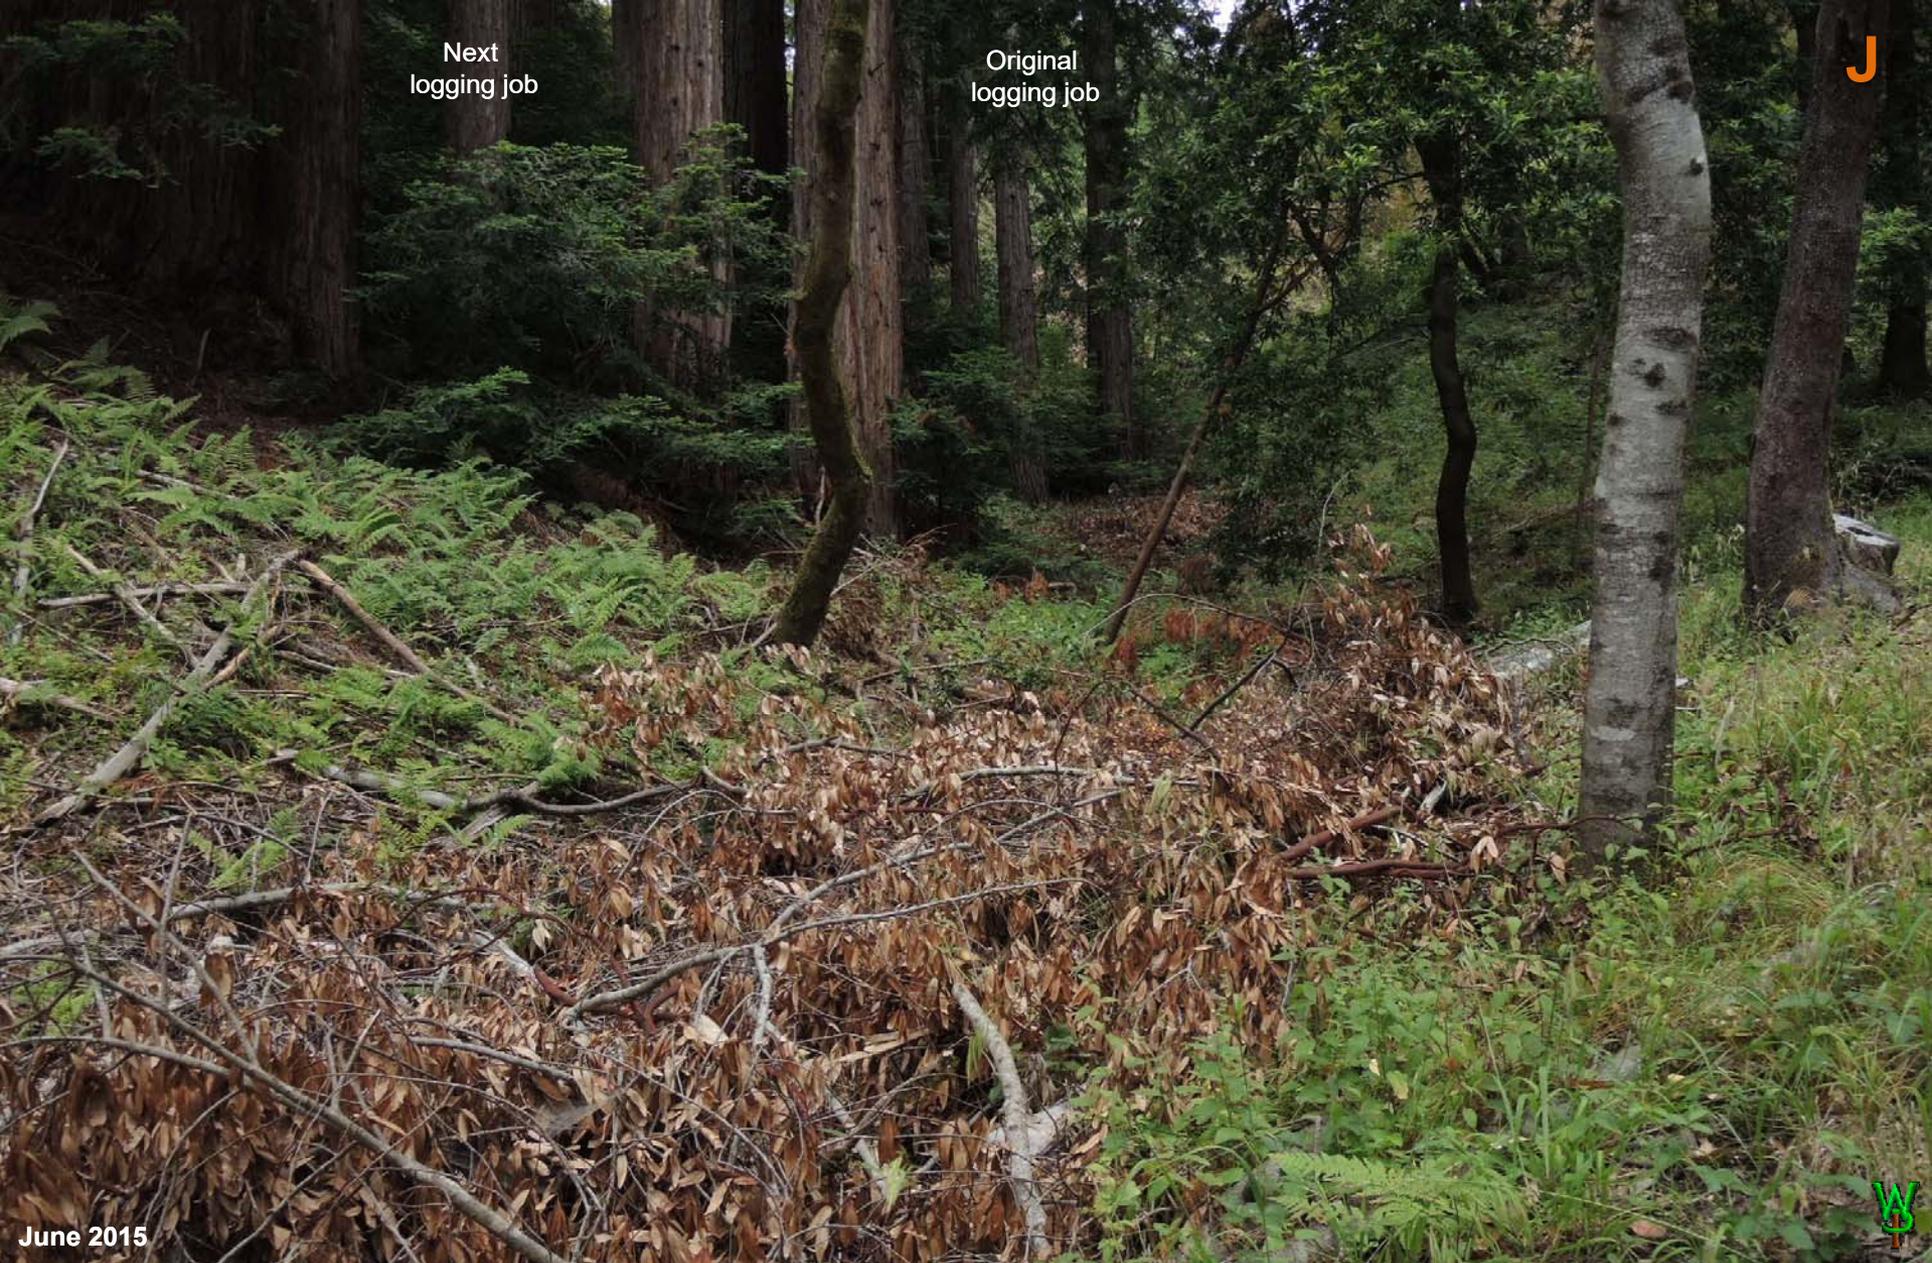
June 2015

But first I'll need the necessary filter media! This represents about as much as I can use for now. We have some large older bay trees with signs of Gannoderma in their trunks that will probably die in the near future, so I'll burn the tops and use the trunks to divert surface water, although bay decomposes quickly. When I do, I will use those piles as a continuing diagnostic for what might be in the seed bank. I have plenty of decent young trees... now. So, does this really work better than what the anti-logging activists want?

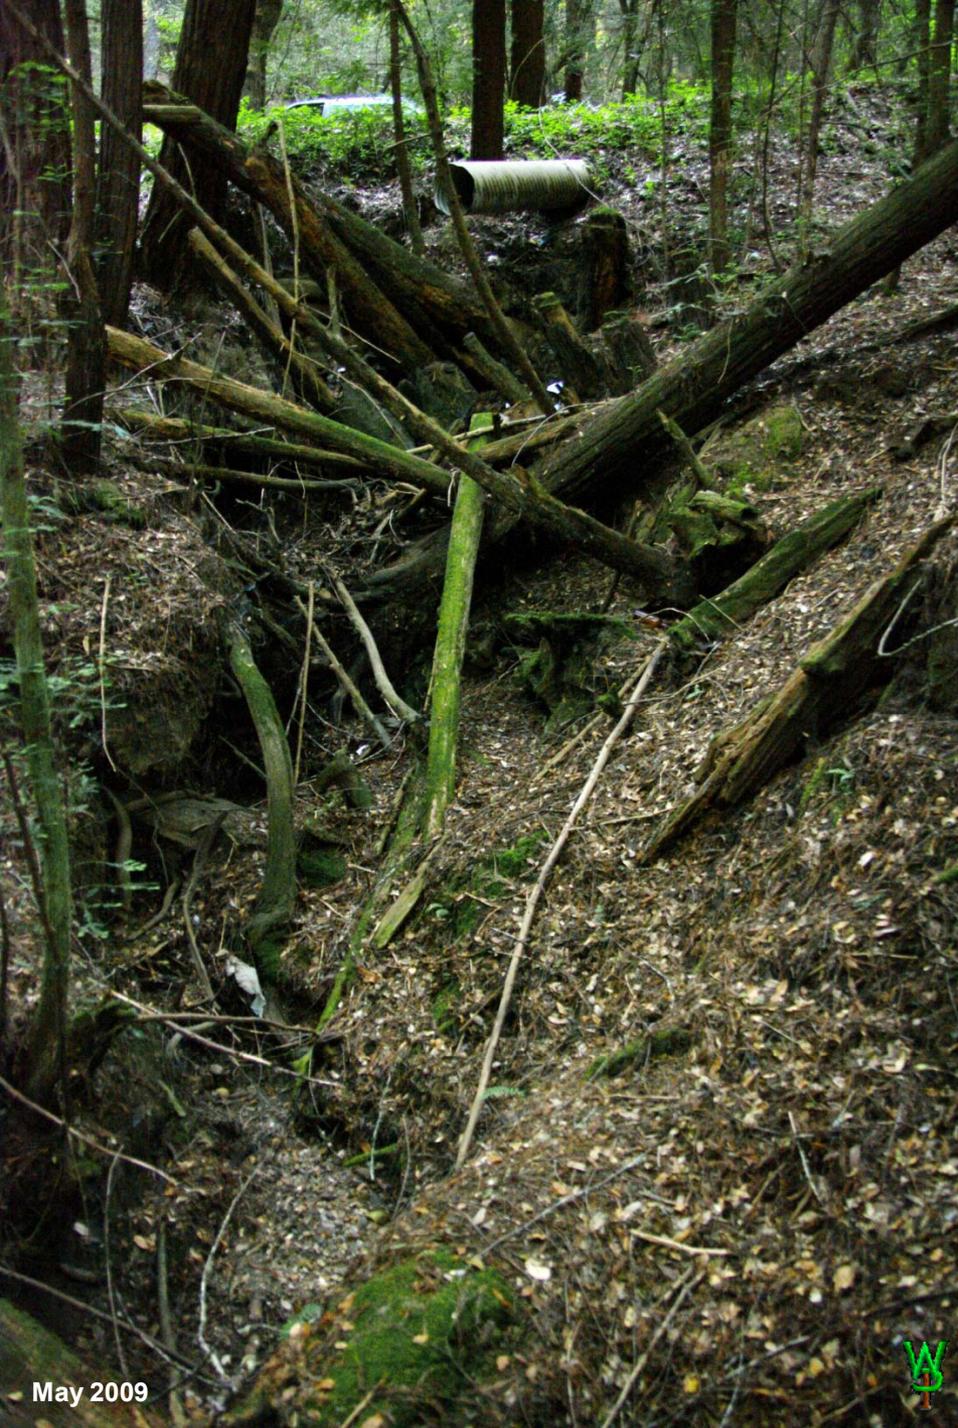
What if I had done nothing? That experiment is EASY to find! Let's take a look at a "Natural" stream bed in a nearby redwood grove. I did not have to go far to find this; it's only the fourth drainage down the road. **This stream bed was not here before the original logging**; the flow was channeled away from a failed culvert just up the road and into this one long after this area was logged and new trees were well established. This 24" pipe is about 30 years old, a fairly small flow in these mountains. There hasn't been ANY logging here for at least 50 years. Additionally, this particular drainage has unusually gentle average slopes for this area making the risk of bank failure fairly low. So this is as advantageous a location for such a trial as one could find.

It's shady here, to the point that there are no groundcovers at all. See how the root masses on the left are undercut? As bank erosion causes the banks to collapse under the weight of the trees, they fall, just as planned. So, what happens? The logs hit the opposite bank while still hanging from the roots **bridging the channel**. The stream keeps washing the now loose soil on the root mass away and the bed keeps cutting! The channel here is 30-40 feet wide and well over 20 feet deep. This is what would have happened to my "wall of wood."

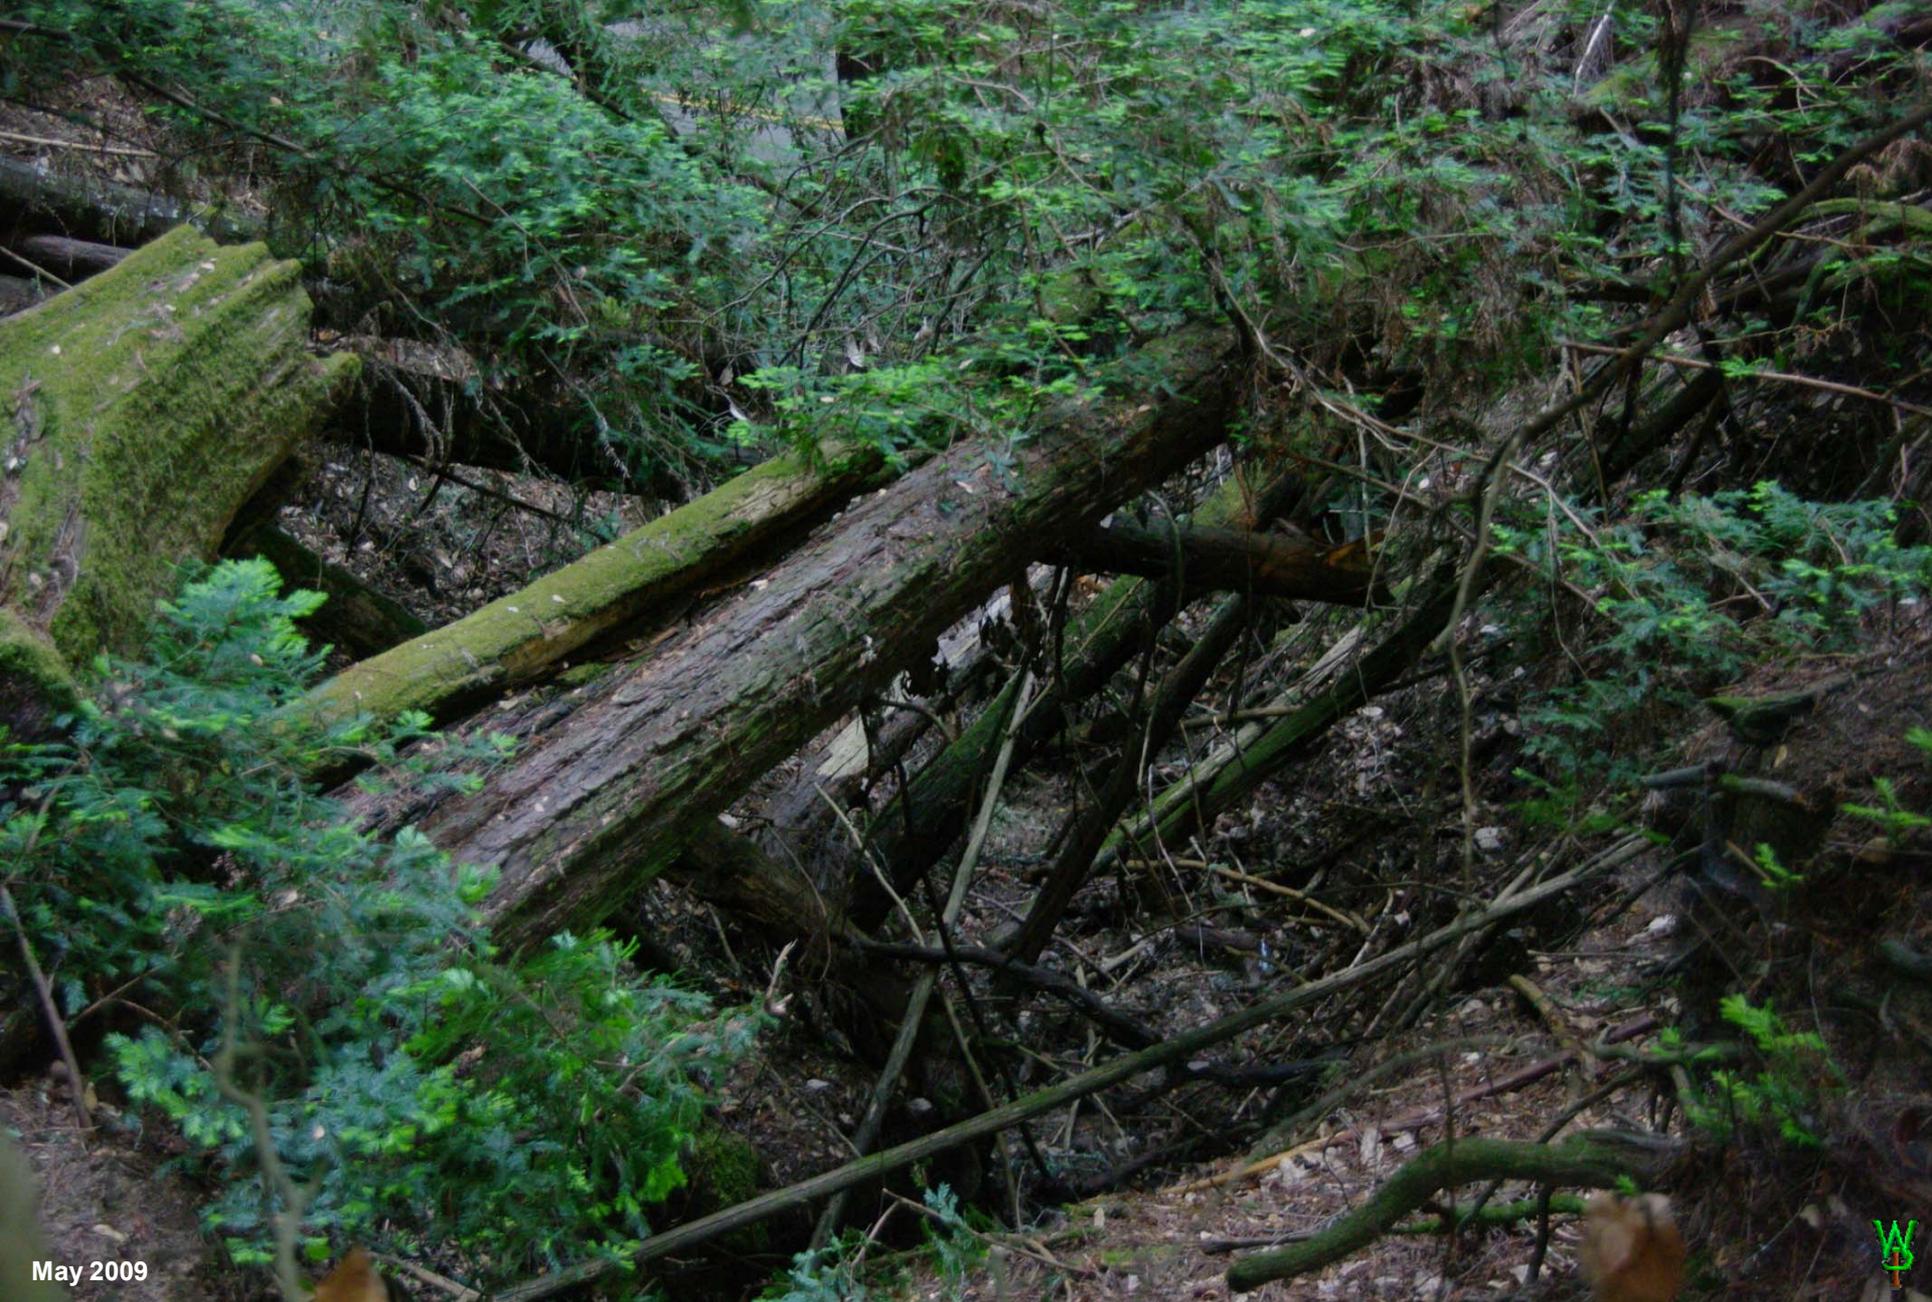
May 2009

This is about 100' below the culvert outlet, looking downstream. We have "recruitment," yet the incision is still getting worse! There are no effective groundcovers because it is way too dark. The logs bridge the channel so the stream is still cutting beneath them. This is "preservation," "recruitment," and "canopy protection" at its best. What you see is what you *will* get in a situation like this.

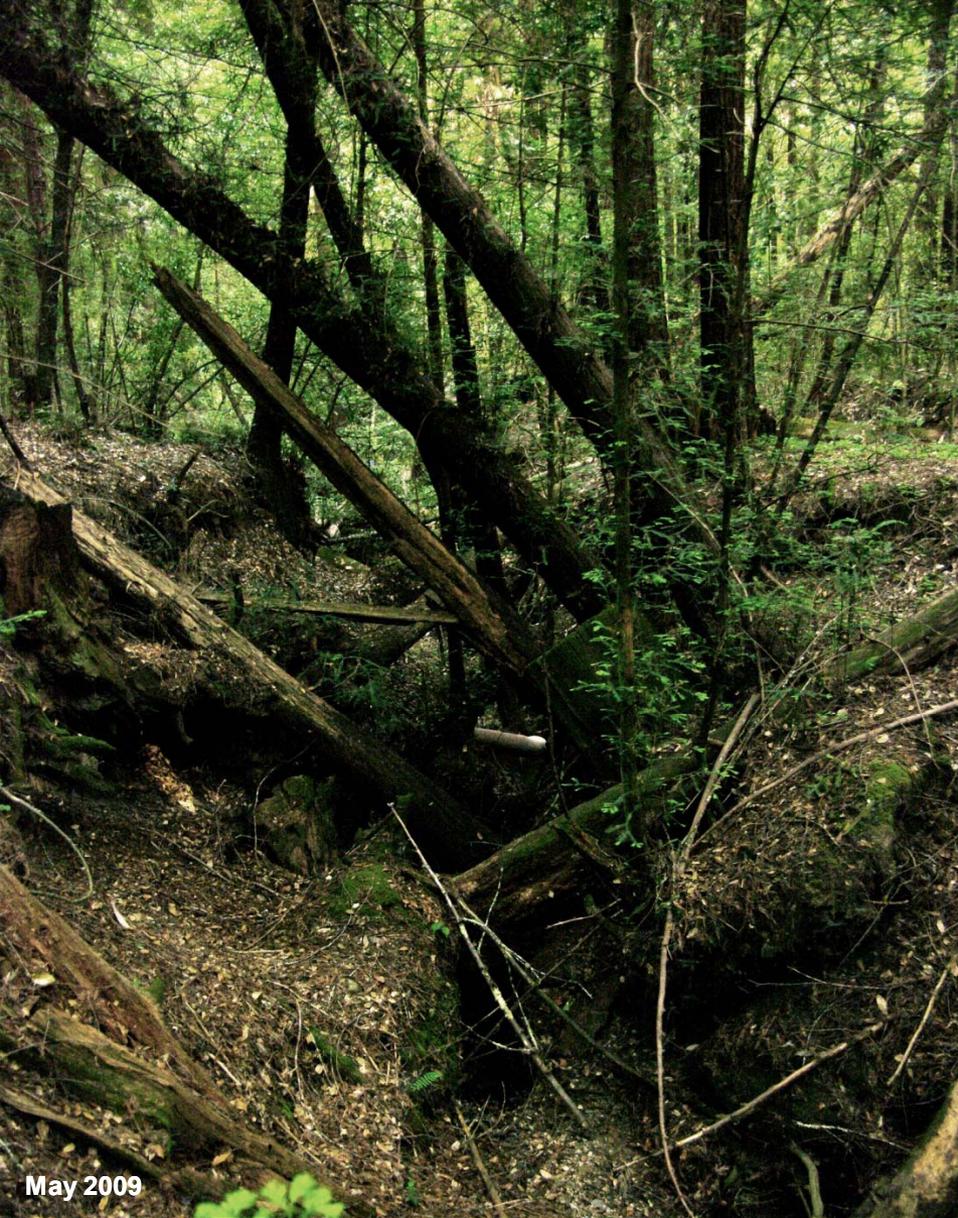
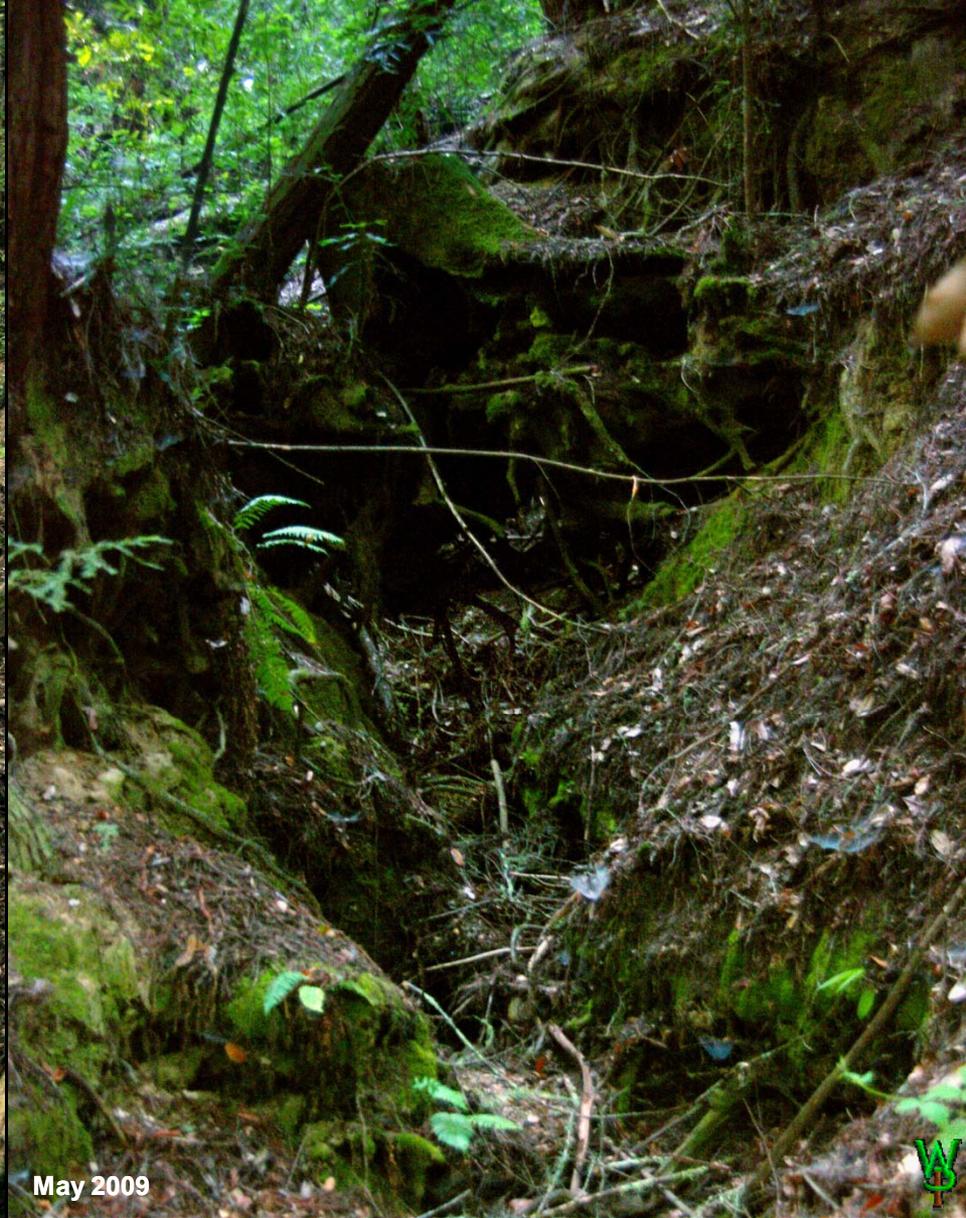
This channel is only about 75 yards long. There isn't any part of it where "recruitment" or dark canopy are working. At right is the bottom of the channel at the lower County road, which effectively limits the cutting by making a hard bottom. Here you see a root wad spanning the bottom of the channel. If "recruitment" was going to work, you would see it here. It did not. The belief underlying the regulations that 'Nature can heal anything' is just as dumb as was fire suppression and for the same reason: Suppress fire and you get catastrophic fire; suppress logging to stop erosion and what you will get is catastrophic landslides into incised channels.

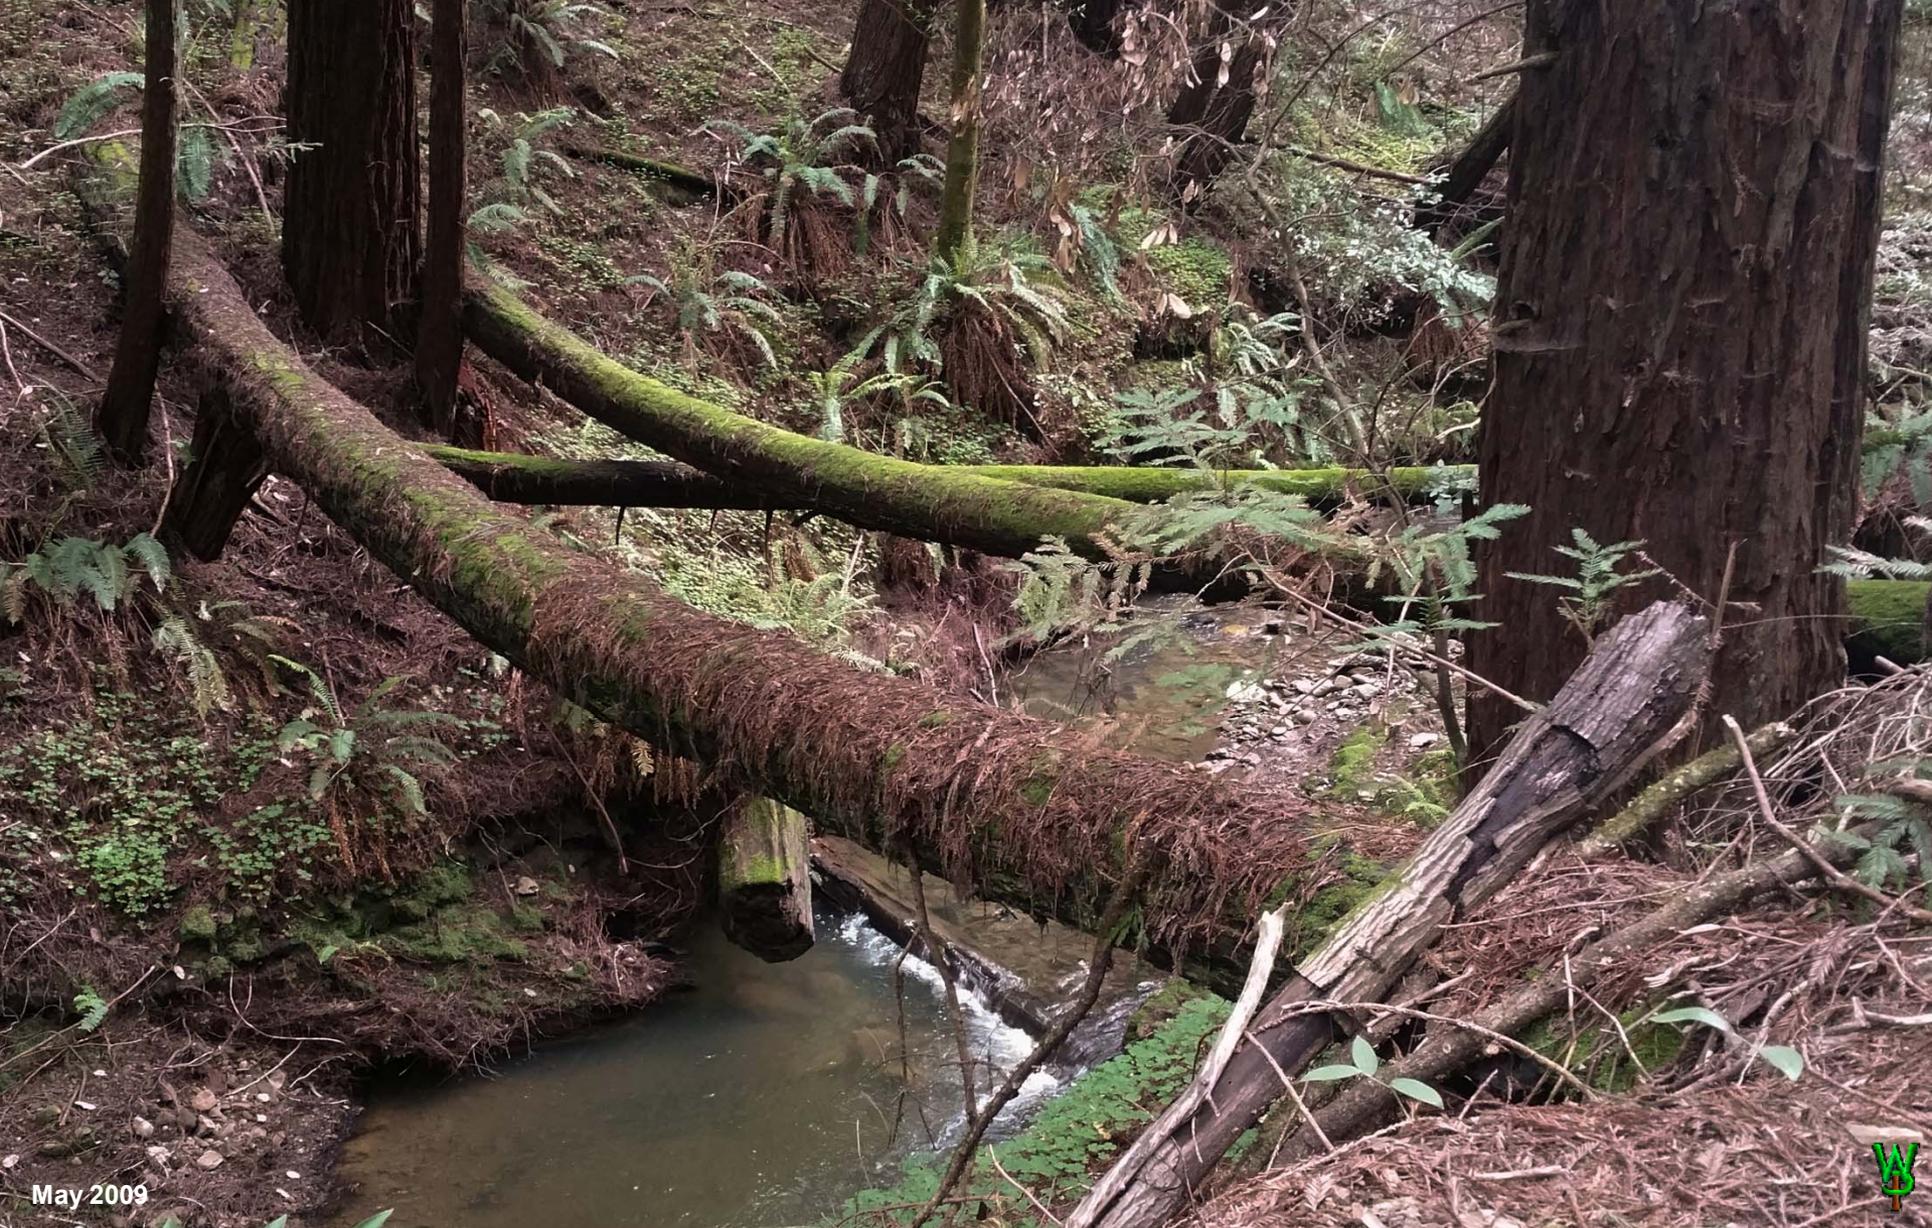
May 2009

Channel incision gets ever more problematic with scale. This is Bean Creek. The drainage discussed during the last few pages empties directly into this channel not far downstream from here. Within 50 yards of this spot, there are **eight** logs like these bridging this creek. Some end at the edge of the County road just begging some kid to walk atop the log across the creek 20 feet below. As you can see, there is some wood in the creek reducing the scouring and channel incision, but they went in back in the old days when people used to cut them up. But is channel incision a problem here too? You bet, both a destructive and an expensive one too.

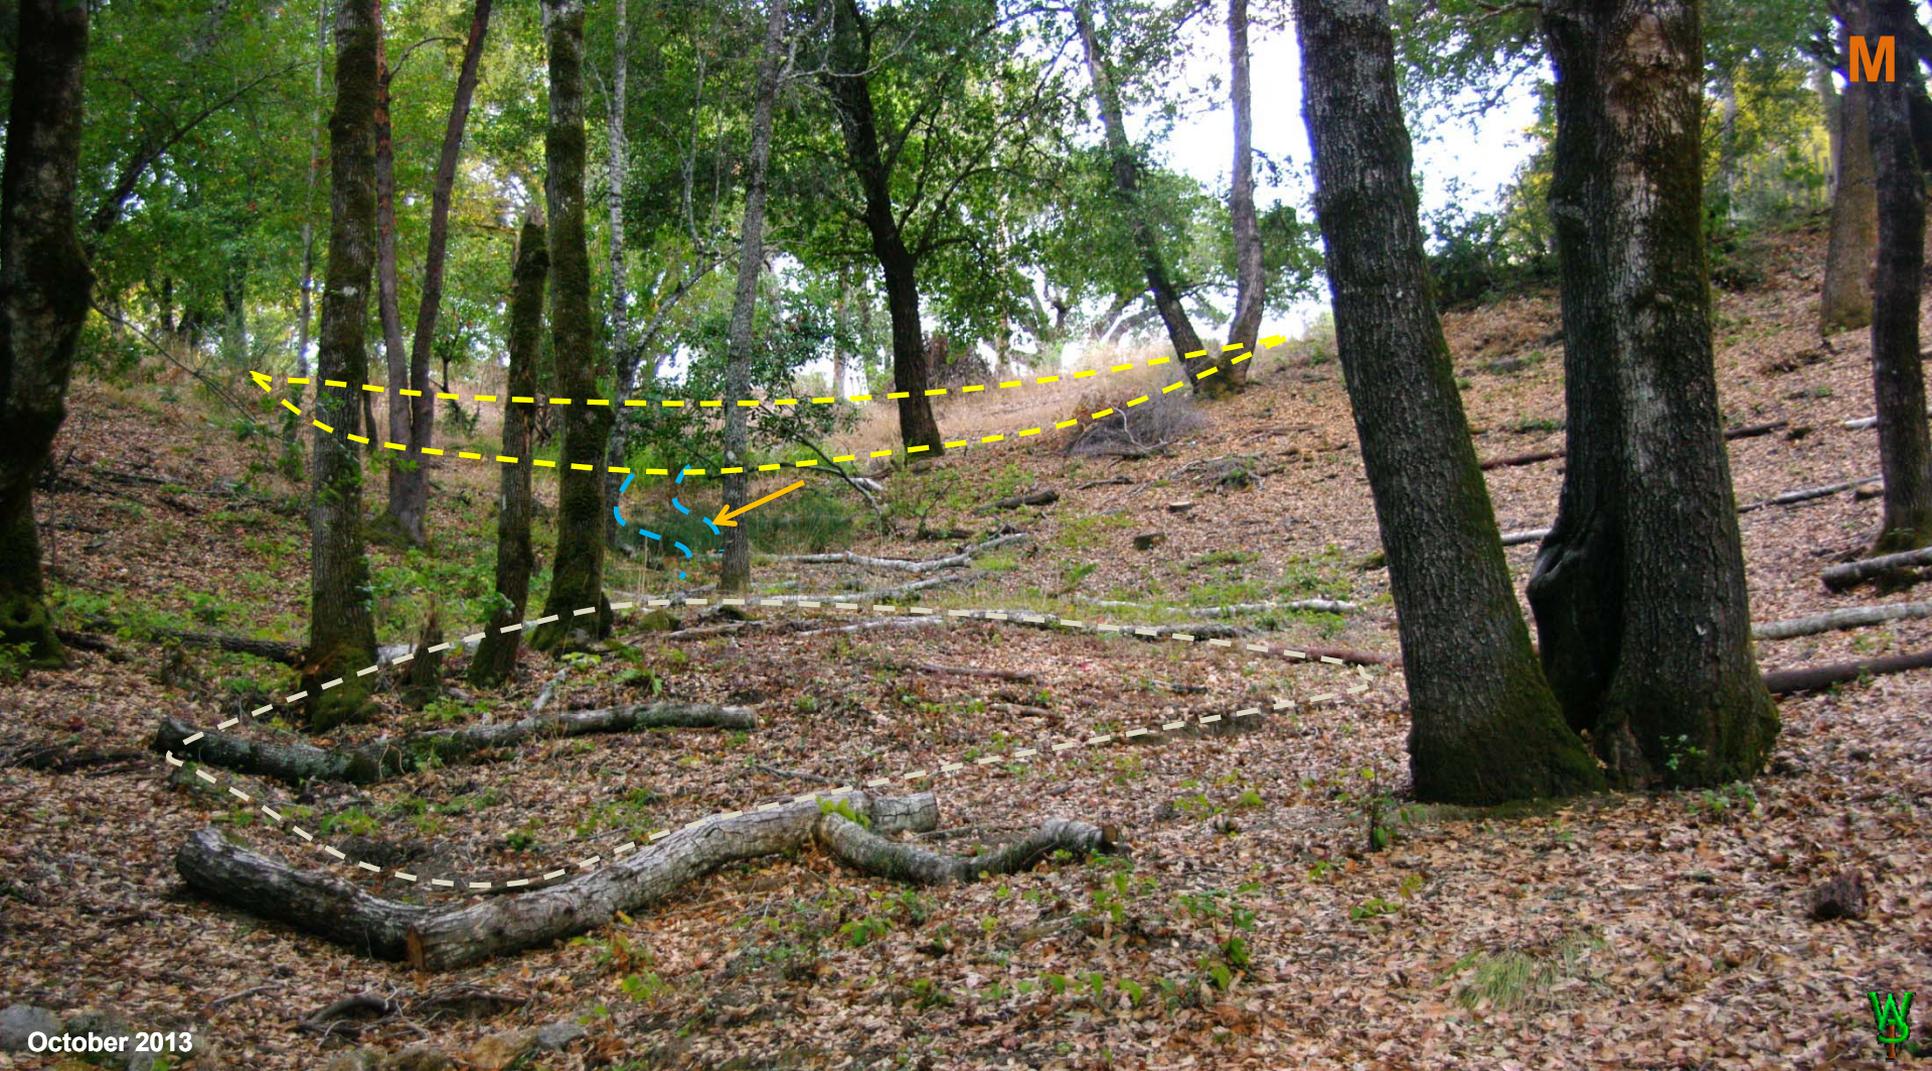
October 2013

This is another case on our property where I reversed stream channel incision. As you will learn in [the chapter on roads](#), the County reversed the original grade for Charlie McKiernan's Road to reduce very serious channel incision to the southeast that was undermining the road. The new design captured all the water off the ridge into a culvert at the head of this channel. The thought at the time was that the best place to have the water run is a "Natural" drainage channel pursuant to the insane belief that Nature is stable. As a result, this channel now receives far more runoff than originally because in addition to the road collecting the runoff, all the developed "hardscape" from the house up the hill no longer absorbs any rainfall. When we started this project, the culvert had rotted out taking out [the roadside embankment](#), and this channel was opening into a trench four feet deep ([arrow](#) in about the middle of this image). But the situation was worse than that. Note the hump of alluvial deposition in the middle of this photo. The culvert had plugged and/or failed and washed out the embankment on this side of the road. That embankment was the source of the hump.
