FEELING DRAINAGE

WILDERGARTEN 6.4

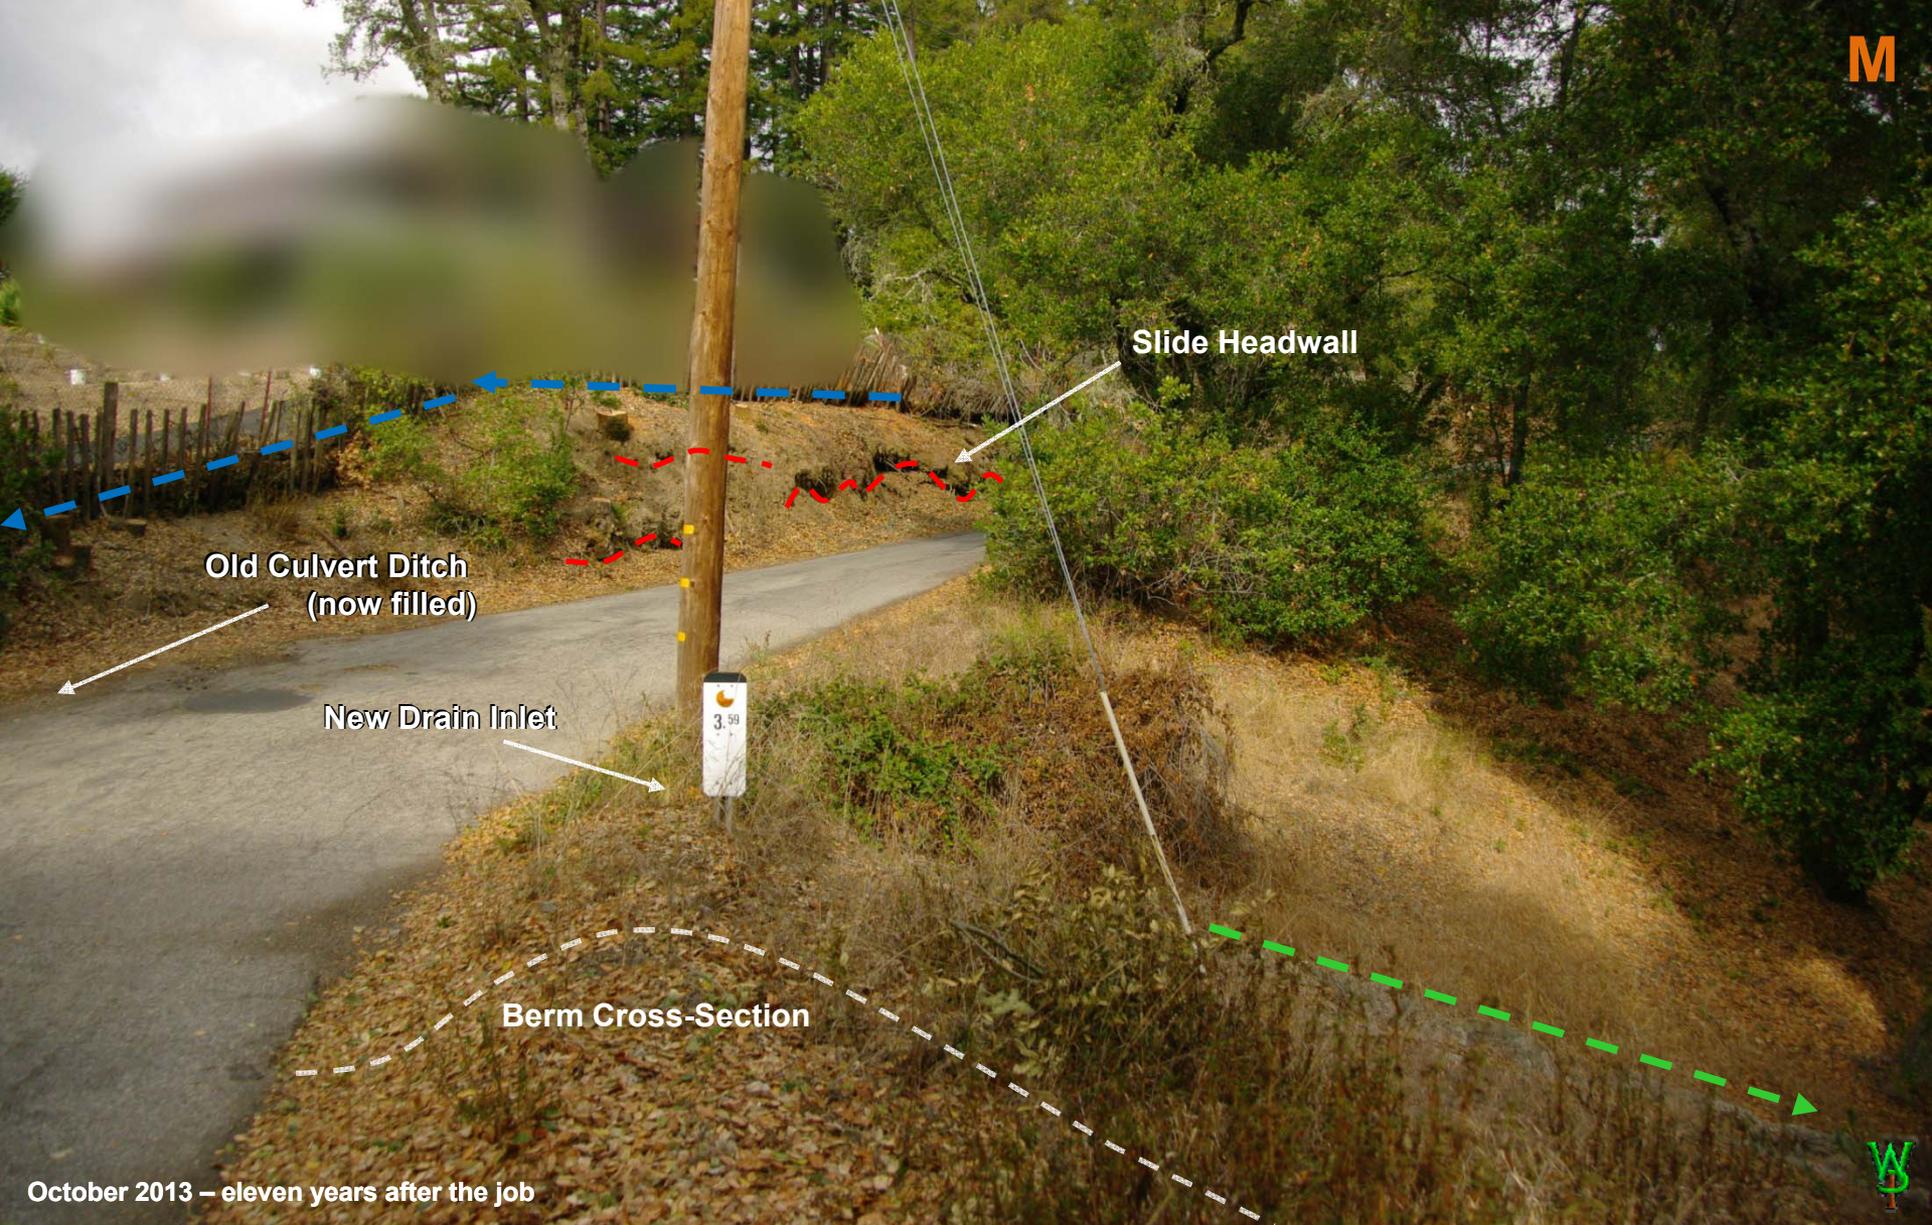
October 2013 – eleven years after the job

Adding to the collection area, behind the fence (blue line) there is a curb at the lower edge of the driveway to protect the embankment on which it is sitting, **now undermined by County ditch cleaning**. The driveway, curb, and the road collect and shed nearly an acre of rainwater runoff concentrated here at the corner, more than double what comes off the ridge. The grade of the road once tilted to the left, channeling the water to the culvert. When the culvert plugged, the water went down the embankment on the right and washed the soil away. I know, you see soil here. I fixed it.

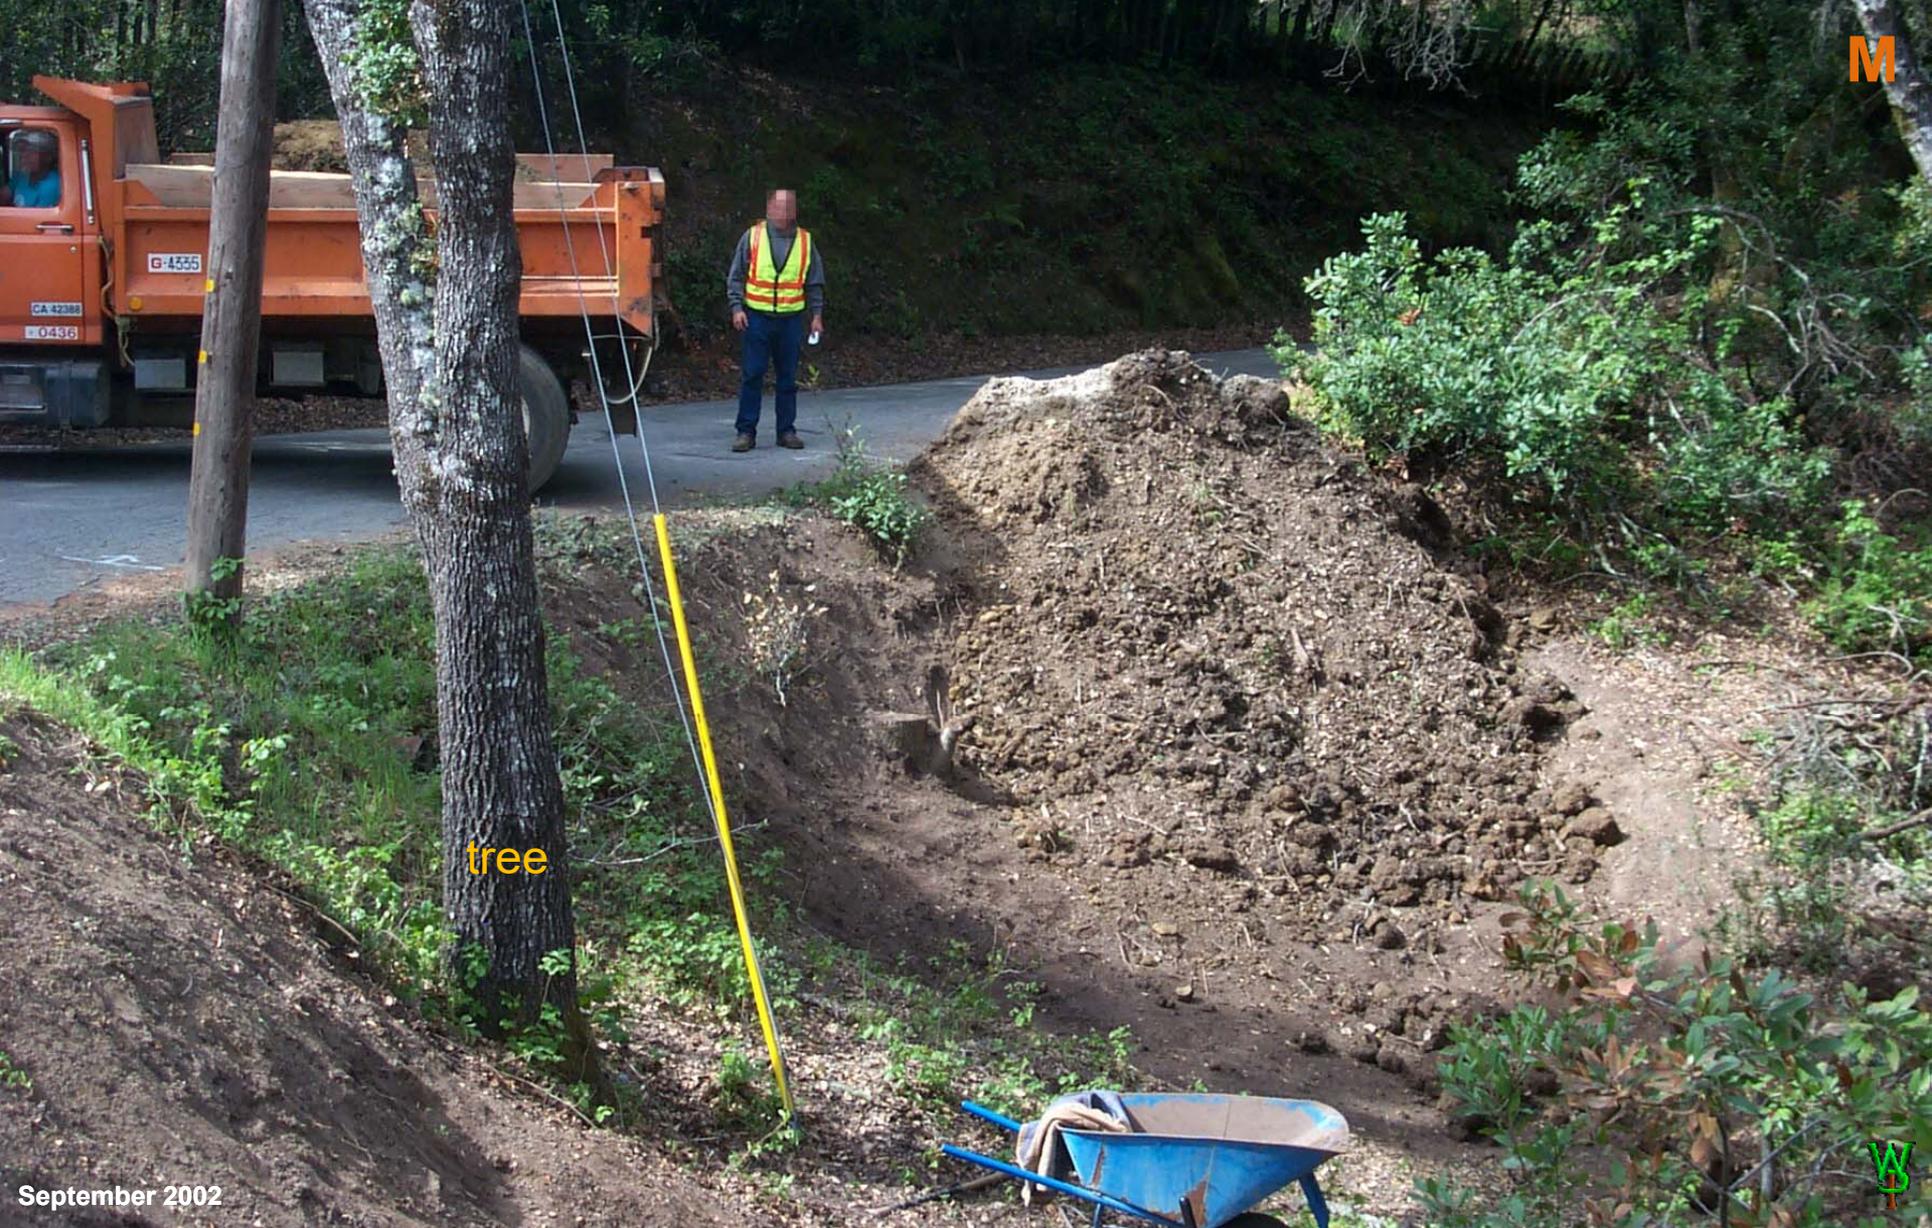
September 2002

I cleared the vegetation (the **tree** went down that day) and scraped off the organic layer. The County dumped in ditch cleanings as fill (it doesn't get much easier). I had it packed and shaped with an excavator. I rocked in the old culvert ditch on the opposite side and the County paved it next time they came in with a patch crew, making the road wide enough that cars can now pass each other at the corner. I got free fill dirt to repair the damage the culvert had done; they saved money on trucking dirt and the job reinforced the road's stability. Everybody wins... except the engineers, contractors, and inspectors who usually make such projects unaffordable.

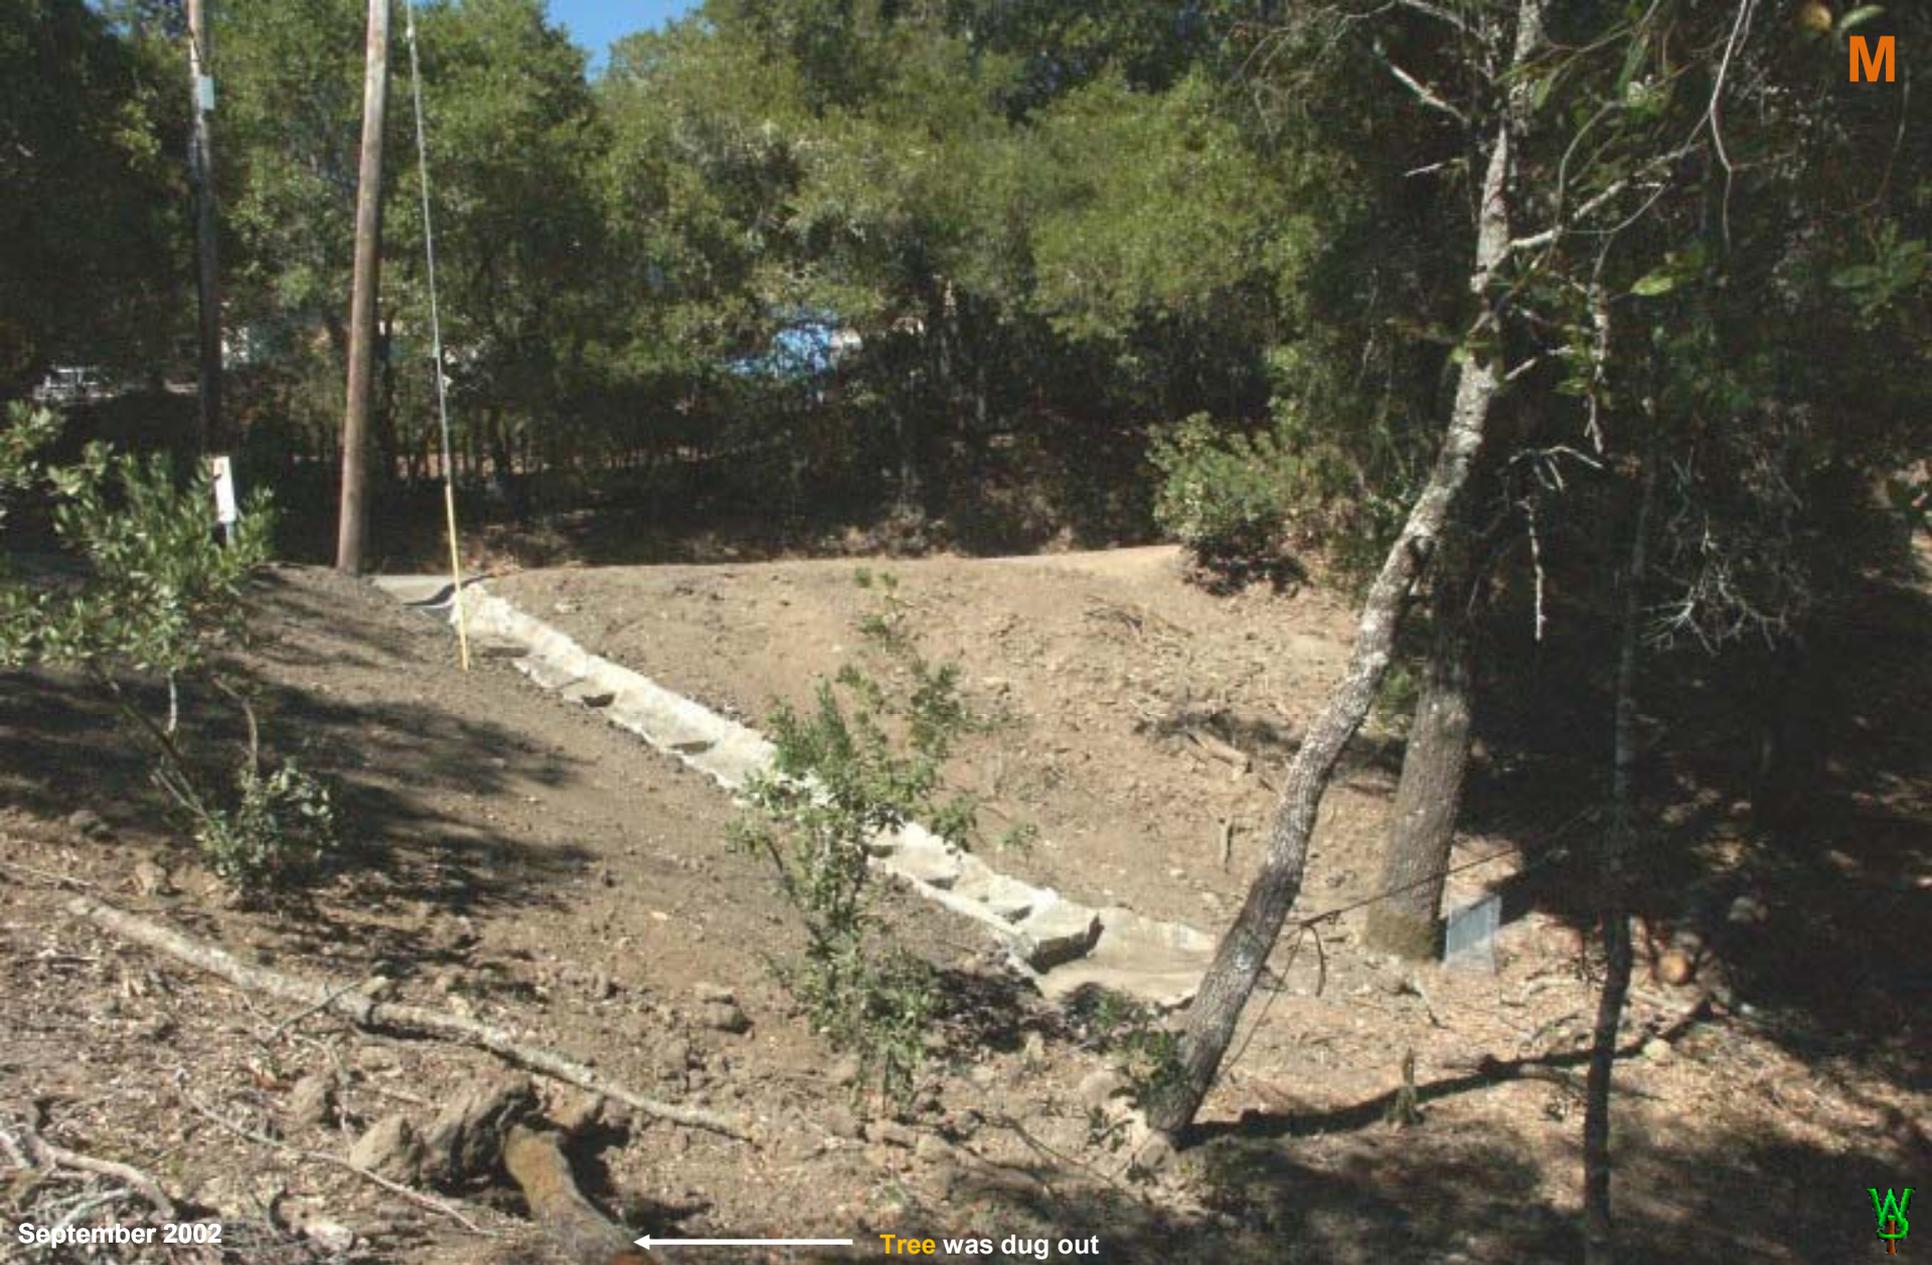
September 2002

To accommodate the water, I built this drainage channel/stairway with recycled slab concrete. The bottom has a domed surface to dissipate the flow into a wall with two side outlets. This allows me to alternate the outlet path with a log placed such the it deflects the flow. I sowed the slope with hand-collected native grass seed. But I needed one more thing to complete the revegetation to hold the seed. I needed mulch and I could not import straw because it would contaminate the area with new weeds. Little did I know.

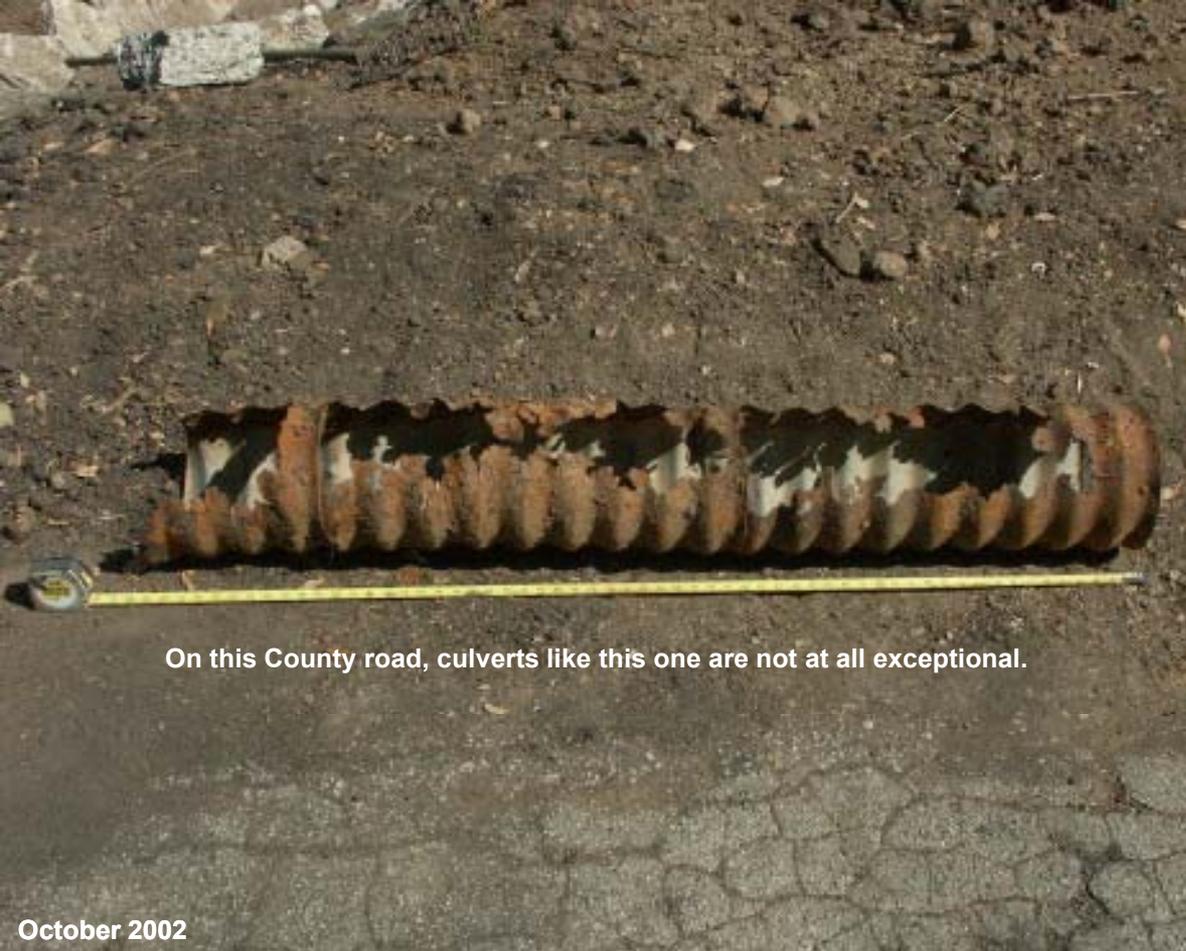
On this County road, culverts like this one are not at all exceptional.

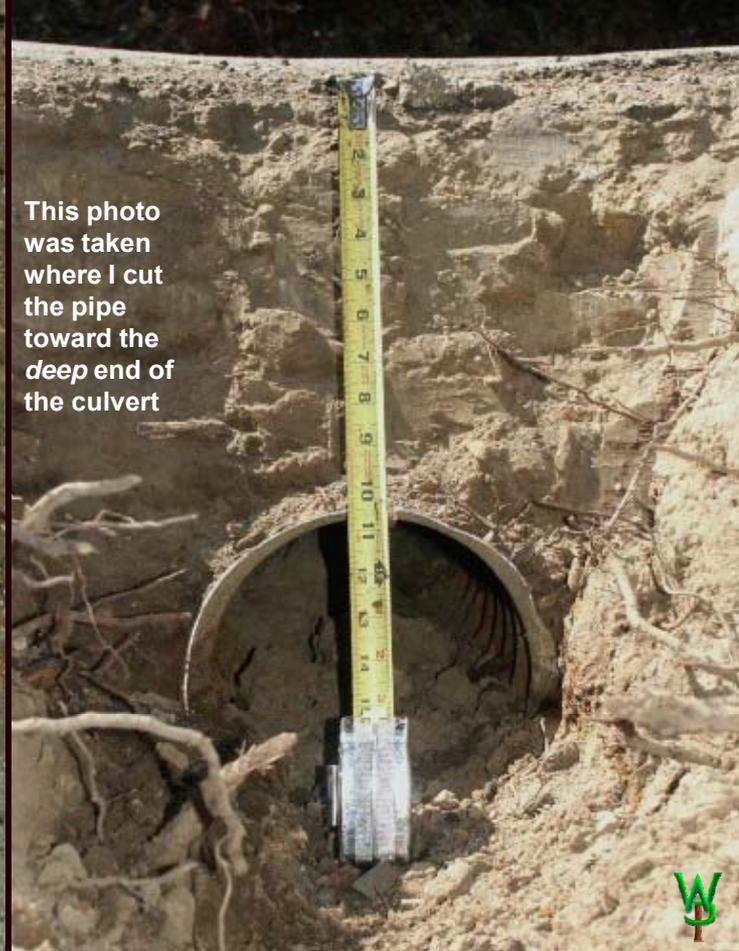
This photo was taken where I cut the pipe toward the *deep* end of the culvert

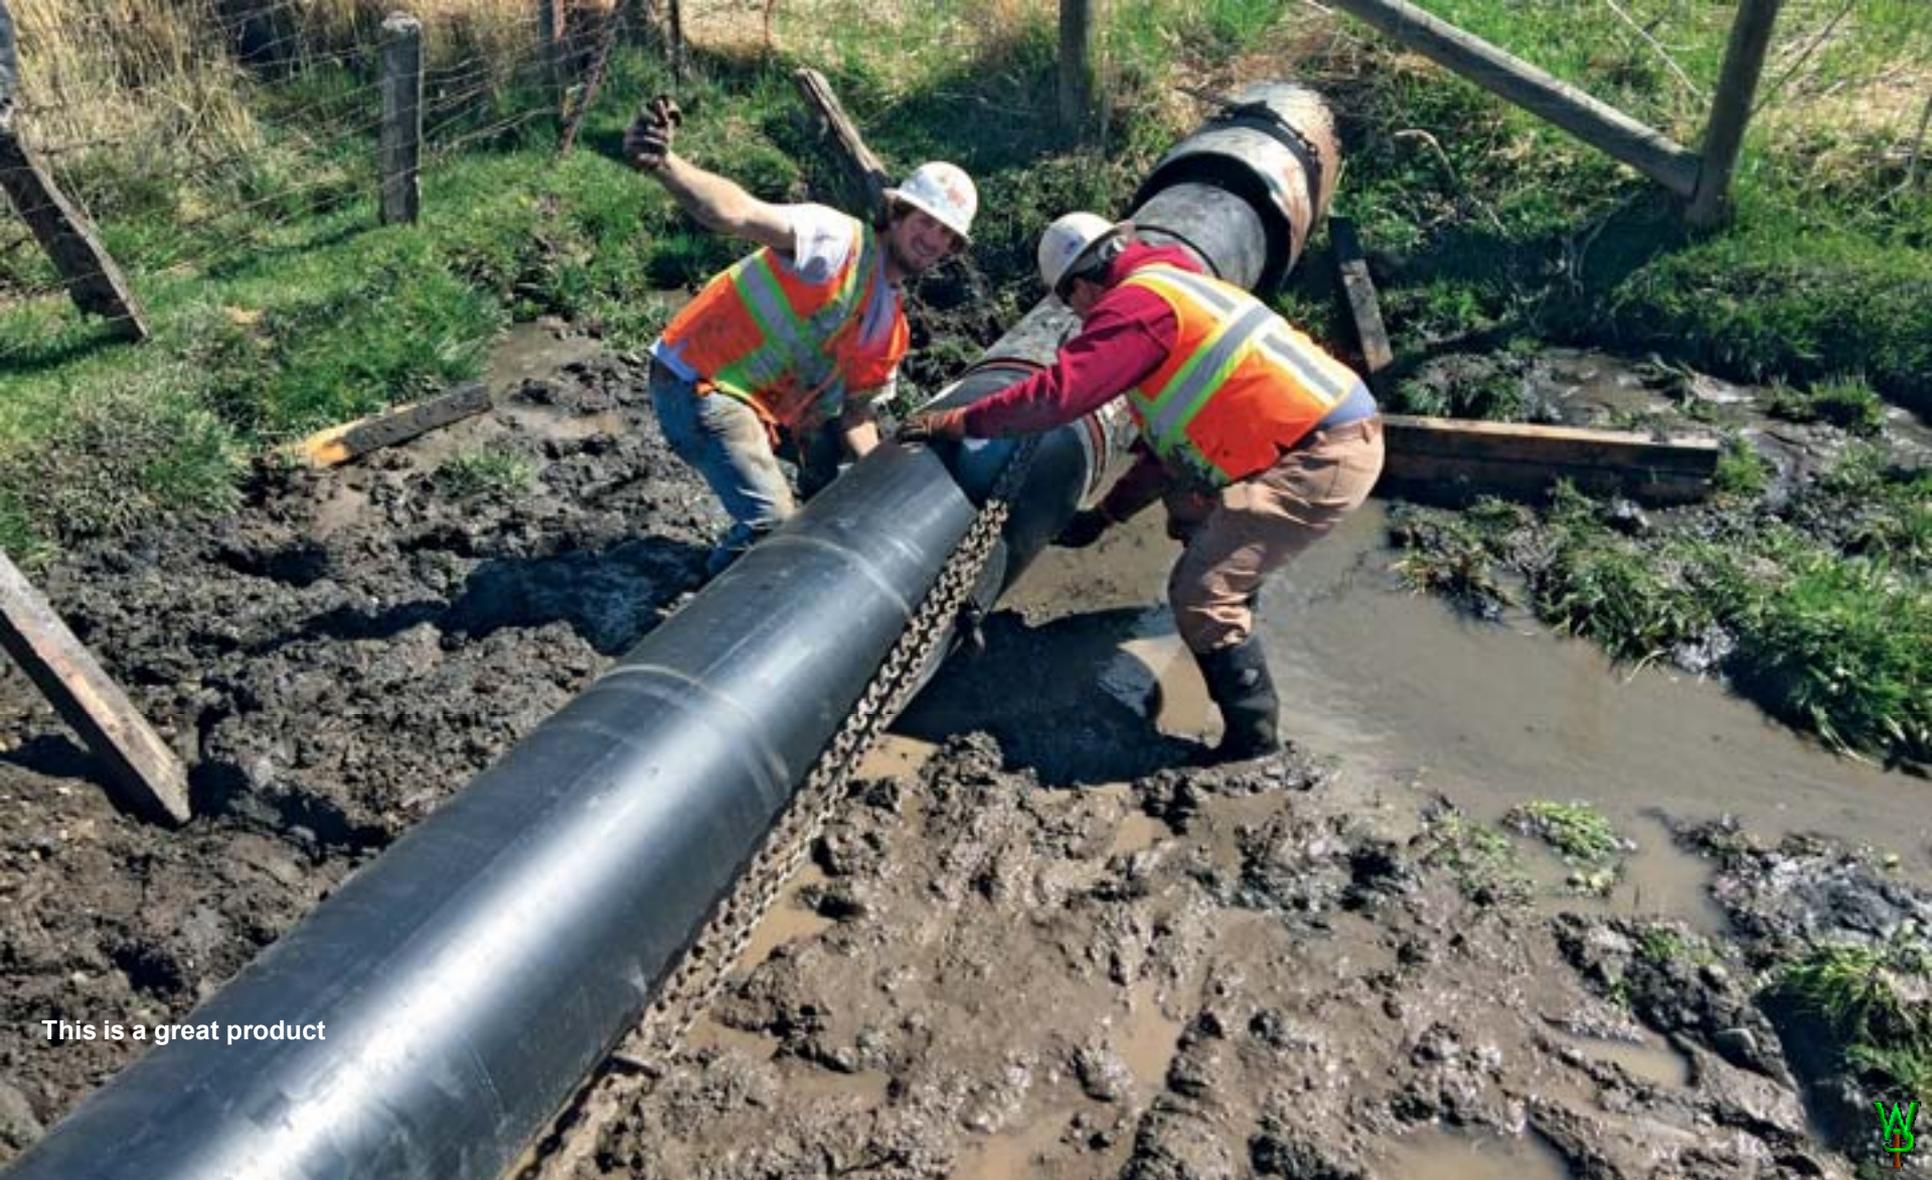
This is a great product

Worse yet, DFW specifies use of plastic pipe for culverts, which WILL burn out in a fire. The correct alternative to plastic culverts is to insert a plastic liner into the old galvanized steel pipe as a protective sleeve. Above is Snap-Tite[®]. It requires no excavation or paving. Simply slide the plastic liner into the rotted steel culvert and seal the inlet with grout (extensions snap together as shown above). If needed, the cavity under the old pipe can be filled with a sand slurry or grout. If desired, a new protective steel outlet sleeve can be installed, hopefully with energy dissipation to slow the water coming out and impacting soil. With a coating of a light-weight gunnite or stucco, the plastic liner pipe is protected until the fire has passed. It beats digging out the old pipe and installing one that will burn.

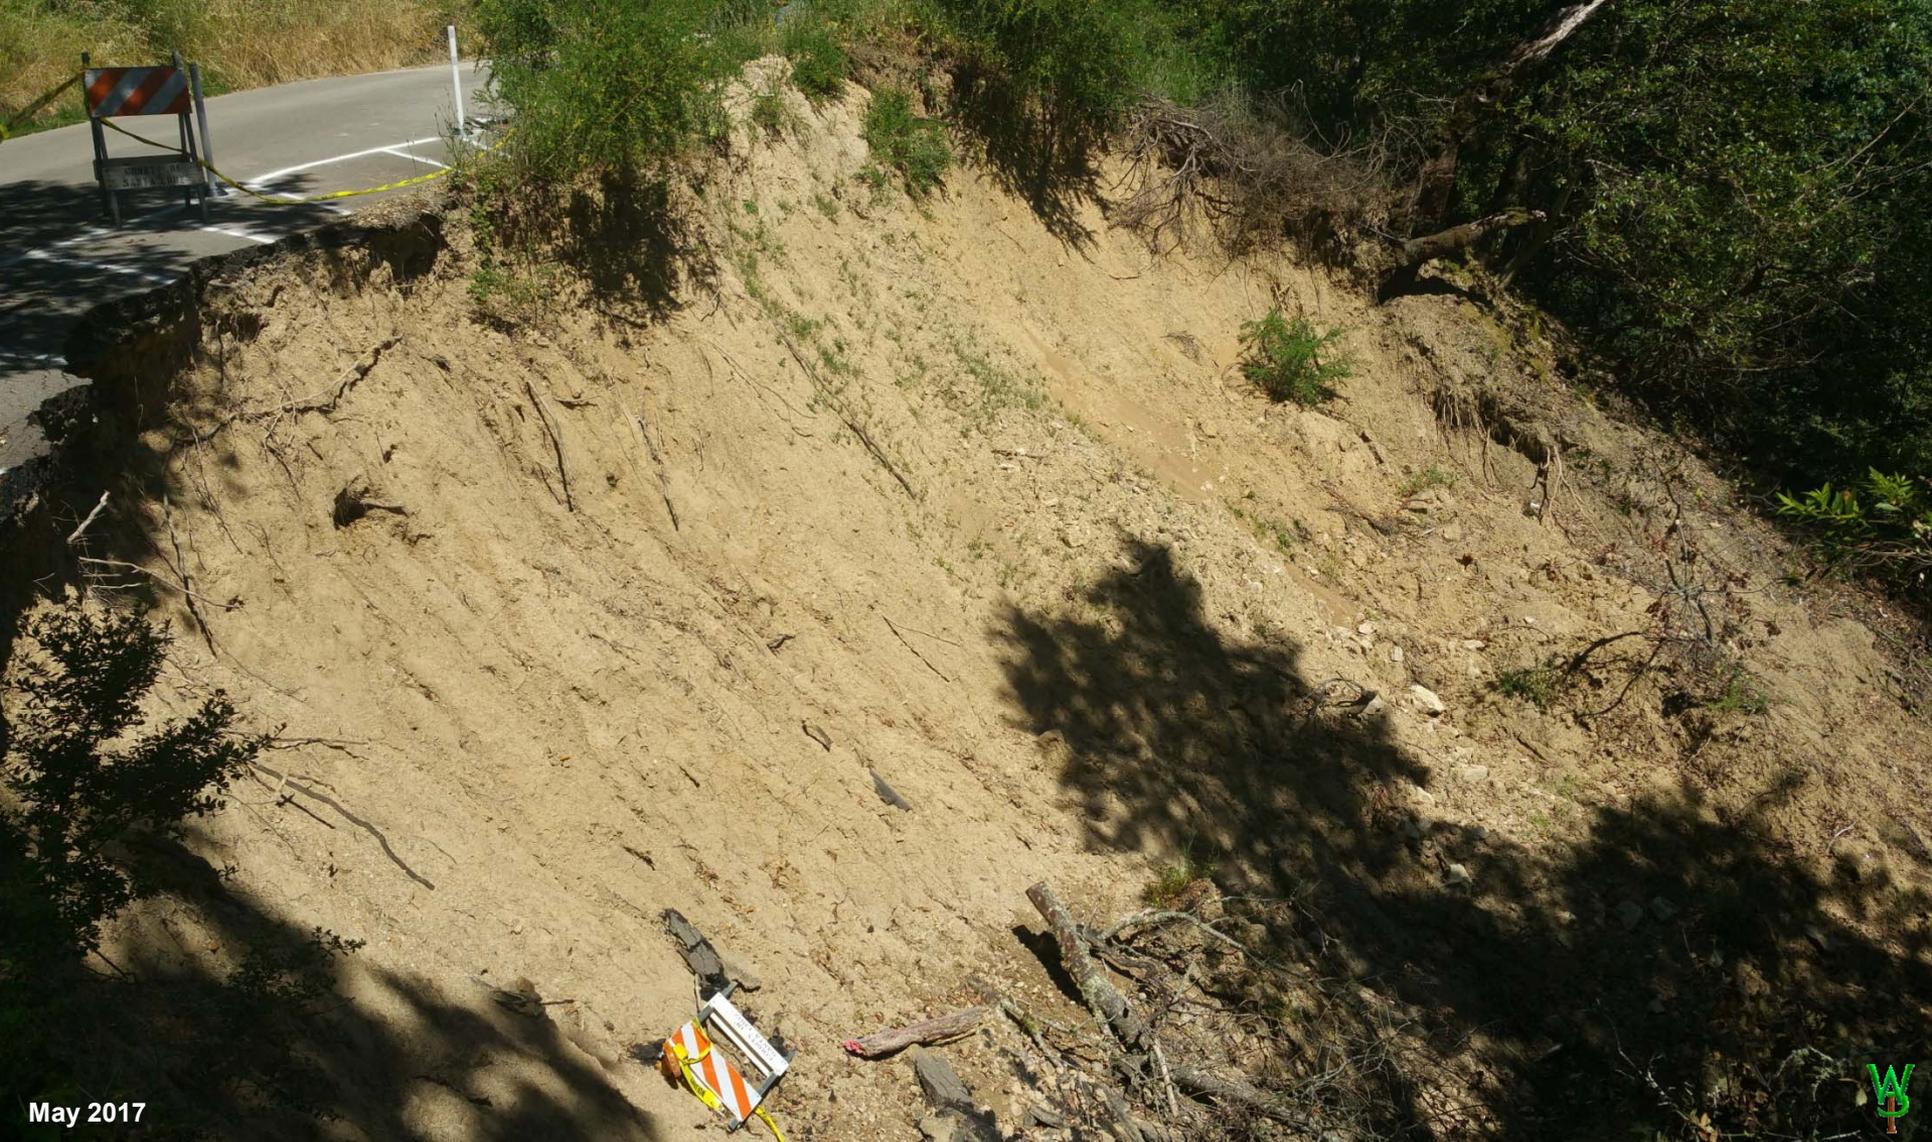
May 2017

With the 200% normal rainfall over the winter of 2016-17, the “authorities” deemed it to be a natural disaster. Of the five major failures along the road in 2017, three were caused by failed culverts with the other two by top-heavy leaning trees that fell and took the embankment with them. It’s all so predictable that to call this a “natural disaster” while erecting ever more tangled barriers to fixing these problems is to betray only the “nature” of bureaucratic management. Yes, the roads were badly designed and constructed. Yes, these mountains are geologically unstable and erosive. With a history and baseline conditions like these there will be failures. Yet there is no excuse for failures of this magnitude and frequency. Moreover, these results pale in comparison to what would have happened if there had been a major earthquake in **any** winter, a standard for which any responsible government would be preparing.

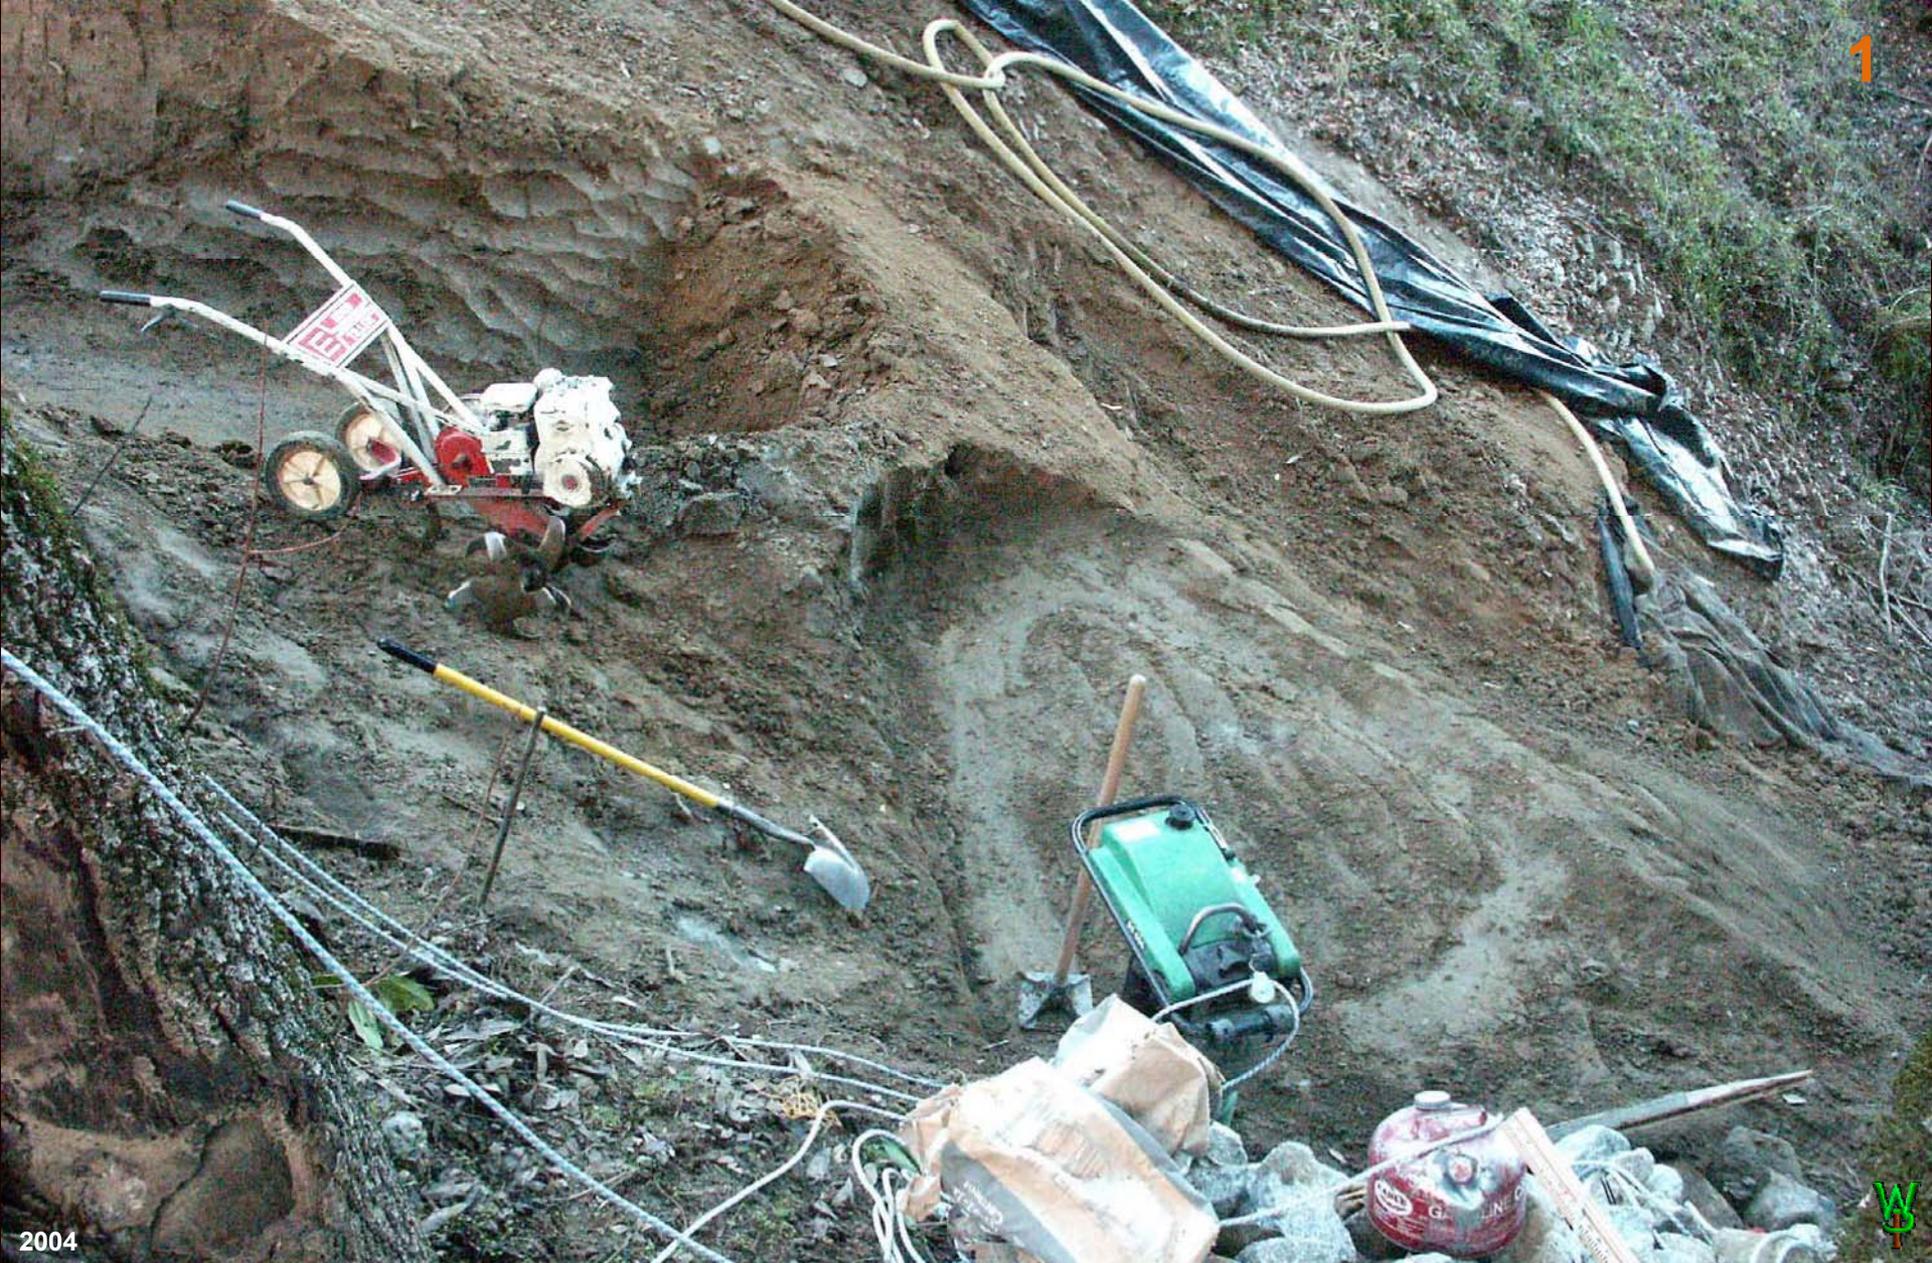
2004

In parts of this project, I used the equivalent of a half-sack mix of cement in the soil to reinforce the structure to simulate the attributes of the parent rock and withstand tunneling by ground-squirrels without caving in. Interestingly, the grasses seem to prefer this cemented fill compared to the parent material. In the background is a temporary energy dissipater from a small culvert made of plastic wrapped around the pipe several times at the top end. Works great.

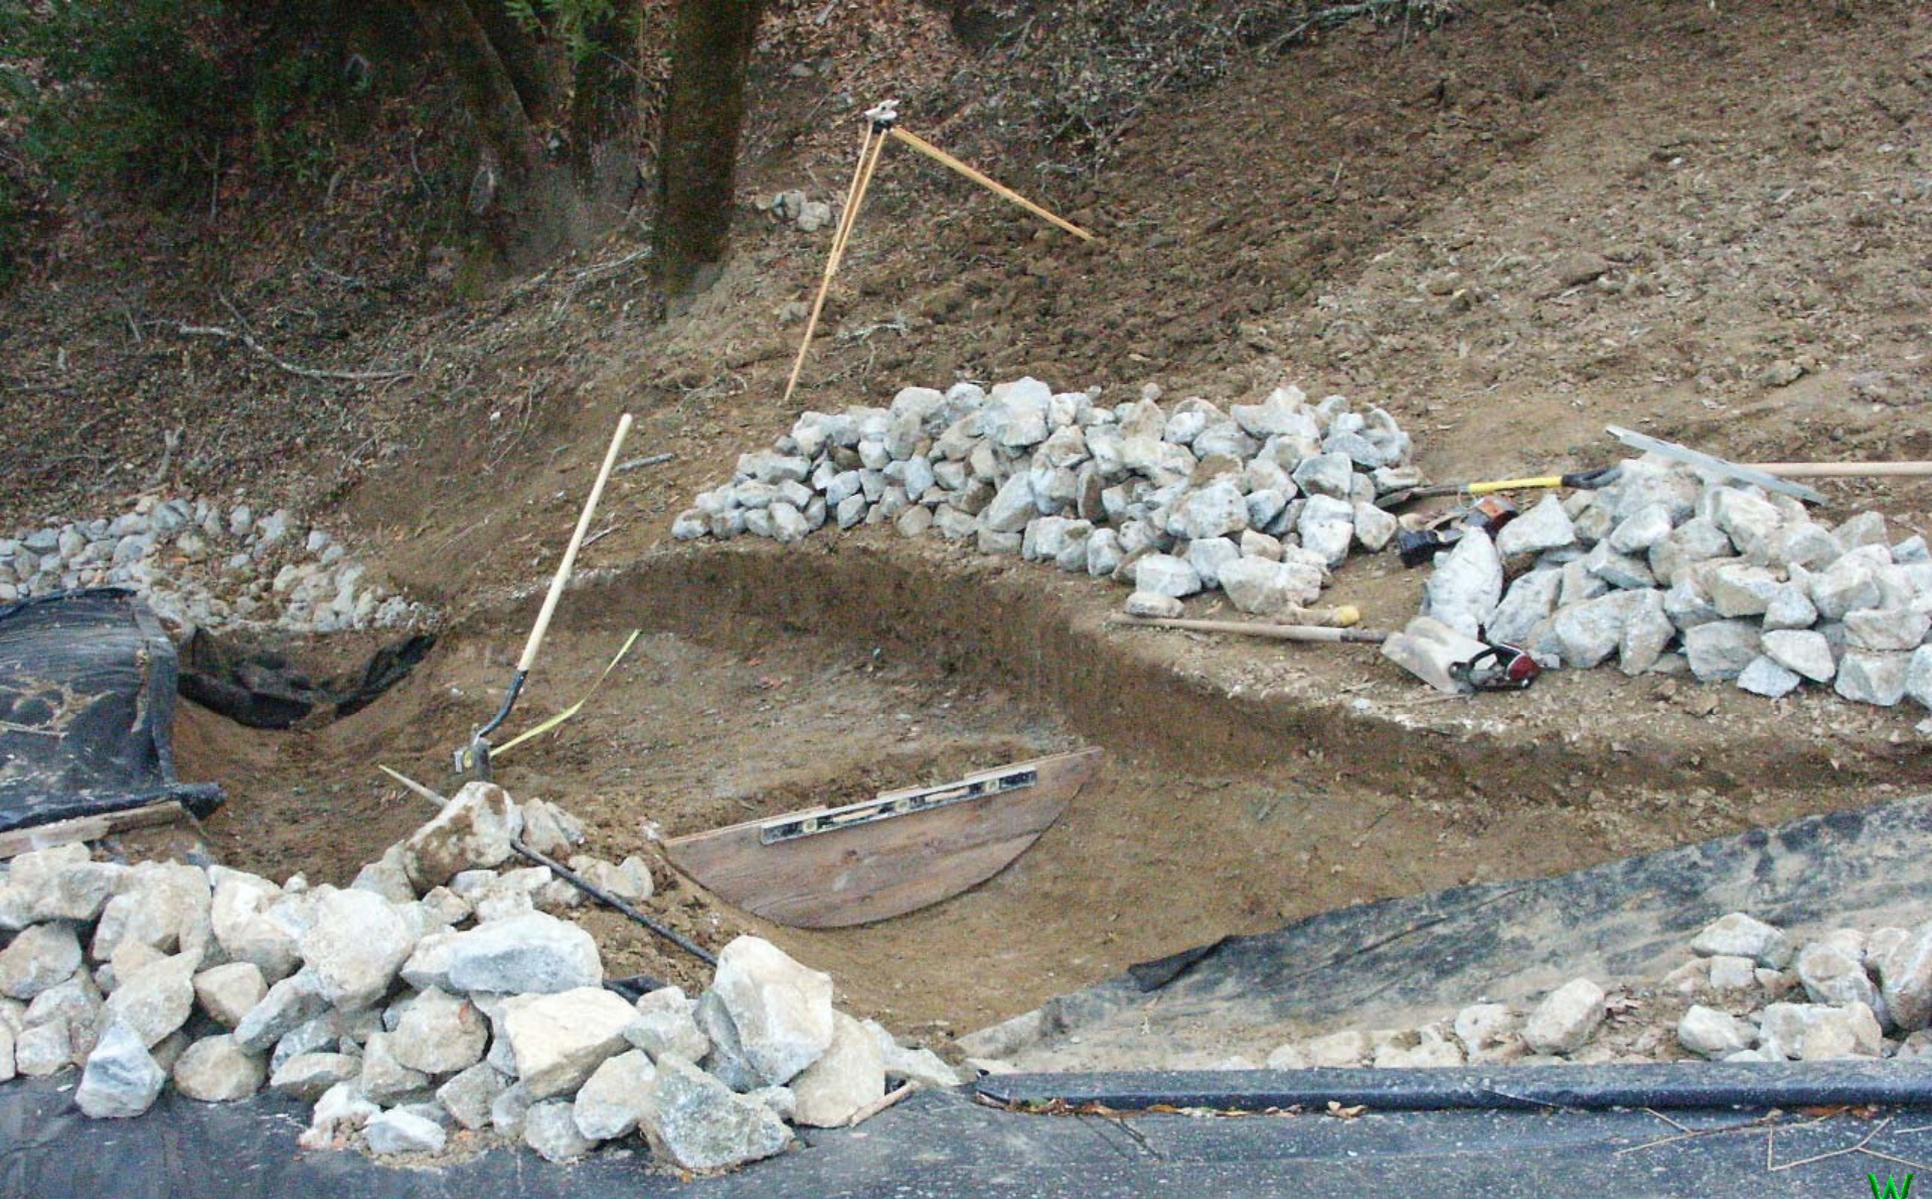
2004

When digging one of these affairs, the process is somewhat iterative. Obviously I had surveyed the slope and laid out the future grade on the computer so that I would have the rate of fall worked out as I dug it. There is also the problem of staging the materials, both those that come out and those that go in. The goal is to have a mass balance between the two to minimize the need either to add or remove fill or rock while simultaneously reducing the need to move it any farther than is absolutely necessary.

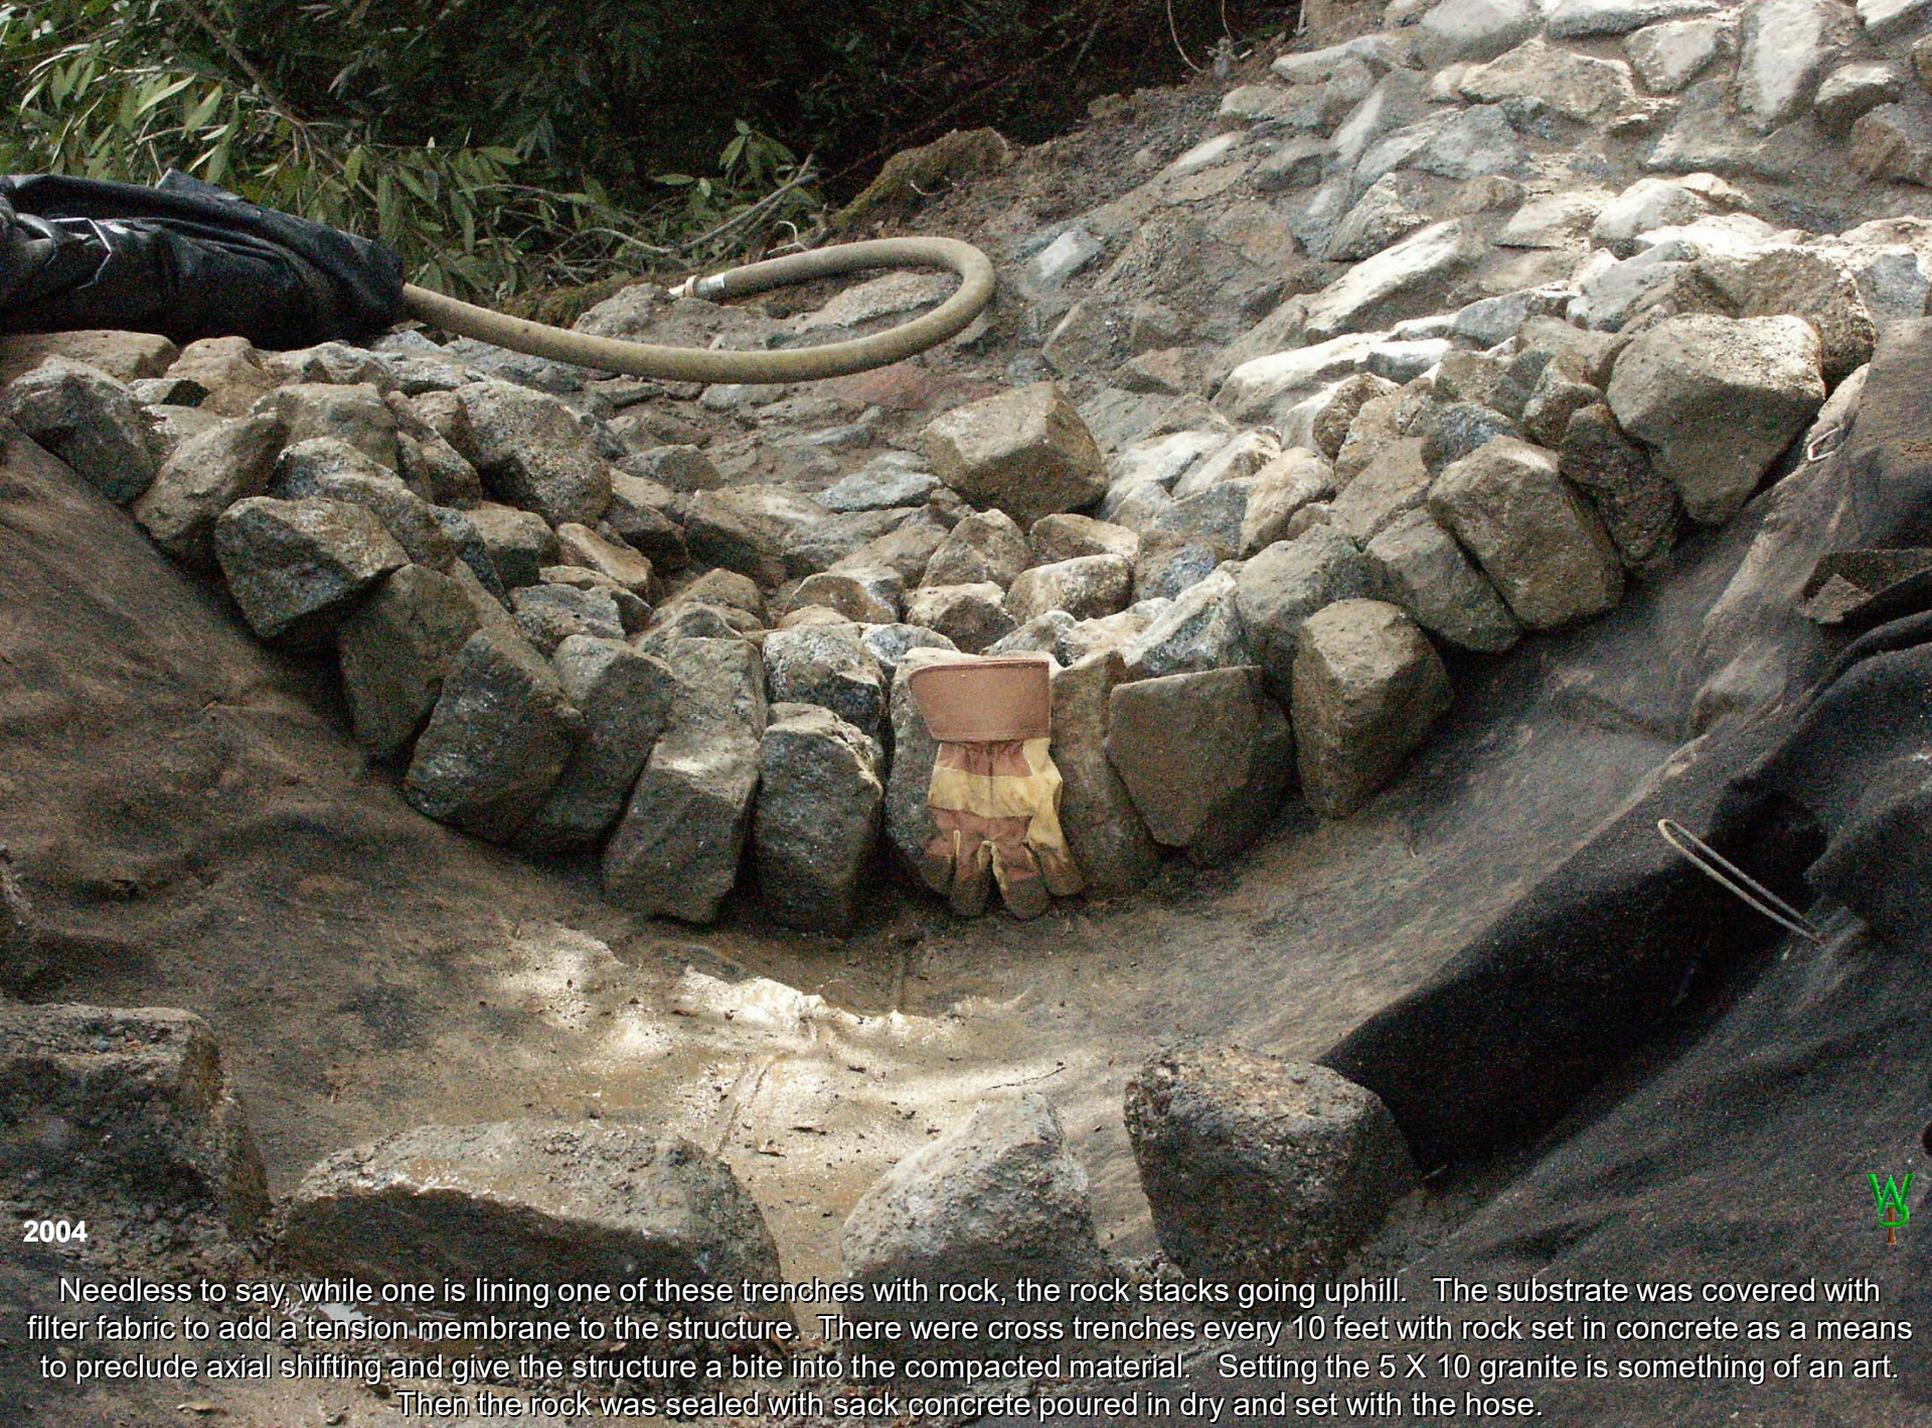
2004

Needless to say, while one is lining one of these trenches with rock, the rock stacks going uphill. The substrate was covered with filter fabric to add a tension membrane to the structure. There were cross trenches every 10 feet with rock set in concrete as a means to preclude axial shifting and give the structure a bite into the compacted material. Setting the 5 X 10 granite is something of an art. Then the rock was sealed with sack concrete poured in dry and set with the hose.
