FEELING DRAINAGE

WILDERGARTEN 6.4

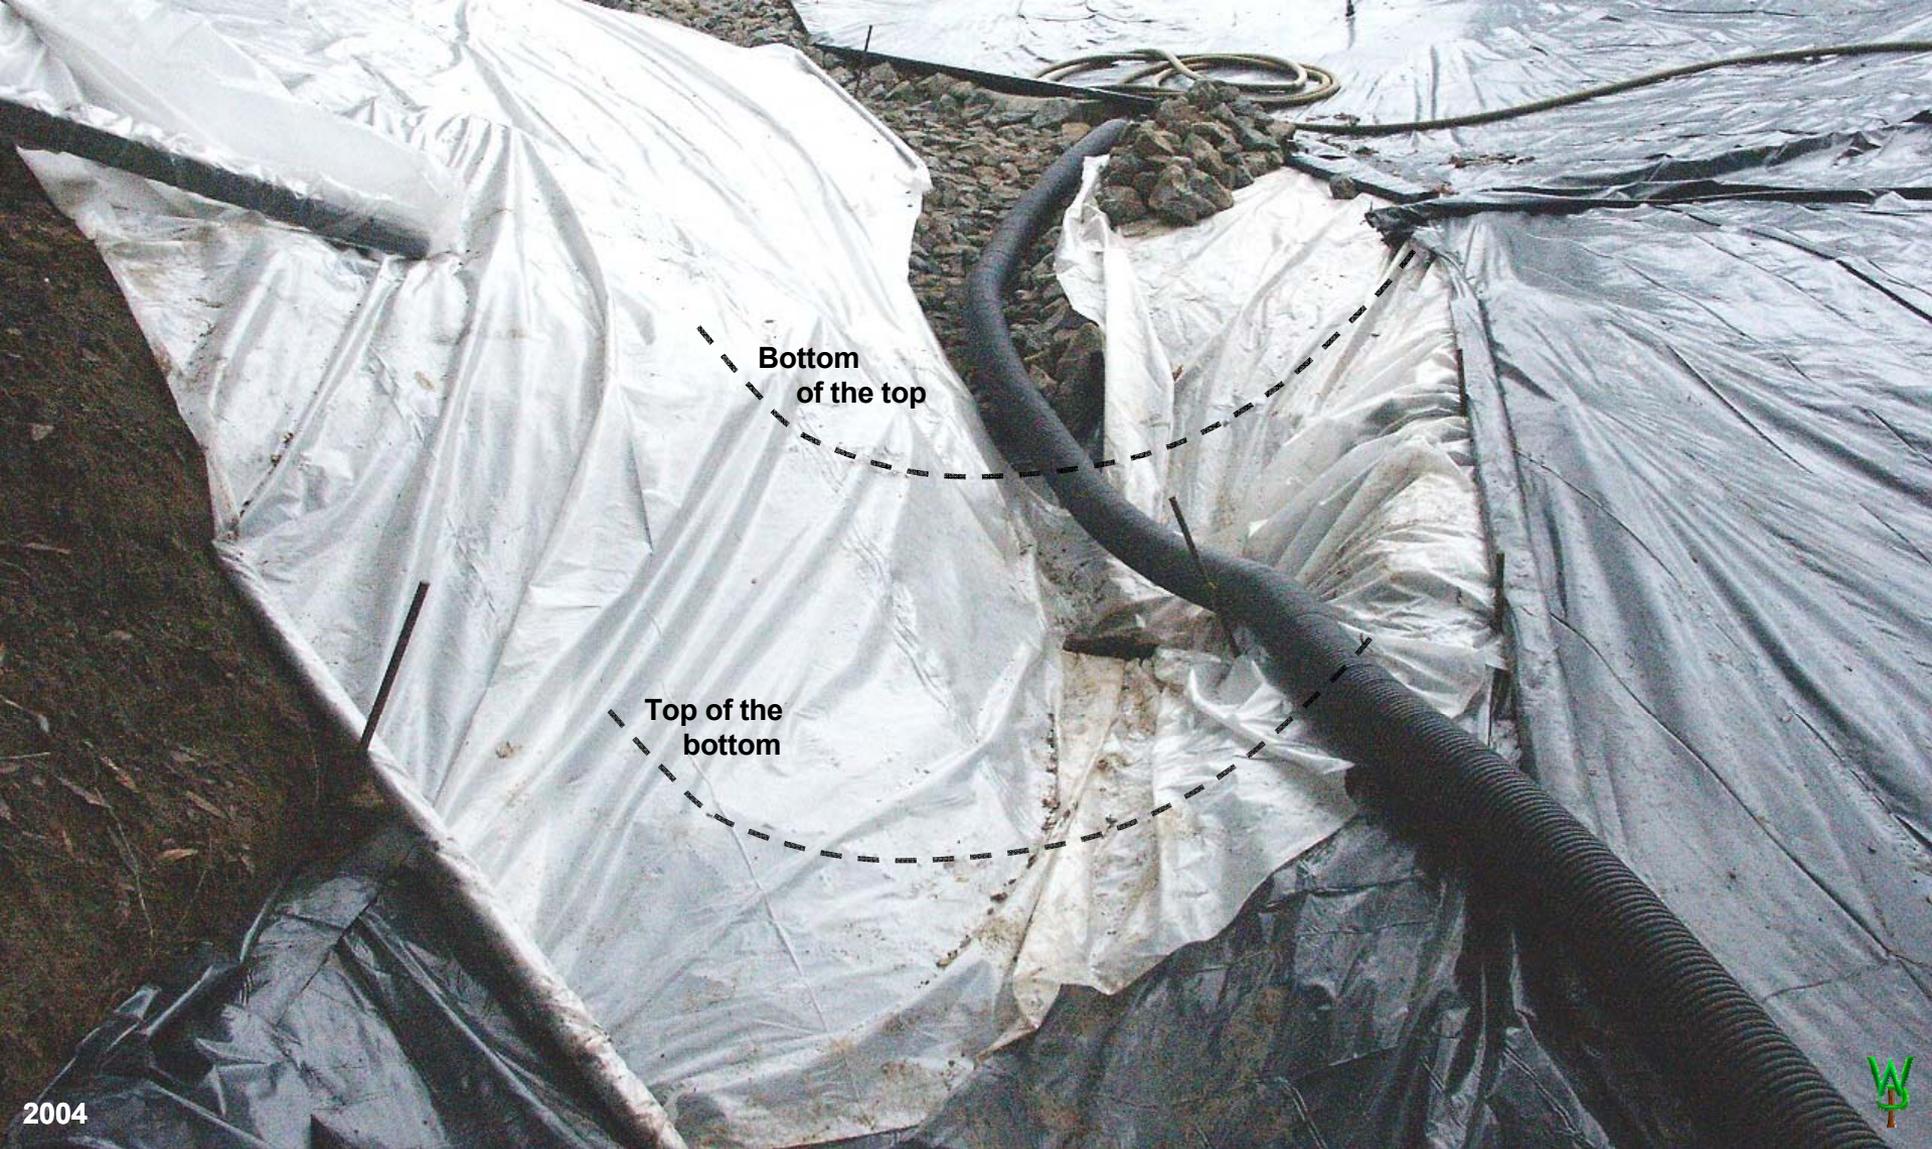
2004

One builds the rock liner from bottom-to-top, yet once I got close to the target, I started upward from a cross ditch near the inlet up to meet it and then met that cross ditch from the one immediately below it to assure a smooth transition. Yet at the same time, there is the risk that if it rains during the job, the water comes from the top down, from which there can be a enough of a flow to wipe out the entire job. The technology to manage the water is not terribly difficult, but the discipline required to assure that it is installed in time while simultaneously under the pressure to finish can be demanding, as there are details involved that make all the difference in its ruggedness that do take time to install. The plastic is stapled to the battens, which then are rolled and screwed to stakes. The hose is screwed to the outlet of a pipe collecting surface drains.

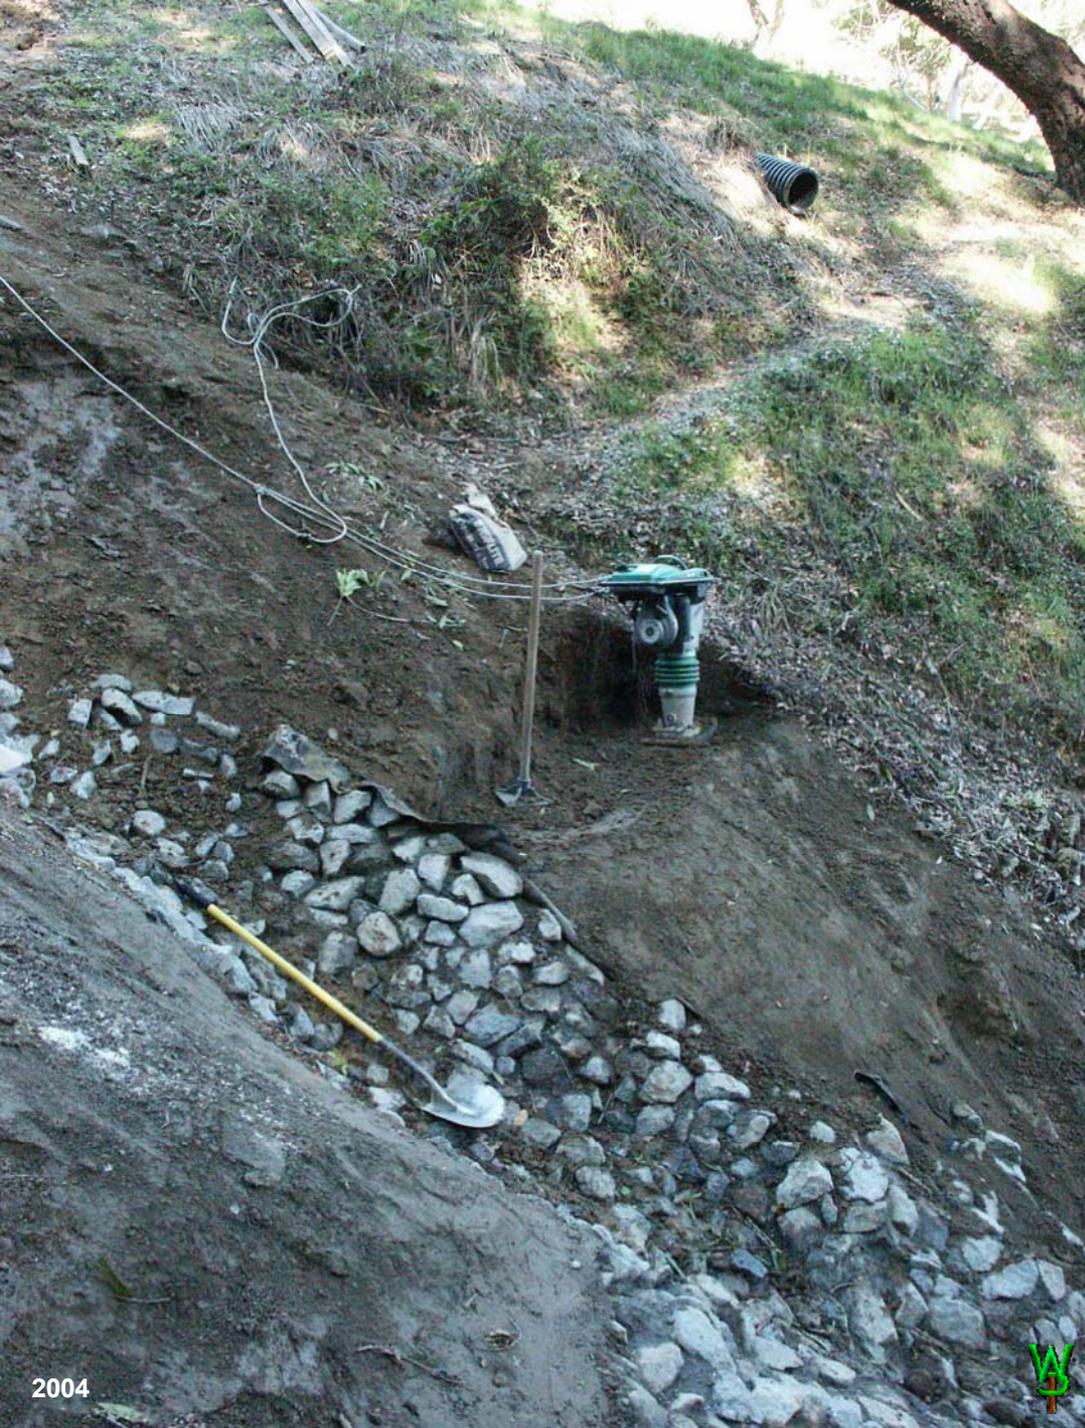
Once the rock was done, I had to pack the remaining fill from the trench. This slope is steeper than it looks. The small amount of extra fill I needed was brought down in buckets. Footing was treacherous. The hand-tamping marks to tighten the surface are visible. I don't think I'll ever forget slamming that iron plate into it over and over. Day after day, wrestling that thumper out of the way and on top of the pile, starting it up and getting control on a tiny bench like that. This was one heck of a lot of work.

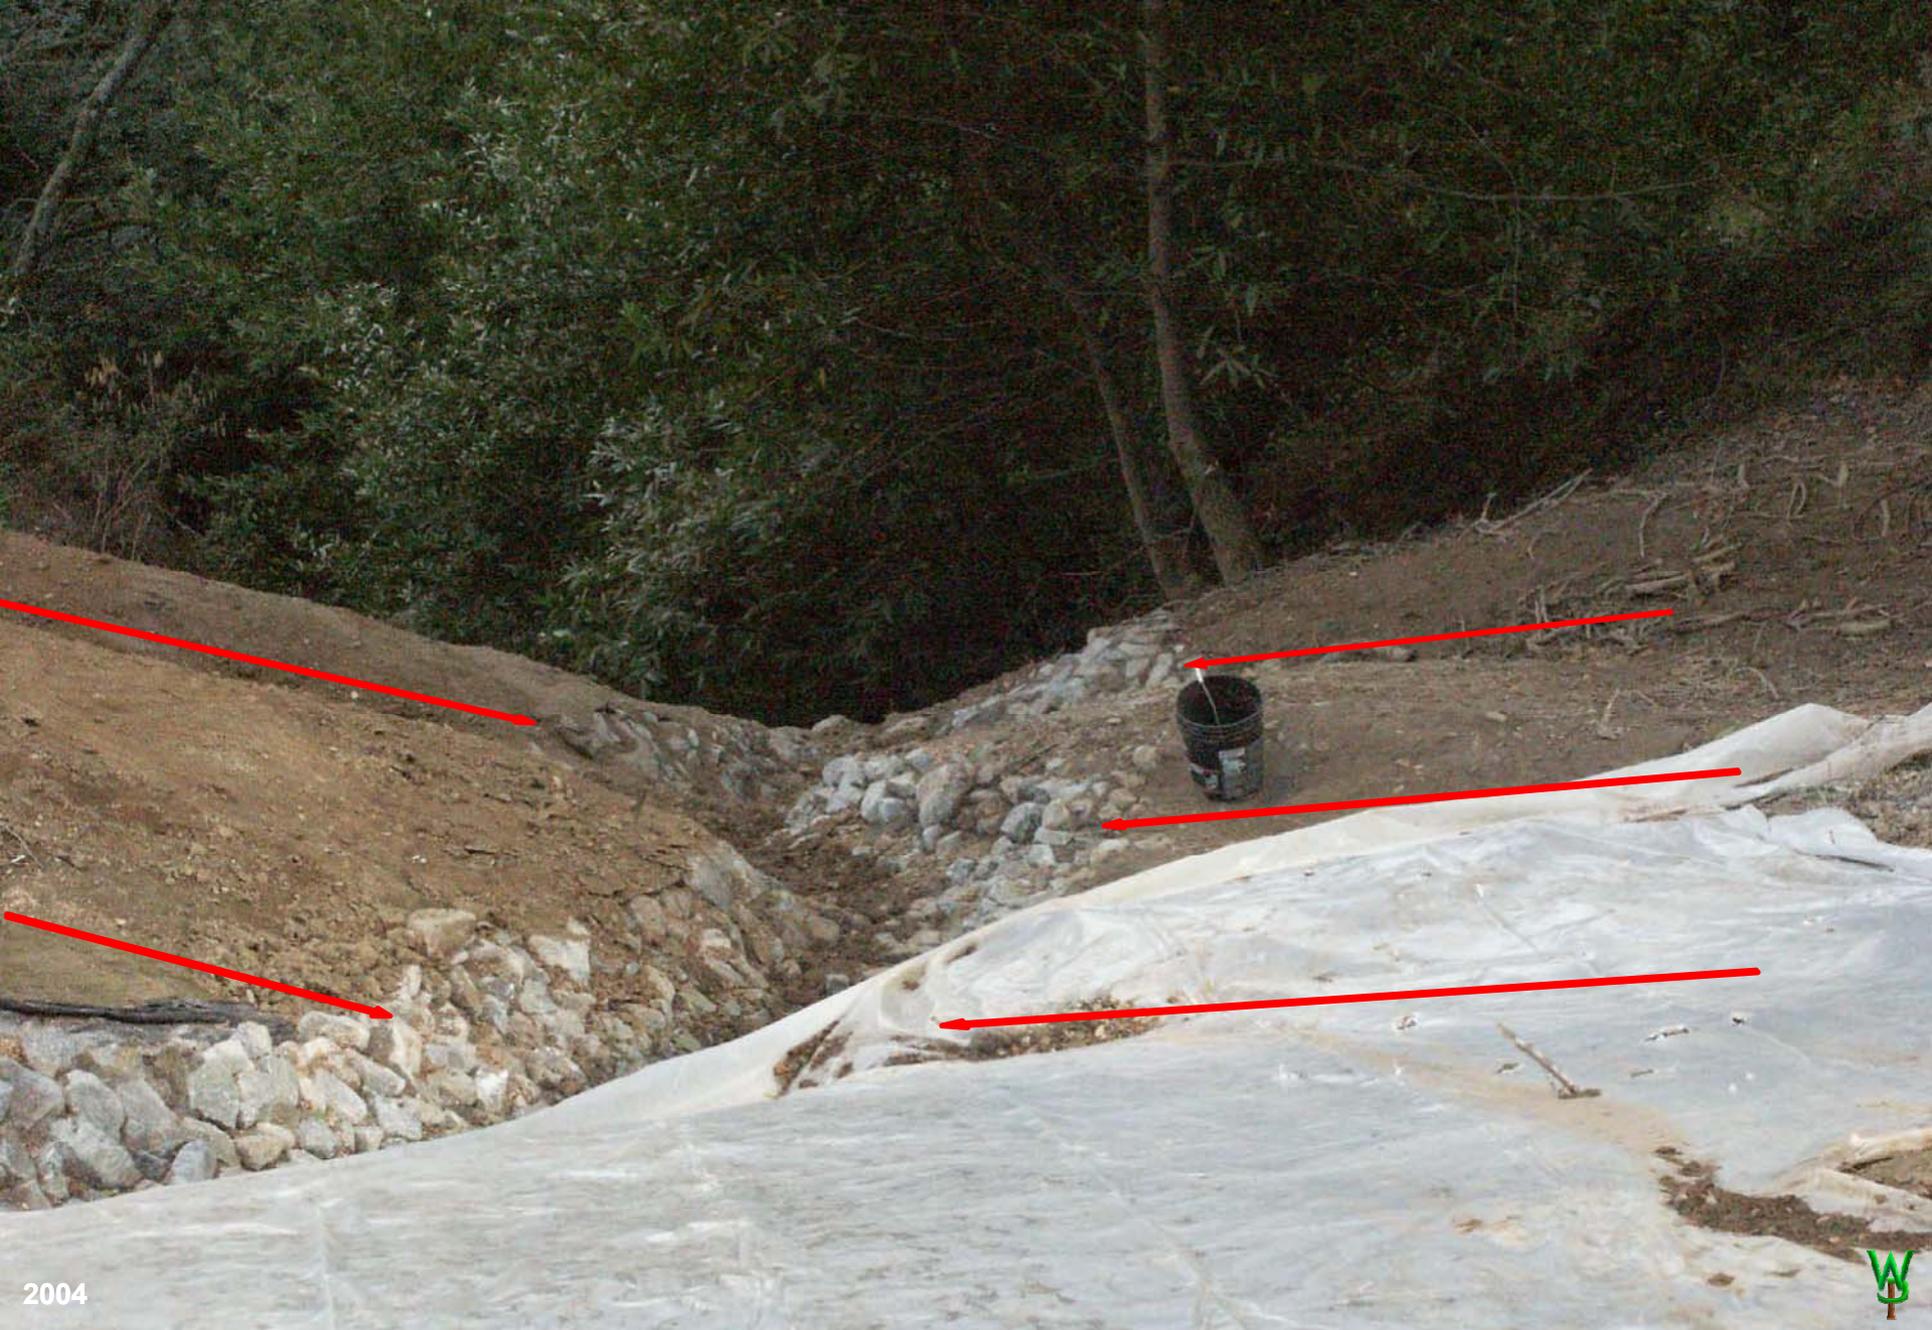
2004

The arrows indicate the alternating benches to catch and redirect sheet wash to the channel. The plastic was not only to preclude rain impingement and sheet wash but it was part of a multivariable revegetation experiment. Then it rained...

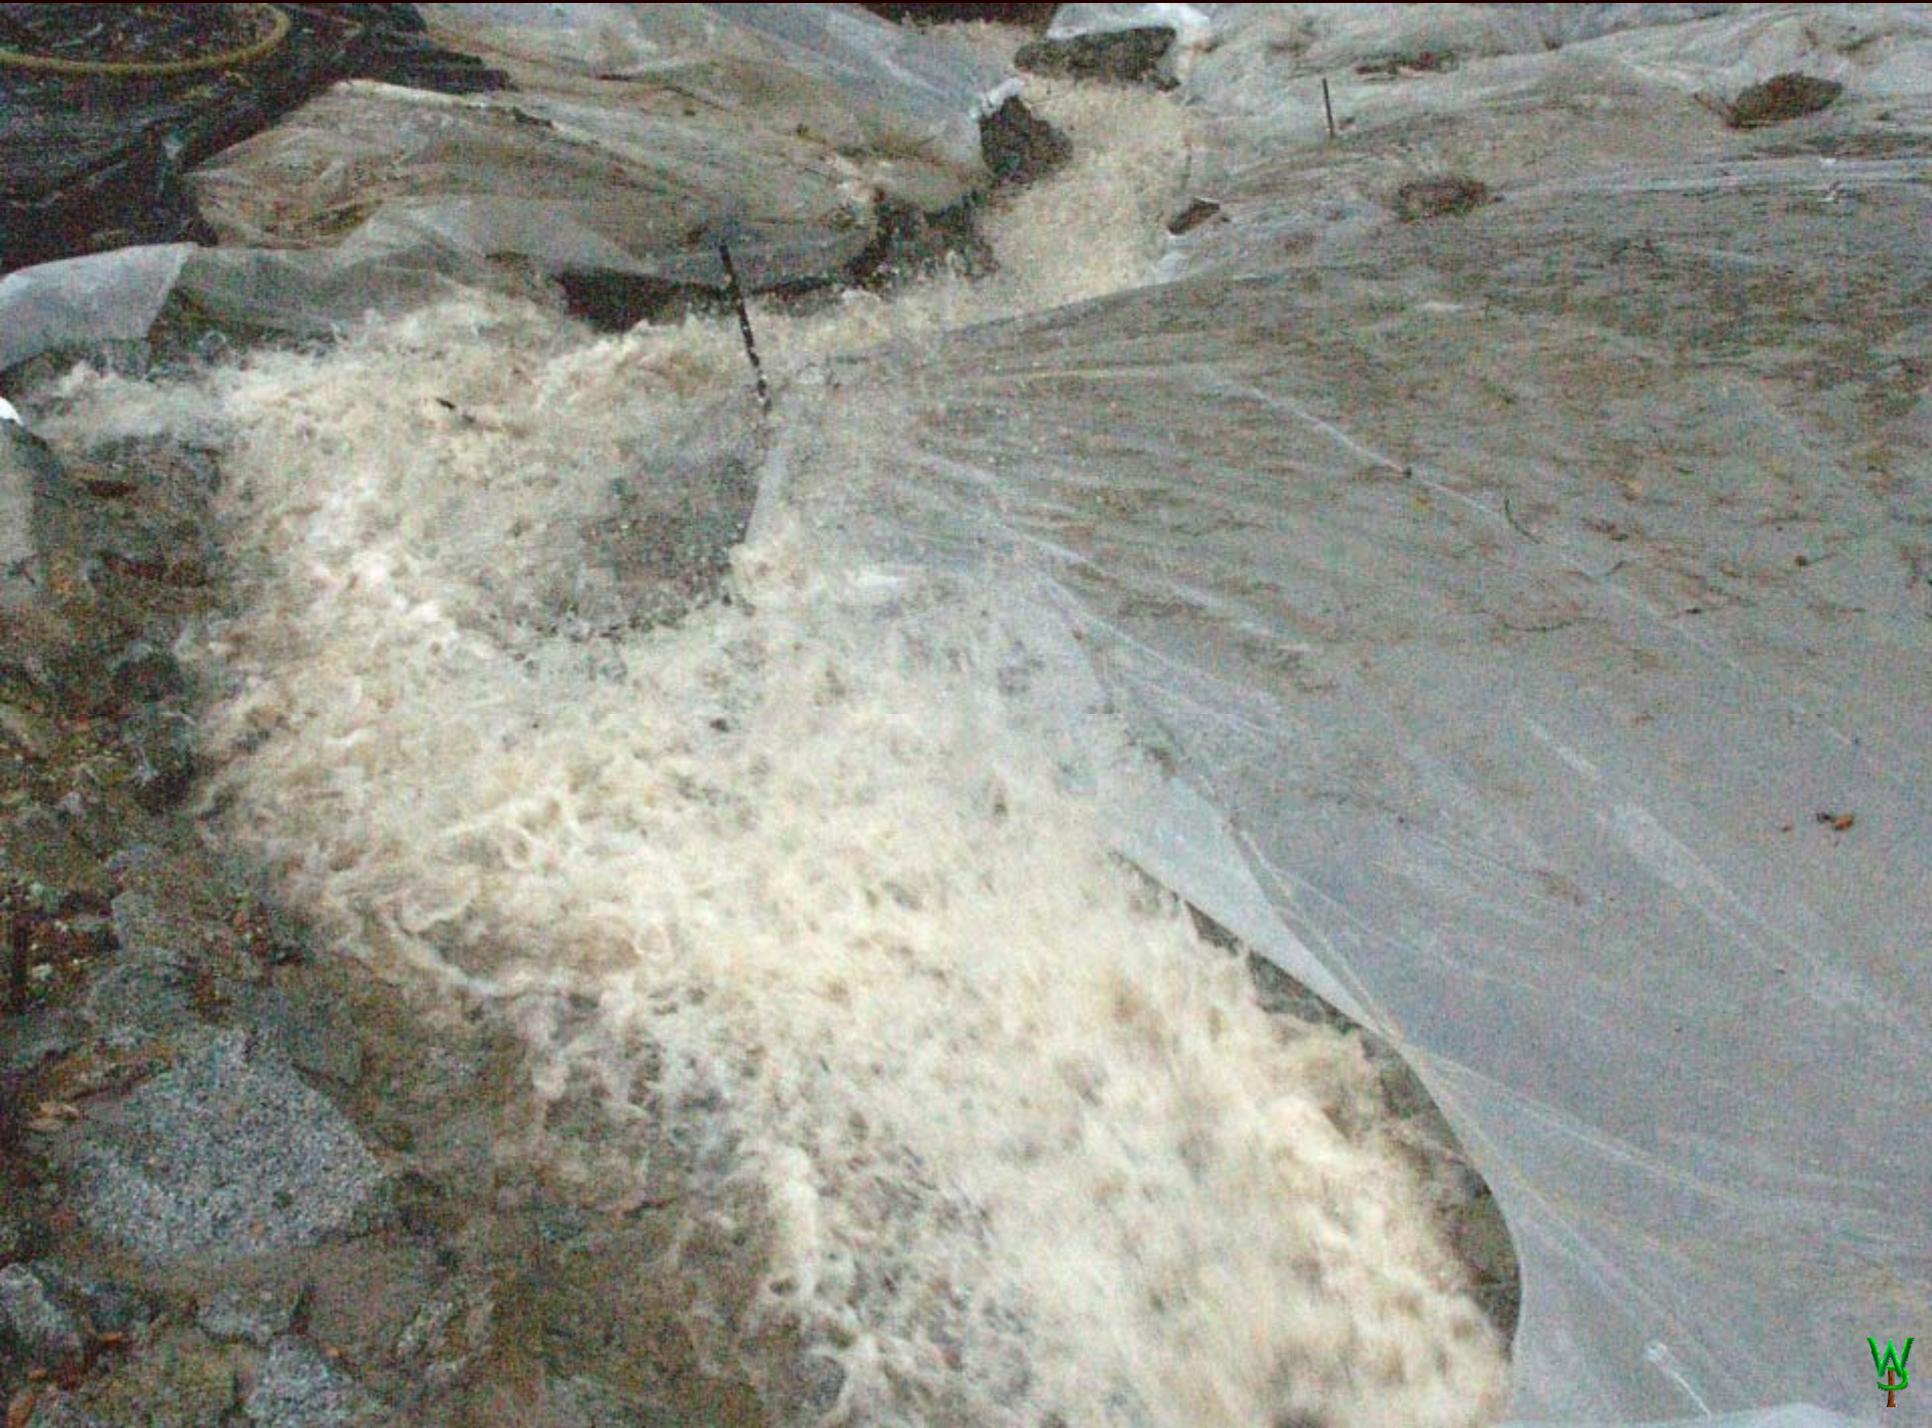
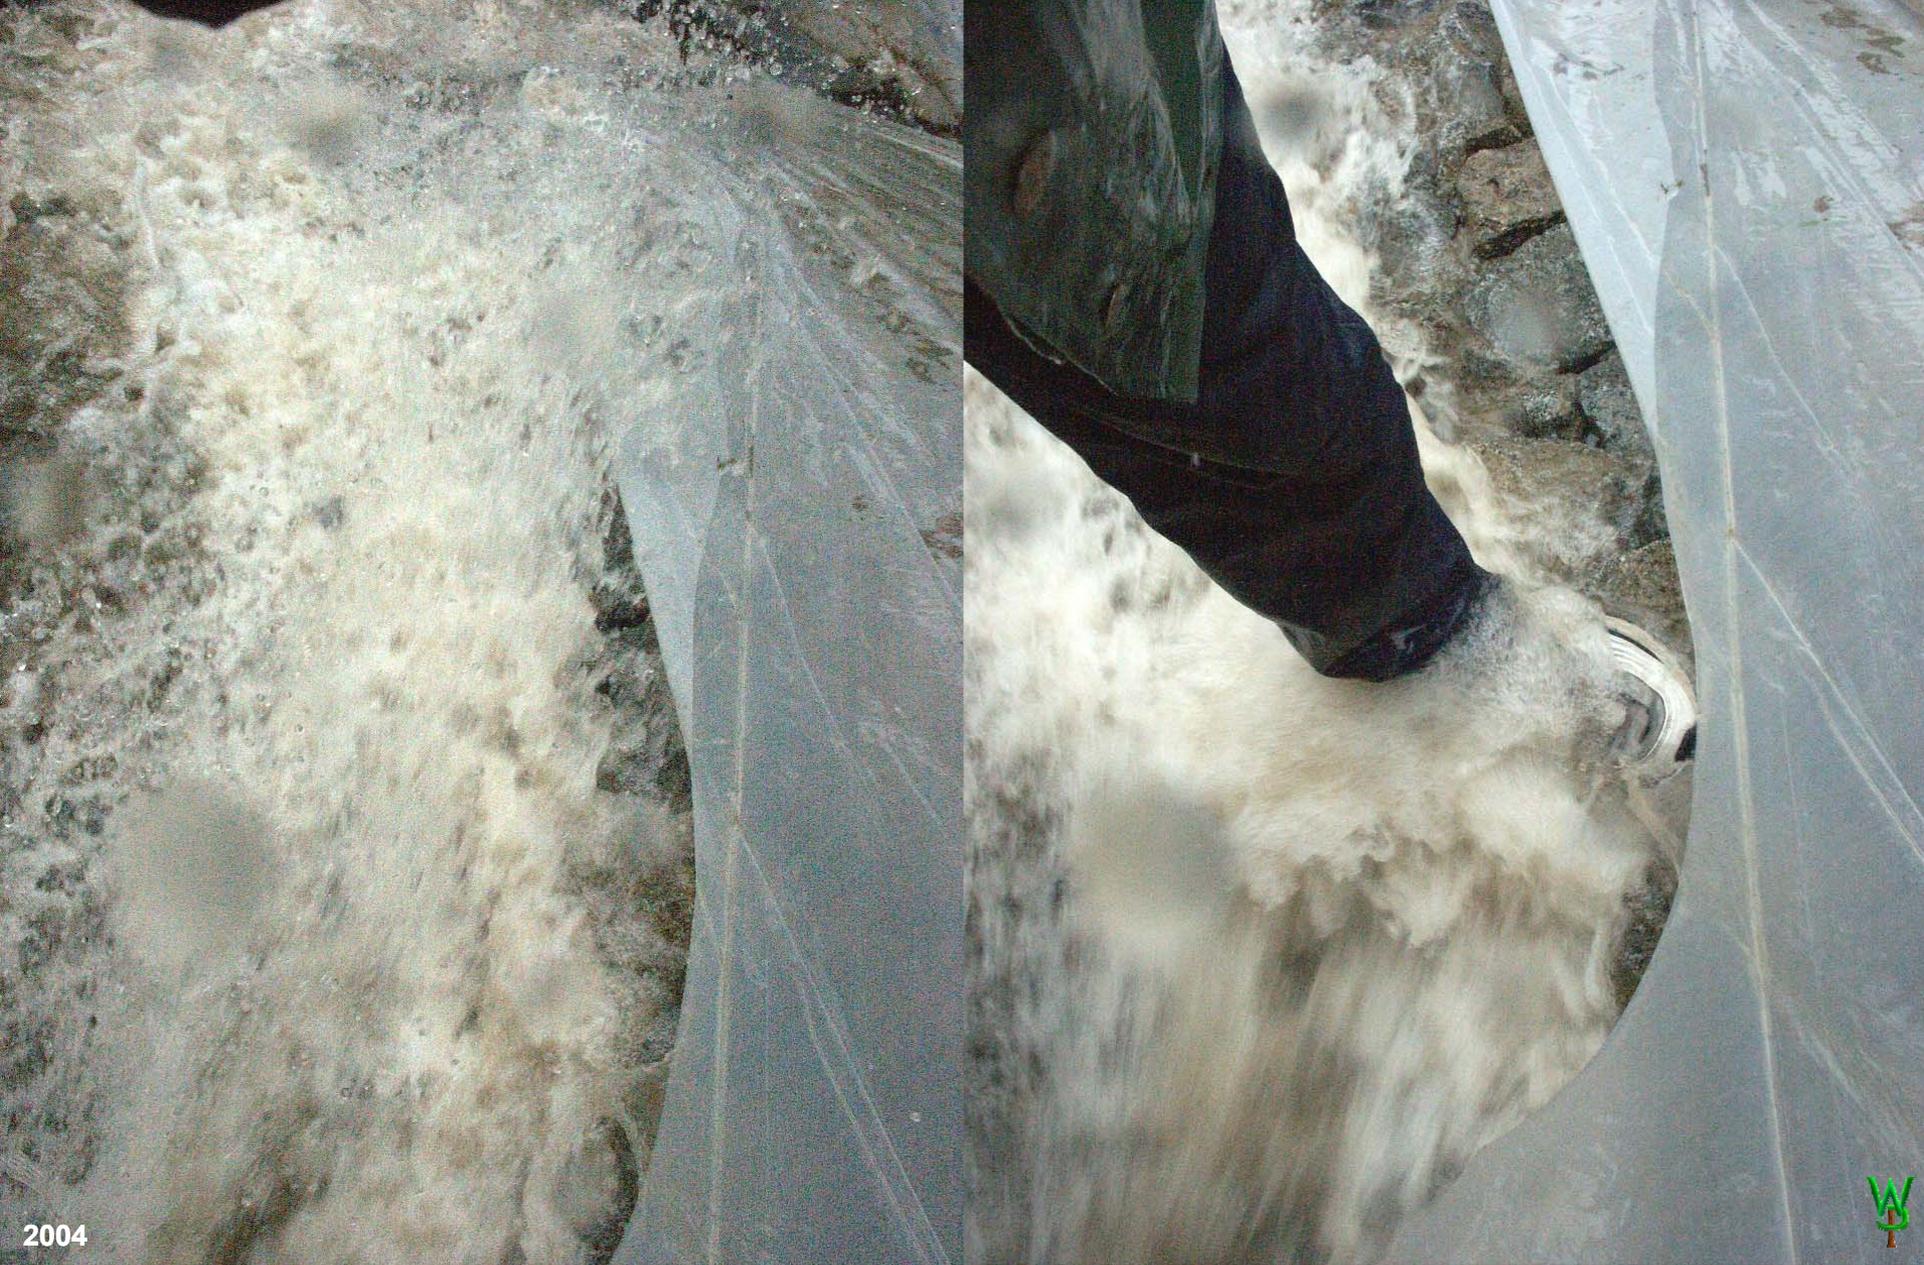
2004

This is when one gets to do the final tweaking. It is very hard to predict how the flow will behave when it exits a pipe and enters the trench. So I waited before dry-setting the rock around the outlet until a storm came to know exactly where and how to adjust for splashing. In this instance it took a couple of hours to reshape the surface.

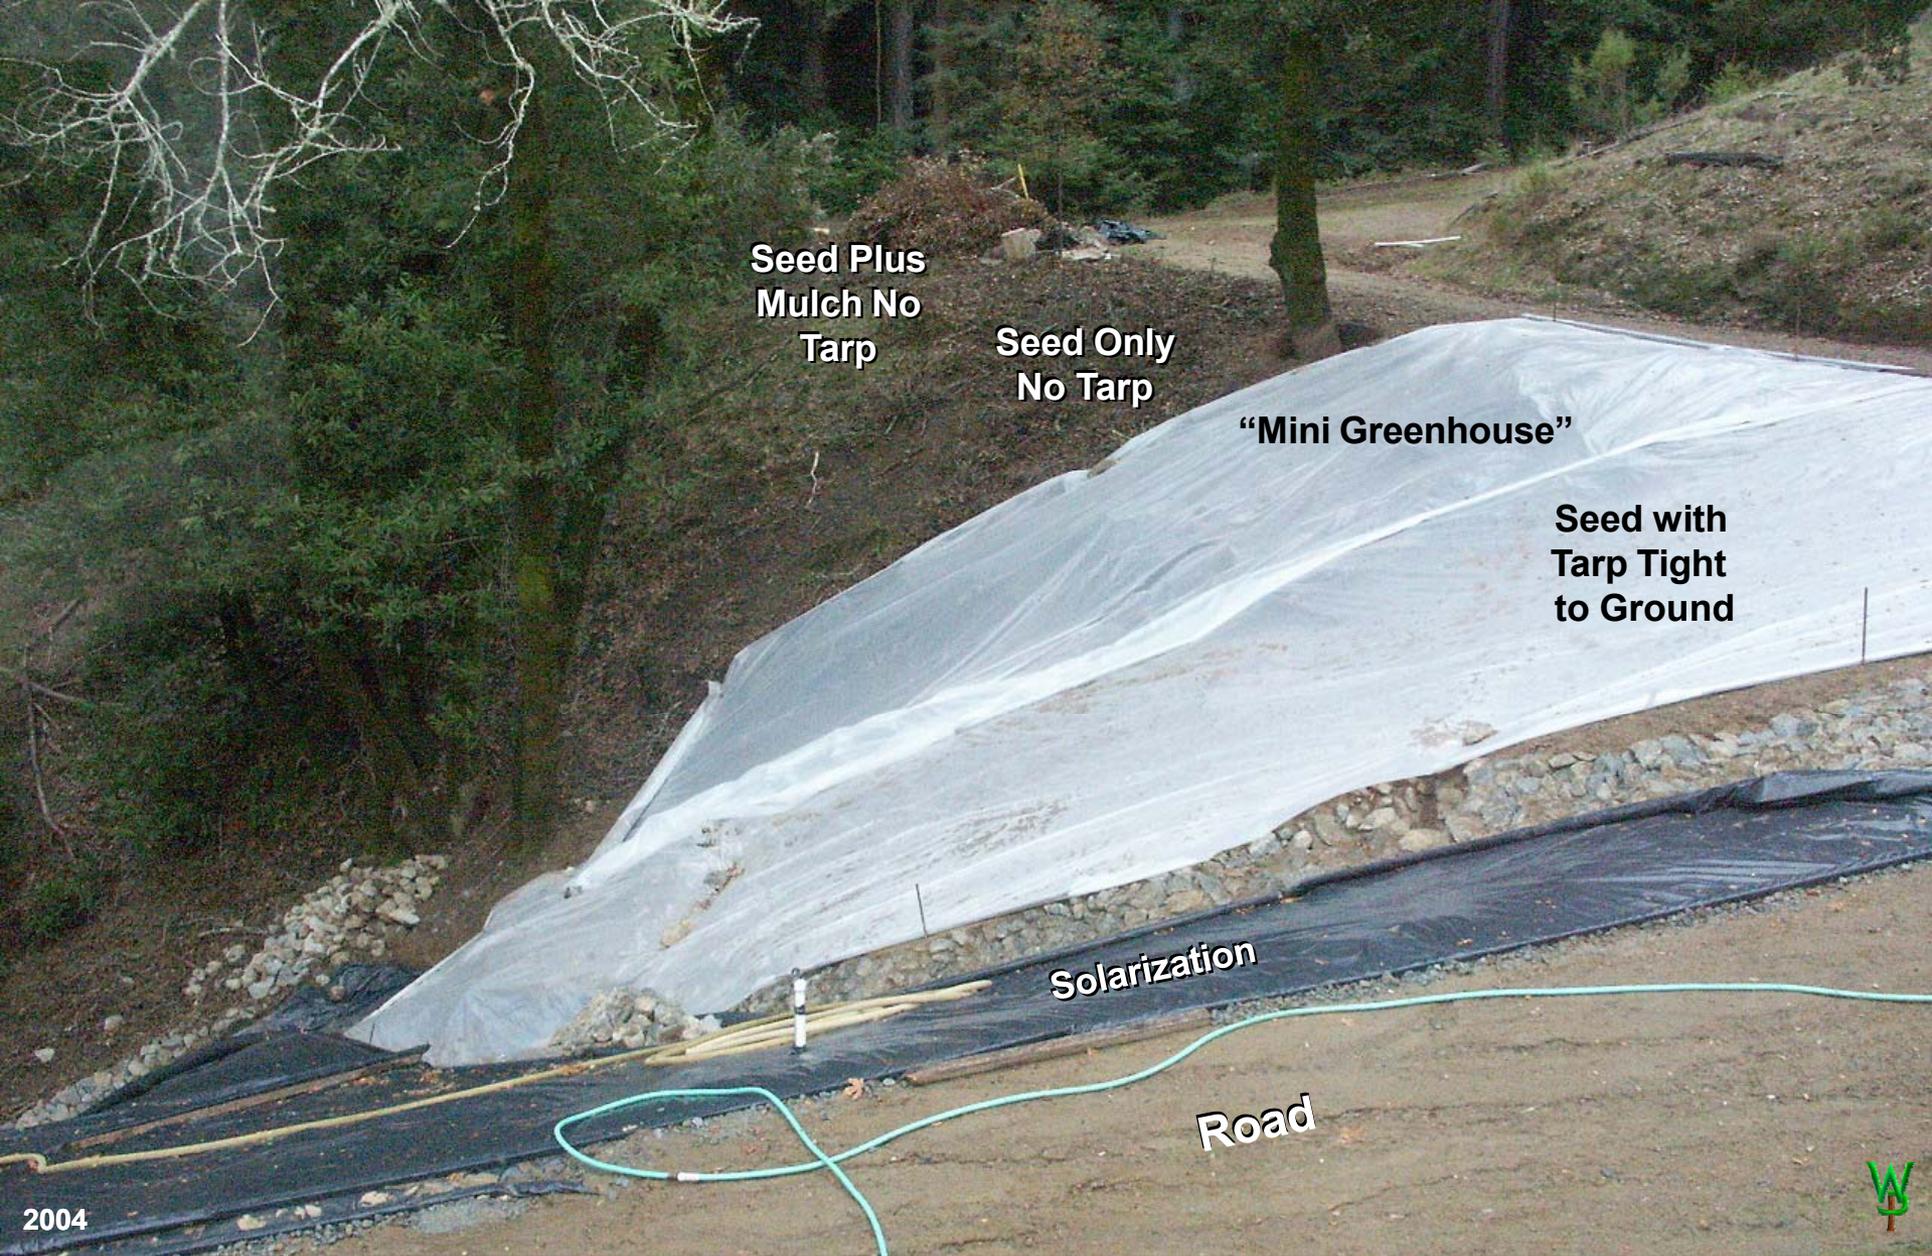
As long as one doesn't use too much mulch and there is enough moisture getting under the plastic to keep the grasses going, these tarp-houses at least **triple** grass growth.

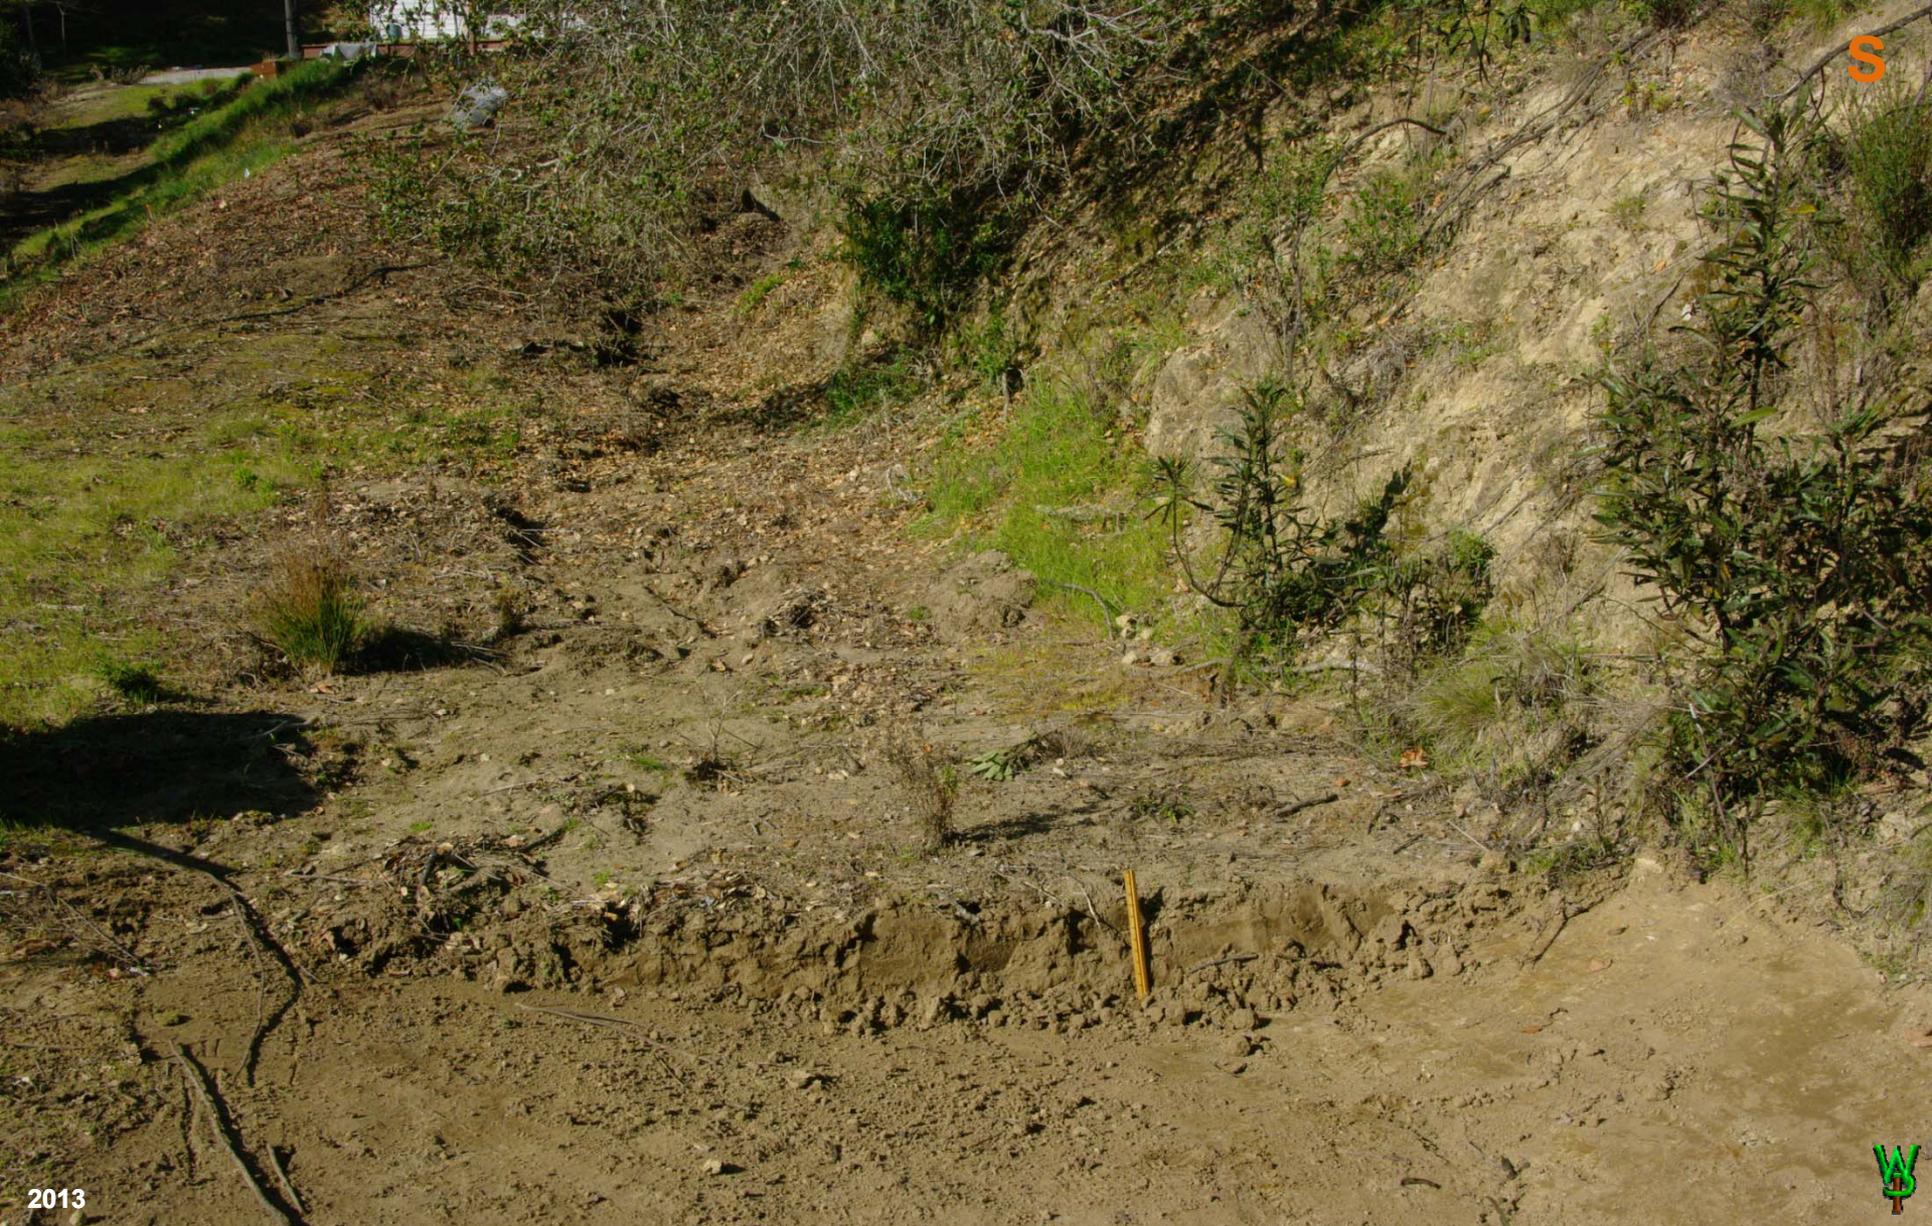
2013

You do not always get your choice of routes for runoff because of the history of how the land was used. In this case, there is a series of old benches of perched fills that once supported various out-buildings with a road below them traversing the top edge of a steep slope, so steep that if this much water were to go over the outside of those fills, there would be severe damage to the hillside. So I transit the flow from three acres on a low grade along the top of the benches, where this spot serves as a catchment basin for sediment. About every 10 years, I dig it out; else the water would eventually dump down those erosive fill slopes.

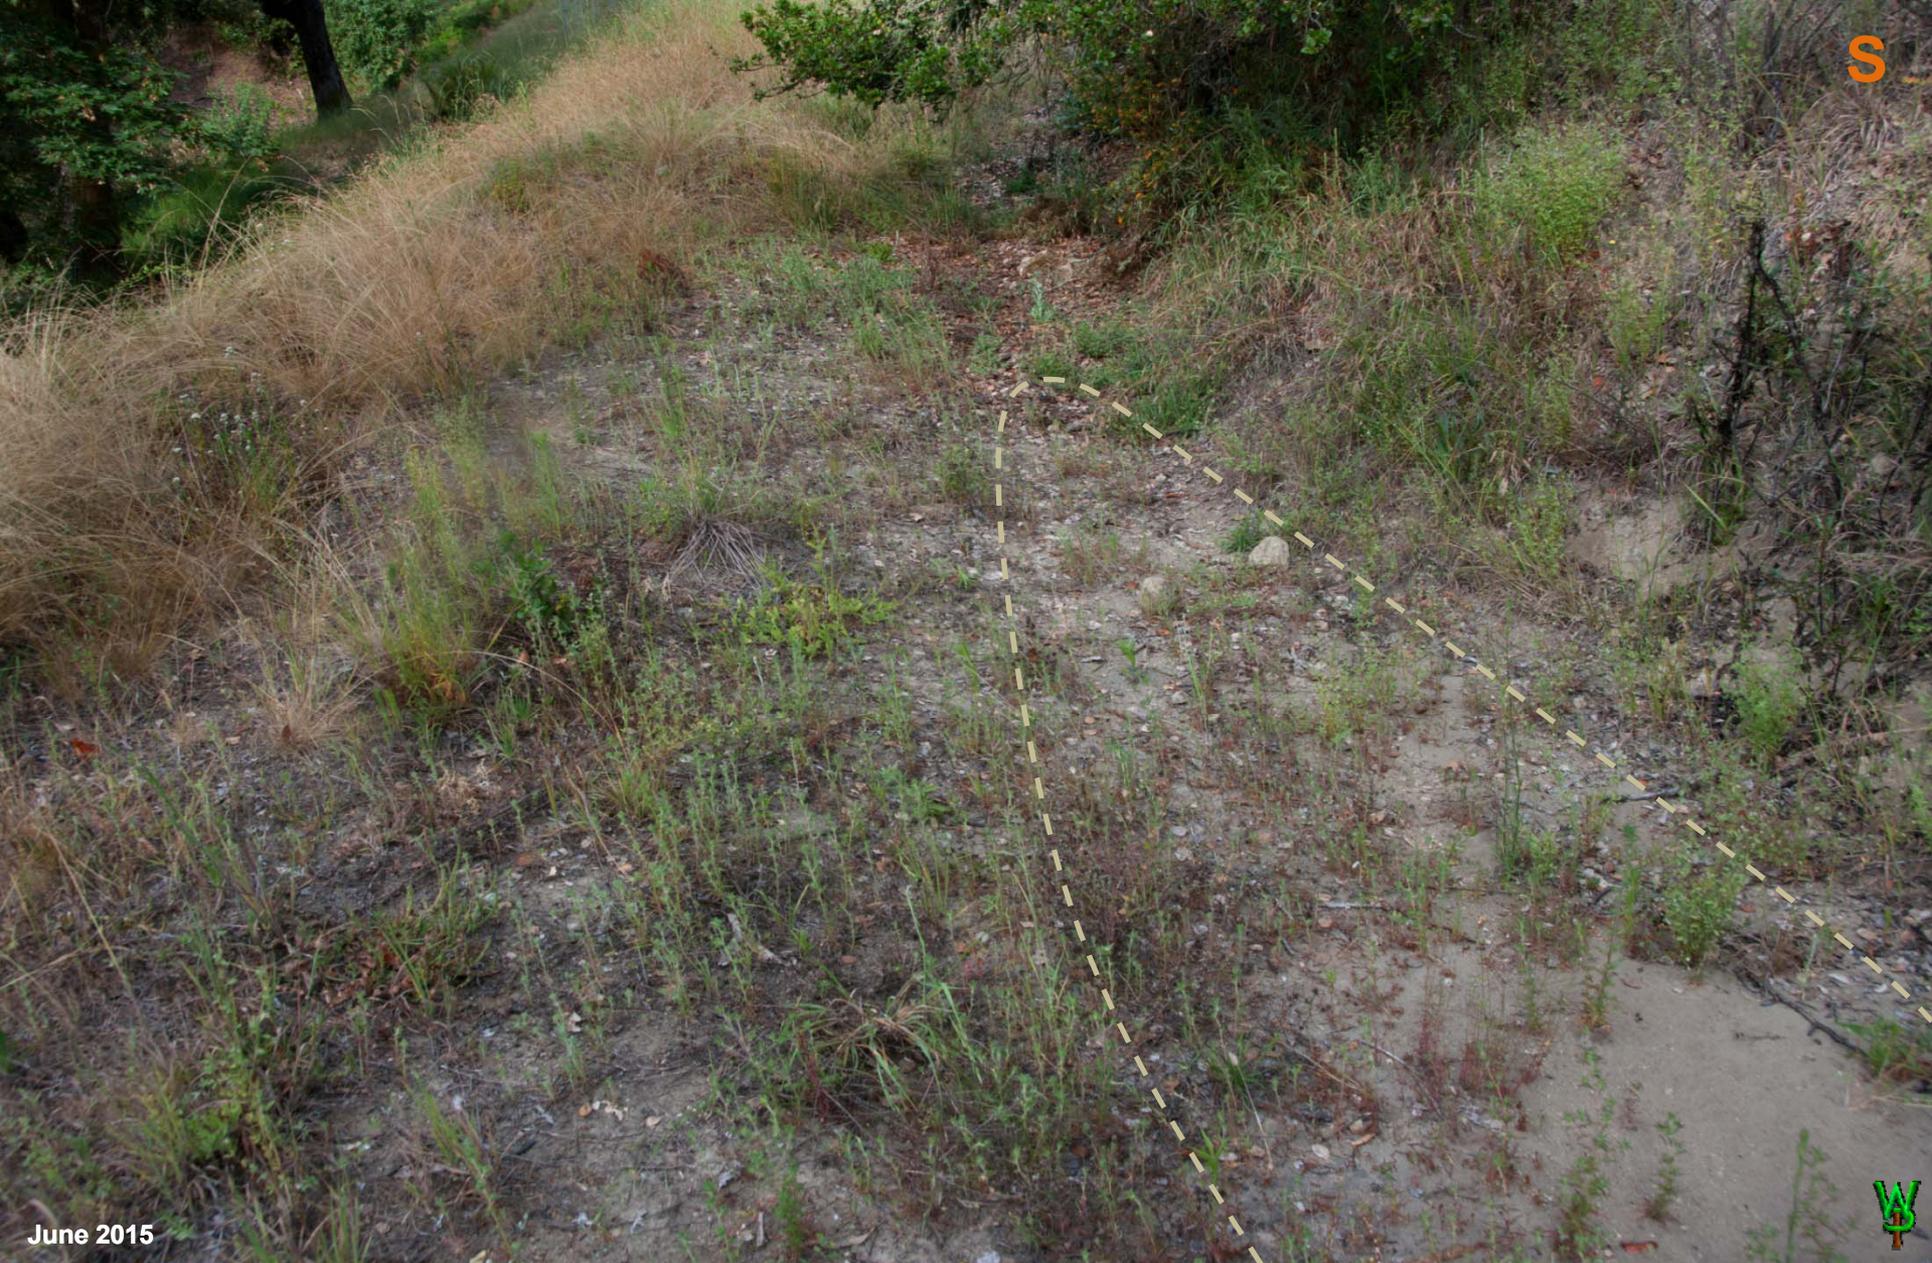
June 2015

Two years later, the captured sediment is now populated with native sand hill species, primarily *Navarretia atractyloides*. Considering that this is a recently disturbed soil in a settlement area with three acres of runoff contaminated with whatever seed is upstream (it runs below our sand hill area), this is a VERY clean result. In years past, this was an area I would often write off as too populated with exotics to bother weeding at all and just spray it. So this is a very good sign that weed control upstream is working.

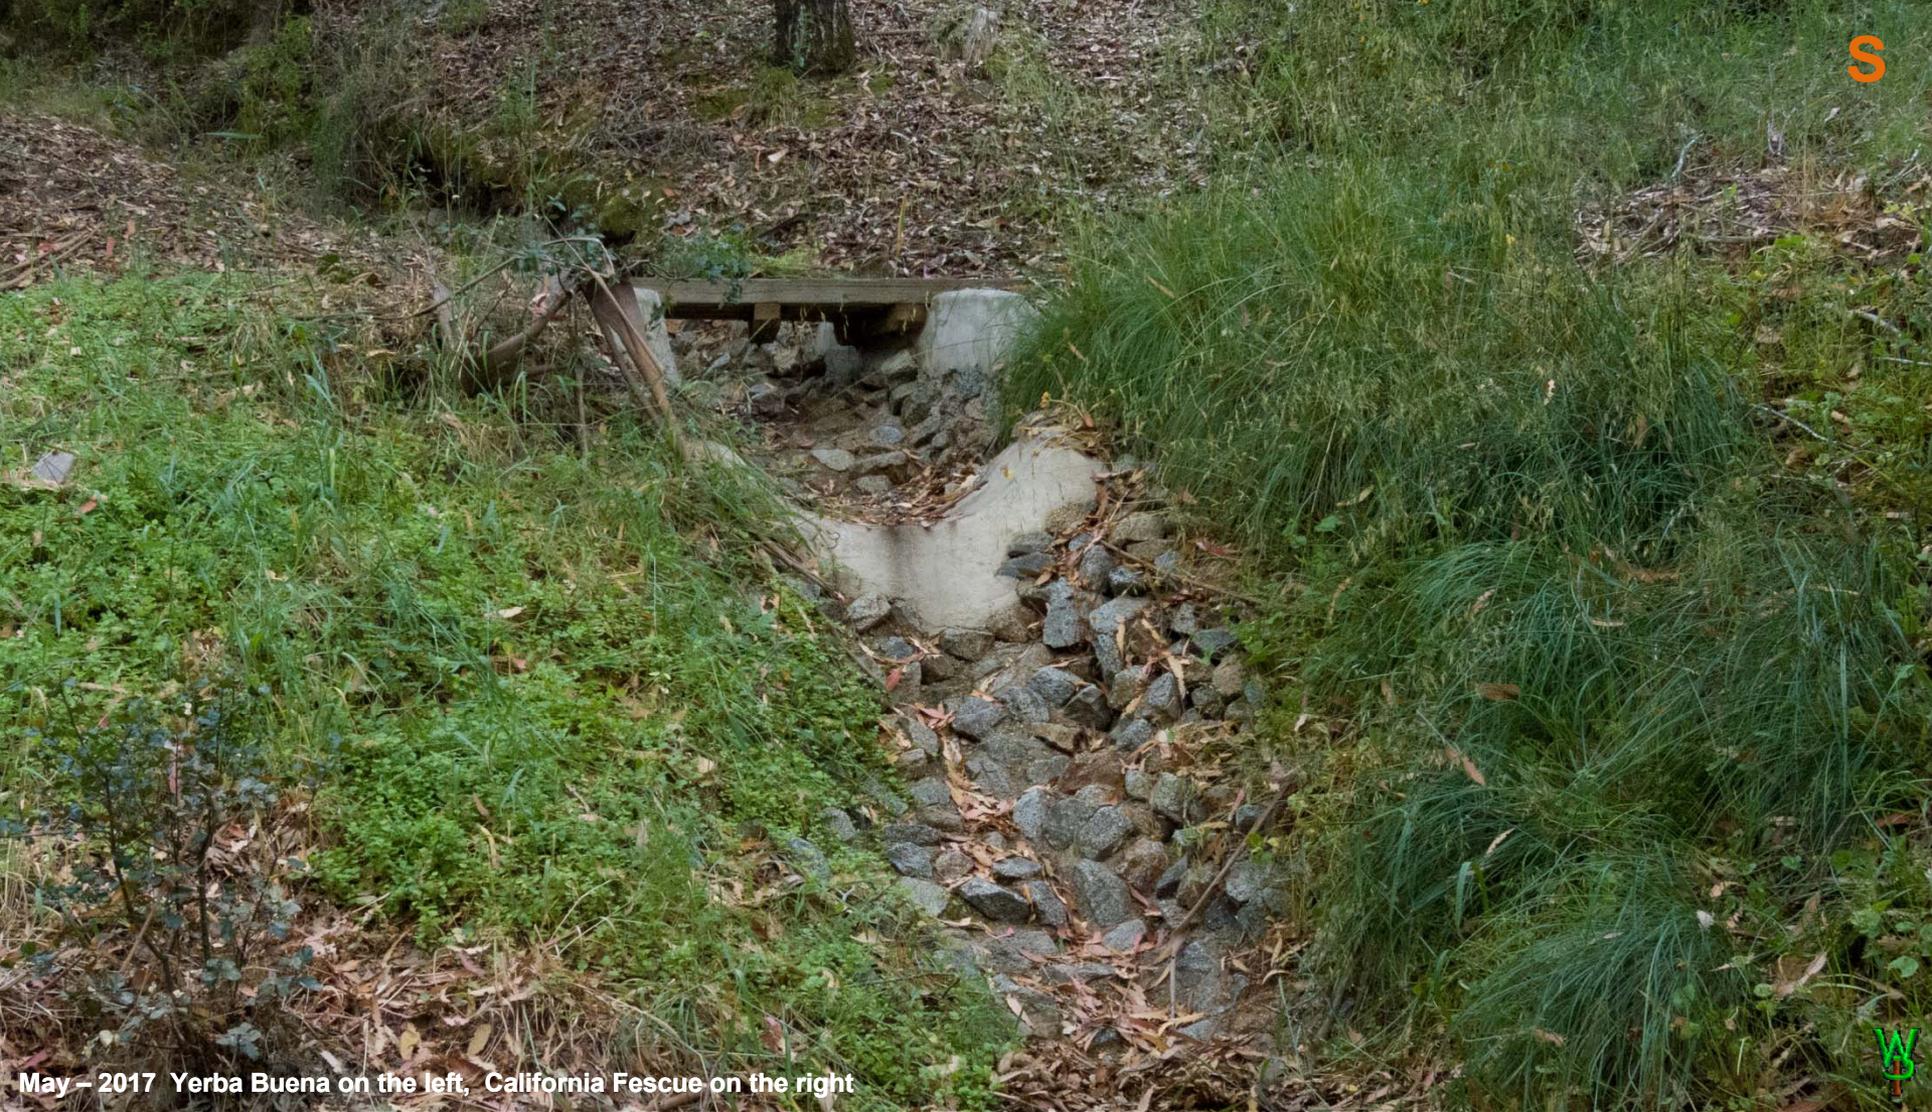
May – 2017 Yerba Buena on the left, California Fescue on the right

This outlet from that channel drops the water onto the road below which acts as a second transit and sediment catchment area. The bridge is a way to wheel the sediment out of the basin on the prior page to where the fill serves useful purposes. First, it was packed into what was a rather ugly eroded hole once cut by water diverted around one an old cabin that burned down in 1979. Later on, it will be to give the water bar to the right a more gentle slope. The final drop to the bottom of the property comes next, but it is so steep that it will constructed as stairs and thus double as a trail. Each of these projects deals with history. They are expensive and time-consuming. “We” can either “leave it alone” and allow whole slopes to fail and weep sediment for decades, or we can fix old problems and maintain it. Yet if the policy preference is to leave it alone, then the policy makers should admit that they don’t really care about erosion and sediment, because the resulting larger failures will keep them in power while destroying the wealth needed to fix it.
