FEELING DRAINAGE

WILDERGARTEN 6.4

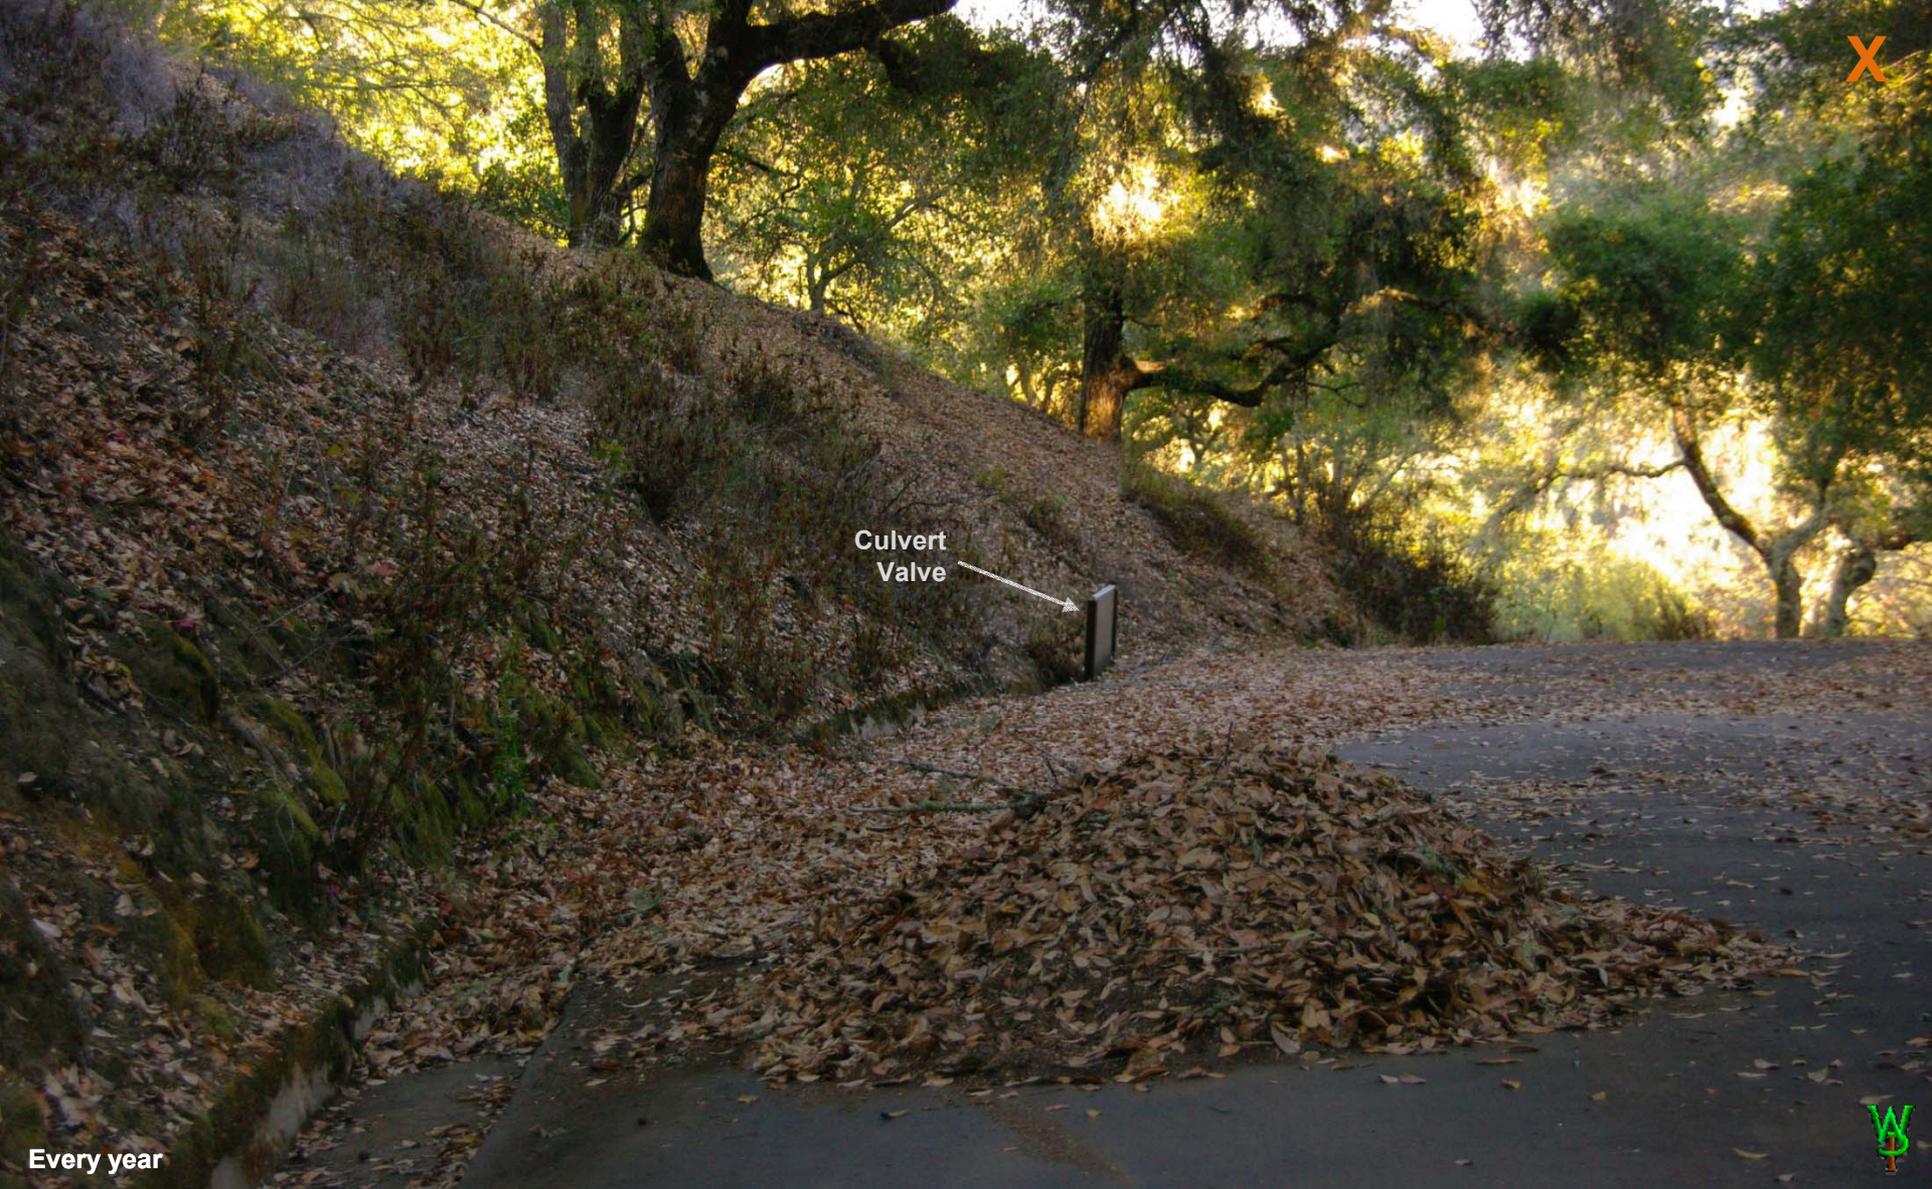
Culvert
Valve

This was another one of those “things you learn along the way.” Every year, just before it rains, I clean almost four truckloads of leaves out of the drain channel along the driveway. Rather than import non-native straw for my reseeded project, I use that oak leaf litter as a protective mulch for the seed to keep the surface moist and reduce erosion due to rain impingement. Well, it worked for that, but it also brought me a crop of exotic large seeded rattlesnake grass (*Briza maxima*) a patch of which had been not far uphill from the top of the driveway. I learned right there that the old maxim about ‘what goes downhill’ applied to seed too. I’ve since prioritized my native grass reestablishment projects from the top-down in the same manner. Since then, the leaves have been clean.

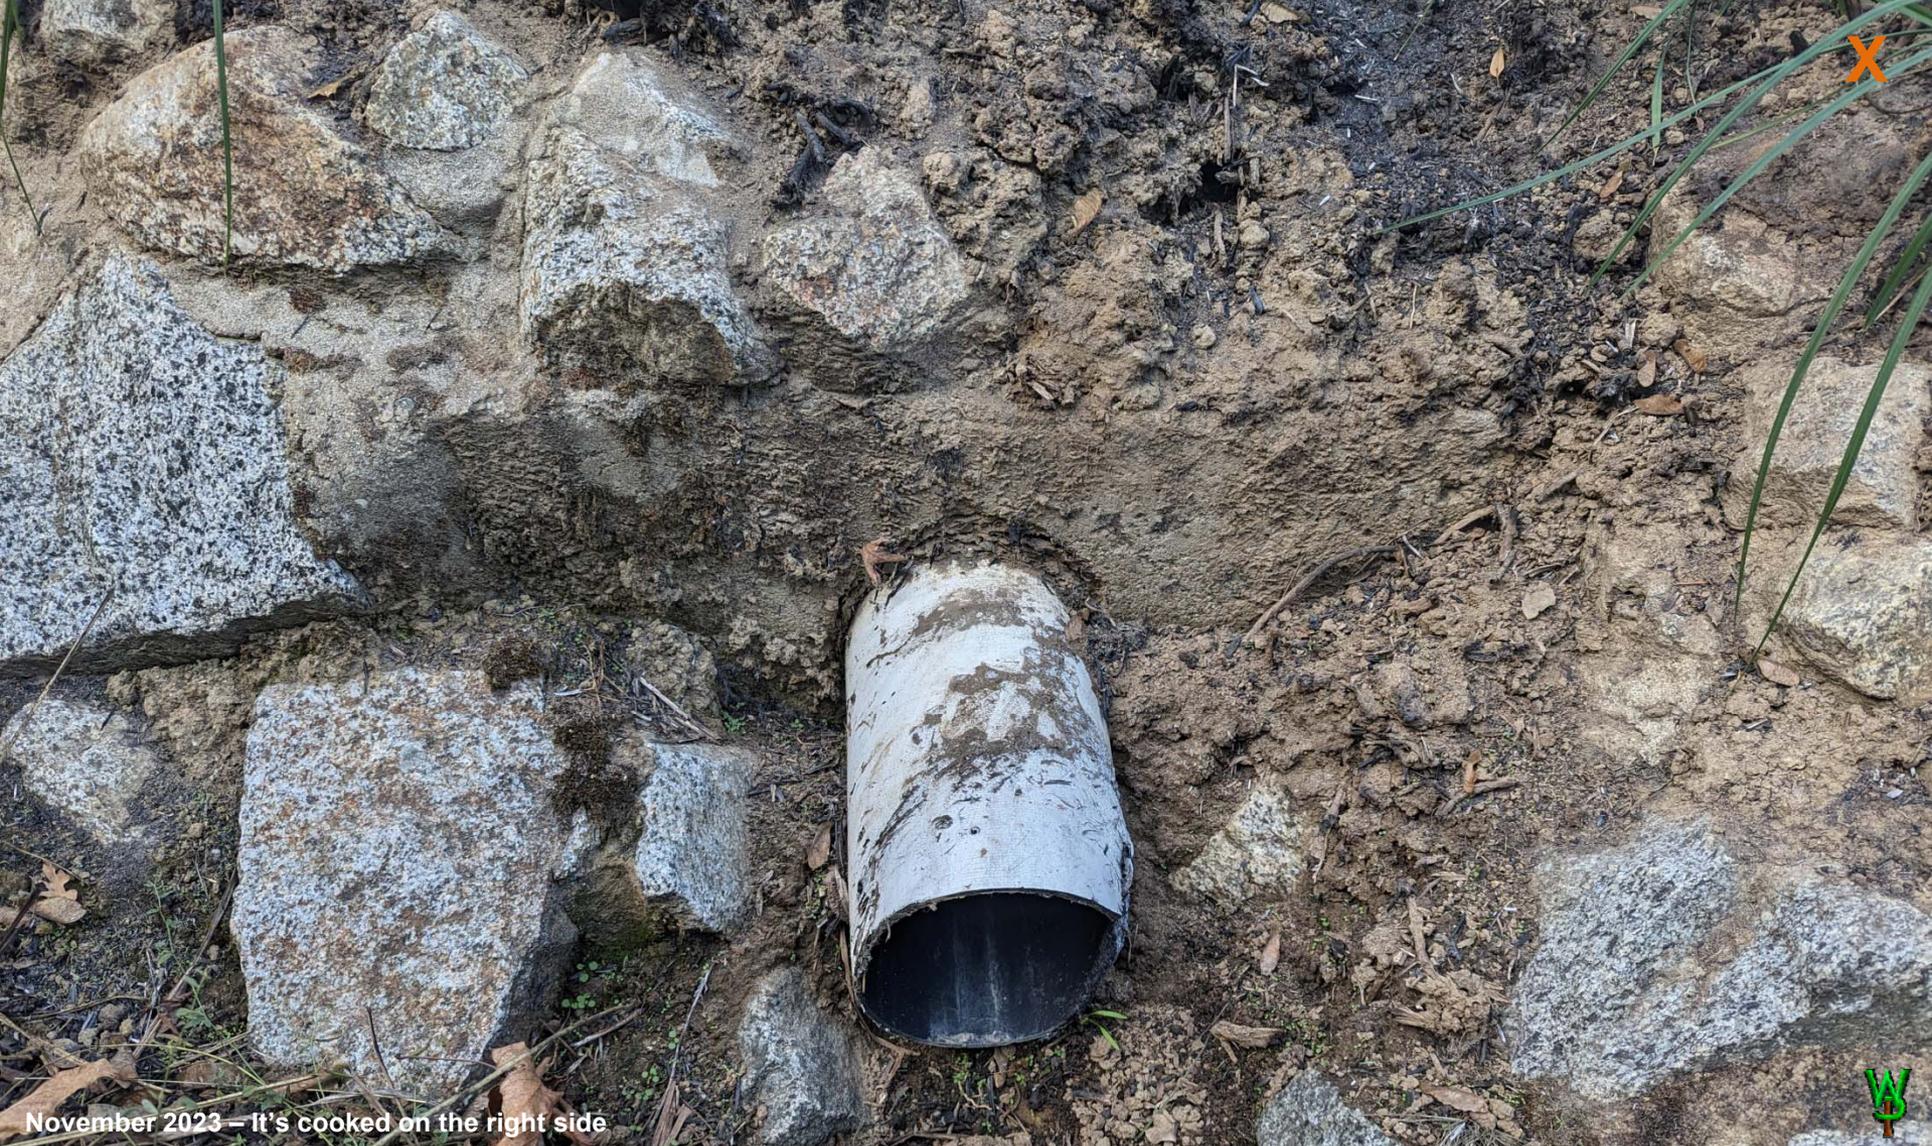
November 2023 – It's cooked on the right side

Modifying our drainage measures for fire is not just good disaster planning; it aids both slope stabilization and weed control. This is the outlet to the main storm drain from our house roof gutters and parking area that empties into the rock lined drainage discussed above. The outlet extends from the concrete to hold an elbow intended to dissipate the energy and direction of that flow as it joins the main channel. Above it is Santa Barbara Sedge, an important plant here for managing rainwater runoff and stabilizing slopes. Burning sedge every 2 years keeps it fresh and dense as well as discourages invading poison oak or blackberry. Unfortunately, there are pipes, usually made of various plastics like this polyethylene, which melts and burns like wax. Obviously, one could remove the pipe before burning, but there's this 'little problem' where it comes out of the ground, or even worse, from out from a concrete headwall.

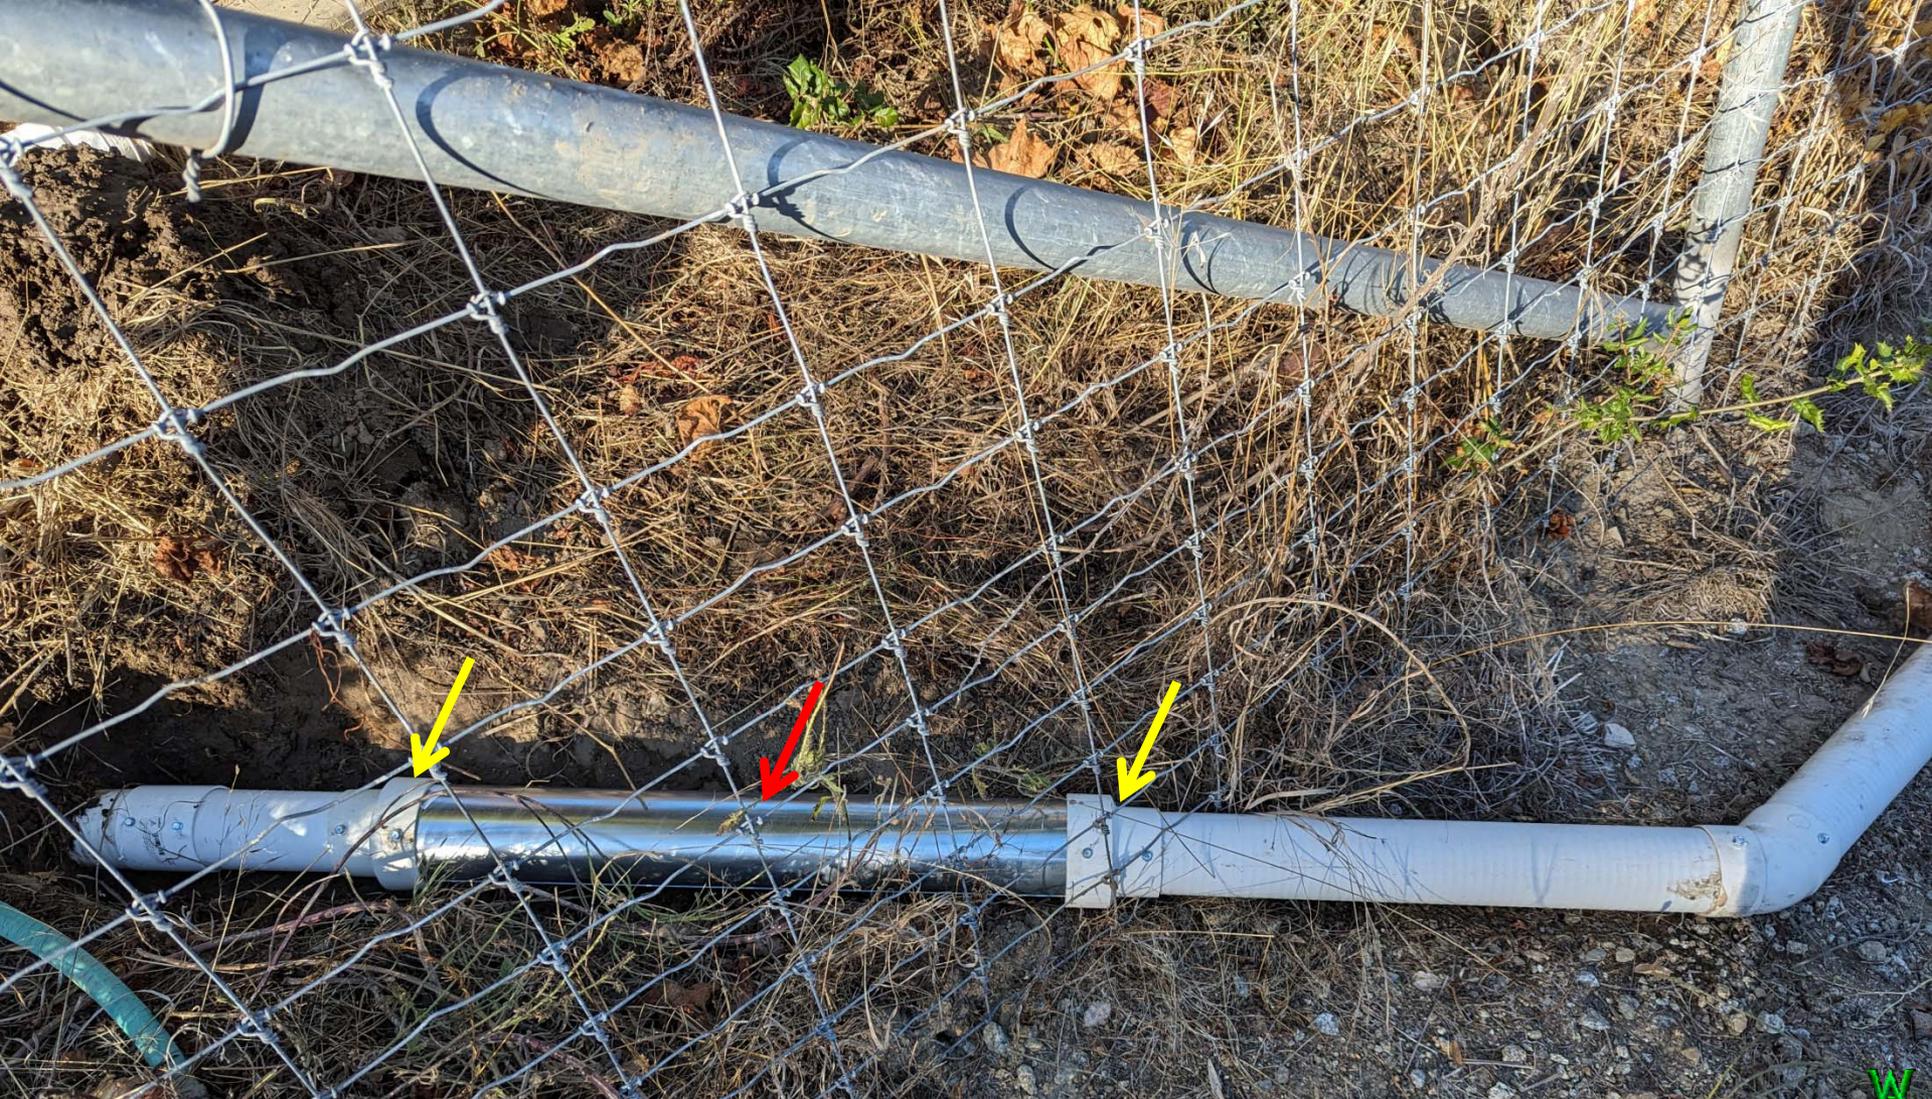
November 2023 – Yet to be buried

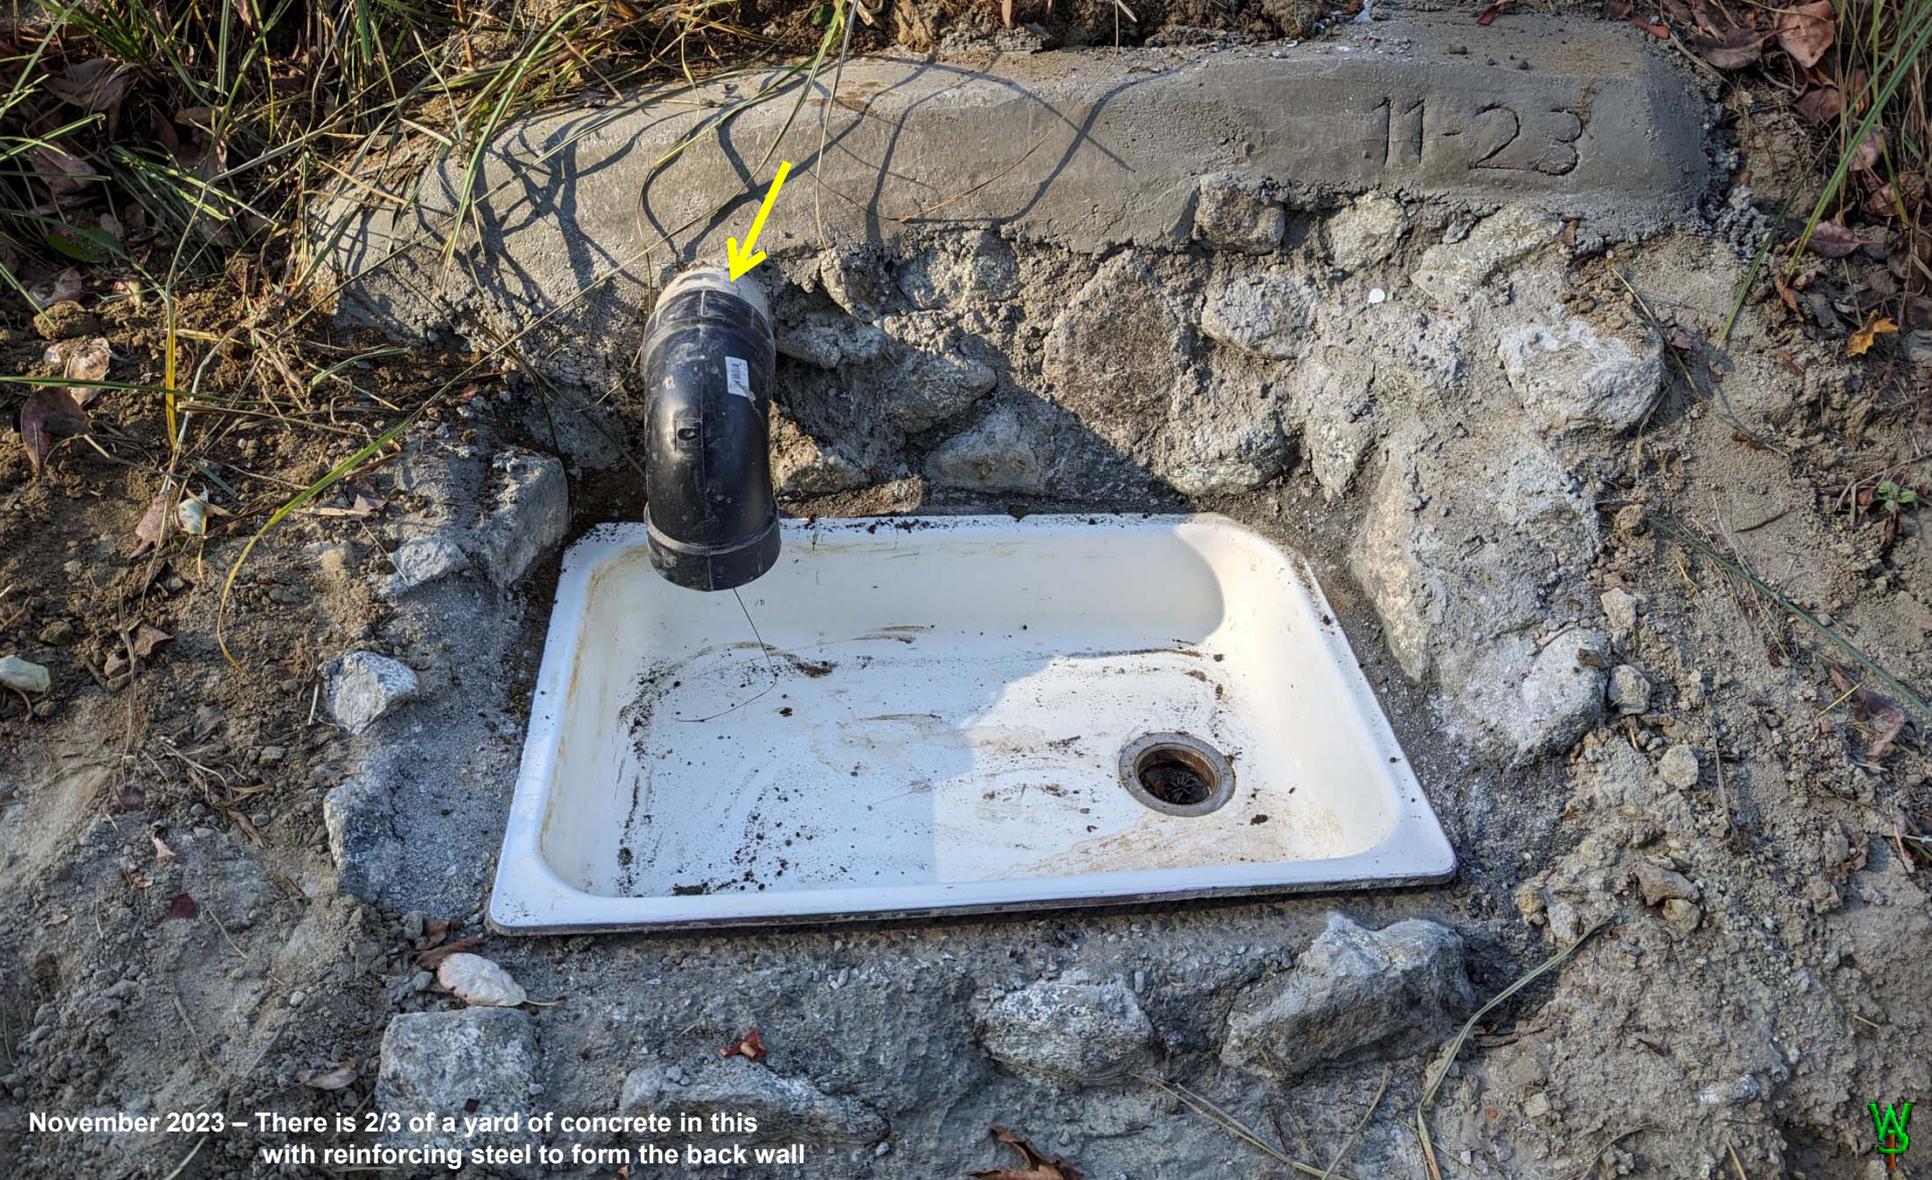
November 2023 – There is 2/3 of a yard of concrete in this with reinforcing steel to form the back wall

We found this old sink when we first moved here in 1990. It now dissipates energy from the pipe inlet. The sink is also fed by the overflow from the patio pond such that wildlife will be able to stop by for a drink! Where the pipe emerges from concrete, the 4" ABS plastic feed line behind the wall is buried, feeding into a **stainless flue pipe** embedded in the concrete. The mating ABS elbow in the soil behind the wall has a seal to the stainless comprised by first greasing the female ABS fitting with silicone stopcock grease, and coating the end of the flue pipe with silicone RTV caulking, making a sort of O-ring that can accommodate soil movement.

The goal of such a fancy seal is to inhibit root intrusion by the sedges.
