# ROADS TO HELL AND BACK, SOMEWHAT

# WILDERGARTEN 6.2

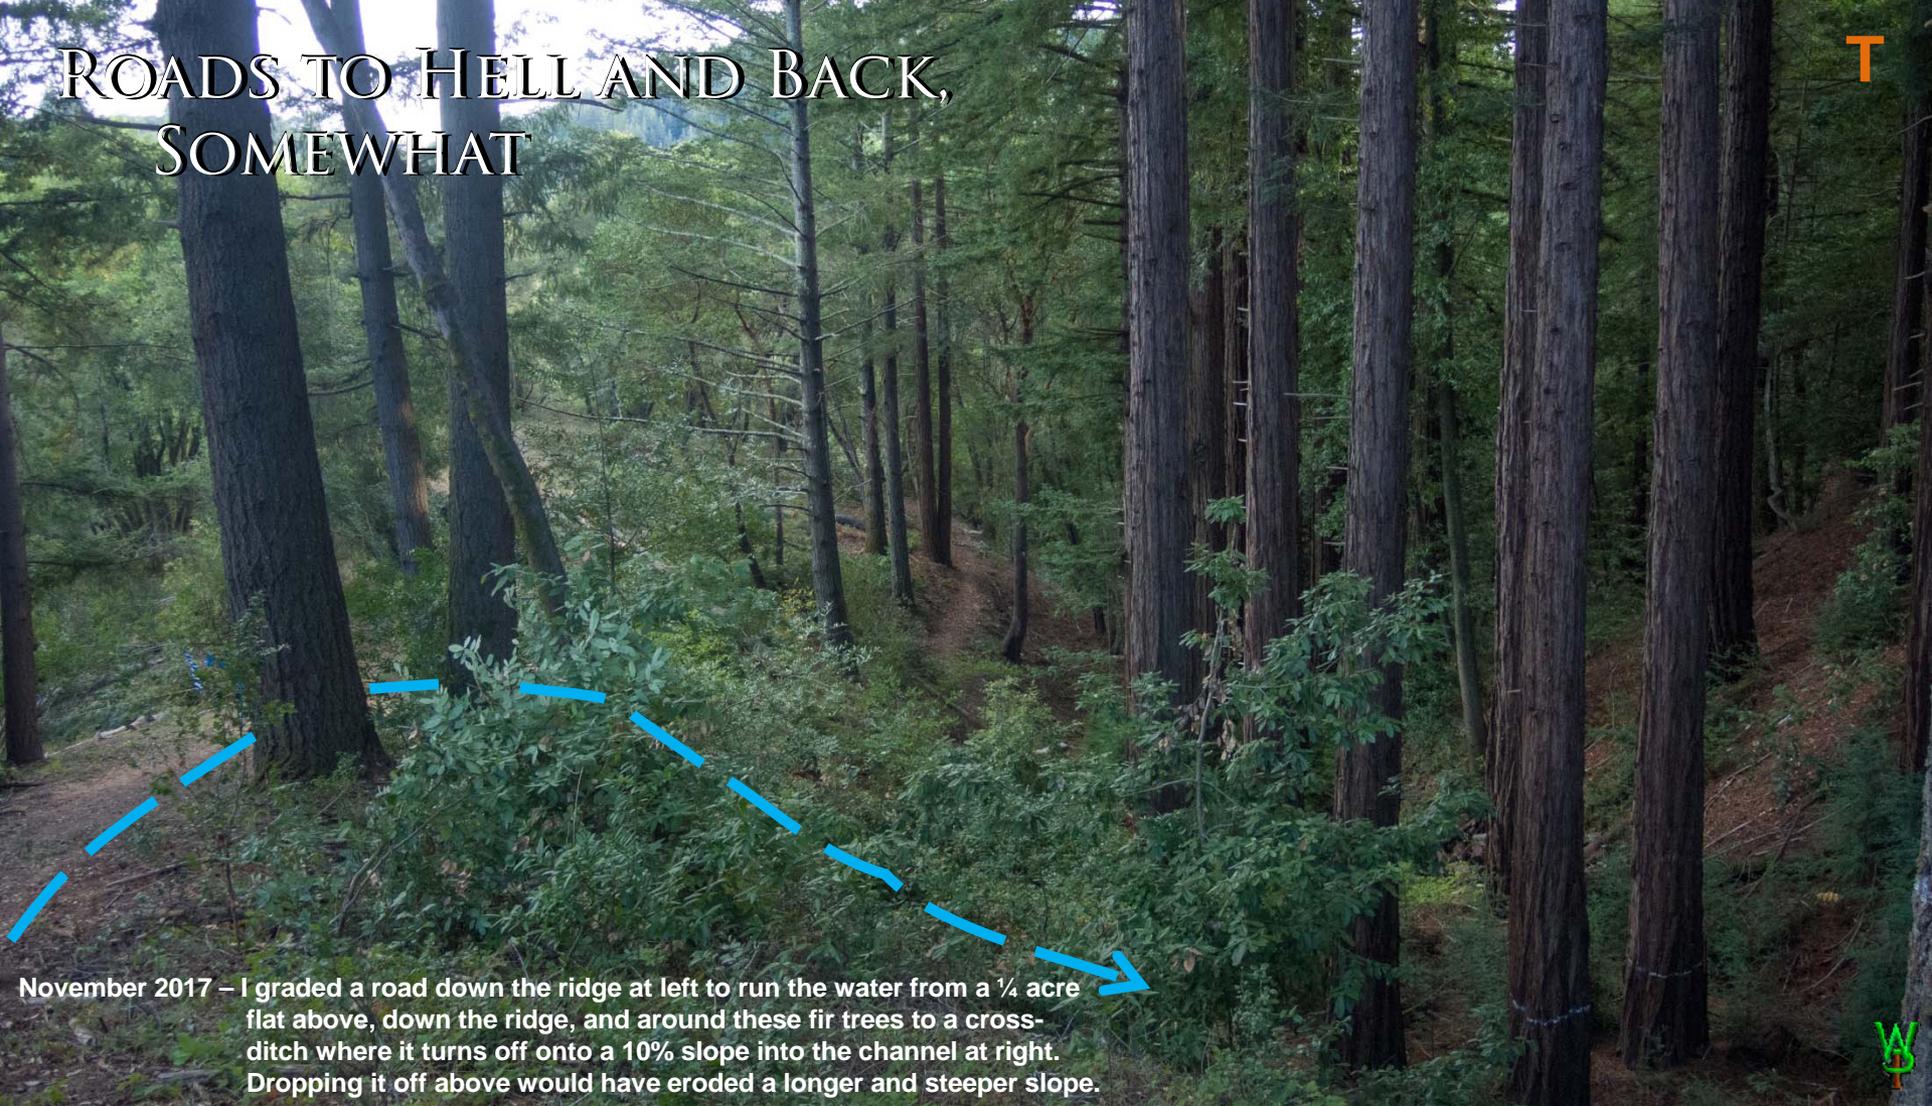
November 2017 – I graded a road down the ridge at left to run the water from a ¼ acre flat above, down the ridge, and around these fir trees to a cross-ditch where it turns off onto a 10% slope into the channel at right. Dropping it off above would have eroded a longer and steeper slope.

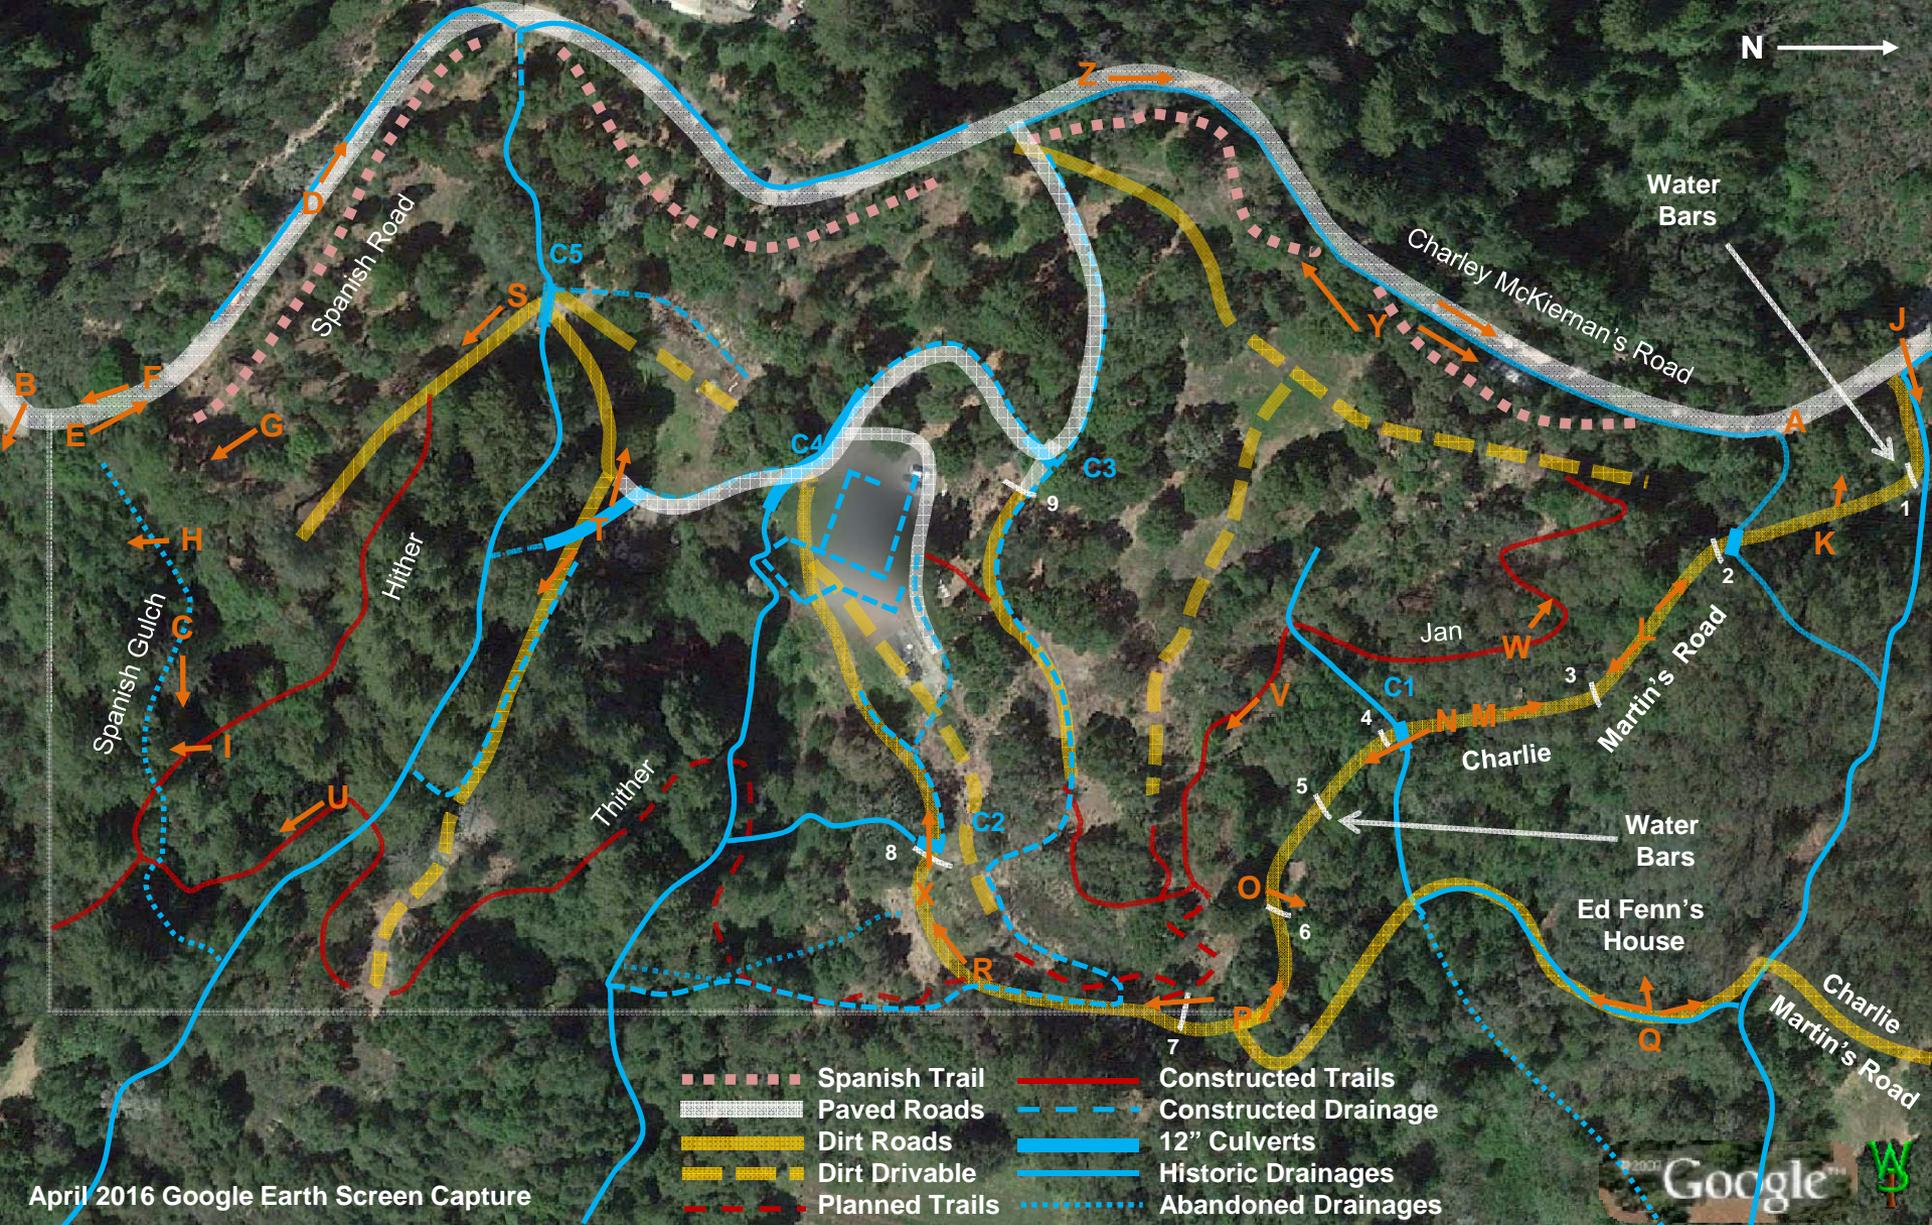
This is a map of all the roads, trails, and drainages on this property. Each orange letter on this and the other aerial images in this chapter corresponds to where they were taken (some with an arrow indicating the direction). If you wish to keep track while reading, there is a separate file consisting of this image which you can then keep open in another window as you read. My purpose in documenting them this carefully is to help locate future repeat photos as the situation changes, as forestry is elemental to many of these road and drainage management problems.

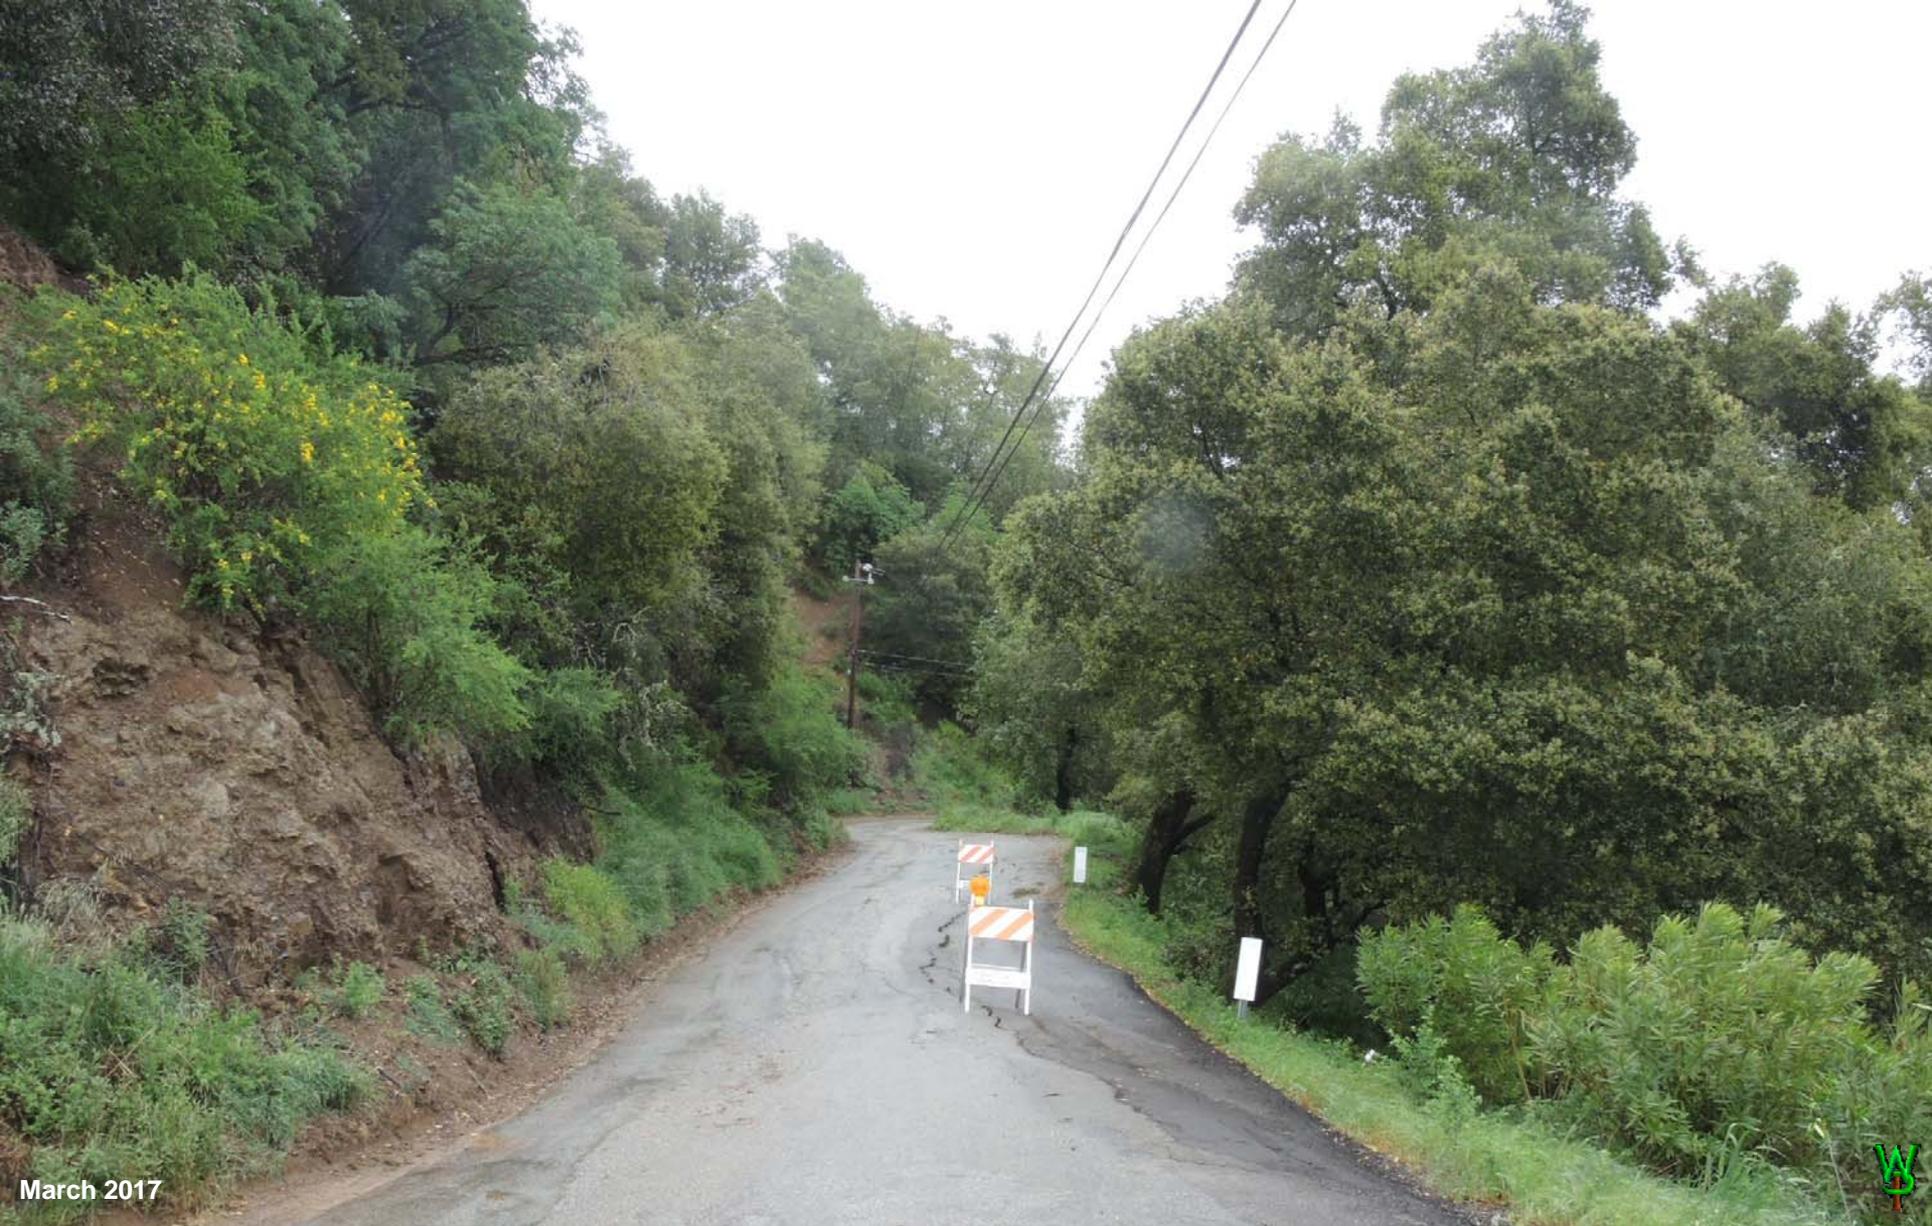
March 2017

Two years later, 80 inches of rain added significant weight and plasticity to the cake, cracking the surface, permitting entry of water, inducing the cake to slide 4-6 inches in but a few weeks. If it fails, the County will call it a “Natural” disaster. I call it bad road construction and maintenance. Nobody argues that it would have been cheaper to fix the road before the storms. So, WHY are we systematically waiting? It’s about using the “disaster” to justify State and Federal money that ultimately comes from taxpayers anyway. Yet the amount of water on this road is not entirely the County’s fault.

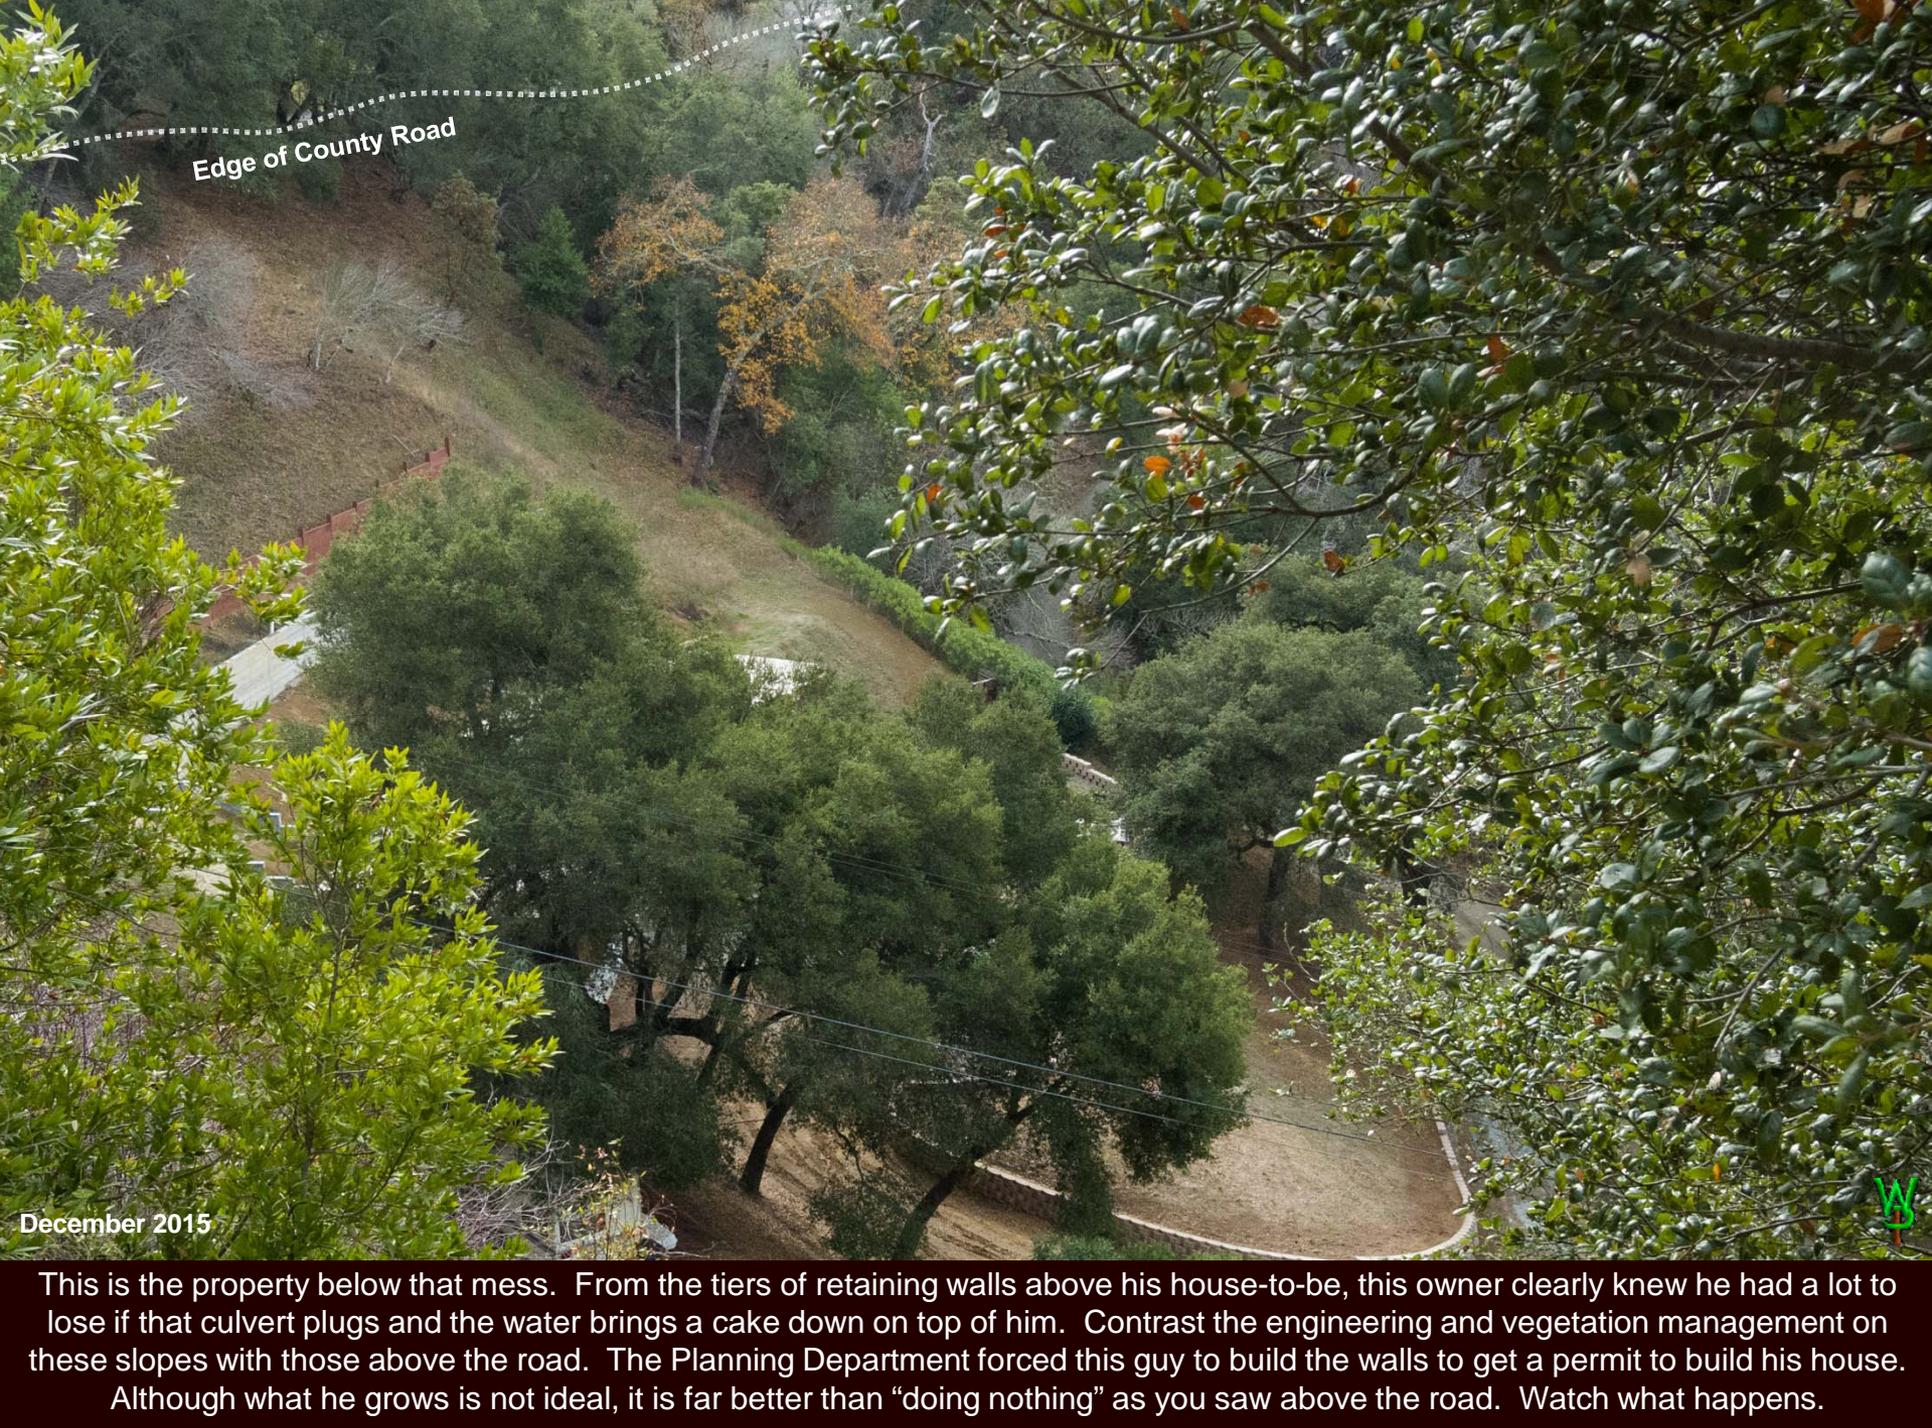
An aerial photograph showing a hillside. At the top, a road is marked with a dashed white line and labeled "Edge of County Road". Below the road, a property is visible, featuring a large, dense tree canopy and a curved concrete curb. The surrounding area is covered in green trees and vegetation. The image is framed by large, out-of-focus green leaves in the foreground.

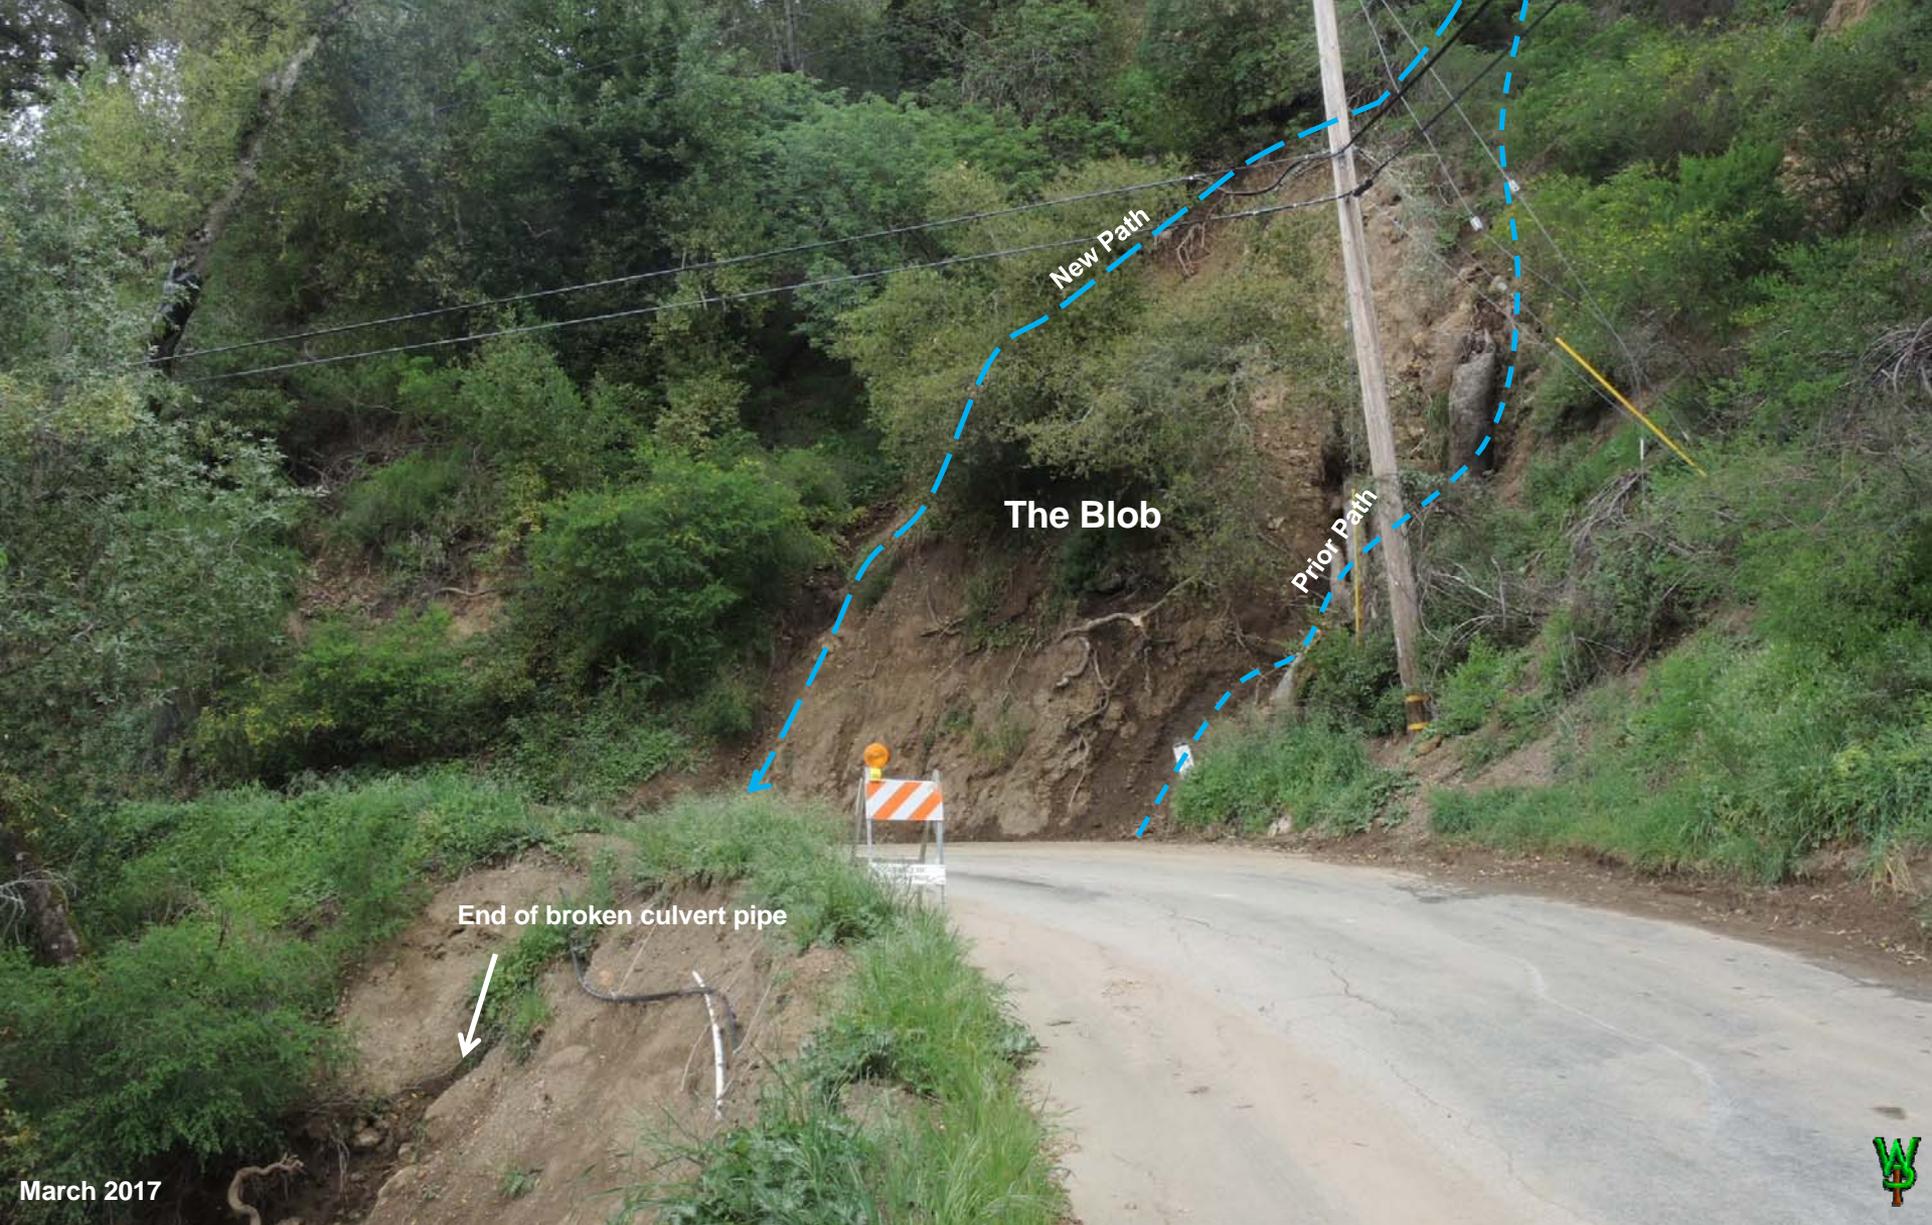
The runoff from above found a new path, thus creating a blob of unsupported “rock” above the slope. Said “new” path brought down another 20 yards of soil, which obviously inhibited the performance of the culvert. Eventually the bottom of the pipe rusted out, leaking water into the substrate, soaking the cake, and allowing it to creep on that organic slip. One stick catching on a corroded surface inside the pipe could then capture sediment until the rotting pipe supporting the weight collapsed. The County had cut the road maintenance budget severely. All they could do was put up a sandwich sign telling people not to drive off a cliff.

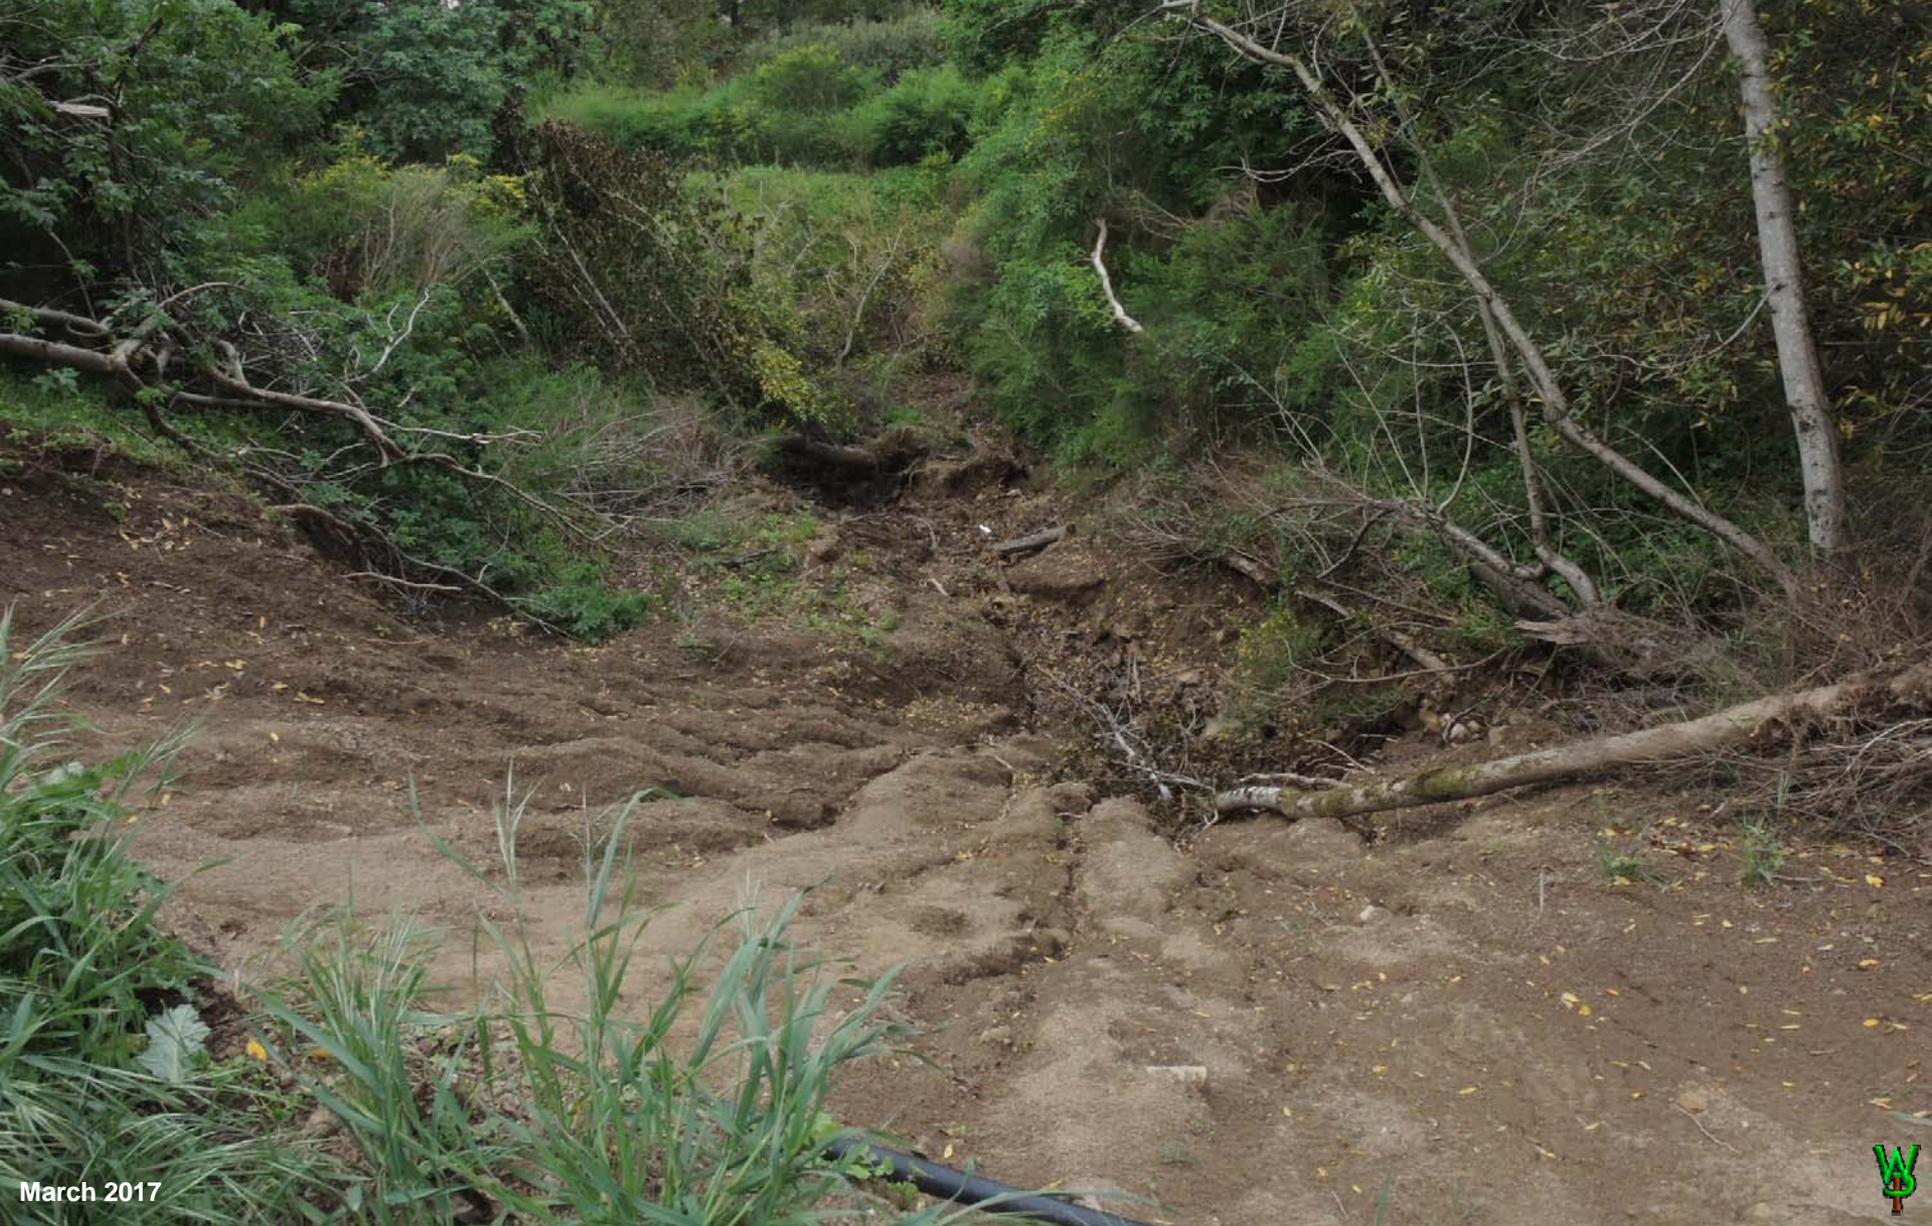
March 2017

The rotted culvert (to the right of this image) broke and just took the cake, dumping at least 100 cubic yards down the hill to that guy who had cleaned the culvert for years. He had finally satisfied the planners. He was just starting to build his house. He had the foundation and first floor built. Then that poor guy just died. The people up the hill who've been dumping water down that trench with the tree in it remain, and the County has done NOTHING to hold them accountable for the failure of the slope below them.

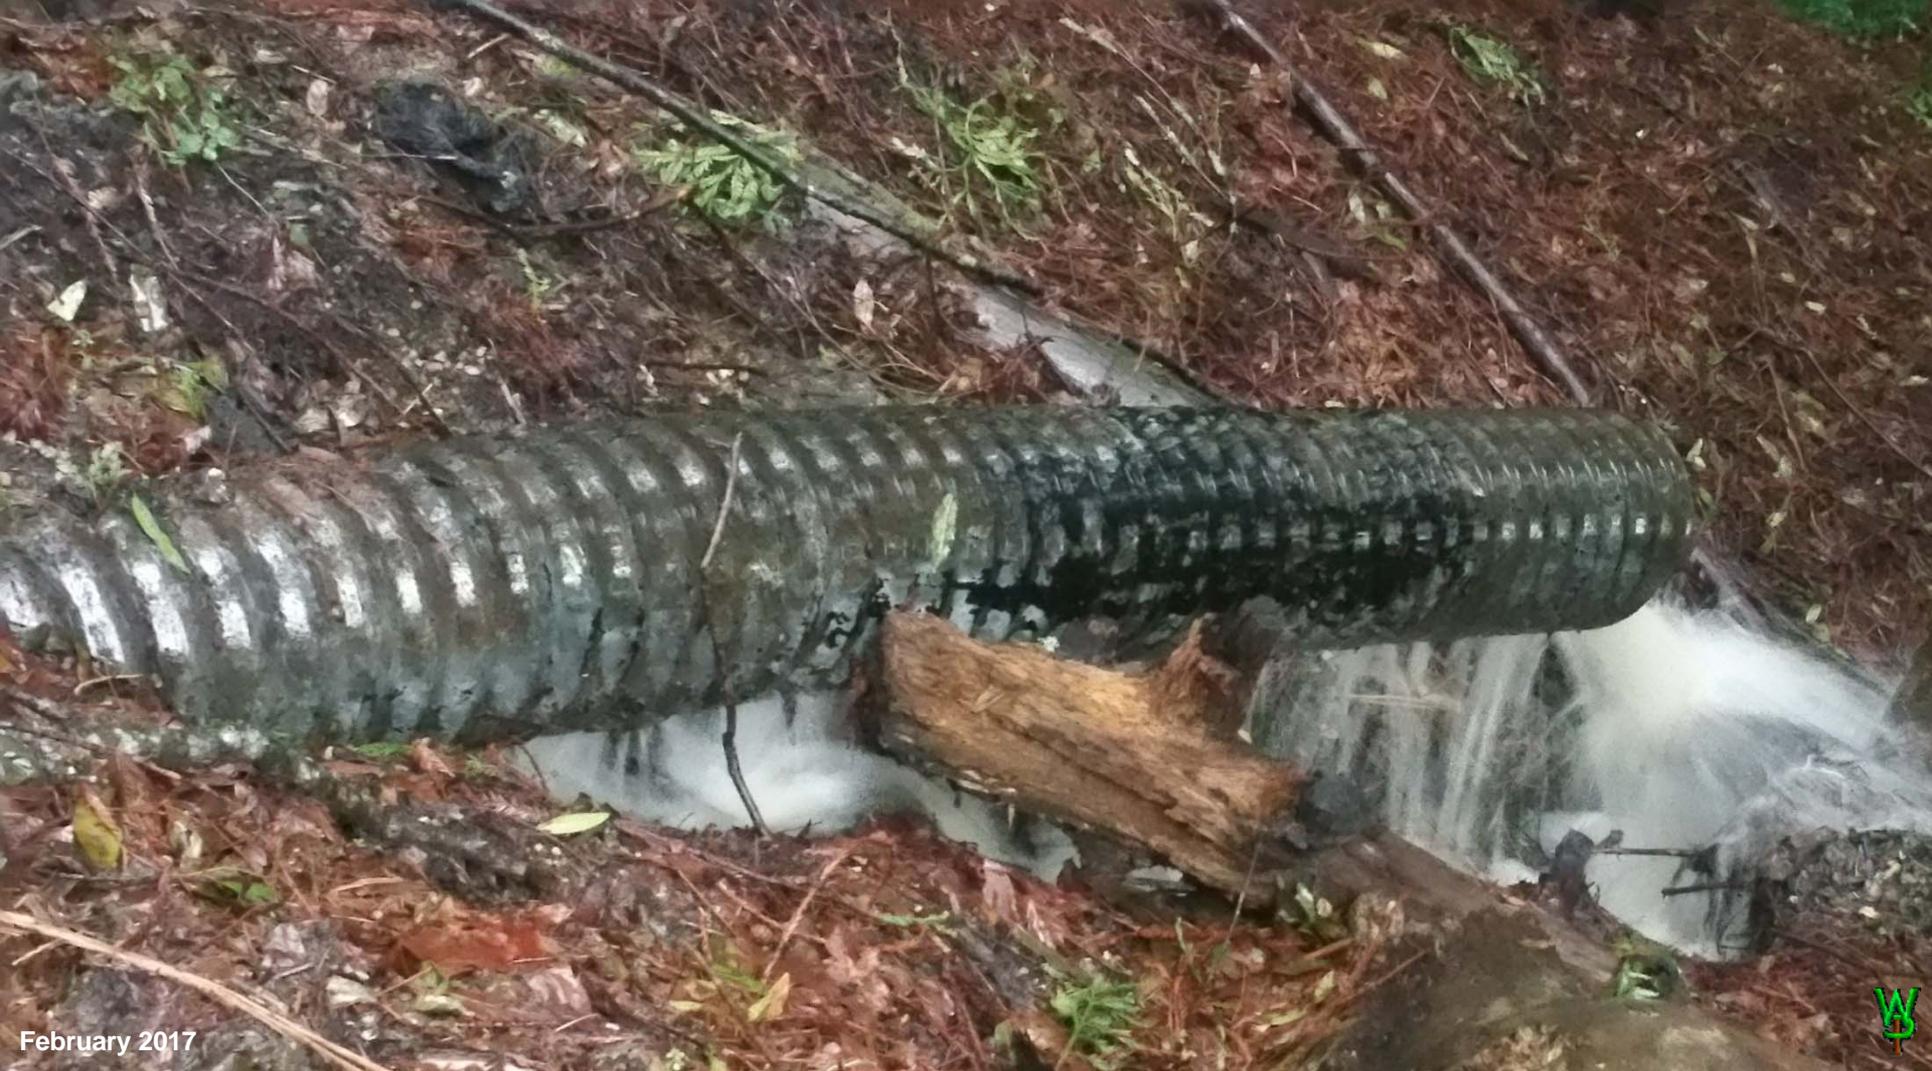
February 2017

This is another culvert just up the road, so eroded that it is leaking out the bottom along its entire length, just like the one that made the slide. In fact, there were three wash-outs along this road in 2017, all with this same cause and with this one still yet to come! One reason the County doesn't fix culverts in advance is simple: It takes YEARS for the County to get a permit for a new culvert from the State Department of Fish and Wildlife. They are "protecting" coho salmon, an introduced fish fraudulently listed as endangered with County personnel as instigators (see my book, *Natural Process*). This permitting process, supposedly to protect the fish from silt in streams, is so slow and expensive that it causes more culverts to fail, resulting in **more silt in streams than without the State's bureaucrats and rules!** Besides, negligence brings in more State and Federal "disaster" **money**. The democratized commons is becoming a **socialized commons**: bureaucrats holding public assets hostage to increase cash flow, producing even lousier roads at higher cost with more environmental damage. All the contractors know how this works.

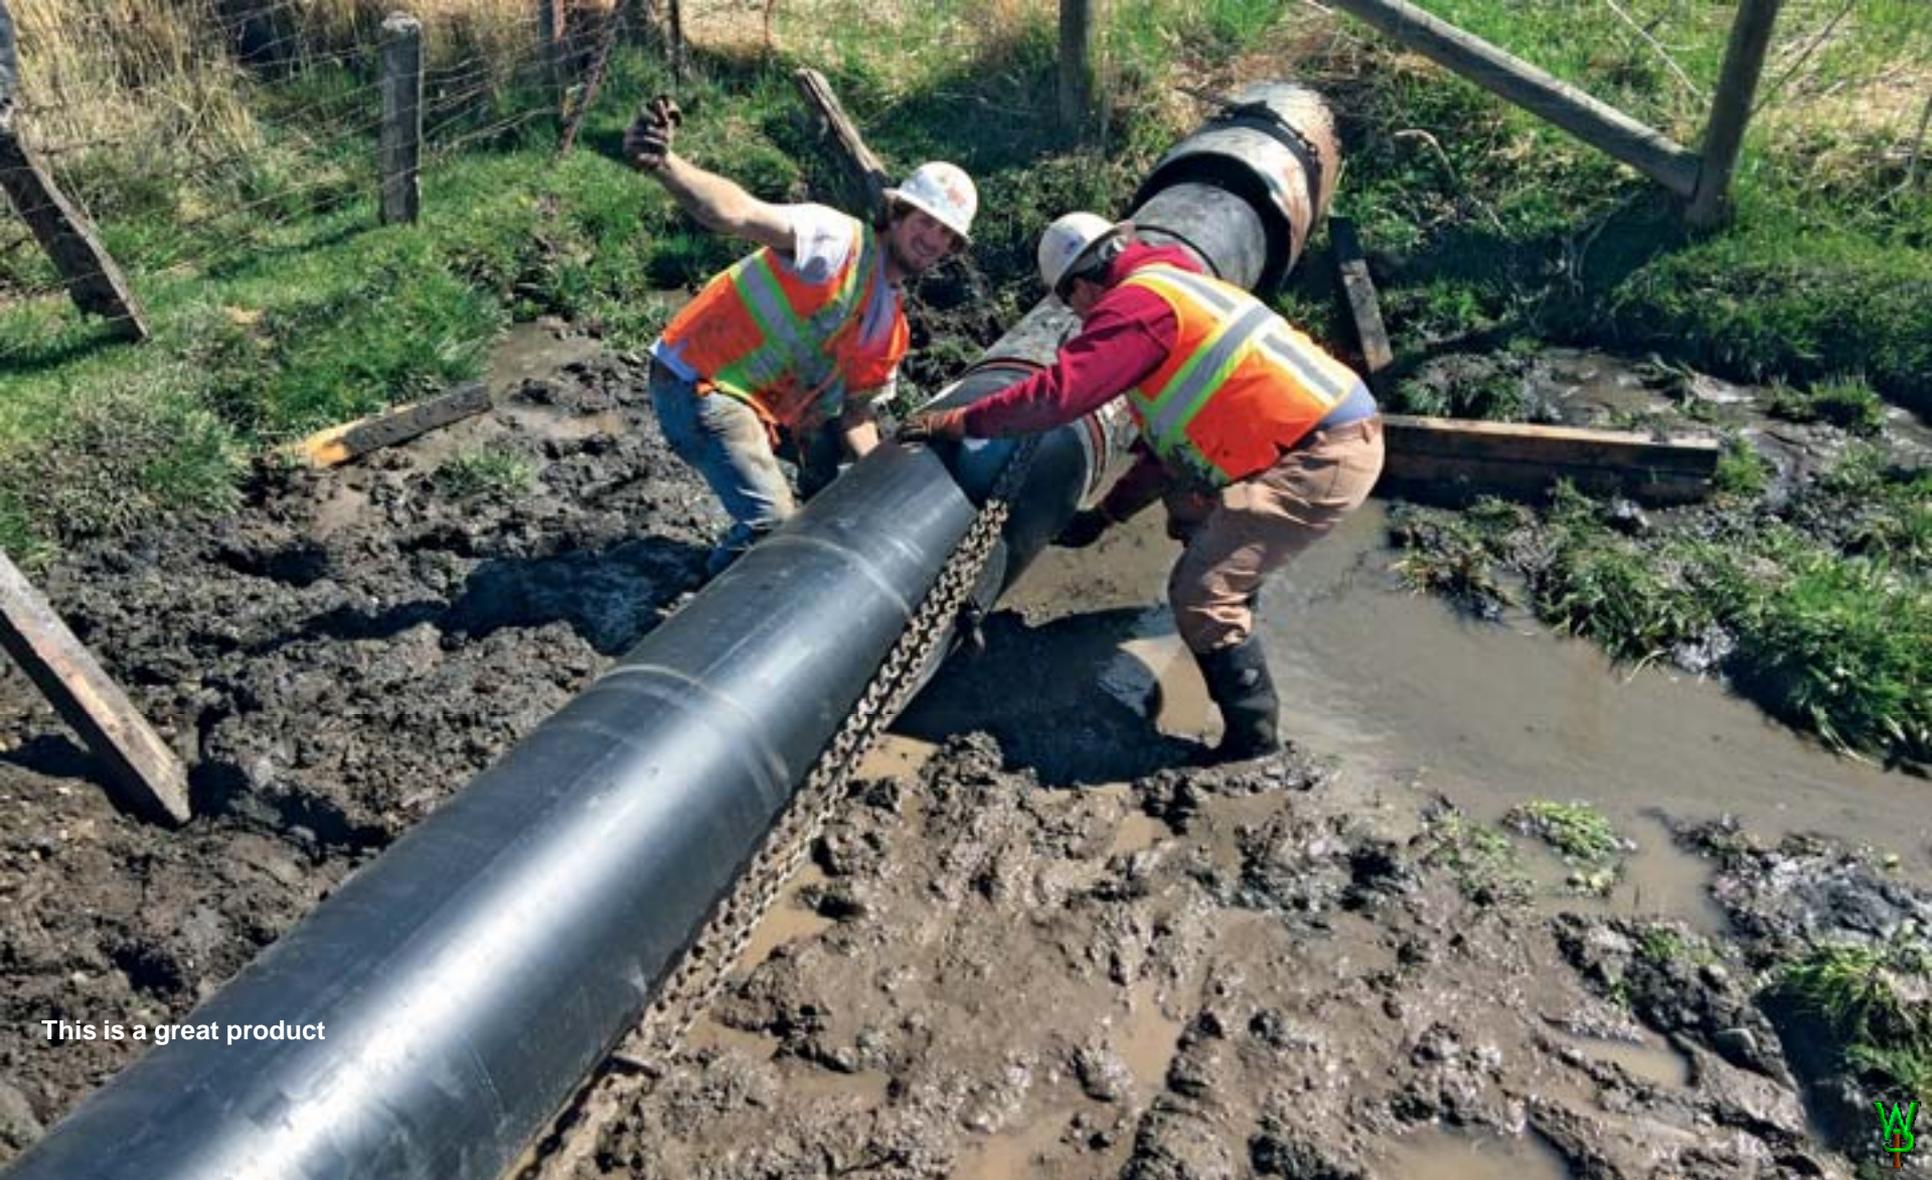
This is a great product

Worse yet, DFW specifies use of plastic pipe for culverts, which WILL burn out in a fire. The correct alternative to plastic culverts is to insert a plastic liner into the old galvanized steel pipe as a protective sleeve. Above is Snap-Tite®. It requires no excavation or paving. Simply slide the plastic liner into the rotted steel culvert and seal the inlet with grout (extensions snap together as shown above). If needed, the cavity under the old pipe can be filled with a sand slurry or grout. If desired, a new protective steel outlet sleeve can be installed, hopefully with energy dissipation to slow the water coming out and impacting soil. With a coating of a light-weight gunnite or stucco, the plastic liner pipe is protected until the fire has passed. It beats digging out the old pipe and installing one that will burn.

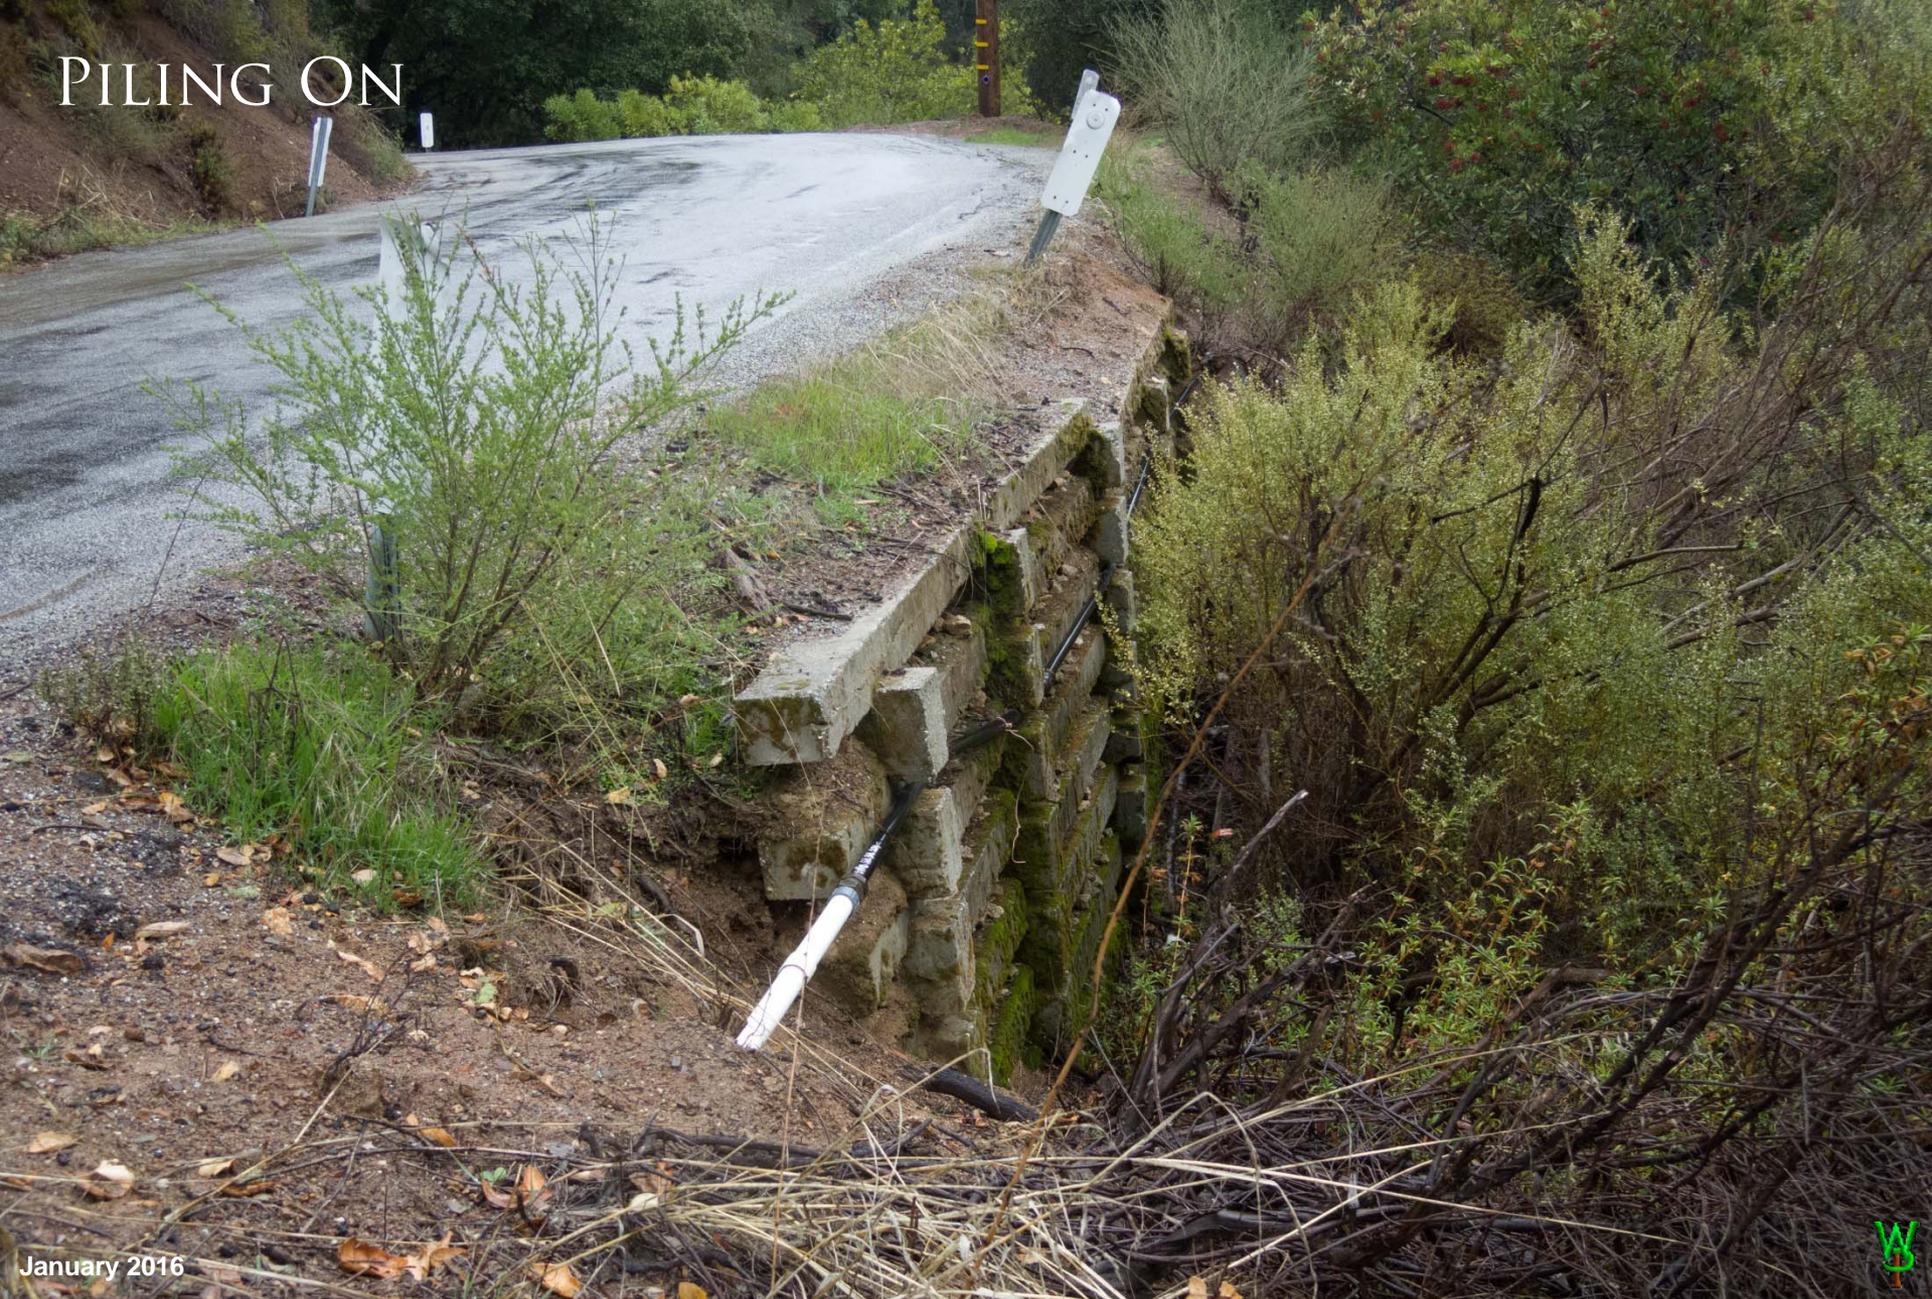
January 2016

The usual fix for small Type I failures is called a “crib,” basically digging out the cake, making a box with a flat floor on a “stable” substrate, and filling it with rock. Sometimes it is done with concrete “Lincoln logs” and “gabion rock” like you see here. Note: The 2” pipe is the water supply for nearly 70 of said “expensive homes,” many lacking sufficient water storage to fight a fire.
