# ROADS TO HELL AND BACK, SOMEWHAT

# WILDERGARTEN 6.2

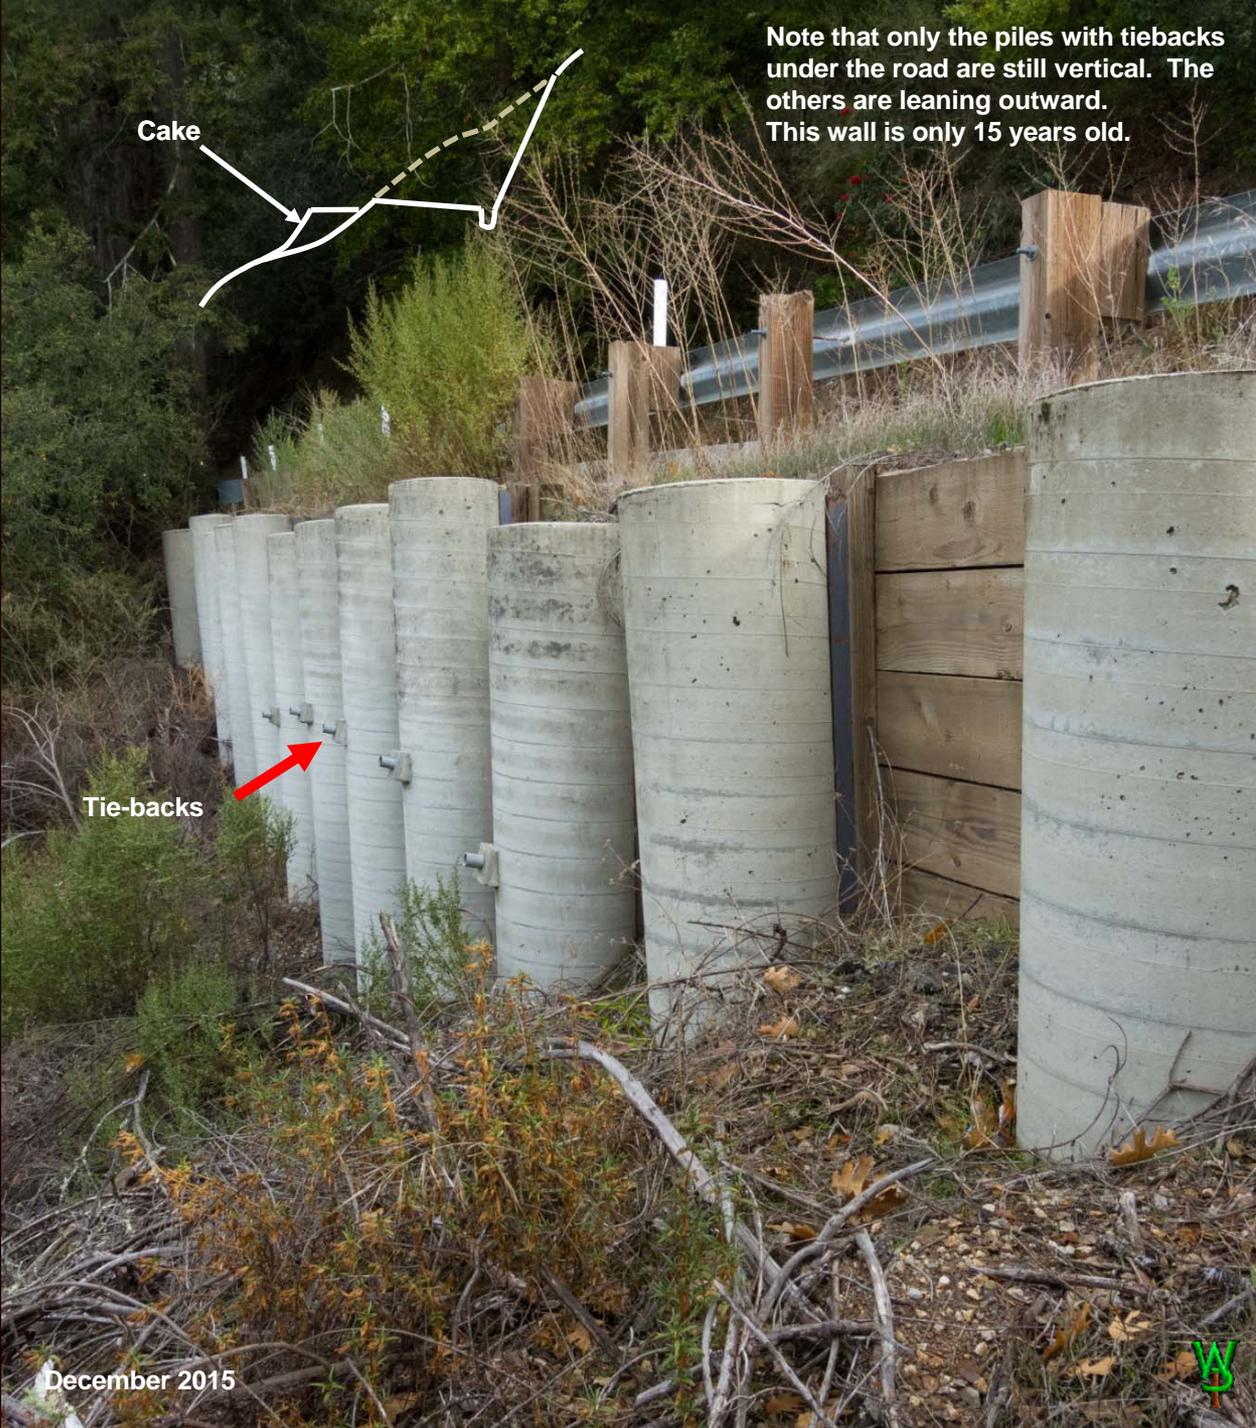
Note that only the piles with tiebacks under the road are still vertical. The others are leaning outward. This wall is only 15 years old.

When the pilings get too tall to hold the load or if the substrate is too soft to hold the pilings under load, they are connected with "**tie-backs**" (steel rods either anchored into blobs of concrete "dead men" or screwed directly into the hill (right).

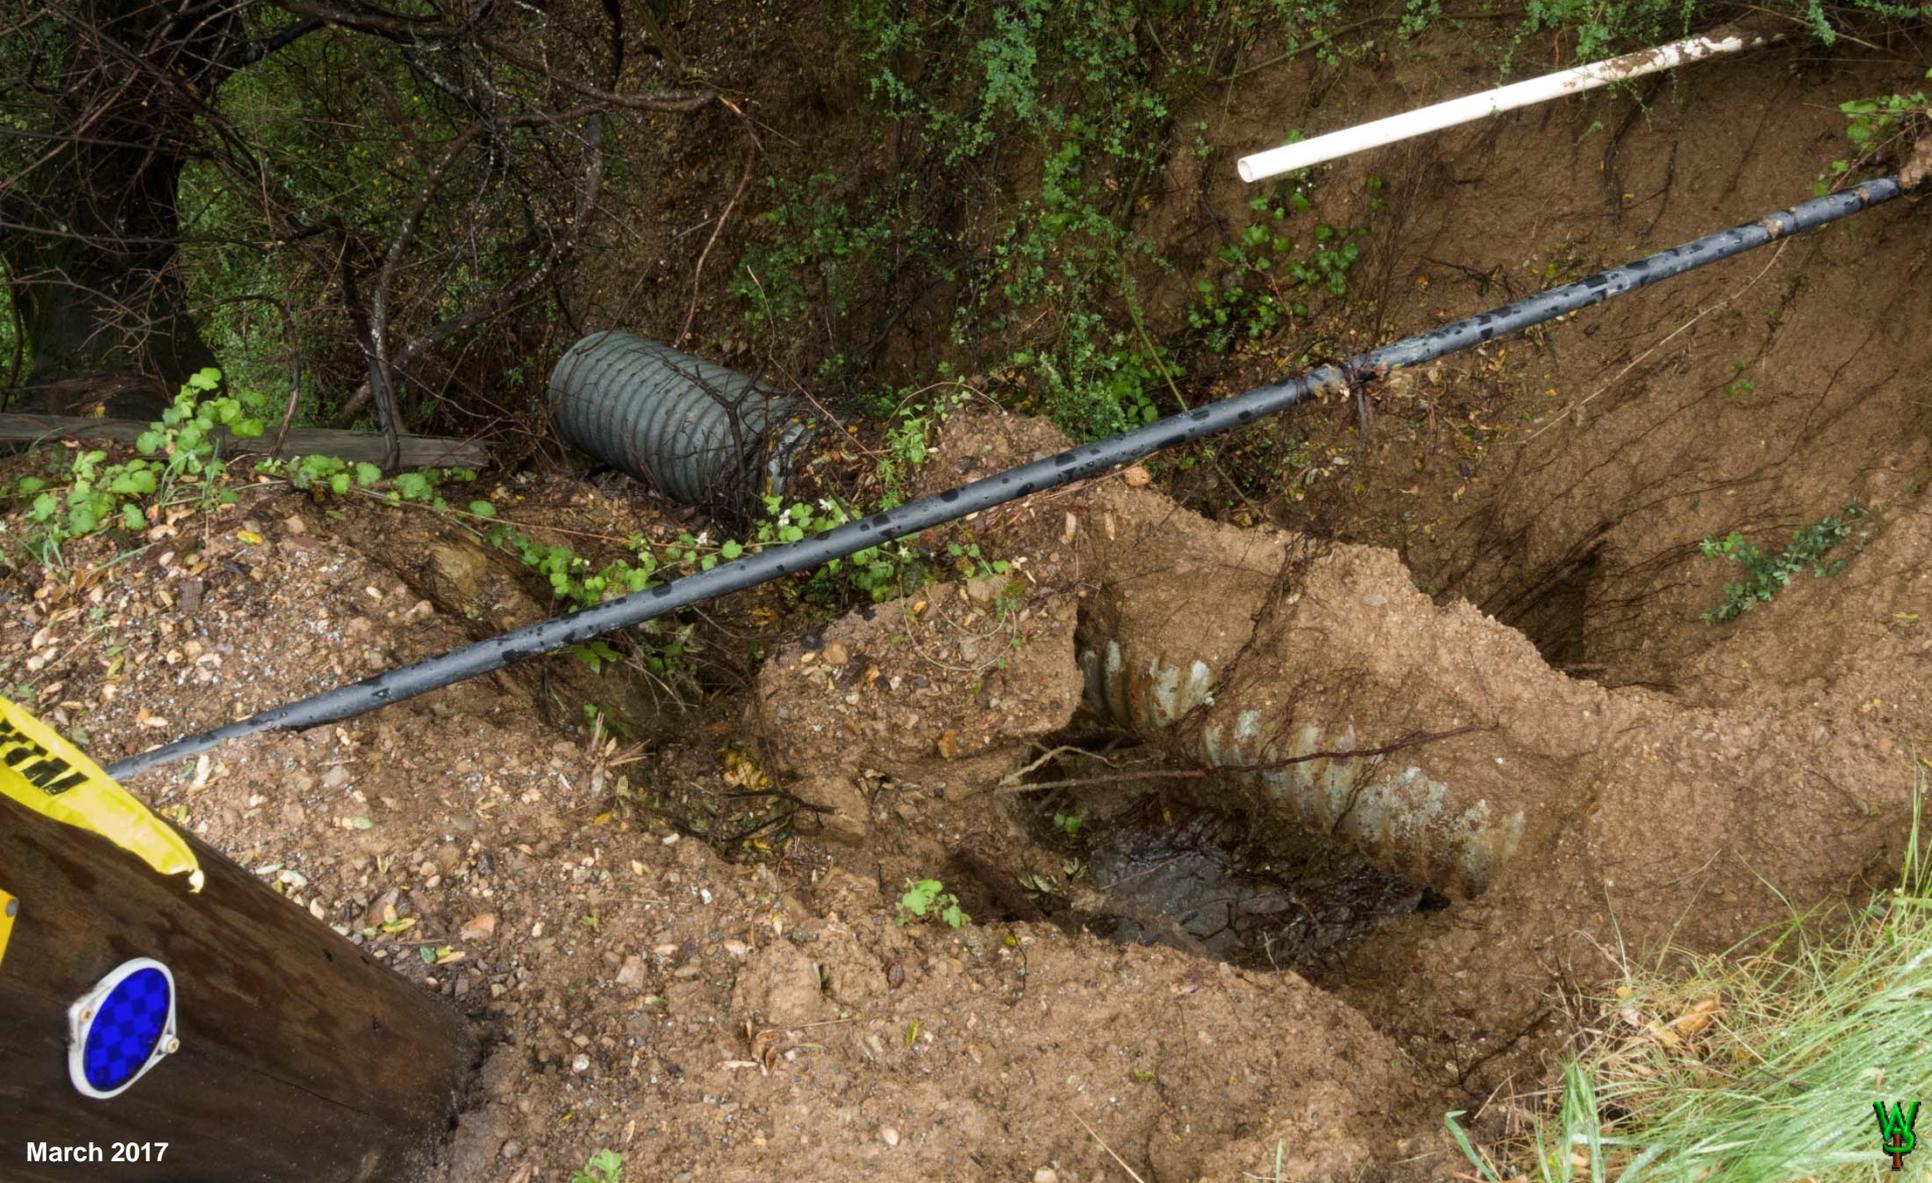
March 2017

Type I road failures are a big deal in this area because the geology is so active. The “rock” is so erosive, unstable, and subject to landslides and earthquakes, that everything is moving. Here we see a culvert outlet with no splash blocks. The water impacting the soil dug a ditch 20 feet wide and 10 feet deep (until the pipe broke). Note the power pole next to it, now lacking support. If the pole falls in the dry season the result could be a rather expensive holocaust. Wouldn't be cheaper to pipe the water to the bottom of the hill? If plastic pipes on top of the surface burn, they are not expensive to replace. **Maintaining fixed assets when everything is moving means eventual big failures.** Yet when it comes to “big” you ain't seen nothin' yet. Compared to the Spanish, these moderns are saints.

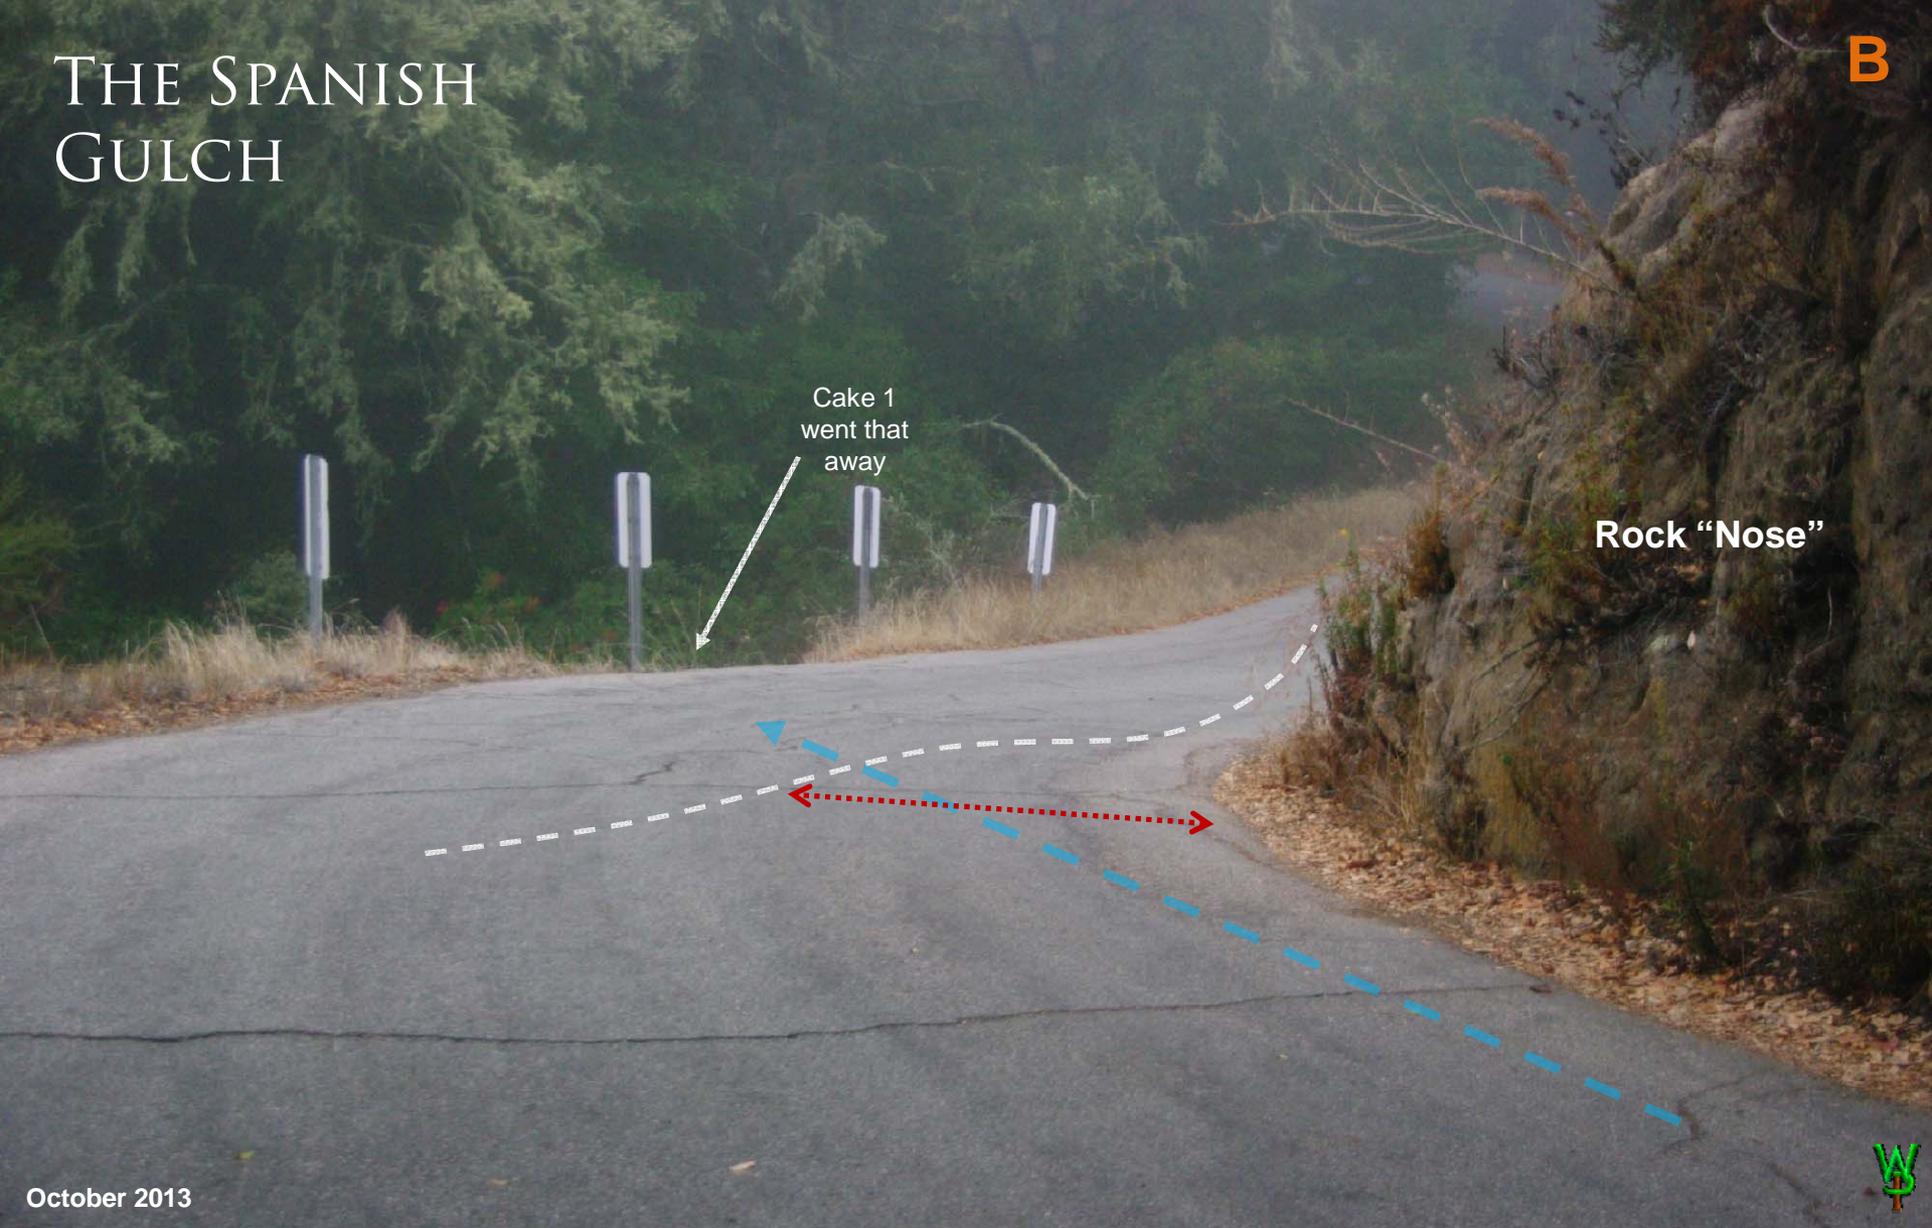
October 2013

I discovered what caused what I then named “Spanish Gulch” in the process of witnessing this smallish Type I failure in 2011, just beyond the south end of our place. It caught me by surprise because the pavement was so good there and the collection area for rainfall was so small. The cake at this turn had slumped far enough that most of the road surface sloped away from the ditch but the substrate was hard and surface smooth. The remaining **in-sloped grade** collected accumulated sediment. In 2011, a short cloudburst fed the water running around the corner with sufficient momentum to hit the sediment, run across the road, and... it took a bite of cake.

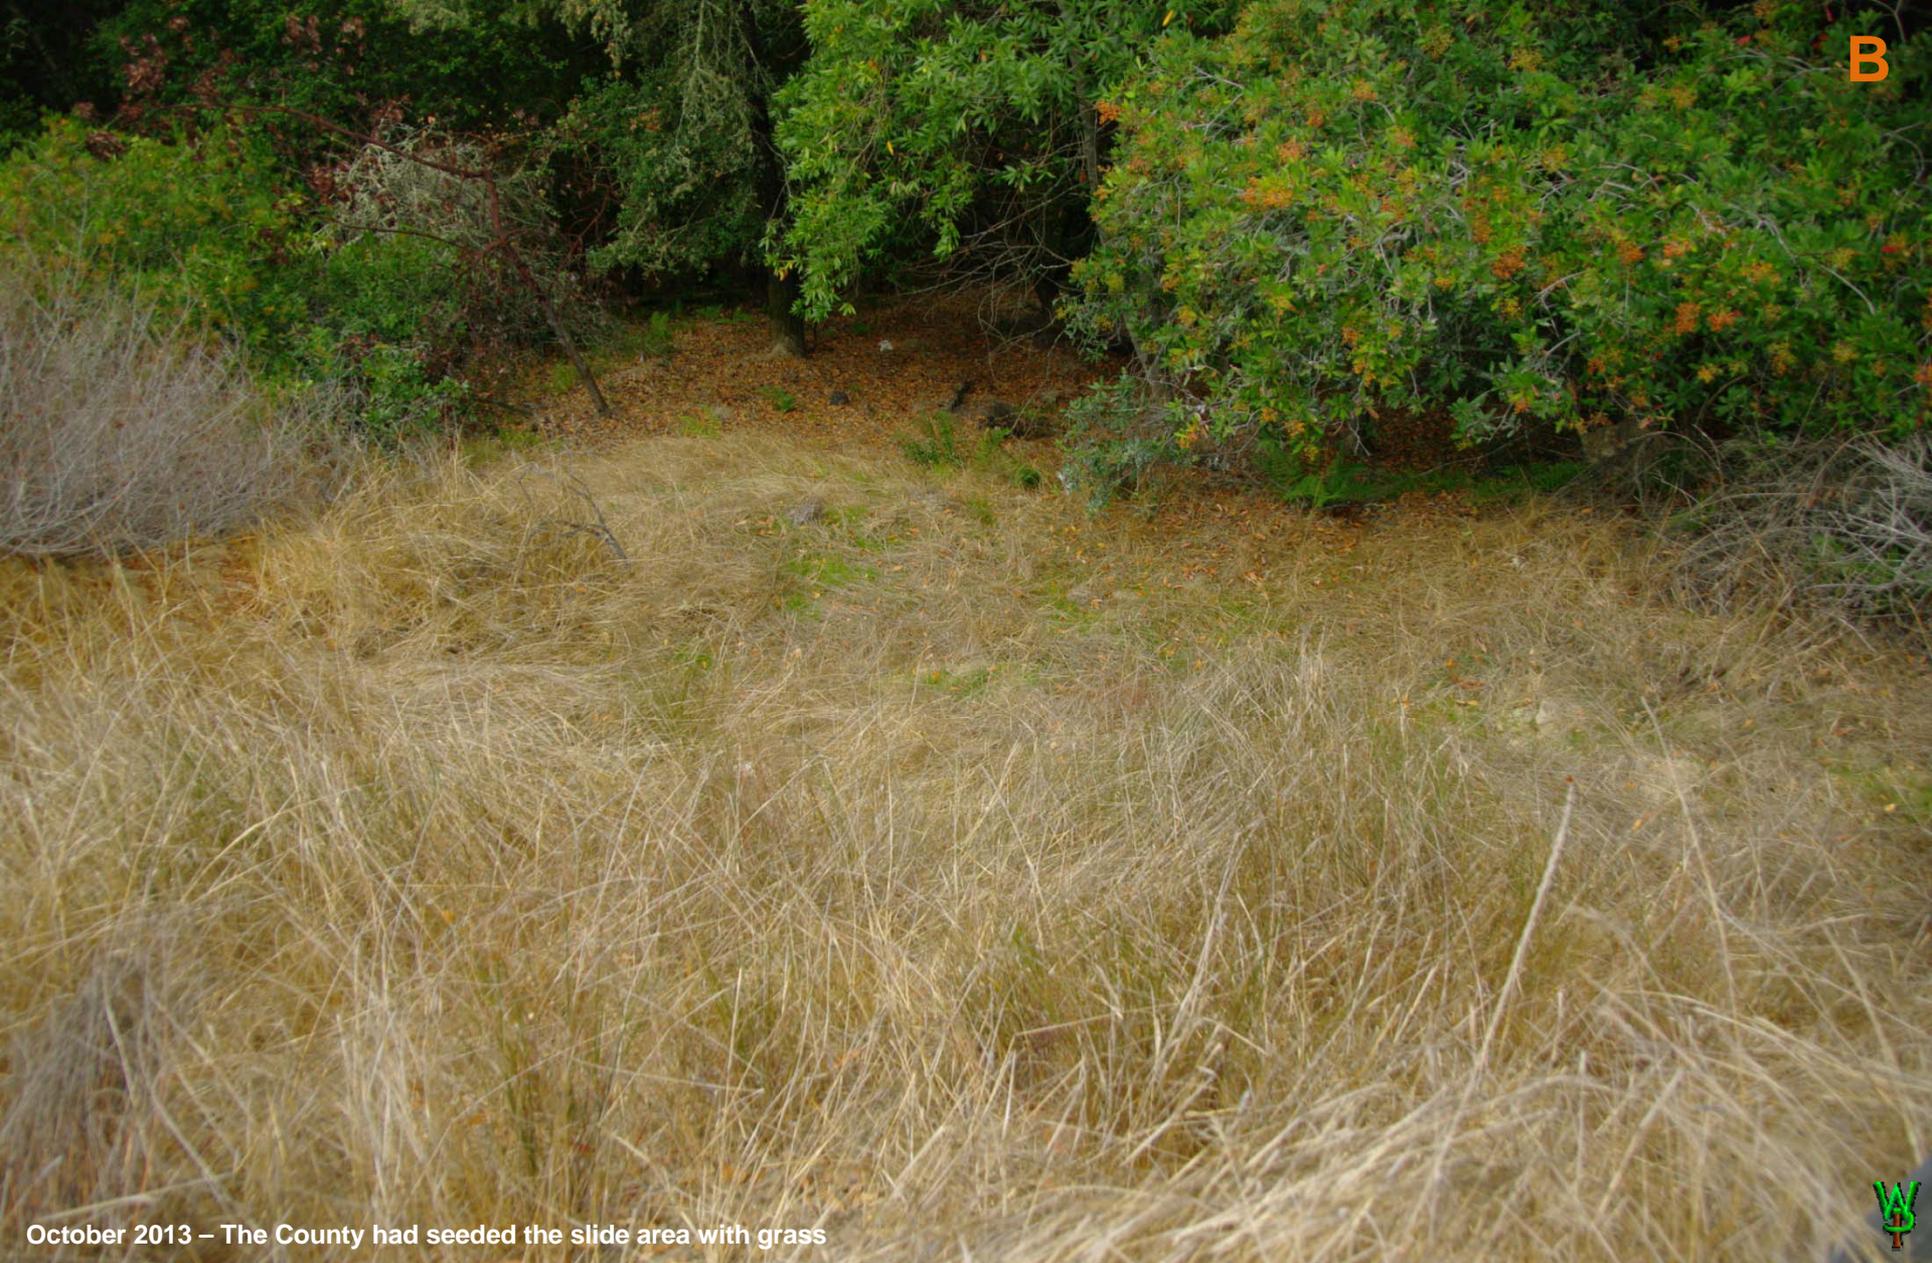
October 2013 – The County had seeded the slide area with grass

Now, this particular failure is particularly interesting, not because of how it happened, but because of its history. This situation is less usual in that said “cake” was fully compacted. Before the slide, the pavement lacked the usual cracking and subsidence. Why? Well, this sluffed parent material has had LOTS of time to consolidate. This fill was old, VERY old. The whole hillside is composed of eroded sandstone from the “rock nose” forming the end of the ridge above, slowly accumulating that alluvium for thousands of years.

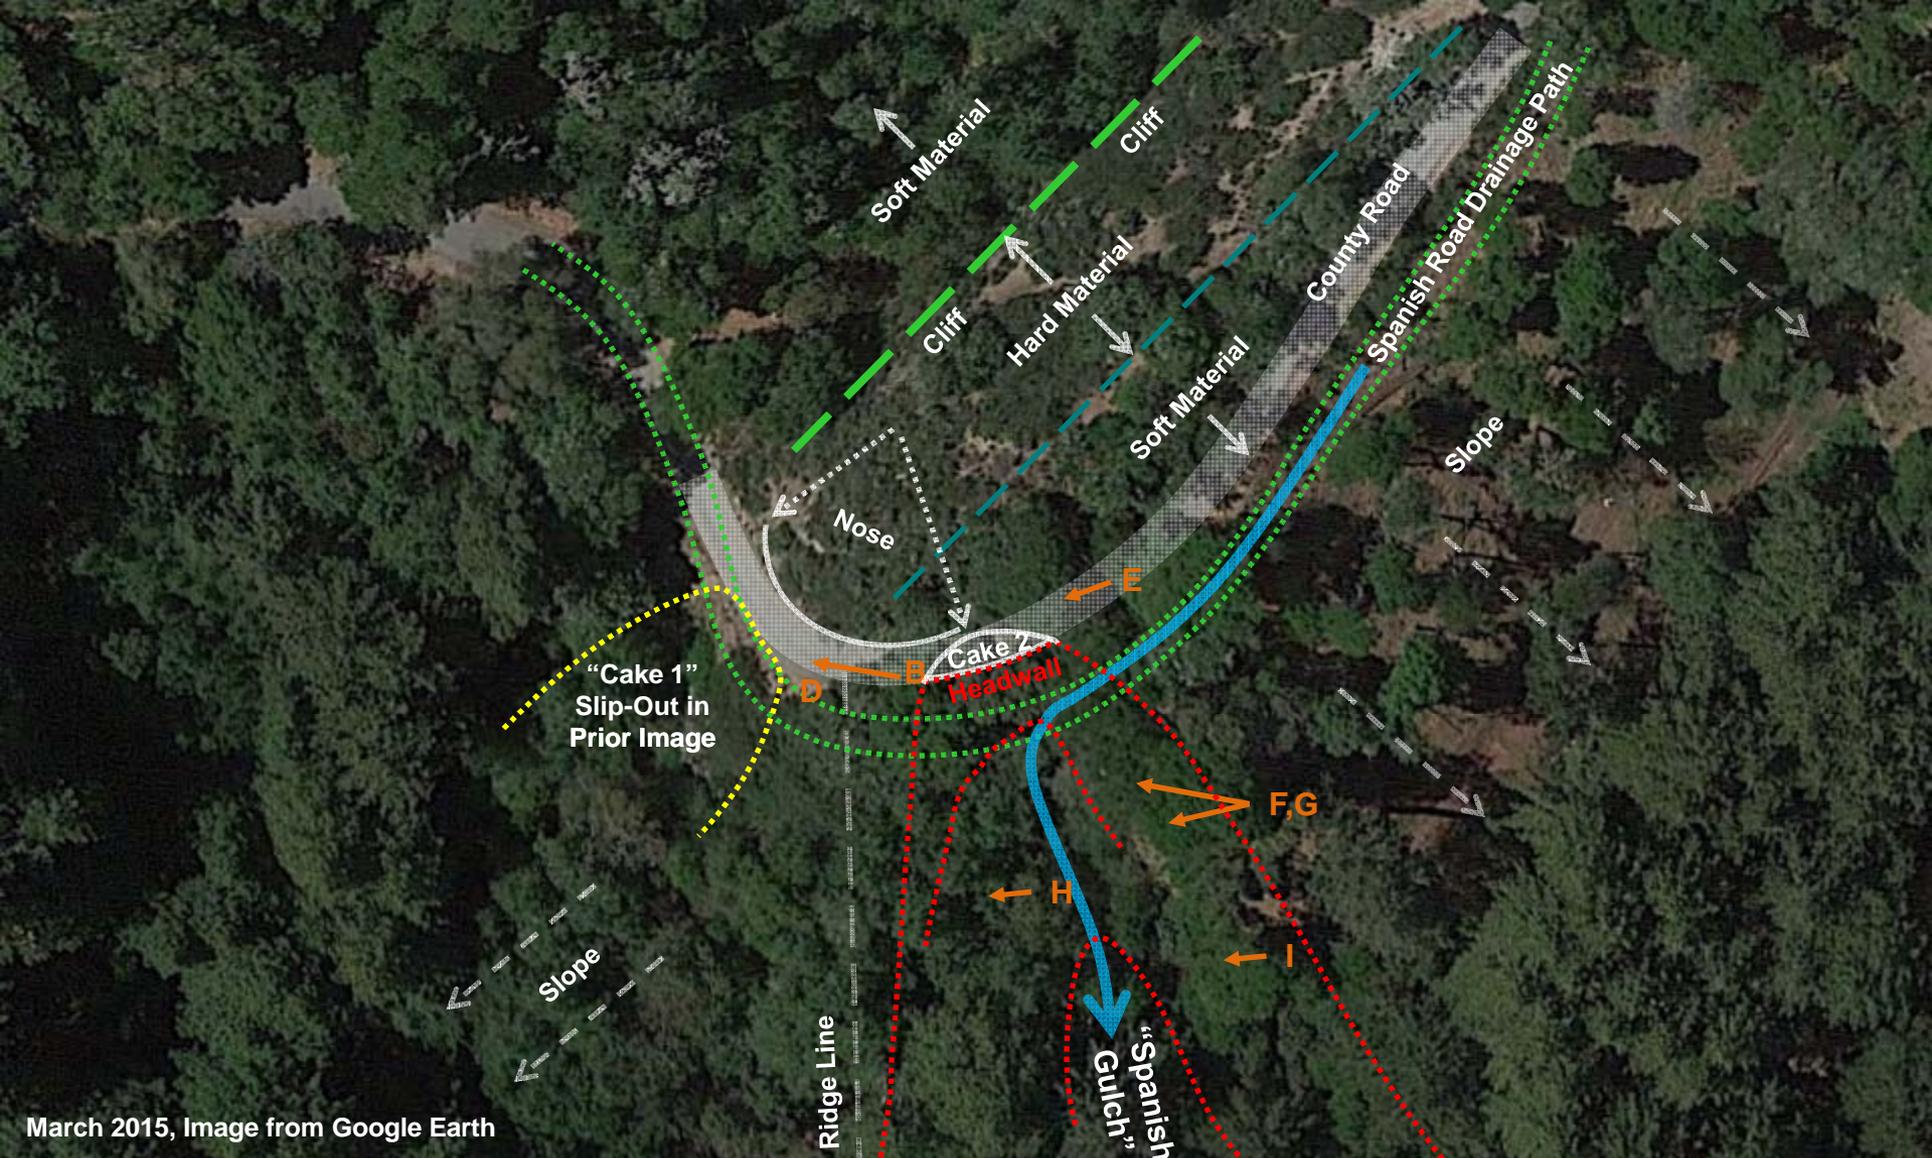
March 2015, Image from Google Earth

Geology is the ultimate “decision maker” here. Note the vegetation change from brush to trees above the **green dashed line**. That line is a cliff of harder sandstone about 30-40 feet high forming a ridge that just ends where the road wraps around it (what I call a “nose”). The slopes around it are loose alluvium eroded off the harder ridge. The old Spanish road (**green dotted lines**) was built on that softer sluff because all the Indians had for grading in 1791 was sticks, baskets, and *maybe* a few shovels. For at least 100 years thereafter, wheel ruts collected and carried all of the water off that ridge to where it didn’t make around the outside corner and ran down the hill (**blue**), thus cutting a gully (**red headwall contours**) into the alluvium in a manner very much the same as the failed culvert outlet discussed earlier. The resulting series of slides eventually took the whole road.

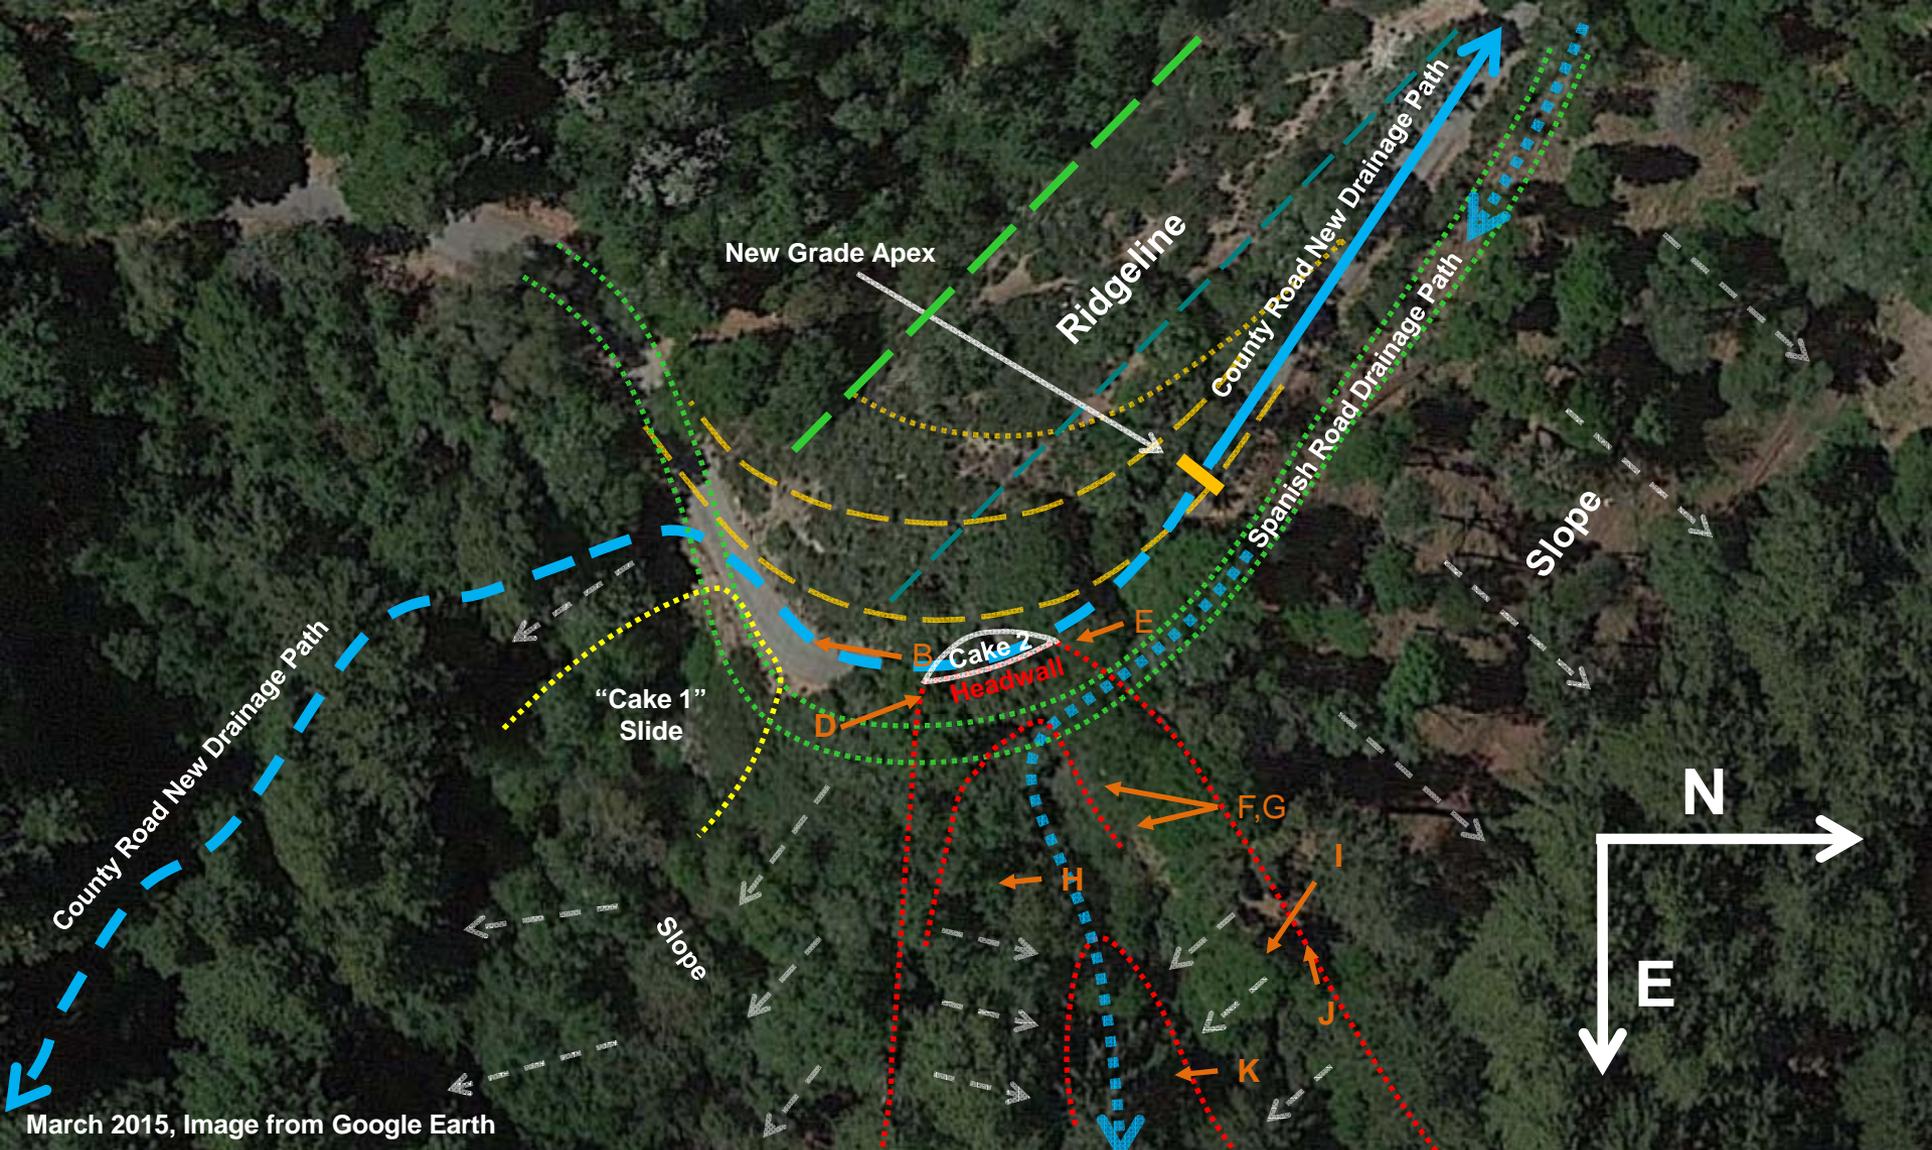
The County had no choice but to fix it, but back then they were not so hog-tied by State and Federal regulations (or their own bureaucracies). They simply cut into the nose with an excavator, graded the corner with a higher apex point and then sloped a paved road the opposite way (solid blue line) to channel the water away from Spanish Gulch. They still had to get the road down to the next level to the south but cars could easily handle the steeper grade compared to horse-drawn wagons. It was a good idea, but not sufficient because the Cake II headwall is collapsing for reasons to be discussed. Some of the runoff still went around the corner (dashed blue)... except when it didn't, the result of which was the Cake 1 slide in 2011. That is softer material including some of the loose fill made when they cut the new path and made Cake 1. Today we can pack that fill with a hydraulic rammer on an excavator.

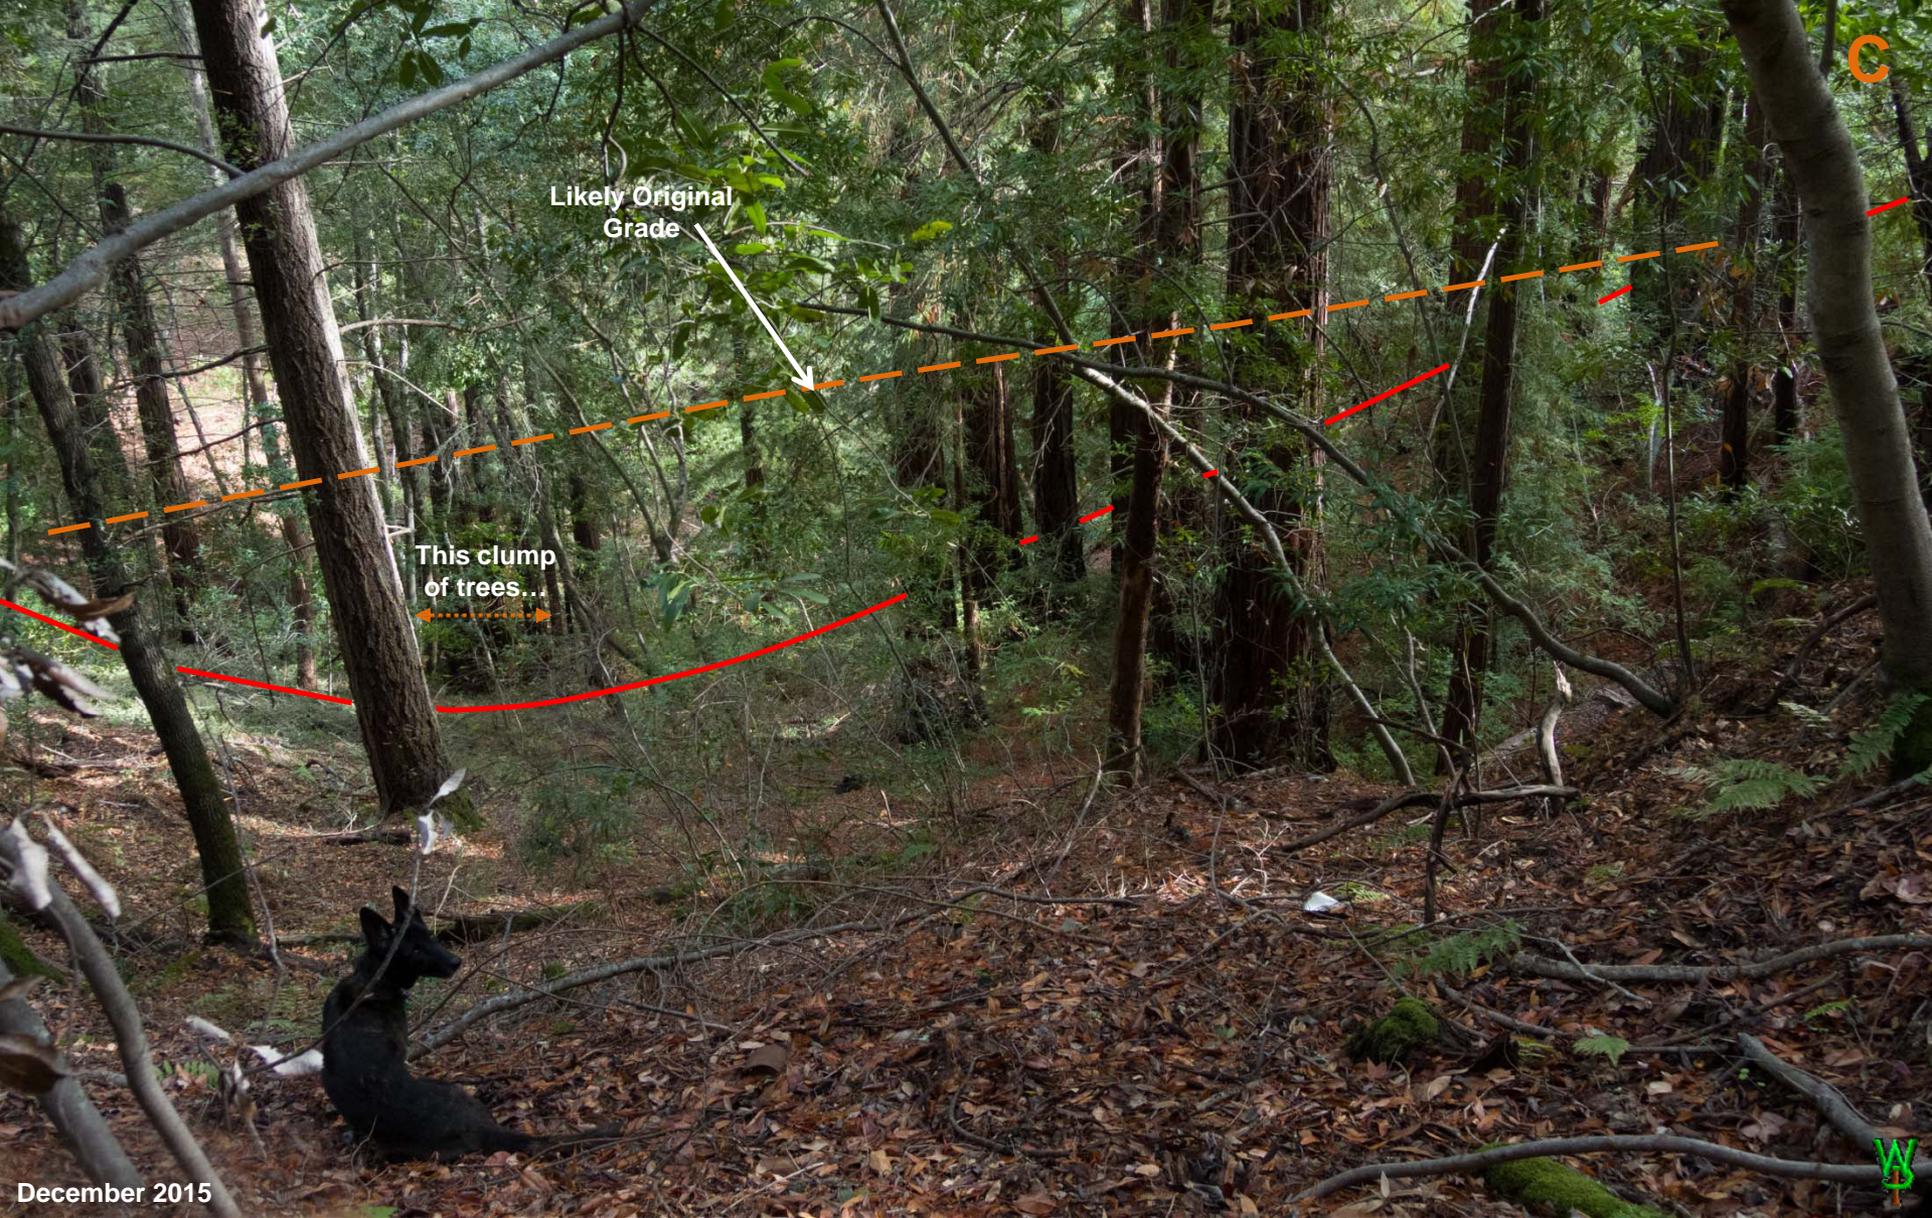
This is looking down Spanish Gulch from midway up. It is hard to visualize the loss of the 30,000 cubic yards that made this channel (channel bottom in red). There has been no stream here since the road grade was changed when the County fixed it, but once something like this starts, it will keep getting bigger even without the water. It is history that teaches what we are seeing. That story will be completed in the forestry chapter on **drainage** to come next. Without scrambling over every inch of ground equipped with that history, it is very hard to see what to do about it and the tendency will be to fall back upon whatever is familiar.

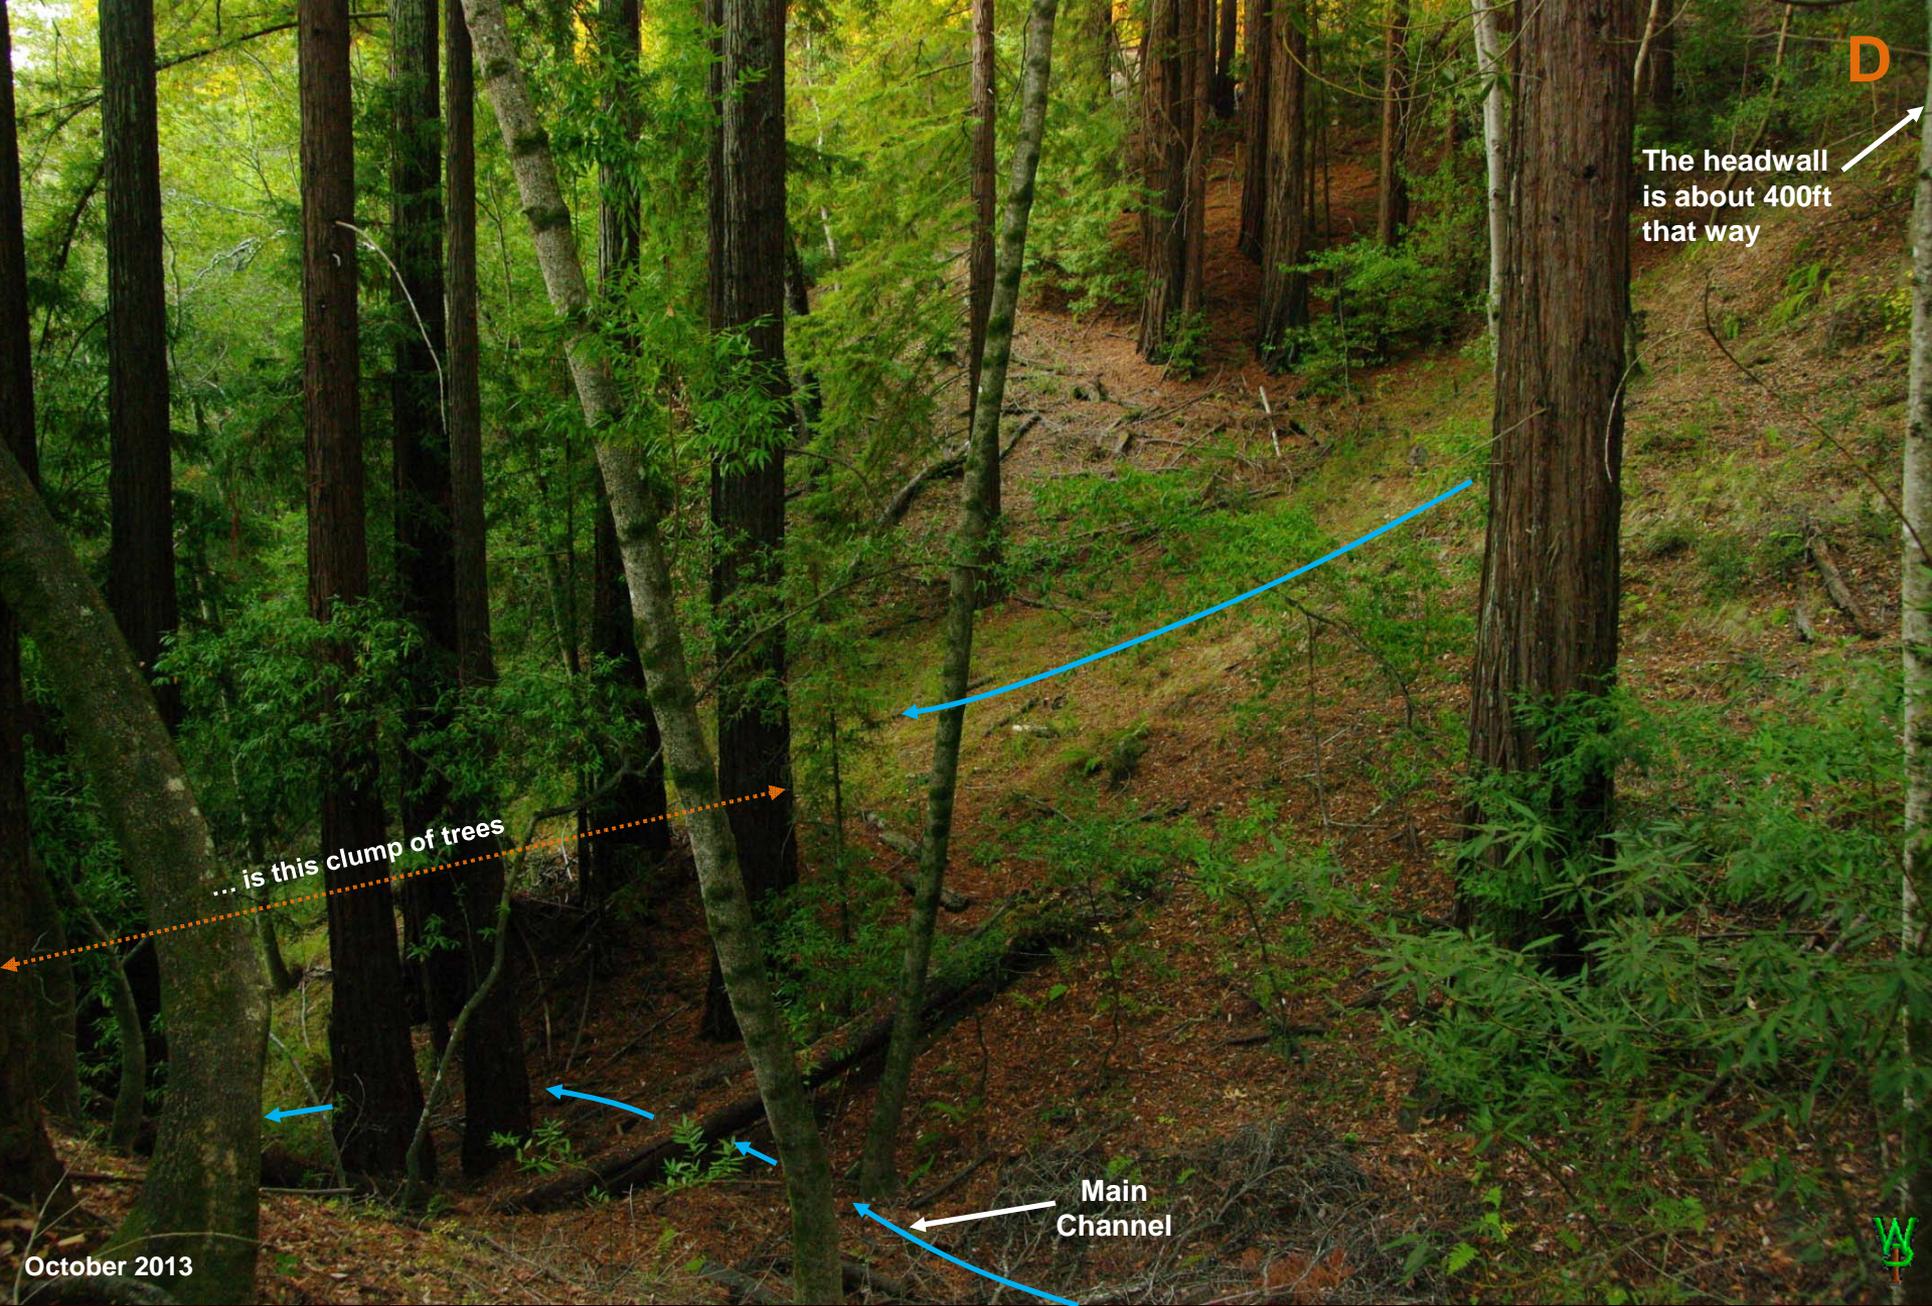
The headwall is about 400ft that way

It's big. The gully headwall is "400 feet that way" (upper right) along the County road ("Cake 2," 4 slides prior). From what I can tell, this drainage channel, representing about 30-50,000 cubic yards of lost material, was started when the Spanish channeled the water and dumped it off at the corner onto the colluvium, but there was more to it as the process didn't stop there.

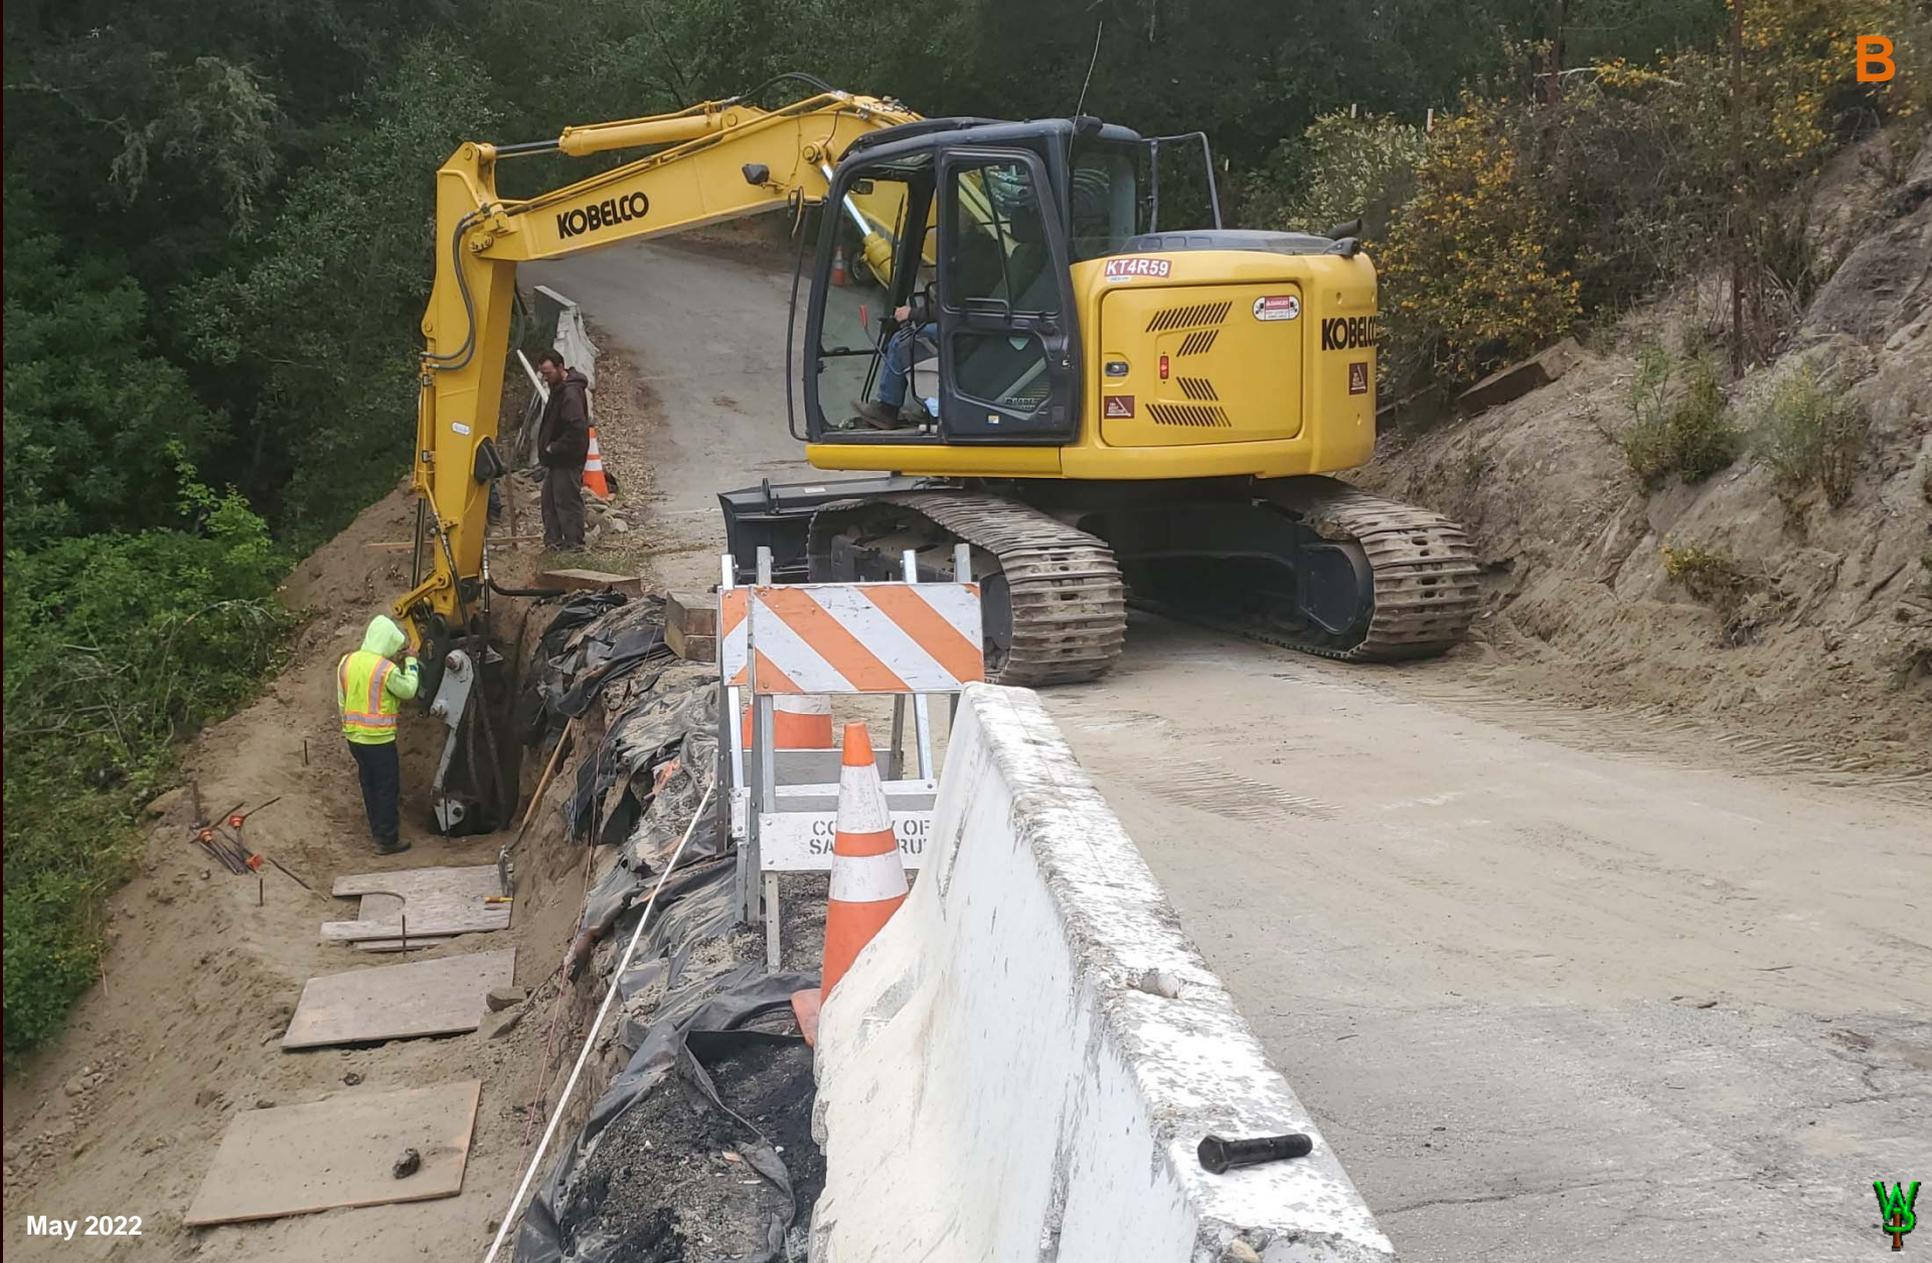
So it gets worse, again. Cake 2 atop Spanish Gulch is settling. It will not take much sluff to kick out a flow over the old headwall "the fix" was meant to avoid. With enough rain, the flow could be sufficient to develop enough momentum to go down the headwall. Since the fix, trees in soft material have grown, are leaning out over the road, ready to fall to fill that drainage path. Unless the ditch is maintained perfectly, eventual failure becomes imminent. Thus Cake 1 and soon Cake 2.
