# ROADS TO HELL AND BACK, SOMEWHAT

# WILDERGARTEN 6.2

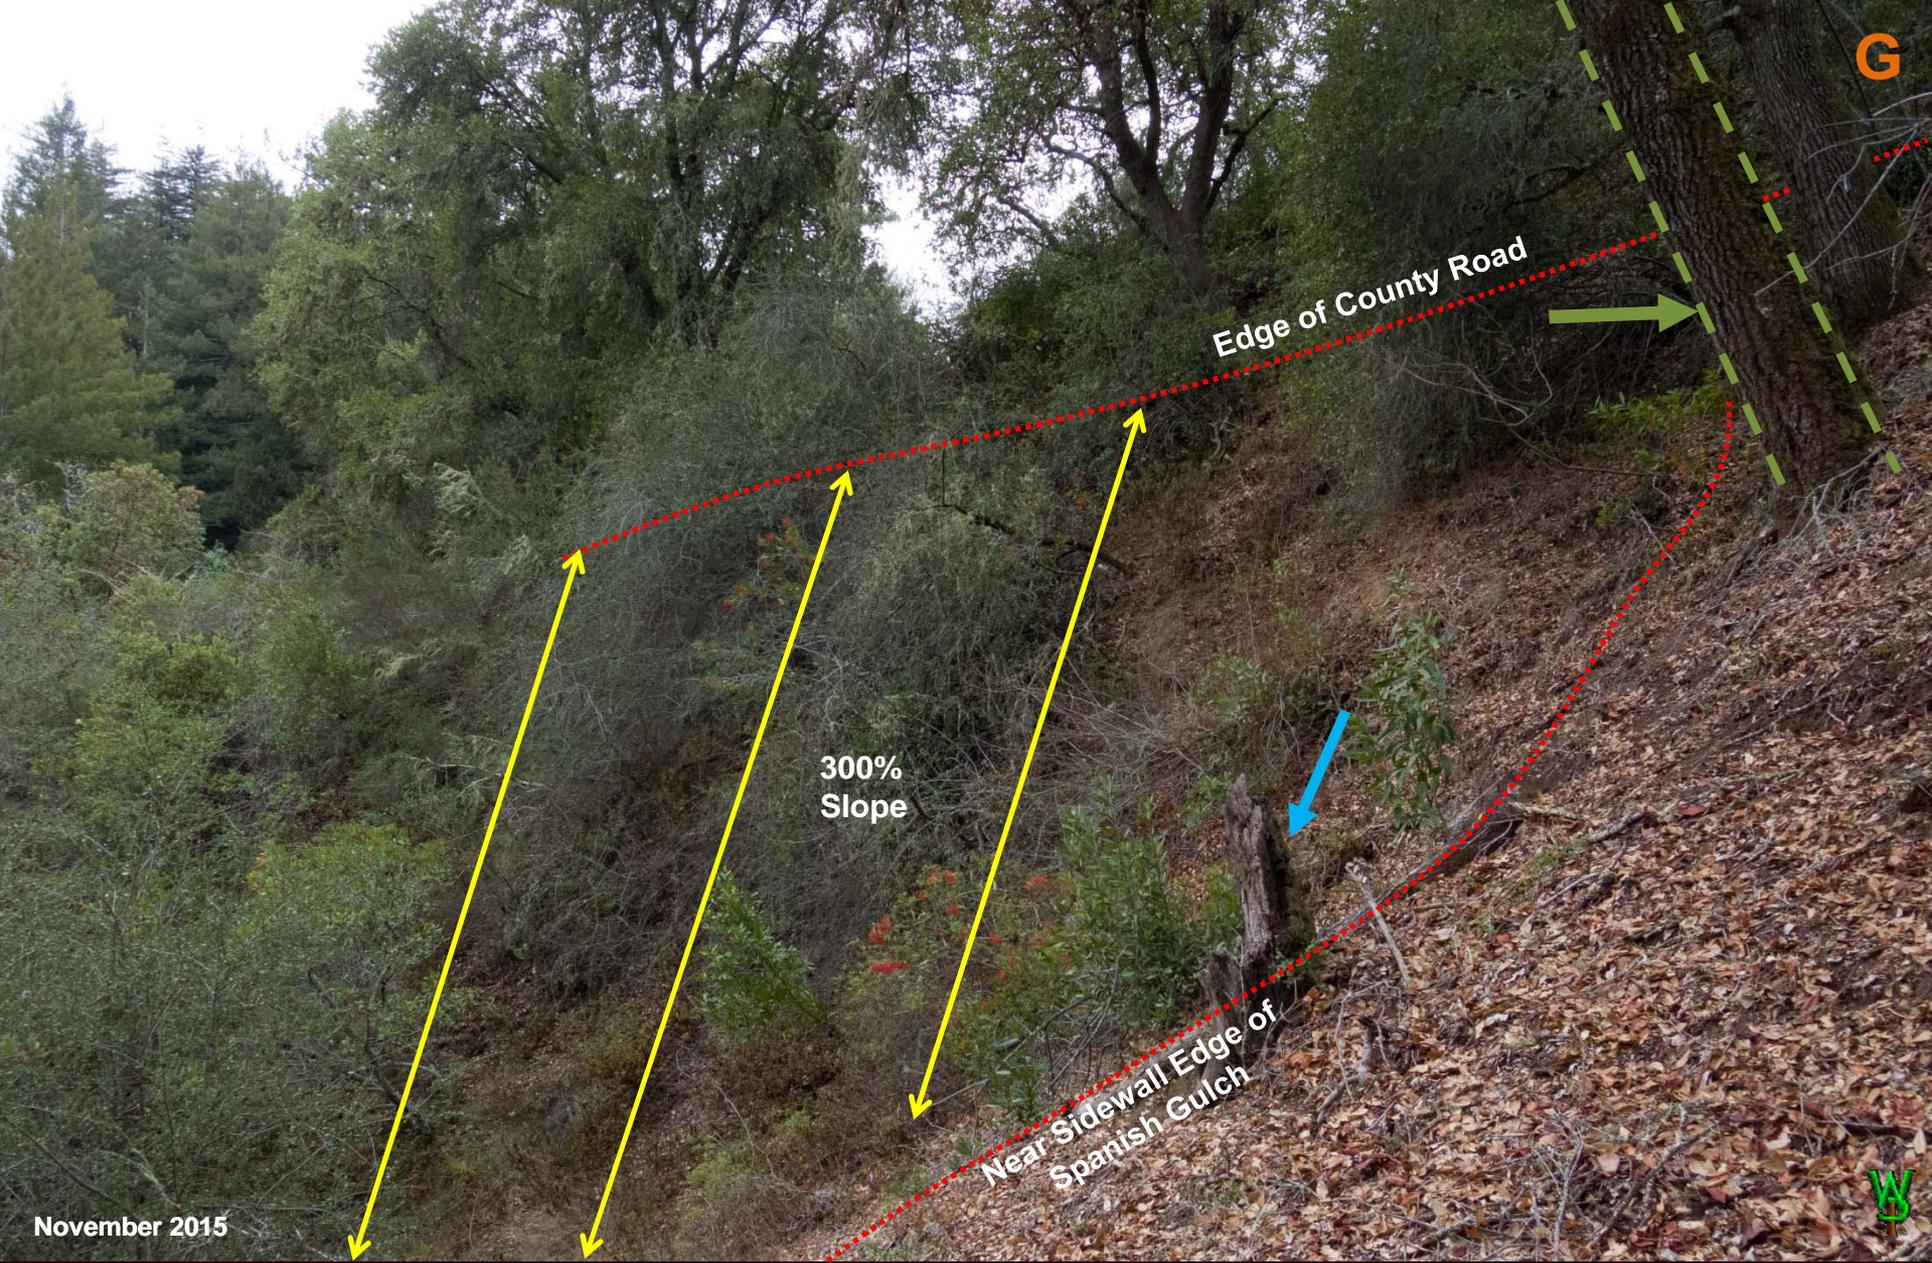
November 2015

This is an oblique view of the headwall below “Cake 2,” and this is just the beginning. Note that what you do see on most of it is light, early successional brush such as this *Ceanothus cuneatis*, and a **madrone stump** indicating that the most recent slide on this side of the gully was only about 50 years ago. One would think that in a place that can grow trees very rapidly, there would be more here. The reason there aren’t is that **they lean into the Gulch for sunlight**, hanging onto material so soft they fall down, frequently.

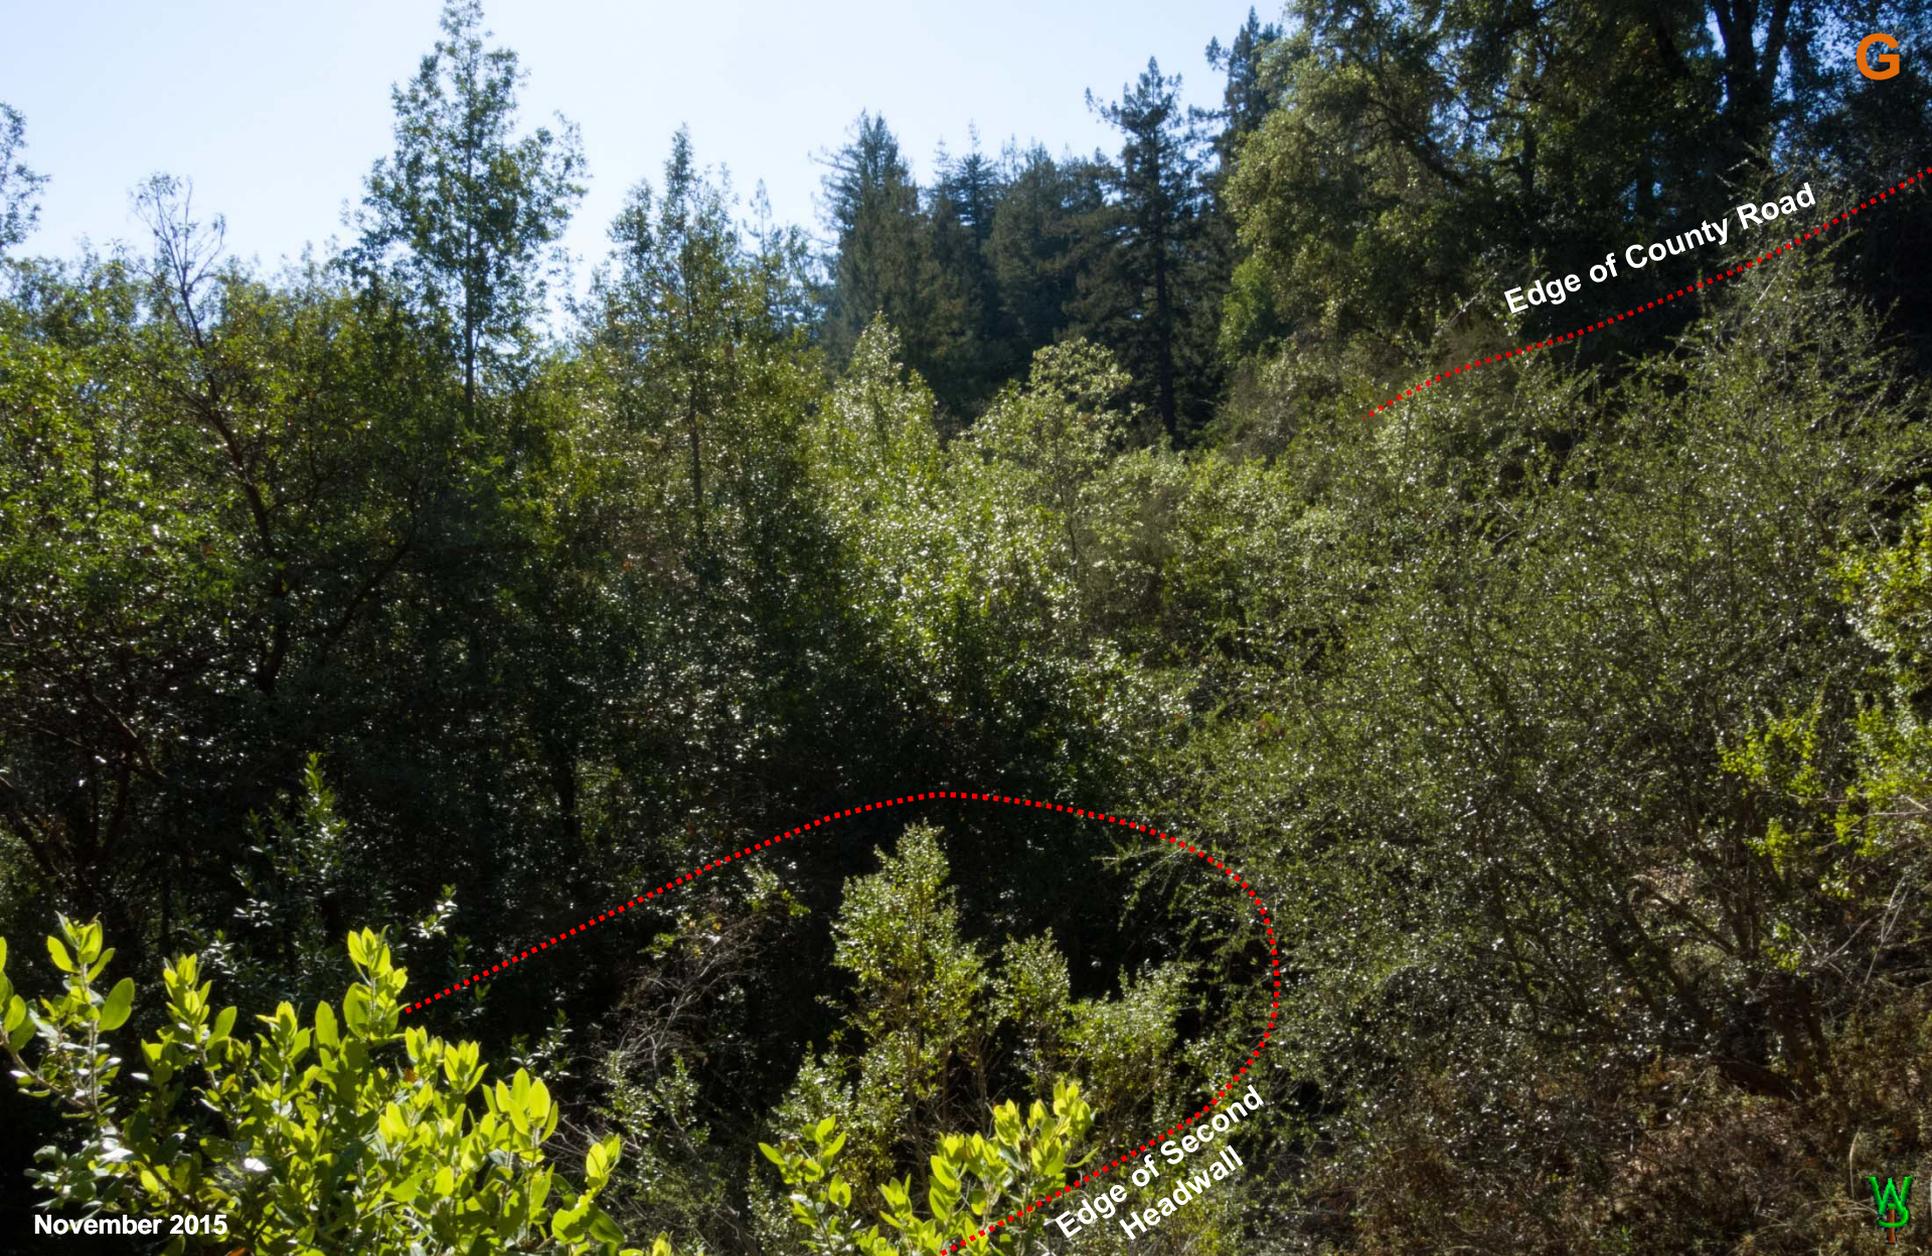
November 2015

Panning left, below the next headwall is the original Spanish Gulch filled with trees, and here is why I am going into so much detail on roads in a chapter under “Forestry”: **Poor drainage and lack of vegetation management came together to make this very expensive erosion problem even worse for the land, for wildlife, and for people.** This gully stair-steps in successive slides with headwalls having a 300% slope, one 50 feet high (too tall to simply drill pilings for a retaining wall). It got this way...*because of trees?*

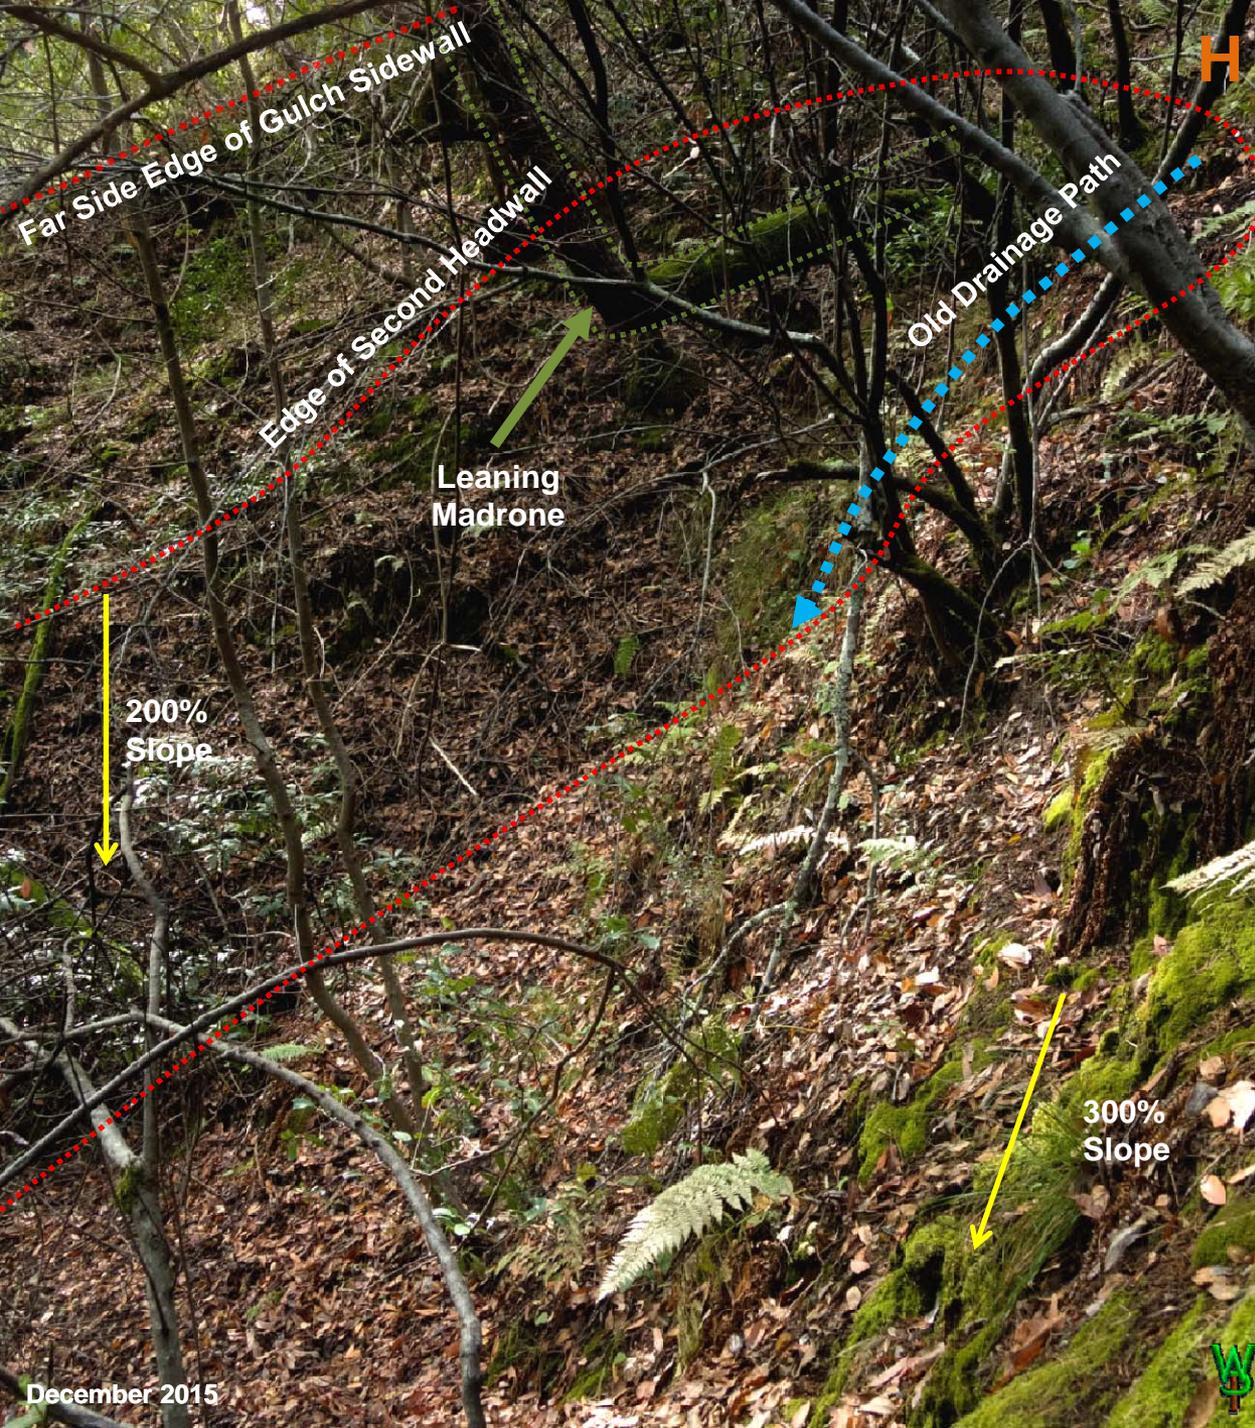
Yes. Trees both hold this headwall and undermine it when they fall. We are to the north and down-slope from the second headwall looking across and uphill from the right sidewall. On the far side on the north-facing wall are older trees, of which the leaning madrone is archetypical: it grew outward from the loose sluff, fell, and then it grew upward again, now putting considerable leverage against the slope and threatening to tear out the root wad. That soil material is so soft one can dig it with bare hands.

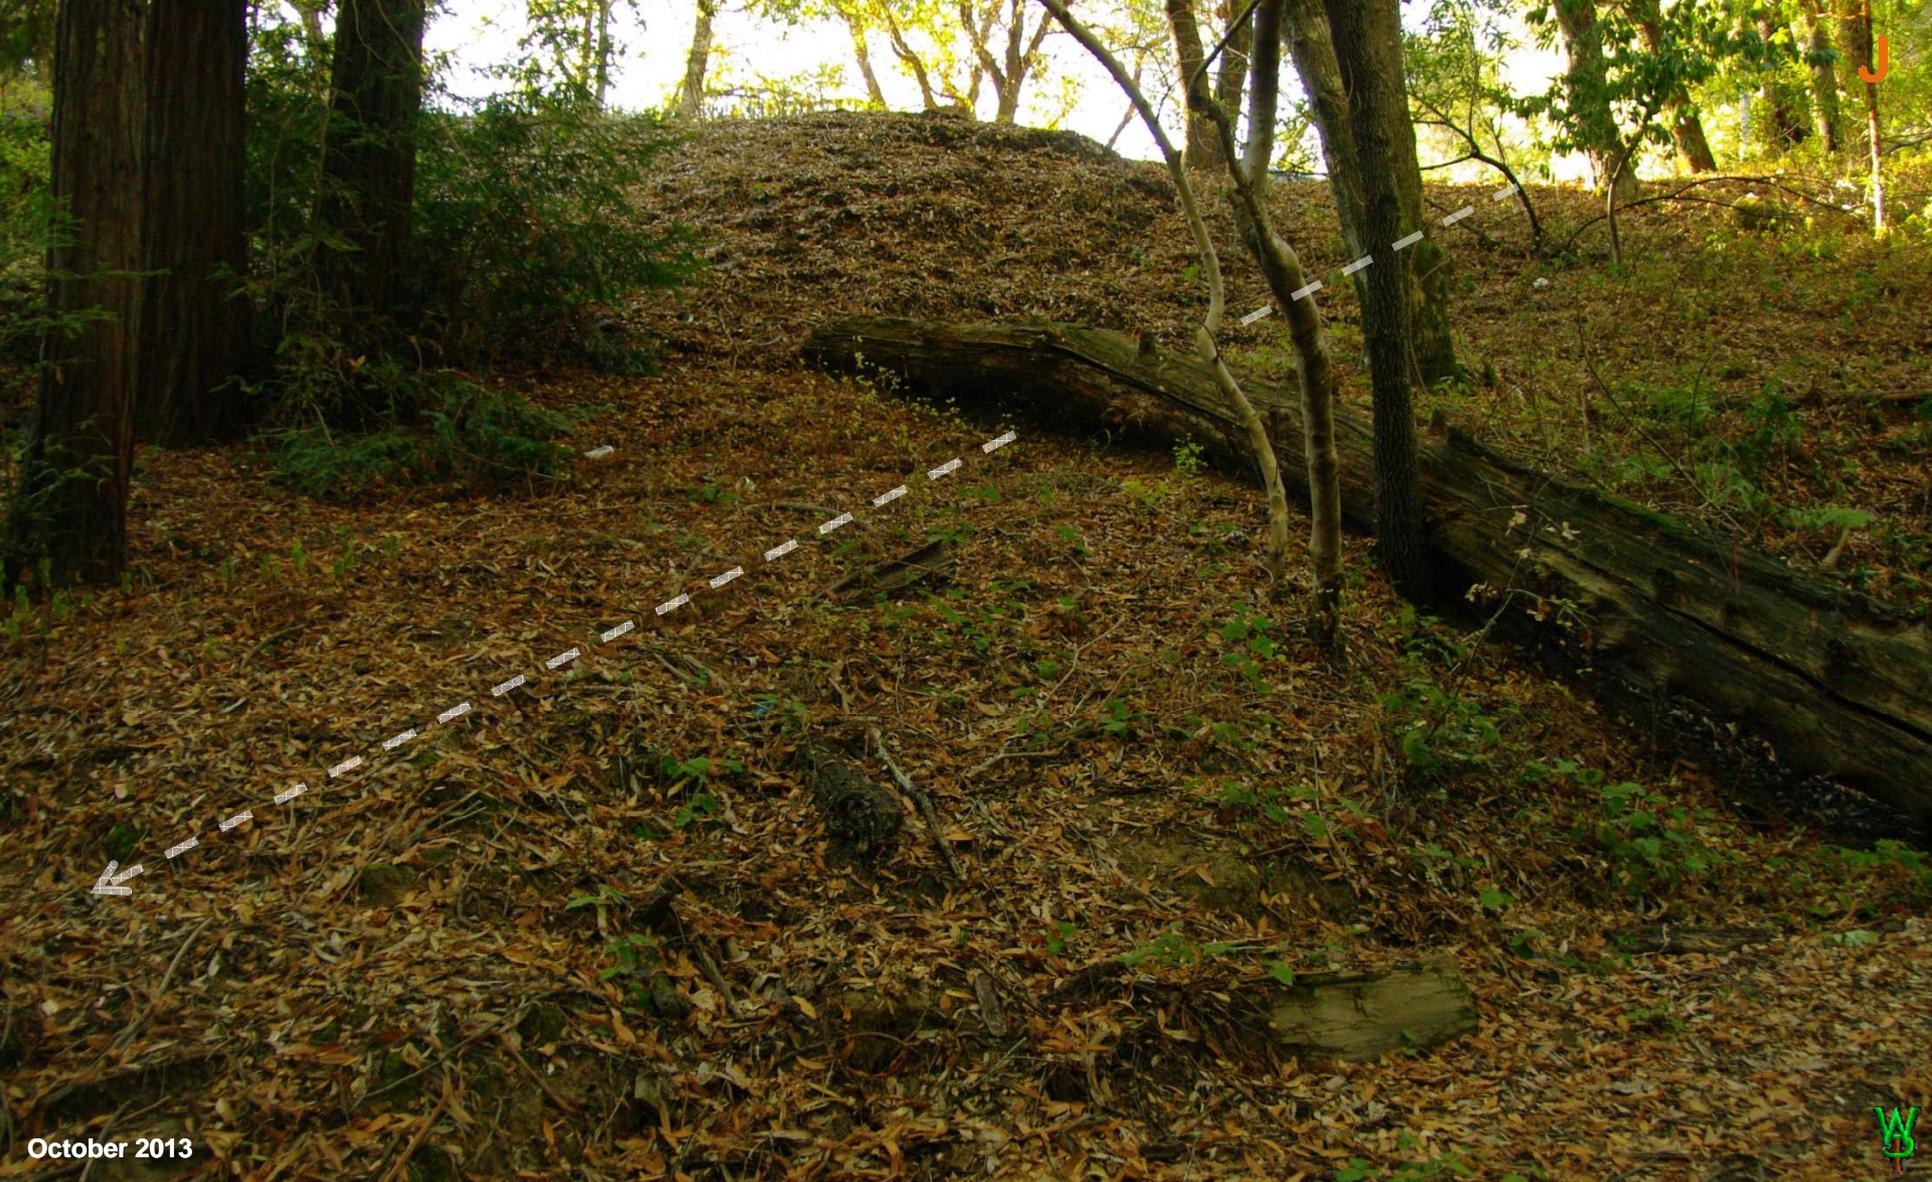
October 2013

About 100 feet down Martin's Road, this was First Cut (that original entrance cut for Martin's road), which then turned into a useless gully. This was a classic Type II failure. I retired it in 2003 by talking the County into filling the channel with ditch cleanings I then graded out by hand. This kind of project takes a lot of fill, 6-8 dump trucks worth. The County lawyers ordered the Department of Public Works (DPW) to stop doing it because somebody sued them for fill contaminated with wood despite having signed a release agreement to take it as is. Without this fill, the County would have been forced to **truck it 35 miles** to a landfill. We all have a harder time getting fill to fix old problems and the dump fills up faster with dirt. Much of your road taxes go toward similarly wasted energy.

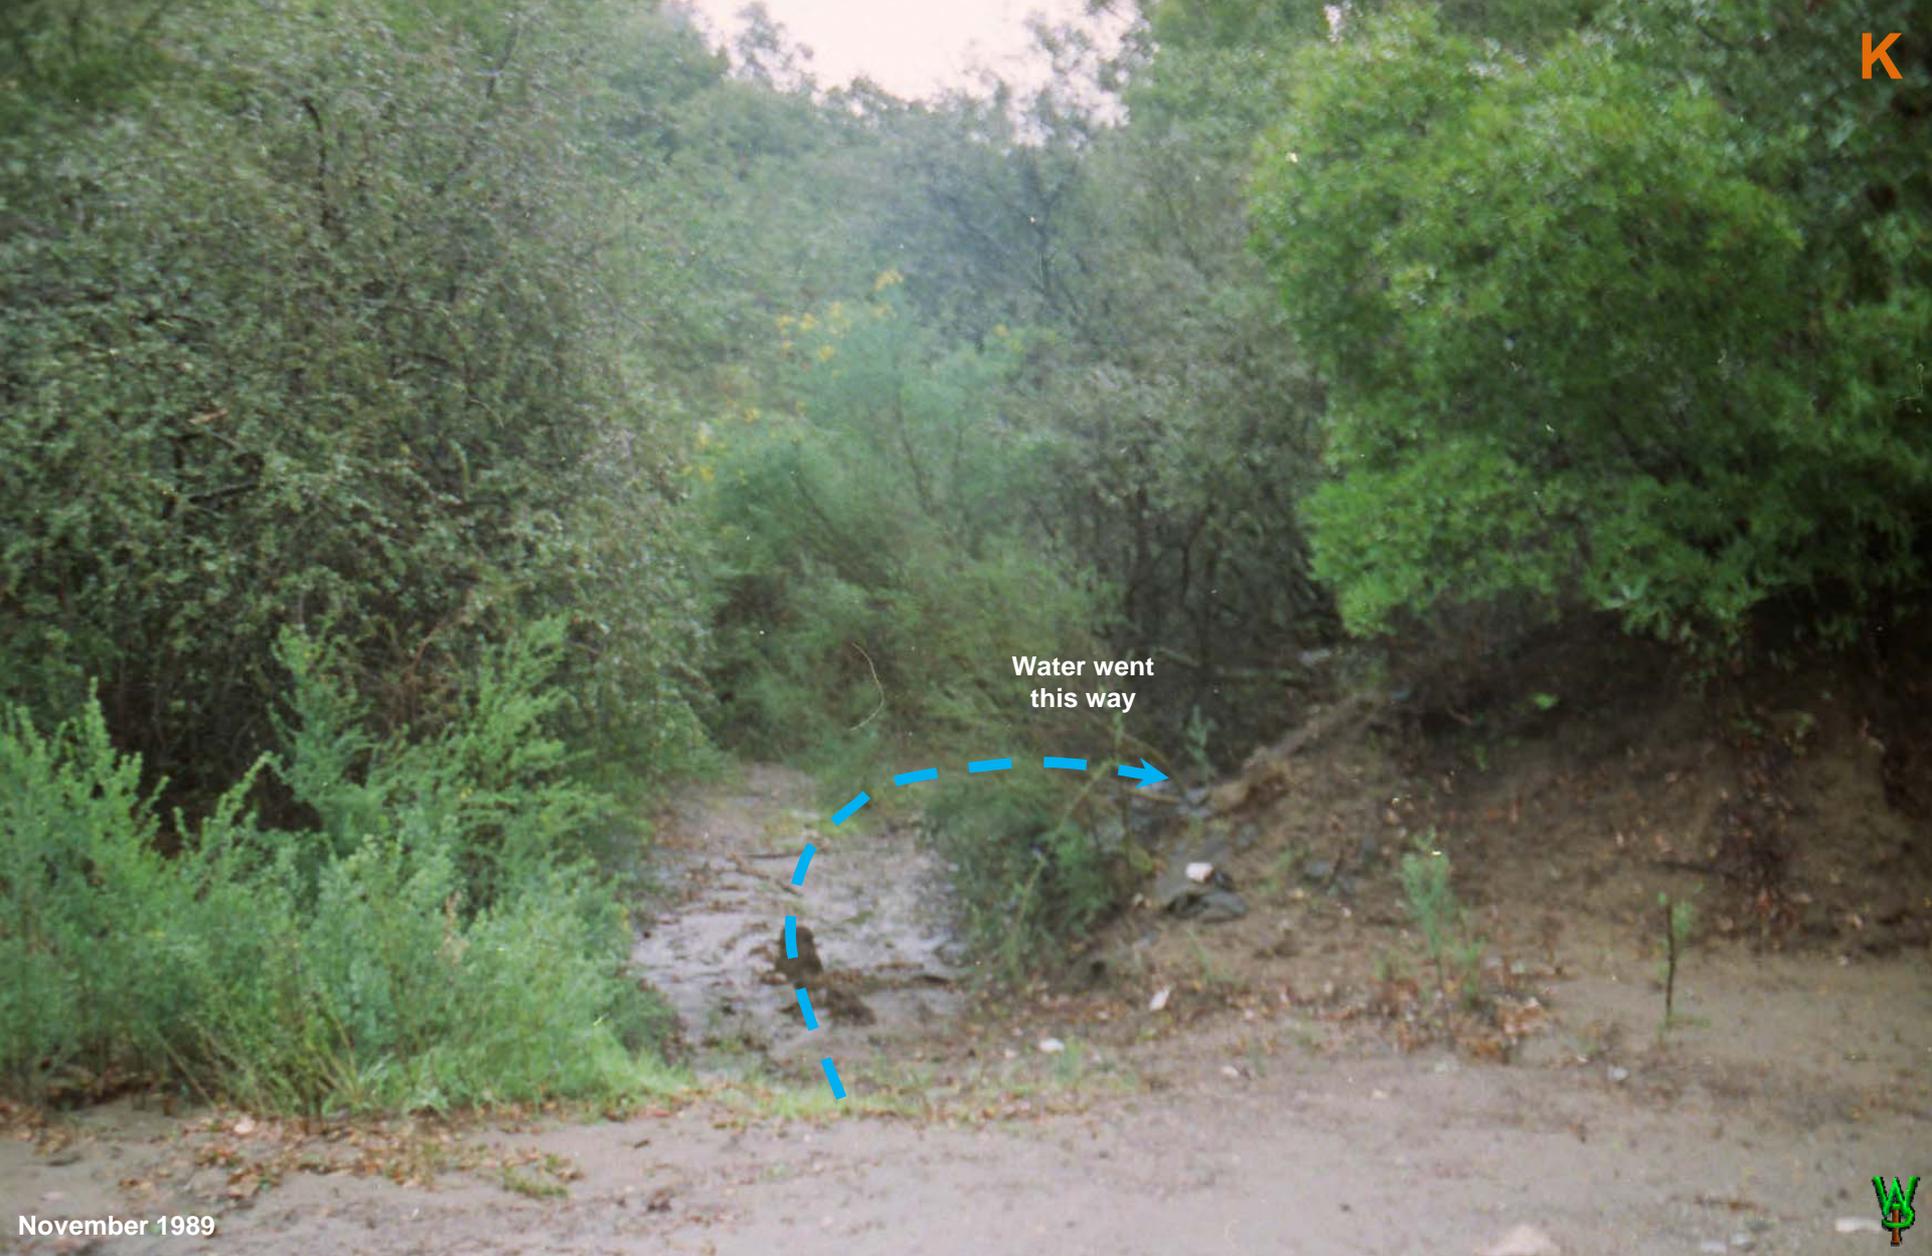
This was the original fix for **First Cut**, which channeled the water into the drainage past Ed Fenn's house, then necessitating planting the Eucalyptus. If you go back to the previous 1931 aerial photo, at the top you will see where the County put in the culvert (probably in the 1970s) to reduce the runoff into the watershed draining into Glenwood. If that culvert plugs, guess where the water goes? Yup, back into what was Charlie Martin's road entry. And this was an improvement!

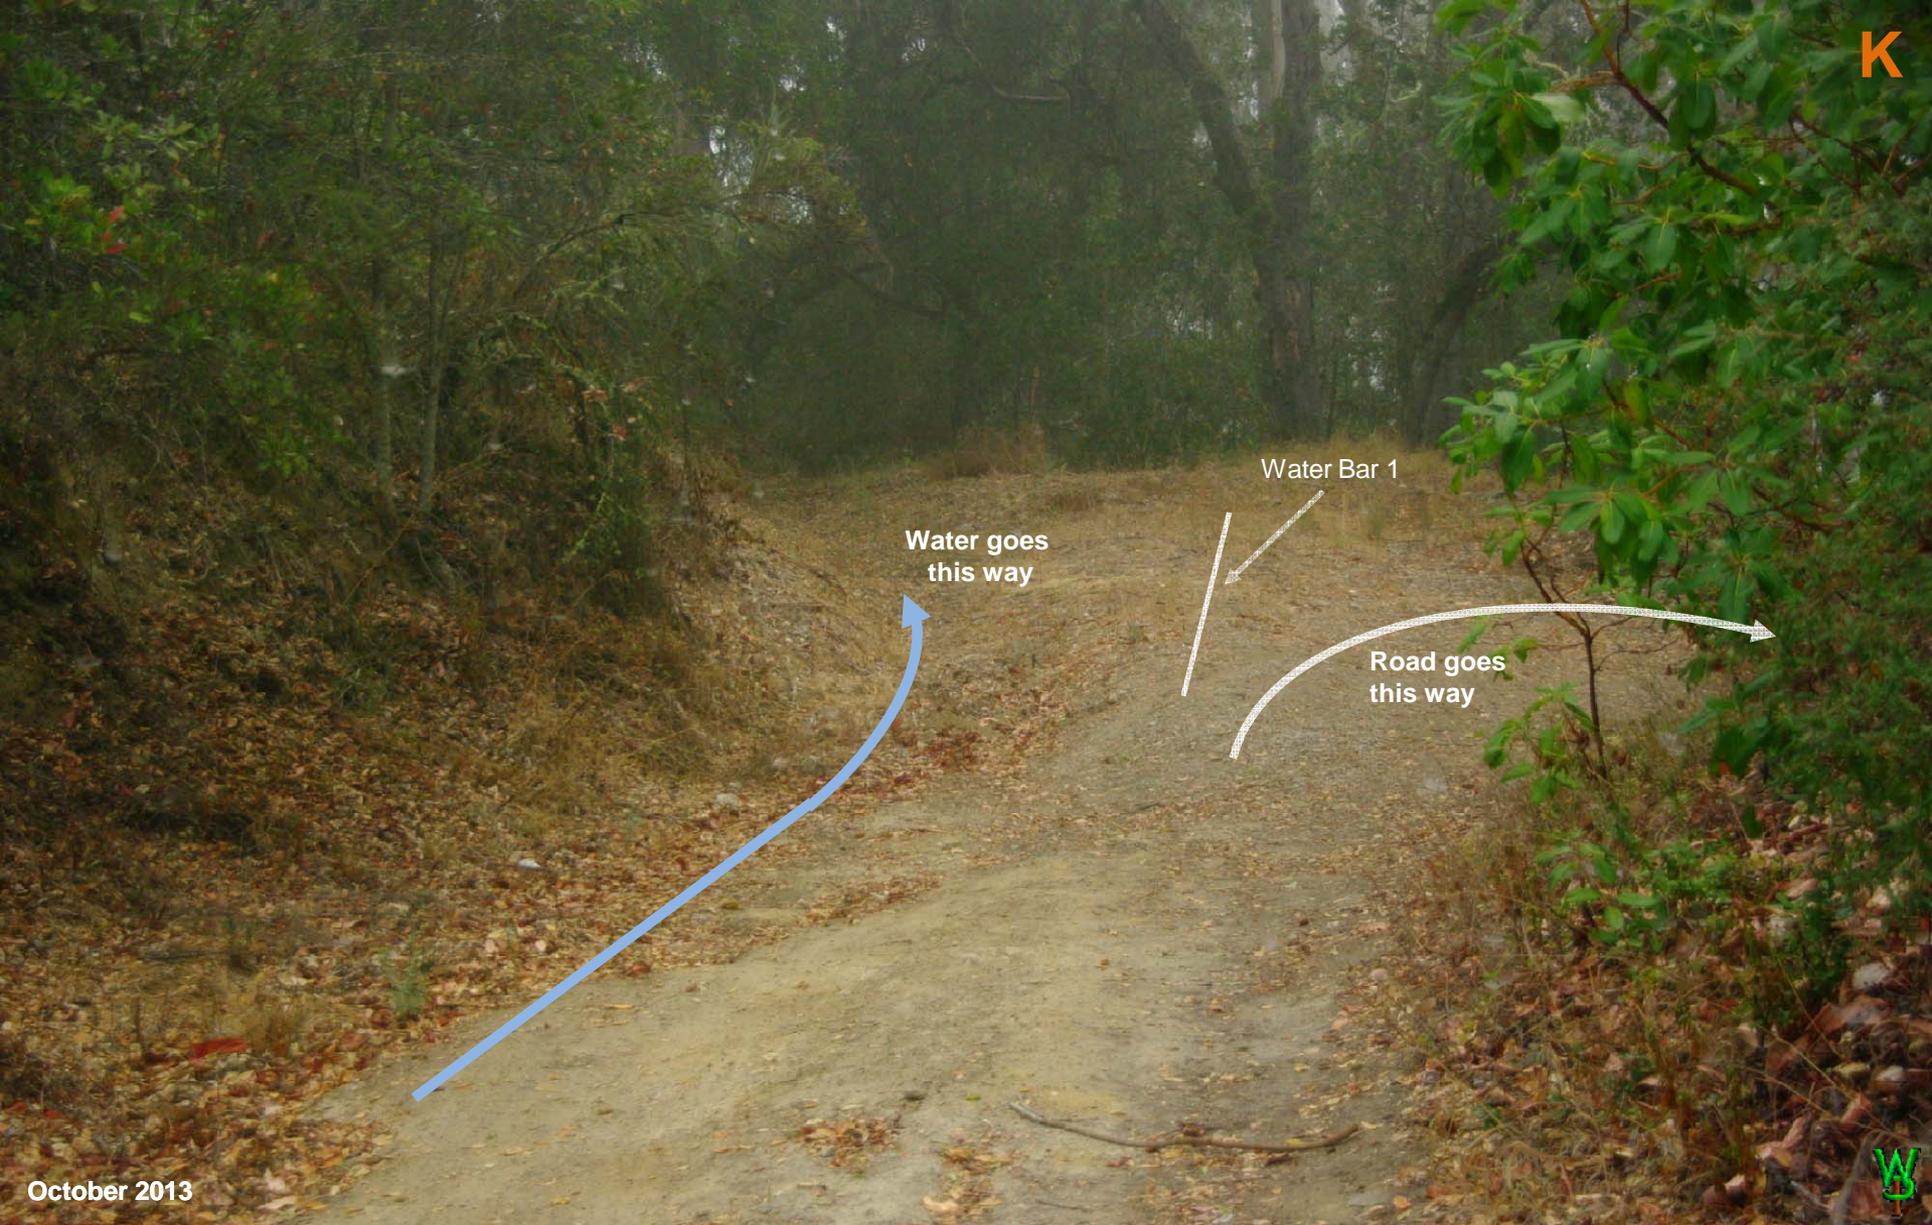
To reduce erosion on Martin's Road I diverted the flow of water onto it at the entrance and distributed the rest. Since the County put in the culvert up above, most of the time, there is very little water here. Yet in the event that culvert plugs (it's happened), this diversion into the Eucalyptus stand entailed a requirement for sufficient capacity to take all the water coming down the County road. That collection area is about 10 acres because so many landowners along that stretch dump their water onto the County road... because it is **a commons**. So I simply made the best of things until we can grow redwood trees to replace the Eucalyptus.

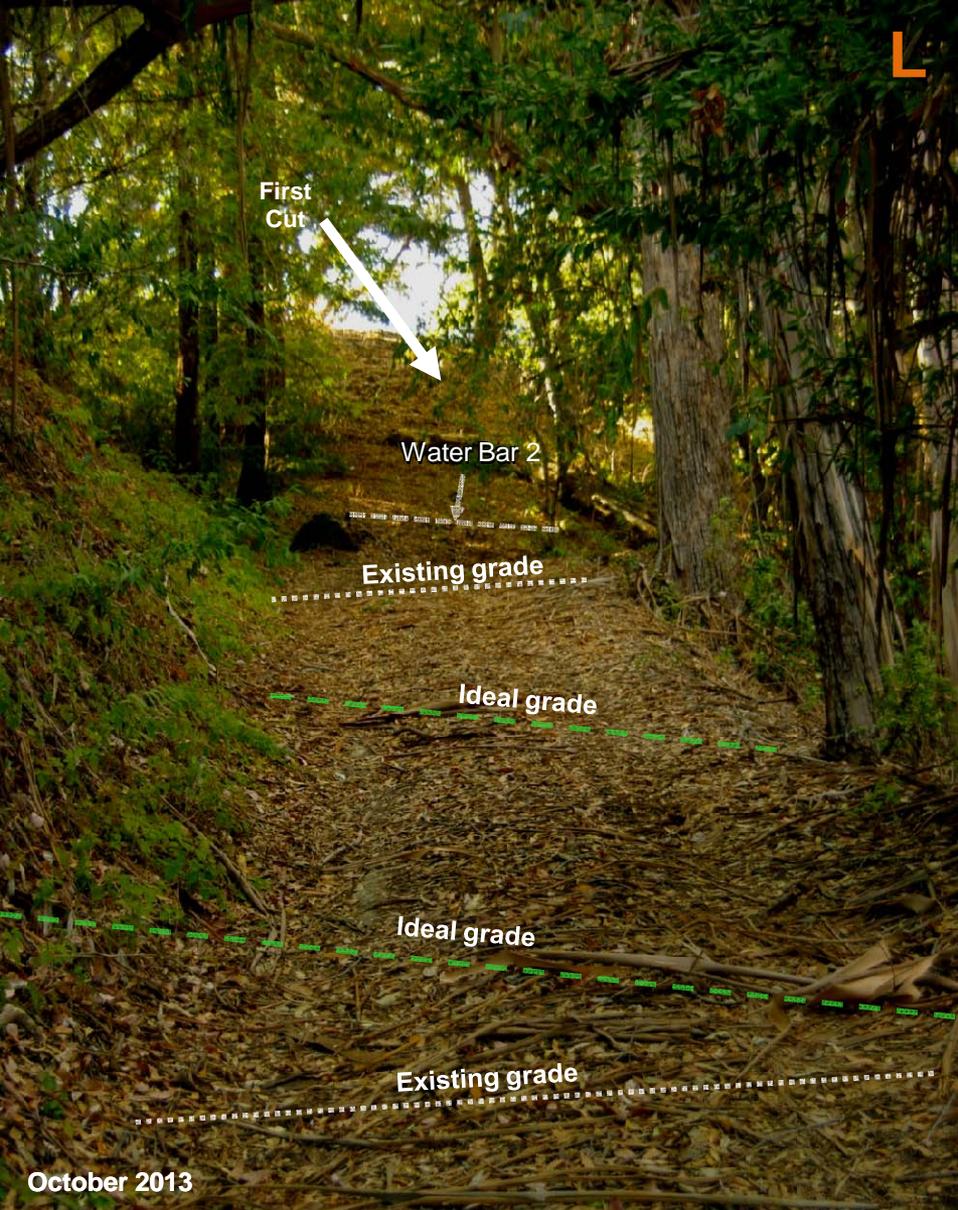
Down the road, I distribute the runoff. I installed and maintain 2 concrete culverts (plastic pipe burns) with water-bars behind them in case they plug (the culvert at left is above Water Bar 2). Farther down the road at outside corners (right), I also had out-sloped water-bars made to shed the water. These drainage improvements are separated by less than 100 feet. As long as the culverts are cleaned (and we install a gate to keep joy-riders from tearing up the water bars in the winter), this is stable. If and when I come up with more material, I can then build up an out-sloped configuration between water bars which will eliminate the remaining concentrated flows.

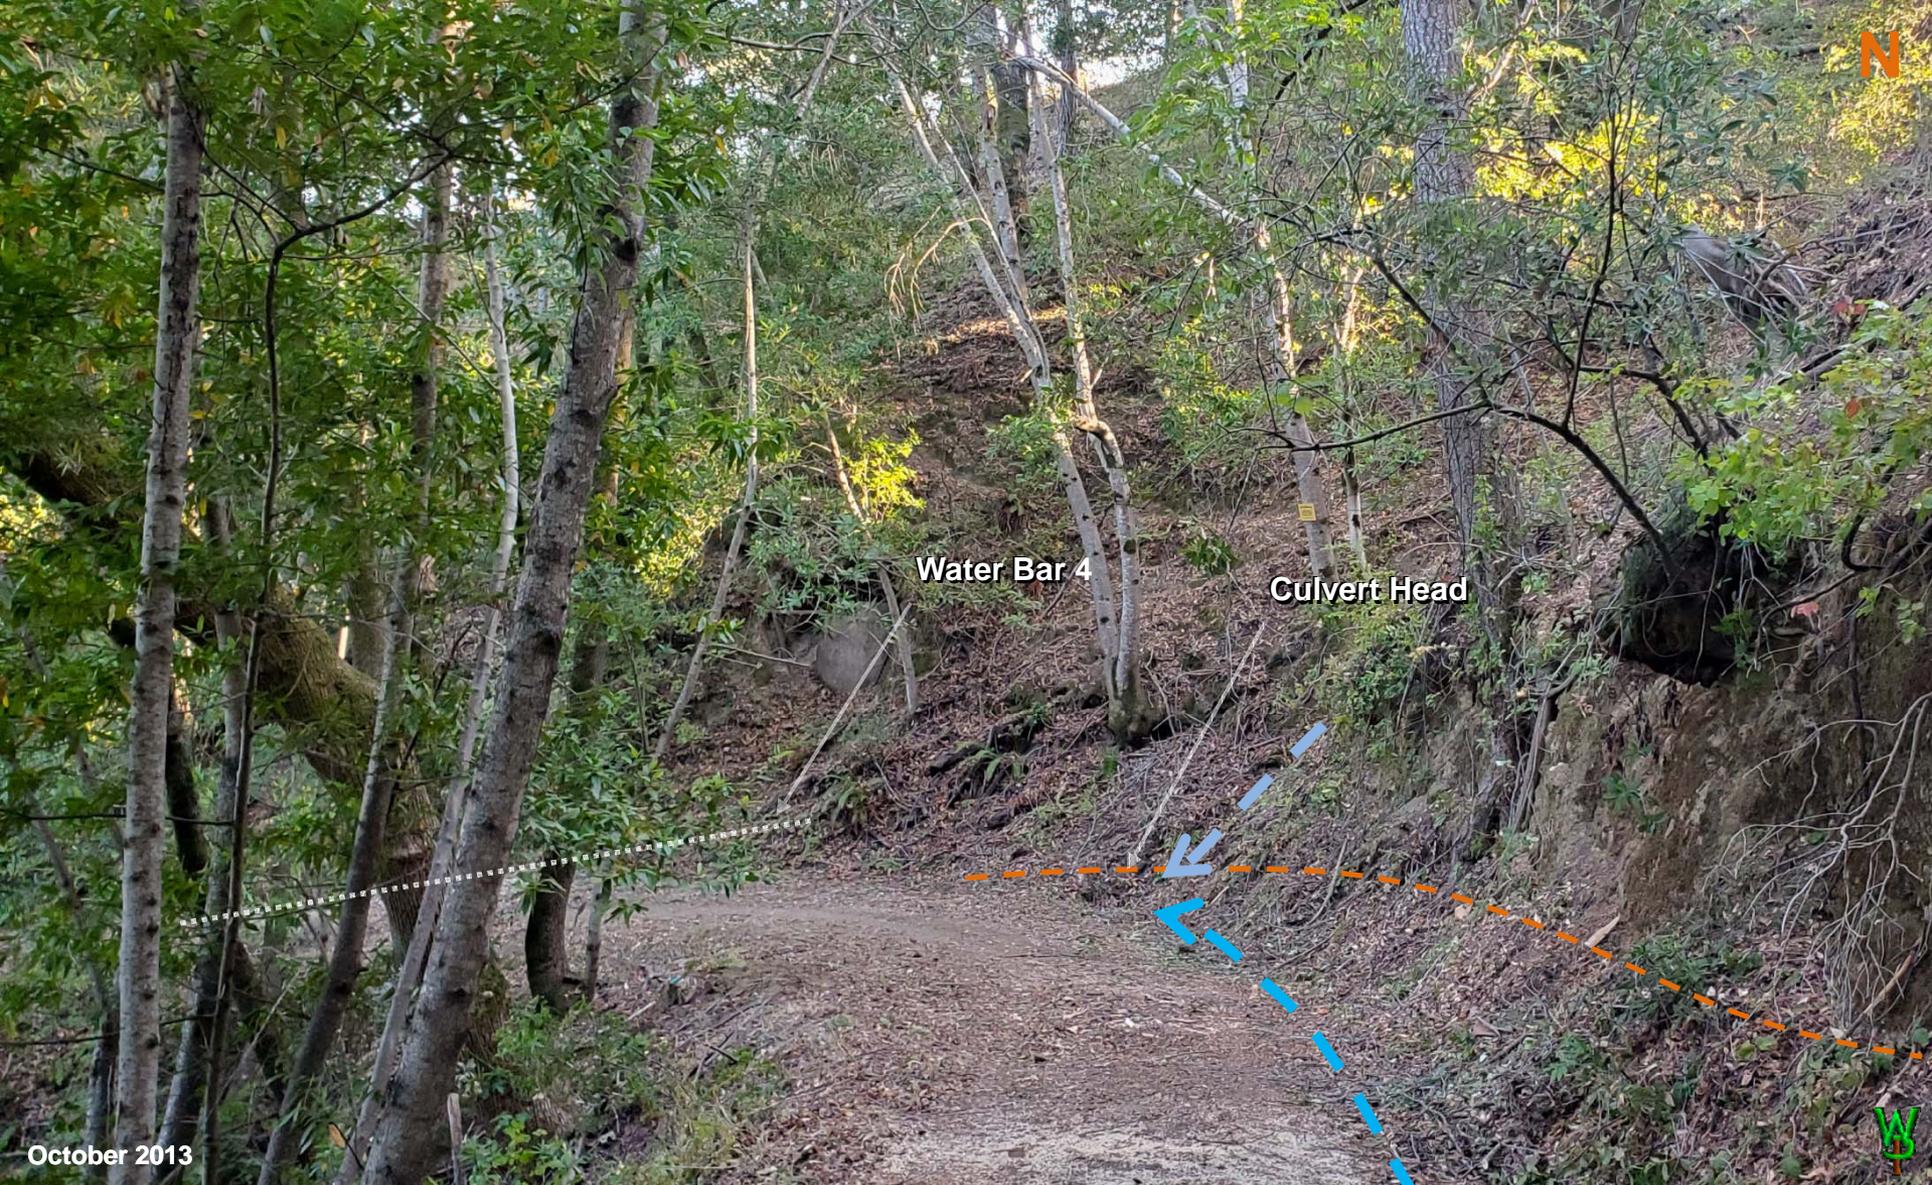
Water Bar 4

Looking down the road from about the same spot, originally, all of the flow from Charlie McKiernan's road came **down the in-sloped road**. Here, **runoff from Collection Area 2 (p34)** added to that flow. Originally, there was an 8" square wooden culvert I had replaced with 12" concrete with Water Bar 4 behind it (so far, never needed). My guess is that the road level had dropped at least 6-8 feet being graded, eroded, and graded again over the years. With this new water bar system, loose fill material slowly accumulates as a **sluff pile** on the right. Over time, I will deposit up that sluff plus what fill I have available starting behind the water bars and working downward with the new grade. Because of the flow from Collection Area 2, even with the out sloped surface above it, the culvert will be needed.

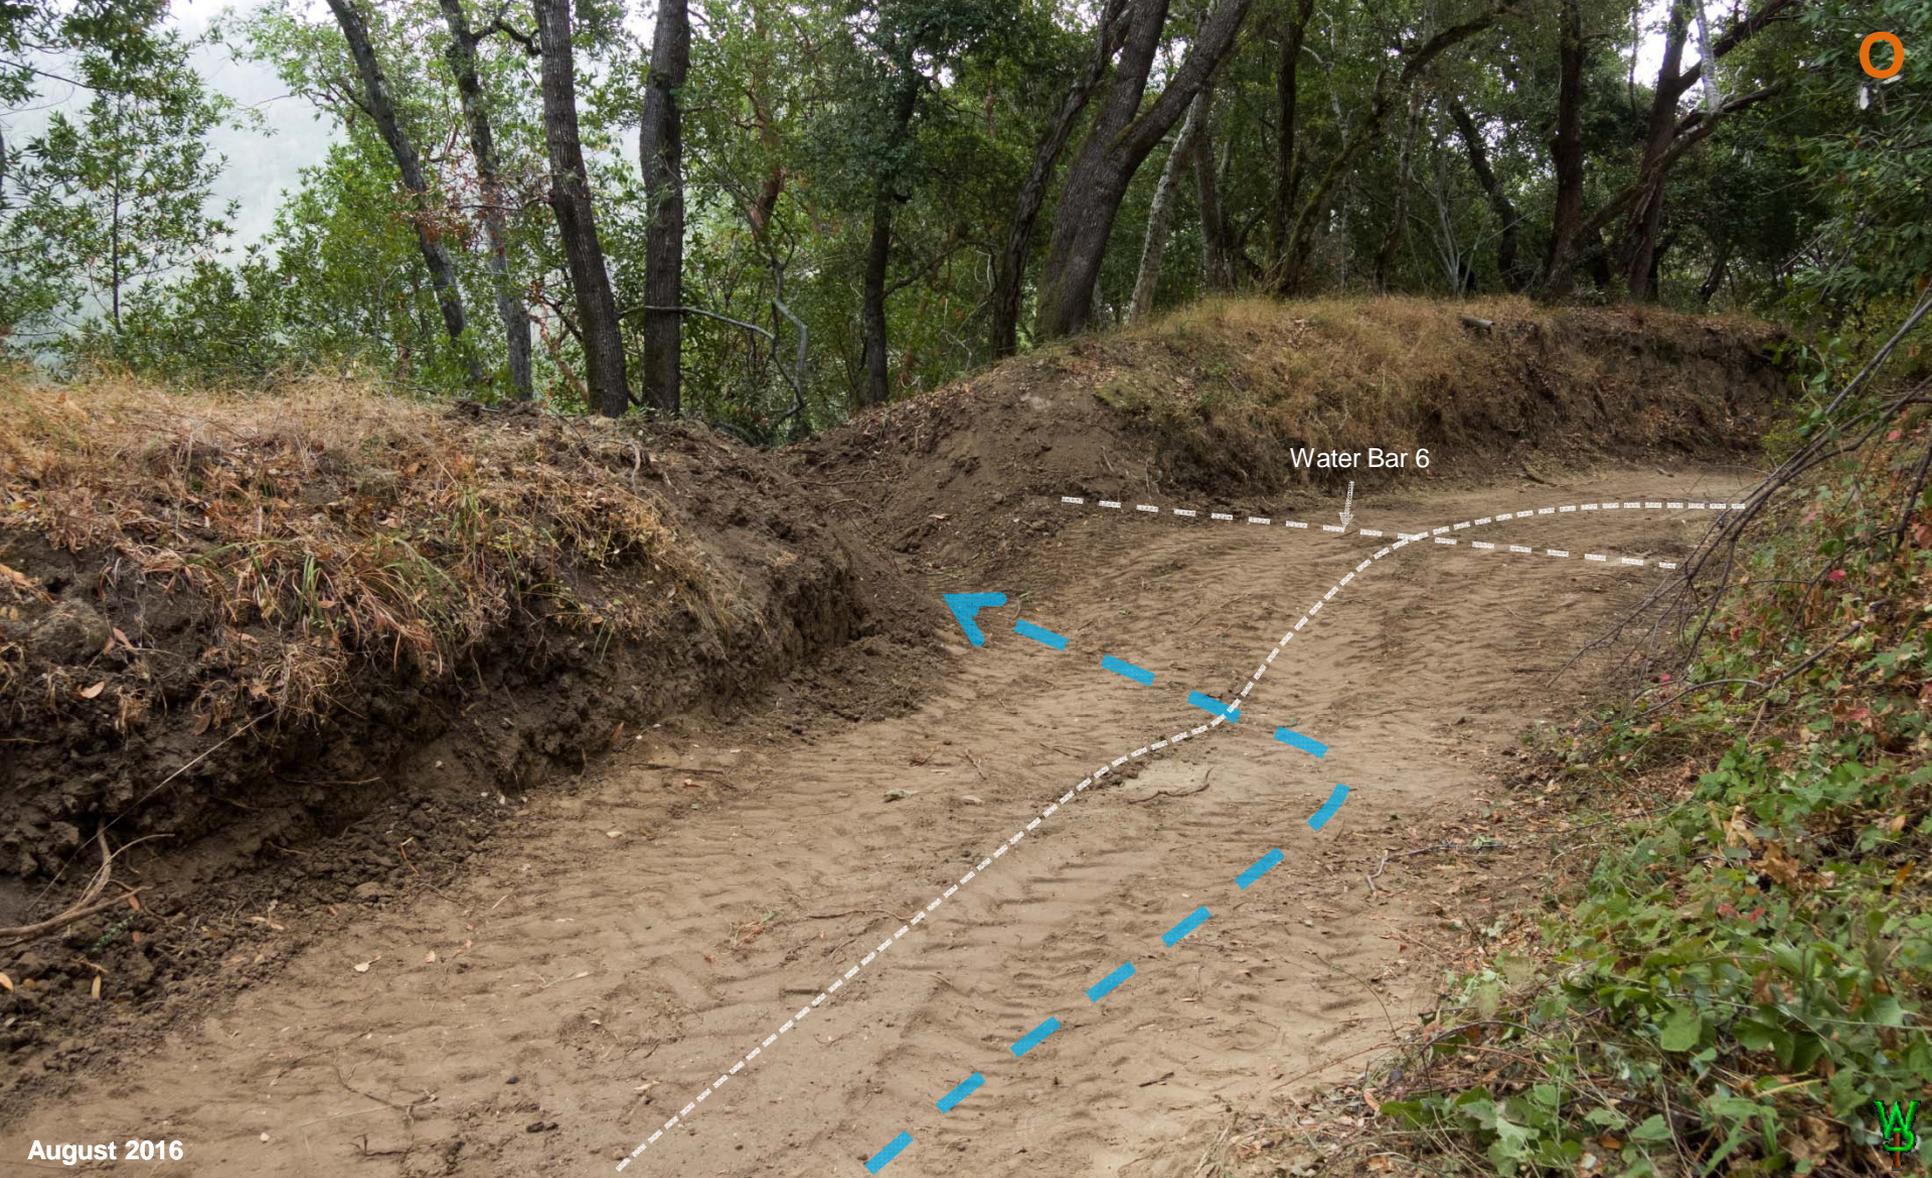
August 2016

Farther down Martin's Road adjacent to our property is this Type II channel. The cut extended over 150' without an outlet, so it became an incising bog in winter. Here, I've made a substantial and gradual water bar out of an overhang that I sloped off farther down, channeling the water through the embankment. In making that outlet, I exposed what may be the best accumulation of native soil I have yet found. It will definitely be analyzed, as such opportunities are rare. I've come to hate driving a backhoe over water bars!!! Years ago, I would have wanted to take out the entire outside bank just to have the road out-sloped and "fixed." Since then, I've realized that this is easily available material for future maintenance, simply removing it from the ends of the outside embankment.
