# ROADS TO HELL AND BACK, SOMEWHAT

# WILDERGARTEN 6.2

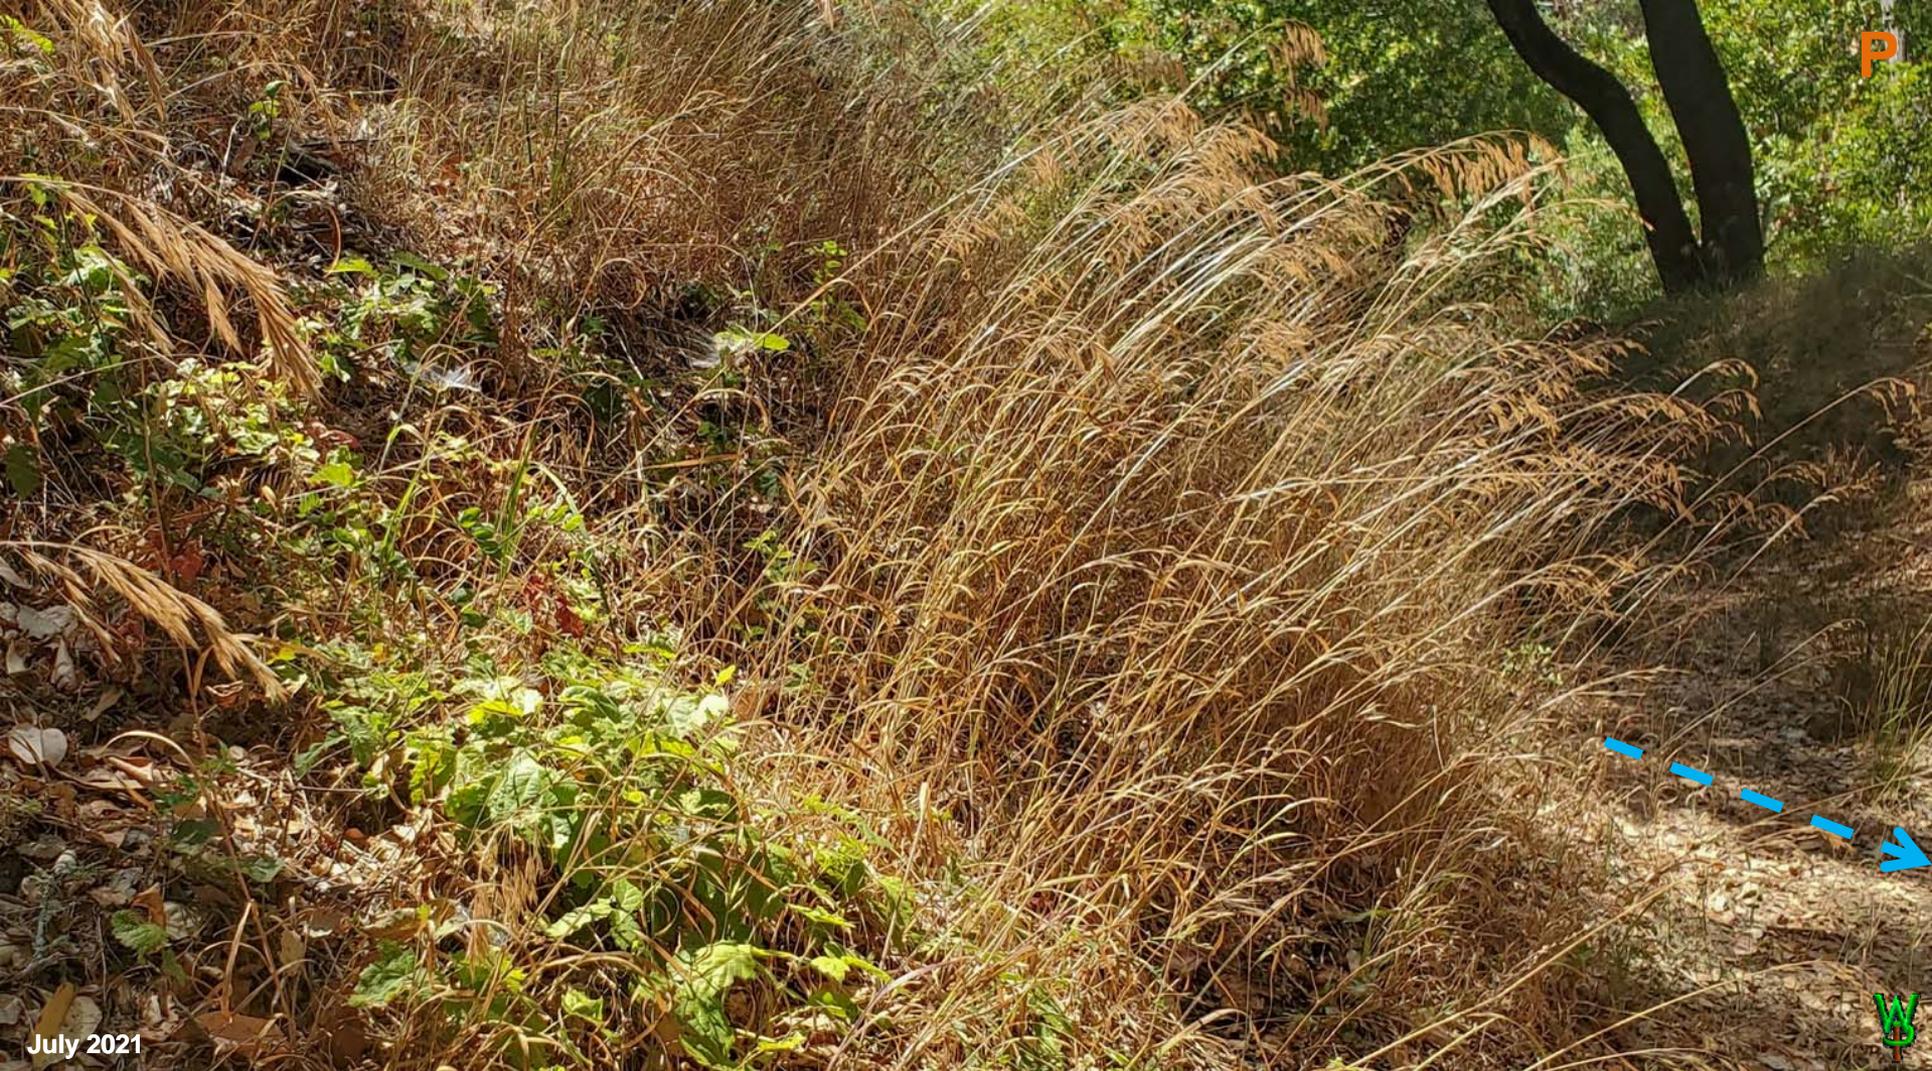
This cut channel was a Type II classic! The road was graded to make it possible for horse-drawn wagons and early vehicles. Drainage was a lower priority. When it got nasty, they just cut it deeper until these walls were 7 feet high on both sides. I saw that overhang on our side as an opportunity to correct the slope and make water-bar 5 on the preceding page. Fortunately, I had little respect for the usual sediment mitigation methods required for projects under permit (this project involving less than 100 cubic yards). Five years later, here is native blackberry and nodding brome grass (*Bromus laevipes*). But I had to wait for them to establish, which in this case took four winters, starting with an exposed rock surface. How? When I was done with the backhoe, I used it to sprinkle some blobs of topsoil onto it and smeared them into cracks, digs and other flaws I'd left on the rock face. Up came some of this grass the next winter. I weeded it, sprayed whatever catchweed bedstraw (*Galium aparine*) or hedge parsly (*Torilis arvensis*) came up, and that is all I have done. Restoration really can be this easy. The most important thing is to know how to identify the plants and to weed it on time.

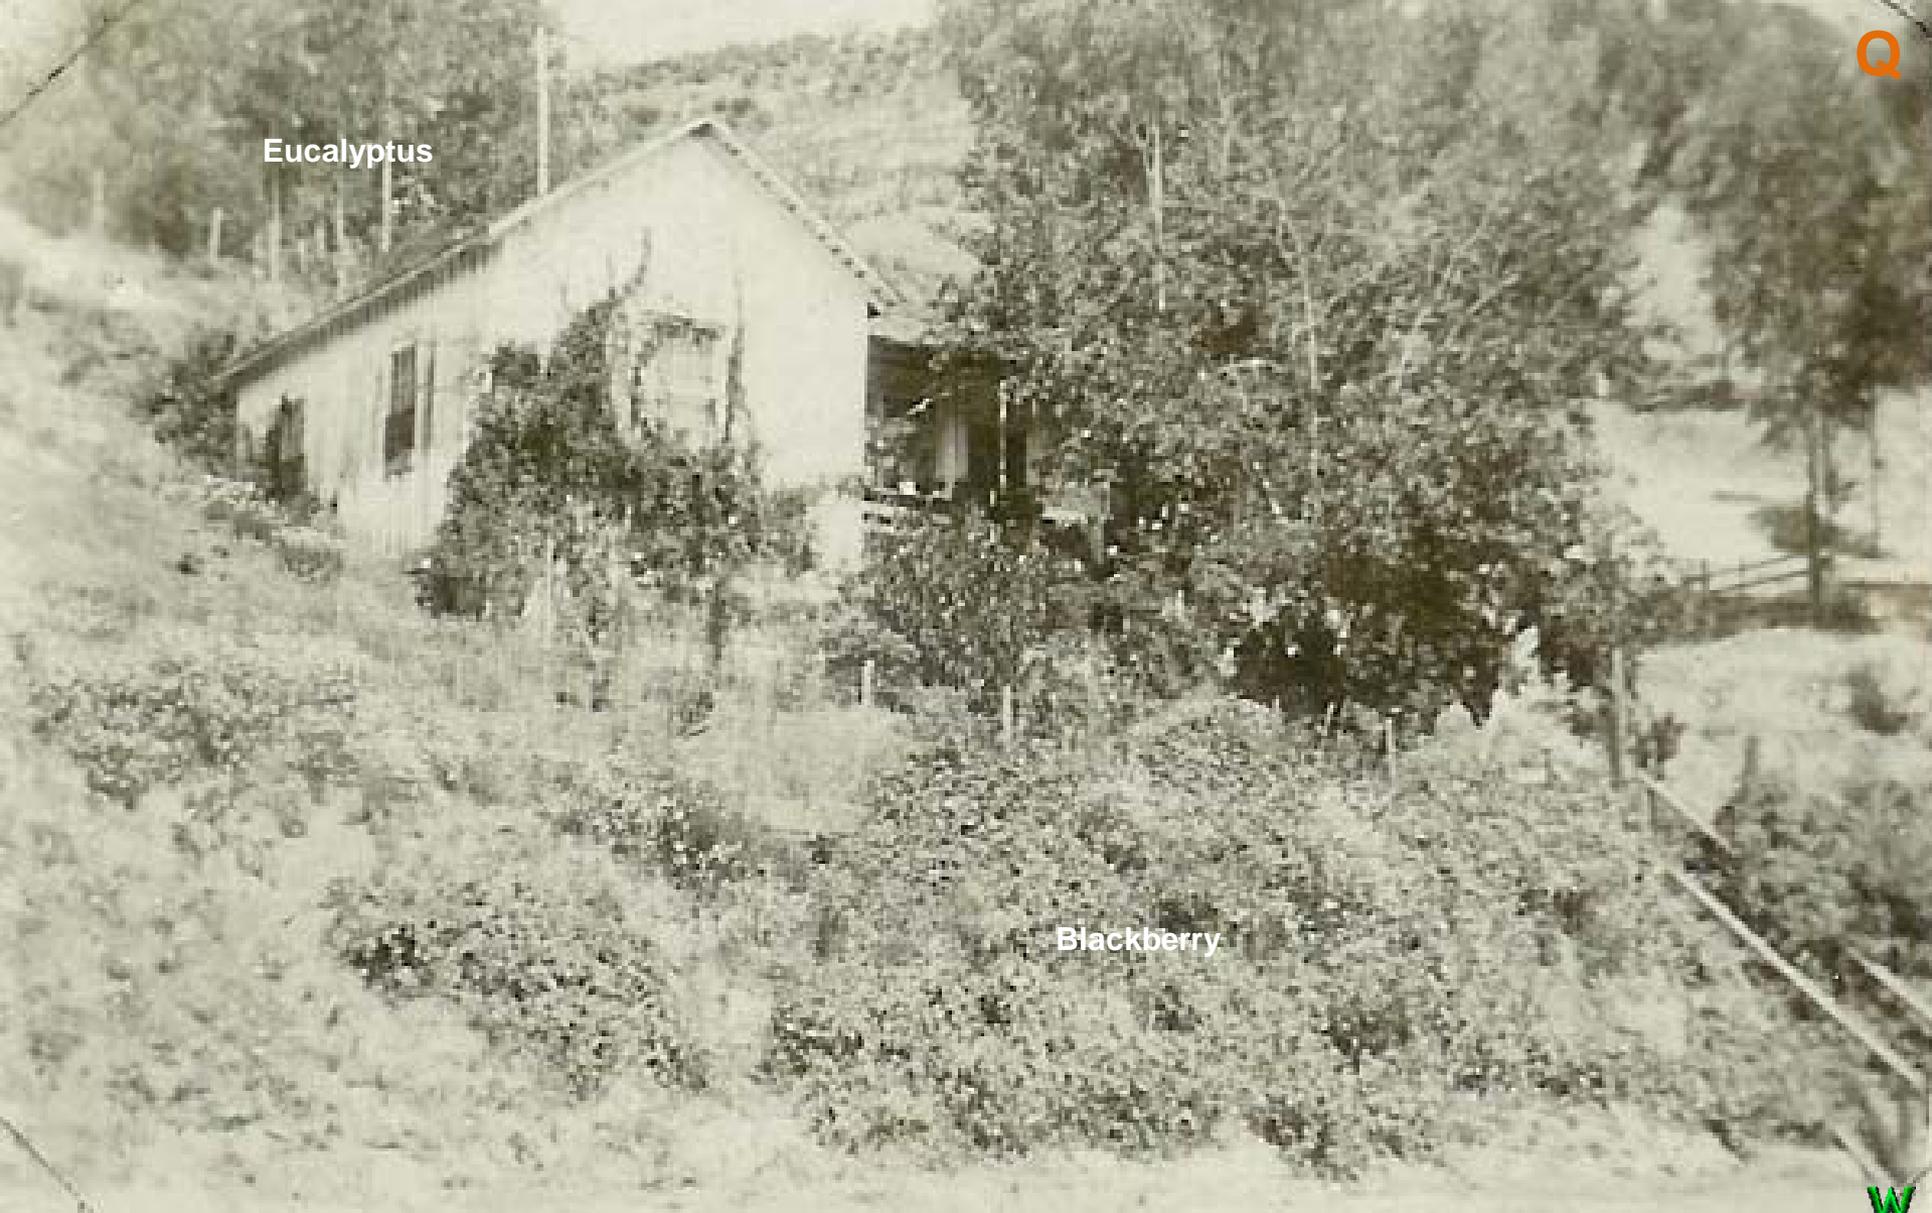
Another 300 feet down the road, this was Ed Fenn's house along Charlie Martin's road. It was graded level across and then rutted and eroded as the water channeled down the road to the right, leading to "deeper." The drainage channel with the Eucalyptus came down to the right of the stairs accepting that water and ending the Type II failure where the channel crossed the road. Despite the diversion from the County culvert. Note the embankment of blackberry below the house, the eucalyptus behind, and the stairs at the right front.

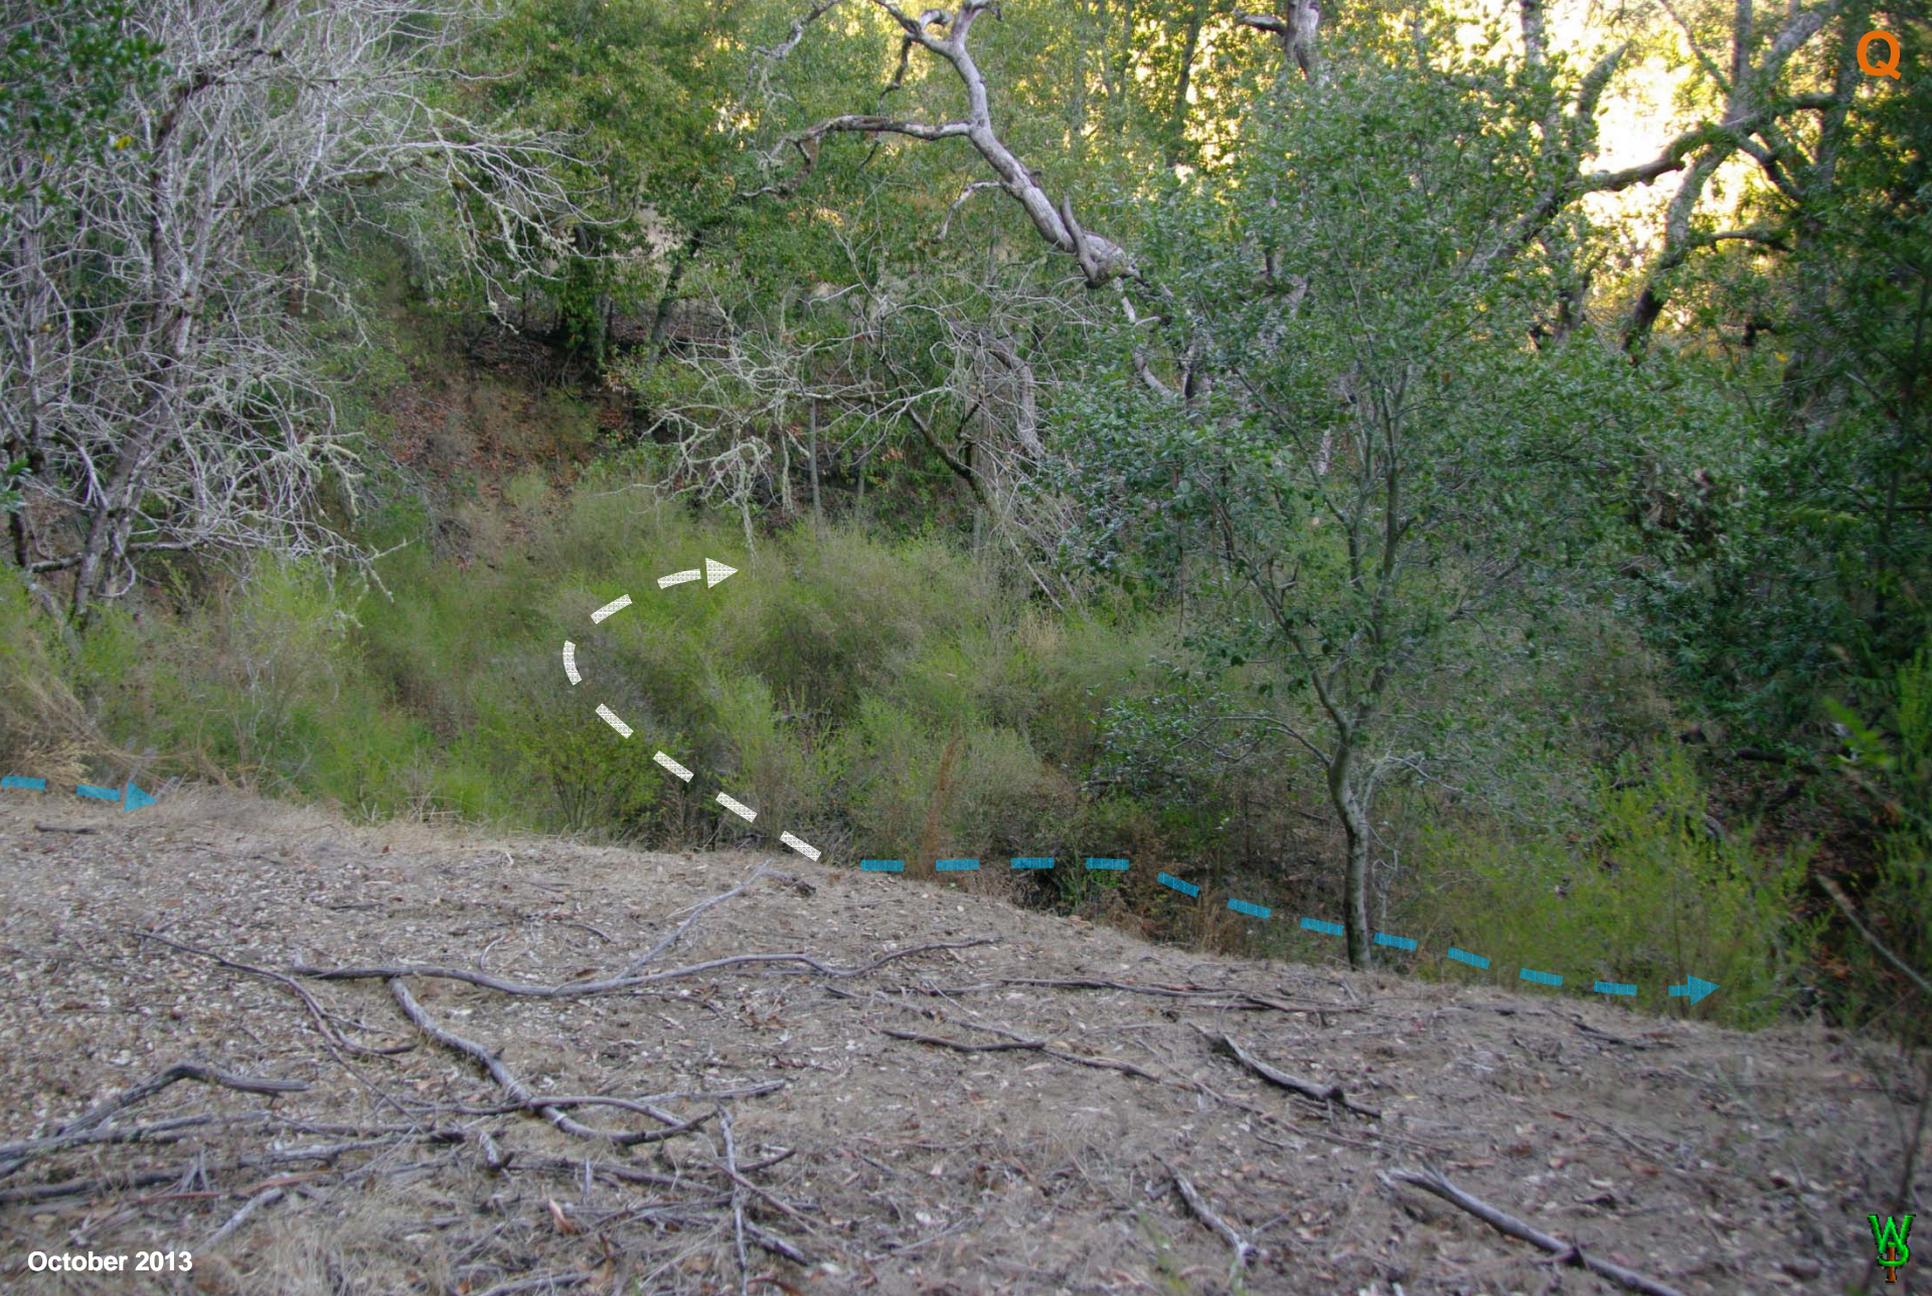
This is a view of that same spot today from closer to the edge (because of vegetation) and without benefit of the height of the porch. Obviously, it would be easier to see what happened without all that broom. I'll see what I can do to get a better image after the property owner and I cut some trees. The channel into which the water returned is indicated in blue.

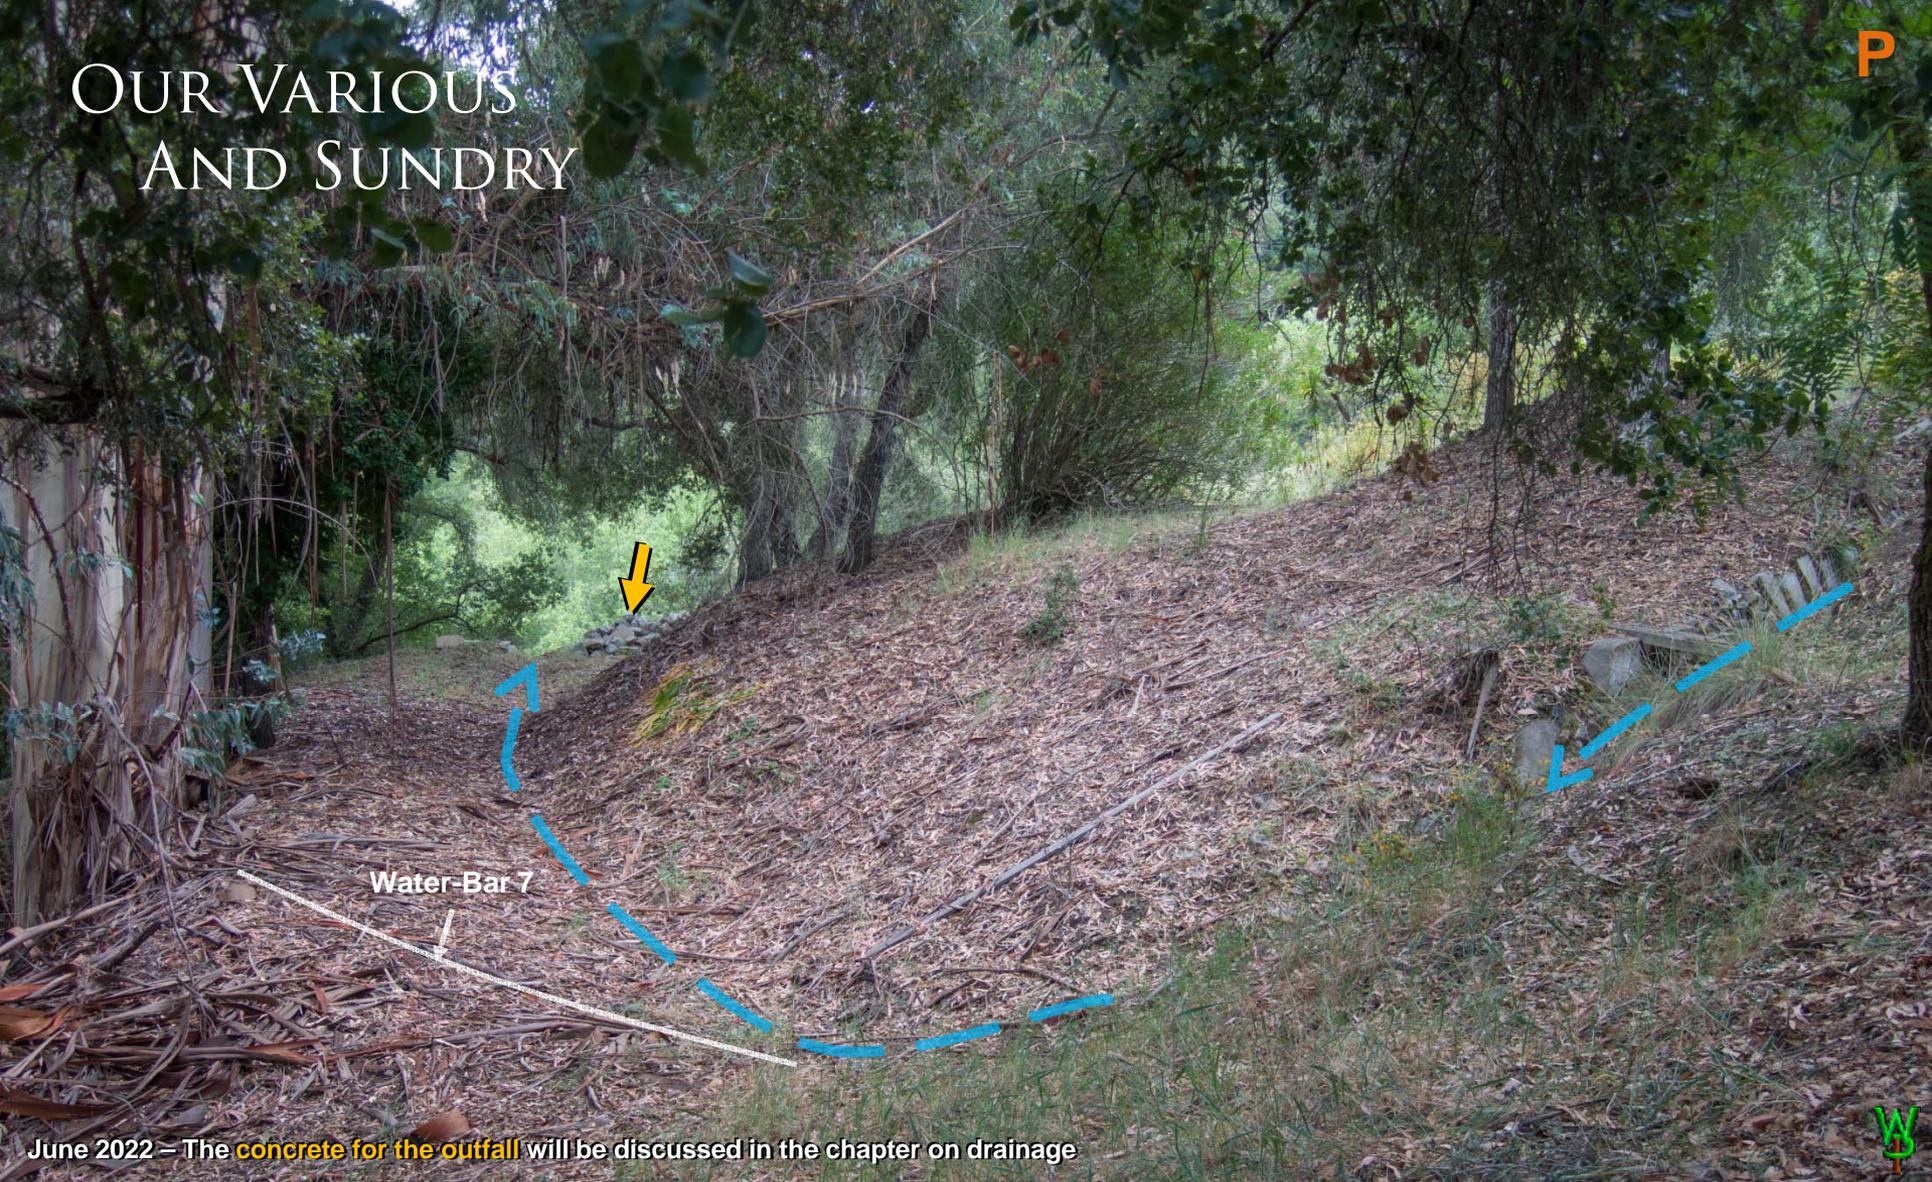
Water-Bar 7

June 2022 – The concrete for the outfall will be discussed in the chapter on drainage

Above that drainage outlet, I reshaped the road to an out-slope in 2006. This is typical of the design for timber haul roads today. It is virtually maintenance free and particularly resistant to gopher damage, because there is not enough water at any one point to enter a hole and turn it into a trench. So, why don't I do it elsewhere? I don't have the fill material I need and any dirt project adds to weeding.

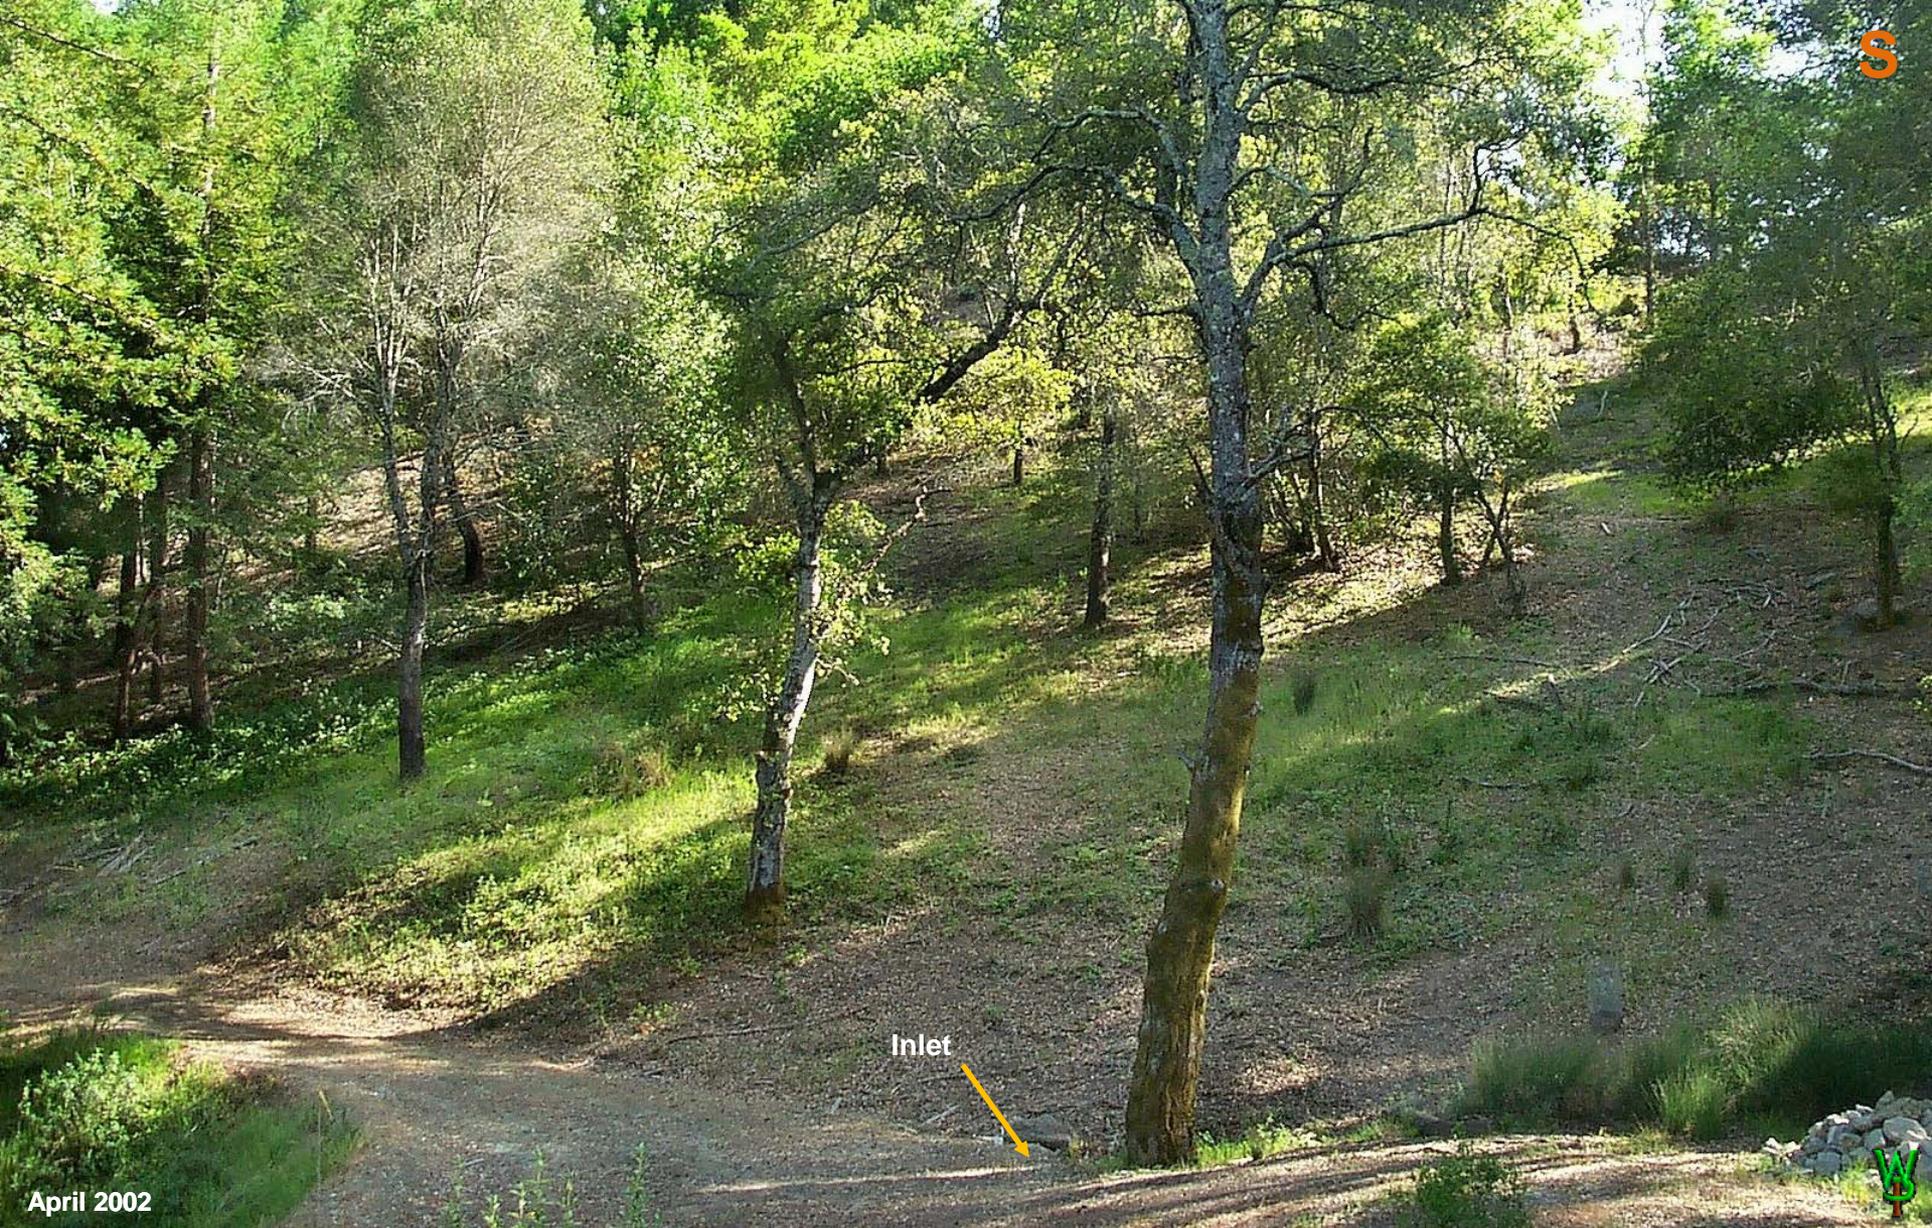
This road was reconstructed in 1993 to gain access to the redwood forest at left because it had blown out at this stream crossing long before. That job was followed with a series of improvements as I learned more about road design. I sloped the road grade outward in 2004 (next slide), added the rocked backup crossing surfaced with 3X5 granite gabion rock atop filter fabric in 2006, and finished with a splash channel and wall around the outlet of 5X10 gabion rock in 2015 when **the tree at the culvert inlet** finally went down. The culvert itself is now of current Forest Service design and otherwise unremarkable.

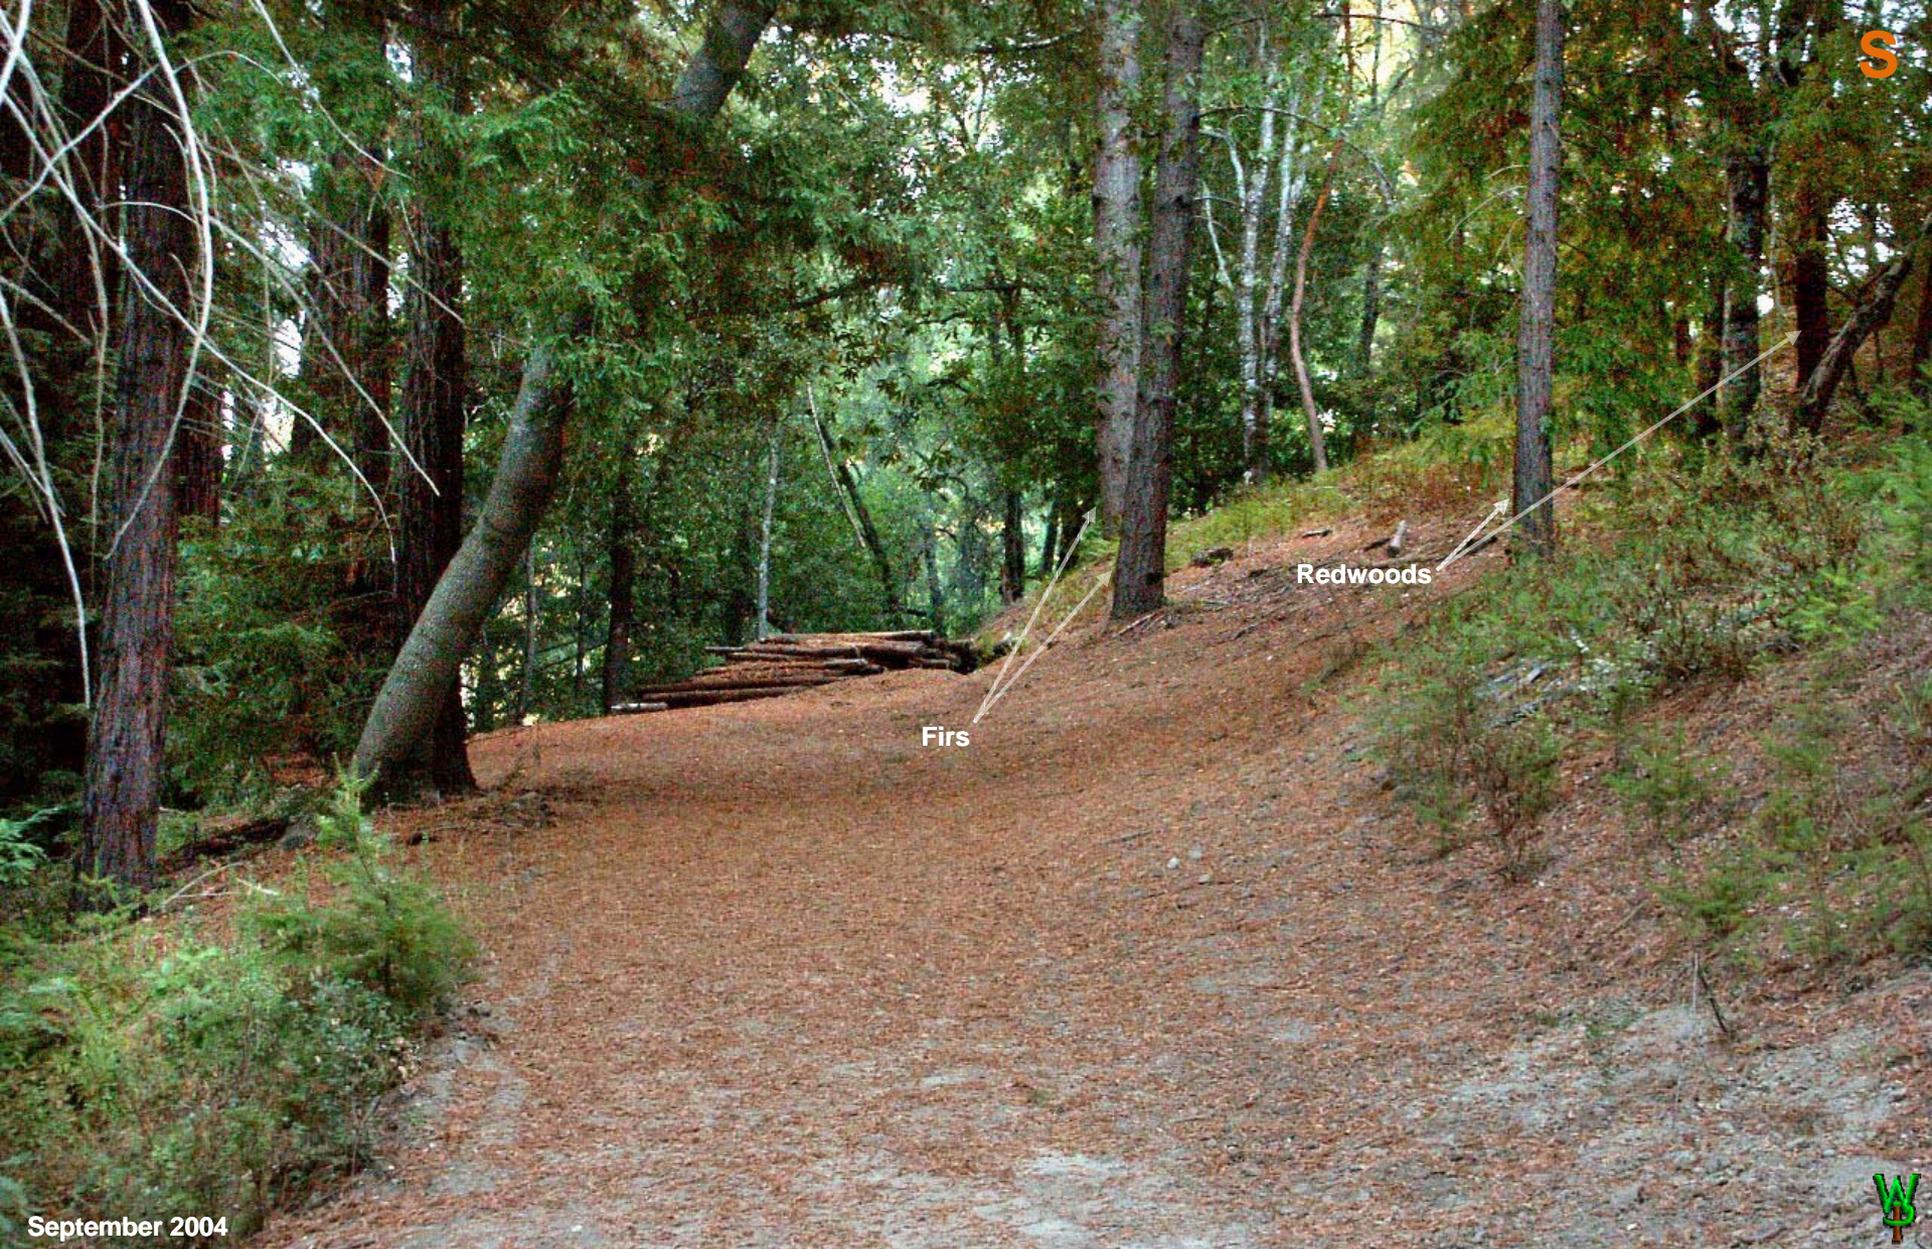
This old road was re-graded to get equipment in and material out for both forest thinning and fuel control. I first changed the grade from an in-sloped to this out- sloped configuration, making more room to turn around and reducing water through the culvert. It has has required no maintenance at all other than weeding. The two fir trees on the right were left as a windbreak and for high-lead yarding redwood logs out of the stand on the left. The young redwoods invading the upland to the right are now gone.

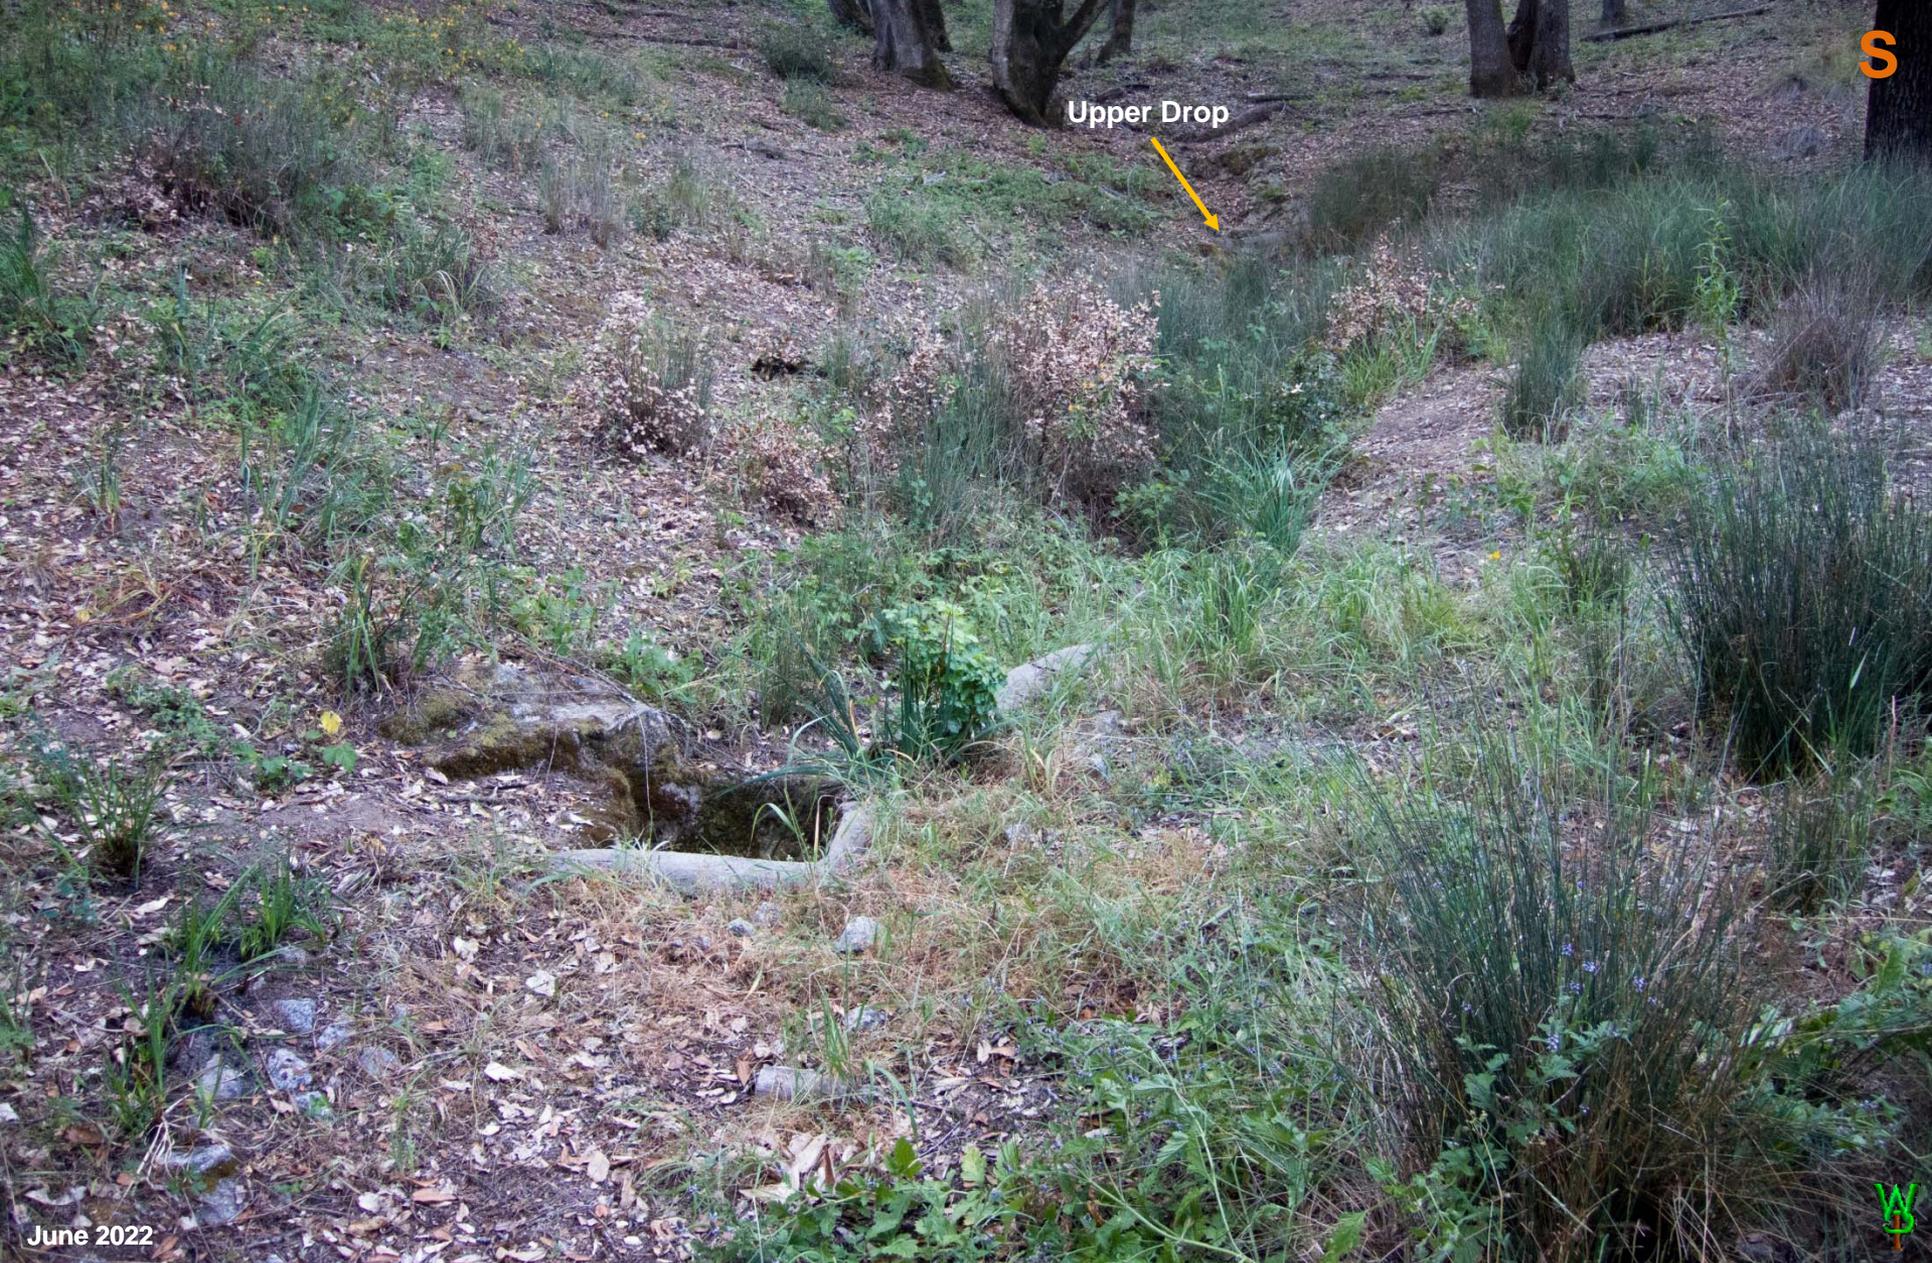
Upper Drop

What made this crossing particularly trouble free is how the water gets to it. **The upper drop** of mortared broken concrete is tall enough to allow a lower grade below it for slower water flow. I have rushes in that channel to act as a filter and slow the water down so that it won't carry twigs and such into the pipe inlet box. The channel grade has sufficient reserve capacity in its cross section that the water stays in it even if the vegetation captures something. Roads before drainage, drainage before roads...

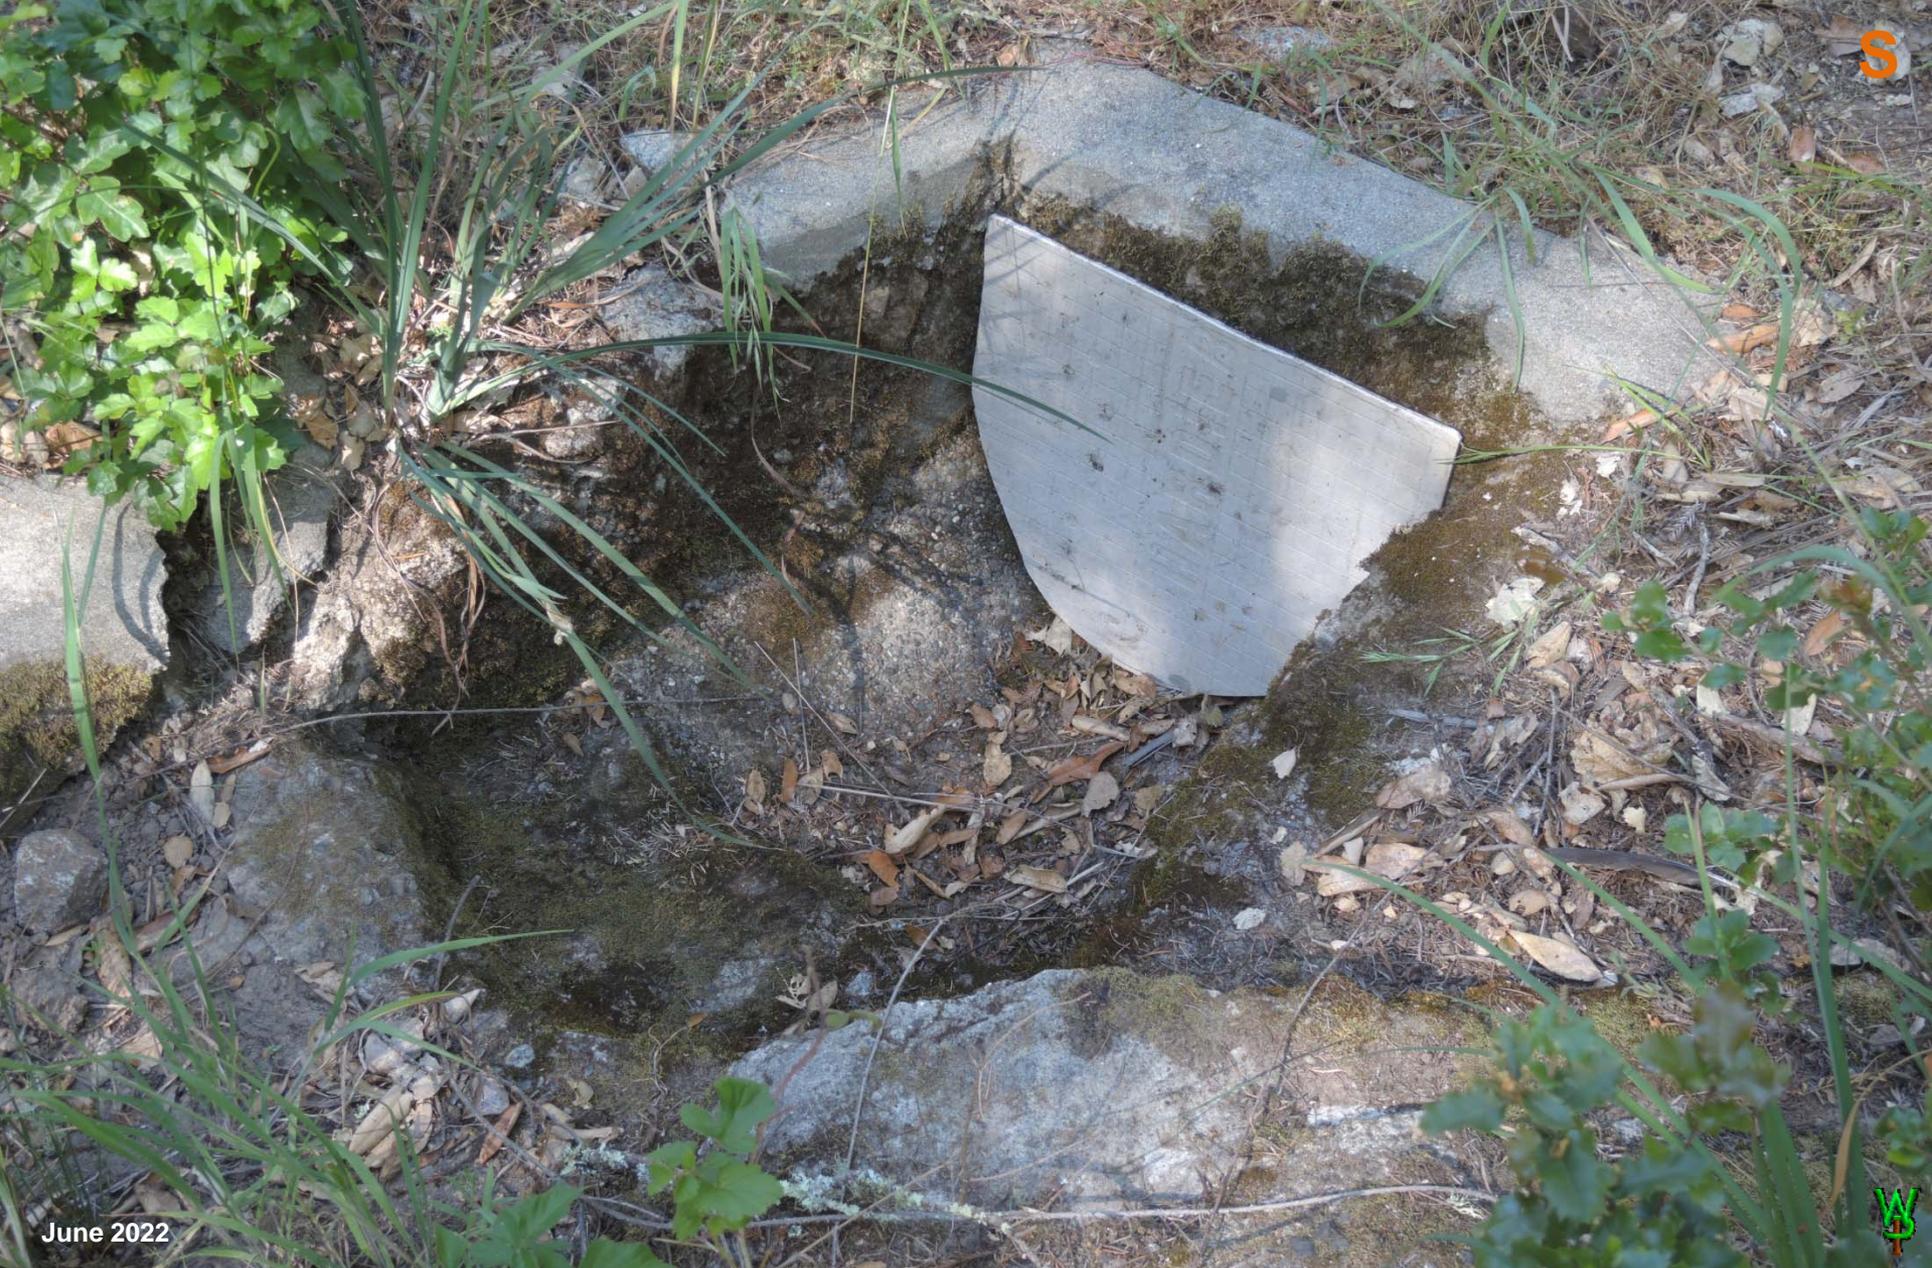
June 2022

This culvert is plastic. When the 2020 CZU Fire north of Santa Cruz got out of control, I bought some Hardiboard® and made shields to fit these culvert openings, figuring that if gases couldn't flow through they wouldn't burn. To lock them in takes only a sand bag. I never did find out if they would work, but I kept them as they don't take a lot of space and are quick to install. Because of the inlet design and vegetation to the left of this picture, there is no need for a trash rack here.

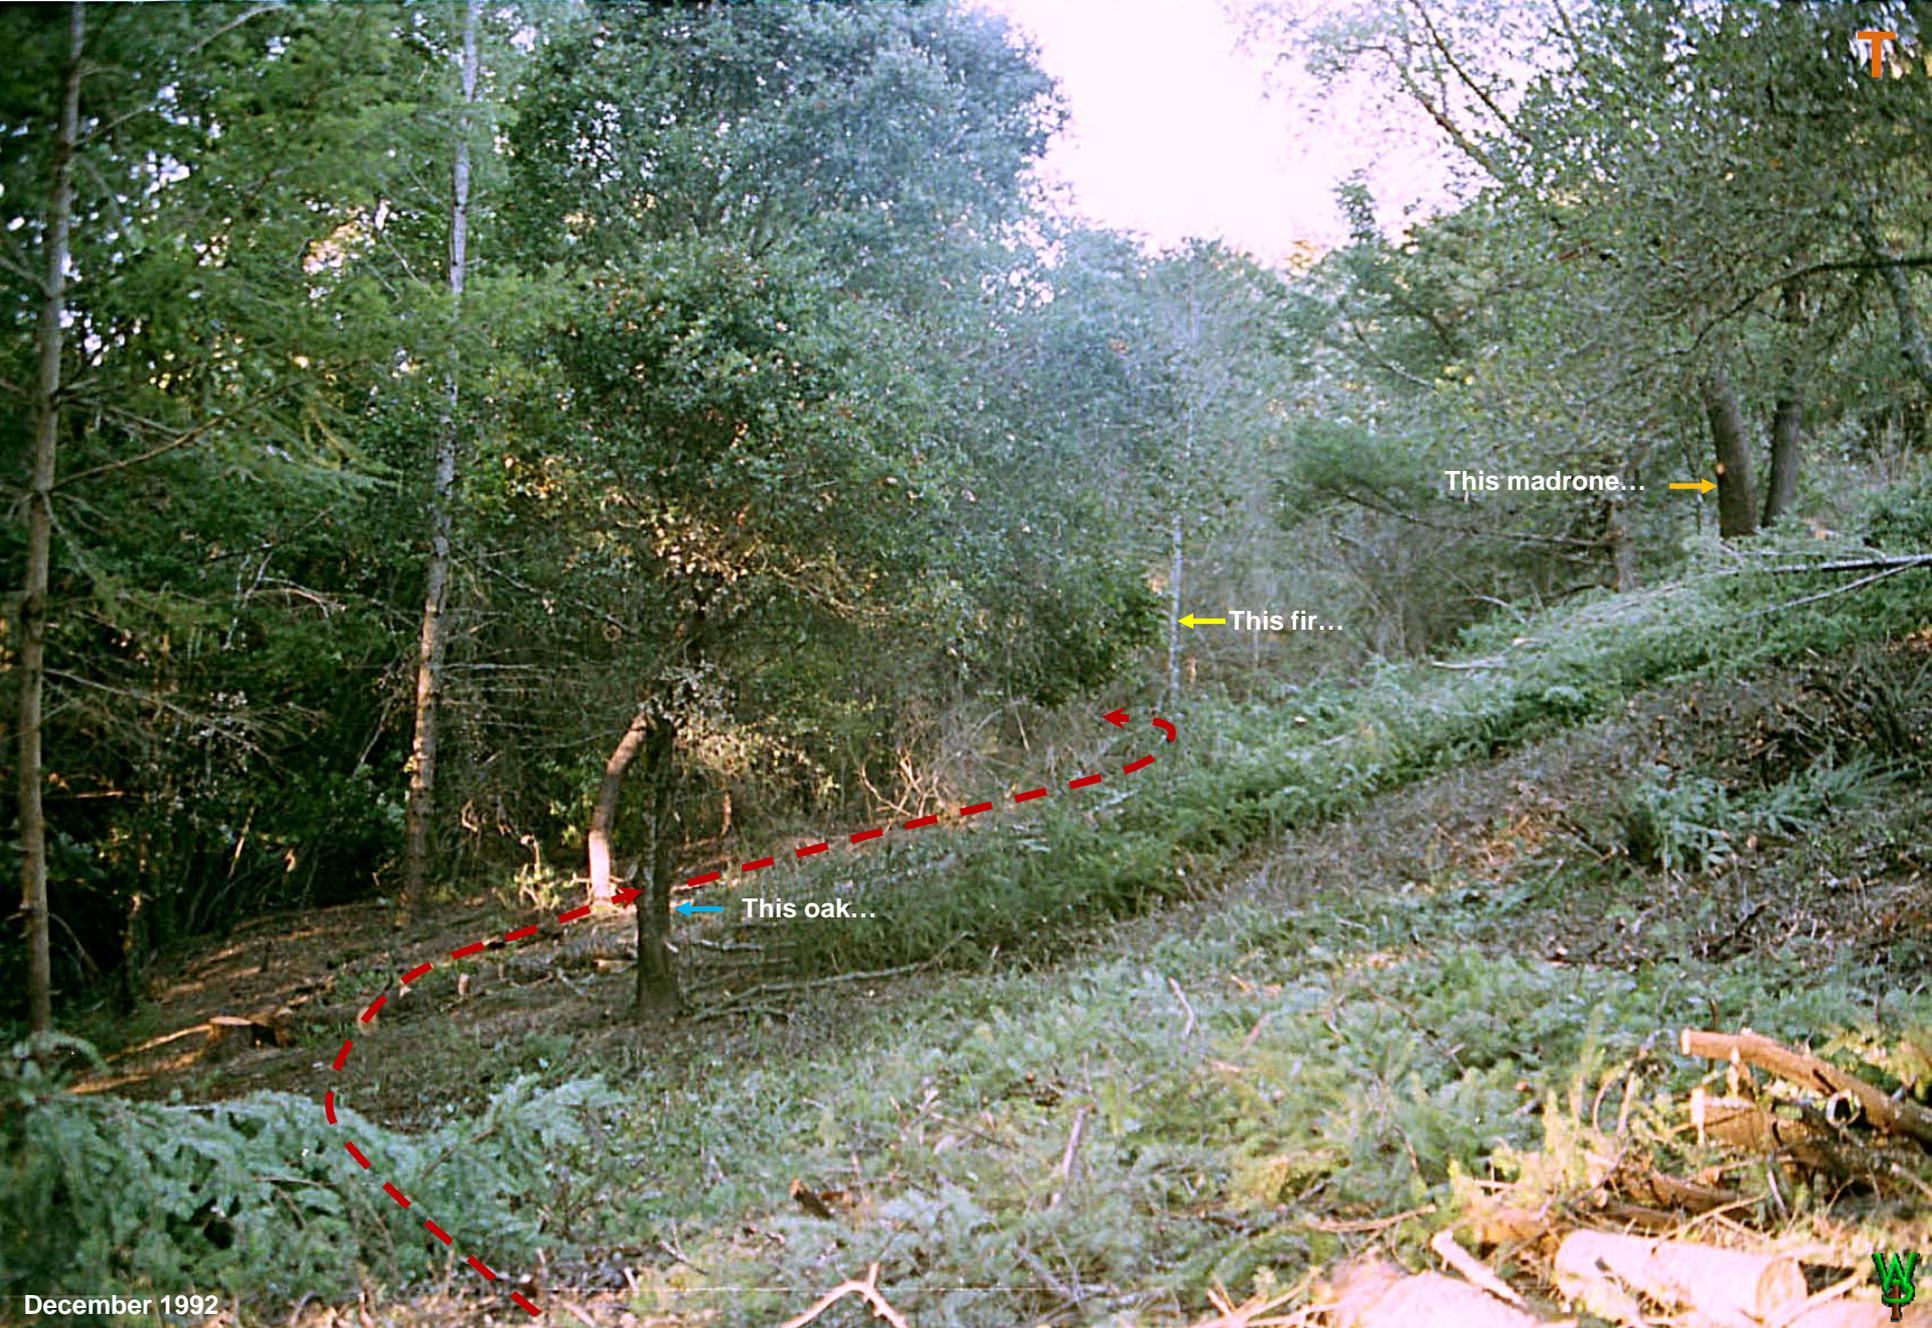
This project was to recover the use of a pre-existing road up to that crossing which wrapped around the redwood stand to the left. We also cut in a flat on the right under the madrone for a goat pen and small barn with a chicken coop below it to eat fly larvae.
