# ROADS TO HELL AND BACK, SOMEWHAT

# WILDERGARTEN 6.2

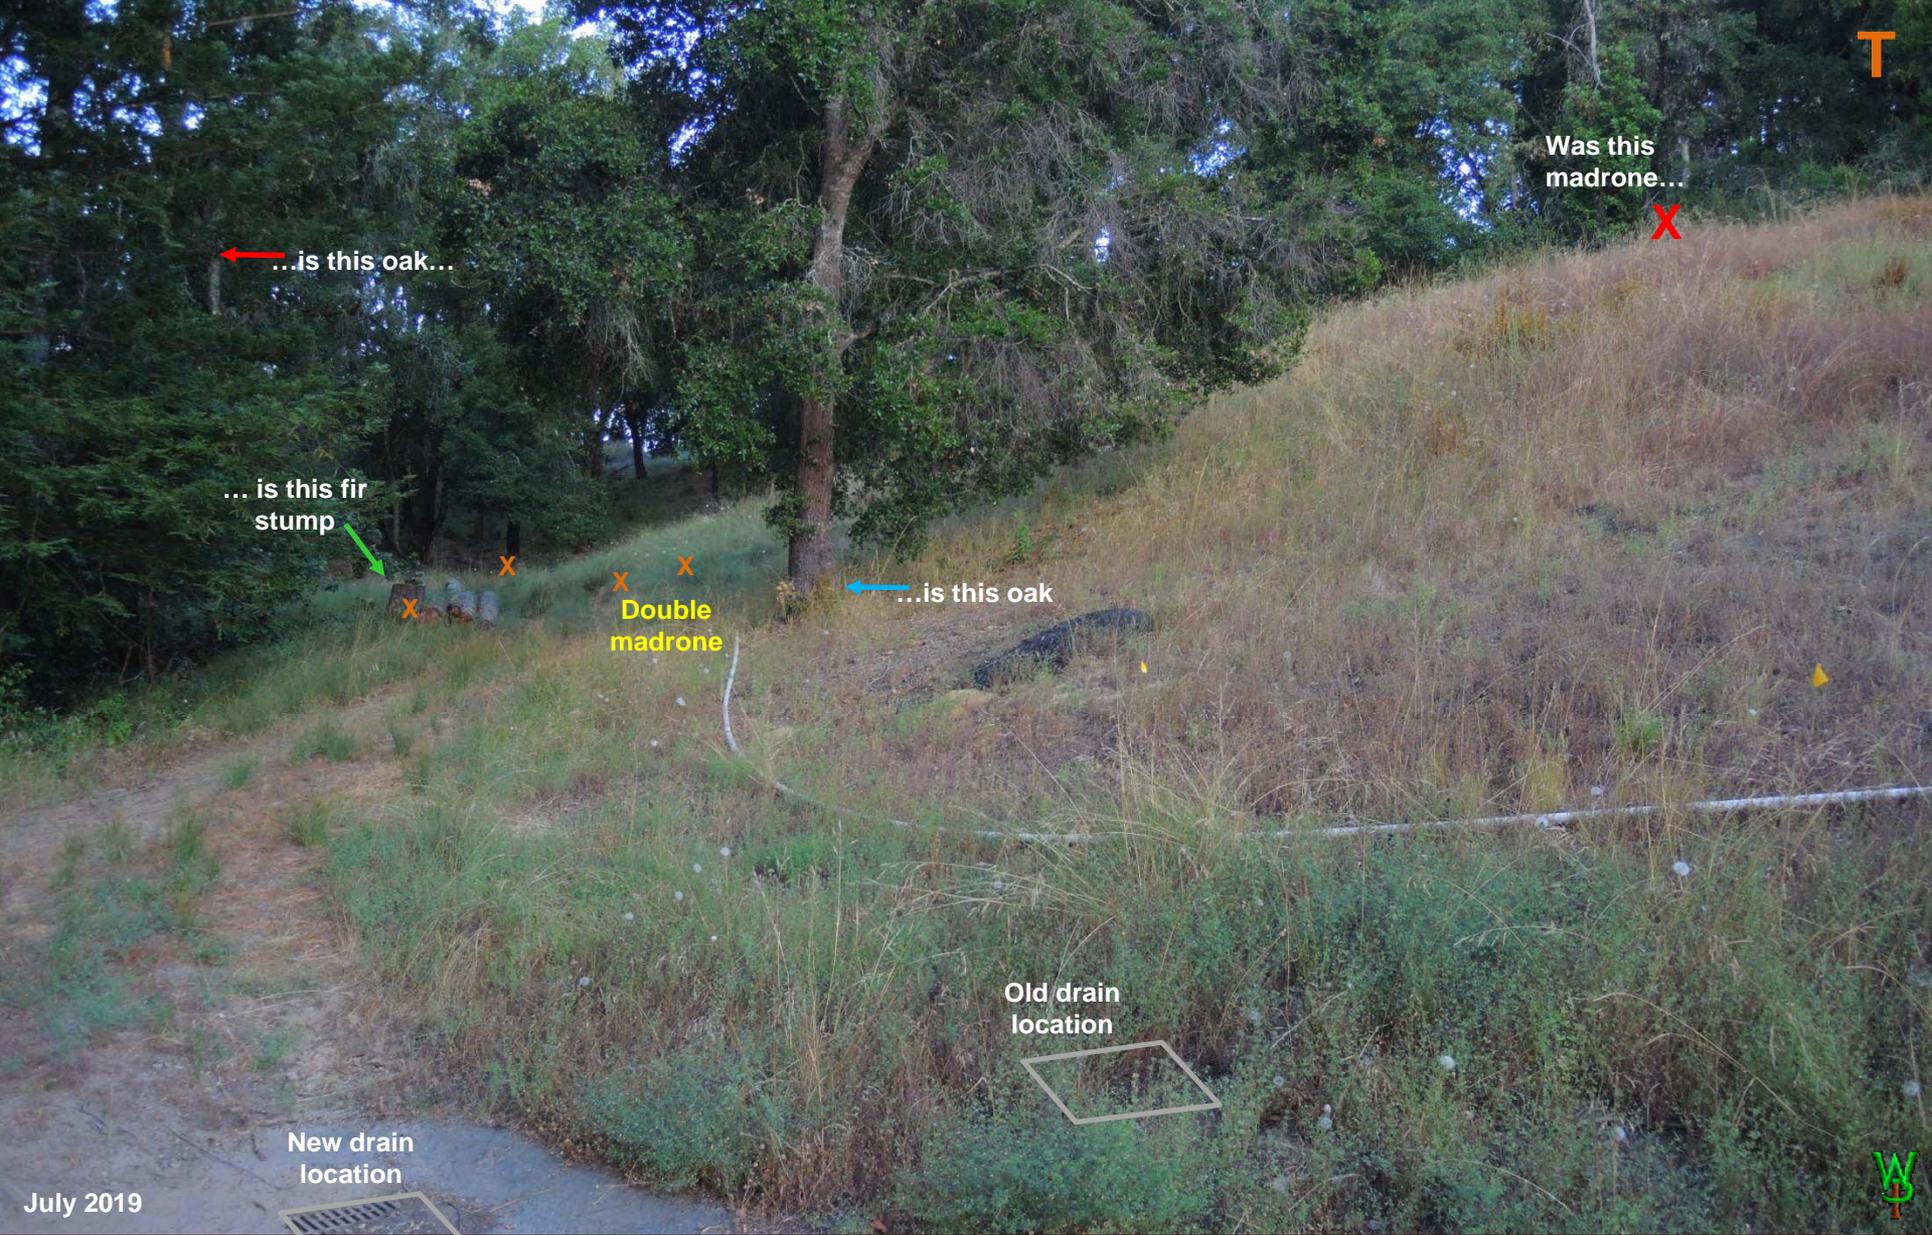
July 2019

I repented of that old road design in steps. In 2004 I added fill along the base of the slope on the right and moved the old drain because I never liked Roger's notch for water. I didn't have the fill to slope the road, so I used 4 cross ditches to divert water away from the culvert, which stopped the erosion from the discharge. I added another 60yds of fill in 2016 from the embankment job (to come) to slope the grade outward, eliminating all but one of the ditches. I plan to add another 40 yards I acquired from the County's reconstruction of a failure in February 2017, now stockpiled to finish that slope and ease the transition turning up the ramp to the flat.

“Strategically placed”  
branches direct flow  
over this stump hump  
and away from the  
steeper slope at left

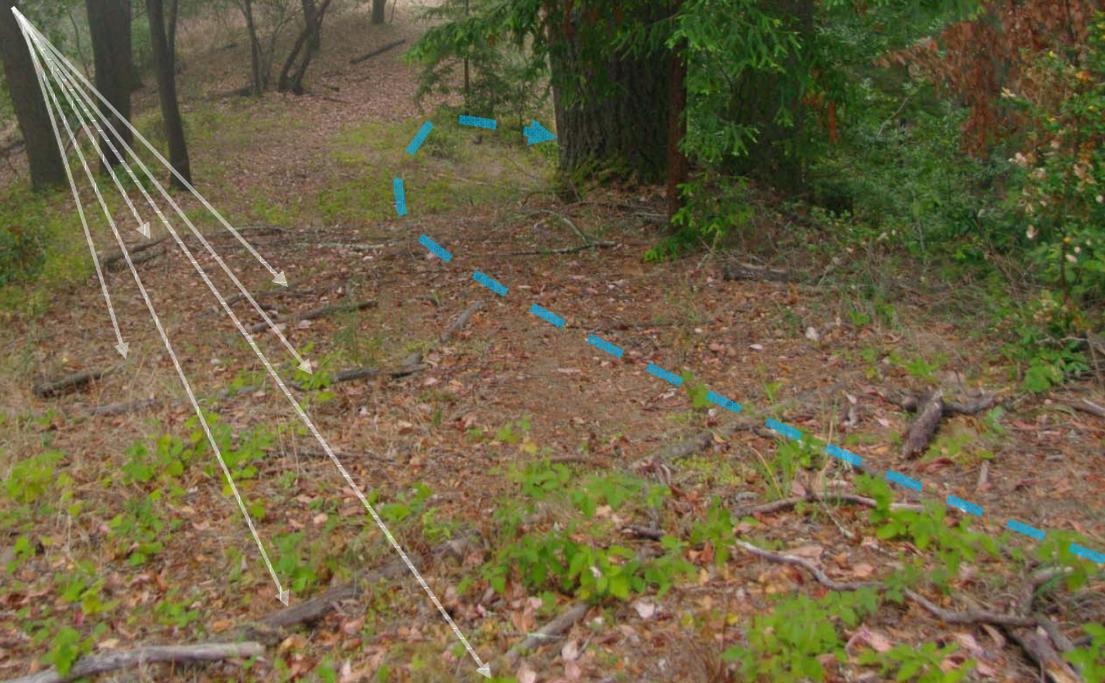
This narrow ridge extending eastward from the same flat has very steep sidewalls. If the culvert above fails; then there is no good place to drop the water from the flat above off to the sides. So the road is graded to carry drainage down the spine of the ridge while slowing the water and retaining it atop the spine of the ridge with strategically placed and angled branches, losing altitude until I could divert it to the right into where the slope to the channel below was much more gradual. Still, the propensity for a convex surface is to break up the flow into smaller and more chaotic flows, thus reducing concentrated flows. The branches last about 15 years.

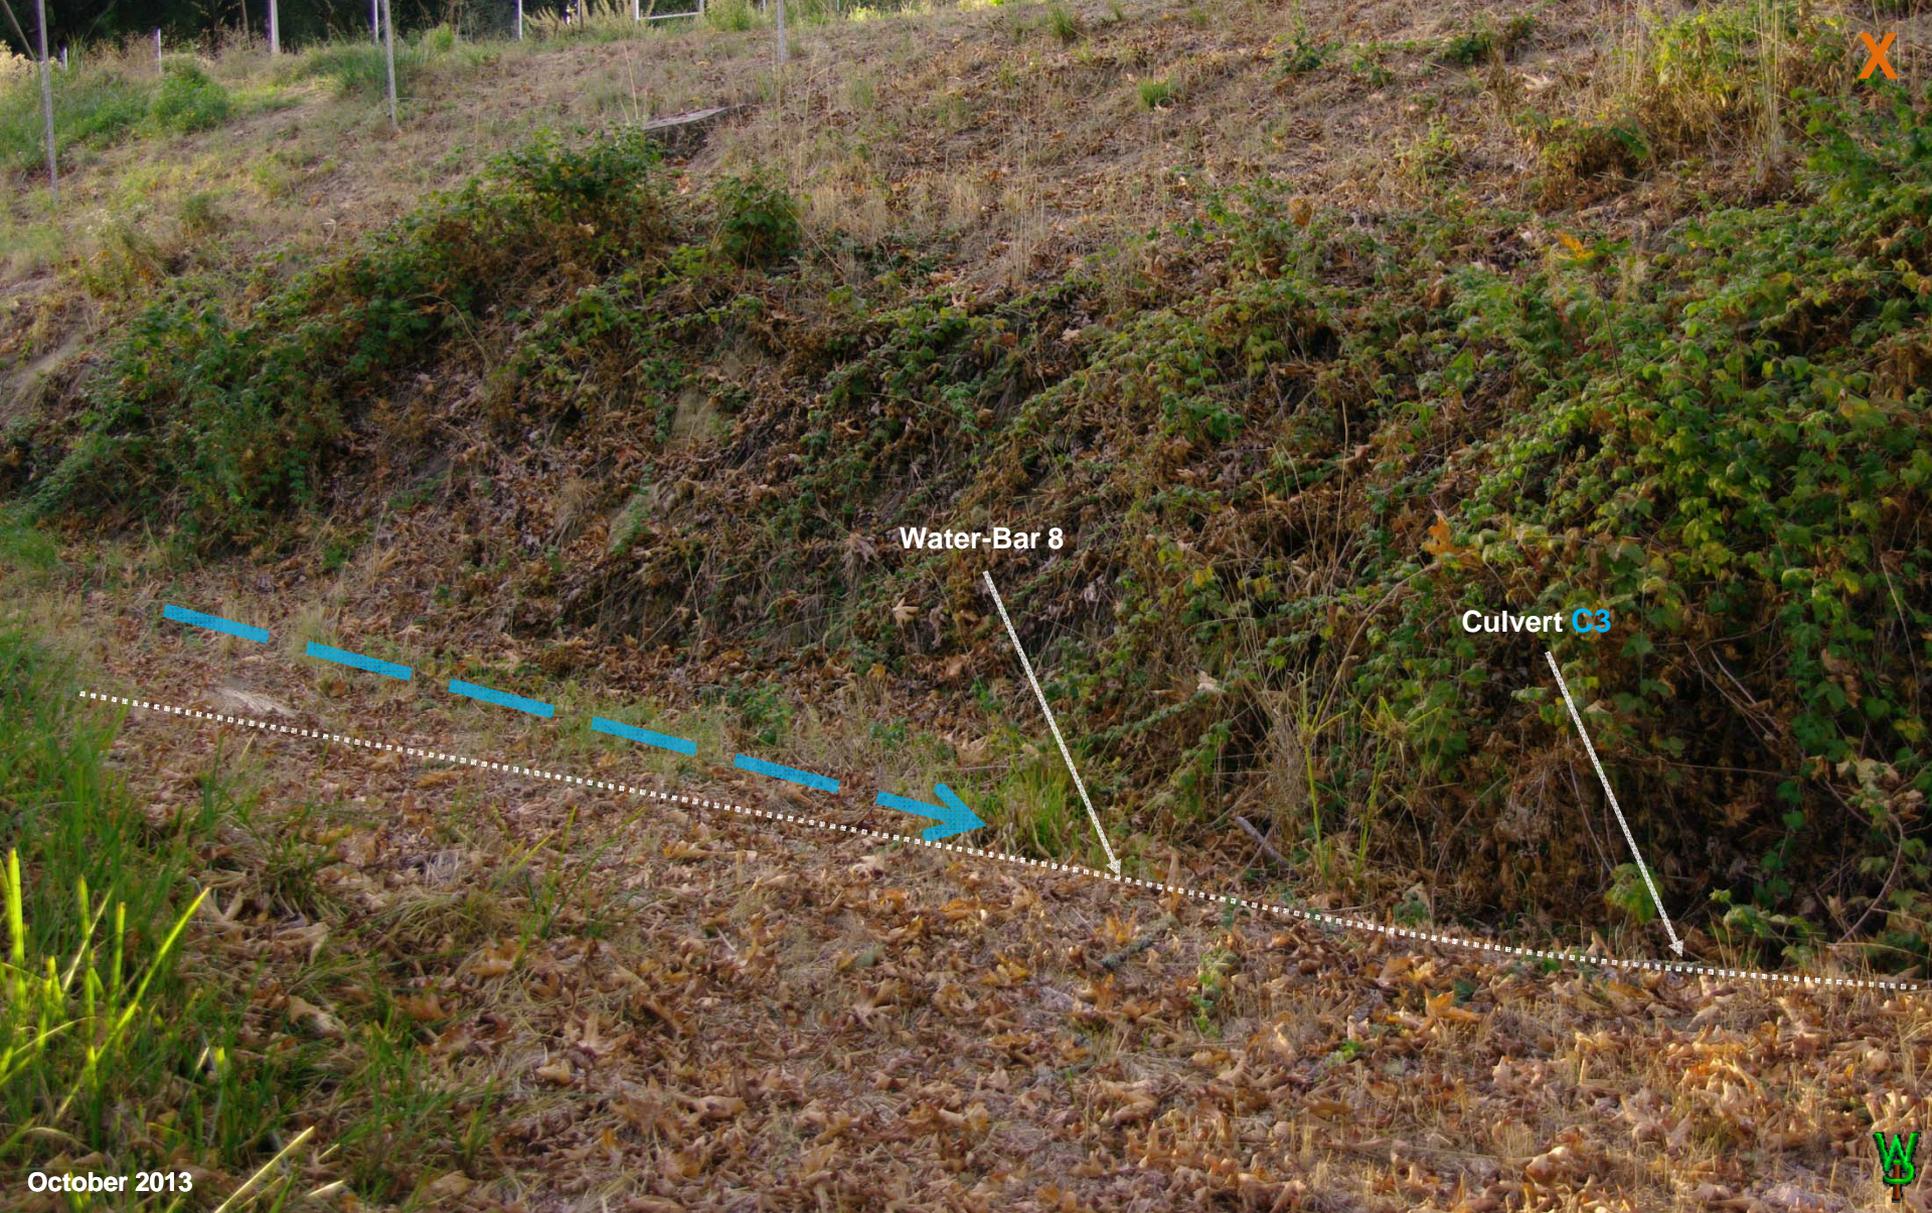
But are all my roads perfect? No! There are some that could be better, particularly in how they collect water. The problem with this culvert is that the east facing slope on the northern half of this place (down to the left) is so steep, there is no better place to run the water down. Sometimes you have to make one, as we did in the case of the rock drainages you will see. That just takes time and money to get done. I've done two channels 7-10 years apart with this and another left to do. Hopefully I will have the situation corrected within my lifetime. In any case, as I reduce the collection area above it, this one gets its ditch and culvert head cleaned.

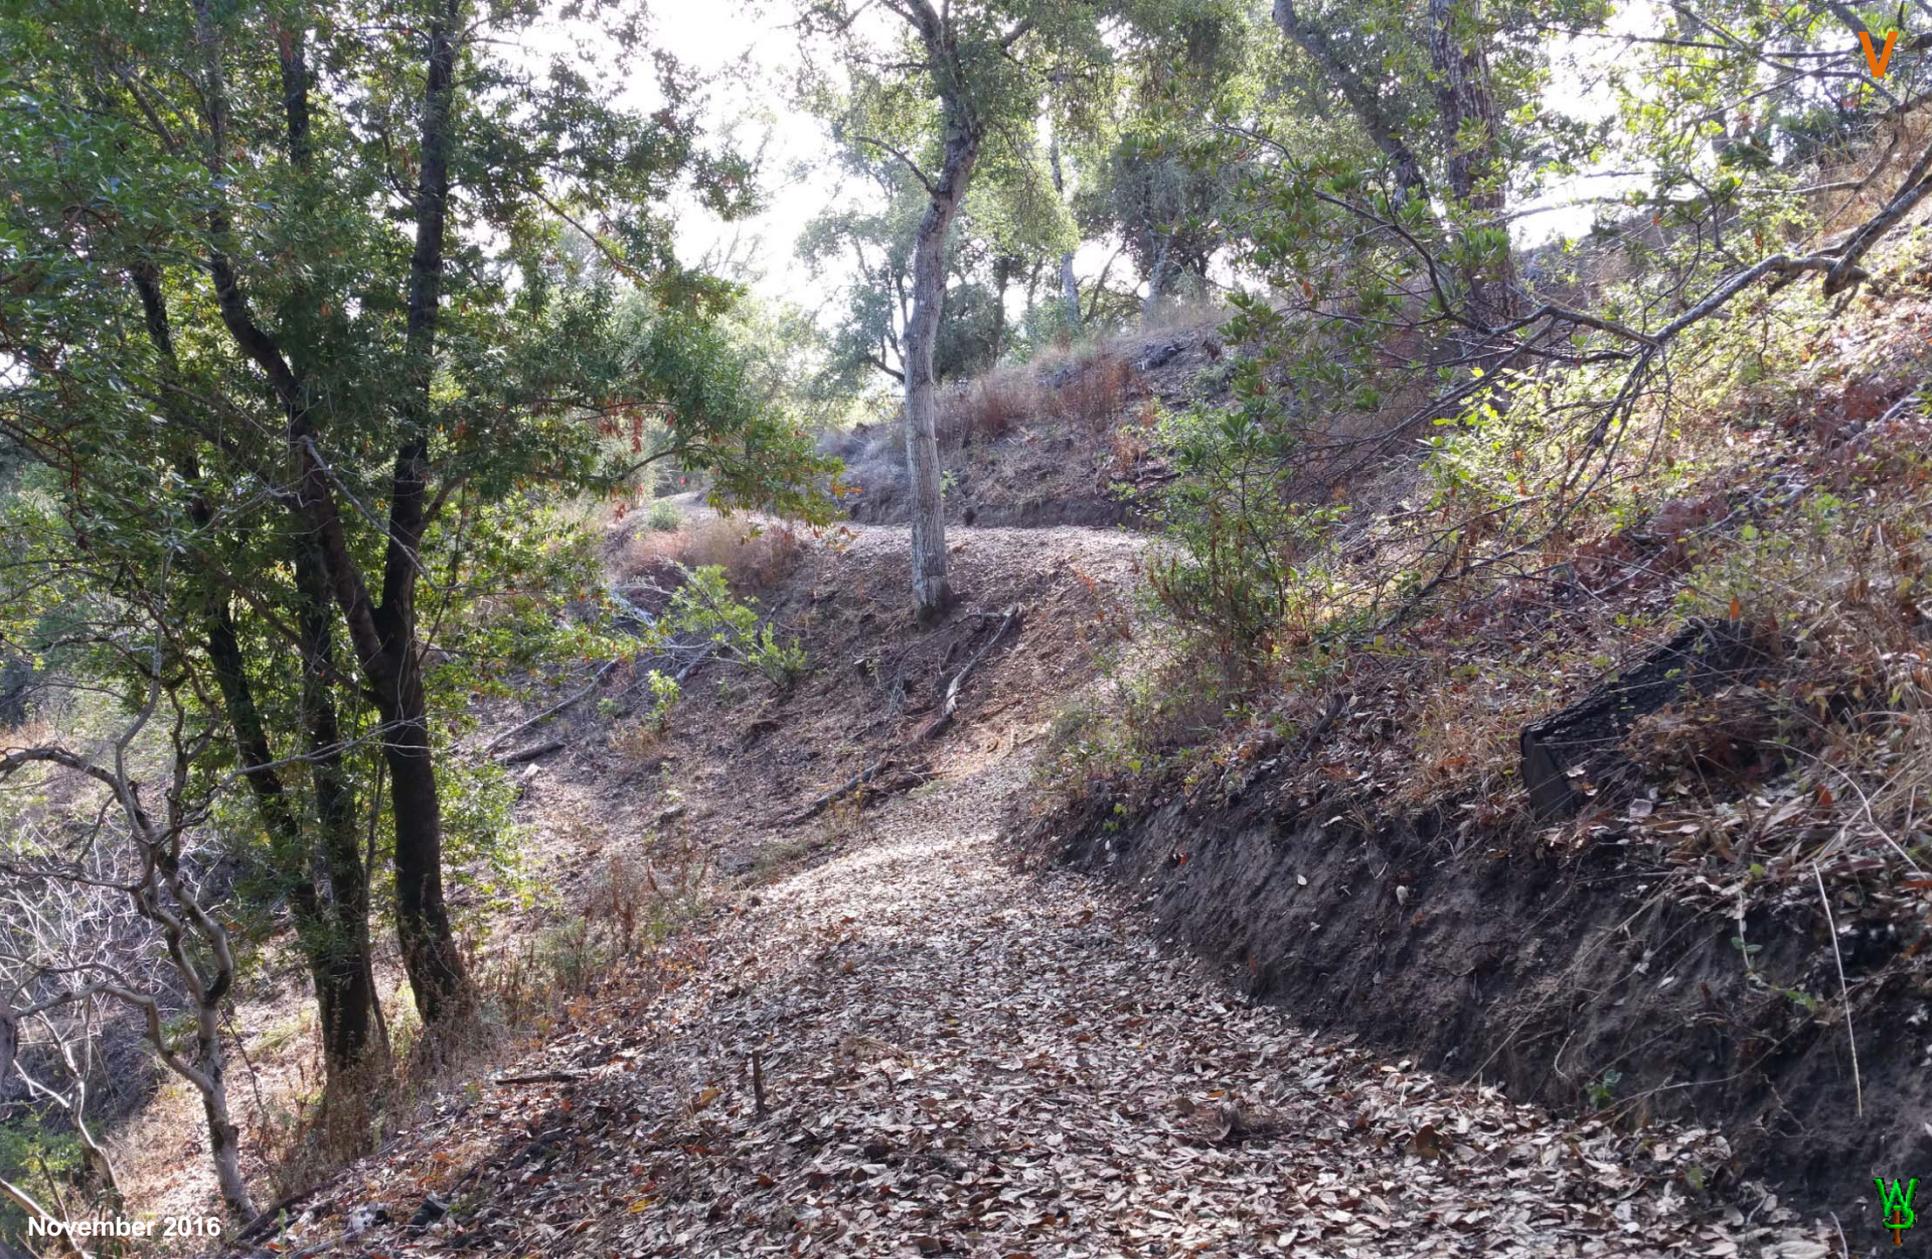
November 2016

Making trails is a lot of work. A small excavator capable of digging one cannot make an out-sloped surface (too dangerous to the operator when he catches a root). The out-slope gets built by pulling material back up to the uphill side of the path with a rake, or in buckets and chipping off the top edge of the cut from above with a pick. Clods were broken with a vibratory plate. Then hand-rake the surface. Water and pack it with the vibe plate. Then "pave" it with leafy duff to protect it from raindrop impingement.

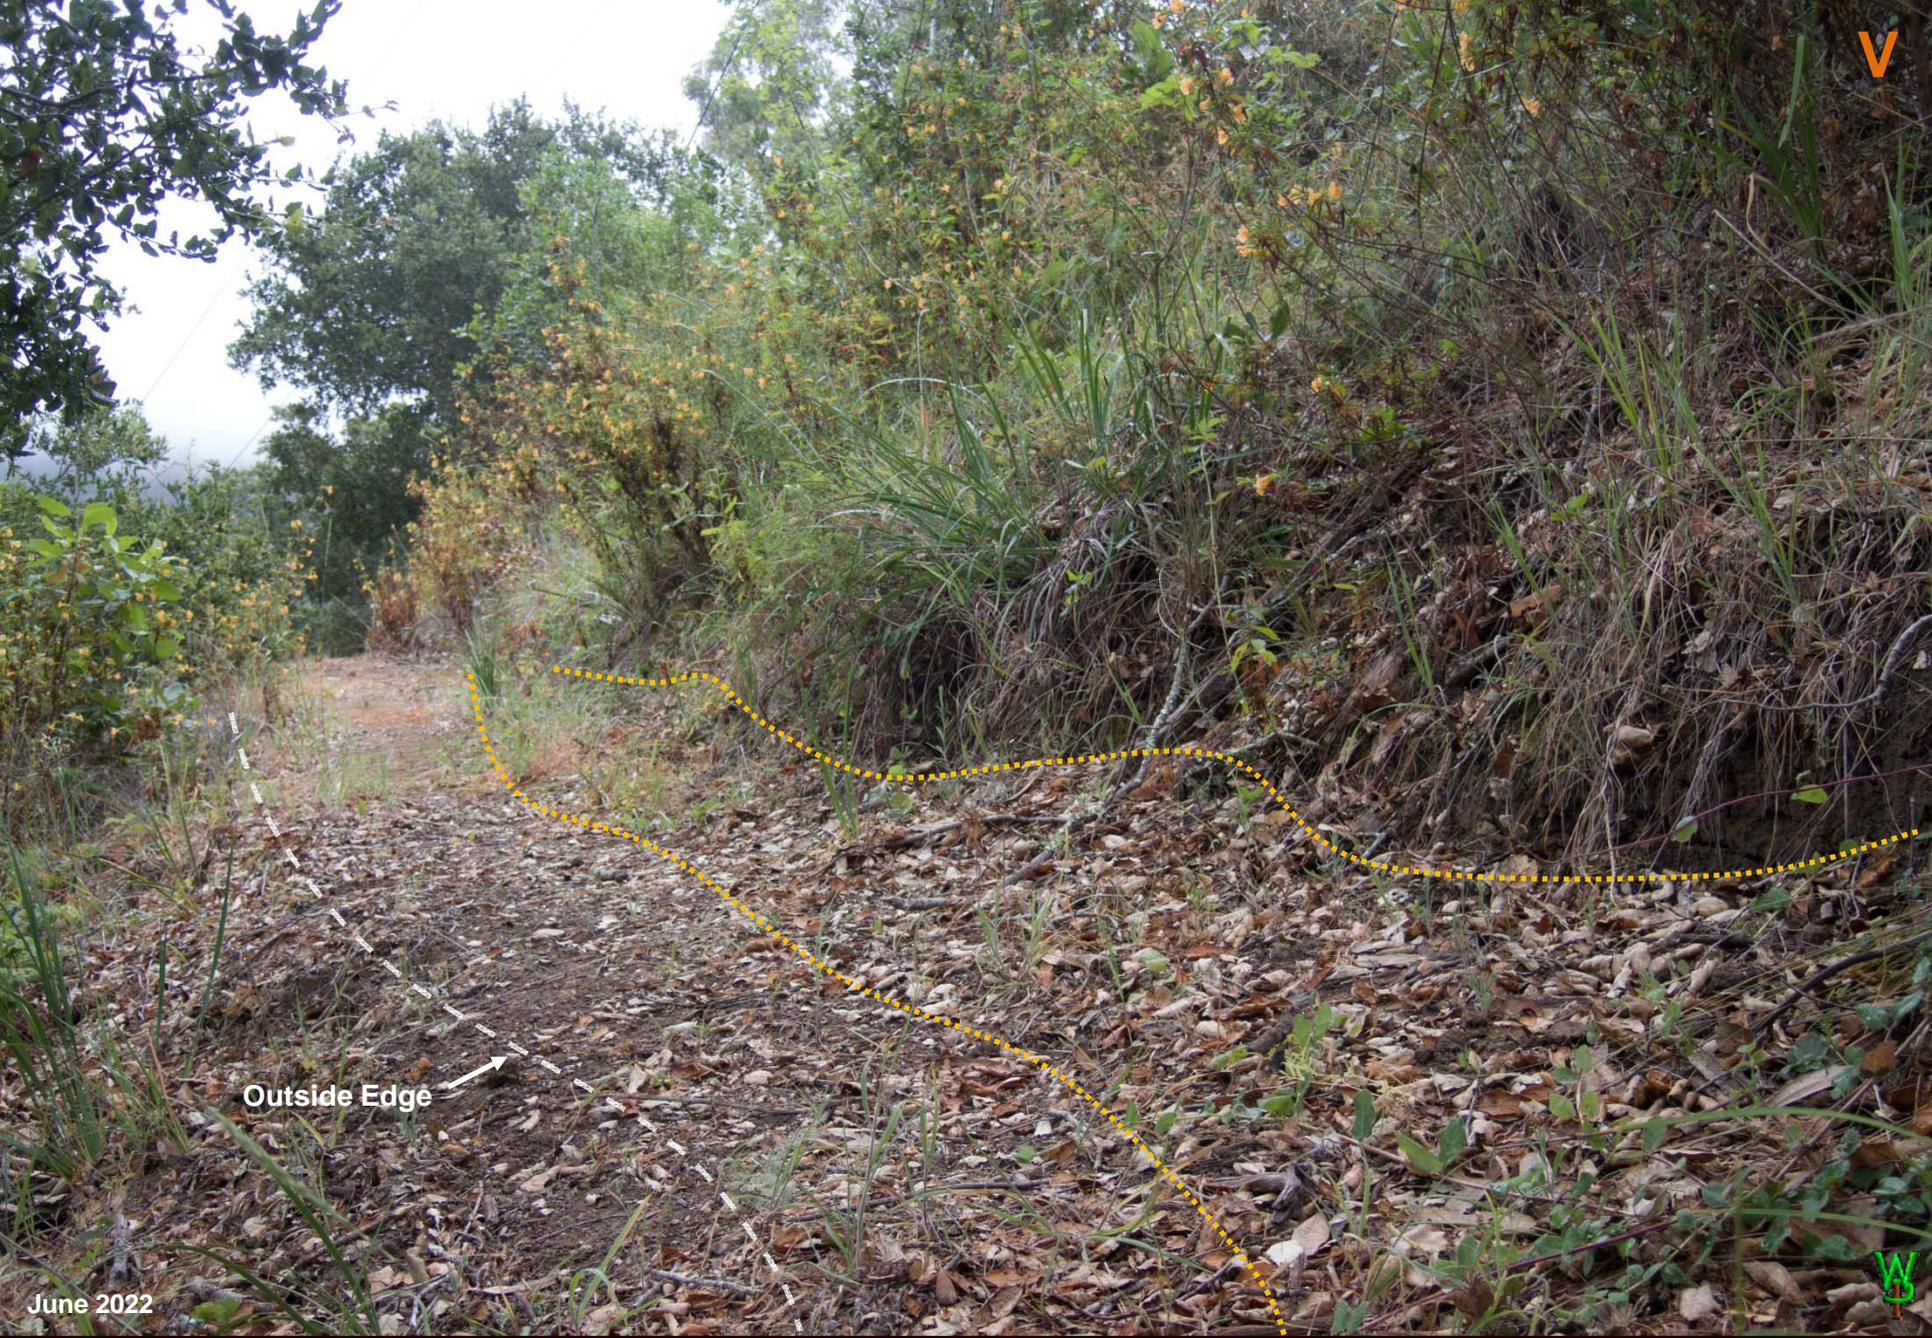
Outside Edge

Trails teach how fast surface erosion in these Mountains really is. The inside edge builds a **sluff bank over half its width** in only a few years, then demanding a transit with a shovel, packing gopher holes (and setting traps), spreading seed... makes for a nice day.

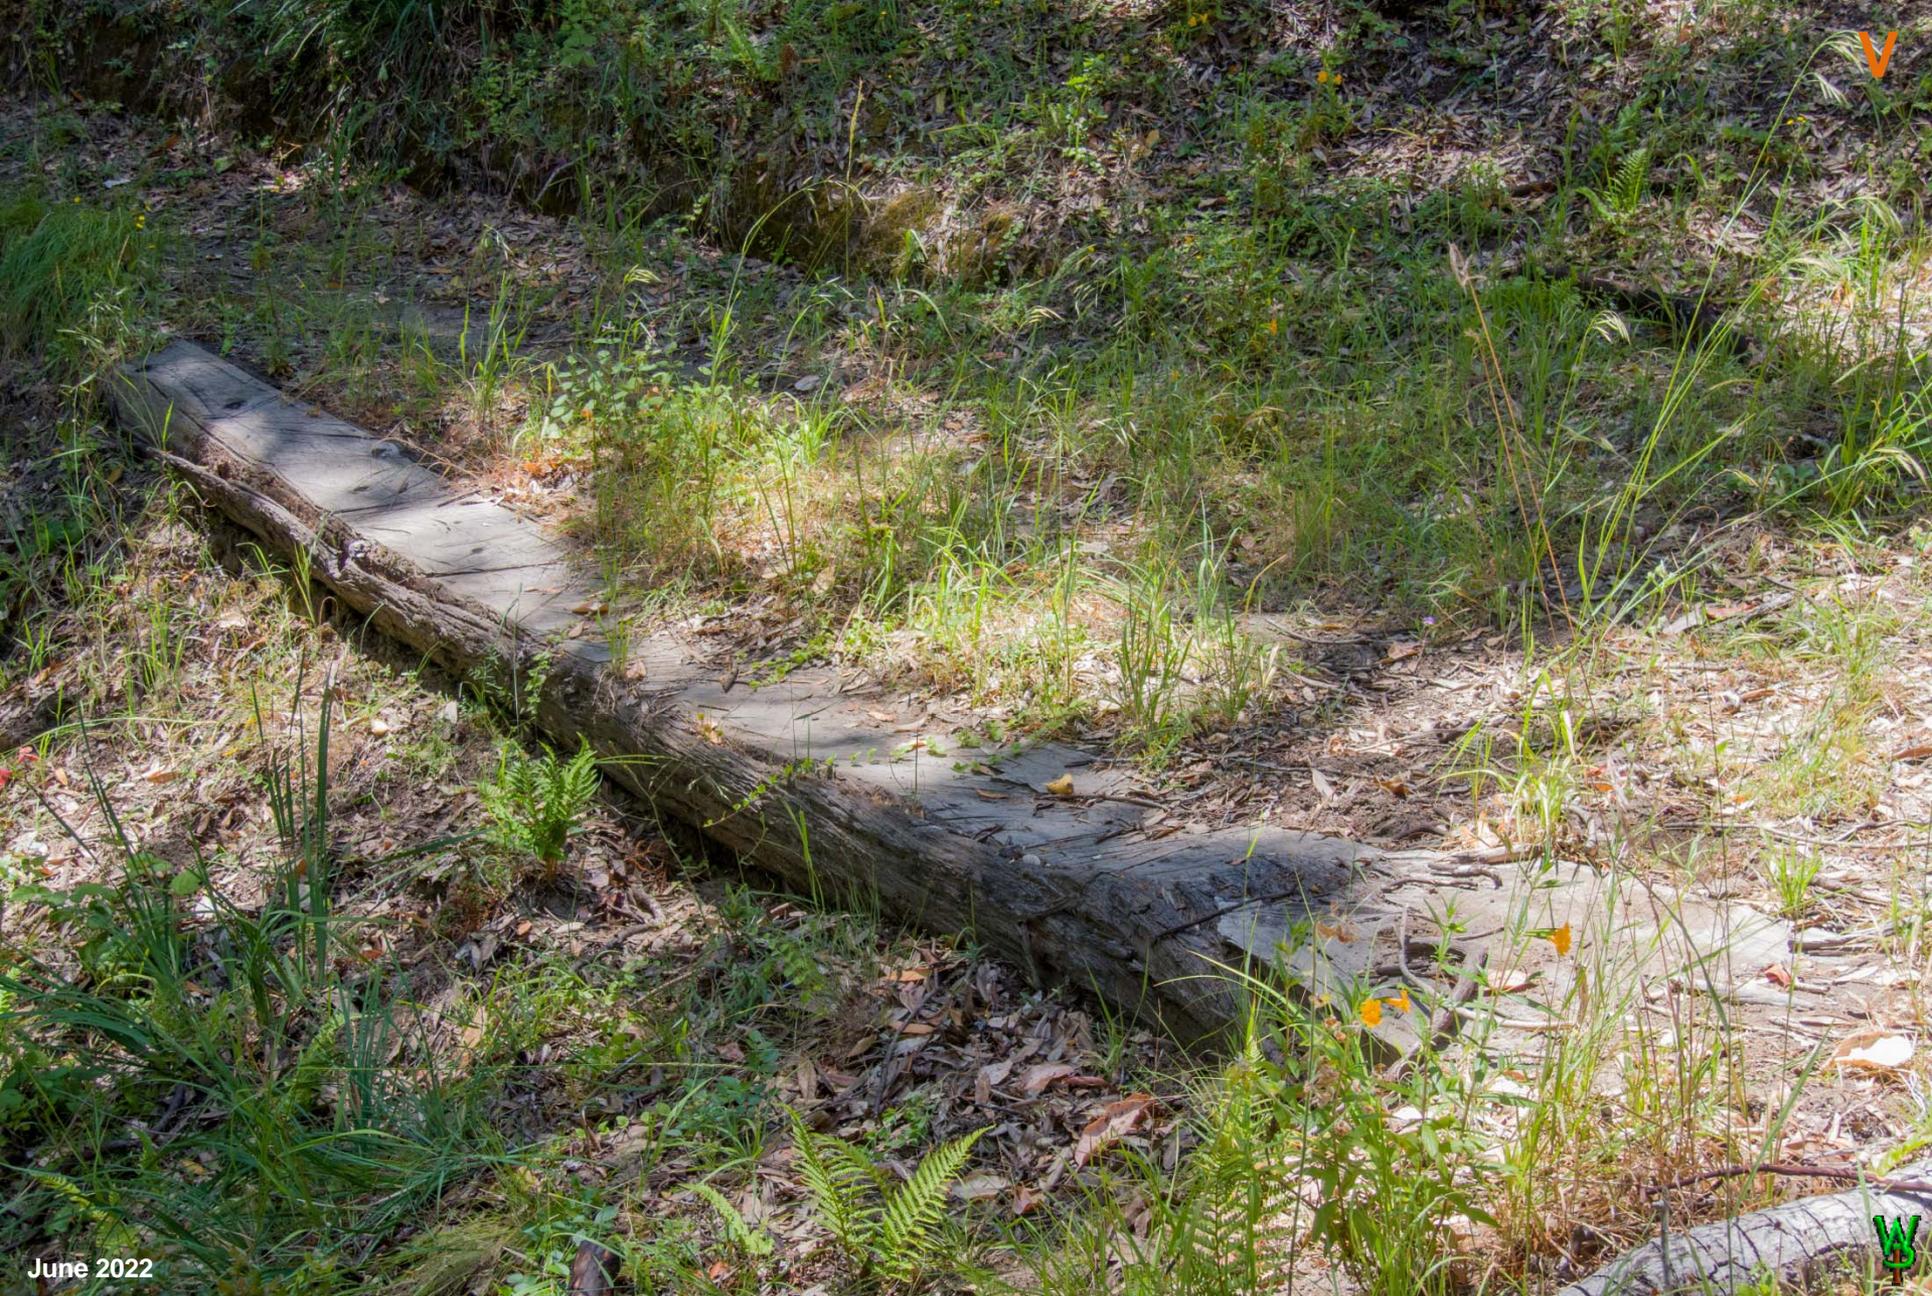
June 2022

Trails can have stream crossings too but culverts often carry the risk of plugging. I made this crossing out of a redwood log into which I'd ripped a slowly dipping face. The bark and sapwood is likely to erode and rot, while the dip keeps the bulk of flow in the middle, distributing the flow as a thin sheet that resists plugging with twigs the way a pipe could more easily do. This crossing is six years old.

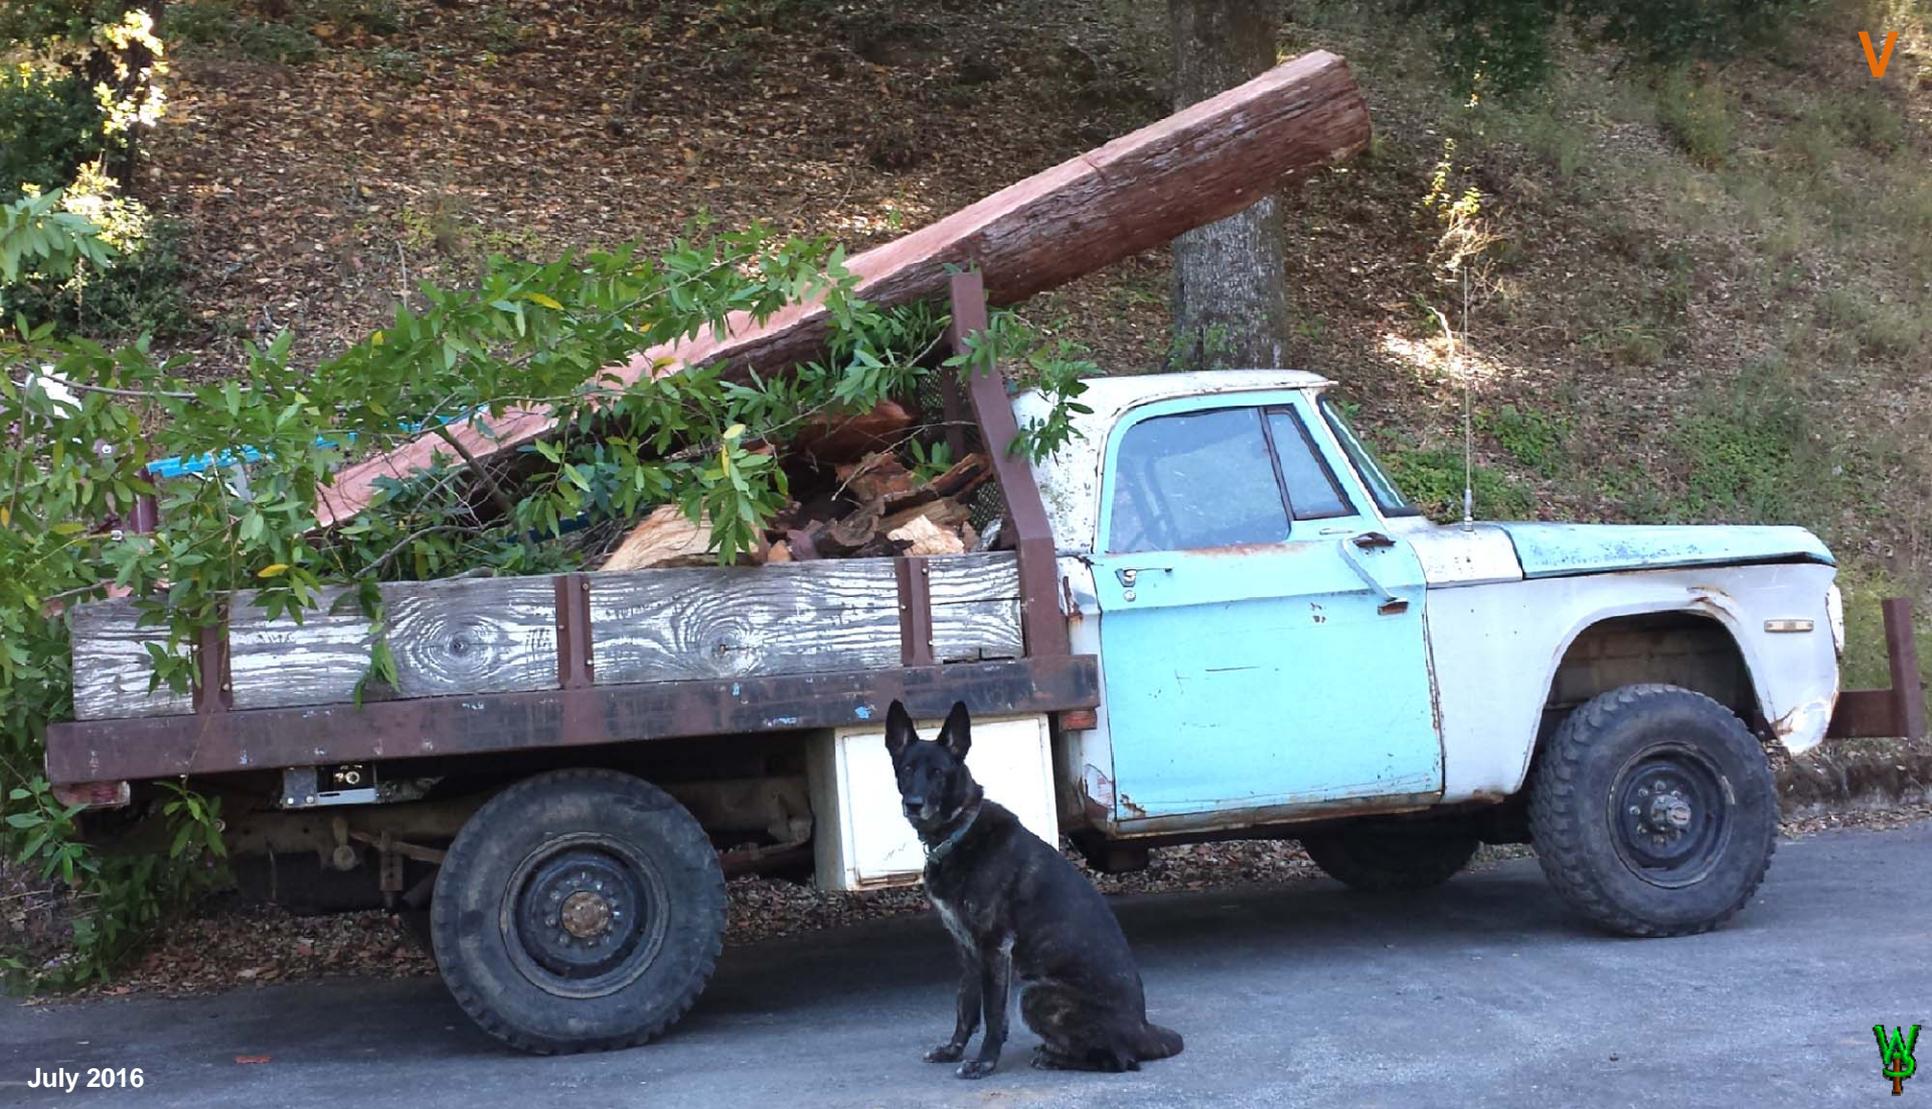
Getting the log to the north draw from the far southern end of the property demanded a bit of improvisation. I raised the bed (it dumps) and strapped the front end of the log to the rack over the end of the flatbed while in raised position. Then I lowered the bed, which didn't work because the front of the bed needed weight. So I added most of a burn-pile-to-be worth of trash to the front. That was enough to pick up the end of the log. I blocked the log in place and repeated the operation until the nose was high enough to get onto the bed. I strapped that end of the log to the front of the bed, dragged it across the dip at the rocked stream crossing, and then backed up the truck against the butt seated in the dip. That shoved the log over the top of the cab. Then I drove it to the ridge overlooking the north draw, chained the butt to a tree, and drove out from under it. That dumped the log, and it rolled it down the hill as desired to within 50' of the stream crossing. The Kubota mini-excavator that installed it did the rest. I miss that dog. Dax was a good girl.

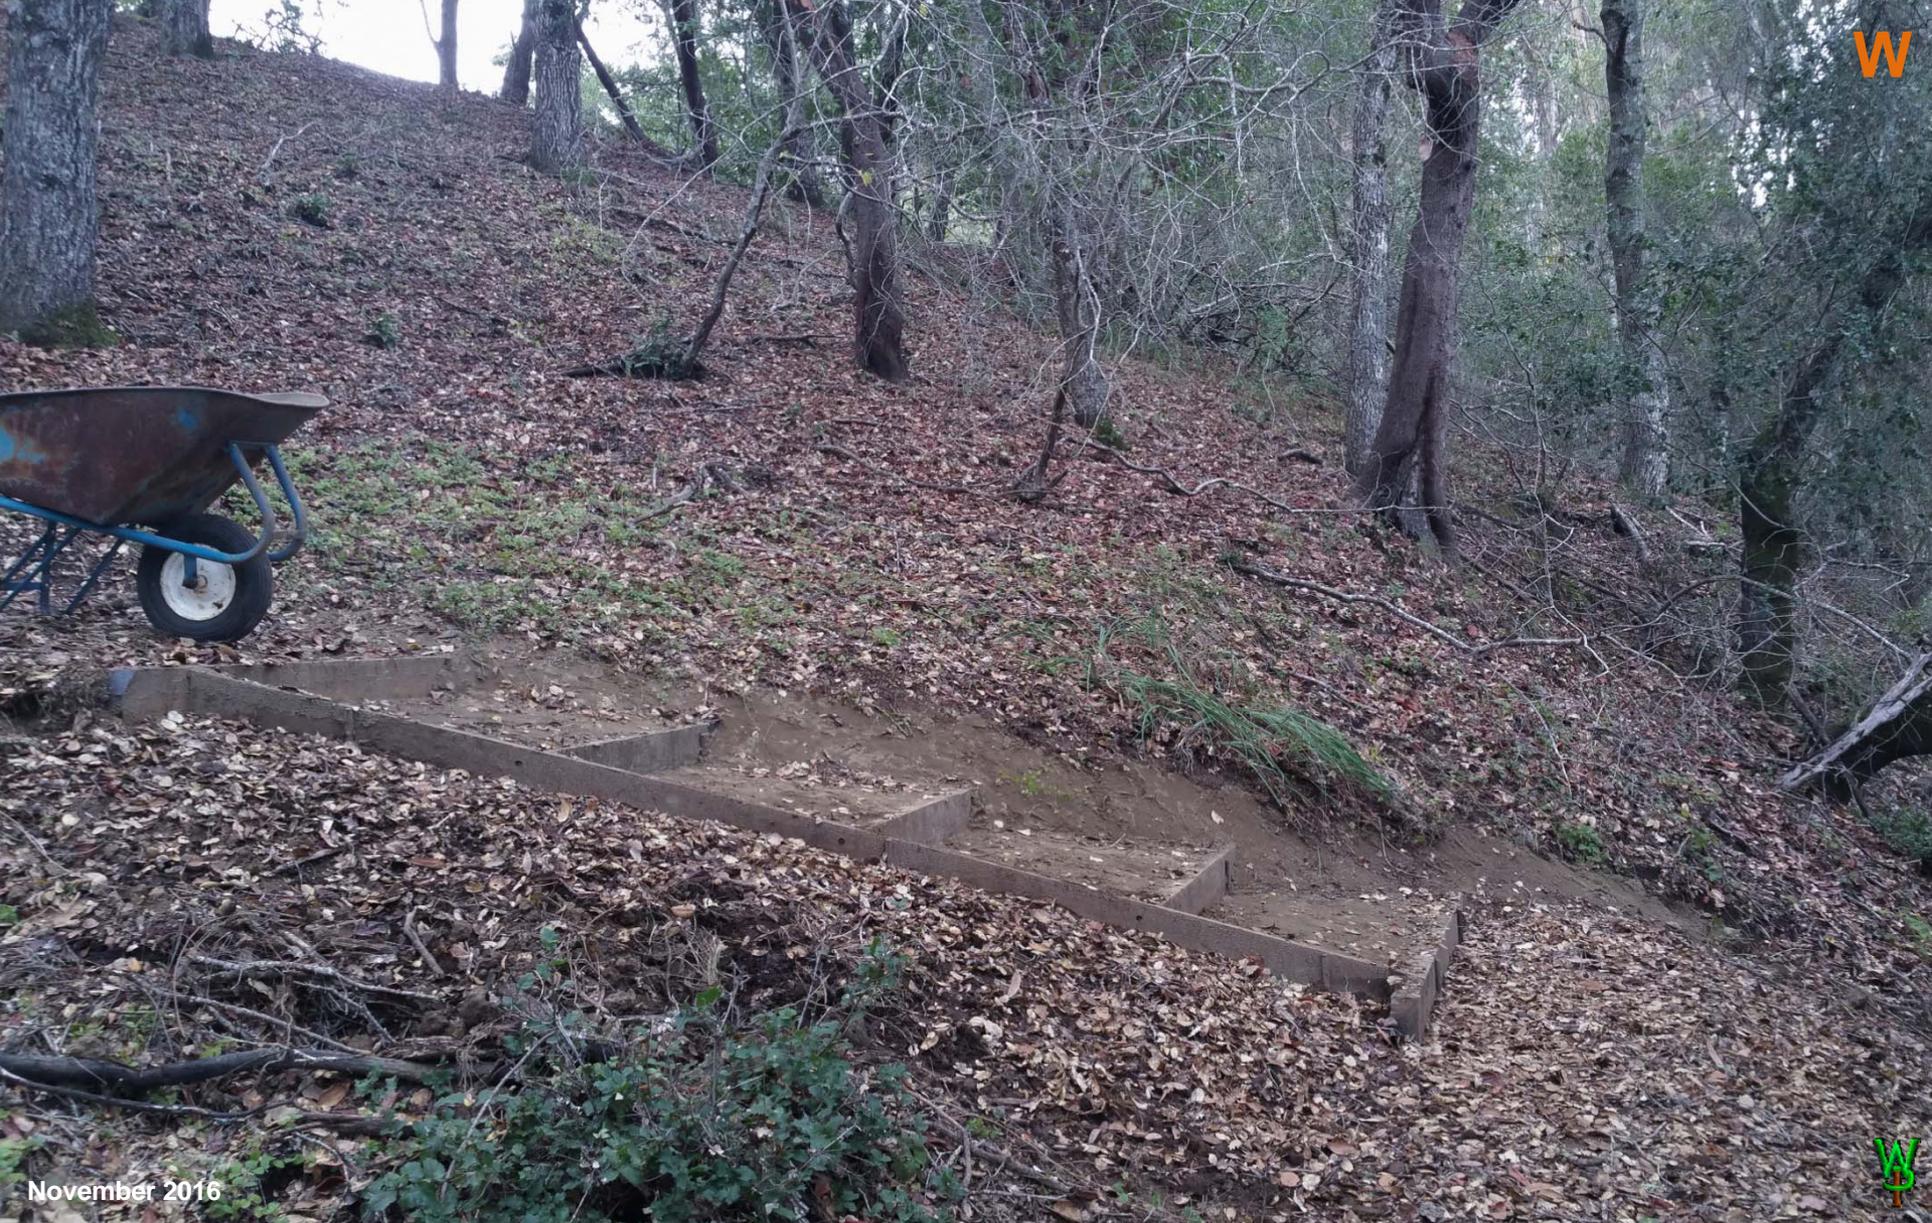
These stairs helped keep the trail grade above less impactful and more manageable. Making the stair frame is one thing, bringing in the fill is another, and the height of a cut bank without the stairs yet a third. By the time this part of the trail was compacted, the landing below them required almost six yards, which may not be a lot of fill to move with a tractor, but it's a lot to load into a wheelbarrow by hand and creep down a steep grade for a couple hundred yards. So it's wise to plan the route such that moving dirt is minimized but then, it's also wise to keep the grade of the trail low to minimize surface erosion later onto the trail. It's about tradeoffs.

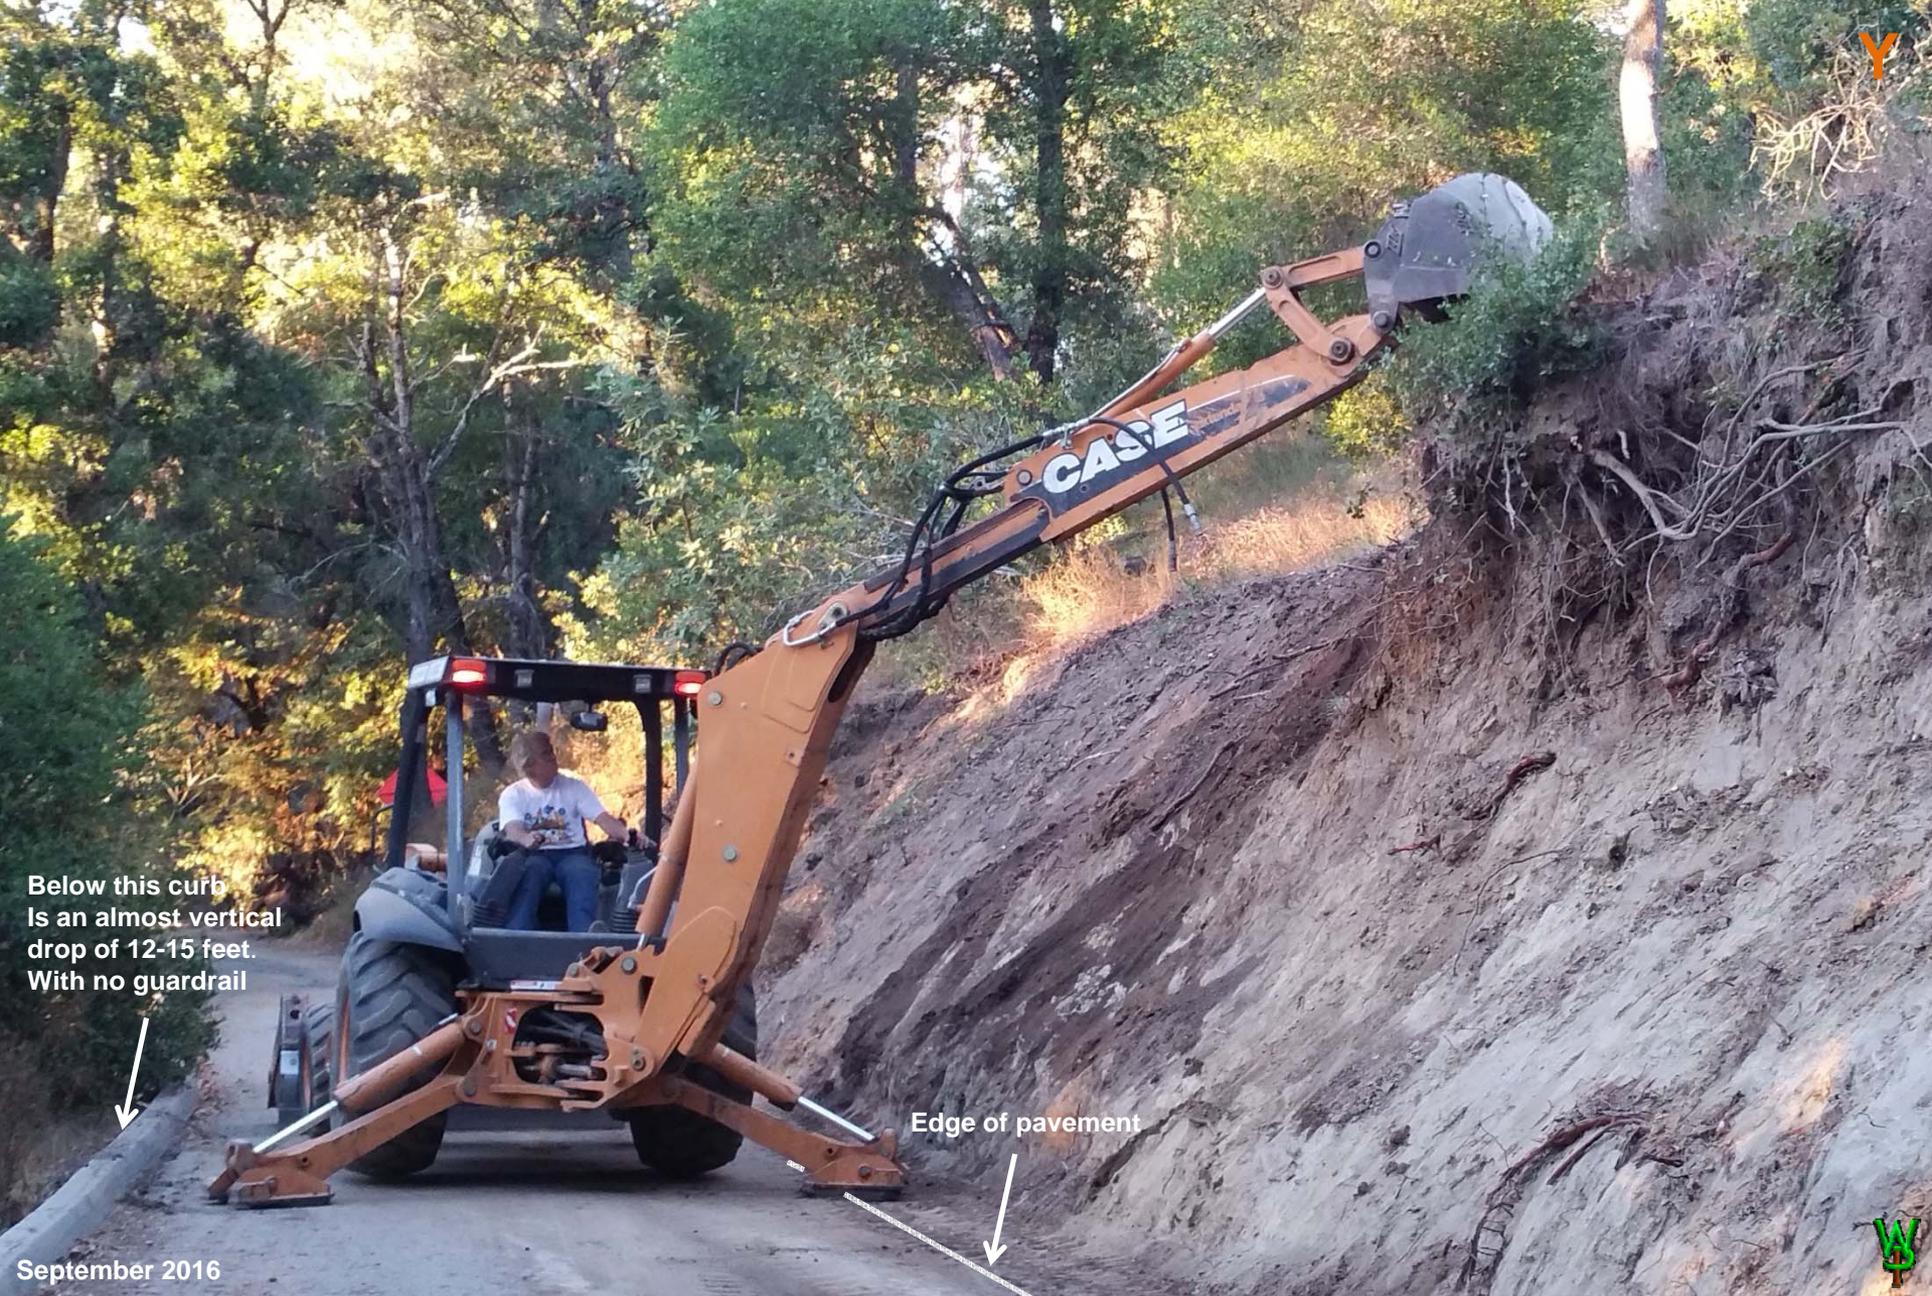
Yet there was a complication to beginning the job to which you are now a witness, a moral obligation to do a bit of extra work for posterity because of [the site history](#) you have already read. Note that the slope to the right of the **dashed yellow line** becomes almost flat to the left of the line. Note also how this flat section follows the same course as the County road below. The natural slope would never have been level across it as it is here and the pathway is wrong for a terrace for a row of apples. The soil beneath that yellow line is very soft and dark with organic matter, as if it was an old drainage ditch that had filled in, absorbing water like a sponge. It is as if this was an older road, abandoned long ago... except the only older road made before the 1850s when Charley McKiernan built the one below was opened in August 1791, made by Indians of Mission Santa Clara with sticks and baskets. Accordingly, it seems to me that this may indeed be that old Spanish track. Unfortunately, the repair to reslope that overhanging embankment would remove just about all of the old road. What to do? Get the permit, check it with a metal detector, document it for the archaeological record, scrape off the surface to stockpile native grasses, save the topsoil for the revegetation job, and fix it. It is saddening to take out this likely vestige of the mission era, and it does cause one to ponder what the Indians had to do to build it or how the land might have looked to the Spanish when they passed by this very spot 222 years previously, but it's just how things have to be.

Below this curb  
Is an almost vertical  
drop of 12-15 feet.  
With no guardrail
