# ROADS TO HELL AND BACK, SOMEWHAT

# WILDERGARTEN 6.2

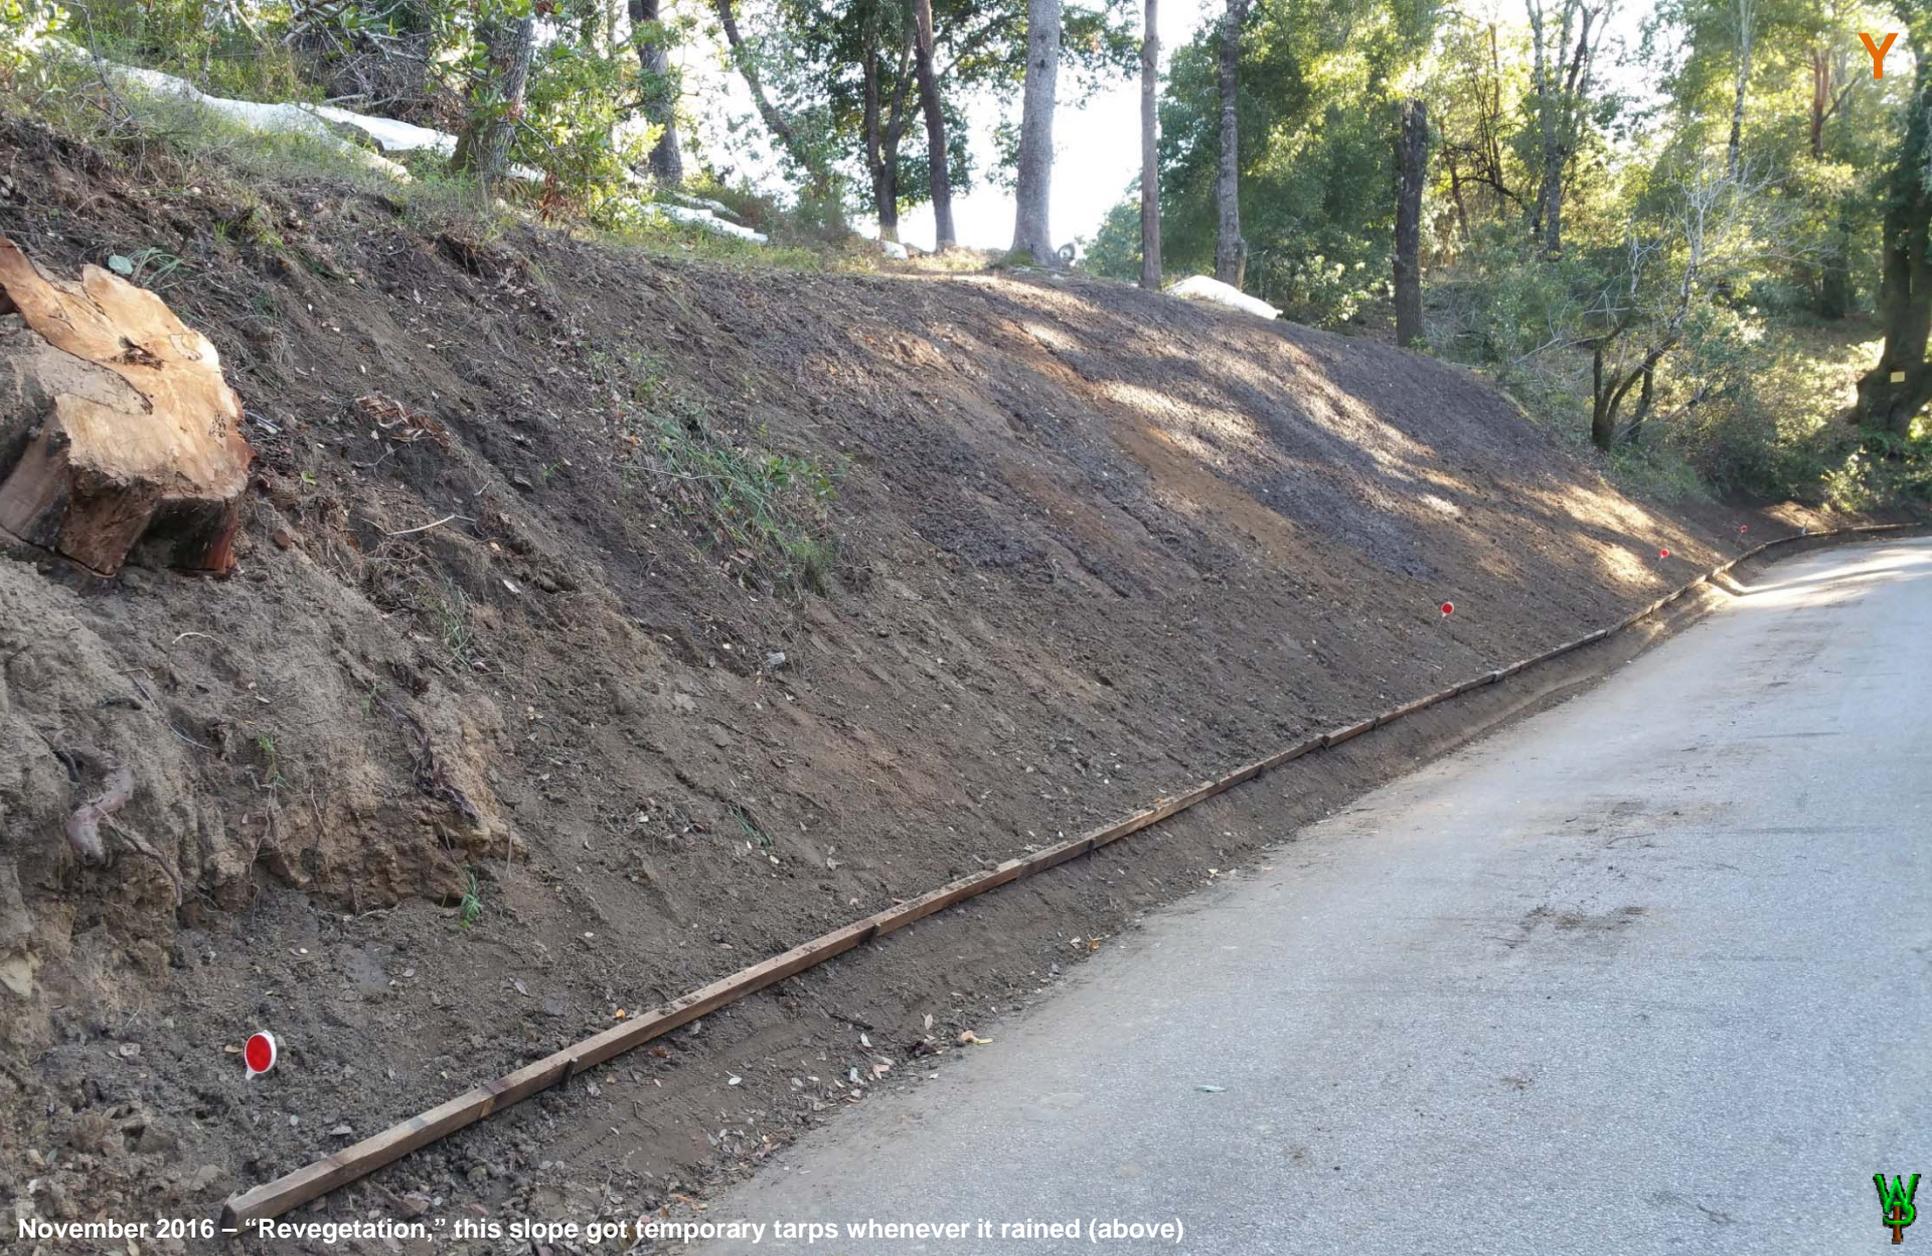
November 2016 – “Revegetation,” this slope got temporary tarps whenever it rained (above)

Revegetation started with a topsoil slurry from the top. It was spread by hand, but it could be done with a hopper mixer feeding an articulated conveyor. The bottom third was tossed with a shovel. Water it down so that it forms a film. Plop in some irises, sedges, buckeye seeds, toyon seedlings, elderberry started from cuttings, Ceanothus, and other such. Keep watering until the rains come for regeneration from remnant roots of wild peas and our awesome grasses for steep slopes, *Calamagrostis rubescens*, and *Agrostis halii*.

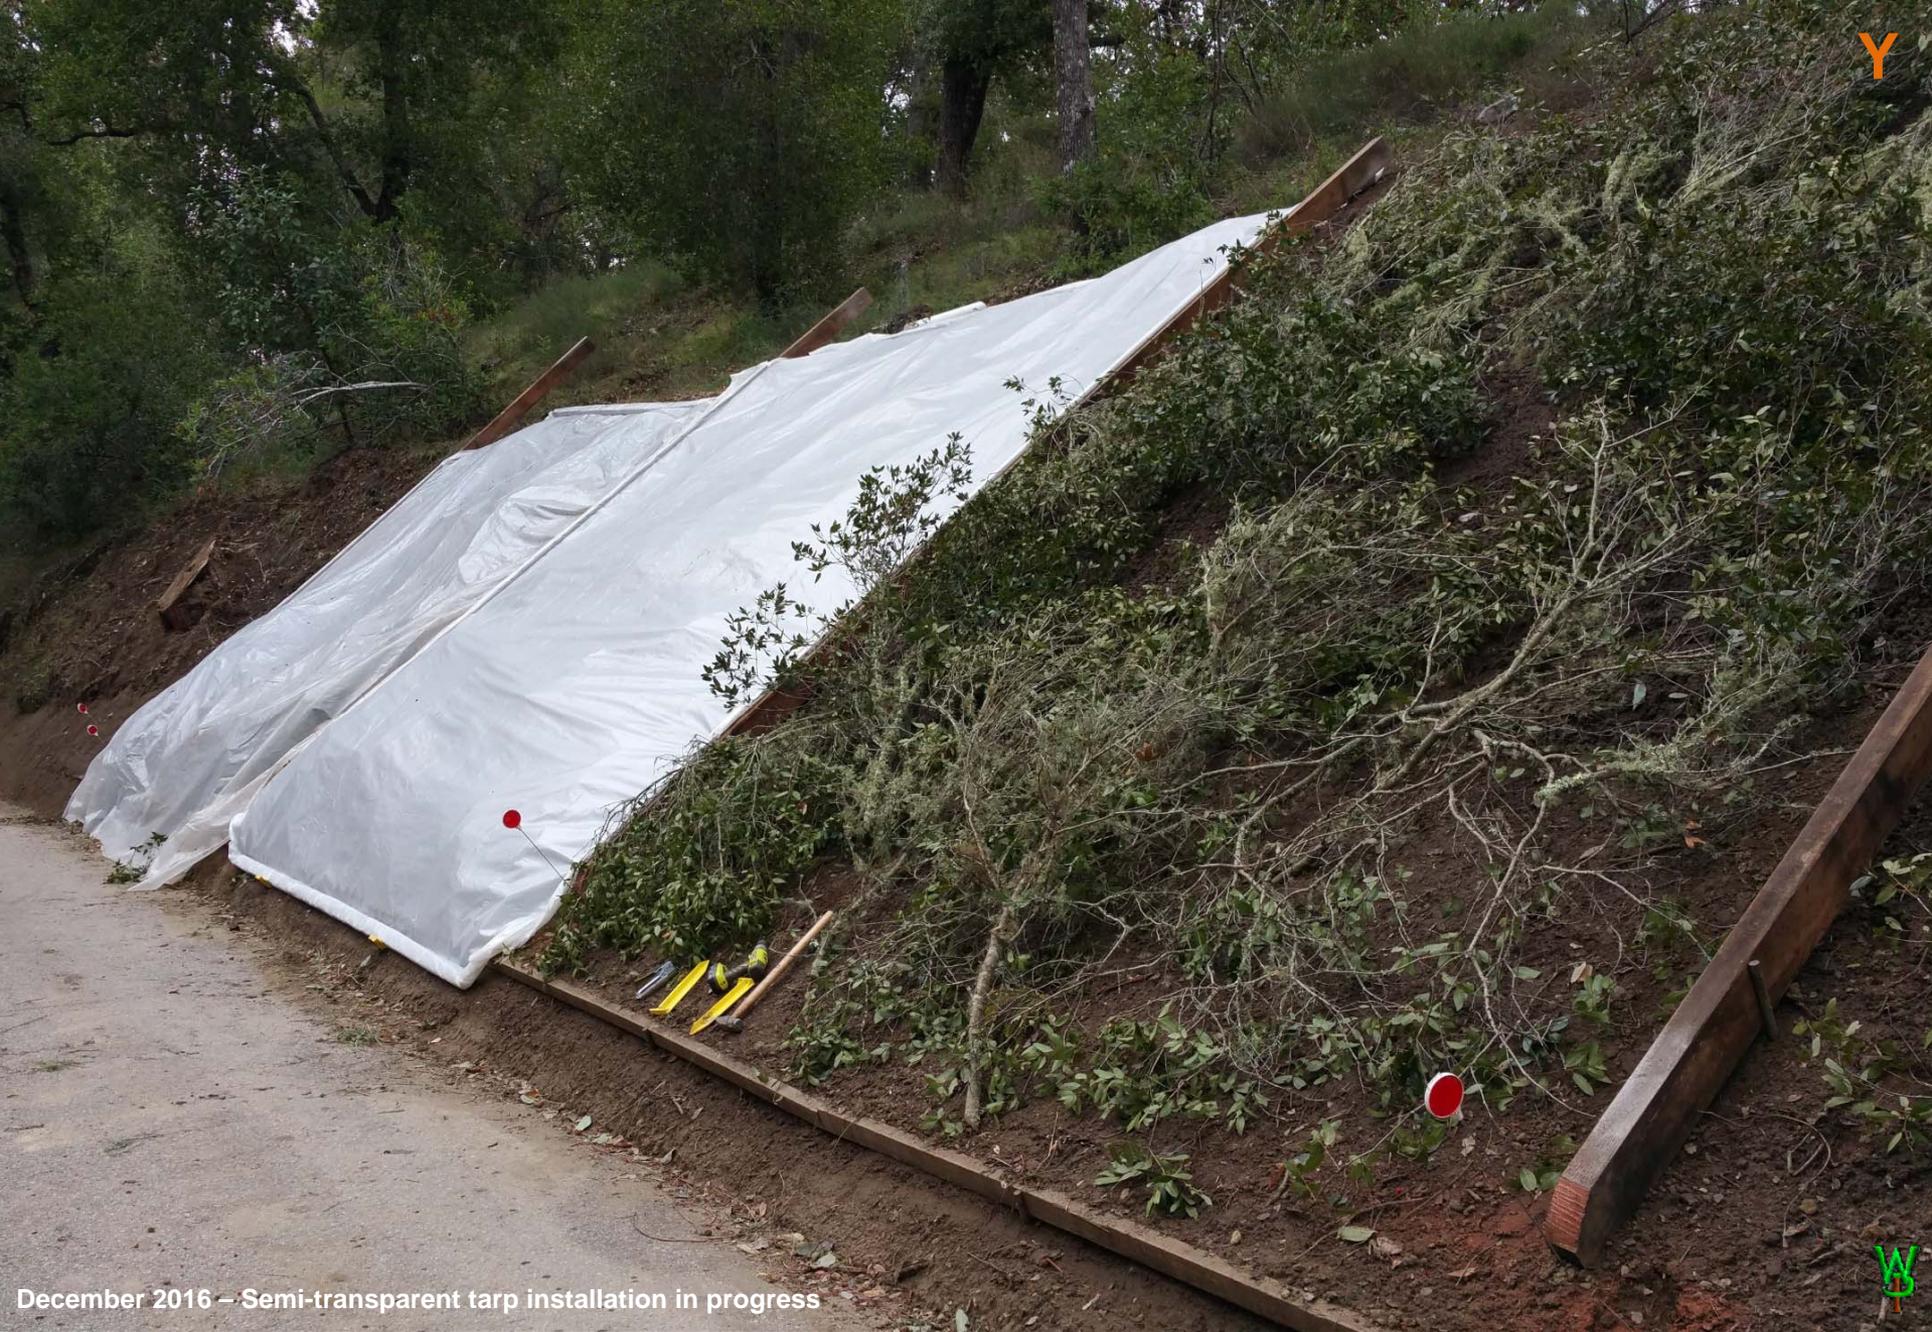
December 2016 – Semi-transparent tarp installation in progress

When the heavy rains came it got cold, with a plastic cover with the edges wrapped in battens screwed to 3X6 timbers. Effectively, this is similar to the “mini-greenhouse” technology used in the [drainage](#) chapter. Note the date. Unfortunately, I was too late.

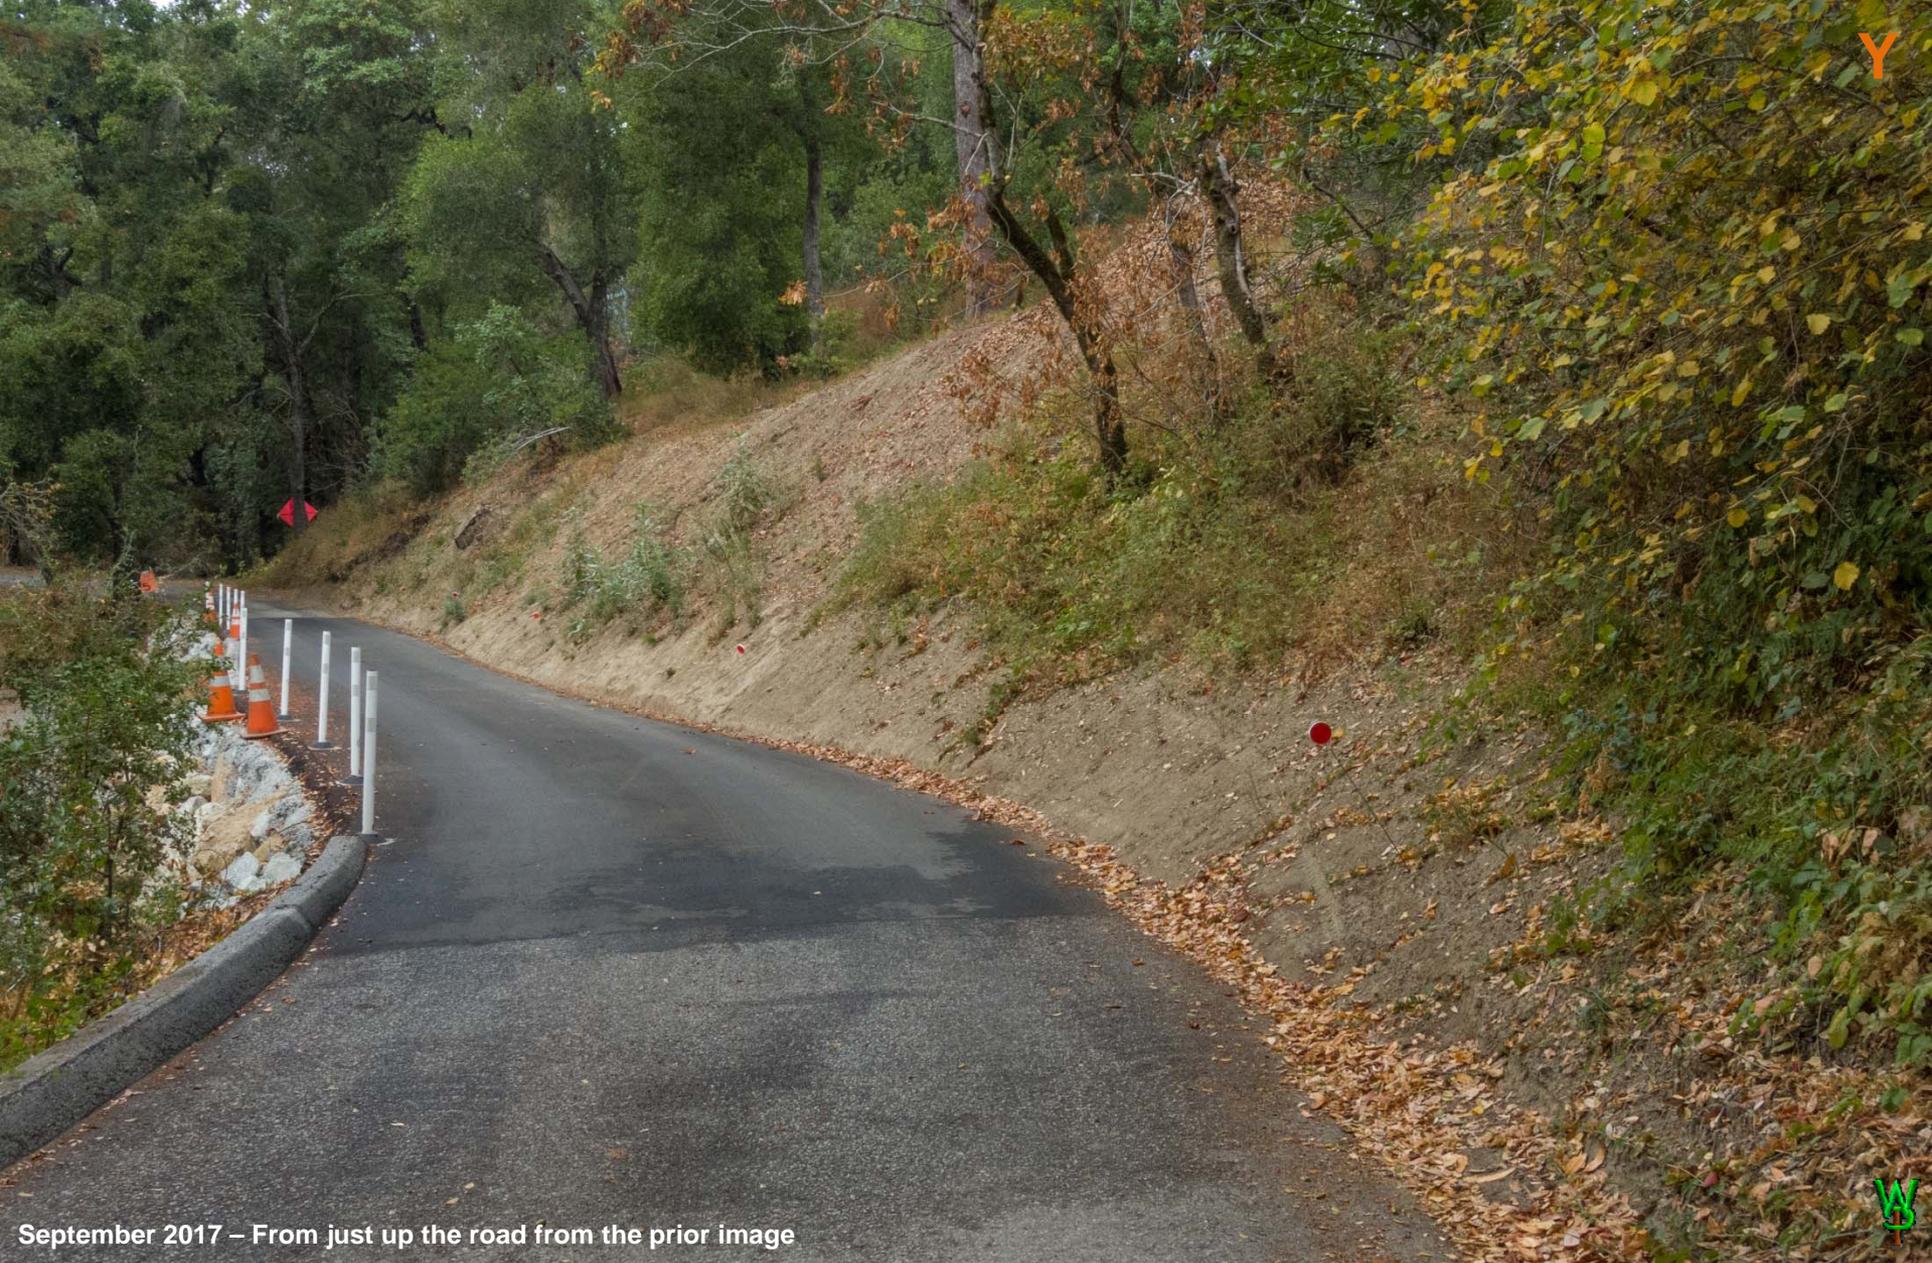
September 2017 – From just up the road from the prior image

I was too late finishing the project and it got too cold for the roots to sprout, partly because this part of the project was in shade almost all day when the winter sun was at a low angle. That winter, we got that infamous 87 inches of rain. Some of the plants I put in did take (especially the shrubs), but I am sure by now the bulk of those root nodes I spread on the surface are dead. So this part received a classic seed and mulch treatment and was watered before being again covered with timbers, tops and plastic as before.

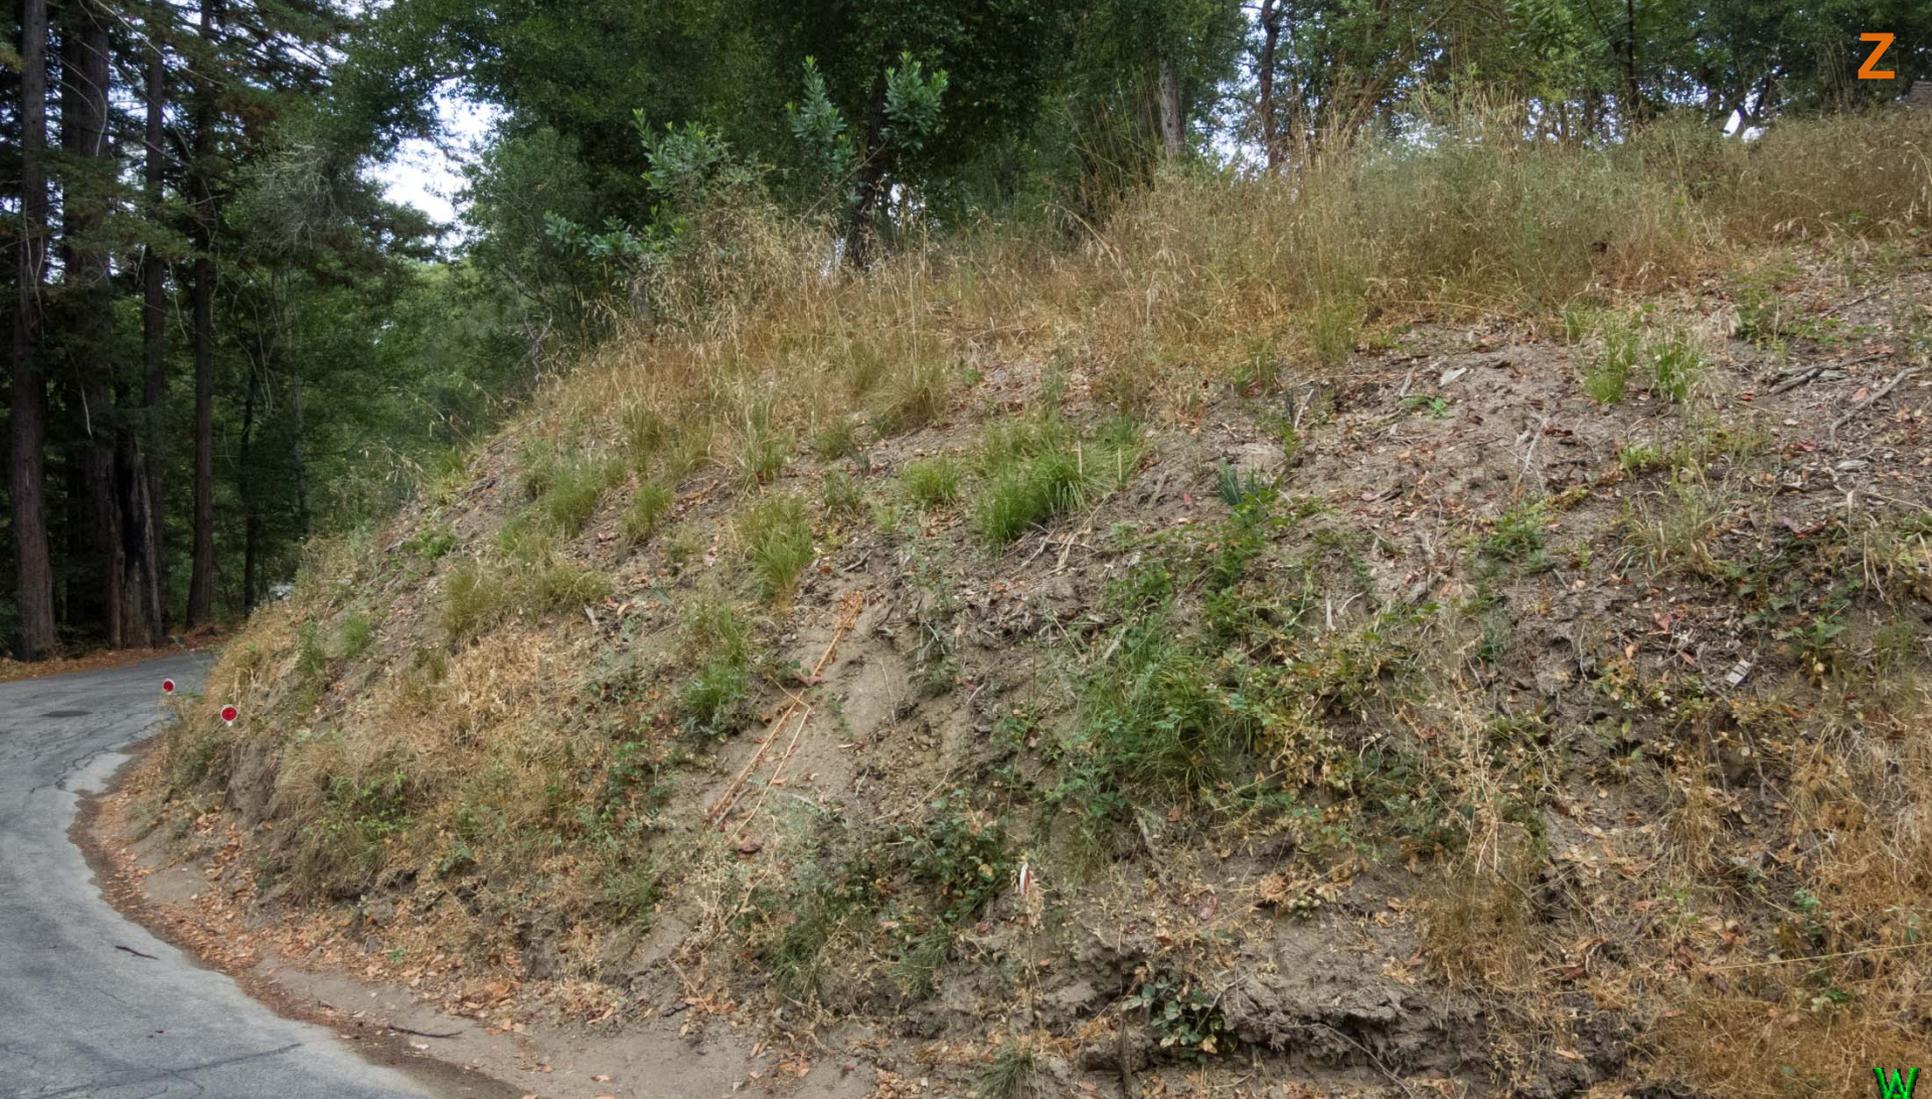
September 2017 – Just down the road from the prior image

In the same project, I had sloped off an overhang to improve visibility around this blind corner, having witnessed a cyclist hit by a car here. This part of the project got rain in early fall, and was then covered by mid-October. That provided enough warmth for good root development. I removed the plastic to weed it in the spring. To me, this is a perfectly acceptable outcome because I have sufficient number deep-rooted individuals of species that spread by rhizomes well enough distributed to establish a full cover. To the County, this is not yet enough cover for an erosion control project, principally because they usually seed with annuals that cover every inch with shallow rooted grasses. Yet this is September, and these native bunch grasses are green. Had I watered it over the summer, they would have met that full cover expectation with more soil-holding power than do the annuals the County uses. We have only to wait.

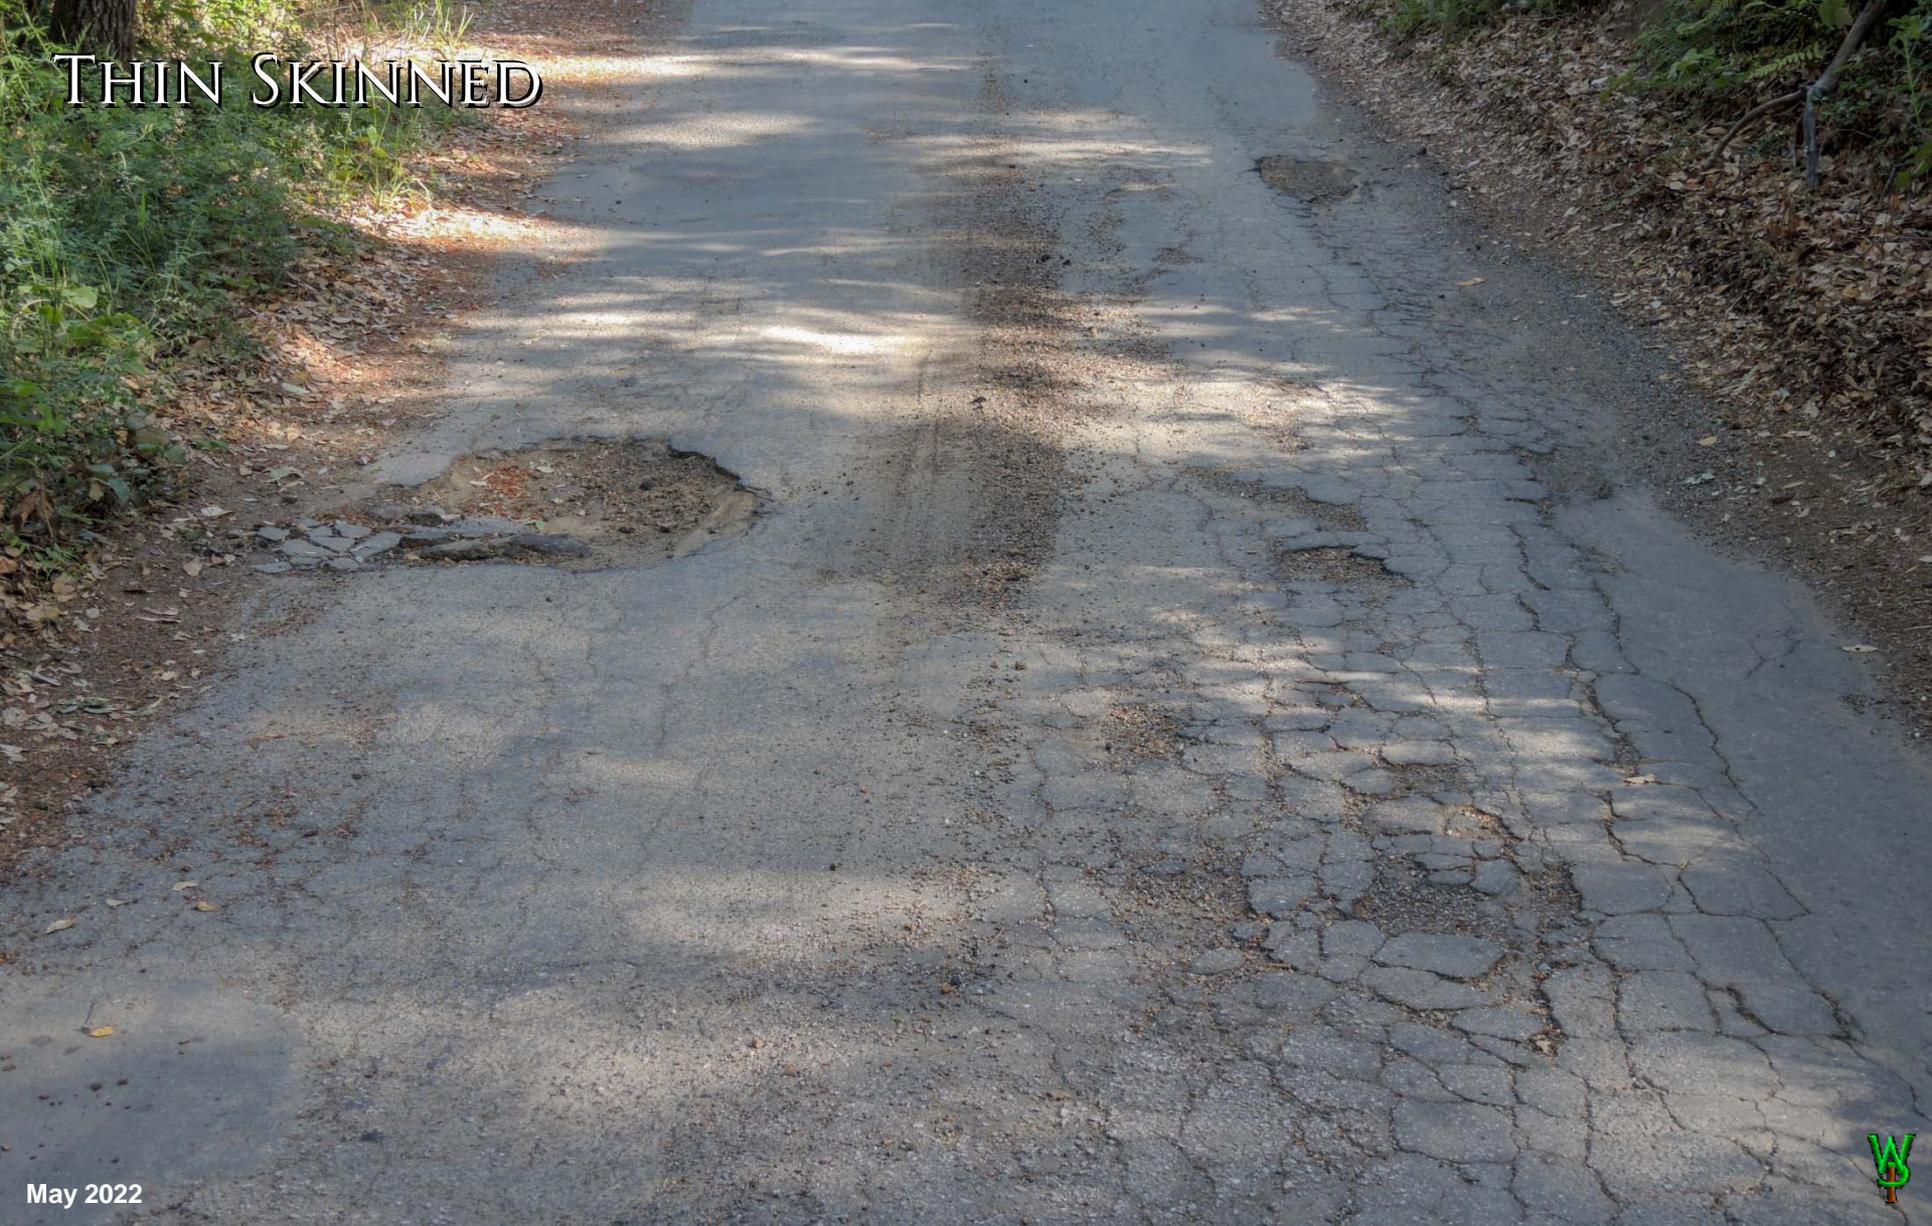
May 2022

The principal determinant in maintaining good roads at lower cost is paving. The original construction method for County roads up here was typically oil and screens on bare dirt built up to about a half-inch thick. It was a huge improvement over dirt, and a thin skin is not necessarily deficient. As long as the substrate is good, a good surface skin is all that is necessary, particularly on straight sections where the tires do not scrub against the surface nearly as much as in corners. In some places on bare rock, that coating has held up with a very occasional refresh for decades longer than places with 2" of asphalt concrete on a poor substrate.

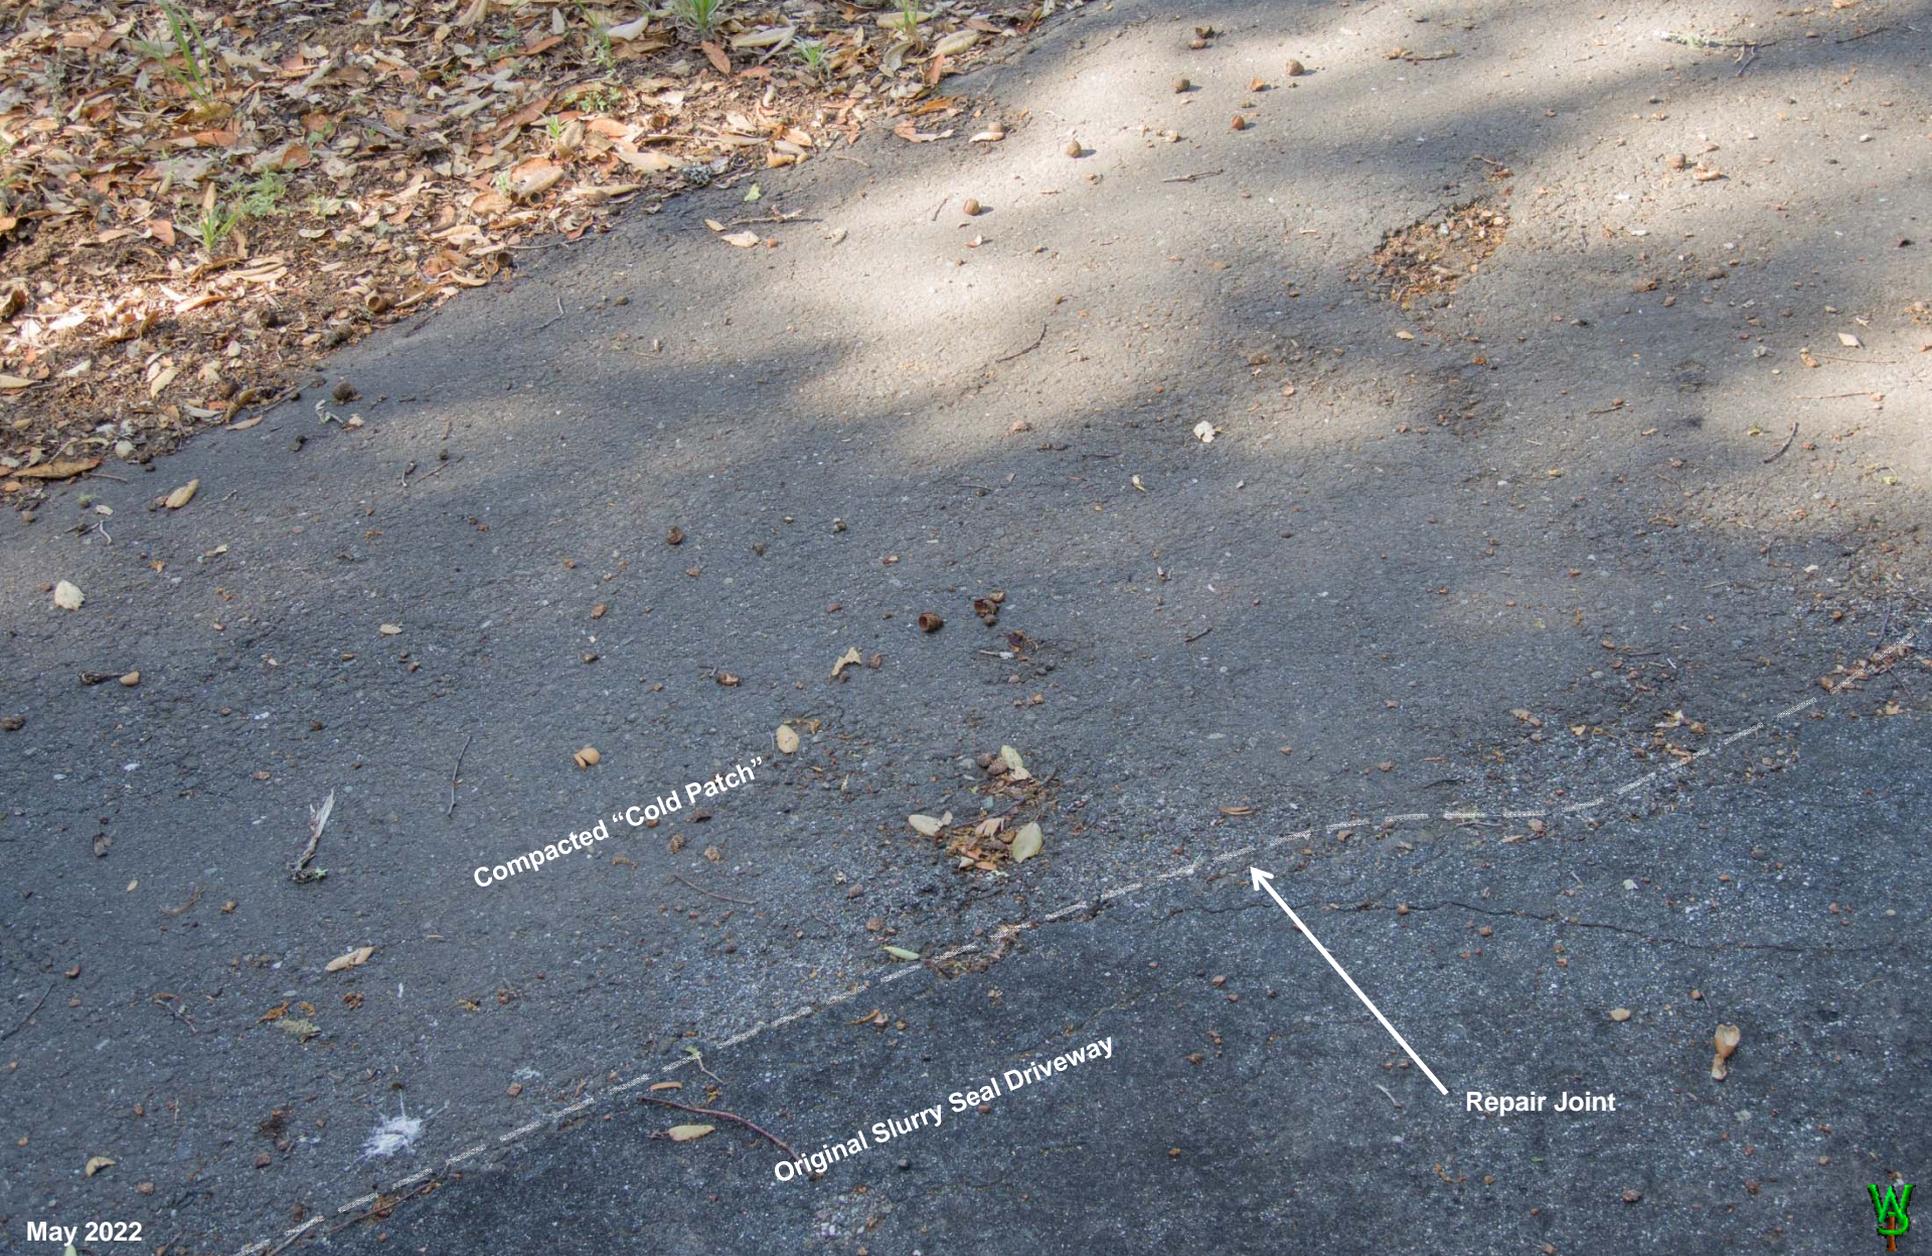
Compacted "Cold Patch"

Repair Joint

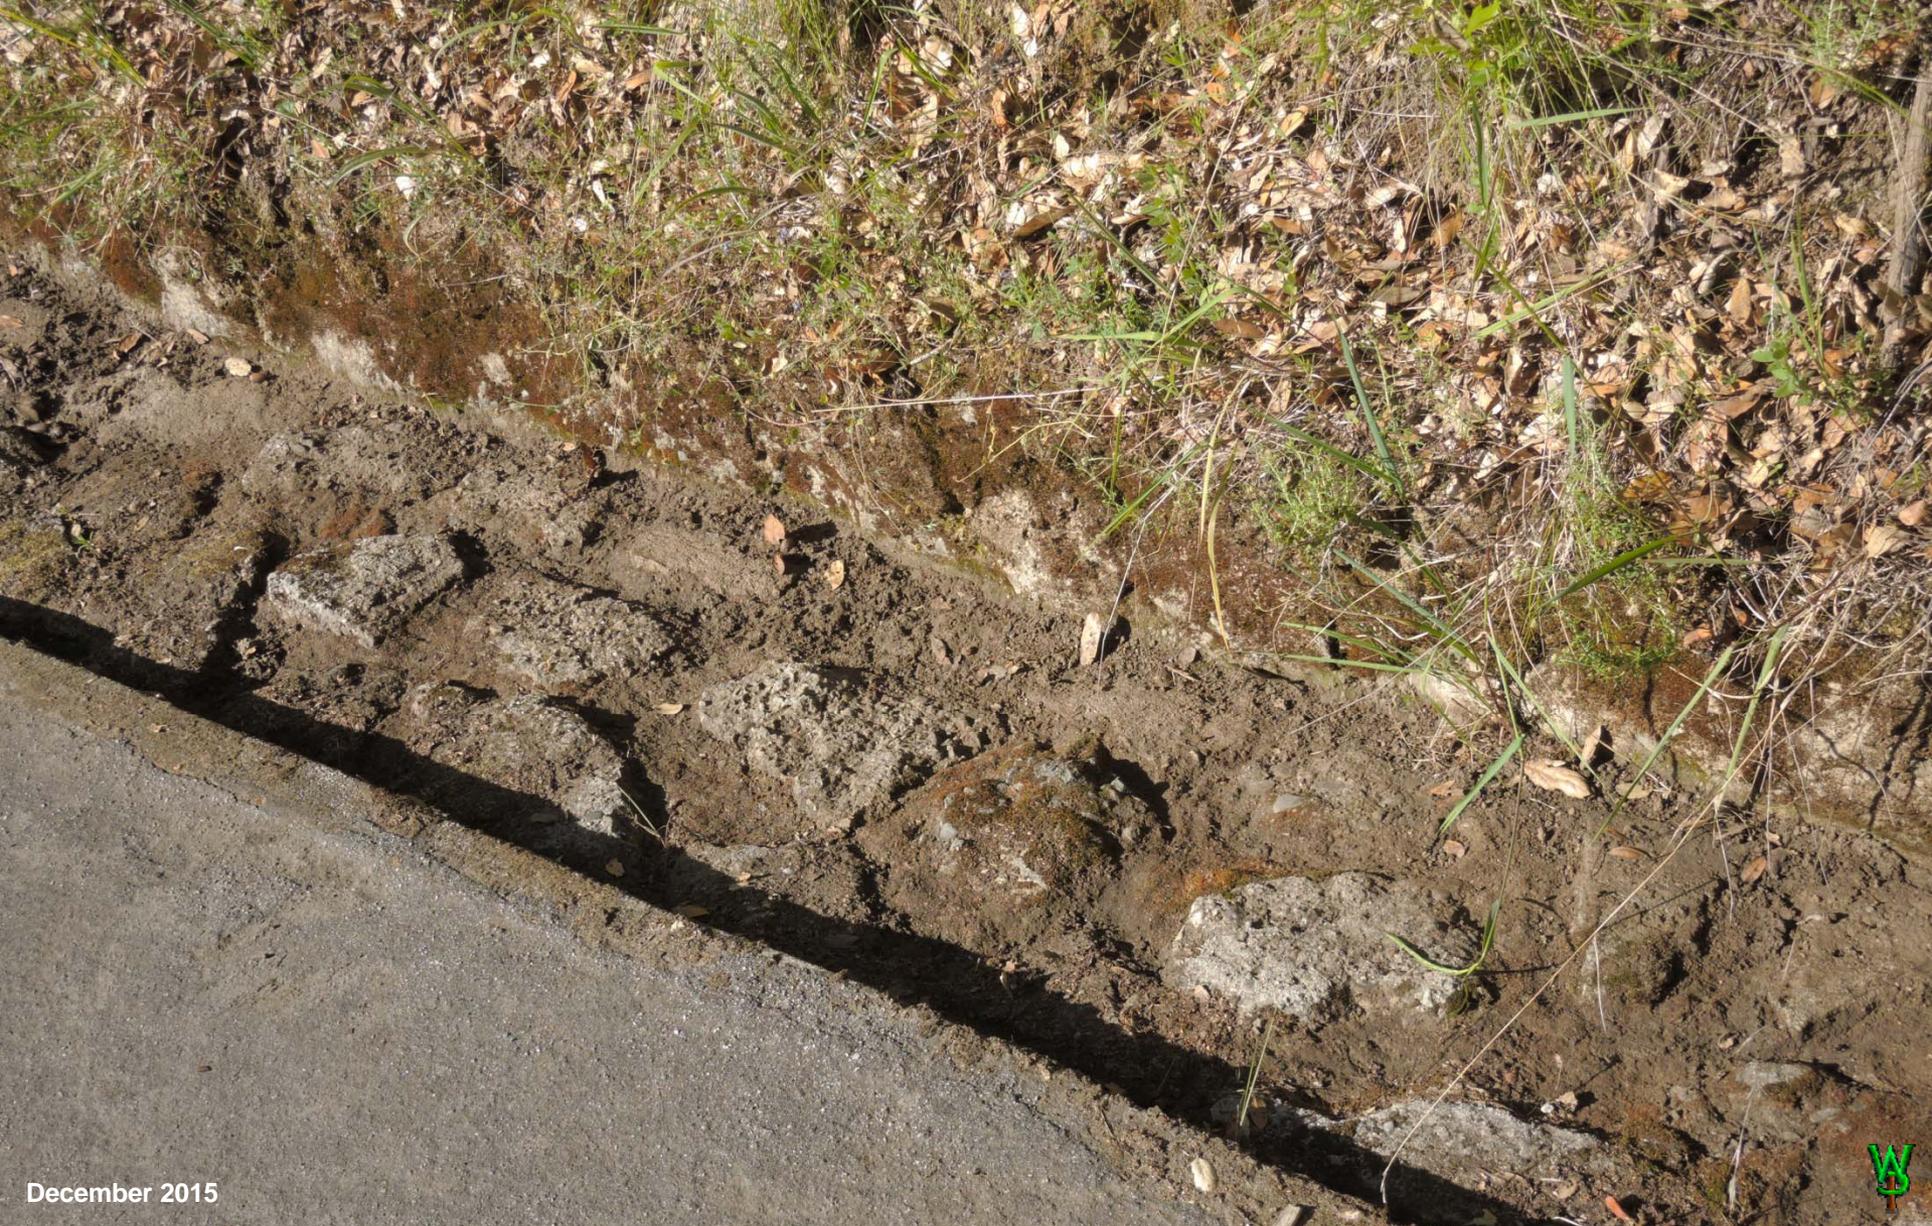
December 2015

Any gutter I would build in the future would be constructed in a manner similar to this, something I wish I'd done on the whole system instead of forming full concrete gutters with a backsplash. I simply formed and poured edge with a #4 bar in it while making the back splash out of similar pieces "grouted" with a mix of base rock and Portland cement. I then laid down broken concrete from sidewalks (bottom side up) for texture in the bottom, and poured dry sack concrete into the joints. Rain set the concrete. The bottoms of the chunks look sort of like rock and slow the water down. Recycling at its finest. Broken concrete slab material has many uses here.

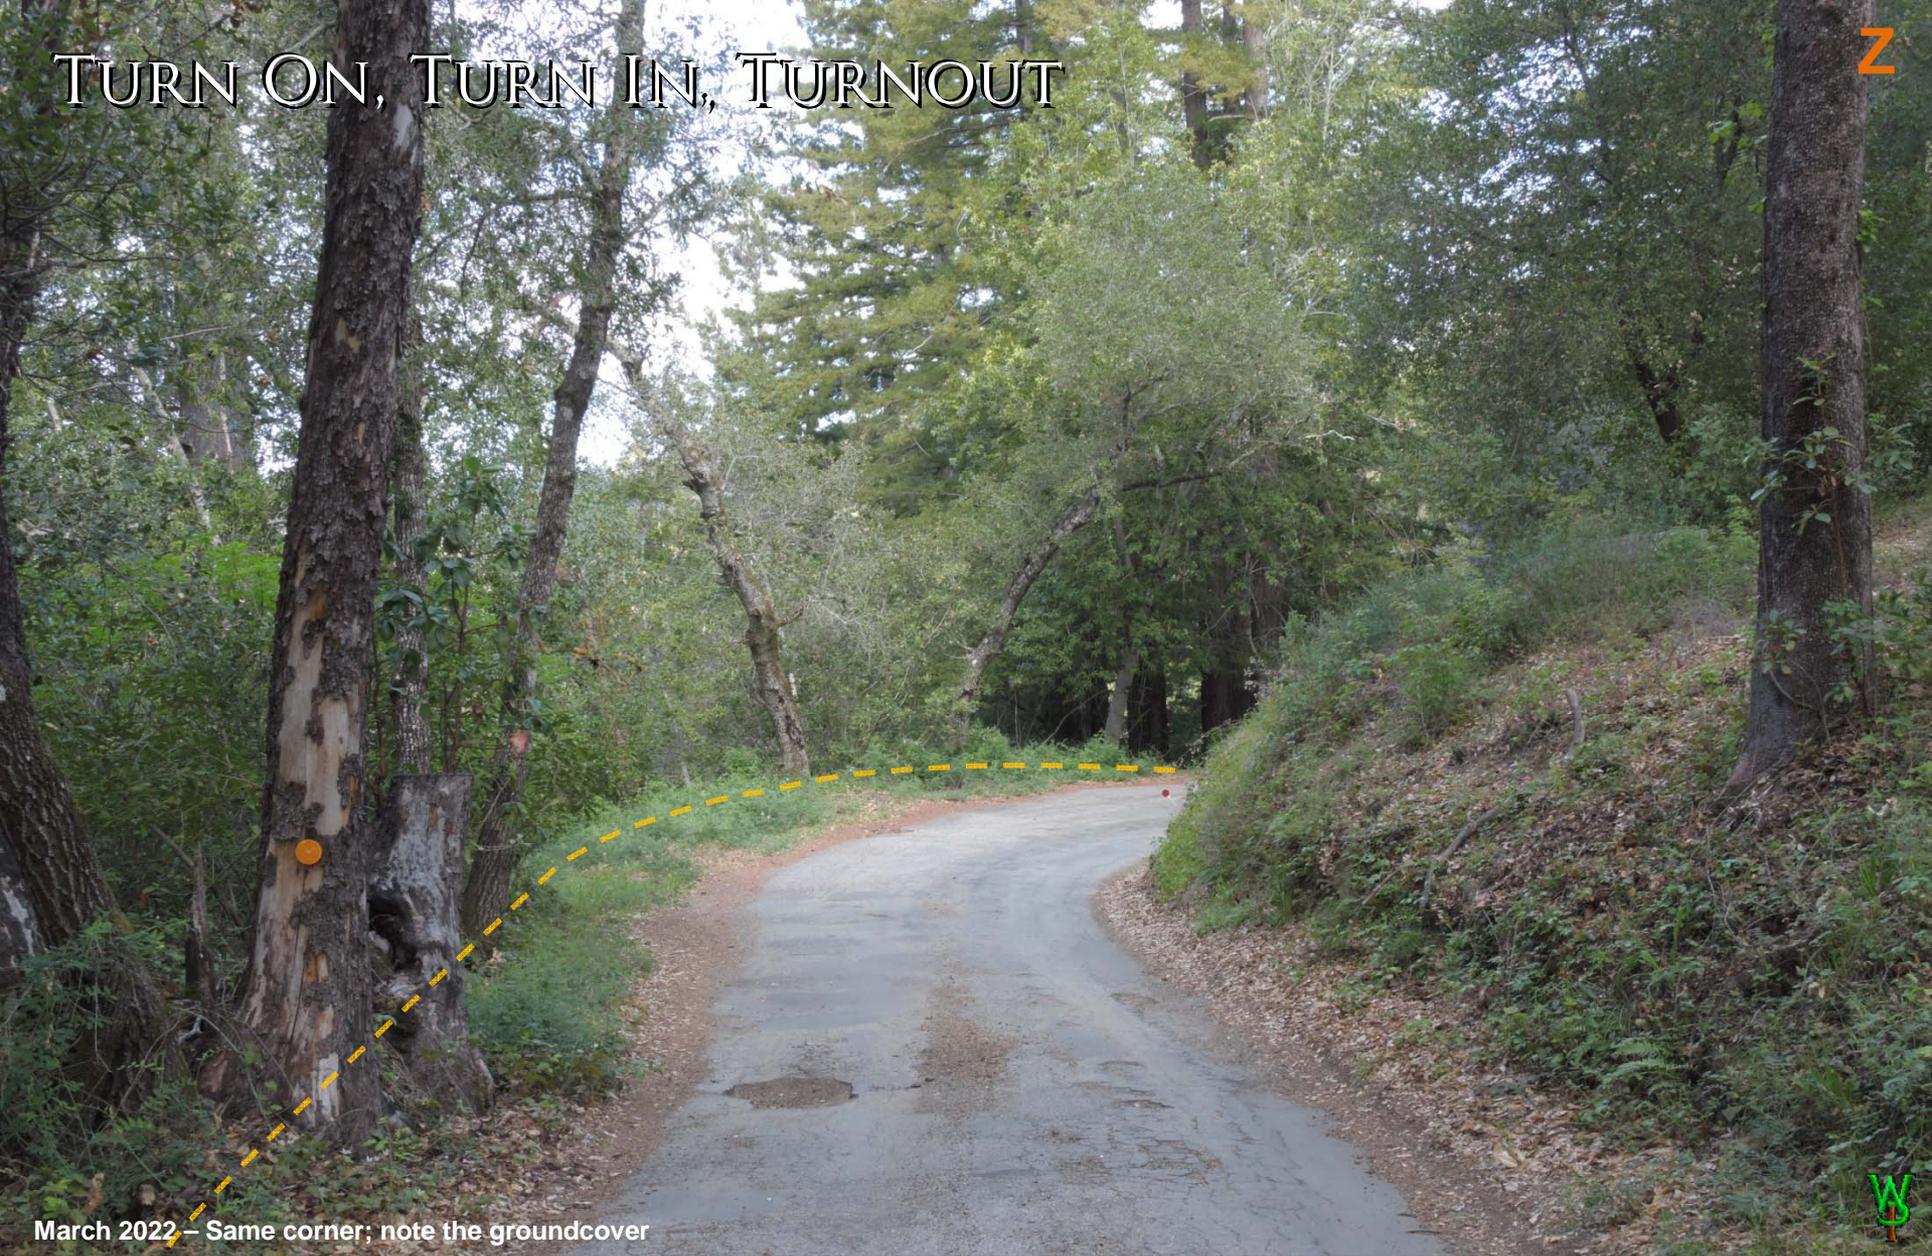
March 2022 – Same corner; note the groundcover

This is the same blind corner I had sloped off, illustrating one of my pet peeves on one-lane roads up here: a lack of turnouts. This one was the first I made back in 1990 to give the mailman a safe place to pull off the road and deliver until we had a driveway to the house we had yet to build. Because it sits at the apex of a blind corner, I'd like to pave it to 2-lanes wide, giving drivers a place to avoid an accident when meeting an opposing driver from the other side, thus making head-on collisions less likely (it has happened).

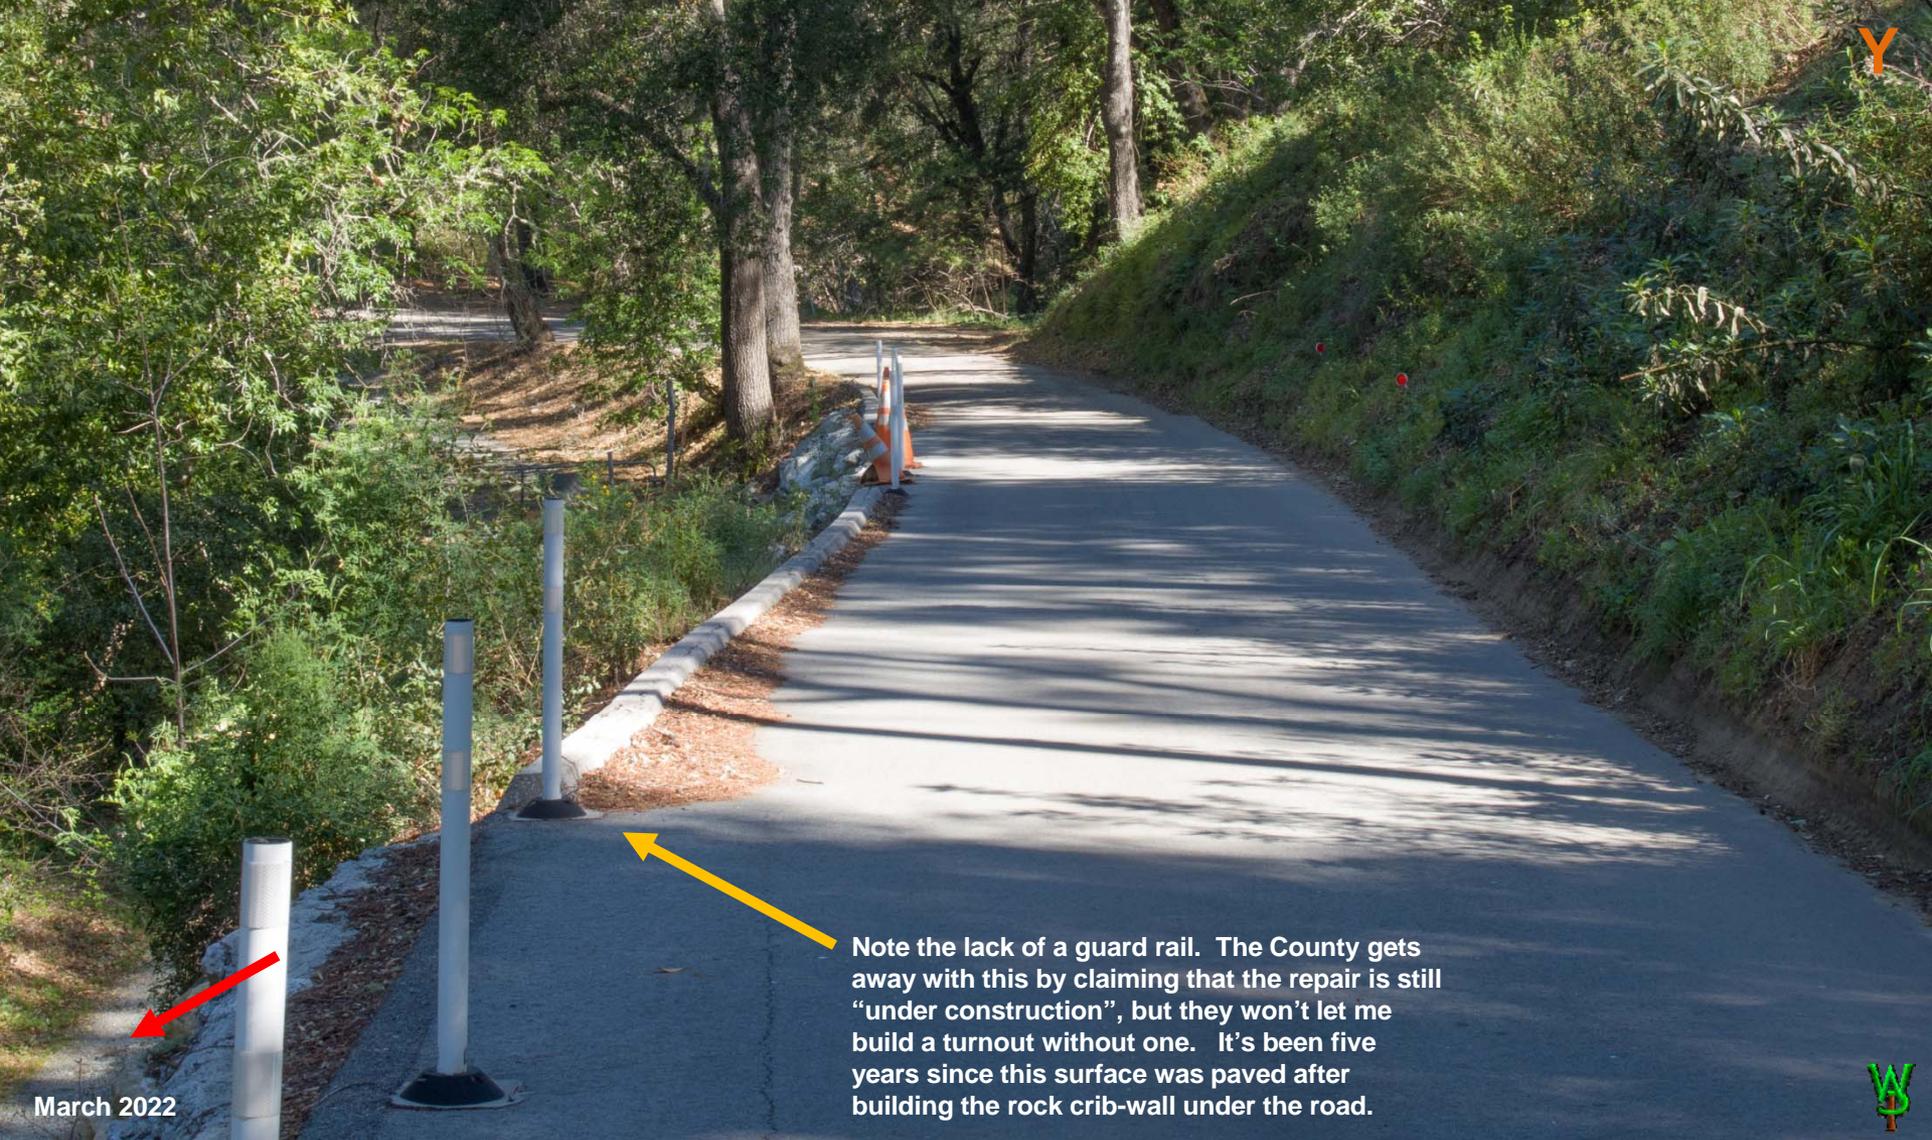
March 2022

Note the lack of a guard rail. The County gets away with this by claiming that the repair is still “under construction”, but they won’t let me build a turnout without one. It’s been five years since this surface was paved after building the rock crib-wall under the road.
