# ROADS TO HELL AND BACK, SOMEWHAT

# WILDERGARTEN 6.2

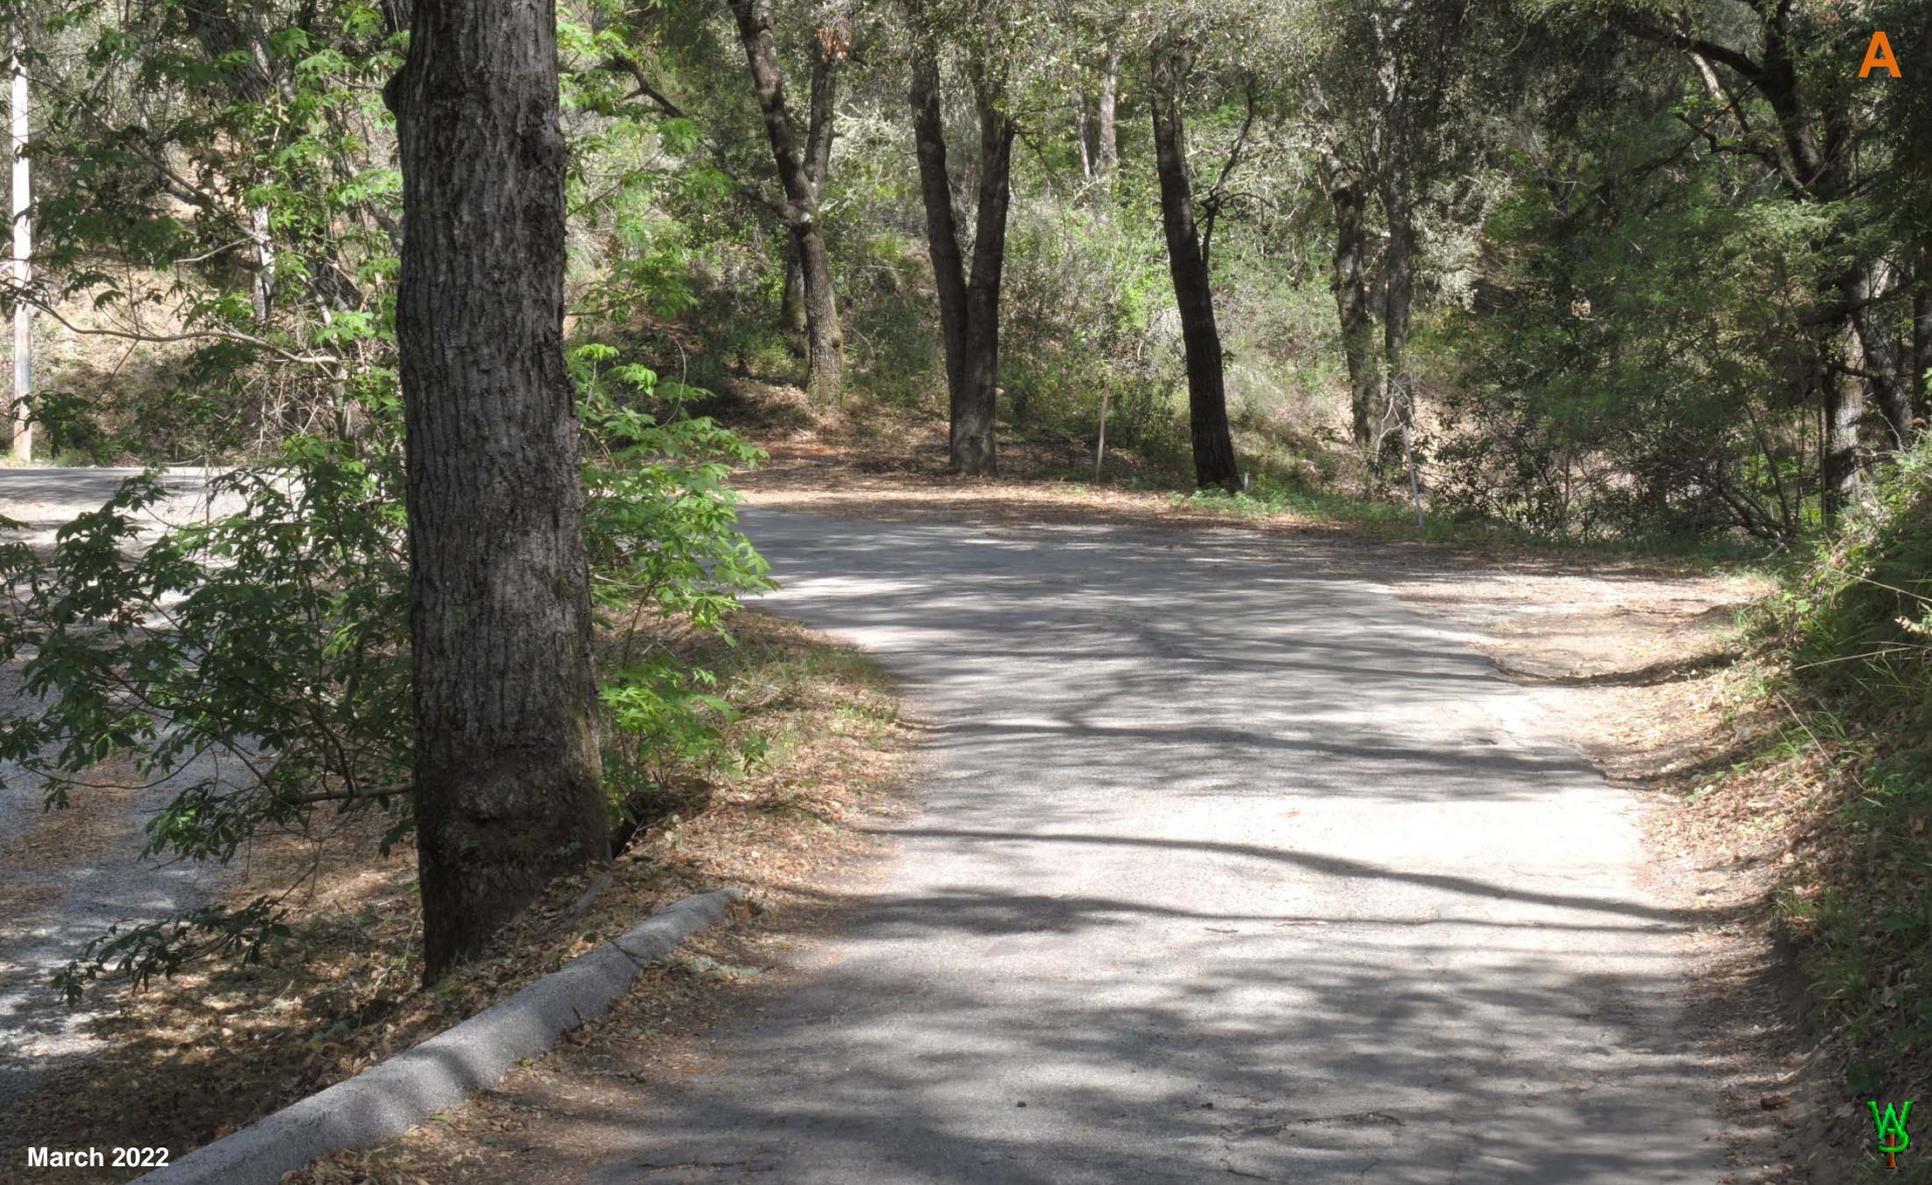
March 2022

I later realized that the biggie for making big turnouts is when there is a genuine emergency. The rains of early 2017 caused landslides of such magnitude that the State closed Highway 17. Thousands of commuters were stranded, and what did they do? They asked Google, Waze, or MapQuest for an alternative route. This one-lane road was it, complete with its own washouts and slides. The traffic jam of scared and desperate drivers was almost 5 miles long. How would an emergency vehicle get by without frequent turnouts on which to park the cars? With this one at 130' long X 20' wide, I had the cars park diagonally so that "convoys" could get by each other. For emergency vehicles such as an ambulance or fire truck, turnouts can mean life or death.

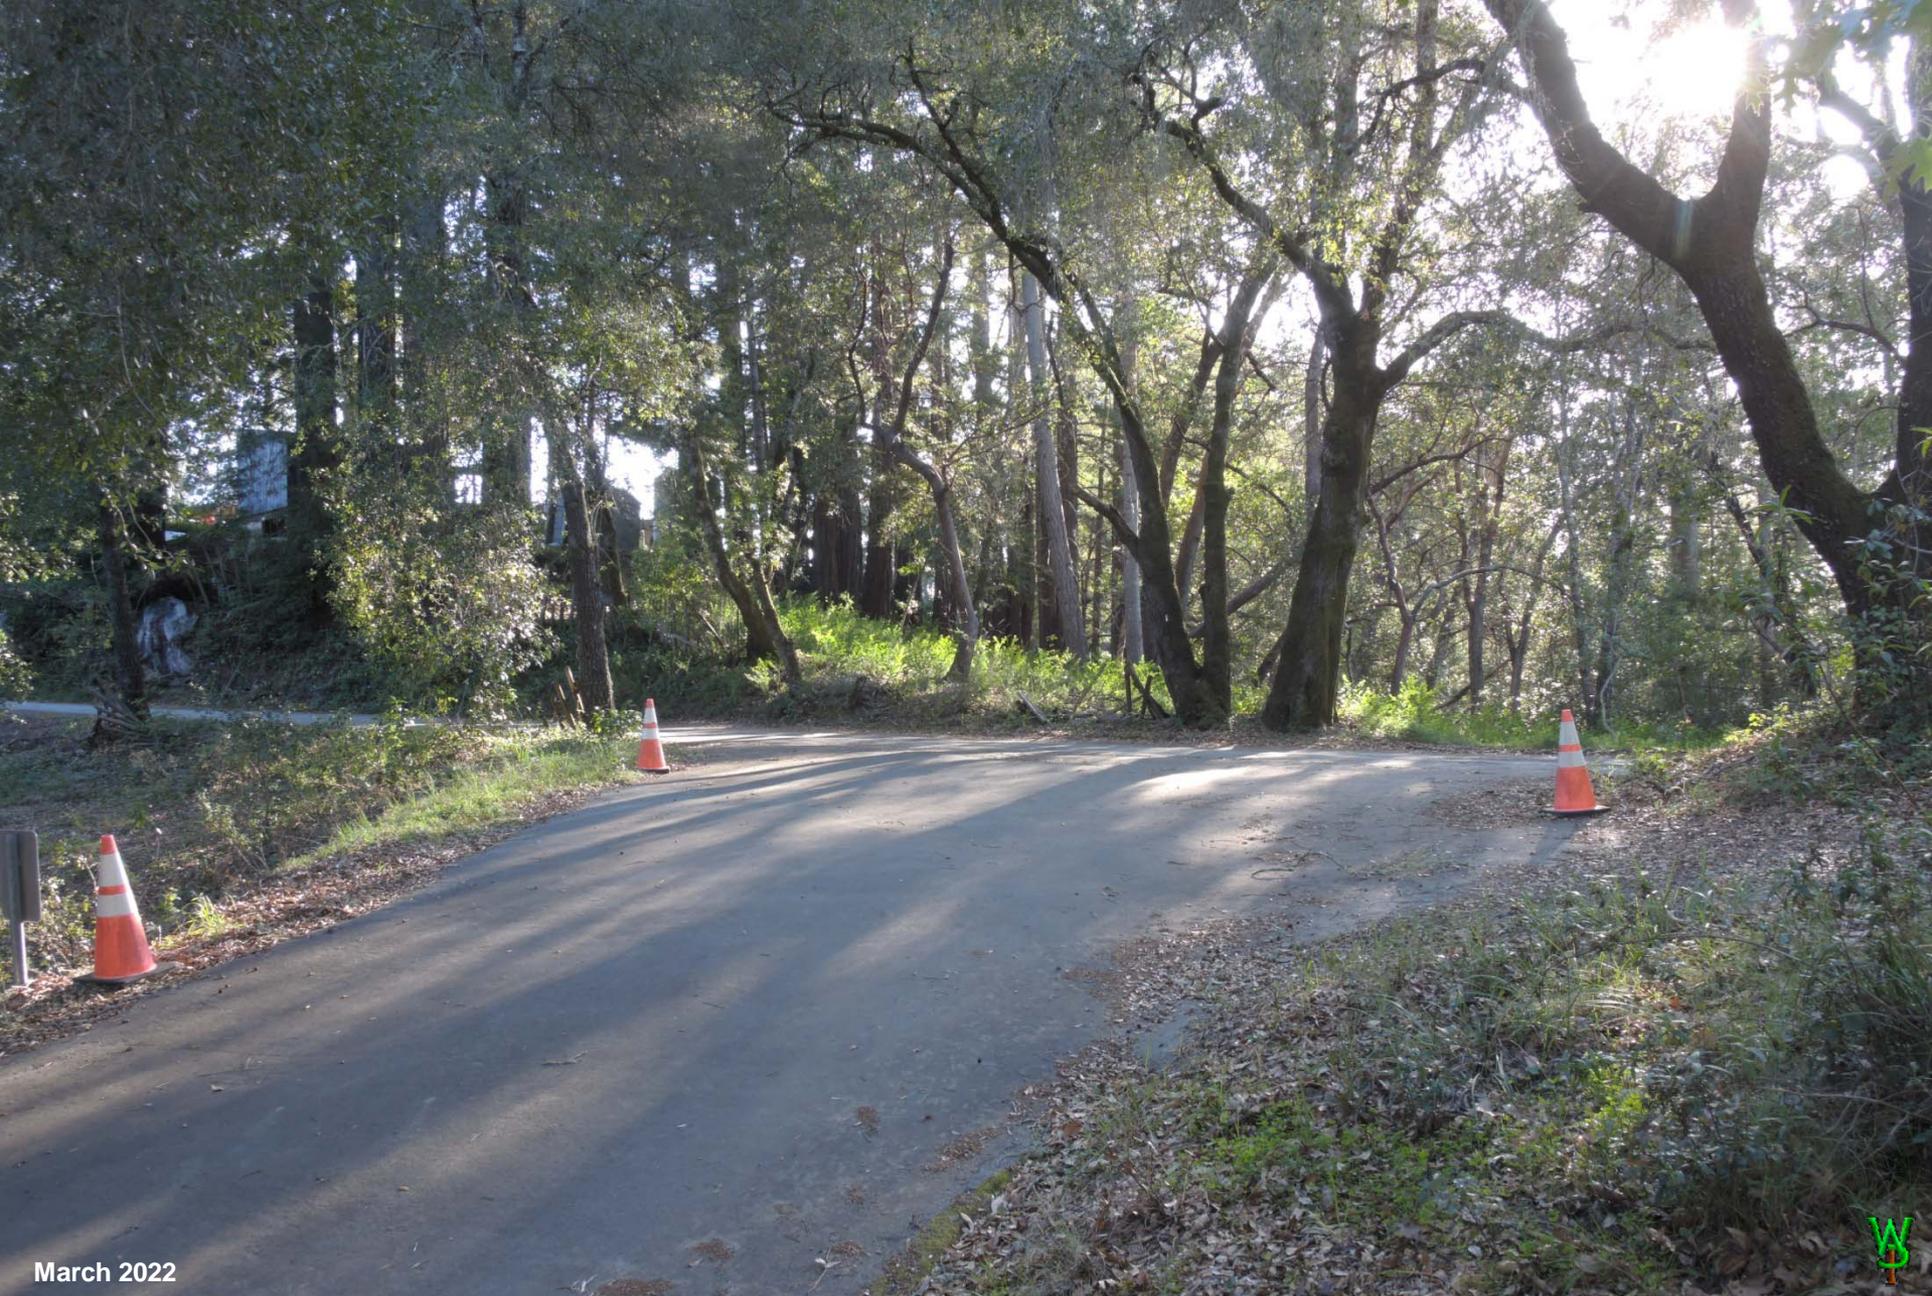
March 2022

The top of our driveway forms an automotive turnout (too short for a tractor-trailer truck). It too forms a T junction (a.k.a. “hammerhead”) into which one can back in a trailer to turn around. The driveway and paved road system could easily hold 20 cars. If I included parking on dirt, that number rises to perhaps 50. In a real emergency, just knowing those numbers matters.

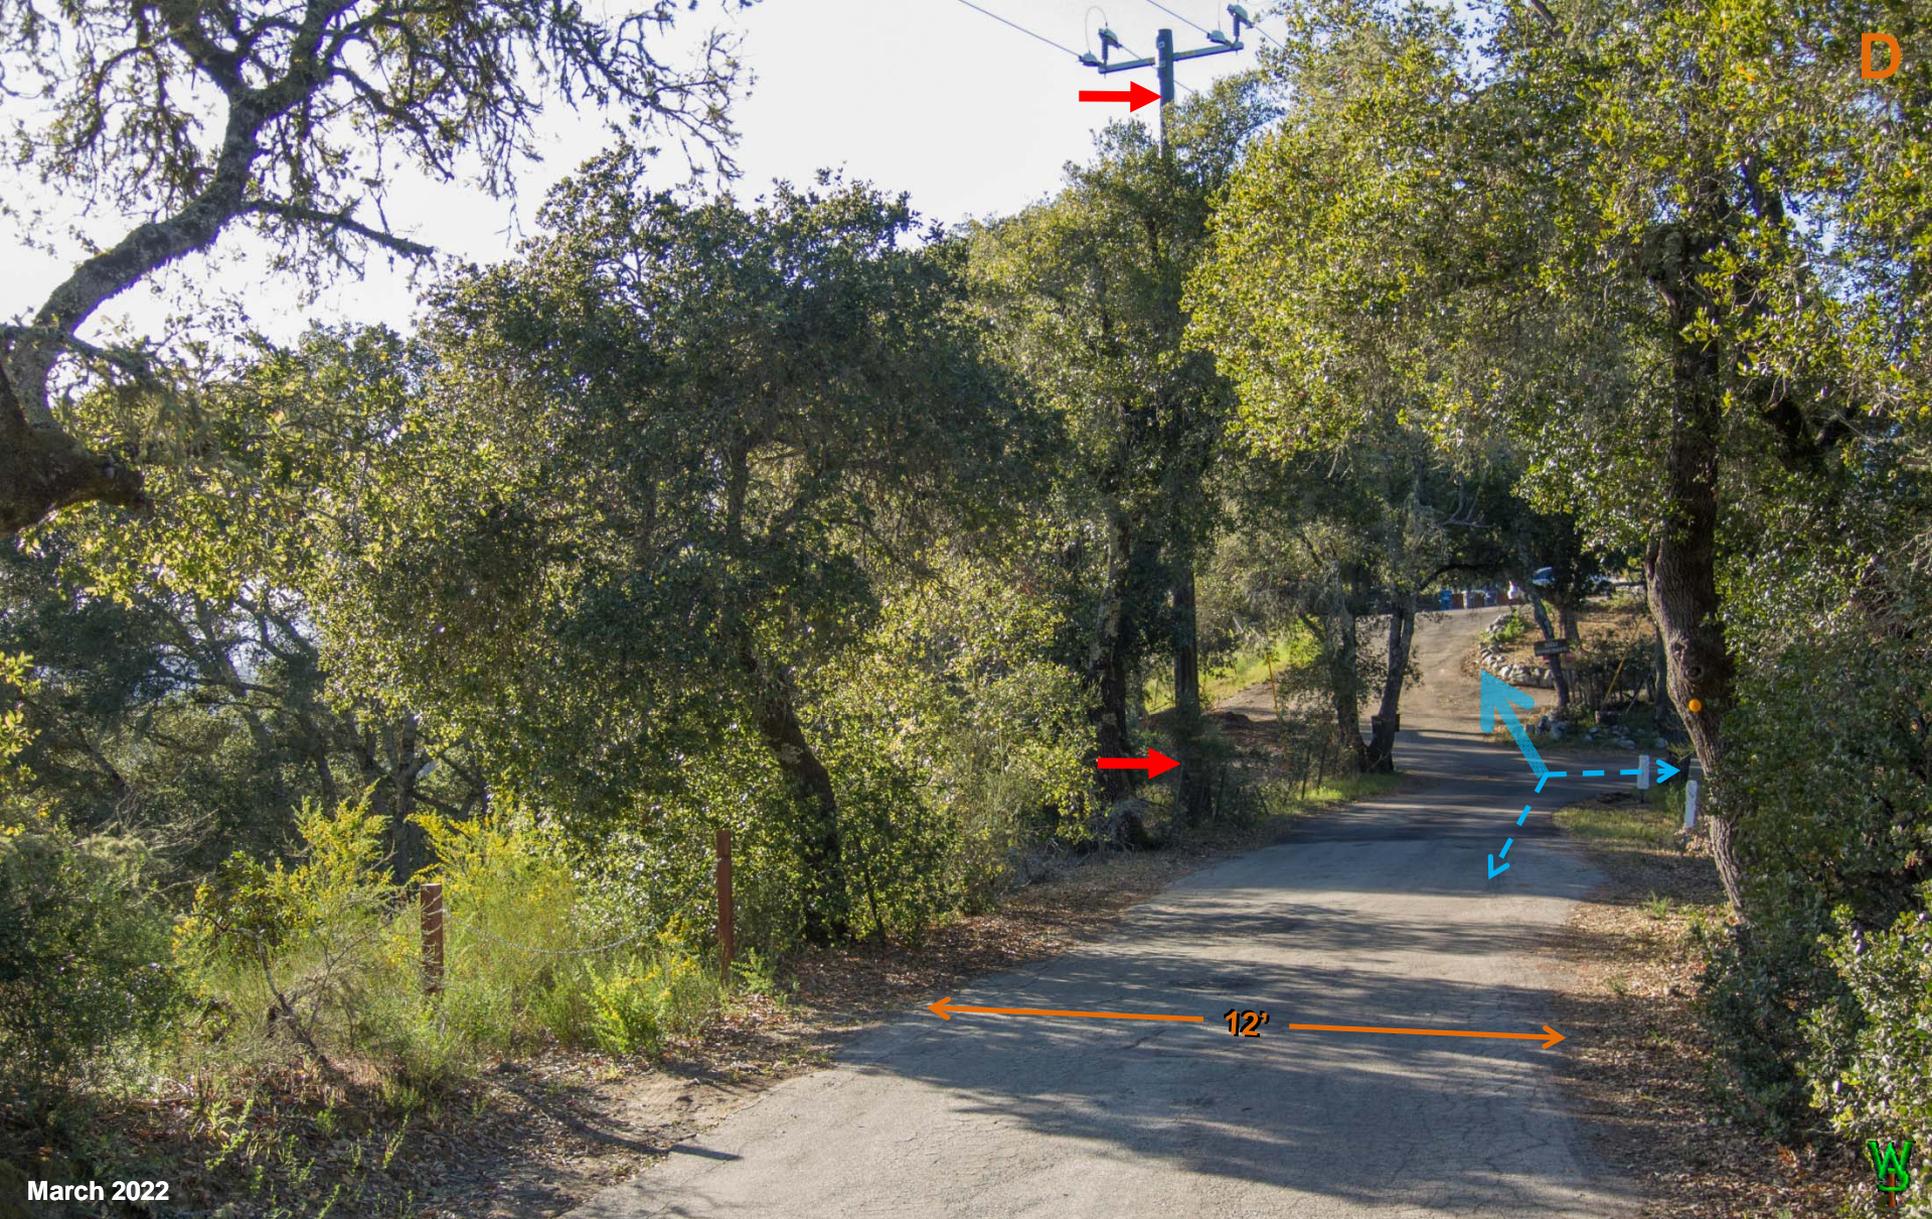
March 2022

To the left is **what could have been a “legally qualifying” turnout**, again with the driveway as a **“hammerhead”** long enough to turn a trailer. It sits between two stretches of the road **too narrow to pass**, each over 150 yards. In 2020, PG&E replaced the **power pole**. This was an opportunity to relocate the pole behind what could then be said “legally qualifying turnout” capable of handling a truck delivering heavy equipment or to allow a fire truck to get by a line of evacuating cars. Yes, I told the owner all of those reasons to move the pole in advance so the job could be done for free. No, he didn’t do it. Wait until he finds what that mistake could cost him.

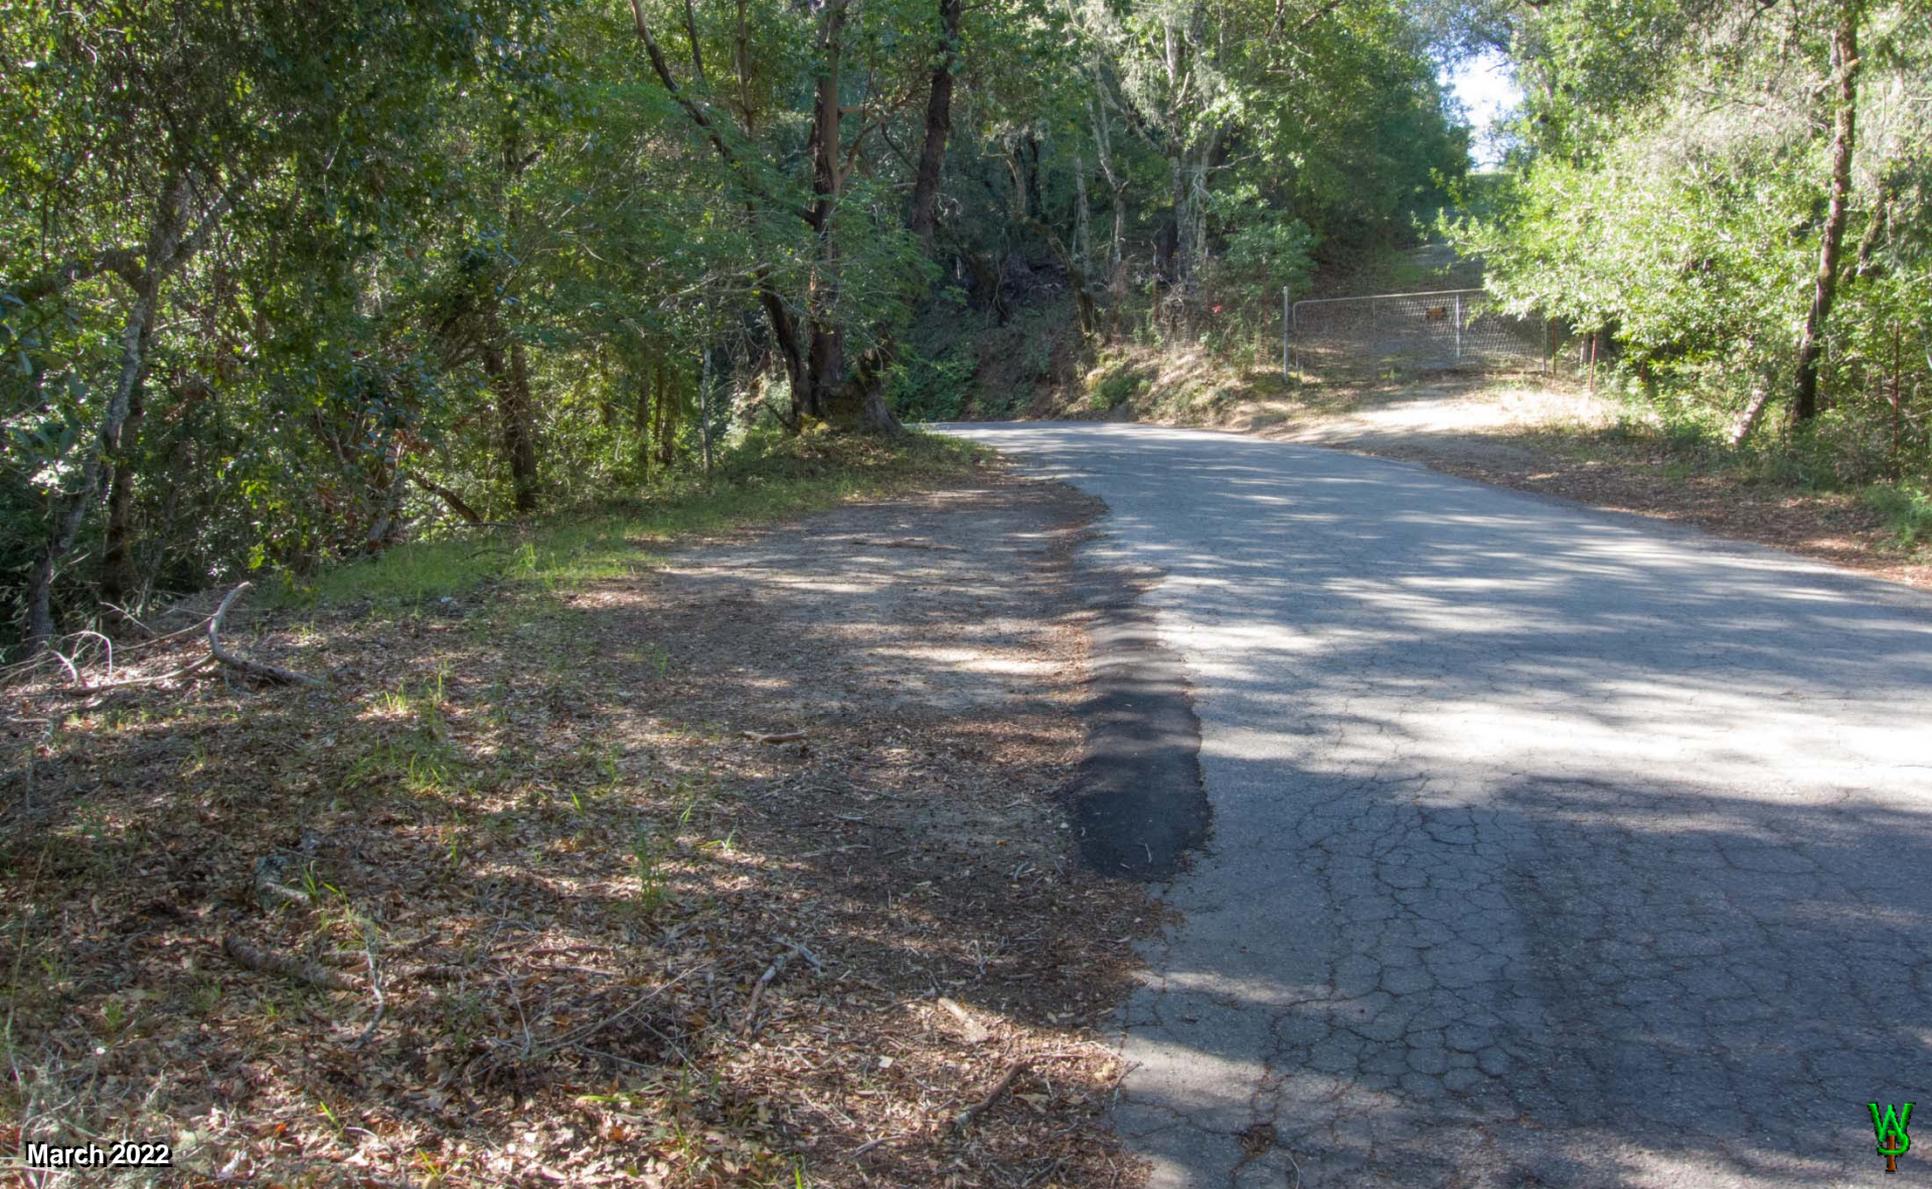
March 2022

Just below the Spanish Gulch beyond our property line, just **over ¼ mile** from our qualifying northern turnout, is this qualifying turnout I made with the owner's permission. Hence, the entire road and any branch roads off of it would not qualify for building permits without one in between. Had my neighbor asked PG&E to relocate the pole, we could have covered this section very inexpensively. Now it will cost in excess of \$30,000 just to move the pole in addition to a bit of compacted fill he would need to make it 12' wide. My guess as to the reason for the rule is that the firefighters' union demanded more turnouts, because a total of 3 firefighters (nationwide) have died in traffic accidents in the last decade. Turnouts matter to firefighters. Hopefully, now they matter to you too.

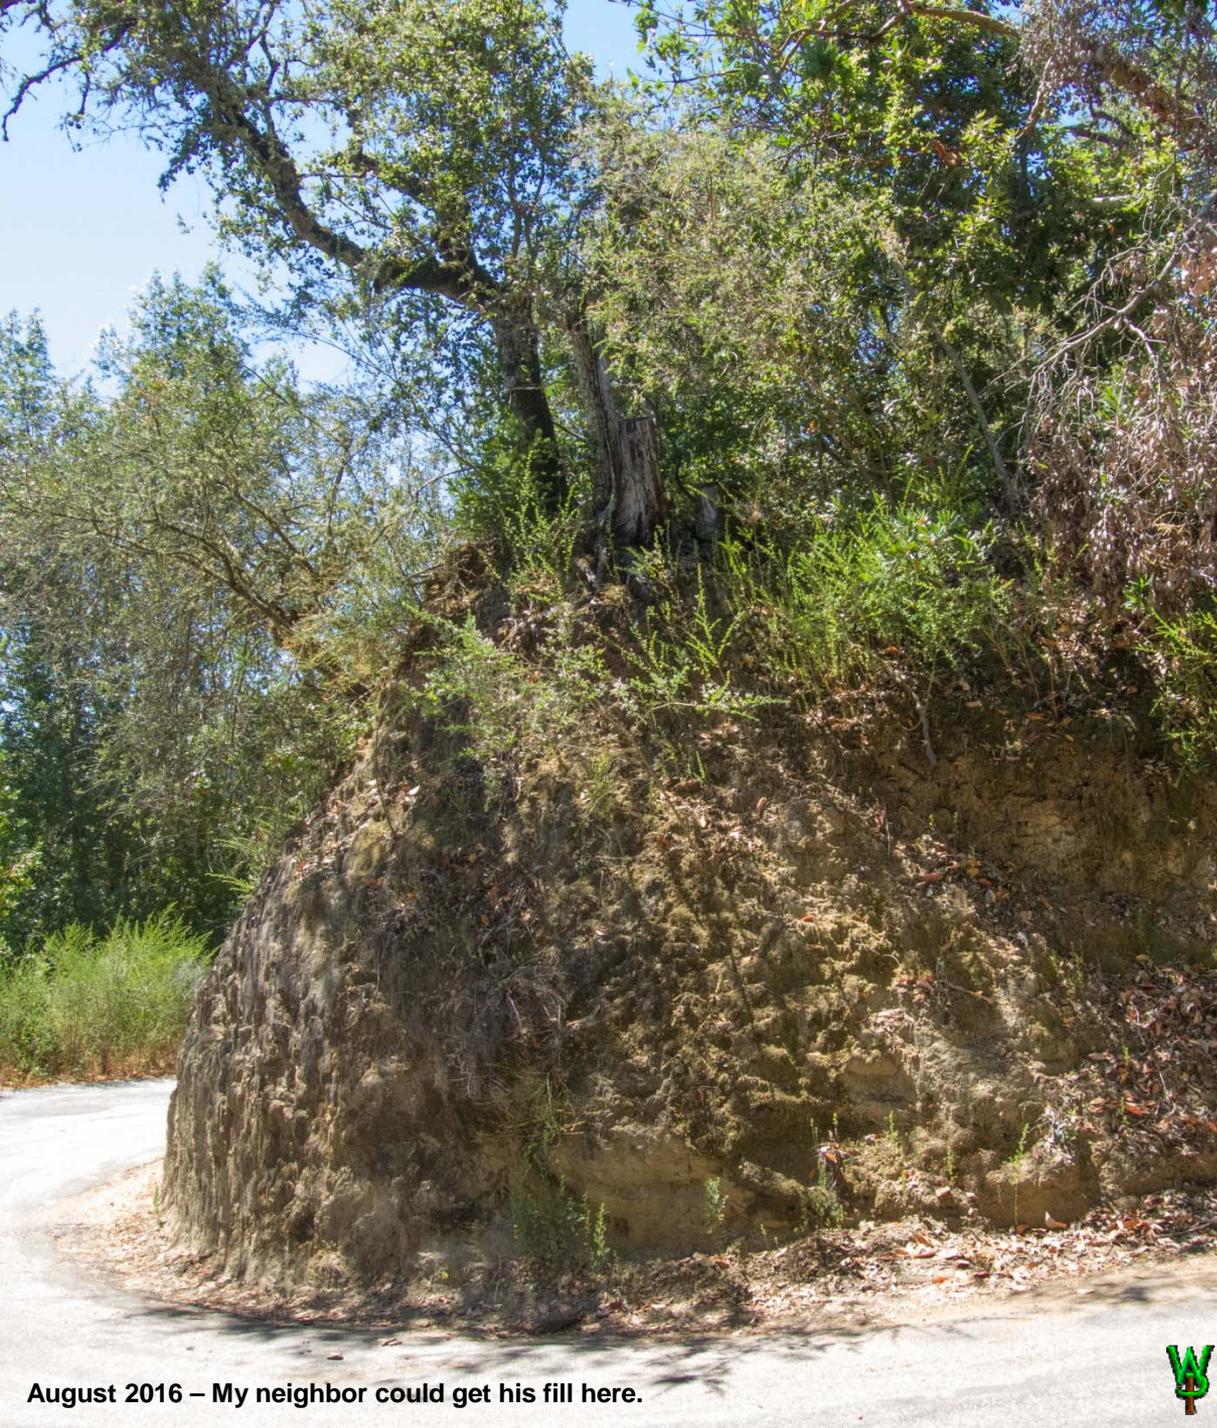
This “bump” of dirt is just above the headwall of the “Spanish Gulch” (see the [chapter on drainage](#)). Uphill traffic has the right of way. If you were driving down this slope into a blind corner, would you like to back up to [this crest](#) behind you with no escape? If you were driving uphill, would you use a [turnout](#) to avoid a clueless driver suddenly heading downhill after a long straightaway ending at a blind corner they can't see coming? I asked the County for permission to build it. They said I would have to install a \$10,000 guardrail. Consider the depth of hypocrisy in demanding a guardrail for a turnout when they don't have one across the top of Spanish Gulch!
