ROADS TO HEAVEN, TO HELL, AND BACK, SOMEWHAT

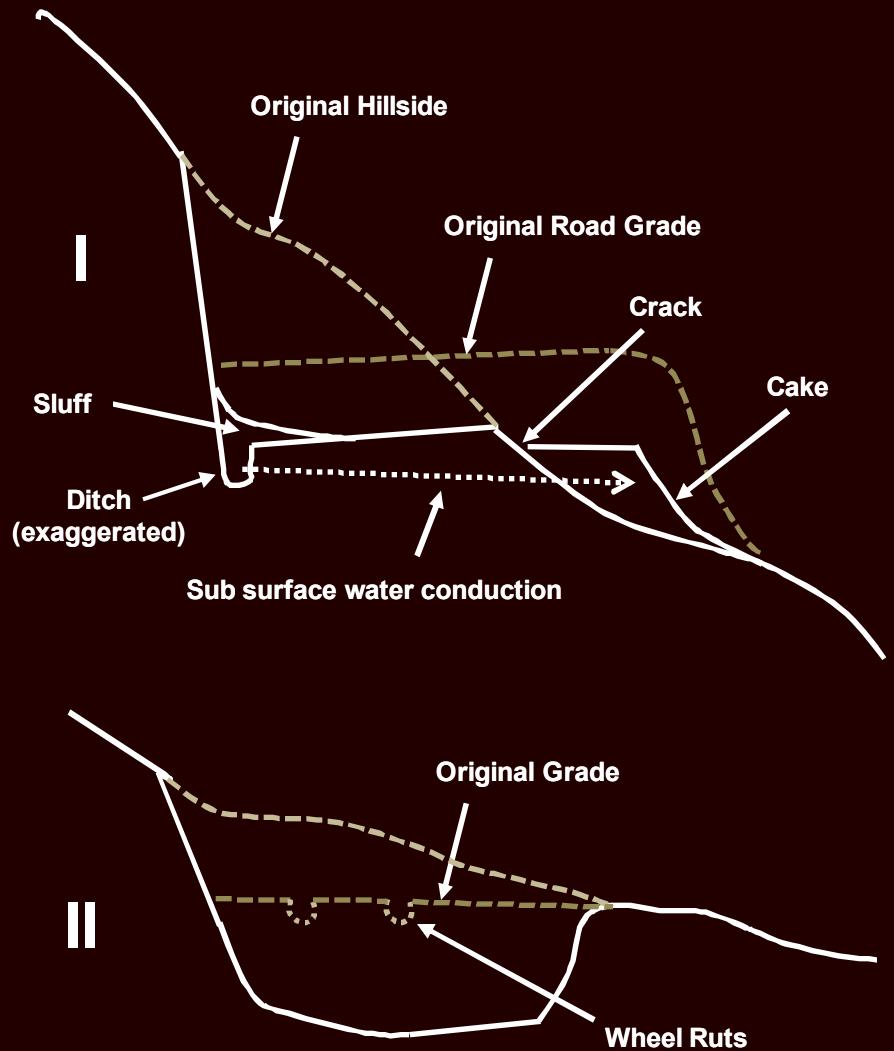
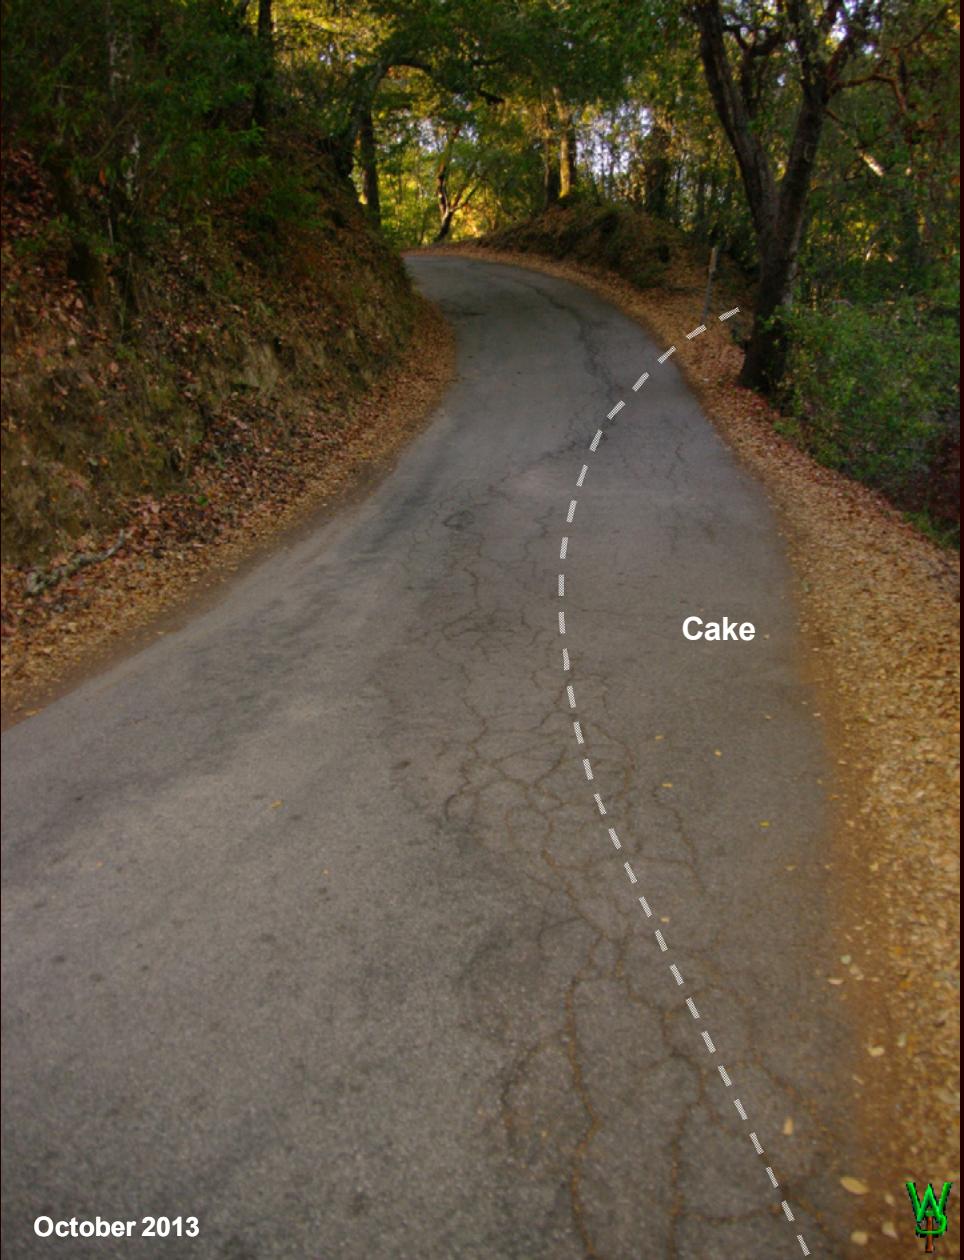
Grades for the original dirt roads traversing these mountains were designed so that horse wagons with iron "tires" would not slide off the mountain in the winter. In general, roads were blasted out of hillsides and graded with horse-drawn blades. In cases like Type I, the outside "cake" or "perched fill" slowly slides downhill on a "slip" of decayed organic matter that was surface soil of the original fill-slope (above). In Type II cases, even simple wheel ruts can enlarge and turn the dirt road into a muddy creek.
