ROADS TO HEAVEN, TO HELL, AND BACK, SOMEWHAT

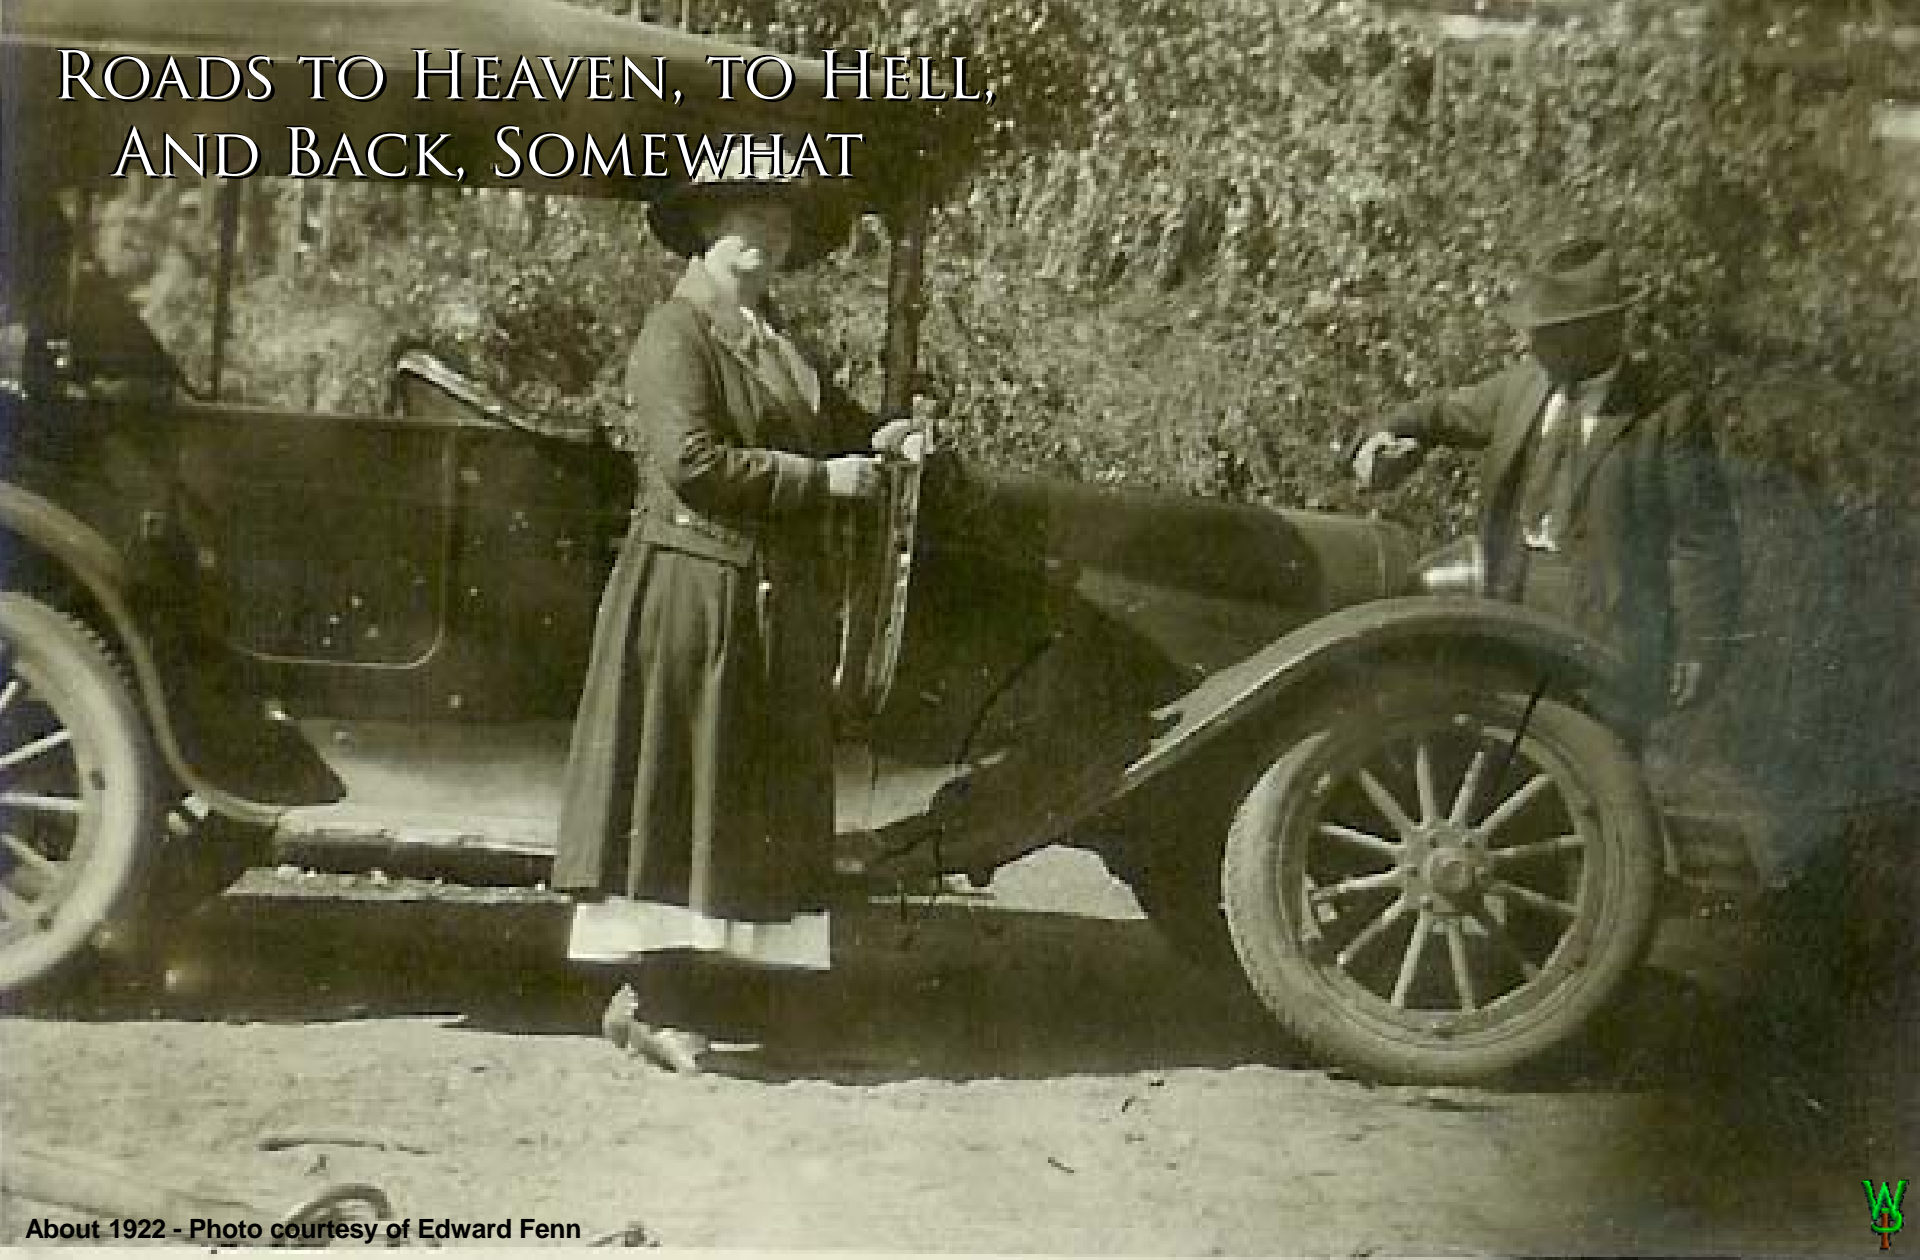
About 1922 - Photo courtesy of Edward Fenn

Recall from [the site history](#), that Ed Fenn bought property along Mr. McKiernan's road astride Charlie Martin's road from Glenwood. This is that road as it passed in front of his house (note the *Vinca major* on the bank behind the car). Typical road construction back then was with dynamite, shovels, and horse-drawn grading blades. Slopes receiving the fill were not cleaned or benched and the fills were not compacted. If it slid, they fixed it. What few culverts were installed were wood. In the winter, the surface was mud.

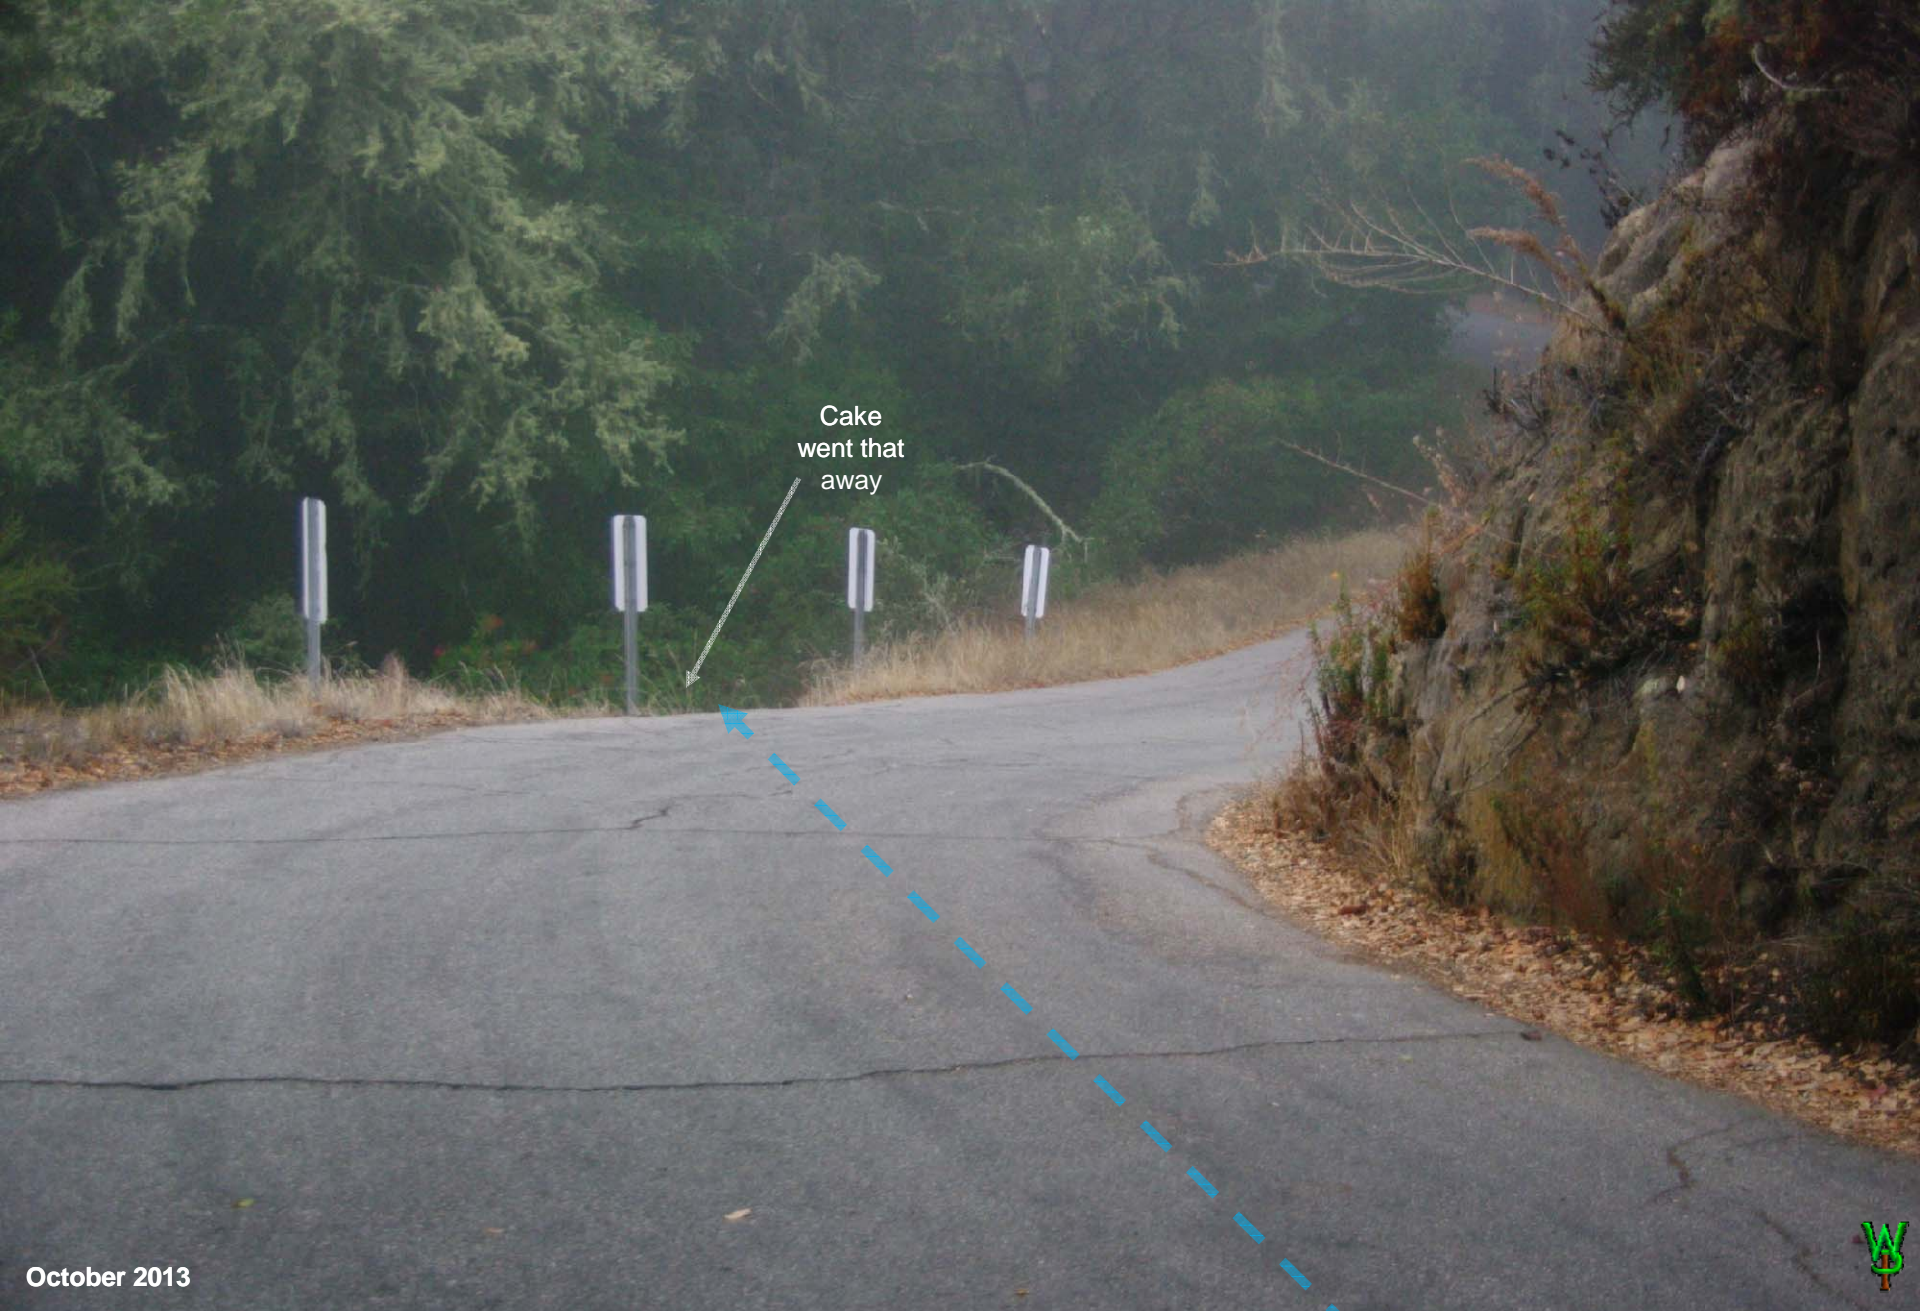
October 2013

A few feet farther down from the prior photo, the road suffered a Type I failure: In-sloped grades collected water that ran down the ditch to where it kicked out due to accumulated sediment. It then ran down the surface away from the ditch, hit the corner (above), kept going, and just took the cake.

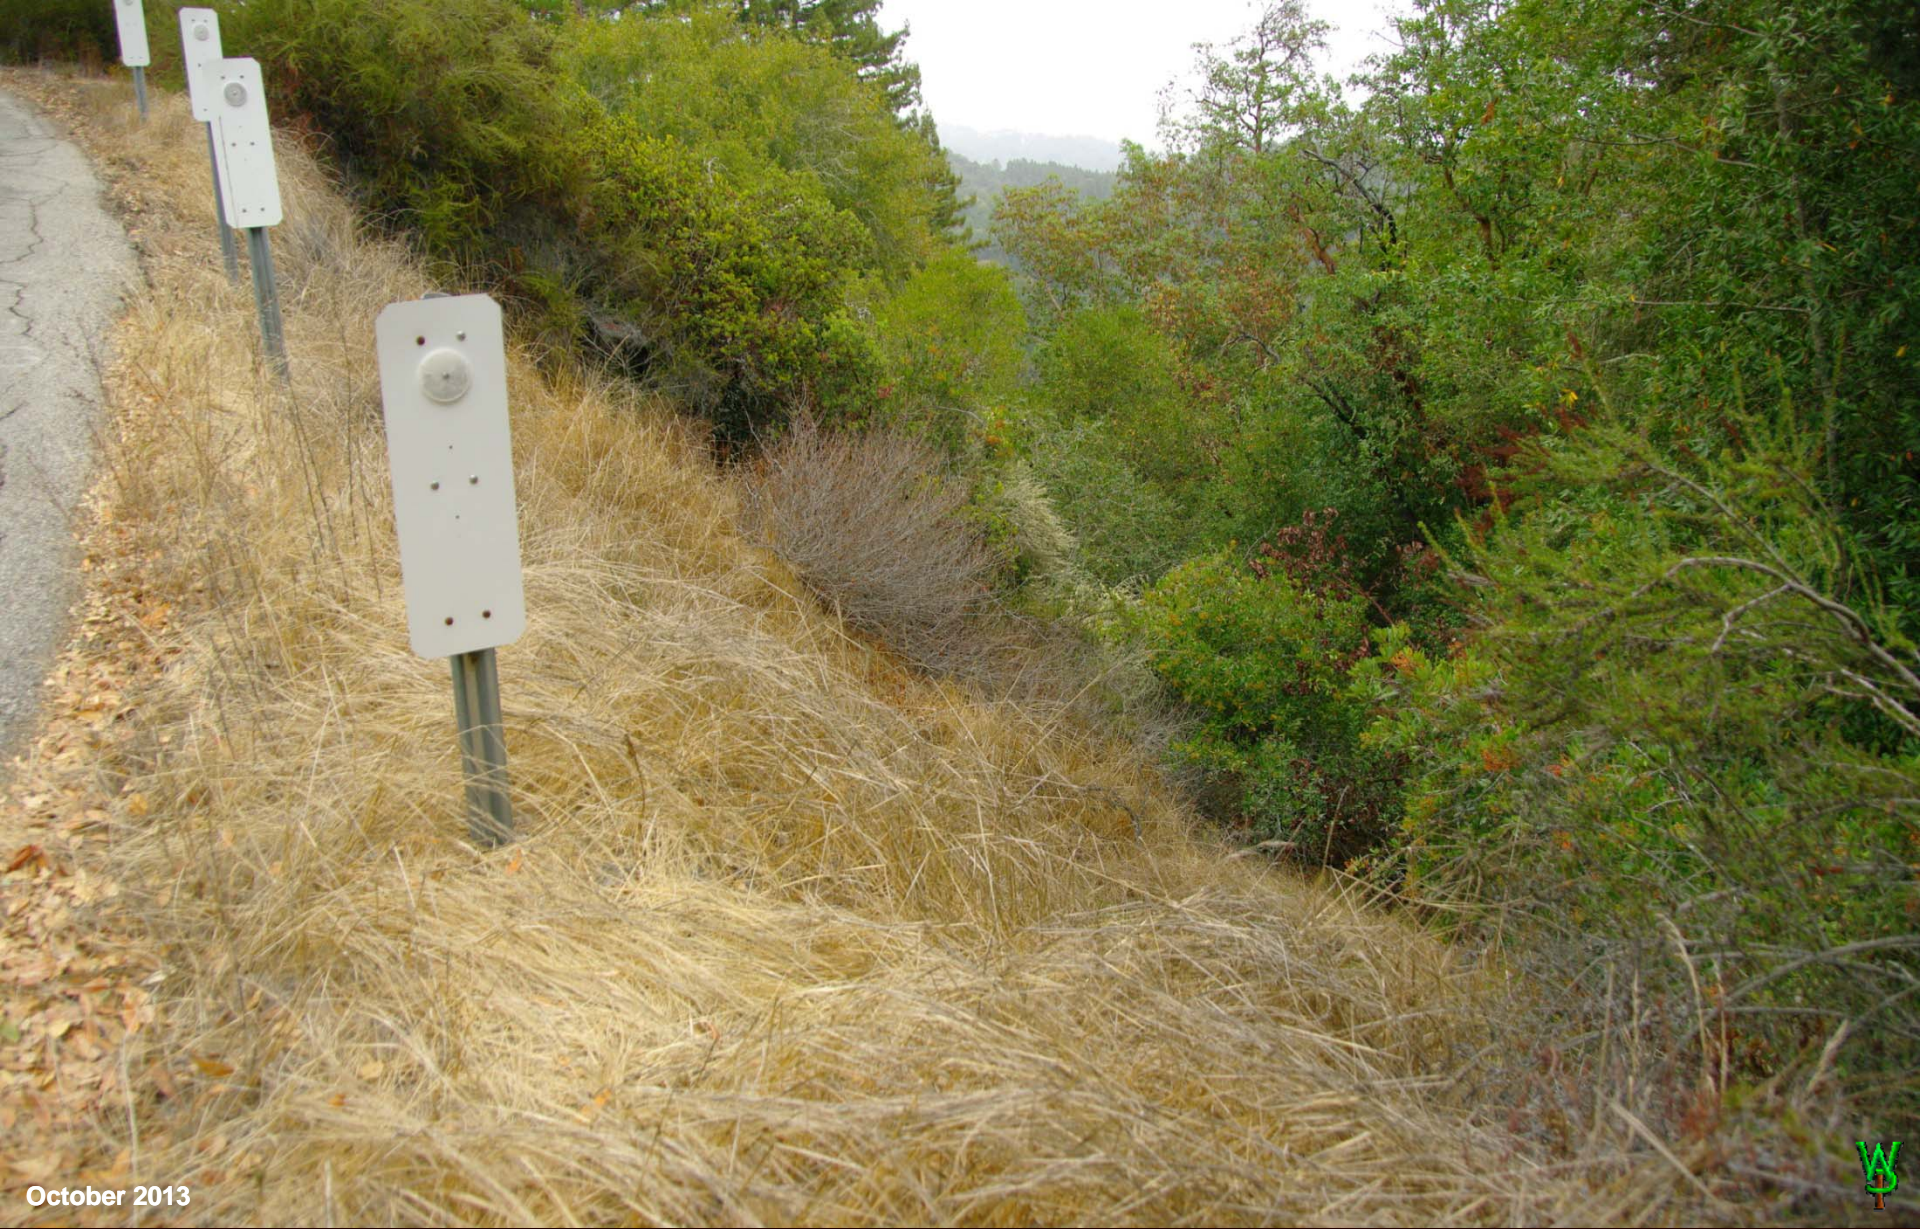
October 2013

Why? Well, the cake was simply loose fill when Charley McKiernan blasted out the rock and pushed it aside to make the road. The fill was neither benched nor compacted. When the ditch across the road filled (and it didn't take much) the water came across, and it took the cake. Unfortunately, despite my offer to reseed it with native grass for free, the County chose to hydro-seed it with Italian rye and soft chess; i.e., the usual. You do what you can, not what you can't. It is just as true for the County as it is for me.

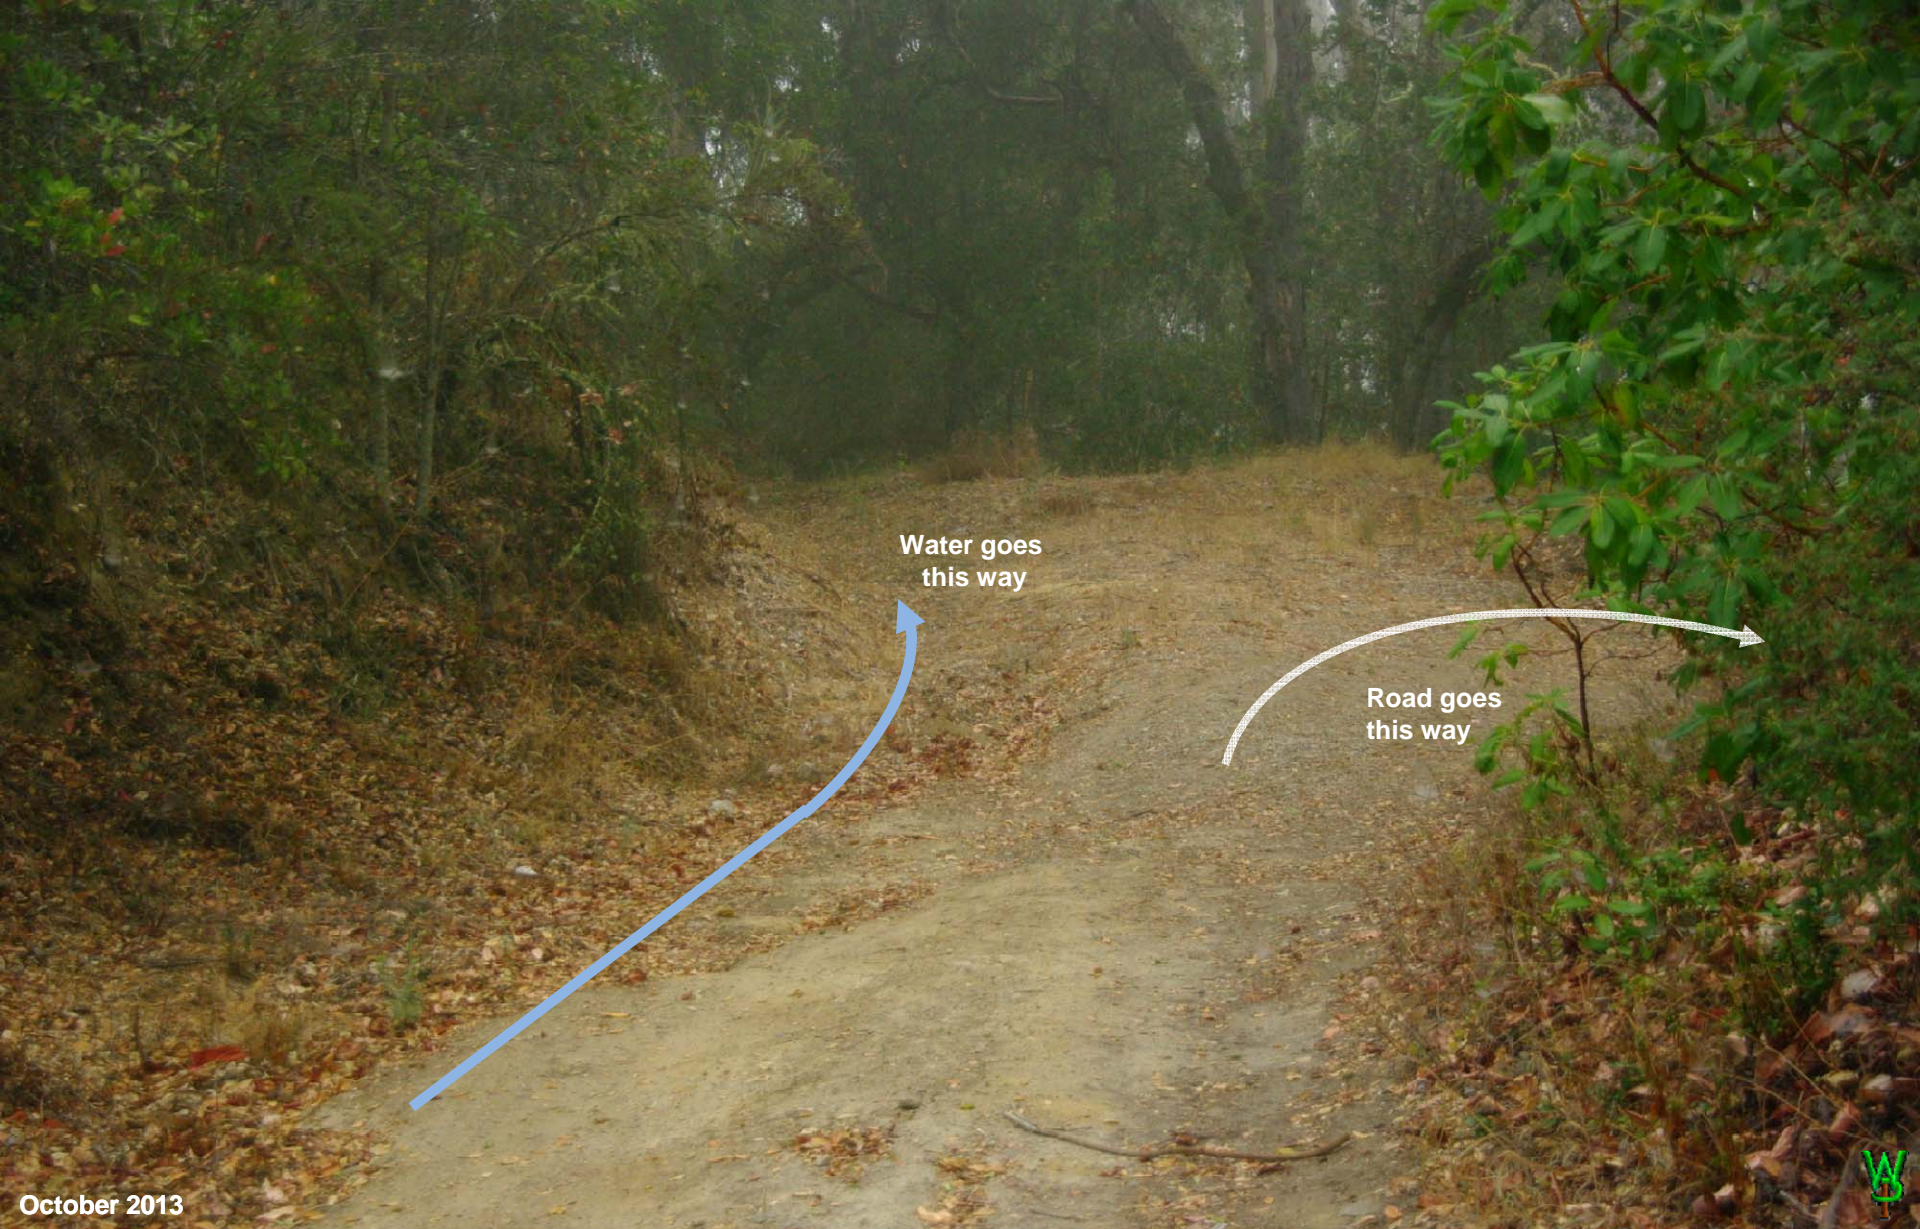
October 2013

To reduce erosion on the road below I had to reduce the flow of water onto it at the entrance and then distribute the rest. The first step was to divert what was coming off the County road into the eucalyptus stand. This entailed a requirement for sufficient capacity to take all the water coming down the County road for nearly a quarter mile in the event that but a single County culvert plugs (it's happened). That collection area is 5-6 acres because so many landowners along that stretch dump their water onto the County road... because it is **a commons**. It was already coming down this road entry so I simply made the best of things. I need to clean it out too.

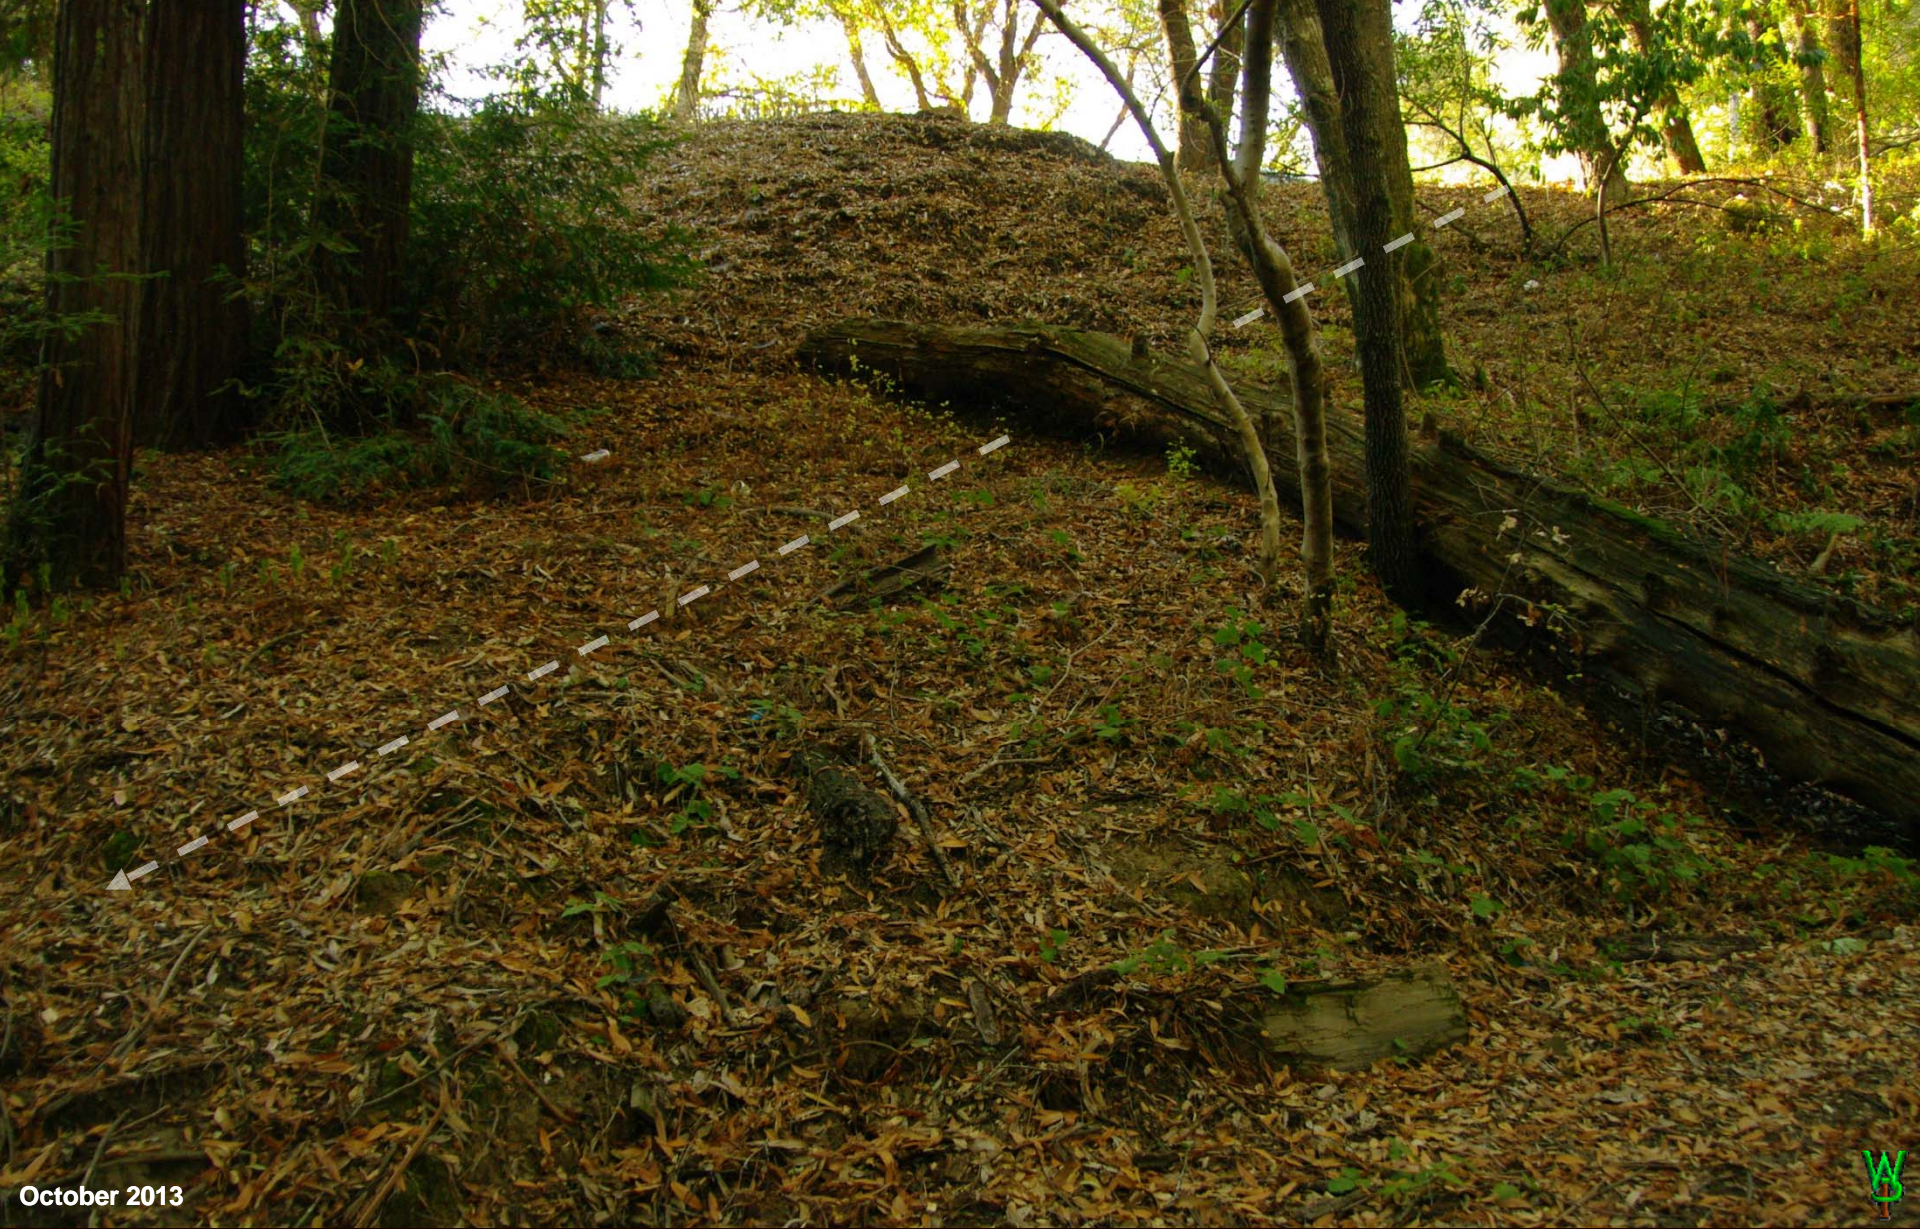
October 2013

Then I filled in this long abandoned road segment (arrow) where the water originally entered Fenn's road. This was a Type II case turned into a useless gully. So, I retired it in 2003 by having the County fill it with ditch cleanings and then I graded it out. This kind of thing takes a lot of fill, 6-8 dump trucks worth. The County lawyers ordered the Department of Public Works not to do this because somebody sued them for fill contaminated with wood (despite having signed a release agreement to take it as is). The lawyers said that Public Works must truck the fill some 20 miles to a landfill and I have a harder time getting fill with which to fix old problems.

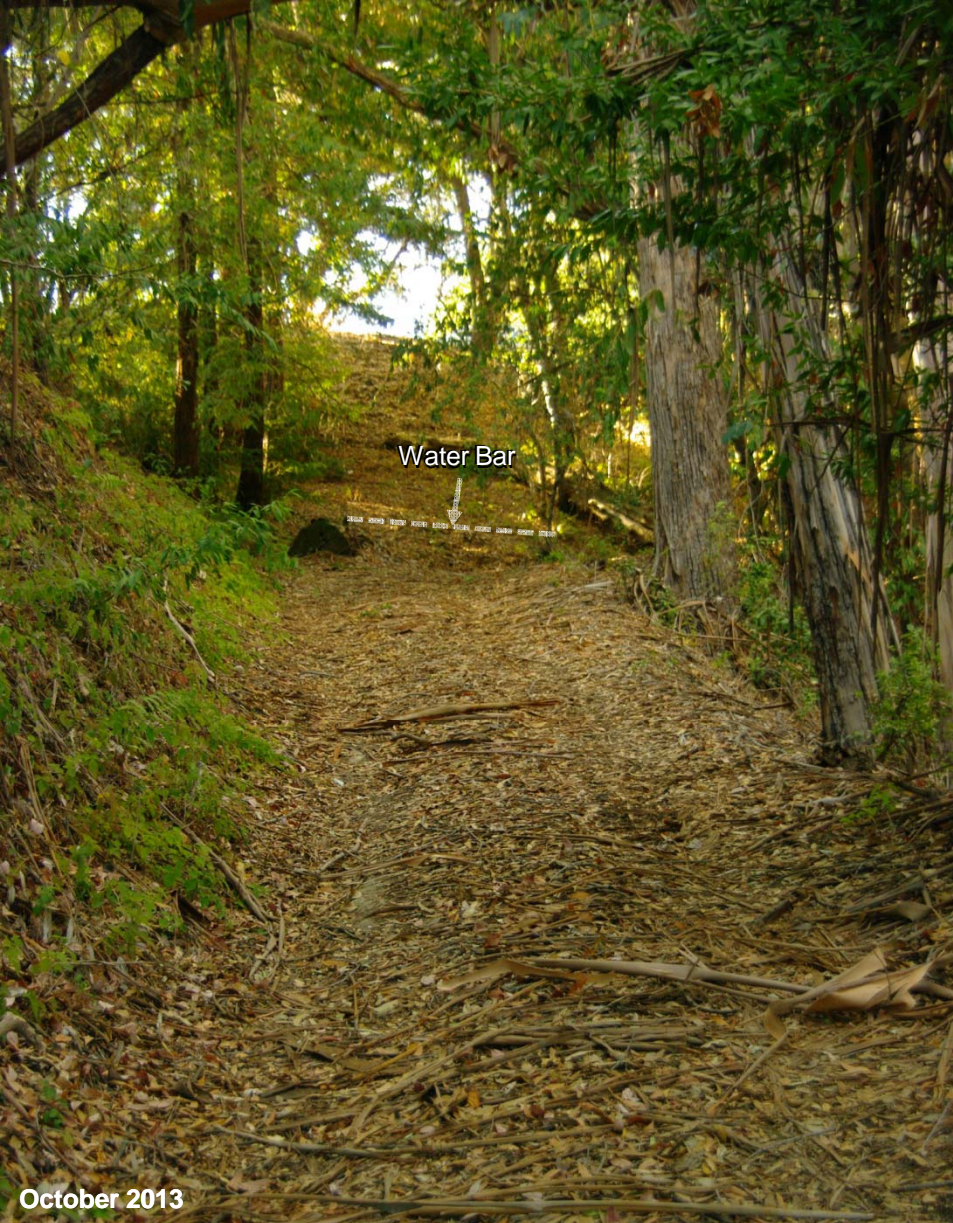
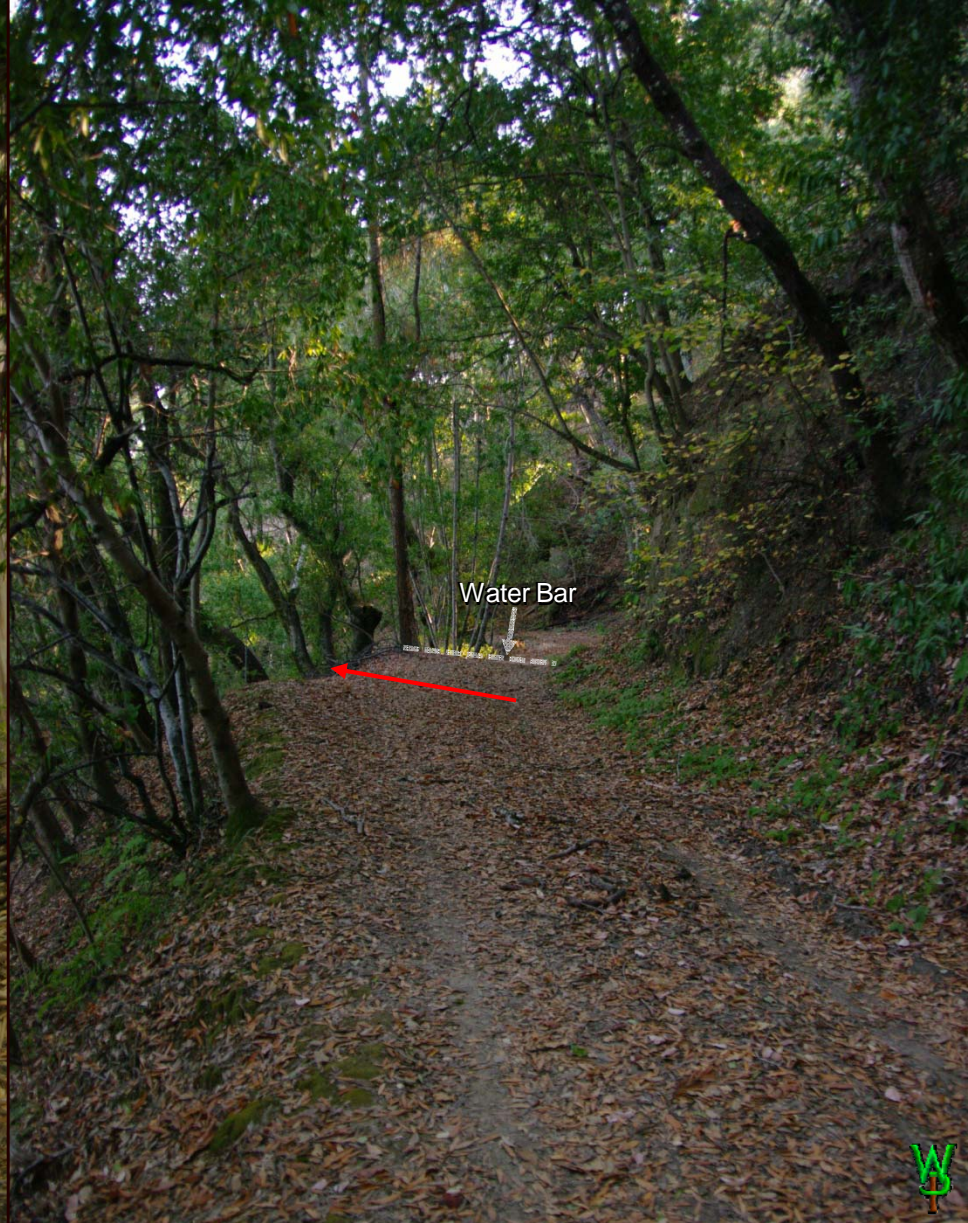
October 2013

Down the road, I installed and maintain 2 concrete culverts (concrete burns less easily) with water-bars behind them in case they plug (the culvert at left is above the water bar). I also had other out-sloped water-bars made to shed the water at outside corners (right). These drainage improvements are separated by less than 100 feet. As long as the culverts are maintained, and we install a gate to keep idiot joy-riders from tearing up the water bars in the winter, this is stable. If and when I come up with more material, I can then reinforce the water bars and build more of an out-sloped configuration which will eliminate these concentrated flows.

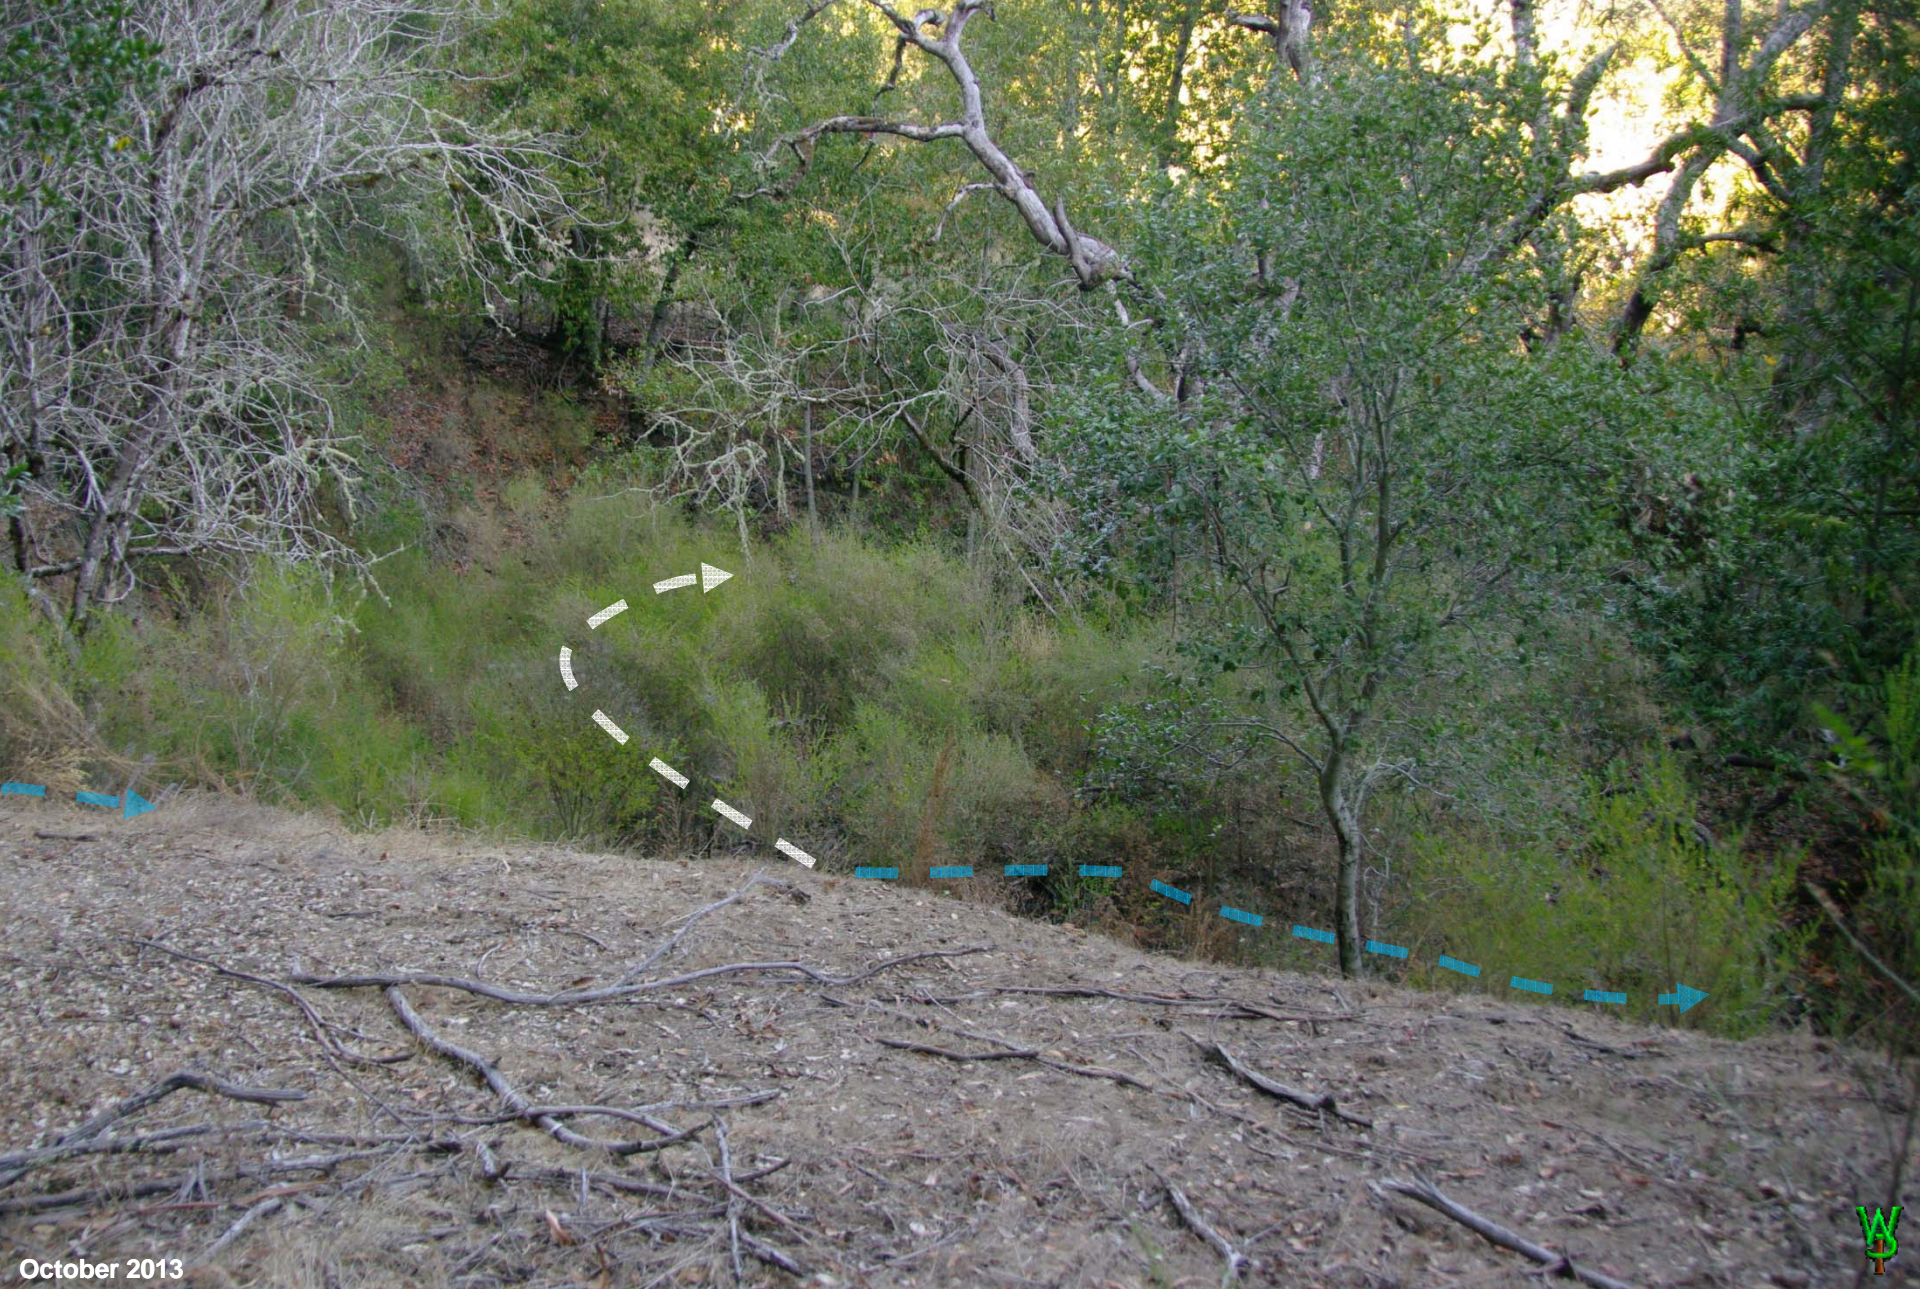
October 2013

This is a view of that same spot today from closer to the edge (because of vegetation) and without benefit of the height of the porch. Obviously, it would be easier to see what happened without all that broom. I'll see what I can do to get a better image after the property owner and I cut some trees. The channel to which I returned the water is indicated in blue.

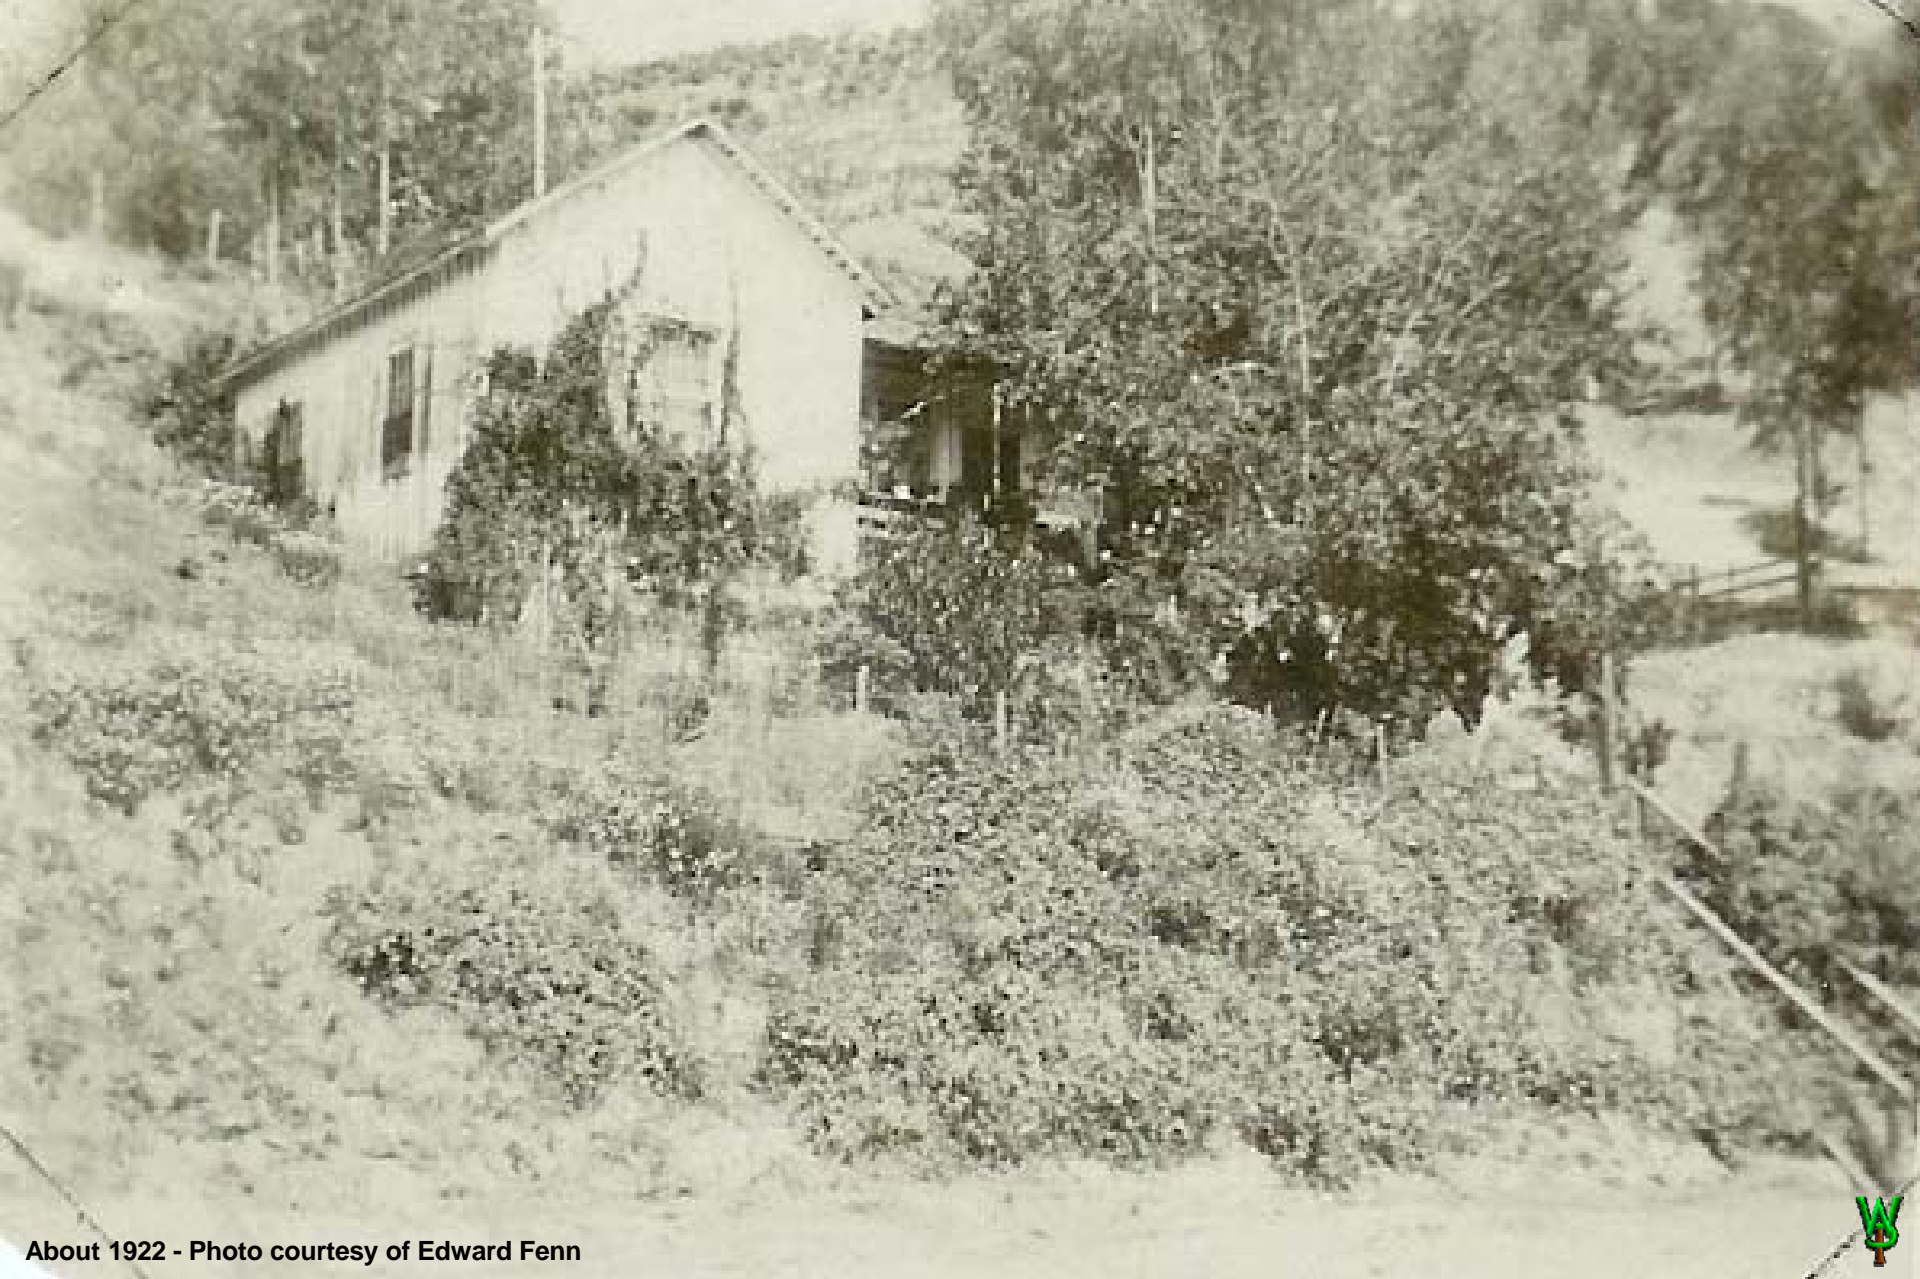
About 1922 - Photo courtesy of Edward Fenn

Returning to the original photo, what developed in front of the house was a Type II failure. The road was graded level across from the slope above. It then rutted and eroded as the water channeled down the surface to the right. The former creek channel is to the right of the stairs in the right front foreground. Despite the diversion above, the collection area is still substantial. Please note the blackberry shrubs on the slope in the foreground, the eucalyptus behind, and the stairs to the right front.

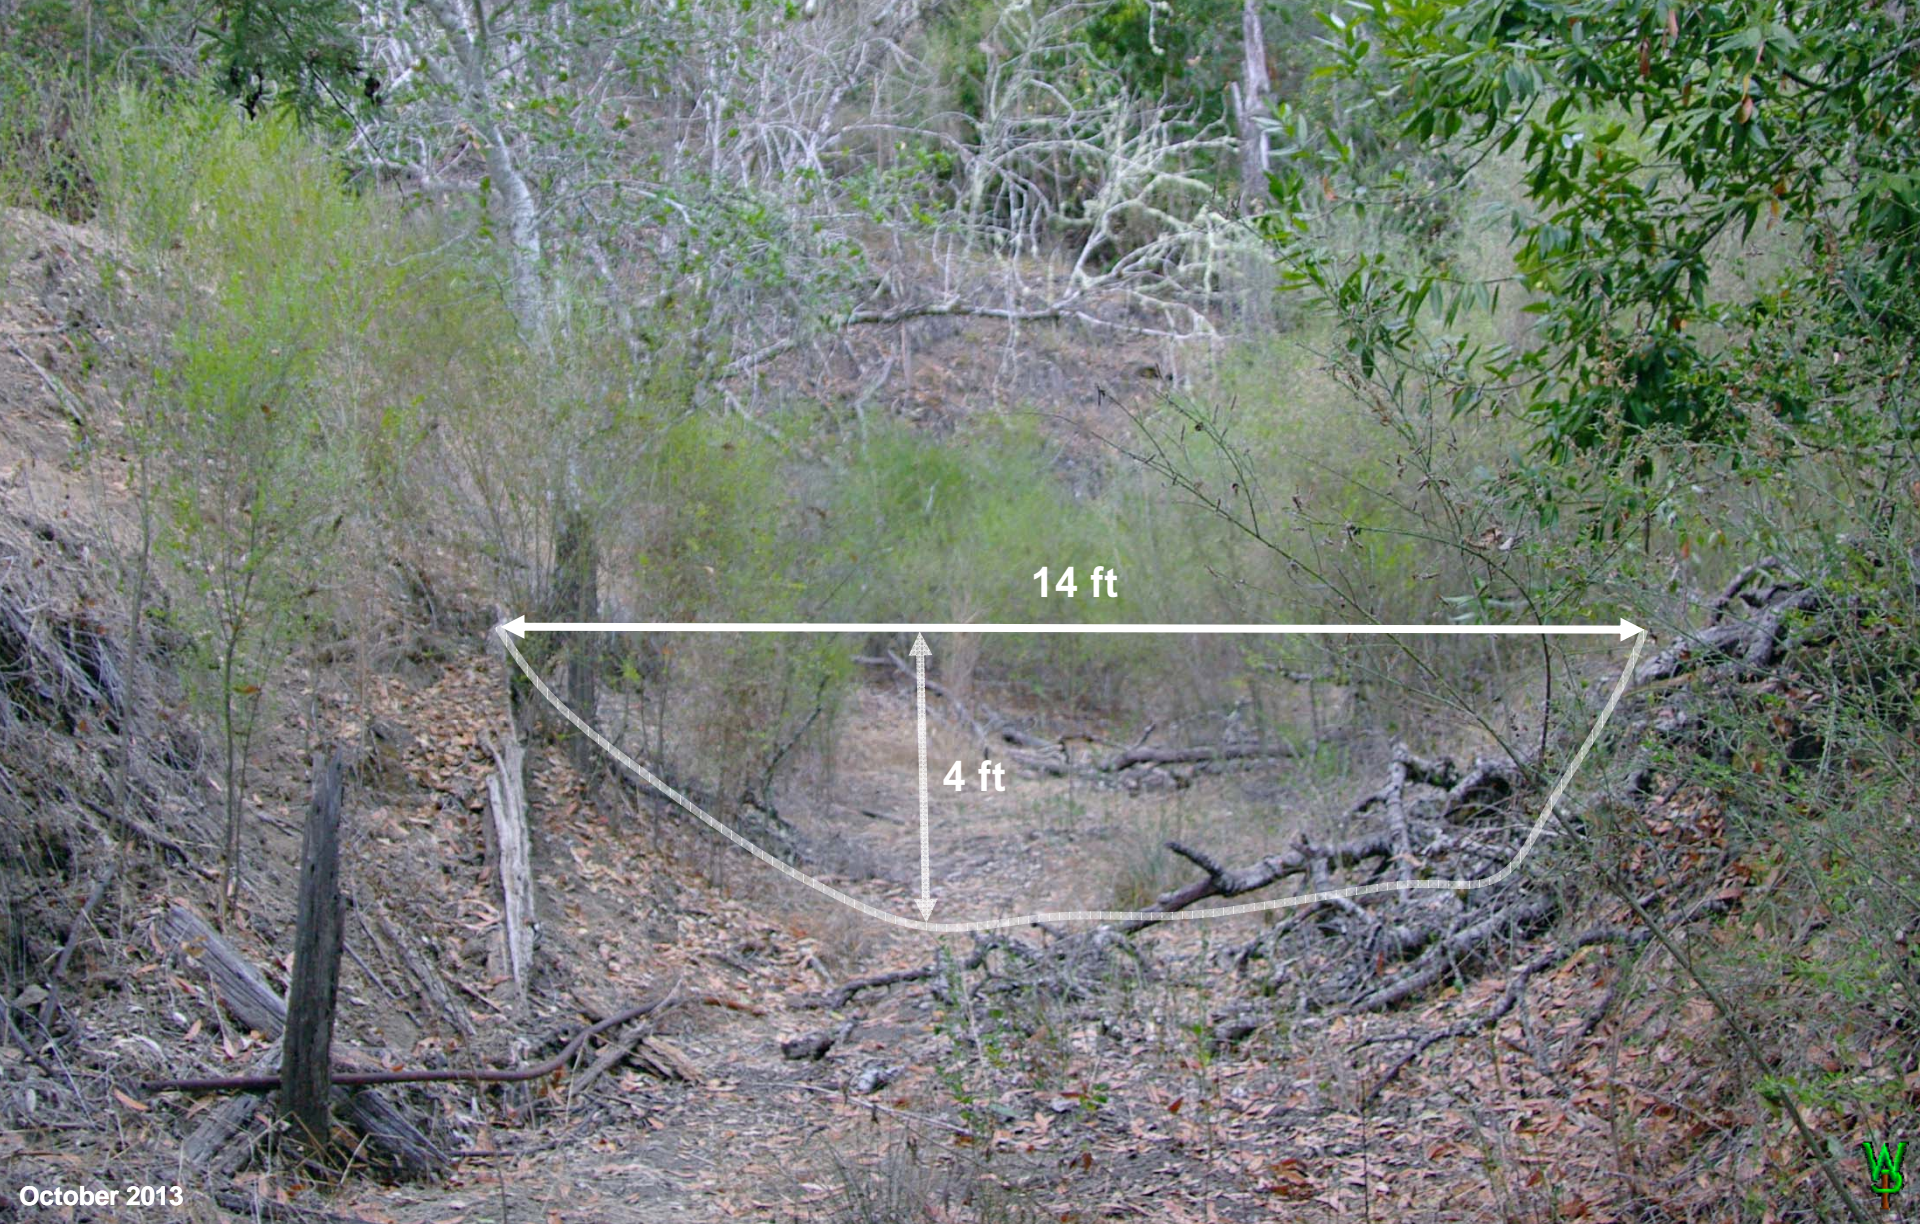
October 2013

Here is the repeat cross-section (although I would need a ladder for the original perspective). Altogether, I estimate that over 2,000 cubic yards of material have been lost from in front of this old house site. I have had a County planner tell me with a straight face that "The County wants these old roads to go back to Nature." From its appearance, don't you think we've lost a fair bit of "Natural" subsoil already? Do you really think this situation would have corrected on its own or, if I hadn't diverted that water at the top, would the stream have just kept cutting? Yet this is not our property. Did I do the right thing? Does our planner know what he's talking about?
