ROADS TO HEAVEN, TO HELL, AND BACK, SOMEWHAT

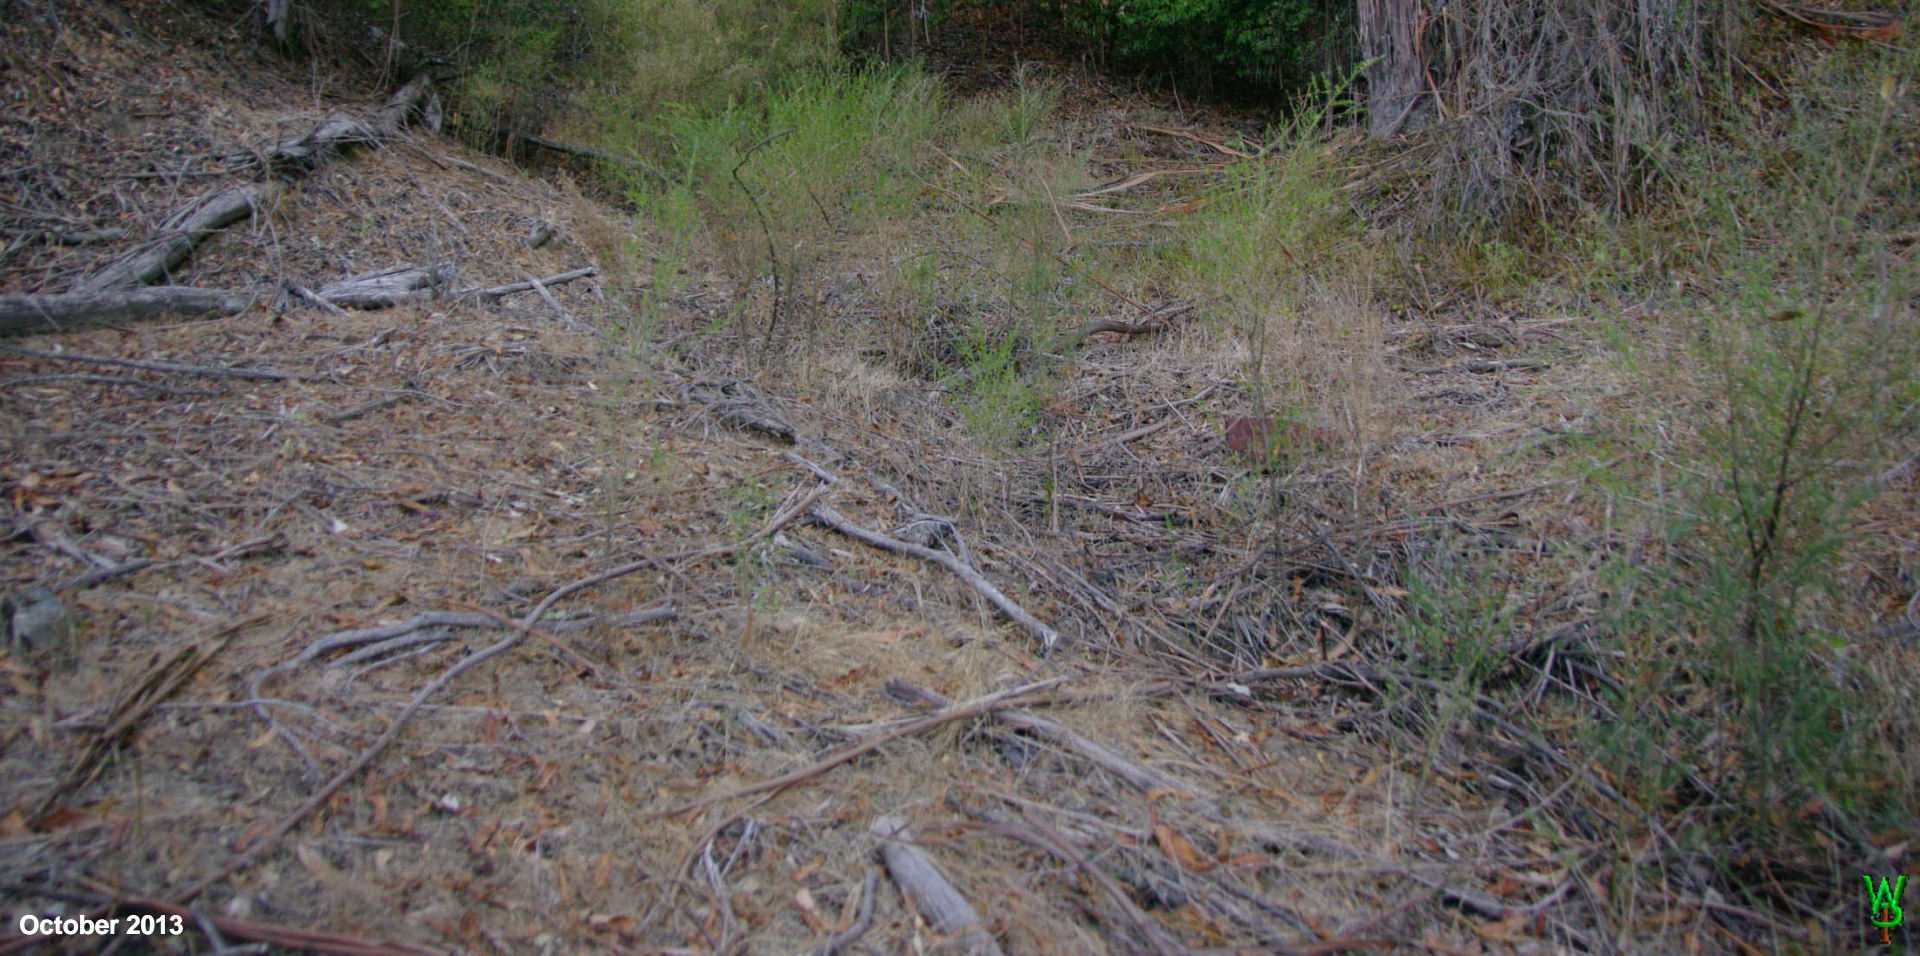
October 2013

Here is where the water now comes out of the eucalyptus grove that Fenn probably planted to reduce erosion. If so, it quite apparently did its job, as there is little apparent channel incision here after 23 years at full flow except at the very bottom where there are no trees. Effectively, my diverting the water at the top into that original channel and diffusing the rest arrested the channeling of the road surface. It's a fixable situation now. Do you see the material available to do slow it down even more? Yes, eucalyptus works fine for that. It is dense, rots slowly, and is obviously plentiful, although it is a problem in other respects. Slow the water with eucalyptus logs, replace the eucalyptus with redwood, and we could have the best of both worlds. The good news is that the new landowner is amenable to such a plan. So, in your opinion, should he be forced to hire the County's expensive experts, inspectors, and consultants, paying probably \$50,000 for a permit or should we be allowed to proceed on our own? Wouldn't it be even better if he could sell that redwood as a return on his investment in removing the eucalyptus, and planting the redwood? Well, the "environmentalists' County agents won't allow him do that and even if he could the State would make him spend ANOTHER \$50,000. I hope you aren't expecting the County to *make* the landowner fix it; as they have already made this problem worse than it had to be. More to the point, they are already busy enough with their own problems, many of their own making. And no, they have not learned their lesson. Do I know what I'm doing?

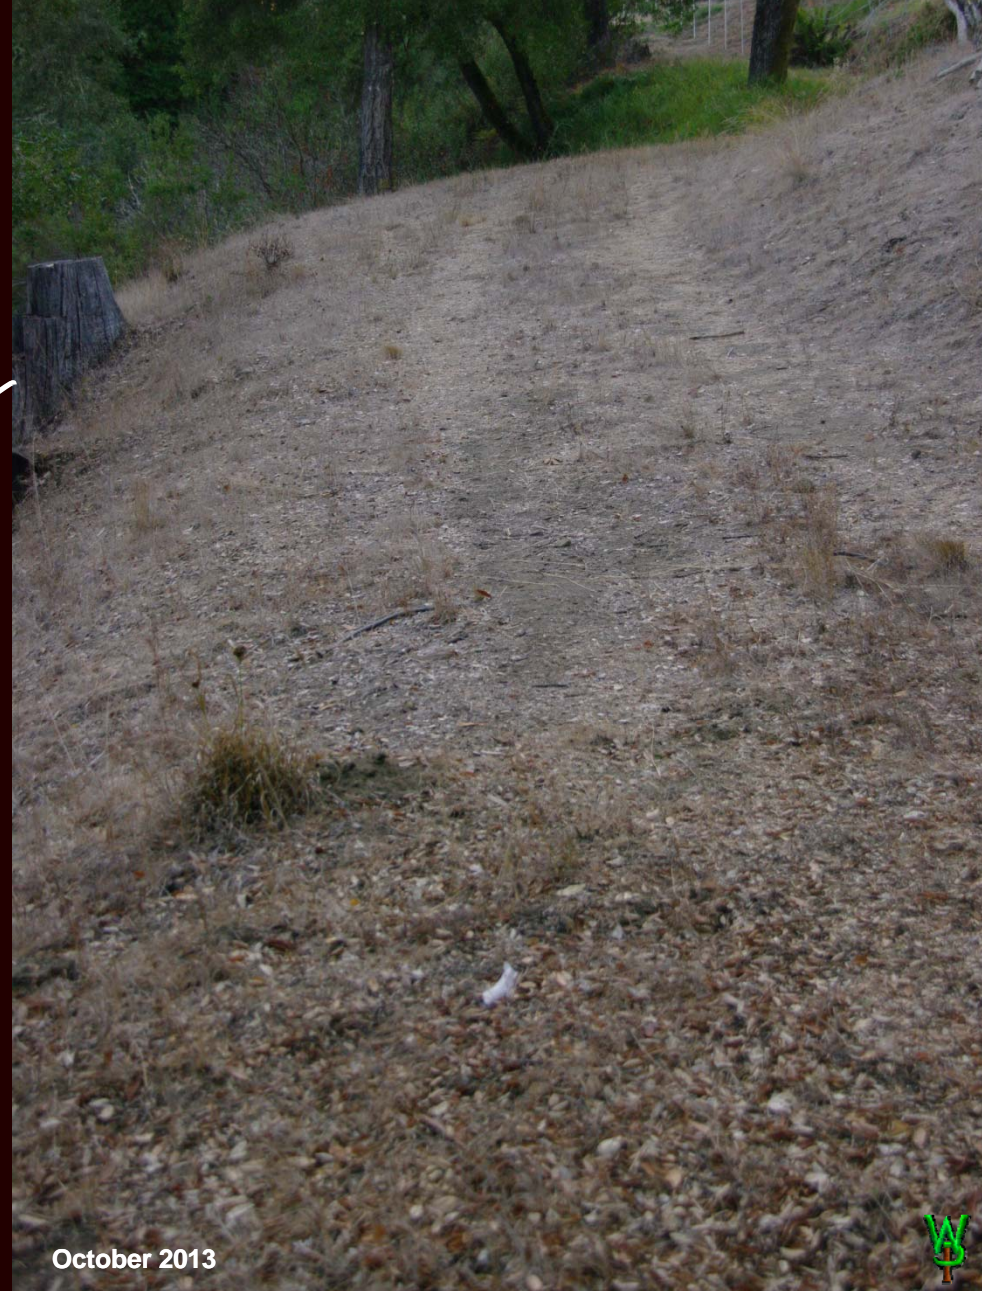
This road on my place was reshaped in 2006. It is typical of the design for timber haul roads today. This section of the road is out-sloped, wide, and maintenance free. This kind of road is particularly resistant to gopher damage, because there is not enough water at any one point to enter a hole and turn it into a trench. So, why don't I do it elsewhere? I don't have the fill material I need, yet.

“Strategically placed
branches” direct flow
over this stump hump

This road is the backup drainage for a flat that occasionally spills off one end. The ridge has impossibly steep sidewalls; so there is really no good place to drop the water off to the sides. So what I did is run the water down the spine while slowing and retaining it with strategically placed branches, losing altitude until the grade into the channel was much more gradual. The presumption is that the ridges are of harder material than the gullies (that may not be true). Still, the propensity for a convex surface is to break up the flow into smaller and more chaotic flows, thus reducing surface wear. The branches last about 15 years.

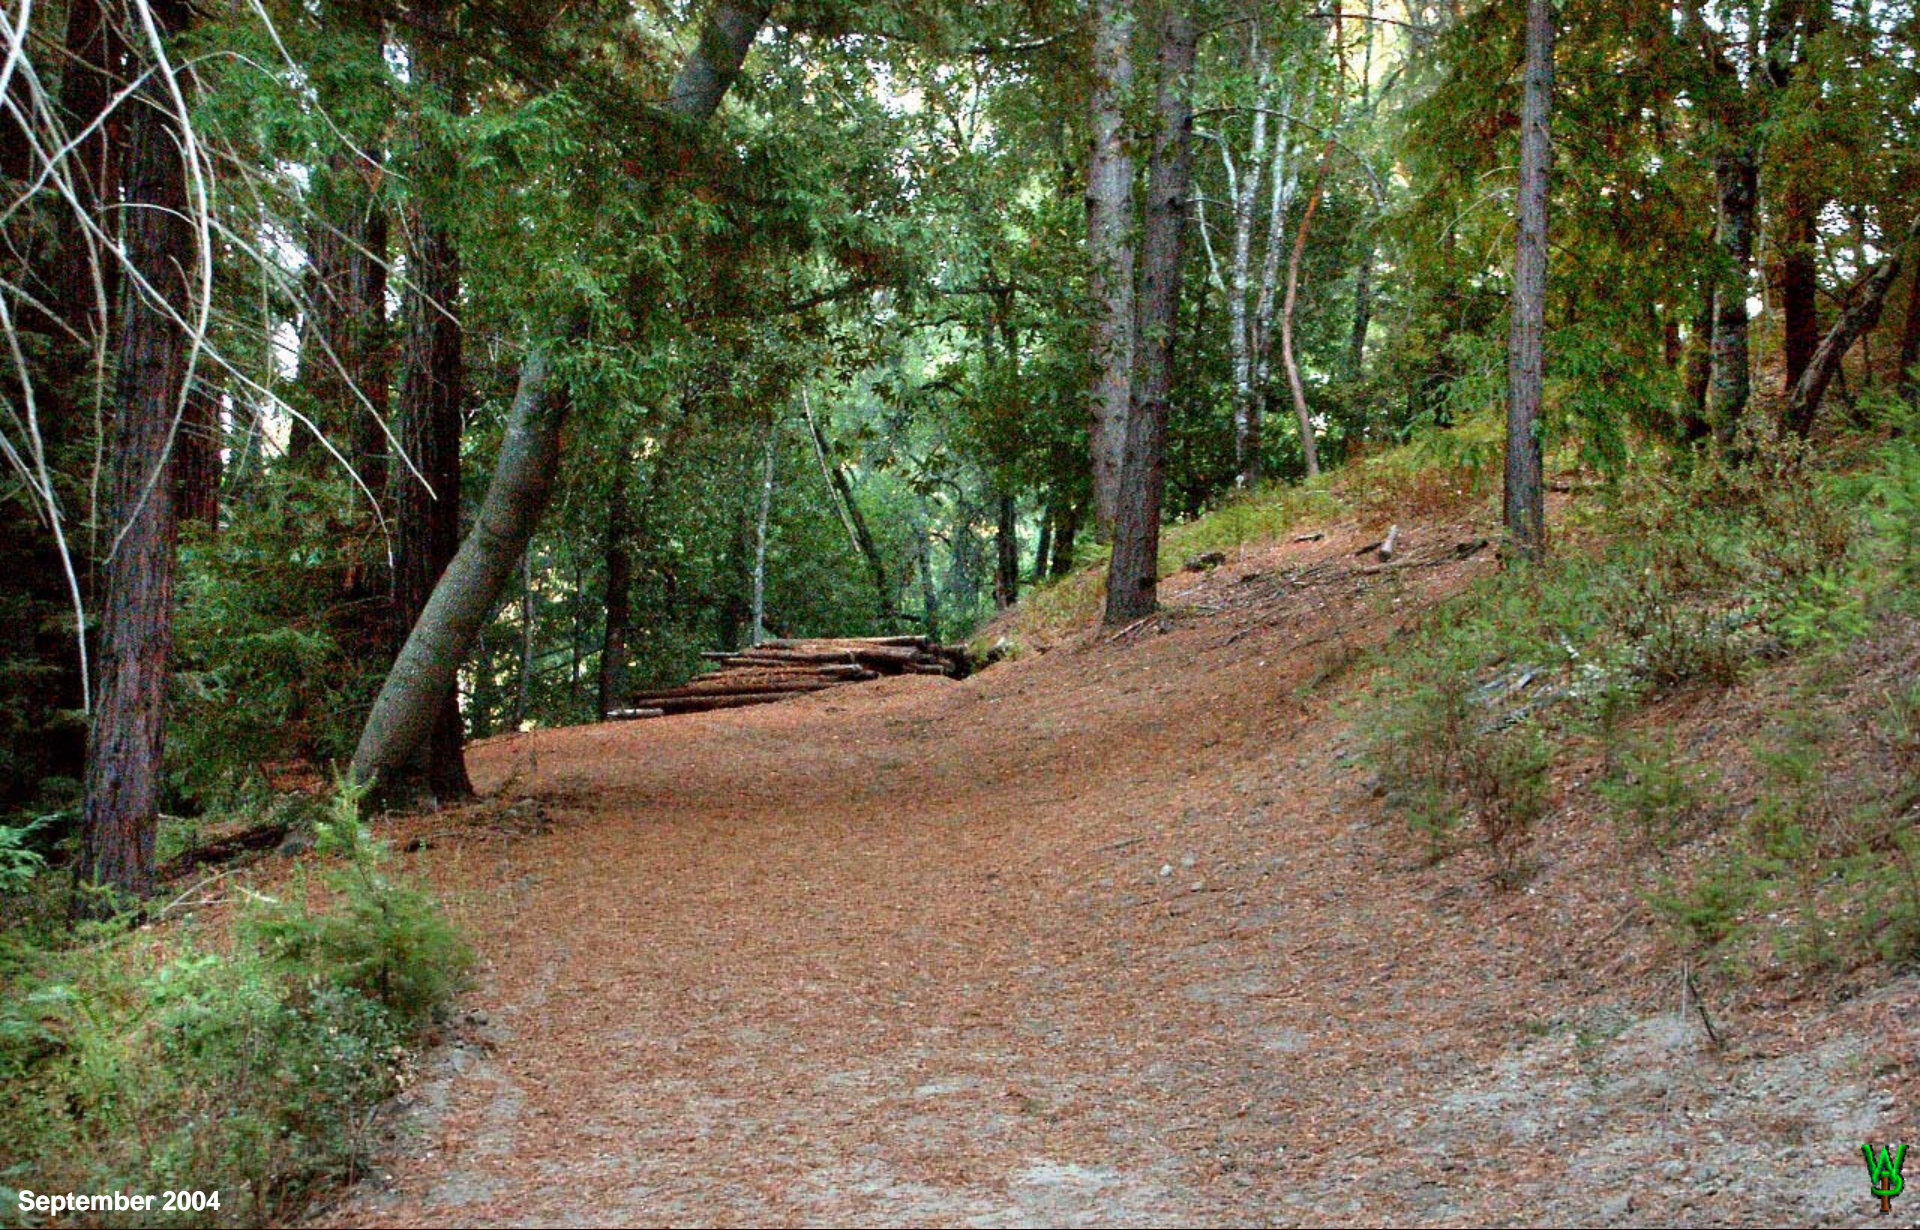
September 2004

This old road was re-graded to get equipment in and material out for forest thinning or brush and weed control. To that end, I changed the grade from an in-sloped to an out- sloped drainage configuration, thus eliminating the need for culverts. It has worked beautifully to reduce the flow in the channel below, and has required no maintenance at all other than weeding. The two fir trees on the right are there to be gin-poles for purpose of high-lead yarding redwood logs out of the stand. The deck of skinny logs at the end of the road are for future corral posts or a pole barn should the need arise. I can't sell them to anyone with a better use.

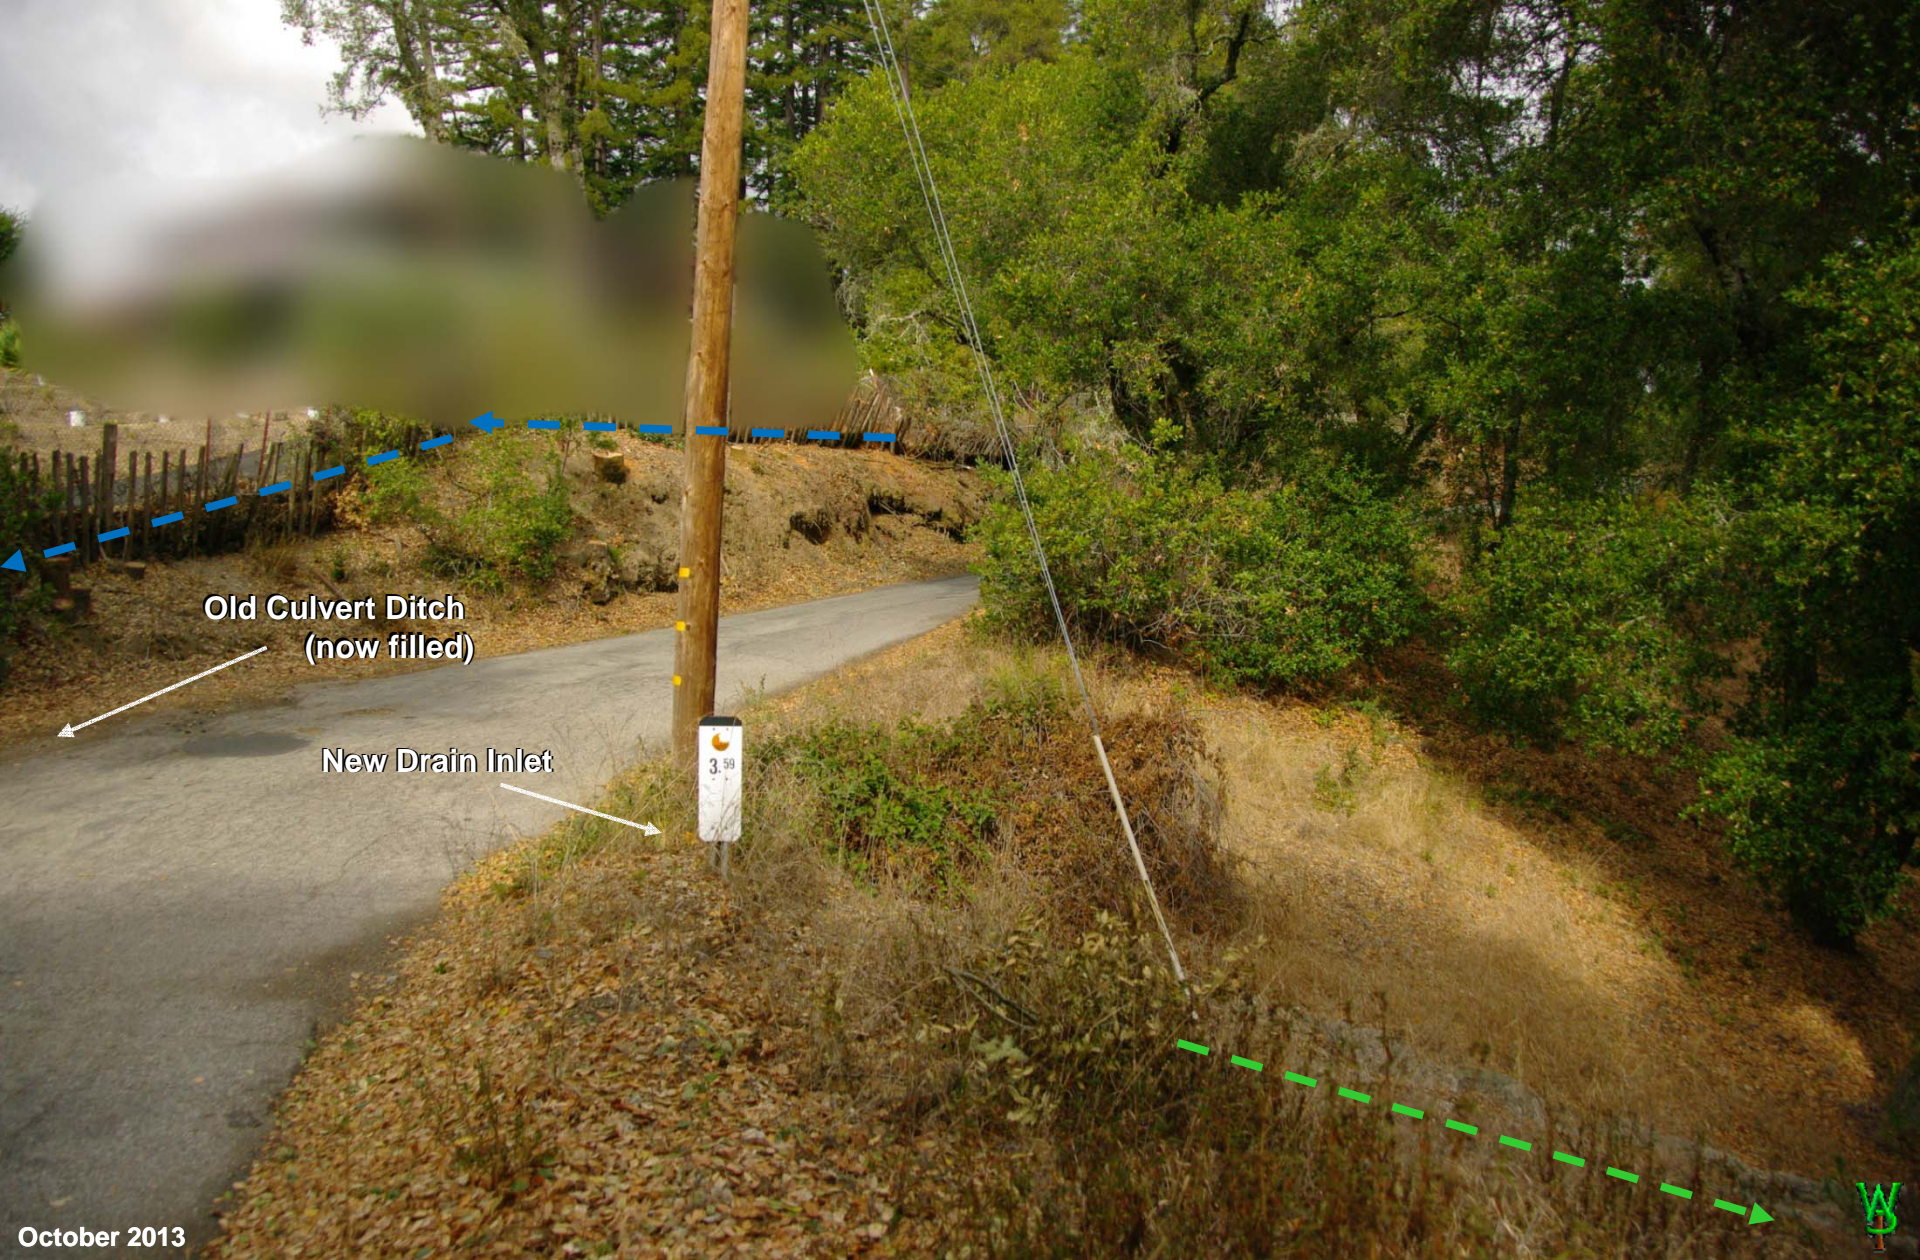
October 2013

Old Culvert Ditch
(now filled)

New Drain Inlet

Above and behind the fence, there is a curb (blue line) at the lower edge of the driveway to protect the near-vertical embankment of fill upon which it is sitting, now undermined by County ditch cleaning. The curb and the road collect over an acre of rainwater runoff and concentrate it here at the corner. Here, the grade of the road used to tilt to the side opposite where there was a culvert. When the culvert plugged, the water went down the embankment on the right and washed the soil away. I know, you see soil here. I fixed it.

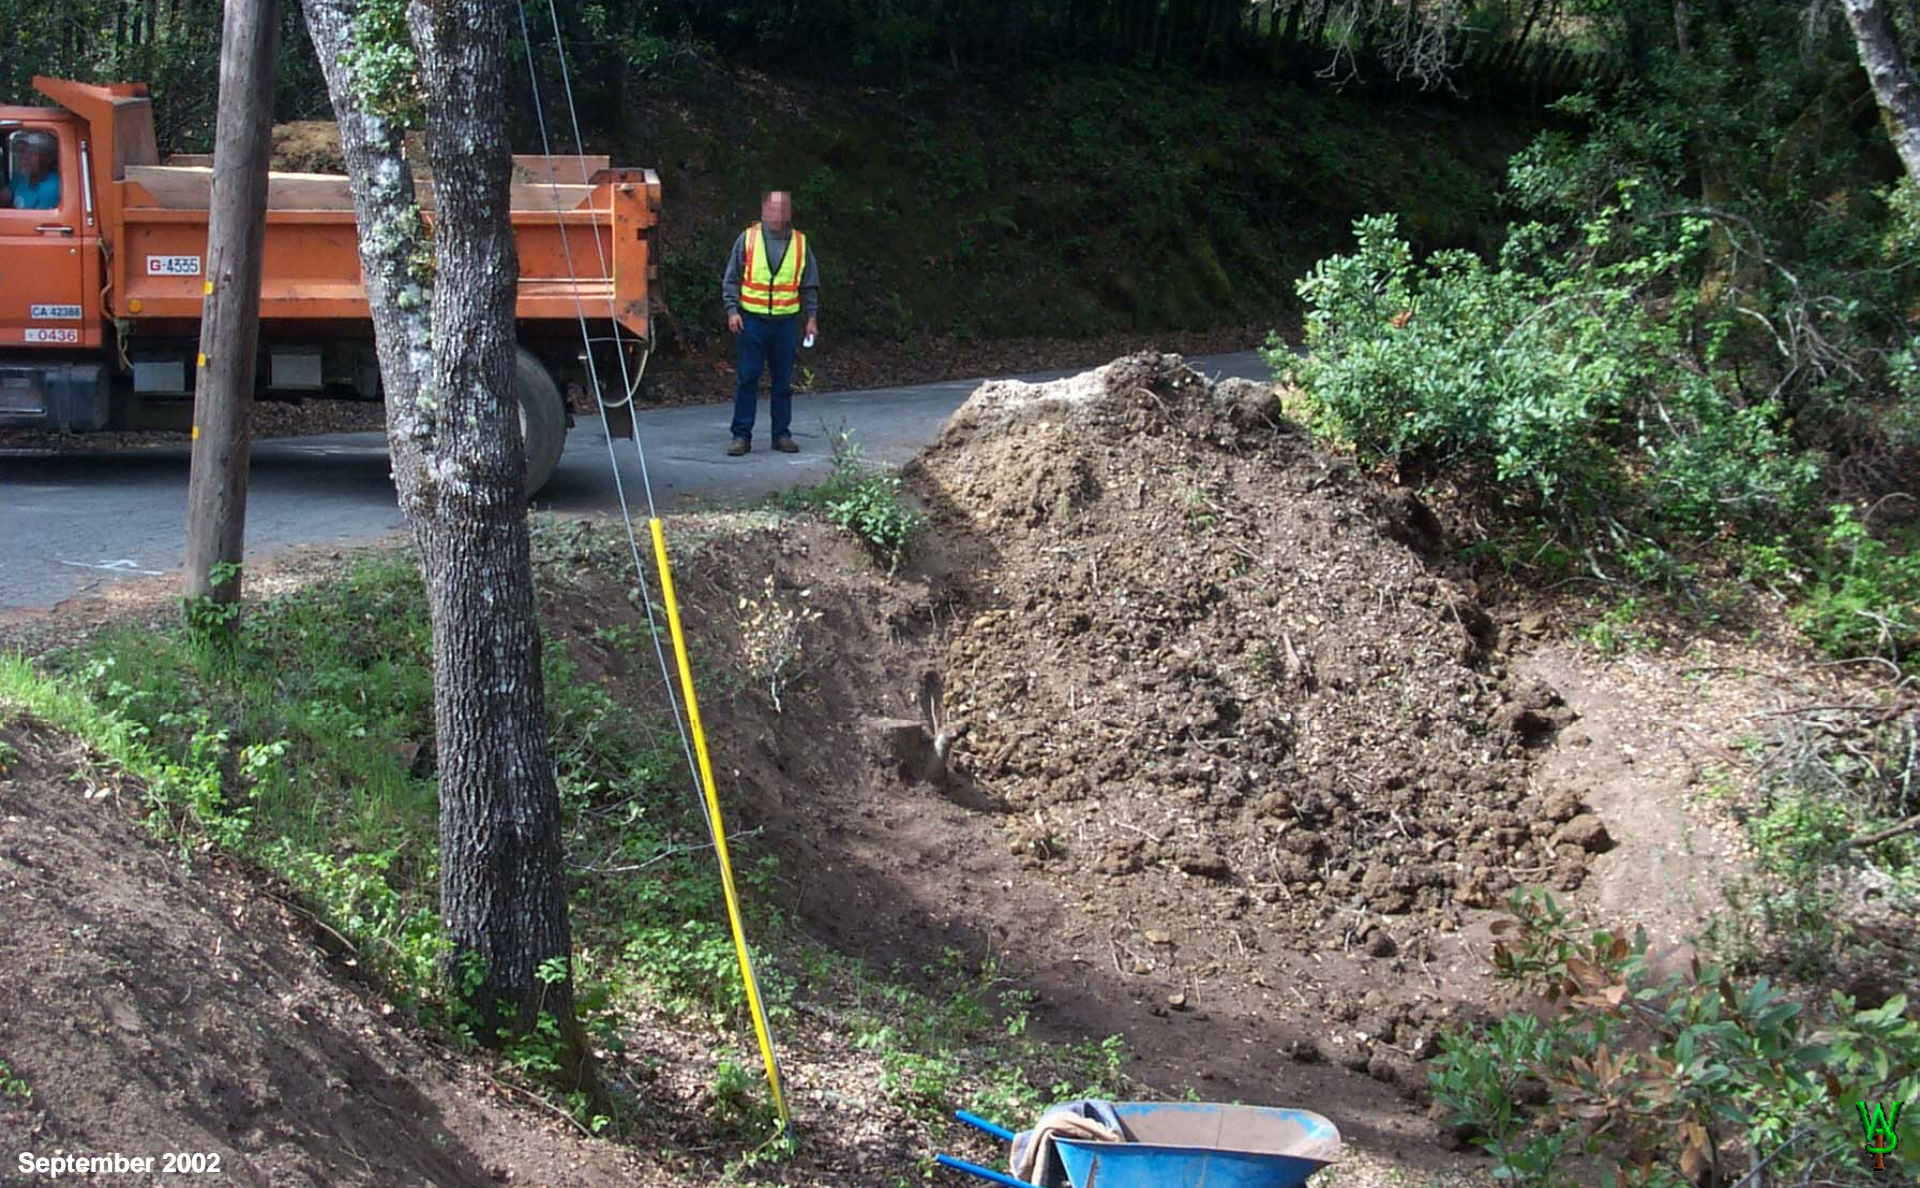
September 2002

I cleared the vegetation (the tree went that day). The County dumped in ditch cleanings as fill. I had it packed and shaped. I rocked in the old culvert ditch on the opposite side. The County paved it next time they came in with a patch crew, making a spot where cars could pass each other at the corner. I got free fill dirt to repair the damage the culvert had done; they saved money on trucking dirt and reinforcing the road. Everybody wins, right? Well, the lawyers have made such a project impossible now. No, this is not as good as “engineered fill.” It is not as good as digging it all out and compacting it to specification. It has settled a little, which was expected. I have a supply of material nearby with which to fill those few spots that will need it. Slowly it will stabilize and for far less money.

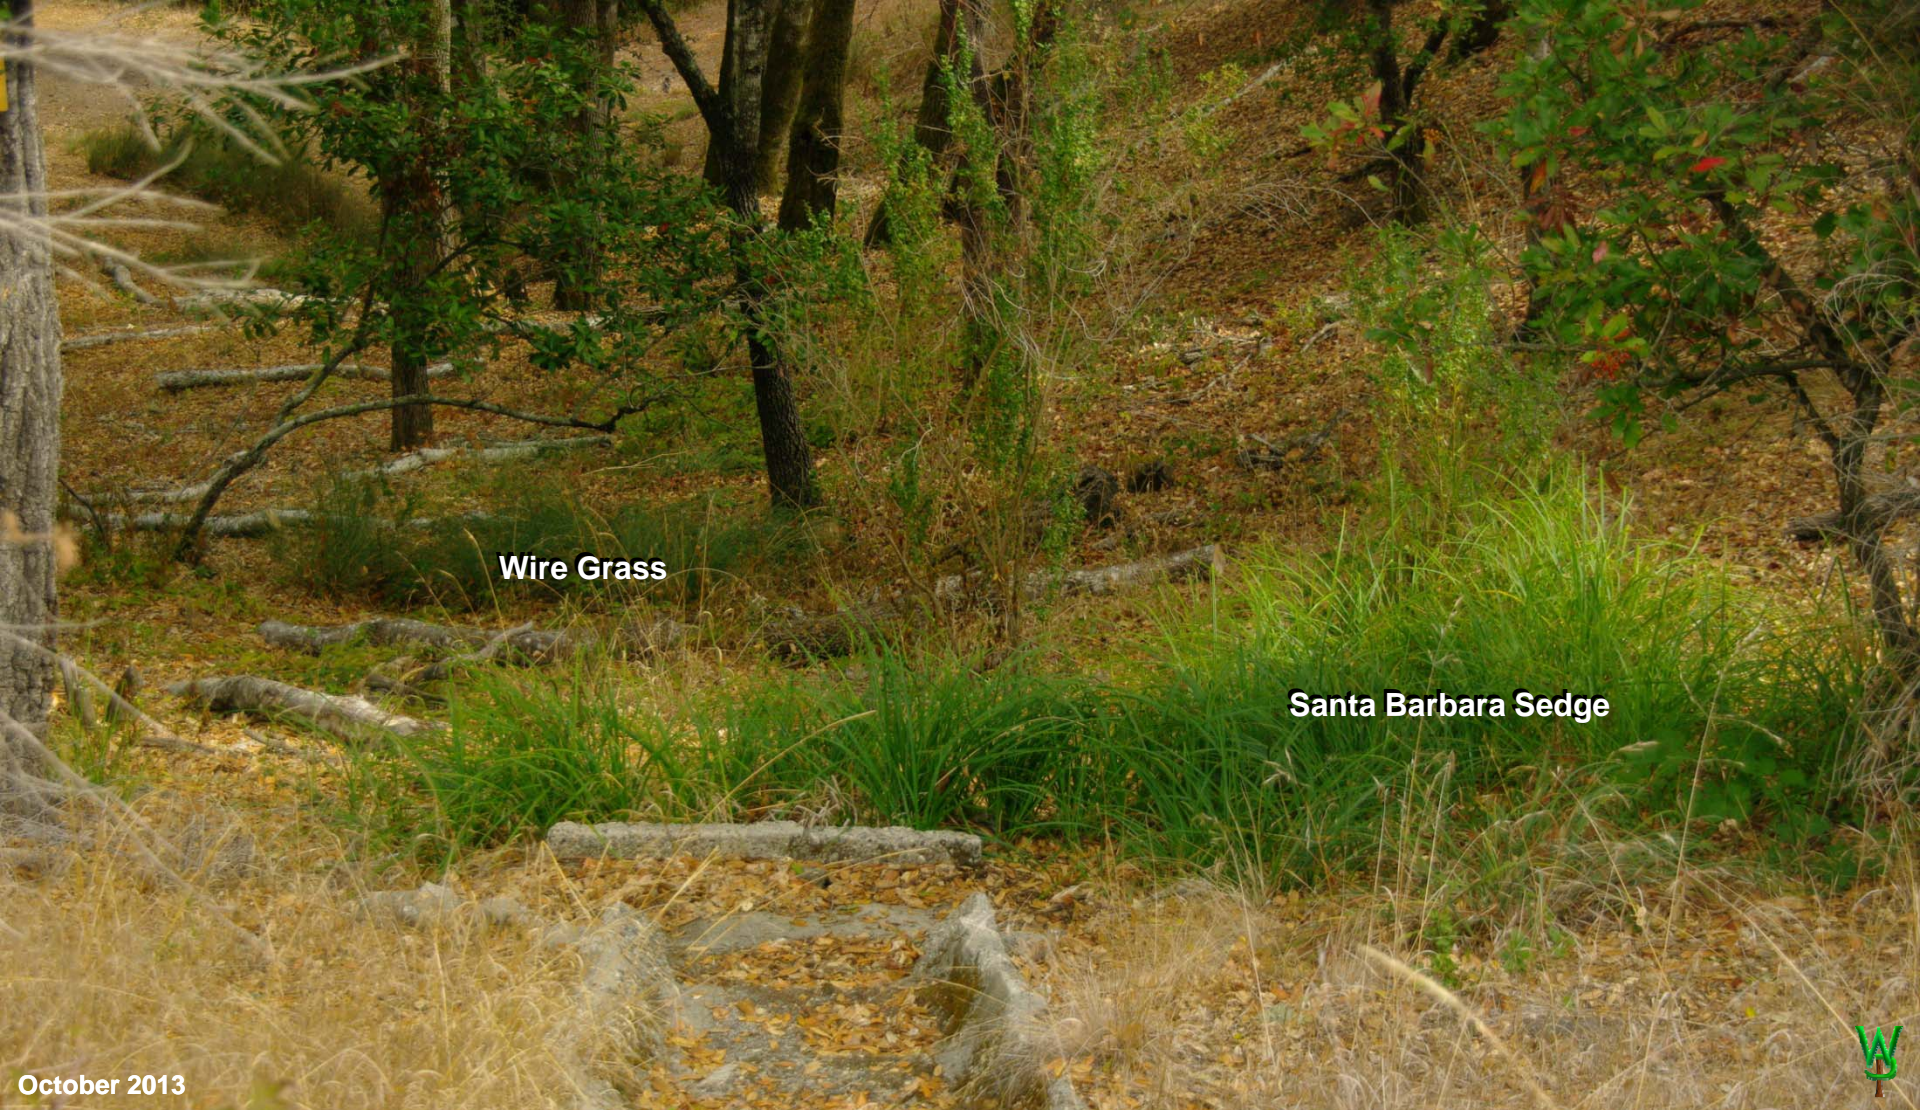
October 2013

Wire Grass

Santa Barbara Sedge

I transplanted our friend Santa Barbara sedge (*Carex barbarae*) at the outlet to dissipate the energy. Below it, wood steers the separated flows to minimize incision. Below that is another tough riparian plant, wire grass (*Juncus patens* - not really a grass but a rush). The functional difference between the rush and the sedge is that the wire grass is better at collecting sediment but does not lay down flat under water flow like the sedge does. It also grows in clumps, not making as continuous a surface as the sedge. I hope to have a lot more coverage in this drainage now that I thinned it this year, with more to come in the winter of 2013 (I'll probably get rid of the coyote brush). The channel that once ran down the middle of this drainage below was then three to four feet deep. I chocked that with wood and filled it. So with rot and compaction I may yet need to bring in a little more fill and transplant more sedges. Yes, I did all this work to deal with a runoff problem caused by my neighbor and the County long ago. It's cheaper than fighting over it.

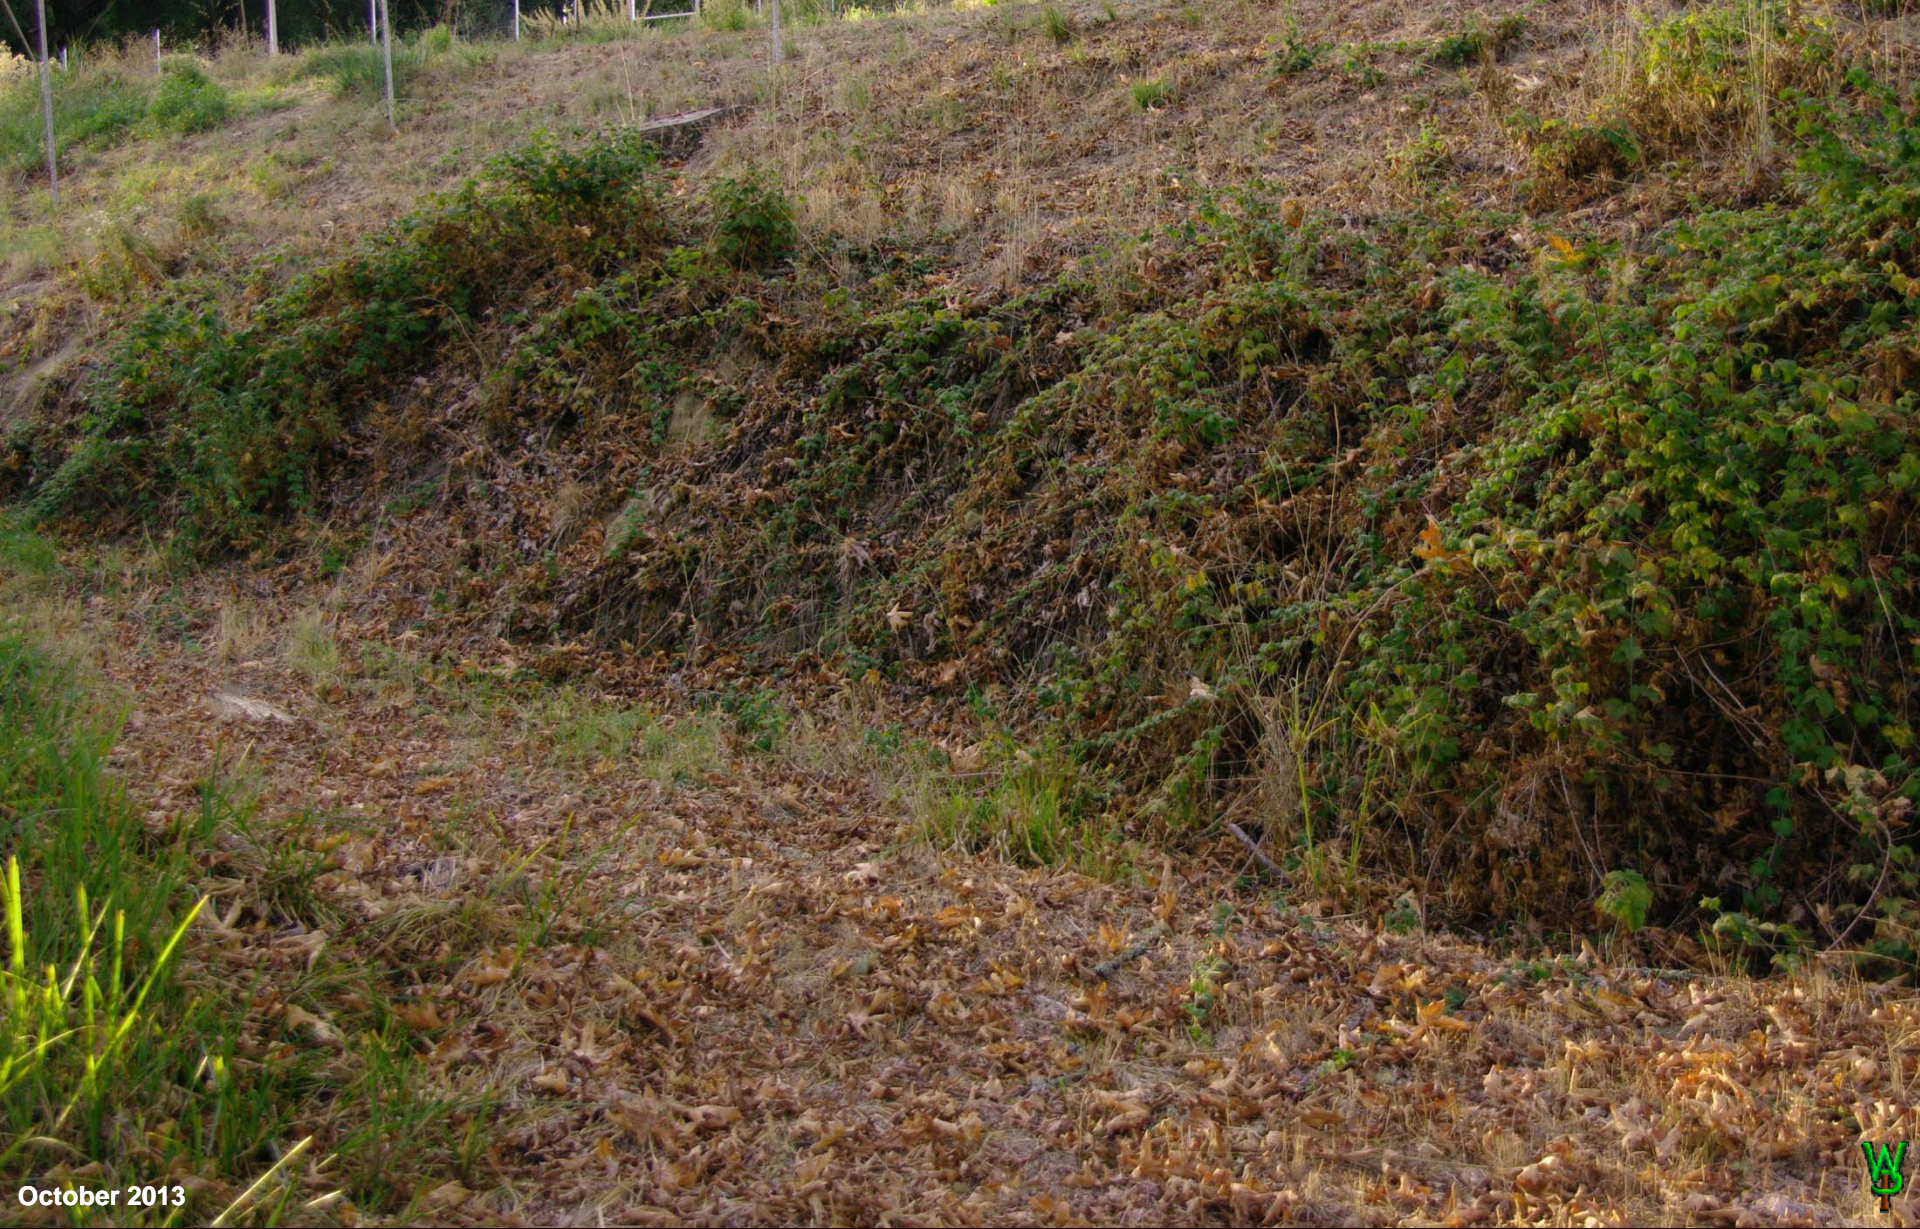
October 2013

But are all my roads perfect? No! There are some that could be better, particularly in how they collect water. The problem with this culvert is that the east facing slope on the northern half of this place (down to the left) is so steep, there is no good place to run the water down it. Sometimes you have to make one, as we did in the case of the rock drainages you have seen. That just takes time and money to get done. I've done one channel every several years with the one below here left to do. Hopefully I will have the situation corrected within my lifetime. In any case, this one gets its ditch cleaned and a bigger water-bar as soon as I get to...

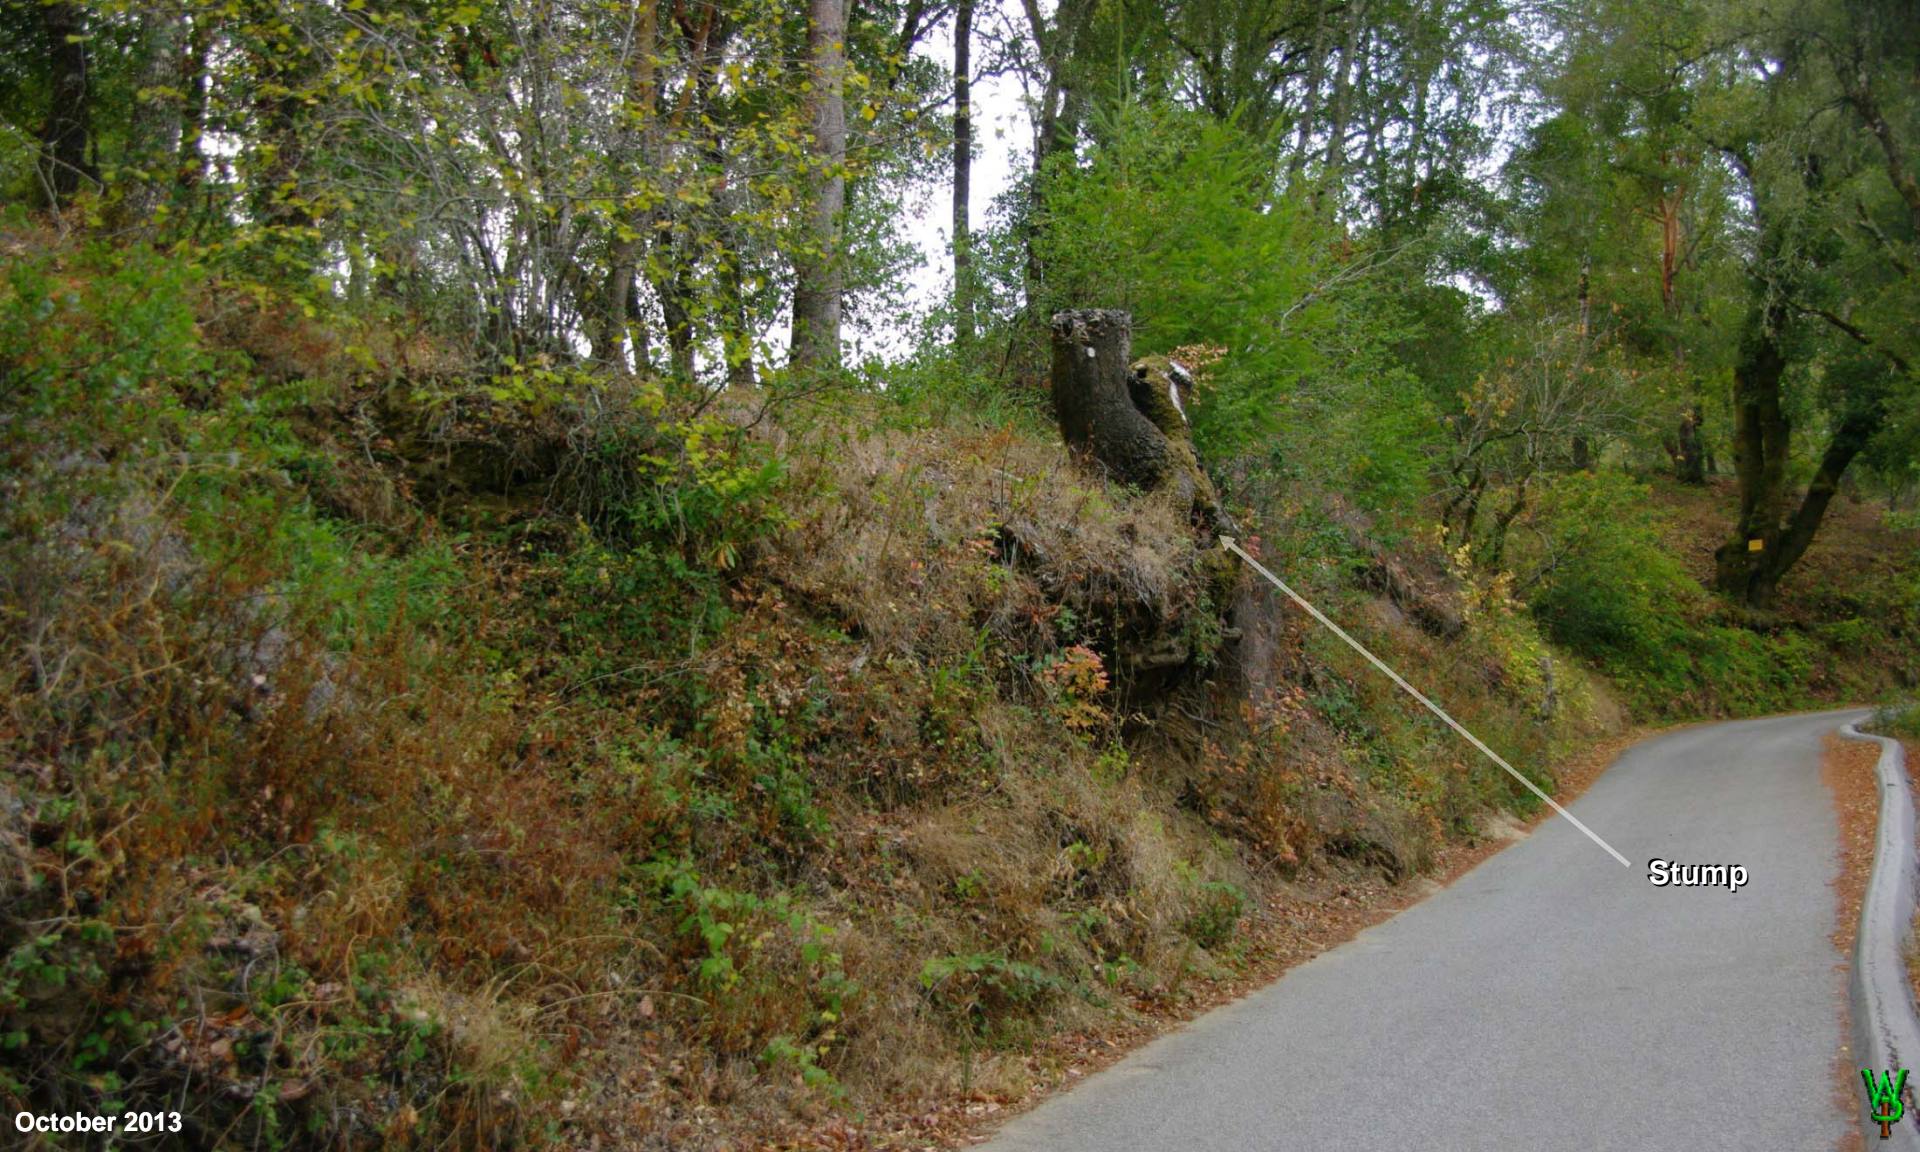
October 2013

Stump

...this. This is a different type of problem, one that is **going** to happen, since made more complex by lawyers. The original problem is the stump. Although I removed the weight of the tree, it was doomed to slide. However, it slid a LOT sooner because the County cleans the ditches (since filled with sluff) to keep the water off the pavement. Ditch cleaning undermined the slope by digging the blade into the hillside and allowed water to seep *under* the pavement, thus making it crack. The County lawyers have spoken: 'There shall be no water on pavement,' because they don't want to be sued. The problem with that "logic" is that anybody stupid enough to drive fast enough to hydroplane on this single-lane, treacherous, windy road deserves what they will get. The ditch fills within a couple of months anyway, and the water runs on the pavement anyway. What to do?

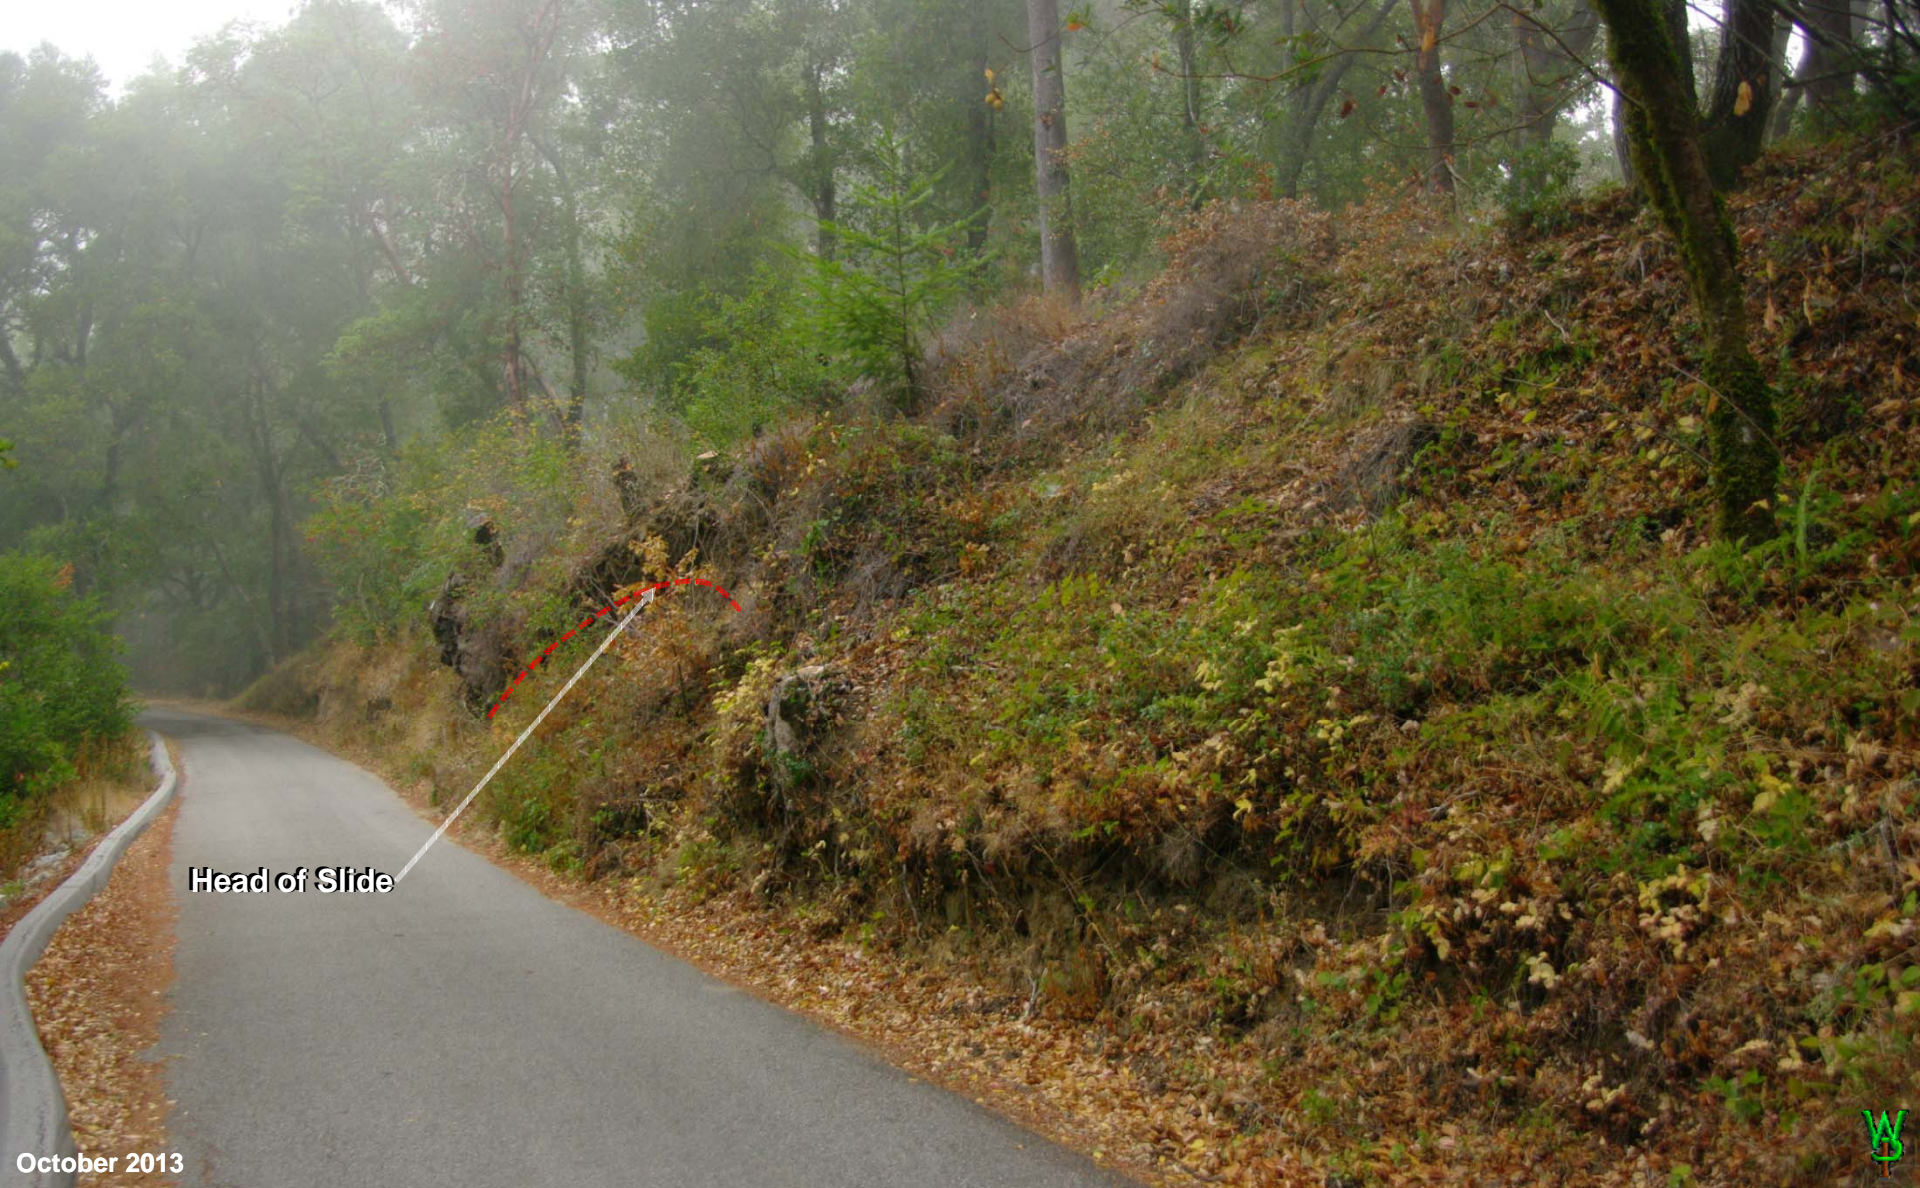
October 2013

Head of Slide

Here is a view from the other side. As the stump slid, the roots tangled with other stumps started to pull the top off the whole slope. The reason I am making a point of this is that the customary landowner practice is to wait for a storm and allow the stump to fall and block the road. Then the County comes along (after dealing with probably bigger problems elsewhere) and cleans it up for free. Then they hydro-seed the whole slope with exotic grasses and hope it doesn't fail. I can't let that happen. So the Department of Public Works gave me a permit (free) to get rid of this mess. I'll reslope the whole bank and you will get to see a revegetation project like no one has ever seen. After all, innovative process development using native plants is what this place is all about. We'll see if it works.
