ROADS TO HEAVEN, TO HELL, AND BACK, SOMEWHAT

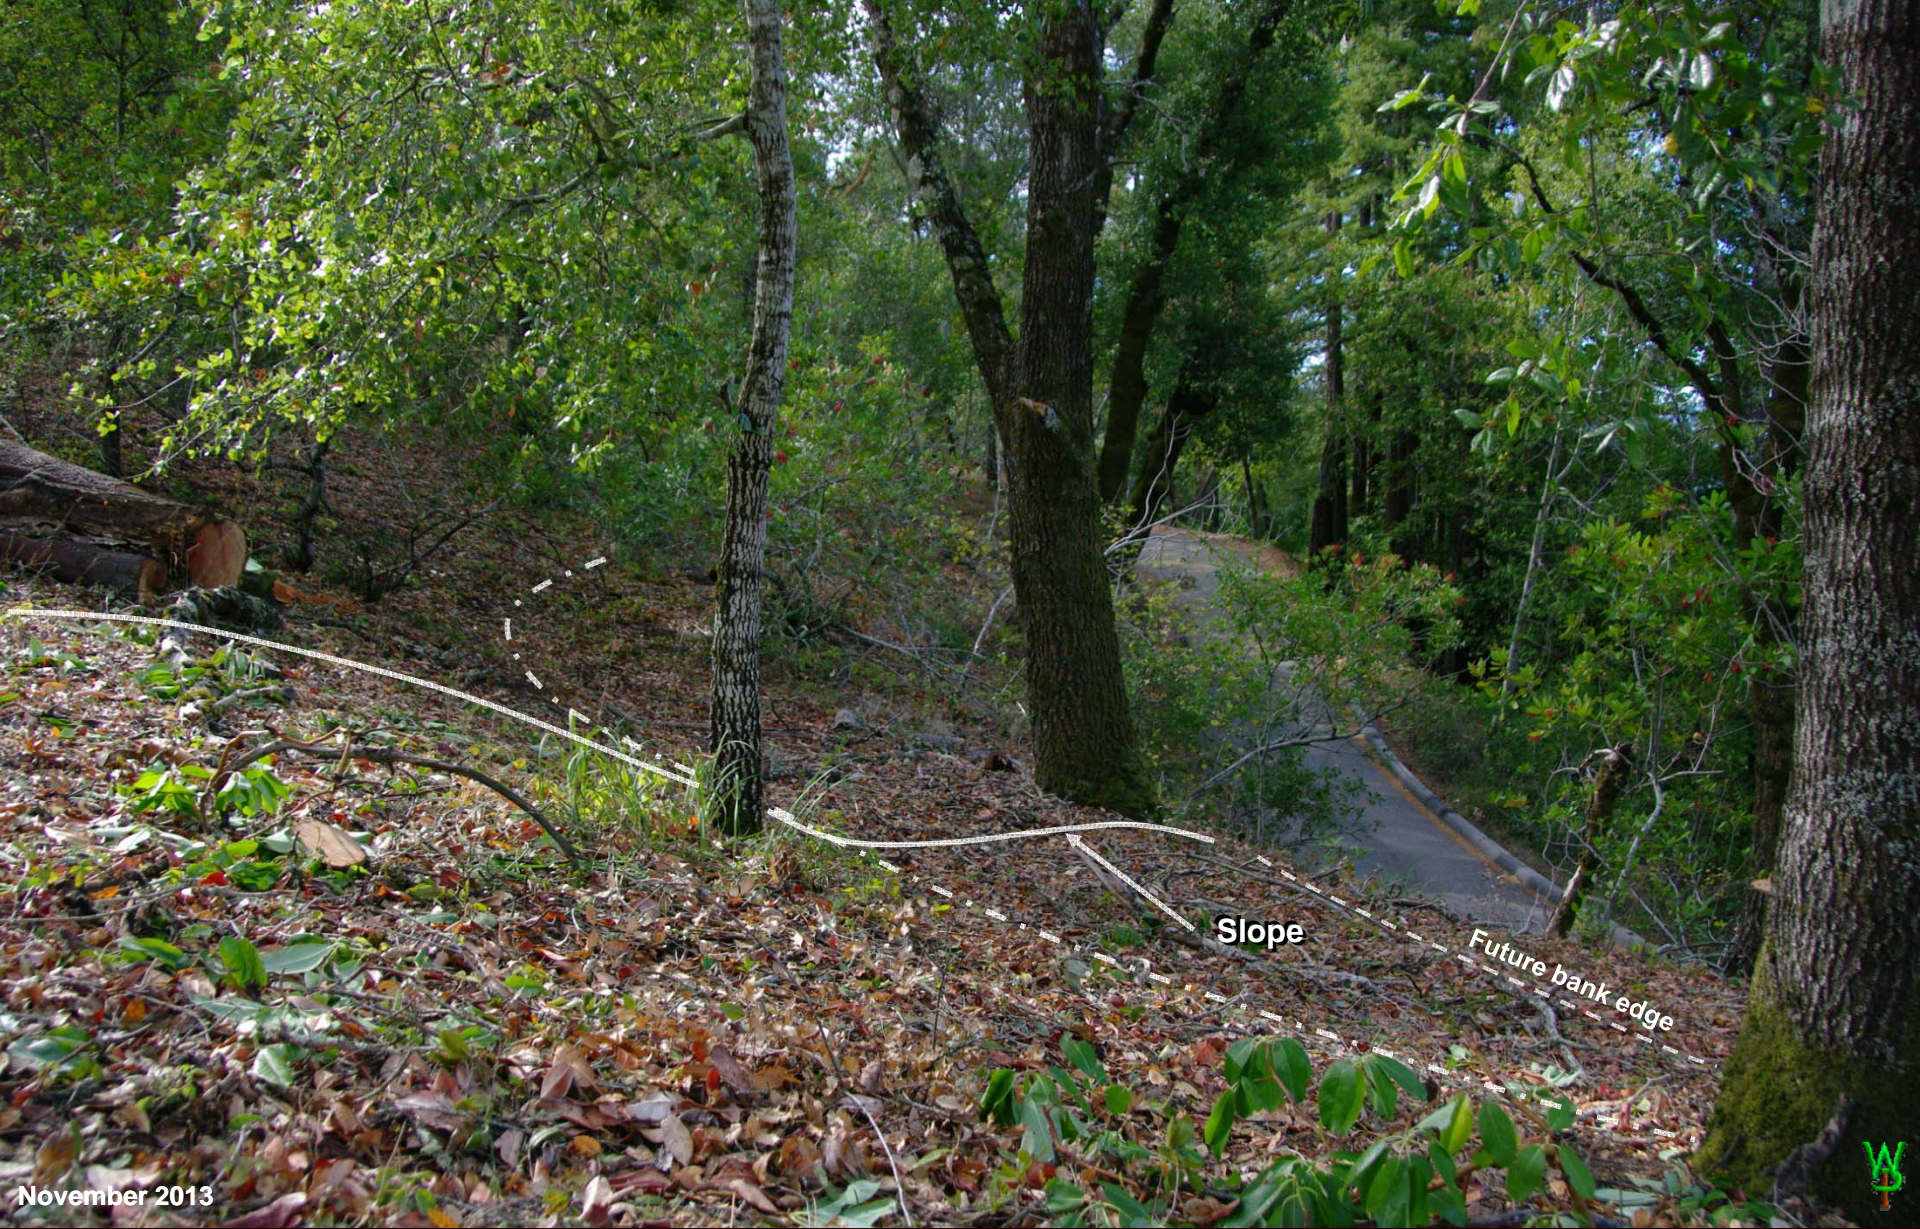
November 2013

Here we are just south and above what will be the beginning of where I will be cutting into the slope to reshape it. The track is about six to eight feet wide, too narrow for a car, or even most wagons. Even without Mr. McKiernan's road below, the original slope would never have been level across it as it is here. It is almost as if this was an even older road, one made long ago, except that the only "older road" made before Charley McKiernan built his toll road in the 1850s, was the path made by the Indians of Mission Santa Clara for the Spanish in August of 1791.

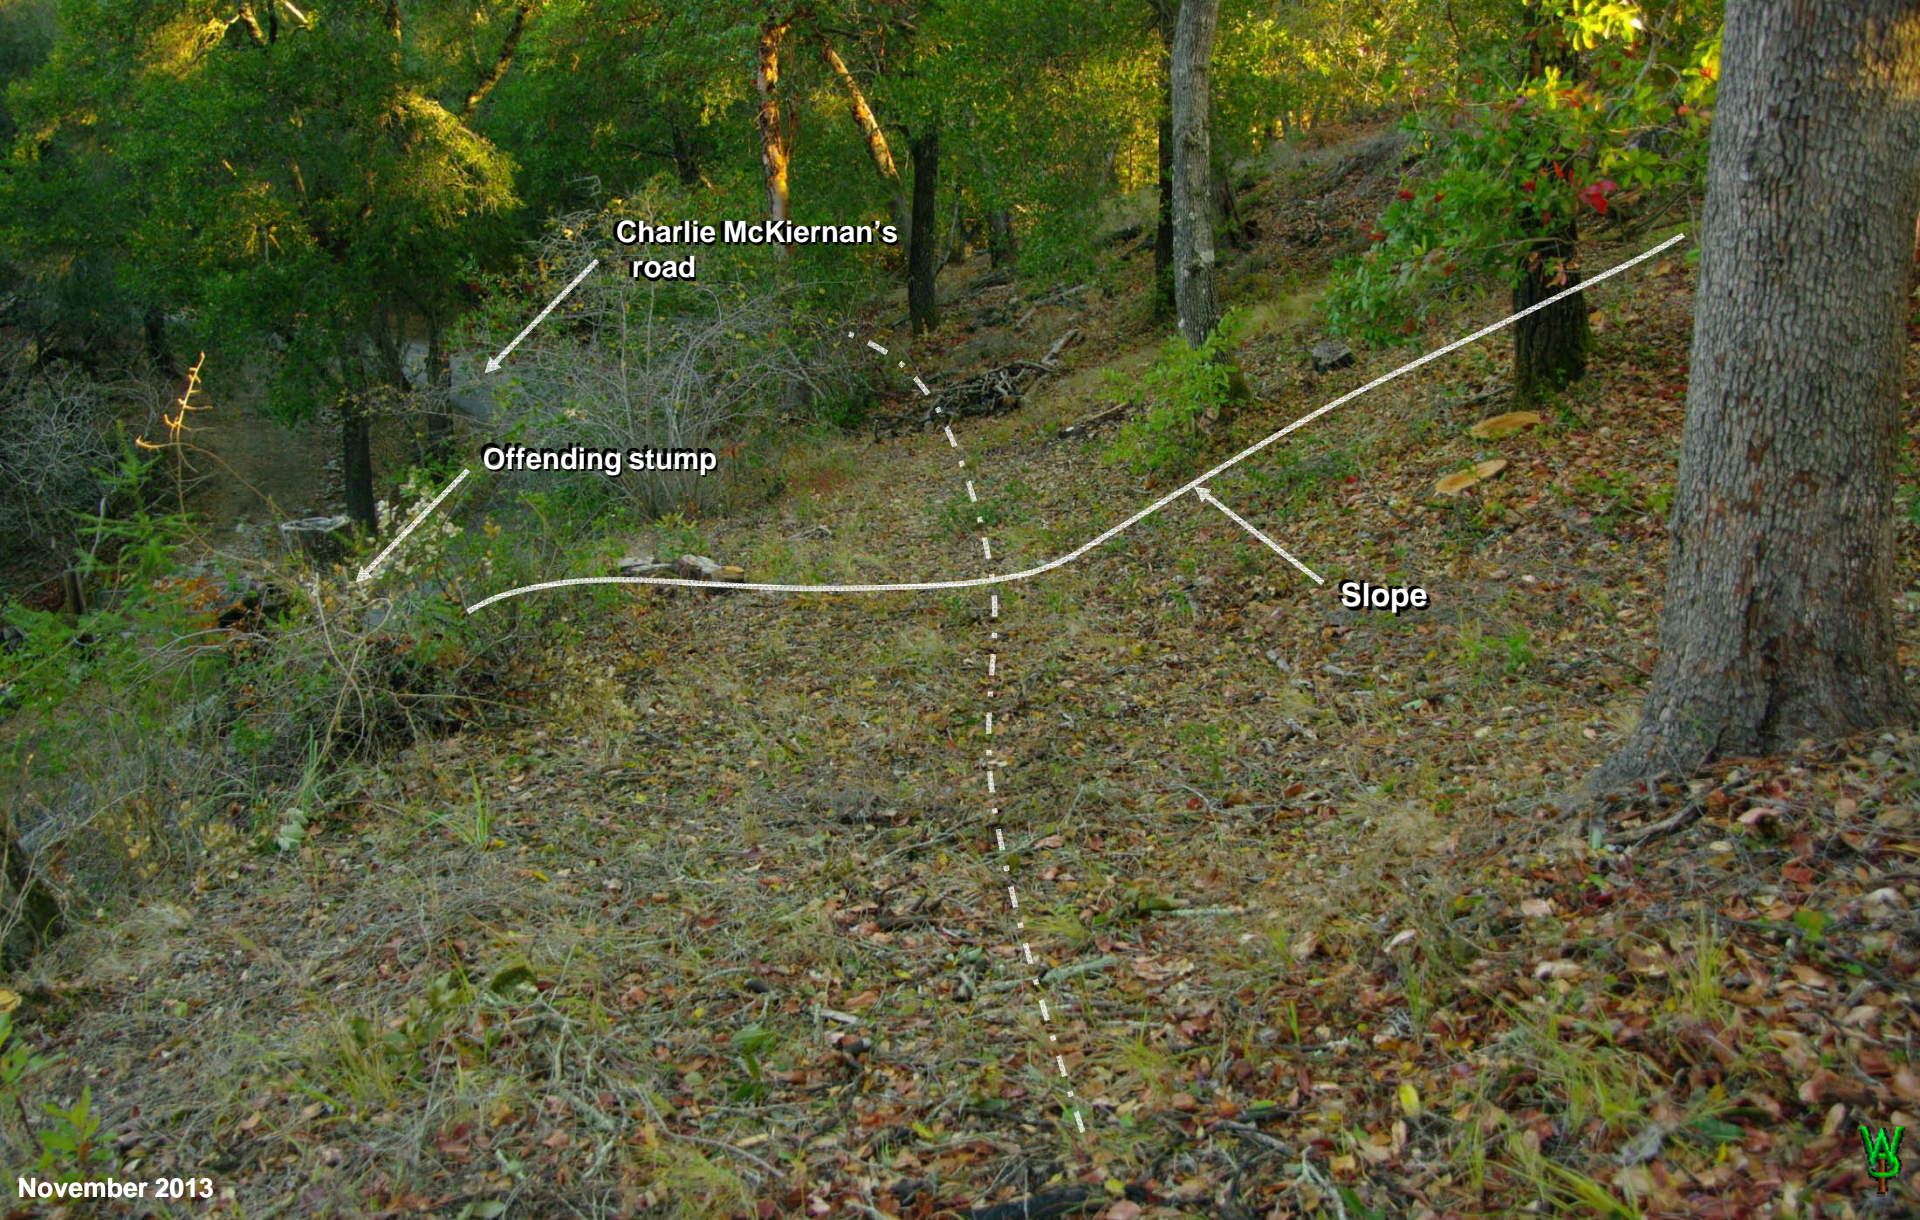
November 2013

Charlie McKiernan's
road

Offending stump

Slope

Accordingly, it seems likely that this may indeed be that old Spanish track. Unfortunately, the repair to reslope this overhanging embankment will remove just about all of the old road. What to do? Get the permit, document it for the archaeological record, check it with a metal detector, scrape off the surface to stockpile native grasses and save the topsoil for the revegetation job, and fix it. It is saddening to take out this likely vestige of the mission era, and it does cause one to ponder what the Indians had to do to build it or how the land might have looked to the Spanish when they passed by this very spot 200 years ago, but it's just how things have to be.
